**BORDER TO GOWRIE** REVISED DRAFT ENVIRONMENTAL IMPACT STATEMENT

## Geomorphology Report

## Baseline field inspection site records and photos

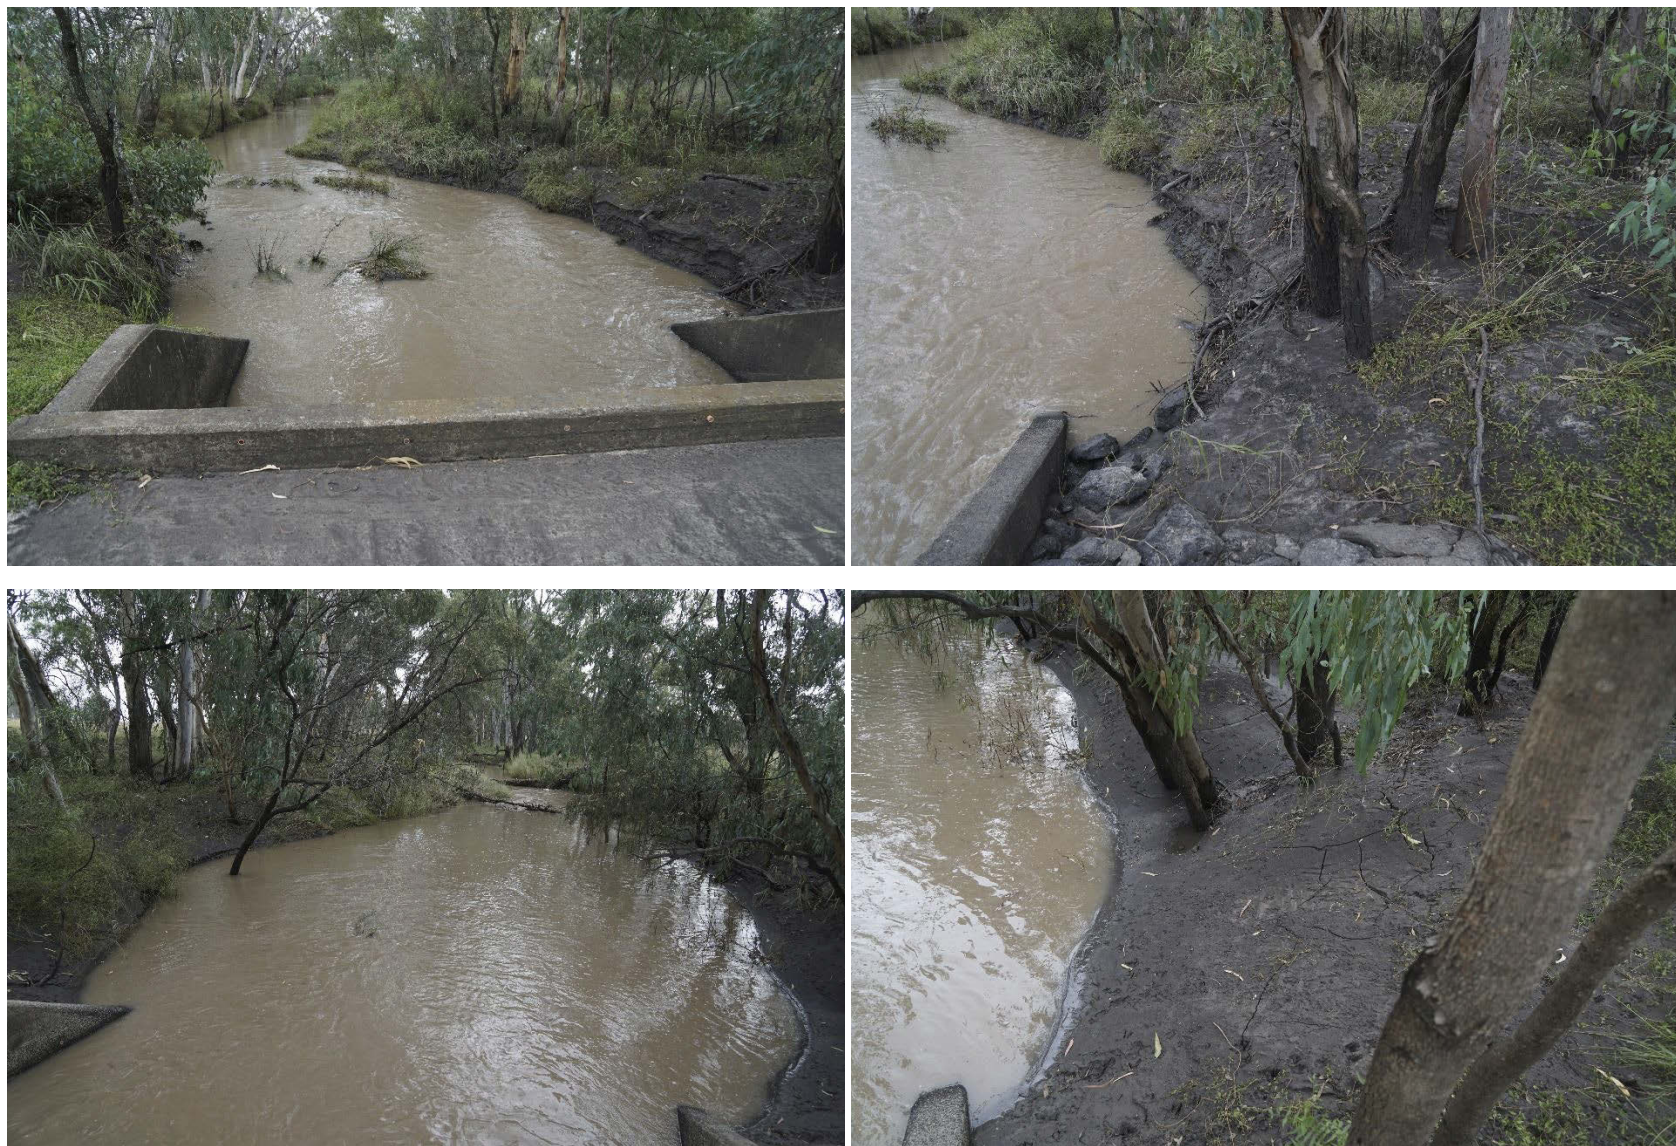
| Coordinates | | | | | | | | | Erosion Potential (sites with existing infrastructure) | | Channel | | | | | Material | | Floodplain | | | |
|---|---|---|---|---|---|---|---|---|---|---|---|---|---|---|---|---|---|---|---|---|---|
| EP1a | EP | Local- poorly developed channel | | Gowrie Creek | vertosols | ferrosols | 386118 | 6958498 | Rail bridge, retaining wall on right bank | Erosion on both banks, erosion and failure behind retaining wall. Deposition of silty sand material on inside of bends. Localised gravel dropout on inside of bend downstream of bridge on right | Meandering | Channel approx. 10-15m wide. Main channel 1.5-3m deep (from top of water level). Steep/subvertical banks. Approx. 5-6m from water level to underside of bridge. | In channel bars. | Grass on banks | Bank erosion downstream of bridge. Silty fine overbank deposits on both bends. | Silt/sand with minor gravels | Dark, silt/clay. Some ~400mm diameter boulders in grass on left bank deposited. | NA | NA | NA | Indications of water flow to approx. 0.5m below underside of rail bridge (flattened grass). |

F. 1 Site 1a photographs. Upstream (top left), upstream detail (top right), downstream (bottom left), downstream detail (bottom right).

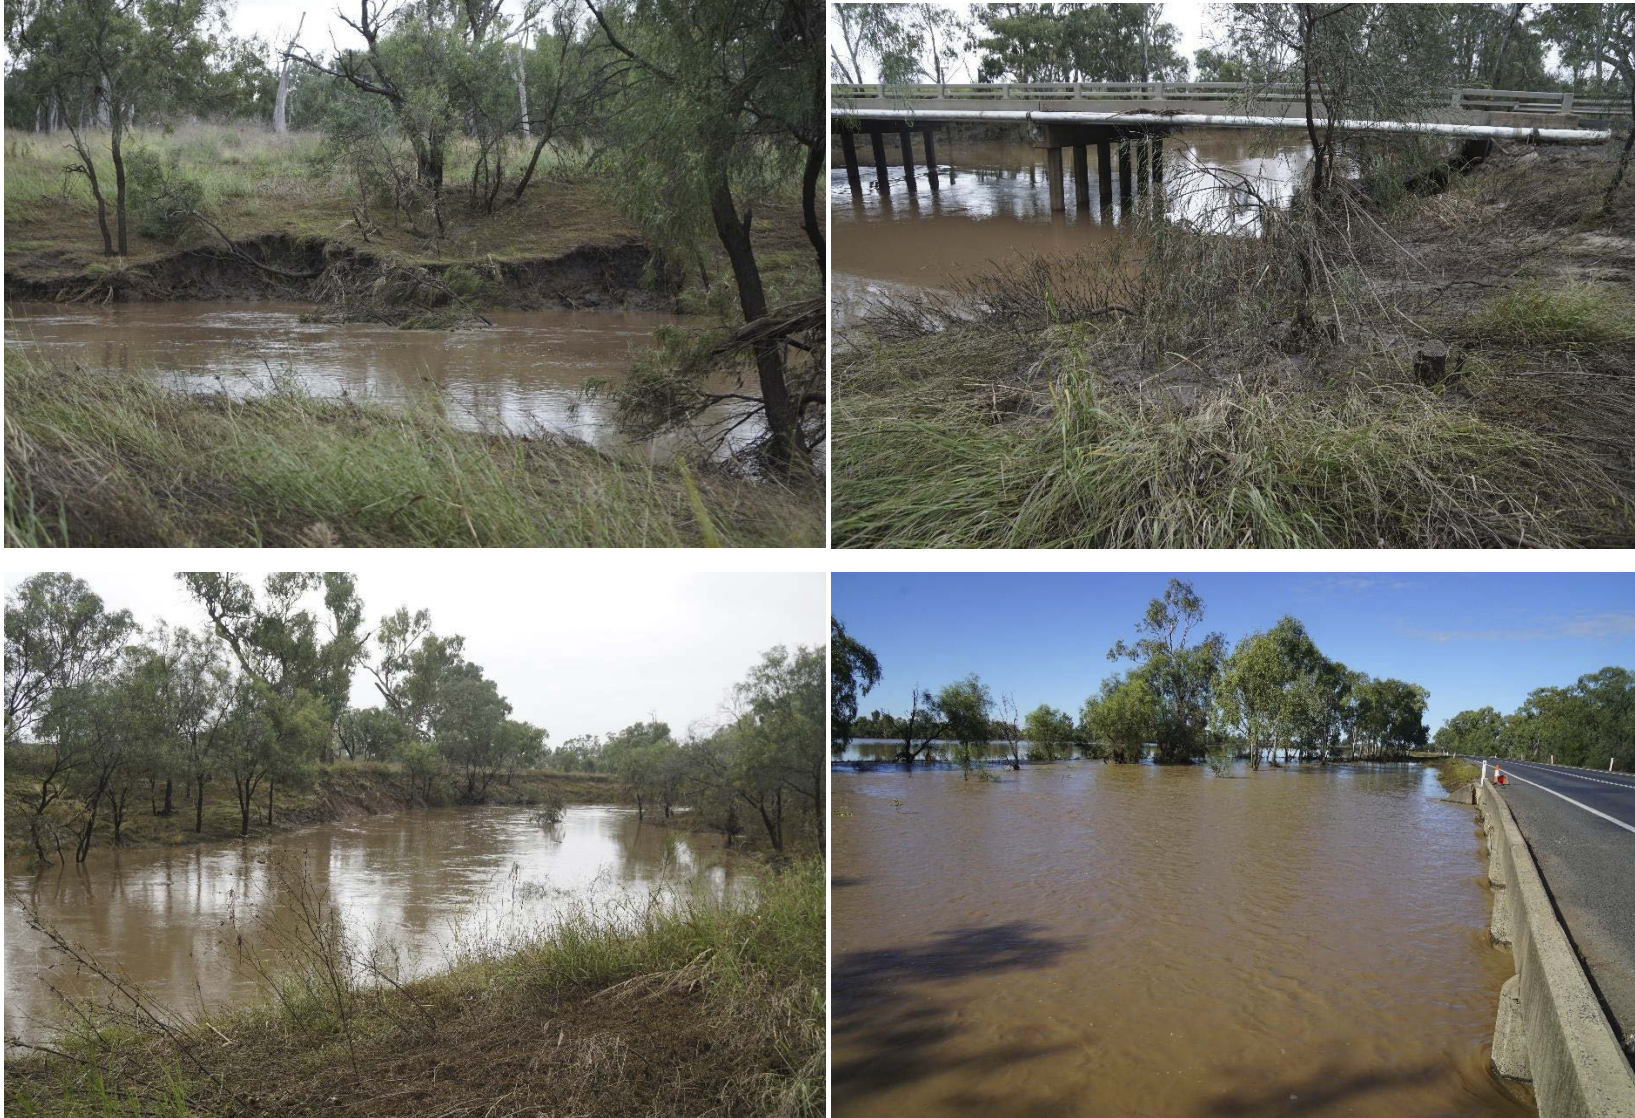
| Coordinates | | | | | | | | | Erosion Potential (sites with existing infrastructure) | | Channel | | | | | Material | | Floodplain | | | |
|---|---|---|---|---|---|---|---|---|---|---|---|---|---|---|---|---|---|---|---|---|---|
| 1d/ EP16 | Both | Main stem | C2 | Condamine River | vertosols | no data | 338742 | 6922932 | Multiple culverts and bridge along 200m stretch of road. Bridge ~35m span. Water flowing through under road at two main box culverts. Culvert site 1 is approx. 40m south of bridge, small wing walls, span approx. 8m. Culvert 2 site approx. 100m south of bridge. Span approx. 22m. One more culvert site approx. 50m downstream from culvert 2. Similar size and style to culvert 1. | Scour leading to bank failures approx. 20-30 m long both upstream and downstream of the bridge, channel appears narrower upstream of bridge. | Meandering | Banks are 35-45 degrees close to bridge, becoming less steep further away. Banks approx. 4m tall. | Failure in right bank on outside of slight left bend approx. 100m up river from bridge. Failure is full height of bank, approx. 20-30m long. Downstream on right bank, outside of slight bend, 40-50m from bridge 3 bank failures observed 7-15m long, subvertical backscarp, scalloped failure. | | Erosion occurring on bends both upstream and downstream of bridge, deposition on banks/adjacent floodplain. | Dark silt/clay | Silt deposits on river banks. Lower banks are slightly bare, but not obviously over steepened or eroded. | NA | NA | NA | Field to south of main watercourse totally flooded. Large tree trunks lodged between bridge and pipe flow. Bridge was overtopped. Revisited site later in week at lower flows. Online data 11/03 @ 3pm, river level at 3.23m, last observed on Tues 08/03 @ 8am water level was 5.7m. Peak on 04/03 was 6.75m. |

F. 3 Site 1d/EP16 photographs. Downstream failures (top left), bridge from downstream side (top right), from upstream left bank (bottom left), true left upstream (culverts underwater) (bottom right)

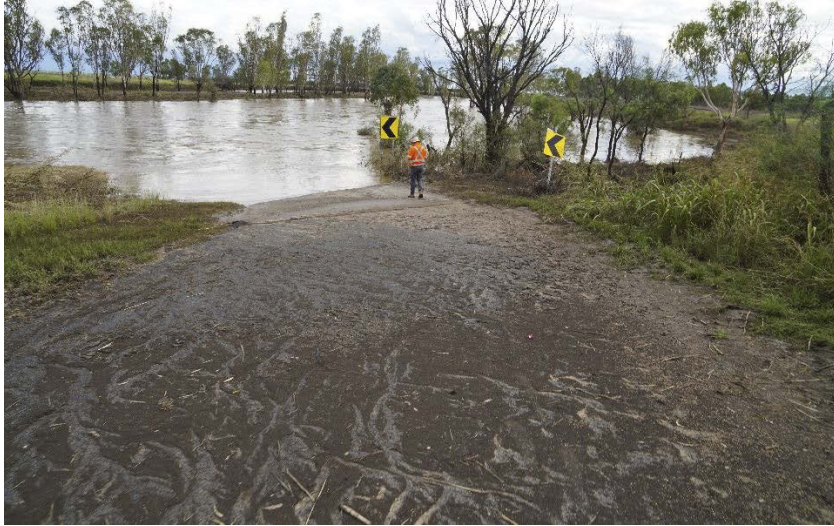
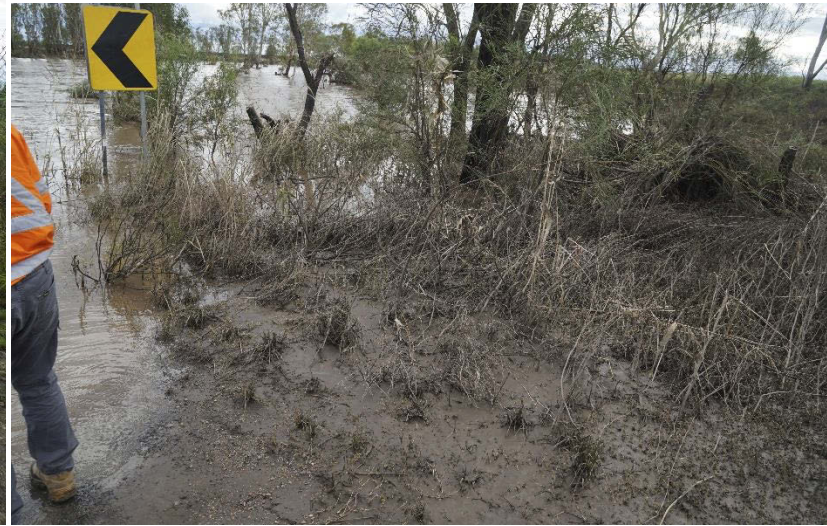
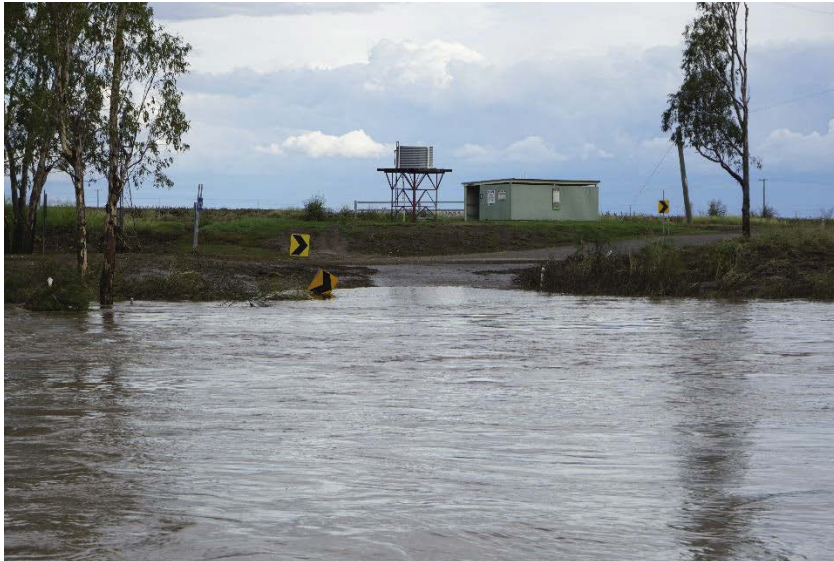
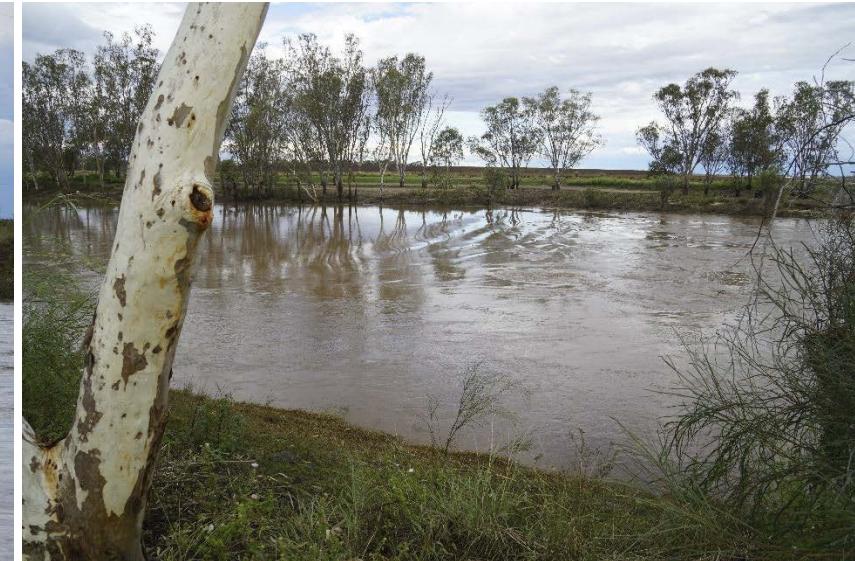
F. 4 Site 1h/EP16a photographs. From right bank (top left), right bank detail (top right), across channel towards true left bank (bottom left), Looking upstream towards the weir (under water) from right bank (bottom right)

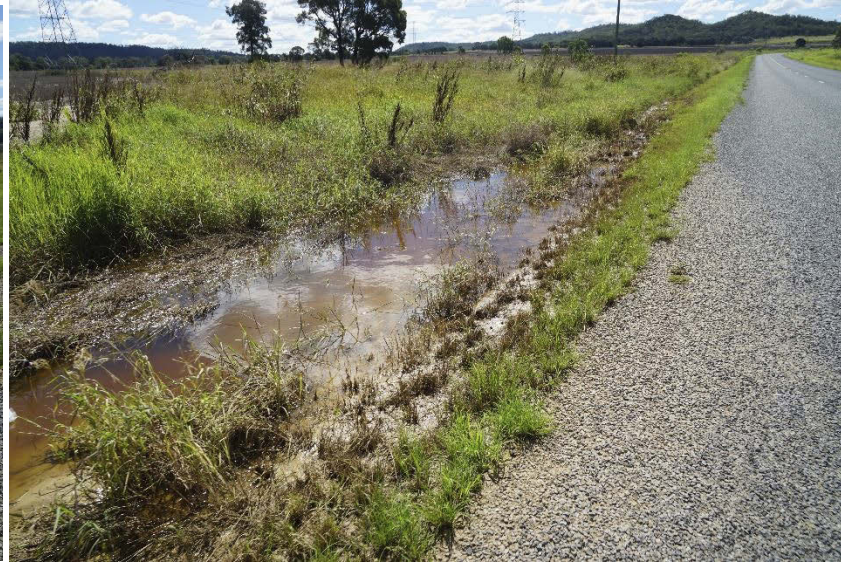
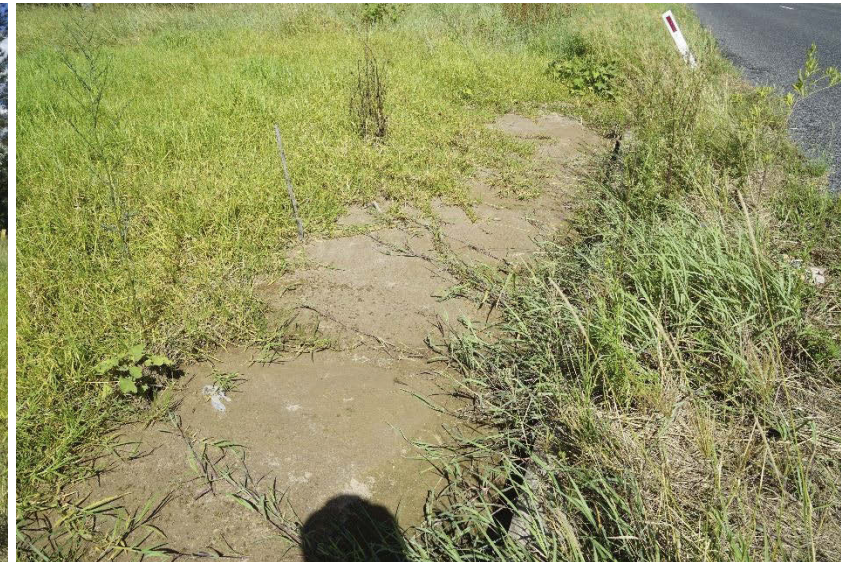
F. 10 Site 7a photographs. Upstream (top left), upstream detail (top right), downstream (bottom left), downstream detail (bottom right)

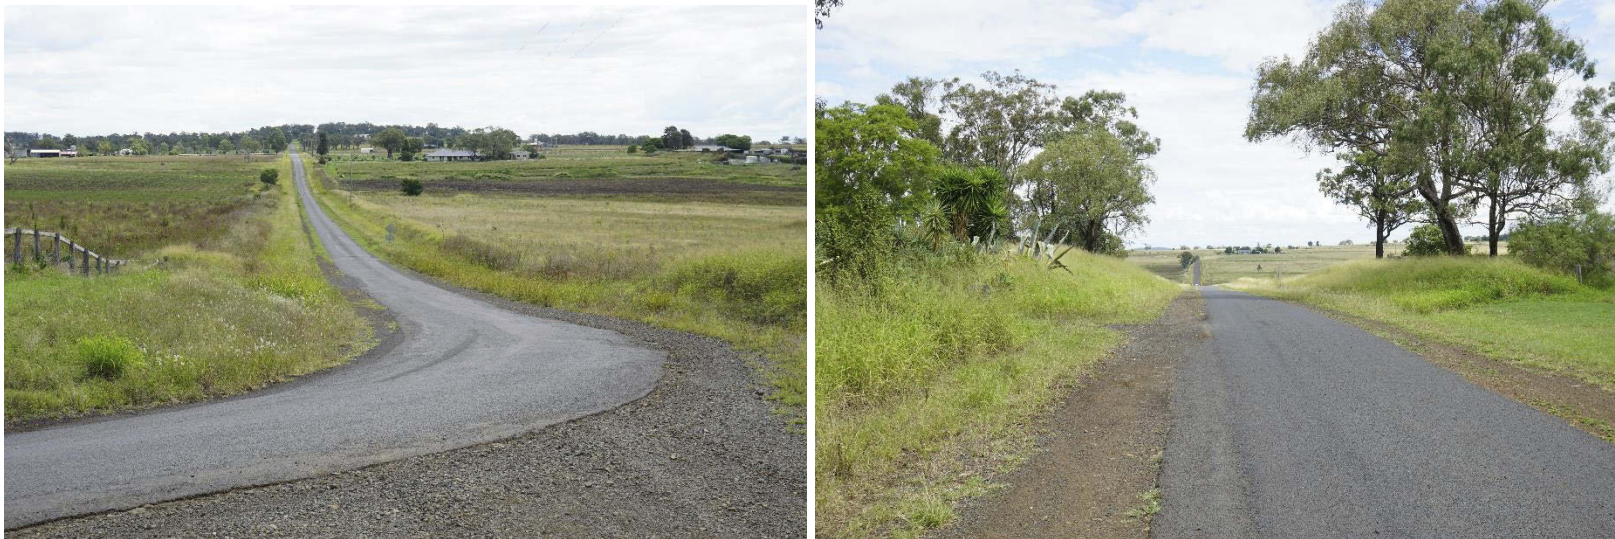
*F. 11 Site 9 photographs. Corner of Athol School facing west (left), and south (right).*

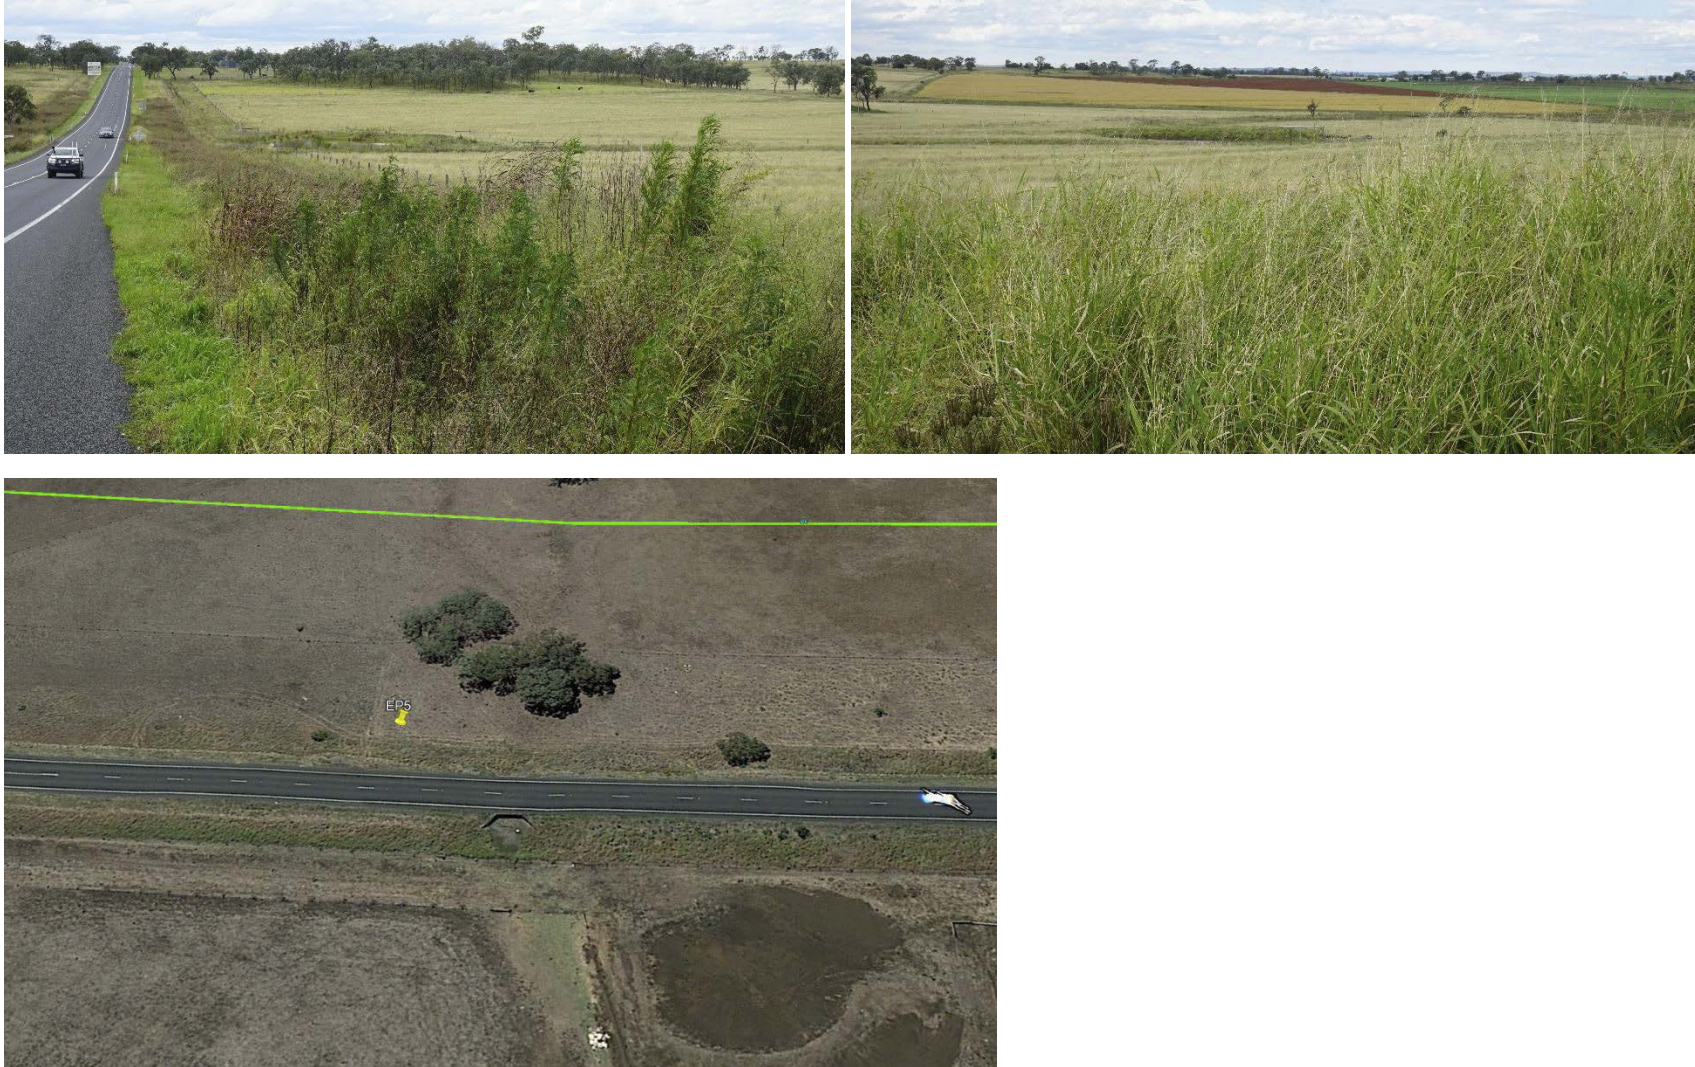
F. 27 EP5 photographs. SW of site looking back 1 (top left), SW of site looking back 2 (top right). View looking northwest from google earth, green line is proposed rail alignment (bottom).

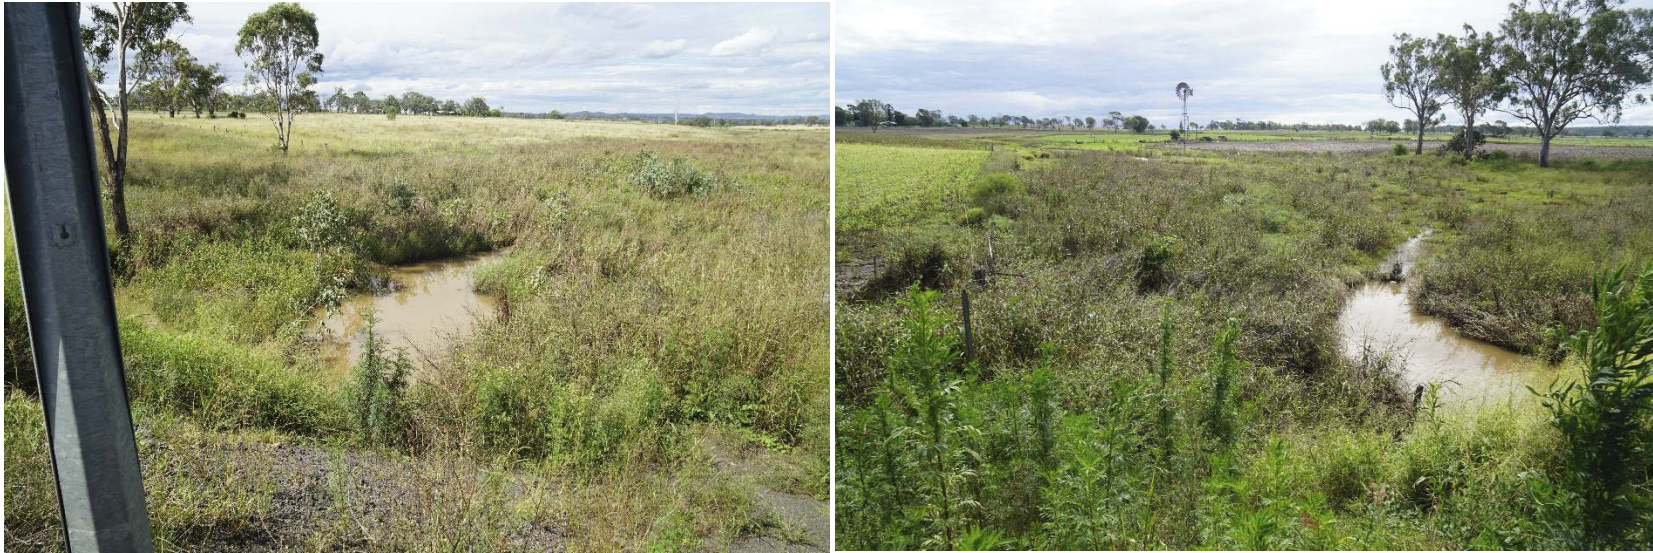
F. 29 EP8 photographs. Downstream (left), upstream (right).

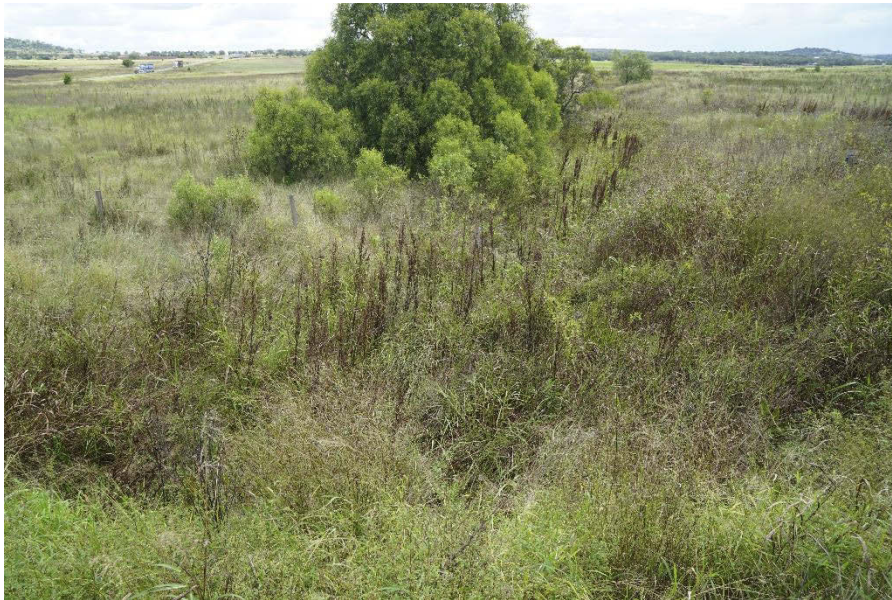
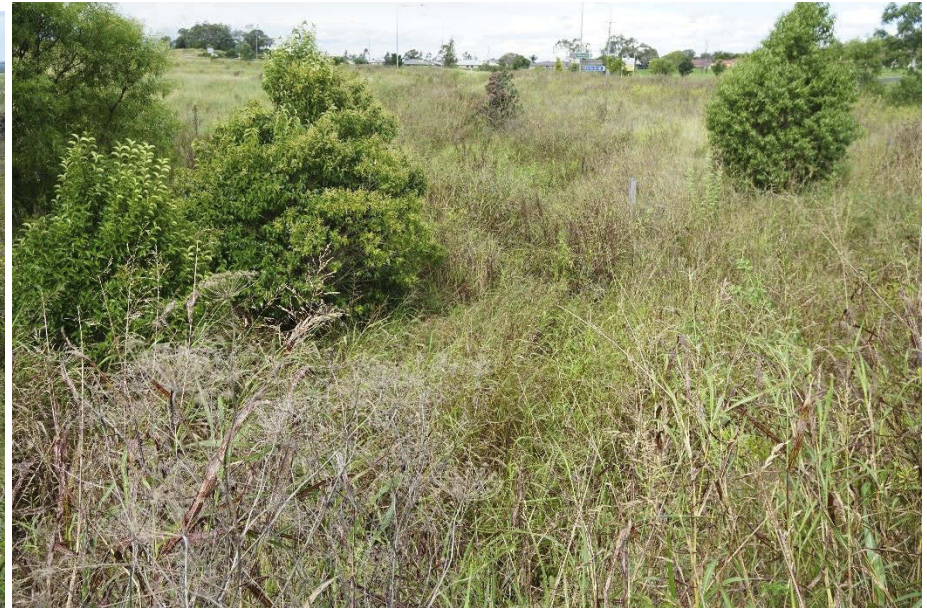
*F. 30      EP11 photographs. Facing SSW (left), facing NNE (right).*

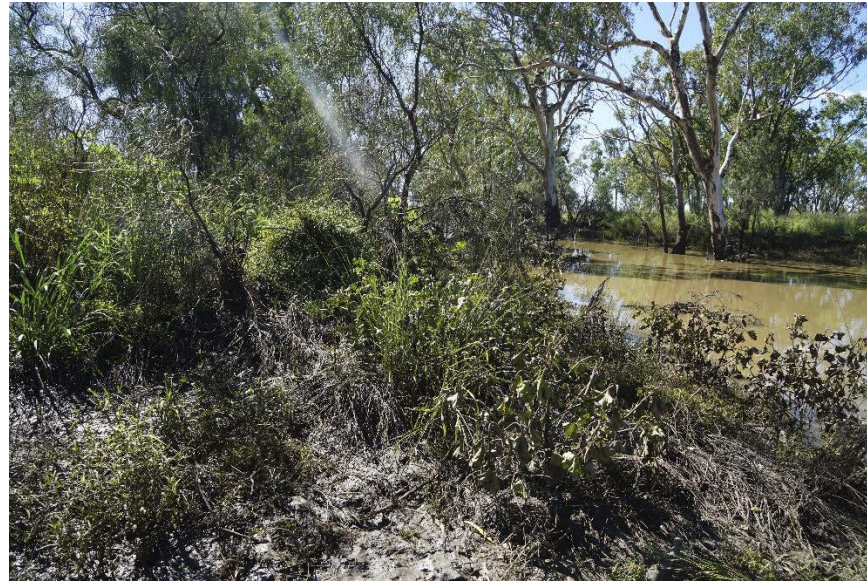
F. 31      EP17 photographs. From right bank (top left), detail 1 (top right), detail 2 (bottom).

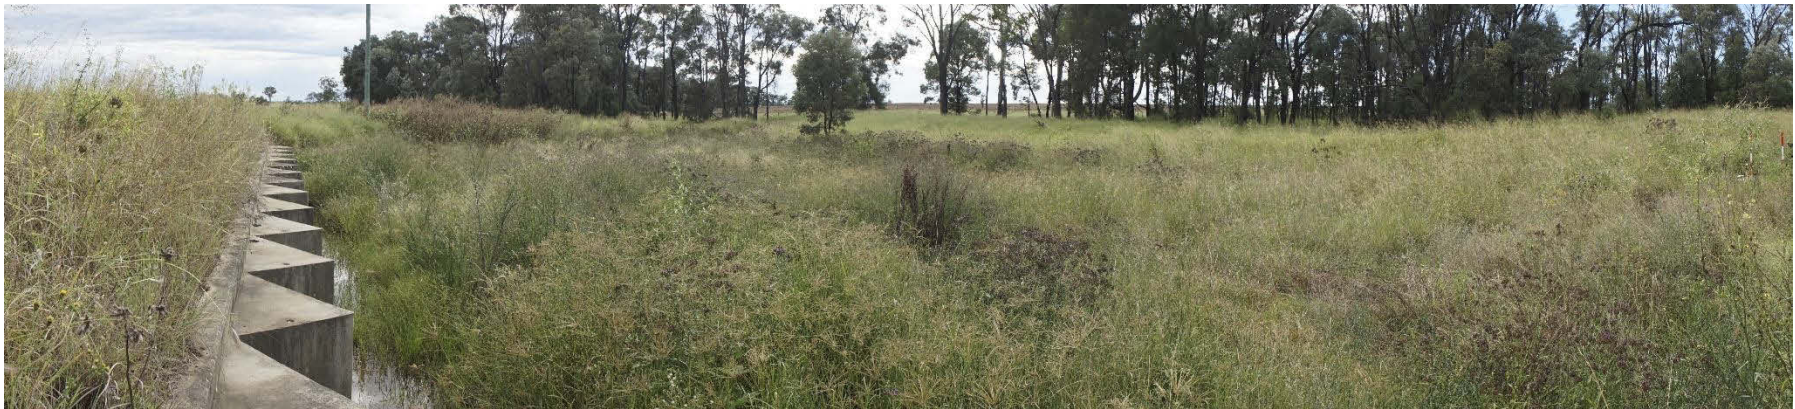
F. 38 EP23 photographs. Upstream detail 1 (top left), upstream detail 2 (top right), downstream (bottom).

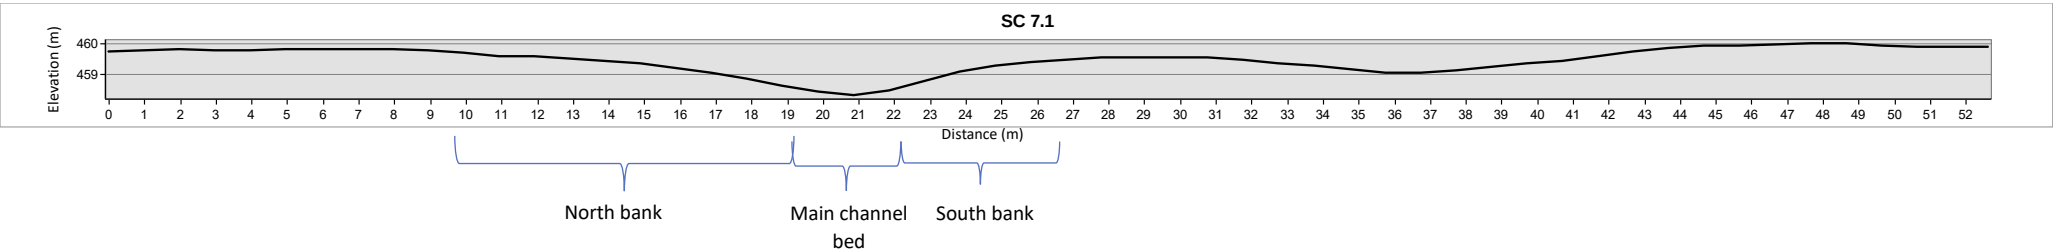
SC 7.1 – upstream of alignment

| Contemporary Channel Morphology | Bed and Bank Material | Vegetation | Erosion Observations | Manning's roughness 'n' |
|---|---|---|---|---|
| Channel has been modified upstream of culvert, waterway flows into pond. Downstream of pond, the channel is well defined, sinuous and grassed with some areas of ponding water. Main water flow appears to be to the true left of the pond based on erosion observed in historic aerial imagery. | Bed and bank are dominantly grassed. Bank material when exposed is an organic silty clay underlain by a silty sand. | Weed/grassed channel with sparse shrubs and established trees. Floodplain is grassed pasture with sparse trees. Woody debris present within channel. | Grassed channel, no major erosion observed during site visit at main channel. Historical imagery indicates extensive scour along the true left of the pond approx. 180 m in length. Some bank erosion in black soils was observed at this location. | 0.030 – 0.035<br><br>Some grass/weeds, little or no brush<br><br>Theoretical 'n' = 0.0325* |

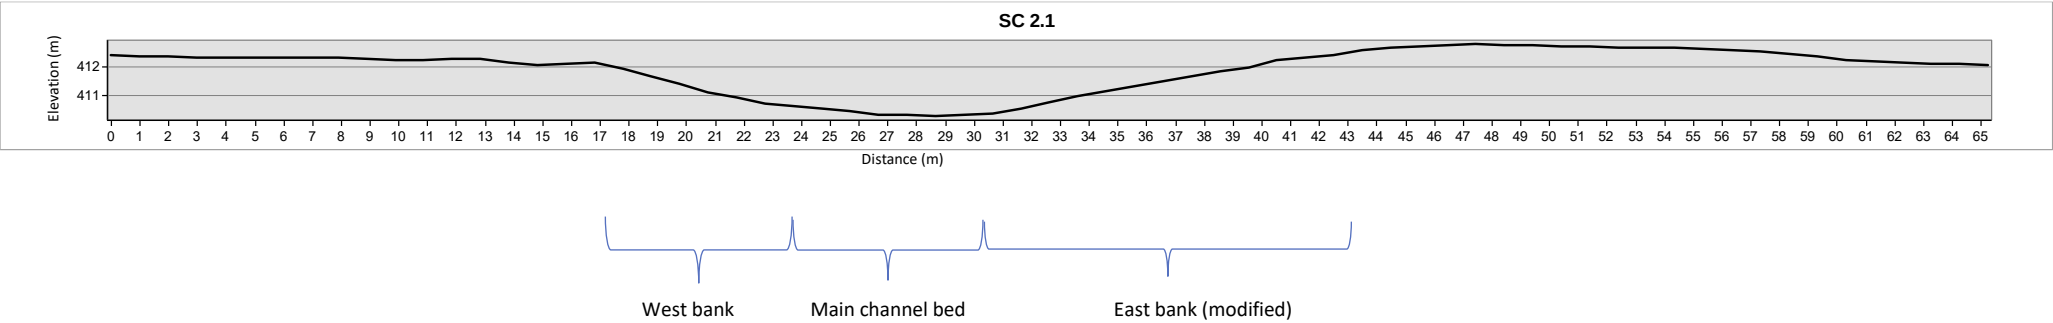
SC 2.1 – at meander bend

| Contemporary Channel Morphology | Bed and Bank Material | Vegetation | Erosion Observations | Manning's roughness 'n' |
|---|---|---|---|---|
| Modified channel around bend, a grassed embankment/dammed area has been constructed to restrict flow to the east. Sinuous channel, incised, with banks up to 2 m in height. | Bank material is generally grass covered silty sand or sandy silty clay. Bed material where exposed is either fine to coarse sand or silt with gravel armouring. | Grassed banks with established trees lining channel. Sparse in channel vegetation (grass/weeds). Floodplain is grassed pasture with sparse trees. | Erosion observed consistent with meandering channels, erosion on outside of bends, deposition on inside of bends. | 0.030 – 0.035/0.04 - 0.55<br>Some grass/weeds, little or no brush + irregular section with pools/channel meander<br>Theoretical 'n' = 0.0325* |

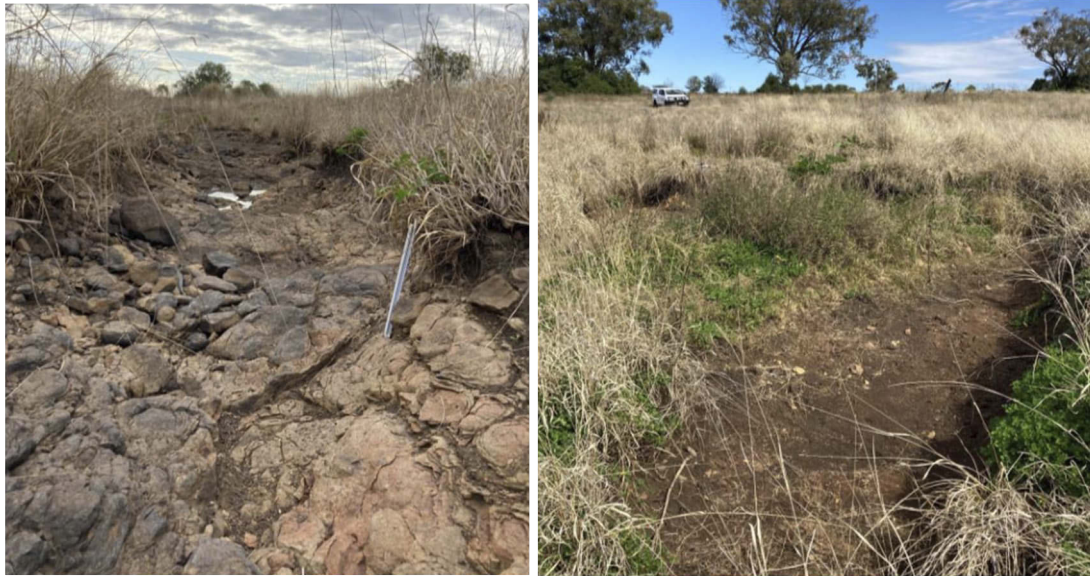
Four areas of erosion were observed (E1 to E4), including along bank erosion and scour holes of minor to moderate consequence category (Appendix A of Revised draft EIS Geomorphology technical report, Drawing Set E 3 for site locations). They all occurred downstream of the Project alignment in soil. One site (E4) may have been human-made or altered. Along bank erosion areas were located as expected on the outside of channel bends, with along bank eroding length of about 2 m. Flattened vegetation adjacent to the main channel indicates recent out of channel flow. No erosion of the rock-lined channel banks or bed was observed. Figure 1 provides site photo examples.

**Figure 1 NC 11 site photos. Left, Photos P9 – rock channel near design culvert. Right, Photo P10 – minor erosion (erosion site E2) in the silty clay channel bed, 1 m drop in bed level directly upstream of this erosion. See Appendix A drawing E3 for photos locations and descriptions.**

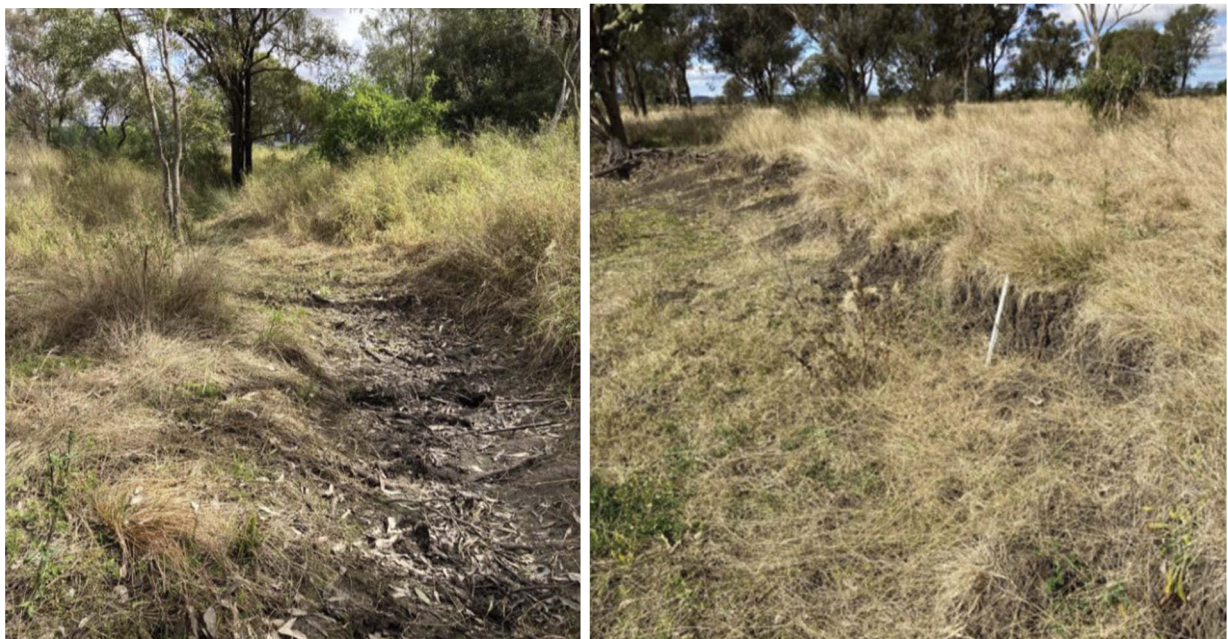
Following the terminology of the Queensland Bridge Scour Manual (*Supplement to Austroads Guide to Bridge Technology Part 8, Chapter 5: Bridge Scour 2018*) the type of scour at this site is classed as *long-term degradation*.

Figure 2 SC 7 site photos. Left, Photos P2 – looking upstream towards proposed culvert location. Right, Photo P9 – minor erosion on true right bank downstream of pond.

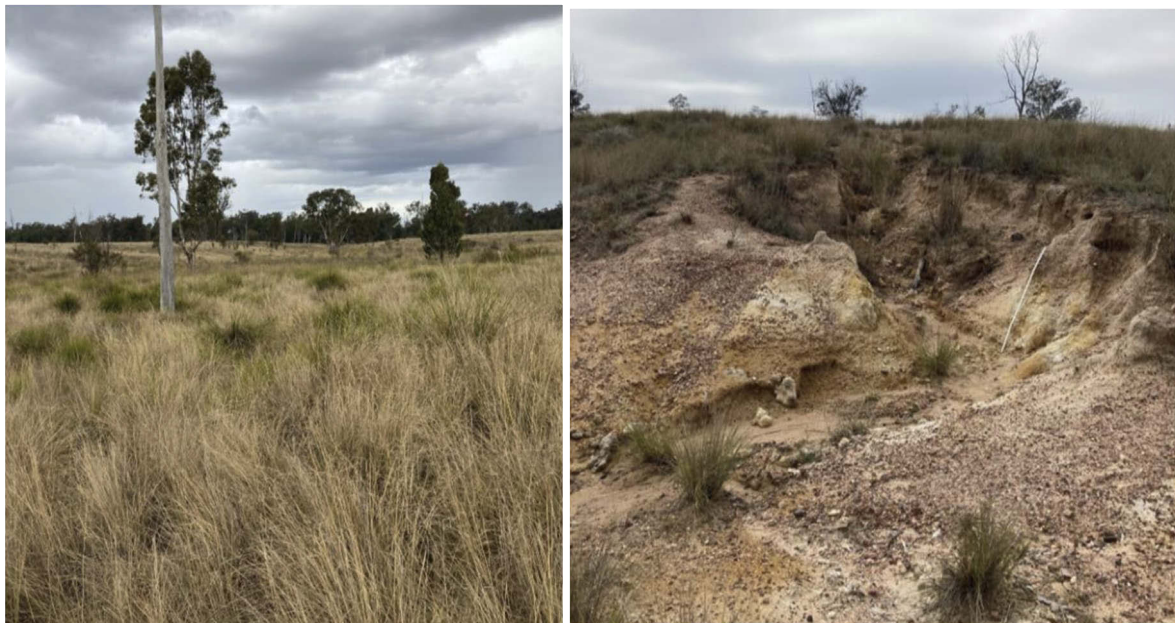
Following the terminology of the Queensland Bridge Scour Manual (*Supplement to Austroads Guide to Bridge Technology Part 8, Chapter 5: Bridge Scour 2018*) the type of scour at this site is classed as *long-term degradation*.

Figure 3 C Ck 16 site photos. Left, Photos P3 – looking downstream towards proposed culvert location. Right, Photo P9 – gulley erosion on side gully downstream of Project alignment, just outside the earthworks area.

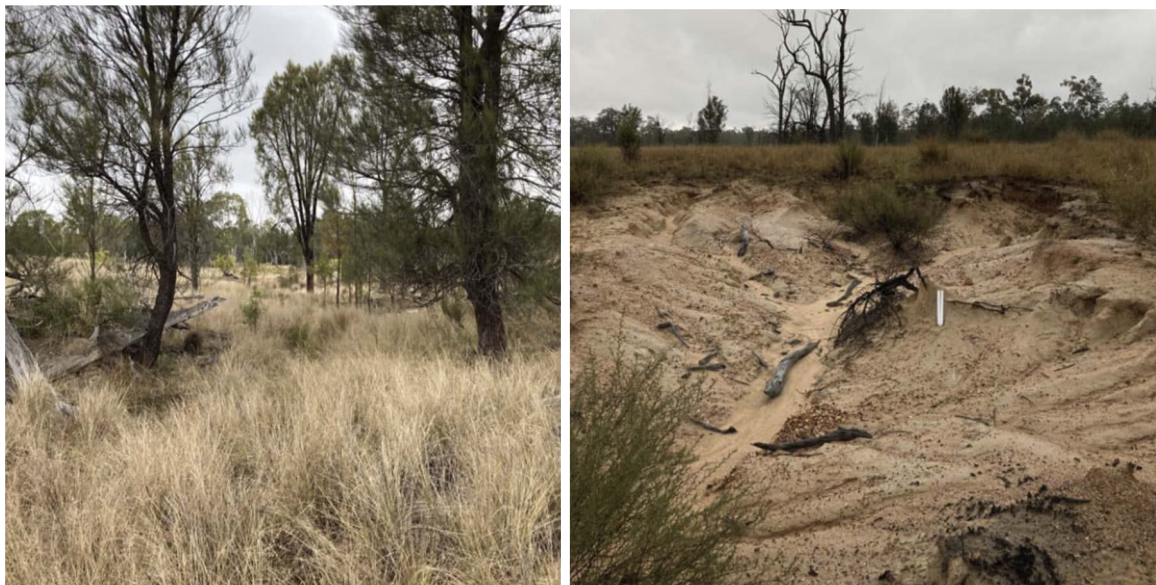
Following the terminology of the *Queensland Bridge Scour Manual (Supplement to Austroads Guide to Bridge Technology Part 8, Chapter 5: Bridge Scour 2018)* the type of scour at this site is classed as *long-term degradation*.

Figure 4 CCs 21 site photos. Left, Photos P1 – looking downstream from proposed culvert location. Right, Photo P6 – gully erosion on side gully at true right of design culvert location.

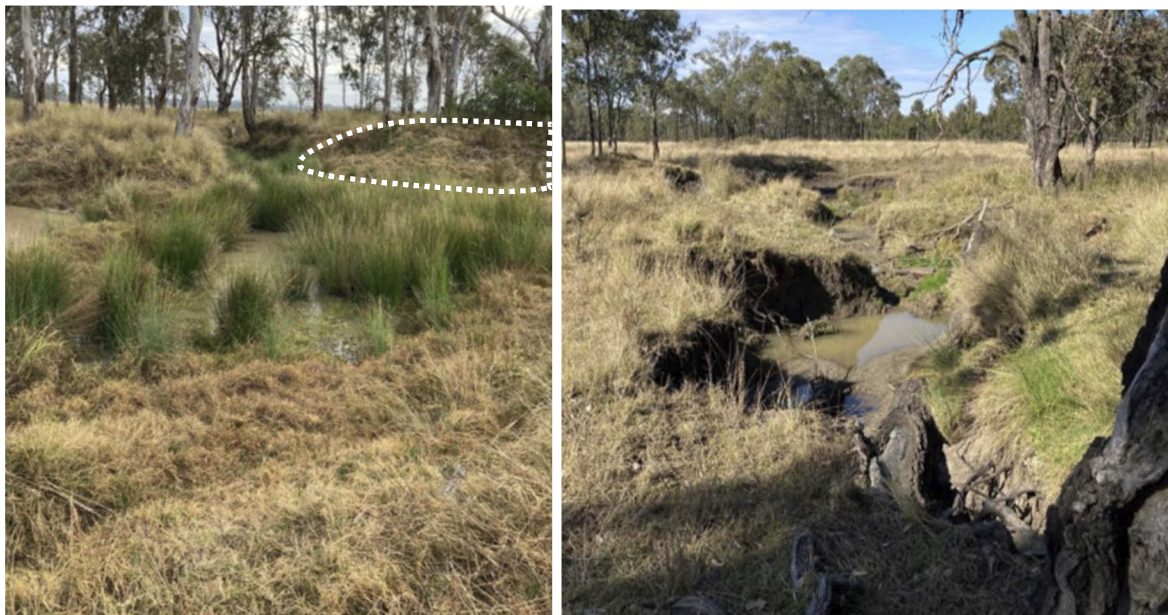
Following the terminology of the *Queensland Bridge Scour Manual (Supplement to Austroads Guide to Bridge Technology Part 8, Chapter 5: Bridge Scour 2018)* the type of scour at this site is classed as *long-term aggradation/degradation and short-term bend scour*.

**Figure 5 SC 2 site photos.** Left, Photos P3 – looking downstream from apex of meander bend towards human made embankment in channel (indicated by the dashed white line). Right, Photo P16 – Major channel erosion that starts ~75 m downstream of the existing road culvert.
