## Riverbank Erosion Assessment

**Cardno (Qld) Pty Ltd**

## NORTHEAST BUSINESS PARK RIVERBANK EROSION ASSESSMENT

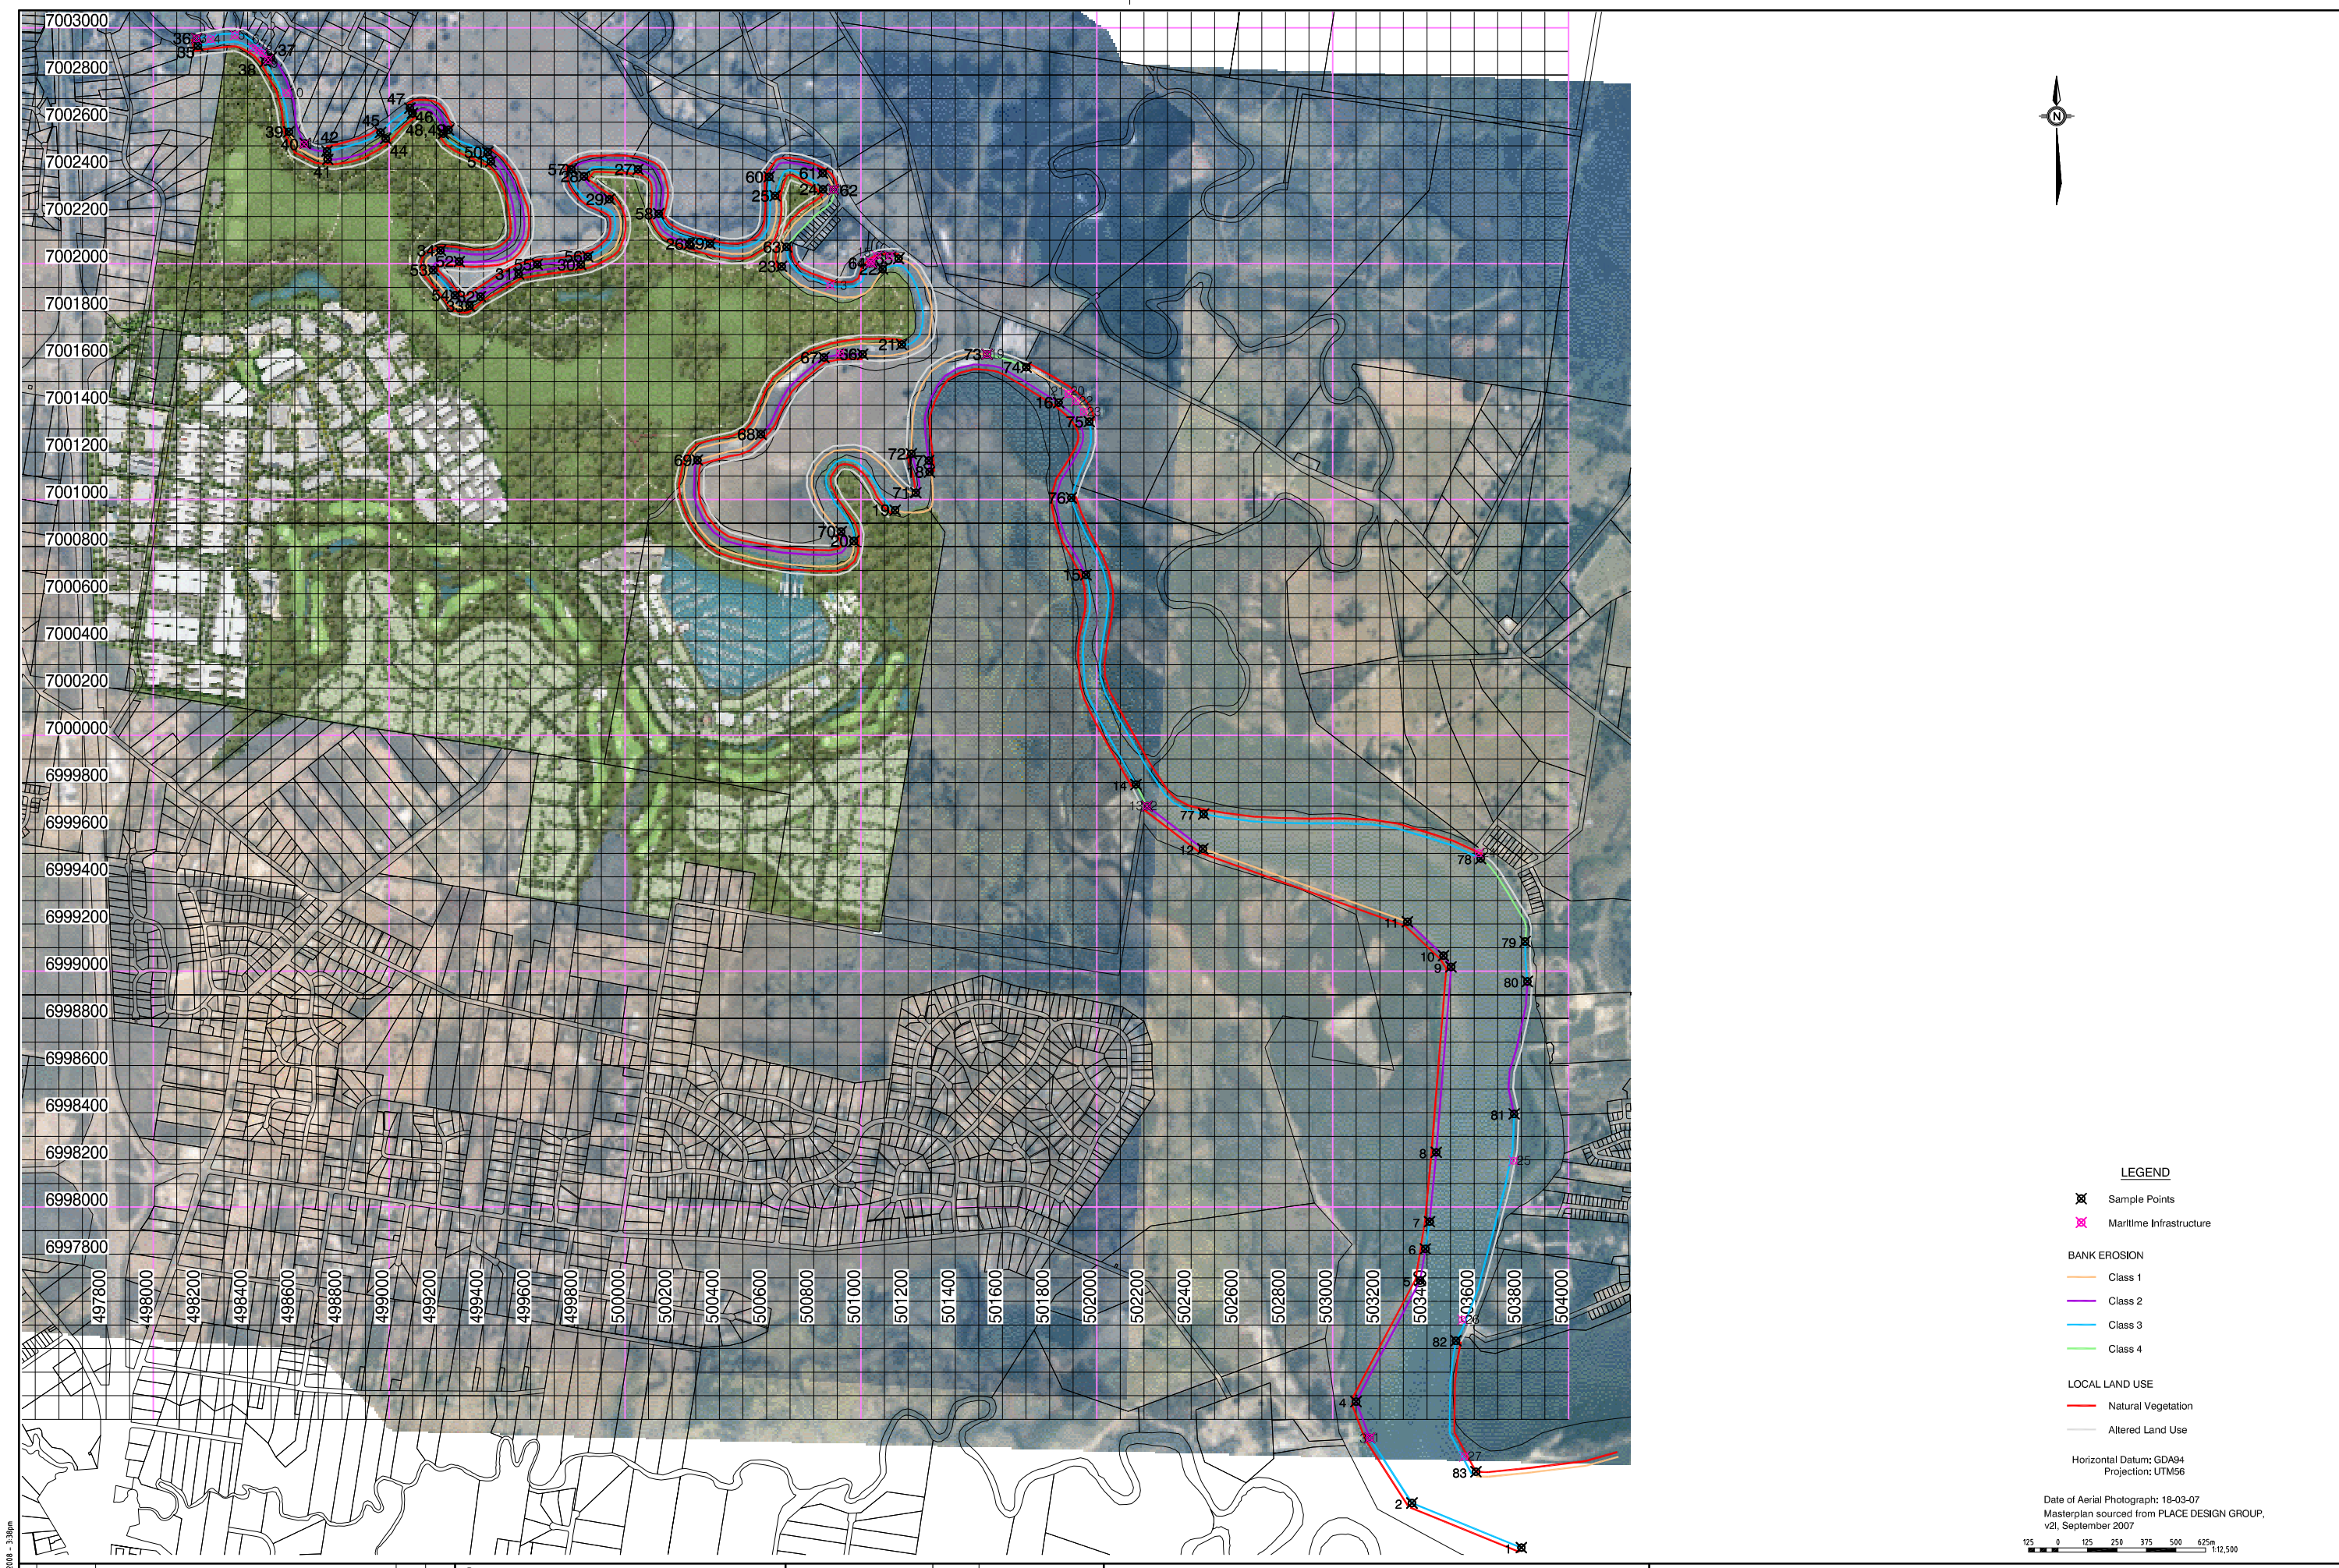
| | FIGURE 2 | | 0 |

Severe erosion was found in close proximity to the NEBP site in reaches 6-9 in the upstream portion of the Caboolture River study area. Downstream of the NEBP project area erosion was less severe. This corresponds to an increase in altered land uses in the upstream portion of the study area, specifically grazing and forestry practices.

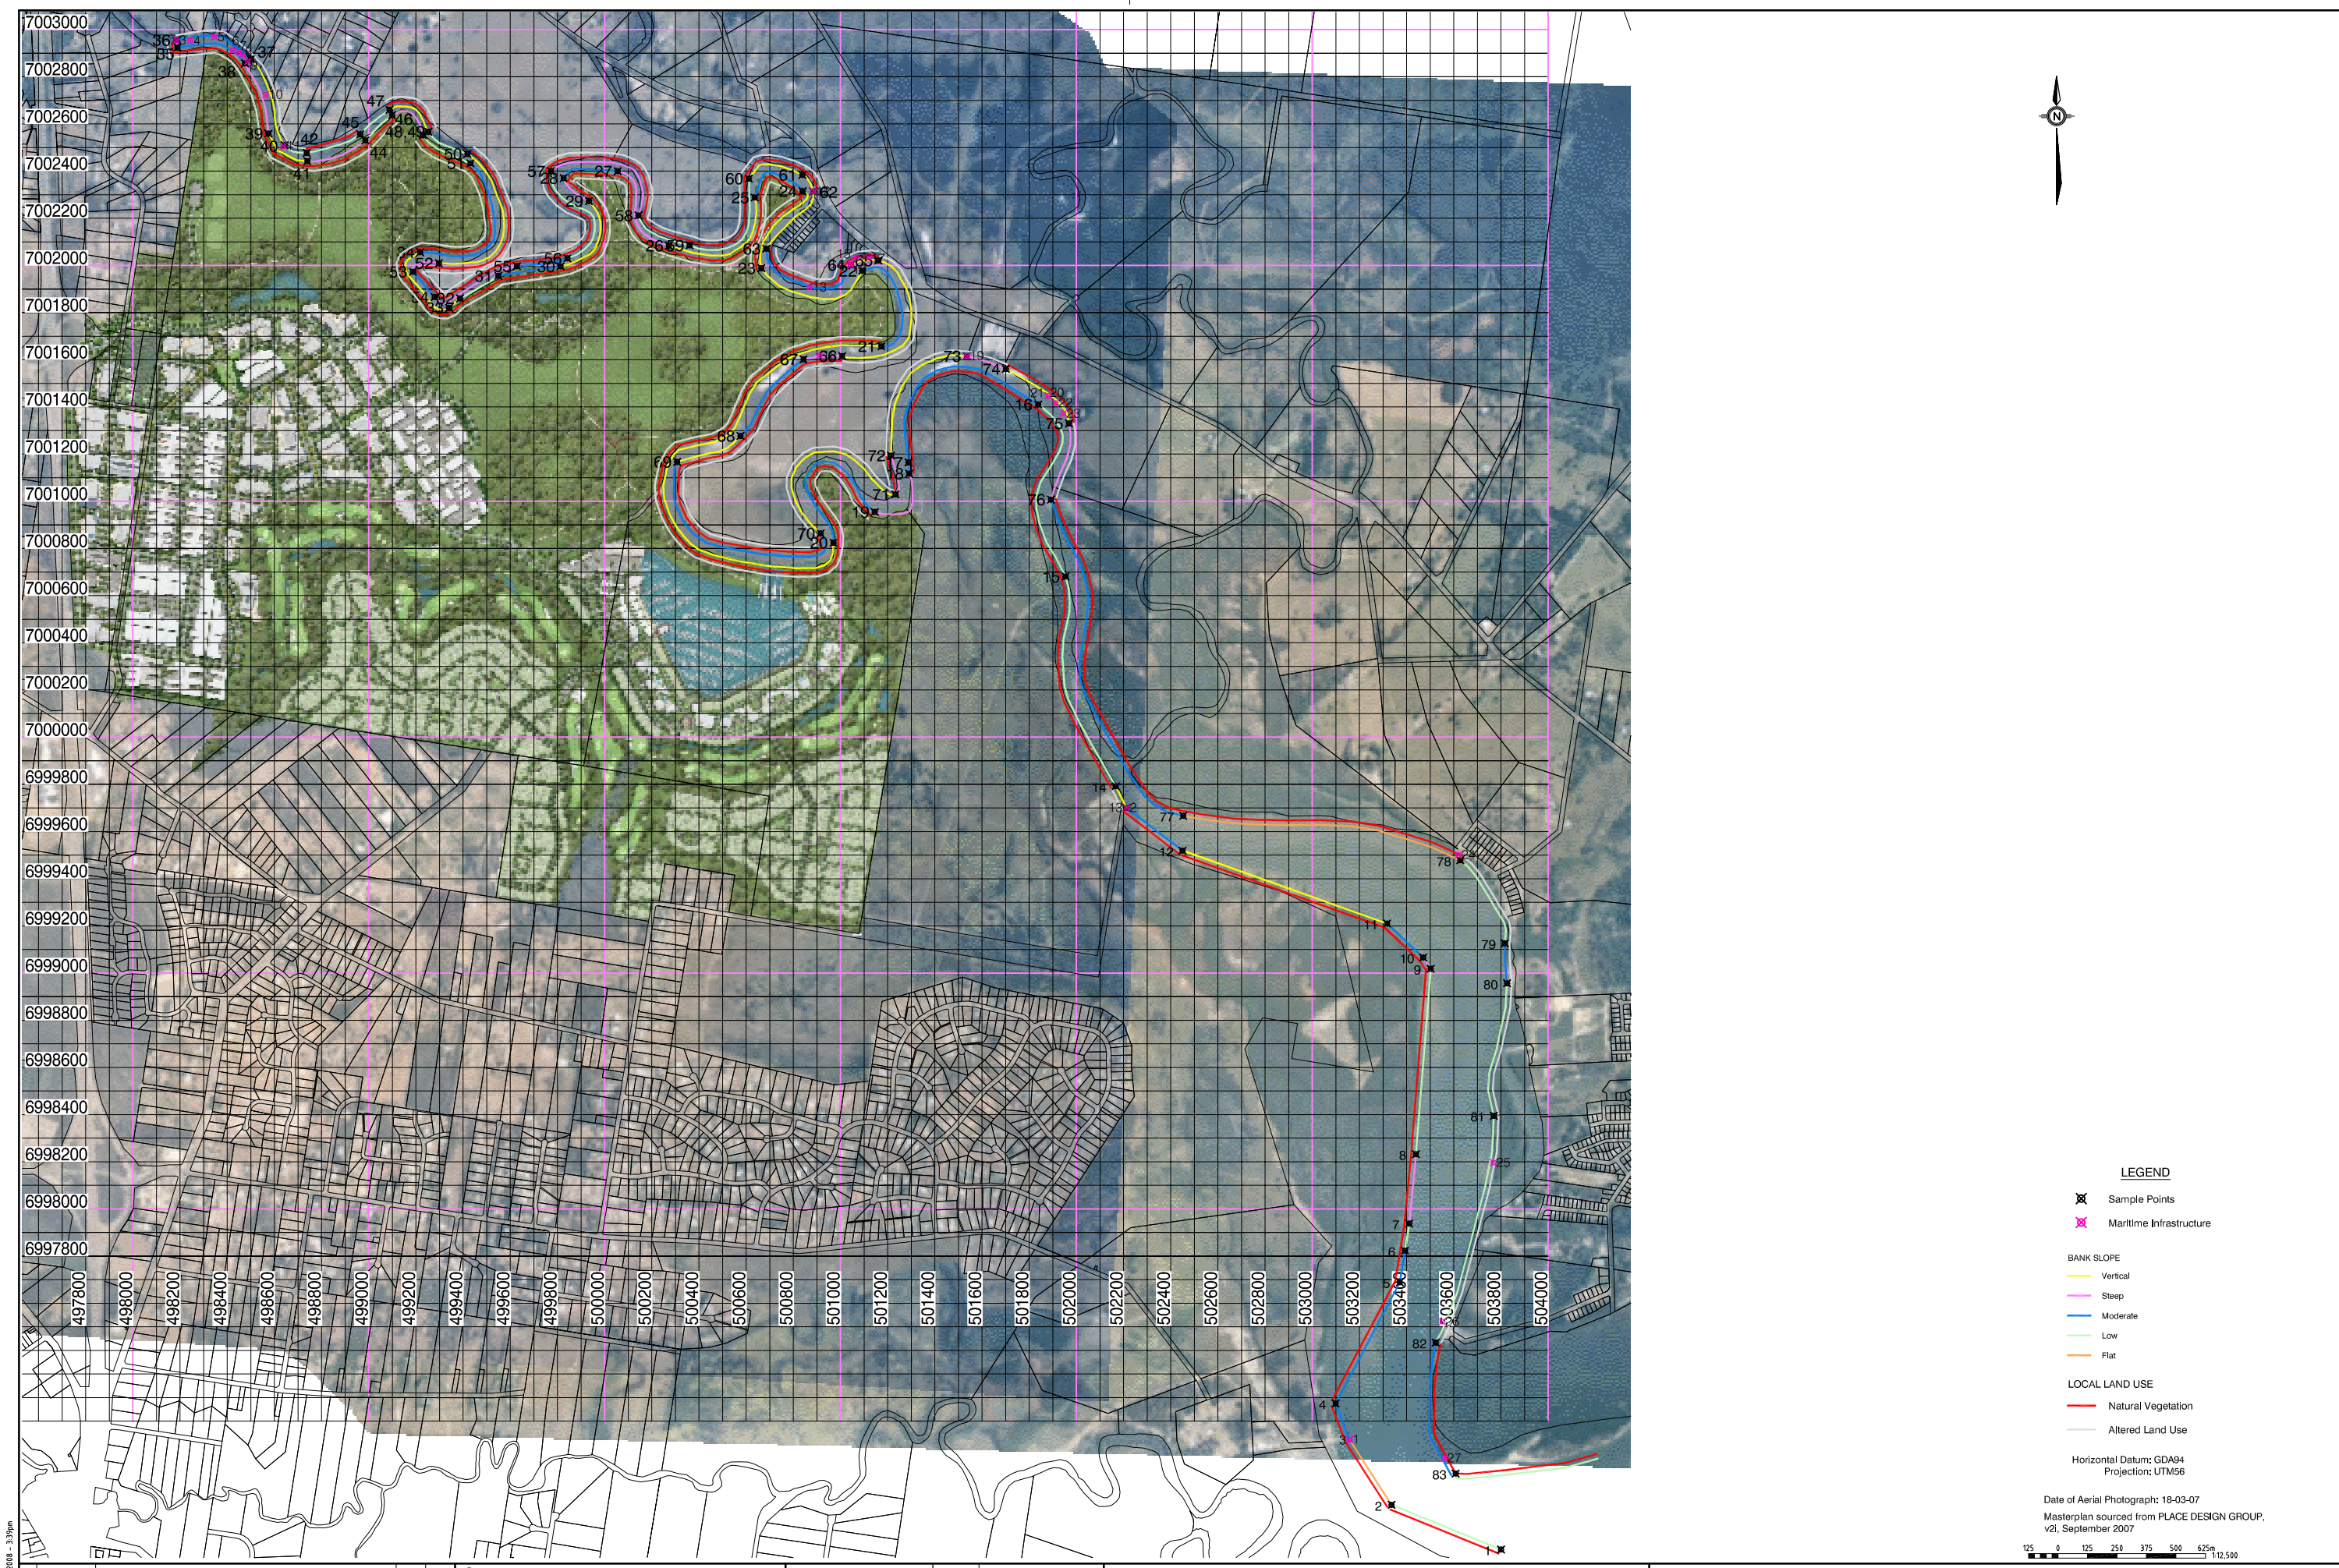
**FIGURE 3**

On the right bank, a relationship between erosion class and bank slope is evident with severe erosion often observed on banks with a steep to vertical slope and less severe erosion observed on banks with moderate to low slope.

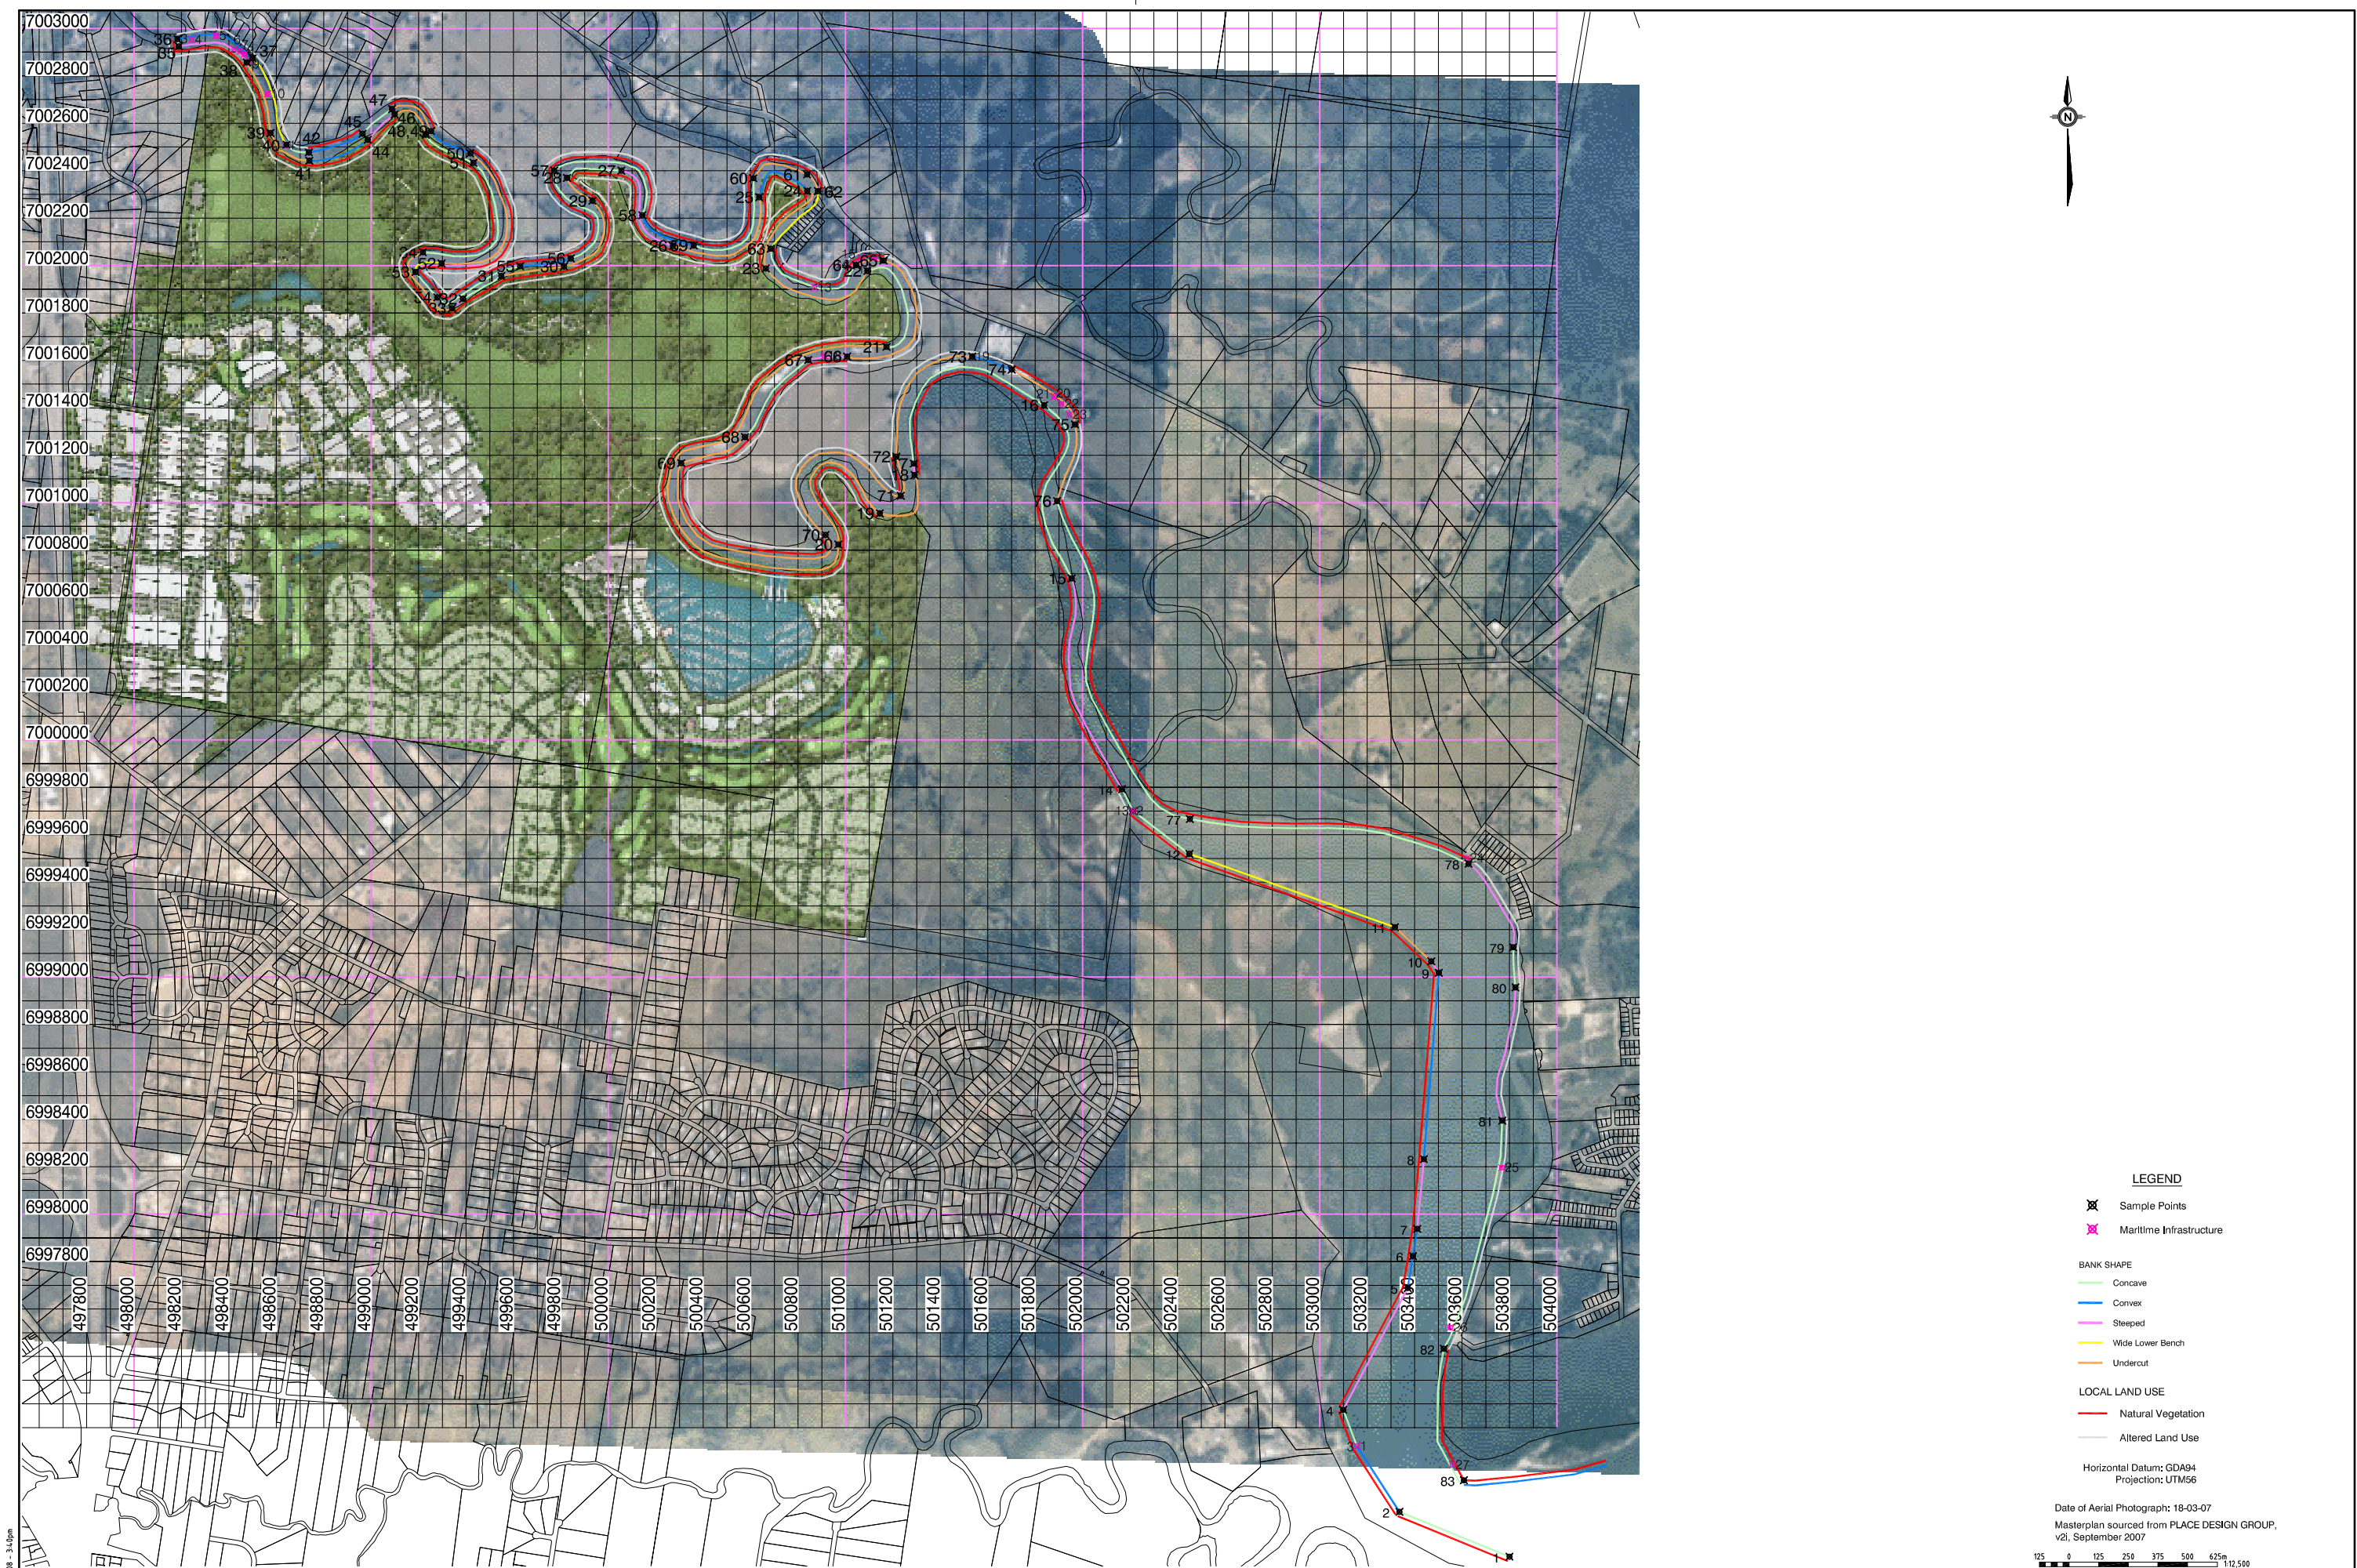
| FIGURE 4 | | 0 |

On the left bank similar relationships were observed between erosion class and bank slope and shape. A decrease in erosion class was found to correspond to a decrease in slope. The shape of the riverbank was closely related to erosion class with undercut the dominant bank shape when erosion class 1 and vertical/steep slopes were observed.
