# REPORT

## URS Site Visit Notes

**BHP Billiton Mitsubishi Alliance**

27 February 2009

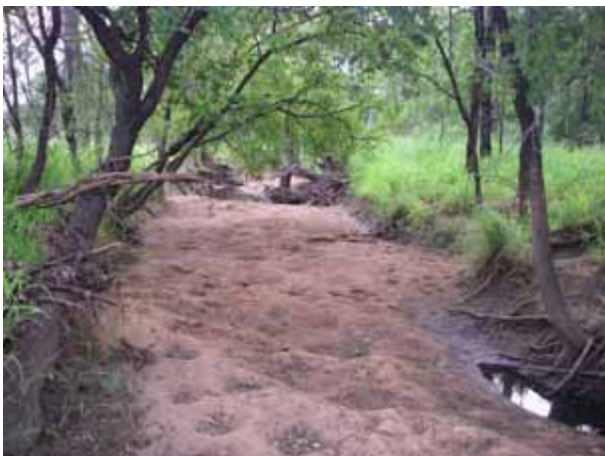
**Plate 1-1 Cherwell Creek, Tributary 1 Site 1**

Looking downstream from fence post

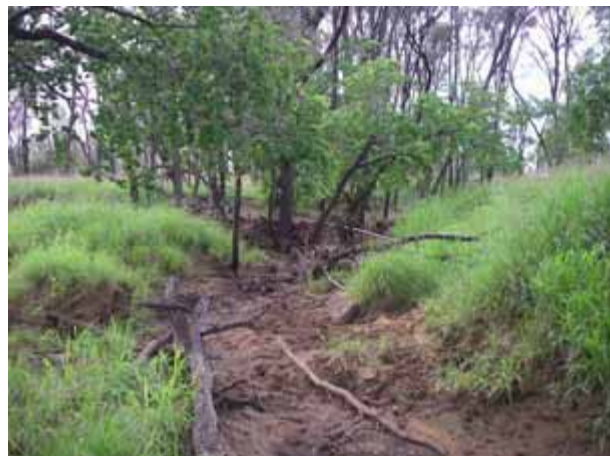
Debris and tree roots: Log jams present (approximately 30% waterway obstruction)

Looking upstream at a log jam.

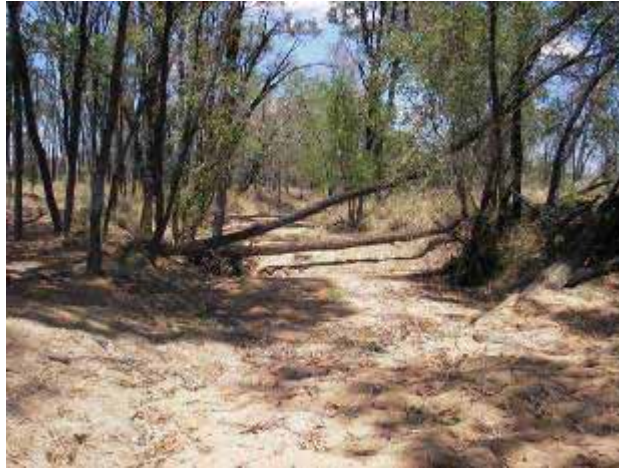
**Section 1****Cherwell Creek Tributary 1****November 2007****Plate 1-2 Cherwell Creek Tributary 1 Site 1 Upstream**

Looking upstream

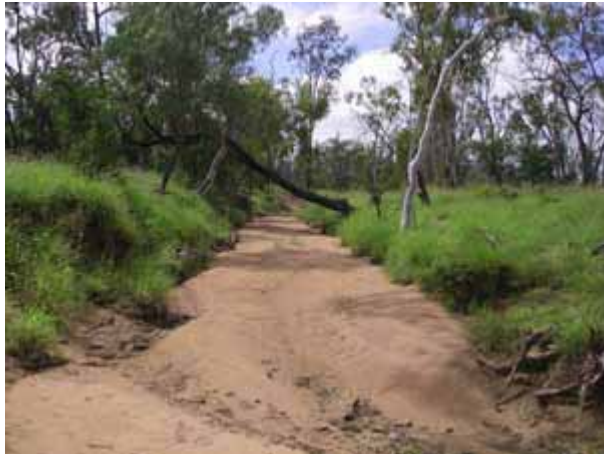
**Plate 1-3 Cherwell Creek Tributary 1 Site 2**

Looking downstream, sandy base

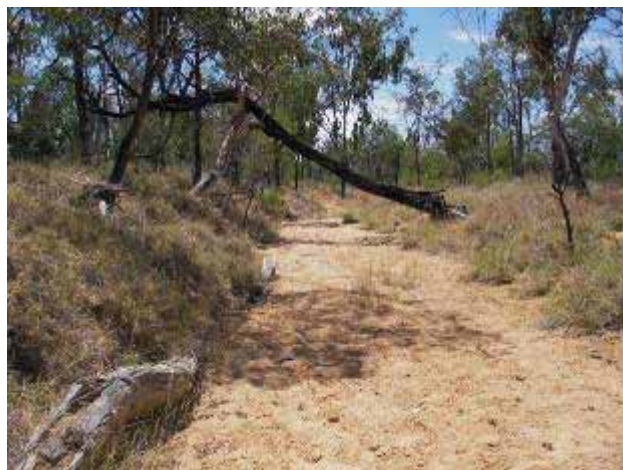
**Plate 1-4 Cherwell Creek Tributary 1 Site 2 Downstream**

Looking downstream

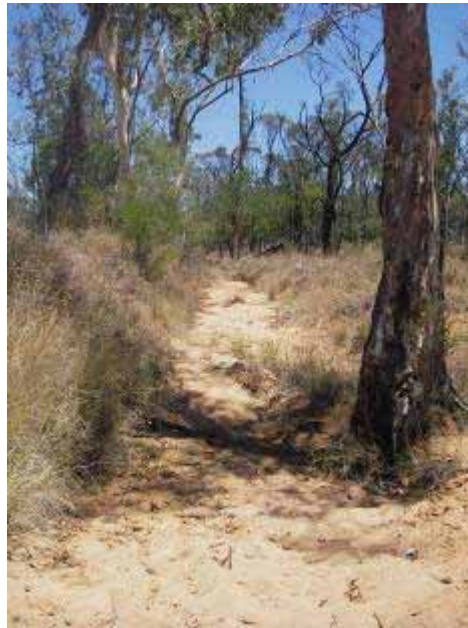
Plate 1-5

Looking upstream

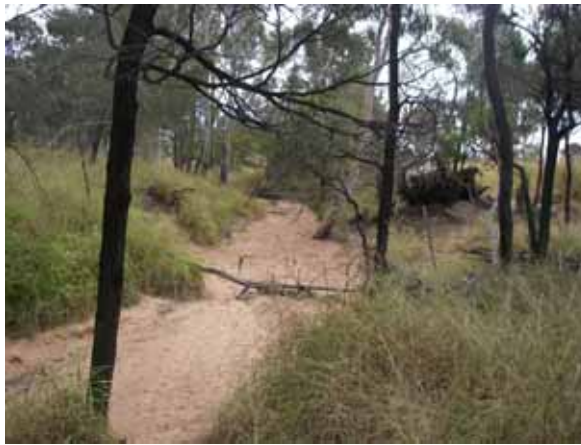
**Plate 2-1 Cherwell Creek Tributary 1 South Site 1 Upstream**

Looking upstream

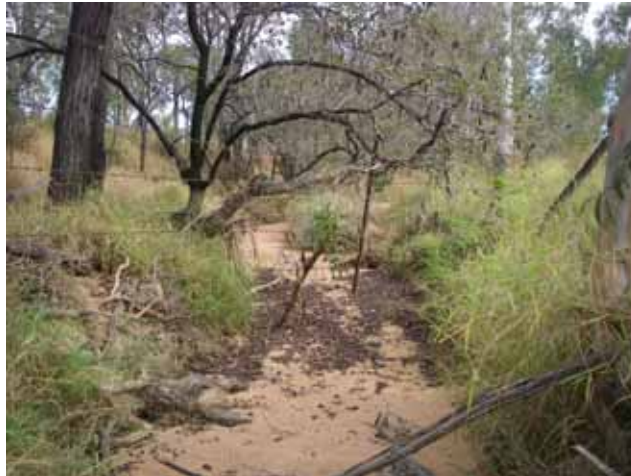
Plate 2-2

Looking downstream

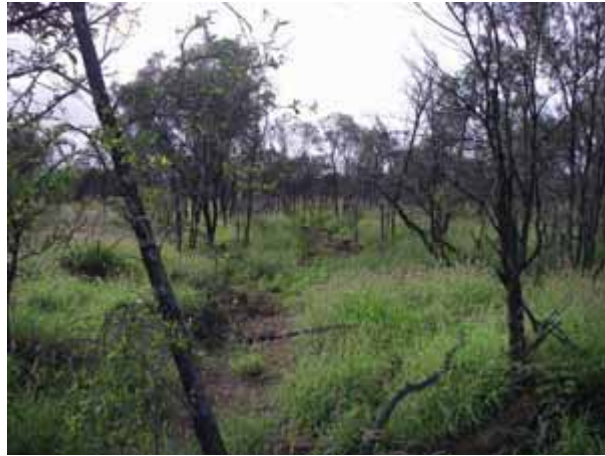
**Section 3****Cherwell Creek Tributary 2****Plate 3-2 Cherwell Creek Tributary 2, Site 1**

Looking downstream towards highway.

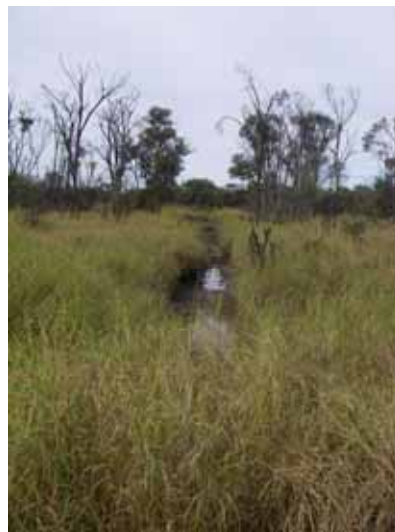
**June 2008****Plate 3-3 Cherwell Creek Tributary 2, Site 1 Downstream**

Looking downstream

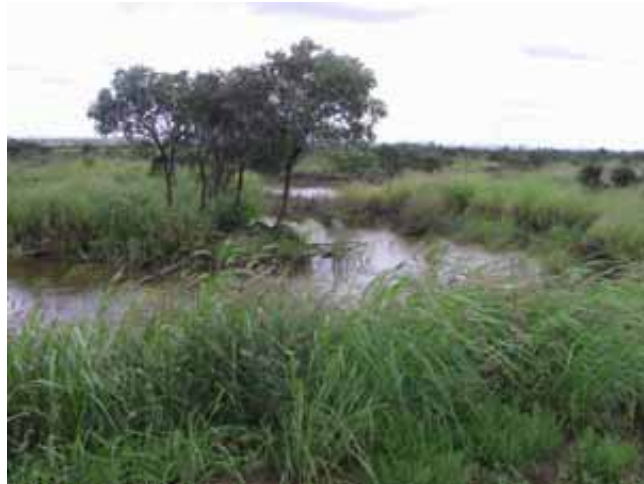
**Plate 3-4 Cherwell Creek Tributary 2, Site 2 towards Dam**

Looking towards dam

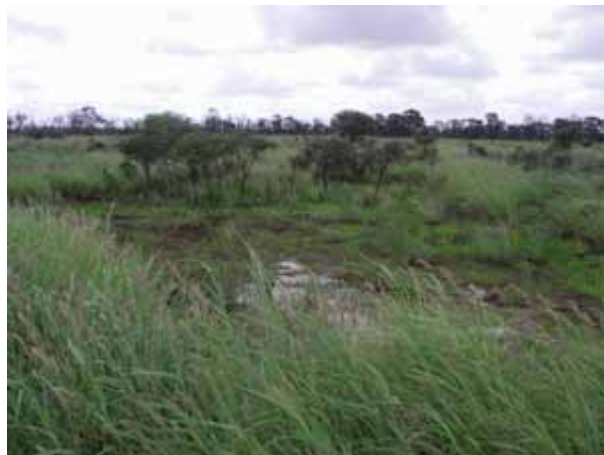
**Plate 3-5 Cherwell Creek Tributary 2, Site 2 Away from Dam**

Looking away from dam

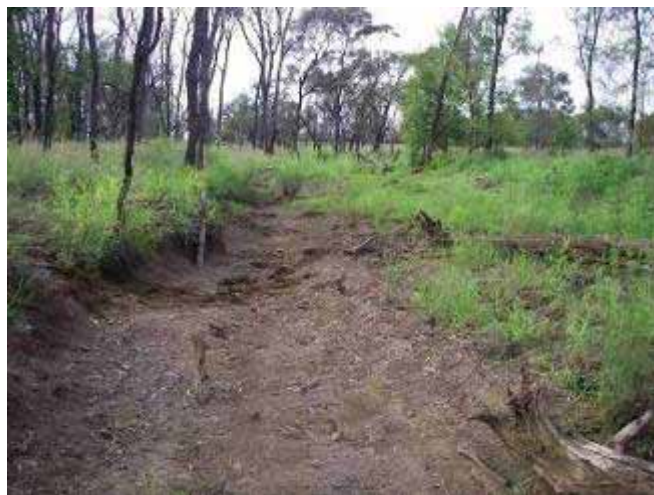
**Plate 4-1 Cherwell Creek Tributary 3, Site 1 Downstream**

Looking downstream, brown silty soil and sparse gravel

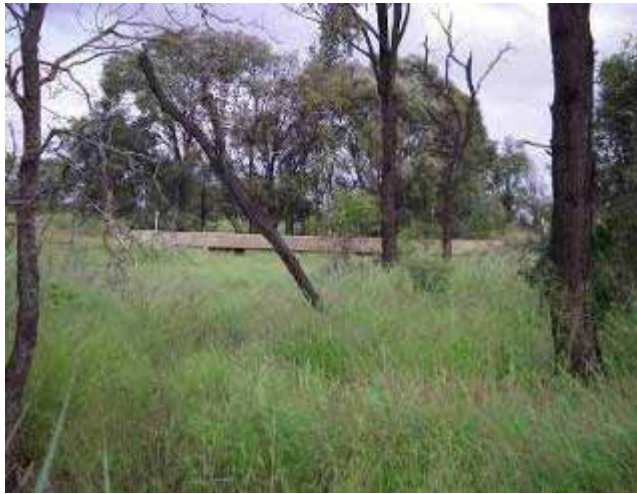
**Section 4****Cherwell Creek Tributary 3****Plate 4-2 Cherwell Creek Tributary 3, Site 1 Culvert Crossing Peak Downs Highway**

Culvert crossing Peak Downs Highway

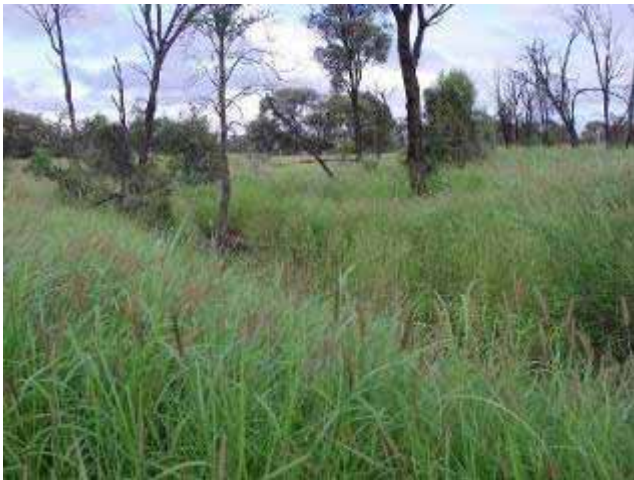
**Plate 4-3 Cherwell Creek Tributary 3, Site 1 Culvert Crossing**

Culvert crossing and creek

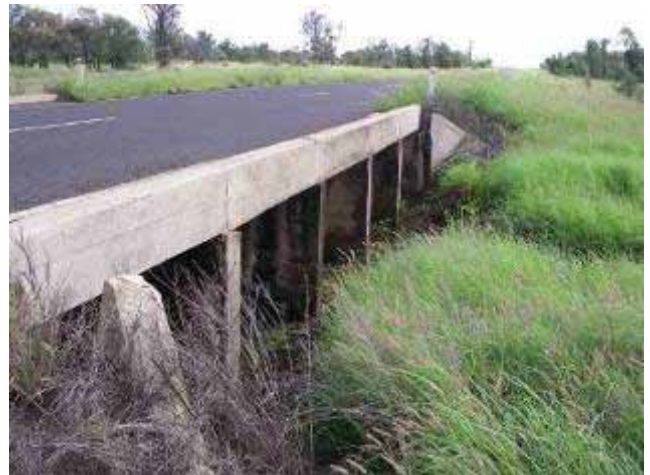
Additional Comments: Peak Downs Highway crossing consists of 5 Reinforced Concrete Box Culverts 2.1m wide by 1.6-1.8m deep).

Five box culverts

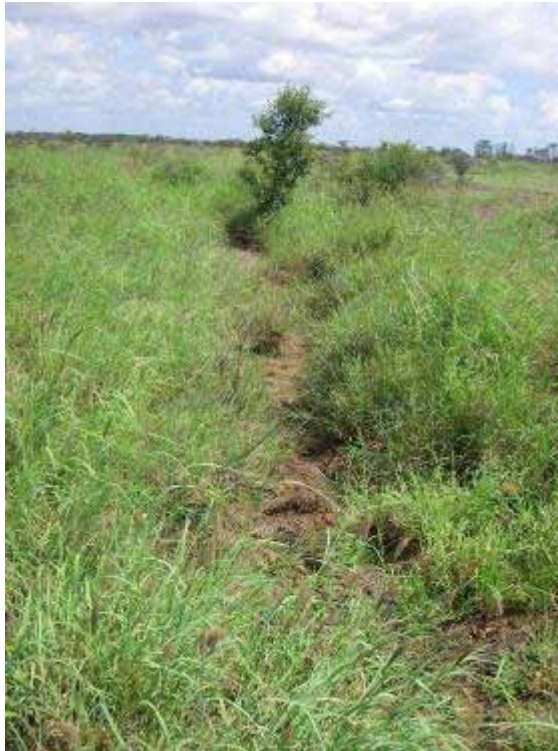
**Plate 4-4 Cherwell Creek Tributary 3, Site 2**

Looking downstream

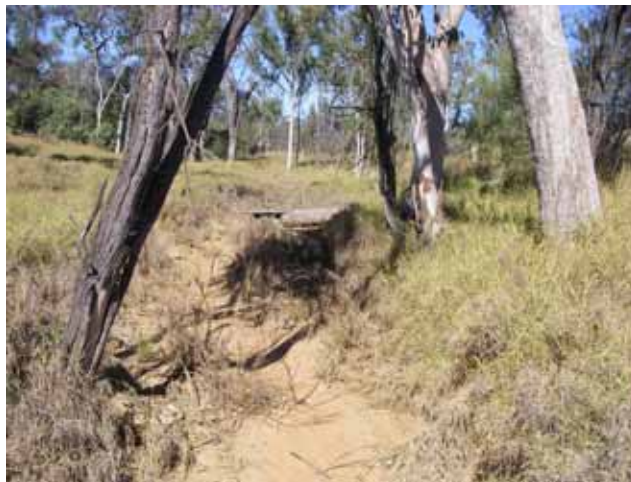
**Plate 5-1 Cherwell Creek Tributary 4 South, Site 1 upstream**

Looking upstream (upstream of new back access road)

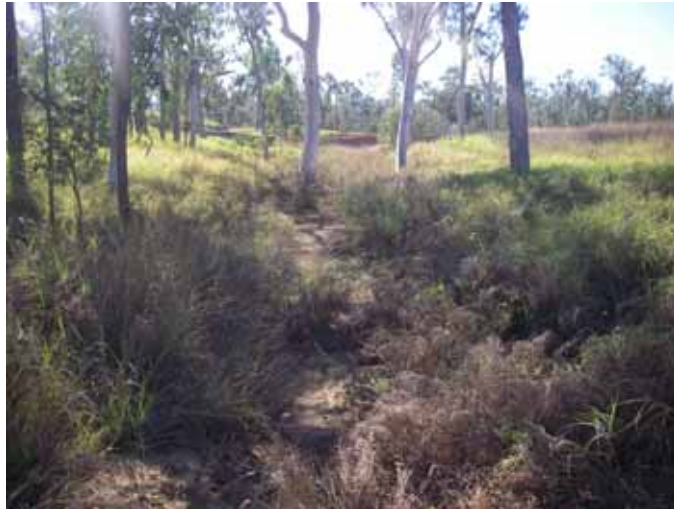
**Plate 5-2** Cherwell Creek Tributary 4 South, Site 1 downstream

Looking downstream (downstream of new back access road).

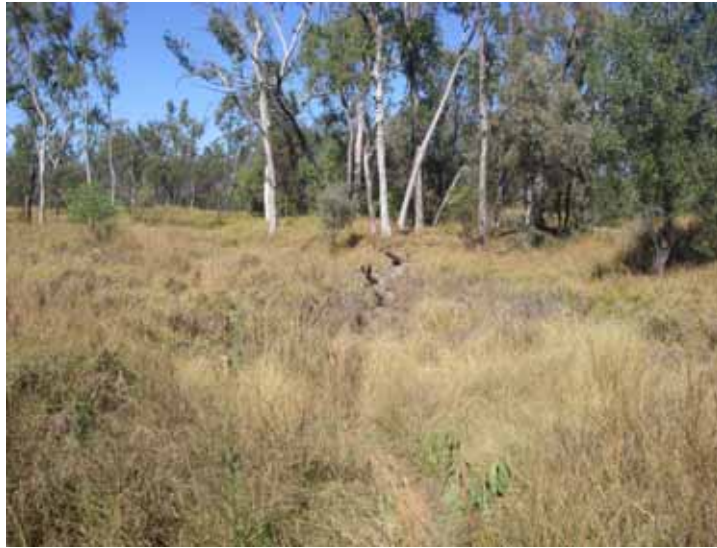
**Plate 5-3** Cherwell Creek Tributary 4 North, Site 1 upstream

Looking upstream (upstream of new back access road)

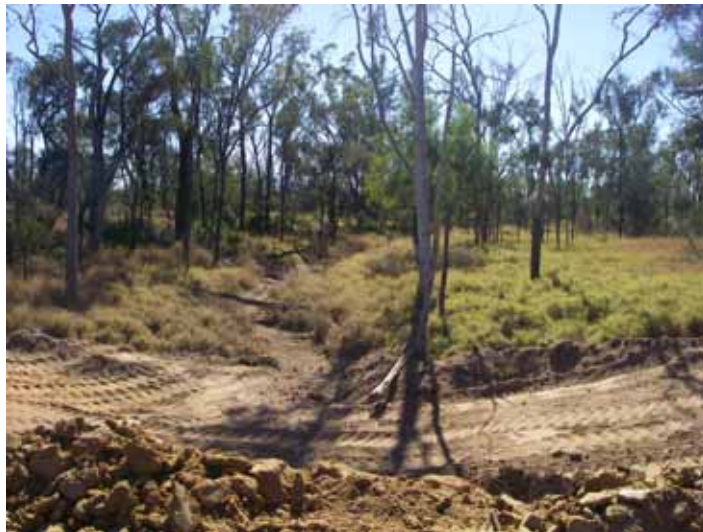
**Plate 5-4** Cherwell Creek Tributary 4 North, Site 1 downstream

Looking downstream (downstream of new back access road)

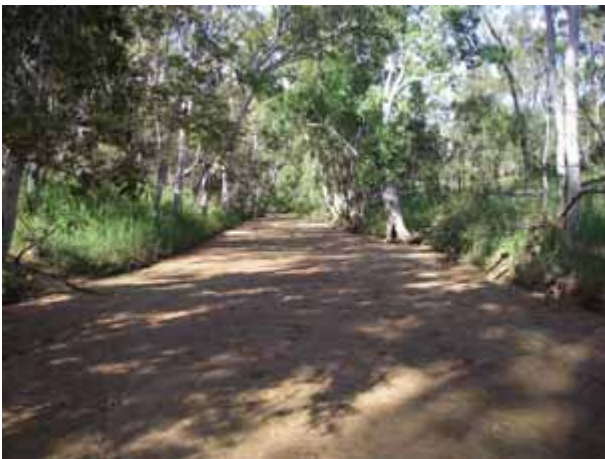
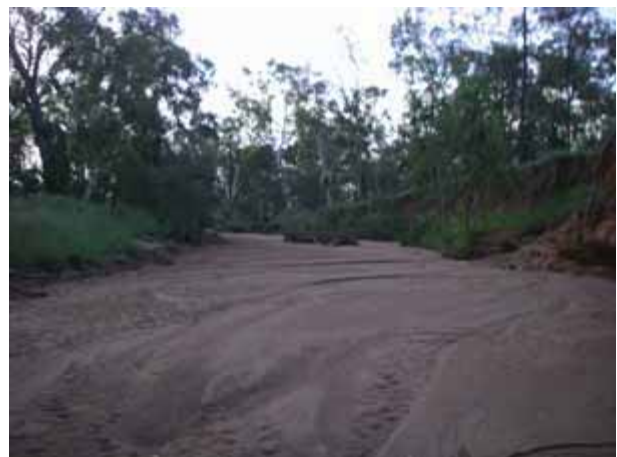
**Plate 6-1**      **Nine Mile Creek**

Stability of banks: Moderate: most areas covered with vegetation (grasses and trees), however undermining of the banks is occurring at bends.

Both looking downstream

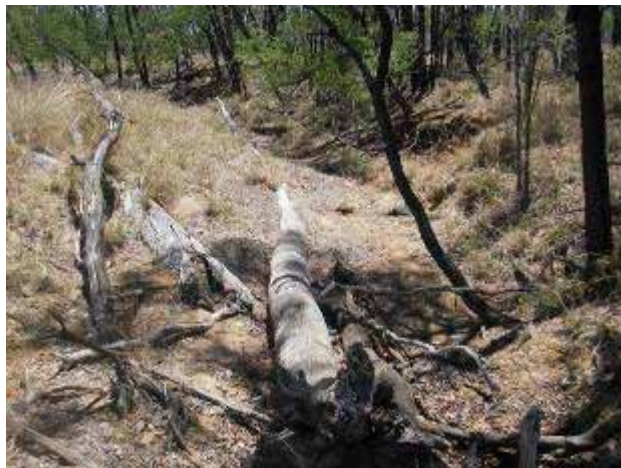
**Plate 7-1 Horse Creek Site 1 Downstream from crossing**

Downstream from road crossing

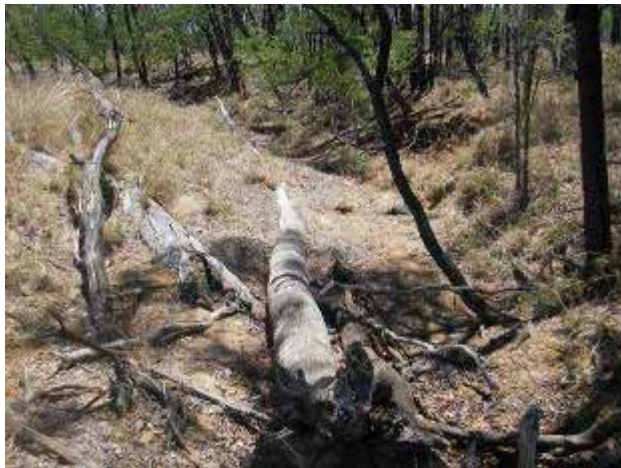
**Plate 7-2 Horse Creek Site 2 Upstream**

| Stability of banks: | Poor: undermining and over bank erosion. |
| Additional comments: | Track and cow path causing water to pond upstream. High amounts of fine suspended solids. |

Looking upstream

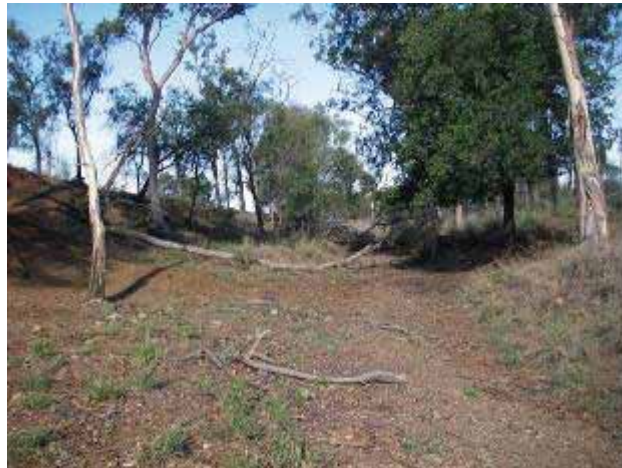
**Plate 7-3 Horse Creek Site 3 Downstream**

| Debris and tree roots: | A number of log jams were present – obstructing approximately 70% waterway area. |

Looking downstream

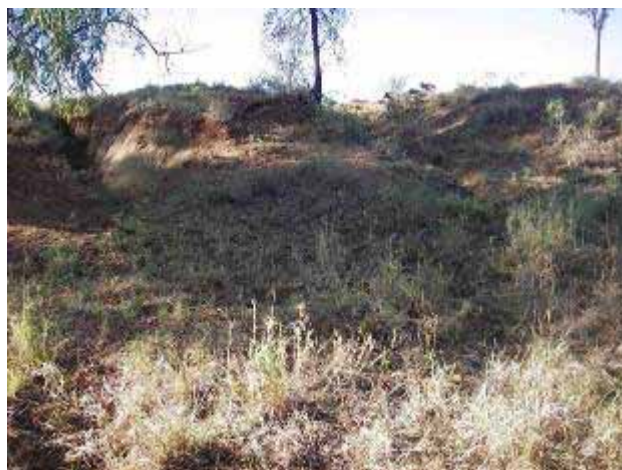
**Plate 7-4 Overbank Erosion**

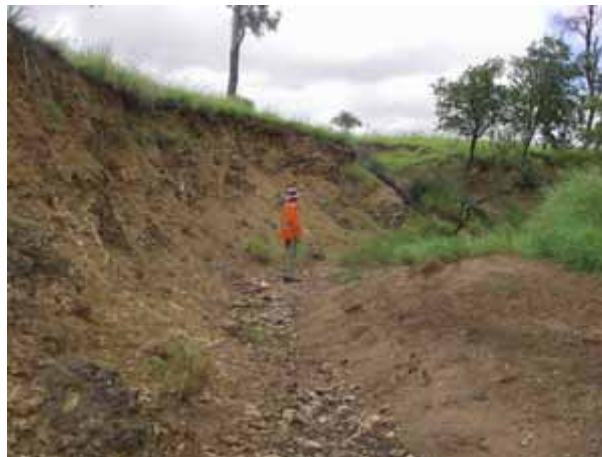
**Plate 7-5 Horse Creek Site 4**

Weathered basalt on bend

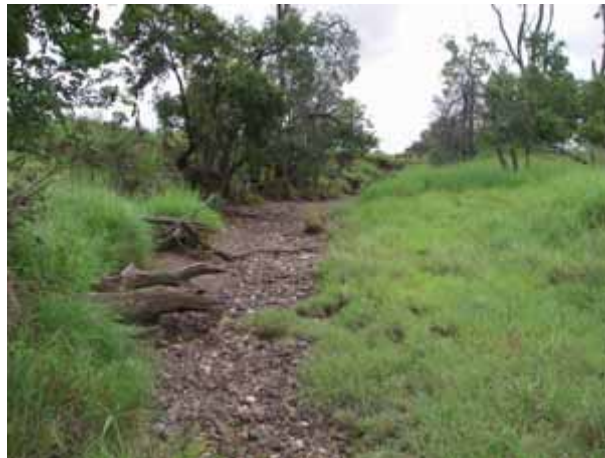
Plate 7-6 Horse Creek Site 4

Rock bed material, approximately 15-20cm

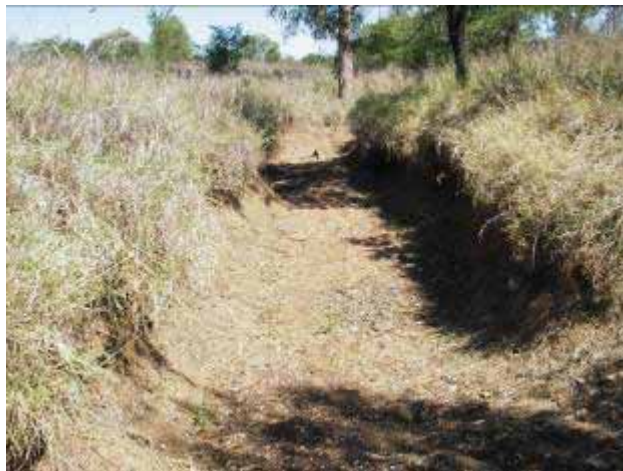
**Plate 7-9 Horse Creek Site 6 Downstream**

Stability of banks: Moderate: direct bank scour, undermining and some overland erosion. Evidence of disturbance by cattle.

Looking upstream

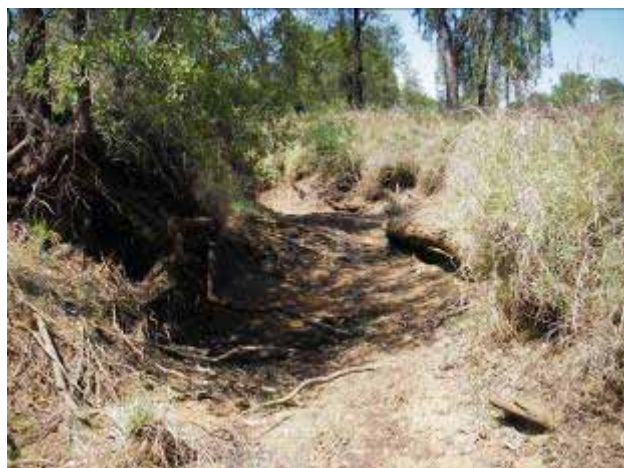
**Plate 7-10 Horse Creek Site 6 Upstream**

Looking downstream at pool

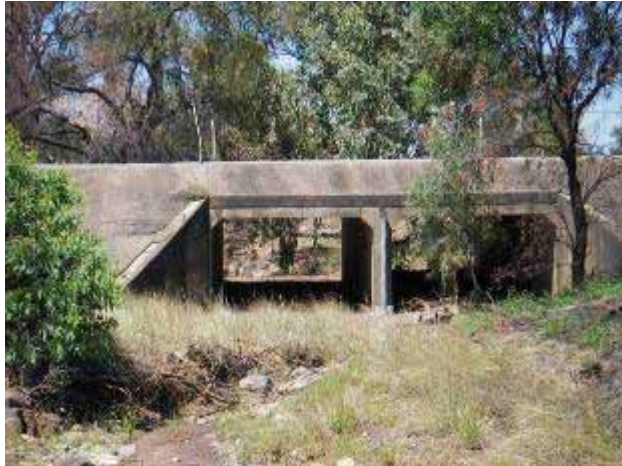
**Plate 7-11 Culverts on Horse Creek (Site 6)**

This site is located at E609878, N7560360 (refer attached figure). It is upstream of the road crossing which consists of two 3m wide by 1.8m high culverts (located at E609997, N7560449). The distance from the obvert to the road crest is 1m.

Horse Creek crossing culverts, looking downstream

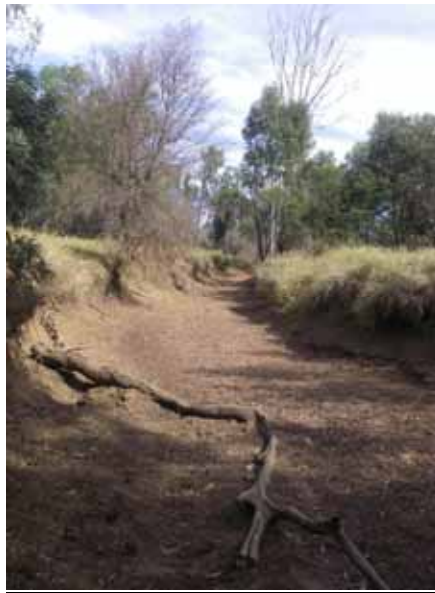
**Plate 7-12 Horse Creek Site 6 Upstream**

Looking upstream from road crossing

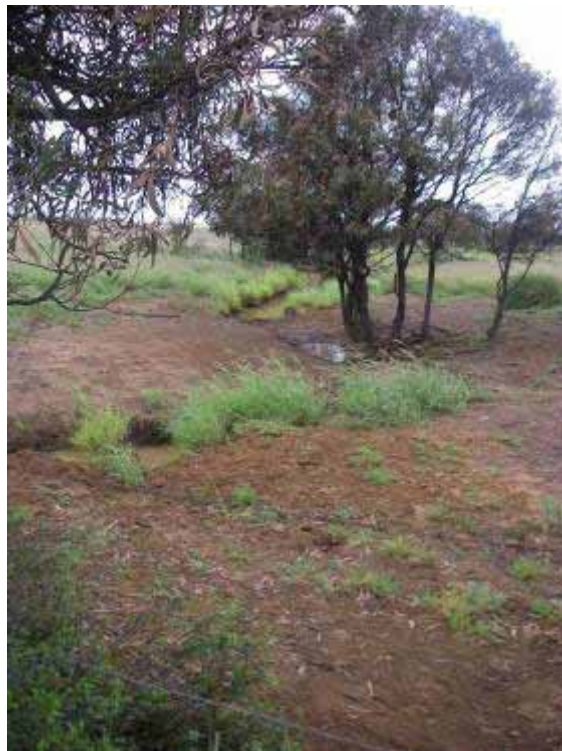
**Plate 8-1 Horse Creek Tributary 1 Site 1**

Additional comments: Profile of the creek is altered by the track and cattle interference in this location.

Horse Creek tributary

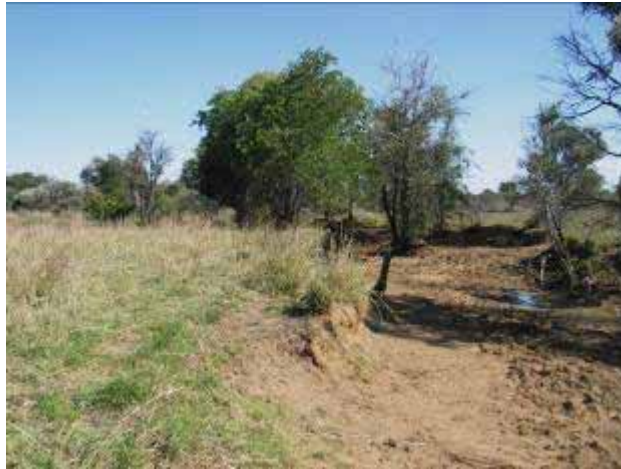
**Plate 9-2 Horse Creek Tributary 2 Upstream**

Just upstream of dam

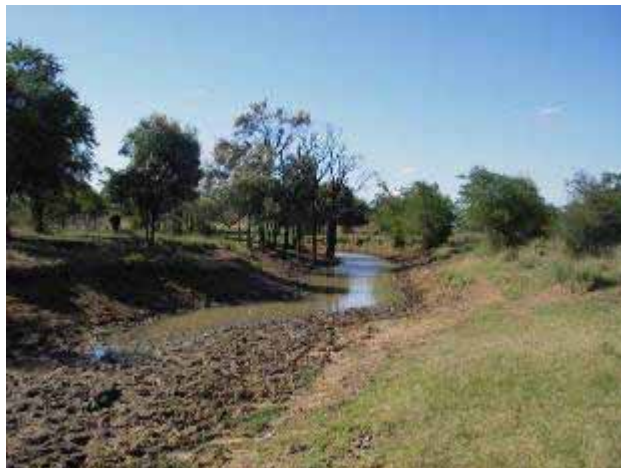
**Plate 9-3 Horse Creek Tributary 2 Downstream**

Downstream of dam

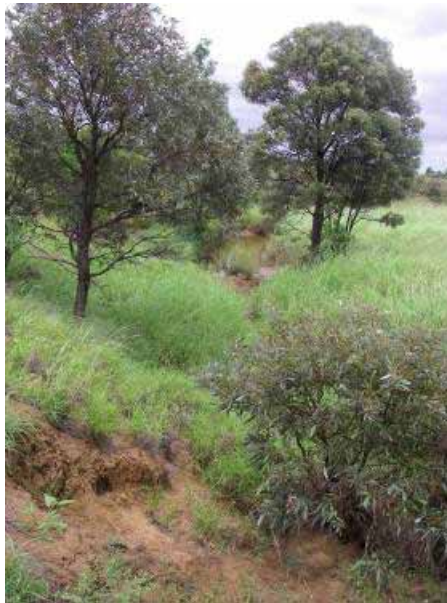
**Plate 9-4 Horse Creek Tributary 2 Site 2**

Pool upstream of crossing

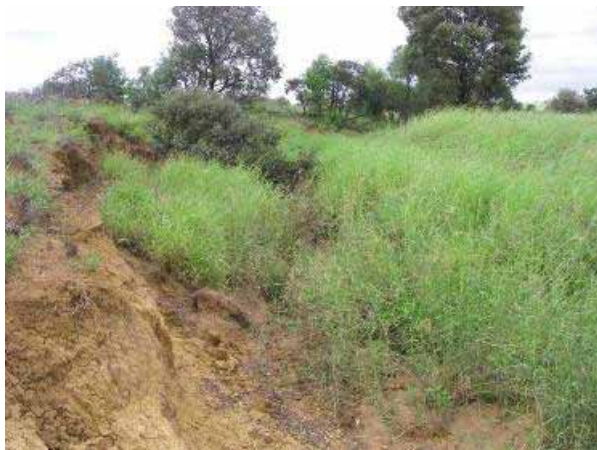
**Plate 9-5 Horse Creek Tributary 2 Site 2**

Looking upstream from crossing

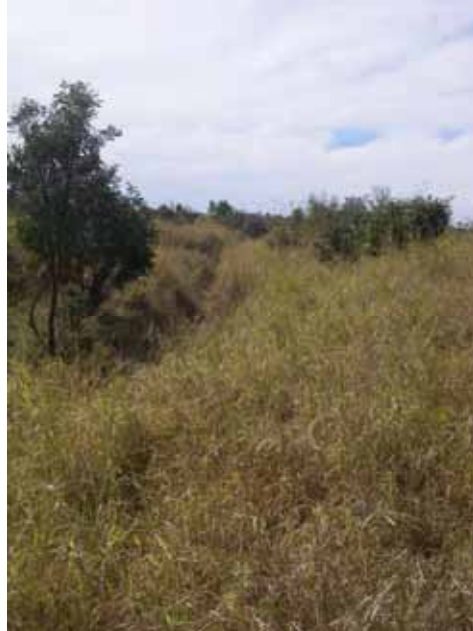
**Plate 9-6 Horse Creek Tributary 2 Site 2 Upstream**

Looking upstream

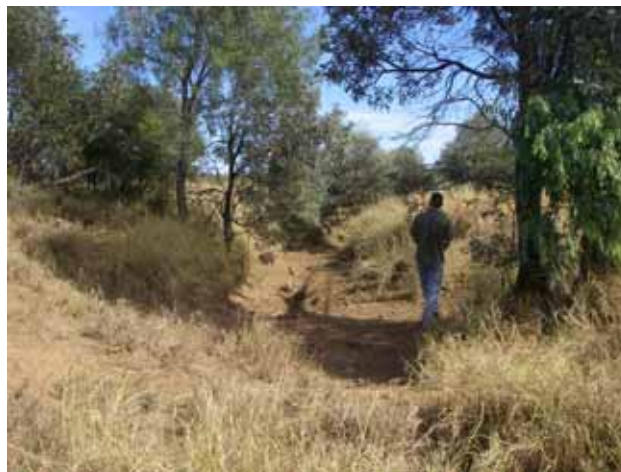
**Plate 9-7 Horse Creek Tributary 2 Site 2 Downstream**

Looking downstream

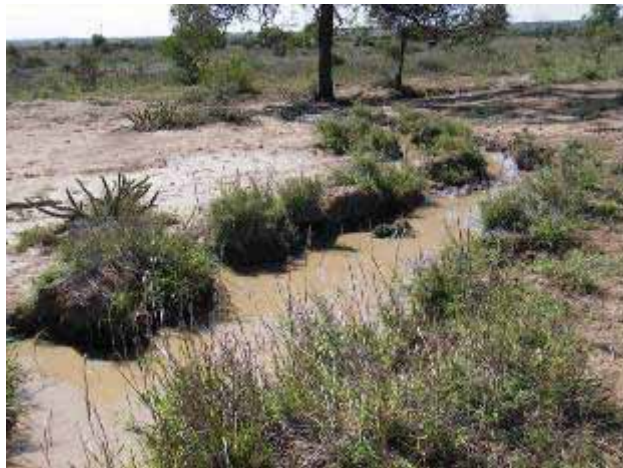
**Plate 10-1 Horse Creek Tributary 3 Downstream**

Additional comments: Creek ends downstream may have been earthworks.

Looking downstream

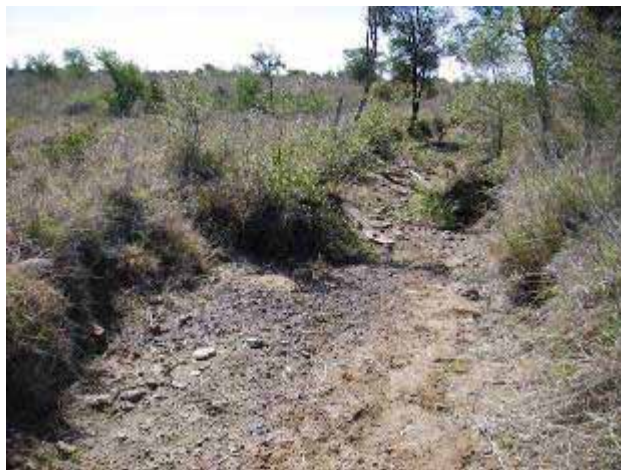
**Plate 11-1 Horse Creek Tributary 4 Downstream**

Looking downstream

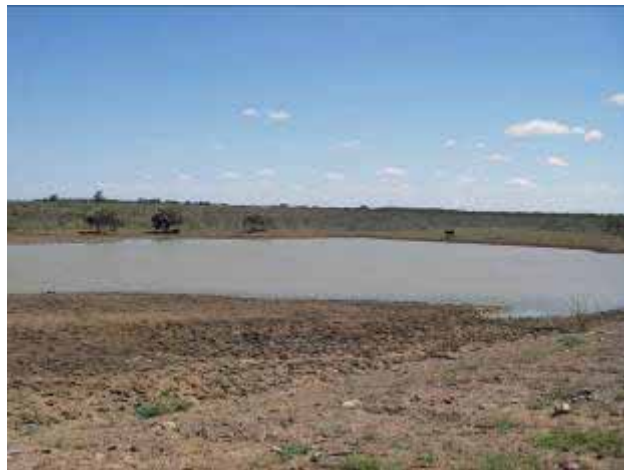
**Plate 11-2 Horse Creek Tributary 4 Site 2, Farm Dam**

Substrate: Muddy  
Water: Translucent (yellow/green)  
Debris and tree roots: None  
Overbanks: Grasses with sparse riparian vegetation  
Additional comments: Water backed up from dam.

Dam looking upstream
