# LINDEMAN GREAT BARRIER REEF RESORT PROJECT

# PRELIMINARY GEOTECHNICAL ASSESSMENT

## LINDEMAN ISLAND REDEVELOPMENT

HRP15078

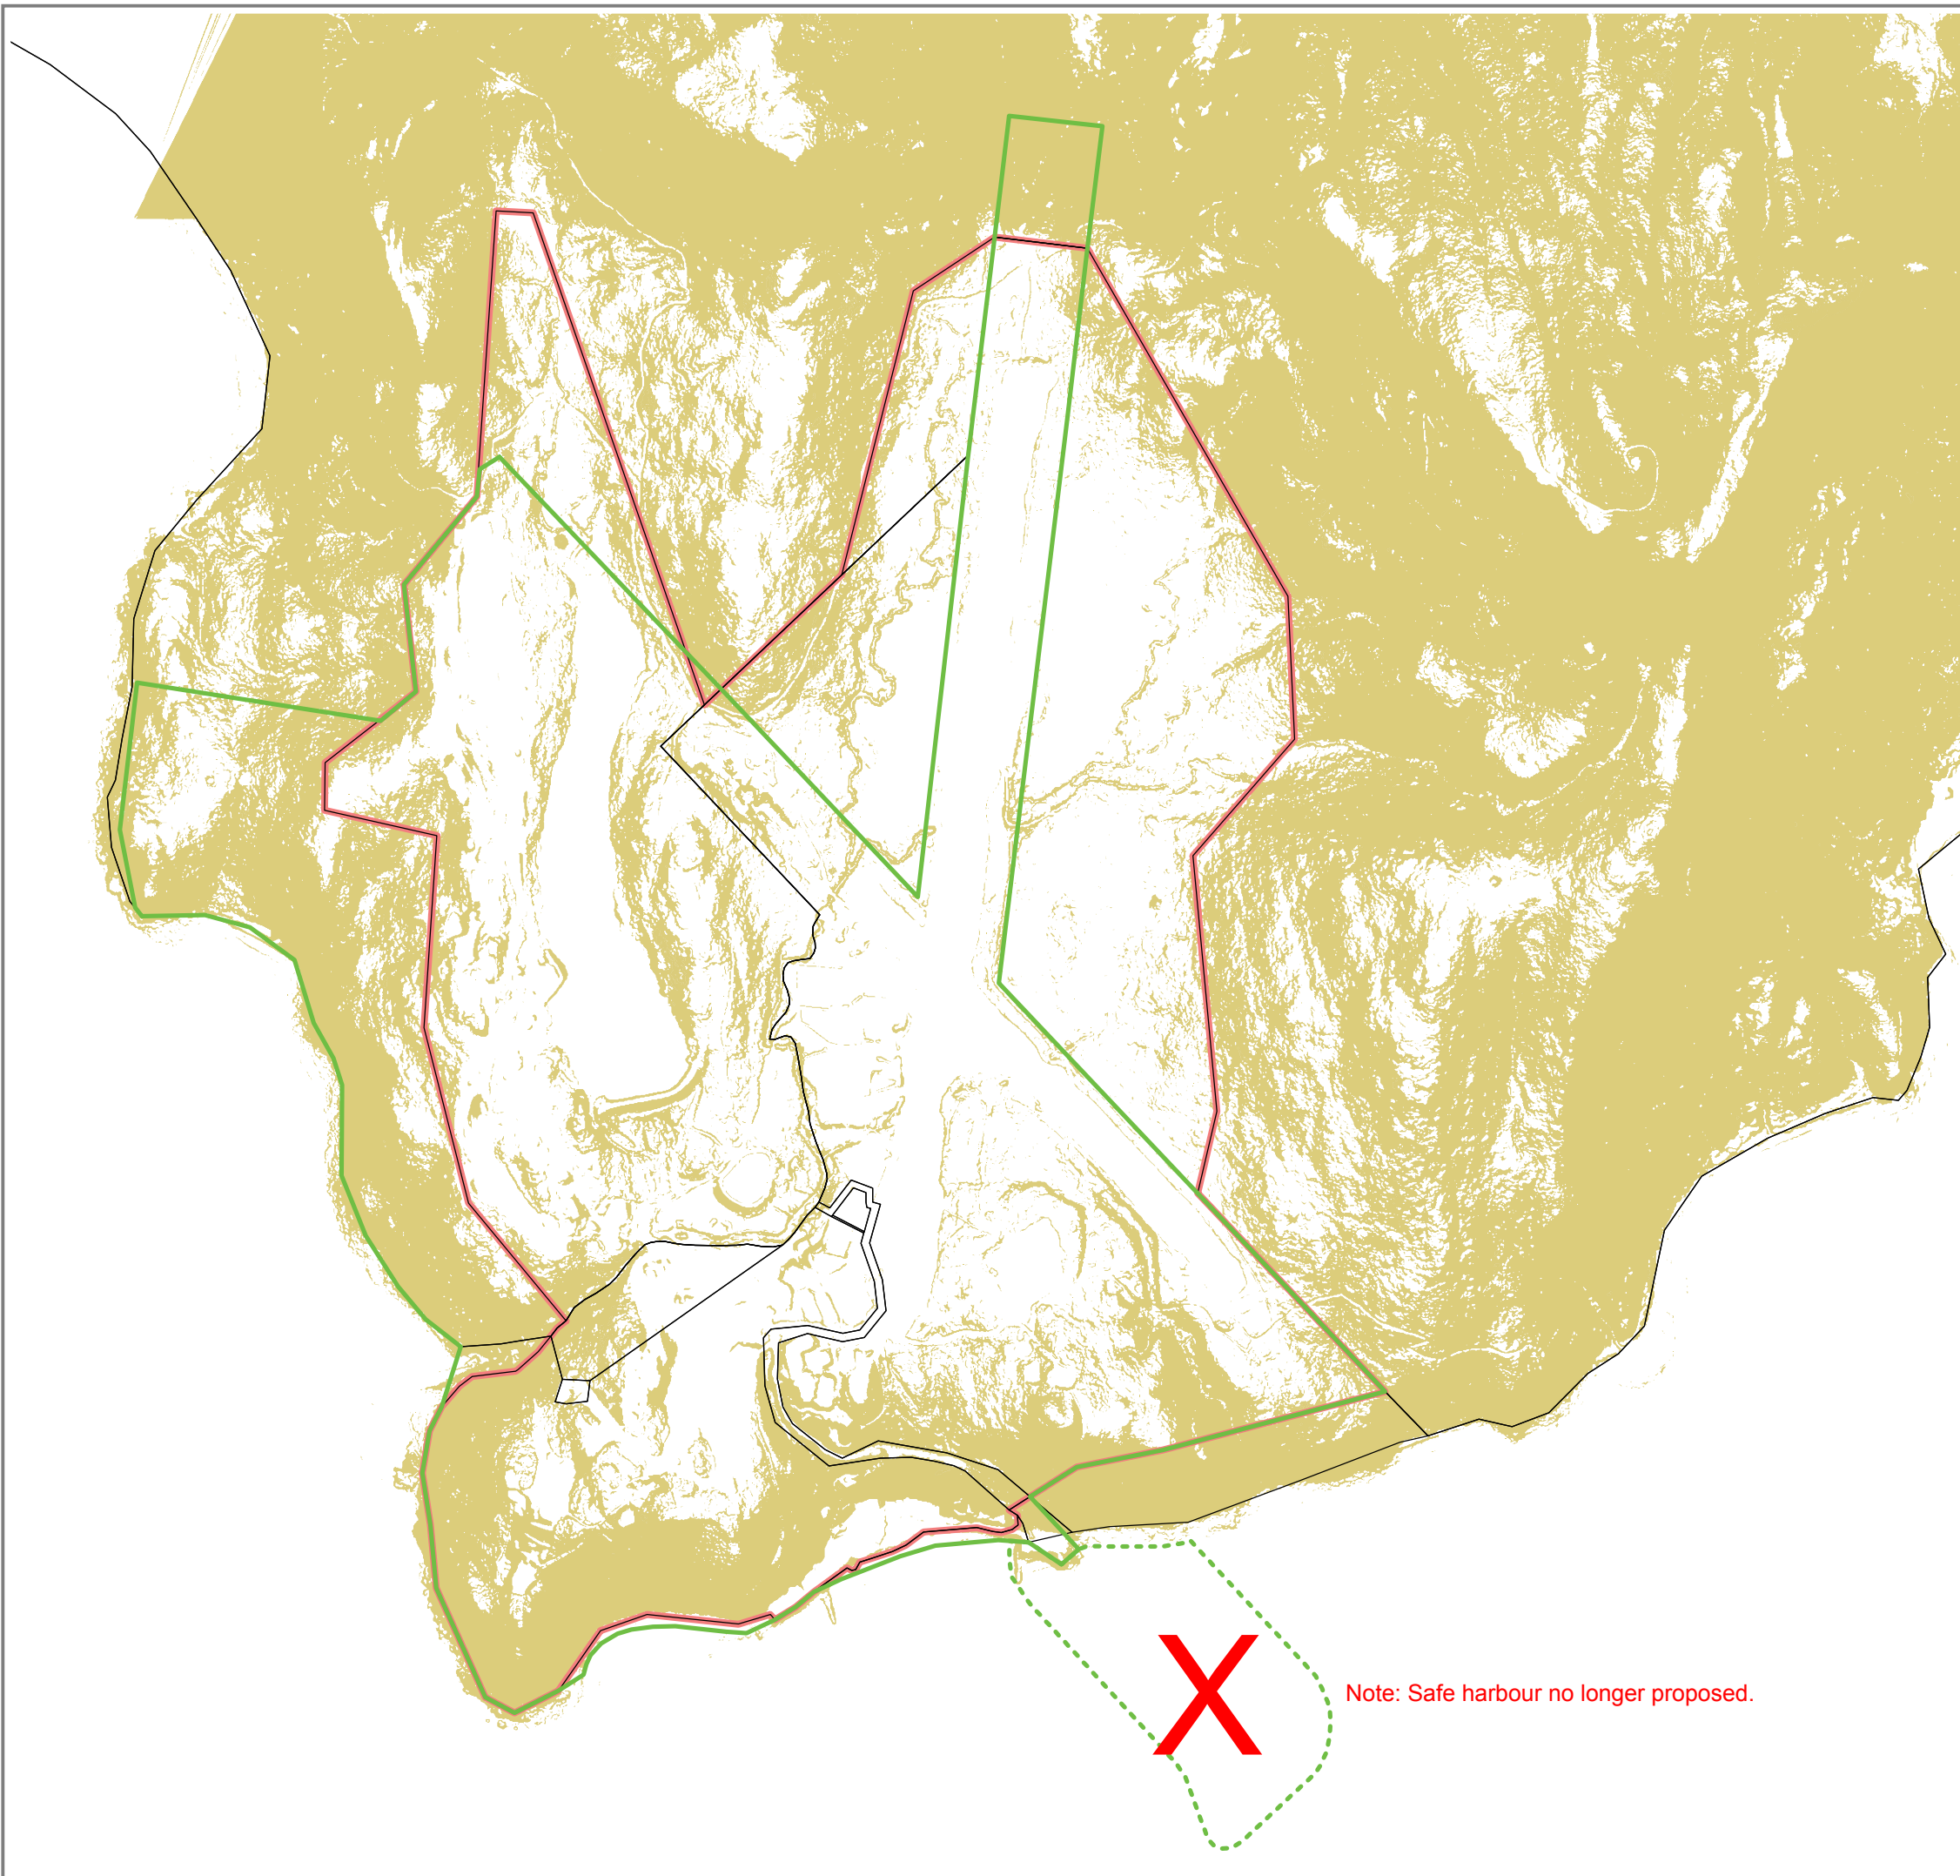
FIGURE **2**

The slopes on the island in the areas of proposed new and redevelopment appears to be suitable for the proposed structures and infrastructure. The slopes greater than 15% see Figure 2, will need to be developed in a manner of best practice (see guidelines in **Appendix D**) for construction of sloping areas. This will include minimising cut and fill earthworks, socketing or anchoring footings into bedrock, ensuring drainage does not concentrate overland flow and revegetating strip areas as soon as possible.

## Location of Slopes Greater than 15%

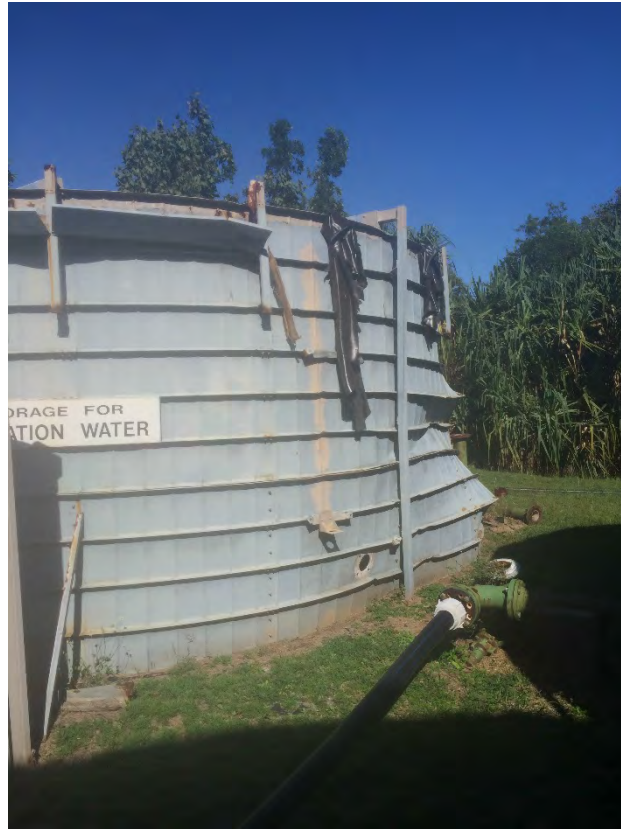
**Photo 5: Burst water storage tank**

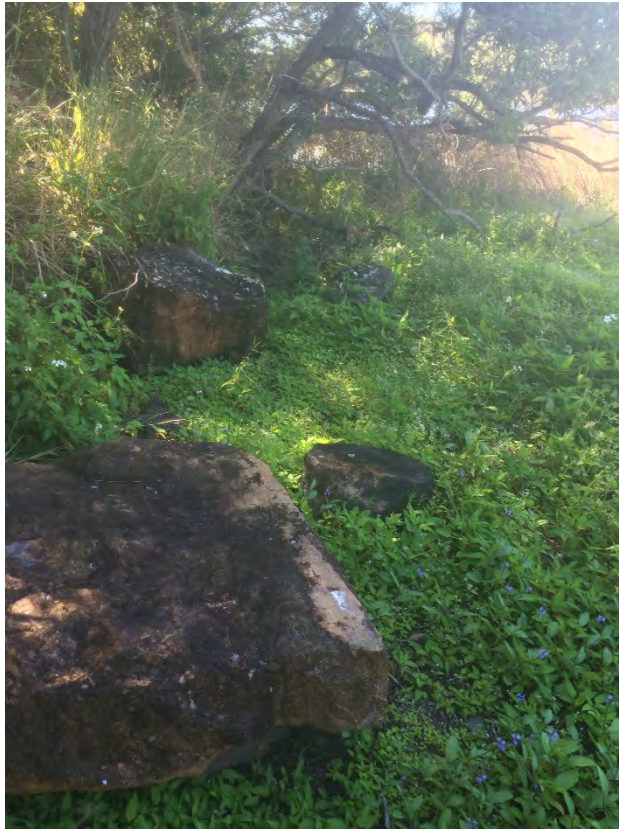
There were trees and shrubs growing on the downstream embankment wall at a low level near the toe. There was also slope fall debris (boulders up to 1.0m) and vegetation in the spillway channel that could obstruct any flow. We recommend the trees are cut and poisoned with follow up visual monitoring to see if there is any increased seepage or piping in the areas where the tree roots exist. The spillway channel needs to be cleaned out.

**Photo 7: Boulder and vegetation in dam spill way**

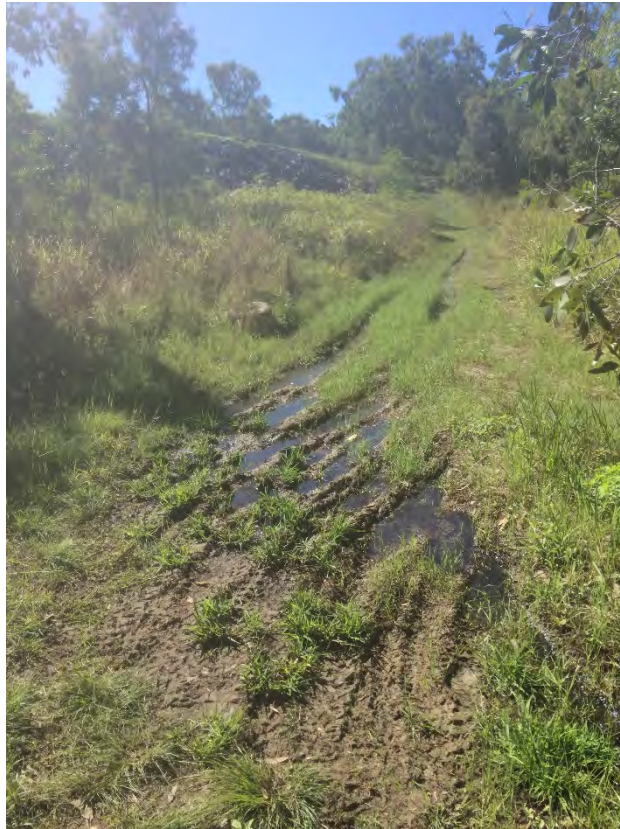
**Photo 11: Dam downstream wall with seepage area**

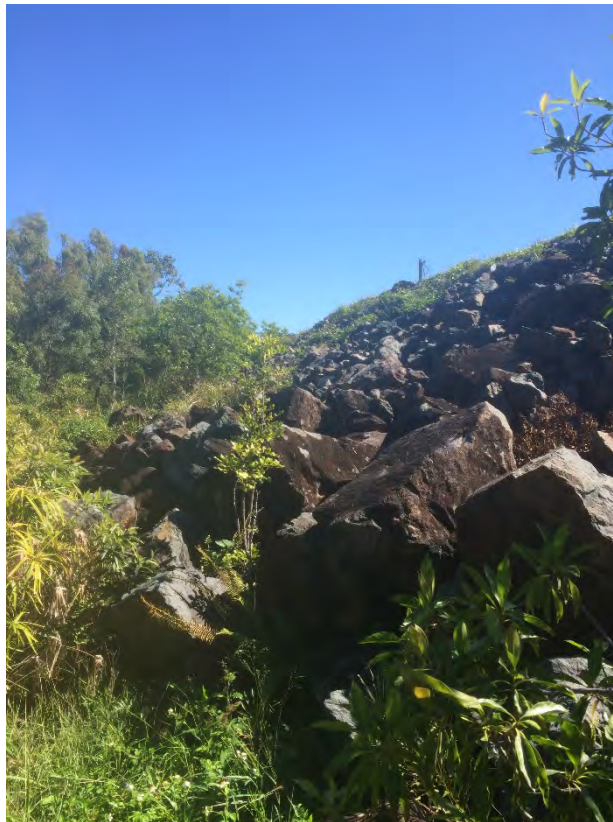
**Photo 12: Downstream dam wall with tree growing**
