# Visual Comparison of Landscape Type

Client: CopperString 2.0  
Reference: J0XXX

This document is a visual comparison of landscapes which was compiled to provide a photographic record both from an aerial and site-based perspective along each of the five corridor selection segments. This ground truthing was utilised to inform the projects appreciation of the six general landscape types which occur across the study area as well as improved confidence in the potential conservation significant species habitat mapped for the CopperString EIS 2.0. It has also been used to confirm expected disturbance associated with construction related activities.

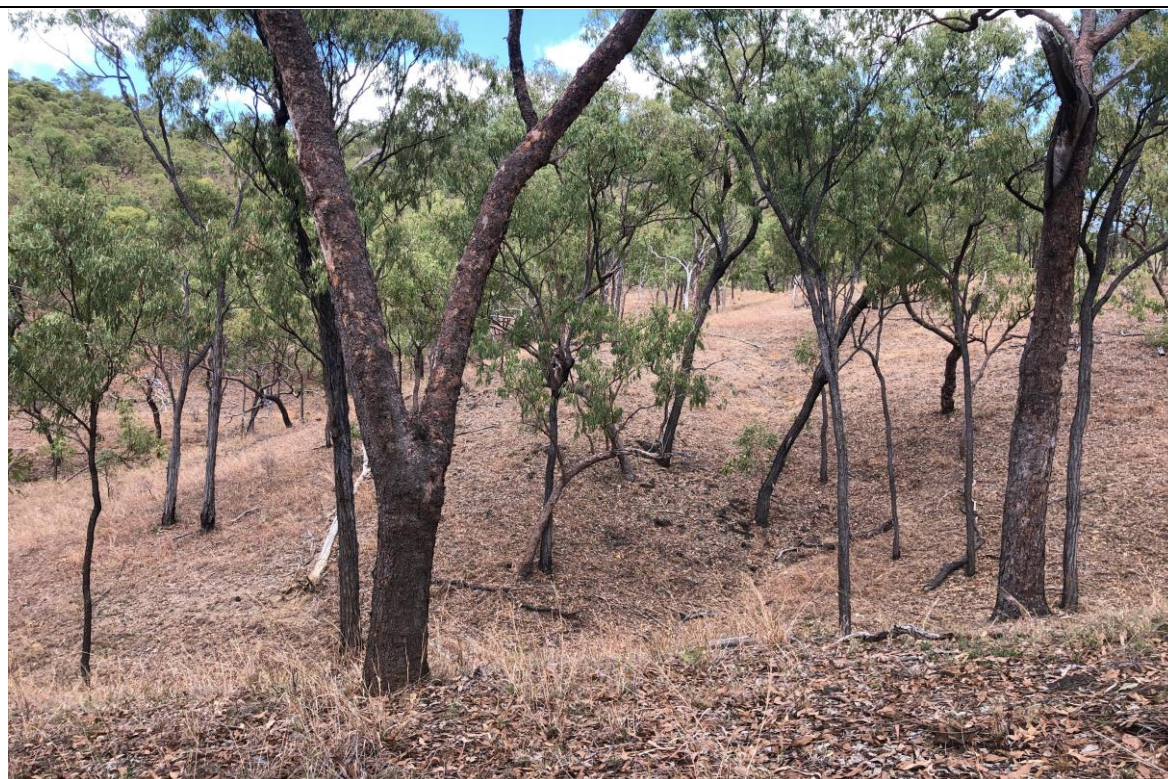
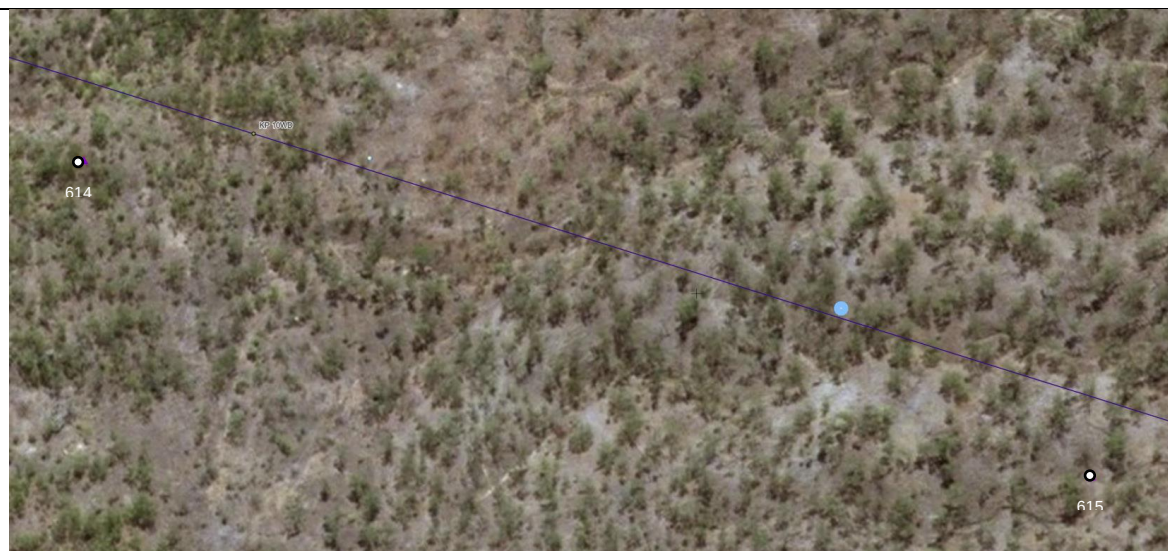
Line 1 KP 9.7 WD (65,0,35,0) Koala survey point (GHD) (blue) near Tower 615  
(419.63m between towers 614-615)

This section is described as 65% very light, 0% light, 35% moderate and 0% heavy by the clearing contractor. Field observations show a mid-dense canopy covers most of this section with tree heights averaging at 15m. Observations on the ground reflect the clearing contractor's description within this section of the alignment

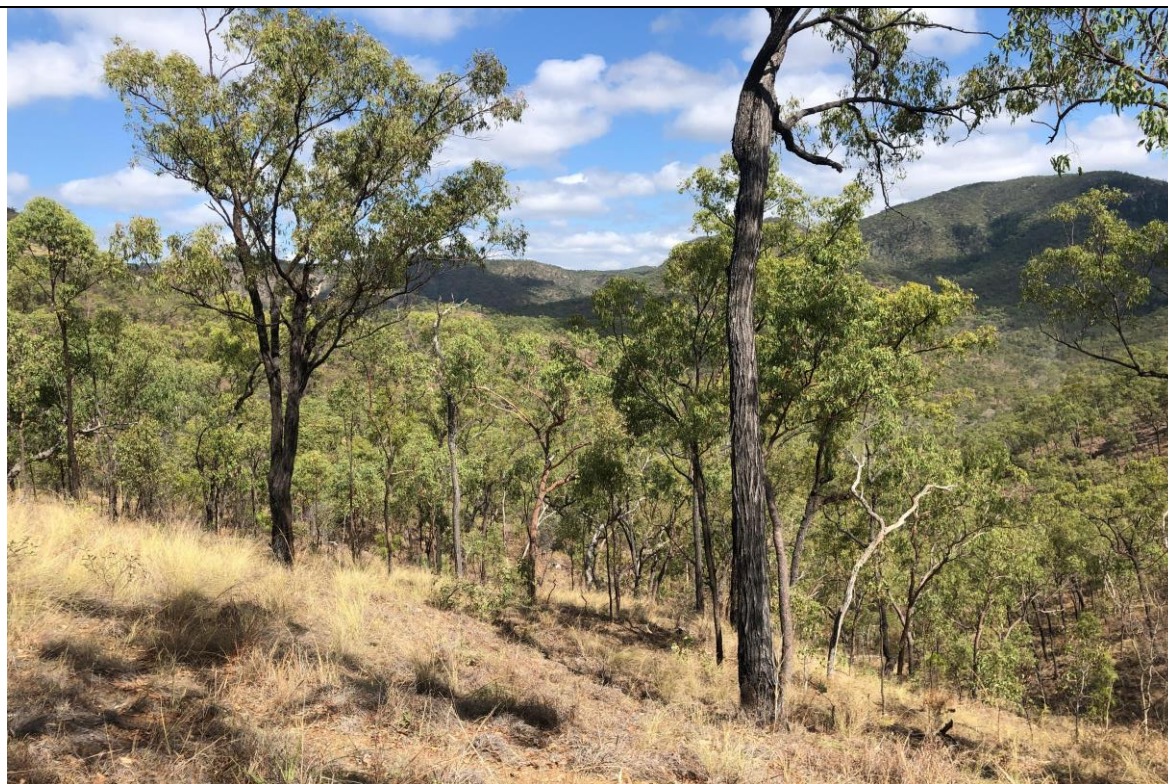
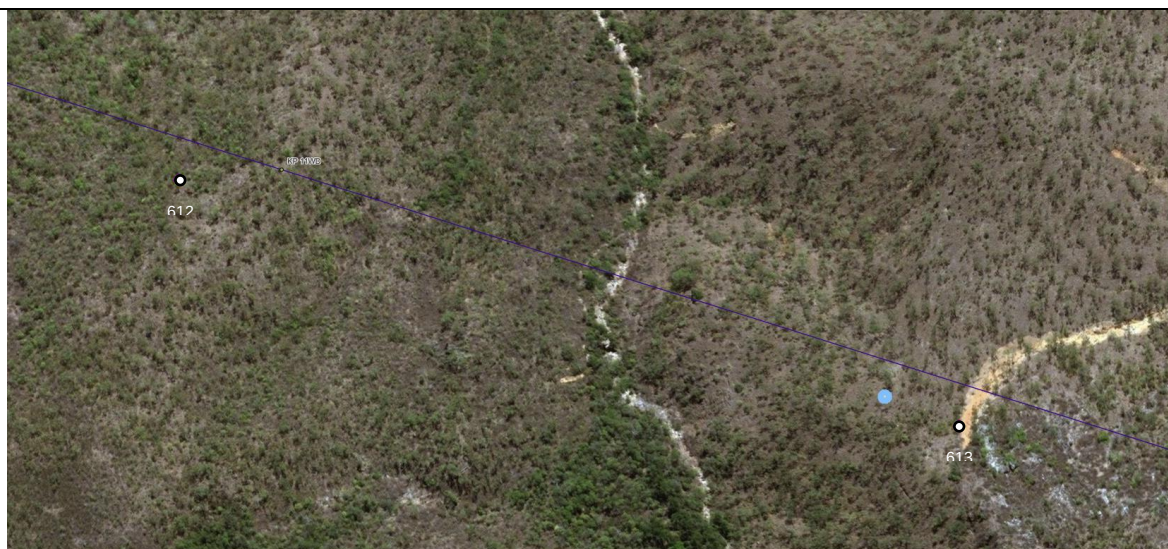
Line 1 KP 10.5 WD (65,0,35,0) Koala survey point (GHD) (blue) near Tower 613  
(650.55m between towers 612-613)

This section is described as 65% very light, 0% light, 35% moderate and 0% heavy by the clearing contractor. Field observations show a riparian woodland along a 10m wide watercourse west of the survey point. The mid-dense canopy covers the riparian canopy that fringes the watercourse and most of this section with tree heights averaging at 9m. Observations on the ground reflect the clearing contractor's description within this section of the alignment.

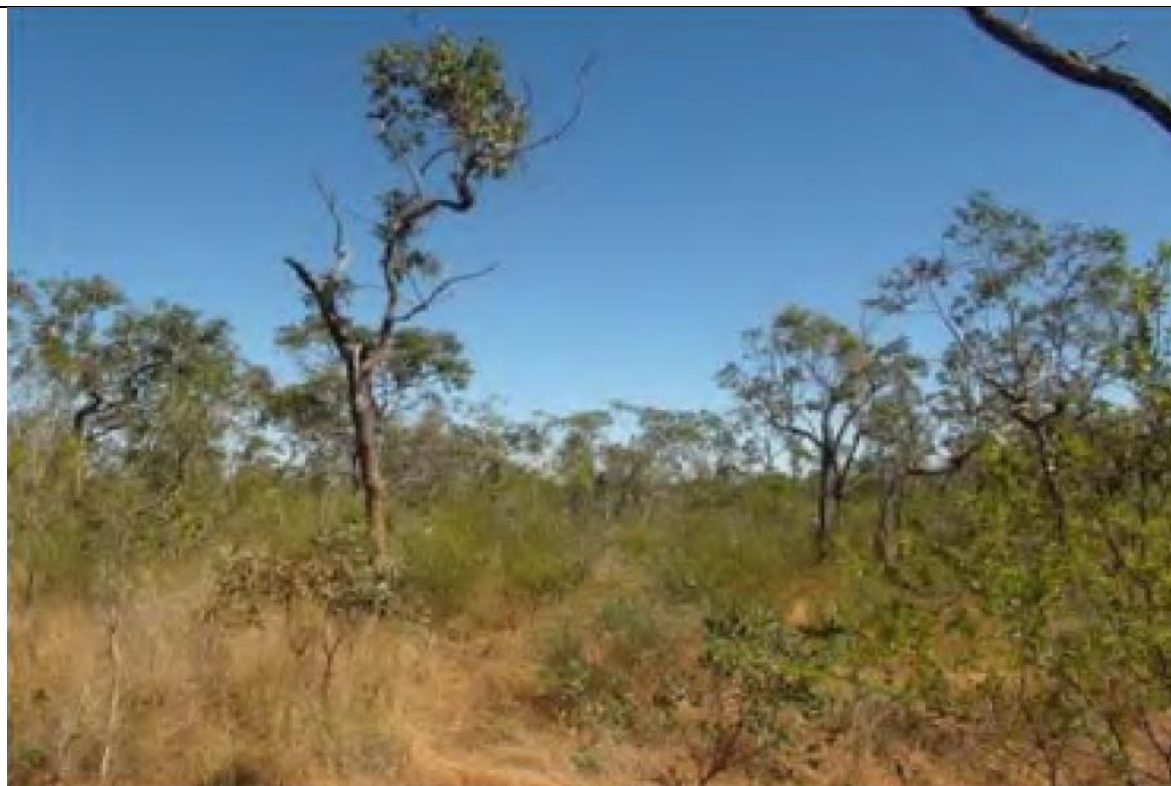
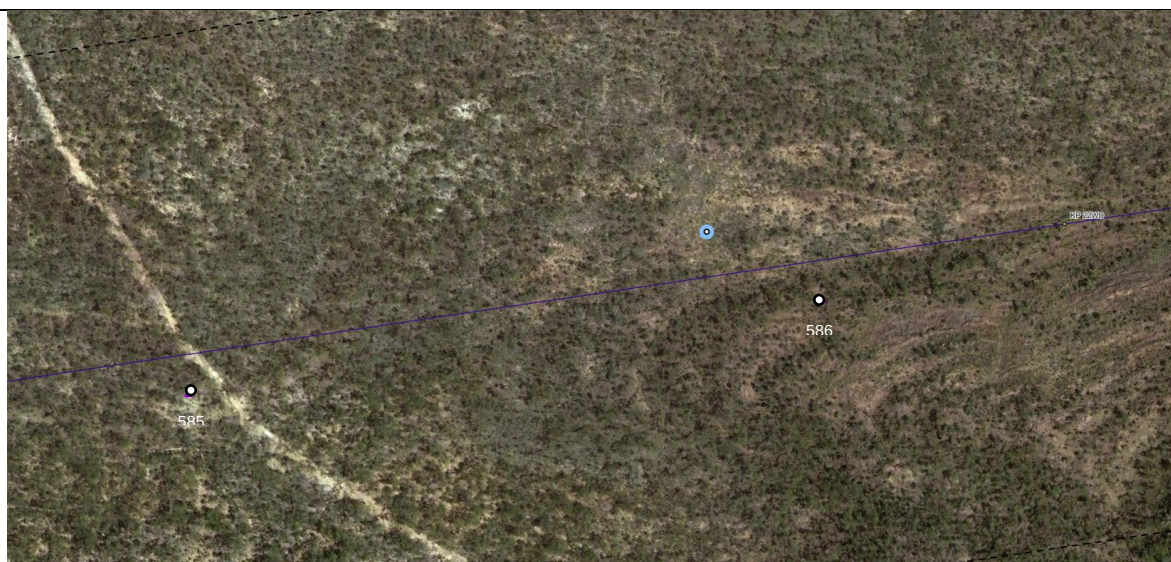
Line 1 KP 22.3 WD (5,0,25,70) Koala survey point (BAAM) (blue) near Tower 586  
(504.57.13m between towers 585-586)

This section is described as 5% very light, 0% light, 25% moderate and 70% heavy by the clearing contractor. Field observations show a sparse to mid-dense canopy covers most of this section with tree heights averaging at 7m. Observations on the ground reflect the clearing contractor's description within this section of the alignment.

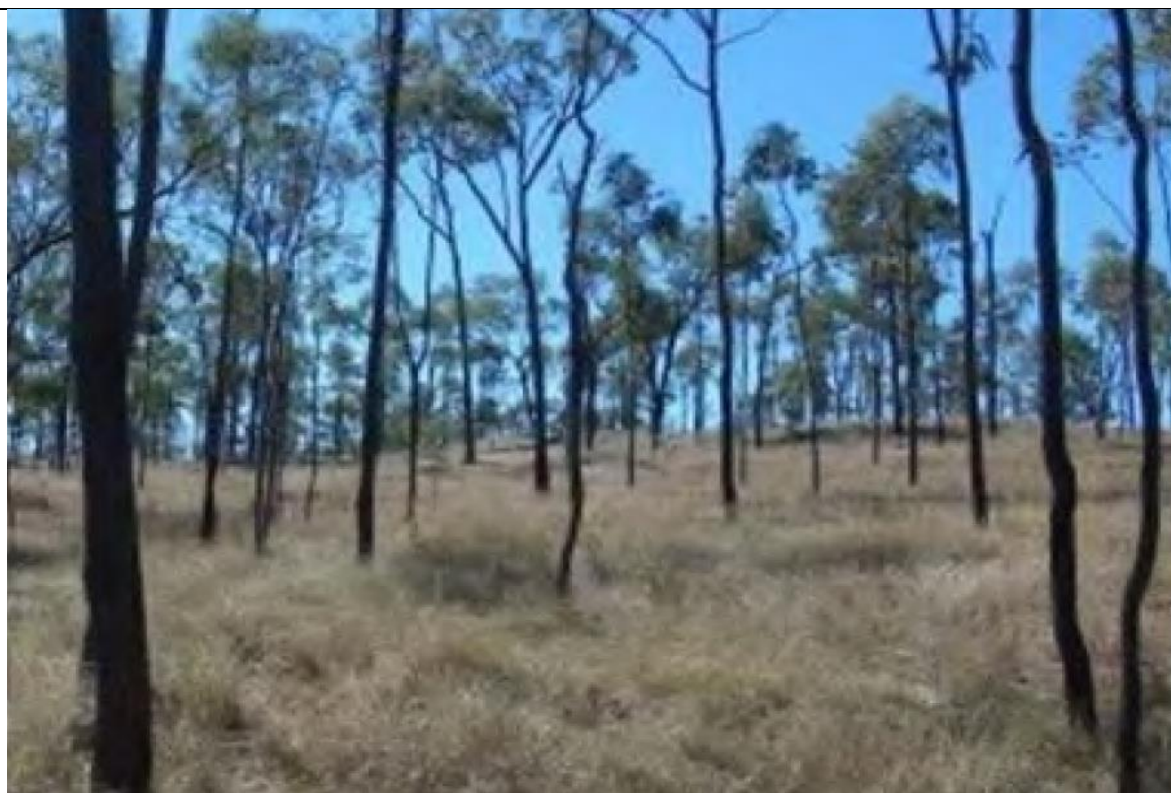
Line 1 KP 28.9 WD (10,0,40,40) Koala survey point (BAAM) (blue) near Tower 571  
(469.13m between towers 570-571)

This section is described as 10% very light, 0% light, 40% moderate and 40% heavy by the clearing contractor. Field observations show a riparian woodland along a 20m wide watercourse west of the survey point. The mid-dense canopy covers the riparian canopy that fringes the watercourse and most of this section with tree heights averaging at 6m. Observations on the ground reflect the clearing contractor's description within this section of the alignment.

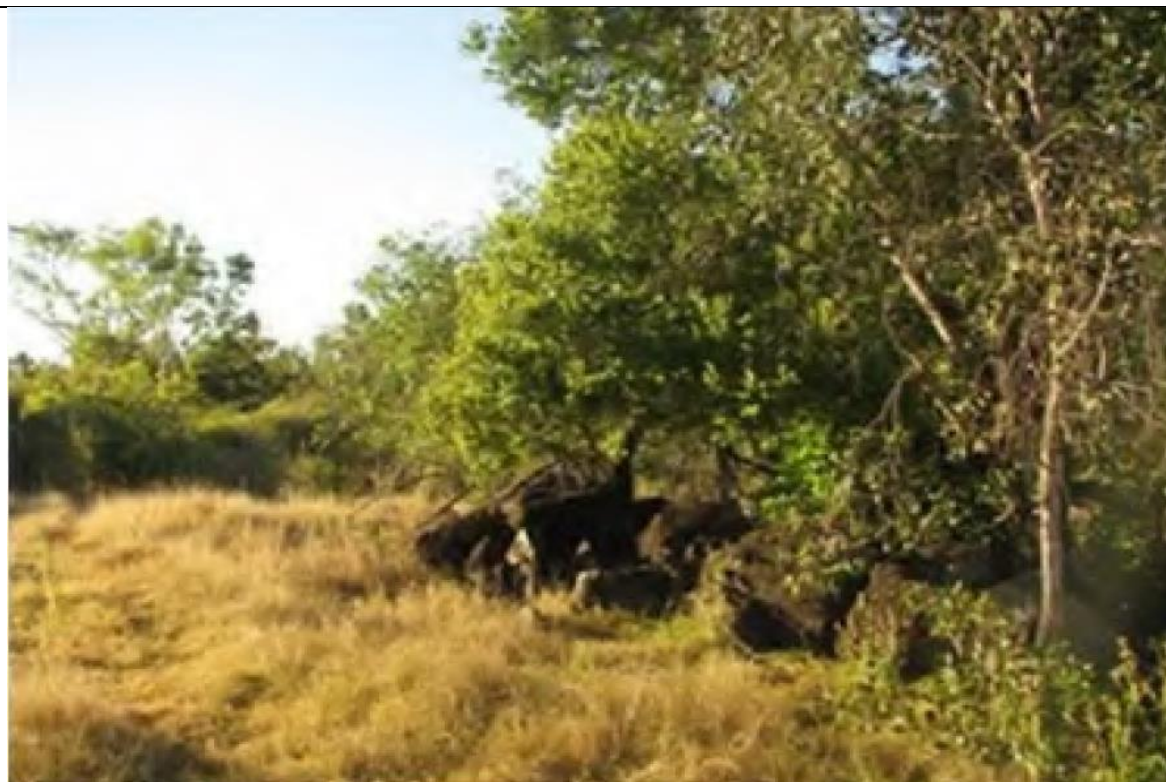
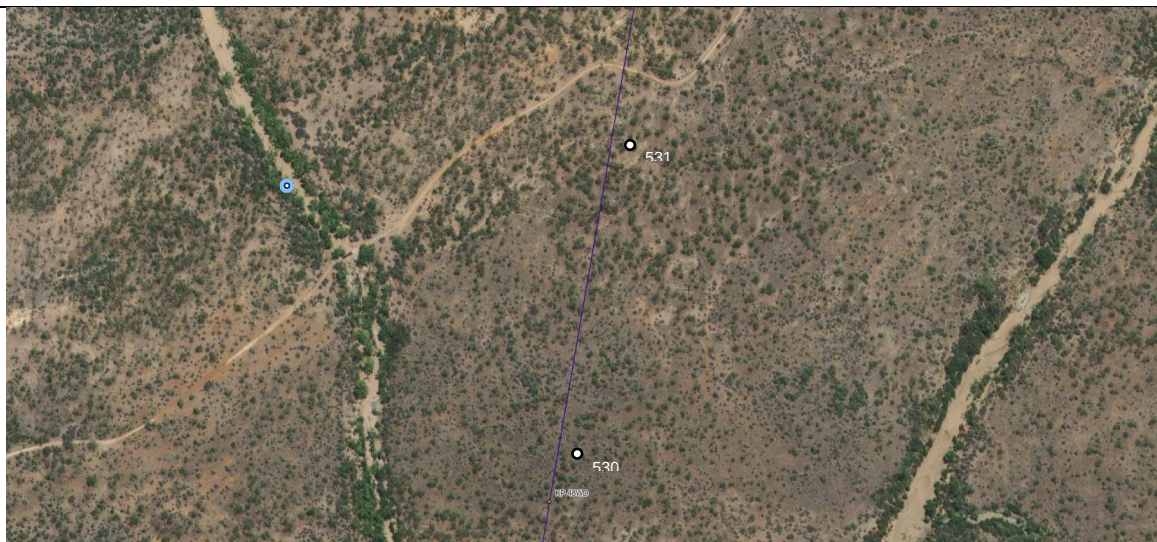
Line 1 KP 47.5 WD (40,0,50,10) Koala survey point (BAAM) (blue) near Tower 530  
(493.02m between towers 530-531)

This section is described as 40% very light, 0% light, 50% moderate and 10% heavy by the clearing contractor. Field observations show a mid-dense canopy covers most of this section with tree heights averaging at 16m. Observations on the ground reflect the clearing contractor's description within this section of the alignment.

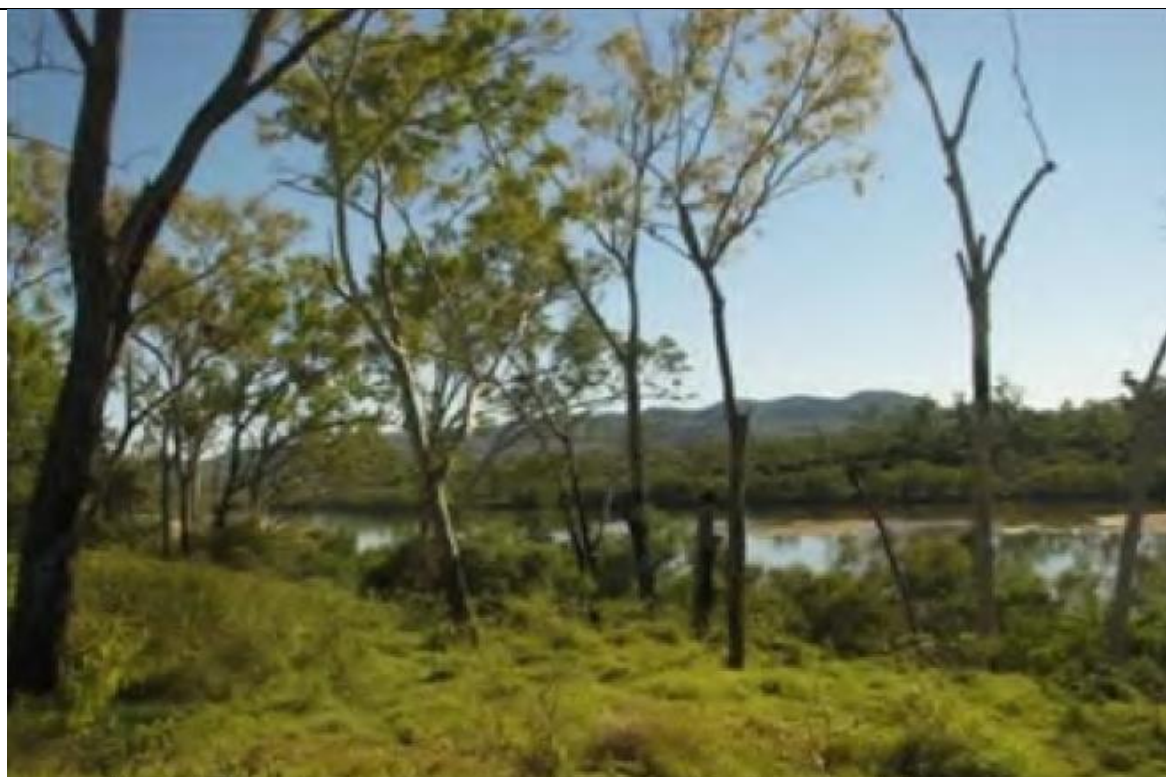
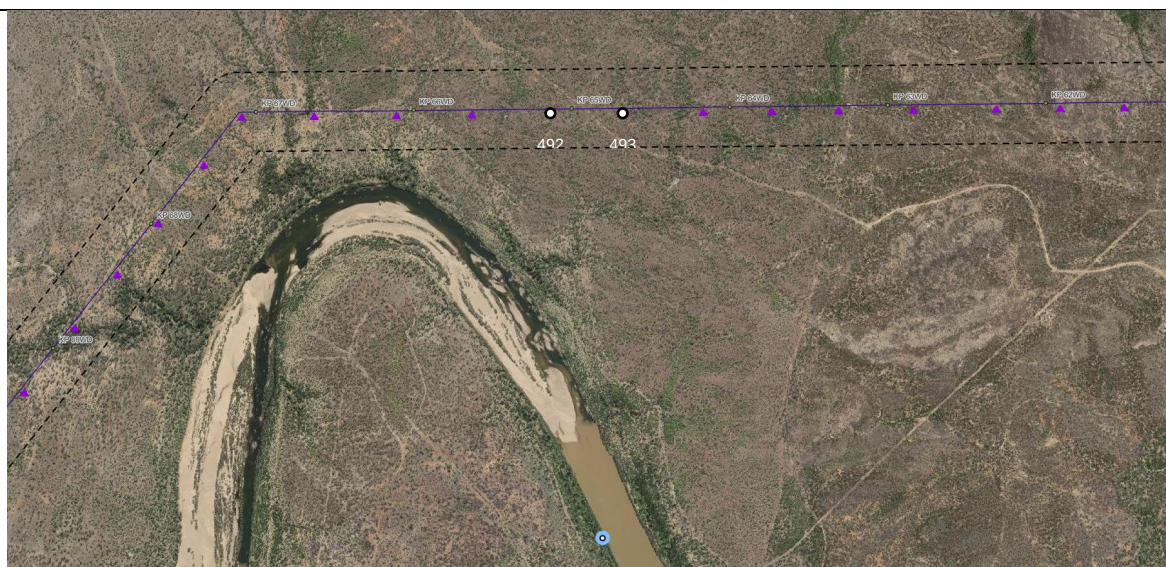
Line 1 KP 64.8 WD 6.7km south (50,10,40,0) Koala survey point (BAAM) (blue) near Tower 493  
(458.98m between towers 492-493)

This section is described as 50% very light, 10% light, 40% moderate and 0% heavy by the clearing contractor. Field observations show a riparian woodland along a 400m wide watercourse on the survey point south of the alignment. The mid-dense canopy covers the riparian canopy that fringes the watercourse and most of this section with tree heights averaging at 18m. Observations on the ground reflect the clearing contractor's description within this section of the alignment.

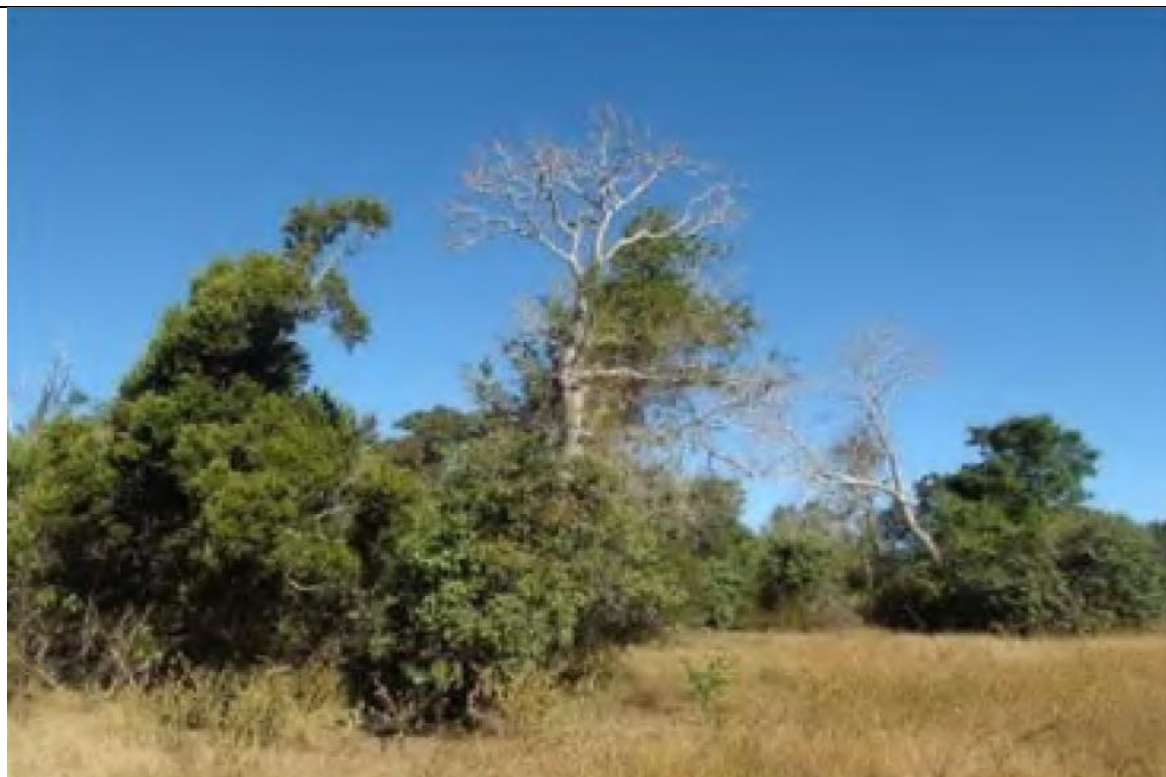
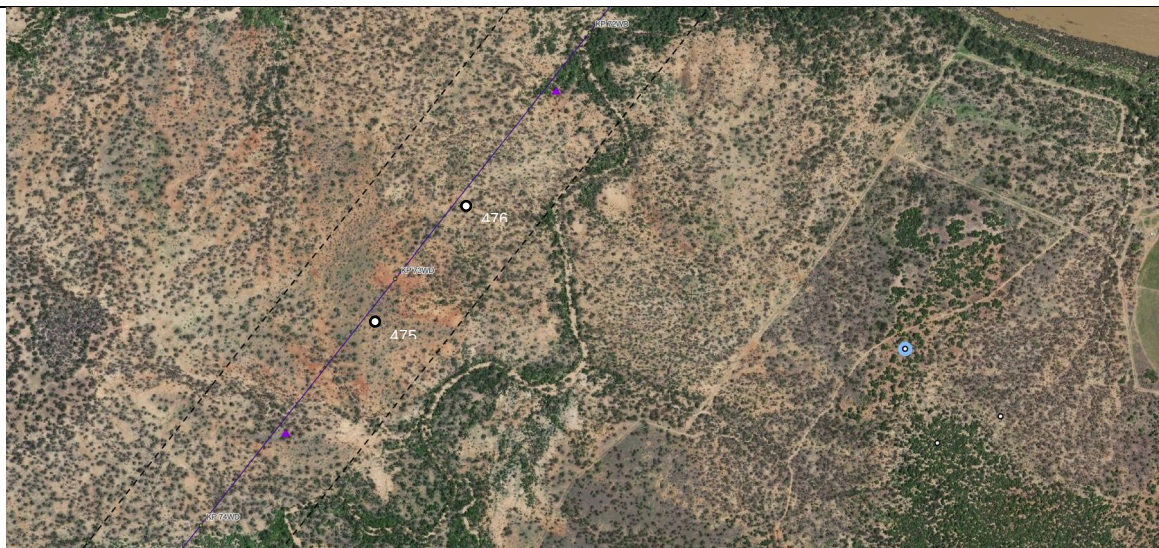
Line 1 KP 72.7 WD (70,20,10,0) Koala survey point (BAAM) (blue) near Tower 476  
(462.74m between towers 475-476)

This section is described as 70% very light, 20% light, 10% moderate and 0% heavy by the clearing contractor. Field observations show a sparse canopy covers a riparian woodland along a gully line and most of this section with tree heights averaging at 9m. Observations on the ground reflect the clearing contractor's description within this section of the alignment.

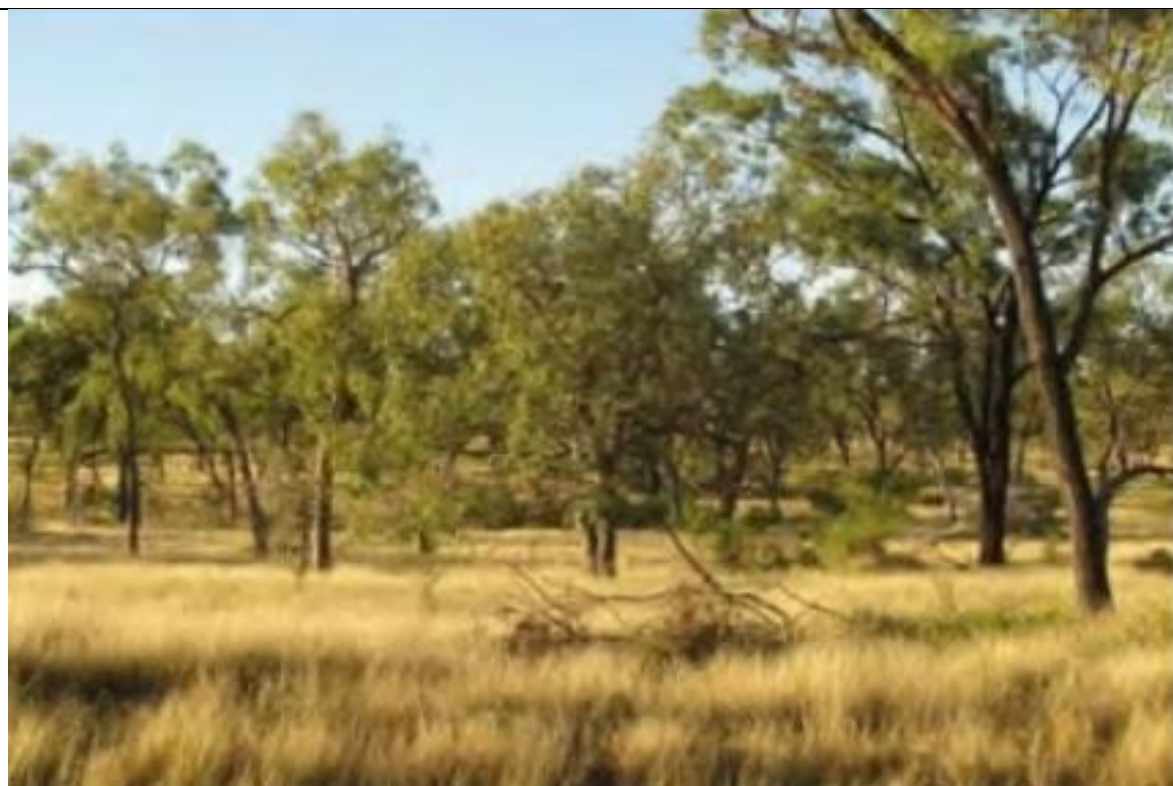
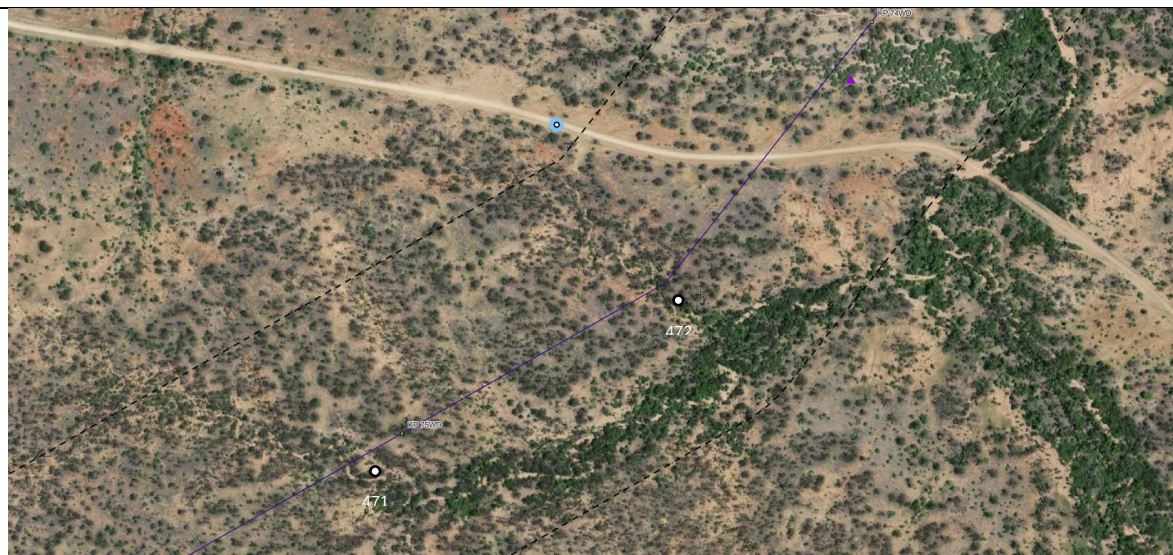
Line 1 KP 74.5 WD (60,10,30,0) Koala survey point (BAAM) (blue) near Tower 472  
(547.58m between towers 471-472)

This section is described as 50% very light, 10% light, 40% moderate and 0% heavy by the clearing contractor. Field observations show a riparian woodland along a 15m wide watercourse southeast of the survey point. The mid-dense canopy covers the riparian canopy that fringes the watercourse and gully line within this section, as well as most of this section with tree heights averaging at 11m. Observations on the ground reflect the clearing contractor's description within this section of the alignment.

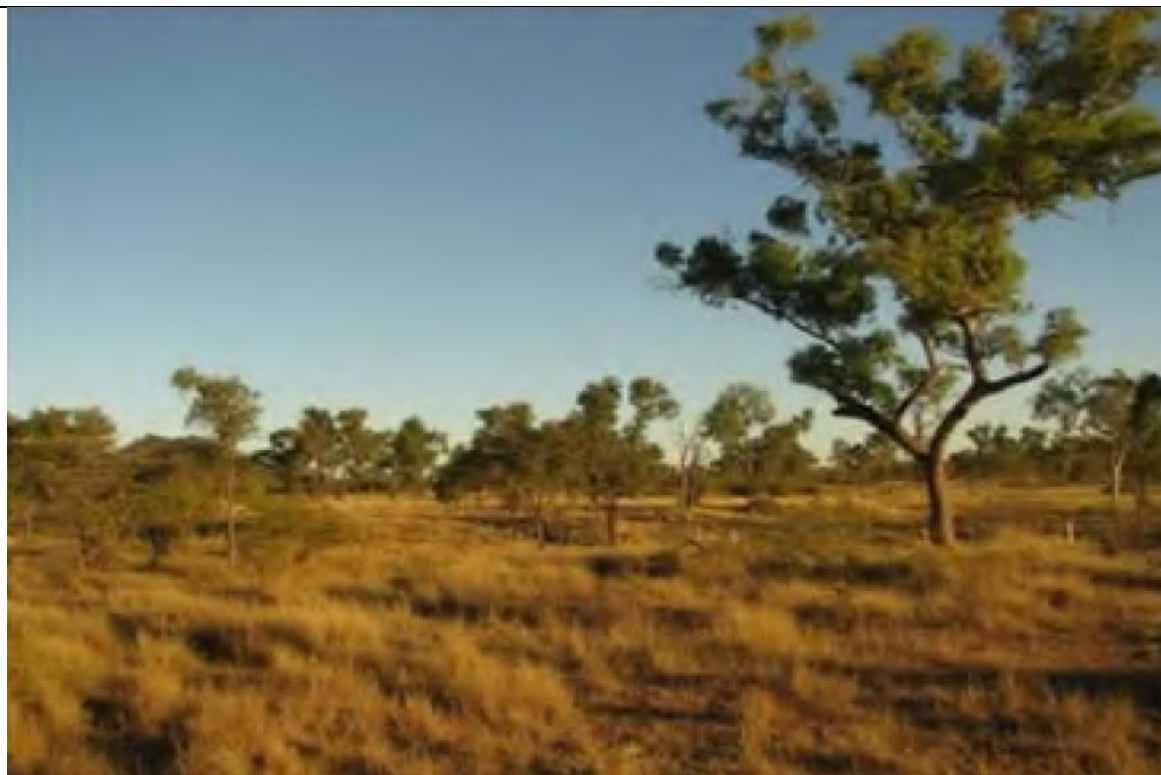
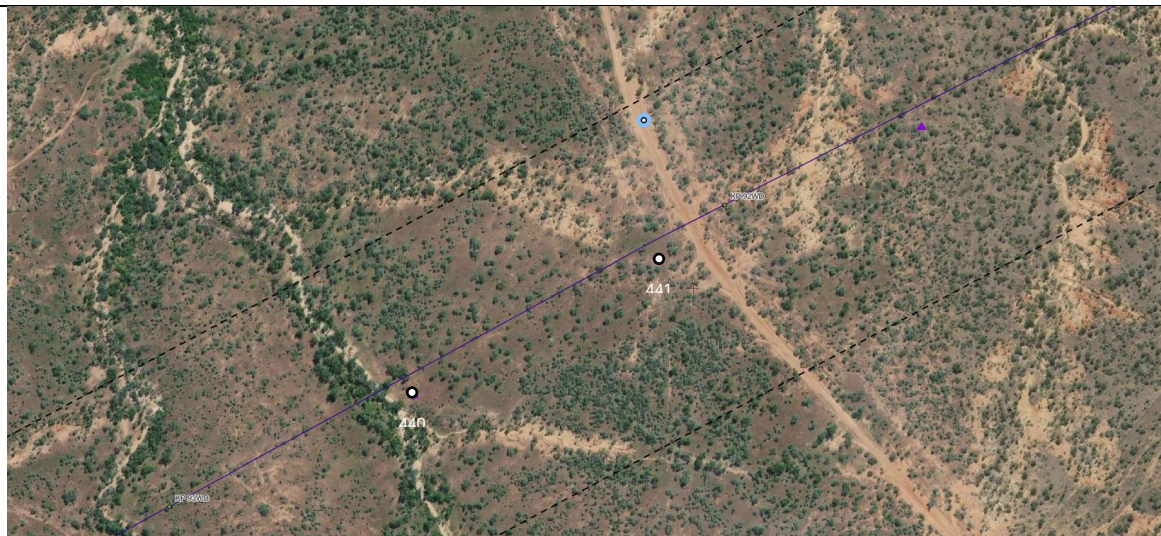
Line 1 KP 92.1 WD (50,0,40,10) Koala survey point (BAAM) (blue) near Tower 441  
(440.68m between towers 440-441)

This section is described as 50% very light, 0% light, 40% moderate and 10% heavy by the clearing contractor. Field observations show a mid-dense canopy covers most of this section with tree heights averaging at 9m. Observations on the ground reflect the clearing contractor's description within this section of the alignment.

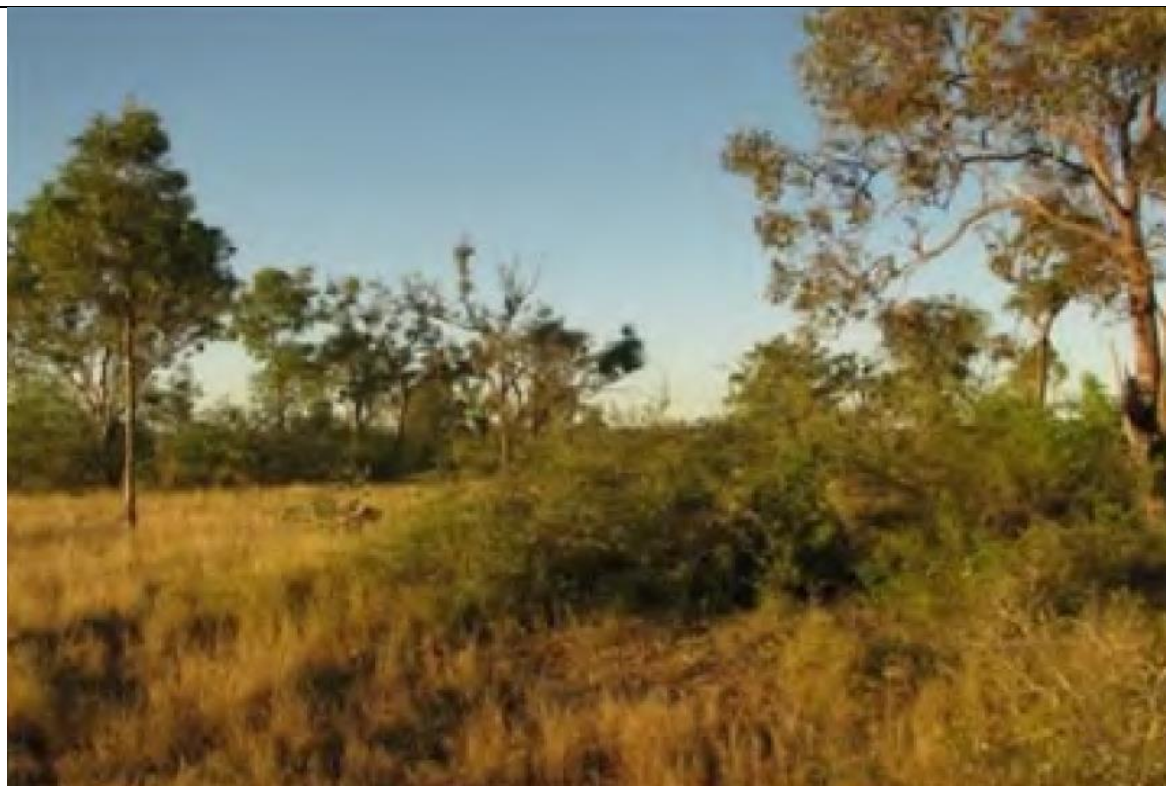
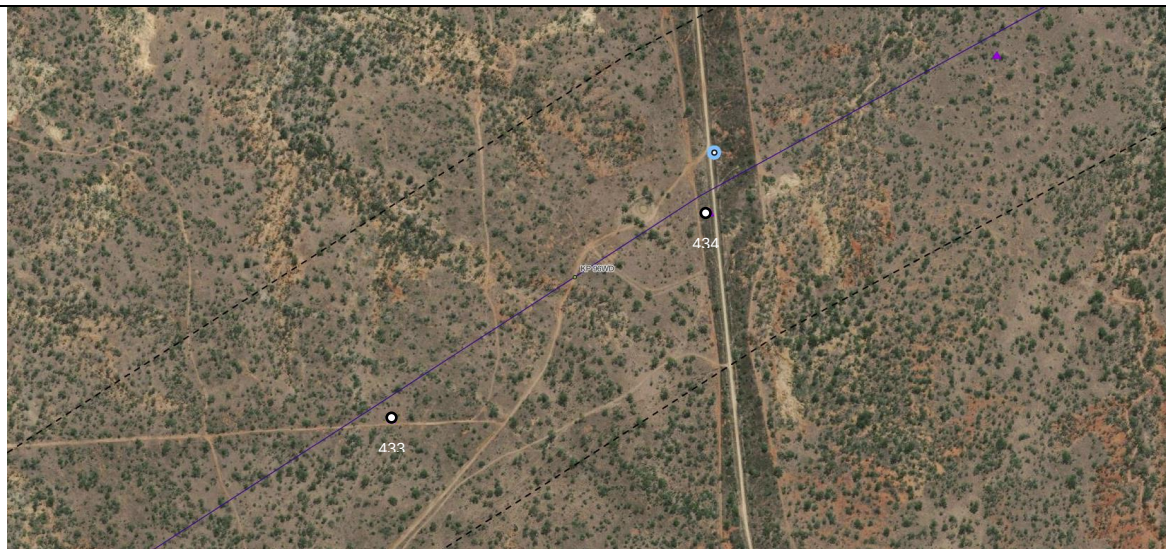
Line 1 KP 95.8 WD (70,20,10,0) Koala survey point (BAAM) (blue) near Tower 434  
(599.60m between towers 433-434)

This section is described as 70% very light, 20% light, 10% moderate and 0% heavy by the clearing contractor. Field observations show a sparse canopy covers most of this section. Observations on the ground reflect the clearing contractor's description within this section of the alignment.

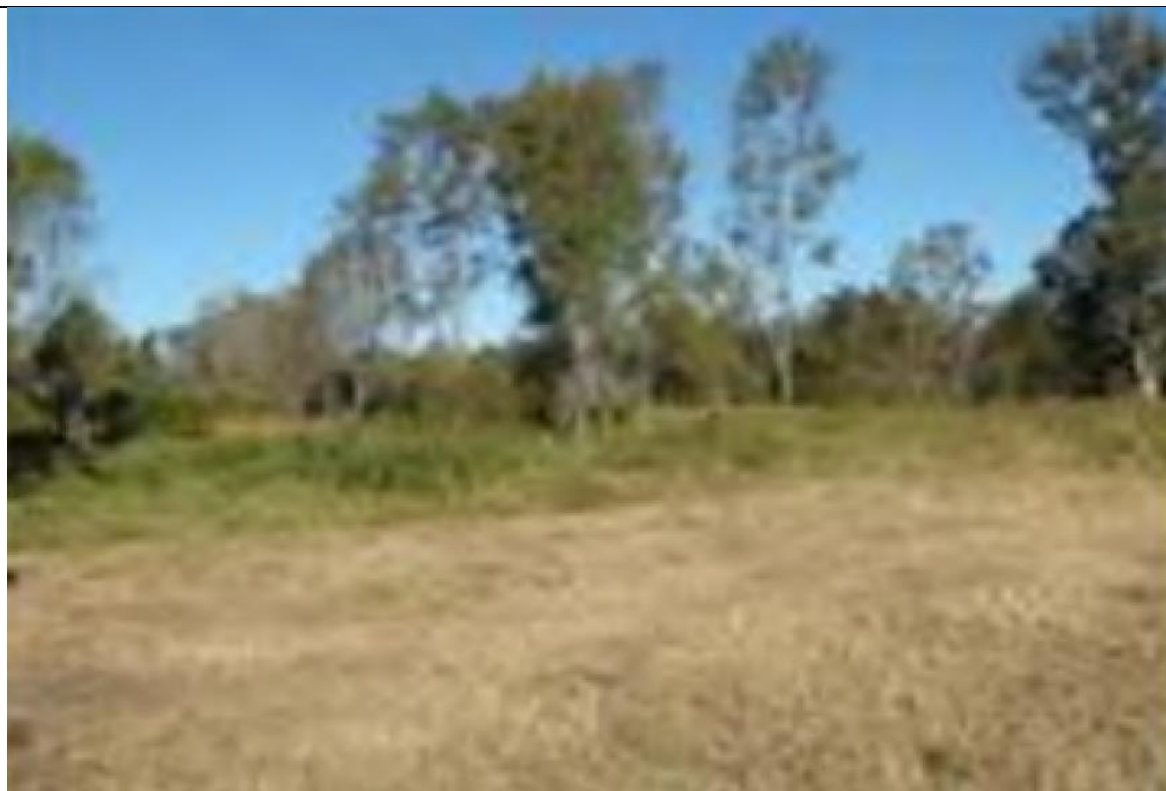
Line 1 KP 101 WD (30,20,50,0) Koala survey point (BAAM) (blue) near Tower 425  
(395.99m between towers 424-425)

This section is described as 30% very light, 20% light, 50% moderate and 0% heavy by the clearing contractor. Field observations show a riparian woodland along a 10m wide watercourse west of the tower 424. The mid-dense canopy covers the riparian canopy that fringes the watercourse and most of the west section. Observations on the ground reflect the clearing contractor's description within this section of the alignment.

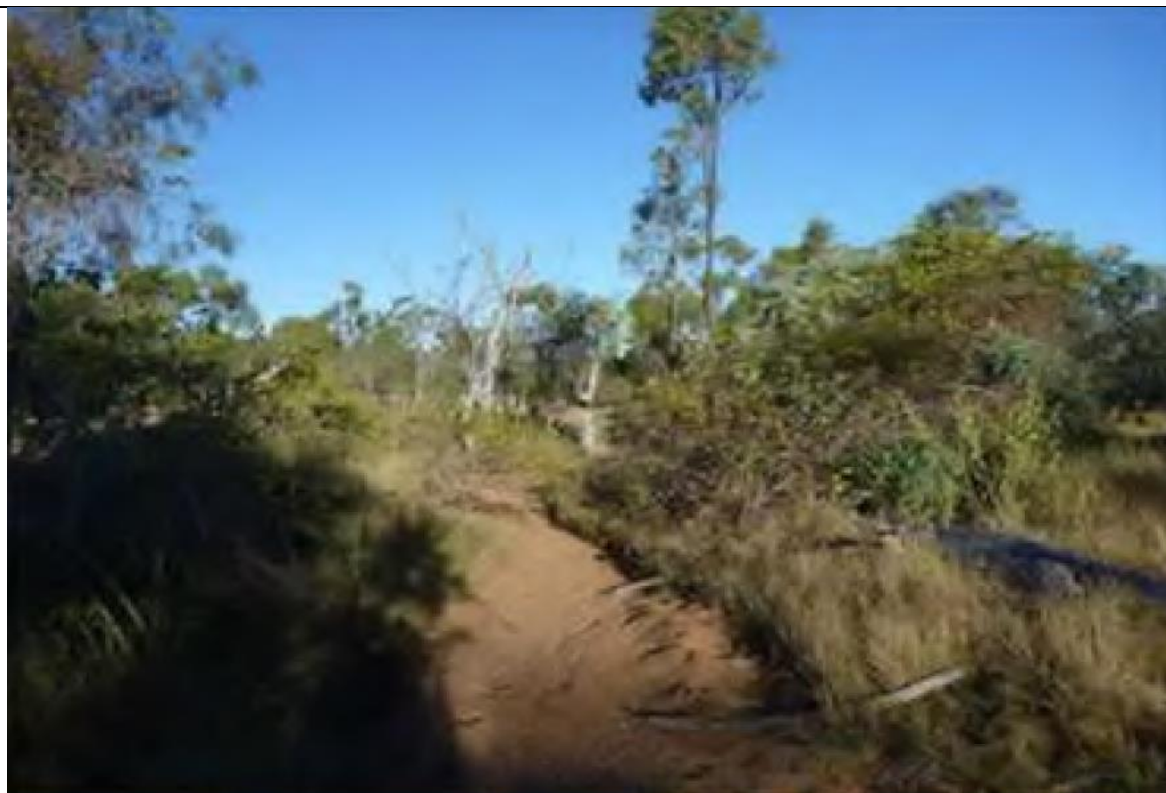
Line 1 KP 119.4 WD (60,10,20,10) Koala survey point (BAAM) (blue) near Tower 392  
(594.82m between towers 391-392)

This section is described as 60% very light, 10% light, 20% moderate and 10% heavy by the clearing contractor. Field observations show a mid-dense canopy covers the riparian canopy that fringes the gully lines and most of this section with tree heights averaging at 6m. Observations on the ground reflect the clearing contractor's description within this section of the alignment.

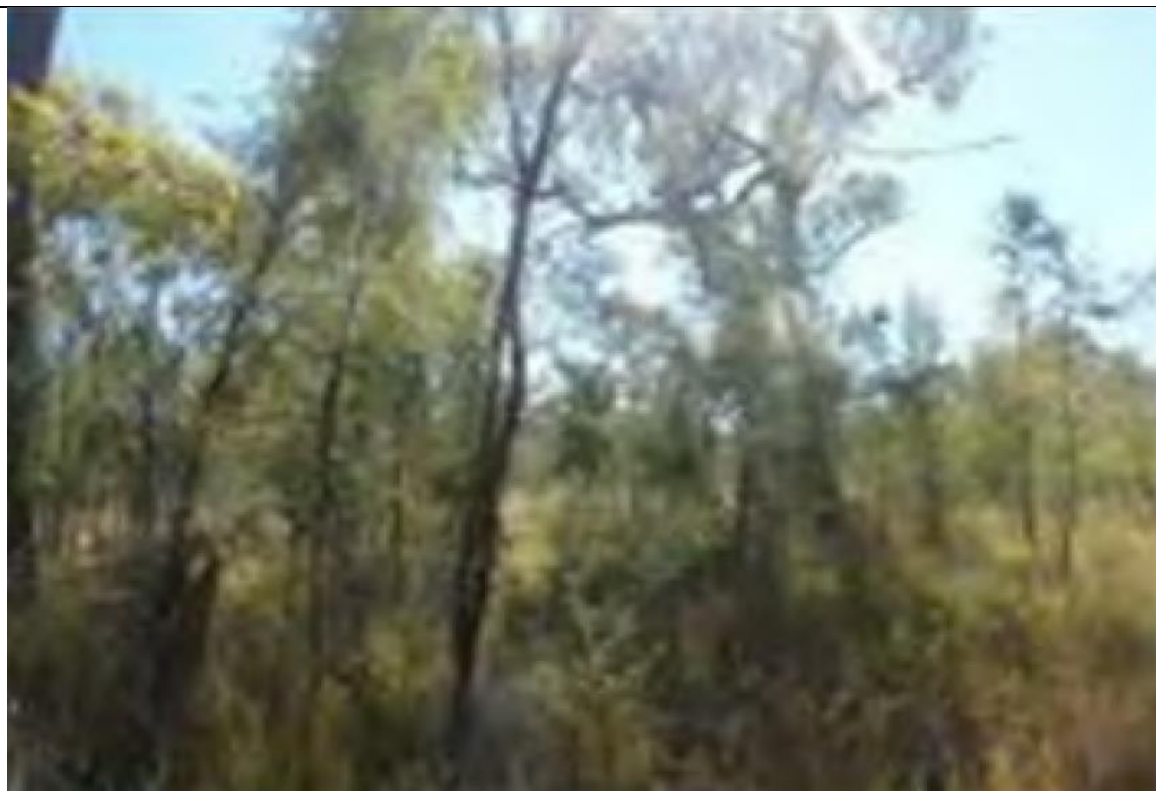
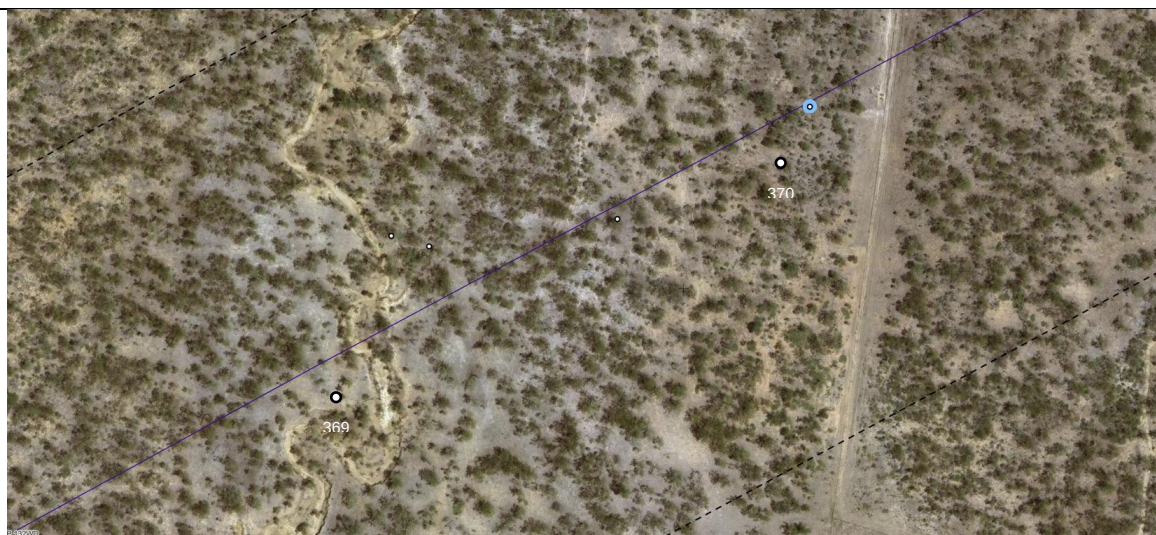
Line 1 KP 131.4 WD (40,40,20,0) Koala survey point (BAAM) (blue) near Tower 370  
(402.35m between towers 369-370)

This section is described as 40% very light, 40% light, 20% moderate and 0% heavy by the clearing contractor. Field observations show a riparian woodland along a 20m wide watercourse west of survey point. The sparse to mid-dense canopy covers the riparian canopy that fringes the watercourse and most of the section with tree heights averaging at 12m. Observations on the ground reflect the clearing contractor's description within this section of the alignment.

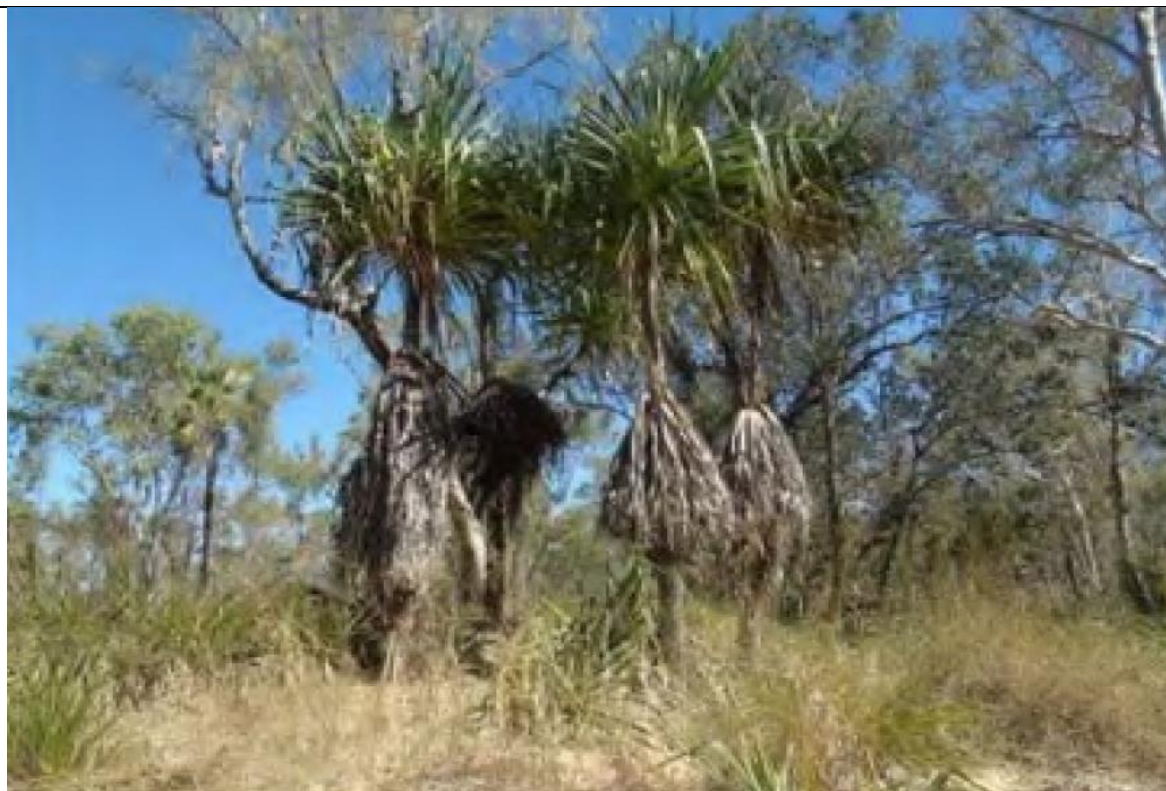
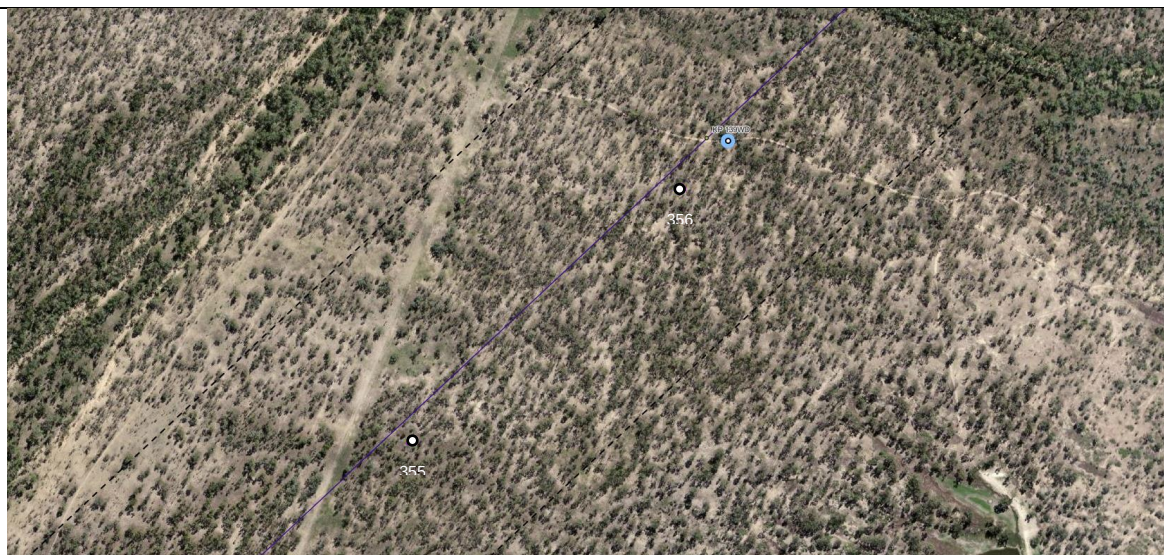
Line 1 KP 139.1 WD (40,40,20,0) Koala survey point (BAAM) (blue) near Tower 356  
(587.56m between towers 355-356)

This section is described as 40% very light, 40% light, 20% moderate and 0% heavy by the clearing contractor. Field observations show a sparse canopy covers most of the section with tree heights averaging at 13.5m. Observations on the ground reflect the clearing contractor's description within this section of the alignment.

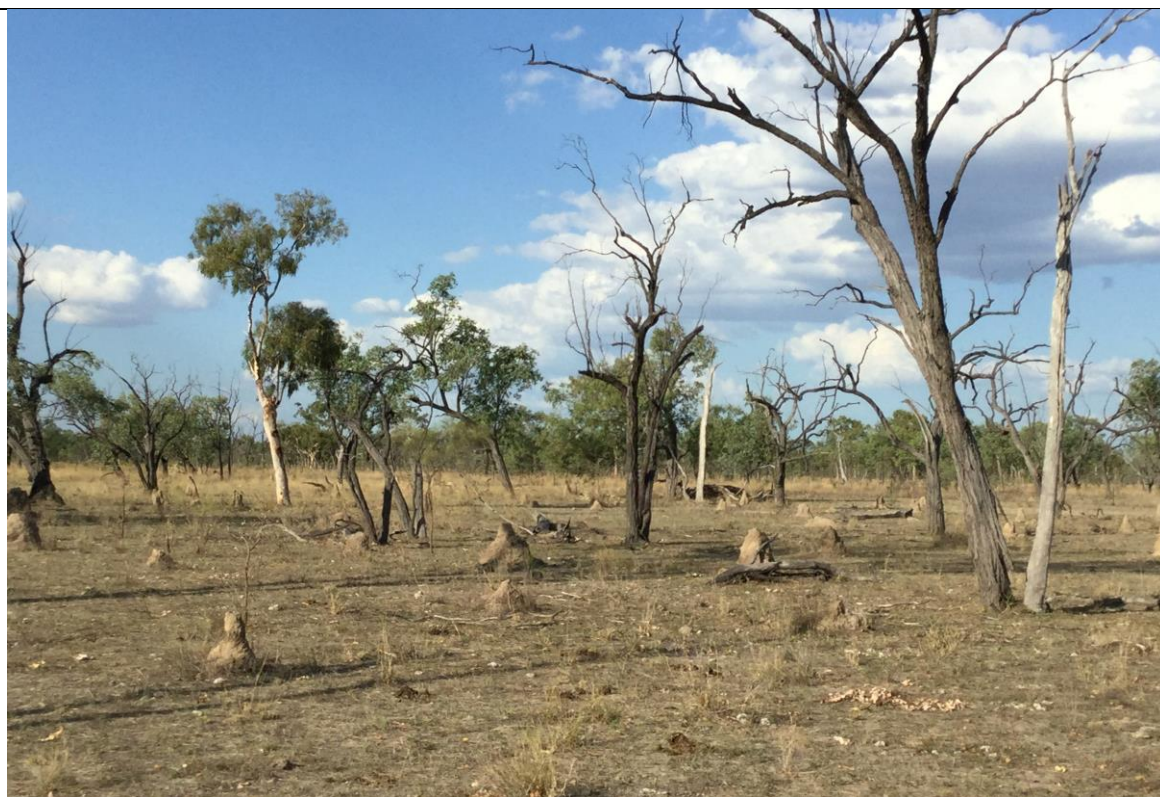
Line 1 KP 150.2 WD (80,0,20,0) Koala survey point (GHD) (blue) near Tower 336  
(580.25m between towers 335-336)

This section is described as 80% very light, 0% light, 20% moderate and 0% heavy by the clearing contractor. Field observations show a sparse canopy covers most of this section with tree heights averaging at 8m. Observations on the ground reflect the clearing contractor's description within this section of the alignment.
