# Visual Comparison of Landscape Type

Client: CopperString 2.0  
Reference: J0XXX

This document is a visual comparison of landscapes which was compiled to provide a photographic record both from an aerial and site-based perspective along each of the five corridor selection segments. This ground truthing was utilised to inform the projects appreciation of the six general landscape types which occur across the study area as well as improved confidence in the potential conservation significant species habitat mapped for the CopperString EIS 2.0. It has also been used to confirm expected disturbance associated with construction related activities.

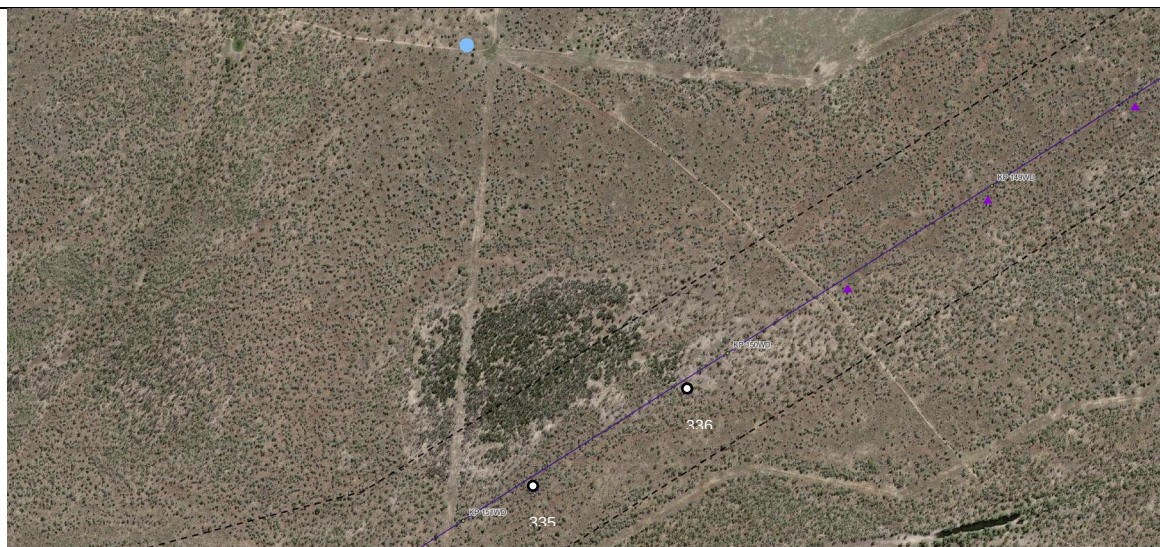
Line 1 KP 150.2 WD (80,0,20,0) Koala survey point (GHD) (blue) near Tower 336  
(580.25m between towers 335-336)

This section is described as 80% very light, 0% light, 20% moderate and 0% heavy by the clearing contractor. Field observations show a sparse canopy covers most of this section with tree heights averaging at 8m. Observations on the ground reflect the clearing contractor's description within this section of the alignment.

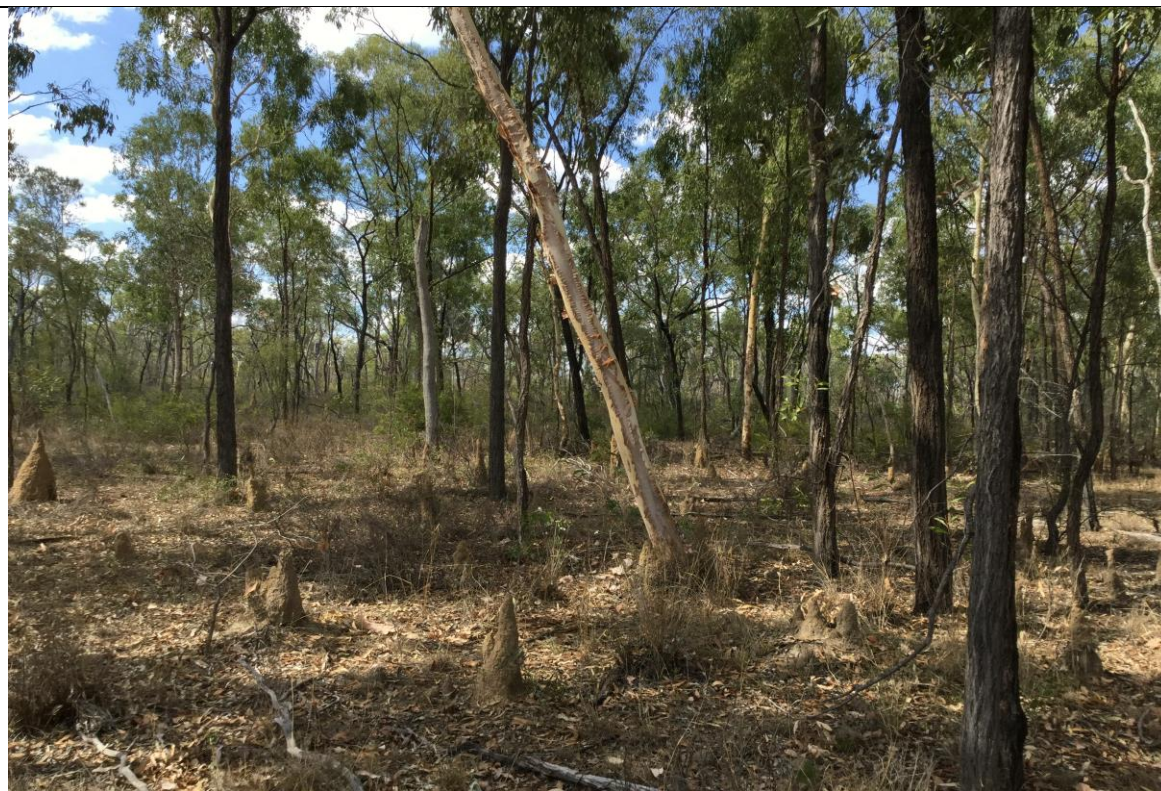
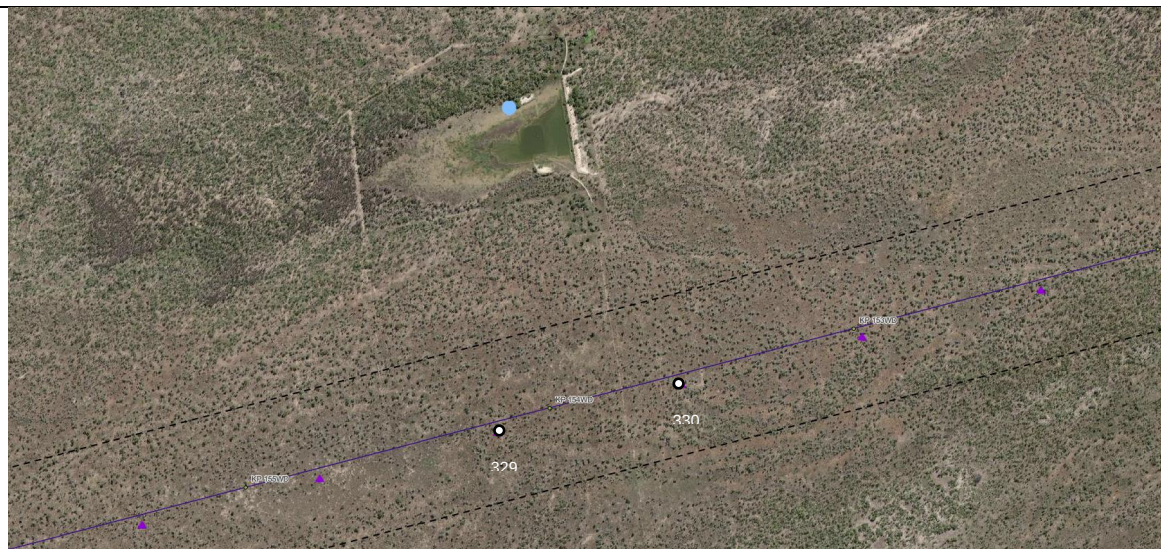
Line 1 KP 161.1 WD (60,10,30,0) Koala survey point (GHD) (blue) near Tower 330  
(604.23m between towers 329-330)

This section is described as 60% very light, 10% light, 30% moderate and 0% heavy by the clearing contractor. Field observations show a sparse canopy covers most of this section with tree heights averaging at 13m. Observations on the ground reflect the clearing contractor's description within this section of the alignment.

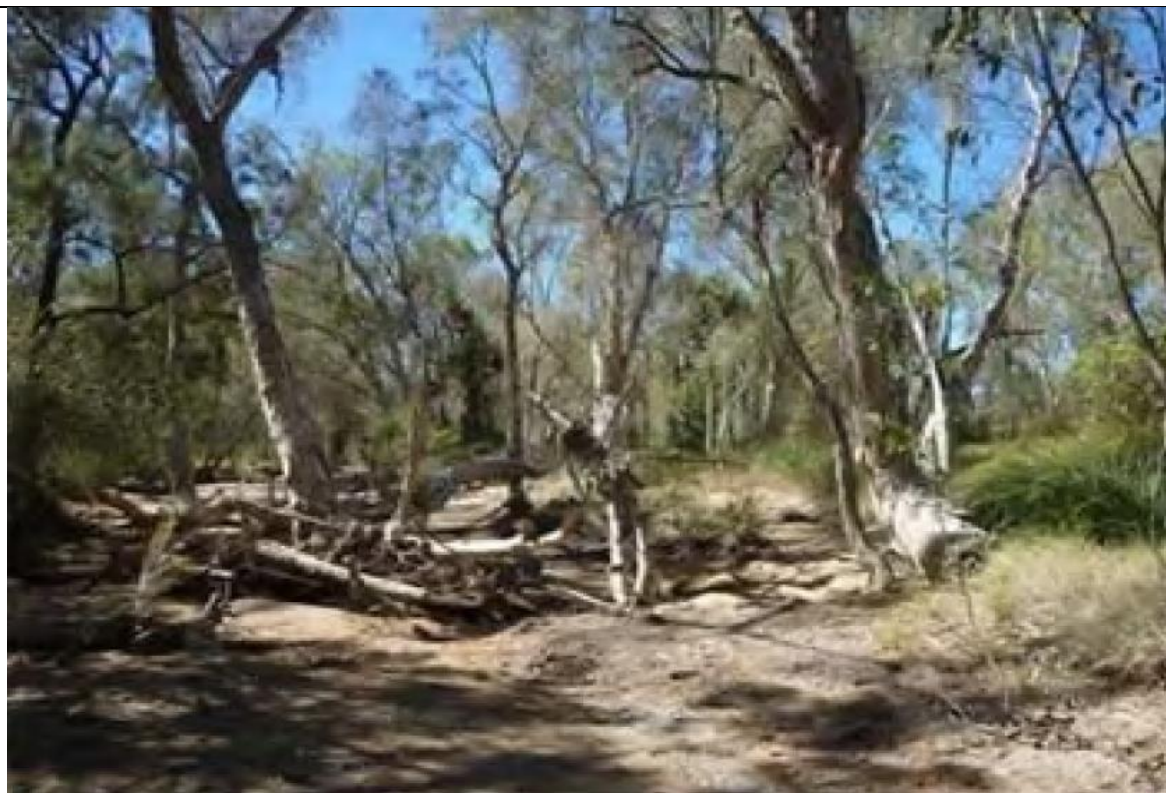
Line 1 KP 158.4 WD (70,10,20,0) Koala survey point (BAAM) (blue) near Tower 322  
(594.51m between towers 321-322)

This section is described as 70% very light, 10% light, 20% moderate and 0% heavy by the clearing contractor. Field observations show a sparse canopy covers most of the section with tree heights averaging at 9.5m. Observations on the ground reflect the clearing contractor's description within this section of the alignment.

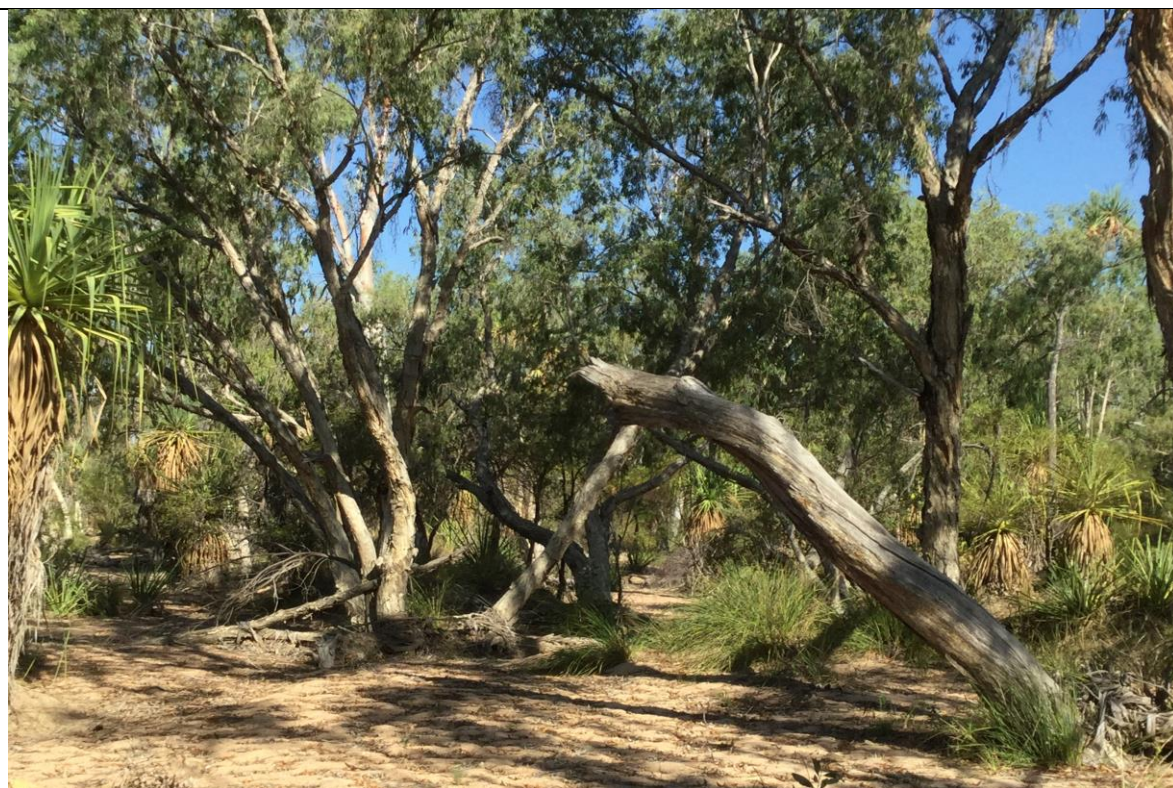
Line 1 KP 161.1 WD (20,10,50,20) Koala survey point (GHD) (blue) near Tower 317  
(633.58m between towers 316A-317)

This section is described as 20% very light, 10% light, 50% moderate and 20% heavy by the clearing contractor. Field observations show riparian woodlands along a braided 140m and 100m wide watercourse south of the survey point. The sparse canopy covers the riparian canopies that fringes both the watercourse and most of this section with tree heights averaging at 16.5m. Observations on the ground reflect the clearing contractor's description within this section of the alignment.

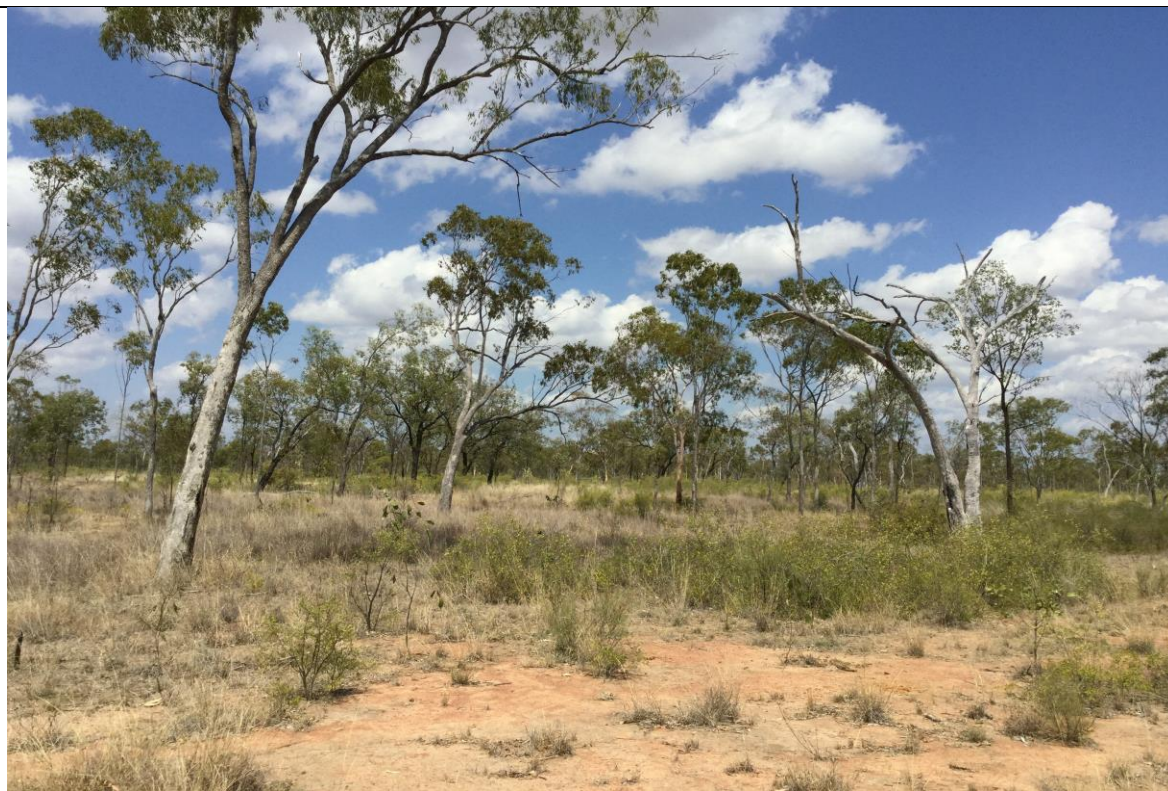
Line 1 KP 168.2 WD (80,10,10,0) Koala survey point (GHD) (blue) near Tower 305  
(587.97m between towers 304-305)

This section is described as 80% very light, 10% light, 10% moderate and 0% heavy by the clearing contractor. Field observations show a sparse canopy covers most of this section with tree heights averaging at 10m. Observations on the ground reflect the clearing contractor's description within this section of the alignment.

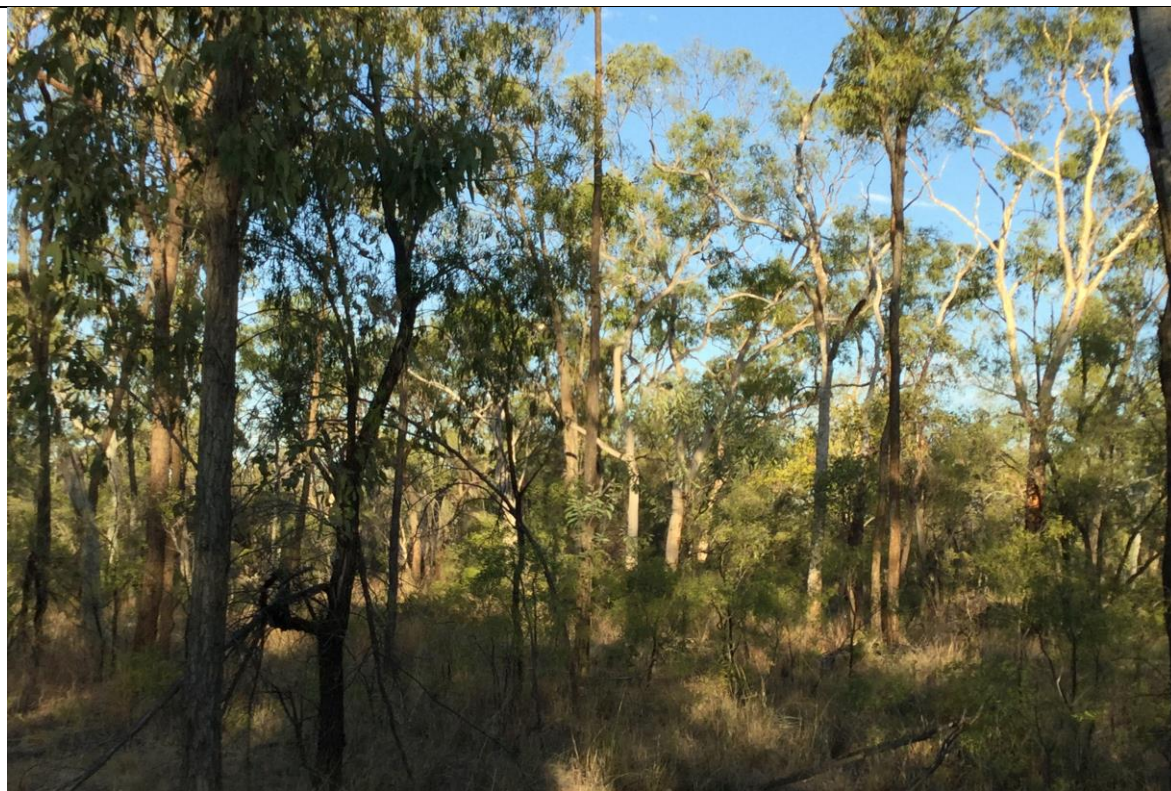
Line 1 KP 175.3 WD (40,0,40,20) Koala survey point (GHD) (blue) near Tower 293  
(580.00m between towers 292-293)

This section is described as 40% very light, 0% light, 40% moderate and 20% heavy by the clearing contractor. Field observations show a riparian woodland along a 10m wide watercourse south of the survey point. The sparse to mid-dense canopy covers the riparian canopy that fringes the watercourse and most of this section with tree heights averaging at 12m. Observations on the ground reflect the clearing contractor's description within this section of the alignment

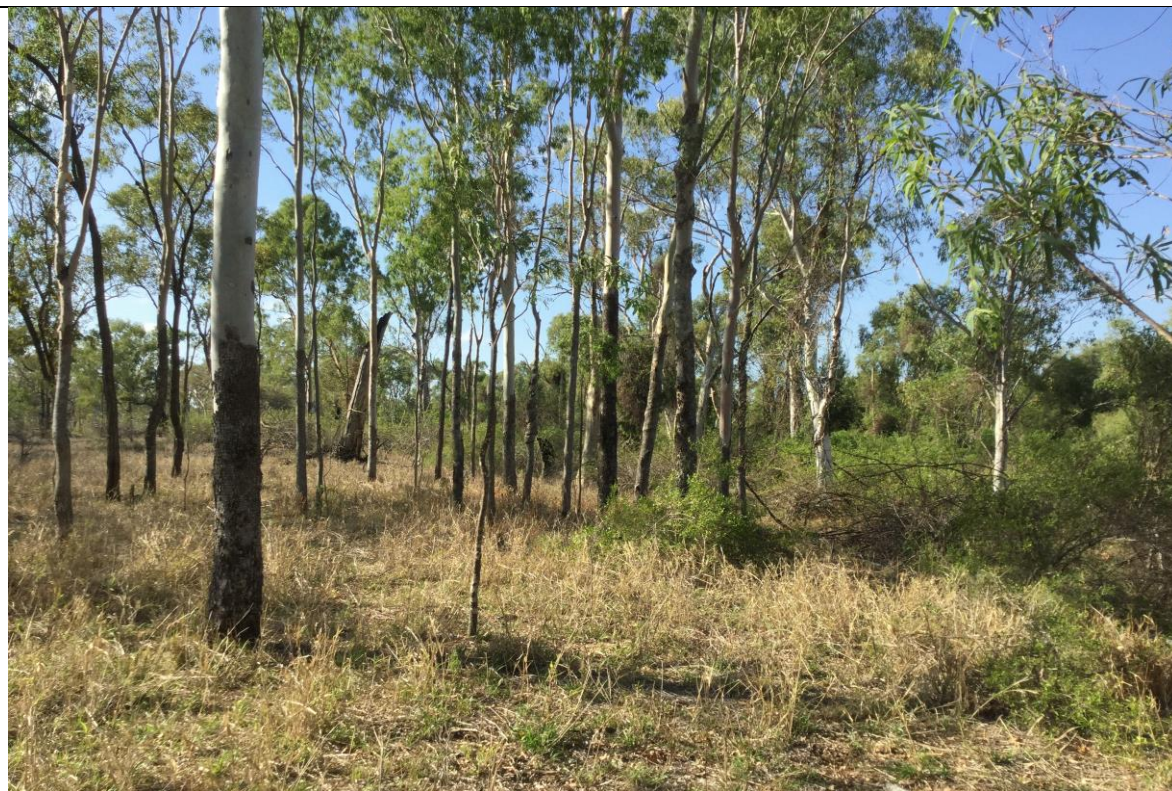
Line 1 KP 180.3 WD (70,20,10,0) Koala survey point (GHD) (blue) near Tower 305  
(564.14m between towers 283-284)

This section is described as 70% very light, 20% light, 10% moderate and 0% heavy by the clearing contractor. Field observations show a riparian woodland along an 80m wide watercourse west of the survey point. The sparse canopy covers the riparian canopy that fringes the watercourse and most of this section with tree heights averaging at 15m. Observations on the ground reflect the clearing contractor's description within this section of the alignment.

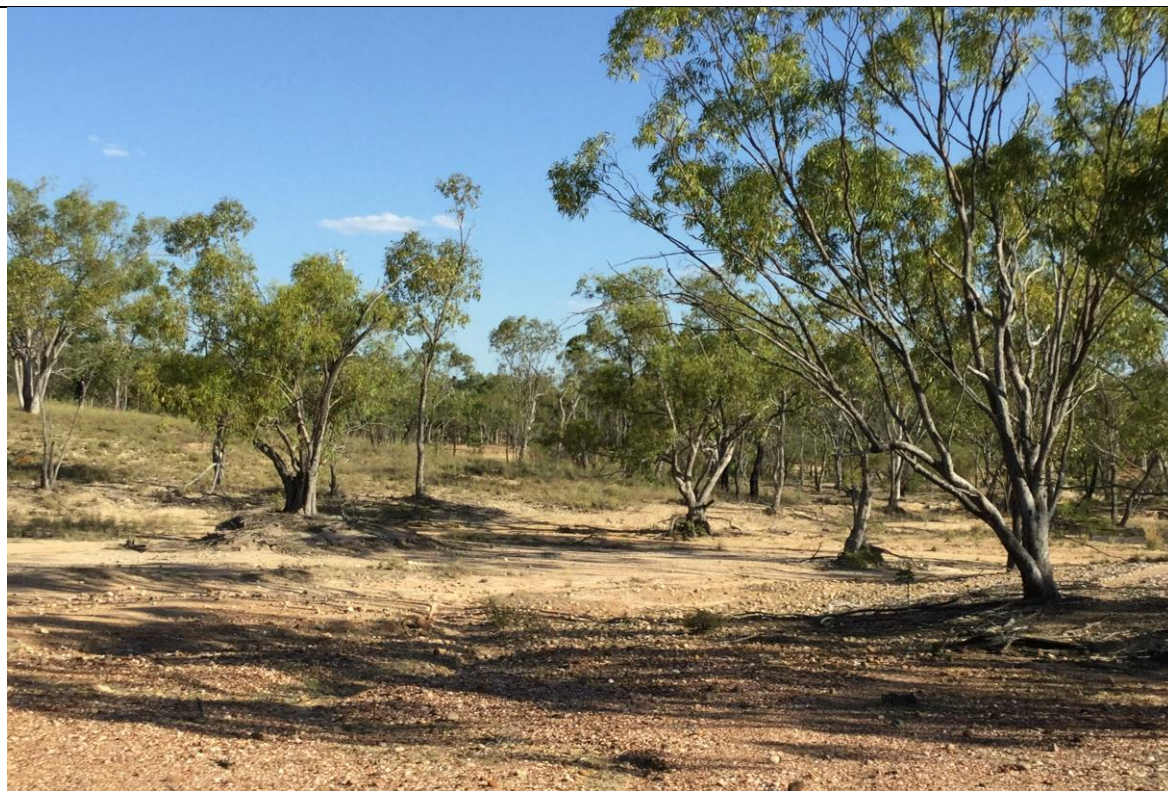
Line 1 KP 200 WD (40,0,60,0) Koala survey point (GHD) (blue) near Tower 249  
(600.52m between towers 248-249)

This section is described as 40% very light, 0% light, 60% moderate and 0% heavy by the clearing contractor. Field observations show a riparian woodland along a 20m wide watercourse south of the survey point. The mid-dense canopy covers the riparian canopy that fringes the watercourse and most of this section with tree heights averaging at 5m. Observations on the ground reflect the clearing contractor's description within this section of the alignment.

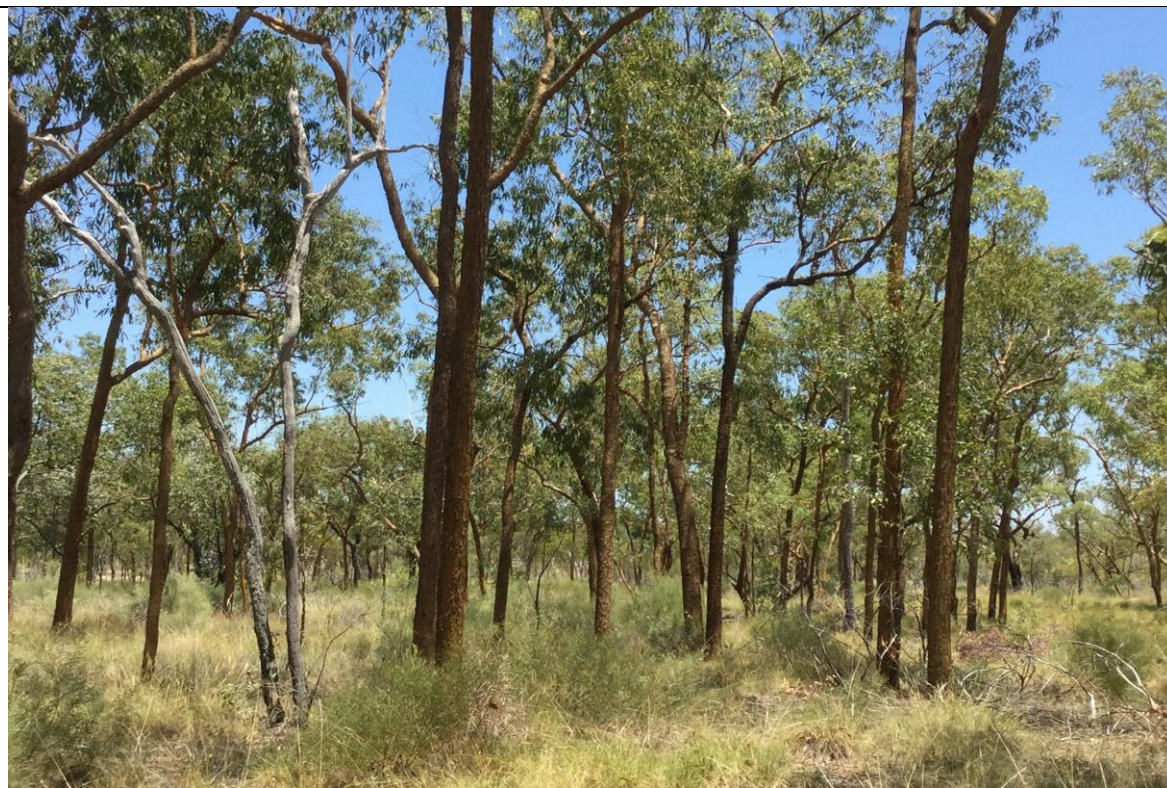
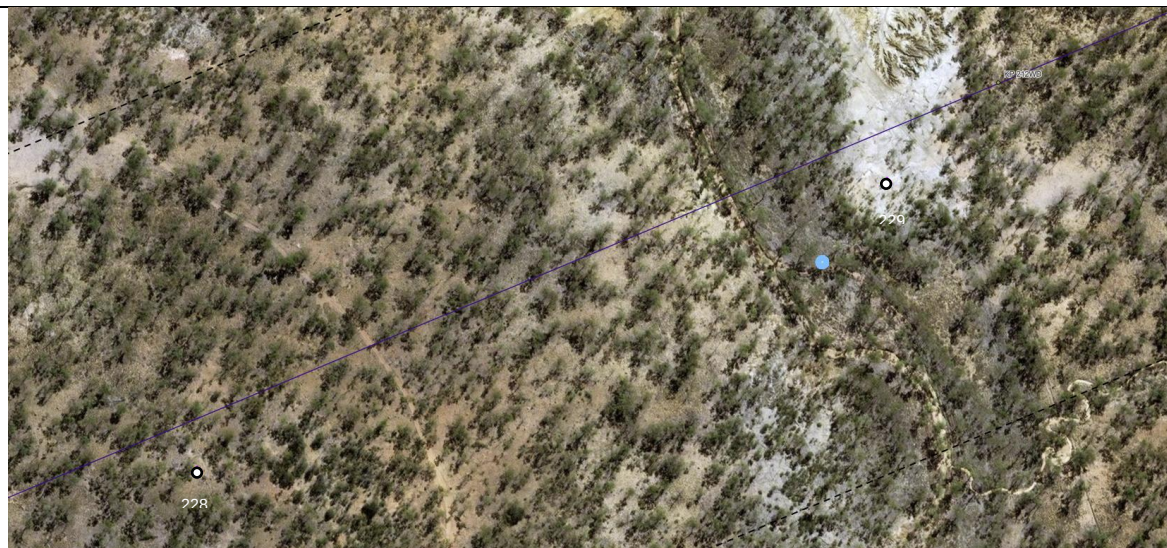
Line 1 KP 212.1 WD (30,30,0,40) Koala survey point (GHD) (blue) near Tower 229  
(591.72m between towers 228-229)

This section is described as 30% very light, 30% light, 0% moderate and 40% heavy by the clearing contractor. Field observations show a riparian woodland along a 15m wide watercourse west of the survey point. The sparse to mid-dense canopy covers the riparian canopy that fringes the watercourse and most of this section with tree heights averaging at 12m. Observations on the ground reflect the clearing contractor's description within this section of the alignment.

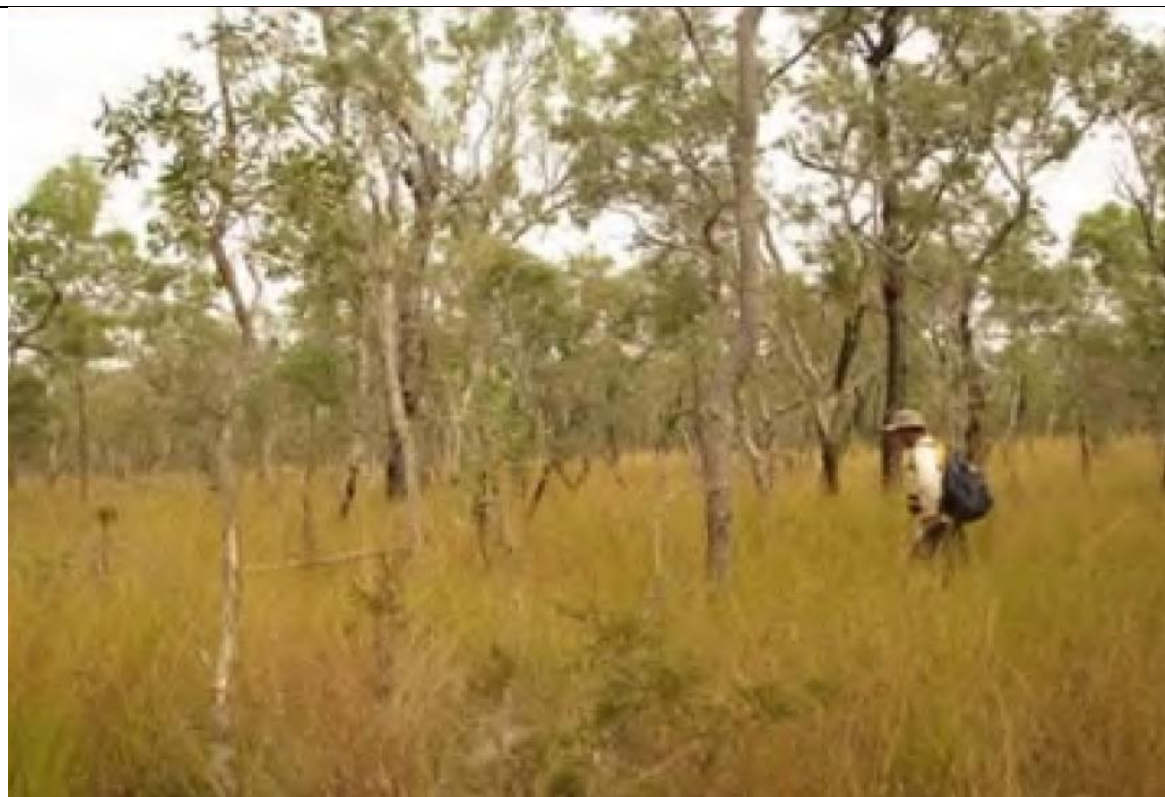
Line 1 KP 216.3 WD (30,0,70,0) Koala survey point (BAAM) (blue) near Tower 222  
(559.30m between towers 221-222)

This section is described as 30% very light, 0% light, 70% moderate and 0% heavy by the clearing contractor. Field observations show a mid-dense canopy covers most of the section with tree heights averaging at 10m. Observations on the ground reflect the clearing contractor's description within this section of the alignment.

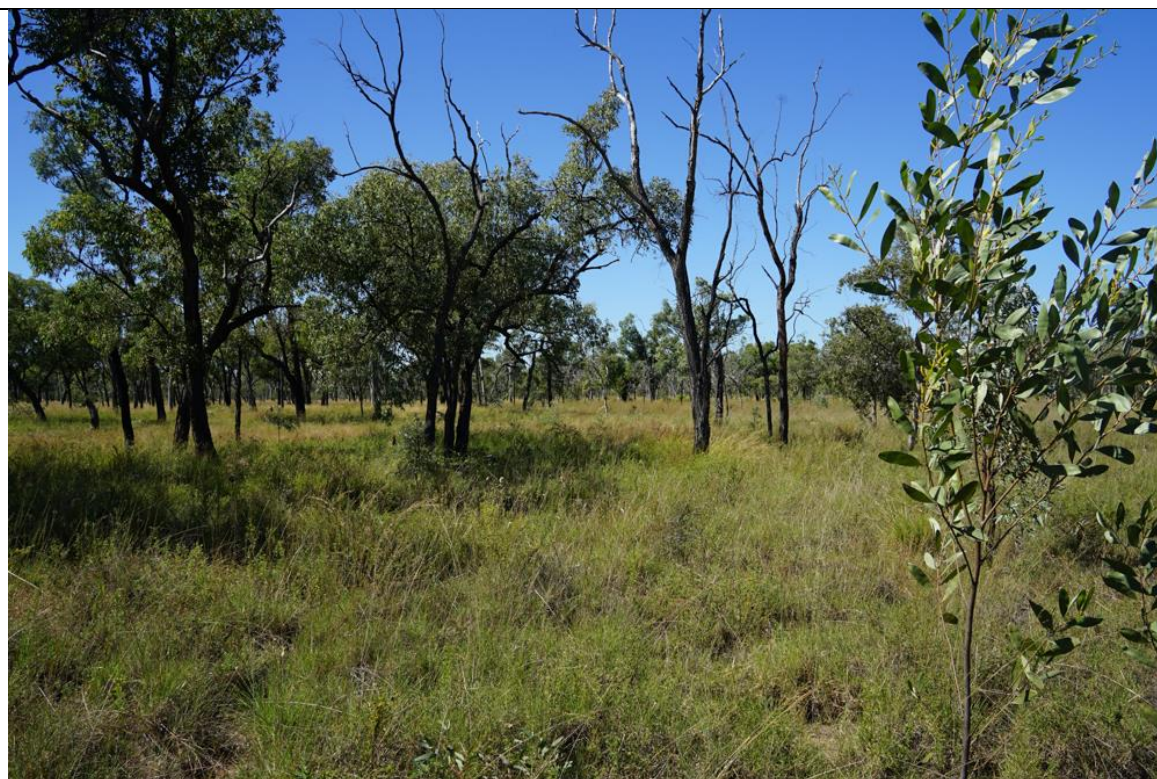
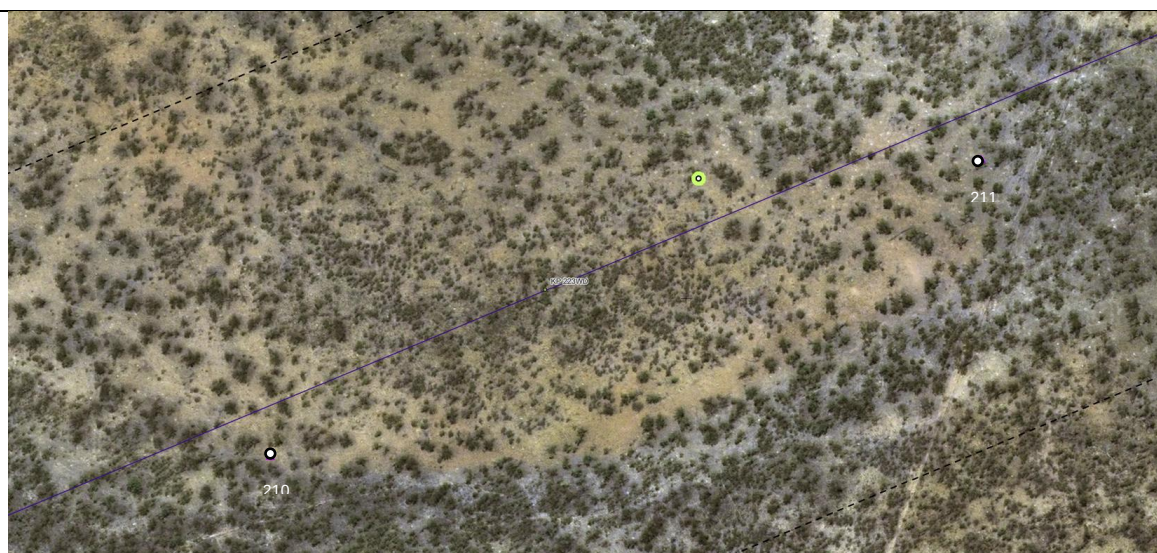
Line 1 KP 222.6 WD (20,0,60,20) Quaternary point (green) near Tower 211  
(612.96m between towers 210-211)

This section is described as 20% very light, 0% light, 60% moderate and 20% heavy by the clearing contractor. Field observations show a mid-dense canopy covers most of this section with tree heights averaging at 10m. Observations on the ground reflect the clearing contractor's description within this section of the alignment.

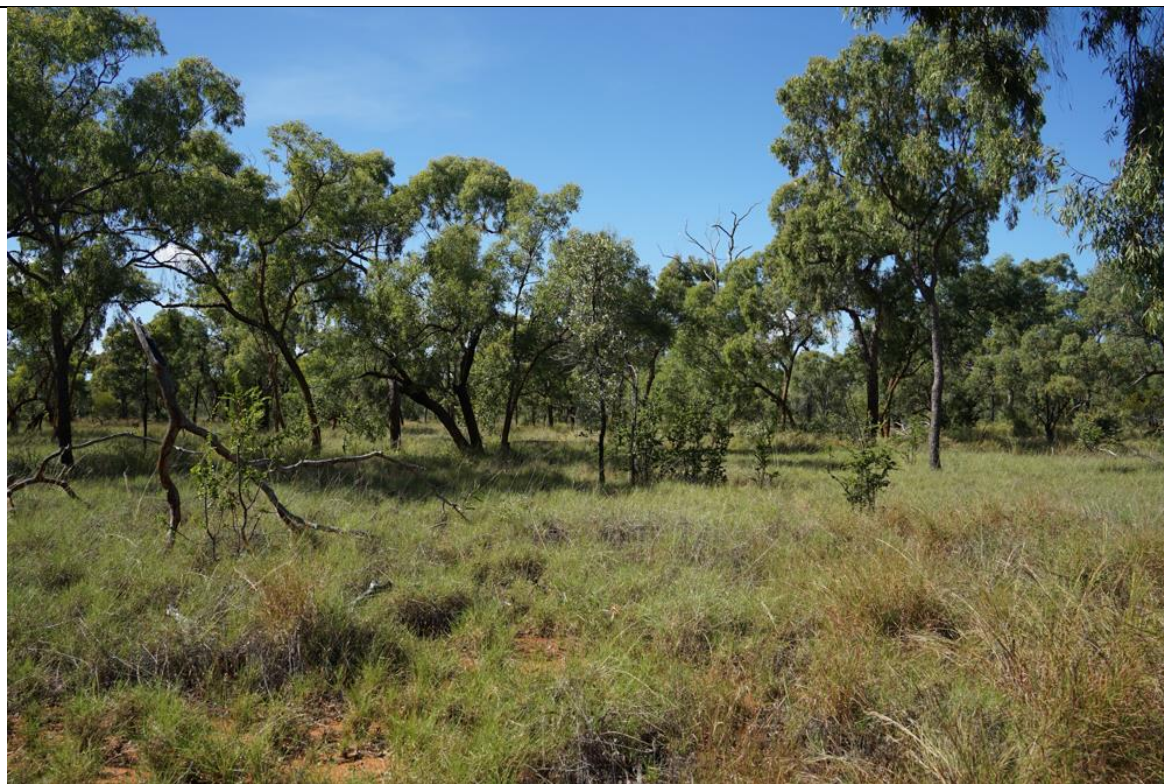
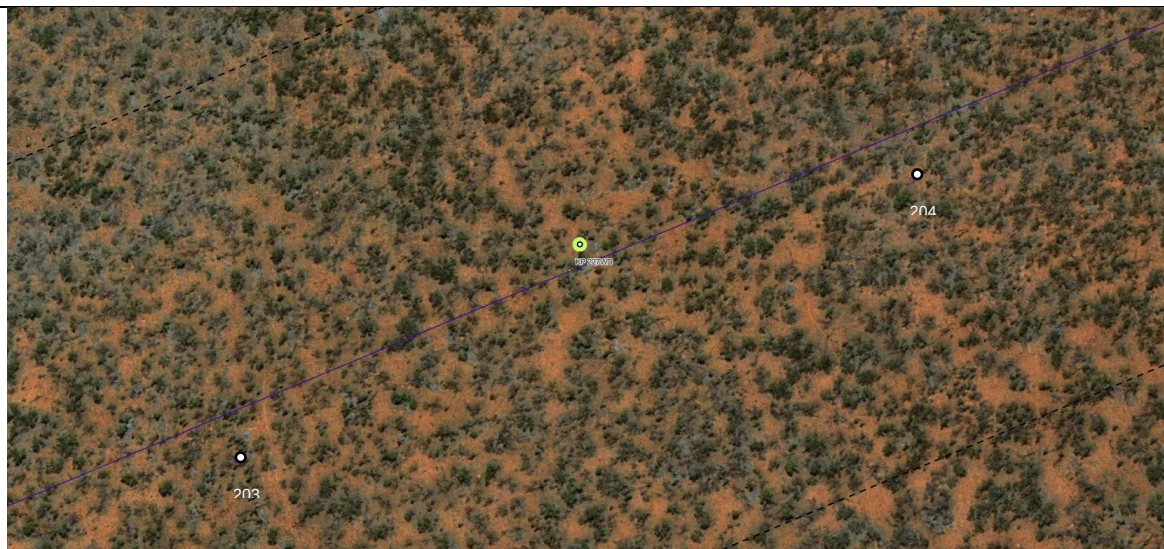
Line 1 KP 226.7 WD (30,0,70,0) Quaternary point (green) near Tower 204  
(584.30m between towers 203-204)

This section is described as 30% very light, 0% light, 70% moderate and 0% heavy by the clearing contractor. Field observations show a mid-dense canopy covers most of this section with tree heights averaging at 10m. Observations on the ground reflect the clearing contractor's description within this section of the alignment.

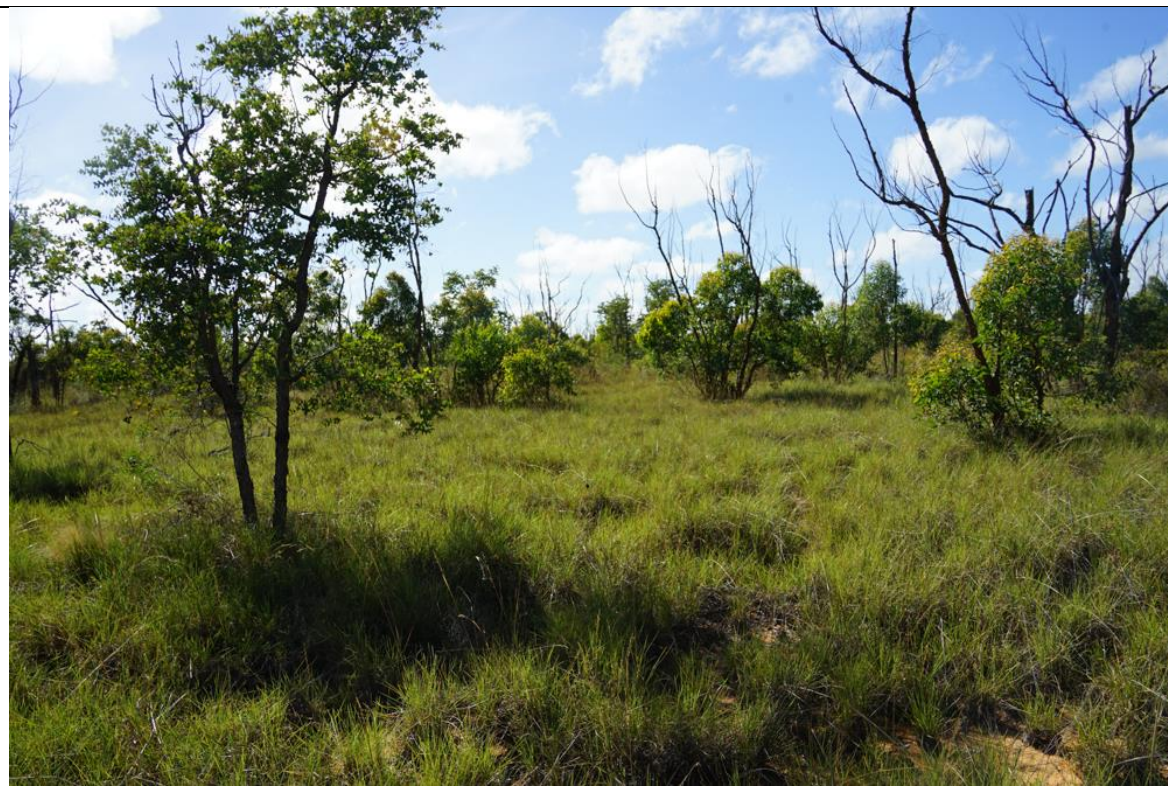
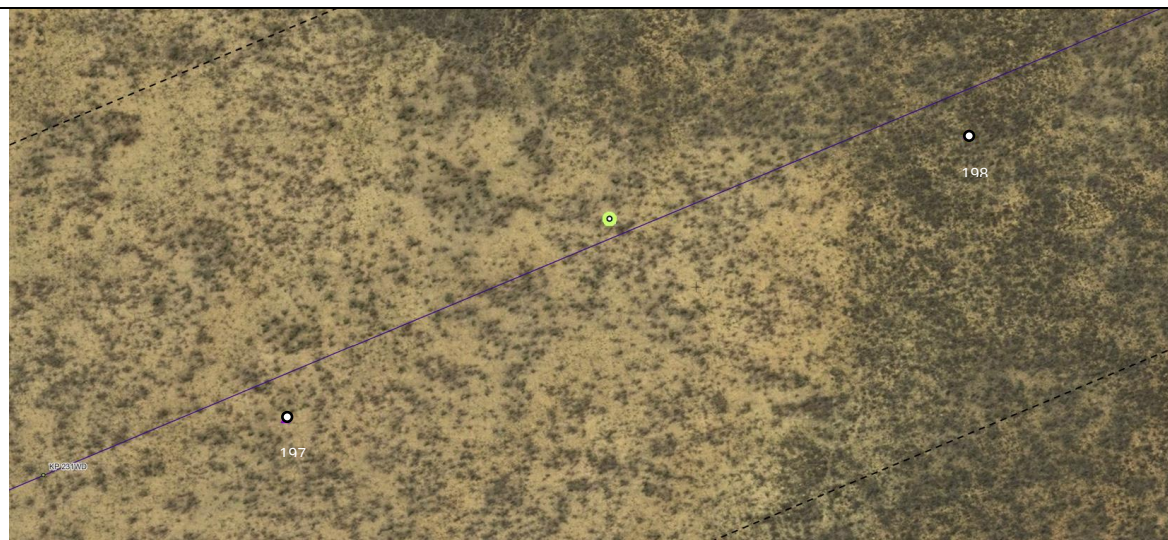
Line 1 KP 230.3 WD (30,0,70,0) Quaternary point (green) near Tower 198  
(584.30m between towers 197-198)

This section is described as 30% very light, 0% light, 70% moderate and 0% heavy by the clearing contractor. Field observations show a mid-dense canopy covers most of this section especially towards the east tower with tree heights averaging at 4m. Observations on the ground reflect the clearing contractor's description within this section of the alignment.

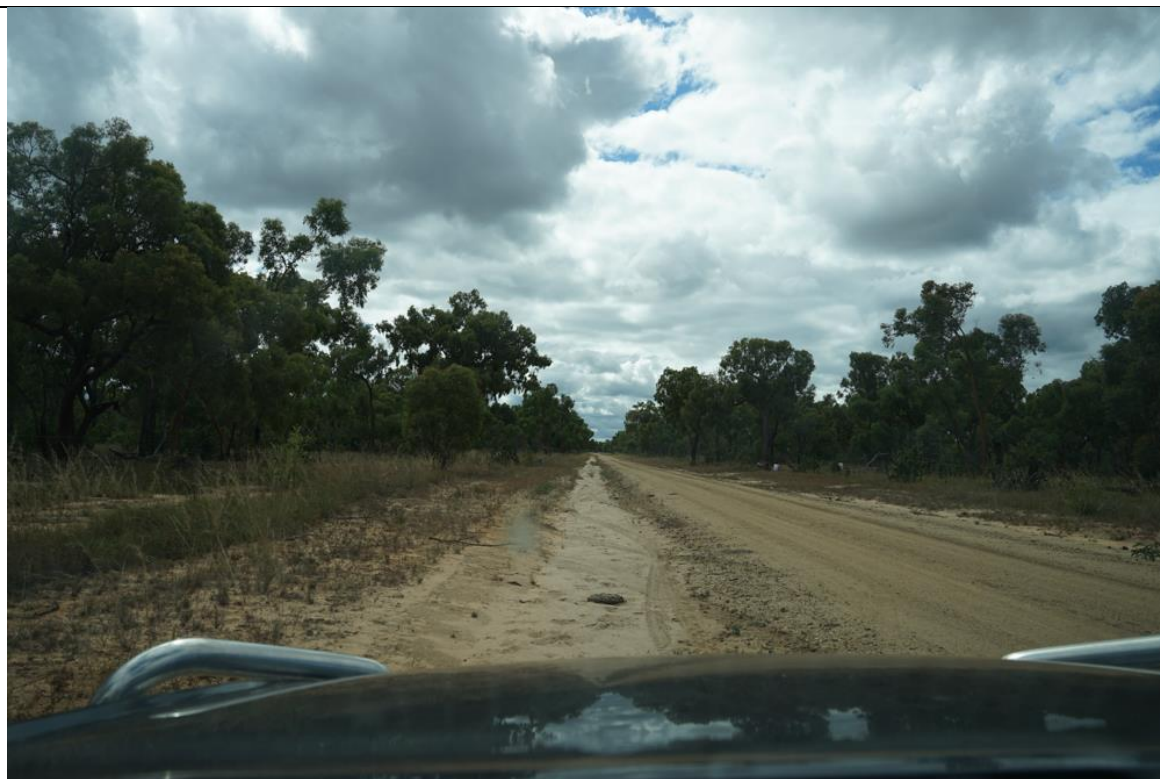
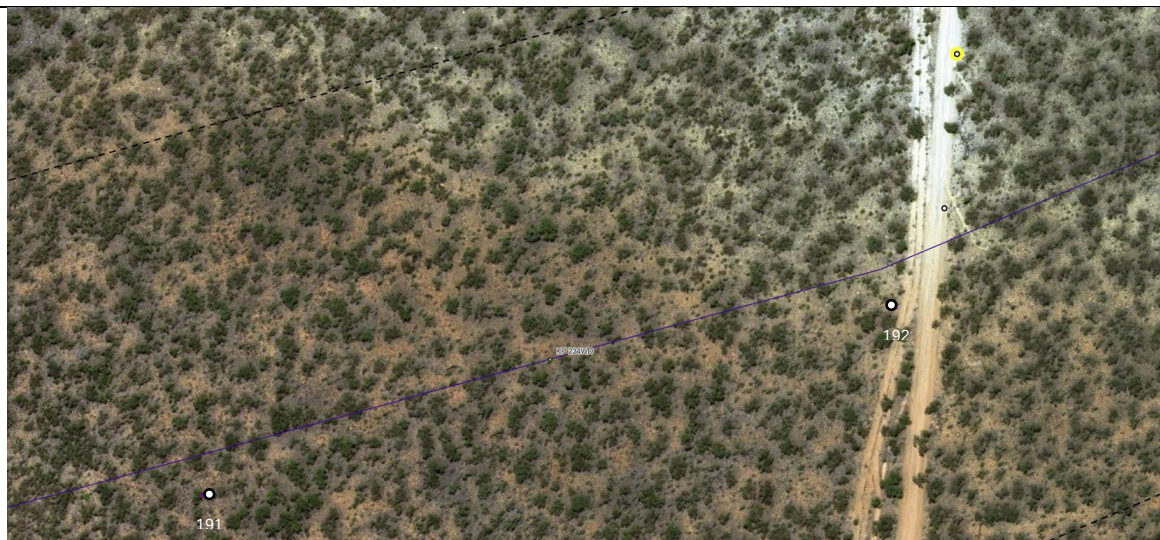
Line 1 KP 233.7 WD (30,0,70,0) Access track (yellow) near Tower 192  
(568.77m between towers 191-192)

This section is described as 30% very light, 0% light, 70% moderate and 0% heavy by the clearing contractor. Field observations show a mid-dense canopy covers most of this section with tree heights averaging at 10m. Observations on the ground reflect the clearing contractor's description within this section of the alignment.

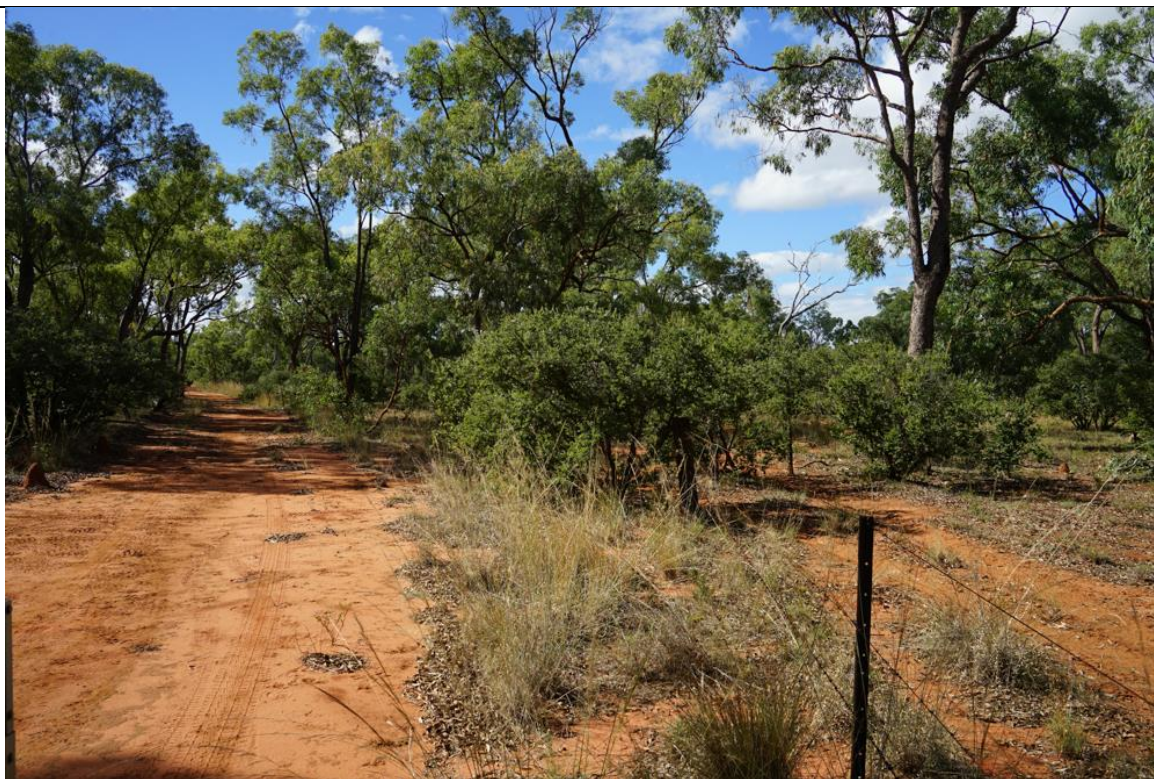
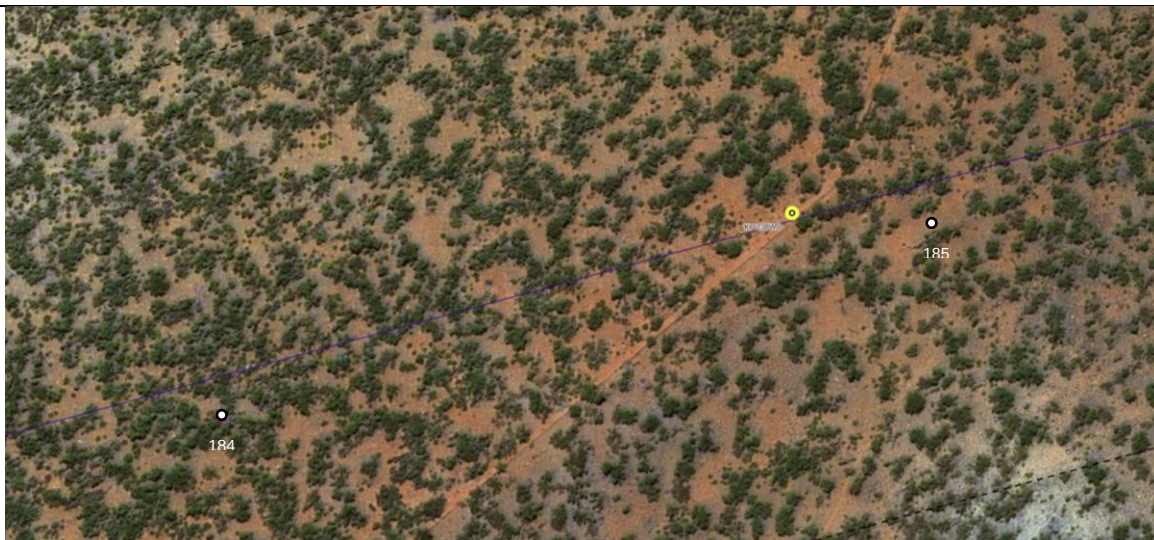
Line 1 KP 238 WD (30,0,70,0) Access track (yellow) near Tower 185  
(589.20m between towers 184-185)

This section is described as 30% very light, 0% light, 70% moderate and 0% heavy by the clearing contractor. Field observations show a mid-dense canopy covers most of this section with tree heights averaging at 12m. Observations on the ground reflect the clearing contractor's description within this section of the alignment.

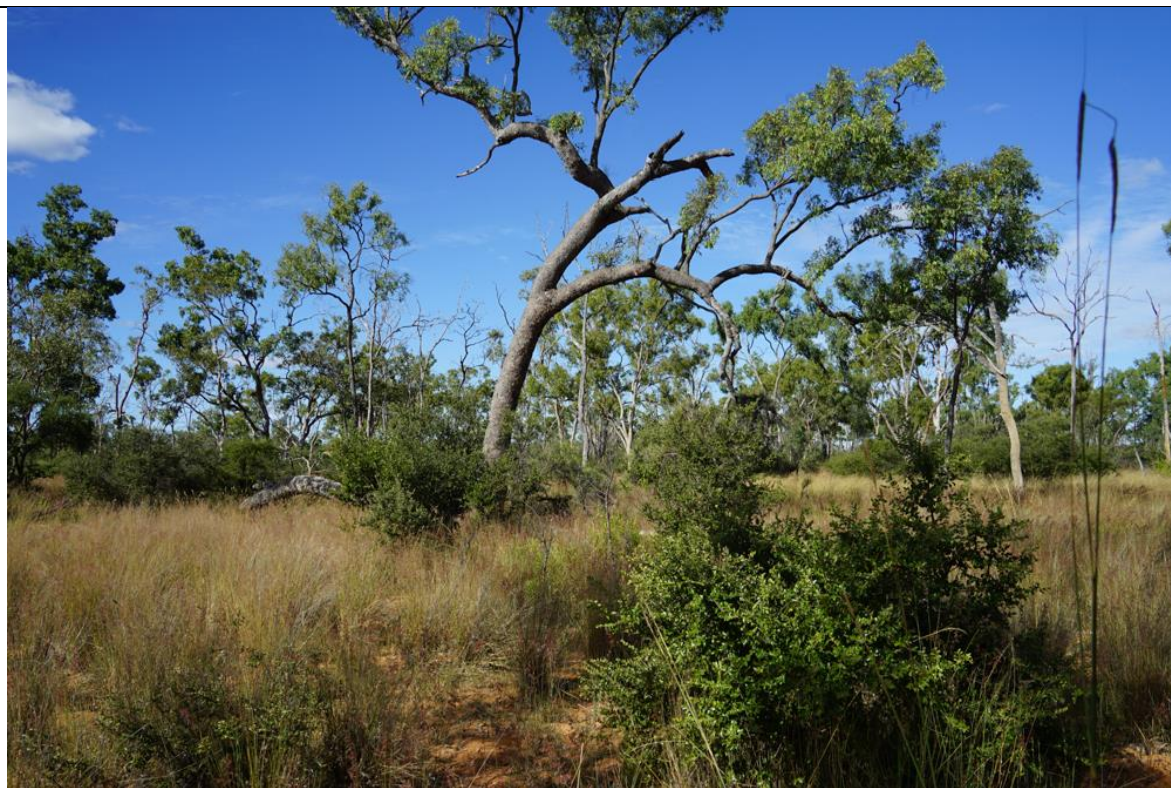
Line 1 KP 240.8 WD (30,0,70,0) Quaternary point (green) near Tower 180  
(594.79m between towers 179-180)

This section is described as 30% very light, 0% light, 70% moderate and 0% heavy by the clearing contractor. Field observations show a mid-dense canopy covers most of this section with tree heights averaging at 12m. Observations on the ground reflect the clearing contractor's description within this section of the alignment.

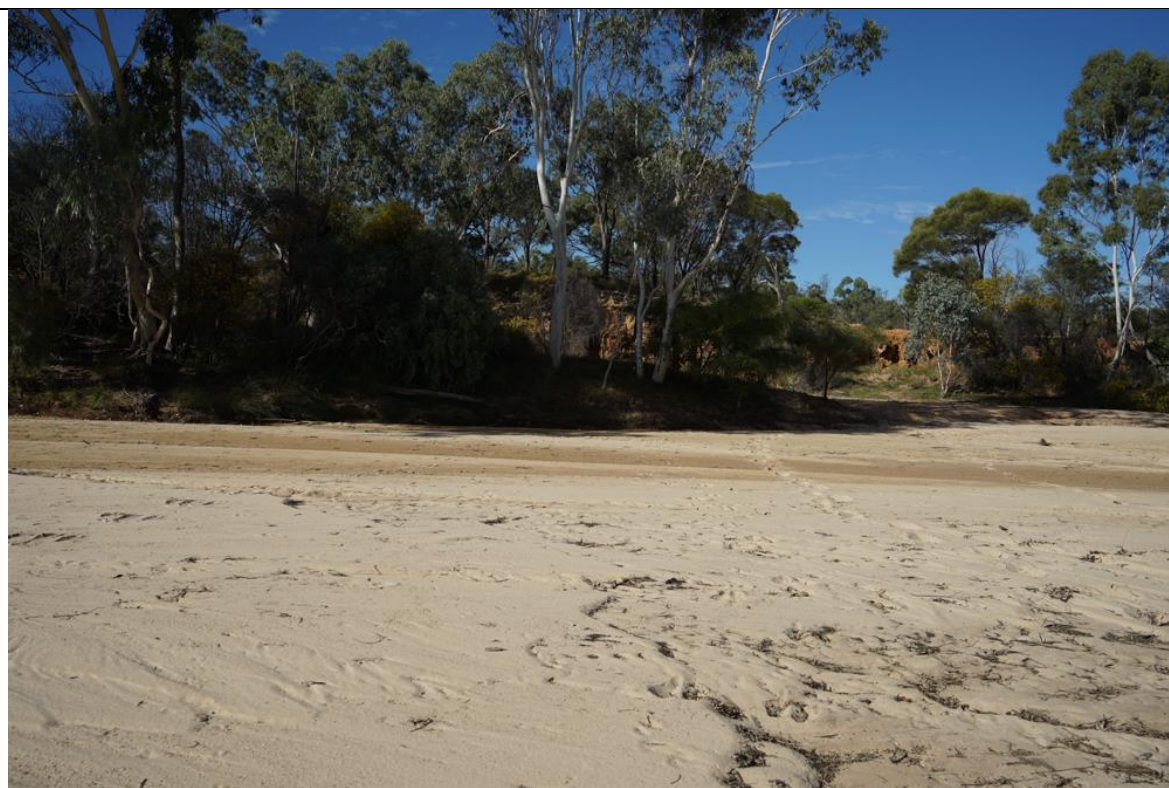
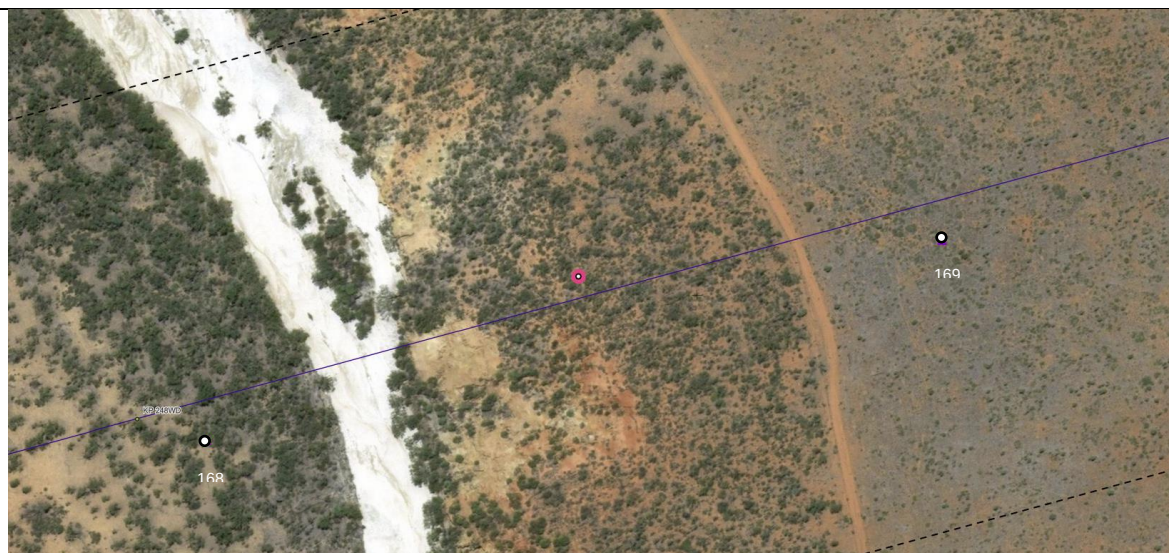
Line 1 KP 247.5 WD (20,0,50,30) Riparian zone (red) near Tower 169  
 (596.26m between towers 168-169) (Major Risk (Purple) DAF – WWBW)

This section is described as 20% very light, 0% light, 50% moderate and 30% heavy by the clearing contractor. Field observations shows a riparian woodland along an 83m wide watercourse. Tree heights ranged up to 18m. The sparse to mid-dense canopy covers the riparian canopy that fringes the watercourse and most of the west section with tree heights averaging around 7m. Observations on the ground reflect the clearing contractor's description within this section of the alignment.
