# Visual Comparison of Landscape Type

Client: CopperString 2.0  
Reference: J0XXX

This document is a visual comparison of landscapes which was compiled to provide a photographic record both from an aerial and site-based perspective along each of the five corridor selection segments. This ground truthing was utilised to inform the projects appreciation of the six general landscape types which occur across the study area as well as improved confidence in the potential conservation significant species habitat mapped for the CopperString EIS 2.0. It has also been used to confirm expected disturbance associated with construction related activities.

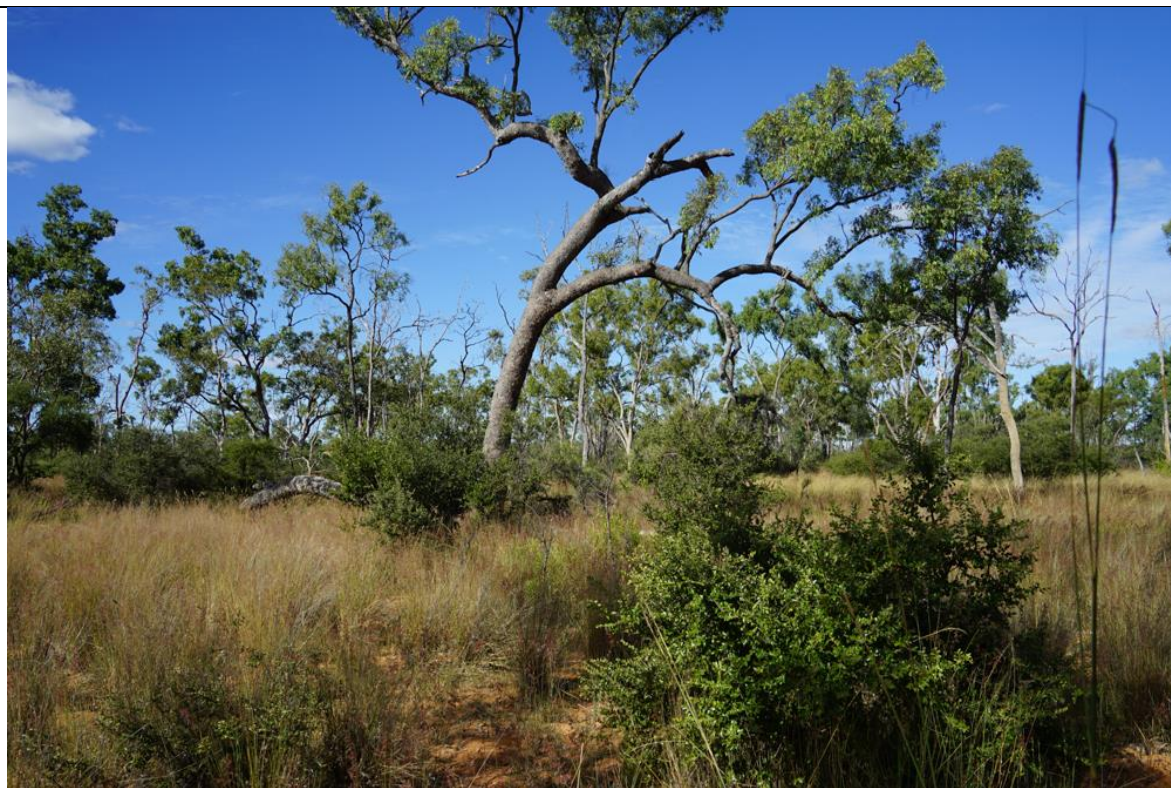
Line 1 KP 248.5 WD (40,0,60,0) Quaternary point (green) near Tower 167  
(502.21m between towers 166-167)

This section is described as 40% very light, 0% light, 60% moderate and 0% heavy by the clearing contractor. Field observations show a mid-dense canopy covers most of this section with tree heights averaging at 15m. Observations on the ground reflect the clearing contractor's description within this section of the alignment.

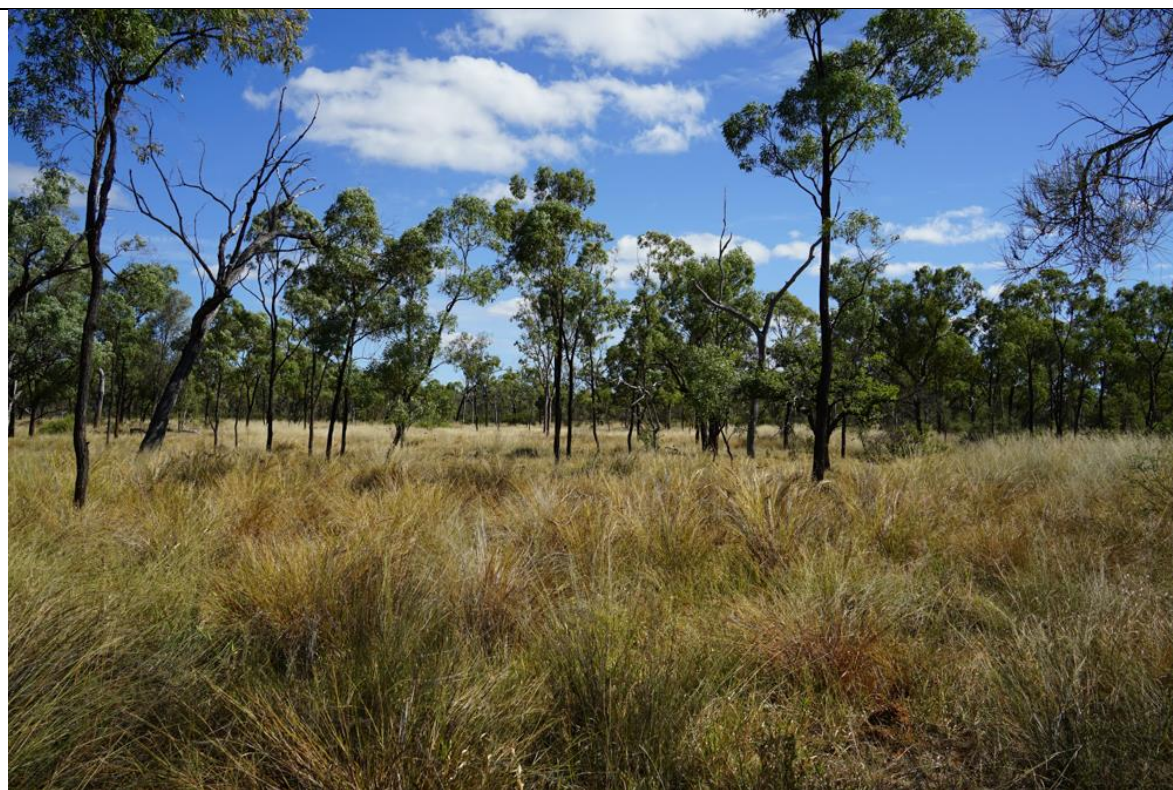
Line 1 KP 249.1 WD (30,0,70,0) Quaternary point (green) near Tower 166  
(488.91m between towers 165-166)

This section is described as 30% very light, 0% light, 70% moderate and 0% heavy by the clearing contractor. Field observations show a mid-dense canopy covers most of this section especially towards the west section with tree heights averaging at 9m. Observations on the ground reflect the clearing contractor's description within this section of the alignment.

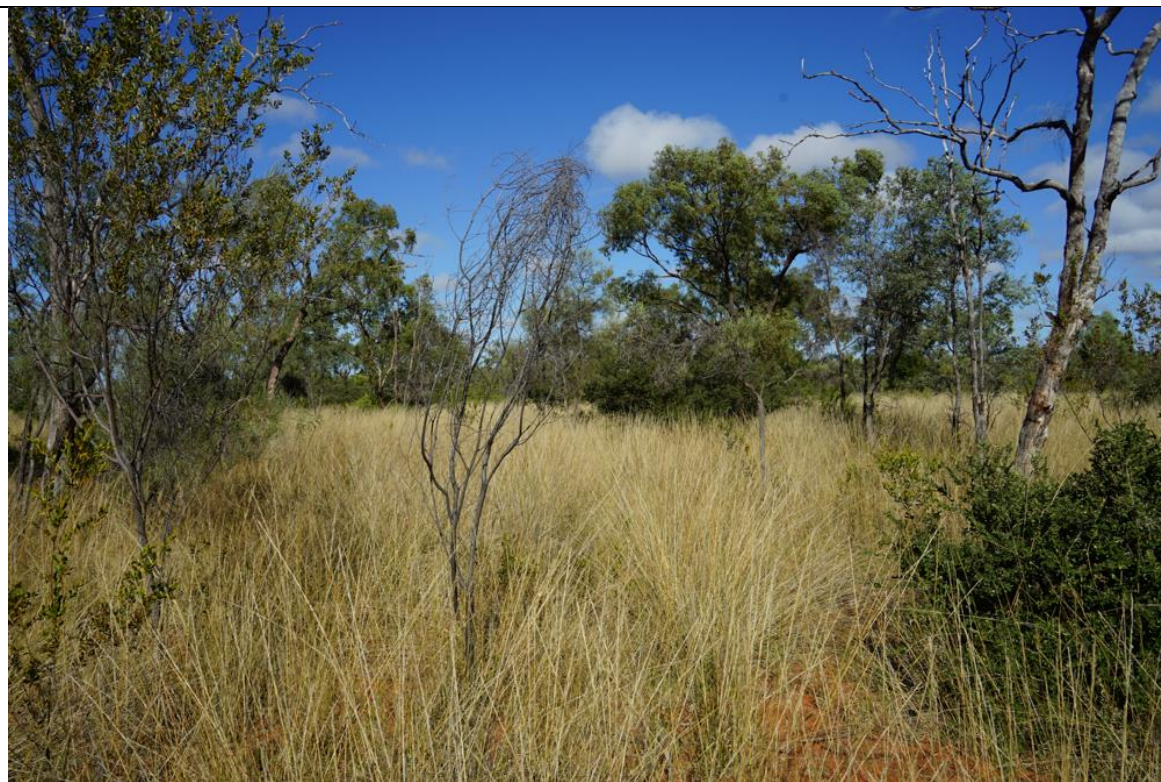
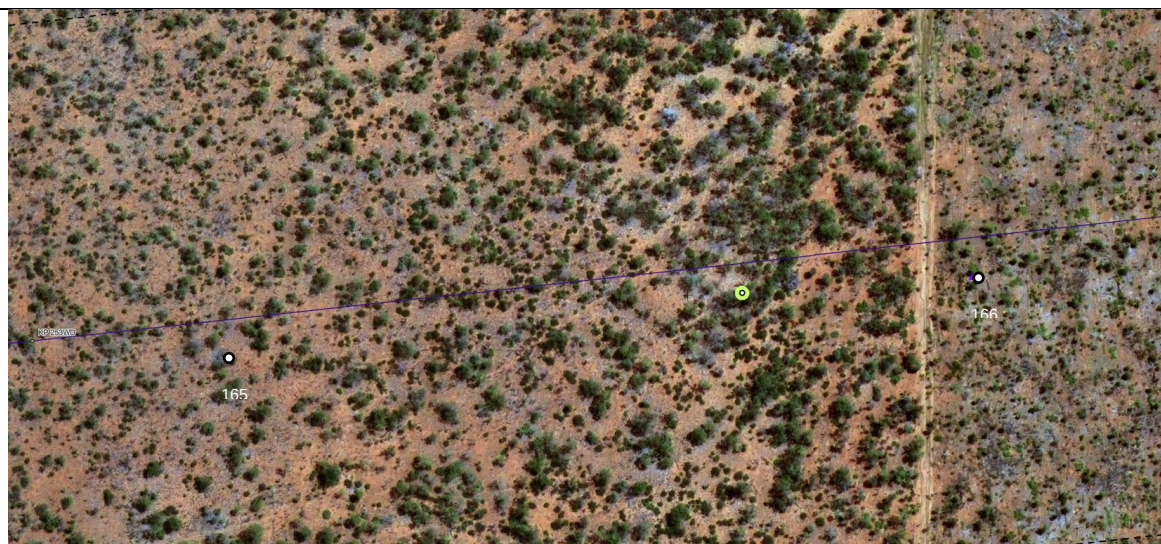
Line 1 KP 252.4 WD (30,0,70,0) Quaternary point (green) near Tower 160  
(595.80m between towers 159-160)

This section is described as 30% very light, 0% light, 70% moderate and 0% heavy by the clearing contractor. Field observations show a mid-dense canopy covers most of this section with tree heights averaging at 11m. Observations on the ground reflect the clearing contractor's description within this section of the alignment.

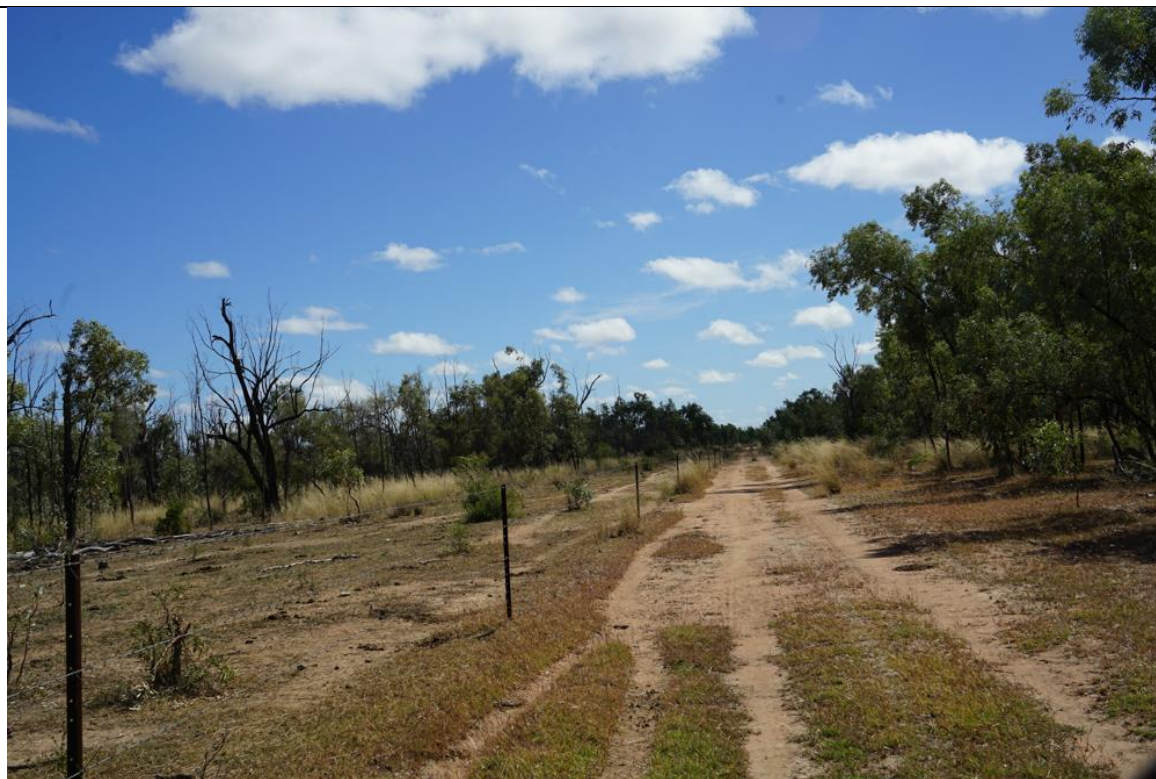
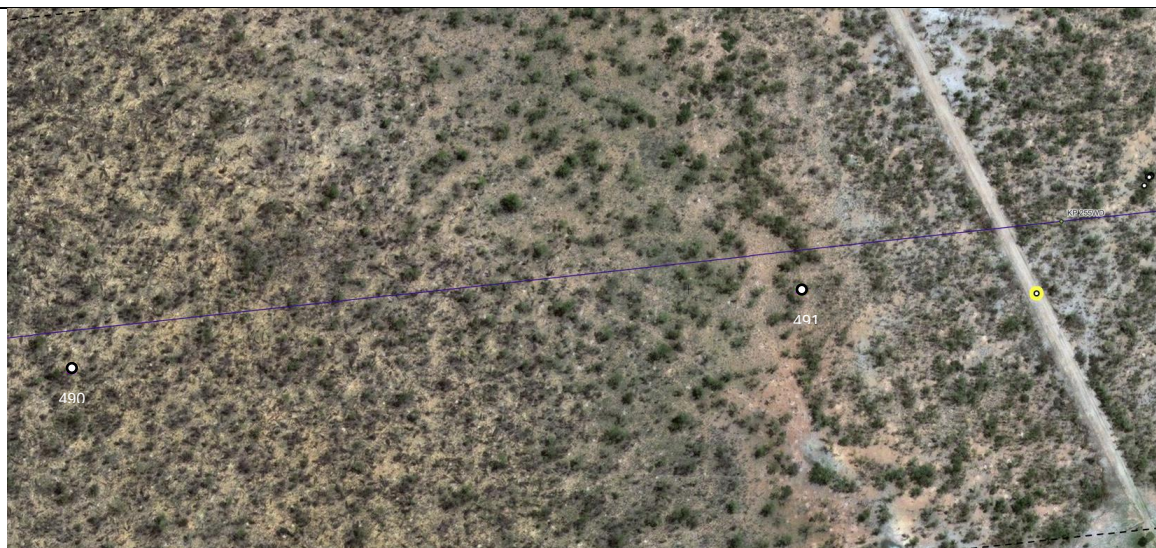
Line 1 KP 255.2 WD (30,0,70,0) Access track (yellow) near Tower 155  
(585.06m between towers 154-155)

This section is described as 30% very light, 0% light, 70% moderate and 0% heavy by the clearing contractor. Field observations show a mid-dense canopy covers most of this section with tree heights averaging at 9m. Observations on the ground reflect the clearing contractor's description within this section of the alignment.

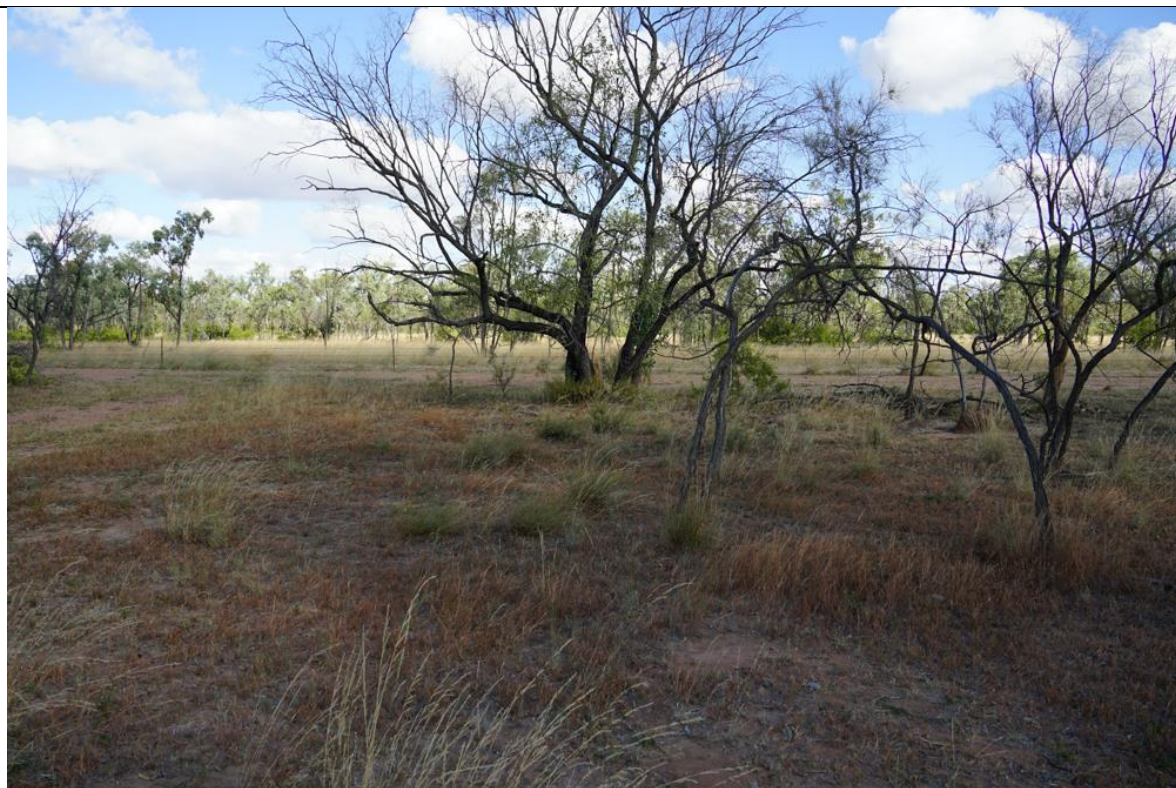
Line 1 KP 262.8 WD (40,30,30,0) Quaternary point (green) near Tower 142  
(571.37m between towers 141-142)

This section is described as 40% very light, 30% light, 30% moderate and 0% heavy by the clearing contractor. Field observations show a sparse canopy covers most of this section with tree heights averaging at 9m. Observations on the ground reflect the clearing contractor's description within this section of the alignment.

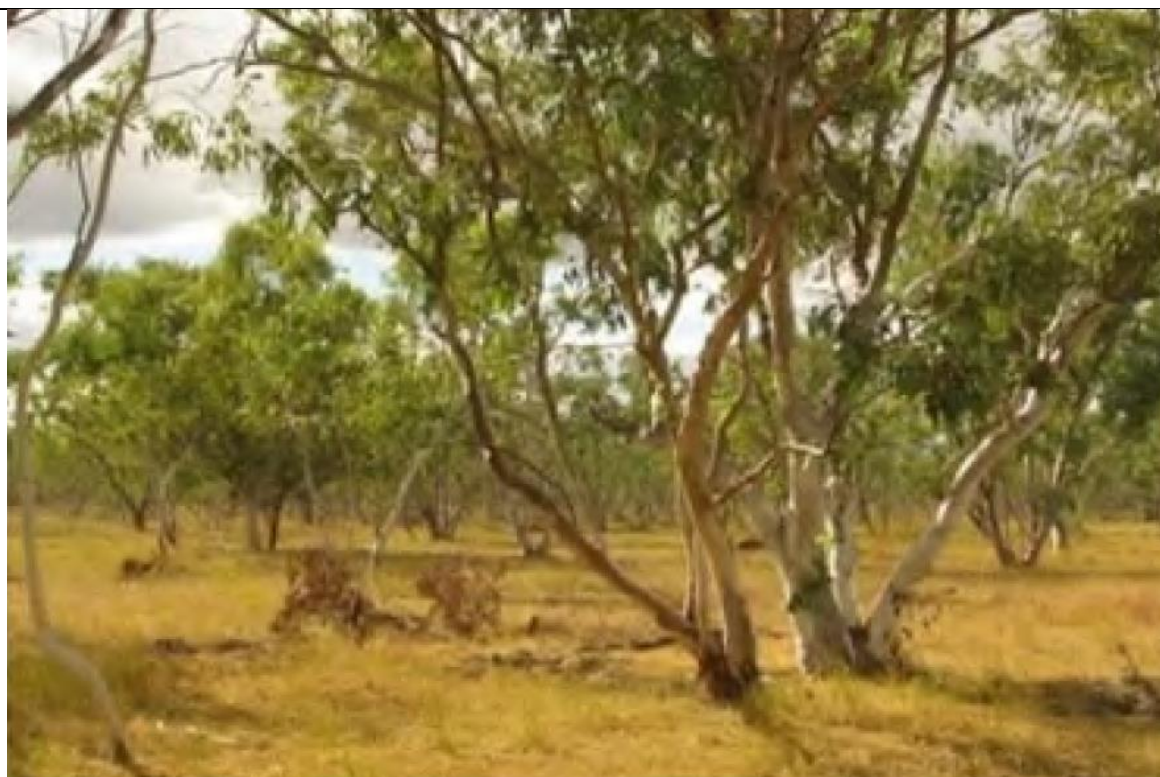
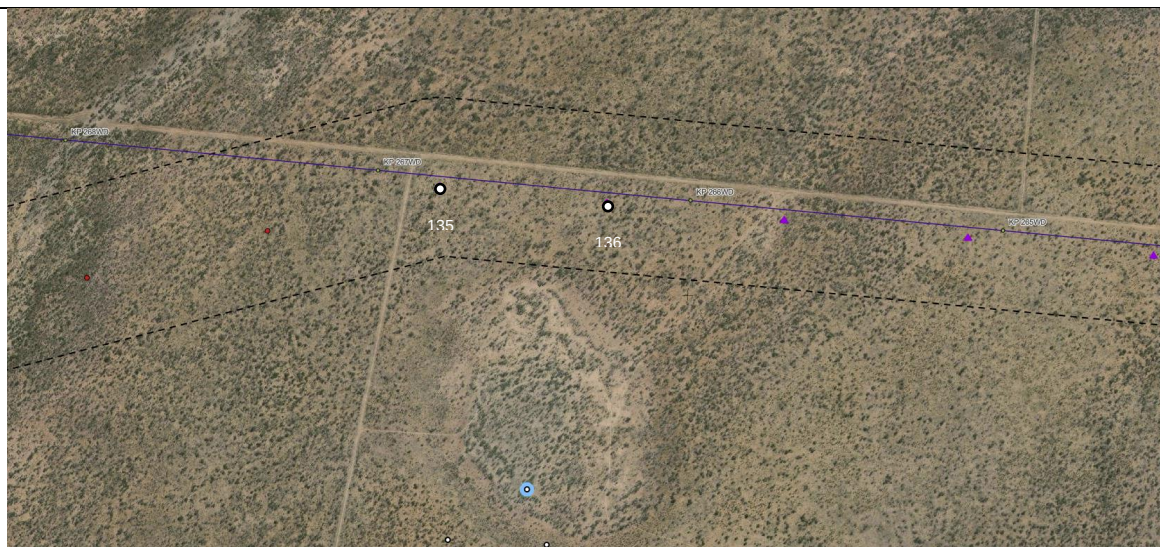
Line 1 KP 266.3 WD (40,30,30,0) Koala survey point (BAAM) (blue) near Tower 136  
(535.39m between towers 135-136)

This section is described as 40% very light, 30% light, 30% moderate and 0% heavy by the clearing contractor. Field observations show a sparse canopy covers most of the section with tree heights averaging at 10m. Observations on the ground reflect the clearing contractor's description within this section of the alignment.

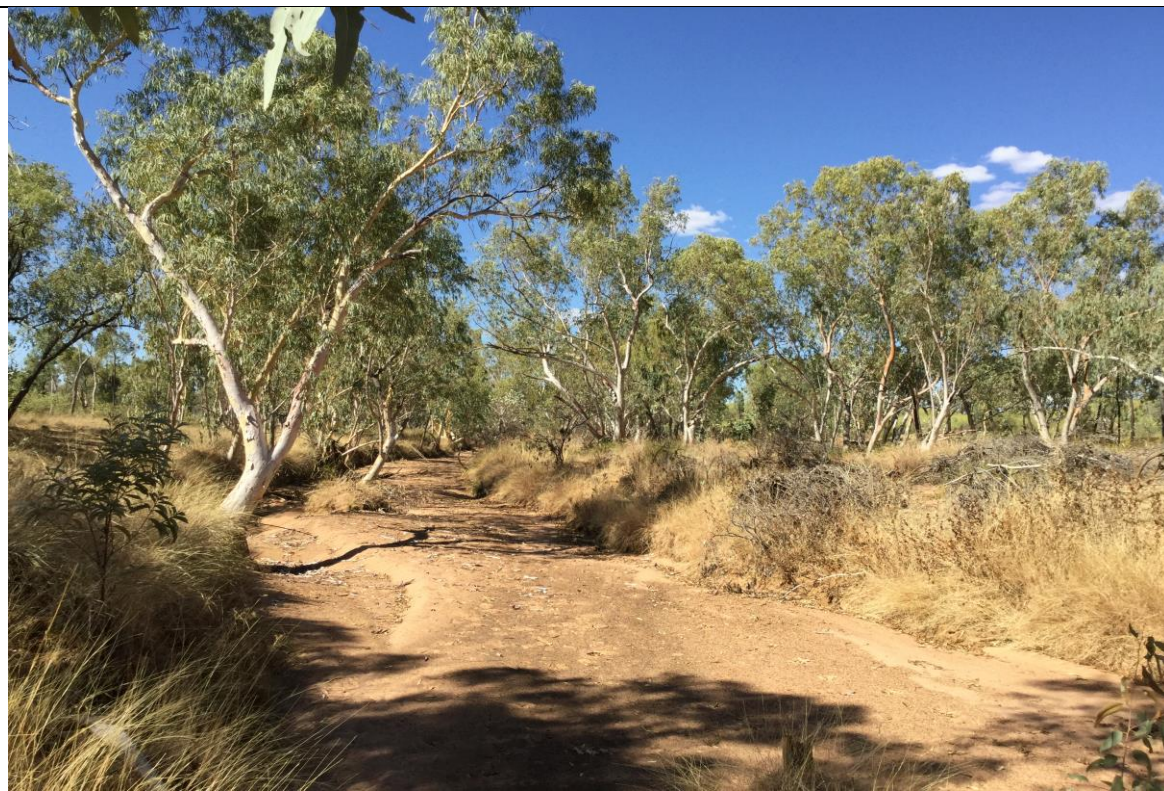
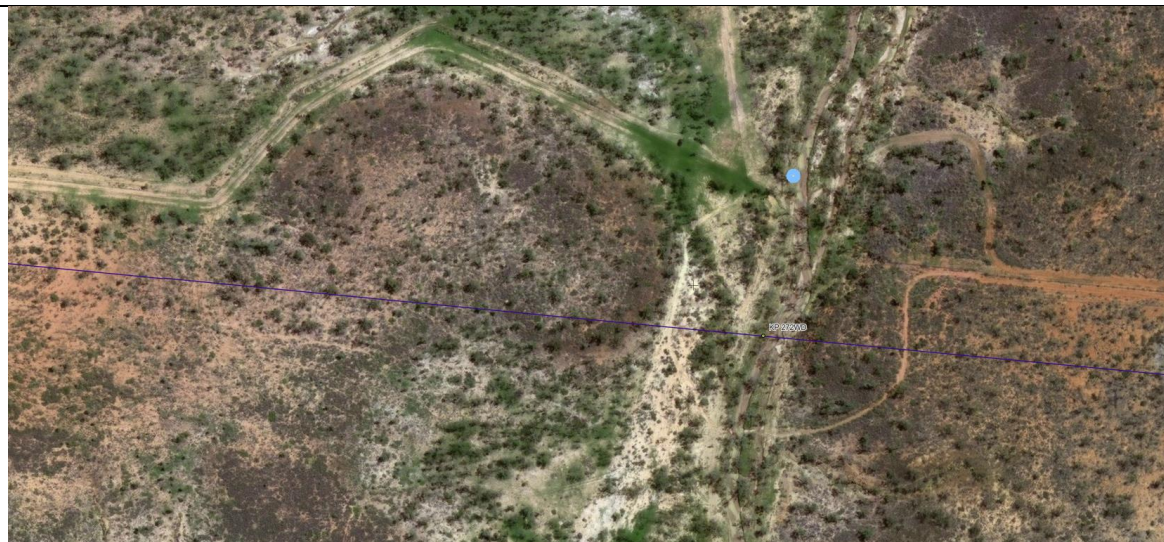
Line 1 KP 272 WD (40,20,40,0) Koala survey point (GHD) (blue) near Tower 127  
(605.07m between towers 126-127)

This section is described as 40% very light, 20% light, 40% moderate and 0% heavy by the clearing contractor. Field observations show a riparian woodland along a 15m wide braided watercourse on the survey point. The sparse to mid-dense canopy covers the riparian canopies that fringe the watercourses and most of this section with tree heights averaging at 16.5m. Observations on the ground reflect the clearing contractor's description within this section of the alignment.

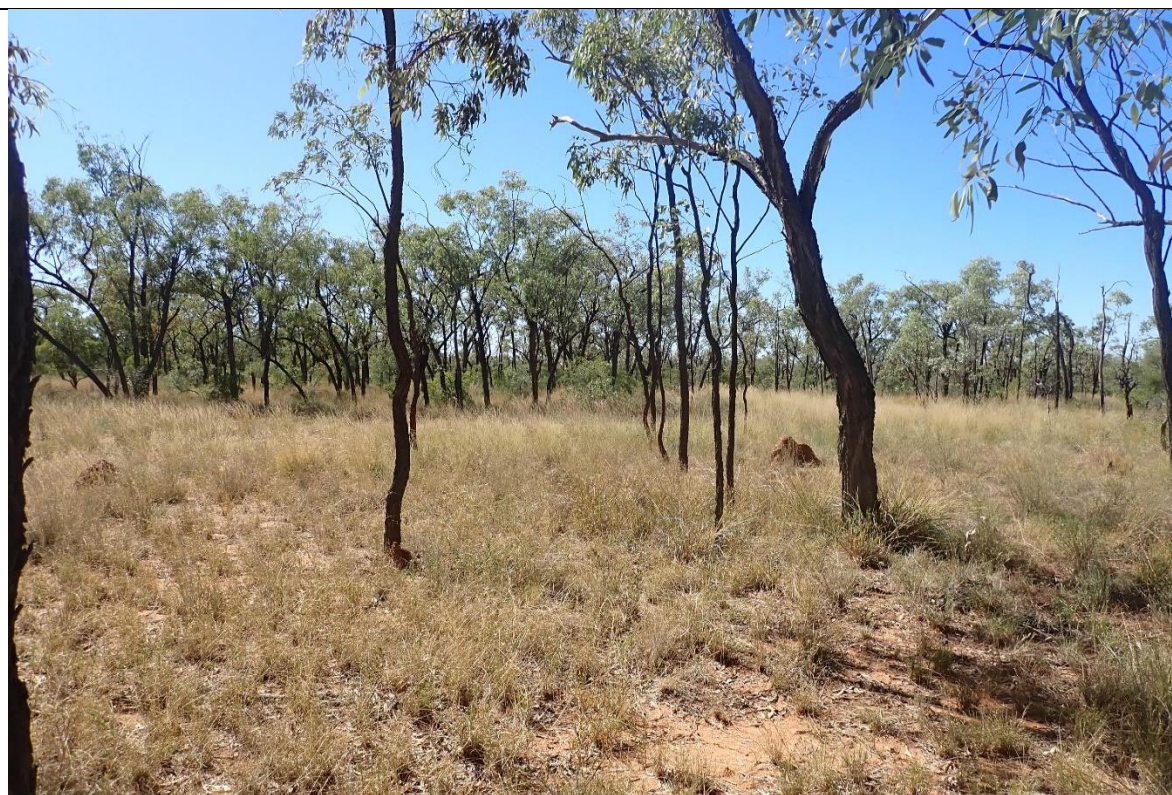
This section is described as 50% very light, 0% light, 40% moderate and 10% heavy by the clearing contractor. Field observations show a riparian woodland along an 10m wide watercourse west of the quaternary point. The sparse canopy covers the riparian canopy that fringes the watercourse and most of this section with tree heights averaging at 12m. Observations on the ground reflect the clearing contractor's description within this section of the alignment.

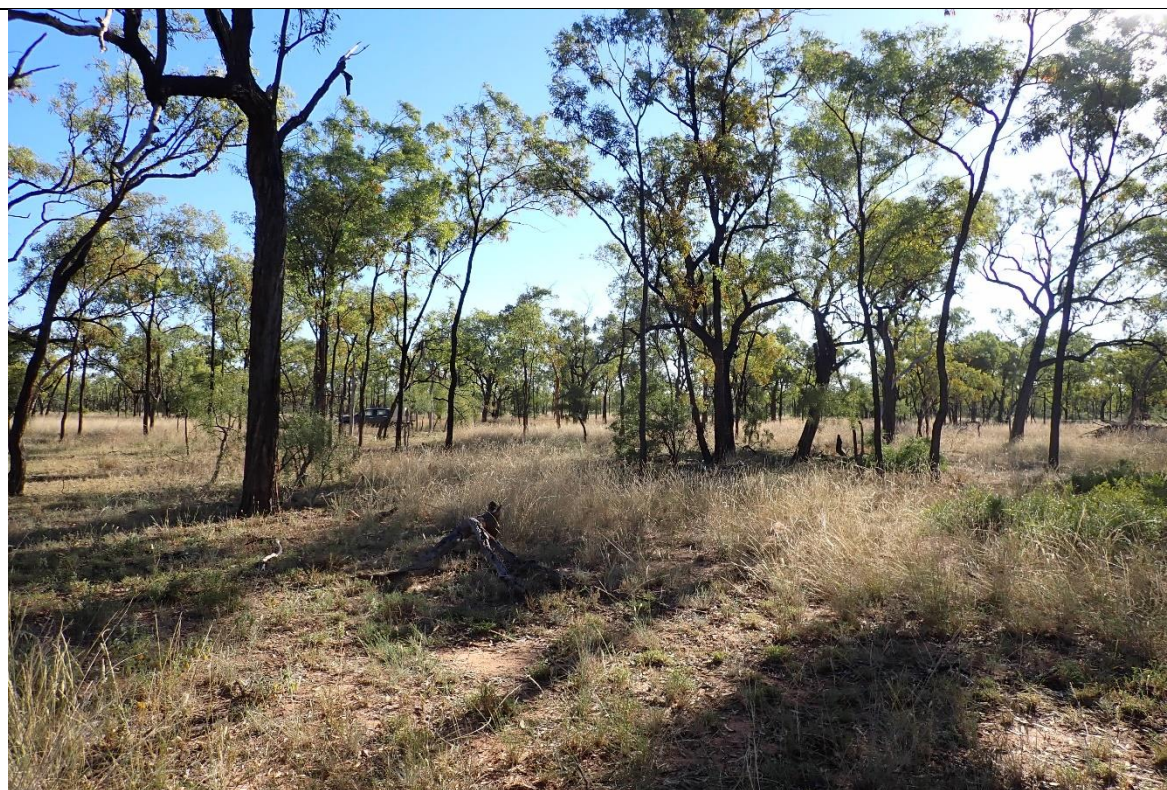
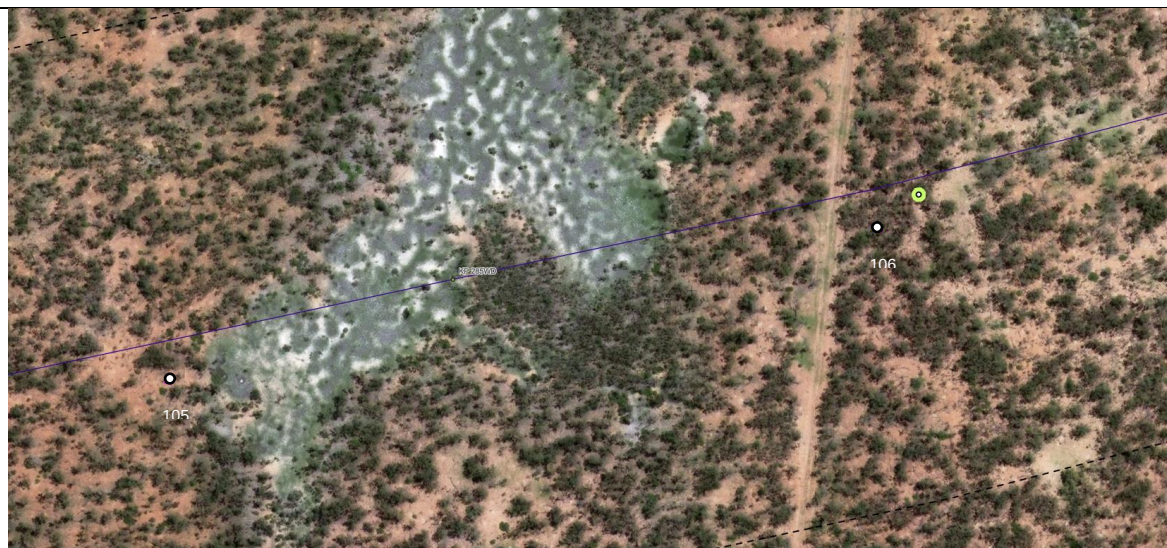
Line 1 KP 284.6 WD (20,0,30,50) Quaternary point (green) near Tower 106  
(574.01m between towers 105-106)

This section is described as 20% very light, 0% light, 30% moderate and 50% heavy by the clearing contractor. Field observations show a sparse to mid-dense canopy covers most of the section towards the east tower with tree heights averaging at 11m. Observations on the ground reflect the clearing contractor's description within this section of the alignment.

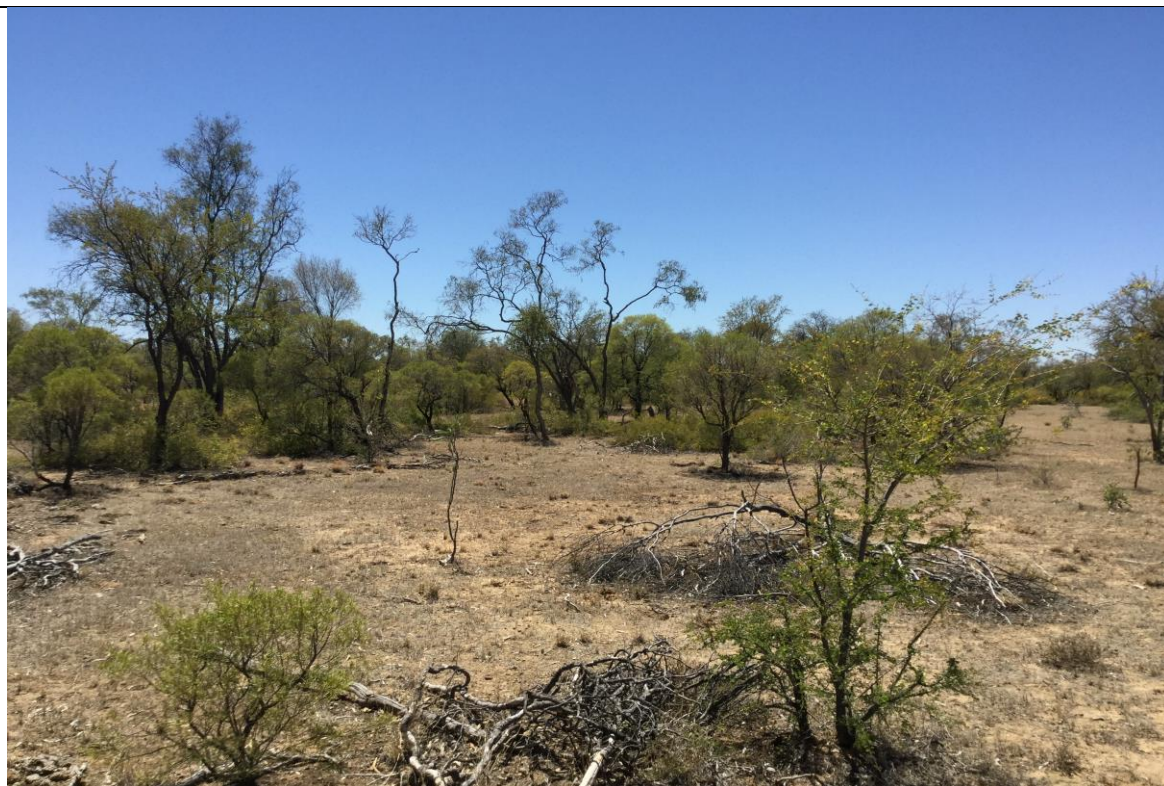
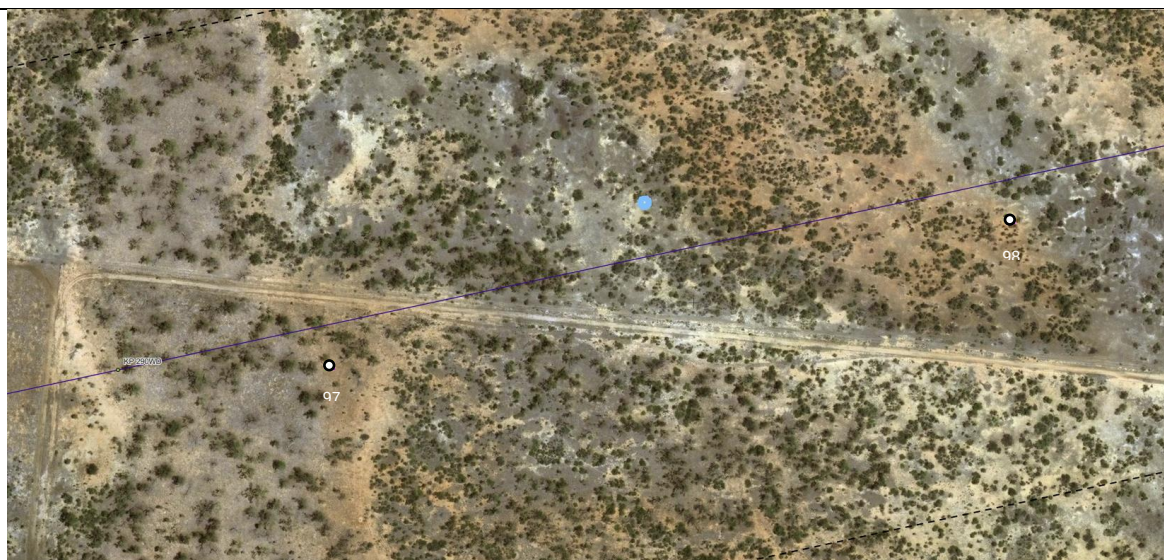
Line 1 KP 289.3 WD (50,10,40,0) Koala survey point (GHD) (blue) near Tower 98  
(549.08m between towers 97-98)

This section is described as 50% very light, 10% light, 40% moderate and 0% heavy by the clearing contractor. Field observations show a mid-dense canopy covers most of this section with tree heights averaging at 5m. Observations on the ground reflect the clearing contractor's description within this section of the alignment.

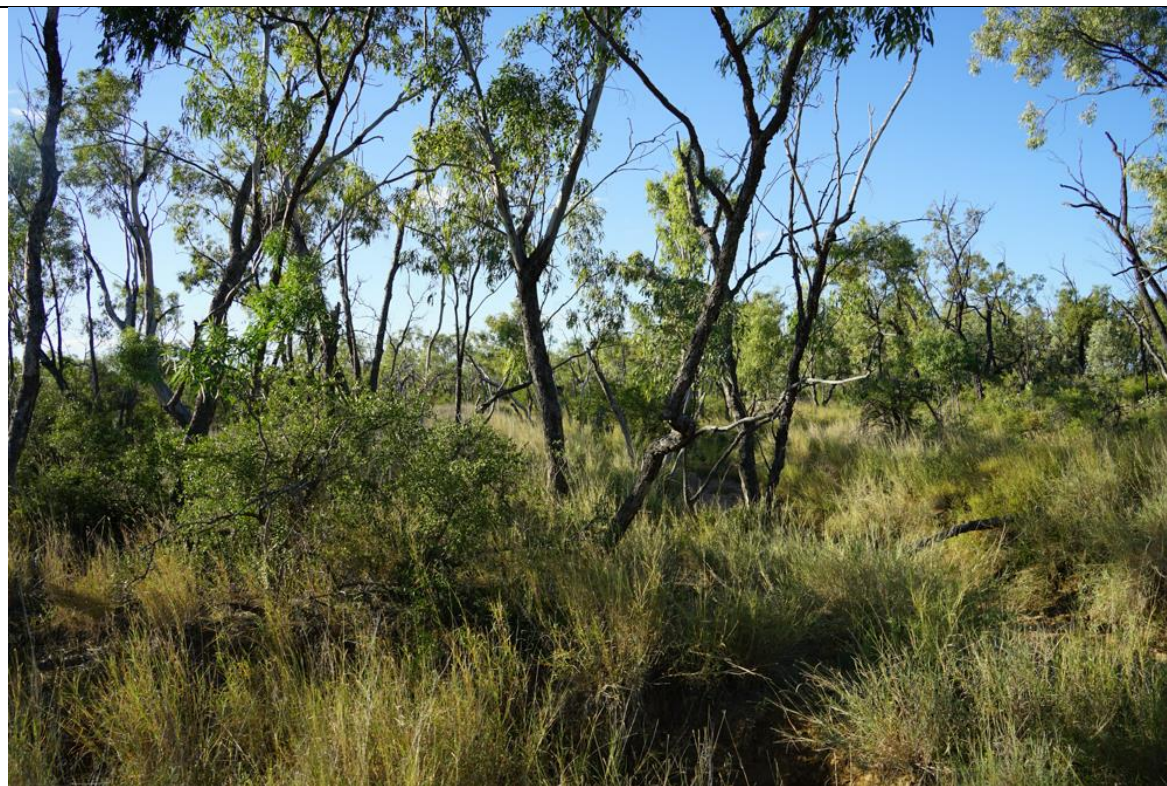
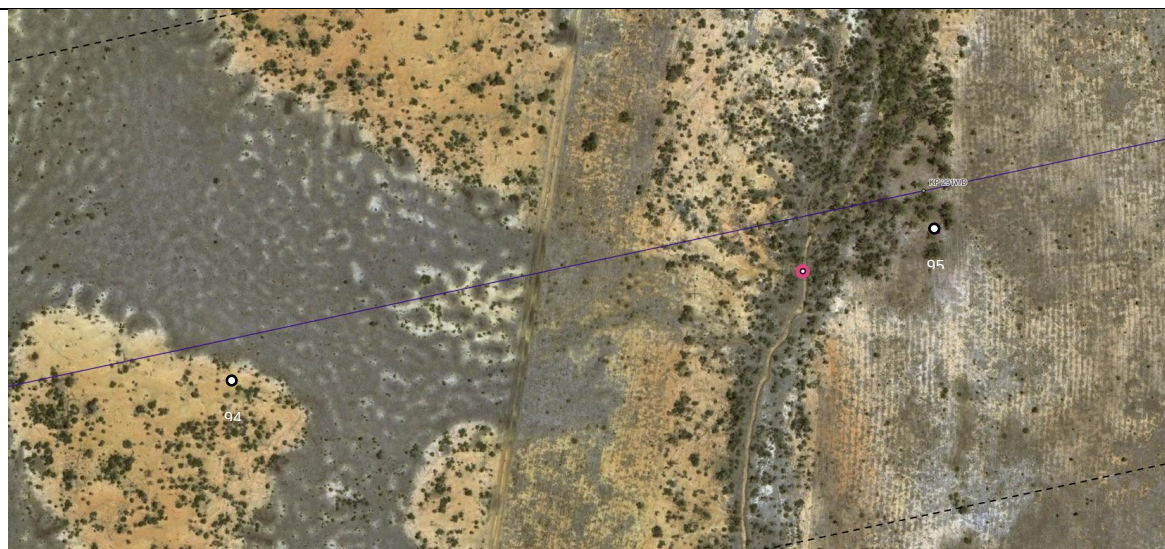
Line 1 KP 291 WD (30,20,20,30) Riparian zone (red) near Tower 95

(569.94m between towers 94-95) (Low Risk (Green) DAF – WWBW)

This section is described as 30% very light, 20% light, 20% moderate and 30% heavy by the clearing contractor. Field observations shows a riparian woodland along an 4m wide watercourse. Tree heights ranged up to 15m. The sparse canopy covers the riparian canopy that fringes the watercourse and most of the east section with tree heights averaging around 11m. Observations on the ground reflect the clearing contractor's description within this section of the alignment.

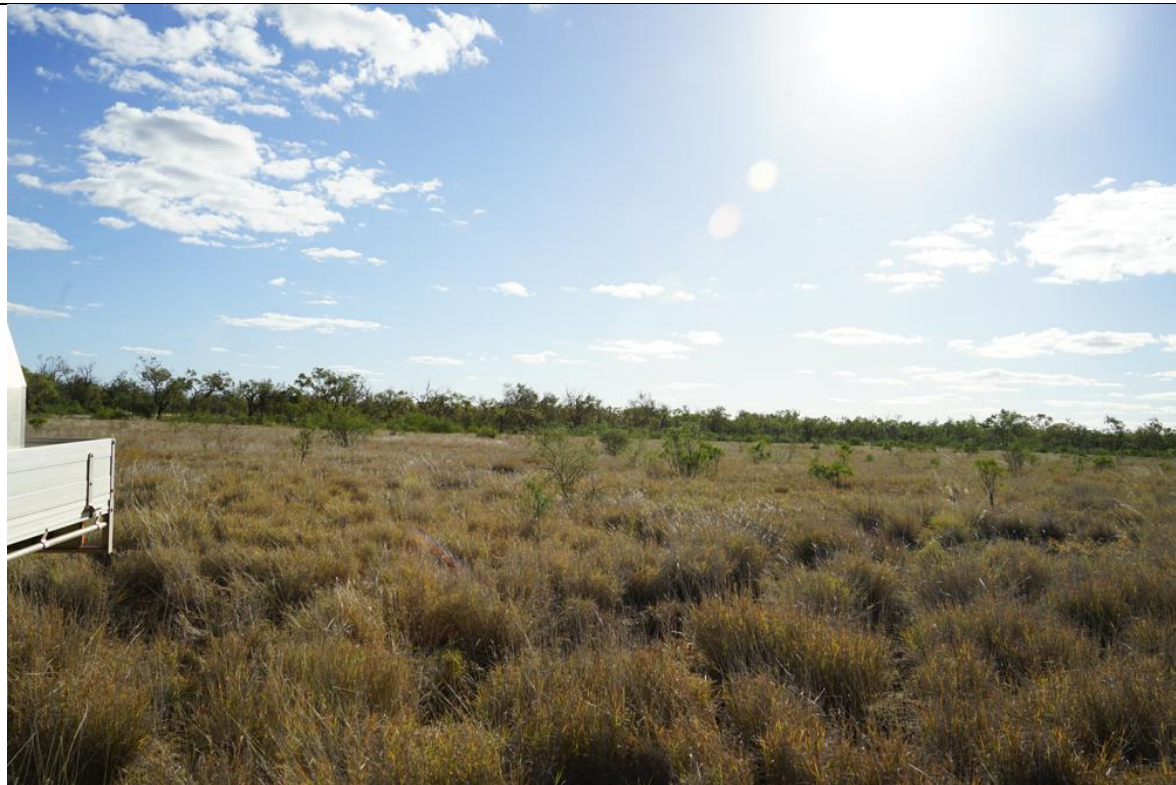
This section is described as 60% very light, 30% light, 10% moderate and 0% heavy by the clearing contractor. Field observations show a sparse canopy covers most of the section towards the west tower with tree heights averaging at 9m. Observations on the ground reflect the clearing contractor's description within this section of the alignment.

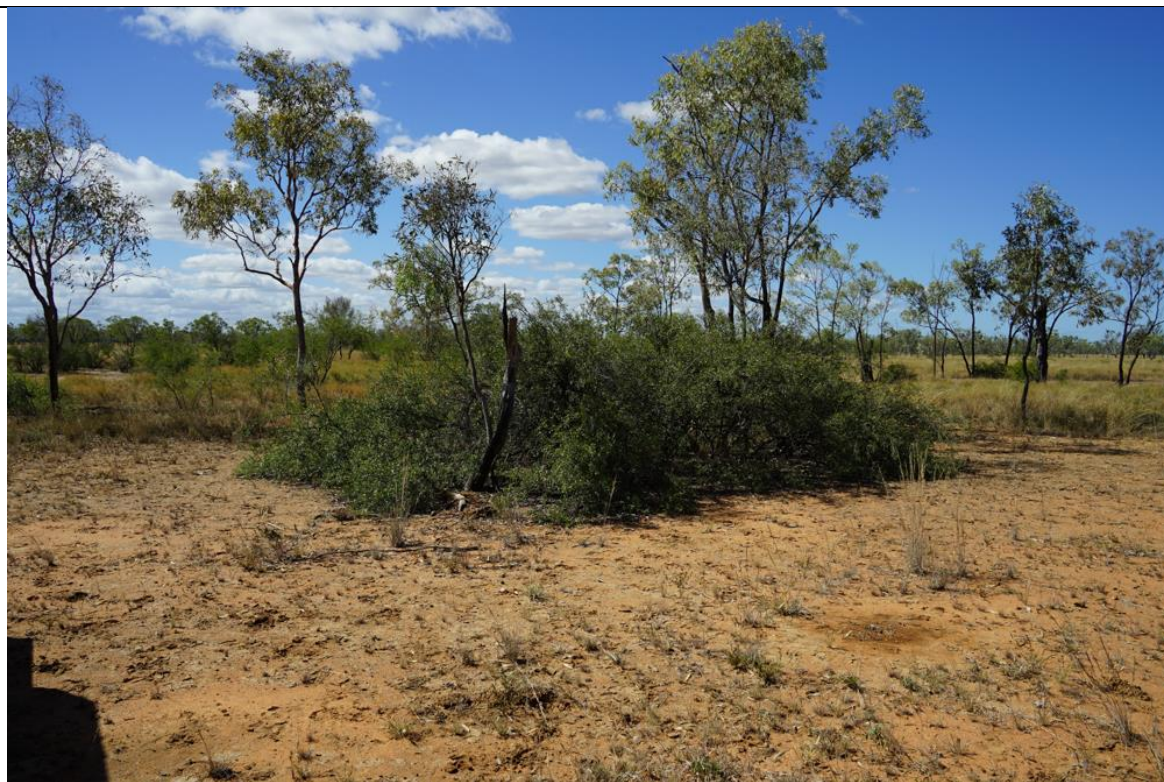
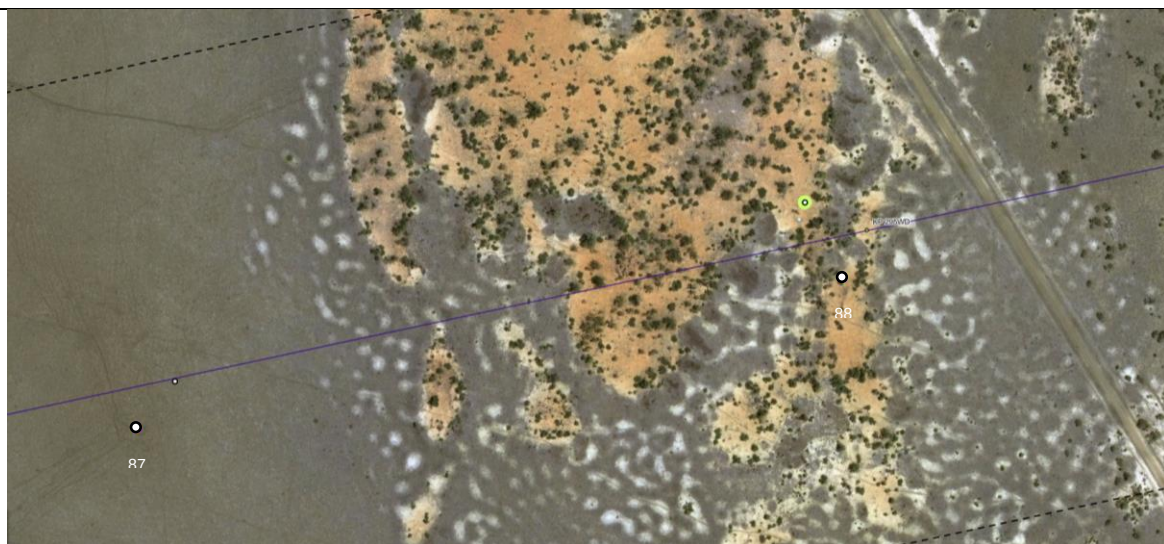
Line 1 KP 295 WD (40,0,60,0) Quaternary point (green) near Tower 88  
(576.14m between towers 87-88)

This section is described as 40% very light, 0% light, 60% moderate and 0% heavy by the clearing contractor. Field observations show a mid-dense canopy covers most of the section towards the east tower with tree heights averaging at 9m. Observations on the ground reflect the clearing contractor's description within this section of the alignment.

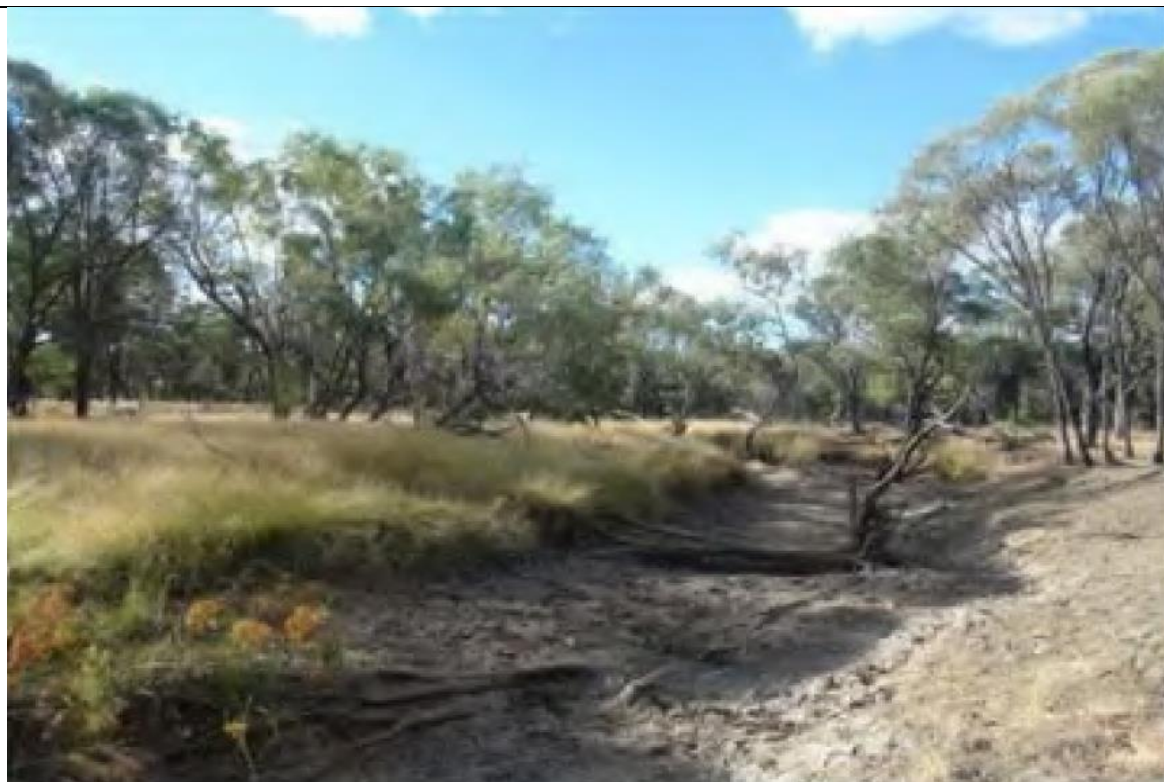
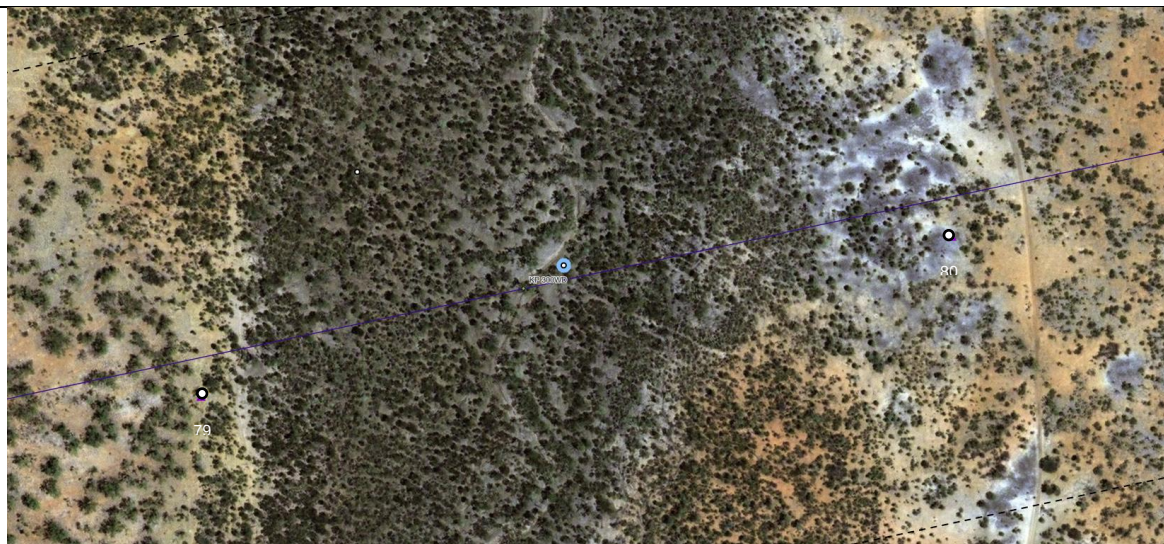
Line 1 KP 299.8 WD (30,0,60,10) Koala survey point (BAAM) (blue) near Tower 80  
(605.60m between towers 79-80)

This section is described as 30% very light, 0% light, 60% moderate and 10% heavy by the clearing contractor. Field observations show a riparian woodland along a 10m wide watercourse on the survey point. The mid-dense canopy covers the riparian canopy that fringes the watercourse and most of this section with tree heights averaging at 10m. Observations on the ground reflect the clearing contractor's description within this section of the alignment.

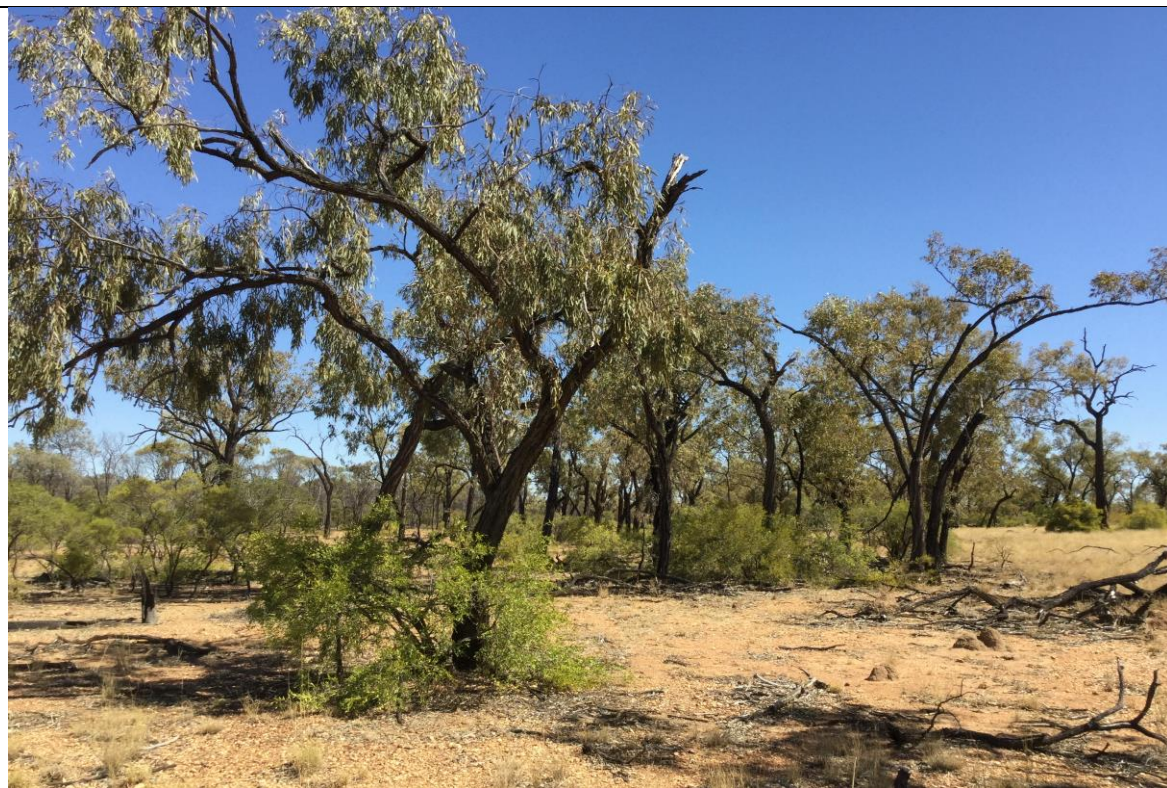
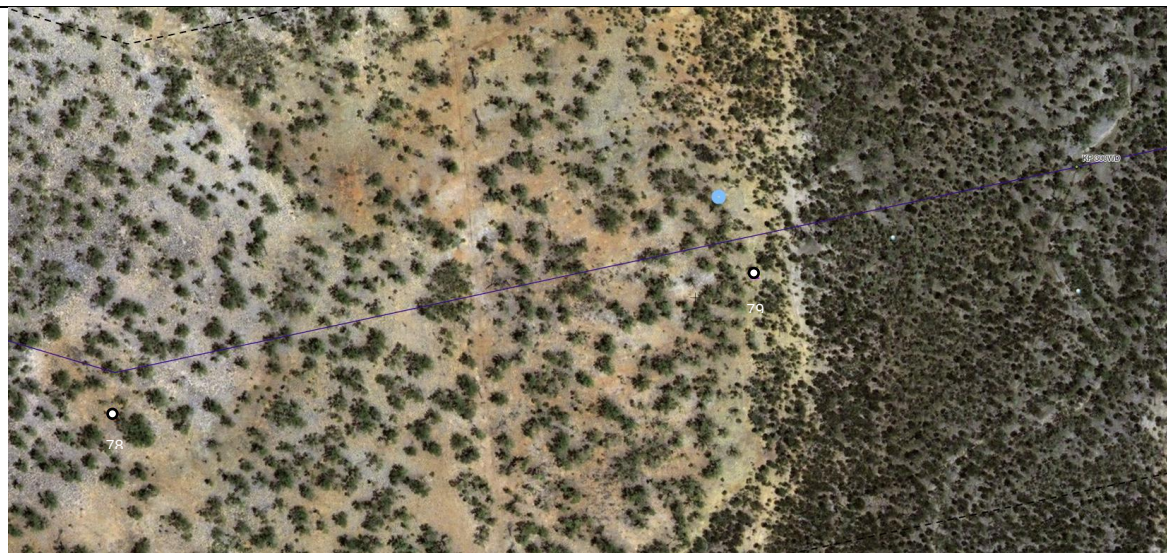
Line 1 KP 300.3 WD (30,0,70,0) Koala survey point (GHD) (blue) near Tower 79  
(518.39m between towers 78-79)

This section is described as 30% very light, 0% light, 70% moderate and 0% heavy by the clearing contractor. Field observations show a mid-dense canopy covers most of this section with tree heights averaging at 7m. Observations on the ground reflect the clearing contractor's description within this section of the alignment.
