# Visual Comparison of Landscape Type

Client: CopperString 2.0  
Reference: J0XXX

This document is a visual comparison of landscapes which was compiled to provide a photographic record both from an aerial and site-based perspective along each of the five corridor selection segments. This ground truthing was utilised to inform the projects appreciation of the six general landscape types which occur across the study area as well as improved confidence in the potential conservation significant species habitat mapped for the CopperString EIS 2.0. It has also been used to confirm expected disturbance associated with construction related activities.

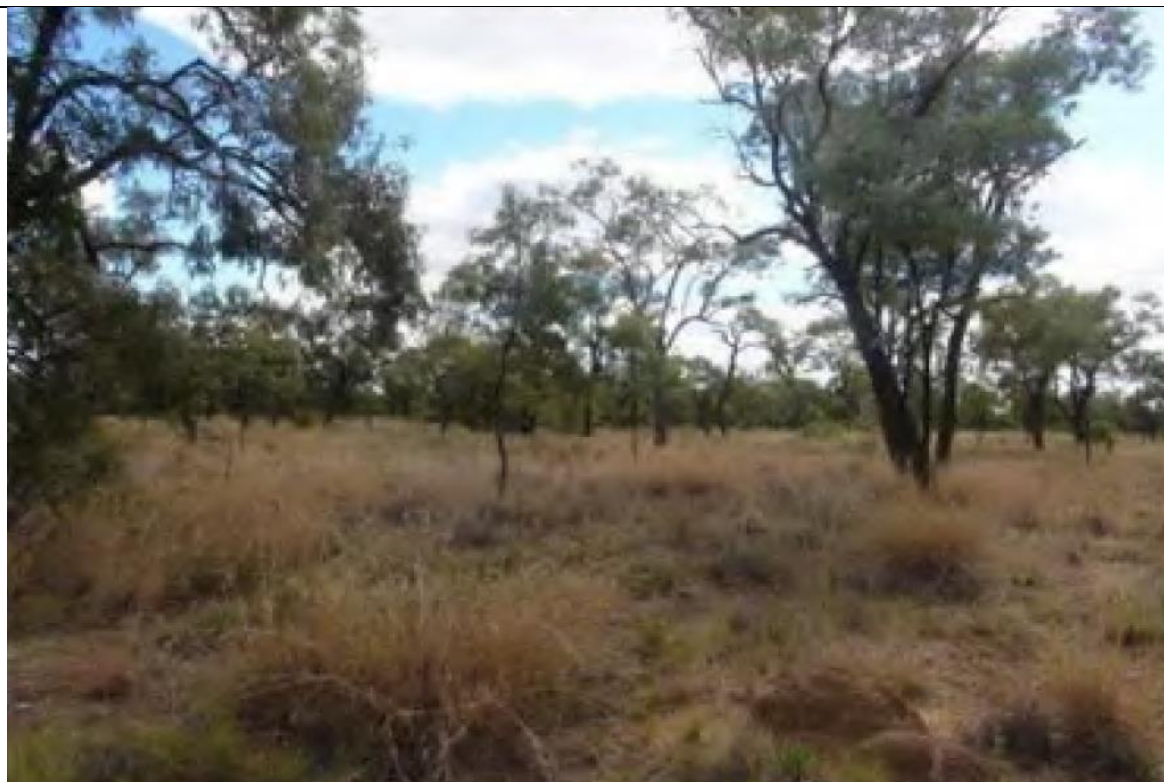
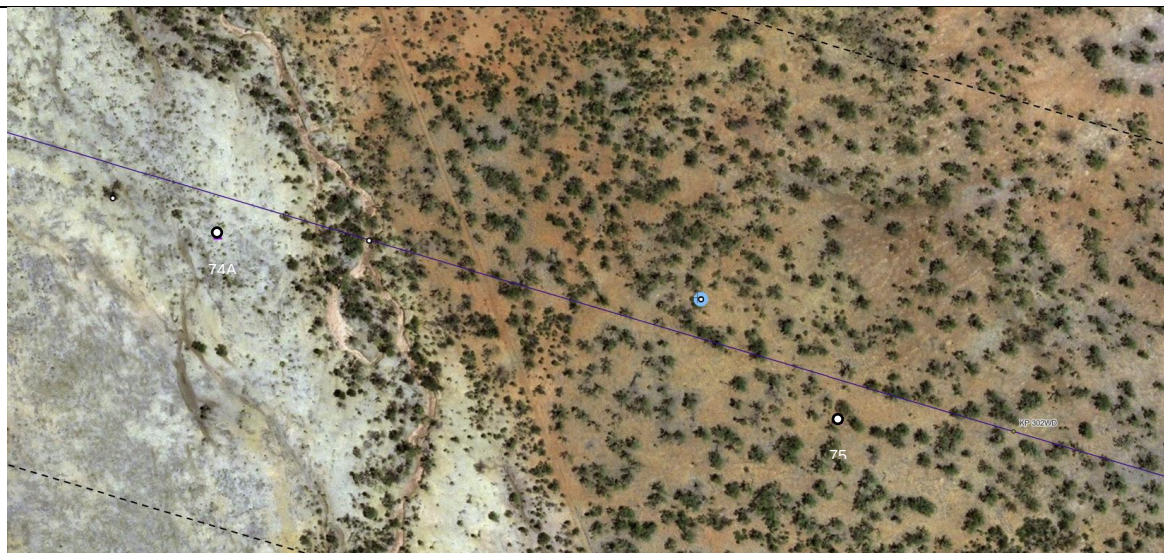
Line 1 KP 302.1 WD (50,0,50,0) Koala survey point (BAAM) (blue) near Tower 75  
(511.33m between towers 74A-75)

This section is described as 50% very light, 0% light, 50% moderate and 0% heavy by the clearing contractor. Field observations show a riparian woodland along a 10m wide braided watercourse west of the survey point. The mid-dense canopy covers the riparian canopies that fringe the watercourses and most of this east section with tree heights averaging at 10m. Observations on the ground reflect the clearing contractor's description within this section of the alignment.

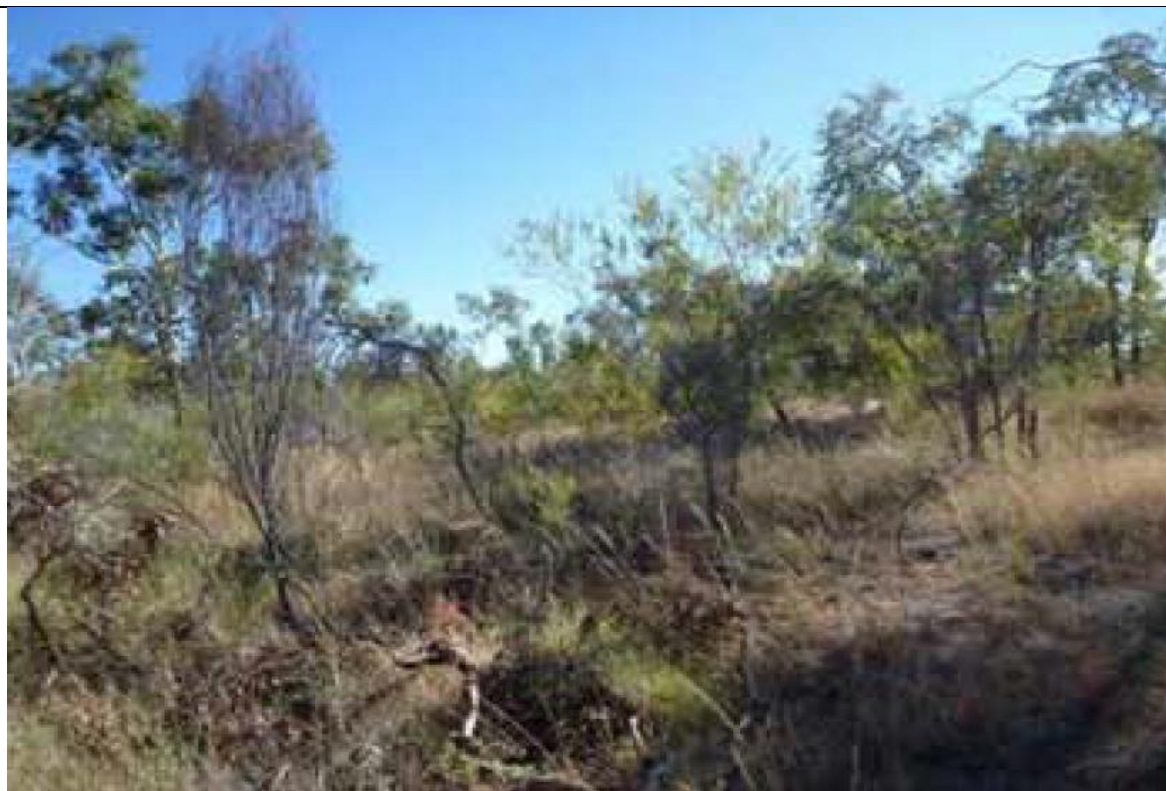
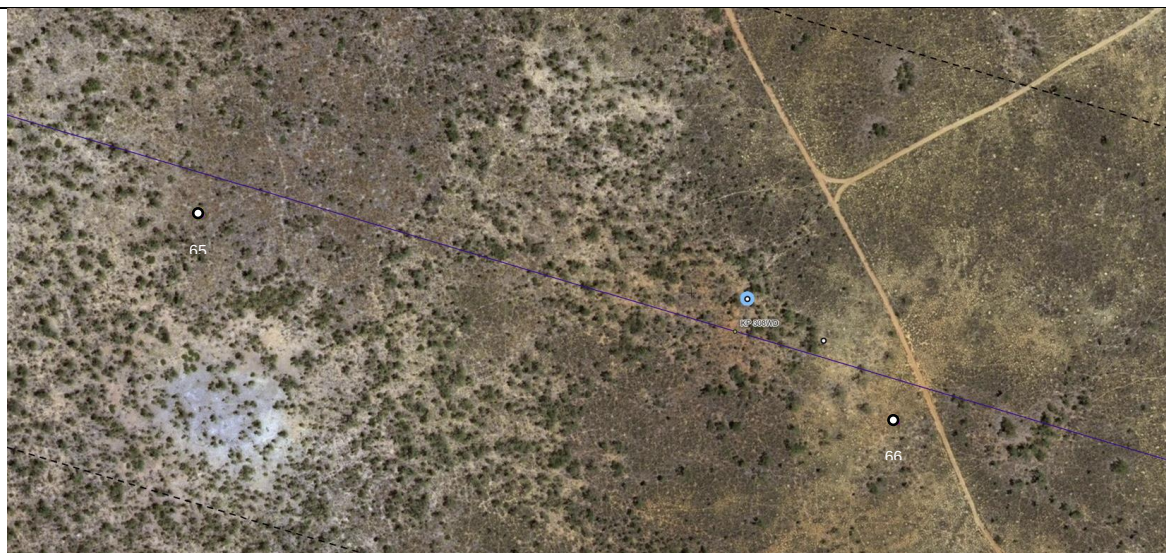
Line 1 KP 307.9 WD (30,0,50,20) Koala survey point (BAAM) (blue) near Tower 66  
(574.08m between towers 65-66)

This section is described as 30% very light, 0% light, 50% moderate and 20% heavy by the clearing contractor. Field observations show a sparse to mid-dense canopy covers most of the middle section with tree heights averaging at 10m. Observations on the ground reflect the clearing contractor's description within this section of the alignment.

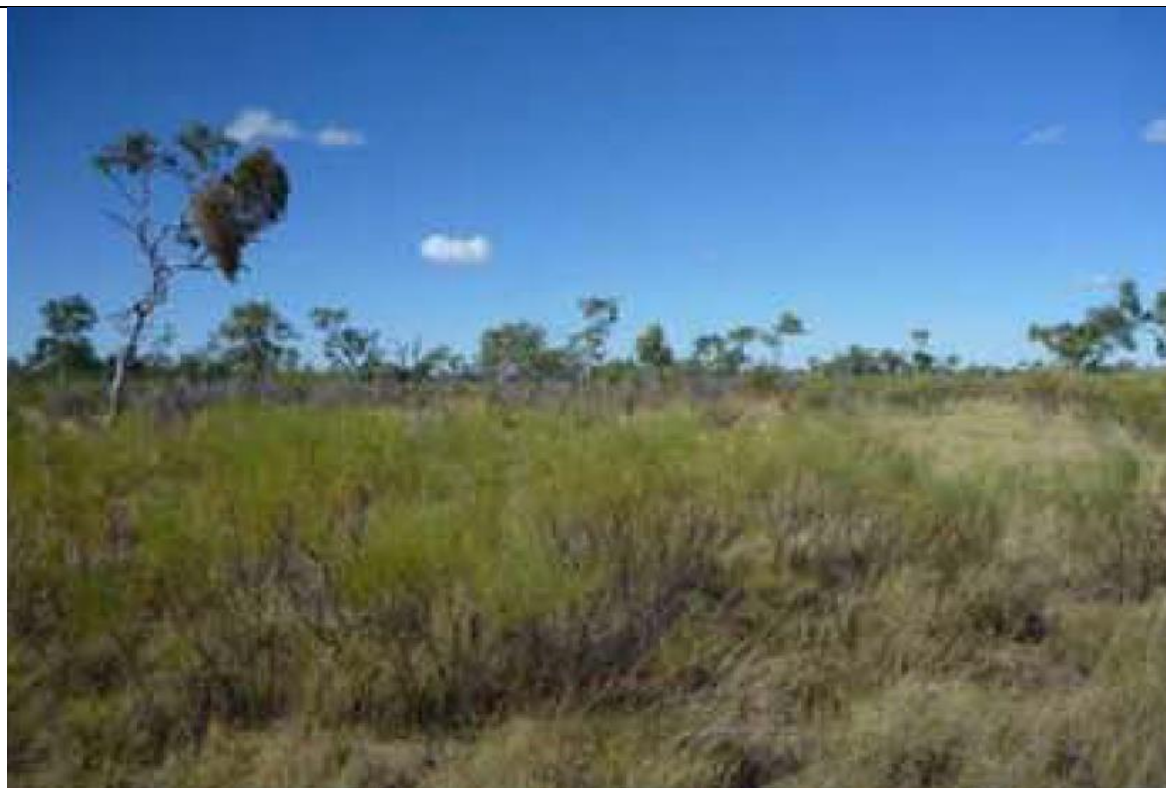
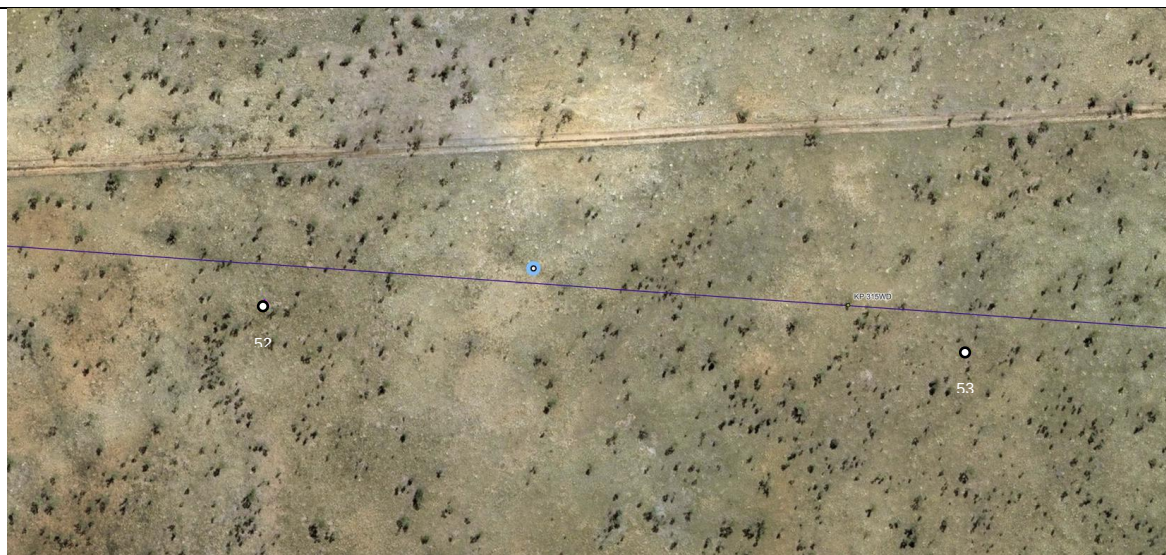
Line 1 KP 314.9 WD (80,20,0,0) Koala survey point (BAAM) (blue) near Tower 53  
(556.10m between towers 52-53)

This section is described as 80% very light, 20% light, 0% moderate and 0% heavy by the clearing contractor. Field observations show a sparse canopy covers most of the section in small patches with tree heights averaging at 12m. Observations on the ground reflect the clearing contractor's description within this section of the alignment.

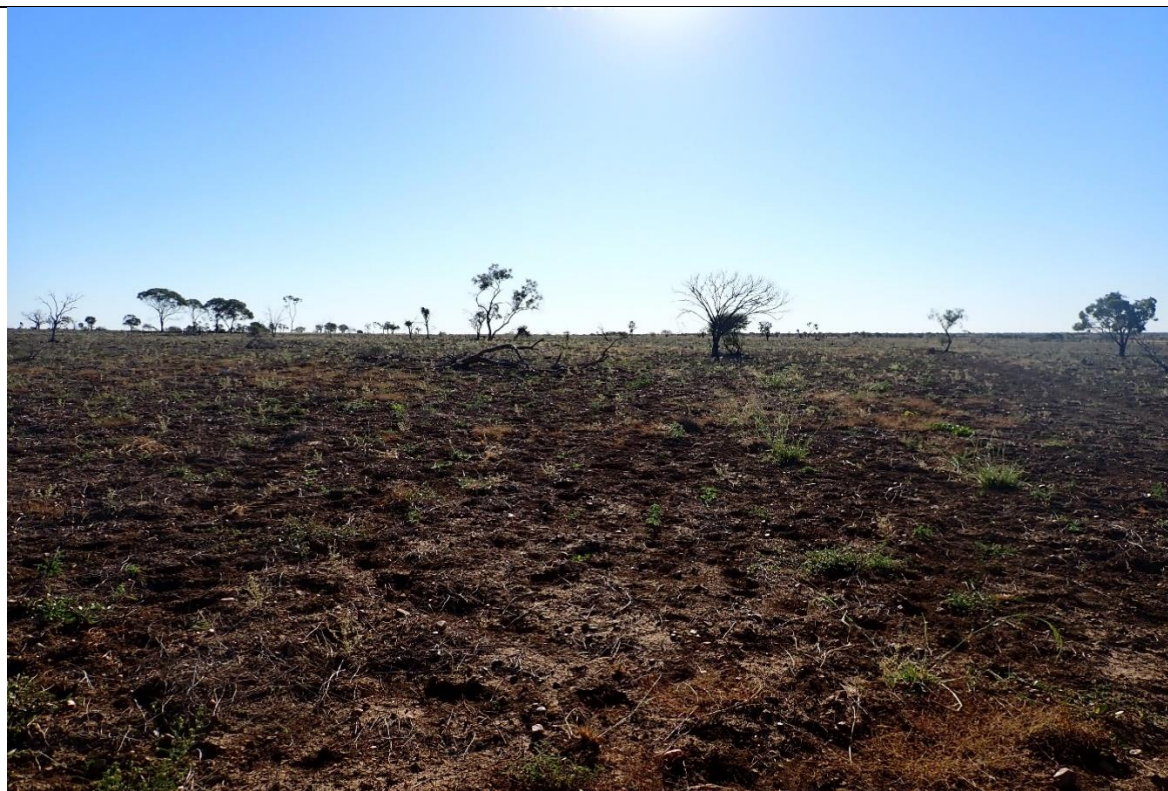
This section is described as 70% very light, 20% light, 10% moderate and 0% heavy by the clearing contractor. Field observations show a sparse canopy covers most of the section towards the east tower with tree heights averaging at 4m. Observations on the ground reflect the clearing contractor's description within this section of the alignment.

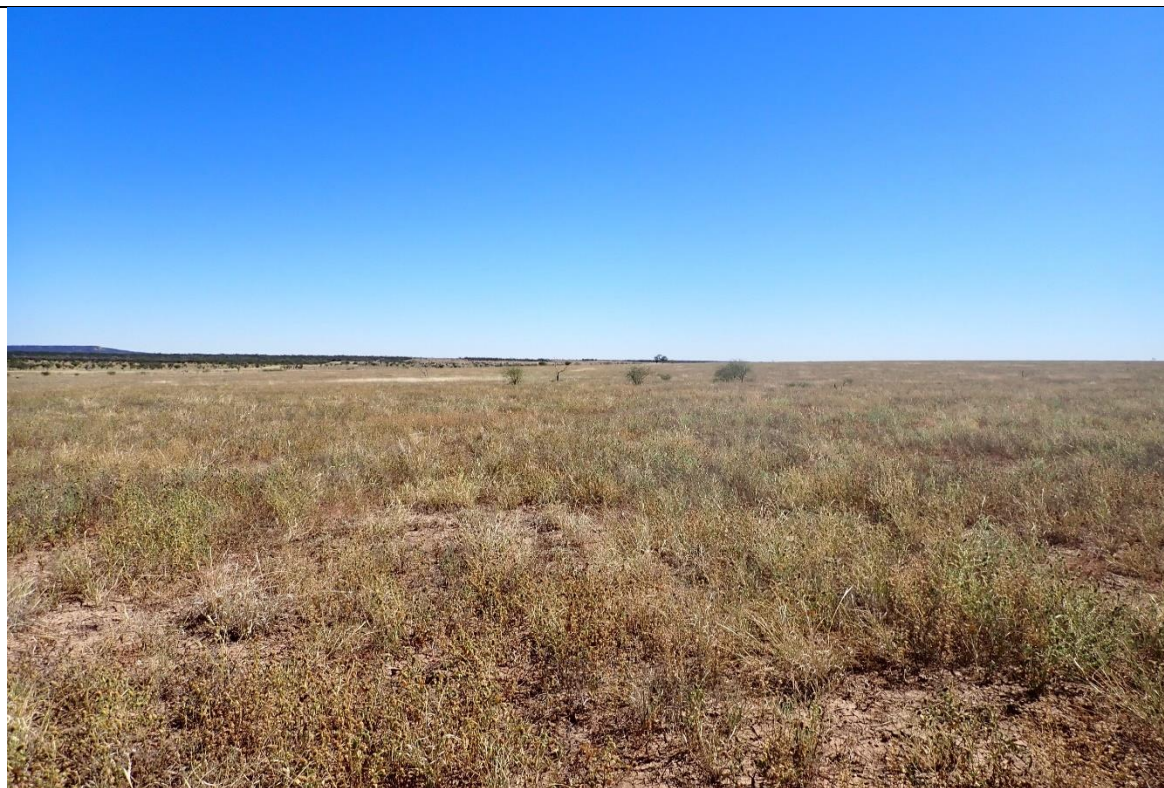
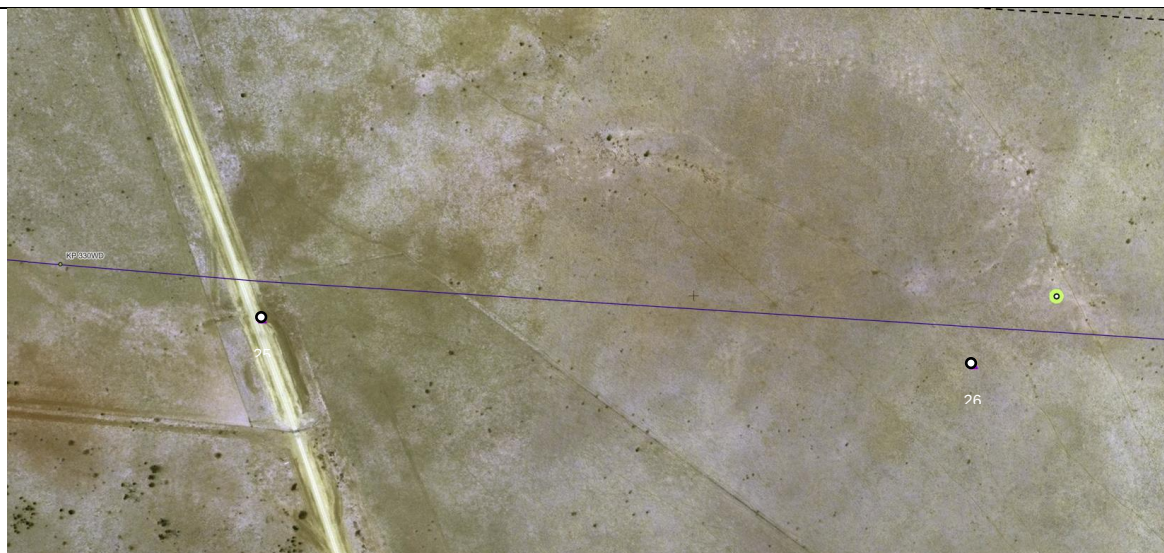
Line 1 KP 329.3 WD (90,10,0,0) Quaternary point (green) near Tower 26  
(562.93m between towers 25-26)

This section is described as 90% very light, 10% light, 0% moderate and 0% heavy by the clearing contractor. Field observations in this section shows canopy coverage is very sparse or absent. Observations on the ground reflect the clearing contractor's description within this section of the alignment.

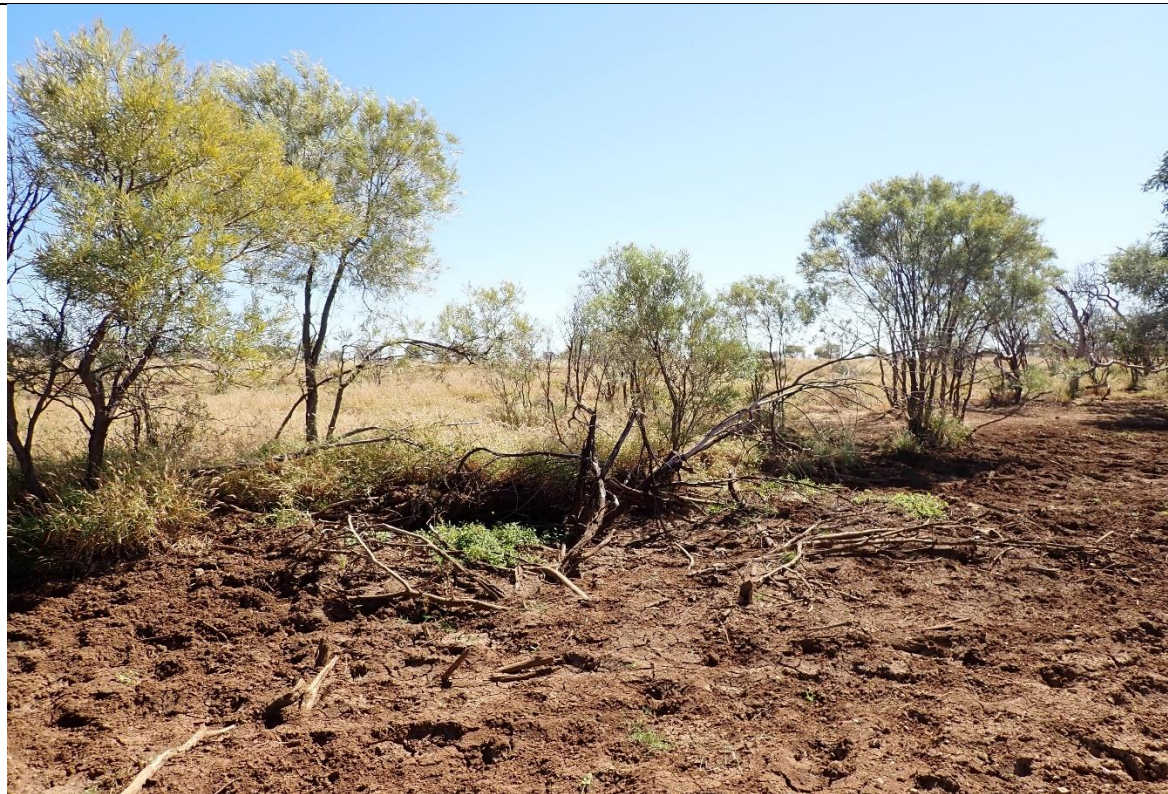
This section is described as 95% very light, 5% light, 0% moderate and 0% heavy by the clearing contractor. Field observations shows a riparian woodland along an 7m wide watercourse. Tree heights ranged up to 6m. The very sparse canopy covers the riparian canopy that fringes the watercourse and most of the east section with tree heights averaging around 1m. Observations on the ground reflect the clearing contractor's description within this section of the alignment.

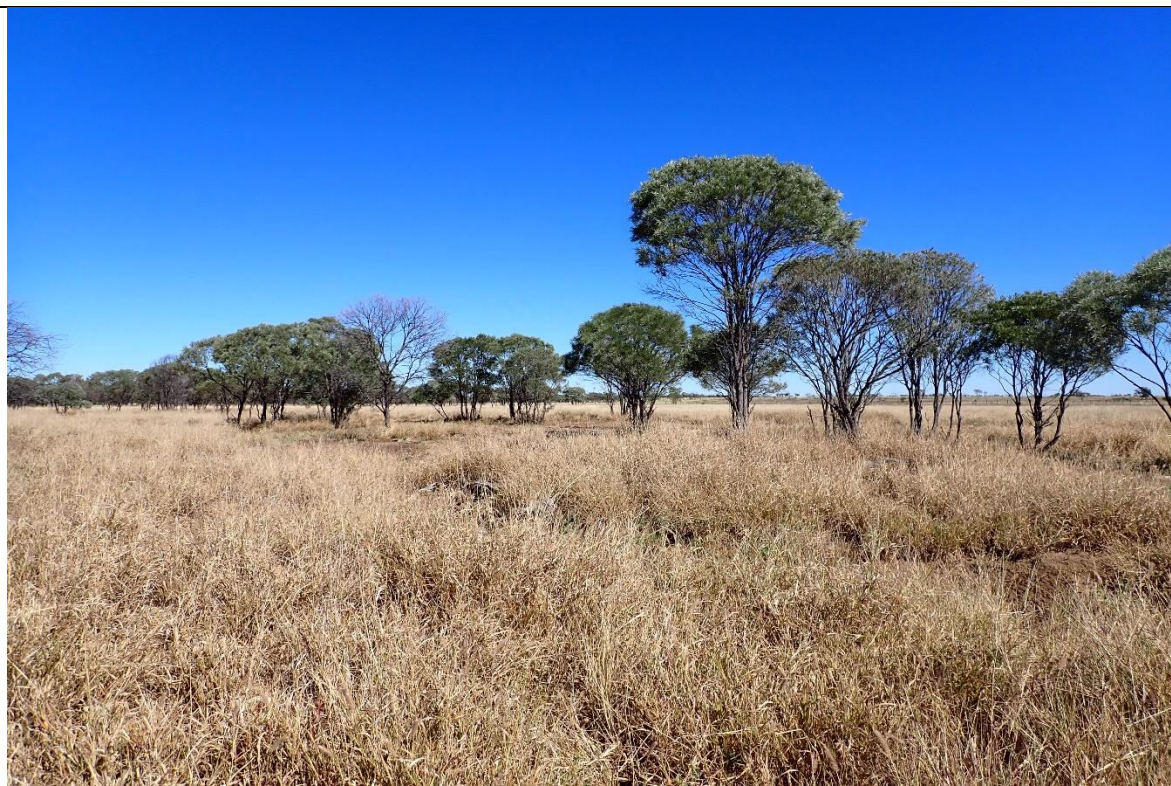
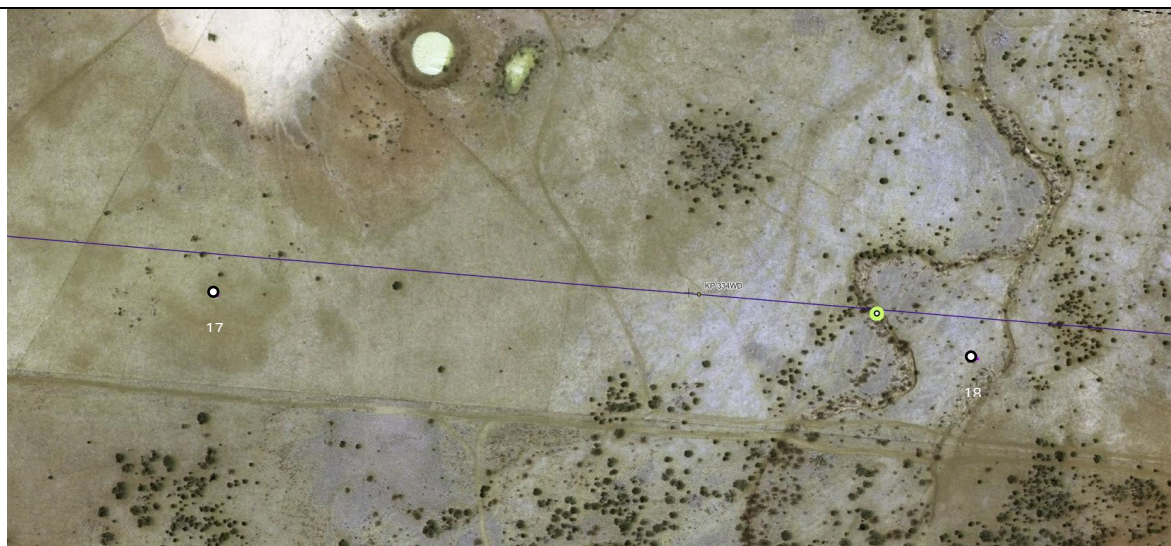
Line 1 KP 333.8 WD (95,5,0,0) Quaternary point (green) near Tower 18  
(601.84m between towers 17-18)

This section is described as 95% very light, 5% light, 0% moderate and 0% heavy by the clearing contractor. Field observations in this section shows a riparian woodland along an 6m wide watercourse. Tree heights ranged up to 5m. The very sparse canopy covers the riparian canopy that fringes the watercourse and most of the east section with tree heights averaging around 5m. Observations on the ground reflect the clearing contractor's description within this section of the alignment.

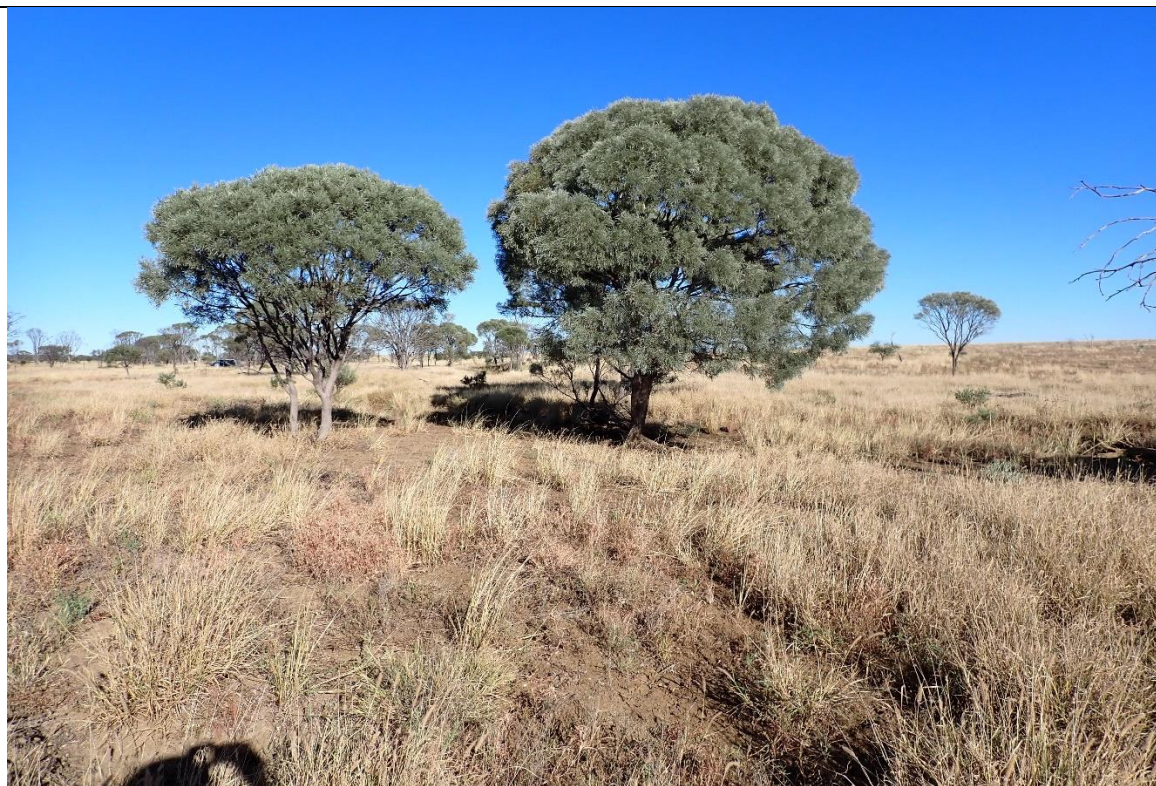
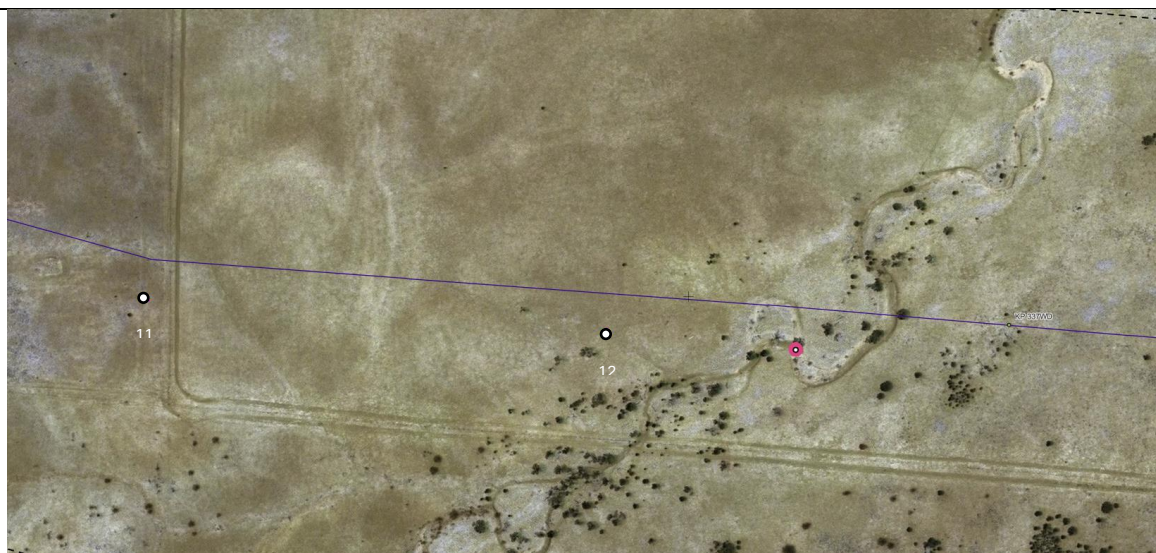
Line 1 KP 337.3 WD (80,10,10,0) Riparian zone (red) near Tower 12  
 (366.49m between towers 11-12) (Low Risk (Green) DAF – WWBW)

This section is described as 80% very light, 10% light, 10% moderate and 0% heavy by the clearing contractor. Field observations shows a riparian woodland along an 7m wide watercourse. Tree heights ranged up to 6m. The very sparse canopy covers the riparian canopy that fringes the watercourse and most of the east section with tree heights averaging around 5m. Observations on the ground reflect the clearing contractor's description within this section of the alignment.

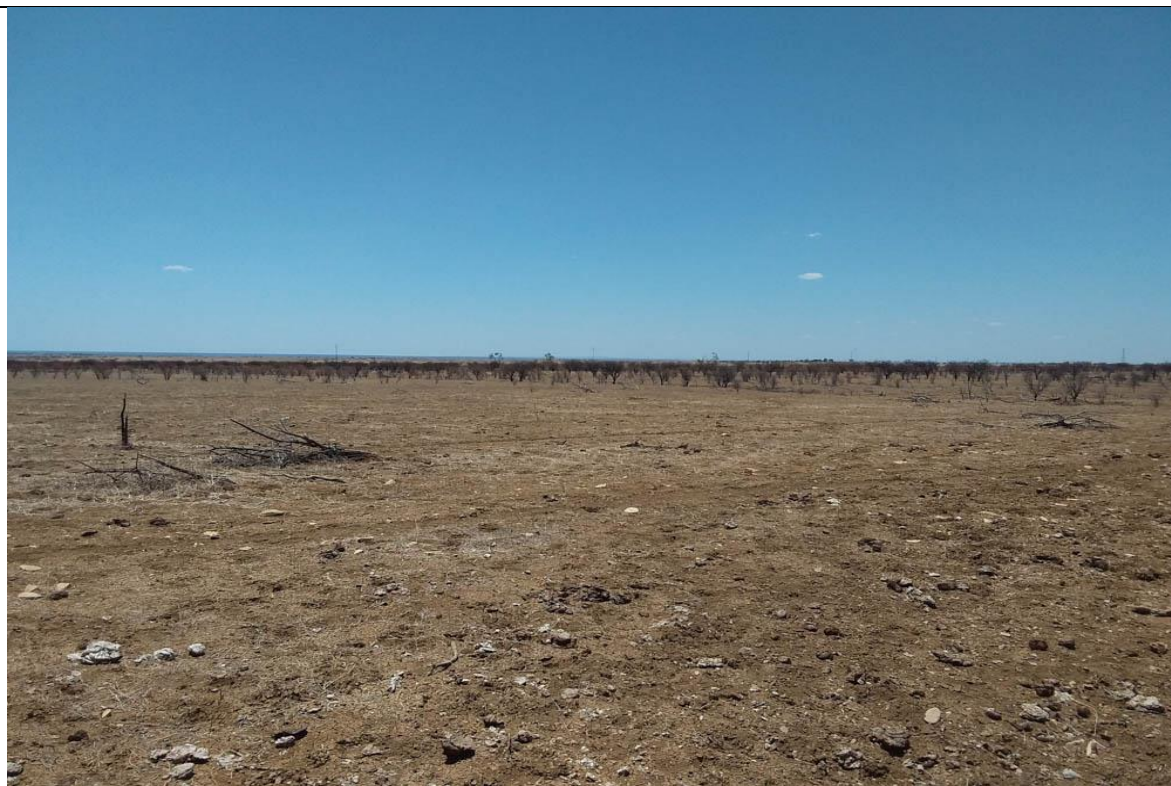
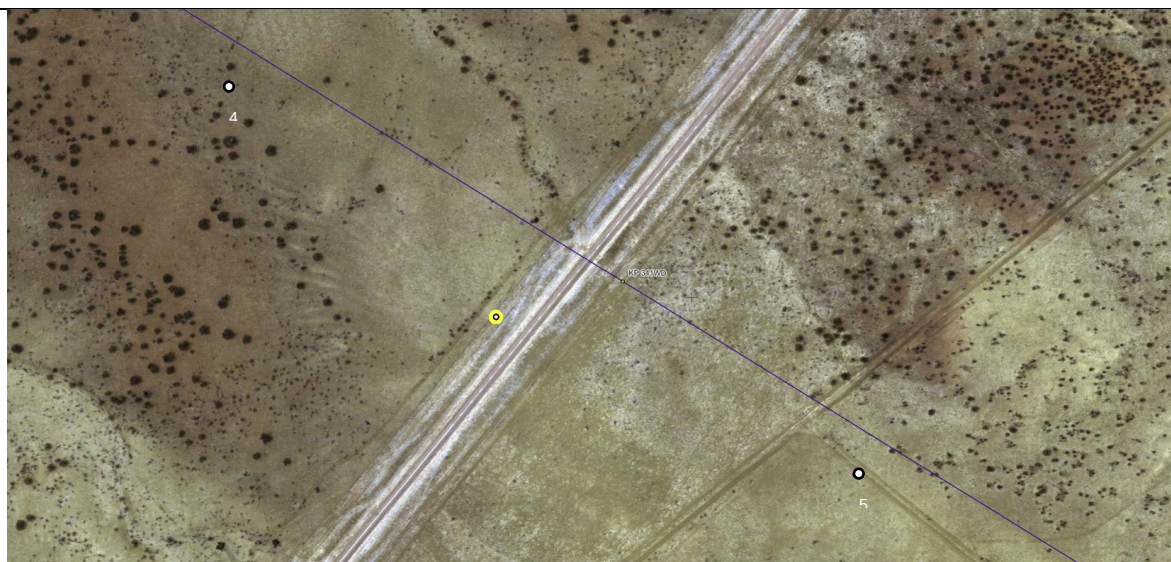
Line 1 KP 340.8 WD (95,5,0,0) Access track (yellow) near Tower 5  
(580.81m between towers 4-5)

This section is described as 95% very light, 5% light, 0% moderate and 0% heavy by the clearing contractor. Field observations in this section shows canopy coverage is very sparse or absent. Observations on the ground reflect the clearing contractor's description within this section of the alignment.

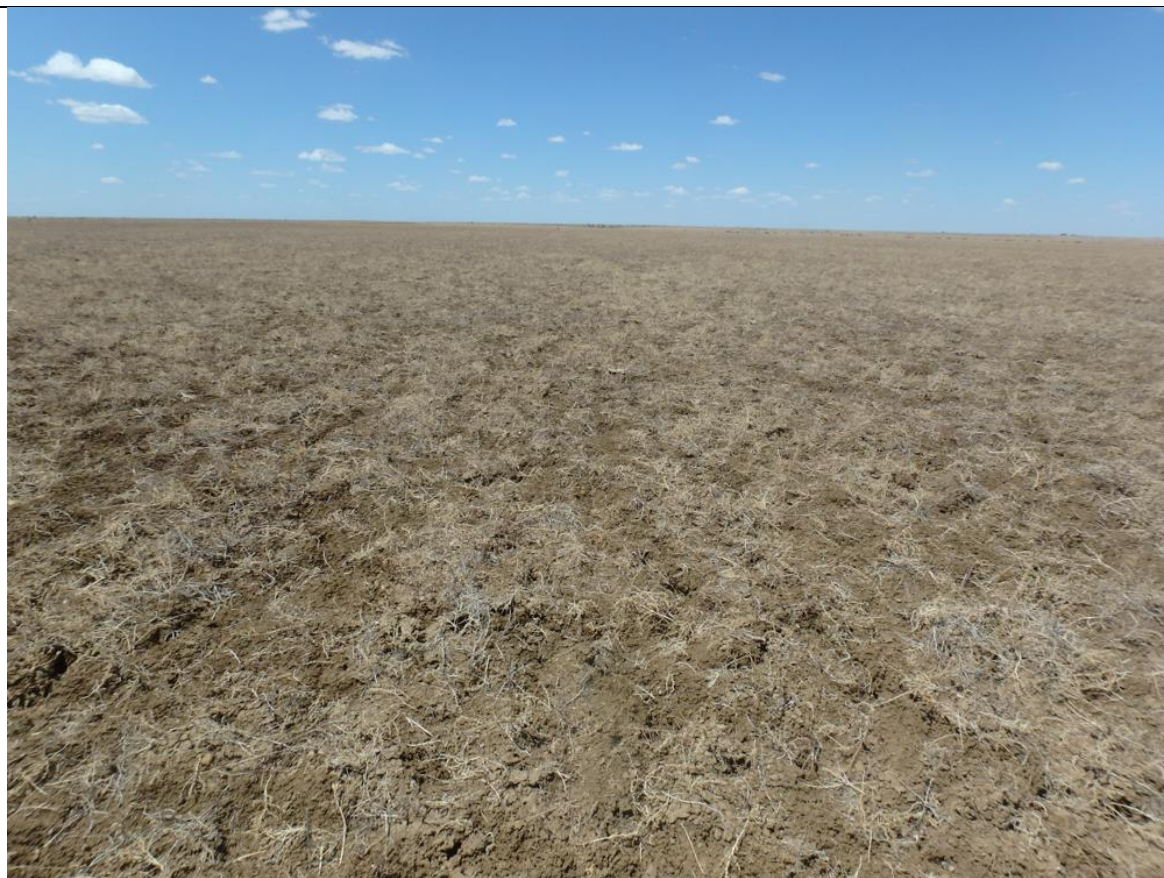
This section is described as 95% very light, 0% light, 5% moderate and 0% heavy by the clearing contractor. Field observations in this section shows canopy coverage is very sparse or absent. Observations on the ground reflect the clearing contractor's description within this section of the alignment.

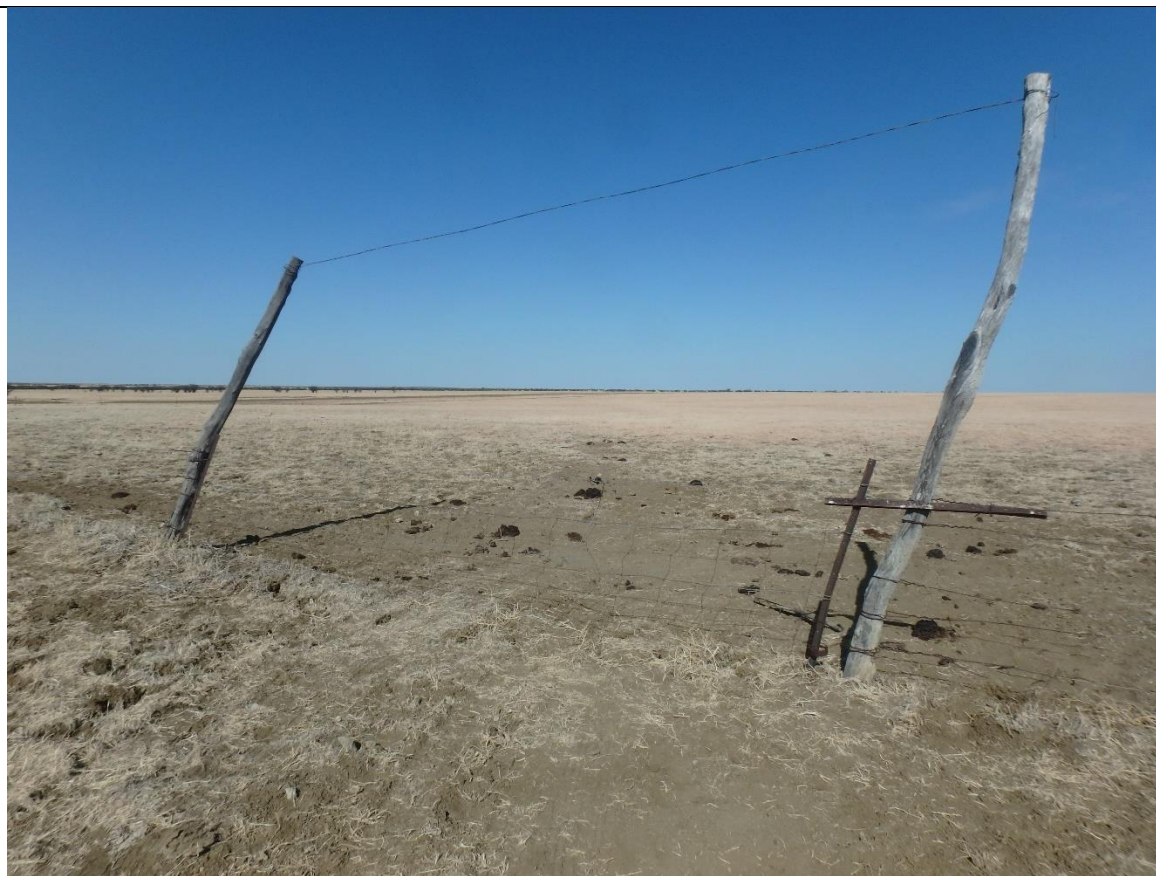
This section is described as 95% very light, 5% light, 0% moderate and 0% heavy by the clearing contractor. Field observations in this section shows canopy coverage is very sparse or absent. Observations on the ground reflect the clearing contractor's description within this section of the alignment.

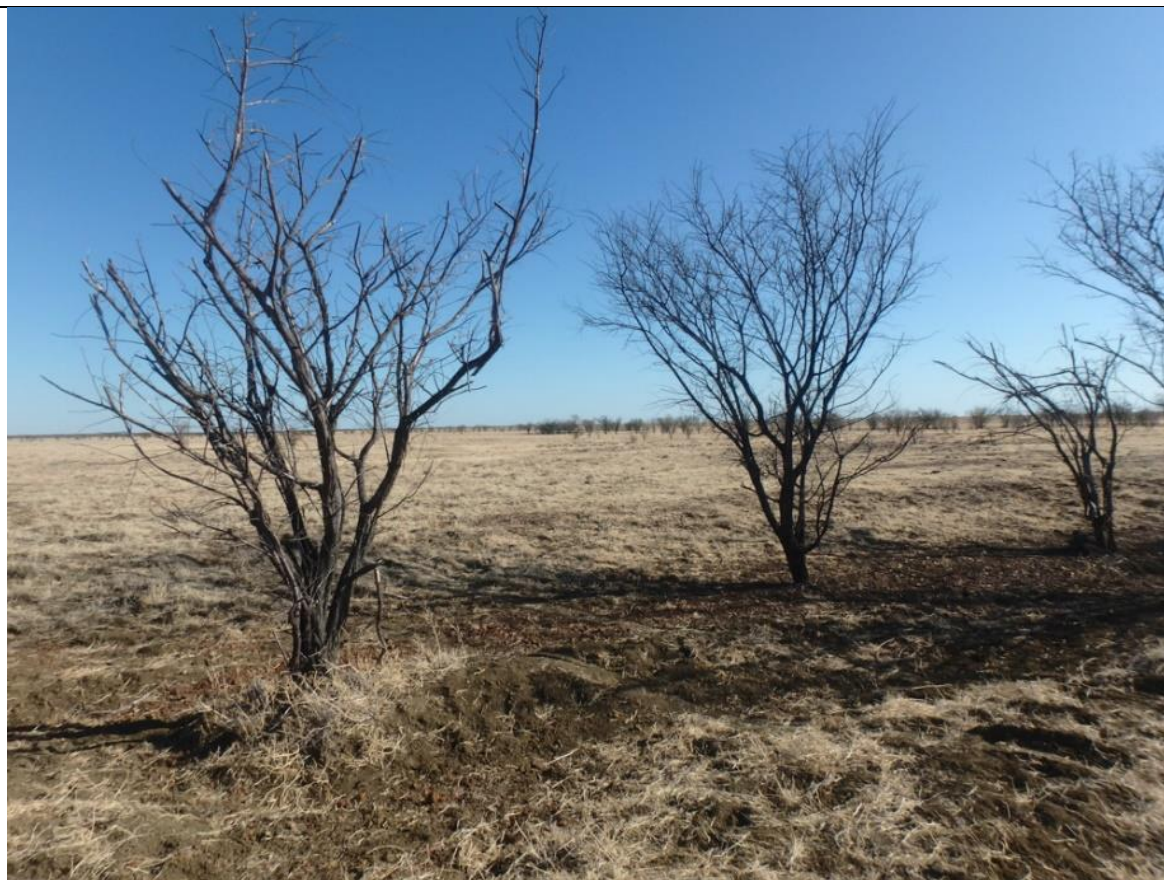
This section is described as 95% very light, 5% light, 0% moderate and 0% heavy by the clearing contractor. Field observations show a riparian woodland along a 30m wide watercourse on the quaternary point. The very sparse canopy covers the riparian canopy that fringes the watercourse in this section with tree heights averaging at 3.5m. Observations on the ground reflect the clearing contractor's description within this section of the alignment.

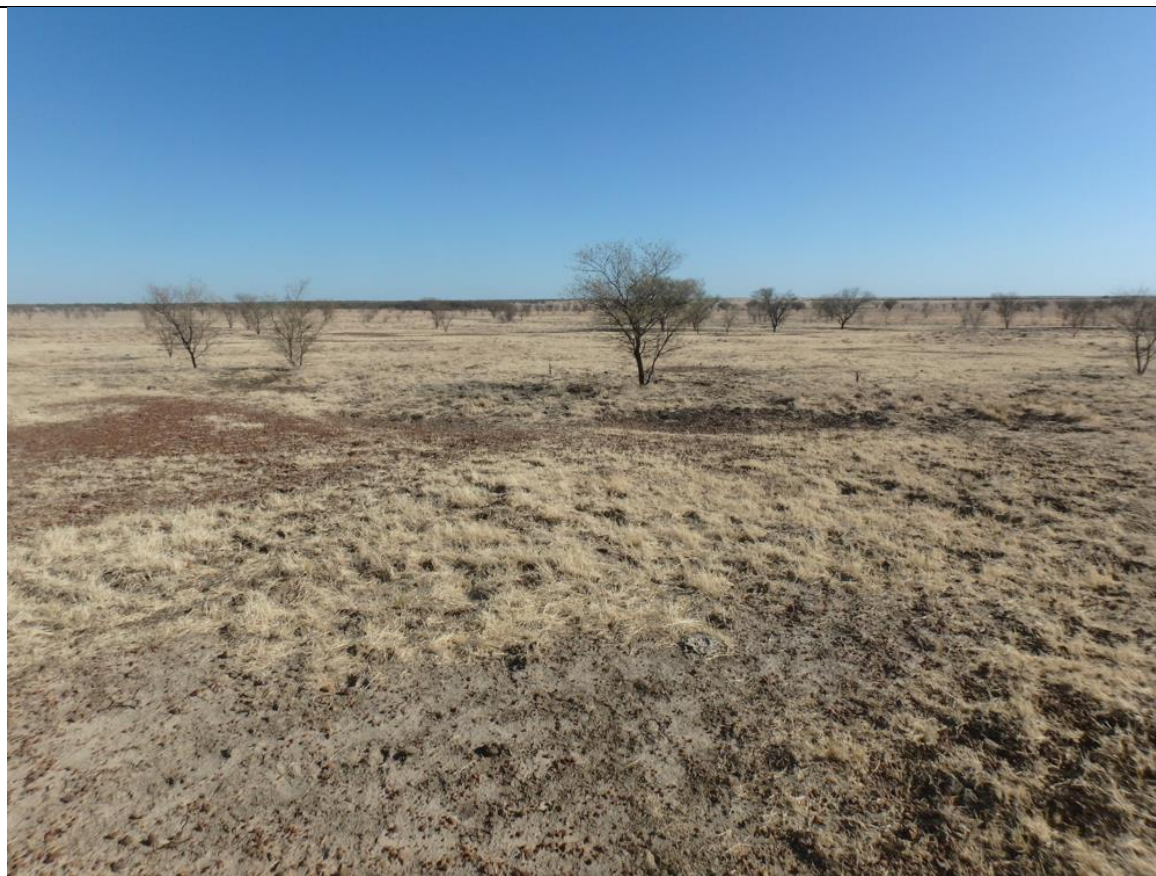
This section is described as 95% very light, 5% light, 0% moderate and 0% heavy by the clearing contractor. Field observations show a riparian woodland along a 10m wide watercourse on the quaternary point. The very sparse canopy covers the riparian canopy that fringes the watercourse in this section with tree heights averaging at 4m. Observations on the ground reflect the clearing contractor's description within this section of the alignment.

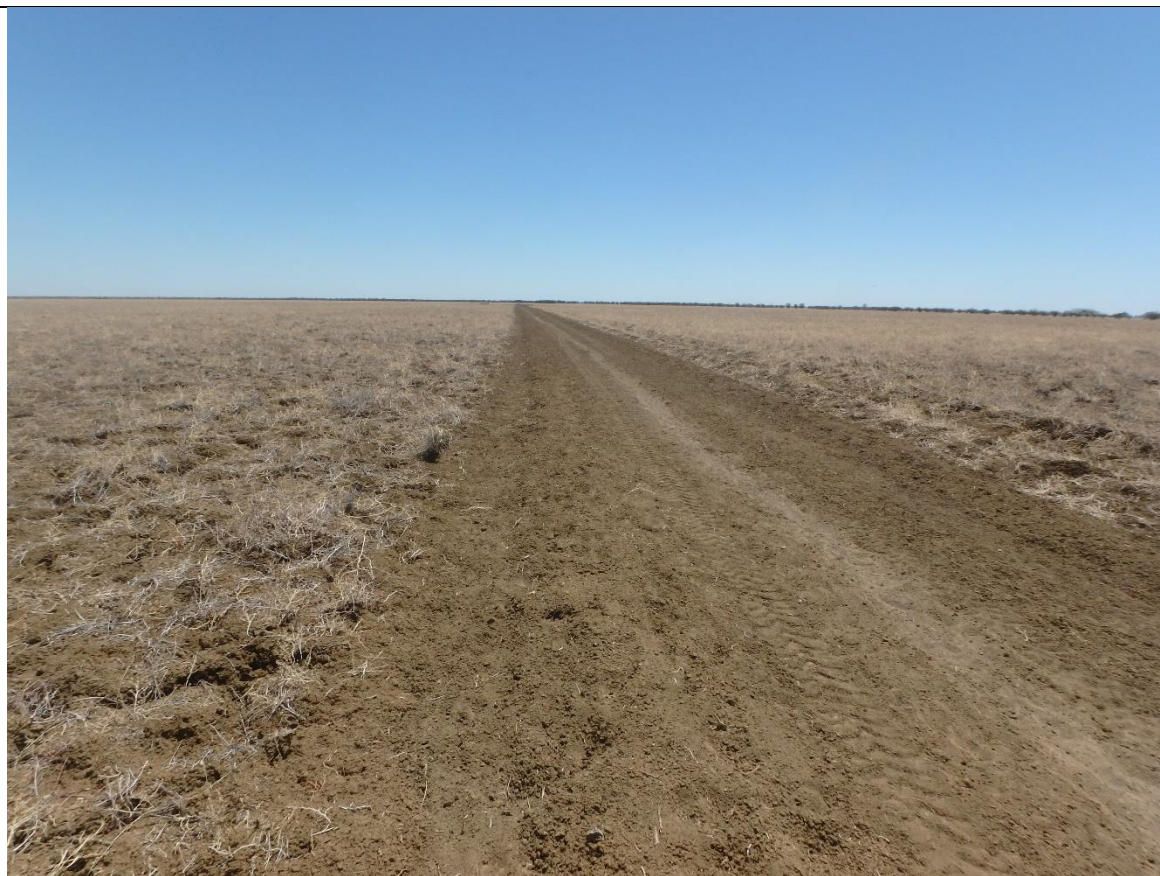
This section is described as 95% very light, 5% light, 0% moderate and 0% heavy by the clearing contractor. Field observations in this section shows canopy coverage is very sparse or absent. Observations on the ground reflect the clearing contractor's description within this section of the alignment.

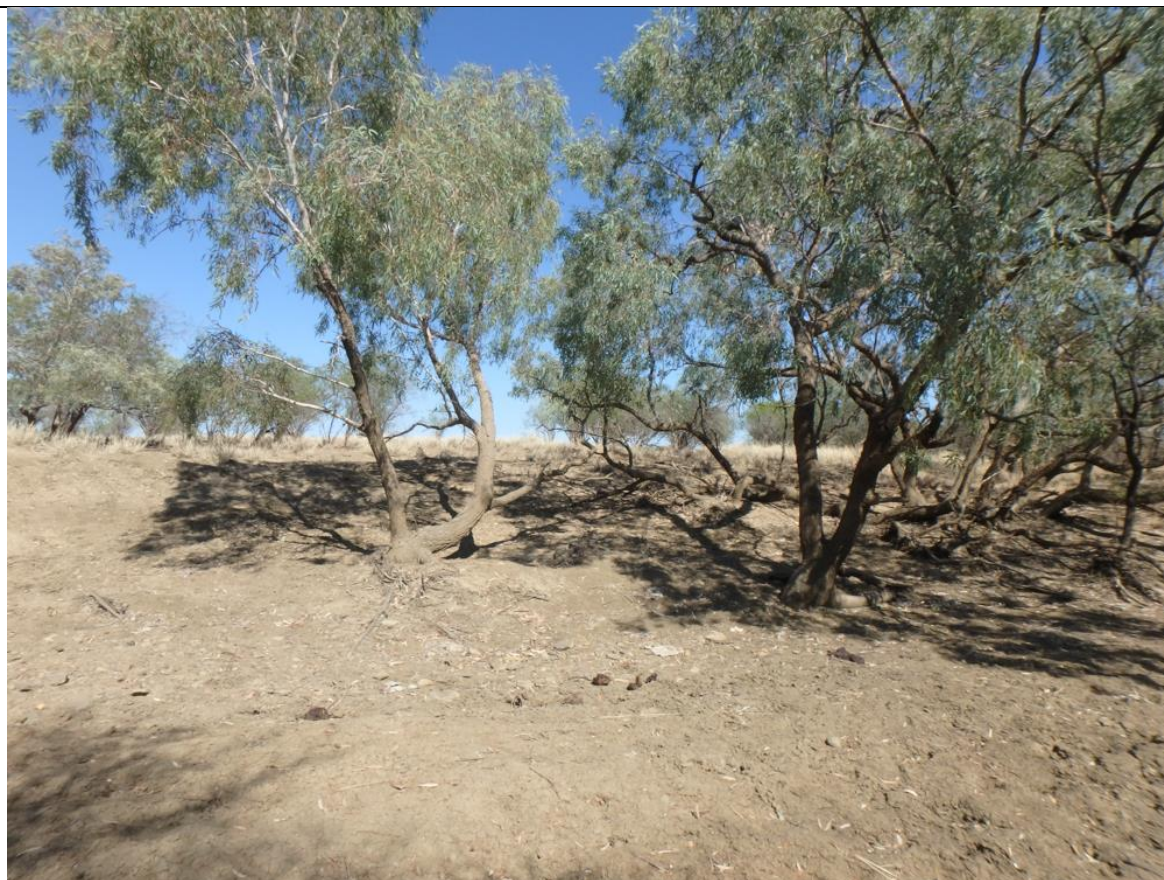
This section is described as 60% very light, 10% light, 30% moderate and 0% heavy by the clearing contractor. Field observations shows riparian woodlands along a braided 15m wide watercourse. Tree heights ranged up to 6m. The sparse canopy covers the riparian canopies that fringe the watercourses in this section with tree heights averaging around 6m. Observations on the ground reflect the clearing contractor's description within this section of the alignment.

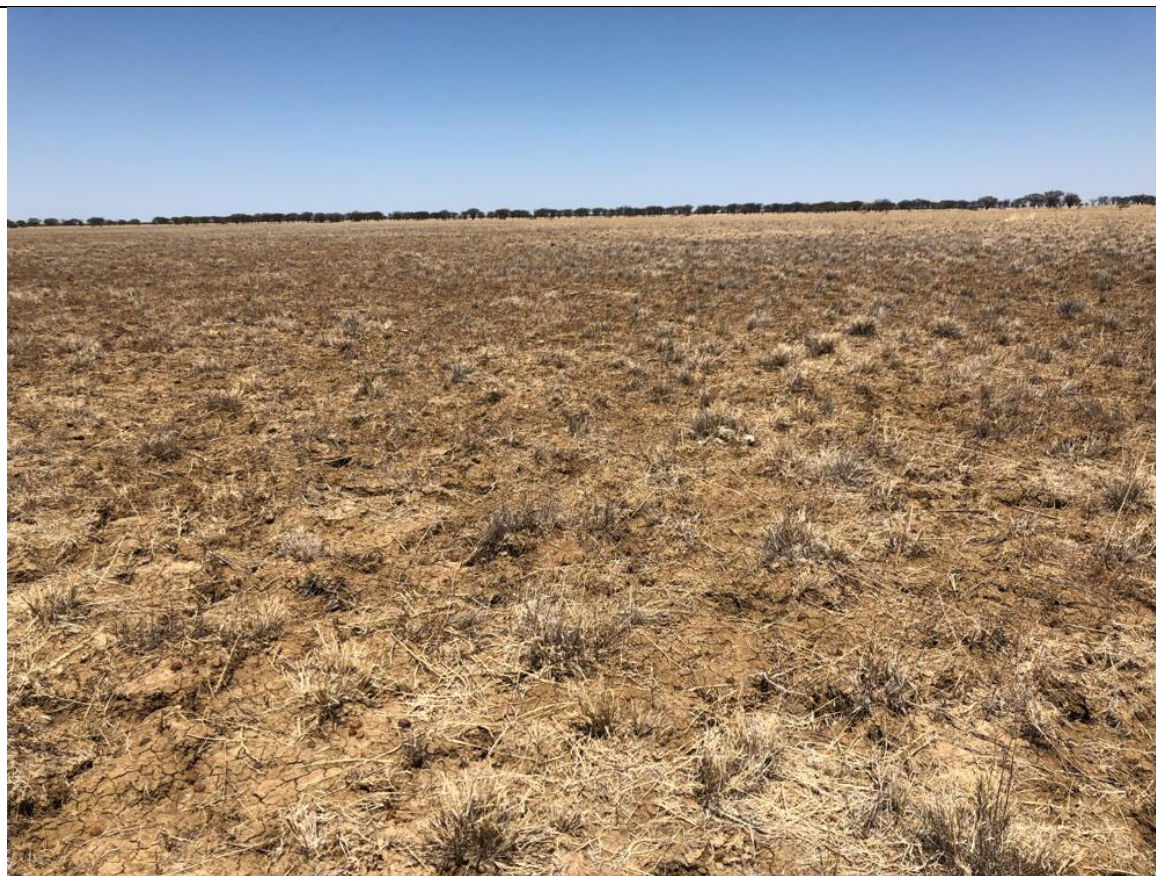
This section is described as 80% very light, 20% light, 0% moderate and 0% heavy by the clearing contractor. Field observations show a very sparse canopy covers most of the east section near the eastern tower with tree heights averaging at 1.5m. Observations on the ground reflect the clearing contractor's description within this section of the alignment.

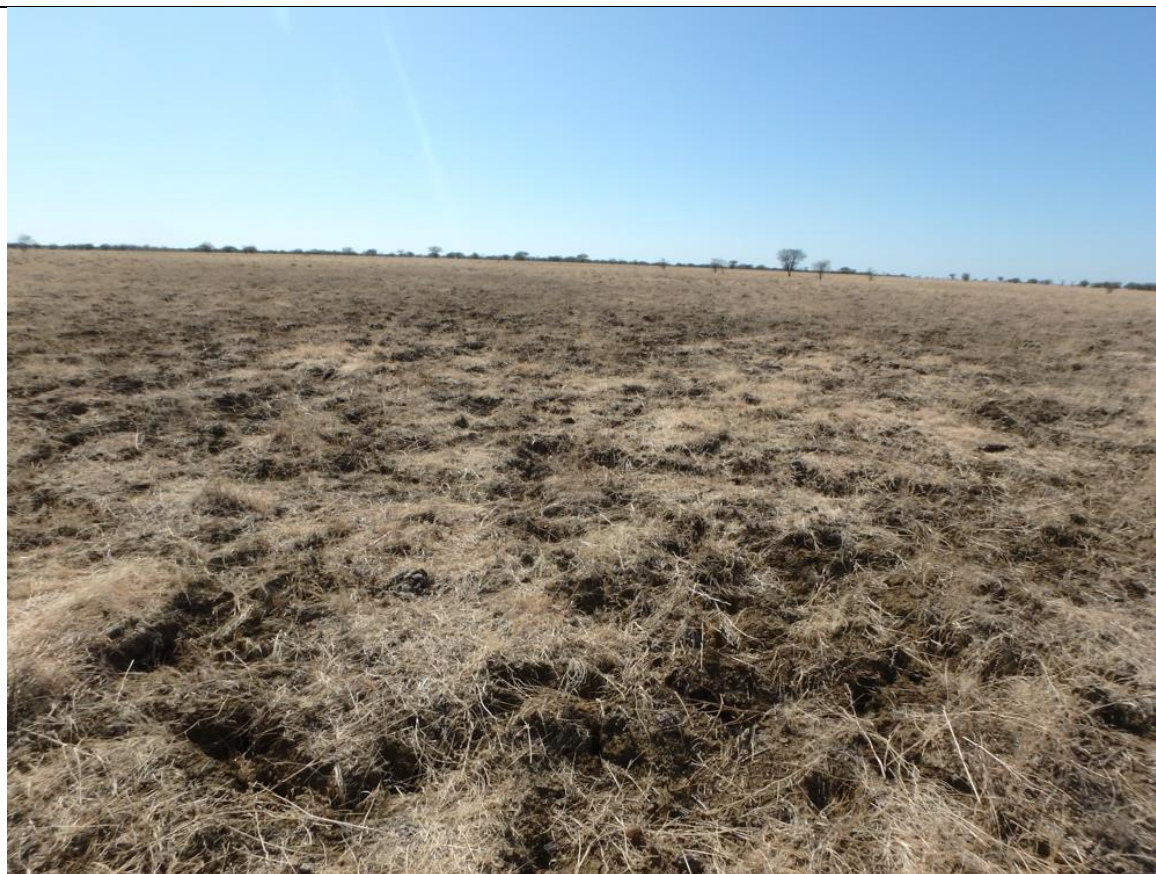
This section is described as 95% very light, 5% light, 0% moderate and 0% heavy by the clearing contractor. Field observations show a very sparse canopy covers a riparian woodland along a gully line west of the quaternary point with tree heights averaging at 2.5m. Observations on the ground reflect the clearing contractor's description within this section of the alignment.
