# Visual Comparison of Landscape Type

Client: CopperString 2.0  
Reference: J0XXX

This document is a visual comparison of landscapes which was compiled to provide a photographic record both from an aerial and site-based perspective along each of the five corridor selection segments. This ground truthing was utilised to inform the projects appreciation of the six general landscape types which occur across the study area as well as improved confidence in the potential conservation significant species habitat mapped for the CopperString EIS 2.0. It has also been used to confirm expected disturbance associated with construction related activities.

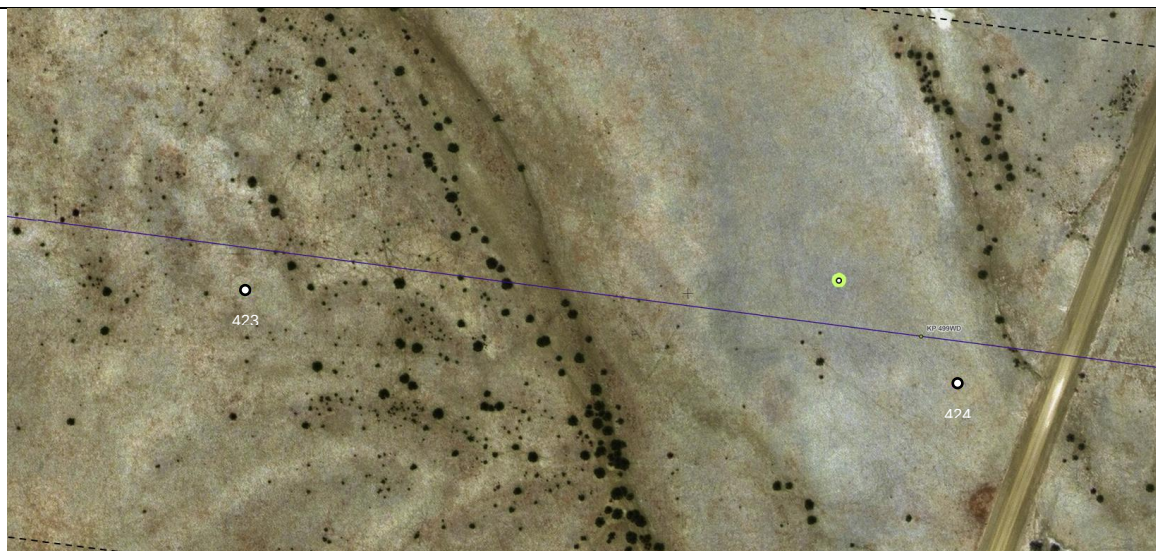
Line 2 KP 498.9 WD (95,5,0,0) Quaternary point (green) near Tower 424  
(567.569m between towers 423-424)

This section is described as 95% very light, 5% light, 0% moderate and 0% heavy by the clearing contractor. Field observations show a very sparse canopy covers a riparian woodland along a gully line west of the quaternary point with tree heights averaging at 2.5m. Observations on the ground reflect the clearing contractor's description within this section of the alignment.

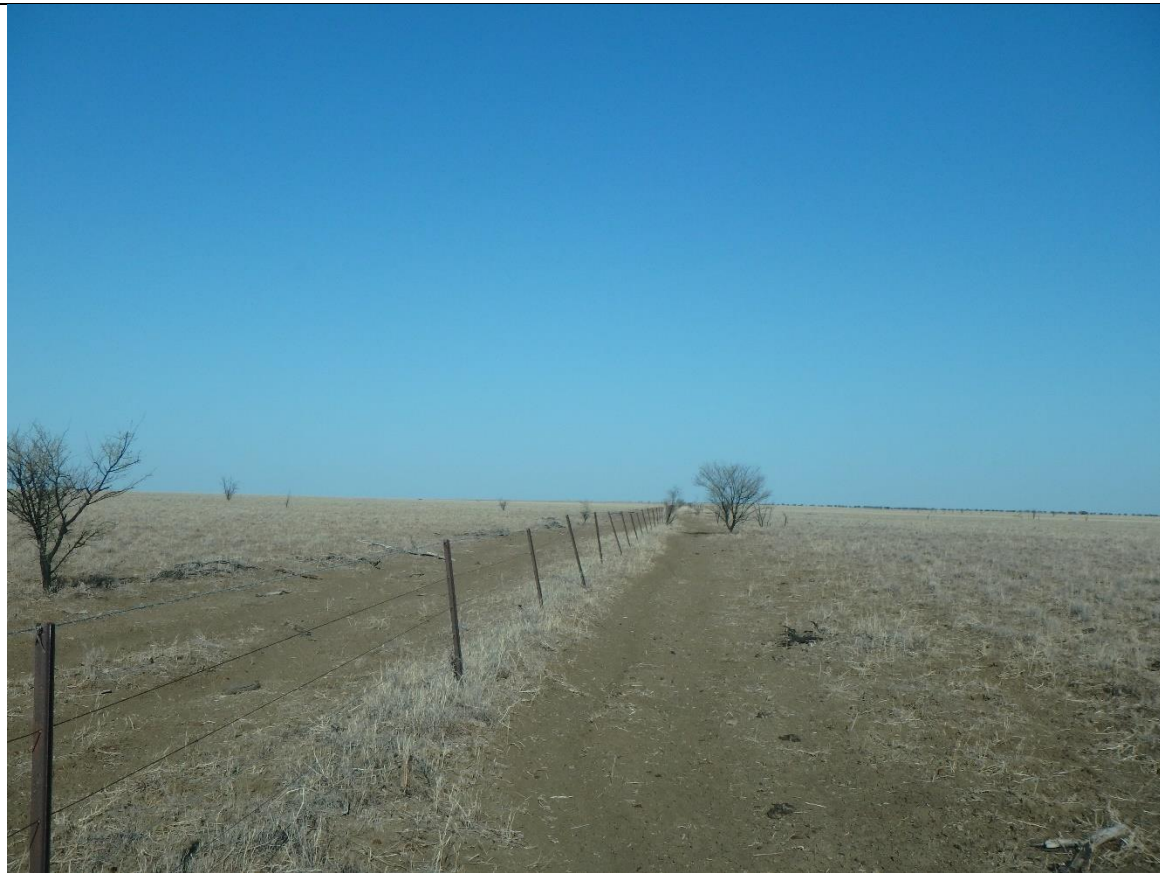
This section is described as 90% very light, 0% light, 10% moderate and 0% heavy by the clearing contractor. Field observations in this section shows canopy coverage is sparse or absent. Observations on the ground reflect the clearing contractor's description within this section of the alignment.

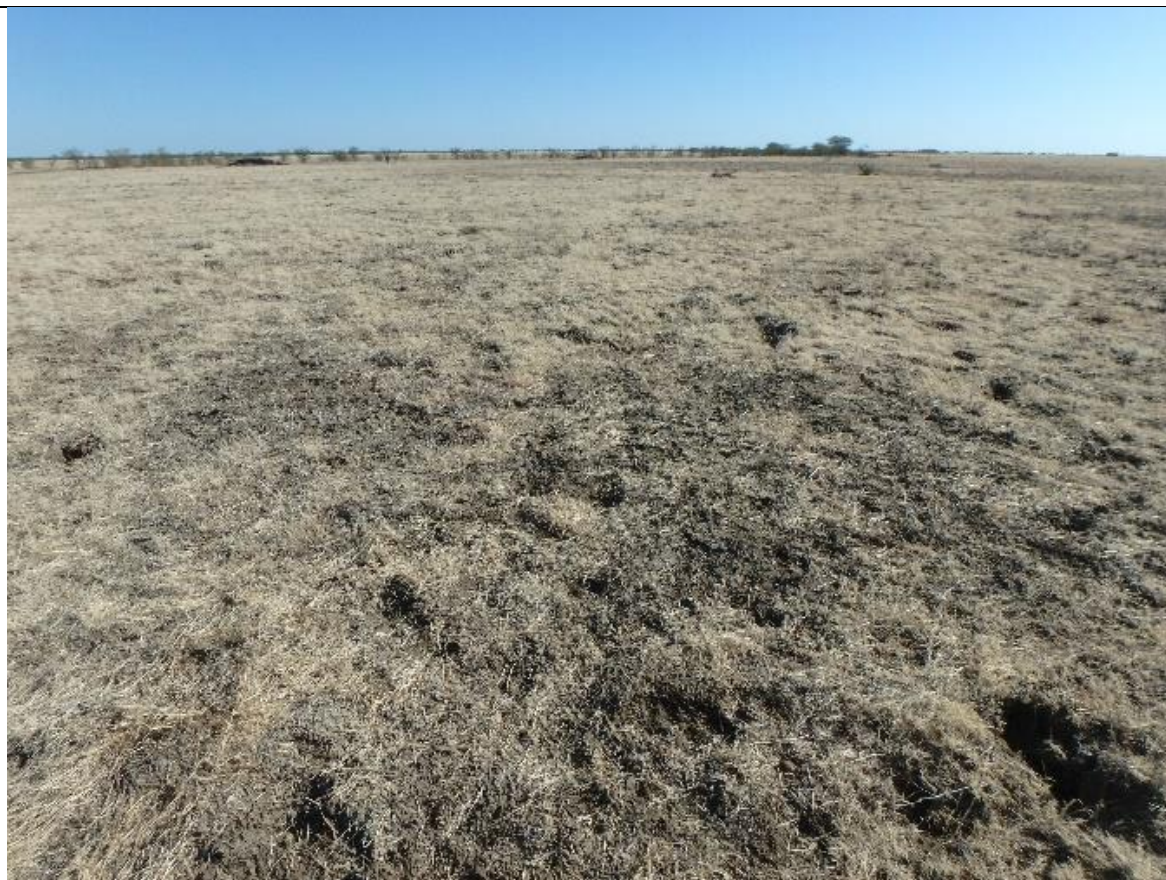
This section is described as 90% very light, 10% light, 0% moderate and 0% heavy by the clearing contractor. Field observations show a riparian woodland along a 20m wide watercourse west of the quaternary point. The very dense canopy covers the riparian canopy that fringes the watercourse in this section. Observations on the ground reflect the clearing contractor's description within this section of the alignment.

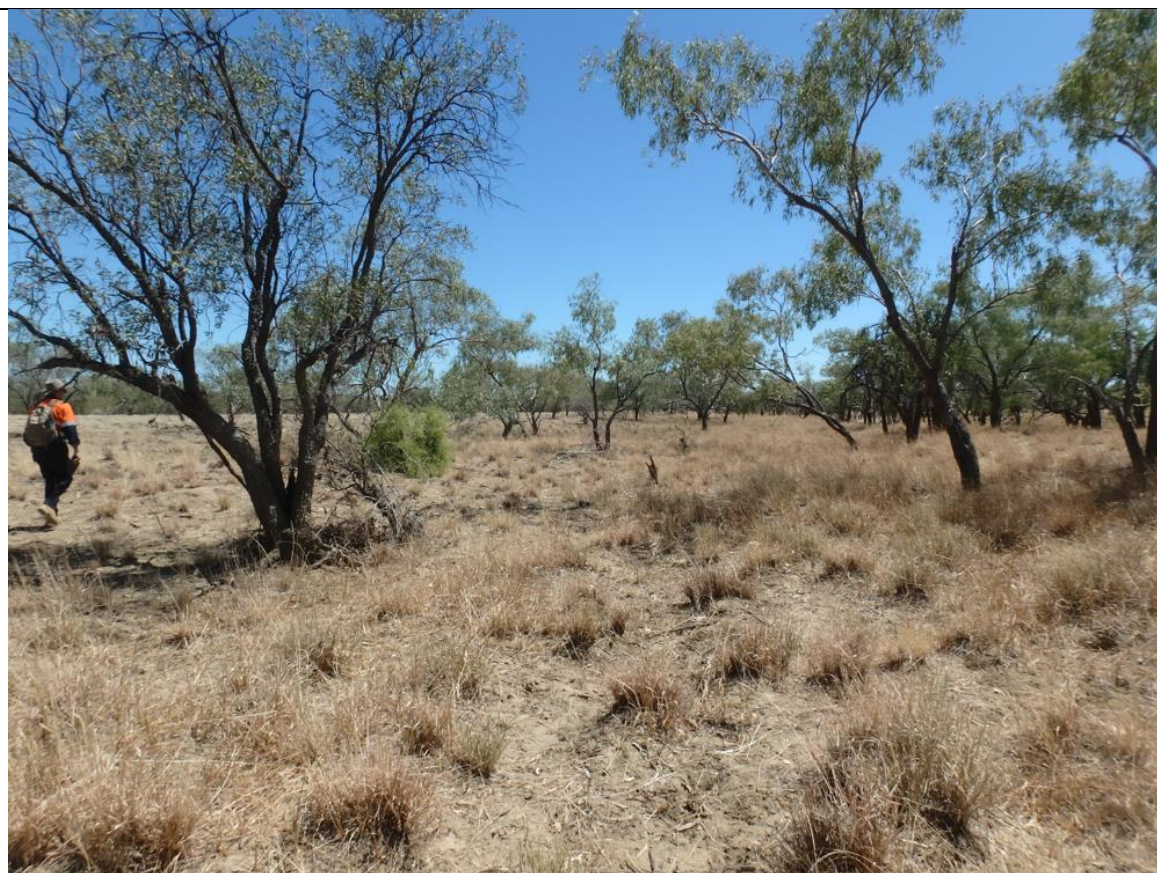
This section is described as 60% very light, 20% light, 10% moderate and 10% heavy by the clearing contractor. Field observations shows riparian woodlands along a braided 15m wide watercourse. Tree heights ranged up to 6.6m. The sparse canopy covers the riparian canopies that fringe the watercourses in this section with tree heights averaging around 6.6m. Observations on the ground reflect the clearing contractor's description within this section of the alignment.

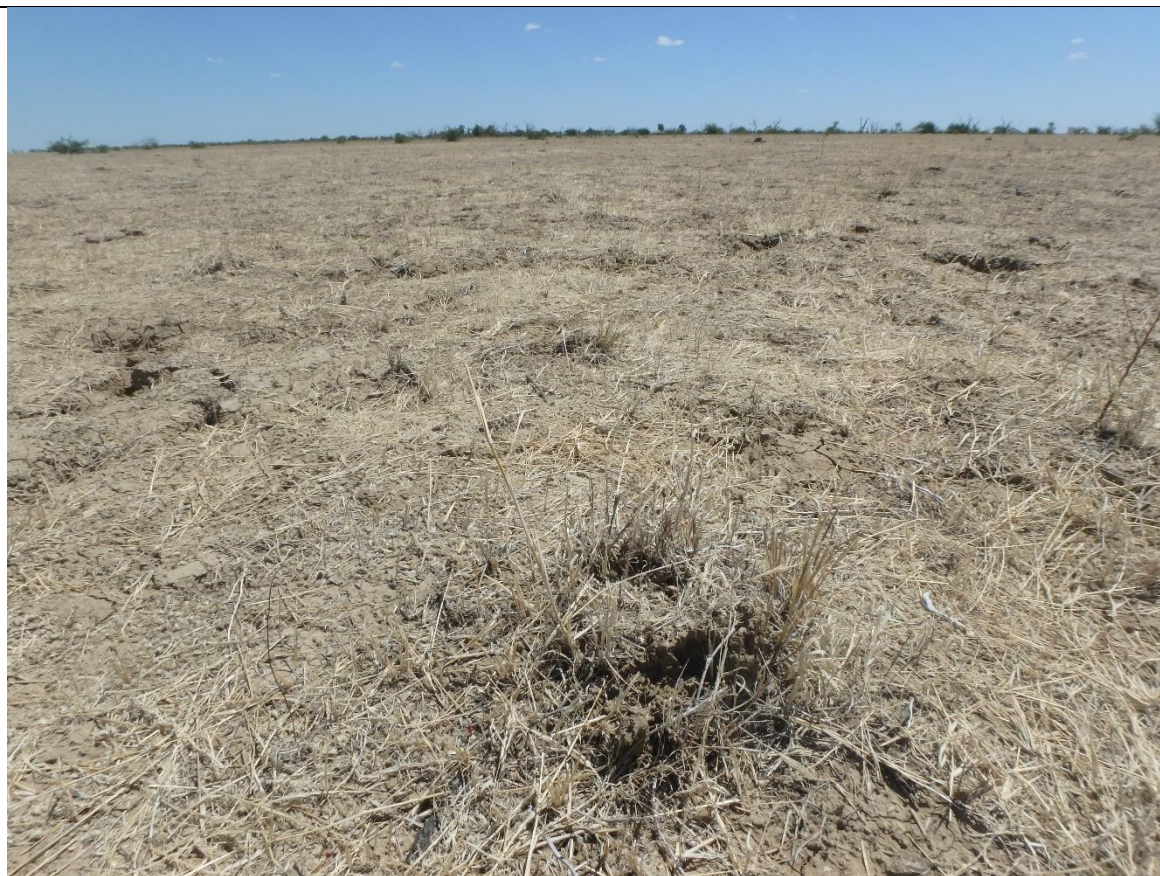
This section is described as 70% very light, 0% light, 10% moderate and 20% heavy by the clearing contractor. Field observations show a riparian woodland along a 20m wide watercourse west of the quaternary point. The sparse canopy covers the riparian canopy that fringes the watercourse in this section with tree heights averaging at 1.5m. Observations on the ground reflect the clearing contractor's description within this section of the alignment.

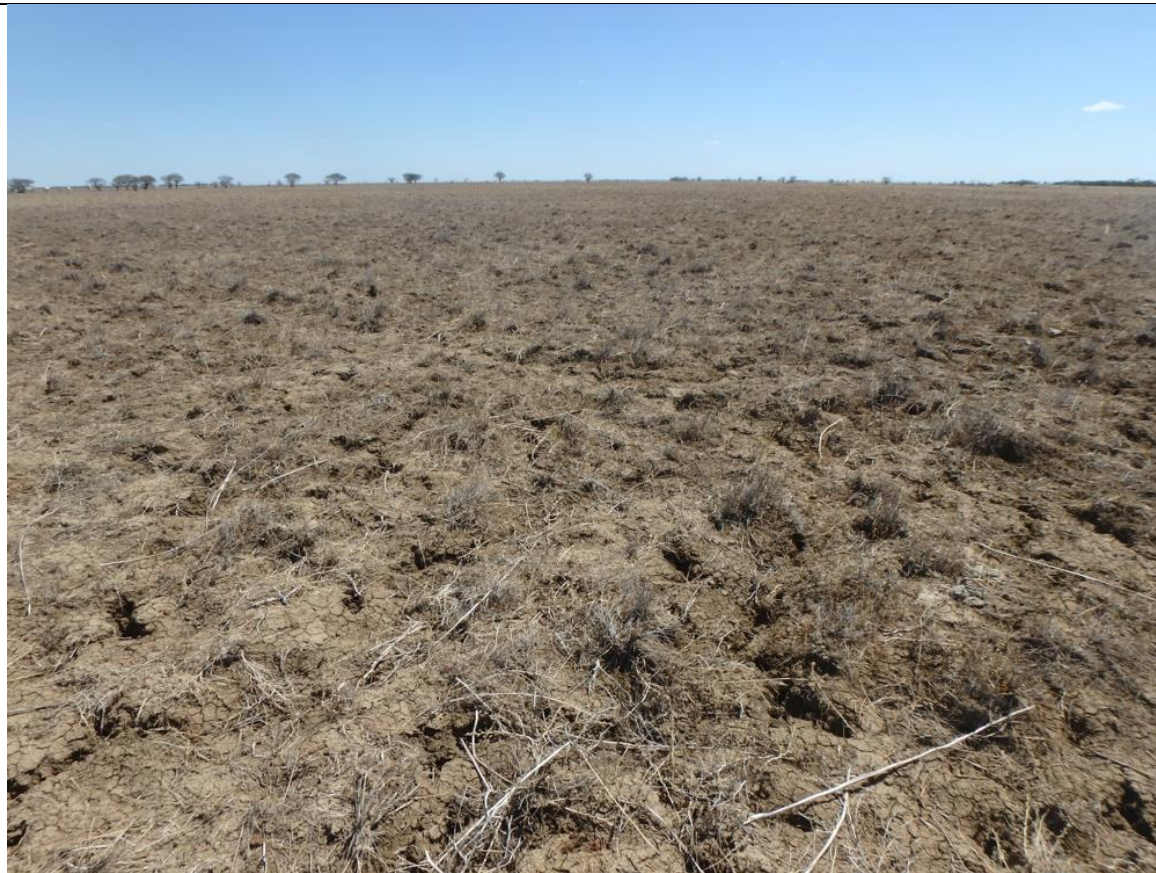
This section is described as 90% very light, 0% light, 10% moderate and 0% heavy by the clearing contractor. Field observations in this section shows canopy coverage is sparse or absent. Observations on the ground reflect the clearing contractor's description within this section of the alignment.

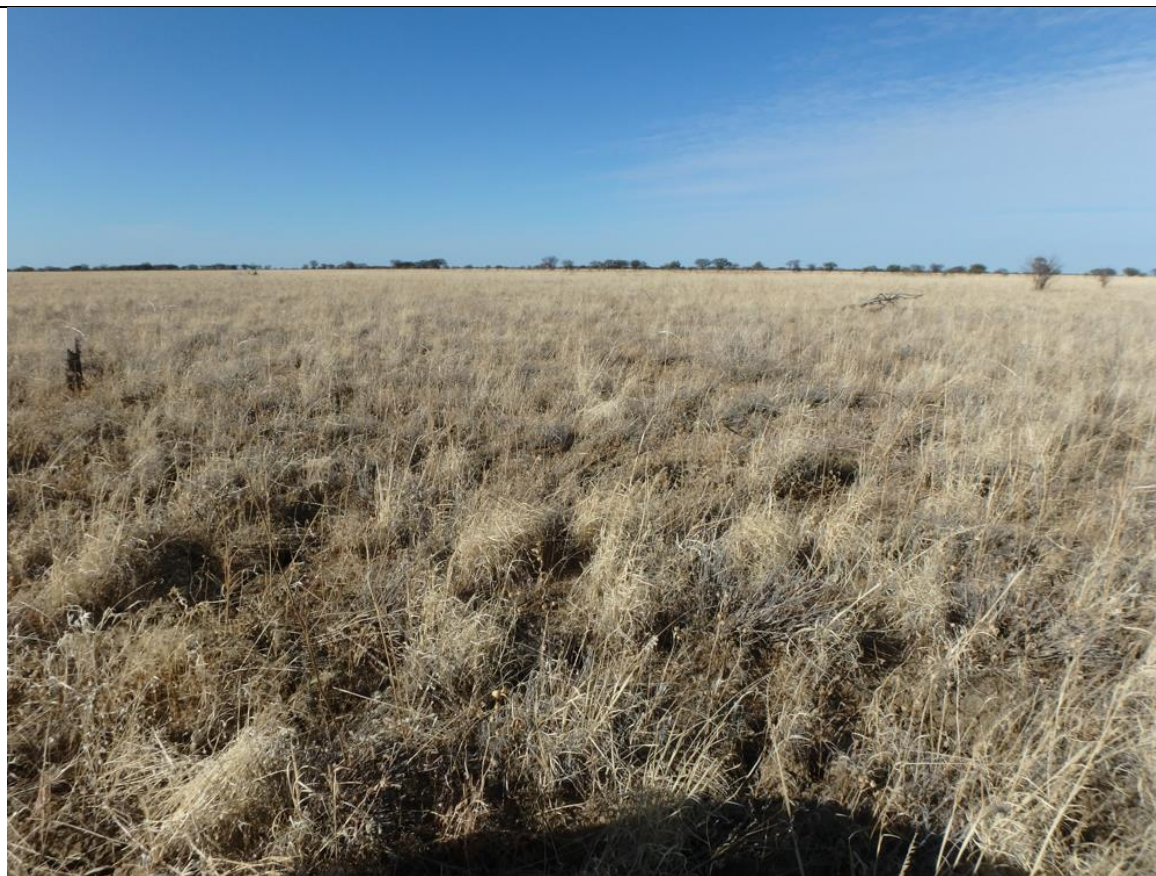
This section is described as 95% very light, 5% light, 0% moderate and 0% heavy by the clearing contractor. Field observations in this section shows canopy coverage is very sparse or absent. Observations on the ground reflect the clearing contractor's description within this section of the alignment.

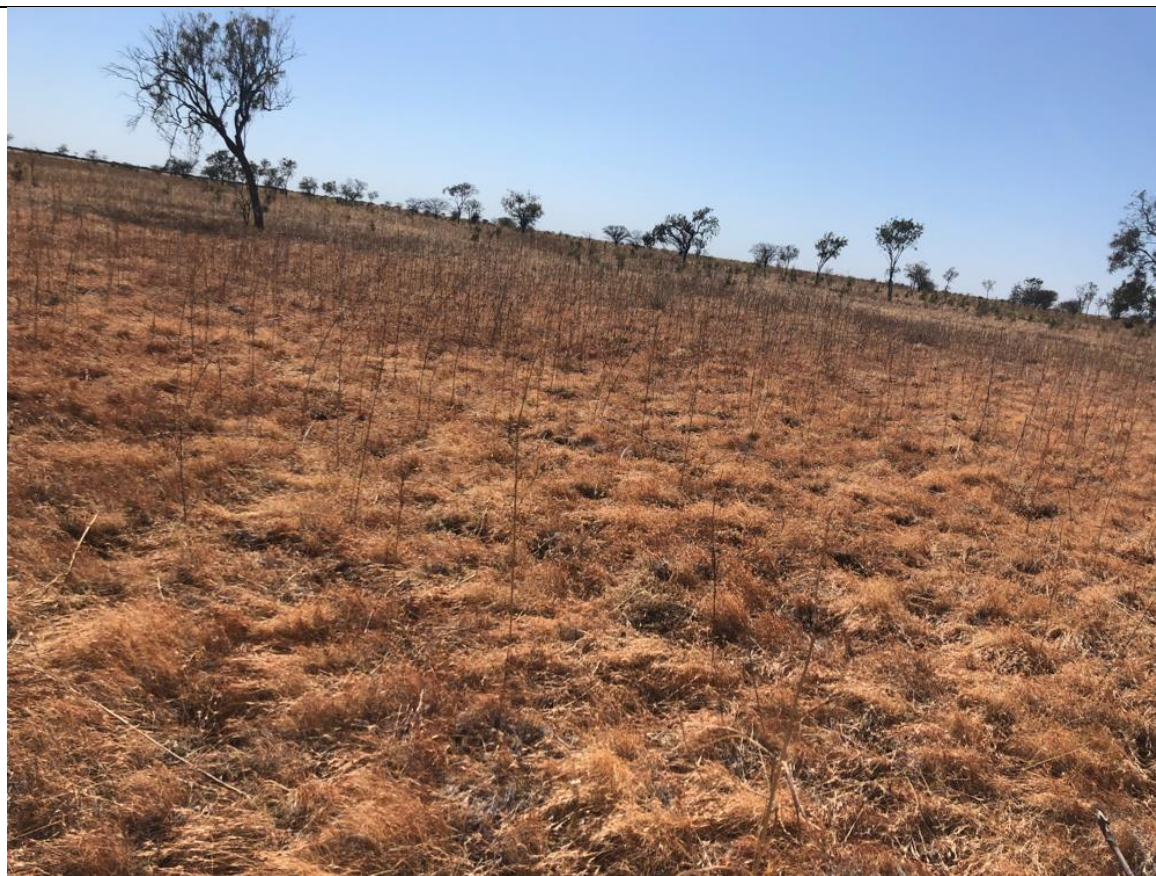
This section is described as 80% very light, 0% light, 20% moderate and 0% heavy by the clearing contractor. Field observations show a riparian woodland along a 30m wide watercourse west of the quaternary point. The sparse canopy covers the riparian canopy that fringes the watercourse in this section with tree heights averaging at 4.5m. Observations on the ground reflect the clearing contractor's description within this section of the alignment.

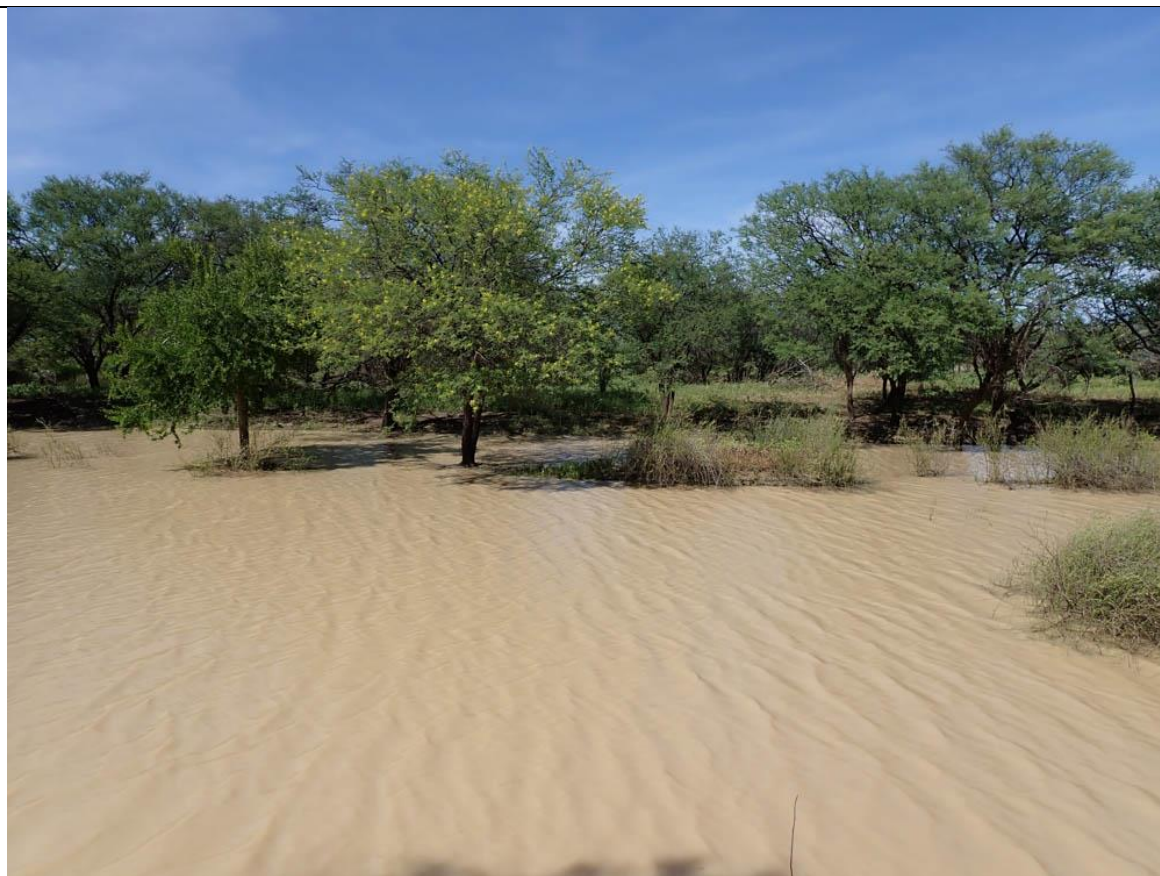
This section is described as 75% very light, 5% light, 20% moderate and 0% heavy by the clearing contractor. Field observations shows riparian woodlands along a braided 25m wide watercourse. Tree heights ranged up to 7m. The very sparse canopy covers the riparian canopies that fringe the watercourses in this section with tree heights averaging around 3.5m. Observations on the ground reflect the clearing contractor's description within this section of the alignment.

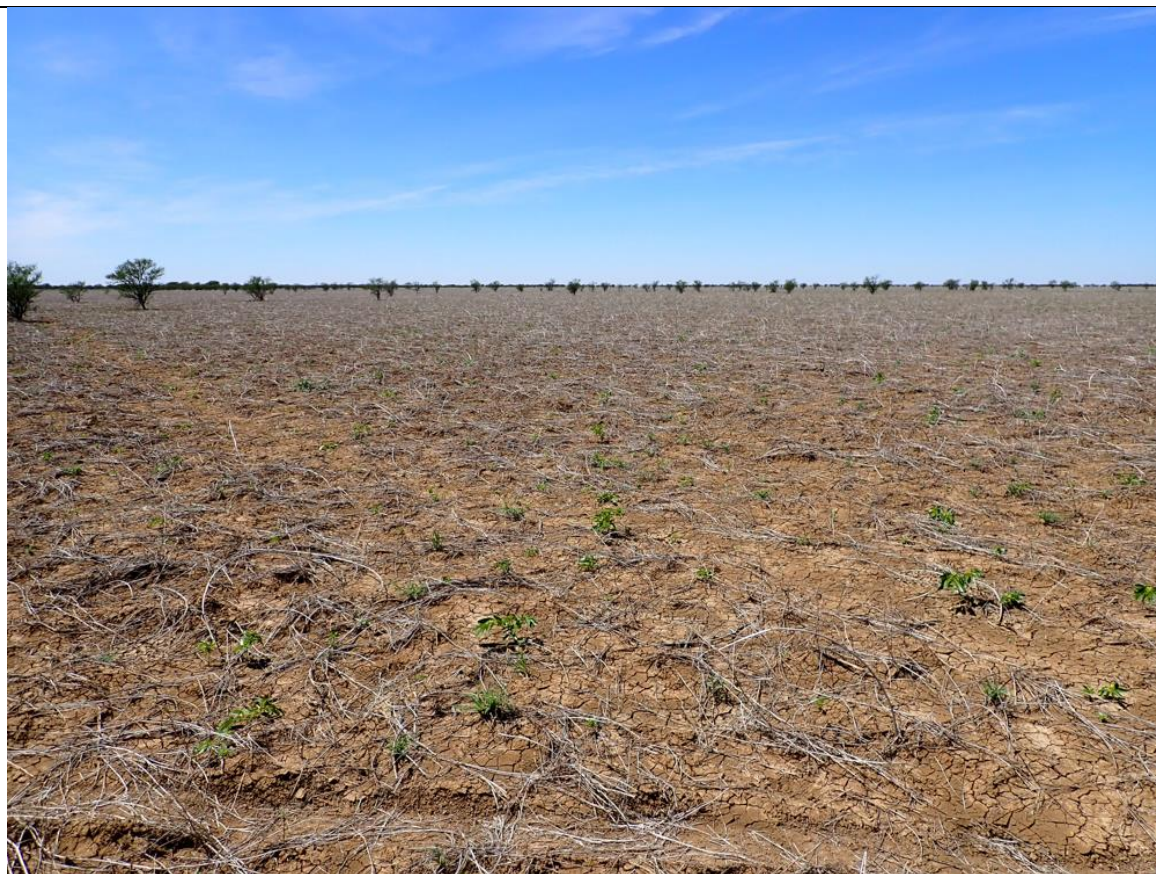
This section is described as 95% very light, 5% light, 0% moderate and 0% heavy by the clearing contractor. Field observations show a riparian woodland along a 15m wide watercourse west of the quaternary point. The very sparse canopy covers the riparian canopy that fringes the watercourse and extending gully line in this section with tree heights averaging at 2m. Observations on the ground reflect the clearing contractor's description within this section of the alignment.

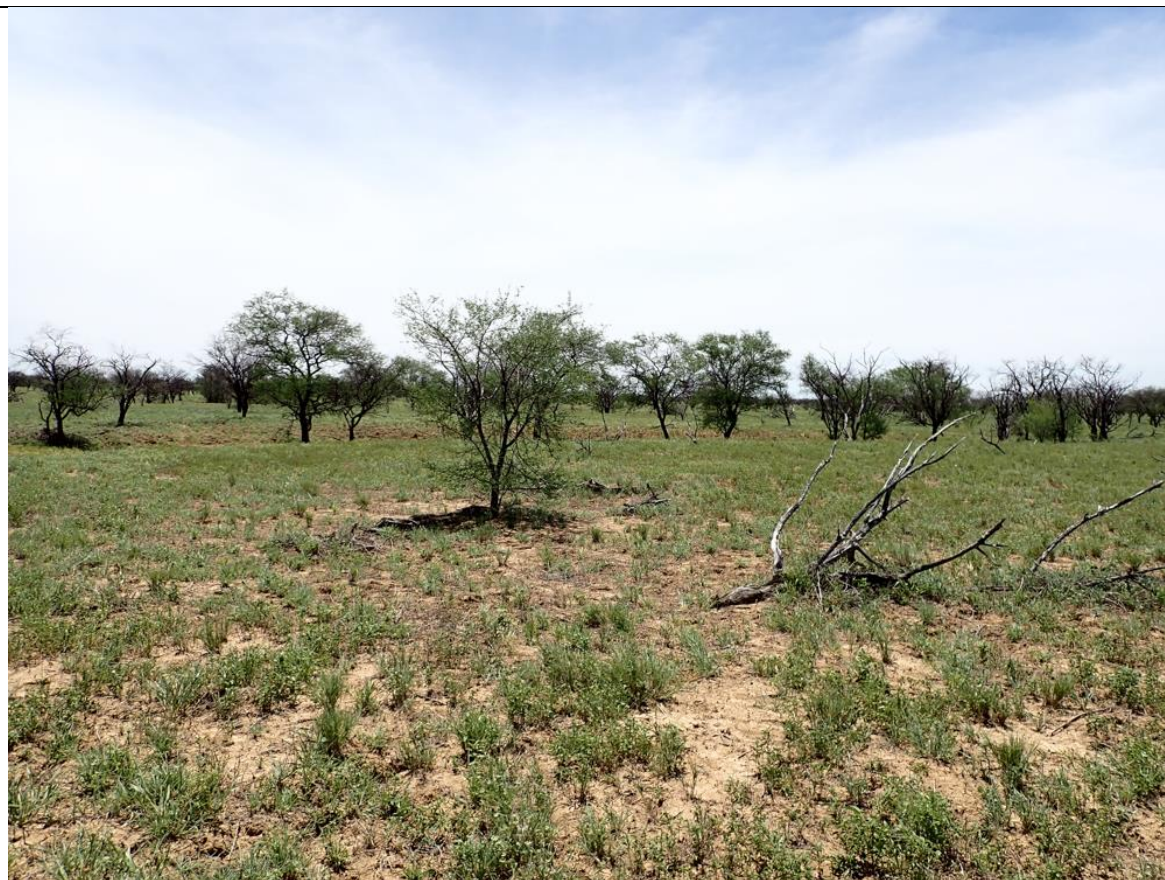
This section is described as 60% very light, 0% light, 40% moderate and 0% heavy by the clearing contractor. Field observations show a riparian woodland along a 10m wide watercourse west of the quaternary point. The mid-dense canopy covers the riparian canopy that fringes the watercourse and scattered patches throughout whole section with tree heights averaging at 2.5m. Observations on the ground reflect the clearing contractor's description within this section of the alignment.

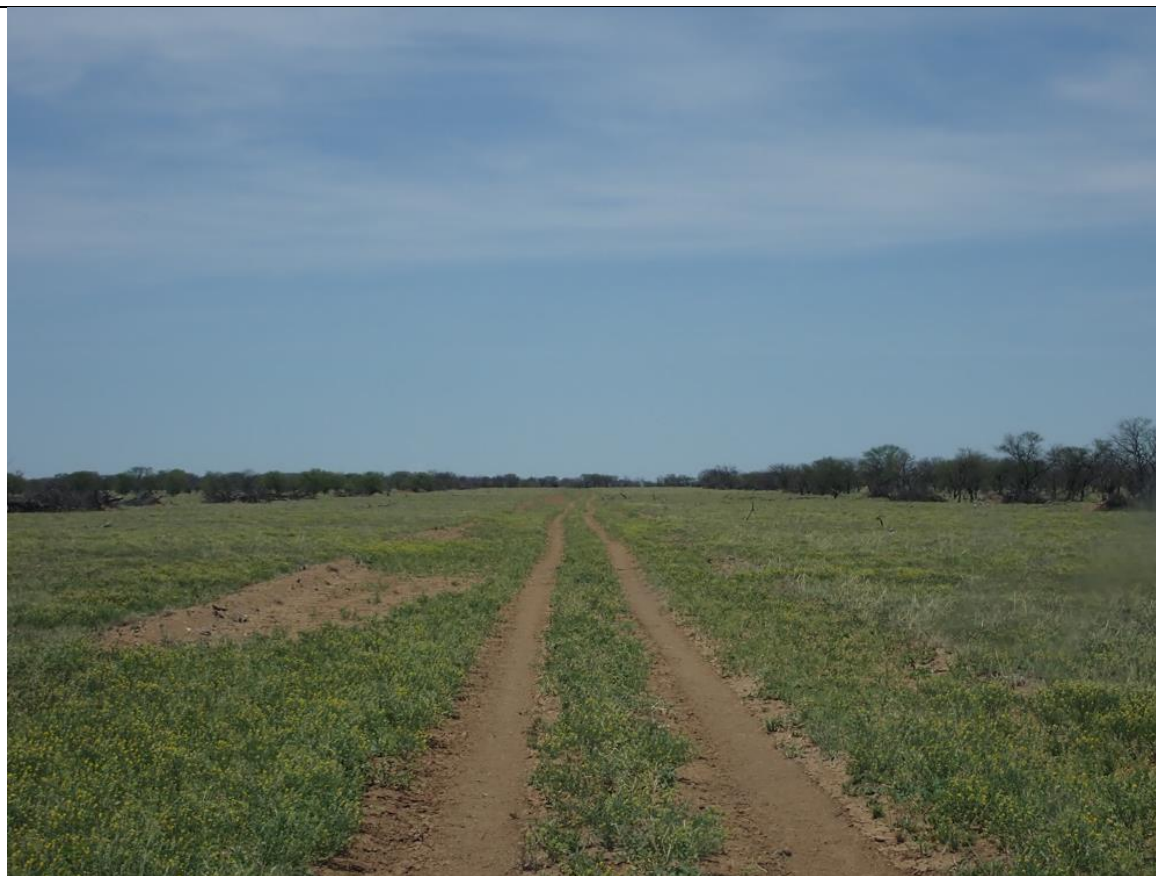
This section is described as 60% very light, 0% light, 40% moderate and 0% heavy by the clearing contractor. Field observations show a riparian woodland along a 10m wide watercourse west of the access track. The mid-dense canopy covers the riparian canopy that fringes the watercourse and most of the section near the eastern tower with tree heights averaging at 2.5m. Observations on the ground reflect the clearing contractor's description within this section of the alignment.

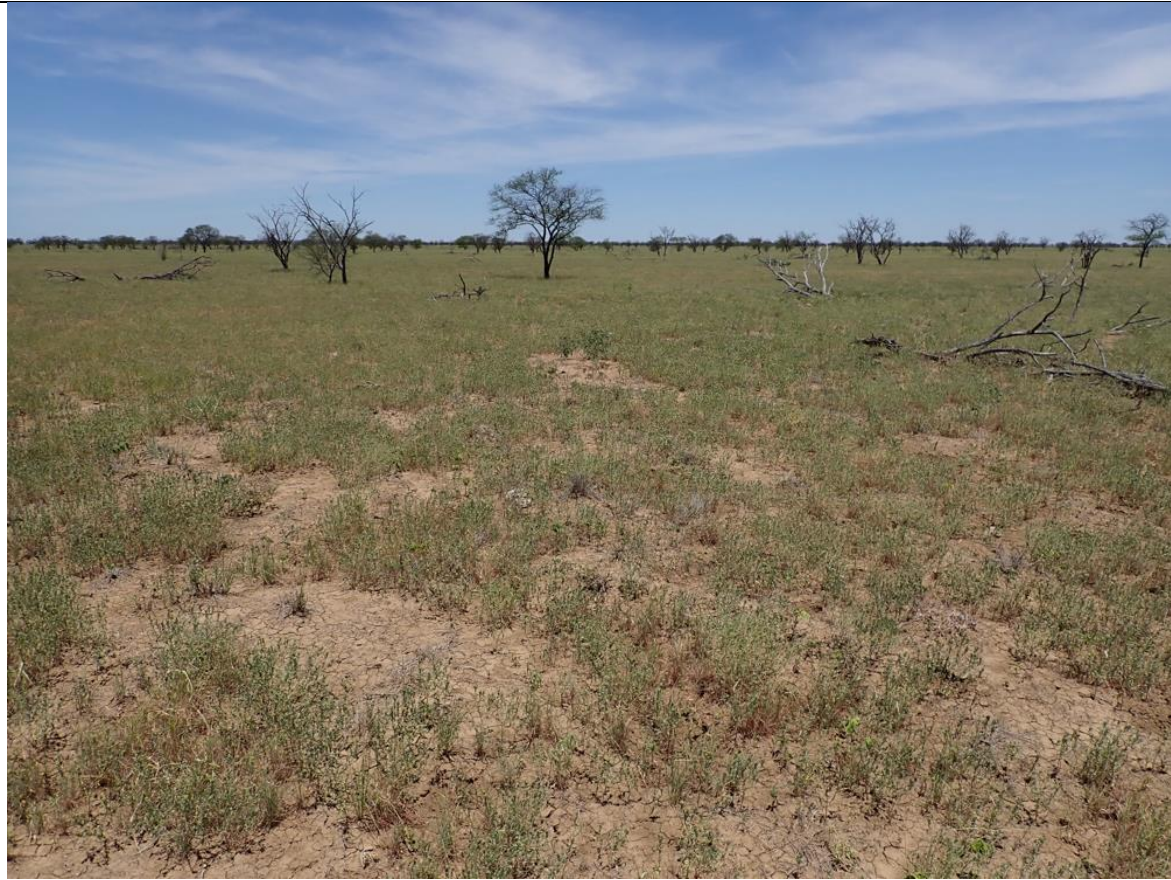
This section is described as 90% very light, 0% light, 10% moderate and 0% heavy by the clearing contractor. Field observations show mid-dense canopy covers scattered patches throughout whole section with tree heights averaging at 2m. Observations on the ground reflect the clearing contractor's description within this section of the alignment.

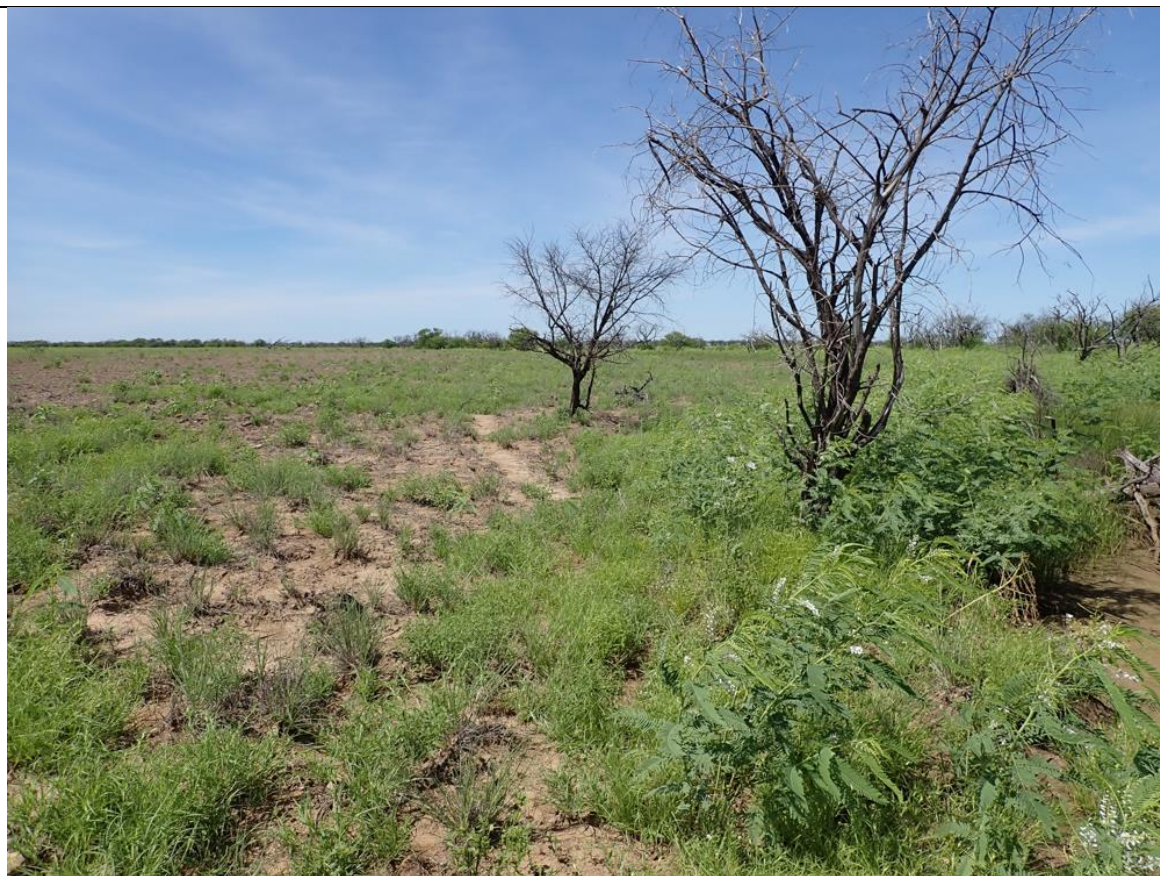
This section is described as 80% very light, 20% light, 0% moderate and 0% heavy by the clearing contractor. Field observations shows a riparian woodland along a 10m wide watercourse. Tree heights ranged up to 2m. The sparse canopy covers the riparian canopy that fringes the watercourse in this section with tree heights averaging around 1.5m. Observations on the ground reflect the clearing contractor's description within this section of the alignment.

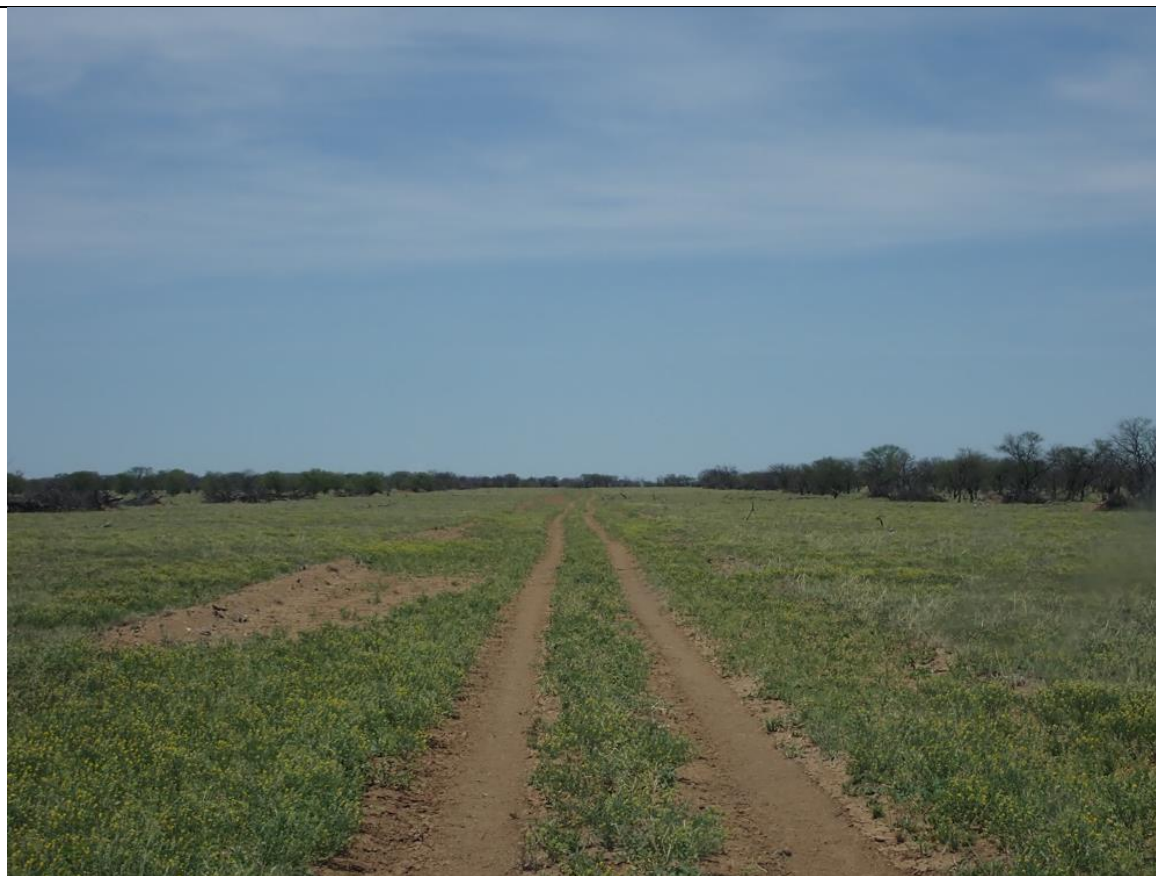
This section is described as 95% very light, 0% light, 5% moderate and 0% heavy by the clearing contractor. Field observations show a mid-dense canopy covers most of the section near the eastern tower with tree heights averaging at 2m. Observations on the ground reflect the clearing contractor's description within this section of the alignment.

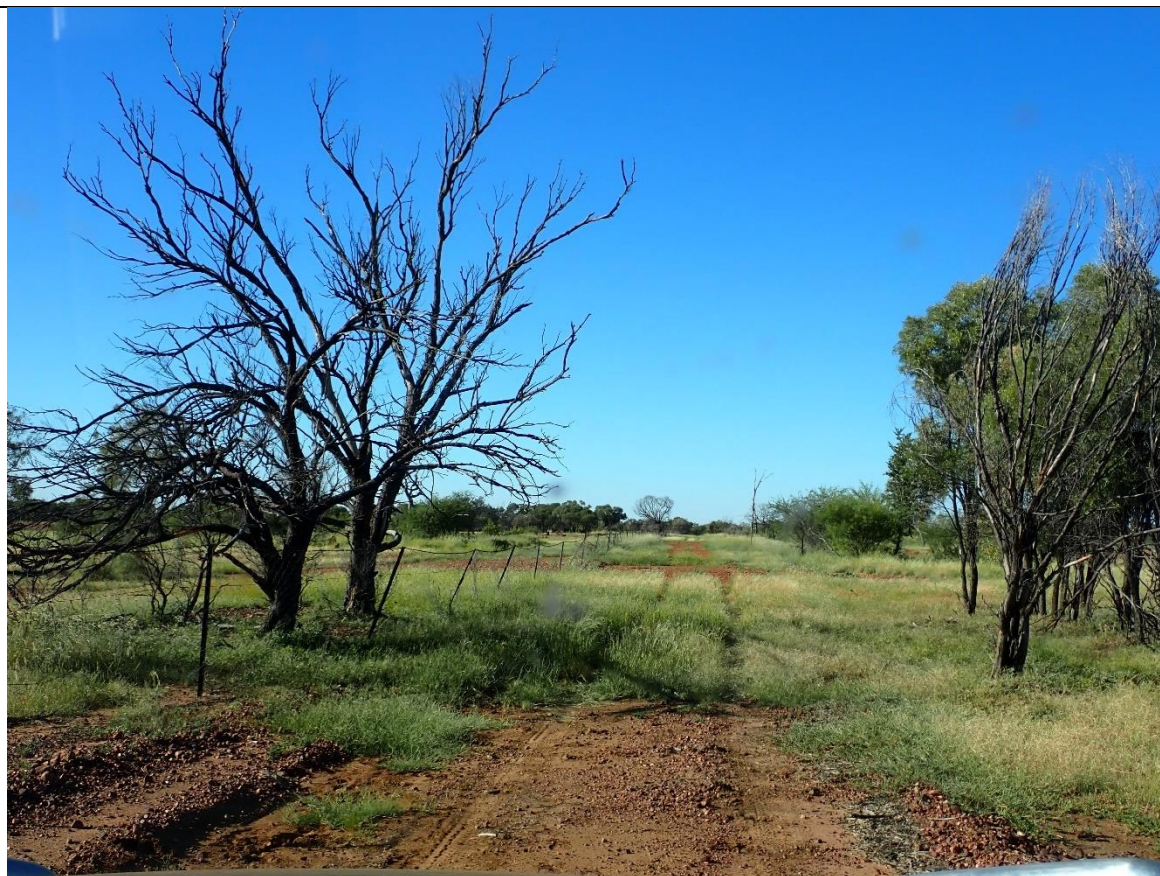
This section is described as 50% very light, 20% light, 30% moderate and 0% heavy by the clearing contractor. Field observations show a sparse canopy covers the whole section although mostly near the access track in this section with tree heights averaging at 5m. Observations on the ground reflect the clearing contractor's description within this section of the alignment.

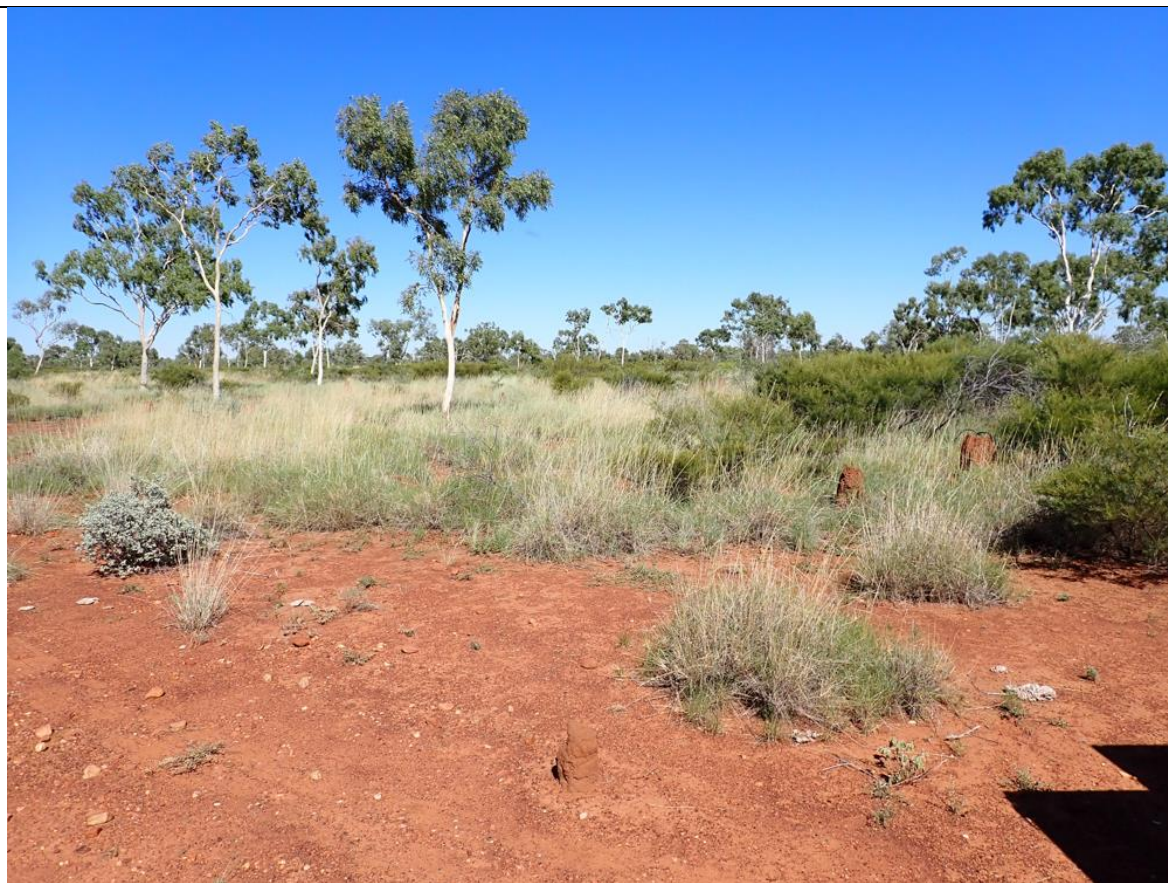
This section is described as 30% very light, 70% light, 0% moderate and 0% heavy by the clearing contractor. Field observations show mid-dense canopy covers most of the mid-section although scattered throughout whole section with tree heights averaging at 8.5m. Observations on the ground reflect the clearing contractor's description within this section of the alignment.

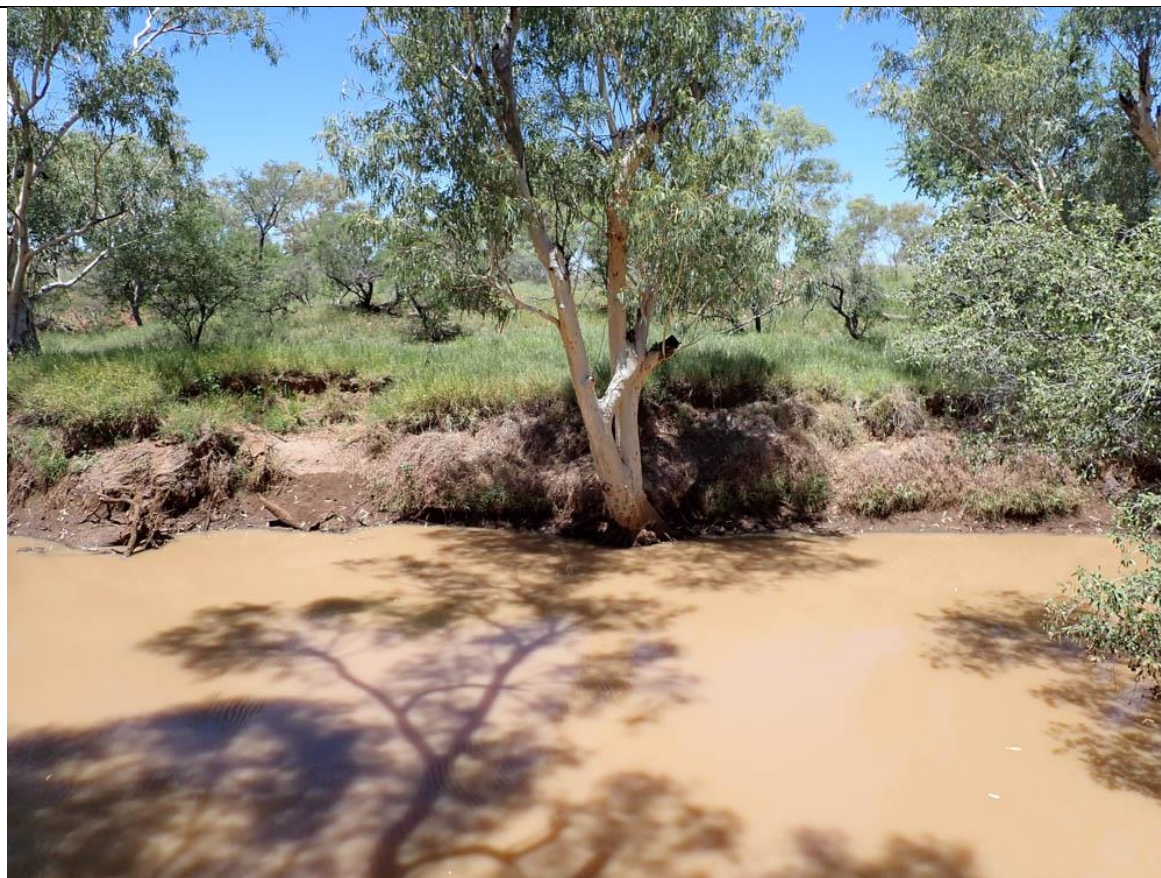
This section is described as 20% very light, 0% light, 80% moderate and 0% heavy by the clearing contractor. Field observations shows riparian woodland along a 90m wide watercourse. Tree heights ranged up to 15m. The dense canopy covers the riparian canopy that fringes the watercourse and gully lines east of riparian zone in this section with tree heights averaging around 7m. Observations on the ground reflect the clearing contractor's description within this section of the alignment.

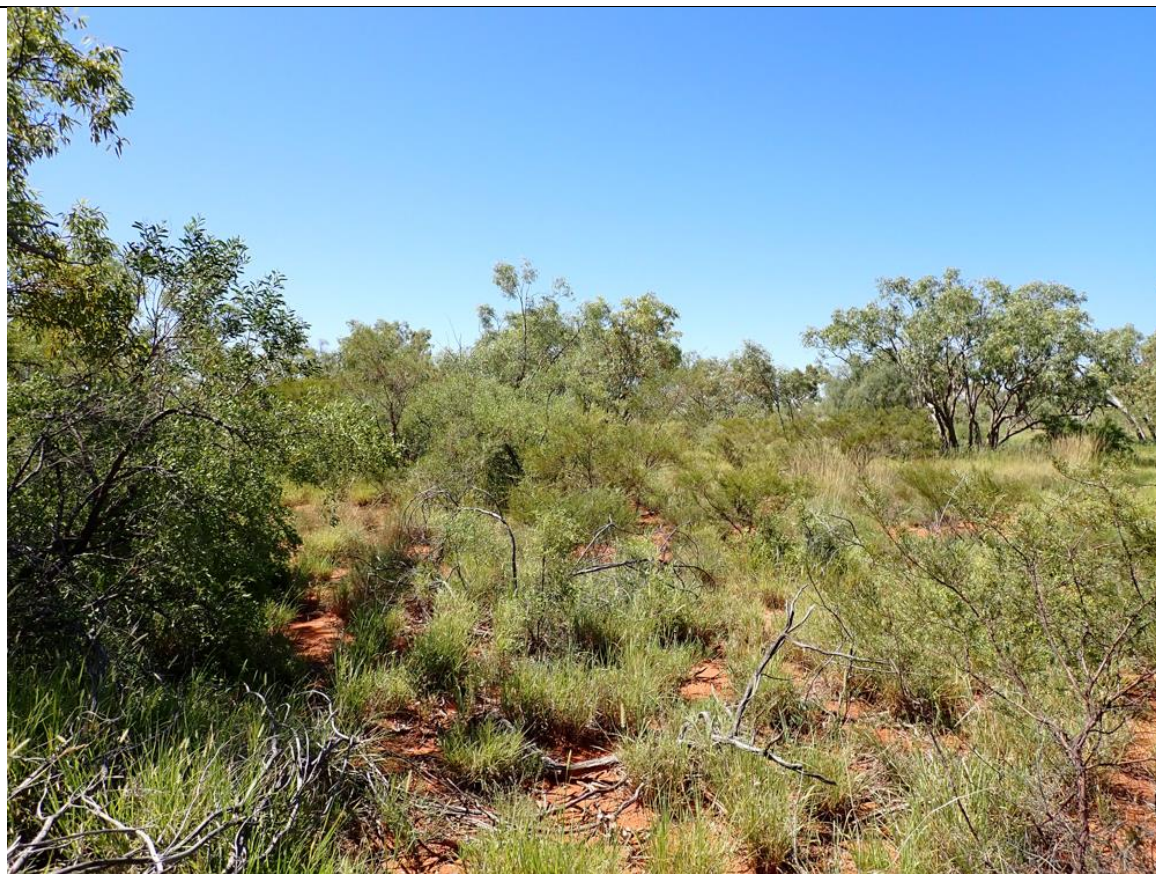
This section is described as 40% very light, 60% light, 0% moderate and 0% heavy by the clearing contractor. Field observations show mid-dense canopy covers most of the east section near the eastern tower although scattered throughout whole section with tree heights averaging at 7.5m. Observations on the ground reflect the clearing contractor's description within this section of the alignment.

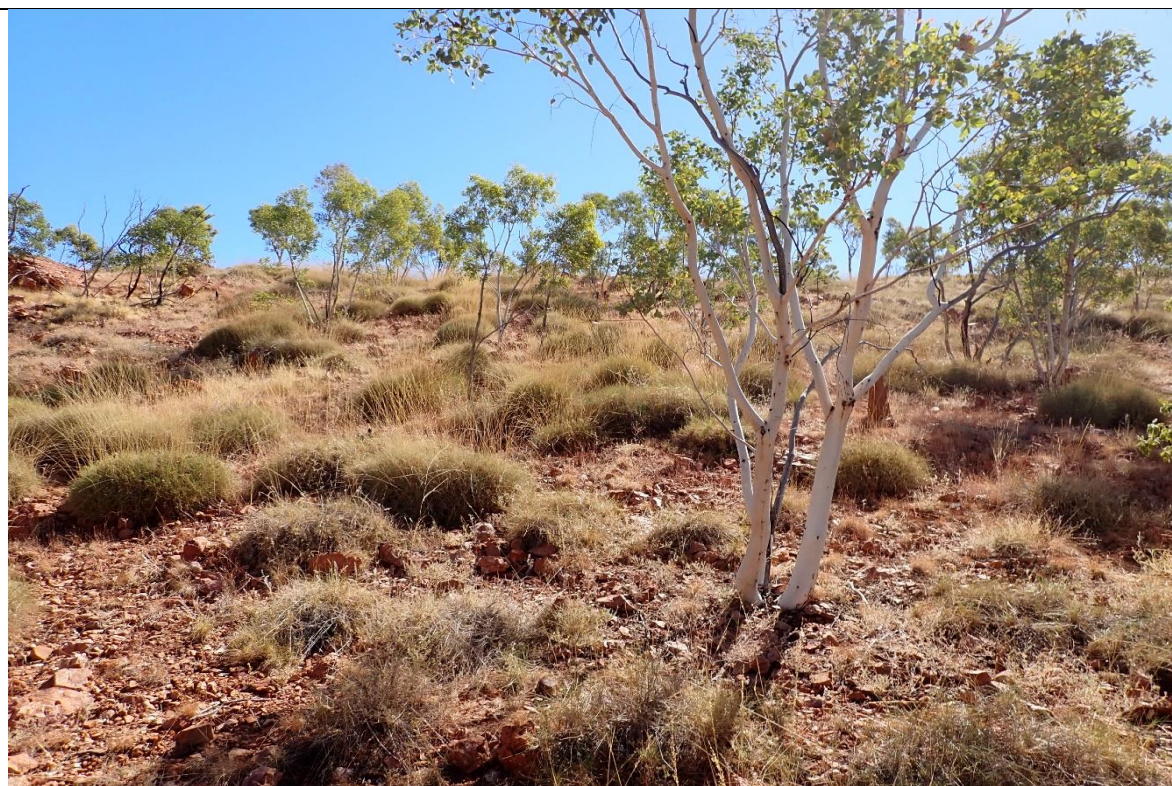
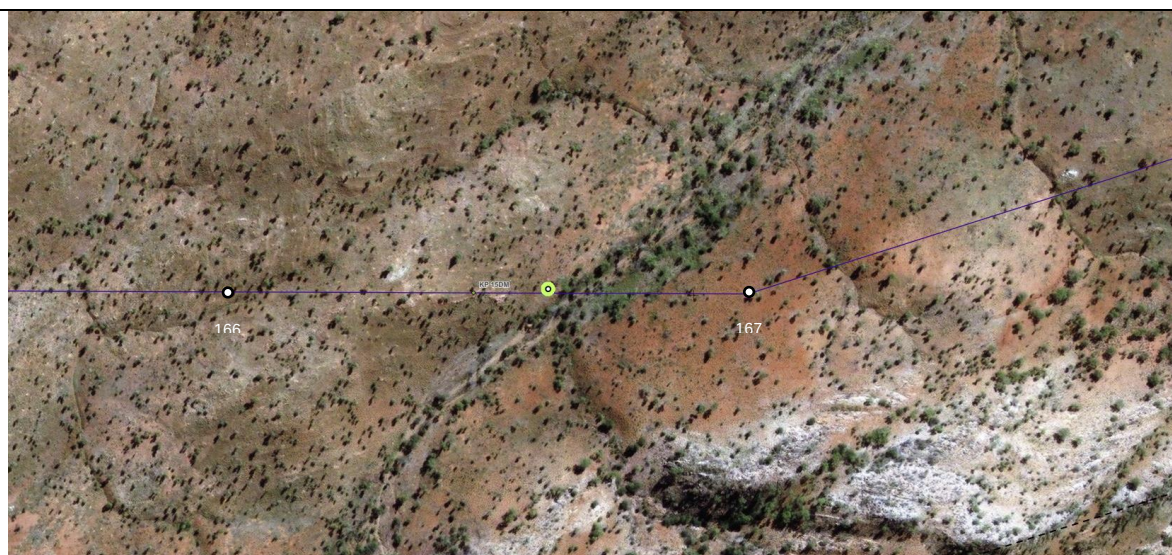
Line 3 KP 14.8 DM (40,20,20,20) Quaternary point (green) near Tower 167  
(410.734m between towers 166-167)

This section is described as 40% very light, 20% light, 20% moderate and 20% heavy by the clearing contractor. Field observations show a riparian woodland along a 30m wide watercourse to the east of the quaternary point. The sparse canopy covers the riparian canopy that fringes the watercourse and most of this section with tree heights averaging at 4m. Observations on the ground reflect the clearing contractor's description within this section of the alignment.
