# Visual Comparison of Landscape Type

Client: CopperString 2.0  
Reference: J0XXX

This document is a visual comparison of landscapes which was compiled to provide a photographic record both from an aerial and site-based perspective along each of the five corridor selection segments. This ground truthing was utilised to inform the projects appreciation of the six general landscape types which occur across the study area as well as improved confidence in the potential conservation significant species habitat mapped for the CopperString EIS 2.0. It has also been used to confirm expected disturbance associated with construction related activities.

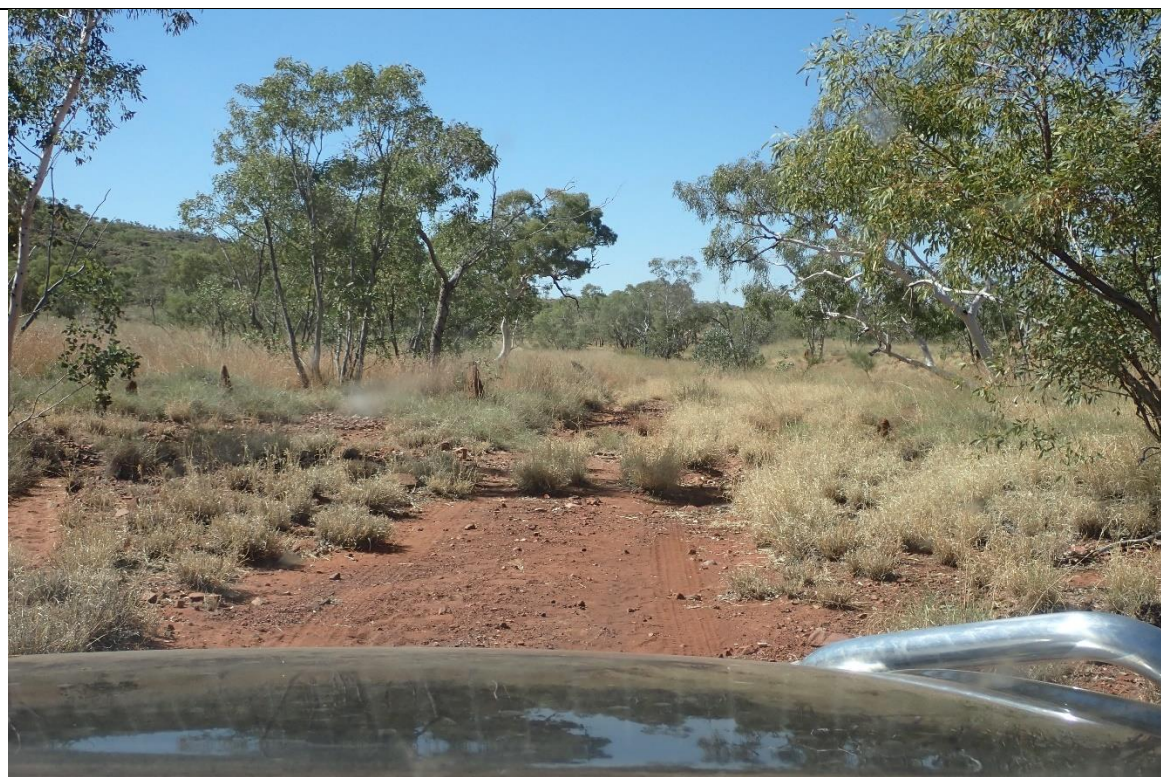
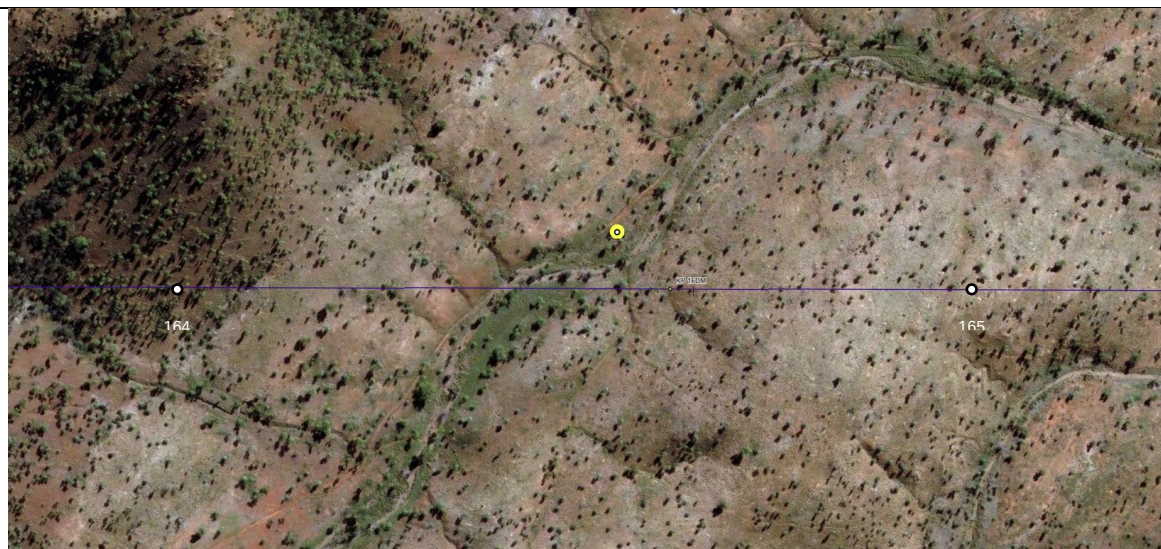
Line 3 KP 15.8 DM (50,0,50,0) Access track (yellow) near Tower 165  
(625.650m between towers 164-165)

This section is described as 50% very light, 0% light, 50% moderate and 0% heavy by the clearing contractor. Field observations show that this access track was slightly overgrown with termite mounds beside. Observations also indicate that there is a riparian woodland along a 30m wide watercourse to the east of the track. The mid-dense canopy covers the riparian canopy that fringes the watercourse and hillslopes throughout this section with tree height averaging at 6m. Observations on the ground reflect the clearing contractor's description within this section of the alignment.

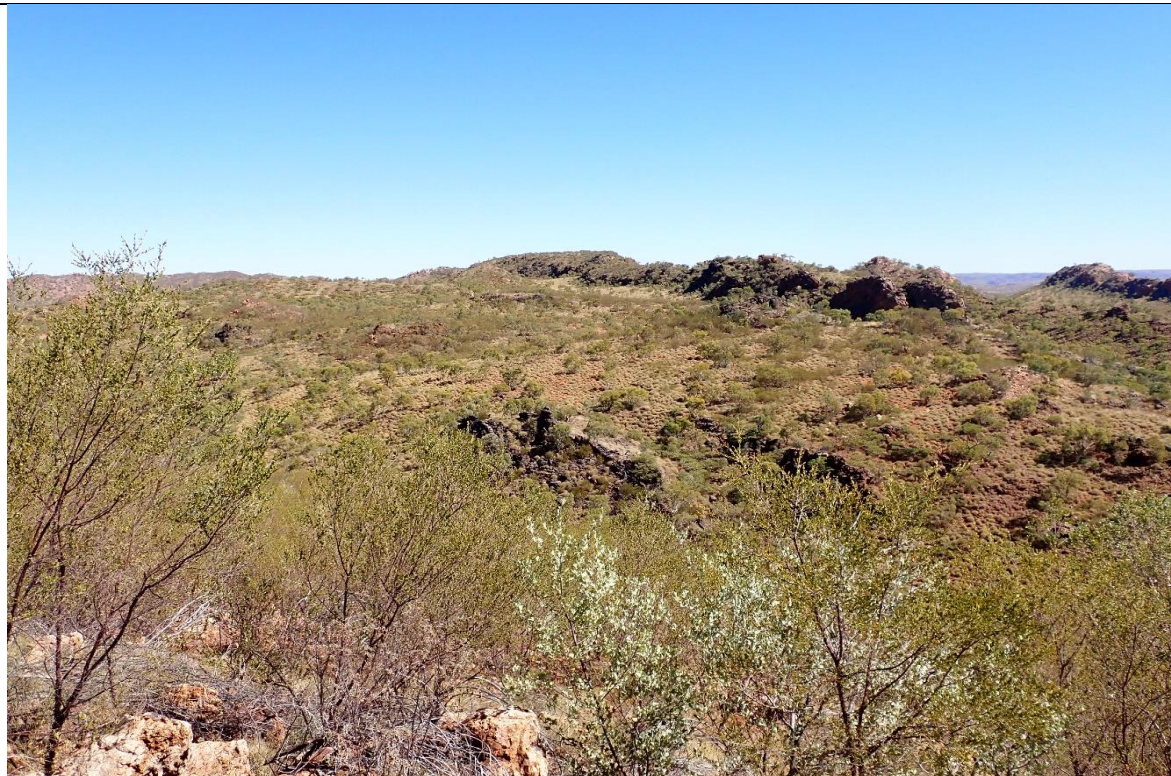
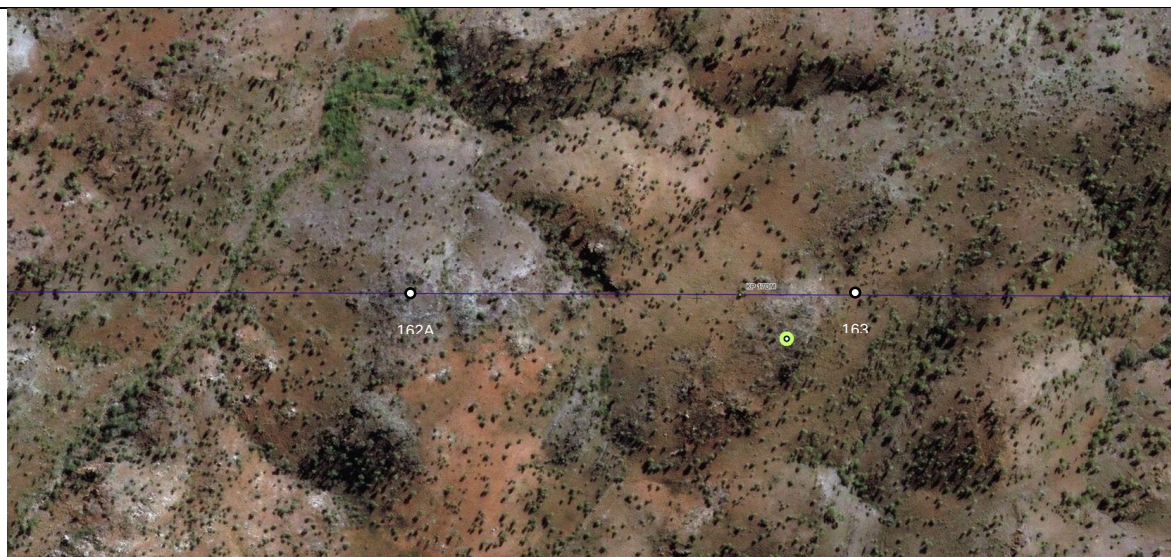
Line 3 KP 16.9 DM (50,0,50,0) Quaternary point (green) near Tower 163  
(354.090m between towers 162A-163)

This section is described as 50% very light, 0% light, 50% moderate and 0% heavy by the clearing contractor. Field observations show that the mid-dense canopy covers most of this section, although congregated on the hillslopes and gully lines with tree heights averaging up to 5m. Observations on the ground reflect the clearing contractor's description within this section of the alignment.

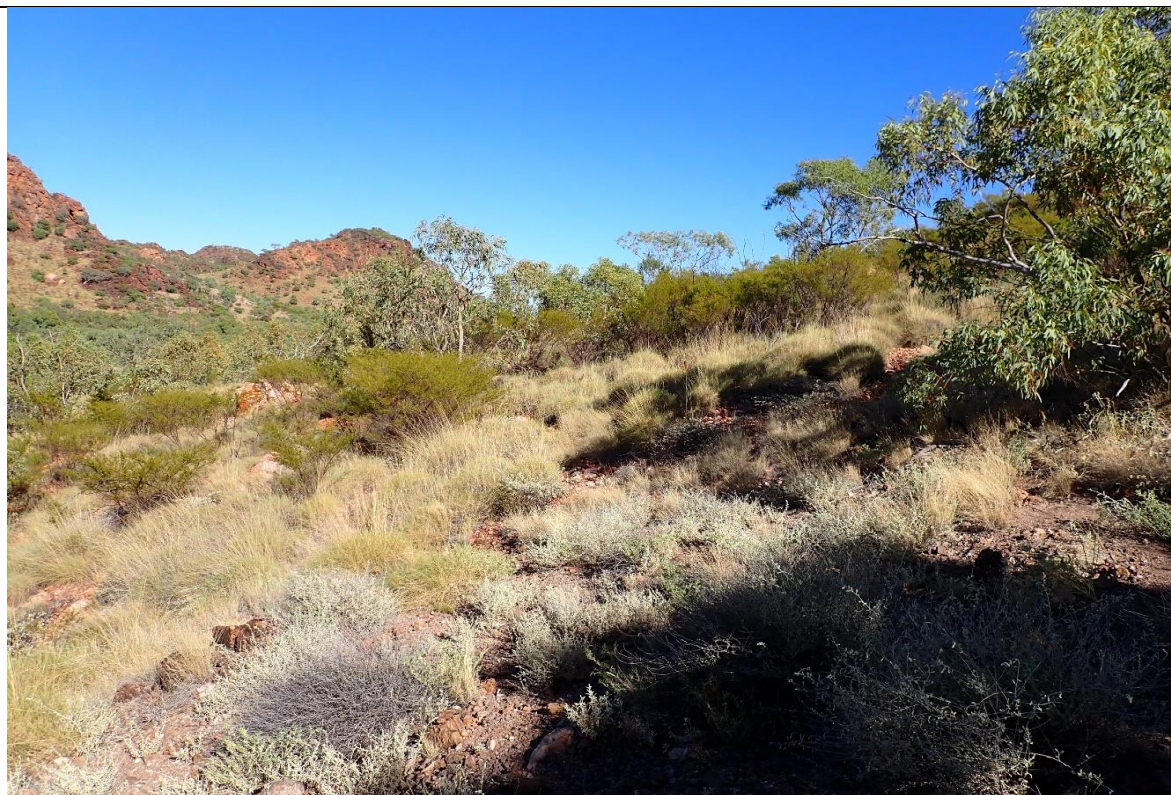
This section is described as 40% very light, 0% light, 60% moderate and 0% heavy by the clearing contractor. Field observations show that the mid-dense canopy covers most of this section, although congregated on the hillslopes and gully lines with tree heights averaging up to 5m. Observations on the ground reflect the clearing contractor's description within this section of the alignment.

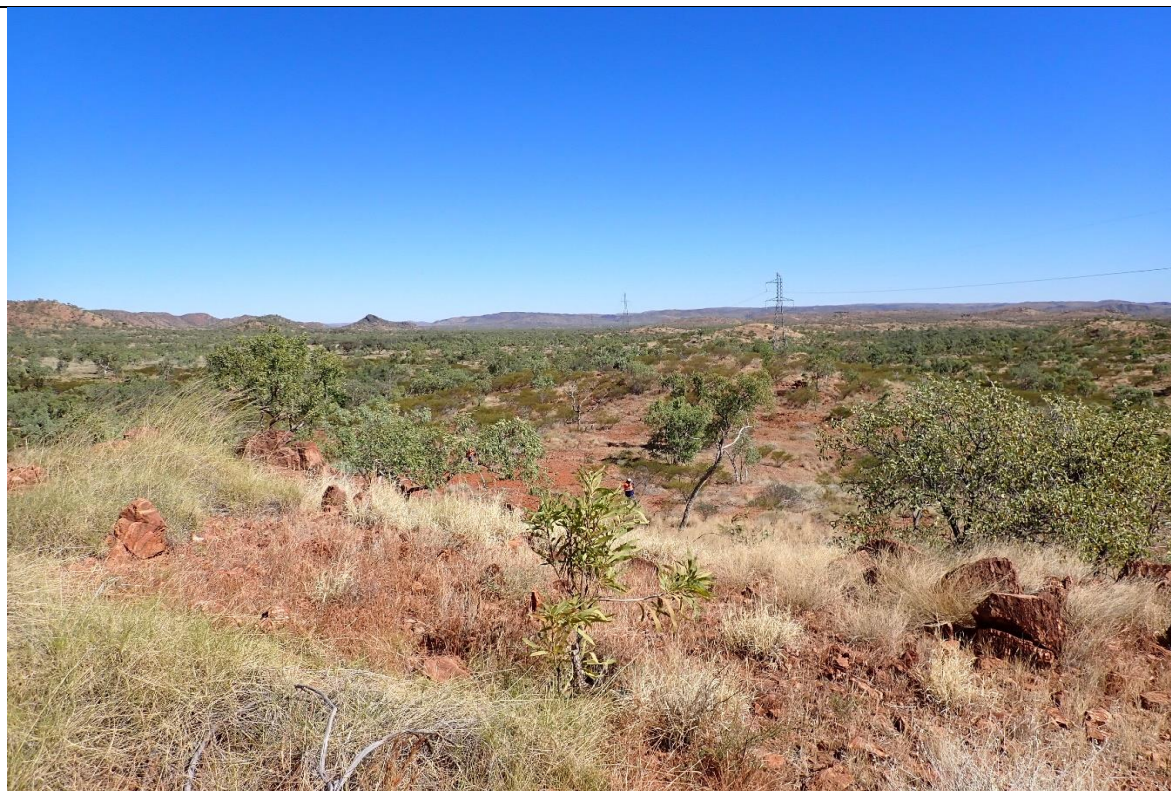
This section is described as 40% very light, 0% light, 60% moderate and 0% heavy by the clearing contractor. Field observations show a riparian woodland along a 30m wide watercourse to the west of the quaternary point. The mid-dense canopy covers the riparian canopy that fringes the watercourse and the western side of this section with tree heights averaging at 5m. Observations on the ground reflect the clearing contractor's description within this section of the alignment.

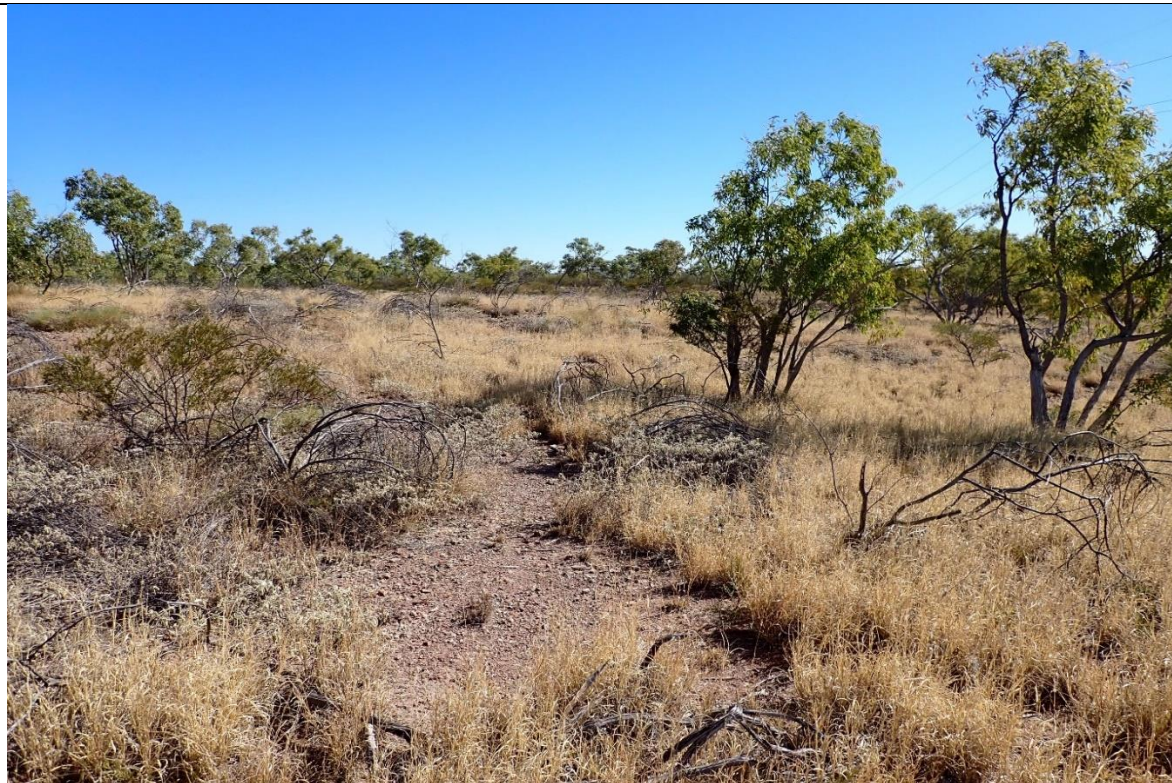
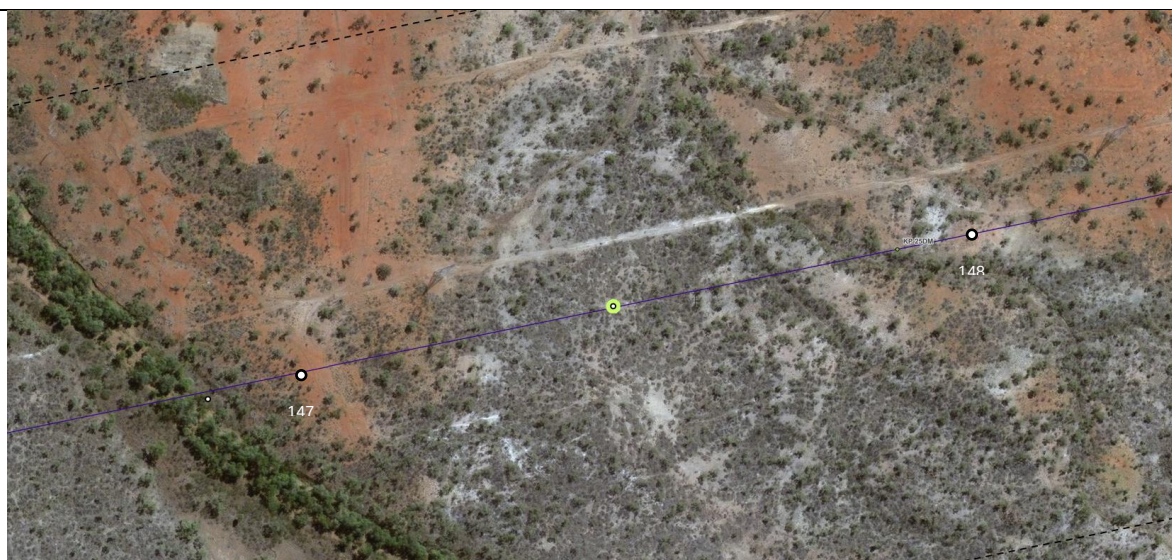
Line 3 KP 24.9 DM (60,0,40,0) Quaternary point (green) near Tower 148  
(542.995m between towers 147-148)

This section is described as 60% very light, 0% light, 40% moderate and 0% heavy by the clearing contractor. Field observations show a riparian woodland along a forked watercourse of 10m and 30m wide to the east of the quaternary point. The mid-dense canopy covers the riparian canopies that fringe the watercourses and the western side of this section with tree heights averaging at 5m. Observations on the ground reflect the clearing contractor's description within this section of the alignment.

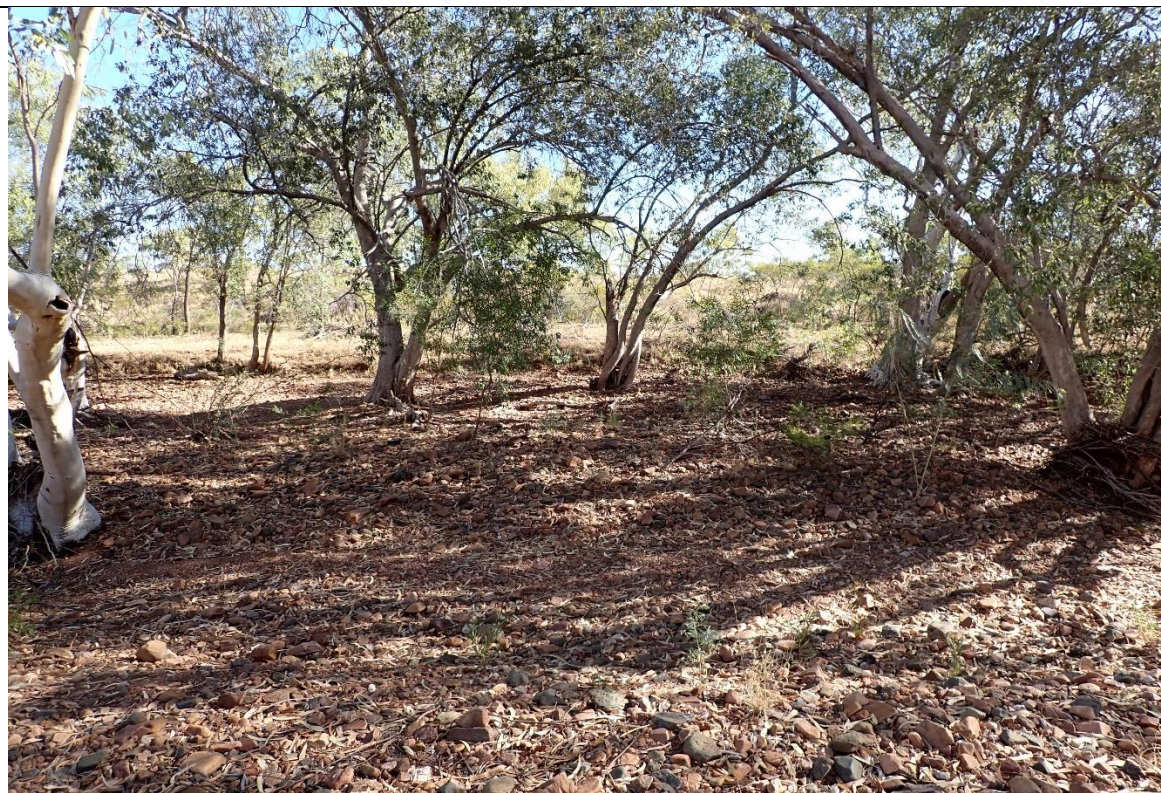
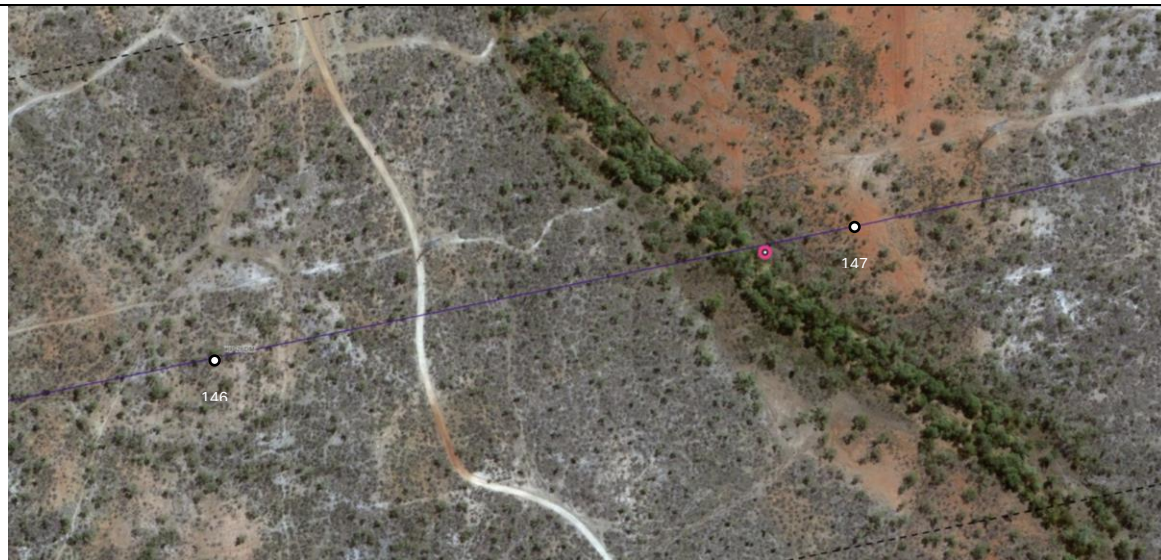
Line 3 KP 25.5 DM (50,0,20,30) Riparian zone (red) near Tower 147

This section is described as 50% very light, 0% light, 20% moderate and 30% heavy by the clearing contractor. Field observations show a riparian woodland along a 60m wide watercourse. Tree heights ranged up to 16m. The sparse canopy covers the riparian canopy fringing the watercourse and most of the western side of this section with tree heights averaging around 8m. Observations on the ground reflect the clearing contractor's description within this section of the alignment.

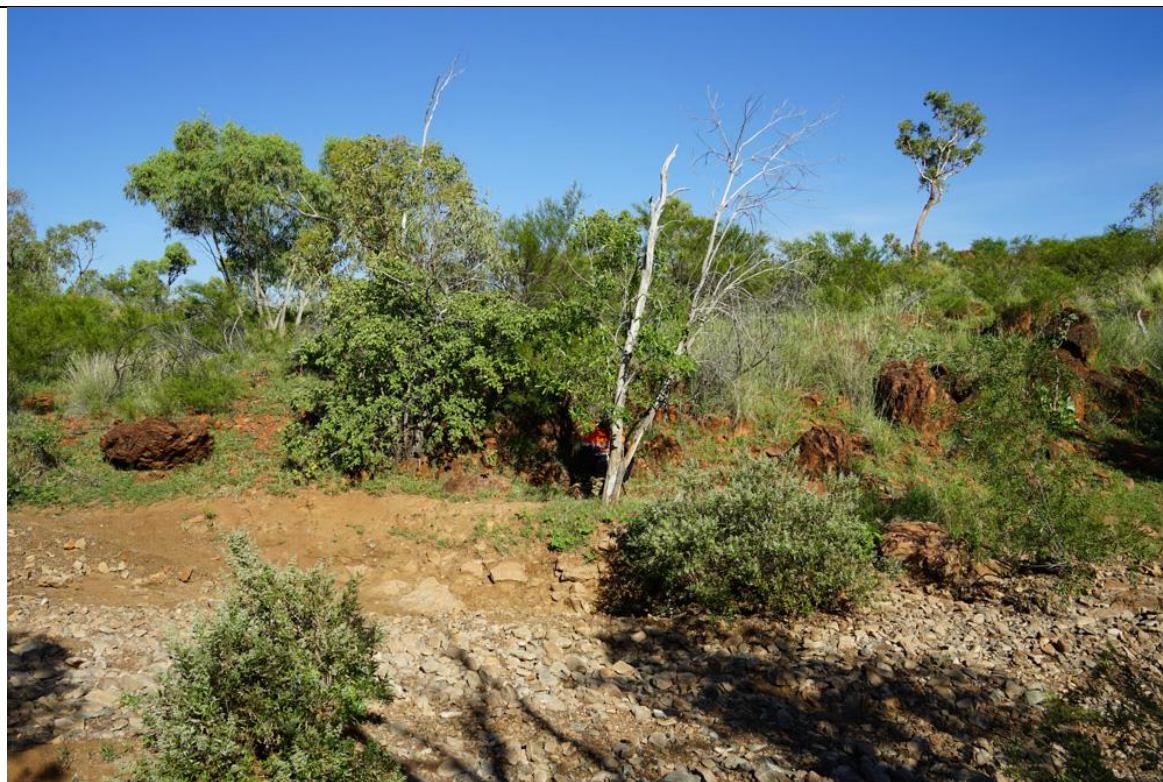
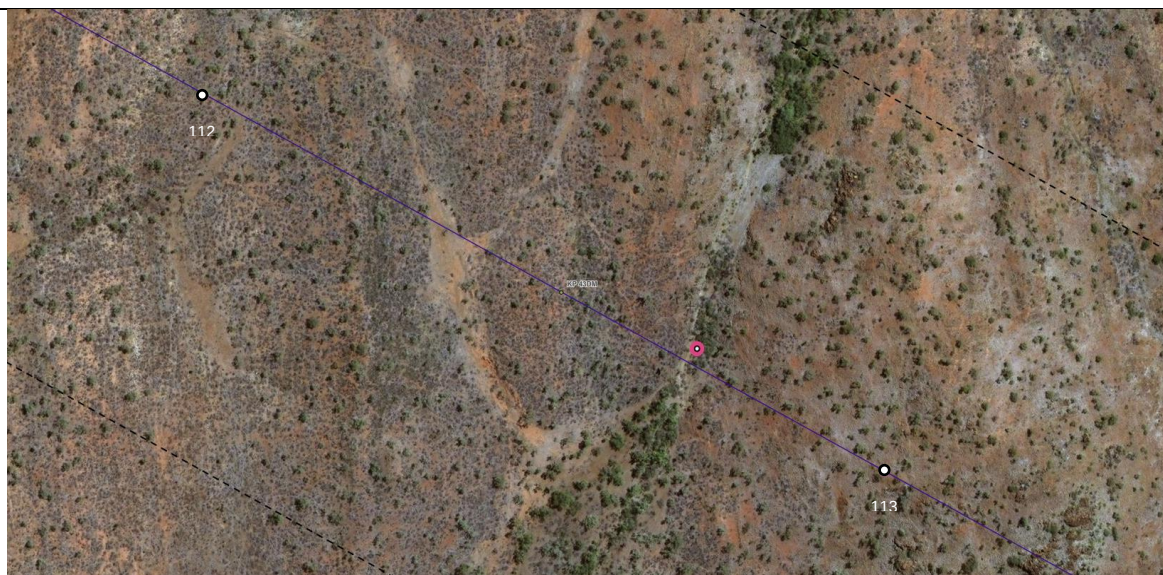
Line 3 KP 42.7 DM (70,0,30,0) Riparian zone (red) near Tower 113  
 (604.867m between towers 112-113) (Low Risk (Green) DAF – WWBW)

This section is described as 70% very light, 0% light, 30% moderate and 0% heavy by the clearing contractor. Field observations show a riparian woodland along a 50m wide watercourse. Tree heights ranged up to 8m. The sparse canopy covers the riparian canopy fringing the watercourse and most of the eastern side of this section with tree heights averaging around 6m. Observations on the ground reflect the clearing contractor's description within this section of the alignment.

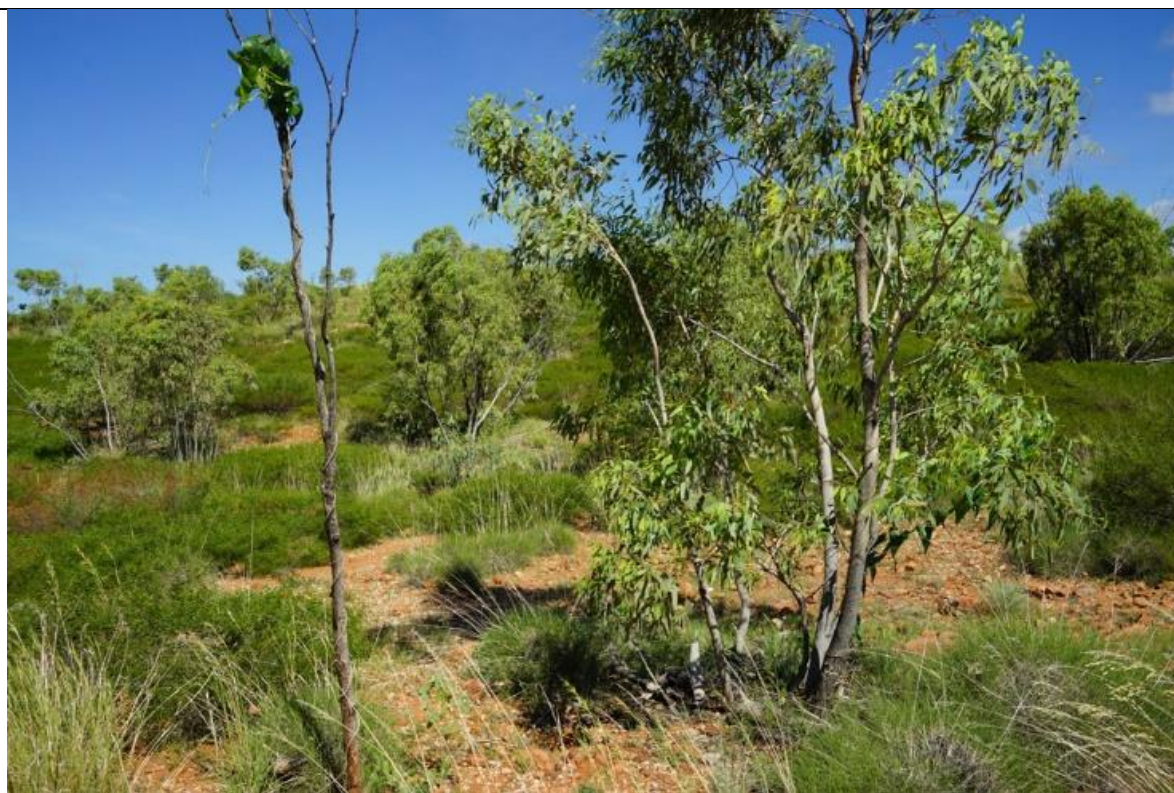
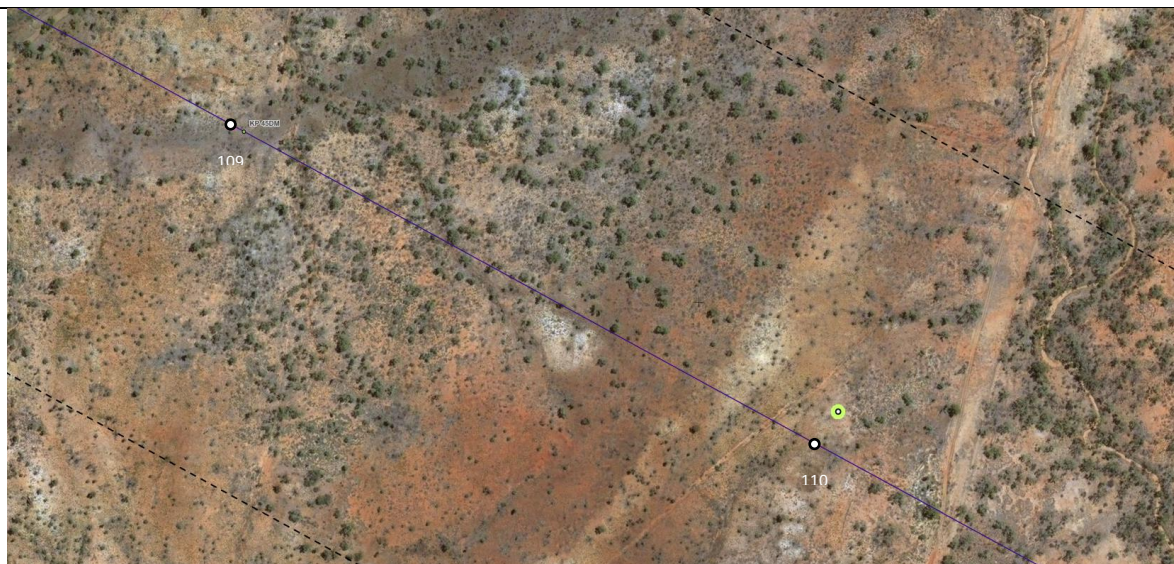
Line 3 KP 44.5 DM (60,0,30,10) Quaternary point (green) near Tower 110  
(520.379m between towers 109-110)

This section is described as 60% very light, 0% light, 30% moderate and 10% heavy by the clearing contractor. Field observations show a riparian woodland along a forked watercourse of 10m and 20m wide to the west of the quaternary point. The sparse canopy covers the riparian canopies that fringe the watercourses and the between them with tree heights averaging at 6m. Observations on the ground reflect the clearing contractor's description within this section of the alignment.

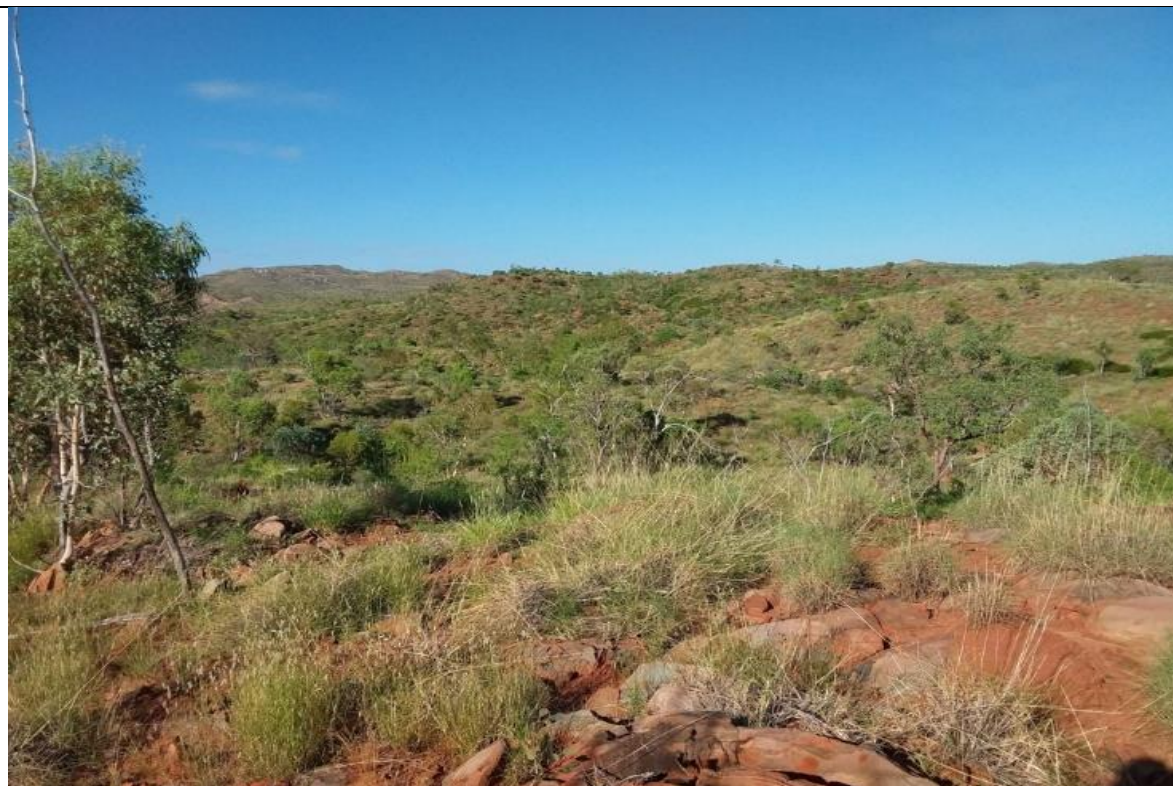
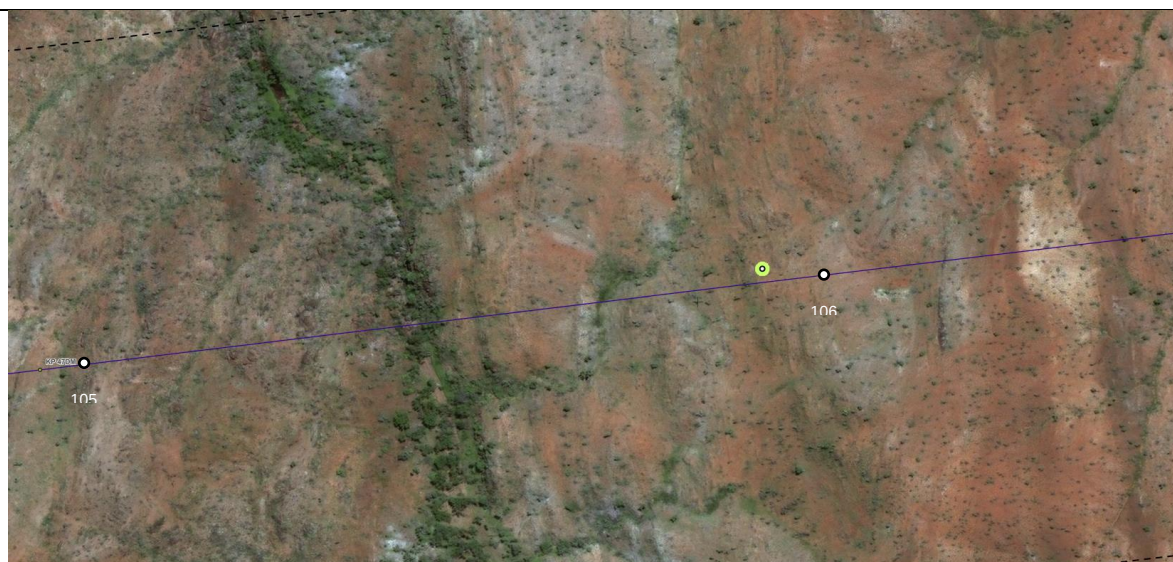
Line 3 KP 46.5 DM (50,0,40,10) Quaternary point (green) near Tower 106  
(585.637m between towers 105-106)

This section is described as 50% very light, 0% light, 40% moderate and 10% heavy by the clearing contractor. Field observations show a riparian woodland along a 30m wide watercourse with gully line to the west of the quaternary point. The sparse to mid-dense canopy covers the riparian canopy that fringes the watercourse and gully line in this section with tree heights averaging at 5m. Observations on the ground reflect the clearing contractor's description within this section of the alignment.

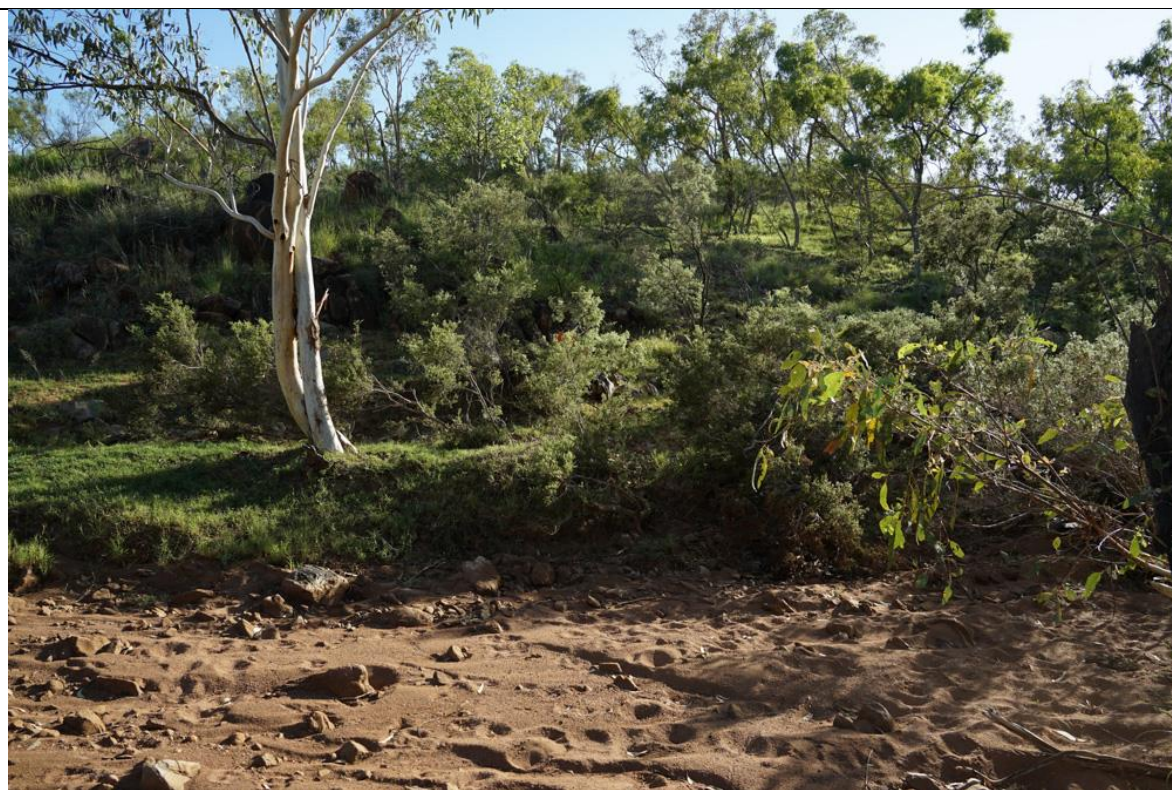
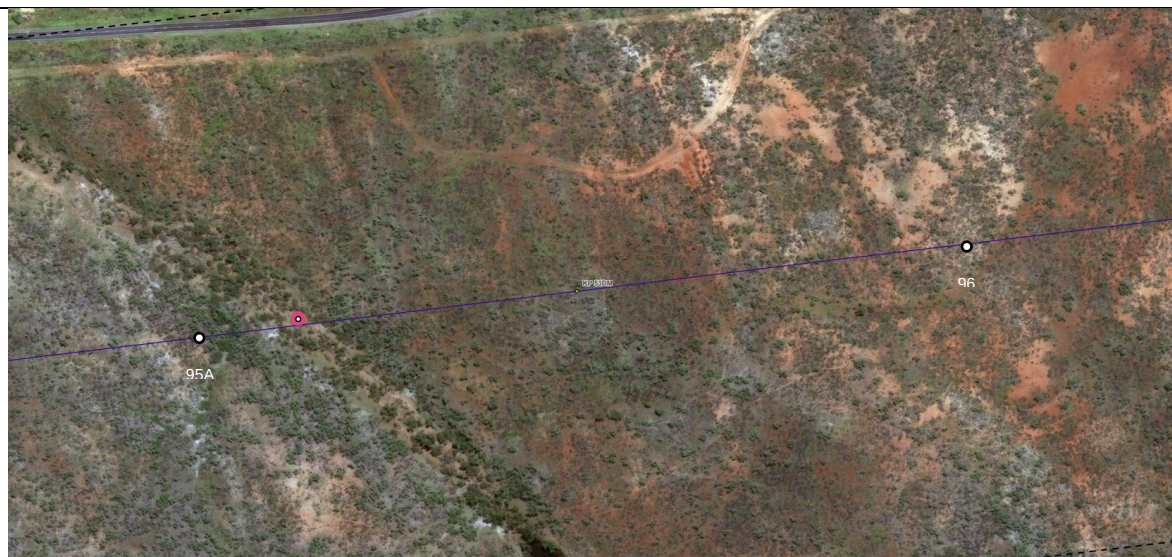
Line 3 KP 52.8 DM (30,0,30,40) Riparian zone (red) near Tower 96

This section is described as 30% very light, 0% light, 30% moderate and 40% heavy by the clearing contractor. Field observations show a riparian woodland along a 45m wide watercourse. Tree heights ranged up to 16m. The sparse to mid-dense canopy covers the riparian canopy fringing the watercourse and mostly the western side of this section, although throughout whole section with tree heights averaging around 7m. Observations on the ground reflect the clearing contractor's description within this section of the alignment.

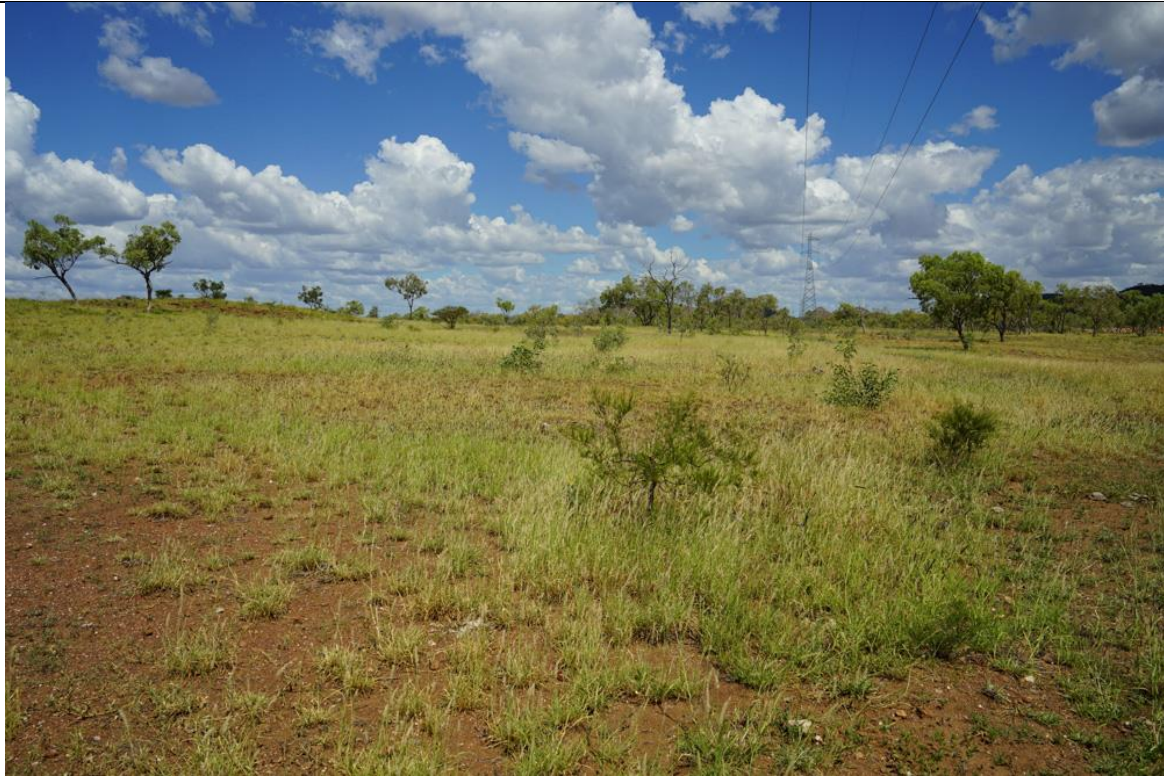
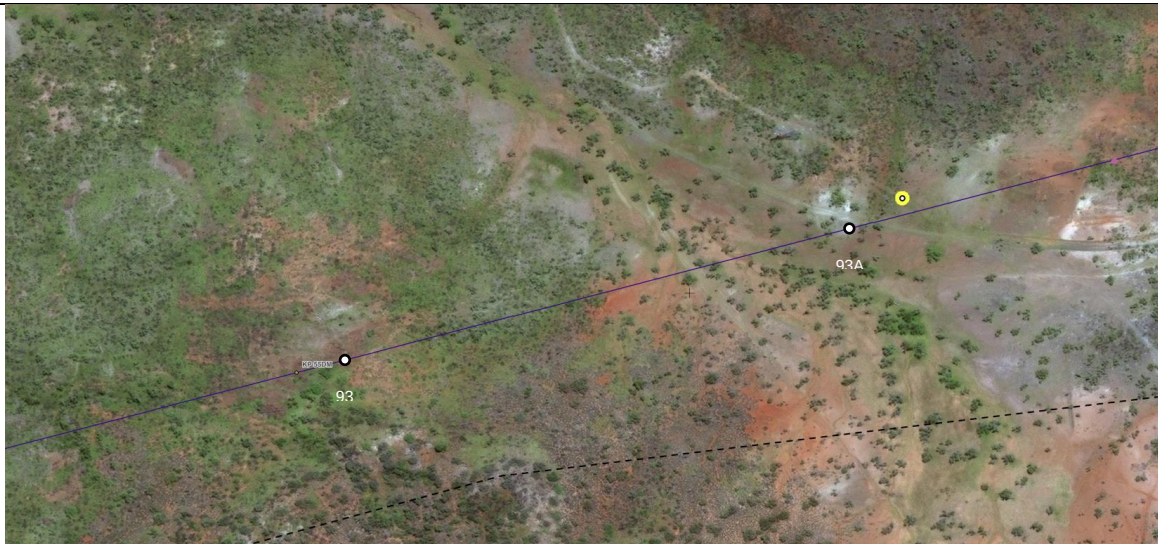
Line 3 KP 54.4 DM (40,30,30,0) Access track (yellow) near Tower 93A  
(418.380m between towers 93-93A)

This section is described as 40% very light, 30% light, 30% moderate and 0% heavy by the clearing contractor. Field observations show that this access track was slightly overgrown with a powerline above. The sparse canopy covers the edges of section towards the towers with clearing in mid-section with tree height averaging at 6m. Observations on the ground reflect the clearing contractor's description within this section of the alignment.

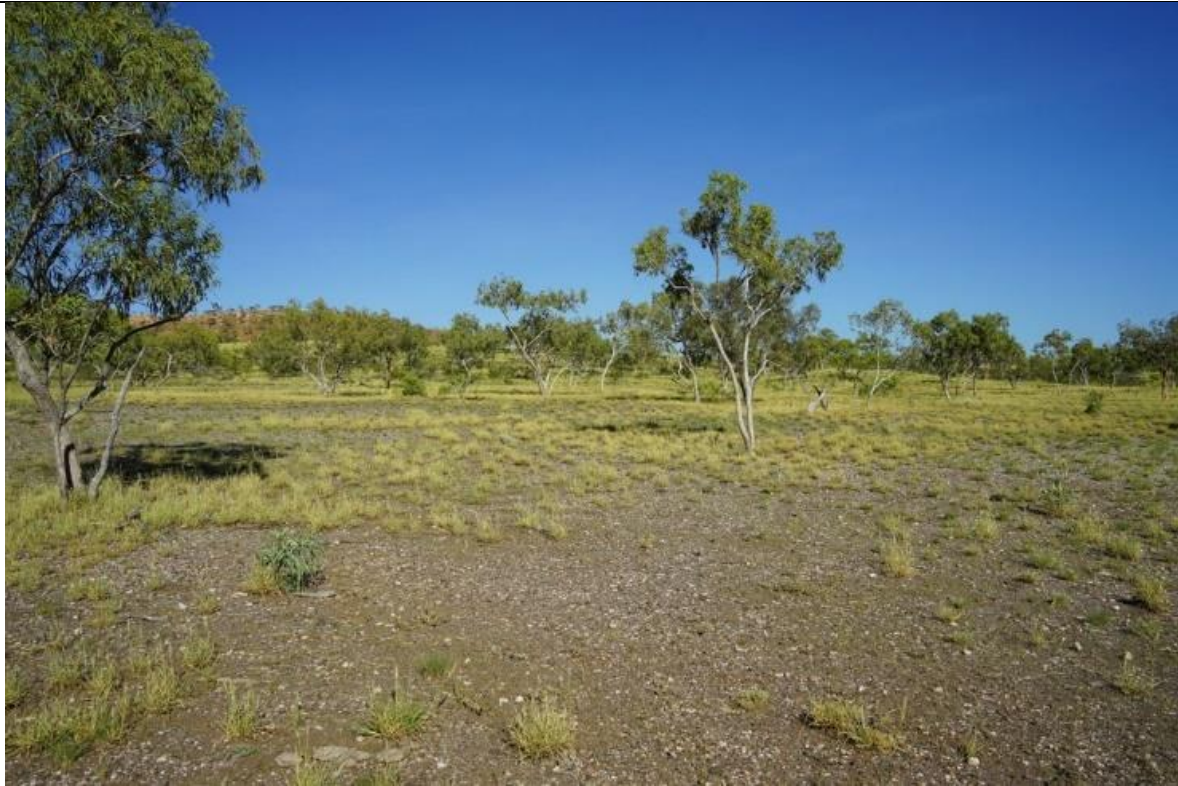
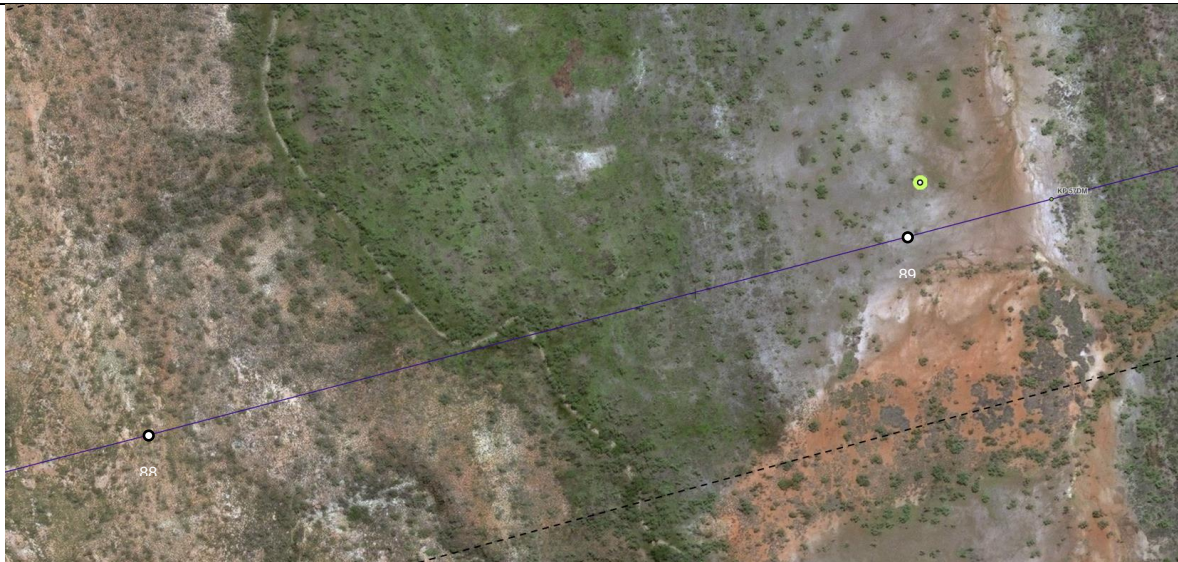
Line 3 KP 57.1 DM (60,0,40,0) Quaternary point (green) near Tower 89  
(616.370m between towers 88-89)

This section is described as 60% very light, 0% light, 40% moderate and 0% heavy by the clearing contractor. Field observations show a riparian woodland along a 10m wide watercourse to the west of the quaternary point. The mid-dense canopy covers the riparian canopy that fringes the watercourse and surroundings in the middle of this section with tree heights averaging at 6m. Observations on the ground reflect the clearing contractor's description within this section of the alignment.

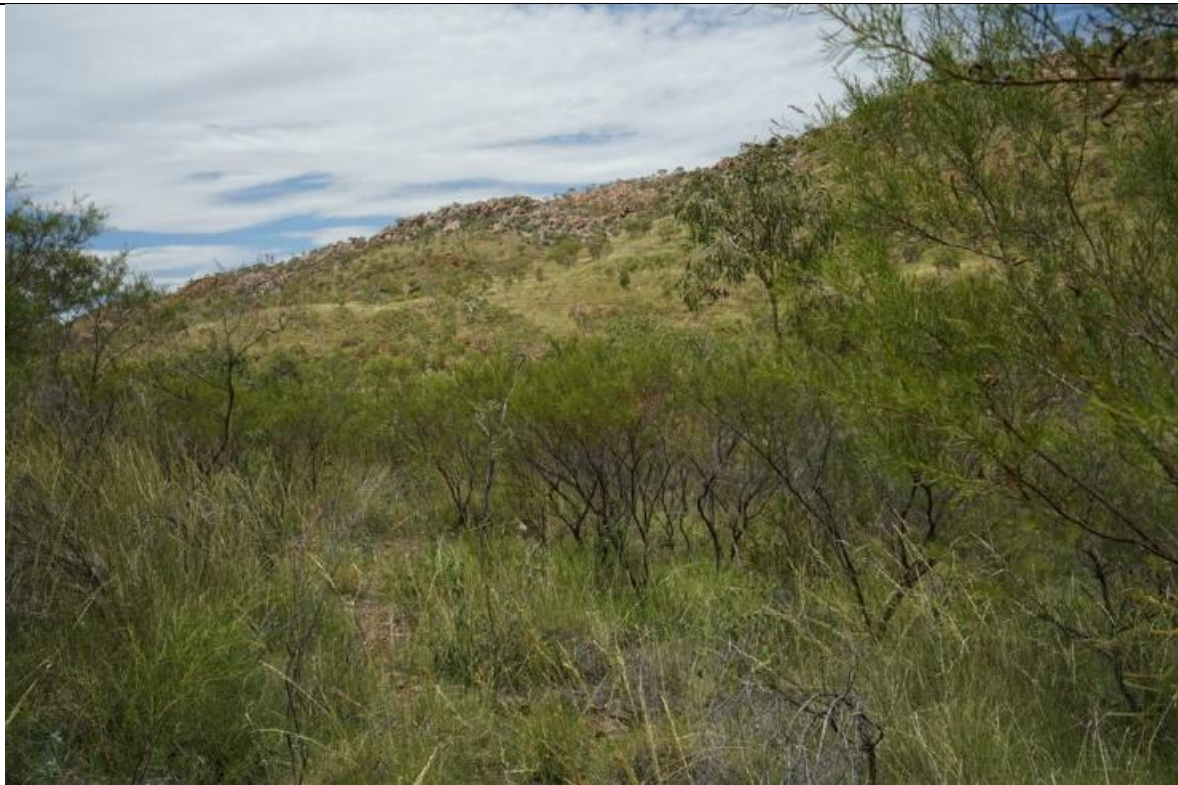
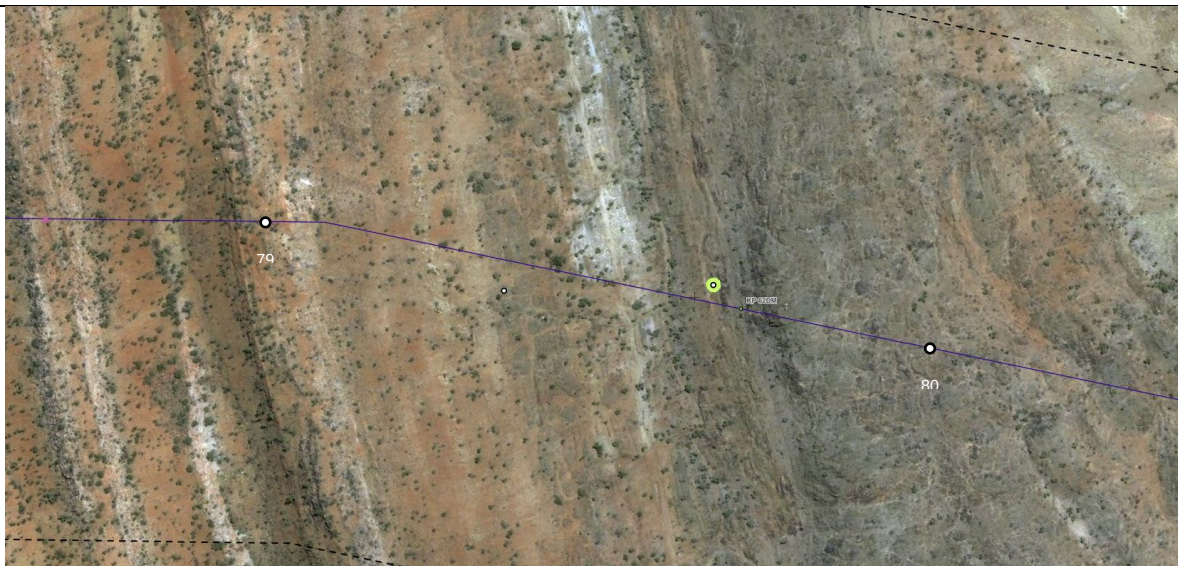
Line 3 KP 61.8 DM (60,0,40,0) Quaternary point (green) near Tower 80  
(528.847m between towers 79-80)

This section is described as 60% very light, 0% light, 40% moderate and 0% heavy by the clearing contractor. Field observations show a mid-dense canopy covers the riparian canopy that fringes the gully line and along ridge lines with tree heights averaging at 6m. Observations on the ground reflect the clearing contractor's description within this section of the alignment.

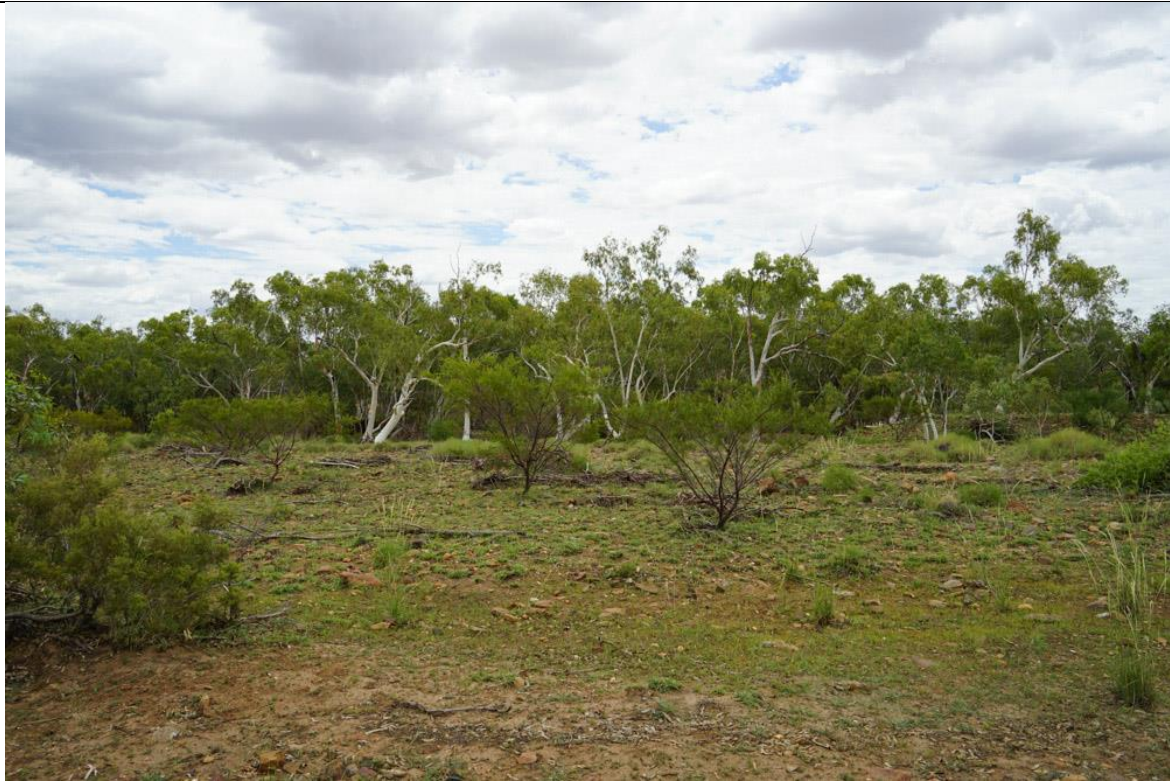
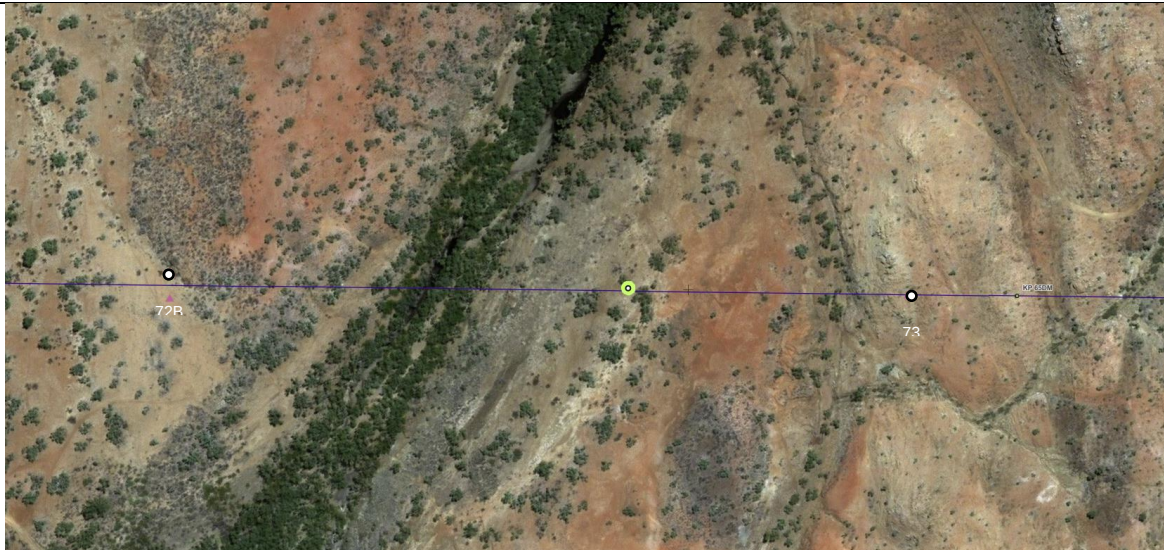
Line 3 KP 65.1 DM (60,0,40,0) Quaternary point (green) near Tower 73  
(586.458m between towers 72B-73)

This section is described as 60% very light, 0% light, 40% moderate and 0% heavy by the clearing contractor. Field observations show a riparian woodland along an 85m wide watercourse. Tree heights ranged up to 18m. The mid-dense canopy covers the riparian canopy fringing the watercourse and small gully lines throughout this section with tree heights averaging around 13m. Observations on the ground reflect the clearing contractor's description within this section of the alignment.
