# Visual Comparison of Landscape Type

Client: CopperString 2.0  
Reference: J0XXX

This document is a visual comparison of landscapes which was compiled to provide a photographic record both from an aerial and site-based perspective along each of the five corridor selection segments. This ground truthing was utilised to inform the projects appreciation of the six general landscape types which occur across the study area as well as improved confidence in the potential conservation significant species habitat mapped for the CopperString EIS 2.0. It has also been used to confirm expected disturbance associated with construction related activities.

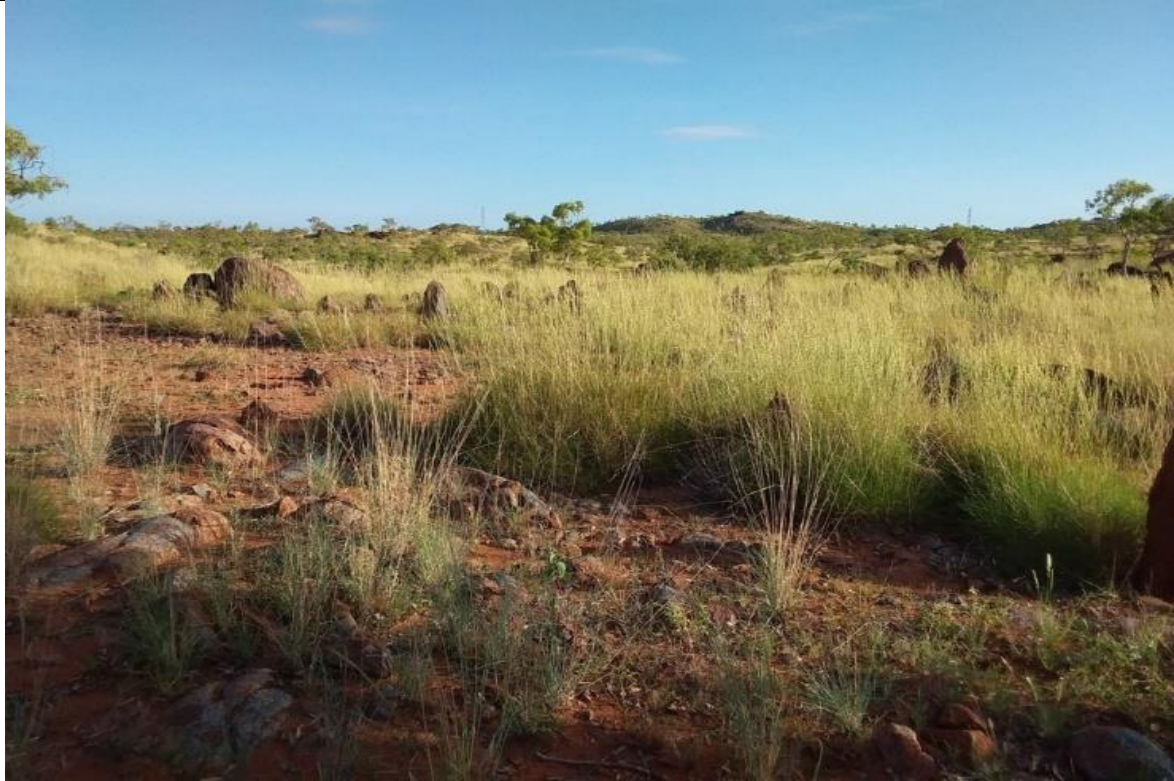
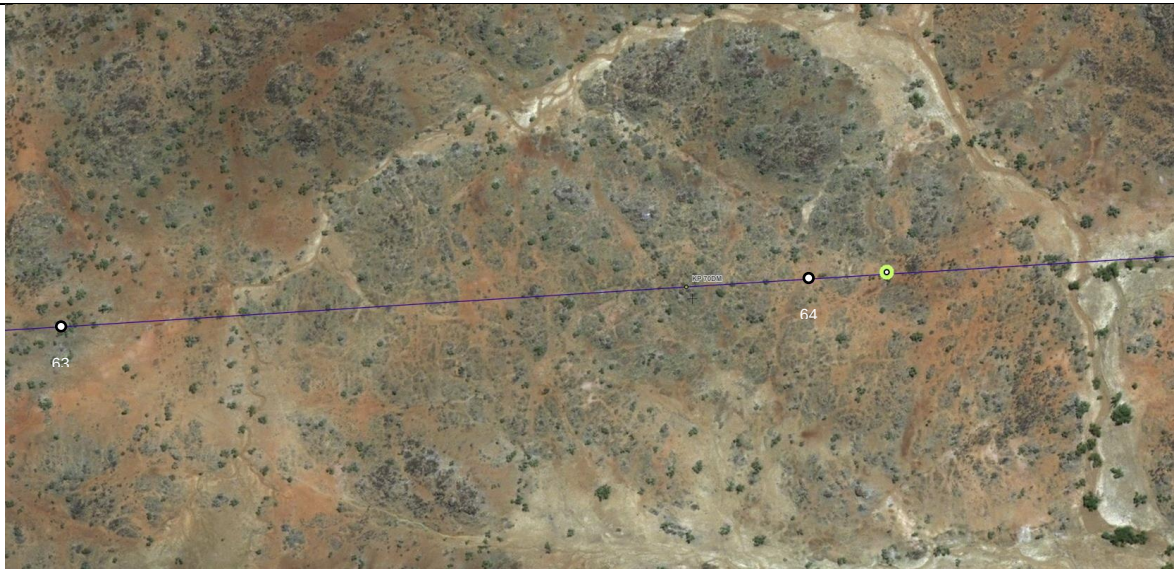
Line 3 KP 69.9 DM (70,0,30,0) Quaternary point (green) near Tower 64  
(593.488m between towers 63-64)

This section is described as 70% very light, 0% light, 30% moderate and 0% heavy by the clearing contractor. Field observations show a sparse canopy covers a few small gully lines scattered throughout this section with tree heights averaging at 6m. Observations on the ground reflect the clearing contractor's description within this section of the alignment.

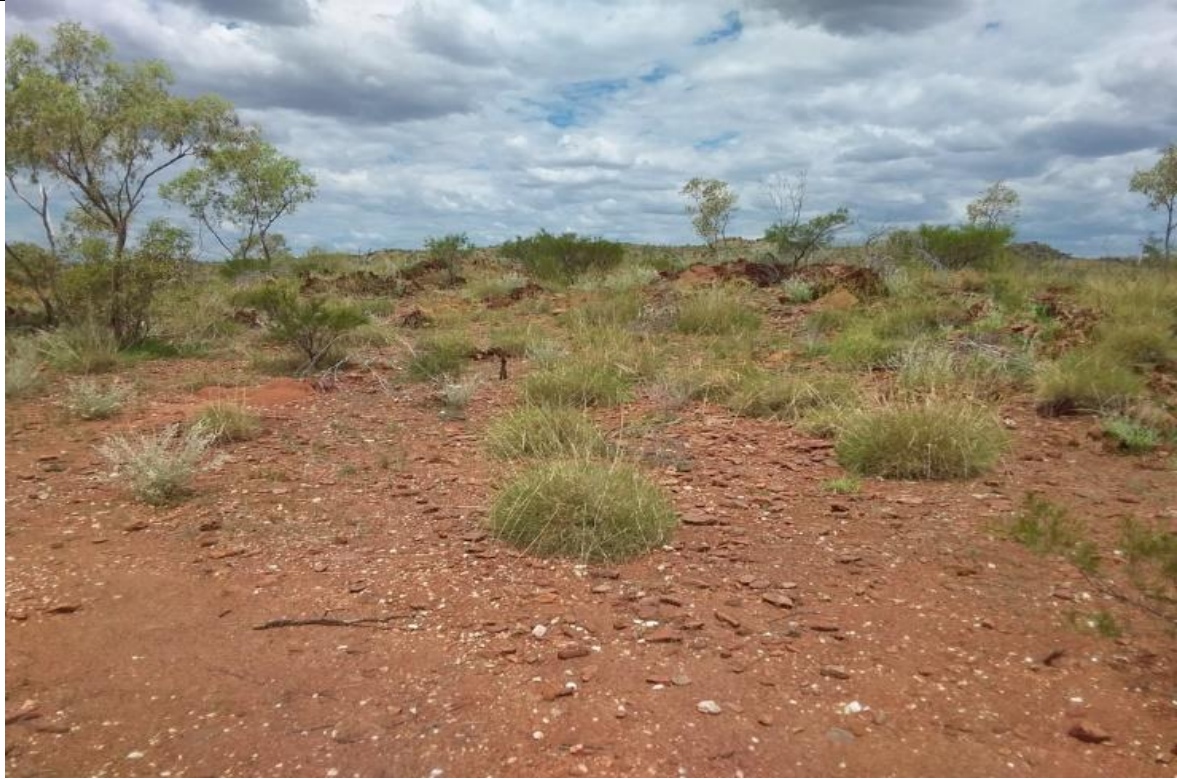
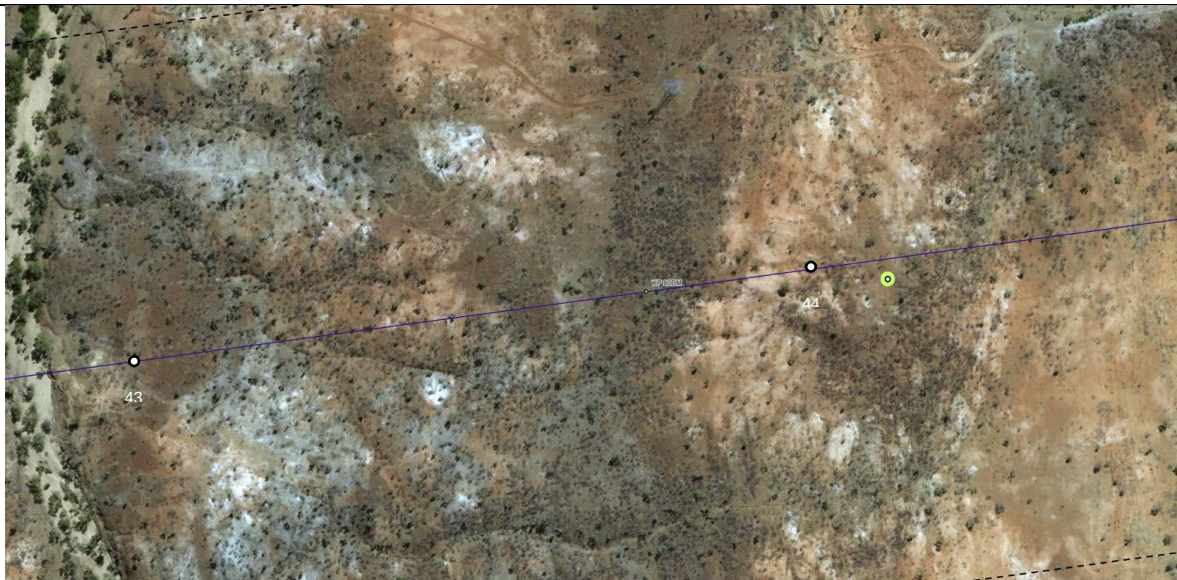
Line 3 KP 79.9 DM (70,0,30,0) Quaternary point (green) near Tower 44  
(541.265m between towers 43-44)

This section is described as 70% very light, 0% light, 30% moderate and 0% heavy by the clearing contractor. Field observations show a sparse canopy covers a few small gully lines scattered throughout this section with tree heights averaging at 5m. Observations on the ground reflect the clearing contractor's description within this section of the alignment.

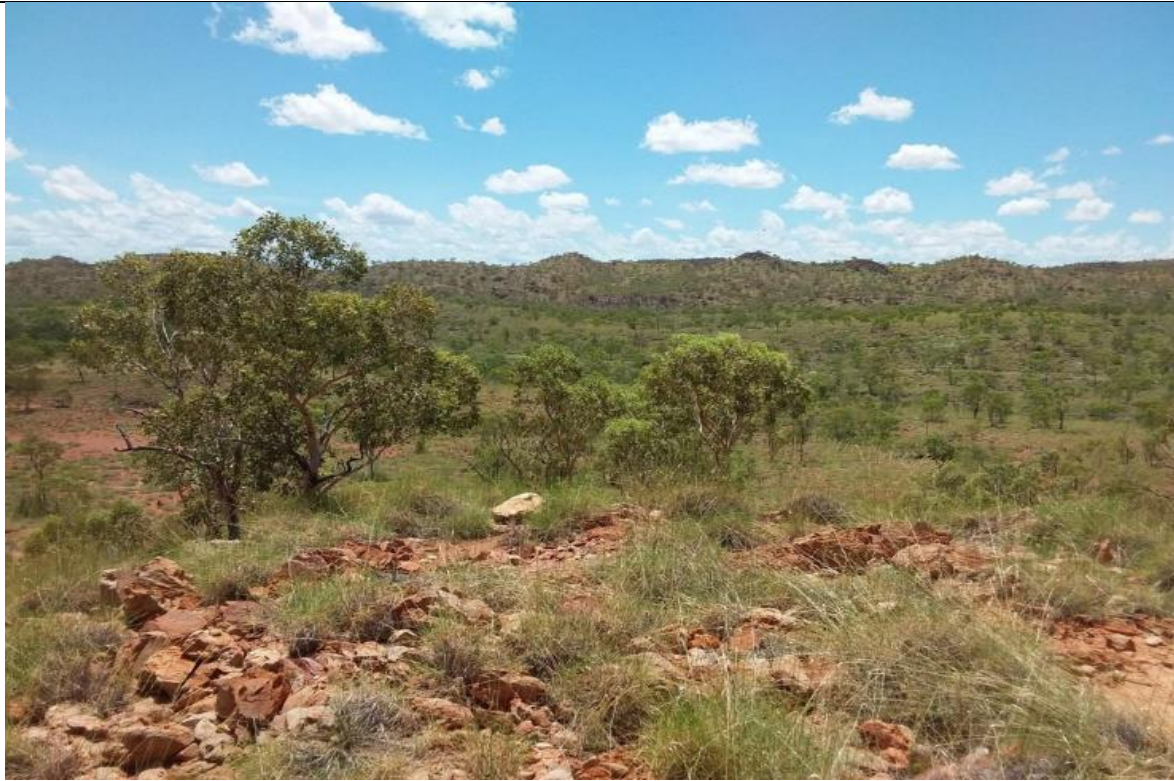
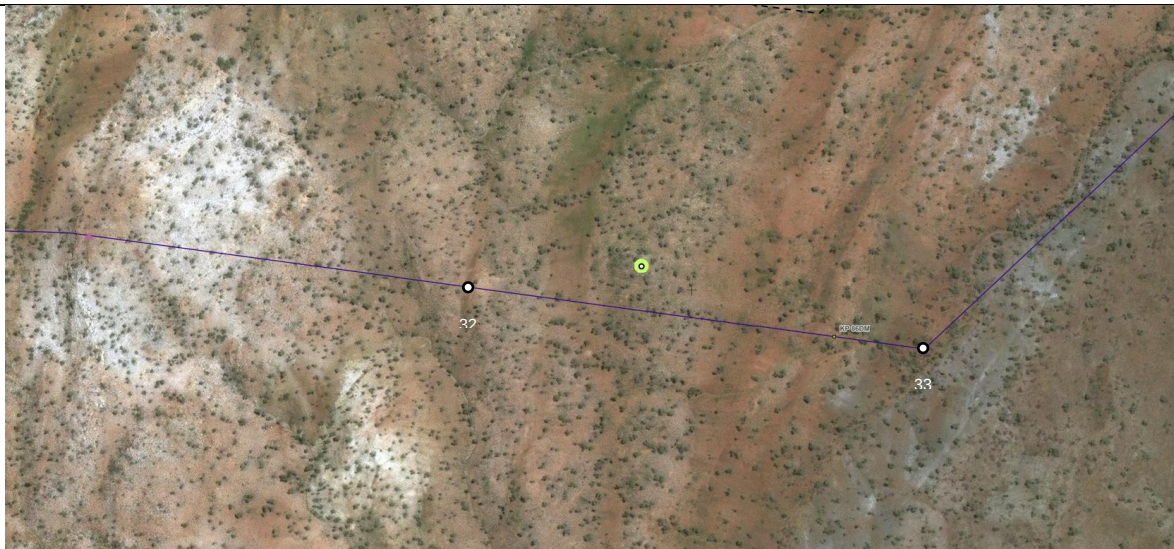
Line 3 KP 86 DM (50,0,50,0) Quaternary point (green) near Tower 33  
(363.449m between towers 32-33)

This section is described as 50% very light, 0% light, 50% moderate and 0% heavy by the clearing contractor. Field observations show a mid-dense canopy covers along hillslopes scattered throughout this section with tree heights averaging at 5.5m. Observations on the ground reflect the clearing contractor's description within this section of the alignment.

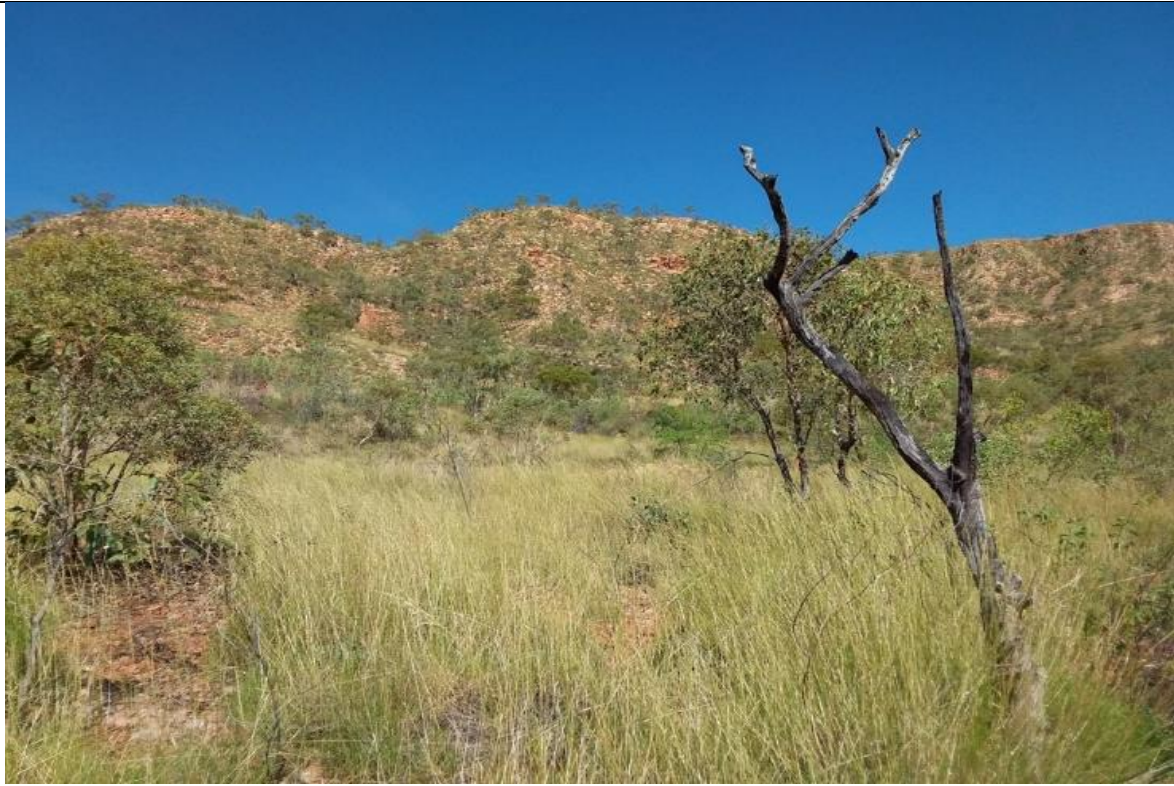
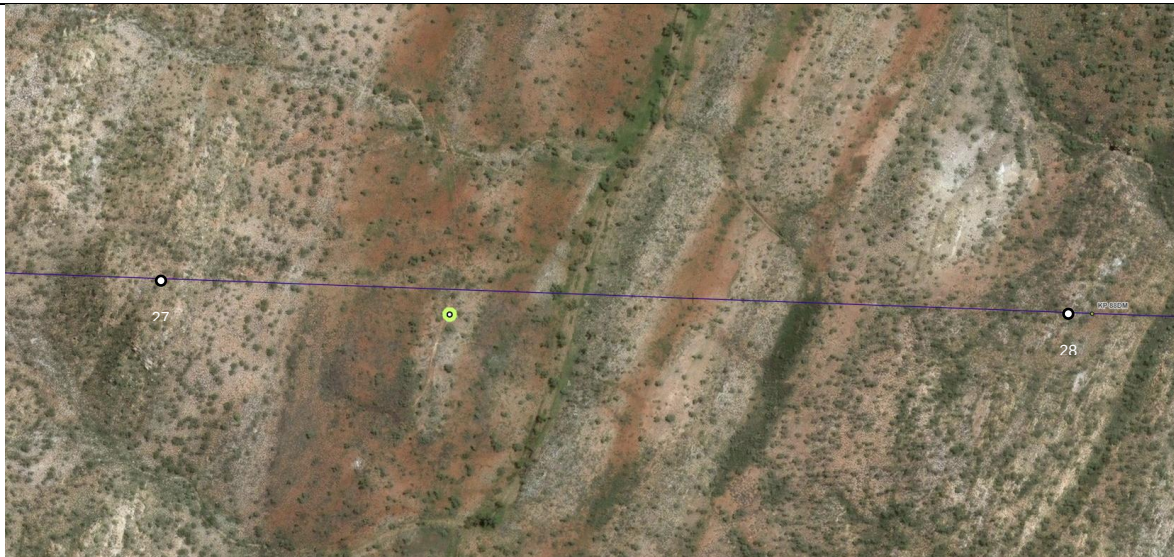
Line 3 KP 88 DM (30,0,30,40) Quaternary point (green) near Tower 28  
(714.422m between towers 27-28)

This section is described as 30% very light, 0% light, 30% moderate and 40% heavy by the clearing contractor. Field observations show a riparian woodland along a 20m wide watercourse to the east of the quaternary point. The sparse to mid-dense canopy covers the riparian canopy that fringes the watercourse and surroundings on hillslopes throughout this section with tree heights averaging at 6m. Observations on the ground reflect the clearing contractor's description within this section of the alignment.

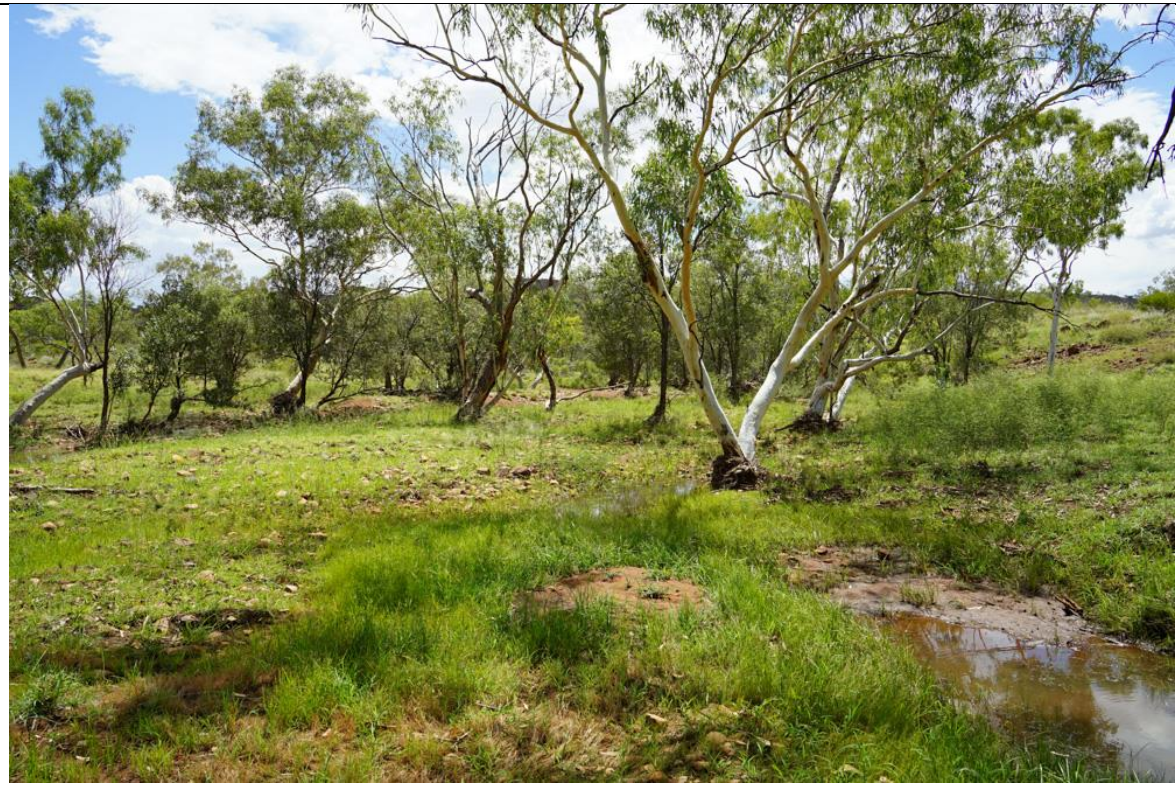
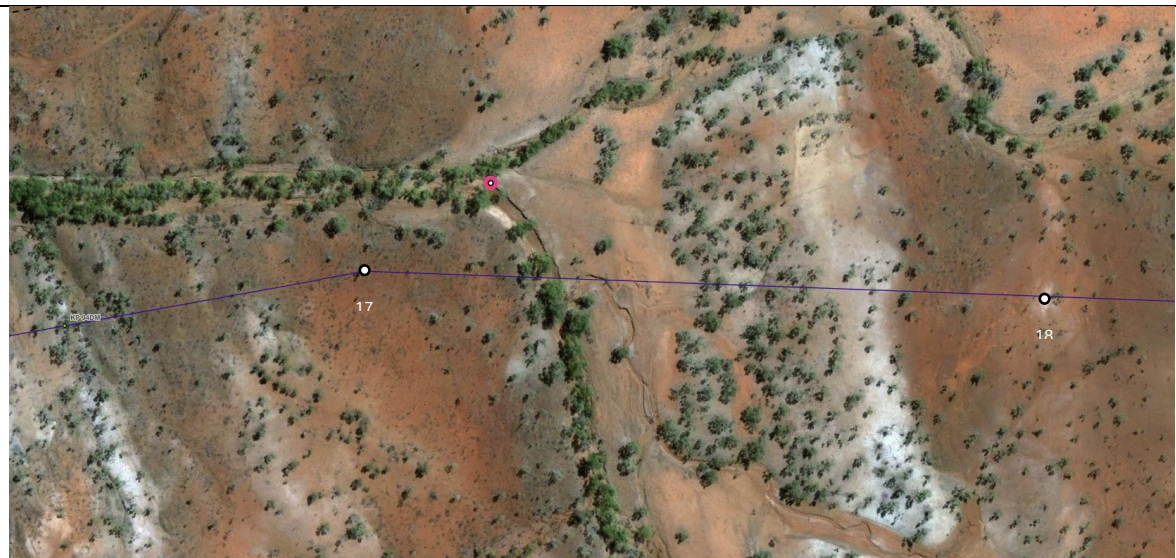
Line 3 KP 93.3 DM (40,40,20,0) Riparian zone (red) near Tower 18  
 (538.702m between towers 17-18) (Low Risk (Green) DAF – WWBW)

This section is described as 40% very light, 40% light, 20% moderate and 0% heavy by the clearing contractor. Field observations show a riparian woodland along a 30m wide watercourse. Tree heights ranged up to 12m. The sparse to mid-dense canopy covers the riparian canopy that fringes the watercourse and most of the eastern side of this section with tree heights averaging around 8m. Observations on the ground reflect the clearing contractor's description within this section of the alignment.

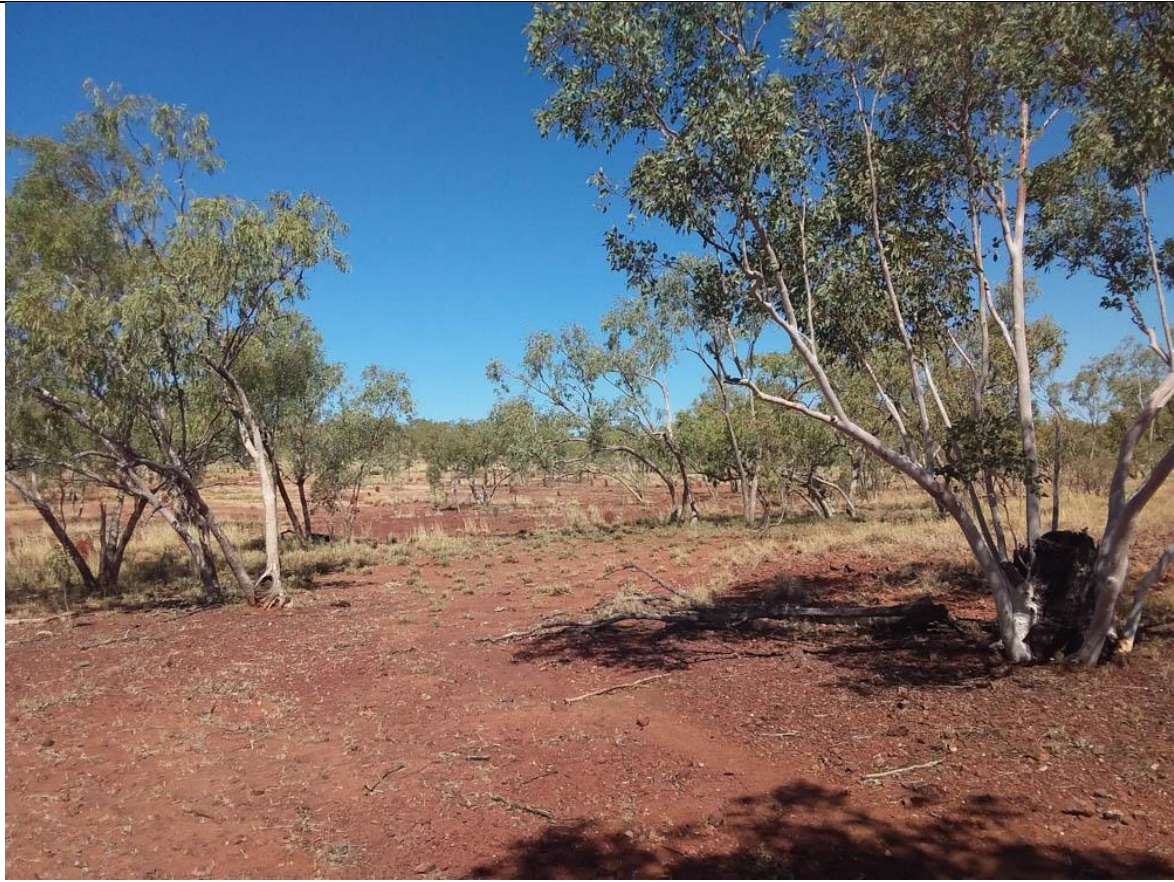
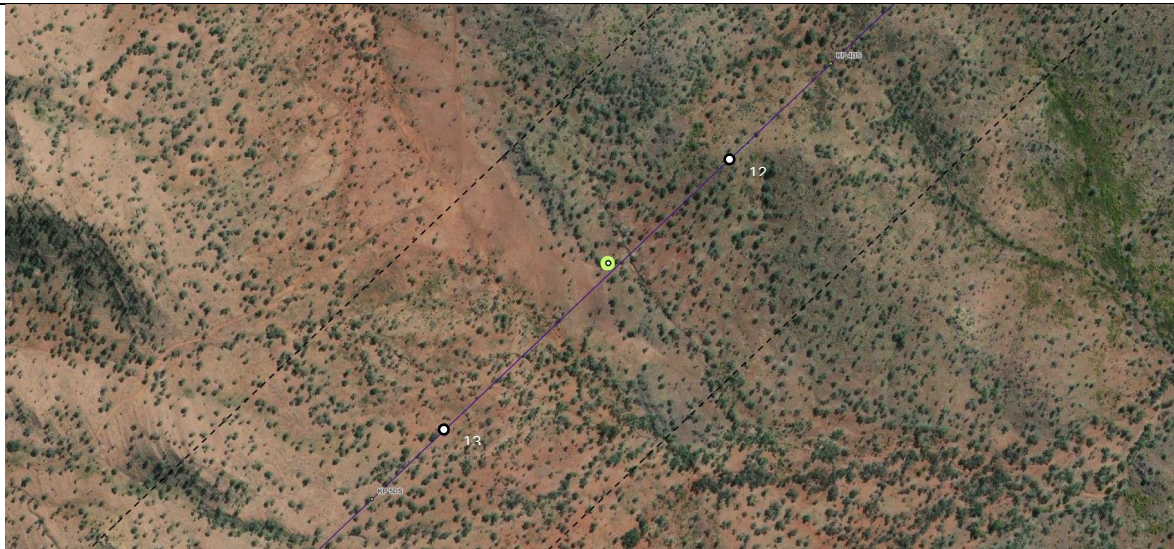
Line 4 KP 4.2 DS (70,0,30,0) Quaternary point (green) near Tower 13  
(622.383m between towers 12-13)

This section is described as 70% very light, 0% light, 30% moderate and 0% heavy by the clearing contractor. Field observations show a sparse canopy covers a few small gully lines scattered throughout this section with tree heights averaging at 7m. Observations on the ground reflect the clearing contractor's description within this section of the alignment.

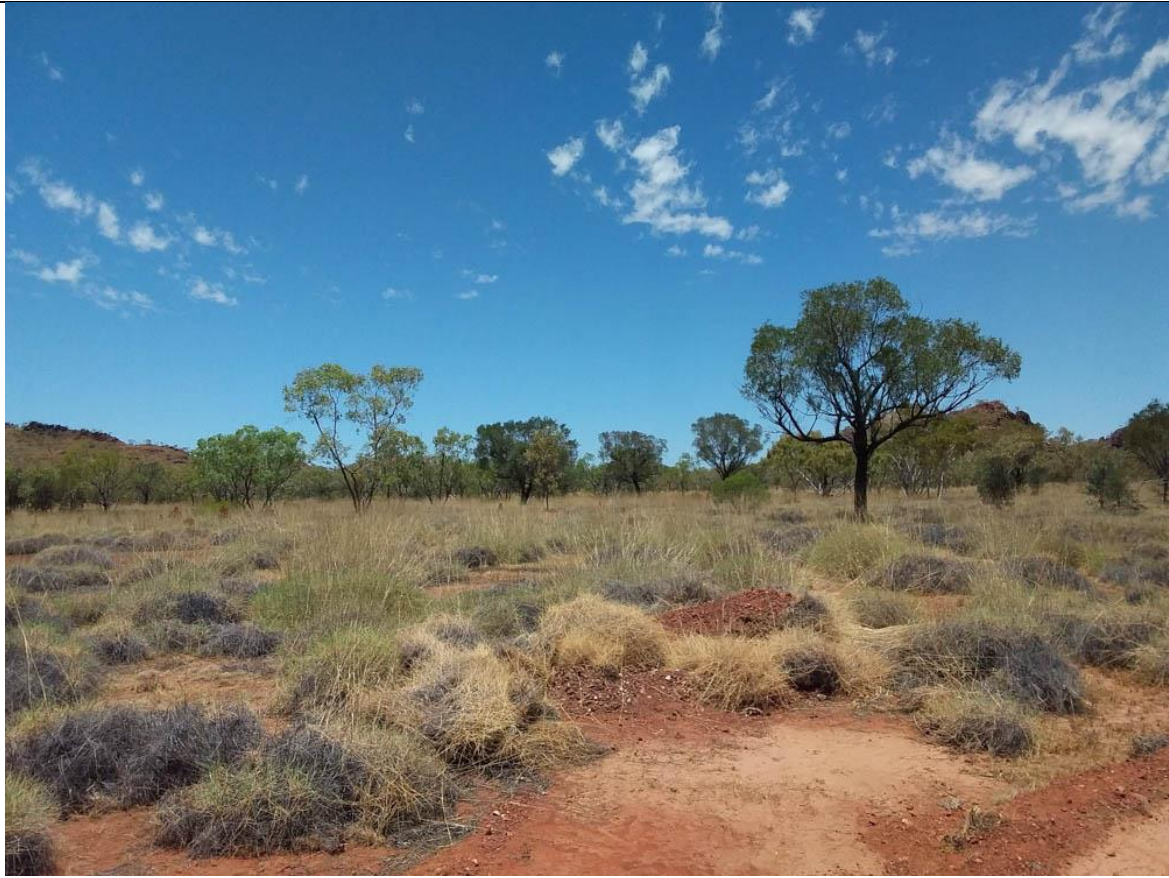
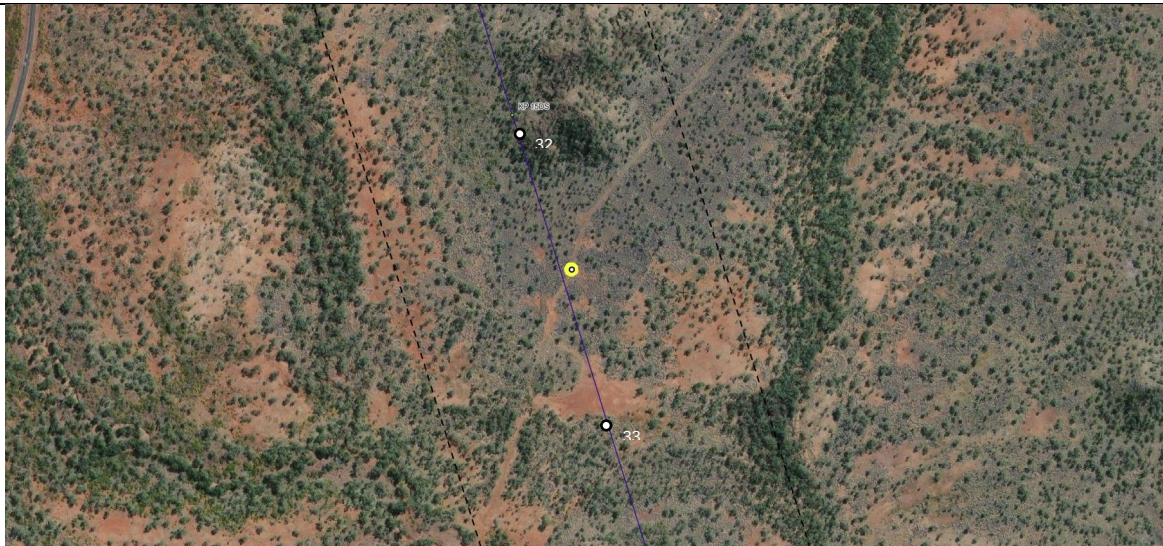
Line 4 KP 15 DS (50,0,50,0) Access track (yellow) near Tower 33  
(486.052m between towers 32-33)

This section is described as 50% very light, 0% light, 50% moderate and 0% heavy by the clearing contractor. Field observations show a mid-dense canopy covers a hillslope toward the north of section and a small patch south of access track with tree heights averaging at 8m. Observations on the ground reflect the clearing contractor's description within this section of the alignment.

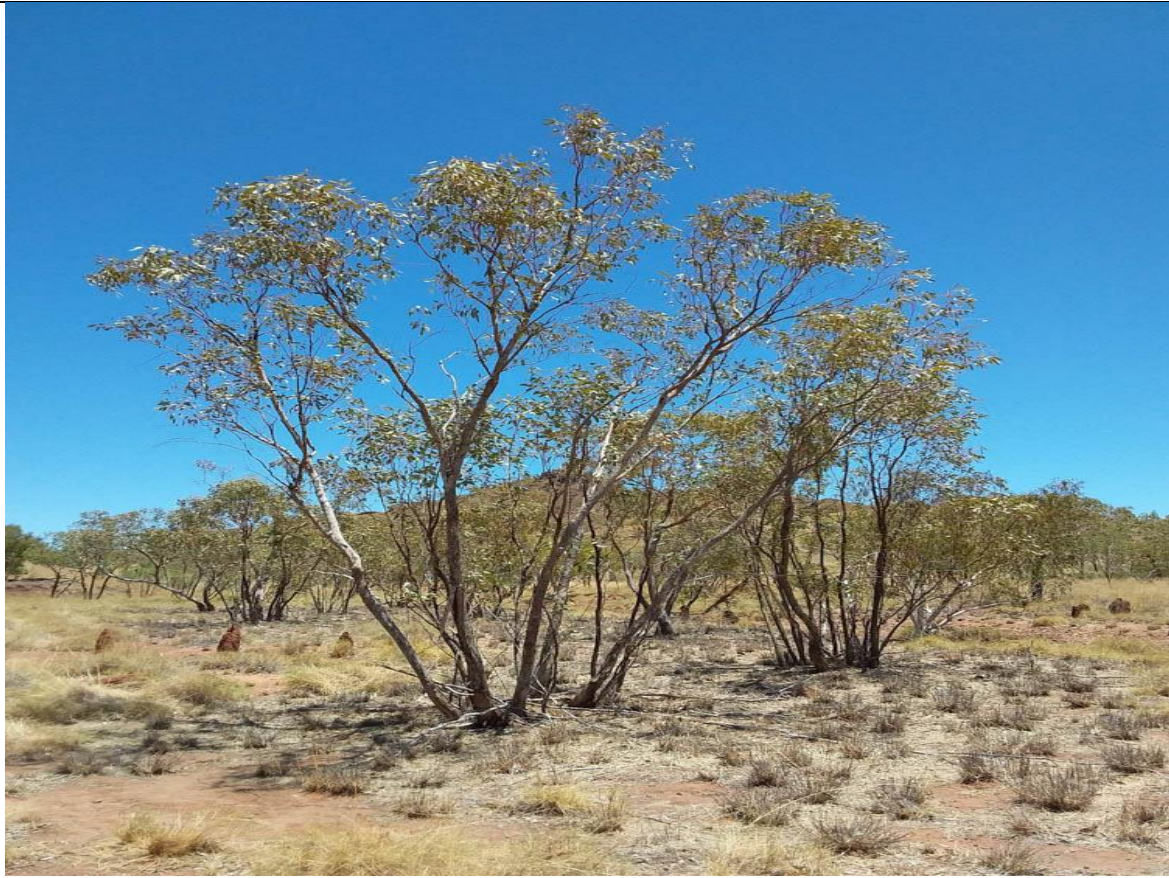
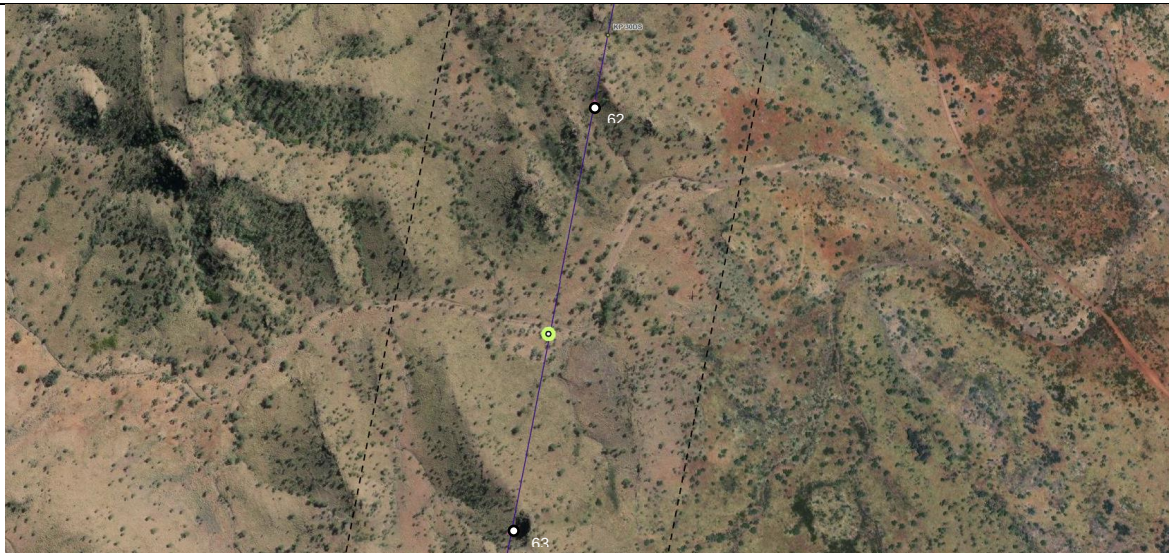
Line 4 KP 30.2 DS (60,0,40,0) Quaternary point (green) near Tower 63  
(684.947m between towers 62-63)

This section is described as 40% very light, 0% light, 40% moderate and 20% heavy by the clearing contractor. Field observations show a riparian woodland along a 16m wide watercourse on the quaternary point. The sparse to mid-dense canopy covers the riparian canopy that fringes the watercourse and hillslopes to north and south near tower locations of this section with tree heights averaging at 7m. Observations on the ground reflect the clearing contractor's description within this section of the alignment.

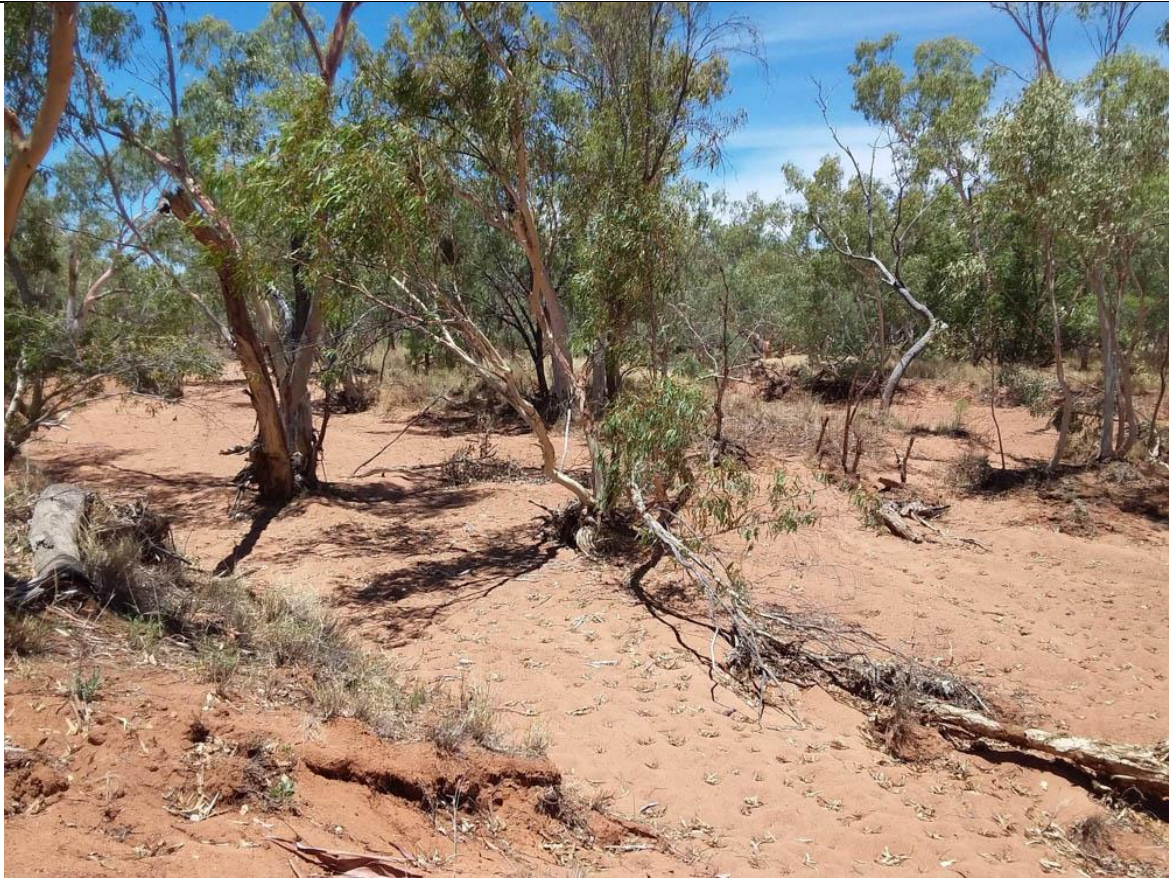
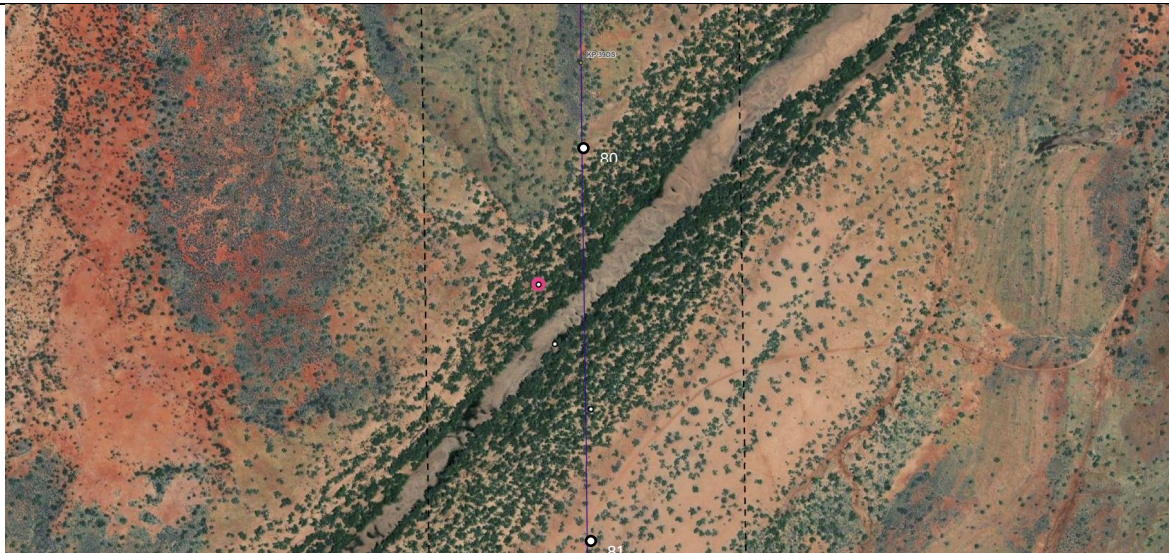
Line 4 KP 39.3 DS (30,40,30,0) Riparian zone (red) near Tower 81  
 (617.879m between towers 80-81) (Major Risk (Purple) DAF – WWBW)

This section is described as 30% very light, 40% light, 30% moderate and 0% heavy by the clearing contractor. Field observations show a riparian woodland along a 260m wide watercourse. Tree heights ranged up to 19m. The sparse to mid-dense canopy covers the riparian canopy that fringes the watercourse with tree heights averaging around 9m. Observations on the ground reflect the clearing contractor's description within this section of the alignment.

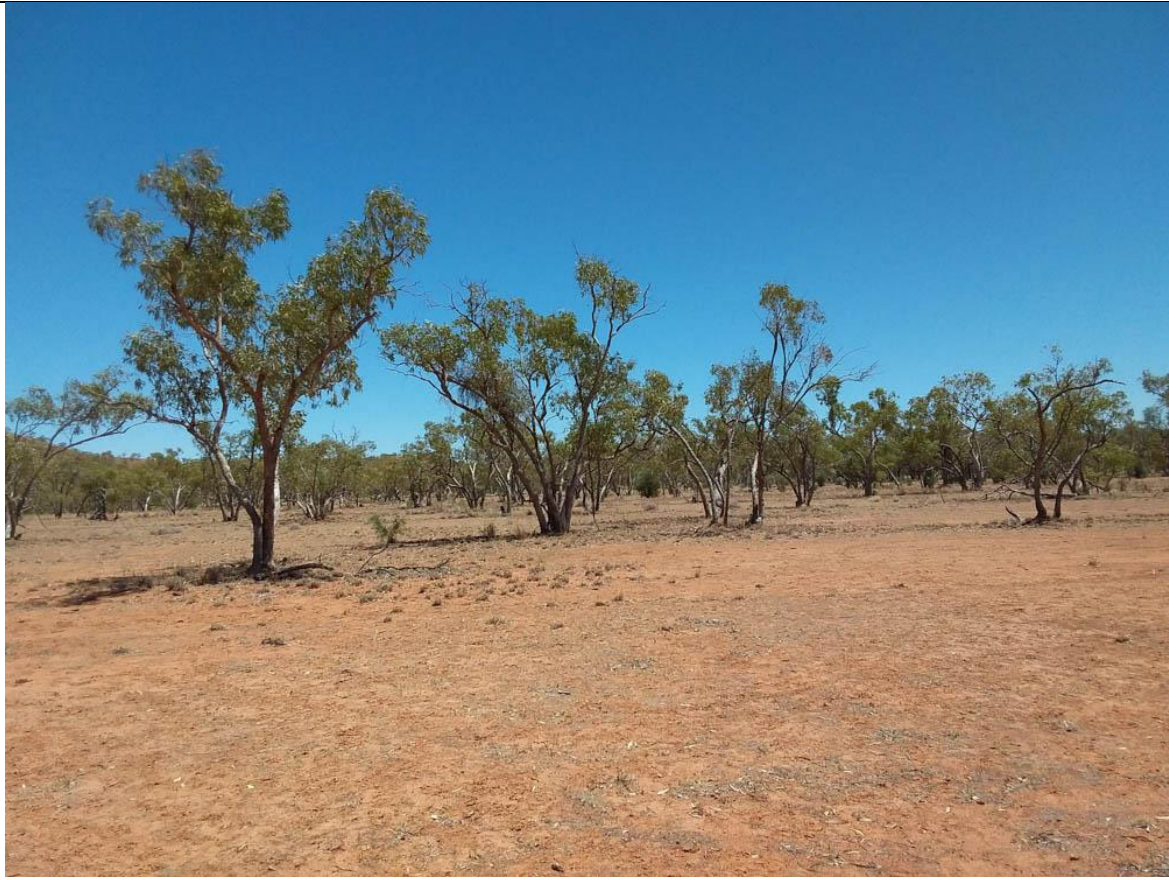
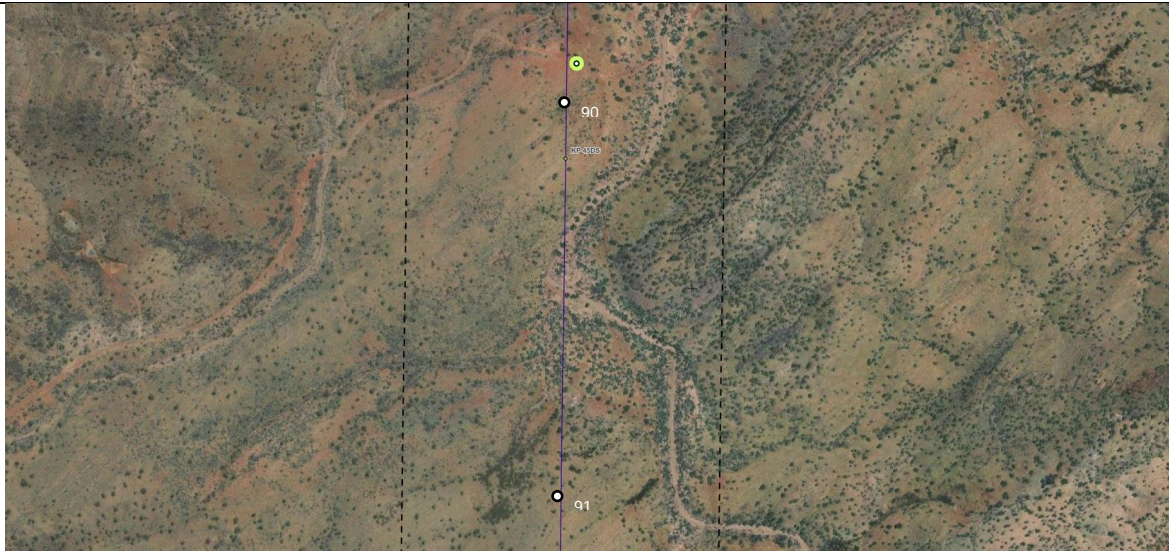
Line 4 KP 44.9 DS (70,0,30,0) Quaternary point (green) near Tower 91  
(618.255m between towers 90-91)

This section is described as 70% very light, 0% light, 30% moderate and 0% heavy by the clearing contractor. Field observations show a riparian woodland along a 15m wide watercourse south of the quaternary point. The sparse canopy covers the riparian canopy that fringes the watercourse and a section south of watercourse with tree heights averaging at 7m. Observations on the ground reflect the clearing contractor's description within this section of the alignment.

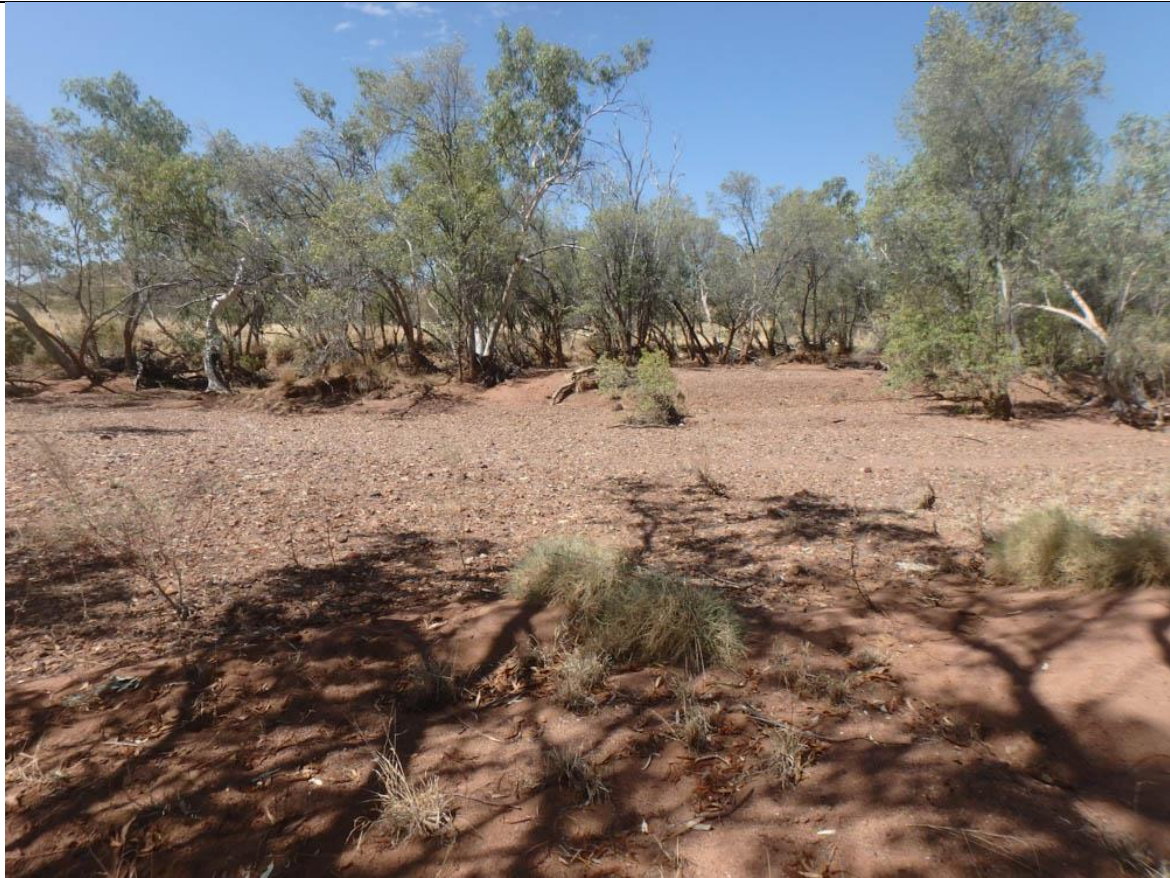
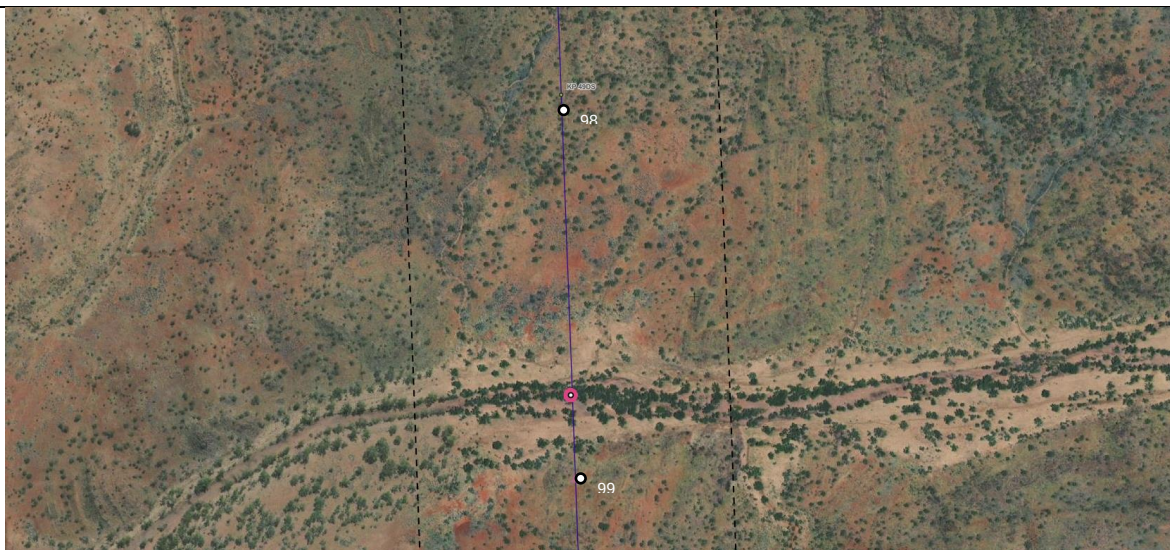
Line 4 KP 49 DS (70,0,30,0) Riparian zone (red) near Tower 99  
 (583.545m between towers 98-99) (High Risk (Red) DAF – WWBW)

This section is described as 70% very light, 0% light, 30% moderate and 0% heavy by the clearing contractor. Field observations show a riparian woodland along a 70m wide watercourse. Tree heights ranged up to 16m. The sparse canopy covers the riparian canopy that fringes the watercourse with tree heights averaging around 7m. Observations on the ground reflect the clearing contractor's description within this section of the alignment.

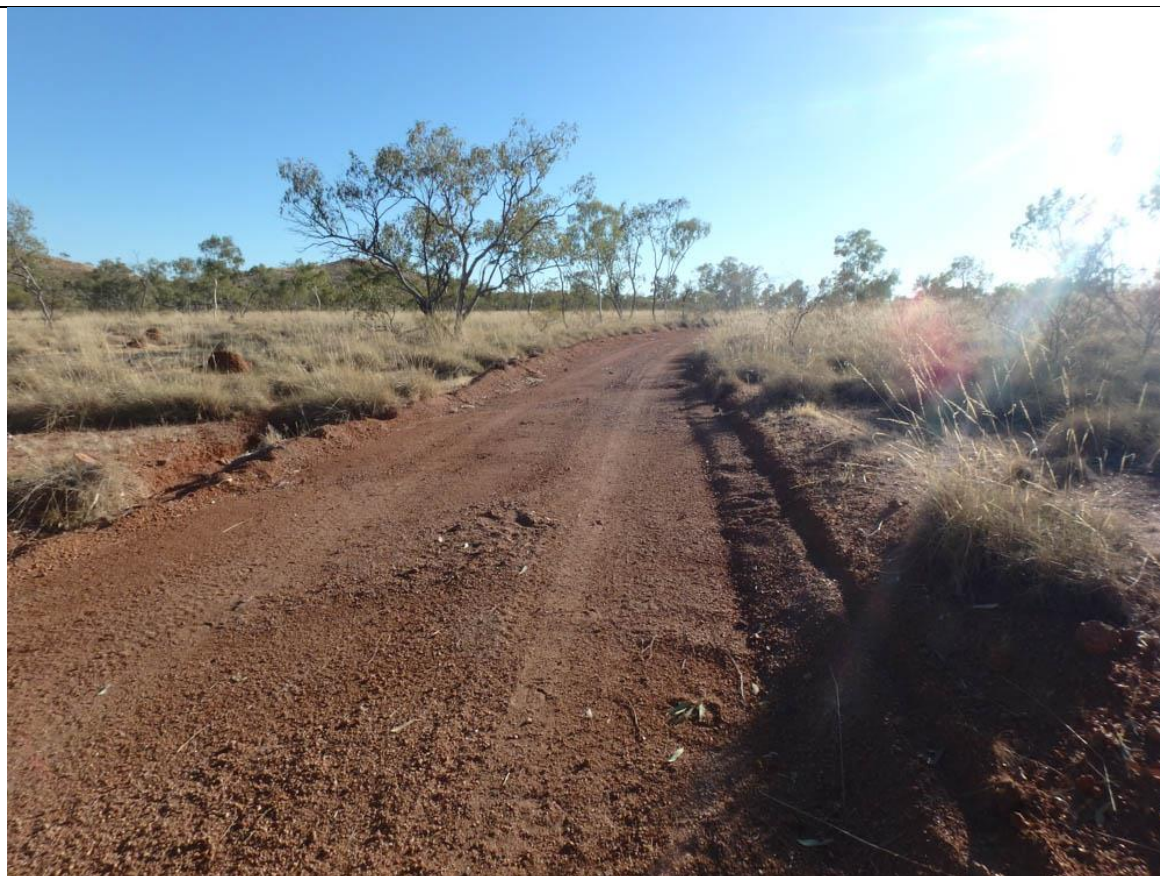
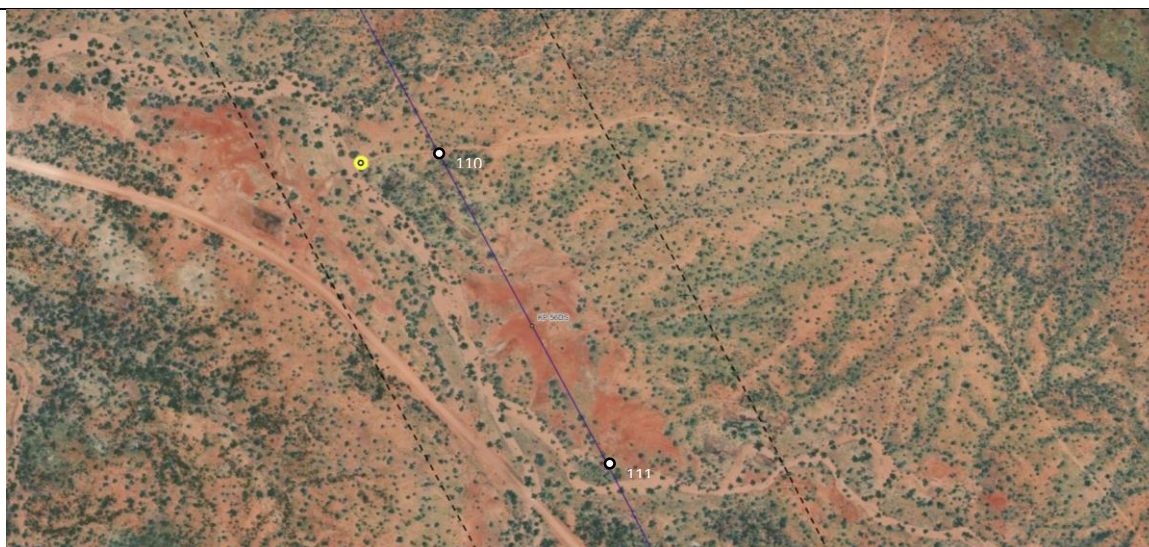
Line 4 KP 55.8 DS (60,0,40,0) Access track (yellow) near Tower 111  
(564.355m between towers 110-111)

This section is described as 60% very light, 0% light, 40% moderate and 0% heavy by the clearing contractor. Field observations show a riparian woodland running within 150m parallel with the alignment. The mid-dense canopy covers the riparian canopy that fringes the watercourse and a section south of the northern tower with tree heights averaging at 5m. Observations on the ground reflect the clearing contractor's description within this section of the alignment.
