# Visual Comparison of Landscape Type

Client: CopperString 2.0  
Reference: J0XXX

This document is a visual comparison of landscapes which was compiled to provide a photographic record both from an aerial and site-based perspective along each of the five corridor selection segments. This ground truthing was utilised to inform the projects appreciation of the six general landscape types which occur across the study area as well as improved confidence in the potential conservation significant species habitat mapped for the CopperString EIS 2.0. It has also been used to confirm expected disturbance associated with construction related activities.

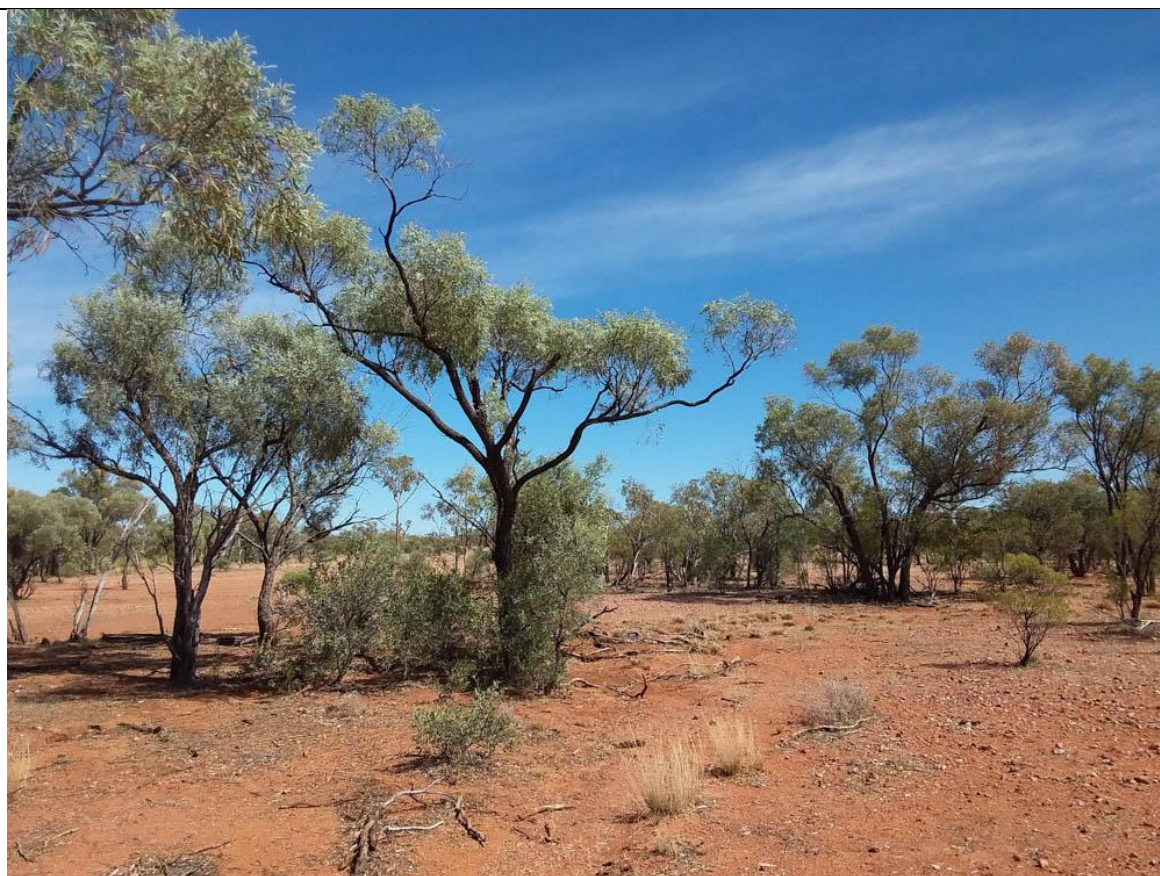
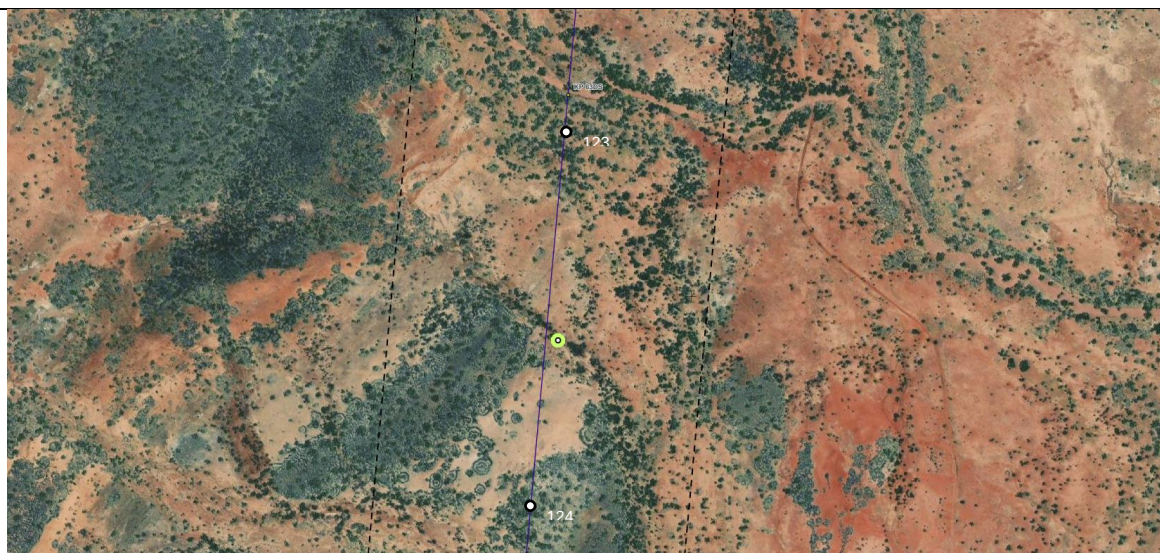
Line 4 KP 63.1 DS (60,0,30,10) Quaternary point (green) near Tower 124  
(588.792m between towers 123-124)

This section is described as 60% very light, 0% light, 30% moderate and 10% heavy by the clearing contractor. Field observations show a riparian woodland along a 25m wide watercourse on the quaternary point. The sparse canopy covers the riparian canopy that fringes the watercourse and a section south of the northern tower with tree heights averaging at 6.5m. Observations on the ground reflect the clearing contractor's description within this section of the alignment.

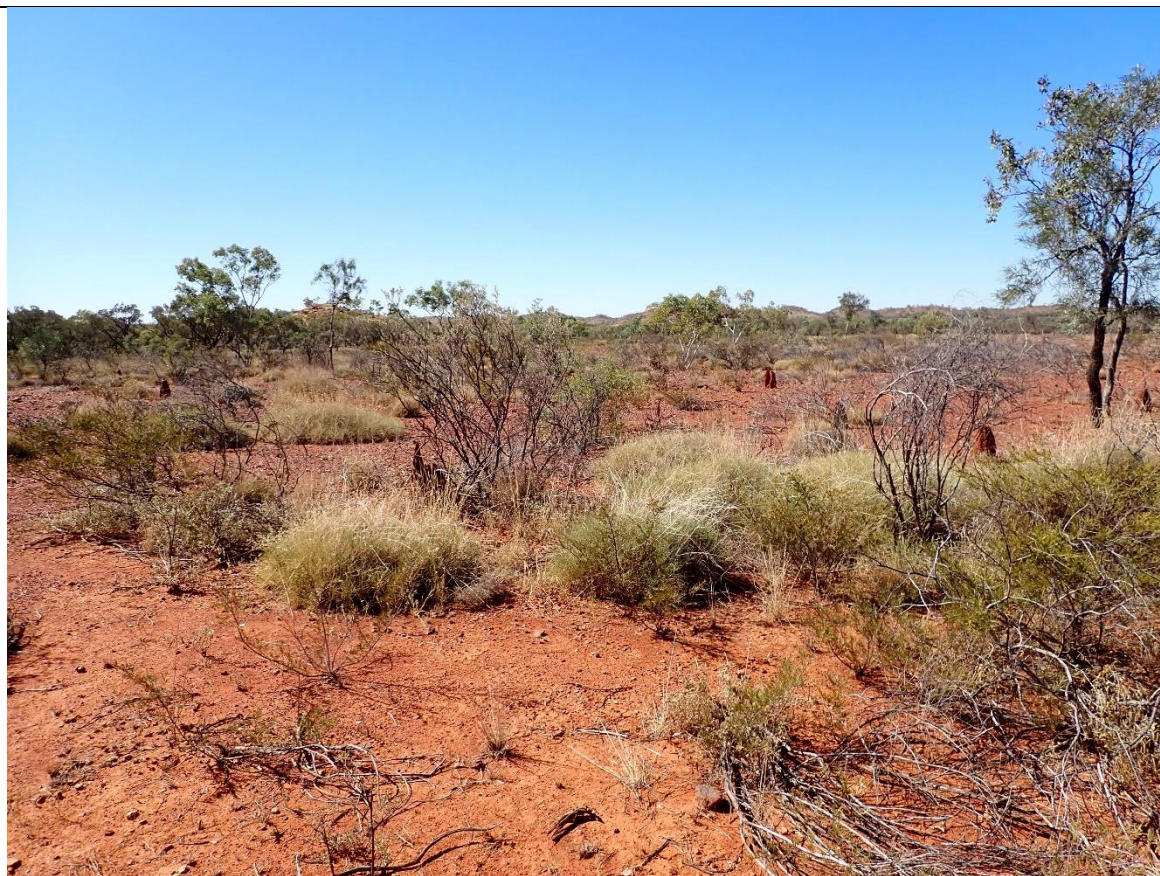
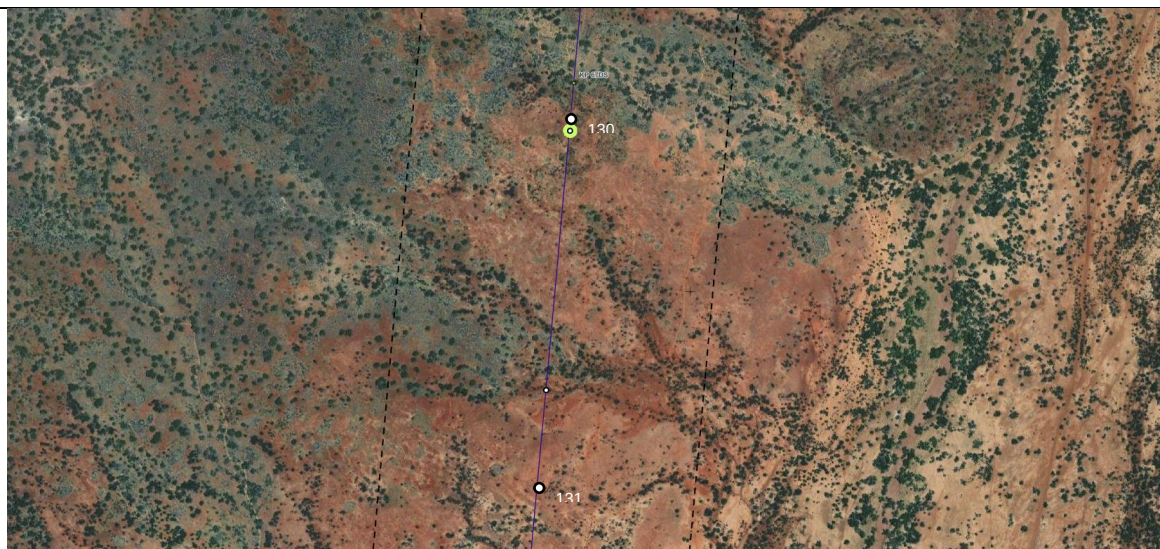
Line 4 KP 67 DS (70,20,10,0) Quaternary point (green) near Tower 131  
(587.439m between towers 130-131)

This section is described as 70% very light, 0% light, 20% moderate and 10% heavy by the clearing contractor. Field observations show a riparian woodland along a forked watercourse of 30m and 35m south of the quaternary point. The sparse canopy covers the riparian canopy that fringes the watercourse with tree heights averaging at 4.5m. Observations on the ground reflect the clearing contractor's description within this section of the alignment.

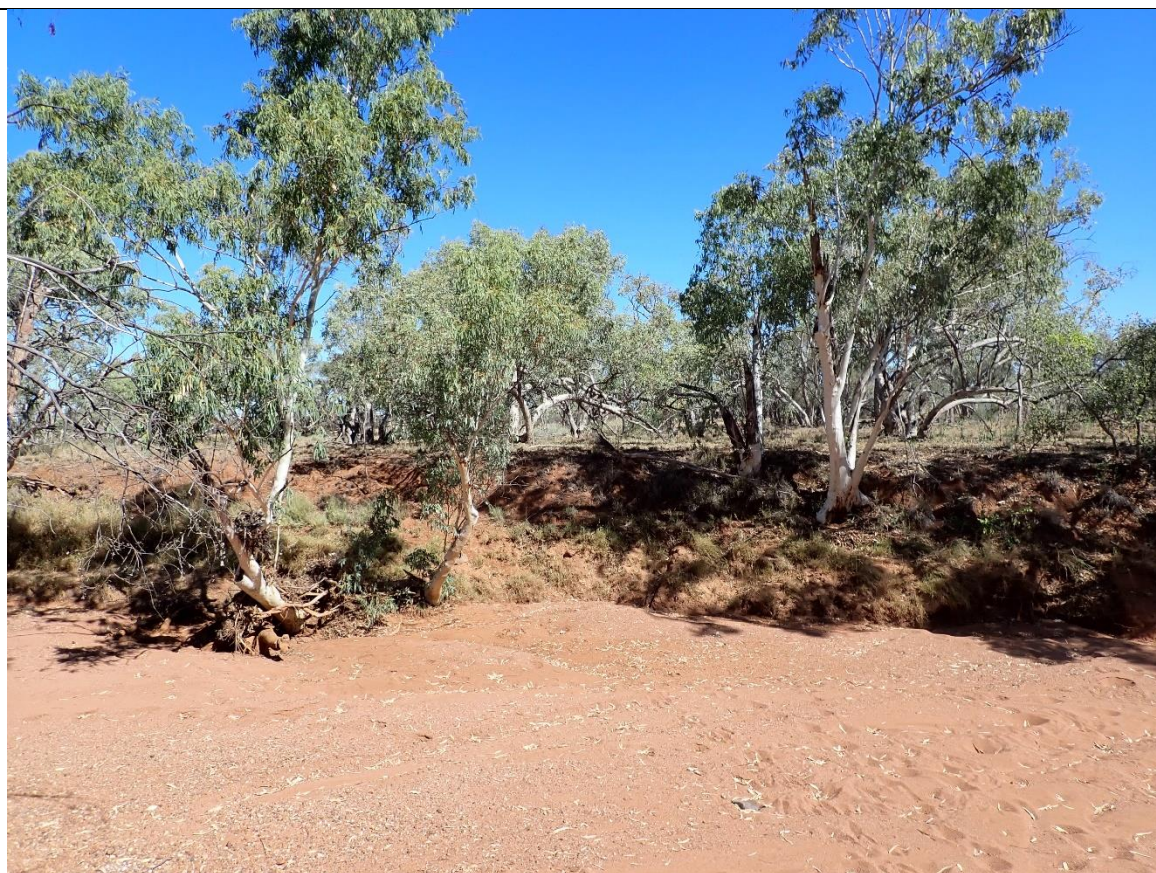
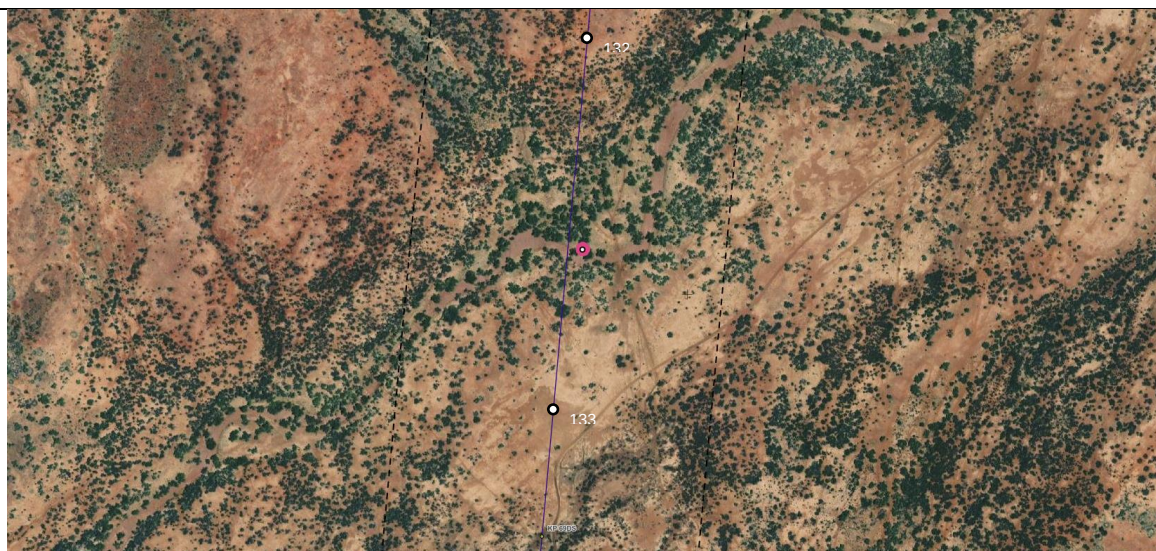
Line 4 KP 68.4 DS (40,0,40,20) Riparian zone (red) near Tower 133

This section is described as 40% very light, 0% light, 40% moderate and 20% heavy by the clearing contractor. Field observations show a riparian woodland along a 24m wide watercourse. Tree heights ranged up to 12m. The sparse to mid-dense canopy covers the riparian canopy that fringes the watercourse and most of the section especially to the north with tree heights averaging around 12m. Observations on the ground reflect the clearing contractor's description within this section of the alignment.

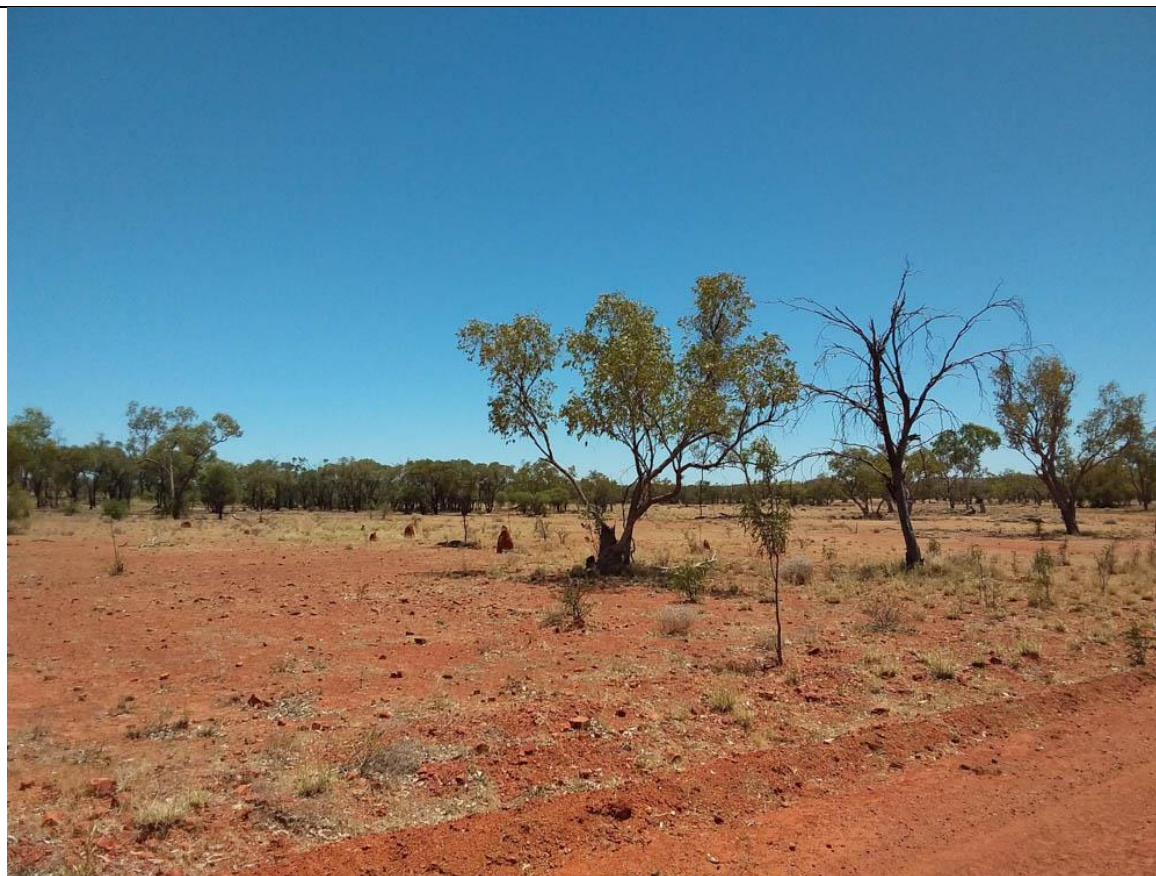
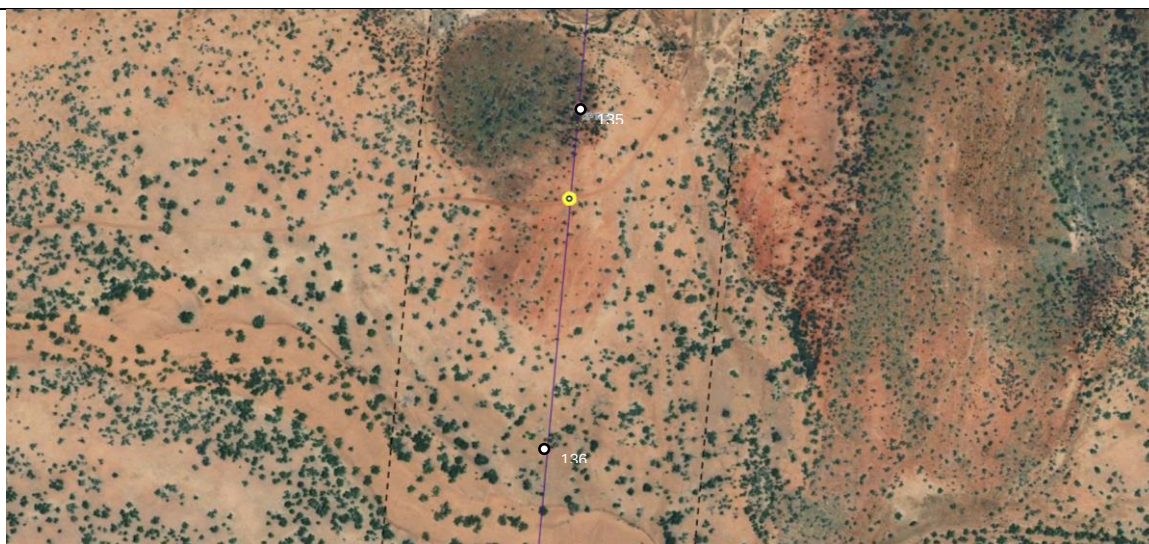
Line 4 KP 70 DS (70,0,30,0) Access track (yellow) near Tower 136  
(551.842m between towers 135-136)

This section is described as 70% very light, 0% light, 30% moderate and 0% heavy by the clearing contractor. Field observations show a sparse canopy covers most of the section especially a section near the northern tower with tree heights averaging at 6m. Observations on the ground reflect the clearing contractor's description within this section of the alignment.

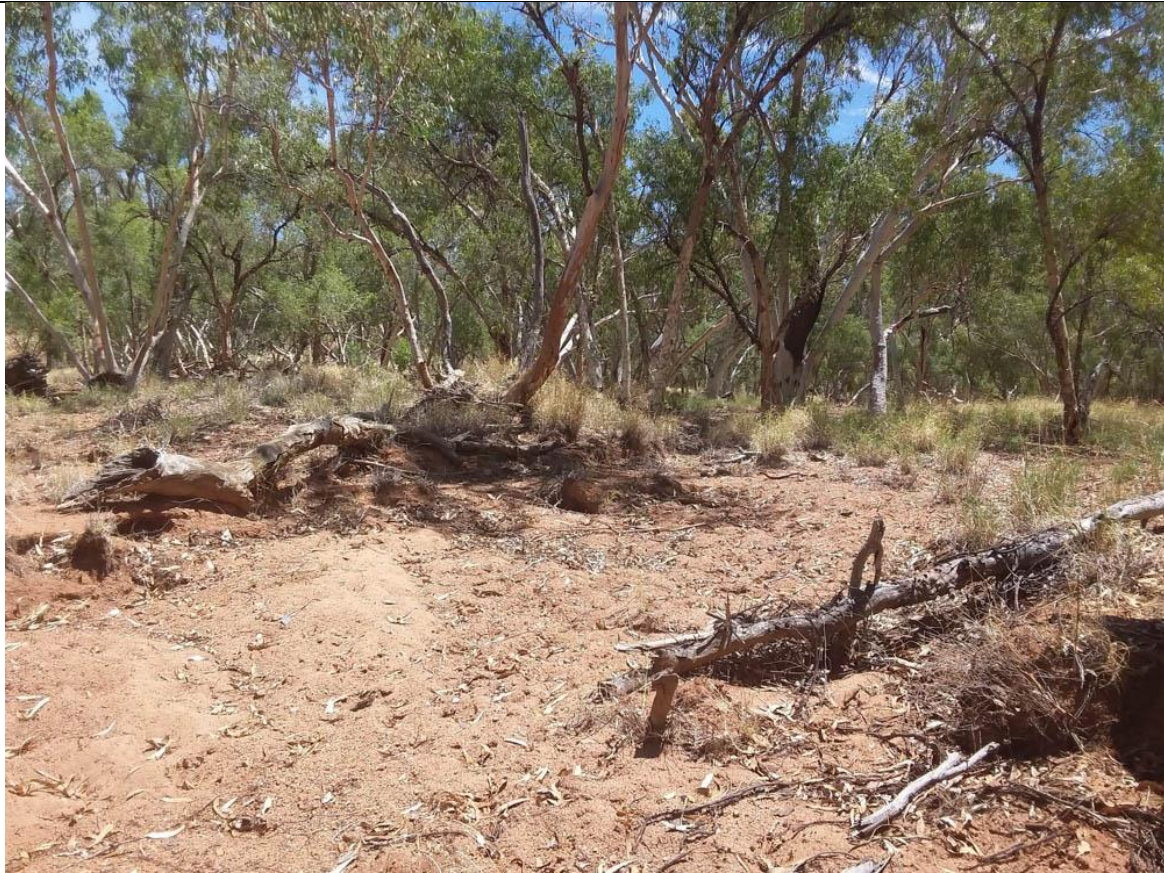
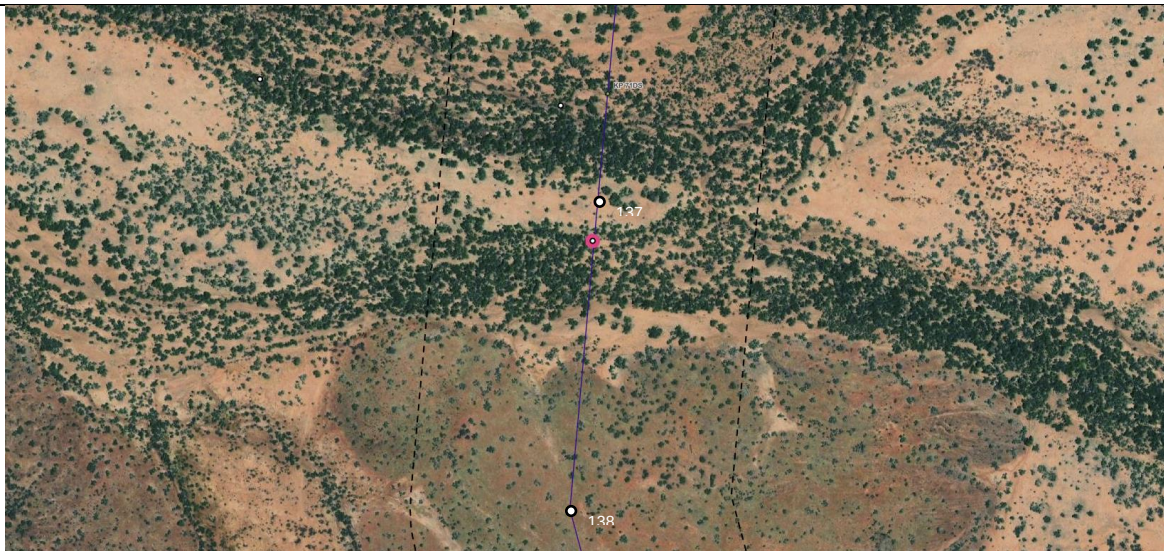
Line 4 KP 71.4 DS (30,0,30,40) Riparian zone (red) near Tower 138  
 (481.181m between towers 137-138) (Major Risk (Purple) DAF – WWBW)

This section is described as 30% very light, 0% light, 30% moderate and 40% heavy by the clearing contractor. Field observations show a riparian woodland along a 148m wide watercourse. Tree heights ranged up to 19m. The sparse to mid-dense canopy covers the riparian canopy that fringes the watercourse and throughout most of this section with tree heights averaging around 8m. Observations on the ground reflect the clearing contractor's description within this section of the alignment.

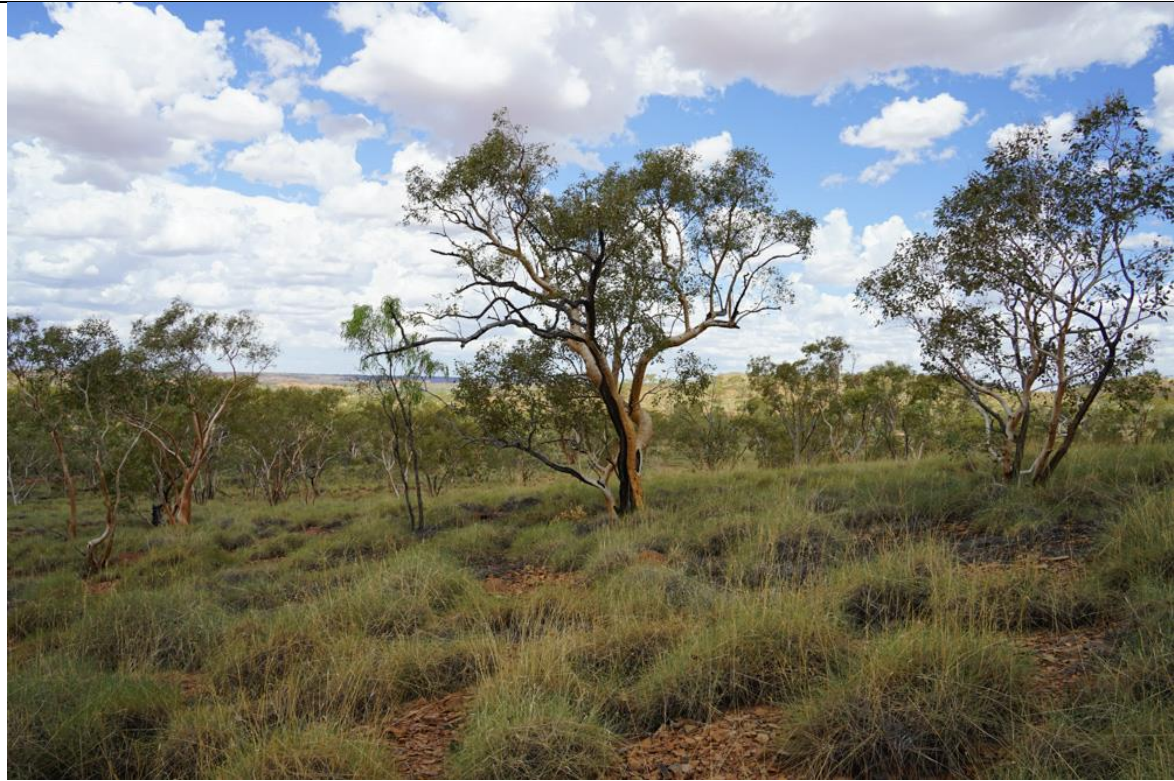
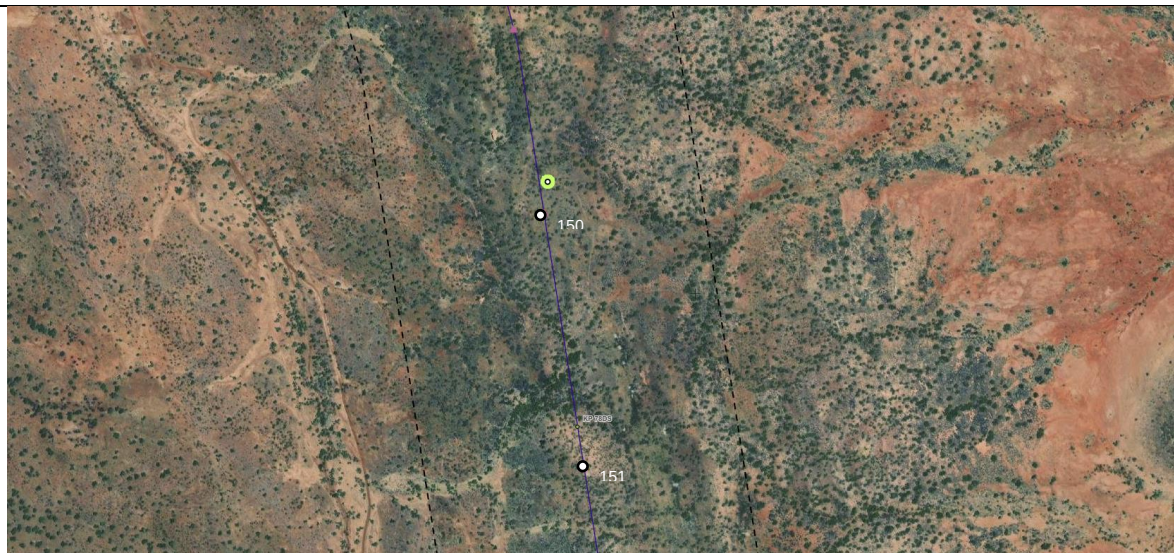
Line 4 KP 77.6 DS (20,0,60,20) Quaternary point (green) near Tower 151  
(401.235m between towers 150-151)

This section is described as 20% very light, 0% light, 60% moderate and 20% heavy by the clearing contractor. Field observations show a riparian woodland along a 20m wide watercourse south of the quaternary point. The sparse to mid-dense canopy covers the riparian canopy that fringes the watercourse and hillslopes throughout the whole section with tree heights averaging at 5m. Observations on the ground reflect the clearing contractor's description within this section of the alignment.

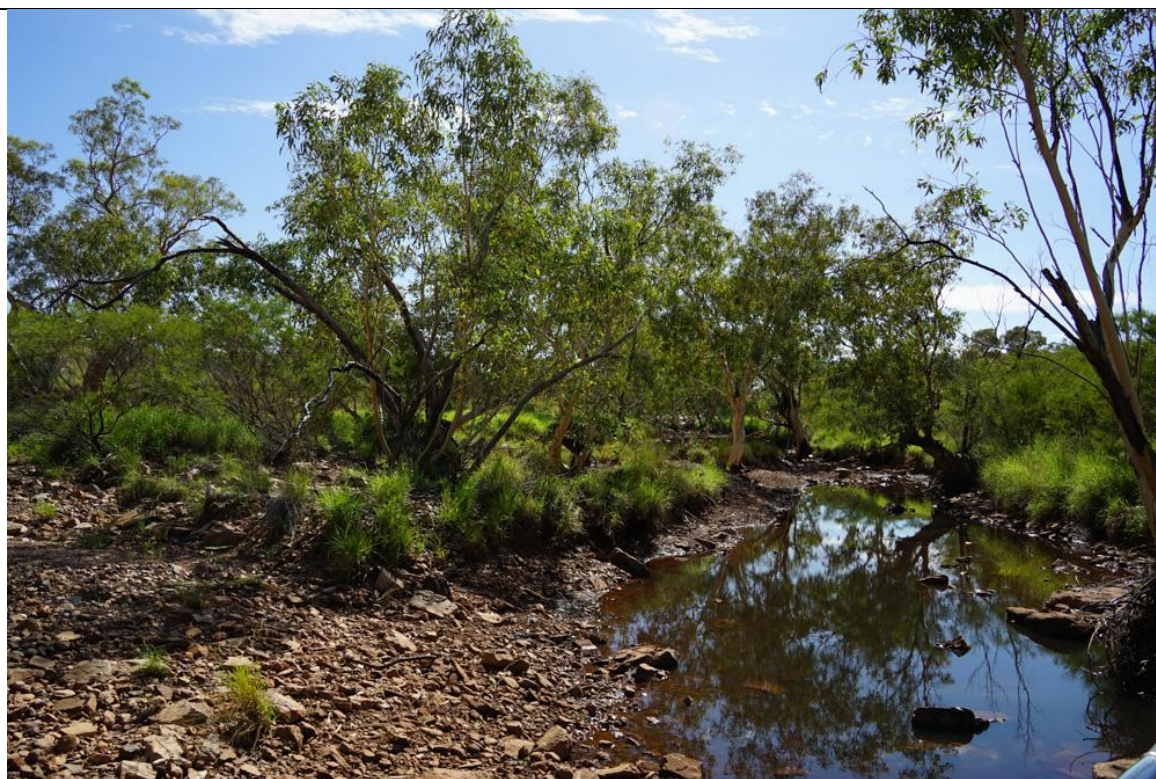
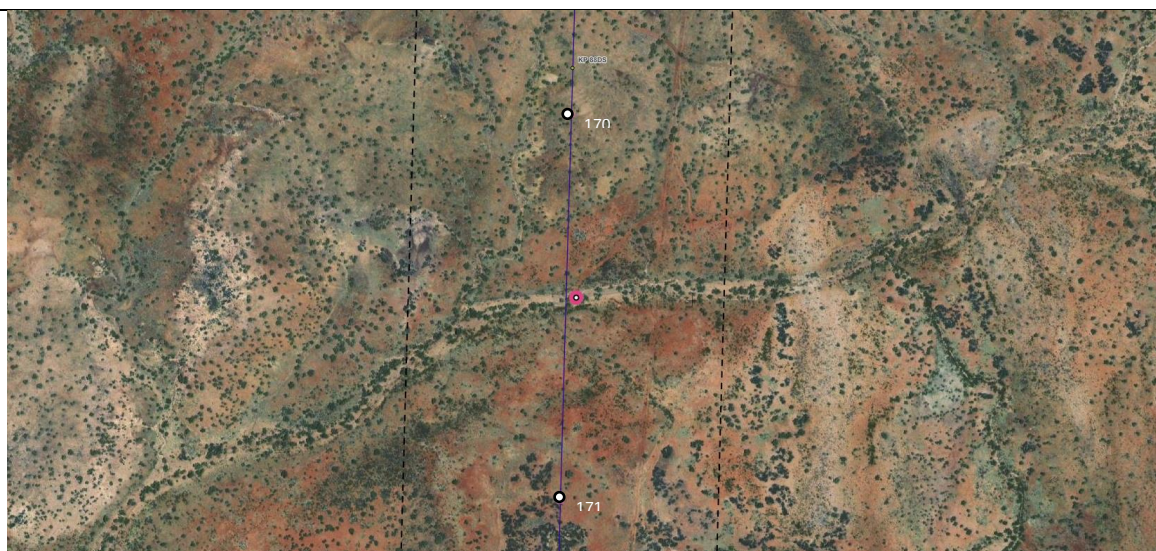
Line 4 KP 88.1 DS (70,0,30,0) Riparian zone (red) near Tower 171

This section is described as 70% very light, 0% light, 30% moderate and 0% heavy by the clearing contractor. Field observations show a riparian woodland along a 15m wide watercourse. Tree heights ranged up to 12m. The sparse canopy covers the riparian canopy that fringes the watercourse and gully lines scattered throughout this section with tree heights averaging around 6m. Observations on the ground reflect the clearing contractor's description within this section of the alignment.

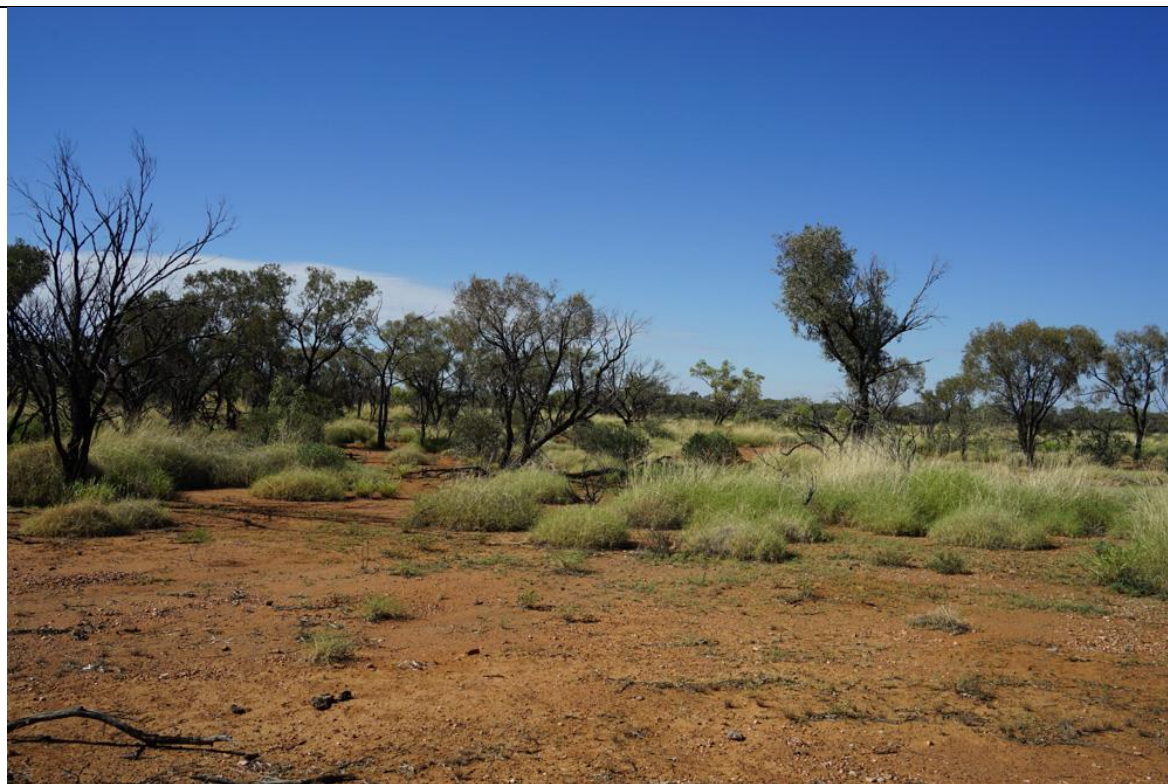
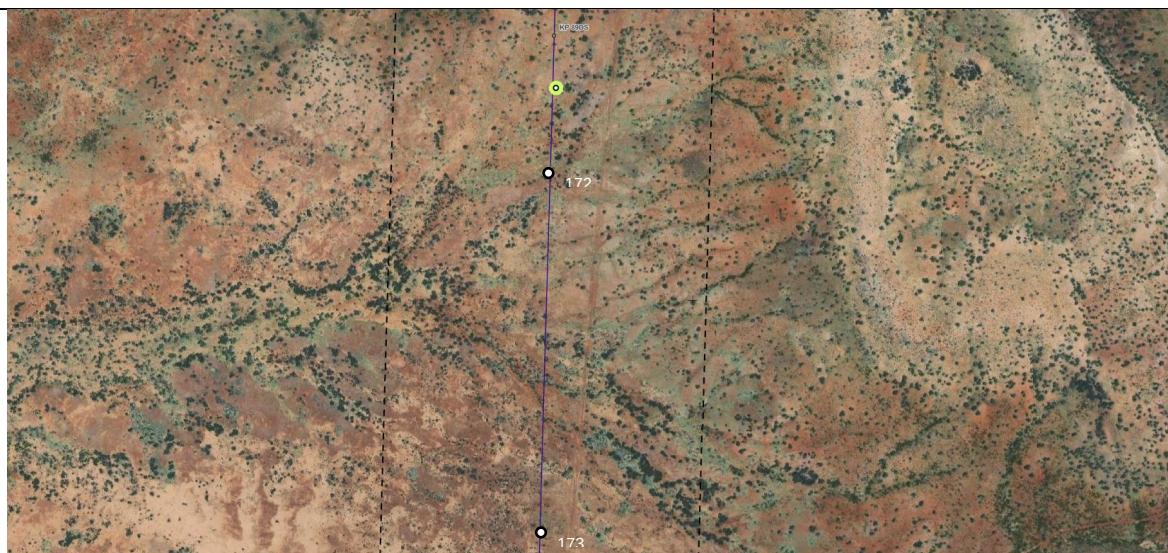
Line 4 KP 89.4 DS (60,0,30,10) Quaternary point (green) near Tower 173  
(565.612m between towers 172-173)

This section is described as 60% very light, 0% light, 30% moderate and 10% heavy by the clearing contractor. Field observations show a riparian woodland along a 40m wide watercourse south of the quaternary point. The sparse canopy covers the riparian canopy that fringes the watercourse and gully lines extending from watercourse throughout the whole section with tree heights averaging at 6m. Observations on the ground reflect the clearing contractor's description within this section of the alignment.

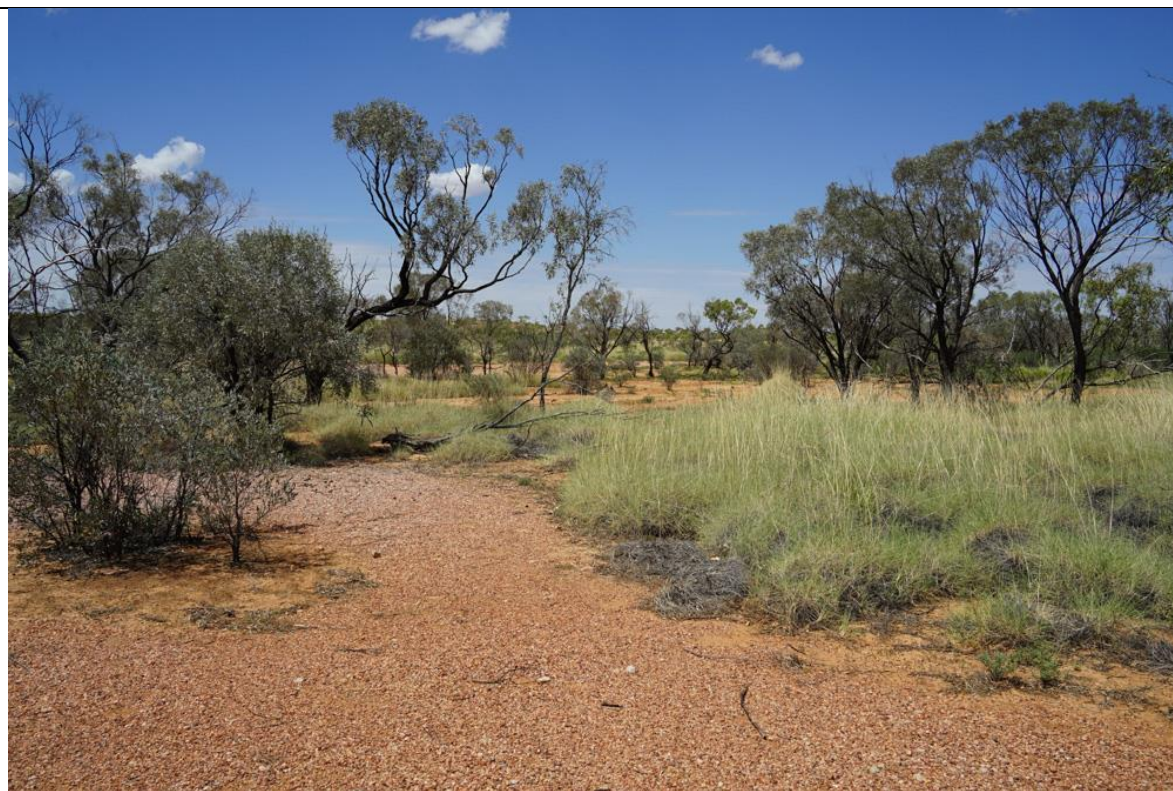
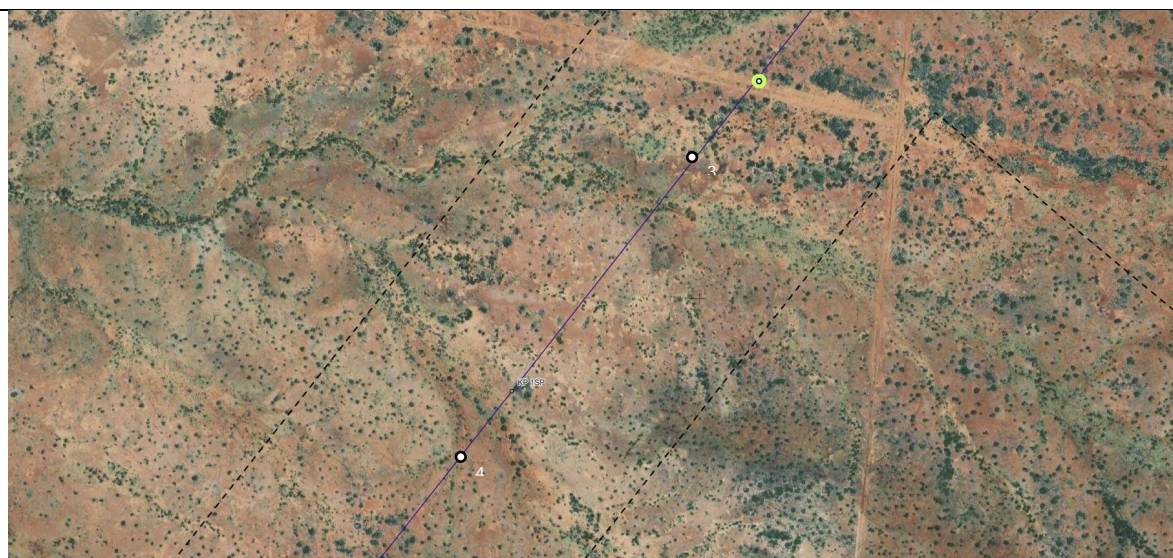
Line 5 KP 0.5 SP (40,0,40,20) Quaternary point (green) near Tower 4  
(583.077m between towers 3-4)

This section is described as 40% very light, 0% light, 40% moderate and 20% heavy by the clearing contractor. Field observations show a riparian woodland along a 15m wide forked watercourse to the south of the quaternary point. The sparse to mid-dense canopy covers the riparian canopies that fringe the watercourses and most of the middle section with tree heights averaging at 6m. Observations on the ground reflect the clearing contractor's description within this section of the alignment.

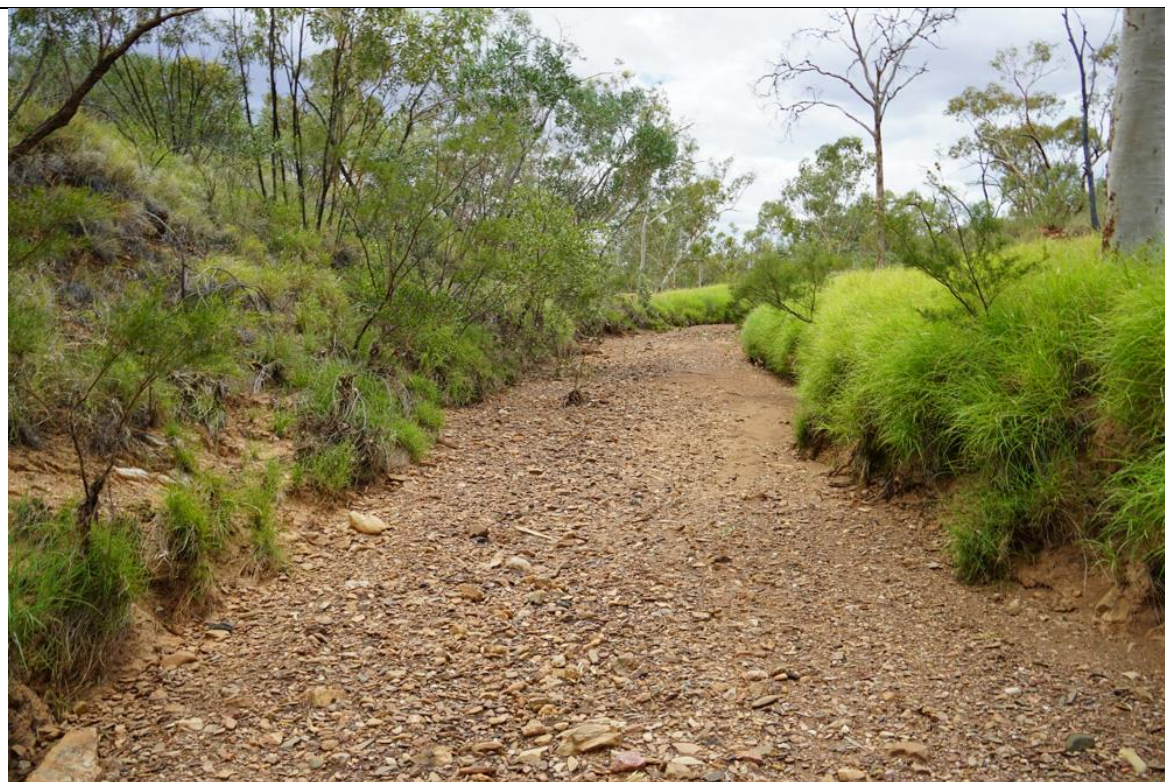
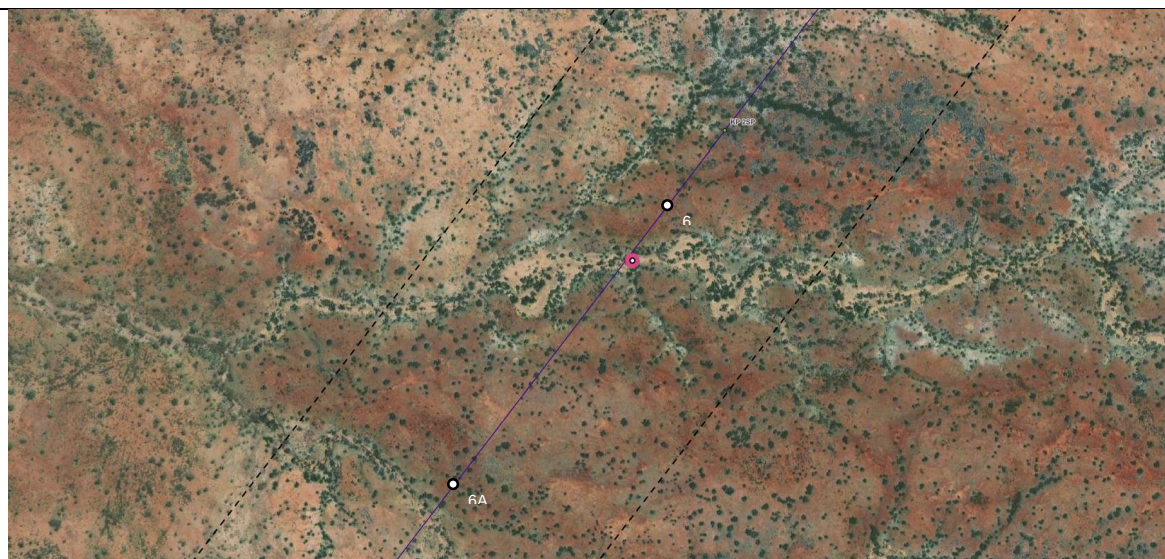
Line 5 KP 2.1 SP (70,0,20,10) Riparian zone (red) near Tower 6A  
 (540.000m between towers 6-6A) (Low Risk (Green) DAF – WWBW)

This section is described as 70% very light, 0% light, 20% moderate and 10% heavy by the clearing contractor. Field observations show a riparian woodland along a 18m wide watercourse. Tree heights ranged up to 10m. The sparse canopy covers the riparian canopy fringing the watercourse and most of the northern side of this section with tree heights averaging around 6m. Observations on the ground reflect the clearing contractor's description within this section of the alignment.

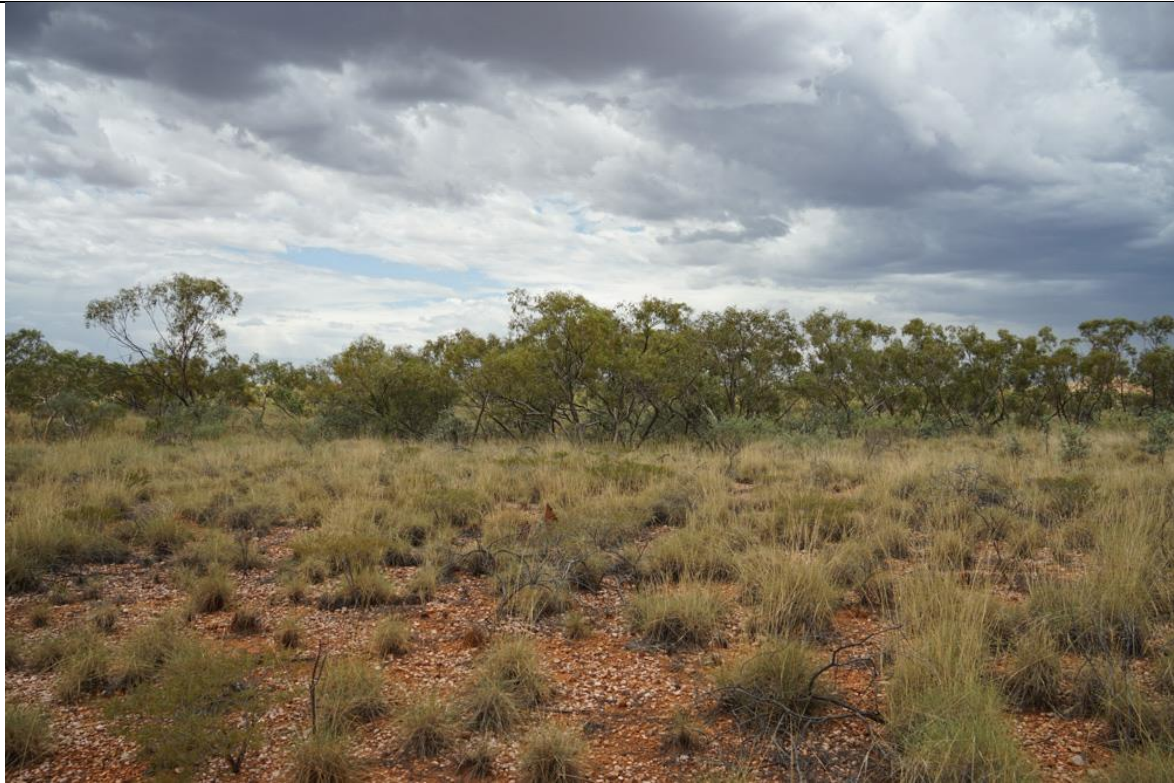
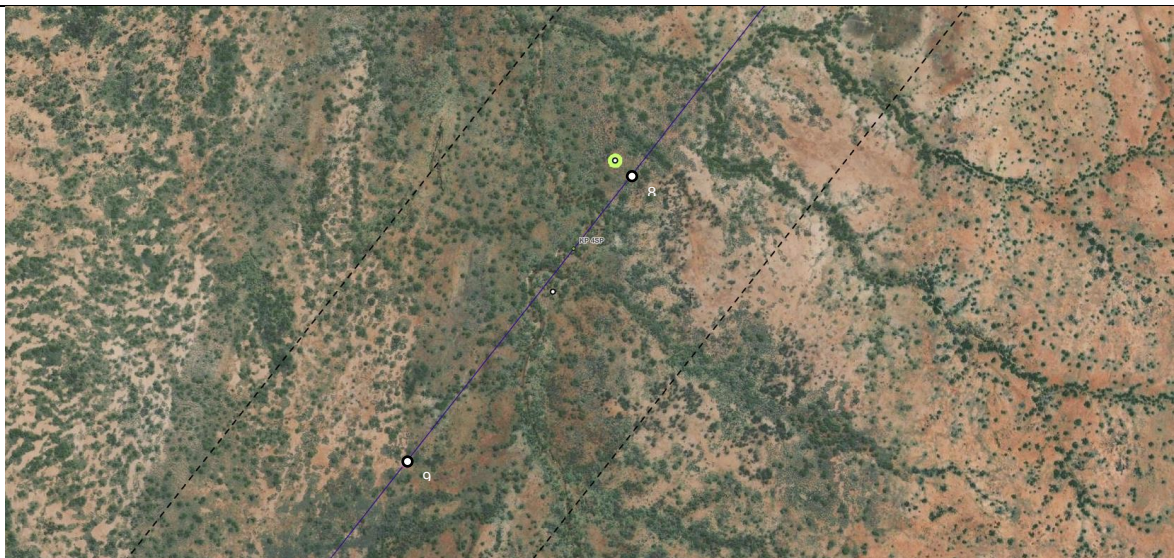
Line 5 KP 3.8 SP (40,20,40,0) Quaternary point (green) near Tower 9  
(570.000m between towers 8-9)

This section is described as 40% very light, 20% light, 40% moderate and 0% heavy by the clearing contractor. Field observations show a riparian woodland along a 15m wide watercourse to the south of the quaternary point. The sparse to mid-dense canopy covers the riparian canopy that fringes the watercourse and most of the north section with tree heights averaging at 4m. Observations on the ground reflect the clearing contractor's description within this section of the alignment.

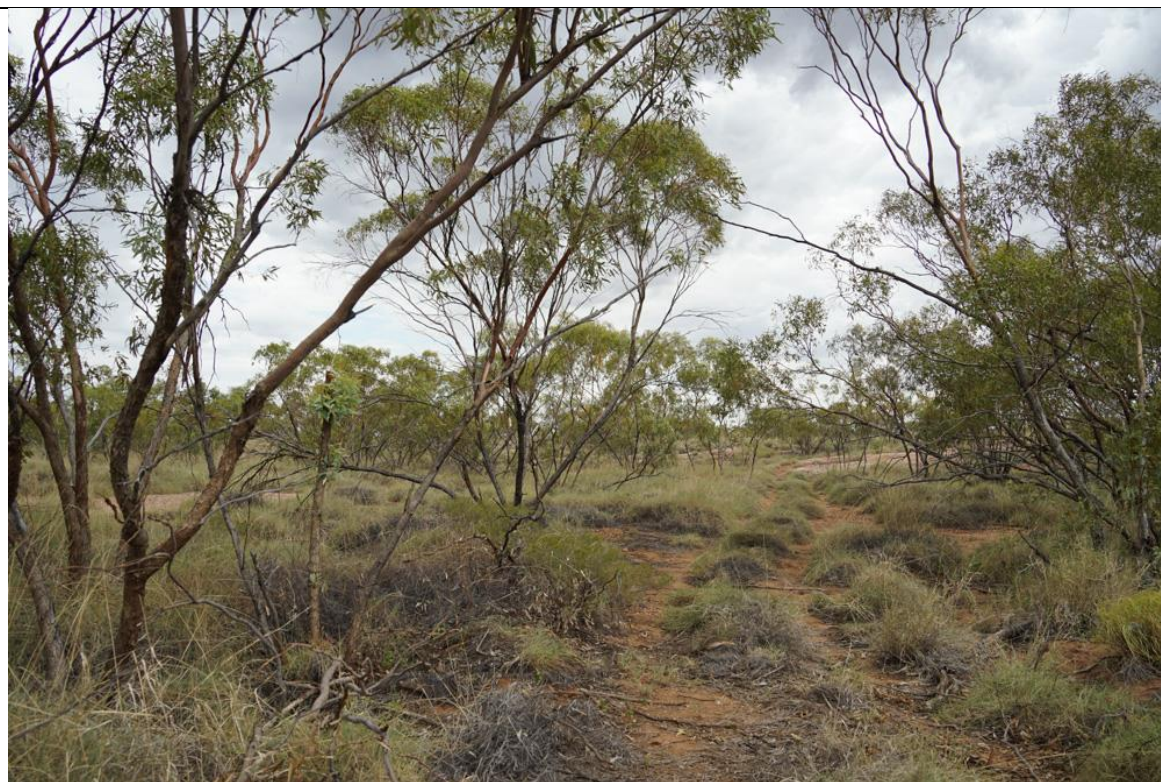
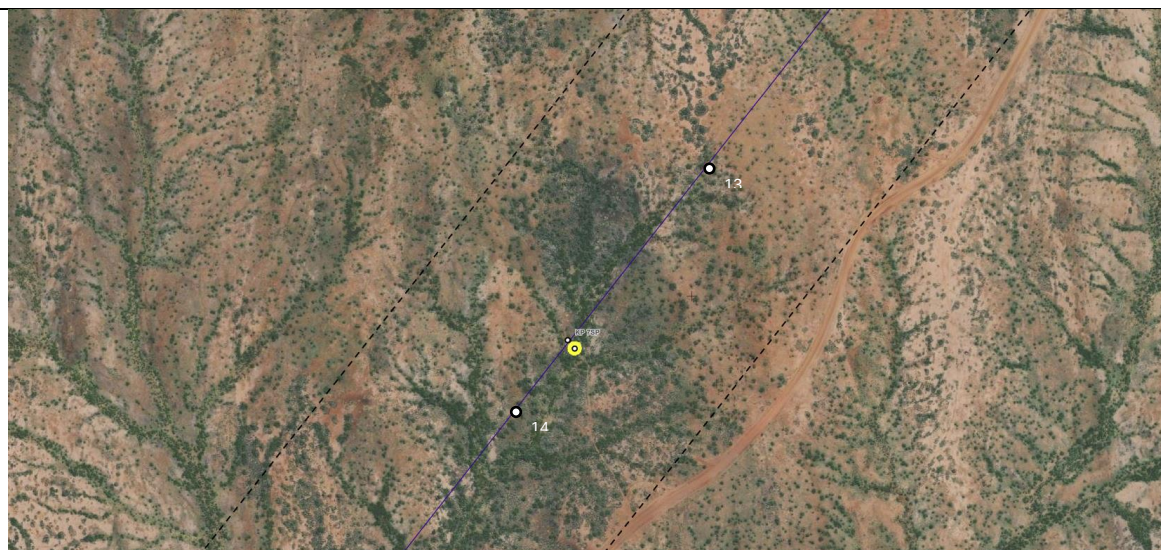
Line 5 KP 6.6 SP (40,20,30,10) Access track (yellow) near Tower 14  
(488.812m between towers 13-14)

This section is described as 40% very light, 20% light, 30% moderate and 10% heavy by the clearing contractor. Field observations show a riparian woodland along a 10m wide watercourse on the access track. The sparse to mid-dense canopy covers the riparian canopy that fringes the watercourse and gully lines, as well as most of the north section with tree heights averaging at 3.5m. Observations on the ground reflect the clearing contractor's description within this section of the alignment.

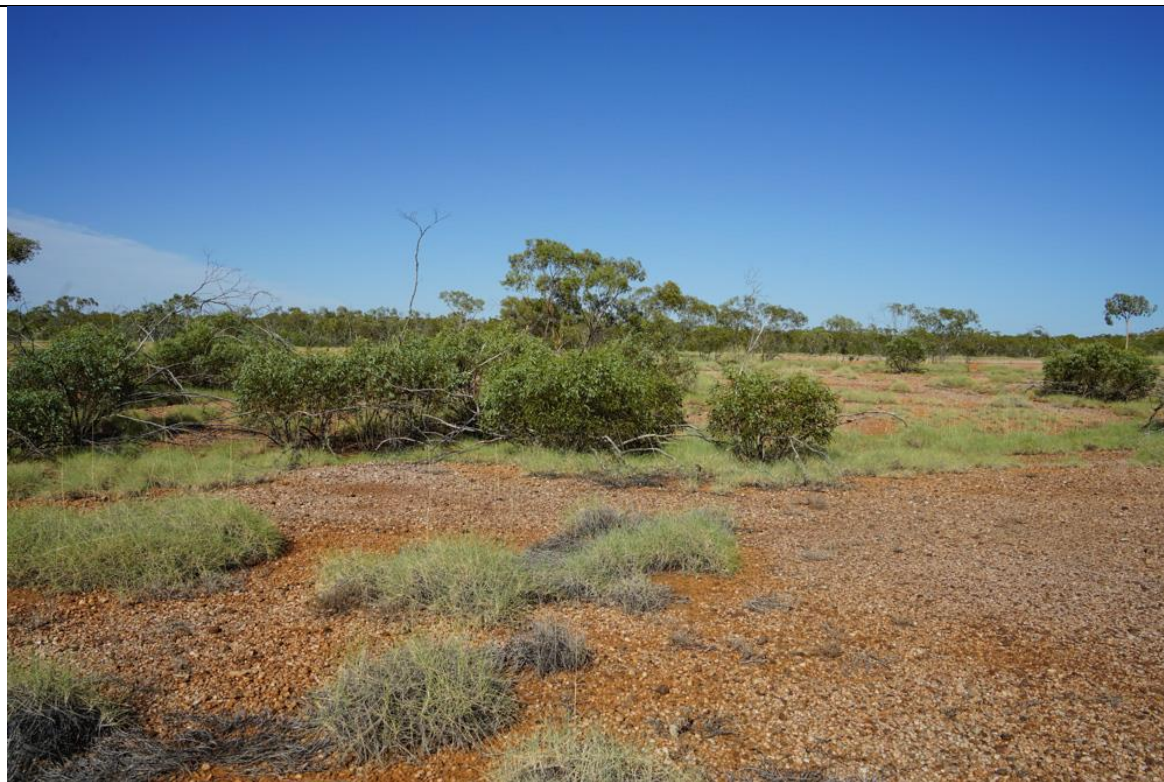
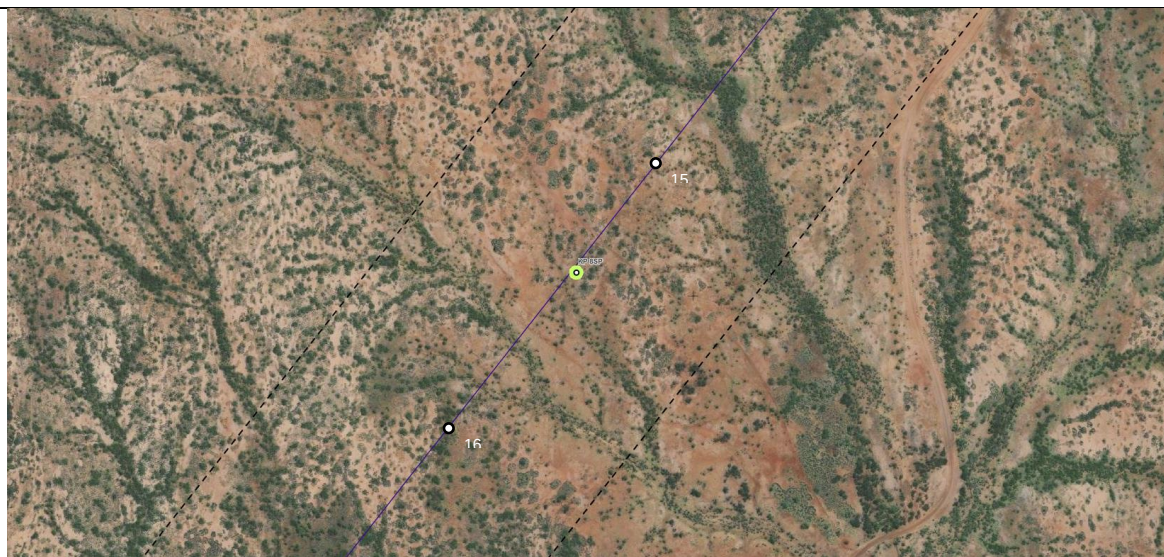
Line 5 KP 7.8 SP (40,20,40,0) Quaternary point (green) near Tower 16  
(528.530m between towers 15-16)

This section is described as 40% very light, 20% light, 40% moderate and 0% heavy by the clearing contractor. Field observations show a riparian woodland along a 10m wide watercourse south of the quaternary point. The sparse to mid-dense canopy covers the riparian canopy that fringes the watercourse and gully lines, as well as most of this section with tree heights averaging at 4m. Observations on the ground reflect the clearing contractor's description within this section of the alignment.
