# Visual Comparison of Landscape Type

Client: CopperString 2.0  
Reference: J0XXX

This document is a visual comparison of landscapes which was compiled to provide a photographic record both from an aerial and site-based perspective along each of the five corridor selection segments. This ground truthing was utilised to inform the projects appreciation of the six general landscape types which occur across the study area as well as improved confidence in the potential conservation significant species habitat mapped for the CopperString EIS 2.0. It has also been used to confirm expected disturbance associated with construction related activities.

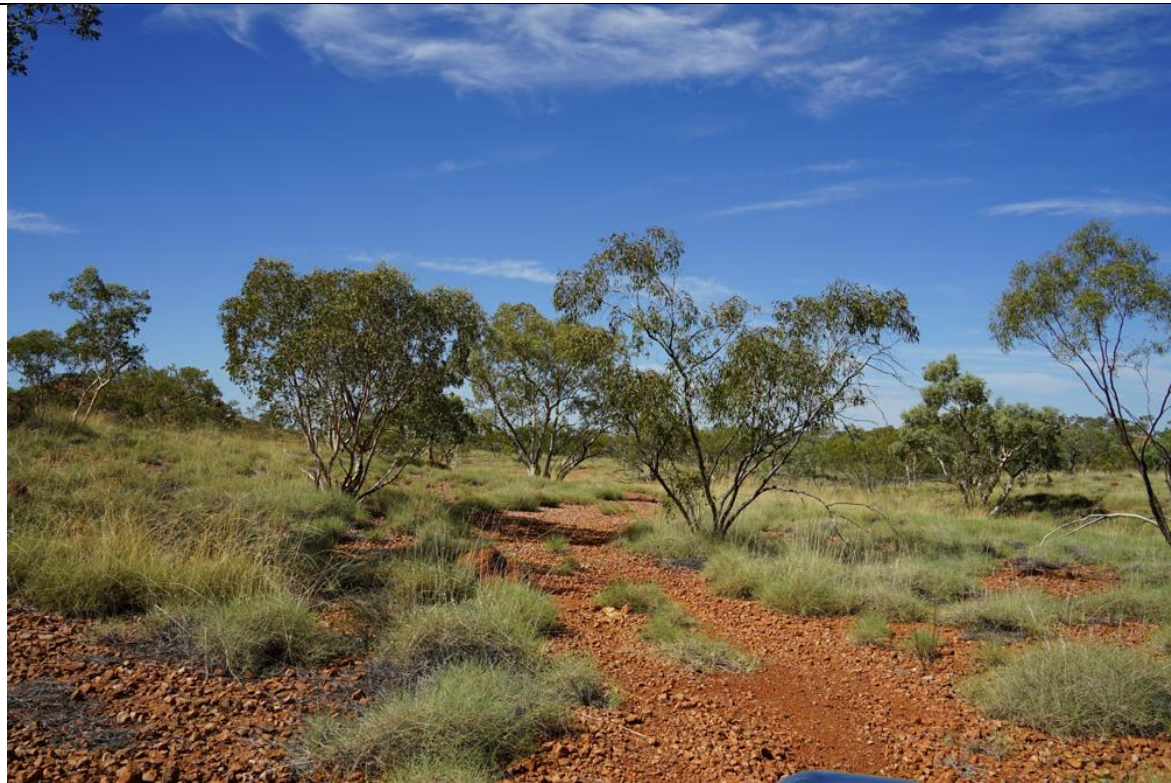
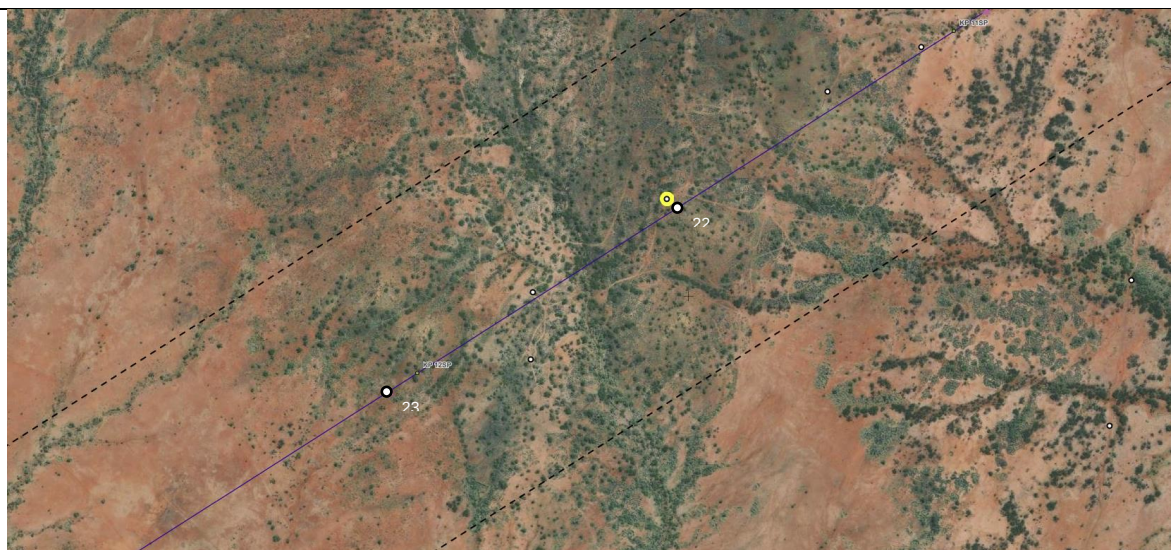
Line 5 KP 11.5 SP (70,0,10,20) Access track (yellow) near Tower 23  
(536.933m between towers 22-23)

This section is described as 70% very light, 0% light, 10% moderate and 20% heavy by the clearing contractor. Field observations show a riparian woodland along a 10m wide watercourse south of the access track. The sparse canopy covers the riparian canopy that fringes the watercourse and gully lines, as well as most of this section with tree heights averaging at 4m. Observations on the ground reflect the clearing contractor's description within this section of the alignment.

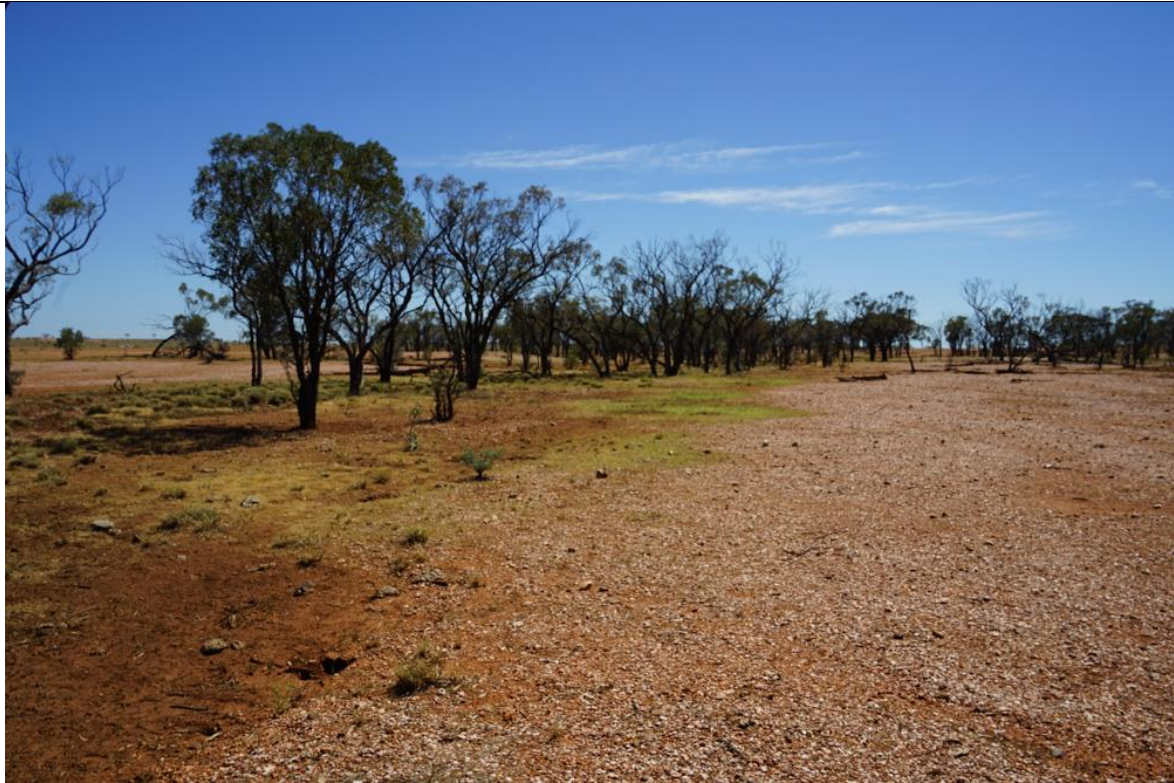
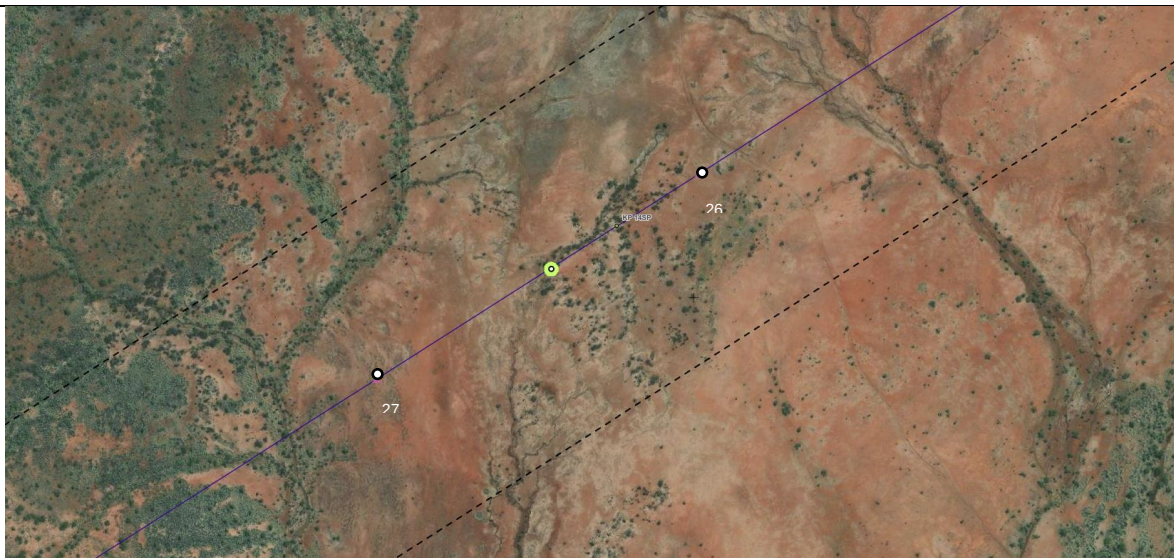
Line 5 KP 13.8 SP (60,0,40,0) Quaternary point (green) near Tower 27  
(593.681m between towers 26-27)

This section is described as 60% very light, 0% light, 40% moderate and 0% heavy by the clearing contractor. Field observations show a mid-dense canopy covers a small patch towards the northern tower of this section with tree heights averaging at 4m. Observations on the ground reflect the clearing contractor's description within this section of the alignment.

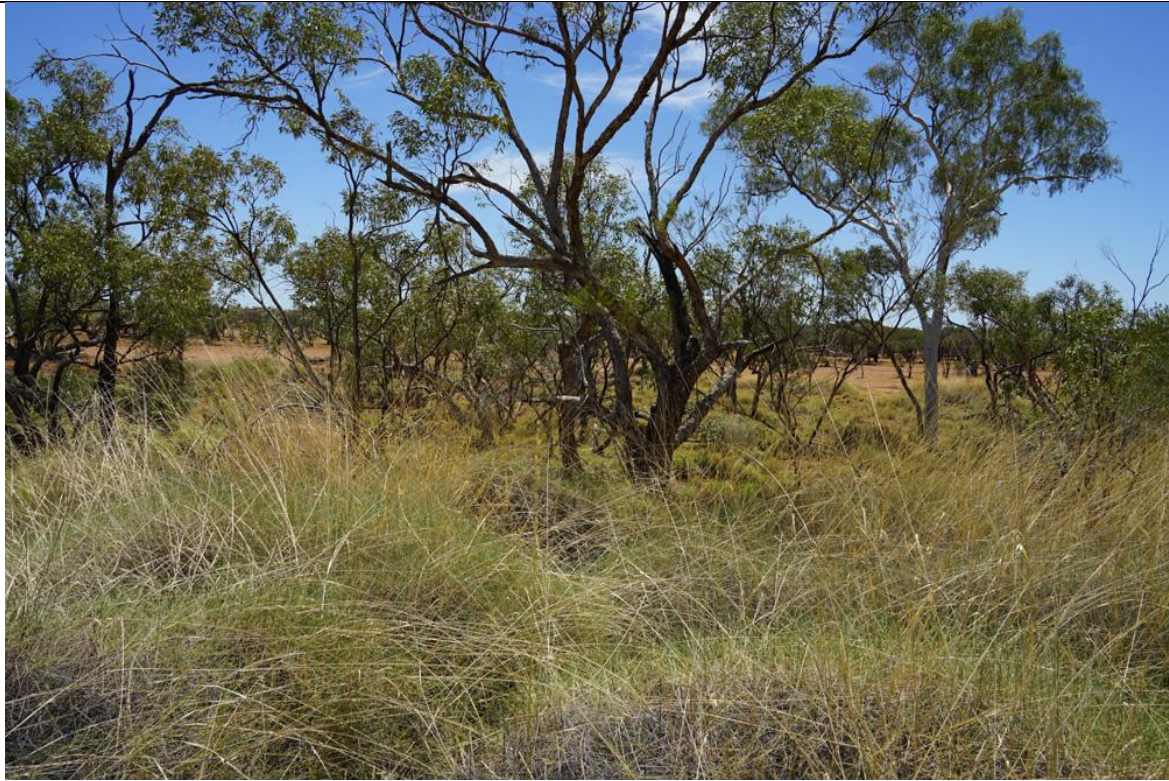
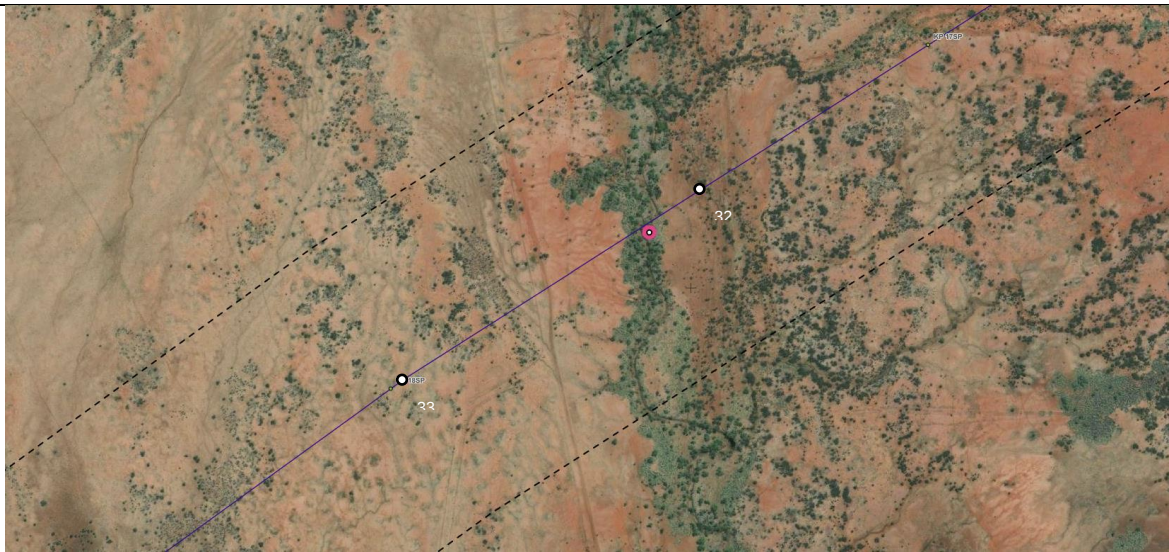
Line 5 KP 17.4 SP (70,0,30,0) Riparian zone (red) near Tower 33  
 (550.173m between towers 32-33) (Low Risk (Green) DAF – WWBW)

This section is described as 70% very light, 0% light, 30% moderate and 0% heavy by the clearing contractor. Field observations show a riparian woodland along a 12m wide watercourse. Tree heights ranged up to 9m. The sparse canopy covers the riparian canopy fringing the watercourse and most of the northern side of this section with tree heights averaging around 8m. Observations on the ground reflect the clearing contractor's description within this section of the alignment.

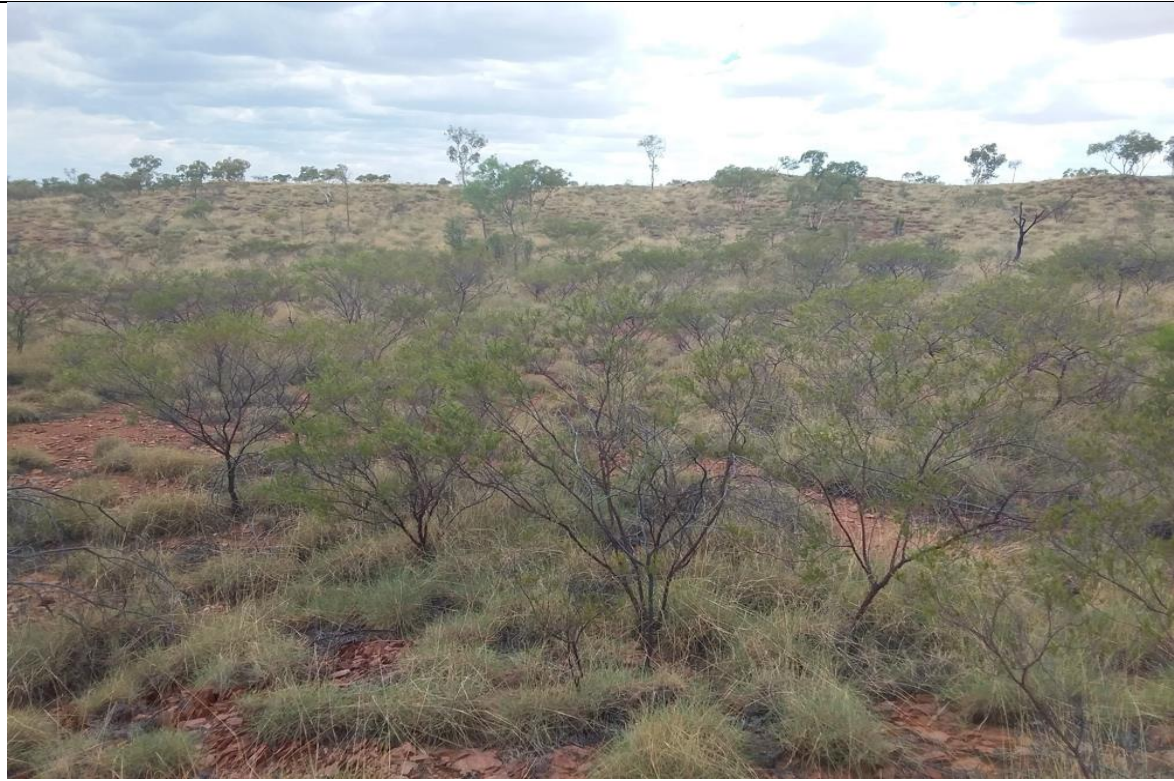
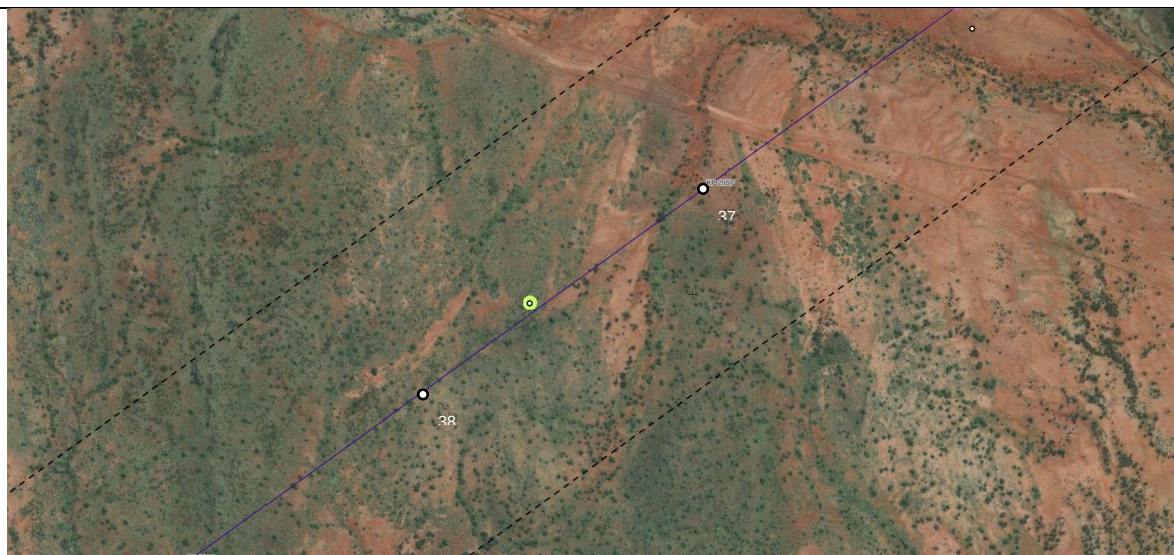
Line 5 KP 20 SP (70,0,30,0) Quaternary point (green) near Tower 38  
(539.100m between towers 37-38)

This section is described as 70% very light, 0% light, 30% moderate and 0% heavy by the clearing contractor. Field observations show a mid-dense canopy covers scattered small patches along this section with tree heights averaging at 6m. Observations on the ground reflect the clearing contractor's description within this section of the alignment.

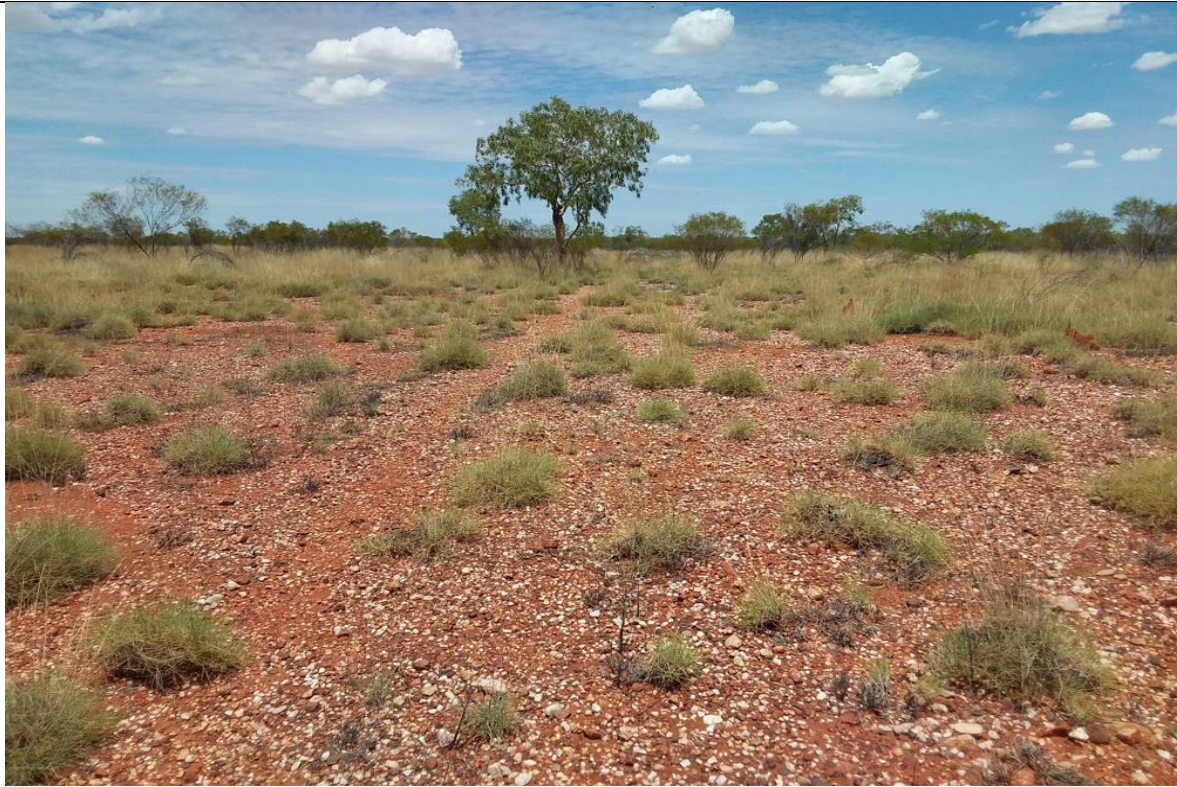
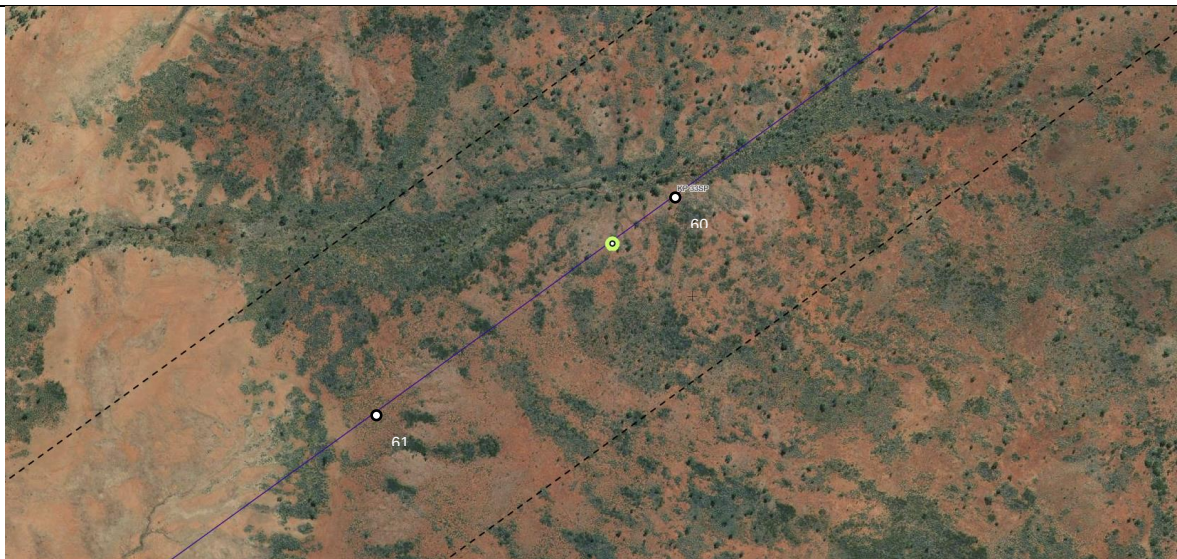
Line 5 KP 33 SP (50,0,50,0) Quaternary point (green) near Tower 61  
(581.622m between towers 60-61)

This section is described as 50% very light, 0% light, 50% moderate and 0% heavy by the clearing contractor. Field observations show a mid-dense canopy covers scattered small patches along this section with tree heights averaging at 7m. Observations on the ground reflect the clearing contractor's description within this section of the alignment.

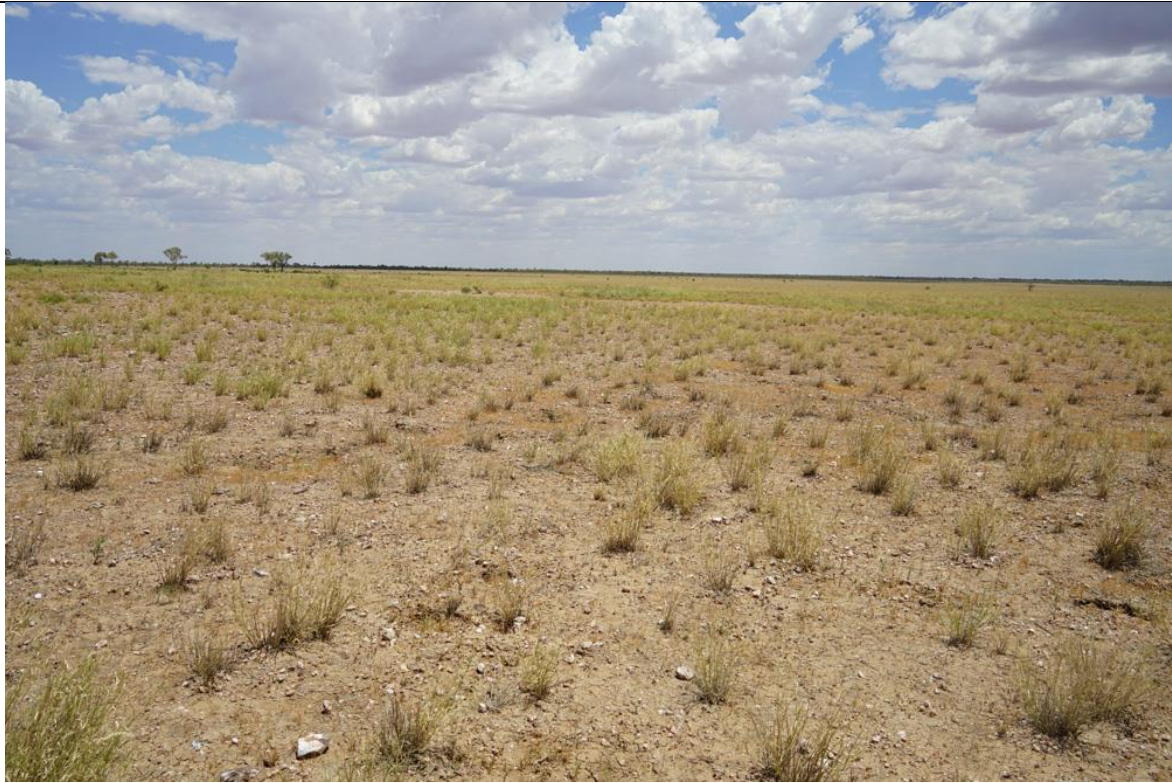
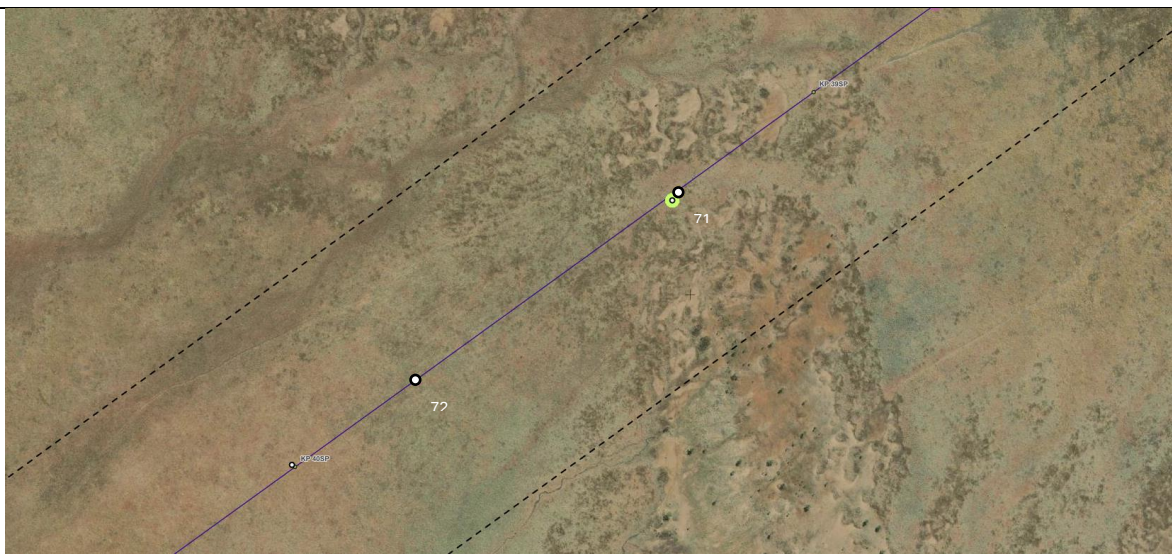
Line 5 KP 39.3 SP (90,0,10,0) Quaternary point (green) near Tower 72  
(499.548m between towers 71-72)

This section is described as 90% very light, 0% light, 10% moderate and 0% heavy by the clearing contractor. Field observations in this section shows canopy coverage is very sparse or absent. Observations on the ground reflect the clearing contractor's description within this section of the alignment.

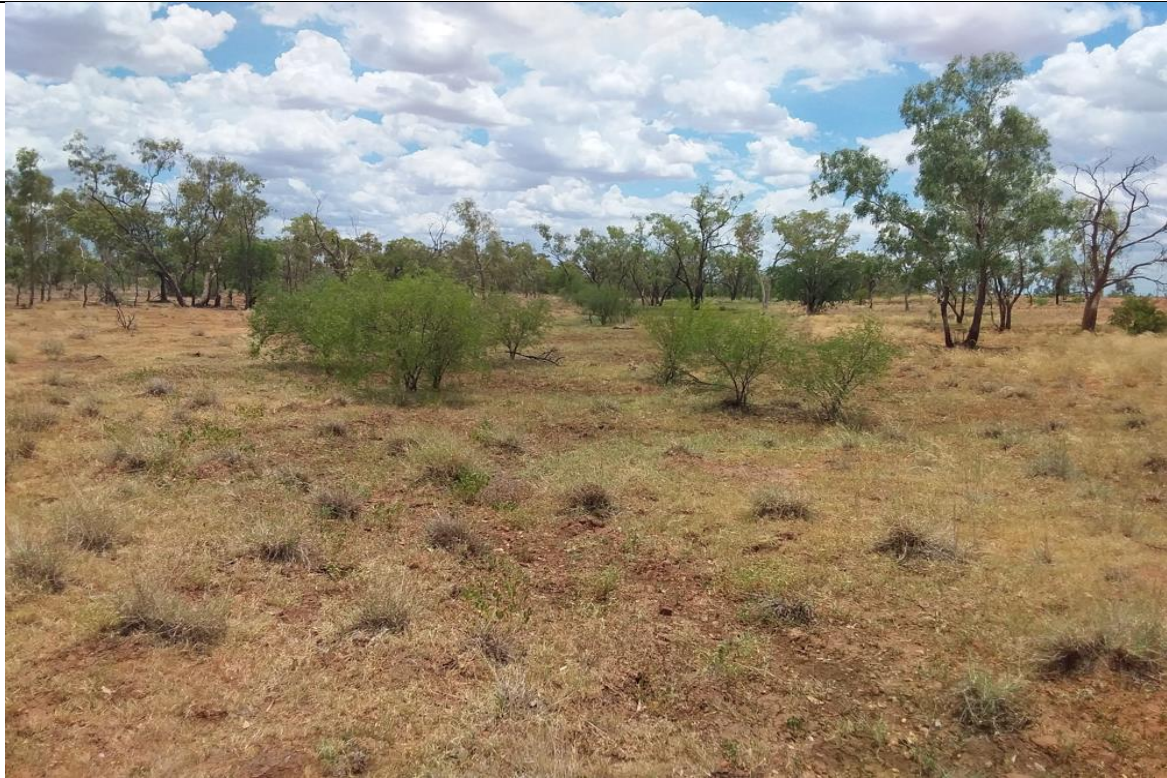
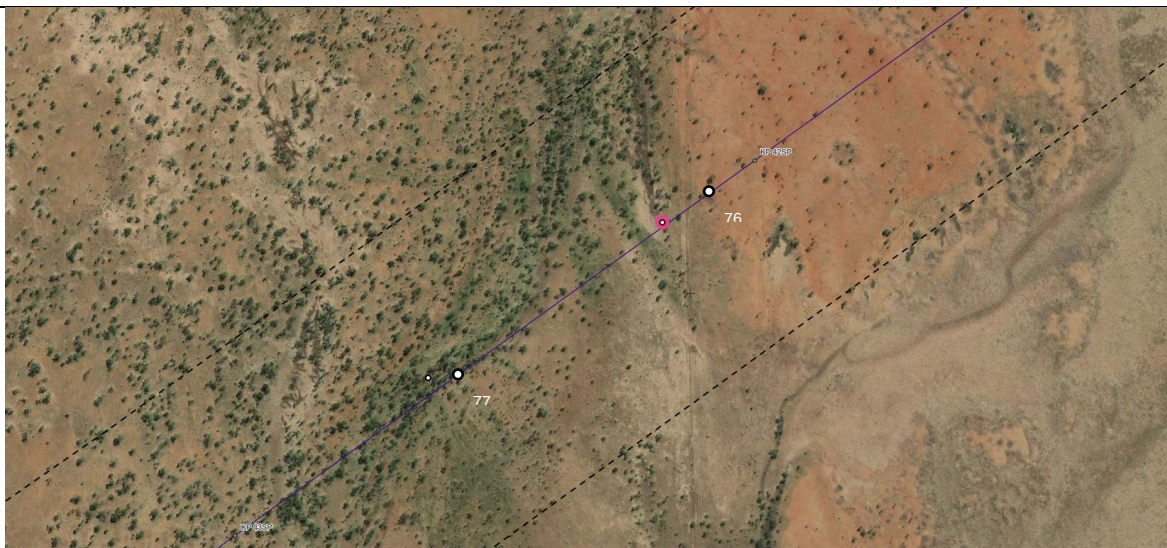
Line 5 KP 42.1 SP (40,0,60,0) Riparian zone (red) near Tower 77  
 (487.275m between towers 76-77) (Moderate Risk (Amber) DAF – WWBW)

This section is described as 40% very light, 0% light, 60% moderate and 0% heavy by the clearing contractor. Field observations show a riparian woodland along a 1m wide braided watercourse. Tree heights ranged up to 8m. The mid-dense canopy covers the riparian canopies that fringe the watercourses and most of the middle section with tree heights averaging around 8m. Observations on the ground reflect the clearing contractor's description within this section of the alignment.

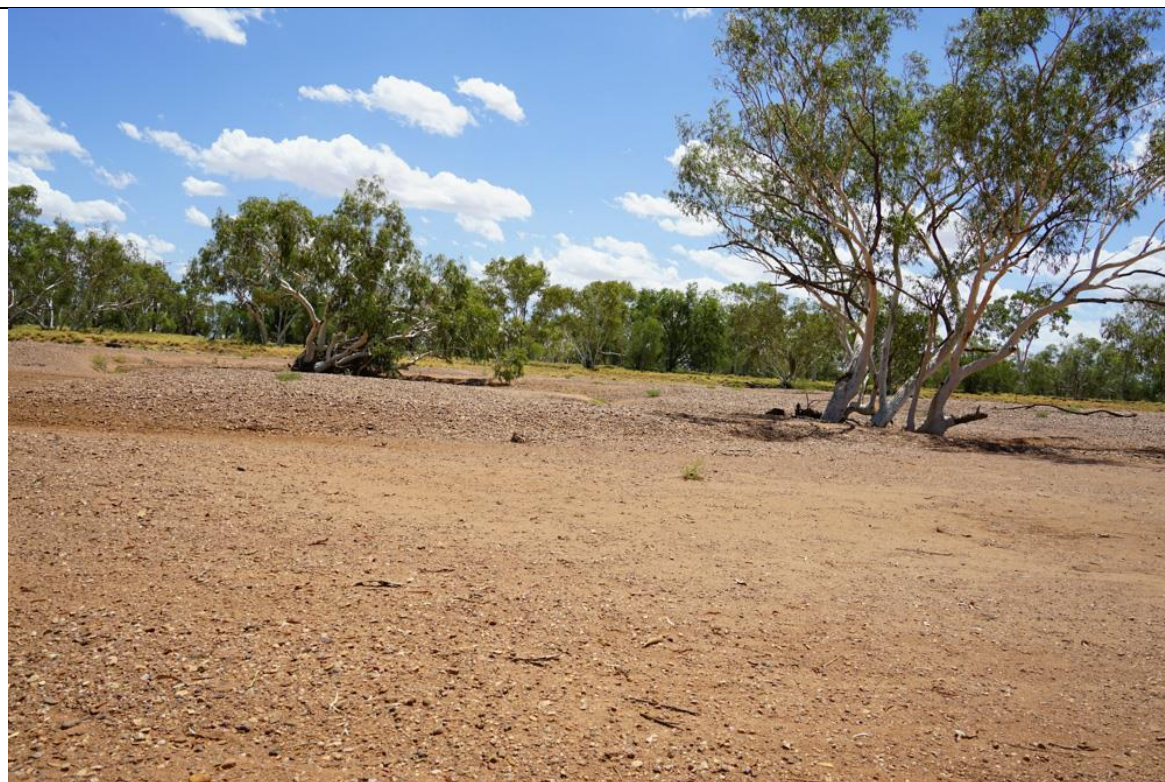
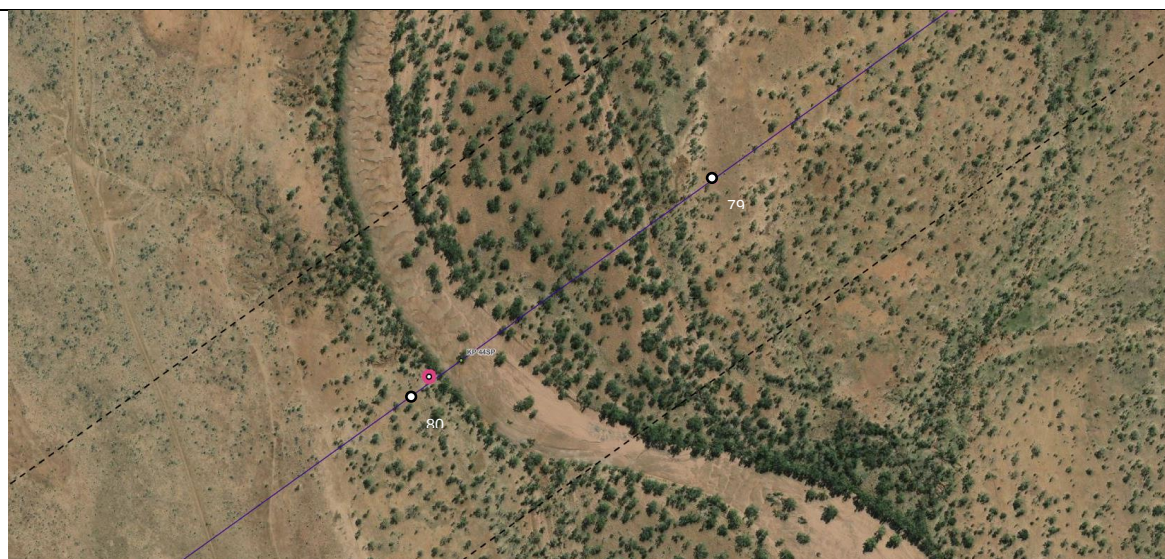
Line 5 KP 43.5 SP (40,10,40,10) Riparian zone (red) near Tower 80  
 (580.103m between towers 79-80) (Major Risk (Purple) DAF – WWBW)

This section is described as 40% very light, 10% light, 40% moderate and 10% heavy by the clearing contractor. Field observations show a riparian woodland along a 120m and 15m wide braided watercourses. Tree heights ranged up to 18m. The very sparse canopy covers the riparian canopies that fringe the watercourses and most of the middle section with tree heights averaging around 8m. Observations on the ground reflect the clearing contractor's description within this section of the alignment.

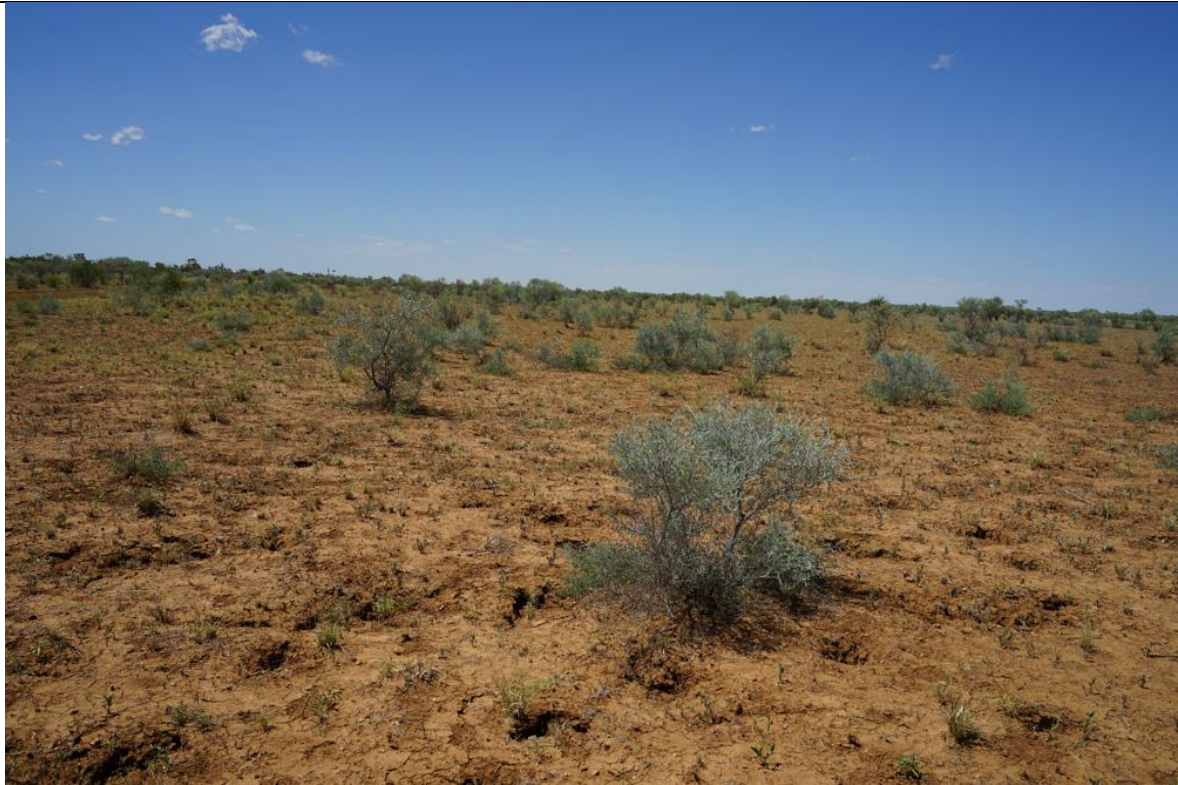
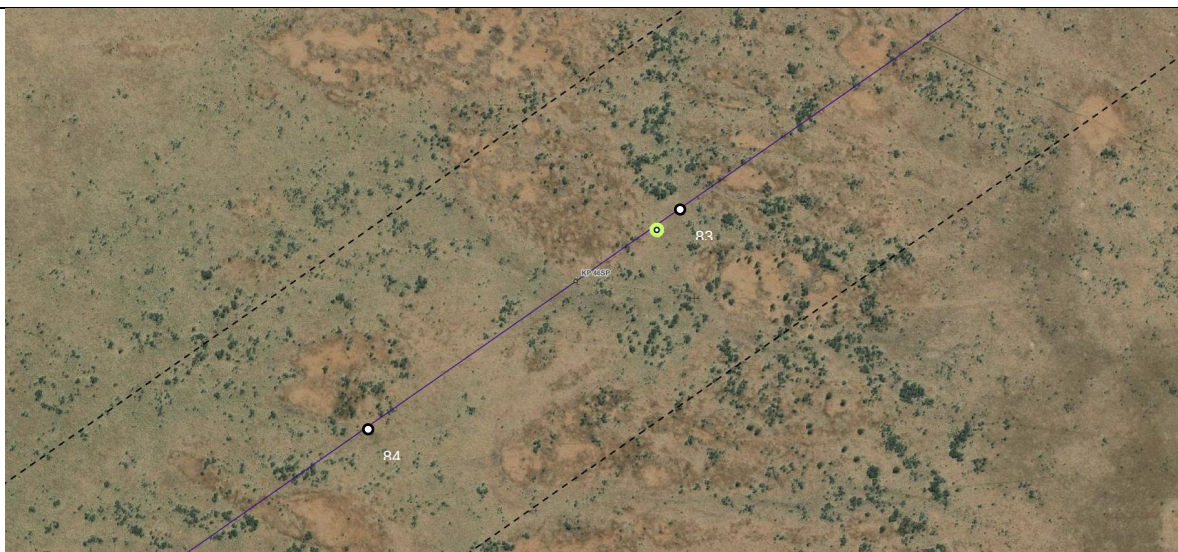
Line 5 KP 45.9 SP (95,5,0,0) Quaternary point (green) near Tower 84  
(587.228m between towers 83-84)

This section is described as 95% very light, 5% light, 0% moderate and 0% heavy by the clearing contractor. Field observations in this section shows canopy coverage is very sparse or absent. Observations on the ground reflect the clearing contractor's description within this section of the alignment.

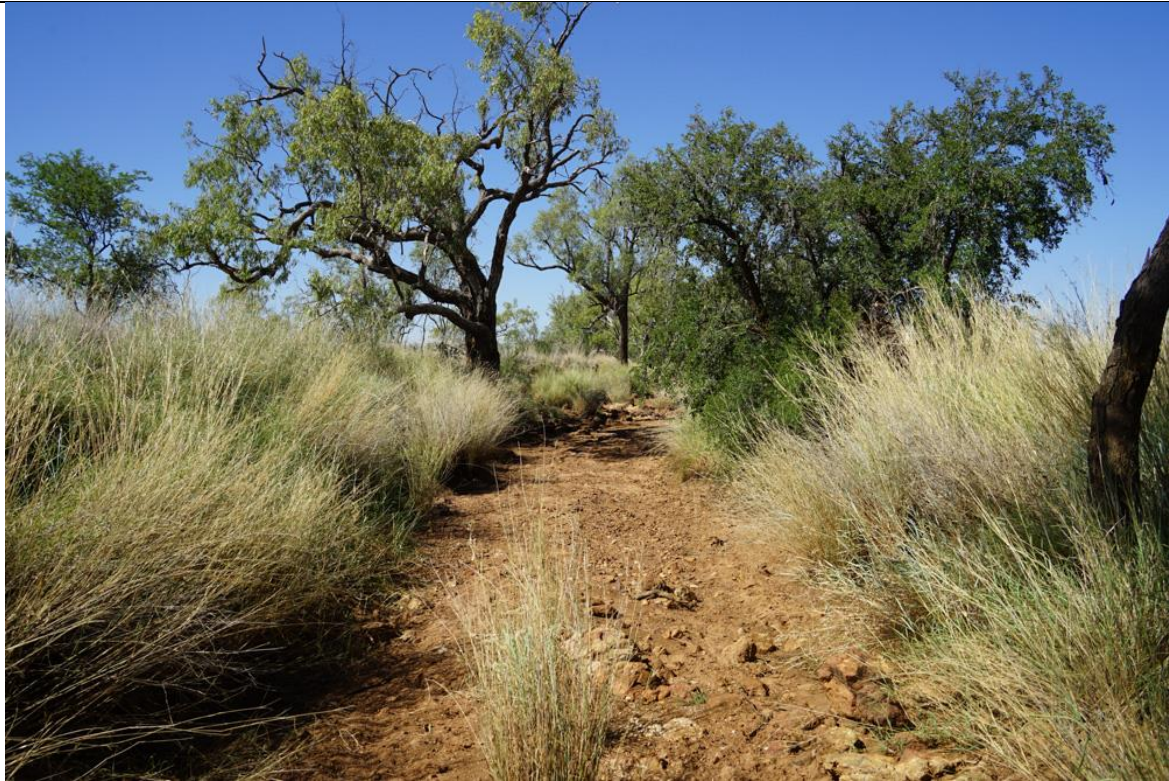
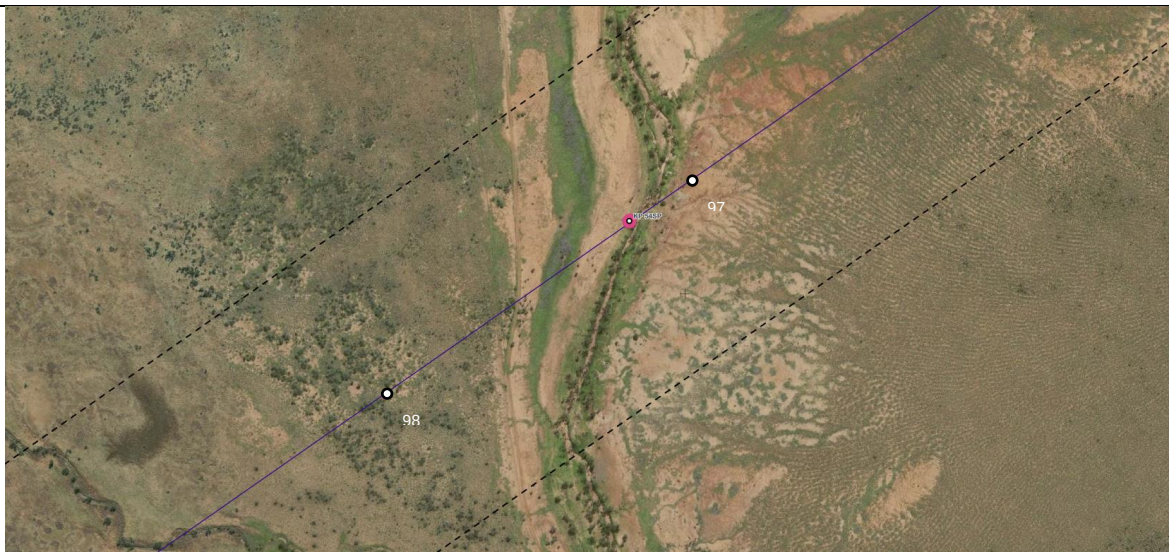
Line 5 KP 53.9 SP (95,5,0,0) Riparian zone (red) near Tower 98  
 (589.557m between towers 97-98) (Moderate Risk (Amber) DAF – WWBW)

This section is described as 95% very light, 5% light, 0% moderate and 0% heavy by the clearing contractor. Field observations show a riparian woodland along a 11m wide watercourse. Tree heights ranged up to 9m. The very sparse canopy covers the riparian canopy fringing the watercourse with tree heights averaging around 3m. Observations on the ground reflect the clearing contractor's description within this section of the alignment.

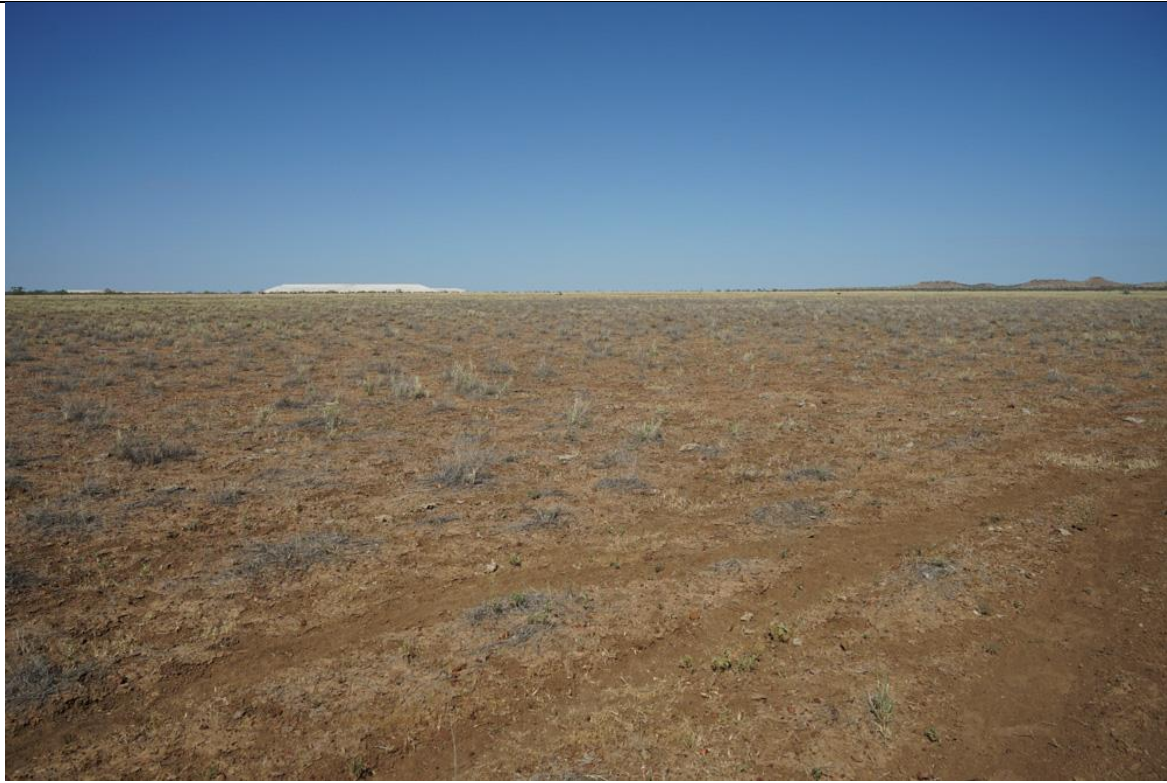
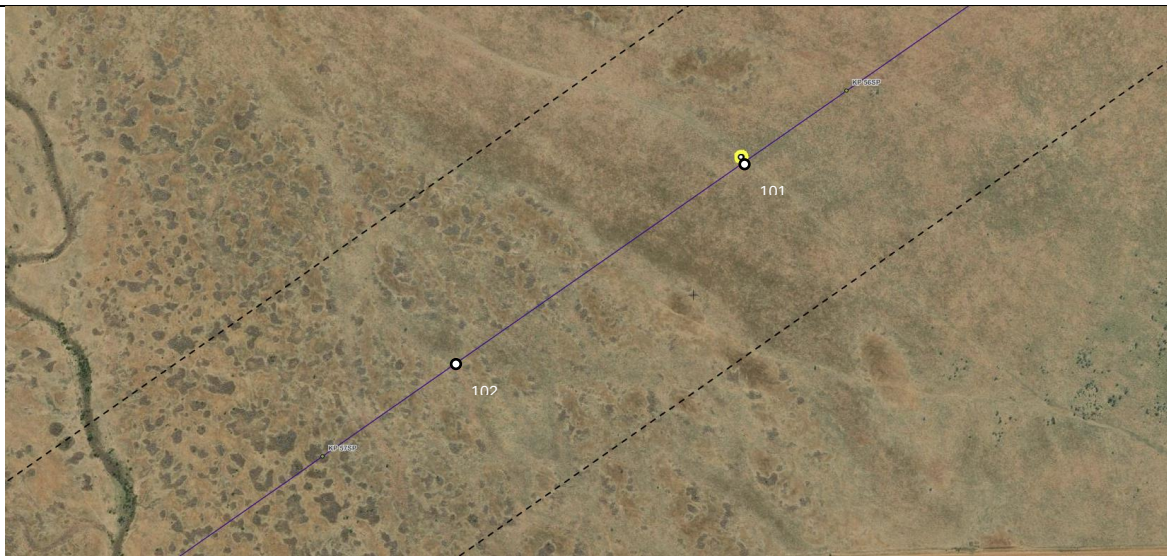
Line 5 KP 56.2 SP (95,5,0,0) Access track (yellow) near Tower 102  
(550.263m between towers 101-102)

This section is described as 95% very light, 5% light, 0% moderate and 0% heavy by the clearing contractor. Field observations in this section shows canopy coverage is very sparse or absent. Observations on the ground reflect the clearing contractor's description within this section of the alignment.

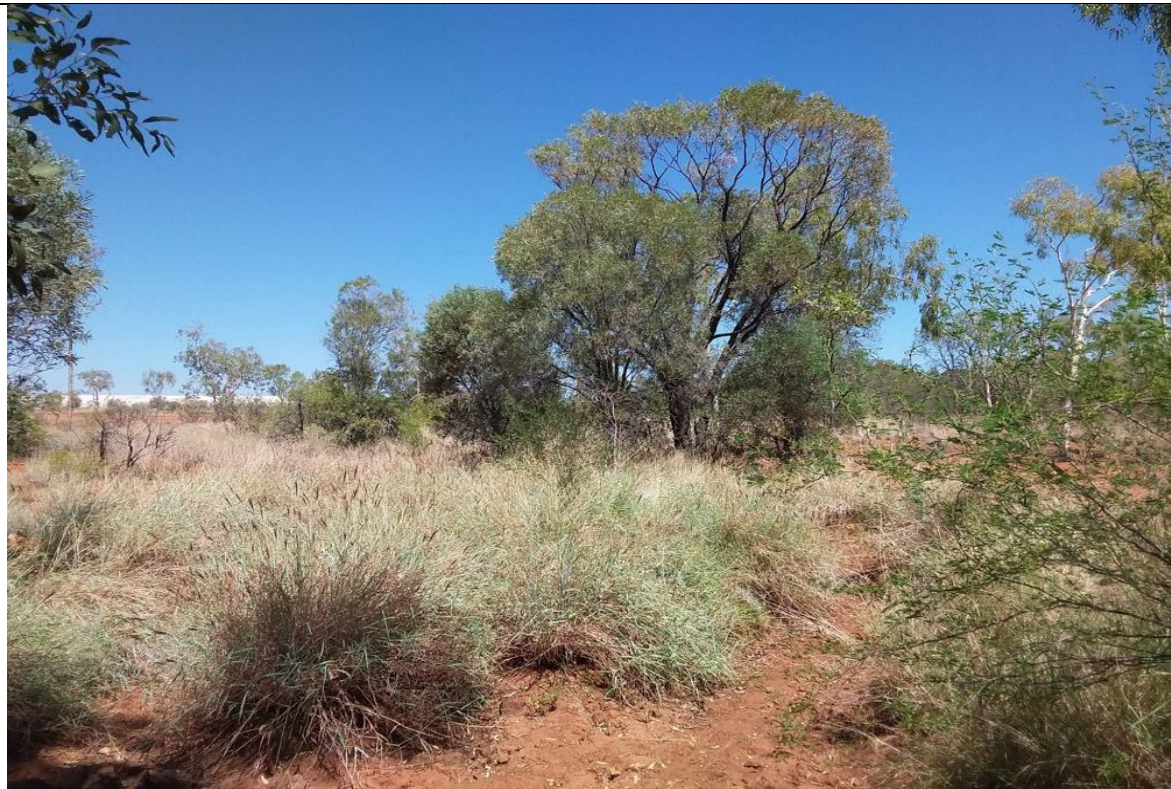
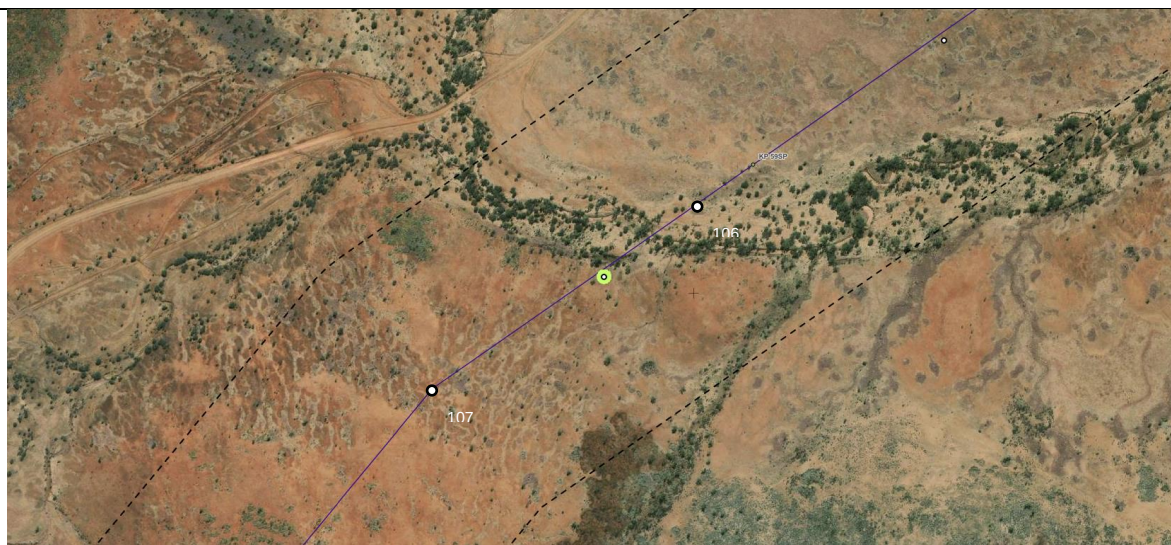
Line 5 KP 59 SP (50,0,50,0) Quaternary point (green) near Tower 107  
(502.746m between towers 106-107)

This section is described as 50% very light, 0% light, 50% moderate and 0% heavy by the clearing contractor. Field observations show a riparian woodland along a 10m wide watercourse north of the quaternary point. The mid-dense canopy covers the riparian canopy that fringes the watercourse with tree heights averaging at 9m. Observations on the ground reflect the clearing contractor's description within this section of the alignment.

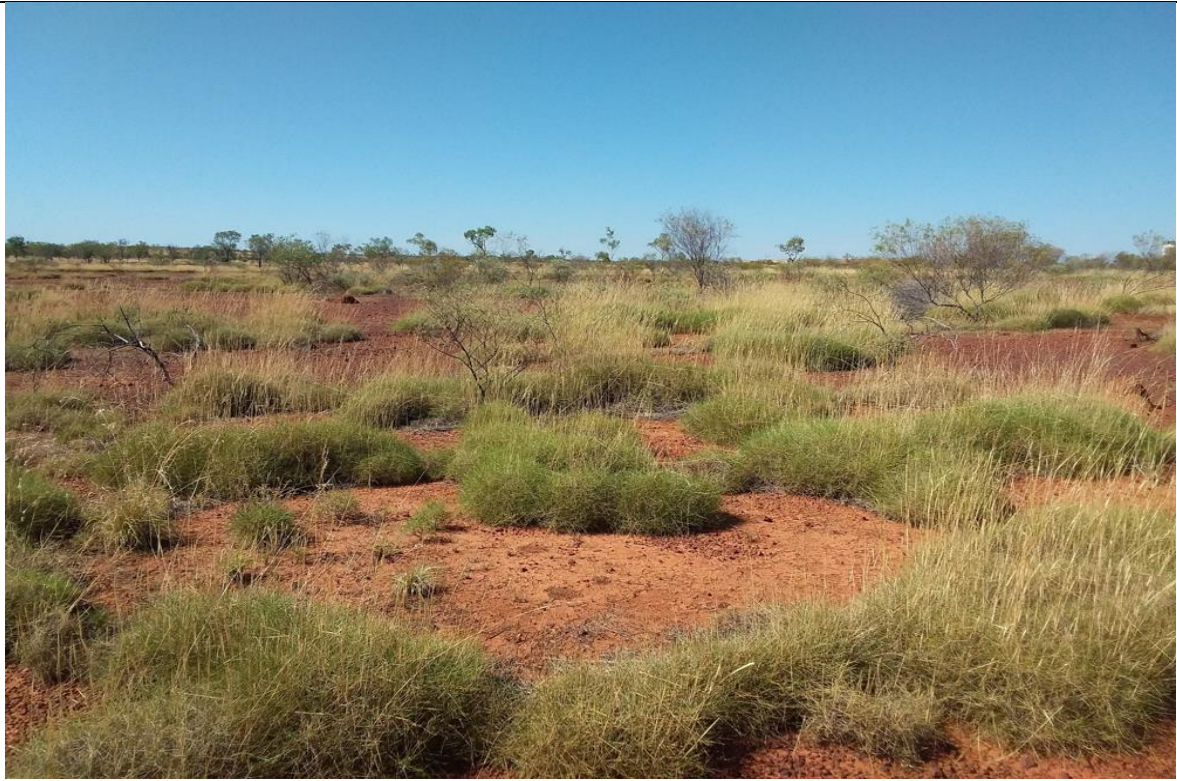
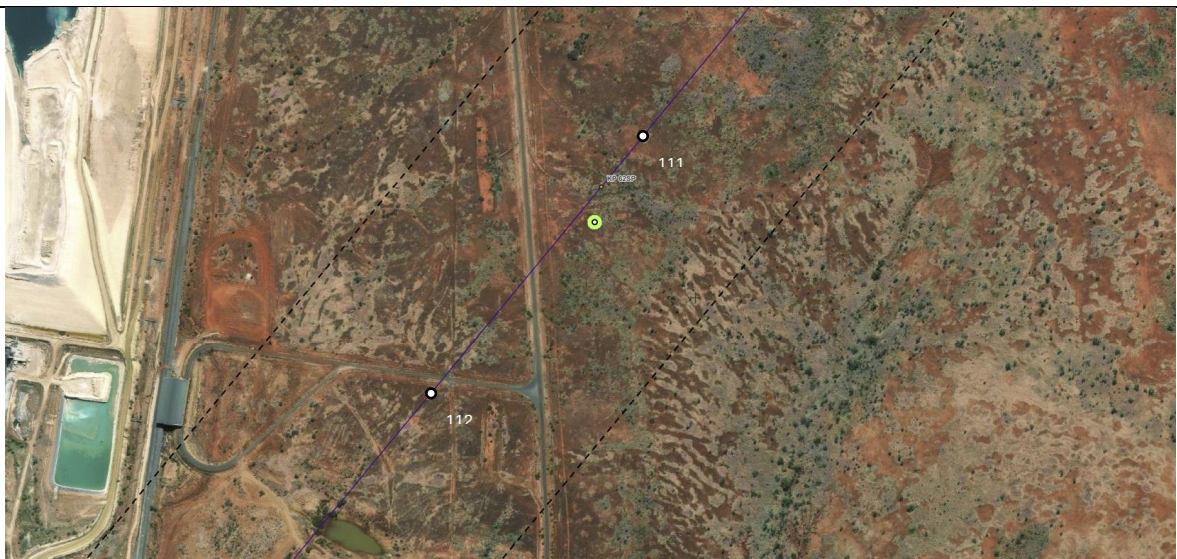
Line 5 KP 61.9 SP (70,30,0,0) Quaternary point (green) near Tower 112  
(522.347m between towers 111-112)

This section is described as 70% very light, 30% light, 0% moderate and 0% heavy by the clearing contractor. Field observations show a sparse canopy covers small patches near both towers with tree heights averaging at 5m. Observations on the ground reflect the clearing contractor's description within this section of the alignment.
