# APPENDIX H

## Geomorphology Report

**BORDER TO GOWRIE** REVISED DRAFT ENVIRONMENTAL IMPACT STATEMENT

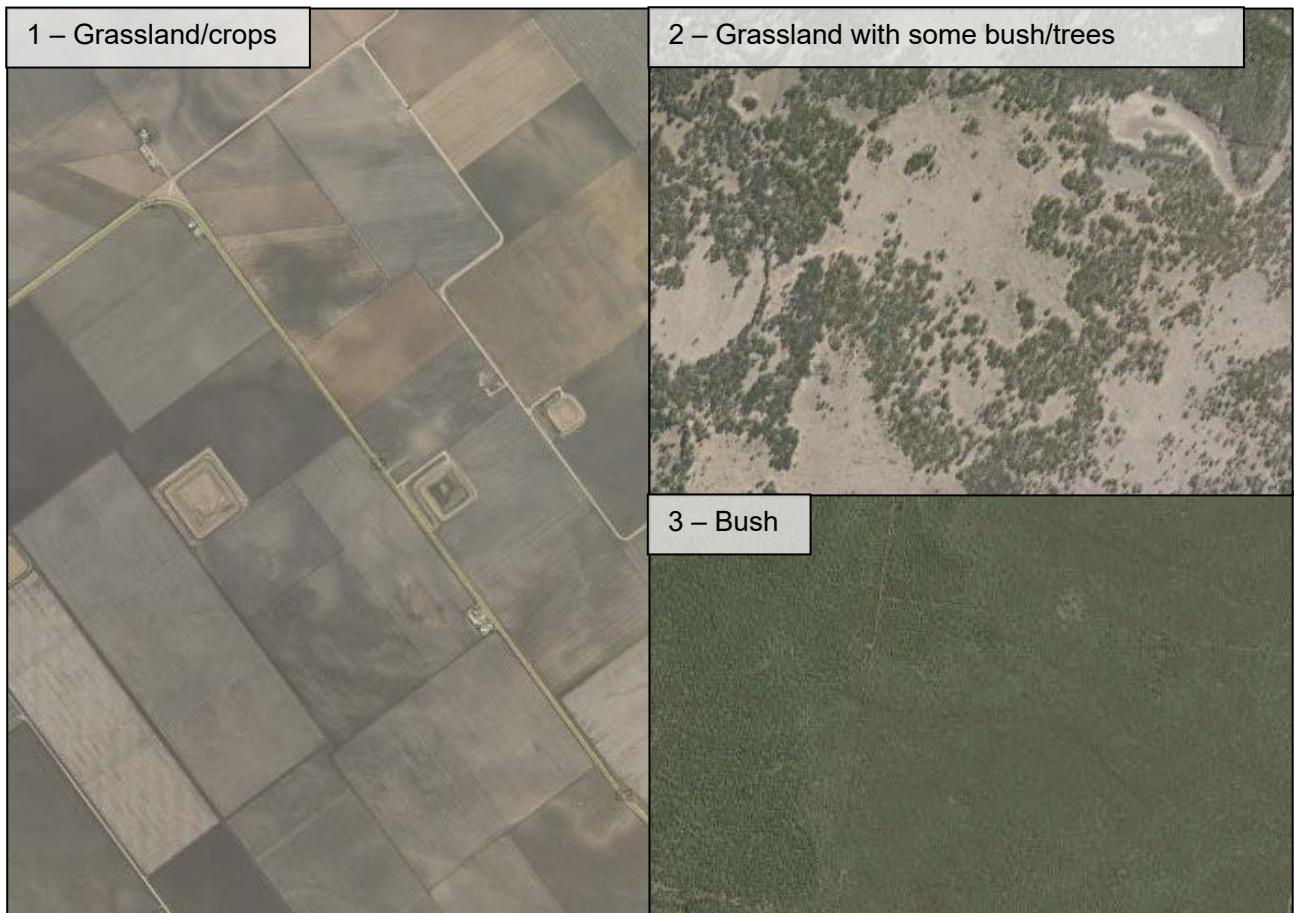
**Figure 3.7** Example catchment vegetation cover groups used in this baseline assessment

1. Grassland/crops - Mainly grass/crops/bare land, very minor bushes/scrub/trees. High sediment generation potential.
2. Grassland with some bush/trees - Mainly grassland but with some areas of bush/trees, often sparse. Moderate sediment generation potential.
3. Bush - Mix of bushes/trees with small pockets of grass/bare land. Low sediment generation potential.

The three types illustrated in Figure 3.7 are:

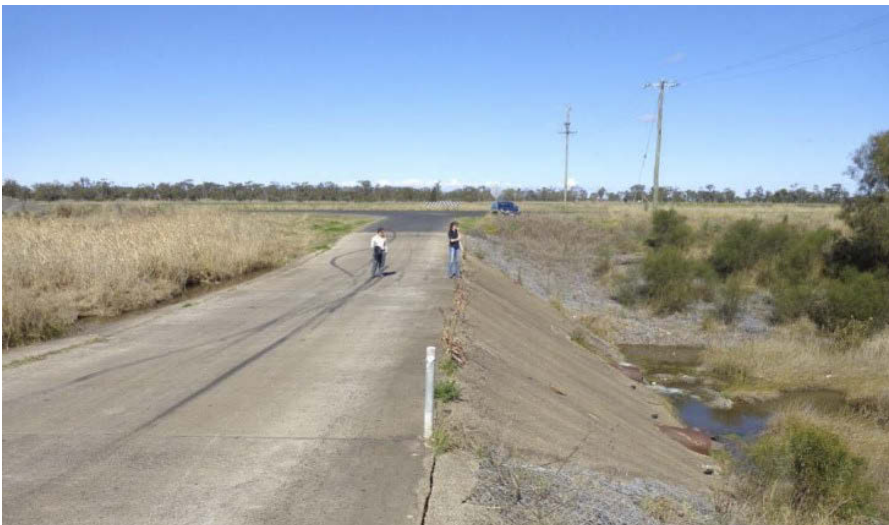
**Figure 3.9** Drop structure at Wallingford Road

- The drop structure at the Wallingford Road crossing across Fourteen Mile Creek is an example of a successful gully stabilisation in vertosols (Figure 3.9). Downstream bed levels are on the order of 4 to 5 m lower than upstream, incision and widening appears to have ceased and the reach appears relatively stabilised. Shrubs, small trees and grass are established on the banks.

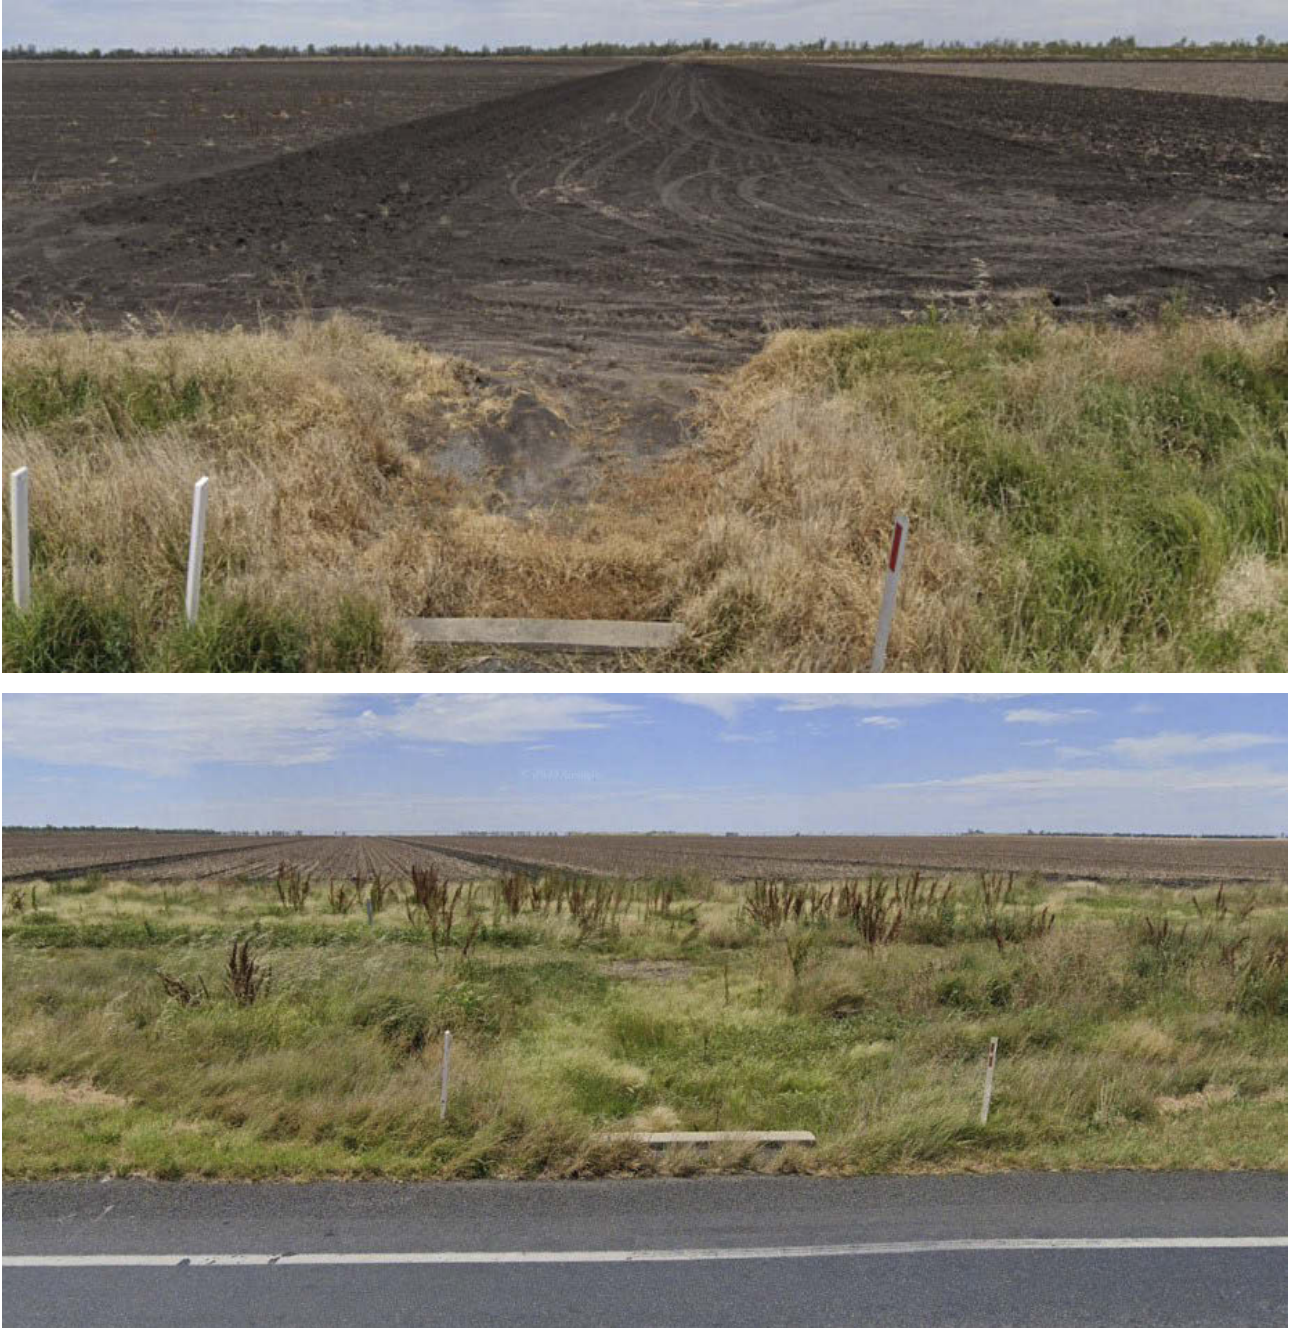
**Figure 3.10** Culvert on the Gore Highway at approximate chainage 145 km. Upper image is looking upstream, silt from bare cropland upstream has been deposited near the inlet, the grass buffer is less than 10m at the time of the photo. Lower image is looking downstream, wide grass buffer between culvert outlet and crop, approximately 40m. The small bare patch roughly halfway between the culvert and crops is a farm track.

Review of more recently designed cross drainage in vertosols along the Gore Highway shows almost all of the culverts in the Condamine have established grass at culvert inlets and outlets, a small number have patchy grass with either bare soil or deposited silt or small areas of ponding (Figure 3.10 for an example). Culverts typically have a grass buffer of between 5 m and 40 m between the inlet/outlet and cropped land.

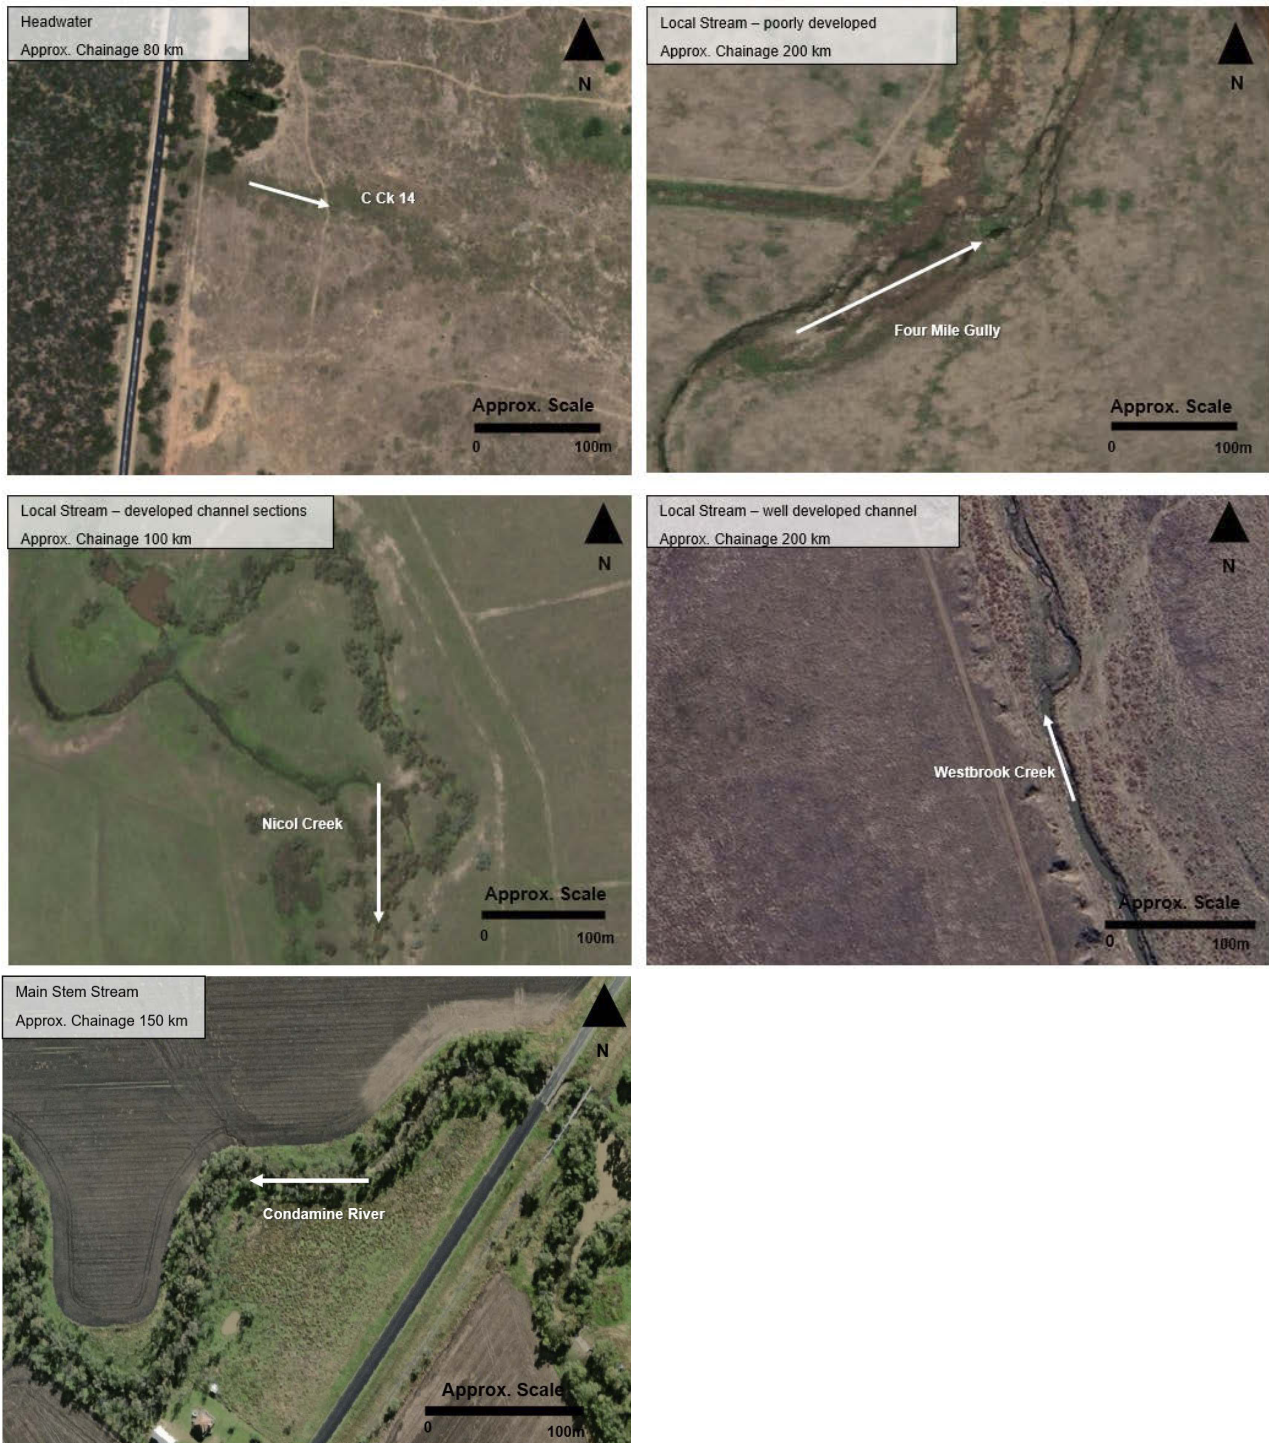
**Figure 3.11** Examples of headwater, local stream – poorly developed channel watercourse types local stream – developed channel sections, well developed channels and main stem watercourse types

Five high-level watercourse types were identified from the 143 watercourses that intersect the Project alignment as summarised in Table 3.10 and illustrated in and Figure 3.11:

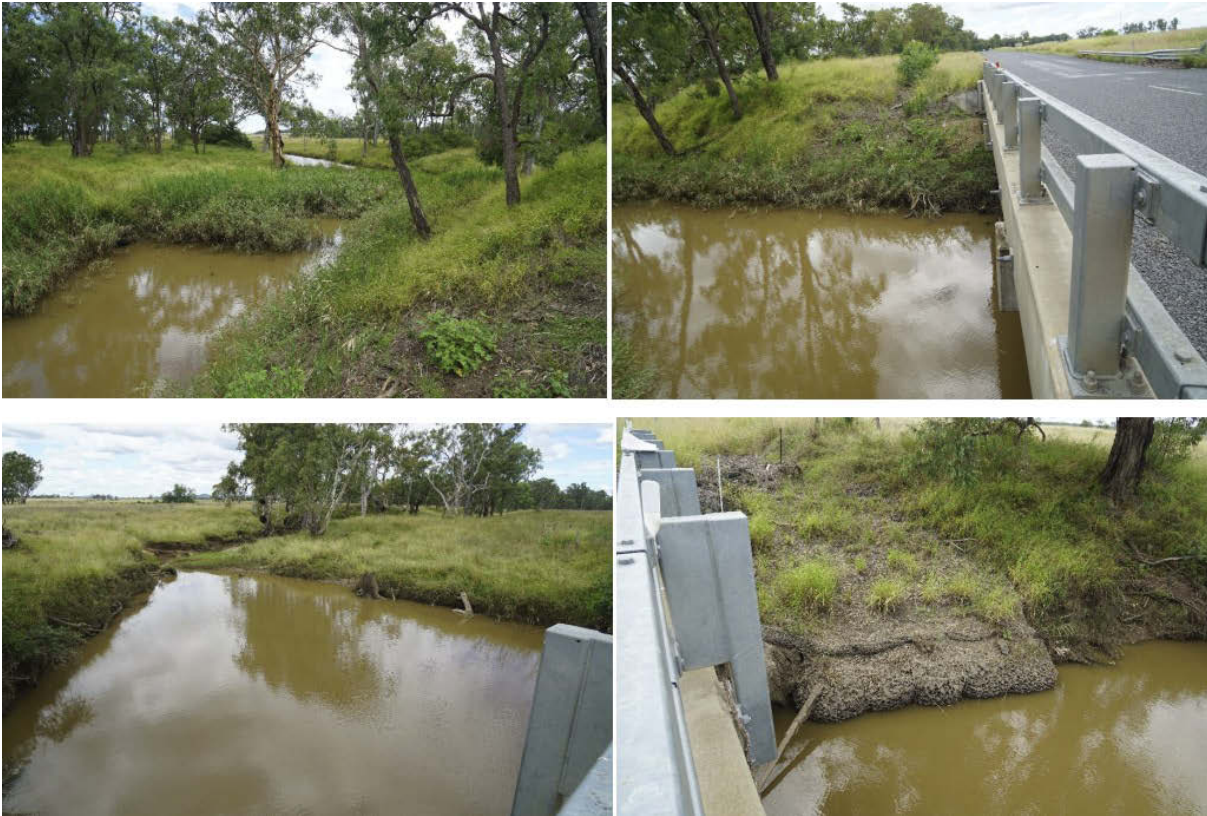
**Figure 3.19** Bringalily Road bridge site inspection (EP29)

- Four Mile Gully
- Bringalily Creek (Figure 3.19)
- Whalan Creek Arm.

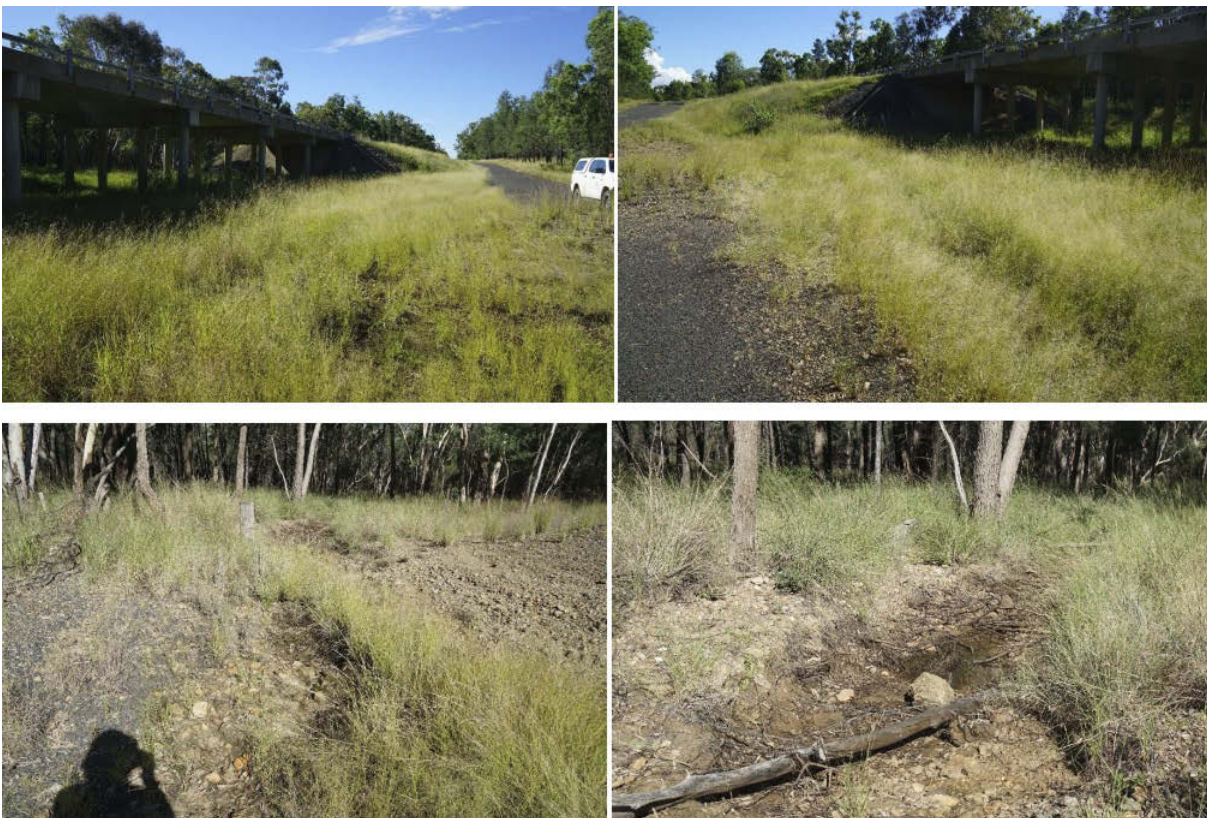
**Figure 3.20** Cattle Creek Road bridge site inspection (2/EP34)

- Westbrook Creek
- SC2
- Native Dog Creek
- Cattle Creek (Figure 3.20).

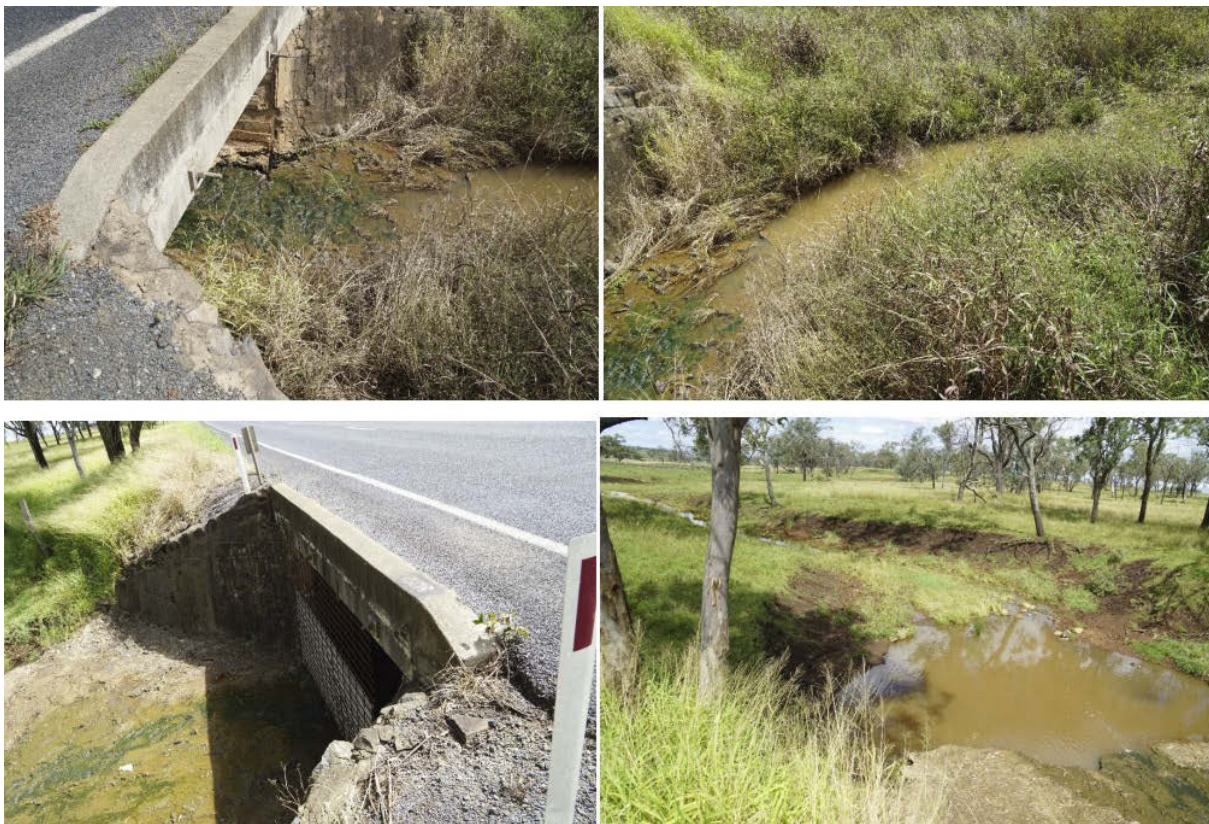
Four sites had channel type or width changes upstream to downstream, indicating moderate (over time) consequence category erosion/deposition (EP6, EP8, site 7a); figures are illustrated in Appendix F. Figure 3.21 is at site EP 6 (NC 2 catchment), where some erosion and undercutting were observed at the transition to natural bed, as well as ponding downstream of culvert. Minor to moderate erosion on true right bank downstream of culvert. Change in channel width upstream to downstream of the culvert from 1 to 2 m to 7 to 15 m wide.

Figure 3.21 Condamine North Branch NC 2 culvert site (EP6) site inspection Cattle creek (2/EP34)

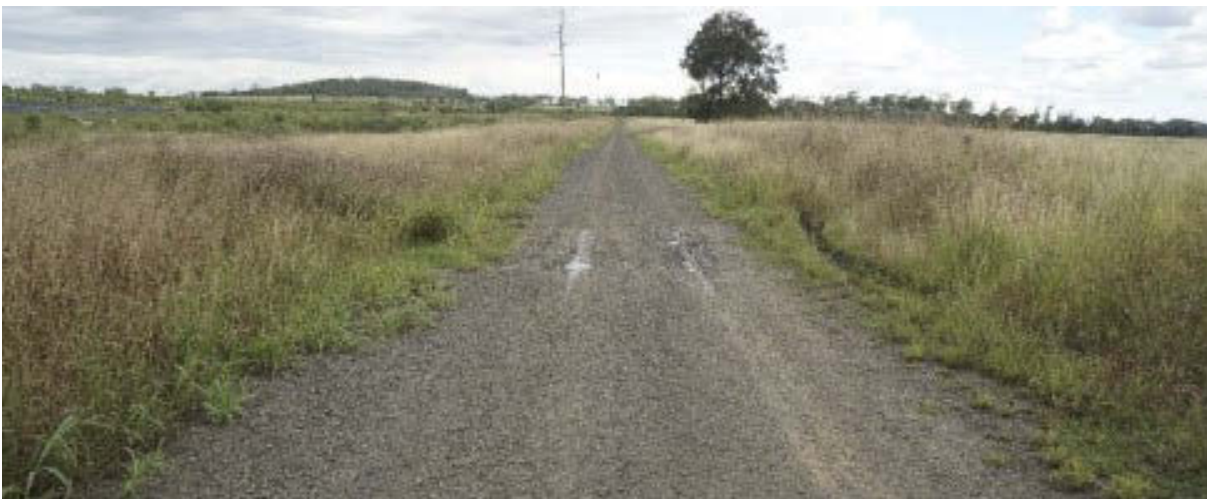
Some channel types, such as non-channelised valley floor flow, are vegetated, and bed/bank material was not able to be observed. Also, many sites had water covering any areas of exposed bed/bank material, and these sites could not be assessed. A total of 29 sites had channels that were either vegetated or underwater during the inspection, and bed/bank material could not be observed. All sites that had vegetated channels were geomorphically stable (Figure 3.22).

**Figure 3.22** Baseline field work site 19, Watercourse (NC 15) flow travels across the road left to right, channel type wash slope/ non-channelised valley floor flow, well vegetated, stable

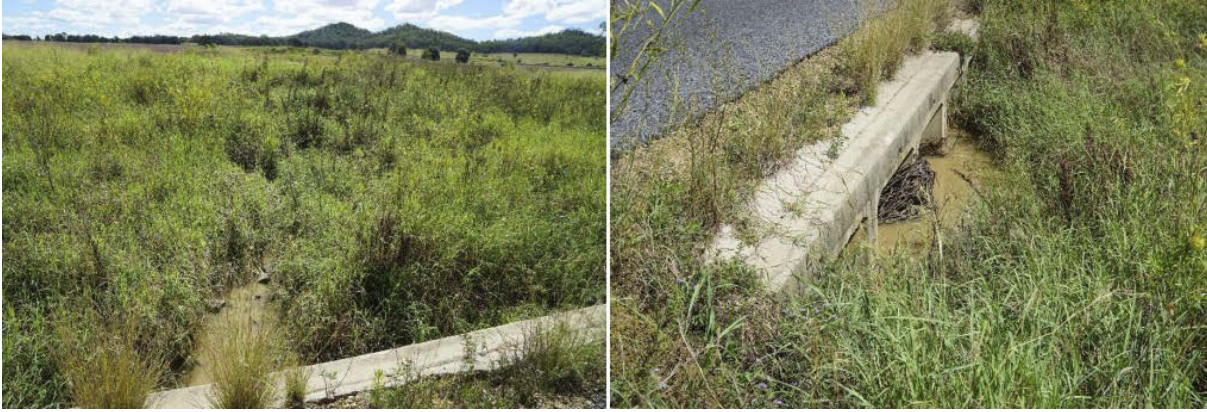
Three of these channels occur in the Condamine and are discussed in Section 3.5.4. The other four channels (Dry Creek, Four Mile Gully, One Mile Gully Creek and SC5) were all mostly vegetated and stable away from the road infrastructure, indicating their vegetated state is a key component of reducing change potential. Adjacent to culvert/bridges, minor erosion and deposition was present (Figure 3.23).

**Figure 3.23** Baseline field work site 8, Watercourse SC 5, channel type wash slope/ non-channelised valley floor flow, away from culvert vegetated and stable

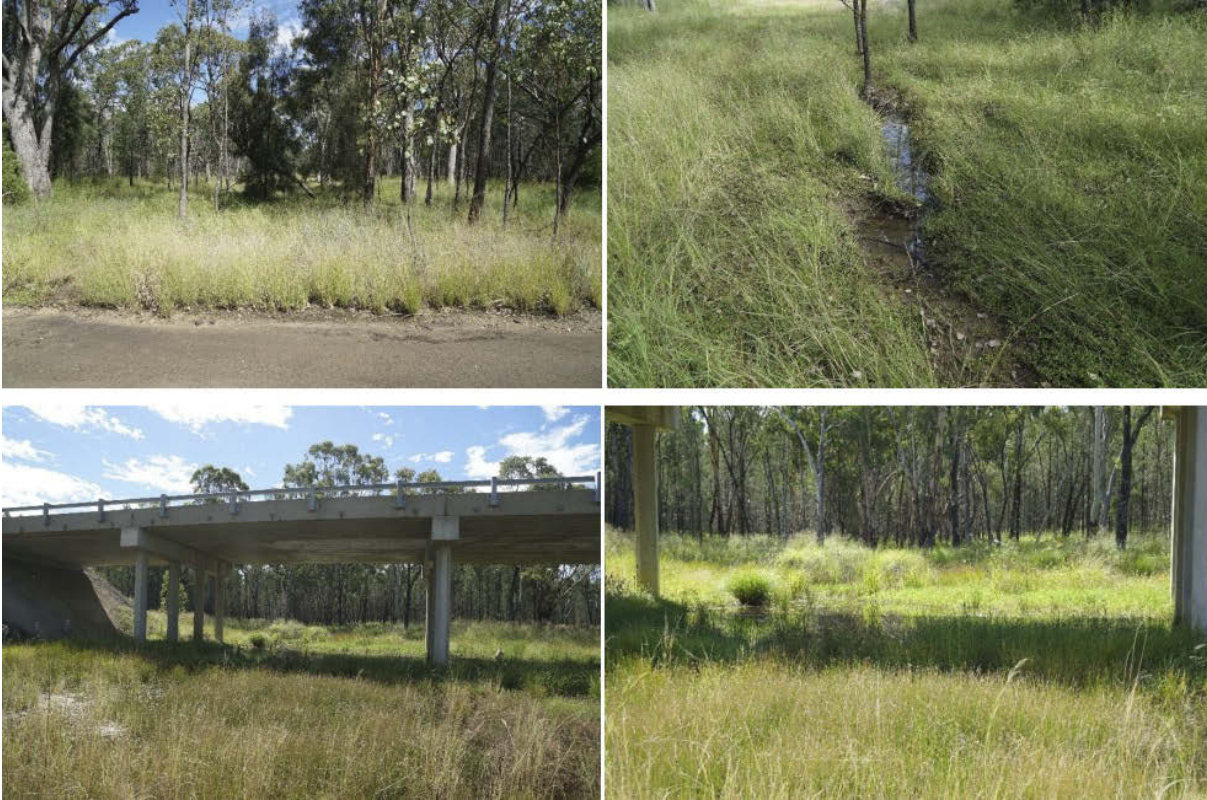
These sites were dominantly in highly erodible sodosols, but also included vertosols, dermosols and kandosol. The amount of erosion appears to be inversely associated with vegetation cover, such that sites with more vegetation cover had less erosion, but this has not been statistically tested. Site MB 5 did not follow this pattern being well vegetated yet exhibiting erosion. This may be due to high proportion of sand bed material, the highest of sites visited.

**Figure 3.24** Baseline field work site 10, Native Dog Creek vegetated non-channelised valley floor flow channel with local areas of very minor erosion, site is also mapped as sodosols

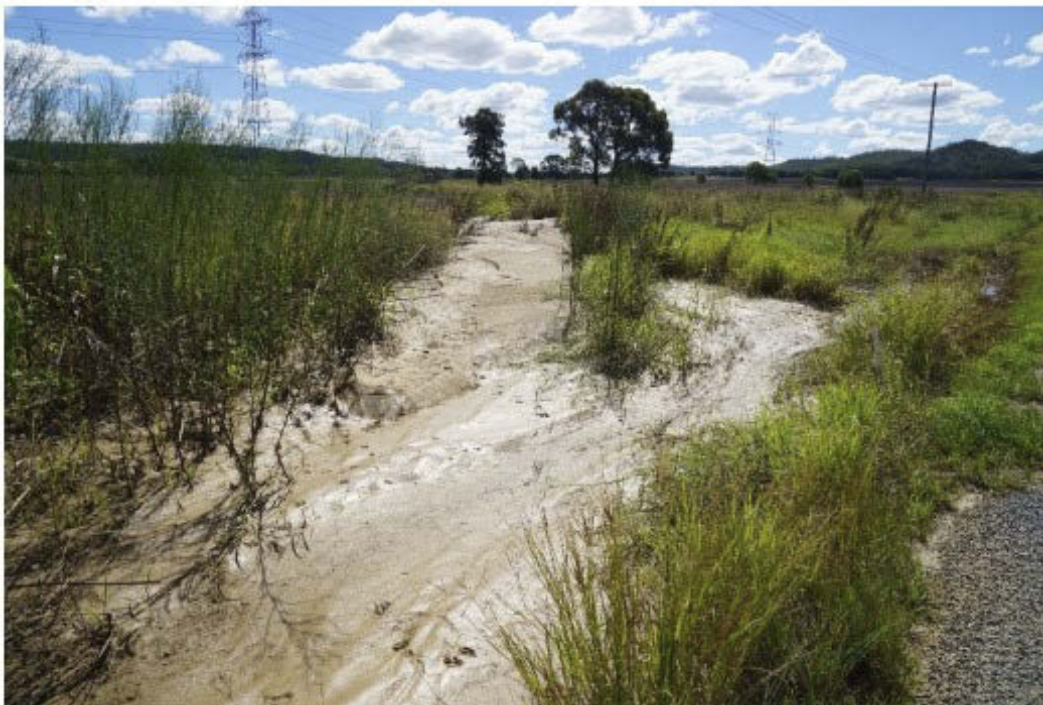
**Figure 3.25** Site 7a – SC 6, deposition has blocked culvert and caused deposition and ponding, indicates erosion occurring upstream of site

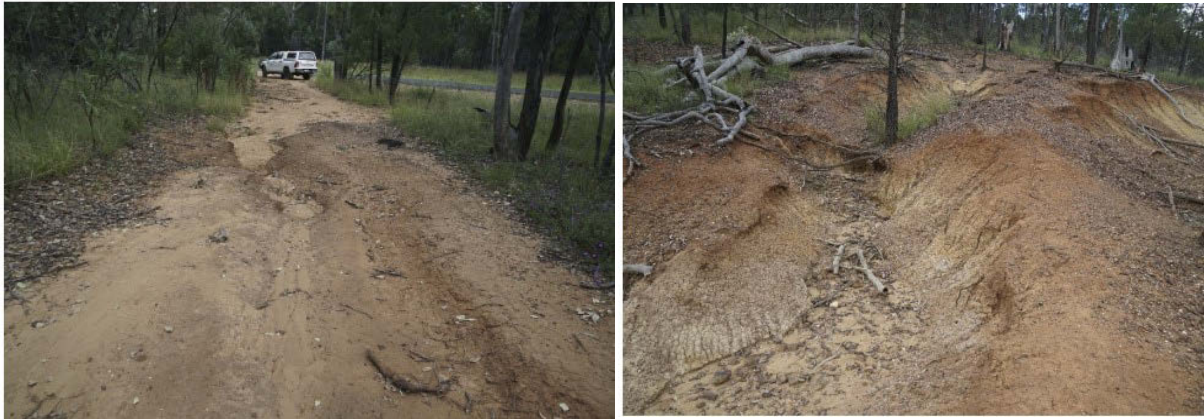
**Figure 3.26** Site 12 – MB 5 approximately 200 m upstream from alignment, intermittent gully erosion occurring, downstream and at alignment channel is non-channelised valley floor with short section of low sinuosity channel

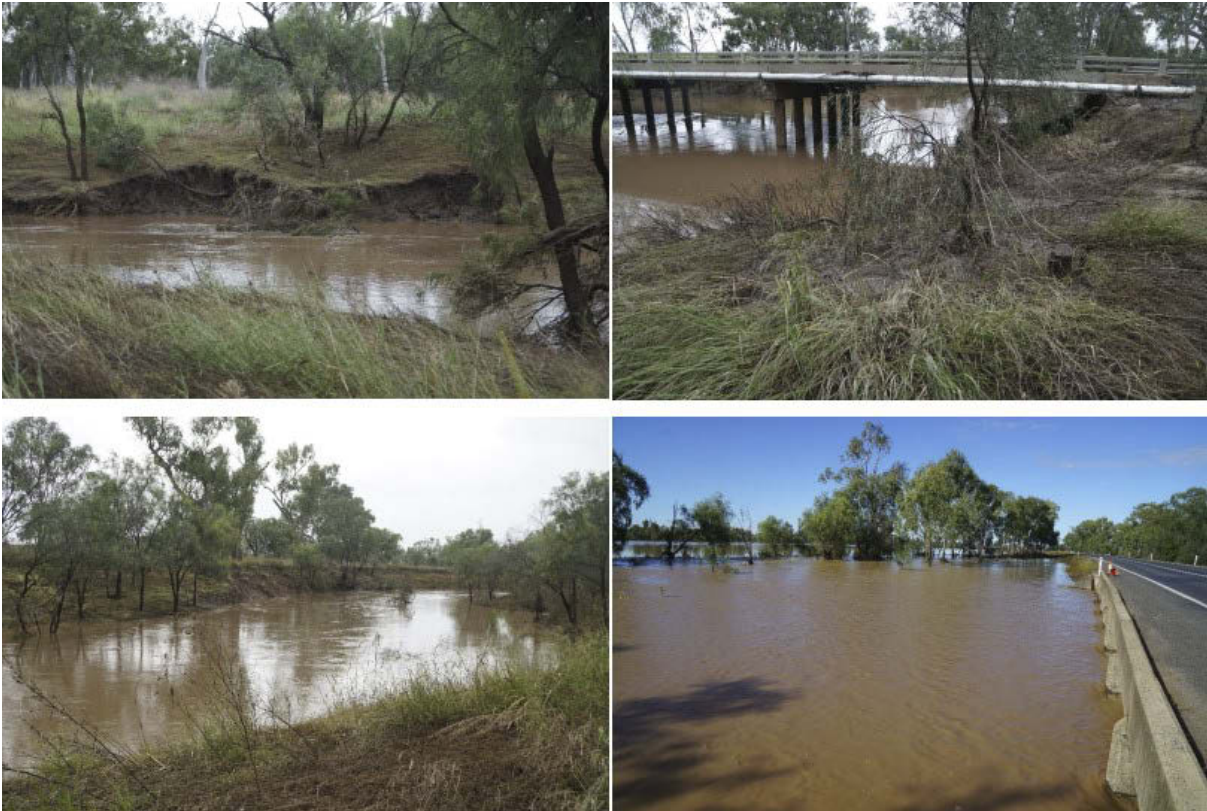
**Figure 3.27** Example of 'major' consequence category on Condamine River Main Branch (field sites 1d/EP16) approximately 2.2 km downstream from the Project alignment on Gore Highway

Examples of 'major' consequence category erosion on the Condamine River Main Branch are shown in Figure 3.27, note that erosion is occurring on the outside of channel bends during an event close to (but slightly above) bank full conditions, which is what would be expected under natural conditions. However, erosion adjacent to the bridge is likely to be associated with the infrastructure.

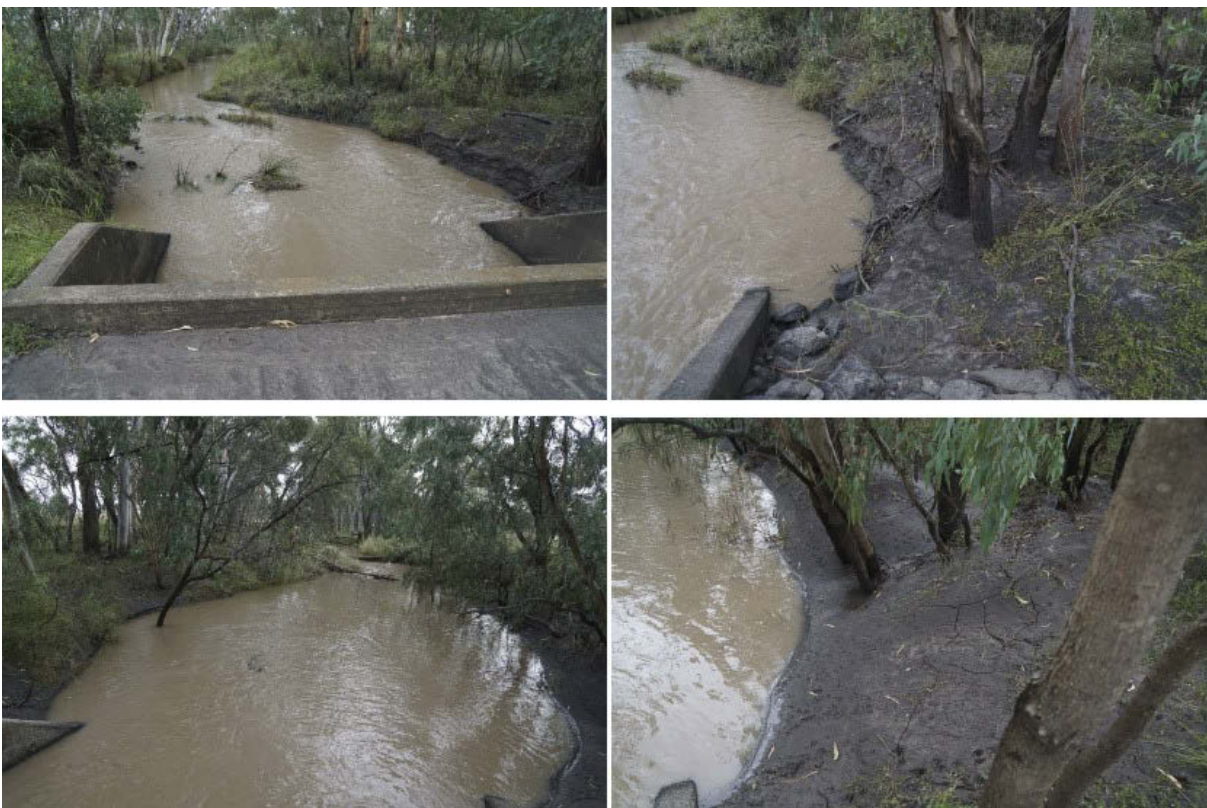
**Figure 3.28** Example of 'moderate' consequence category on the Condamine North Branch (field site 1a) on Hanlon Road, approximately 3 km downstream of the Project alignment

An example of 'moderate' consequence category erosion is shown in Figure 3.28. This erosion is occurring downstream of the bridge on a straight section of channel between two sharp meander bends and is therefore likely directly related to the bridge.

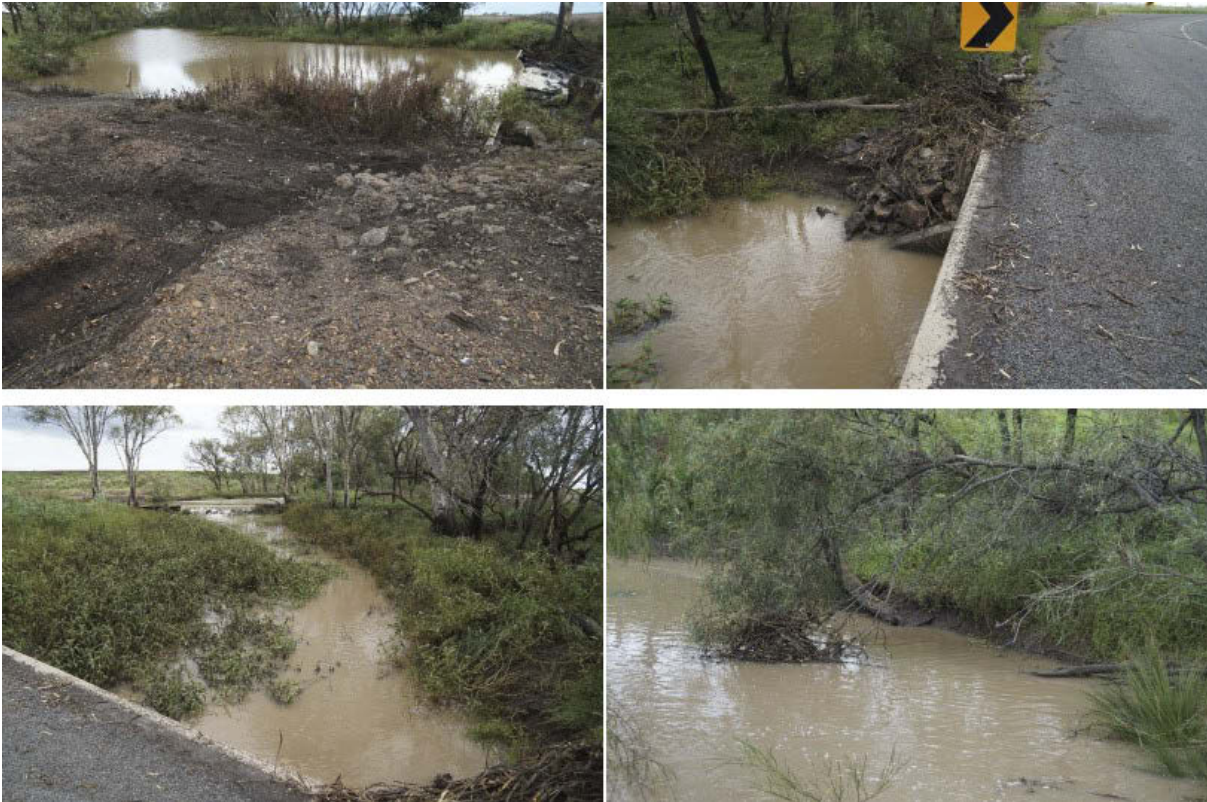
**Figure 3.29** Example of 'minor consequence category on the Condamine North Branch (field site 1b), approximately 800 m upstream of the Project alignment

Figure 3.29 and Figure 3.30 illustrate 'minor' erosion and deposition consequence category. Note that the site in Figure 3.30 on Grasstree Creek, is on a meander bend that is currently being cut off, with the main flow bypassing this meander.

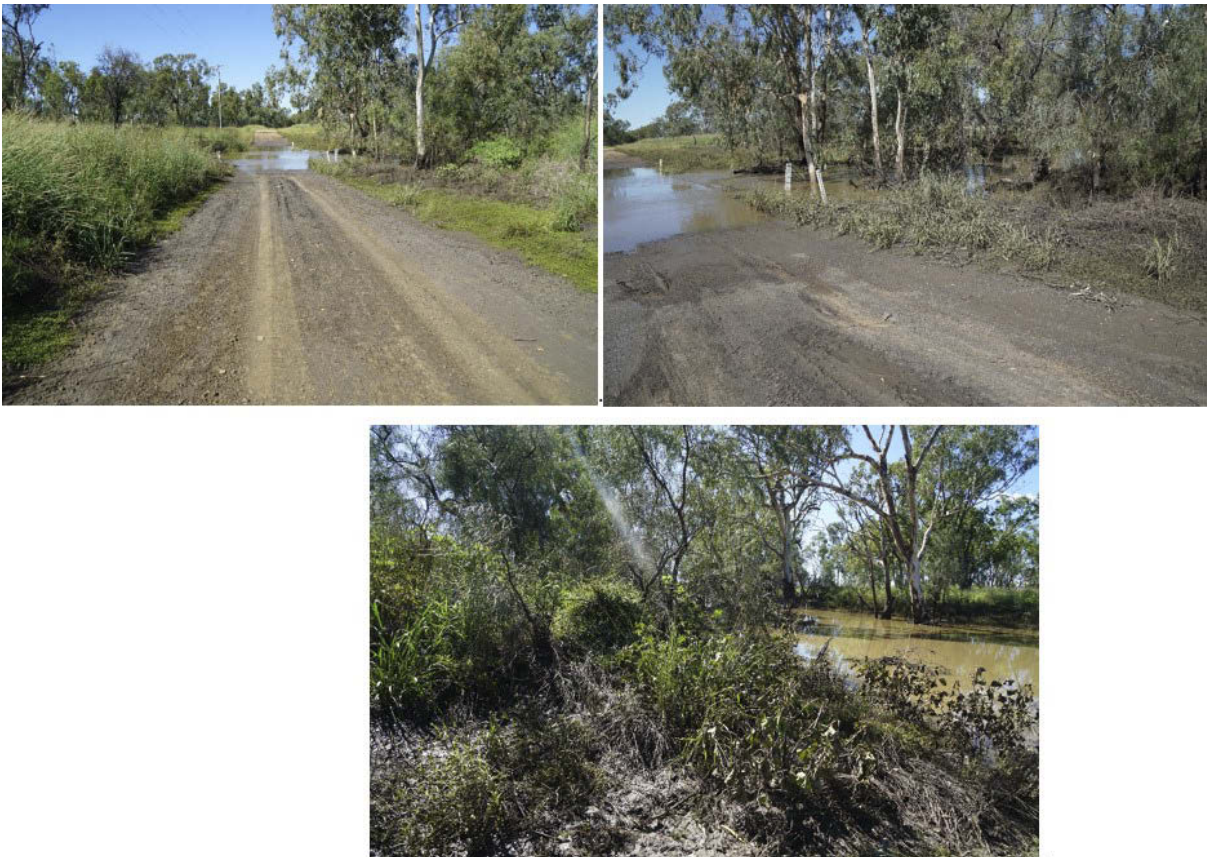
**Figure 3.30** Example of 'minor consequence category on Grasstree Creek (field site EP17), approximately 8.7 km upstream of the Project alignment

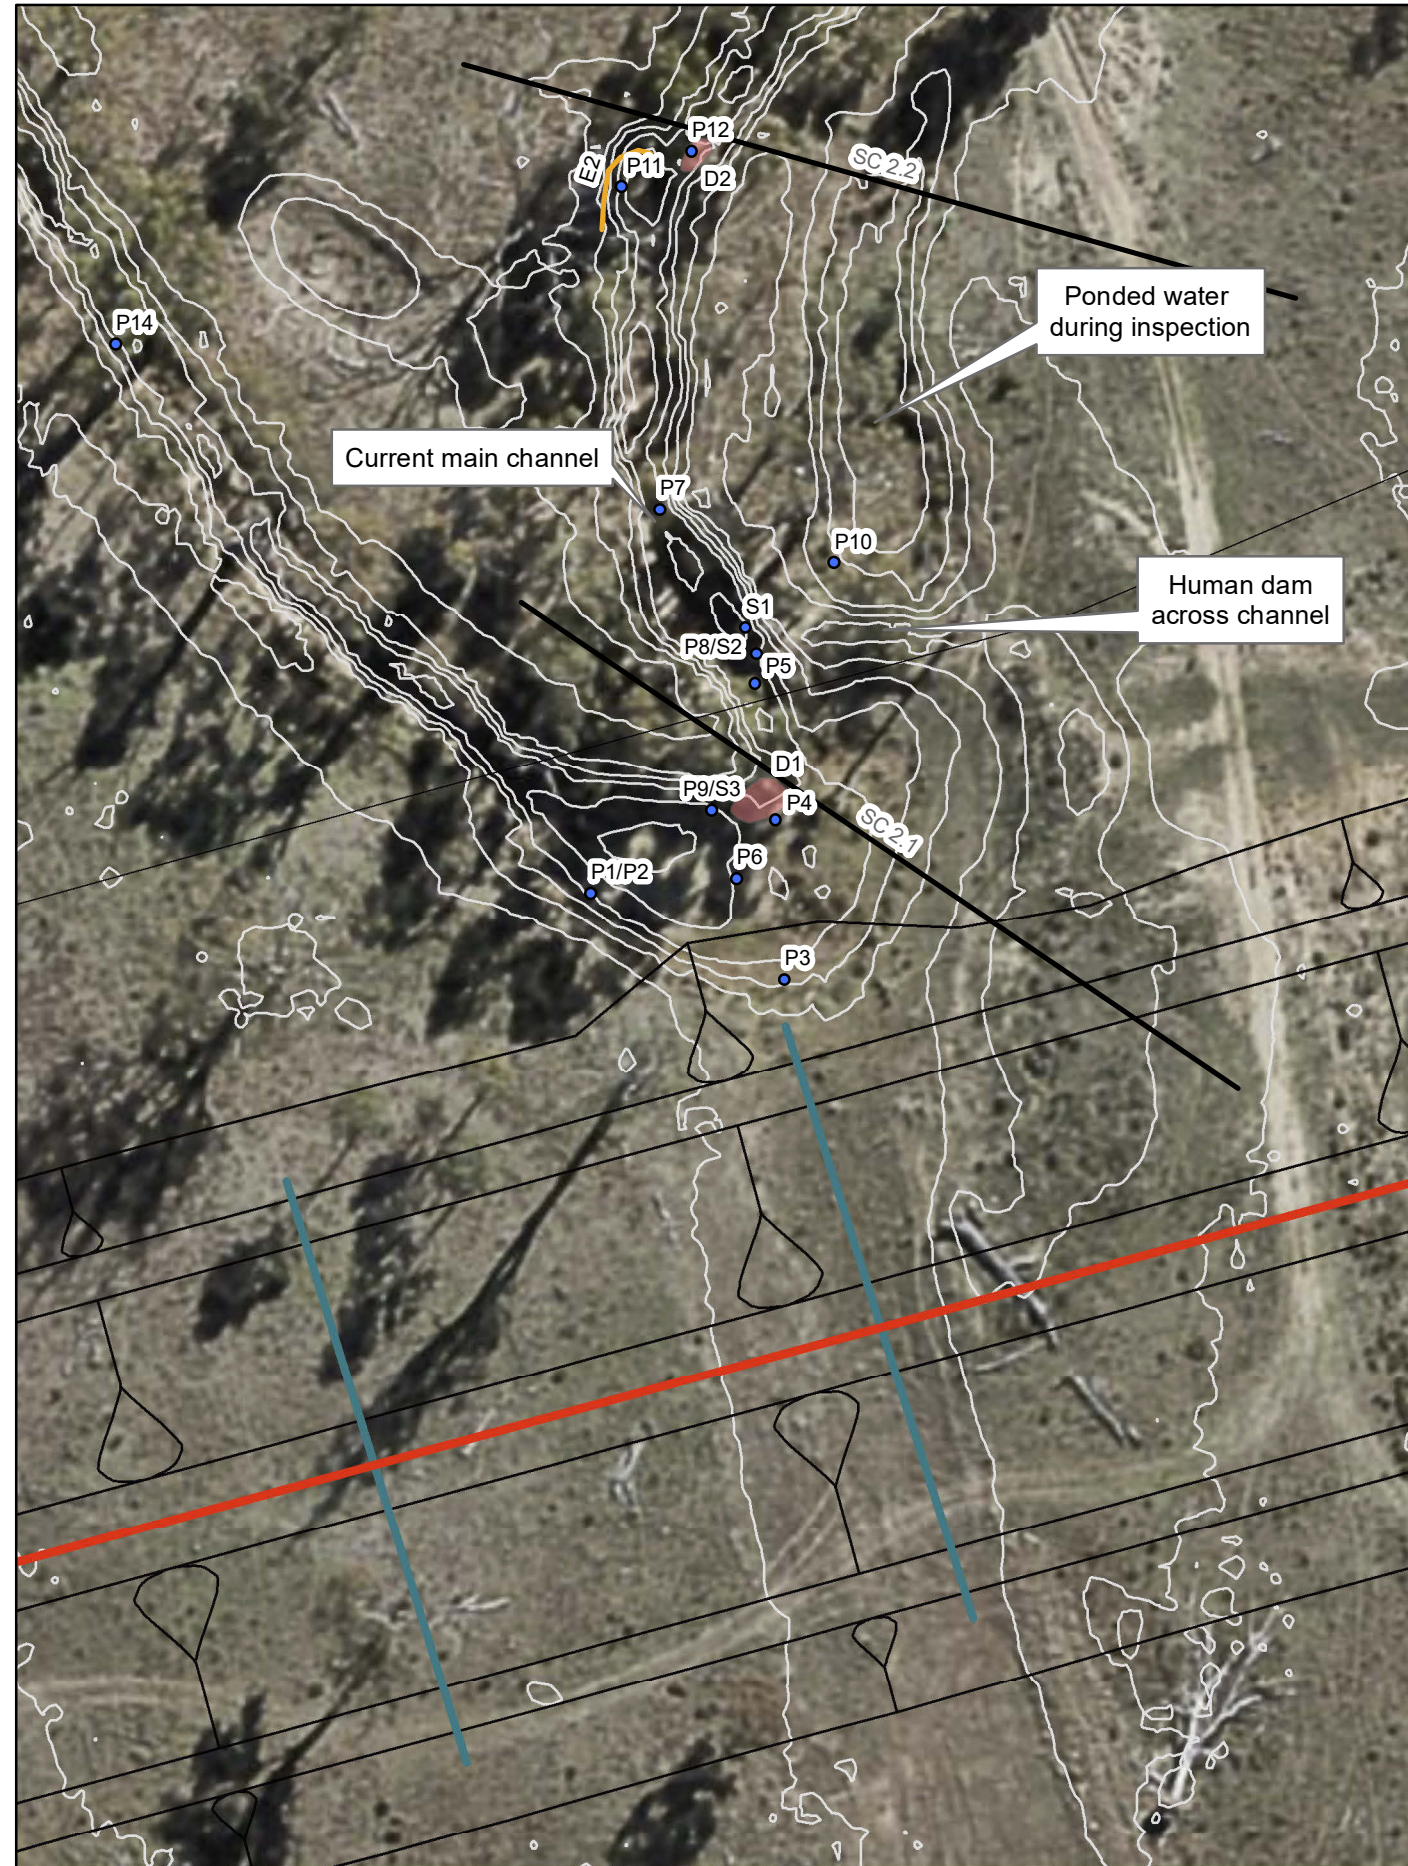
**Border to Gowrie**  
**Drawing Set E.12 of 13**  
**SC2 Geomorphology Map 1**

E2 - Erosion on true left bank on outside of bend, approximately 5 m length, 1.5 - 2 m high bank. Bank material is silty sand.
