**PEMBROKE**

**Olive Downs Coking Coal Project**  
Draft Environmental Impact Statement

**Appendix M**  
**Soil and Land**  
**Suitability**  
**Assessment**

Olive Downs Coking Coal Project

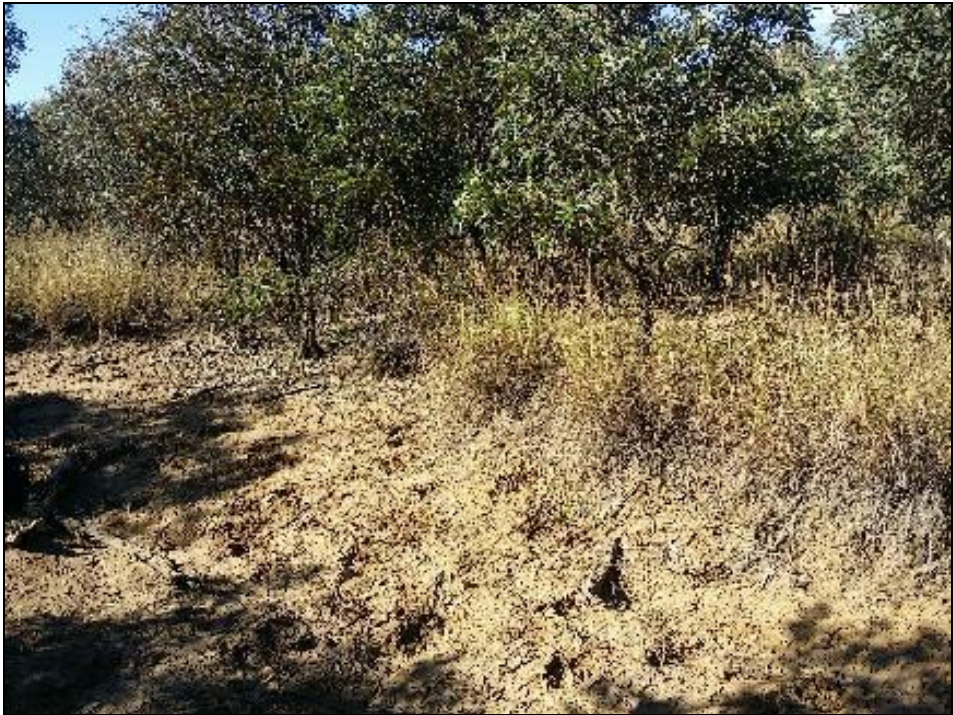
**Table 4: Land Summary for Representative Site 12**

| SMU | C1 | Representative Site Number | Site 12 |
| Site survey type | Detailed.<br>50 mm hand auger. | Vegetation within the SMU | Brigalow, Brigalow with scrub |
| Location (GDA94) | 640307 mE<br>7546621 mN | Disturbance | No effective disturbance |
| Surface coarse fragments | 2%, 2-5 mm coarse fragments and manganese | Surface condition | Surface is firm, cracking with crust, peds >2 mm |

| <b>Erosion potential</b> | <p>This SMU is located on long, flat plains and undulating sloping areas with a firm clay surface. It has a low water erosion hazard in situ.</p> <p>Laboratory results indicated for the mound and depression locations;</p> <p>Mound</p> <ul style="list-style-type: none"> <li>Dispersion Ratio (R1) (Baker et al. 1993) indicate low dispersion ratings (&lt;0.6) within the topsoil soil profile;</li> <li>ESP (sodicity) rating indicates that the topsoil profile is low steadily increasing to sodic levels by 0.60 m to strongly sodic at 0.90 m depth</li> <li>The high Ca/Mg ratio results throughout indicate aggregation of clay particles throughout the profile.</li> </ul> <p>Depression</p> <ul style="list-style-type: none"> <li>Dispersion Ratio (R1) (Baker et al. 1993) indicate low to moderate dispersion ratings (0.6-0.8) within the topsoil soil profile;</li> <li>ESP (sodicity) rating indicates that the topsoil profile is low increasing to sodic and extremely sodic levels from 0.30 m to 0.90 m;</li> <li>Very high Ca/Mg ratio results for topsoil decrease to moderate levels within subsoils indicating soil physical structure and behaviour promoting dispersion clay particles.</li> </ul> <p>Erosion potential for the SMU takes into account the results for both the mound and depression locations. Topsoil erosive qualities are assessed as low however, subsoils have moderate to high dispersive qualities and must be managed appropriately when stockpiling and for reuse of this SMU for rehabilitation activities.</p> |
| <b>Soil quality for mine rehabilitation</b> | <p><u>Recommended topsoil strip depth:</u> 0.00-0.10 mbgl</p> <p><u>Potential topsoil double stripping depth:</u> 0.00-0.20 mbgl</p> <p><u>Recommended topsoil use:</u> Support native vegetation and grasses. For rehabilitation of areas that are relatively flat and very gently undulating areas (less than 3.0% slope)</p> <p><u>Recommended subsoil strip depth:</u> 0.10/0.20–1.00 mbgl</p> <p><u>Recommended subsoil use:</u> Buried supporting subsoils for topsoil</p> |

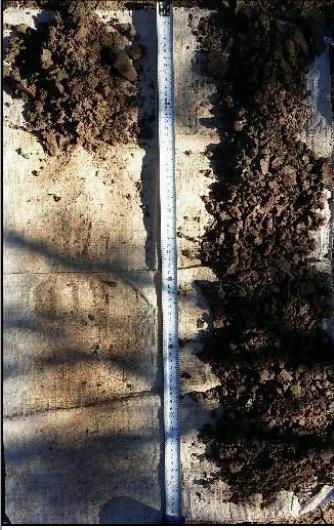
**Table 5: Soil Profile Morphology Summary for Representative Site 12a**

| Site 12a – Depression | Horizon,<br>Depth (m),<br>Boundary | Colour,<br>Mottles,<br>Bleaching | Moisture,<br>Depth (m),<br>Field pH | Texture,<br>Structure,<br>Strength | Coarse<br>Fragments,<br>Roots |
|---|---|---|---|---|---|
| | Horizon:<br>A1<br>Horizon Depth:<br>0.00 – 0.09<br>Boundary:<br>Abrupt | Colour:<br>10YR3/2<br>Very dark<br>greyish<br>brown<br>Mottle:<br>No mottles<br>Bleach:<br>No<br>bleaching | Moisture:<br>Dry<br>Depth:<br>0.05<br>Field pH:<br>6.5<br>Meter pH/EC:<br>7.9 / 0.05 | Texture:<br>Light Clay<br>Structure:<br>Weak, 3-10 mm<br>sub-angular<br>Strength:<br>Firm | Coarse Fragments:<br>2% coarse<br>fragments and<br>manganese, 2-<br>5 mm<br>Roots:<br>Very few, fine<br>down to 0.05 m |
| | Horizon:<br>B2<br>Horizon Depth:<br>0.09-1.00 | Colour:<br>10YR3/3<br>Dark<br>brown<br>Mottle:<br>No mottling<br>Bleach:<br>No<br>bleaching | Moisture:<br>Dry<br>Depth:<br>0.30, 0.60, 0.90<br>Field pH:<br>7.0, 7.0, 7.0<br>Meter pH/EC:<br>8.1 / 0.03 | Texture:<br>Light clay<br>Structure:<br>Moderate,<br>20-50 mm<br>sub-angular<br>Strength:<br>Firm | Coarse Fragments:<br>No coarse<br>fragments<br>Roots:<br>No roots observed |

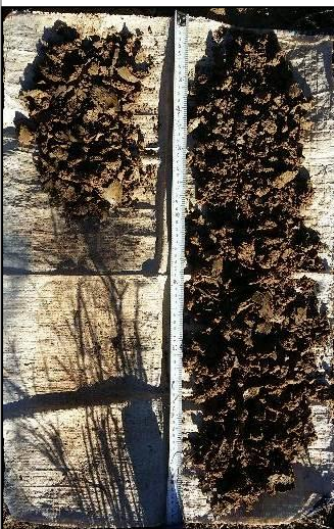
**Table 6: Soil Profile Morphology Summary for Representative Site 12b**

| Site 12b – Mound | Horizon,<br>Depth (m),<br>Boundary | Colour,<br>Mottles,<br>Bleaching | Moisture,<br>Depth (m)<br>Field pH | Texture,<br>Structure,<br>Strength | Coarse<br>Fragments,<br>Roots |
|---|---|---|---|---|---|
| | Horizon:<br>A1<br>Horizon Depth:<br>0.0 – 0.10<br>Boundary:<br>Abrupt | Colour:<br>10YR3/2<br>Very dark<br>greyish<br>brown<br>Mottle:<br>No mottles<br>Bleach:<br>No<br>bleaching | Moisture:<br>Dry<br>Depth:<br>0.05<br>Field pH:<br>6.5<br>Meter pH/EC:<br>7.8 / 0.03 | Texture:<br>Light Clay<br>Structure:<br>Weak, 3-10 mm<br>sub-angular<br>Strength:<br>Firm | Coarse Fragments:<br>2% coarse<br>fragments and<br>manganese, 2-<br>5 mm<br>Roots:<br>Very few, fine<br>down to 0.05 m |
| | Horizon:<br>B2<br>Horizon Depth:<br>0.10-1.00 | Colour:<br>10YR3/3<br>Dark brown<br>Mottle:<br>No mottles<br>Bleach:<br>No<br>bleaching | Moisture:<br>Dry<br>Depth:<br>0.30, 0.60, 0.90<br>Field pH:<br>7.0, 7.0, 7.0<br>Meter pH/EC:<br>8.2 / 0.65 | Texture:<br>Light clay<br>Structure:<br>Moderate,<br>20-50 mm<br>sub-angular<br>Strength:<br>Firm | Coarse Fragments:<br>No coarse<br>fragments<br>Roots:<br>No roots observed |

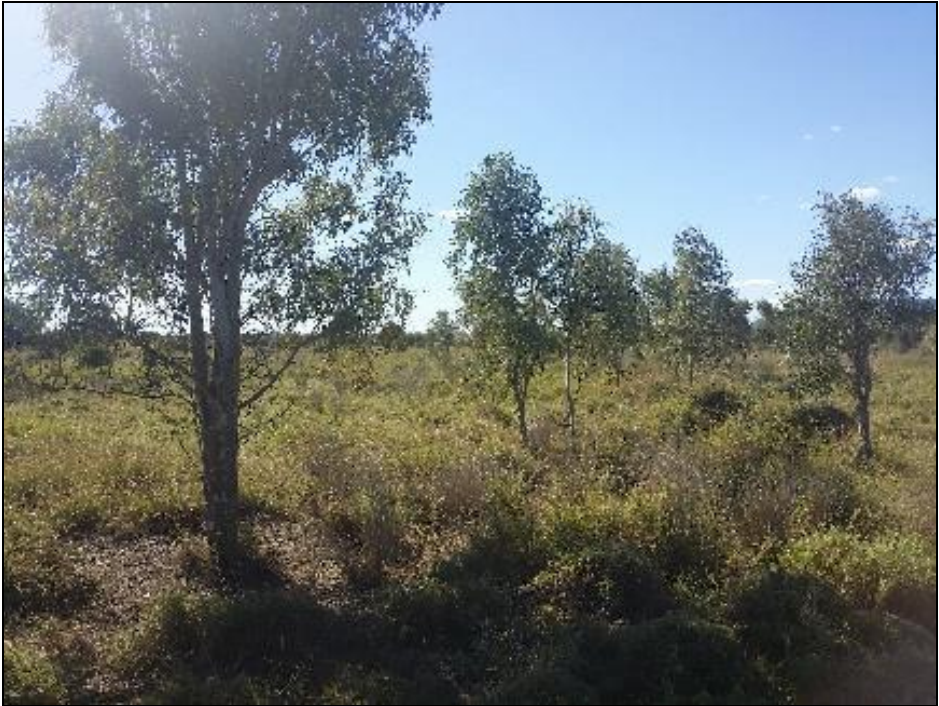
**Table 9: Land Summary for Representative Site 25**

| SMU | C2 | Representative Site Number | Site 25 |
| Site survey type | Detailed.<br>50 mm hand auger. | Vegetation within the SMU | Brigalow |
| Location (GDA94) | 644923 mE 7542220 mN | Disturbance | Slight to extensive clearing |

| <b>Erosion potential</b> | <p>The SMU is generally located on long, flat plains and undulating sloping areas with a firm clay surface. It has a low water erosion hazard in situ.</p> <p>Laboratory results indicated for the mound and depression locations;</p> <p>Mound</p> <ul style="list-style-type: none"> <li>• Dispersion Ratio (R1) (Baker et al. 1993) indicate high dispersion ratings (0.8-0.95) within the topsoil soil profile;</li> <li>• ESP (sodicity) rating indicates the topsoil profile is low increasing sodic (0.30 m) and strongly sodic levels (0.60m) to depth; and</li> <li>• Very high Ca/Mg ratio results throughout indicate aggregation of clay particles throughout the profile.</li> </ul> <p>Depression</p> <ul style="list-style-type: none"> <li>• Dispersion Ratio (R1) (Baker et al. 1993) indicate moderate dispersion ratings (0.6-0.8) within the topsoil soil profile;</li> <li>• ESP (sodicity) rating indicates that the topsoil profile is low increasing to strongly sodic and extremely sodic levels from 0.30 m to 0.90 m; and</li> <li>• Very high Ca/Mg ratio results for topsoil decrease to high levels within subsoils indicating soil physical structure and behaviour promoting dispersion clay particles.</li> </ul> <p>Erosion potential for the SMU takes into account the results for both the mound and depression locations. Topsoil erosive qualities are assessed low to moderate with, subsoils showing preferred high levels of calcium to magnesium, however, ESP indicates poor physical conditions and strong to extremely high levels of sodicity.</p> <p>Subsoils must be managed appropriately when stockpiling and rehabilitation reuse to reduce their dispersive and erosive qualities.</p> |
| <b>Soil quality for mine rehabilitation</b> | <p><u>Recommended topsoil strip depth:</u> 0.00-0.20 mbgl</p> <p><u>Recommended topsoil use:</u> Support native vegetation and grasses. For rehabilitation of areas that are relatively flat and very gently undulating areas (less than 3.0% slope)</p> <p><u>Recommended subsoil strip depth:</u> 0.20 -1.00 mbgl</p> <p><u>Recommended subsoil use:</u> Capping material over waste rock.</p> |

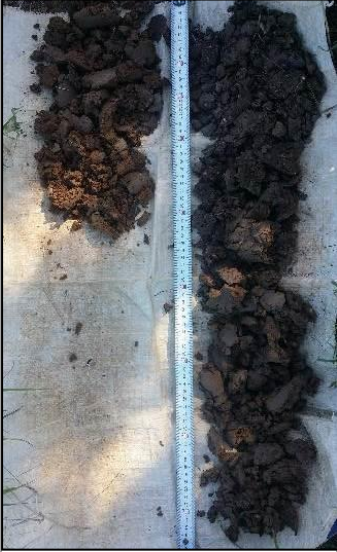
**Table 10: Soil Profile Morphology Summary for Representative Site 25a**

| Site 25a – Depression | Horizon,<br>Depth (m),<br>Boundary | Colour,<br>Mottles,<br>Bleaching | Moisture,<br>Depth (m)<br>Field pH | Texture,<br>Structure,<br>Strength | Coarse<br>Fragments,<br>Roots |
|---|---|---|---|---|---|
| | <i>Horizon:</i><br>A1<br><br><i>Depth:</i><br>0 – 0.21<br><br><i>Boundary:</i><br>Abrupt | <i>Colour:</i><br>10YR4/3<br>Brown<br><br><i>Mottle:</i><br>No mottle<br><br><i>Bleach:</i><br>No<br>bleaching | <i>Moisture:</i><br>Dry, well<br>drained<br><br><i>Depth:</i><br>0.10<br><br><i>Field pH:</i><br>8.0<br><br><i>Meter pH/EC:</i><br>8.4 / 0.08 | <i>Texture:</i><br>Light clay<br><br><i>Structure:</i><br>Weak, <10 mm<br>peds,<br><br><i>Strength:</i><br>Firm | <i>Coarse Fragments:</i><br><2% calcium<br>carbonate<br><br><i>Roots:</i><br>Fine, few |
| | <i>Horizon:</i><br>B21<br><br><i>Depth:</i><br>0.21 – 0.68<br><br><i>Boundary:</i><br>Clear | <i>Colour:</i><br>10YR4/3<br>Brown<br><br><i>Mottle:</i><br>No mottle<br><br><i>Bleach:</i><br>No<br>bleaching | <i>Moisture:</i><br>Moderately<br>moist, well<br>drained<br><br><i>Depth:</i><br>0.30, 0.60<br><br><i>Field pH:</i><br>7.5, 8.0<br><br><i>Meter pH/EC:</i><br>8.7 / 0.32<br>8.6 / 1.03 | <i>Texture:</i><br>Light clay<br><br><i>Structure:</i><br>Weak, <20 mm<br>peds,<br><br><i>Strength:</i><br>Firm | <i>Coarse Fragments:</i><br><2% black nodules<br><5 mm<br><br><i>Roots:</i><br>Very fine, few |
| | <i>Horizon:</i><br>B22<br><br><i>Depth:</i><br>0.68 – 1.00 | <i>Colour:</i><br>10YR4/4<br>Dark yellow<br>brown<br><br><i>Mottle:</i><br>No mottle<br><br><i>Bleach:</i><br>No<br>bleaching | <i>Moisture:</i><br>Moderately<br>moist, well<br>drained<br><br><i>Depth:</i><br>0.90<br><br><i>Field pH:</i><br>8.0<br><br><i>Meter pH/EC:</i><br>8.4 / 0.95 | <i>Texture:</i><br>Light clay<br><br><i>Structure:</i><br>Moderate,<br><20 mm peds,<br><br><i>Strength:</i><br>Firm | <i>Coarse Fragments:</i><br><2% black nodules<br><5 mm<br><br><i>Roots:</i><br>No roots observed |

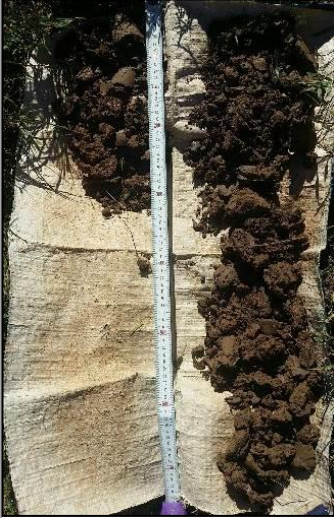
**Table 11: Soil Profile Morphology Summary for Representative Site 25b**

| Site 25b – Mound | Horizon,<br>Depth (m),<br>Boundary | Colour,<br>Mottles,<br>Bleaching | Moisture,<br>Depth (m)<br>Field pH | Texture,<br>Structure,<br>Strength | Coarse<br>Fragments,<br>Roots |
|---|---|---|---|---|---|
| | <i>Horizon:</i><br>A1<br><br><i>Depth:</i><br>0 – 0.21<br><br><i>Boundary:</i><br>Abrupt | <i>Colour:</i><br>10YR4/3<br><br>Brown<br><br><i>Mottle:</i><br>No mottle<br><br><i>Bleach:</i><br>No<br>bleaching | <i>Moisture:</i><br>Dry, well<br>drained<br><br><i>Depth:</i><br>0.10<br><br><i>Field pH:</i><br>8.0<br><br><i>Meter pH/EC:</i><br>8.2 / 0.08 | <i>Texture:</i><br>Light clay<br><br><i>Structure:</i><br>Weak, <10 mm<br>peds<br><br><i>Strength:</i><br>Firm | <i>Coarse Fragments:</i><br><2% calcium<br>carbonate<br><br><i>Roots:</i><br>Fine, few |
| | <i>Horizon:</i><br>B21<br><br><i>Depth:</i><br>0.21 – 0.76<br><br><i>Boundary:</i><br>Clear | <i>Colour:</i><br>10YR4/3<br><br>Brown<br><br><i>Mottle:</i><br>No mottle<br><br><i>Bleach:</i><br>No<br>bleaching | <i>Moisture:</i><br>Moderately<br>moist, well<br>drained<br><br><i>Depth:</i><br>0.30, 0.60<br><br><i>Field pH:</i><br>7.5, 8.0<br><br><i>Meter pH/EC:</i><br>8.7 / 0.98<br>8.6 / 1.84 | <i>Texture:</i><br>Light clay<br><br><i>Structure:</i><br>Weak, <20 mm<br>peds,<br><br><i>Strength:</i><br>Firm | <i>Coarse Fragments:</i><br><2% black nodules<br><5 mm<br><br><i>Roots:</i><br>Very fine, few |
| | <i>Horizon:</i><br>B22<br><br><i>Depth:</i><br>0.76 – 1.00 | <i>Colour:</i><br>10YR4/4<br><br>Dark yellow<br>brown<br><br><i>Mottle:</i><br>No mottle<br><br><i>Bleach:</i><br>No<br>bleaching | <i>Moisture:</i><br>Moderately<br>moist, well<br>drained<br><br><i>Depth:</i><br>0.90<br><br><i>Field pH:</i><br>8.0<br><br><i>Meter pH/EC:</i><br>8.5 / 1.88 | <i>Texture:</i><br>Light clay<br><br><i>Structure:</i><br>Moderate,<br><20 mm peds,<br><br><i>Strength:</i><br>Firm | <i>Coarse Fragments:</i><br><2% black nodules<br><5 mm<br><br><i>Roots:</i><br>No roots observed |

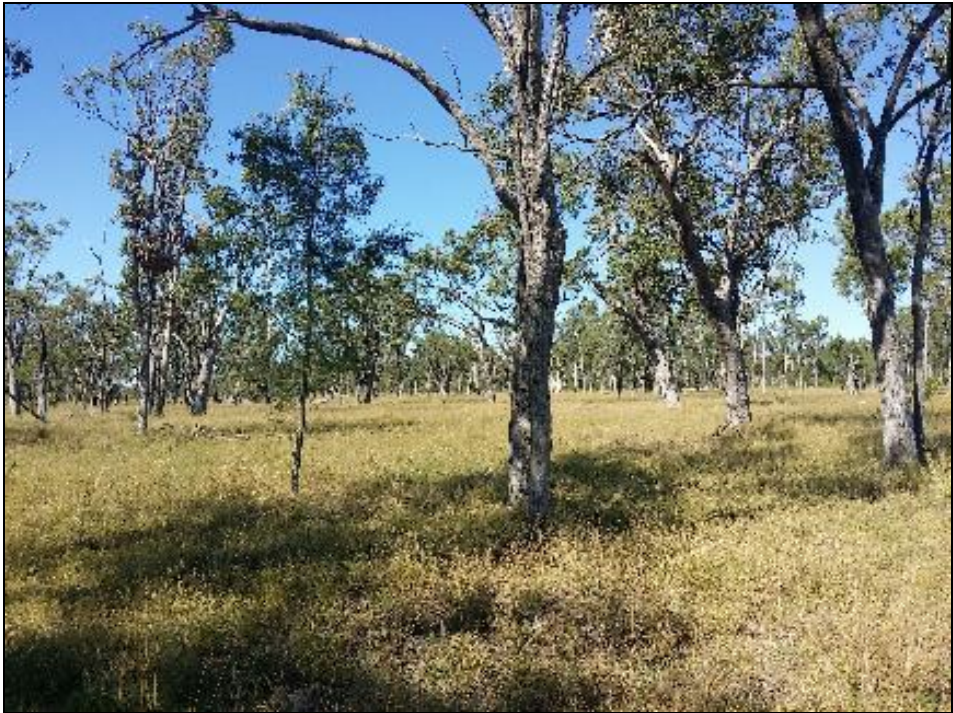
**Table 14: Land Summary for Representative Site 2**

| SMU | S1 | Representative Site Number | Site 2 |
| Site survey type | Detailed.<br>50 mm hand auger. | Vegetation within the SMU | Ironbark, Bloodwood, Blackbutt |
| Location (GDA94) | 638862 mE<br>7548002 mN | Disturbance | No effective disturbance |
| Surface coarse<br>fragments | No coarse<br>fragments | Surface condition | Surface is hard setting |

| <b>Erosion potential</b> | <p>The SMU is generally located on gently undulating sloping areas with a sandy surface. It has a low to medium water erosion hazard in situ.</p> <p>Laboratory results indicated for the mound and depression locations;</p> <ul style="list-style-type: none"> <li>• Dispersion Ratio (R1) (Baker et al. 1993) indicate high dispersion ratings (0.8-0.95) within the topsoil soil profile;</li> <li>• ESP (sodicity) rating indicates that the topsoil profile is very low increasing to sodic and strongly sodic levels from 0.60 m to 0.90 m;</li> <li>• Very high Ca/Mg ratio results for topsoil decrease to moderate levels within subsoils indicating soil physical structure and behaviour promoting dispersion clay particles.</li> </ul> <p>Erosion potential through dispersion is assessed low within topsoil with minor dispersive qualities. Subsoils are considered moderate with an increase in sodicity levels and a reduction in Ca/Mg ratio which will promote dispersion qualities. Subsoils are not recommended for surface rehabilitation due to poor structure and binding capacity when wet. Appropriate management of exposed earths and stockpiling of subsoils is recommended.</p> |
| <b>Soil quality for mine rehabilitation</b> | <p><u>Recommended topsoil strip depth:</u> 0.00-0.30 mbgl</p> <p><u>Recommended topsoil use:</u> Support native vegetation and grasses. For rehabilitation of areas that are relatively flat to sloped areas such as backfill batters.</p> <p><u>Recommended subsoil strip depth:</u> 0.30–1.00 mbgl</p> <p><u>Recommended subsoil use:</u> Buried supporting subsoils for topsoil</p> |

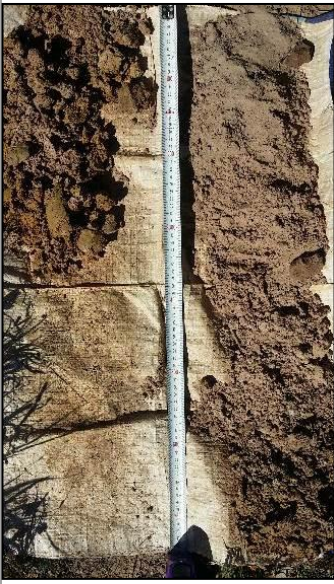
**Table 15: Soil Profile Morphology Summary for Representative Site 2**

| Site 2 | Horizon,<br>Depth (m)<br>Boundary | Colour,<br>Mottles,<br>Bleaching | Moisture,<br>Depth (m)<br>Field pH | Texture,<br>Structure,<br>Strength | Coarse<br>Fragments,<br>Roots |
|---|---|---|---|---|---|
| | <i>Horizon:</i><br>A11<br><i>Horizon Depth:</i><br>0.00 – 0.20<br><i>Boundary:</i><br>Abrupt | <i>Colour:</i><br>10YR3/4<br>Dark yellow brown<br><i>Mottle:</i><br>No mottles<br><i>Bleach:</i><br>None | <i>Moisture:</i><br>Dry<br><i>Depth:</i><br>0.10<br><i>Field pH:</i><br>6.5<br><i>Meter pH/EC:</i><br>6.3 / 0.01 | <i>Texture:</i><br>Loamy sand<br><i>Structure:</i><br>Massive<br><i>Strength:</i><br>Loose | <i>Coarse Fragments:</i><br>No coarse fragments<br><i>Roots:</i><br>Very fine, few |
| | <i>Horizon:</i><br>A12<br><i>Horizon Depth:</i><br>0.20 – 0.60<br><i>Boundary:</i><br>Abrupt | <i>Colour:</i><br>10YR4/3<br>Brown<br><i>Mottle:</i><br>No mottles<br><i>Bleach:</i><br>None | <i>Moisture:</i><br>Dry<br><i>Depth:</i><br>0.30<br><i>Field pH:</i><br>7.0<br><i>Meter pH/EC:</i><br>6.8 / 0.00 | <i>Texture:</i><br>Loamy sand<br><i>Structure:</i><br>Massive<br><i>Strength:</i><br>Very weak | <i>Coarse Fragments:</i><br>No coarse fragments<br><i>Roots:</i><br>No roots observed |
| | <i>Horizon:</i><br>B21<br><i>Horizon Depth:</i><br>0.60 – 1.00 | <i>Colour:</i><br>10YR4/3<br>Brown<br><i>Mottle:</i><br>5% 10YR5/8<br>Yellowish brown<br><i>Bleach:</i><br>None | <i>Moisture:</i><br>Dry<br><i>Depth:</i><br>0.60 / 0.90<br><i>Field pH:</i><br>7.5 / 7.5<br><i>Meter pH/EC:</i><br>7.6 / 0.03 | <i>Texture:</i><br>Clay loam sandy<br><i>Structure:</i><br>Strong structure, sub angular peds <10 mm<br><i>Strength:</i><br>Very firm | <i>Coarse Fragments:</i><br><2% manganese nodules<br><i>Roots:</i><br>No roots observed |

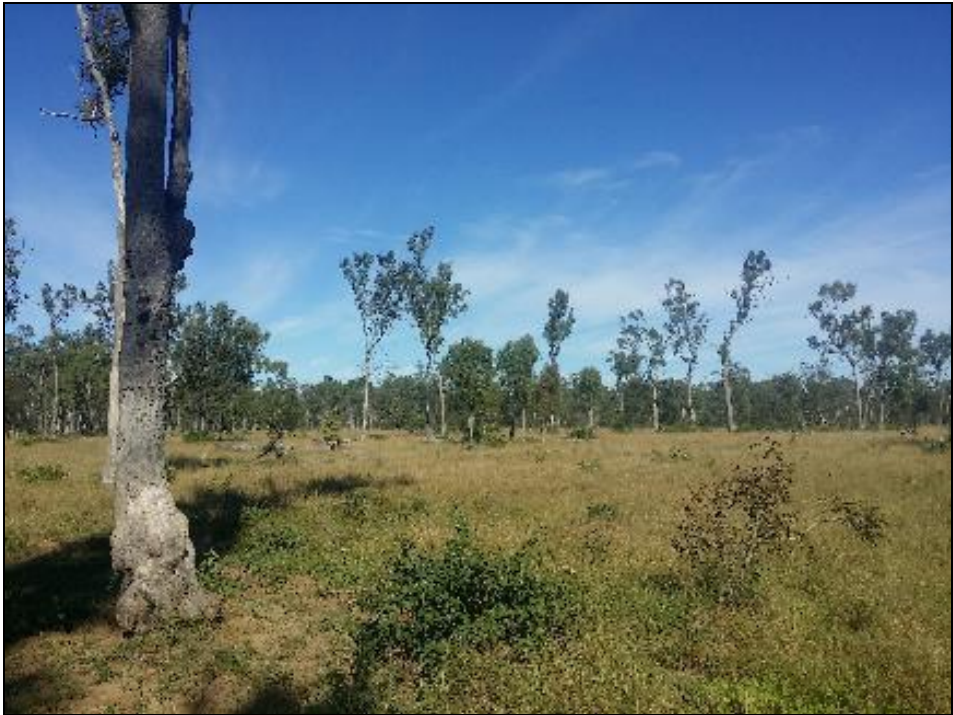
**Table 17: Land Summary for Representative Site 8**

| SMU | S2 | Representative Site Number | Site 8 |
| Site survey type | Detailed.<br>50 mm hand auger. | Vegetation within the SMU | Blackbutt, Assorted Eucalyptus |
| Location (GDA94) | 640823 mE<br>7547668 mN | Disturbance | No effective disturbance |
| Surface coarse<br>fragments | No coarse<br>fragments | Surface condition | Surface is firm, no coarse fragments |

| <b>Erosion potential</b> | <p>The SMU is generally located on very gently undulating sloping areas with a sandy surface. It has a low to medium water erosion hazard in situ.</p> <p>Laboratory results indicated;</p> <ul style="list-style-type: none"> <li>Dispersion Ratio (R1) (Baker et al. 1993) indicate moderate dispersion ratings (0.6-0.8) within the topsoil profile;</li> <li>ESP (sodicity) rating indicates very low to low levels; and</li> <li>the high Ca/Mg ratio results throughout promotes aggregation of clay particles and low dispersive qualities.</li> </ul> <p>Erosion potential through dispersion is assessed as low throughout the soil profile.</p> |
| <b>Soil quality for mine rehabilitation</b> | <p><u>Recommended topsoil strip depth:</u> 0.00-0.50 mbgl</p> <p><u>Recommended topsoil use:</u> Support native vegetation and grasses. For rehabilitation of areas that are relatively flat to sloped areas such as backfill batters.</p> <p><u>Recommended subsoil strip depth:</u> 0.50–1.00 mbgl</p> <p><u>Potential subsoil use:</u> Natural vegetation growth assistance with additional soil fertility conditioning and potentially increase topsoil reserves. Buried supporting subsoils for topsoil</p> |

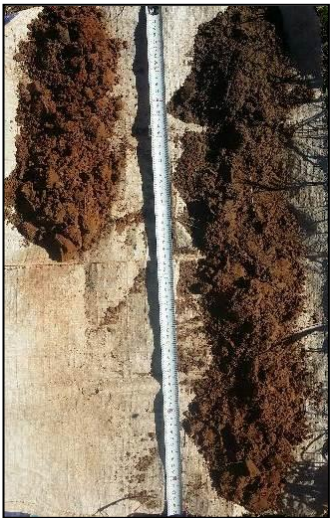
**Table 18: Soil Profile Morphology Summary for Representative Site 8**

| Site 8 | Horizon,<br>Depth (m)<br>Boundary | Colour,<br>Mottles,<br>Bleaching | Moisture,<br>Depth (m)<br>Field pH | Texture,<br>Structure,<br>Strength | Coarse<br>Fragments,<br>Roots |
|---|---|---|---|---|---|
| | <p><i>Horizon:</i> A1</p> <p><i>Horizon Depth:</i> 0 – 0.23</p> <p><i>Boundary:</i> Abrupt</p> | <p><i>Colour:</i> 10YR3/2</p> <p><i>Dark brown</i></p> <p><i>Mottle:</i> No mottles</p> <p><i>Bleach:</i> No bleaching</p> | <p><i>Moisture:</i> Dry, well drained</p> <p><i>Depth:</i> 0.1</p> <p><i>Field pH:</i> 6.5</p> <p><i>Meter pH/EC:</i> 6.6 / 0.01</p> | <p><i>Texture:</i> Clayey sand</p> <p><i>Structure:</i> Weak, peds &lt;10 mm</p> <p><i>Strength:</i> Very weak,</p> | <p><i>Coarse Fragments:</i> No coarse fragments</p> <p><i>Roots:</i> Very fine, few</p> |
| | <p><i>Horizon:</i> B21</p> <p><i>Horizon Depth:</i> 0.23 – 0.57</p> <p><i>Boundary:</i> Gradual</p> | <p><i>Colour:</i> 10YR3/3</p> <p><i>Dark brown</i></p> <p><i>Mottle:</i> No mottles</p> <p><i>Bleach:</i> No bleaching</p> | <p><i>Moisture:</i> Dry, humid</p> <p><i>Depth:</i> 0.3</p> <p><i>Field pH:</i> 6.5</p> <p><i>Meter pH/EC:</i> 6.7 / 0.01</p> | <p><i>Texture:</i> Loamy sand</p> <p><i>Structure:</i> Weak, peds &lt;10 mm</p> <p><i>Strength:</i> Very weak</p> | <p><i>Coarse Fragments:</i> No coarse fragments</p> <p><i>Roots:</i> No roots observed</p> |
| | <p><i>Horizon:</i> B21</p> <p><i>Horizon Depth:</i> 0.57 – 1.00</p> | <p><i>Colour:</i> 7.5YR4/4</p> <p><i>Dark brown</i></p> <p><i>Mottle:</i> No mottles</p> <p><i>Bleach:</i> No bleaching</p> | <p><i>Moisture:</i> Dry, humid</p> <p><i>Depth:</i> 0.6, 0.9</p> <p><i>Field pH:</i> 7.0, 6.5</p> <p><i>Meter pH/EC:</i> 7.1 / 0.00</p> | <p><i>Texture:</i> Loamy sand</p> <p><i>Structure:</i> Moderate, peds 5-20 mm</p> <p><i>Strength:</i> Weak</p> | <p><i>Coarse Fragments:</i> No coarse fragments</p> <p><i>Roots:</i> No roots observed</p> |

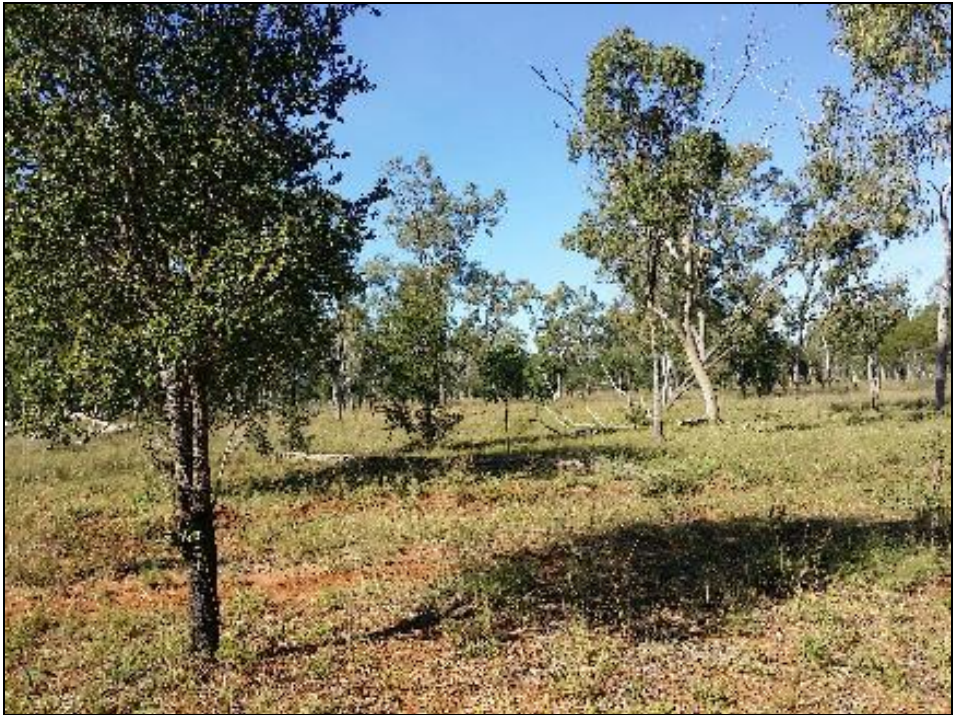
**Table 20: Land Summary for Representative Site 49**

| SMU | R1 | Representative Site Number | Site 49 |
| Site survey type | Detailed.<br>50 mm hand auger. | Vegetation within the SMU | Assorted Eucalypts and Wattle spp. |
| Location (GDA94) | 643862 mE<br>7535154 mN | Disturbance | Limited clearing |
| Surface coarse<br>fragments | No coarse<br>fragments | Surface condition | Surface is soft, no coarse fragments |

| <b>Erosion potential</b> | <p>The SMU is generally located on crests and undulating sloping areas with a sandy surface. It has a low to medium water erosion hazard in situ.</p> <p>Laboratory results indicated;</p> <ul style="list-style-type: none"> <li>• Dispersion Ratio (R1) (Baker et al. 1993) indicate low to moderate dispersion ratings (0.6) within the topsoil;</li> <li>• ESP (sodicity) rating indicates very low to low levels; and</li> <li>• very high Ca/Mg ratio results throughout promotes aggregation of clay particles and low dispersive qualities.</li> </ul> <p>Erosion potential through dispersion is assessed as low throughout the soil profile. Appropriate management of bare earths must be considered when stockpiling and rehabilitation reuse.</p> |
| <b>Soil quality for mine rehabilitation</b> | <p><u>Recommended topsoil strip depth:</u> 0.00-0.35 mbgl</p> <p><u>Recommended topsoil use:</u> Support native vegetation and grasses. For rehabilitation of areas that are relatively flat to sloped areas such as backfill batters.</p> <p><u>Recommended subsoil strip depth:</u> 0.35–1.00 mbgl</p> <p><u>Potential subsoil use:</u> Natural vegetation growth assistance with additional soil fertility conditioning and potentially increase topsoil reserves. Buried supporting subsoils for topsoil.</p> |

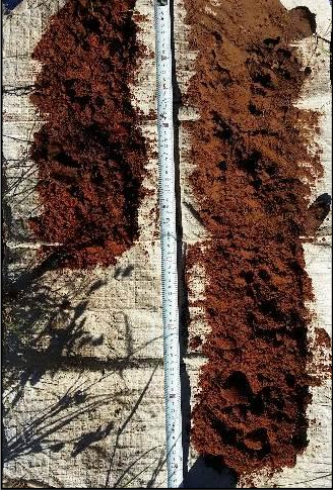
**Table 21: Soil Profile Morphology Summary for Representative Site 49**

| Site 49 | Horizon,<br>Depth (m)<br>Boundary | Colour,<br>Mottles,<br>Bleaching | Moisture,<br>Depth (m)<br>Field pH | Texture,<br>Structure,<br>Strength | Coarse<br>Fragments,<br>Roots |
|---|---|---|---|---|---|
| | <i>Horizon:</i><br>A11<br><i>Horizon Depth:</i><br>0.00 – 0.10<br><i>Boundary:</i><br>Abrupt | <i>Colour:</i><br>2.5YR3/3<br>Dark reddish brown<br><i>Mottle:</i><br>No mottles<br><i>Bleach:</i><br>No bleaching | <i>Moisture:</i><br>Dry, rapid<br><i>Depth:</i><br>0.05<br><i>Field pH:</i><br>6.5<br><i>Meter pH/EC:</i><br>6.4 / 0.00 | <i>Texture:</i><br>Loamy sand<br><i>Structure:</i><br>Massive<br><i>Strength:</i><br>Loose | <i>Coarse Fragments:</i><br>No coarse fragments<br><i>Roots:</i><br>Very fine, very few |
| | <i>Horizon:</i><br>A12<br><i>Horizon Depth:</i><br>0.10 – 0.37<br><i>Boundary:</i><br>Abrupt | <i>Colour:</i><br>2.5YR3/4<br>Dark reddish brown<br><i>Mottle:</i><br>No mottles<br><i>Bleach:</i><br>No bleaching | <i>Moisture:</i><br>Dry, rapid<br><i>Depth:</i><br>0.30<br><i>Field pH:</i><br>6.5 | <i>Texture:</i><br>Loamy sand<br><i>Structure:</i><br>Massive<br><i>Strength:</i><br>Loose | <i>Coarse Fragments:</i><br>No coarse fragments<br><i>Roots:</i><br>Very fine, very few |
| | <i>Horizon:</i><br>A21<br><i>Horizon Depth:</i><br>0.37 – 0.80<br><i>Boundary:</i><br>Abrupt | <i>Colour:</i><br>2.5YR2.5/3<br>Very dusky red<br><i>Mottle:</i><br>No mottles<br><i>Bleach:</i><br>No bleaching | <i>Moisture:</i><br>Dry, well drained<br><i>Depth:</i><br>0.60<br><i>Field pH:</i><br>6.5<br><i>Meter pH/EC:</i><br>6.5 / 0.00 | <i>Texture:</i><br>Loamy sand<br><i>Structure:</i><br>Weak, rounded peds <20 mm<br><i>Strength:</i><br>Weak | <i>Coarse Fragments:</i><br>No coarse fragments<br><i>Roots:</i><br>Very fine, very few |
| | <i>Horizon:</i><br>A22<br><i>Horizon Depth:</i><br>0.80 – 1.00 | <i>Colour:</i><br>2.5YR2.5/3<br>Very dusky red<br><i>Mottle:</i><br>No mottles<br><i>Bleach:</i><br>No bleaching | <i>Moisture:</i><br>Dry, well drained<br><i>Depth:</i><br>0.90<br><i>Field pH:</i><br>6.5 | <i>Texture:</i><br>Loamy sand<br><i>Structure:</i><br>Weak, rounded peds <20 mm<br><i>Strength:</i><br>Weak | <i>Coarse Fragments:</i><br><5% Manganese nodules<br><i>Roots:</i><br>No roots observed |

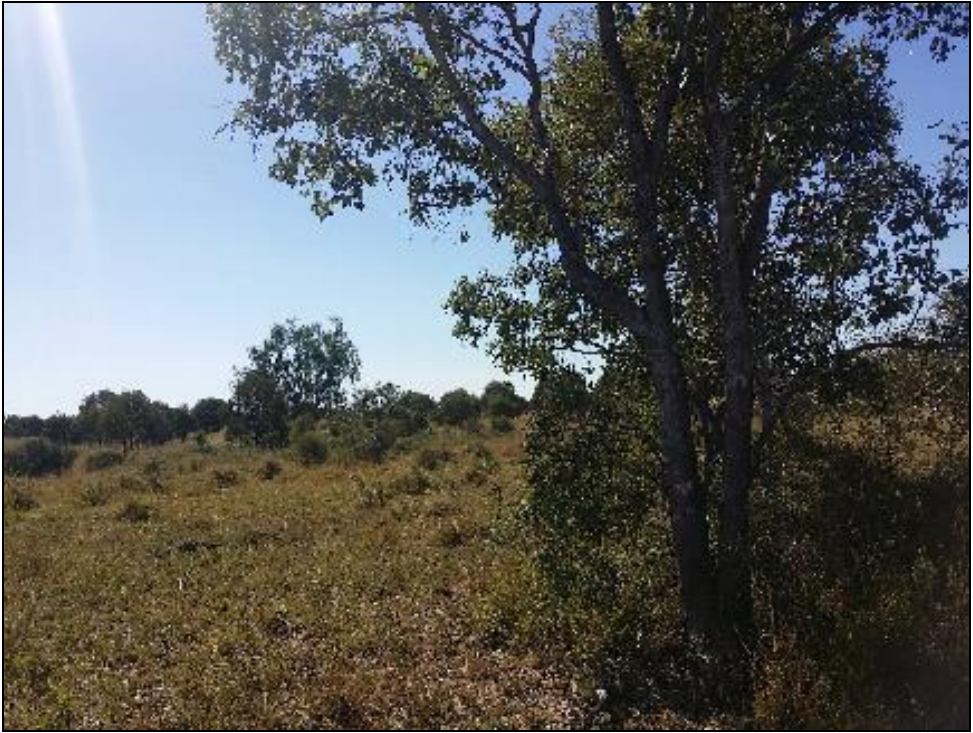
**Table 23: Land Summary for Representative Site 131**

| SMU | R2 | Representative Site Number | Site 131 |
| Site survey type | Detailed.<br>50 mm hand auger. | Vegetation within the SMU | Blackbutt, Eucalypts and wattles |
| Location (GDA94) | 656738 mE<br>7527426 mN | Disturbance | No effective disturbance |
| Surface coarse<br>fragments | No coarse<br>fragments | Surface condition | Surface is firm, no coarse fragments |

| <b>Erosion potential</b> | <p>The SMU is generally located on very undulating sloping areas with a sandy surface. It has a low to medium water erosion hazard in situ.</p> <p>Laboratory results indicated;</p> <ul style="list-style-type: none"> <li>• Dispersion Ratio (R1) (Baker et al. 1993) indicate low dispersion ratings (&lt;0.6) within the topsoil profile;</li> <li>• ESP (sodicity) rating indicates that the topsoil profile is very low to low levels. Subsoils are assessed as non-sodic;</li> <li>• Very high to high Ca/Mg ratio results throughout indicate aggregation of clay particles.</li> </ul> <p>Erosion potential through dispersion is considered low however, appropriate management of bare earths must be considered when stockpiling and rehabilitation reuse.</p> |
| <b>Soil quality for mine rehabilitation</b> | <p><u>Recommended topsoil strip depth:</u> 0.00-0.50 mbgl</p> <p><u>Recommended topsoil use:</u> Support native vegetation and grasses. For rehabilitation of areas that are relatively flat to sloped areas such as backfill batters.</p> <p><u>Recommended subsoil strip depth:</u> 0.50–1.00 mbgl</p> <p><u>Potential subsoil use:</u> Natural vegetation growth assistance with additional soil fertility conditioning and potentially increase topsoil reserves. Buried supporting subsoils for topsoil.</p> |

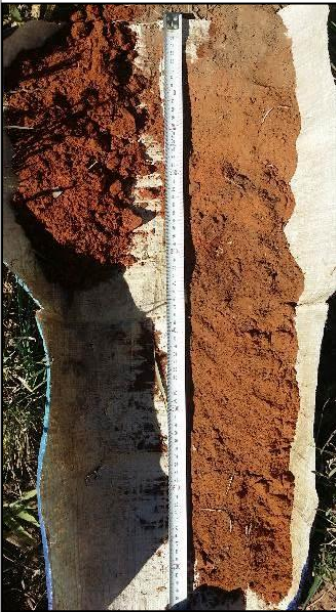
**Table 24: Soil Profile Morphology Summary for Representative Site 131**

| Site 131 | Horizon,<br>Depth (m)<br>Boundary | Colour,<br>Mottles,<br>Bleaching | Moisture,<br>Depth (m)<br>Field pH | Texture,<br>Structure,<br>Strength | Coarse<br>Fragments,<br>Roots |
|---|---|---|---|---|---|
| | <i>Horizon:</i><br>A11<br><i>Horizon Depth:</i><br>0.00 – 0.09<br><i>Boundary:</i><br>Abrupt | <i>Colour:</i><br>10YR4/3<br><i>Brown</i><br><i>Mottle:</i><br>No mottles | <i>Moisture:</i><br>Dry, rapid<br><i>Depth:</i><br>0.05<br><i>Field pH:</i><br>7.0<br><i>Meter pH/EC:</i><br>6.4 / 0.00 | <i>Texture:</i><br>Loamy sand<br><i>Structure:</i><br>Massive<br><i>Strength:</i><br>Weak | <i>Coarse Fragments:</i><br>No coarse fragments<br><i>Roots:</i><br>Very fine, very few |
| | <i>Horizon:</i><br>A12<br><i>Horizon Depth:</i><br>0.09 – 0.60<br><i>Boundary:</i><br>Diffuse | <i>Colour:</i><br>5YR3/3<br><i>Dark reddish brown</i><br><i>Mottle:</i><br>No mottles | <i>Moisture:</i><br>Dry, rapid<br><i>Depth:</i><br>0.30, 0.60<br><i>Field pH:</i><br>7.0, 7.0 | <i>Texture:</i><br>Loamy sand<br><i>Structure:</i><br>Massive<br><i>Strength:</i><br>Weak | <i>Coarse Fragments:</i><br>No coarse fragments<br><i>Roots:</i><br>Very fine, very few |
| | <i>Horizon:</i><br>B2<br><i>Horizon Depth:</i><br>0.60 – 1.00<br><i>Boundary:</i><br> | <i>Colour:</i><br>2.5YR3/3<br><i>Dark reddish brown</i><br><i>Mottle:</i><br>No mottles | <i>Moisture:</i><br>Dry, well drained<br><i>Depth:</i><br>0.90<br><i>Field pH:</i><br>7.0<br><i>Meter pH/EC:</i><br>6.8 / 0.00 | <i>Texture:</i><br>Sandy clay loam<br><i>Structure:</i><br>Moderate rounded peds 10-30mm<br><i>Strength:</i><br>Weak | <i>Coarse Fragments:</i><br>No coarse fragments<br><i>Roots:</i><br>No roots observed |

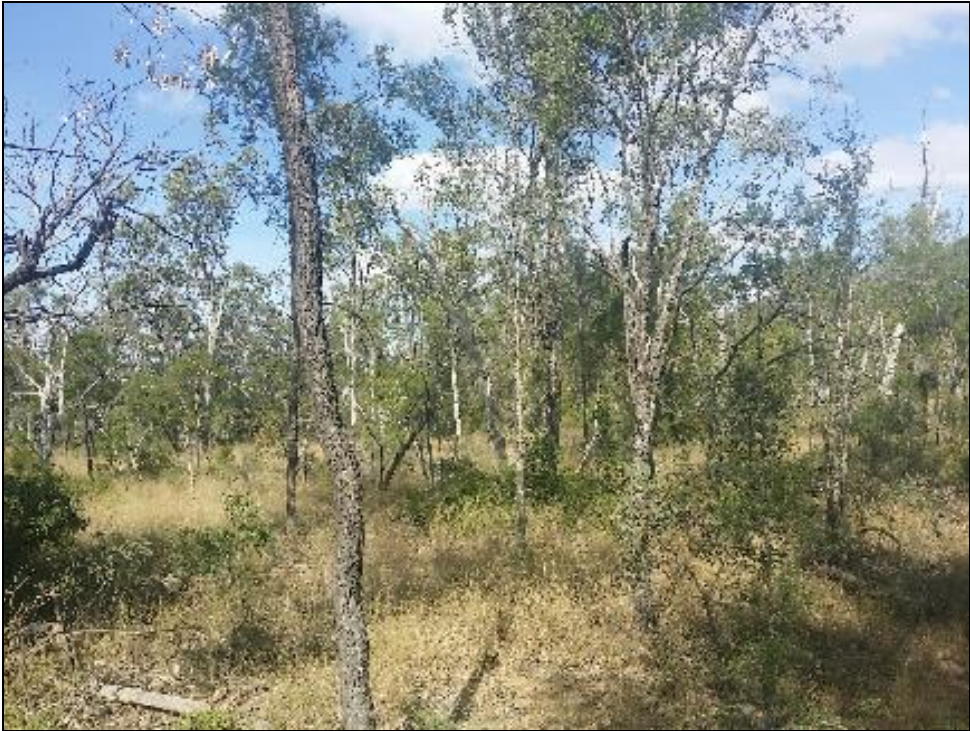
**Table 26: Land Summary for Representative Site 68**

| SMU | L1 | Representative Site Number | Site 68 |
|---|---|---|---|
| Surface coarse fragments | No coarse fragments | Surface condition | Surface is hard setting, very minor cracking, no coarse fragments |

| <b>Erosion potential</b> | <p>The SMU is generally located level to very gently undulating sloping areas with a sandy surface. It has a low water erosion hazard in situ.</p> <p>Laboratory results indicated;</p> <ul style="list-style-type: none"> <li>• Dispersion Ratio (R1) (Baker et al. 1993) indicate low dispersion ratings (&lt;0.6) within the topsoil profile;</li> <li>• ESP (sodicity) rating indicates the topsoil profile is non-sodic. Subsoils are assessed as strongly sodic; and</li> <li>• high Ca/Mg ratio within topsoil results throughout, indicates aggregation of clay particles. Moderate to high levels within subsoils indicate the subsoils have poor physical conditions with dispersive qualities.</li> </ul> <p>Erosion potential through dispersion is assessed as low within topsoil. Subsoils are assessed as moderate with an increase in sodicity levels and a reduction in Ca/Mg ratio promoting dispersion qualities.</p> <p>Subsoils are not recommended for surface rehabilitation due to poor structure and binding capacity when wet. Appropriate management of exposed earths and stockpiling of subsoils is recommended.</p> |
| <b>Soil quality for mine rehabilitation</b> | <p><u>Recommended topsoil strip depth:</u> 0.00-0.10 mbgl</p> <p><u>Recommended topsoil use:</u> Support native vegetation and grasses. For rehabilitation of areas that are relatively flat to sloped areas such as backfill batters.</p> <p><u>Recommended subsoil strip depth:</u> 0.10–0.35 mbgl</p> <p><u>Recommended subsoil use:</u> Buried supporting subsoils for topsoil. Soils below 0.35 m are not recommended to be reused however may be marginally suitable with possible use as capping material over waste rock.</p> |

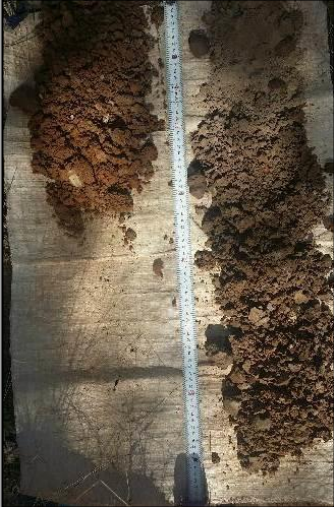
**Table 27: Soil Profile Morphology Summary for Representative Site 68**

| Site 68 | Horizon,<br>Depth (m)<br>Boundary | Colour,<br>Mottles,<br>Bleaching | Moisture,<br>Depth (m)<br>Field pH | Texture,<br>Structure,<br>Strength | Coarse<br>Fragments,<br>Roots |
|---|---|---|---|---|---|
| | Horizon:<br>A1<br>Horizon Depth:<br>0.00 – 0.18<br>Boundary:<br>Abrupt | Colour:<br>10YR4/2<br>Dark greyish brown<br>Mottle:<br>No mottle<br>Bleach:<br>No bleaching | Moisture:<br>Dry, rapid<br>Depth:<br>0.10<br>Field pH:<br>6.5<br>Meter pH/EC:<br>6.5 / 0.01 | Texture:<br>Clayey sand<br>Structure:<br>Massive<br>Strength:<br>Weak | Coarse Fragments:<br>No coarse fragments<br>Roots:<br>Very few, very fine |
| | Horizon:<br>B21<br>Horizon Depth:<br>0.18 – 0.35<br>Boundary:<br>Abrupt | Colour:<br>10YR3/3<br>Dark brown<br>Mottle:<br>No mottle<br>Bleach:<br>No bleaching | Moisture:<br>Dry, well drained<br>Depth:<br>0.30<br>Field pH:<br>6.5<br>Meter pH/EC:<br>7.4 / 0.27 | Texture:<br>Light clay<br>Structure:<br>Moderate sub-angular peds 10-20 mm<br>Strength:<br>Firm | Coarse Fragments:<br>No coarse fragments<br>Roots:<br>No roots observed |
| | Horizon:<br>B22<br>Horizon Depth:<br>0.35 – 0.75<br>Boundary:<br>Abrupt | Colour:<br>10YR4/4<br>Dark yellowish brown<br>Mottle:<br>No mottle<br>Bleach:<br>No bleaching | Moisture:<br>Dry, well drained<br>Depth:<br>0.60<br>Field pH:<br>7.5<br>Meter pH/EC:<br>8.3 / 0.71 | Texture:<br>Light clay<br>Structure:<br>Hard. Moderate sub-angular peds 10-20 mm,<br>Strength:<br>Strong | Coarse Fragments:<br><2% calcium carbonate<br>Roots:<br>No roots observed |
| | Horizon:<br>B23<br>Horizon Depth:<br>0.75 – 1.00 | Colour:<br>7.5YR4/3<br>Brown<br>Mottle:<br>No mottle<br>Bleach:<br>No bleaching | Moisture:<br>Dry, well drained<br>Depth:<br>0.90<br>Field pH:<br>7.5<br>Meter pH/EC:<br>8.4 / 0.72 | Texture:<br>Light clay<br>Structure:<br>Moderate sub-angular peds 10-20 mm, very<br>Strength:<br>Strong | Coarse Fragments:<br><2% calcium carbonate<br>Roots:<br>No roots observed |

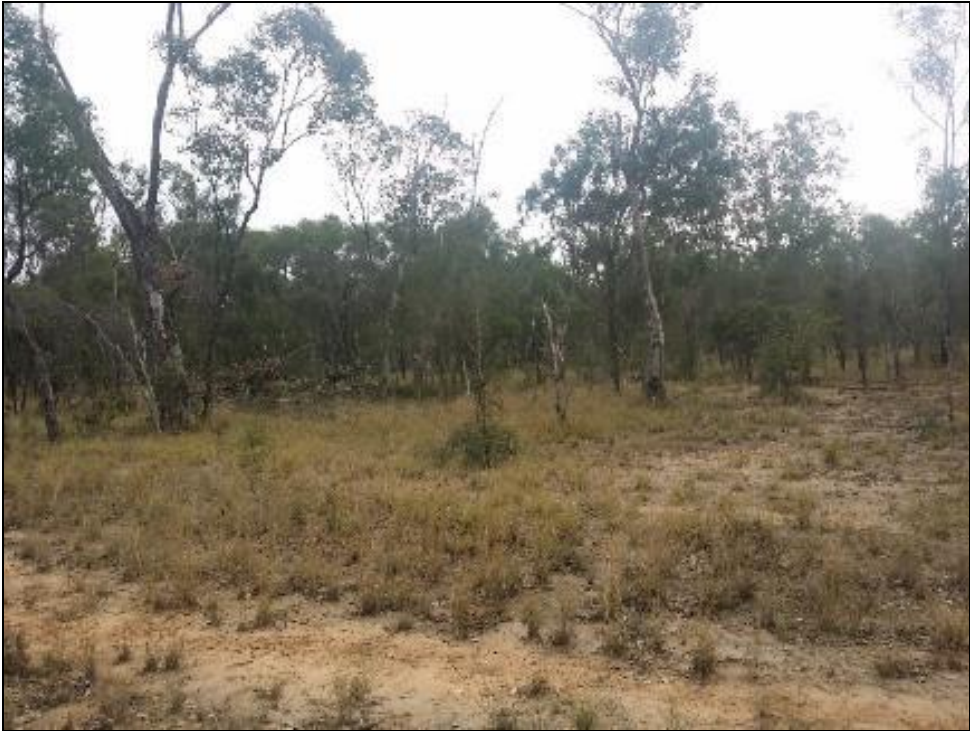
**Table 29: Land Summary for Representative Site 60**

| SMU | L2 | Representative Site Number | Site 60 |
|---|---|---|---|
| Surface coarse<br>fragments | No coarse<br>fragments | Surface condition | Surface is hard setting, very minor cracking,<br>no coarse fragments |

| <b>Erosion potential</b> | <p>The SMU is generally located on crests and undulating sloping areas with a sandy surface. It has a low to medium water erosion hazard in situ.</p> <p>Laboratory results indicated;</p> <ul style="list-style-type: none"> <li>• Dispersion Ratio (R1) (Baker et al. 1993) indicate moderate dispersion ratings (0.6-0.8) within the topsoil profile;</li> <li>• ESP (sodicity) rating indicates the topsoil profile is non-sodic. Subsoils are assessed as strongly sodic; and</li> <li>• high Ca/Mg ratio within topsoil throughout indicates aggregation of clay particles. High levels within subsoils indicate the subsoils may have poor physical conditions with dispersive qualities.</li> </ul> <p>Erosion potential through dispersion is assessed as low within topsoil. Subsoils are assessed as moderate with an increase in sodicity levels and a reduction in Ca/Mg ratio promoting dispersion qualities.</p> <p>Subsoils are not recommended for surface rehabilitation due to poor structure and binding capacity when wet. Appropriate management of exposed earths and stockpiling of subsoils is recommended.</p> |
| <b>Soil quality for mine rehabilitation</b> | <p><u>Recommended topsoil strip depth:</u> 0.00-0.30 mbgl</p> <p><u>Recommended topsoil use:</u> Support native vegetation and grasses. For rehabilitation of areas that are relatively flat to sloped areas such as backfill batters.</p> <p><u>Recommended subsoil strip depth:</u> 0.30–1.00 mbgl</p> <p><u>Recommended subsoil use:</u> Capping material over waste rock.</p> |

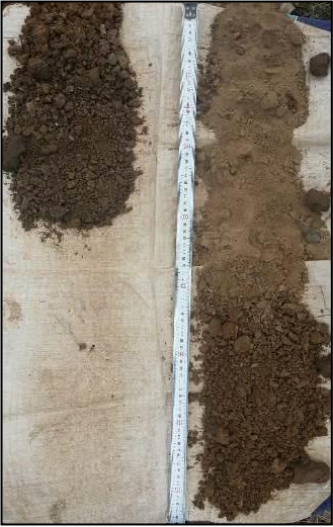
**Table 30: Soil Profile Morphology Summary for Representative Site 60**

| Site 60 | Horizon,<br>Depth (m)<br>Boundary | Colour,<br>Mottles,<br>Bleaching | Moisture,<br>Depth (m)<br>Field pH | Texture,<br>Structure,<br>Strength | Coarse<br>Fragments,<br>Roots |
|---|---|---|---|---|---|
| | Horizon:<br>A11<br>Horizon Depth:<br>0 – 0.12<br>Boundary:<br>Abrupt | Colour:<br>10YR3/3<br>Dark Brown<br>Mottle:<br>No mottle<br>Bleach:<br>No bleaching | Moisture:<br>Dry, rapid<br>Depth:<br>0.05<br>Field pH:<br>6.5<br>Meter<br>pH/EC:<br>6.7 / 0.00 | Texture:<br>Clayey sand<br>Structure:<br>Massive<br>Strength:<br>Loose | Coarse Fragments:<br>No coarse<br>fragments<br>Roots:<br>Fine, very few |
| | Horizon:<br>A12<br>Horizon Depth:<br>0.12 – 0.42<br>Boundary:<br>Abrupt | Colour:<br>10YR3/3<br>Dark brown<br>Mottle:<br>No mottle<br>Bleach:<br>No bleaching | Moisture:<br>Dry, rapid<br>Depth:<br>0.2<br>Field pH:<br>6.5 | Texture:<br>Clayey sand<br>Structure:<br>Massive to weak,<br><10% peds<br><10 mm<br>Strength:<br>Weak | Coarse Fragments:<br>No coarse<br>fragments<br>Roots:<br>Fine, very few |
| | Horizon:<br>B21<br>Horizon Depth:<br>0.42 – 0.60<br>Boundary:<br>Abrupt | Colour:<br>10YR4/4<br>Dark yellowish<br>brown<br>Mottle:<br>No mottle<br>Bleach:<br>No bleaching | Moisture:<br>Dry, well<br>drained<br>Depth:<br>0.6<br>Field pH:<br>7.5<br>Meter<br>pH/EC:<br>7.3 / 0.11 | Texture:<br>Clay loam sandy<br>Structure:<br>Moderate<br>peds 10-30 mm<br>sub angular<br>Strength:<br>Weak | Coarse Fragments:<br>No coarse<br>fragments<br>Roots:<br>No roots observed |
| | Horizon:<br>B22<br>Horizon Depth:<br>0.60 – 0.73<br>Boundary:<br>Abrupt | Colour:<br>7.5YR4/3<br>Brown<br>Mottle:<br>No mottle<br>Bleach:<br>No bleaching | Moisture:<br>Dry, well<br>drained | Texture:<br>Light clay<br>Structure:<br>Moderate<br>peds 10-30 mm<br>sub angular<br>Strength:<br>Weak | Coarse Fragments:<br>No coarse<br>fragments<br>Roots:<br>No roots observed |
| | Horizon:<br>B23<br>Horizon Depth:<br>0.73 – 1.00 | Colour:<br>10YR3/3<br>Dark brown<br>Mottle:<br>No mottle<br>Bleach:<br>No bleaching | Moisture:<br>Dry, well<br>drained<br>Depth:<br>0.9<br>Field pH:<br>7.5 | Texture:<br>Light clay<br>Structure:<br>Moderate<br>peds 10-30 mm<br>sub angular<br>Strength:<br>Weak | Coarse Fragments:<br>No coarse<br>fragments<br>Roots:<br>No roots observed |

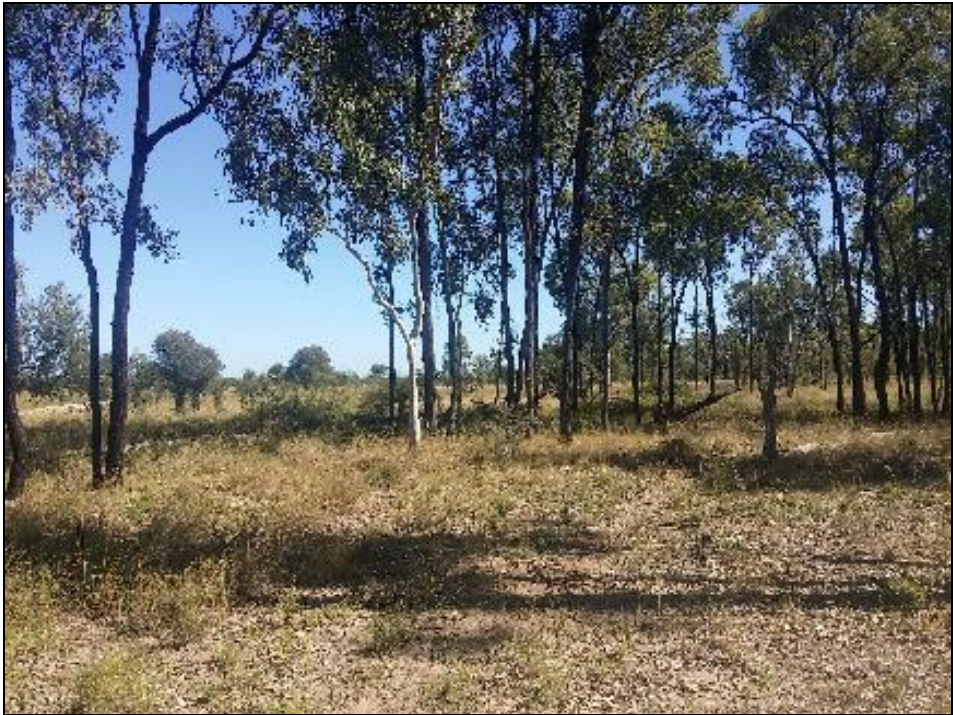
**Table 32: Land Summary for Representative Site 17**

| Representative site number | B1 | Representative Site Number | Site 17 |
|---|---|---|---|
| Surface coarse fragments | <2% black nodules and coarse fragments 2-6 mm diameter | Surface condition | Surface is hard setting and dry |

| <b>Erosion potential</b> | <p>The SMU is generally located on crests and undulating sloping areas with a sandy surface. It has a low water erosion hazard in situ.</p> <p>Laboratory results indicated;</p> <ul style="list-style-type: none"> <li>• Dispersion Ratio (R1) (Baker et al. 1993) indicate moderate dispersion ratings (0.6-0.8) within the topsoil profile.</li> <li>• ESP (sodicity) rating indicates that the profile to 0.46 m is non-sodic. Subsoils from this depth are assessed as sodic.</li> <li>• Very high Ca/Mg ratio within topsoil is results throughout indicates aggregation of clay particles. Moderate levels within subsoils indicate the subsoils have poor physical conditions with dispersive qualities.</li> </ul> <p>Erosion potential through dispersion is assessed as low within topsoil. Subsoils are assessed as moderate with an increase in sodicity levels and a reduction in Ca/Mg ratio promoting dispersion qualities.</p> <p>Subsoils are not recommended for surface rehabilitation due to poor structure and binding capacity when wet. Appropriate management of exposed earths and stockpiling of subsoils is recommended.</p> |
| <b>Soil quality for mine rehabilitation</b> | <p><u>Recommended topsoil strip depth:</u> 0.00-0.30 mbgl</p> <p><u>Recommended topsoil use:</u> Support native vegetation and grasses. For rehabilitation of areas that are relatively flat to sloped areas such as backfill batters.</p> <p><u>Recommended subsoil strip depth:</u> 0.30–1.00 mbgl</p> <p><u>Recommended subsoil use:</u> Natural vegetation growth assistance with additional soil fertility conditioning and potentially increase topsoil reserves for level plains Buried supporting subsoils for topsoil.</p> |

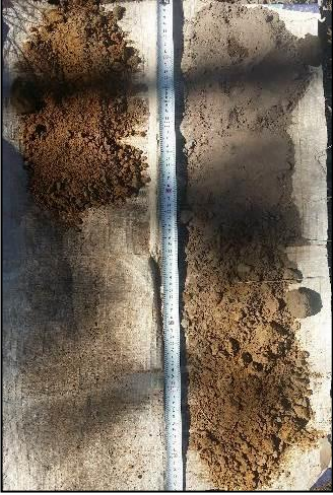
**Table 33: Soil Profile Morphology for Representative Site 17**

| Site 17 | Horizon,<br>Depth (m)<br>Boundary | Colour,<br>Mottles,<br>Bleaching | Moisture,<br>Depth (m) /<br>Field pH | Texture,<br>Structure,<br>Strength | Coarse<br>Fragments,<br>Roots. |
|---|---|---|---|---|---|
| | <i>Horizon:</i><br>A11<br><i>Horizon Depth:</i><br>0.0 – 0.36<br><i>Boundary:</i><br>Abrupt | <i>Colour:</i><br>10YR3/2<br><i>Very dark brown</i><br><i>Mottle:</i><br>No mottle<br><i>Bleach:</i><br>No bleaching | <i>Moisture:</i><br>Dry, rapid<br><i>Depth:</i><br>0.10<br><i>Field pH:</i><br>7.0<br><i>Meter pH/EC:</i><br>6.8 / 0.00 | <i>Texture:</i><br>Loamy Sand<br><i>Structure:</i><br>Massive<br><i>Strength:</i><br>Loose | <i>Coarse Fragments:</i><br>No coarse fragments<br><i>Roots:</i><br>Very few, very fine roots |
| | <i>Horizon:</i><br>A12<br><i>Horizon Depth:</i><br>0.36 – 0.47<br><i>Boundary:</i><br>Abrupt | <i>Colour:</i><br>10YR4/2<br><i>Dark greyish brown</i><br><i>Mottle:</i><br>No mottle<br><i>Bleach:</i><br>No bleaching | <i>Moisture:</i><br>Dry, well drained<br><i>Depth:</i><br>0.36<br><i>Field pH:</i><br>6.5 | <i>Texture:</i><br>Loamy sand<br><i>Structure:</i><br>Weak 1-10 mm peds, sub-angular,<br><i>Strength:</i><br>Weak | <i>Coarse Fragments:</i><br><2% black nodules<br><i>Roots:</i><br>No roots observed |
| | <i>Horizon:</i><br>B2<br><i>Horizon Depth:</i><br>0.47 – 1.0 | <i>Colour:</i><br>10YR4/4<br><i>Dark yellowish brown</i><br><i>Mottle:</i><br>Mottles:<br><5%<br>10YR6/8<br>Brownish yellow<br><2%<br>2.5YR4/6<br>Red<br><i>Bleach:</i><br>No bleaching | <i>Moisture:</i><br>Dry, well drained<br><i>Depth:</i><br>0.60, 0.90<br><i>Field pH:</i><br>6.5, 7.0<br><i>Meter pH/EC:</i><br>6.5 / 0.00 | <i>Texture:</i><br>Silty clay loam<br><i>Structure:</i><br>Weak 1-10 mm peds,<br><i>Strength:</i><br>Weak to firm | <i>Coarse Fragments:</i><br><5% black nodules and coarse fragments<br><i>Roots:</i><br>No roots observed |

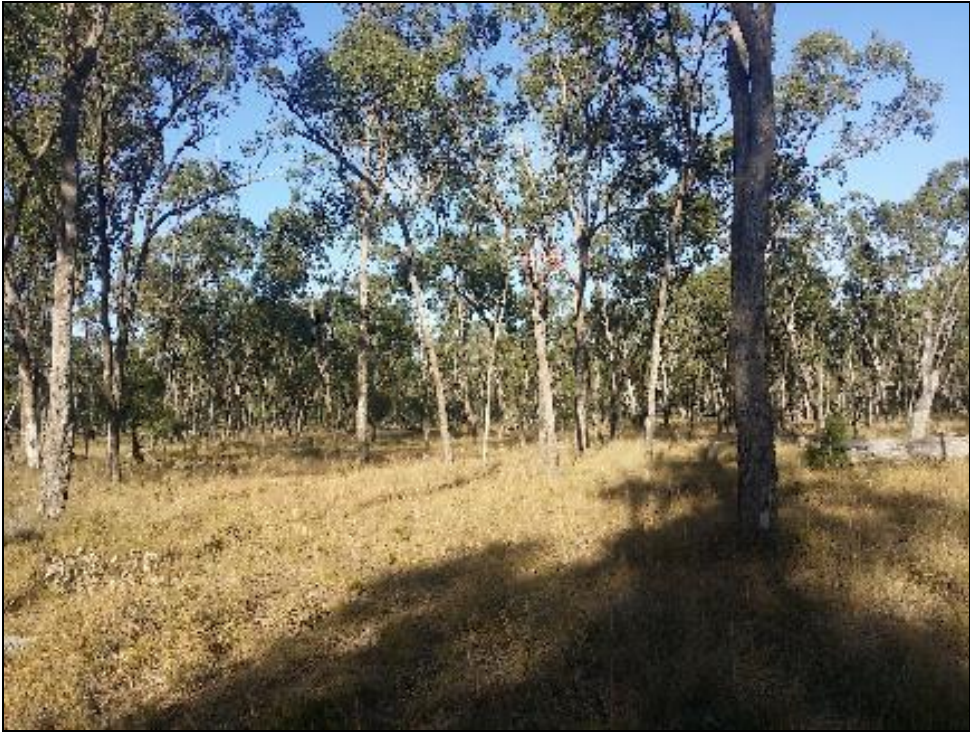
**Table 35: Land Summary for Representative Site 106**

| Representative site number | B2 | Representative Site Number | Site 106 |
|---|---|---|---|
| Surface coarse fragments | No coarse fragments | Surface condition | Surface is cracking and dry. Fine self mulch and peds <10 mm |
| Land suitability summary | <p><b>Effective rooting depth:</b> 0.40 mbgl</p> <p><b>Est. soil water storage:</b></p> <p>Soil water storage is based upon the effective rooting depth, poor structure as observed in the soil profile and marginal sodicity levels within 0.60m of the SMU.</p> <p>PAWC 50-75 mm (Table 2.3 Surrogate field properties for estimating plant available water capacity, LSAT, January 1995).</p> <p><b>Rain fed Cropping class:</b> 5</p> <p><b>Beef Cattle Grazing of Native Pastures class:</b> 3</p> <p><b>Agricultural Land Class:</b> C2</p> | | |

| <b>Erosion potential</b> | <p>The SMU is generally located on flat plains and very undulating sloping areas with a silty loam surface. It has a very low to low water erosion hazard in situ.</p> <p>Laboratory results indicated:</p> <ul style="list-style-type: none"> <li>• Dispersion Ratio (R1) (Baker et al. 1993) indicates moderate dispersion ratings (0.6-0.8) within the topsoil profile.</li> <li>• ESP (sodicity) rating indicates that the profile to 0.26m is non-sodic. Subsoils from this depth are assessed as sodic to strongly sodic (0.90 m).</li> <li>• Very high to high Ca/Mg ratio within topsoil profile A11 and A12 indicates aggregation of clay particles. Moderate levels within subsoils indicate the subsoils have poor physical conditions with dispersive qualities.</li> </ul> <p>Erosion potential through dispersion is assessed as low within topsoil. Subsoils are assessed as moderate with an increase in sodicity levels and a reduction in Ca/Mg ratio promoting dispersion qualities.</p> <p>Subsoils are not recommended for surface rehabilitation due to poor structure and binding capacity when wet. Appropriate management of exposed earths and stockpiling of subsoils is recommended.</p> |
| <b>Soil quality for mine rehabilitation</b> | <p><u>Recommended topsoil strip depth:</u> 0.00-0.20 mbgl</p> <p><u>Recommended topsoil use:</u> Support native vegetation and grasses. For rehabilitation of areas that are relatively flat to sloped areas such as backfill batters.</p> <p><u>Recommended subsoil strip depth:</u> 0.20–0.50 mbgl (but poor quality due to structural attributes of hard setting and sealing)</p> <p><u>Recommended subsoil use:</u> Natural vegetation growth assistance with additional soil fertility conditioning and potentially increase topsoil reserves.</p> <p>Subsoil below 0.5 m would not be favourable for supporting native vegetation growth due to poorly structured, poor water holding and fertility attributes. It would be recommended as buried supporting soils for SMUs within this category.</p> |

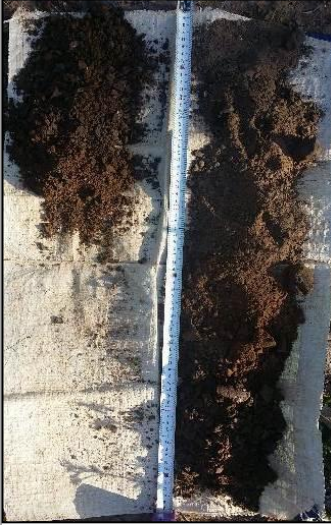
**Table 36: Soil Profile Morphology for Representative Site 106**

| Site 106 | Horizon,<br>Depth (m)<br>Boundary | Colour,<br>Mottles,<br>Bleaching | Moisture,<br>Depth (m)<br>Field pH | Texture,<br>Structure,<br>Strength | Coarse<br>Fragments,<br>Roots |
|---|---|---|---|---|---|
| | <i>Horizon:</i><br>A11<br><i>Horizon Depth:</i><br>0.0 – 0.26<br><i>Boundary:</i><br>Abrupt | <i>Colour:</i><br>10YR4/2<br>Dark grayish brown<br><i>Mottle:</i><br>No mottle<br><i>Bleach:</i><br>No bleaching | <i>Moisture:</i><br>Dry, well drained<br><i>Depth:</i><br>0.05, 0.20<br><i>Field pH:</i><br>6.0, 6.0<br><i>Meter pH/EC:</i><br>6.1 / 0.00 | <i>Texture:</i><br>Silty loam<br><i>Structure:</i><br>Massive<br><i>Strength:</i><br>Loose | <i>Coarse Fragments:</i><br>No coarse fragments<br><i>Roots:</i><br>Very few, very fine roots |
| | <i>Horizon:</i><br>A12<br><i>Horizon Depth:</i><br>0.26 – 0.56<br><i>Boundary:</i><br>Abrupt | <i>Colour:</i><br>10YR4/4<br>Dark yellowish brown<br><i>Mottle:</i><br>No mottle<br><i>Bleach:</i><br>No bleaching | <i>Moisture:</i><br>Dry, well drained<br><i>Depth:</i><br>0.40<br><i>Field pH:</i><br>6.0 | <i>Texture:</i><br>Silty loam<br><i>Structure:</i><br>Massive<br><i>Strength:</i><br>Loose | <i>Coarse Fragments:</i><br>No coarse fragments<br><i>Roots:</i><br>Very few, very fine roots |
| | <i>Horizon:</i><br>B2<br><i>Horizon Depth:</i><br>0.56 – 1.00 | <i>Colour:</i><br>10YR4/3<br>Brown<br><i>Mottle:</i><br>No mottle<br><i>Bleach:</i><br>No bleaching | <i>Moisture:</i><br>Dry, moderately well-drained<br><i>Depth:</i><br>0.60, 0.90<br><i>Field pH:</i><br>6.5, 7.0<br><i>Meter pH/EC:</i><br>6.8 / 0.25<br>7.2 / 0.36 | <i>Texture:</i><br>Light clay<br><i>Structure:</i><br>Moderate, <10 mm peds, sub-angular<br><i>Strength:</i><br>Firm | <i>Coarse Fragments:</i><br>No coarse fragments<br><i>Roots:</i><br>No roots observed |
