**PEMBROKE**

**Olive Downs Coking Coal Project**  
Draft Environmental Impact Statement

**Appendix M**  
**Soil and Land**  
**Suitability**  
**Assessment**

Olive Downs Coking Coal Project

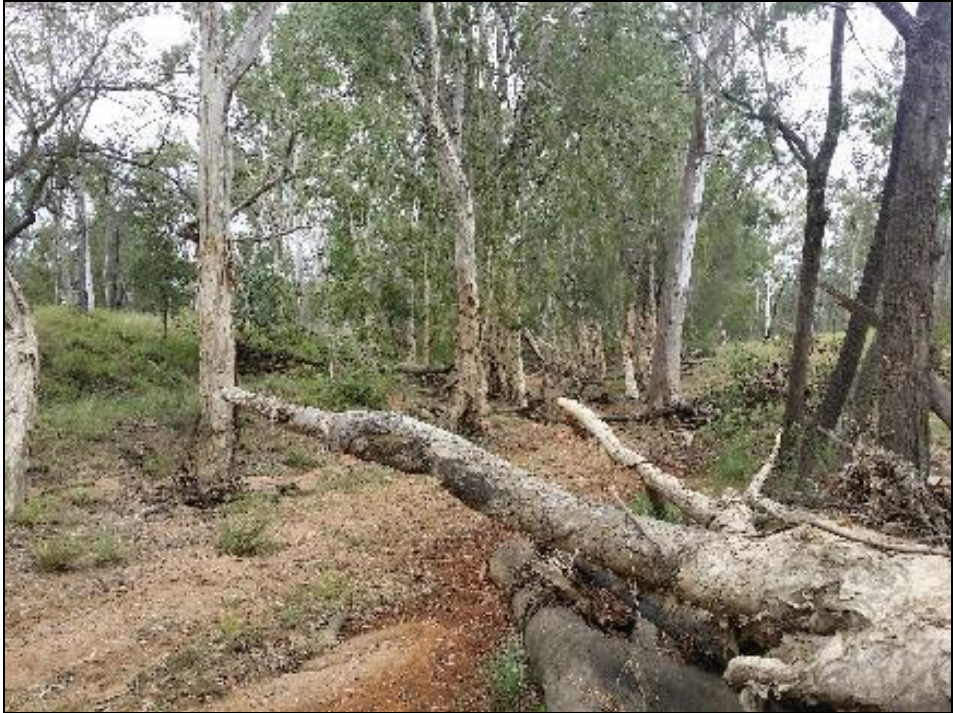
**Table 38: Land Summary for Representative Site 62**

| Representative site number | A1 | Representative Site Number | Site 62 |
|---|---|---|---|
| Location (GDA94) | 641685 mE<br>7533763 mN | Disturbance | Gully erosion |
| Surface coarse fragments | <1 % 1-3 mm coarse fragments | Surface condition | Surface is firm and dry |

| <b>Erosion potential</b> | <p>An open depression area with loam surface predisposes a moderate to high water erosion hazard in situ.</p> <p>Laboratory results indicated:</p> <ul style="list-style-type: none"> <li>Dispersion Ratio (R1) (Baker et al. 1993) indicate low dispersion ratings (&lt;0.6) within the topsoil profile.</li> <li>ESP (sodicity) rating indicates that the soil profile is non-sodic.</li> <li>Very high Ca/Mg ratio results throughout indicate favourable conditions with aggregation of clay particles.</li> </ul> <p>Erosion potential through dispersion is considered low however, appropriate management of bare earths must be considered when stockpiling and rehabilitation reuse.</p> |
| <b>Soil quality for mine rehabilitation</b> | <p><u>Recommended topsoil strip depth:</u> 0.00-0.40 mbgl</p> <p><u>Recommended topsoil use:</u> Support native vegetation and grasses. For rehabilitation of areas that are relatively flat to sloped areas such as backfill batters.</p> <p><u>Recommended subsoil strip depth:</u> 0.40–1.00 mbgl</p> <p><u>Recommended subsoil use:</u> Natural vegetation growth assistance with additional soil fertility conditioning and potentially increase topsoil reserves. Buried supporting subsoils for topsoil.</p> |

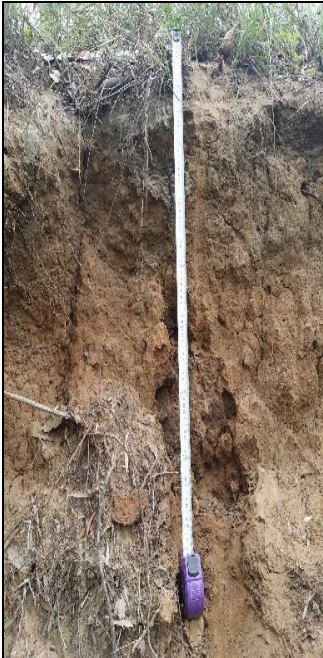
**Table 39: Soil Profile Morphology for Representative Site 62**

| Site 62 | Horizon, Depth (m) Boundary | Colour, Mottles, Bleaching | Moisture, Depth (m) Field pH | Texture, Structure, Strength | Coarse Fragments, Roots. |
|---|---|---|---|---|---|
| | <p><i>Horizon:</i> A1</p> <p><i>Horizon Depth:</i> 0 – 0.55</p> <p><i>Boundary:</i> Abrupt</p> | <p><i>Colour:</i> 10YR3/2</p> <p><i>Very dark greyish brown</i></p> <p><i>Mottle:</i> No mottles</p> <p><i>Bleach:</i> No bleaching</p> | <p><i>Moisture:</i> Dry, rapid</p> <p><i>Depth:</i> 0.1, 0.4</p> <p><i>Field pH:</i> 6.5, 6.5</p> <p><i>Meter pH/EC:</i> 6.9 / 0.01</p> | <p><i>Texture:</i> Loam</p> <p><i>Structure:</i> Massive</p> <p><i>Strength:</i> Loose</p> | <p><i>Coarse Fragments:</i> No coarse fragments</p> <p><i>Roots:</i> Fine, few roots</p> |
| | <p><i>Horizon:</i> B2</p> <p><i>Horizon Depth:</i> 0.55 – 1.00</p> | <p><i>Colour:</i> 10YR3/3</p> <p><i>Dark brown</i></p> <p><i>Mottle:</i> No mottles</p> <p><i>Bleach:</i> No bleaching</p> | <p><i>Moisture:</i> Dry, rapid</p> <p><i>Depth:</i> 0.6, 0.9</p> <p><i>Field pH:</i> 6.5, 6.5</p> <p><i>Meter pH/EC:</i> 7.0 / 0.01</p> | <p><i>Texture:</i> Sandy loam</p> <p><i>Structure:</i> Massive</p> <p><i>Strength:</i> Loose</p> | <p><i>Coarse Fragments:</i> No coarse fragments</p> <p><i>Roots:</i> Fine, few roots</p> |

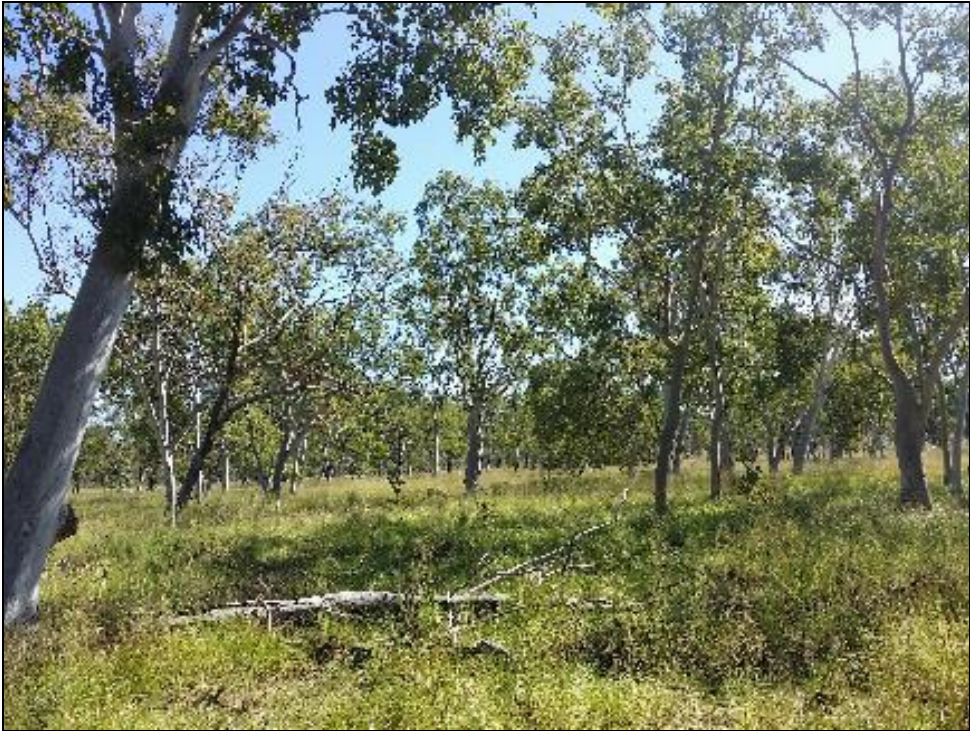
**Table 41: Land Summary for Representative Site 96**

| Representative site number | A2 | Representative Site Number | Site 96 |
|---|---|---|---|
| Location (GDA94) | 644069 mE<br>7534469 mN | Disturbance | Gully erosion |
| Surface coarse fragments | No coarse fragments | Surface condition | Surface is soft and moist |

| <b>Erosion potential</b> | <p>Gently undulating areas with sandy surface predisposes a high water erosion hazard in situ.</p> <p>Laboratory results indicated:</p> <ul style="list-style-type: none"> <li>• Dispersion Ratio (R1) (Baker et al. 1993) indicate moderate dispersion ratings (0.6-0.8) within the topsoil profile.</li> <li>• ESP (sodicity) rating indicates the topsoil profile is non-sodic. Subsoils are assessed as extremely sodic.</li> <li>• Very high Ca/Mg ratio within topsoil indicates aggregation of clay particles. Moderate to high levels within subsoils indicate the subsoils have poor physical conditions with dispersive qualities.</li> </ul> <p>Erosion potential through dispersion is assessed as low within topsoil. Subsoils are assessed as moderate to high with an increase in sodicity levels and a reduction in Ca/Mg ratio promoting dispersion qualities.</p> <p>Subsoils are not recommended for surface rehabilitation due to poor structure and binding capacity when wet. Appropriate management of exposed earths and stockpiling of subsoils is recommended.</p> |
| <b>Soil quality for mine rehabilitation</b> | <p><u>Recommended topsoil strip depth:</u> 0.00-0.15 mbgl</p> <p><u>Recommended topsoil use:</u> Support native vegetation and grasses. For rehabilitation of areas that are relatively flat to sloped areas such as backfill batters.</p> <p><u>Recommended subsoil strip depth:</u> 0.15–1.00 mbgl</p> <p><u>Recommended subsoil use:</u> Capping material over waste rock.</p> |

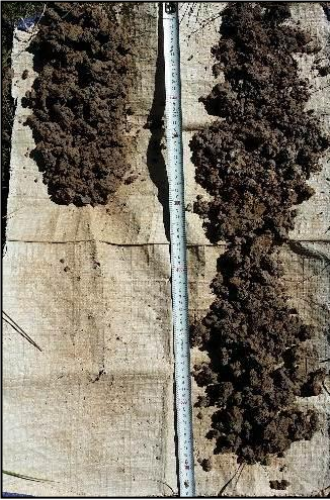
**Table 42: Soil Profile Morphology for Representative Site 96**

| Site 96 | Horizon,<br>Depth (m)<br>Boundary | Colour,<br>Mottles,<br>Bleaching | Moisture,<br>Depth (m)<br>Field pH | Texture,<br>Structure,<br>Strength | Coarse<br>Fragments,<br>Roots |
|---|---|---|---|---|---|
| | <i>Horizon:</i><br>A1<br><i>Horizon Depth:</i><br>0.0 – 0.04<br><i>Boundary:</i><br>Abrupt | <i>Colour:</i><br>10YR4/1<br><i>Dark grey</i><br><i>Mottle:</i><br>No mottles<br><i>Bleaching:</i><br>No<br><i>Bleaching</i> | <i>Moisture:</i><br>Moderately<br>moist, rapid<br><i>Depth:</i><br>0.02<br><i>Field pH:</i><br>6.5<br><i>Meter pH/EC:</i><br>6.6 / 0.01 | <i>Texture:</i><br>Clayey sand<br><i>Structure:</i><br>Weak sub-<br>angular,<br><i>Strength:</i><br>Weak | <i>Coarse Fragments:</i><br>No coarse<br>fragments<br><i>Roots:</i><br>Very fine, very few<br>roots |
| | <i>Horizon:</i><br>A2<br><i>Horizon Depth:</i><br>0.04 – 0.25<br><i>Boundary:</i><br>Abrupt | <i>Colour:</i><br>10YR4/4<br><i>Dark</i><br><i>yellowish</i><br><i>brown</i><br><i>Mottle:</i><br>No mottles<br><i>Bleaching:</i><br>No<br><i>Bleaching</i> | <i>Moisture:</i><br>Moderately<br>moist, rapid | <i>Texture:</i><br>Loamy sand<br><i>Structure:</i><br>Weak sub-<br>angular<br><i>Strength:</i><br>Weak | <i>Coarse Fragments:</i><br>10% coarse<br>fragments 2-4 mm<br><i>Roots:</i><br>Very fine, very few<br>roots |
| | <i>Horizon:</i><br>B2<br><i>Horizon Depth:</i><br>0.25 – 1.00 | <i>Colour:</i><br>10YR4/3<br><i>Brown</i><br><i>Mottle:</i><br>Mottles<br>5% 10YR54<br><i>Yellowish</i><br><i>brown</i><br><i>Bleaching:</i><br>No<br><i>Bleaching</i> | <i>Moisture:</i><br>Moist,<br>imperfect<br><i>Depth:</i><br>0.3, 0.6, 0.9<br><i>Field pH:</i><br>6.5, 6.5, 6.5<br><i>Meter pH/EC:</i><br>7.7 / 0.24<br>8.6 / 0.63<br>8.8 / 0.66 | <i>Texture:</i><br>Light medium<br>clay<br><i>Structure:</i><br>Moderate, sub-<br>angular<br>30-60 mm<br><i>Strength:</i><br>Firm | <i>Coarse Fragments:</i><br>10% coarse<br>fragments 2-4 mm<br><i>Roots:</i><br>No roots observed |

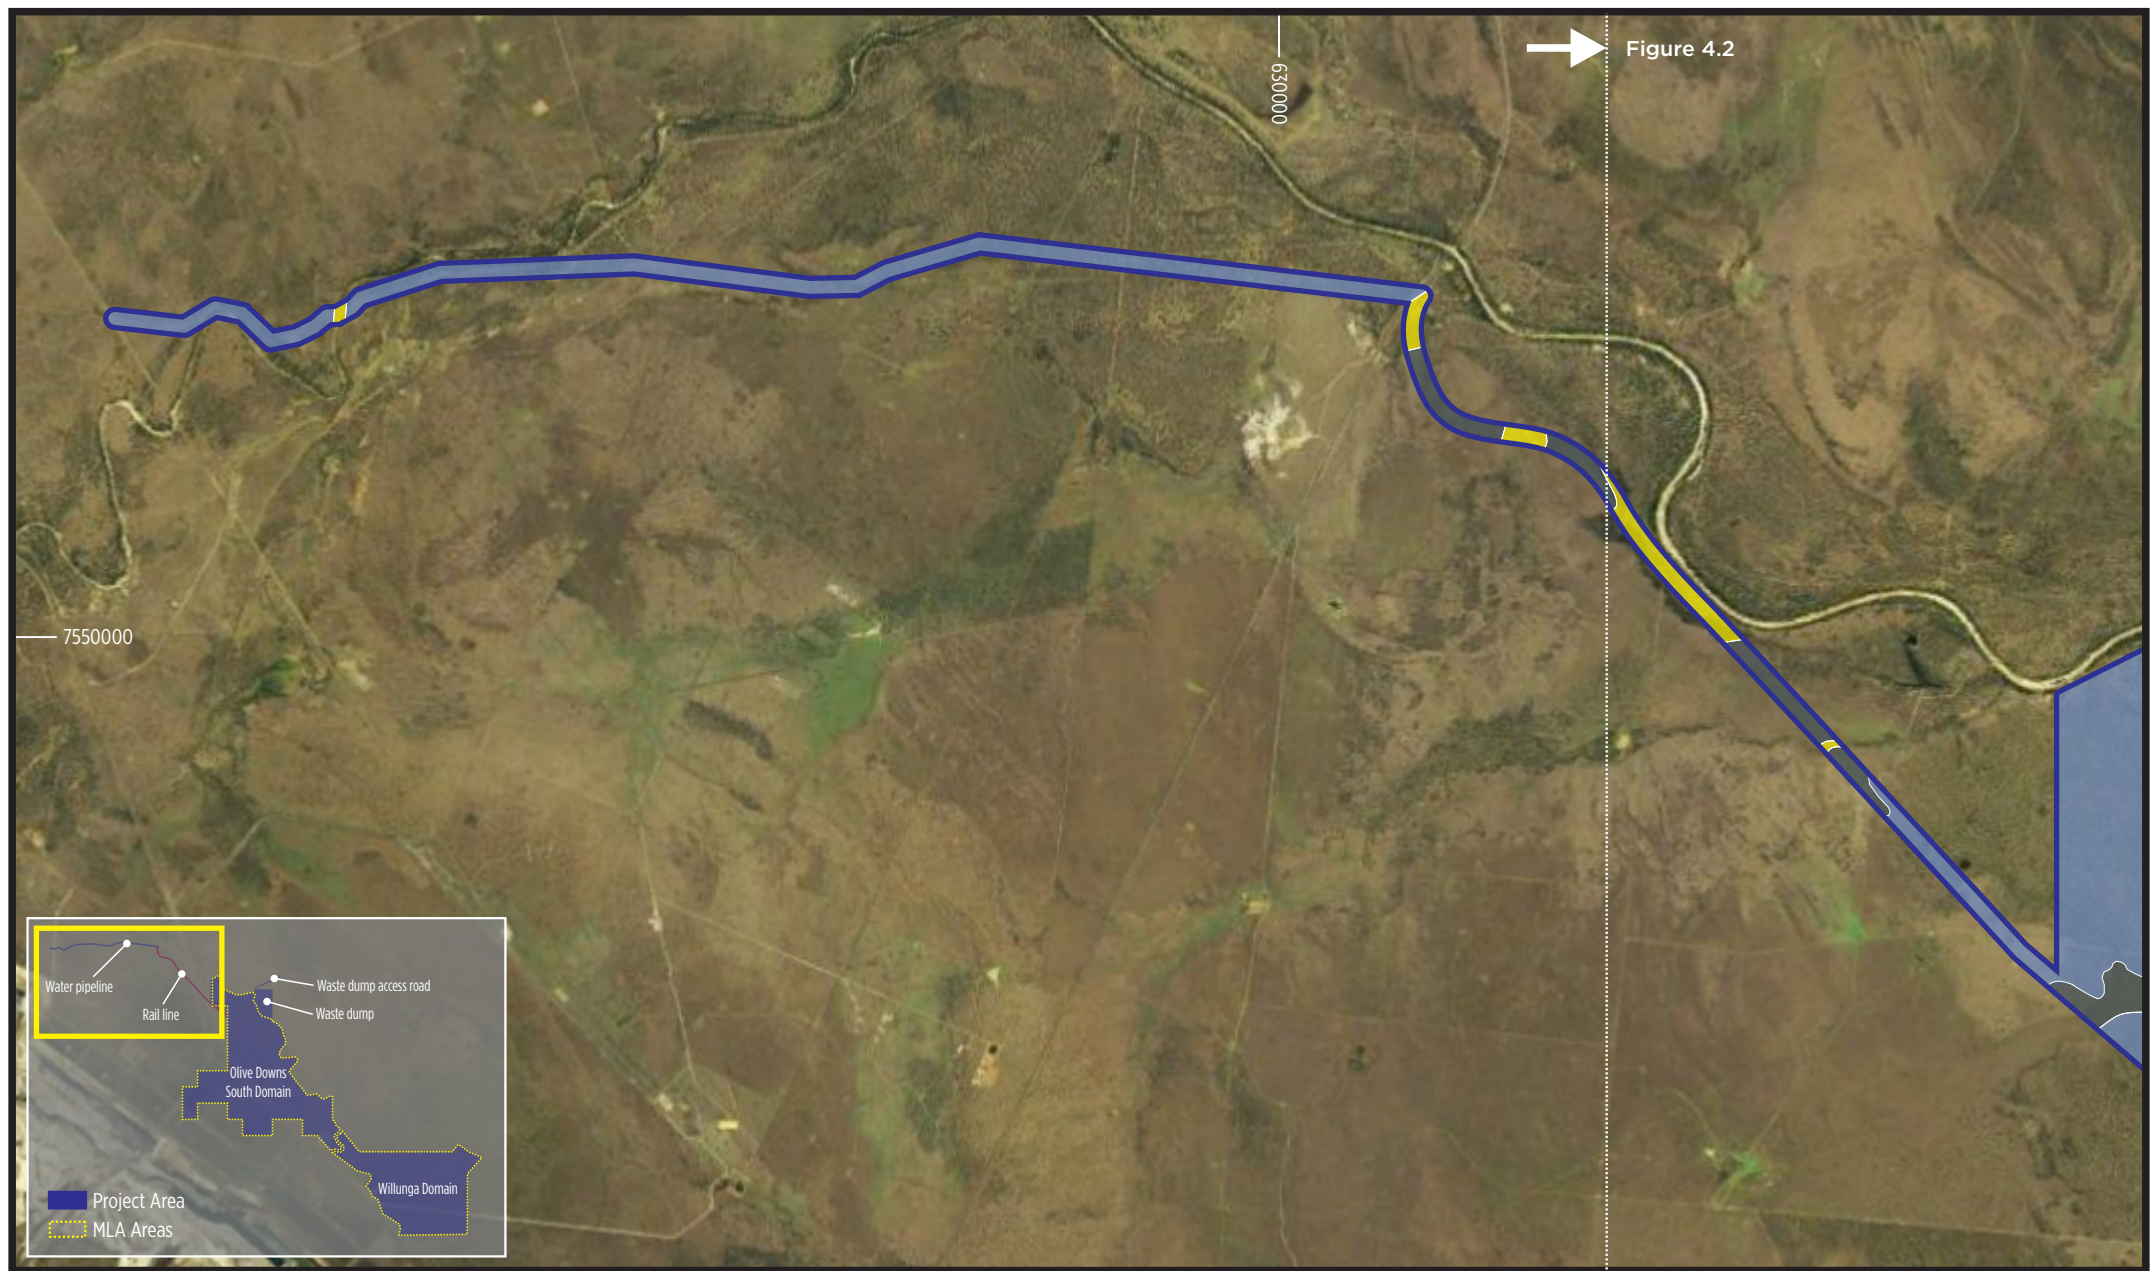
Figure 4.1: Topsoil Stripping Depths

- L2 Deeper (0.40-0.60m) loamy sands to light clay
- B1 Black to brown grey duplex soils with loamy sands, silty clay loams to clayey sands, mottled silty clay loams and clay loams
- B2 Brown silty loams to light clays with cracking surface on lower flat plains
- B2-DV Drainage Variant of B2, surface horizon removed by stream bank erosion
- A1 Loam to loamy sands within active channels
- A2 Clayey sands to light medium clay within alluvial depression

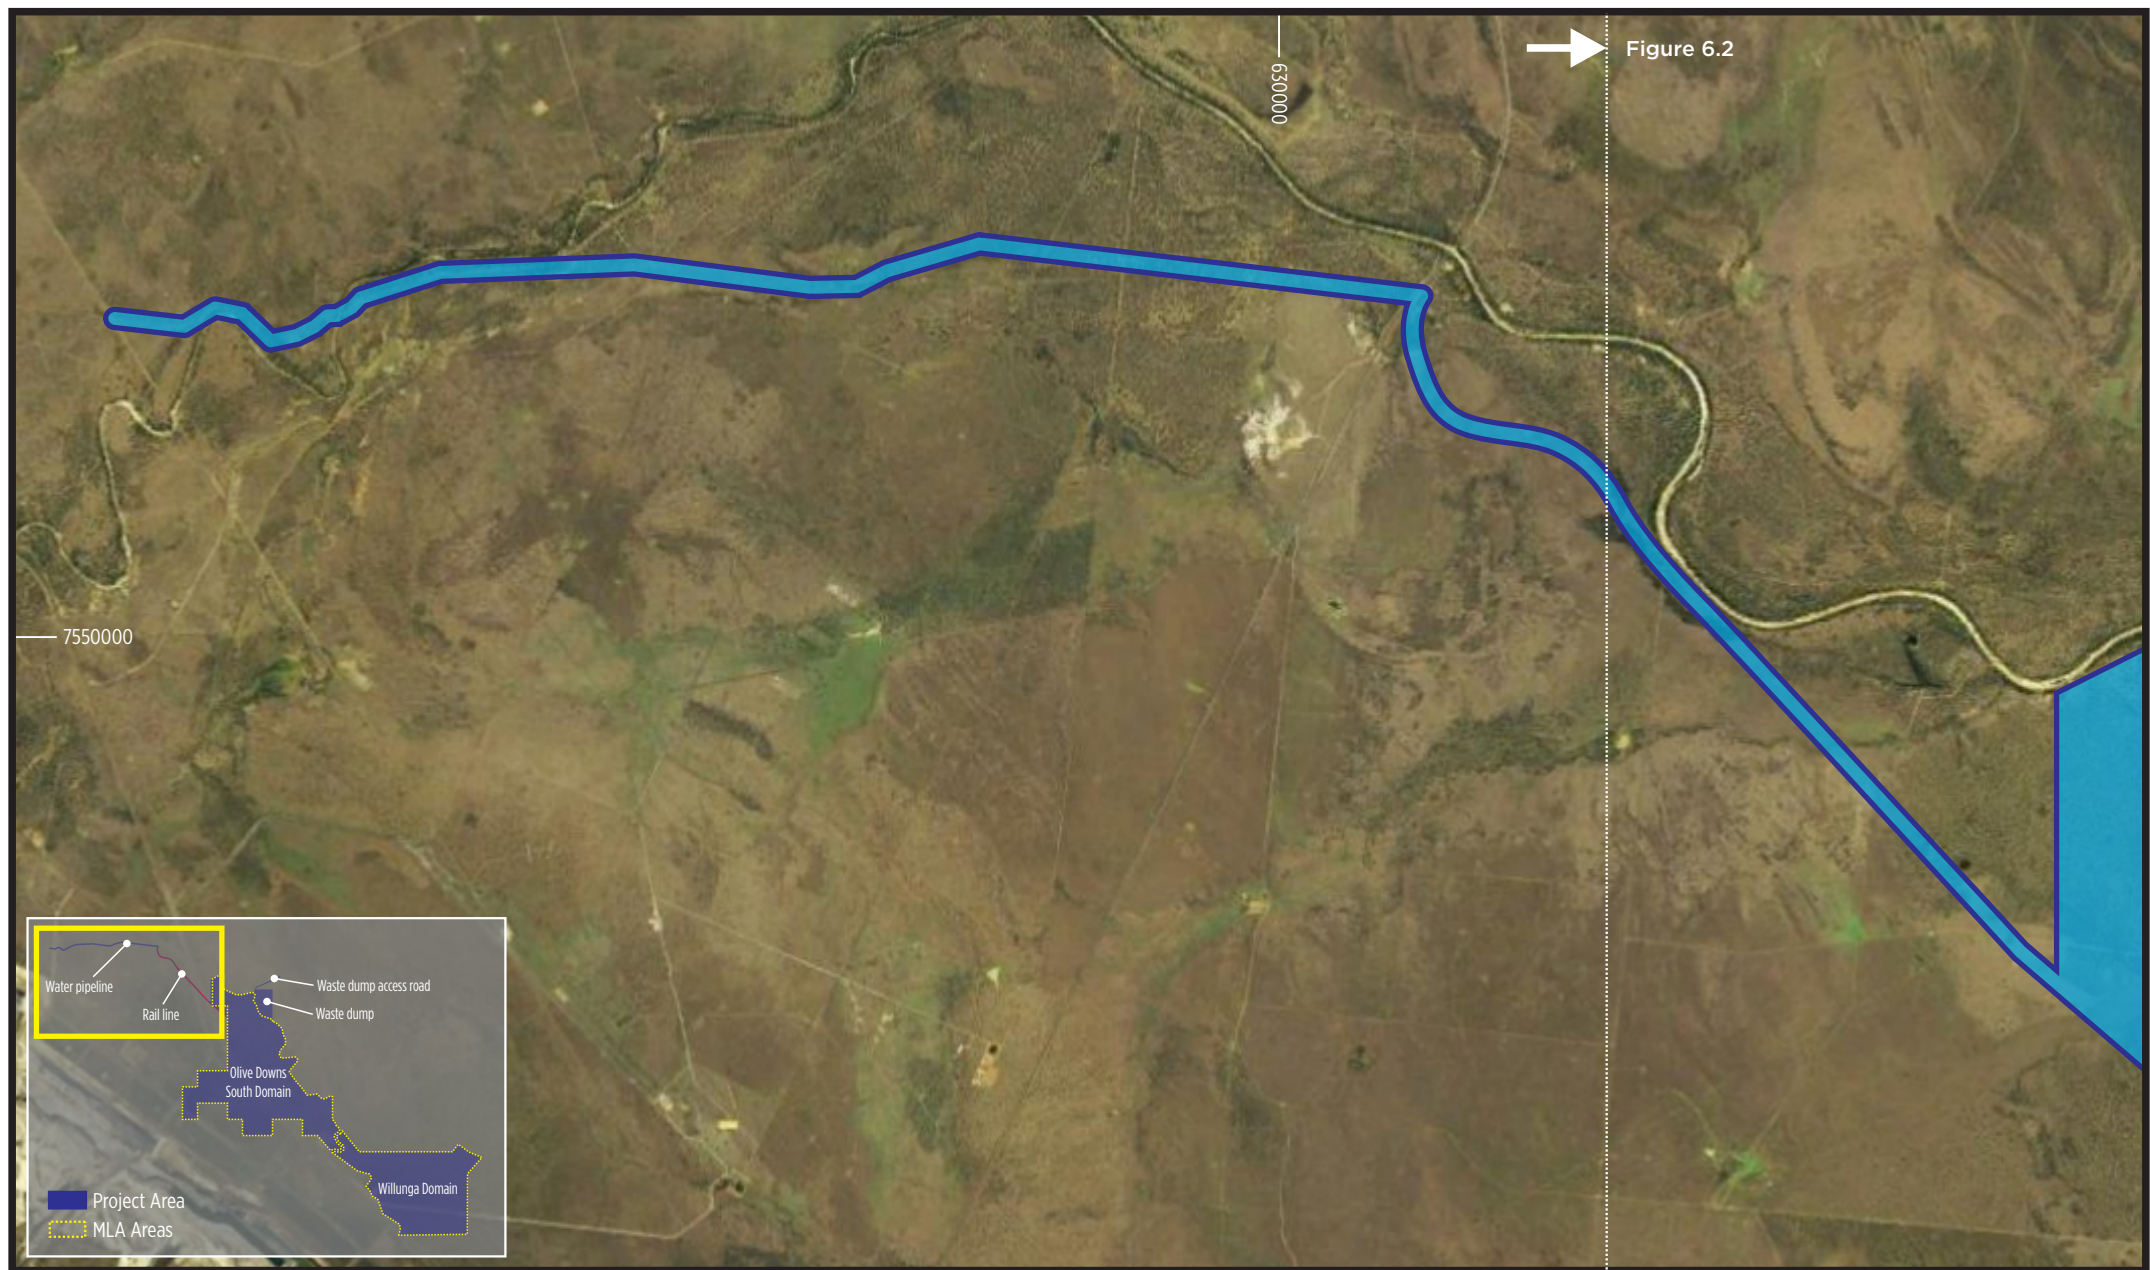
Figure 6.1: Pre Mine - Beef Cattle Grazing

- Project Area
- Class 4
- Class 5

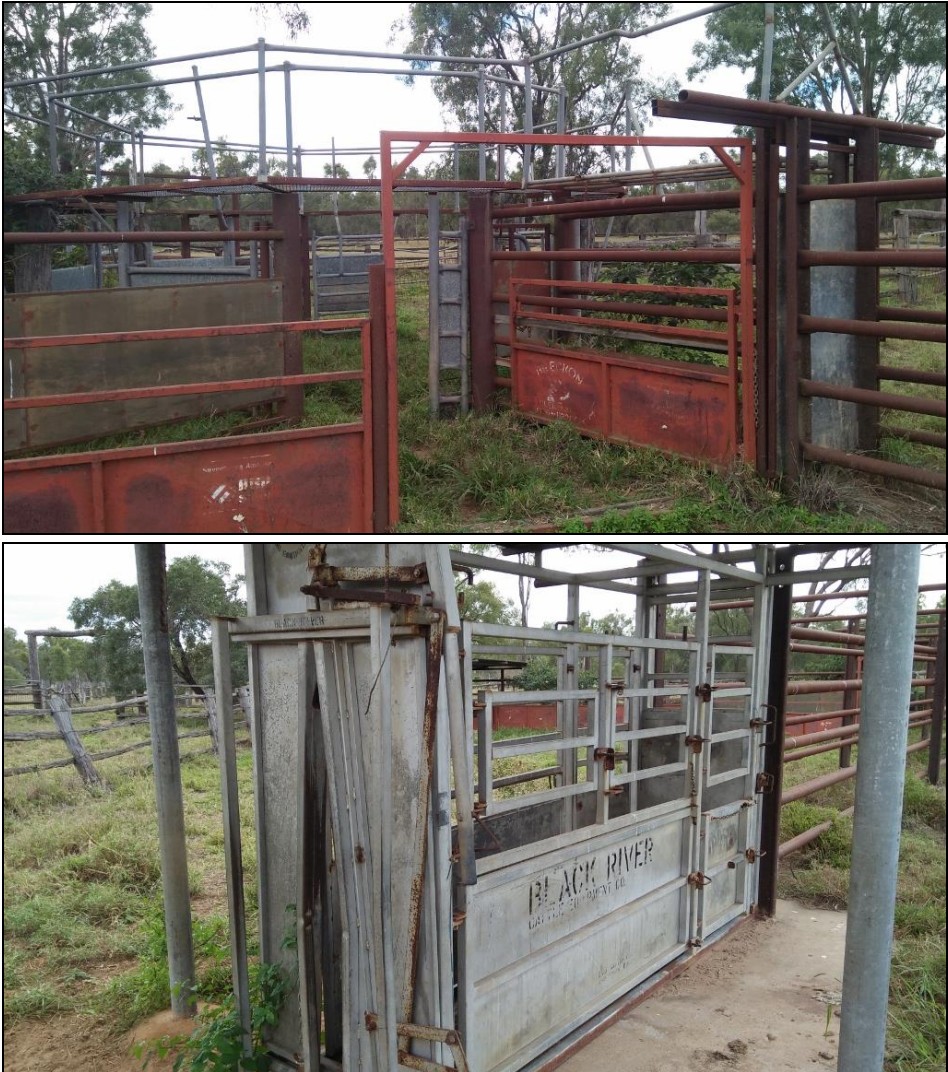
| <b>Main Observations / Nature of Activities</b> | Cattle yards and cattle crush. No cattle dip or spray race observed<br>One (1) unlabelled empty 205L drum.<br>Several holding pens. | | |
| <b>Staining</b> | Surface staining was not observed. | <b>Odours</b> | Odours were not present. |

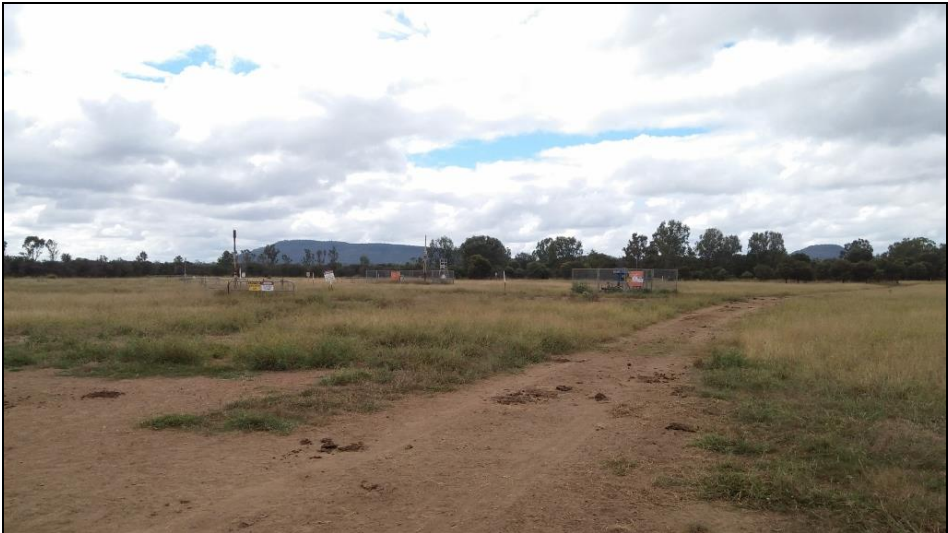
| <b>Staining</b> | Surface staining was not observed. | <b>Odours</b> | Odours were not present. |
| <b>Above Ground Storage Tanks</b> | None observed. | <b>Presence of Underground Storage Tanks</b> | Not observed. |

| Site | Area Proposed to be Disturbed | Recommendation |
|---|---|---|
| CL9 | Yes (open cut) | Further investigation recommended |

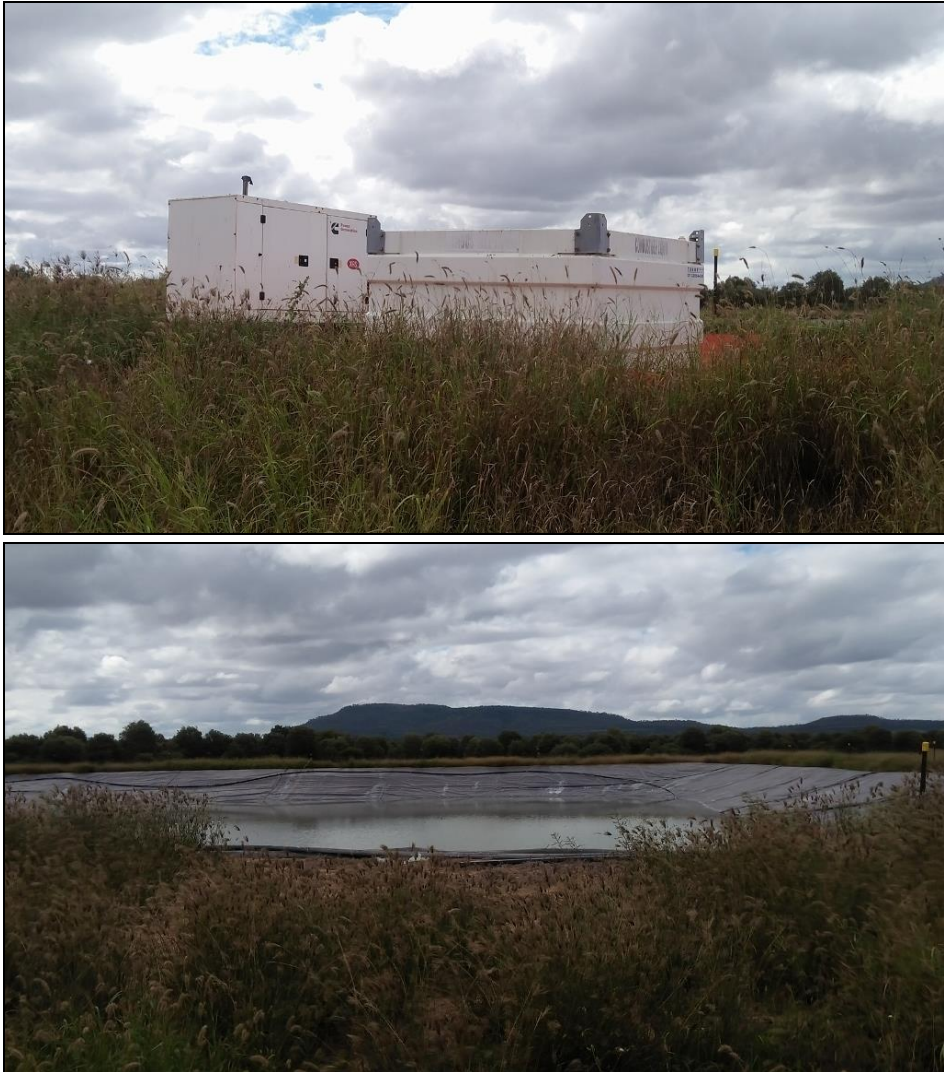
| <b>Above Ground Storage Tanks</b> | Combustible liquid above ground storage tank. | <b>Presence of Underground Storage Tanks</b> | Not observed. |

| Point of Interest | Potential Contamination Source | Potential Pathway/s | Potential Receptor/s | Risk Rating Severity/ Likelihood | Recommendation |
|---|---|---|---|---|---|
| CL10 | Combustible liquid above ground storage tank<br>Generator<br>Water dam | Leaching, Migration, Dermal, Inhalation. | Groundwater<br>Surface water<br>Flora, Fauna, Workforce, Residents. | 3/C Medium | Stage 1 Preliminary Site Investigation inspection and preliminary borehole soil sampling if staining is observed.<br>Identification and potential preliminary water sampling for appropriate discharge of water (if present).<br><br>Stage 2 and 3 ESAs if significantly contaminated and potentially Stage 4 remediation action plan for the area would be prepared, if required. |

- Point of interest CL10 was assessed to be Medium Risk site. It is recommended a Stage 1 Preliminary Site Investigation and preliminary borehole soil sampling are conducted if staining observed. Identification and potential preliminary water samples for appropriate discharge of water (if present). Stage 2 and 3 ESAs are recommended if significantly contaminated and potentially a Stage 4 remediation action plan for the area would be prepared, if required.

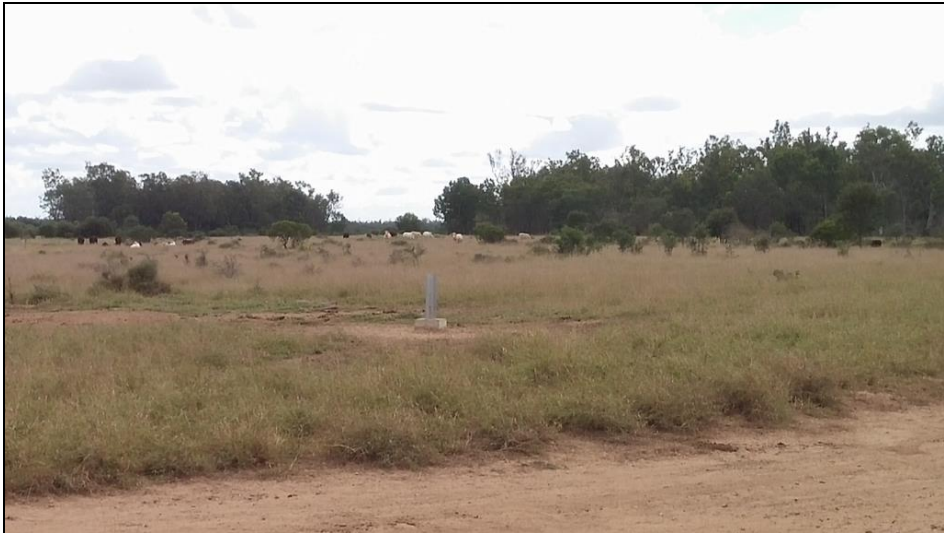
| <b>Staining</b> | Surface staining was not observed. | <b>Odours</b> | Odours were not present. |
| <b>Above Ground Storage Tanks</b> | None observed. | <b>Presence of Underground Storage Tanks</b> | Not observed. |

| Site | Area Proposed to be Disturbed | Recommendation |
|---|---|---|
| CL11 | Yes (out of pit waste rock emplacement) | Further investigation recommended |

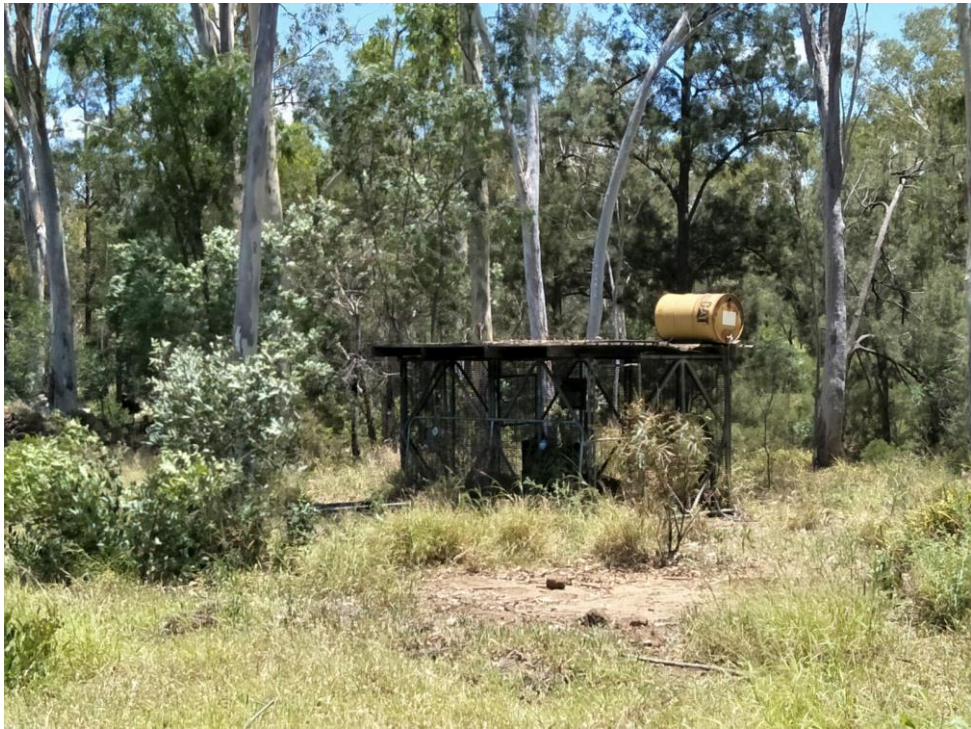
| <b>Staining</b> | Surface staining was not observed. | <b>Odours</b> | Odours were not present. |

| Point of Interest | Potential Contamination Source | Potential Pathway/s | Potential Receptor/s | Risk Rating<br>Severity/<br>Likelihood | Recommendation |
|---|---|---|---|---|---|
| CL15 | Generator<br>205L Drum | Leaching, Migration, Dermal. | Groundwater, Surface water, Flora, Fauna, Workforce. | 1/D<br>Low | Inspection of generator area for staining.<br><br>If staining is observed, Stage 1 Preliminary Site Investigation and preliminary soil sampling to be undertaken. |

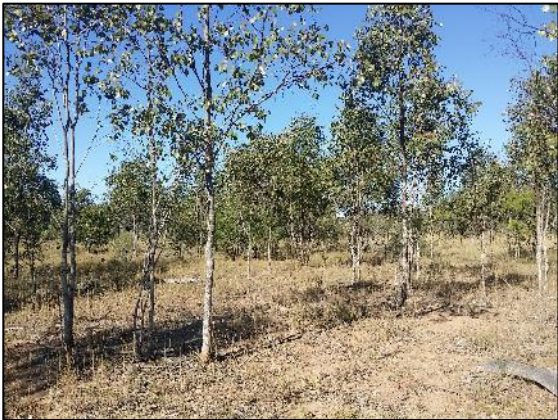
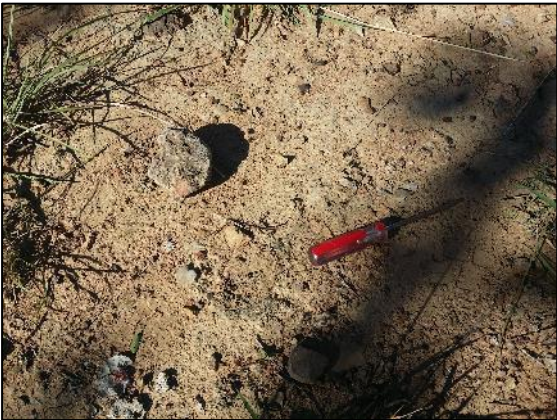
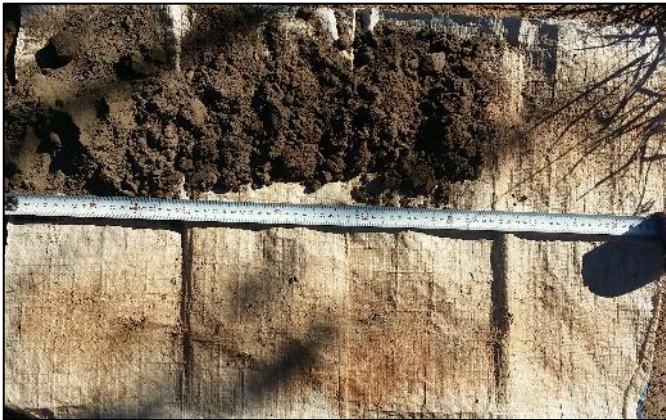
| <b>Soil Mapping Unit:</b><br>S1 | <b>CSIRO Land Systems (Gunn et al 1967):</b><br>Somerby, Monteagle, Connors,<br>Humboldt, Blackwater | <b>Location (GDA ZONE 55):</b><br>638828 mE 7548435 mN | <b>Aust. Soil Class. :</b><br>Brown Sodosol | <b>Site Survey Type:</b><br>Detailed - 50mm hand auger | <b>Survey Date:</b><br>18/06/2017 |

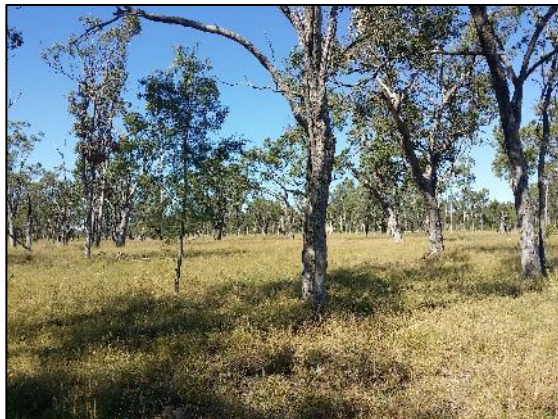
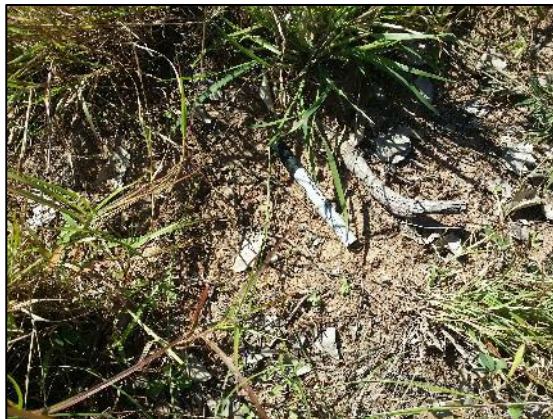
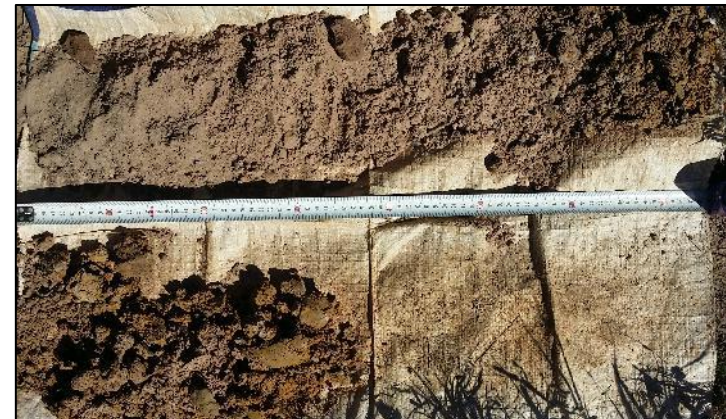
| <b>Soil Mapping Unit:</b><br>S1 | <b>CSIRO Land Systems (Gunn et al 1967):</b><br>Somerby, Monteagle, Connors,<br>Humboldt, Blackwater | <b>Location (GDA ZONE 55):</b><br>638862 mE 7548002 mN | <b>Aust. Soil Class:</b><br>Brown Sodosol | <b>Site Survey Type:</b><br>Detailed - 50mm hand auger | <b>Survey Date:</b><br>18/06/2017 |

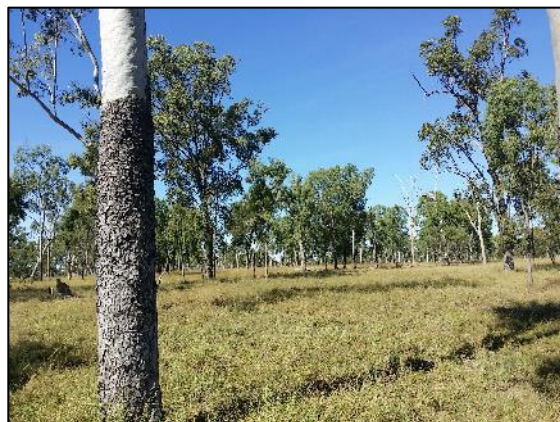
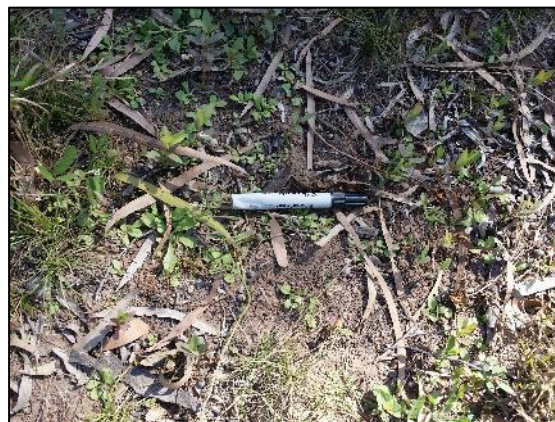
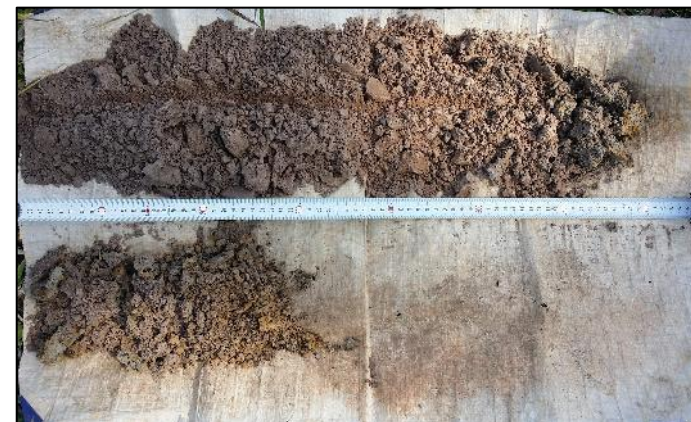
| <b>Soil Mapping Unit:</b><br>S1 | <b>CSIRO Land Systems (Gunn et al 1967):</b><br>Somerby, Monteagle, Connors,<br>Humboldt, Blackwater | <b>Location (GDA ZONE 55):</b><br>638715 mE 7547488 mN | <b>Aust. Soil Class. :</b><br>Brown Sodosol | <b>Site Survey Type:</b><br>Detailed - 50mm hand auger | <b>Survey Date:</b><br>18/6/2014 |

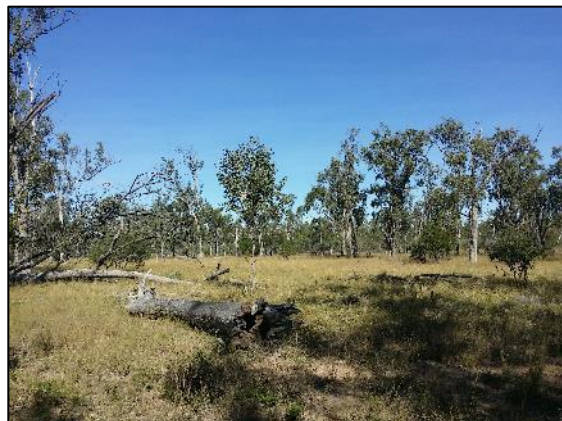
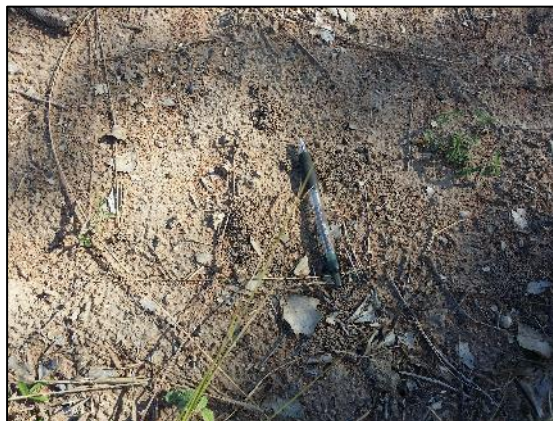
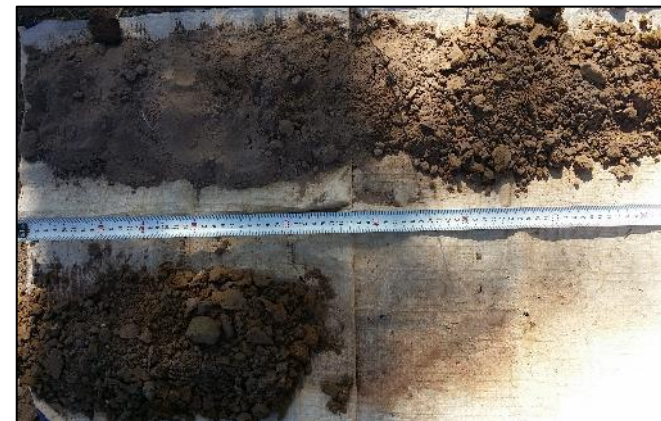
| <b>Soil Mapping Unit:</b><br>S1 | <b>CSIRO Land Systems (Gunn et al 1967):</b><br>Somerby, Monteagle, Connors,<br>Humboldt, Blackwater | <b>Location (GDA ZONE 55):</b><br>639550 mE 7547598 mN | <b>Aust. Soil Class. :</b><br>Brown Sodosol | <b>Site Survey Type:</b><br>Detailed - 50mm hand auger | <b>Survey Date:</b><br>18/6/2017 |

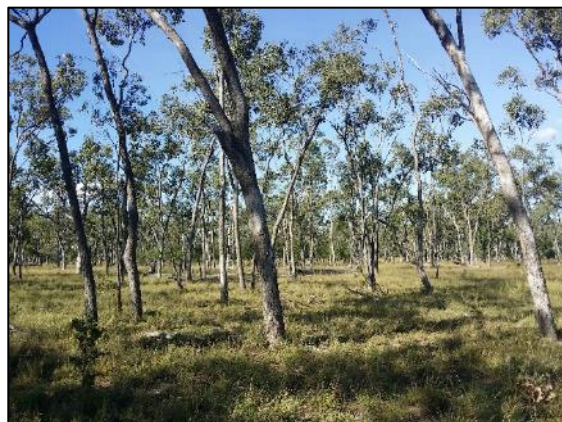
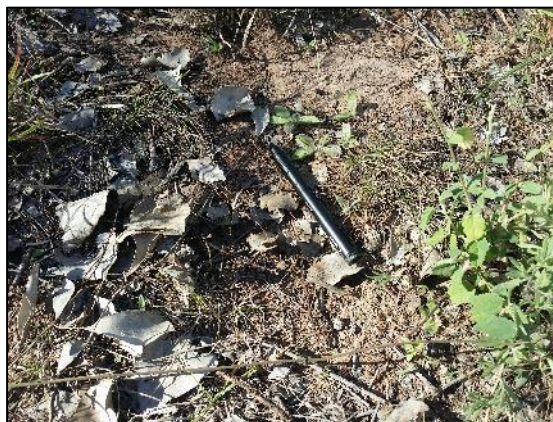
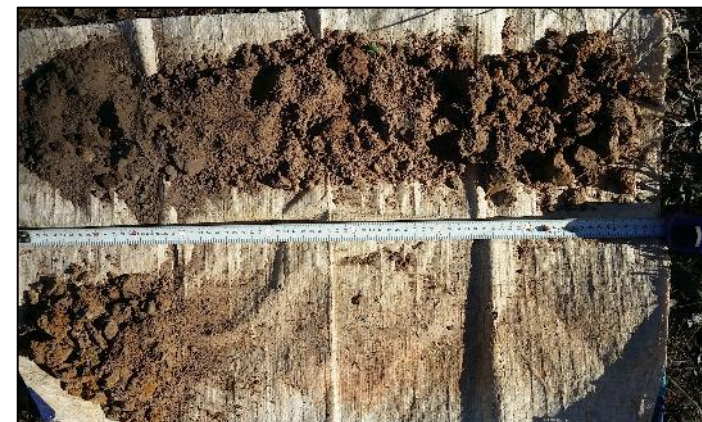
| <b>Soil Mapping Unit:</b><br>S1 | <b>CSIRO Land Systems (Gunn et al 1967):</b><br>Somerby, Monteagle, Connors,<br>Humboldt, Blackwater | <b>Location (GDA ZONE 55):</b><br>638652 mE 7546697 mN | <b>Aust. Soil Class. :</b><br>Brown Sodosol | <b>Site Survey Type:</b><br>Detailed - 50mm hand auger | <b>Survey Date:</b><br>18/6/2017 |

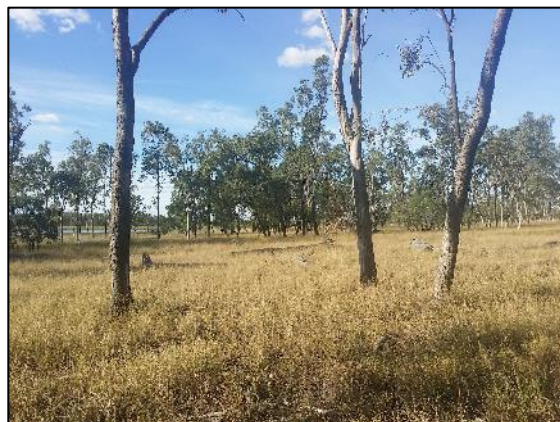
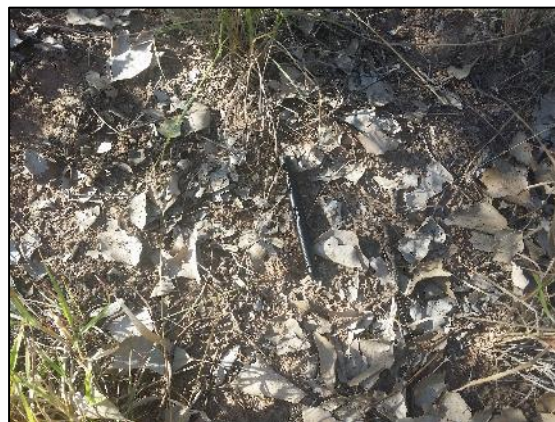
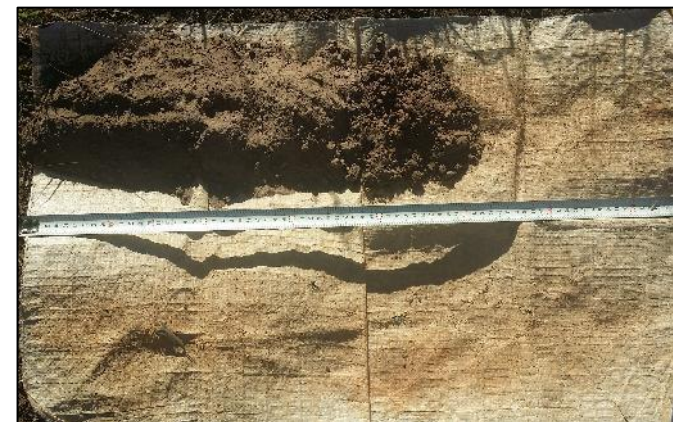
| <b>Soil Mapping Unit:</b><br>S1 | <b>CSIRO Land Systems (Gunn et al 1967):</b><br>Somerby, Monteagle, Connors,<br>Humboldt, Blackwater | <b>Location (GDA ZONE 55):</b><br>639484 mE 7545992 mN | <b>Aust. Soil Class. :</b><br>Brown Sodosol | <b>Site Survey Type:</b><br>Detailed - 50mm hand auger | <b>Survey Date:</b><br>18/6/2017 |

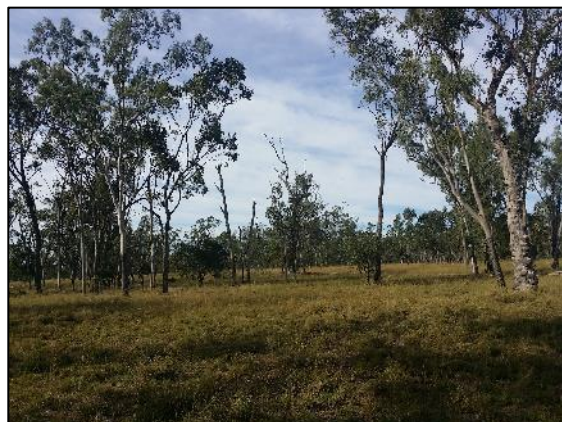
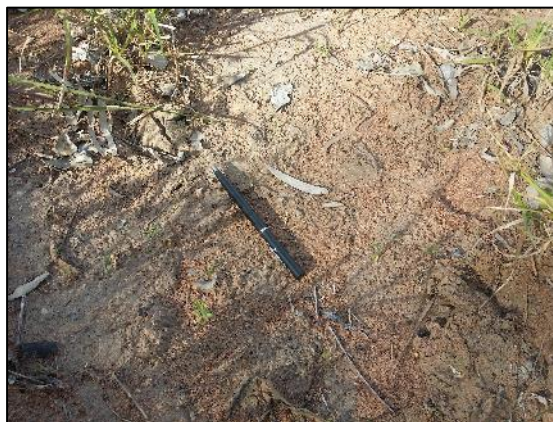
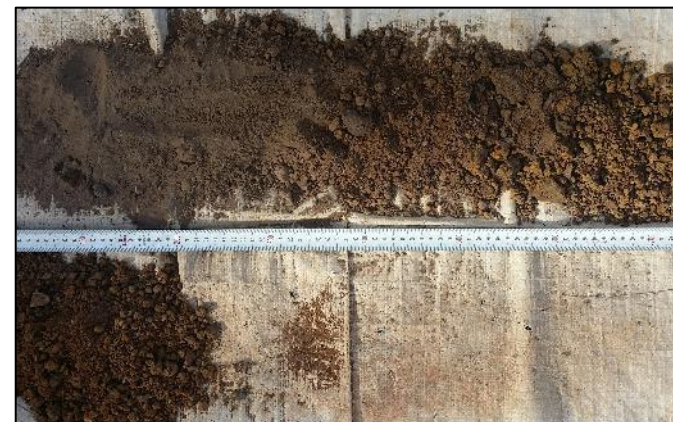
| <b>Soil Mapping Unit:</b><br>S2 | <b>CSIRO Land Systems (Gunn et al 1967):</b><br>Somerby, Monteagle, Connors,<br>Humboldt, Blackwater | <b>Location (GDA ZONE 55):</b><br>639705 mE 7547057 mN | <b>Aust. Soil Class. :</b><br>Haplic Brown Dermosol | <b>Site Survey Type:</b><br>Detailed - 50mm hand auger | <b>Survey Date:</b><br>19/6/2017 |

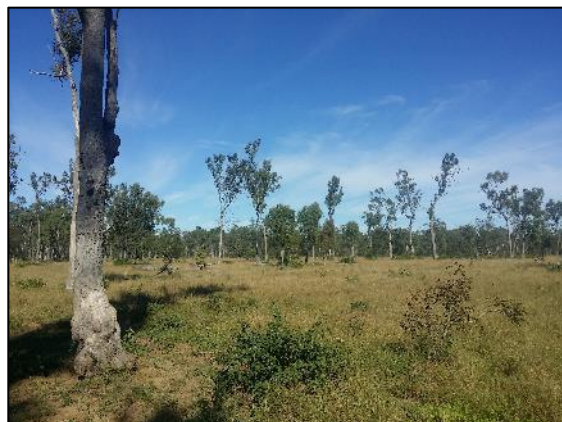
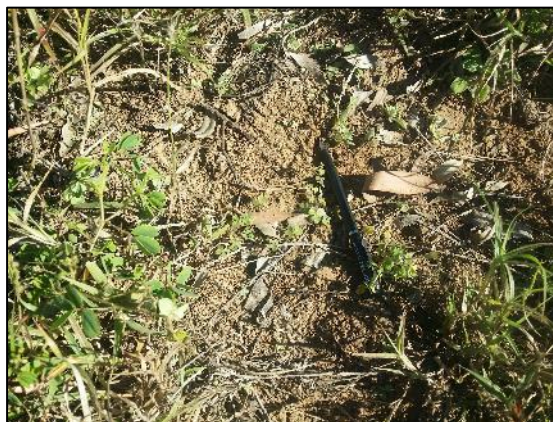
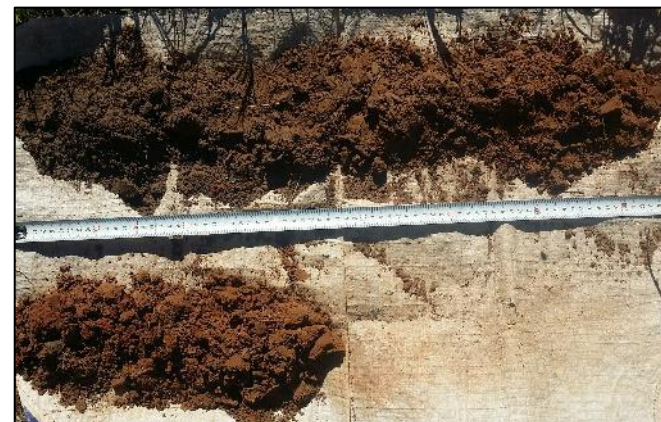
| <b>Soil Mapping Unit:</b><br>S2 | <b>CSIRO Land Systems (Gunn et al 1967):</b><br>Somerby, Monteagle, Connors,<br>Humboldt, Blackwater | <b>Location (GDA ZONE 55):</b><br>640823 mE 7547668 mN | <b>Aust. Soil Class. :</b><br>Haplic Brown Dermosol | <b>Site Survey Type:</b><br>Detailed - 50mm hand auger | <b>Survey Date:</b><br>19/6/2017 |

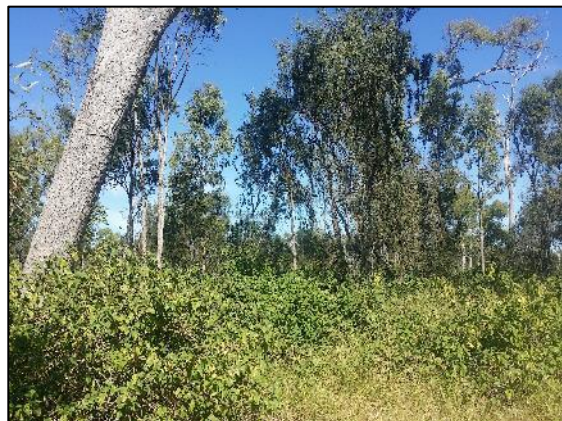
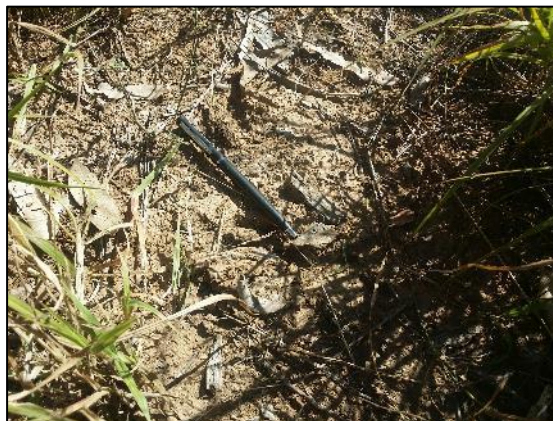
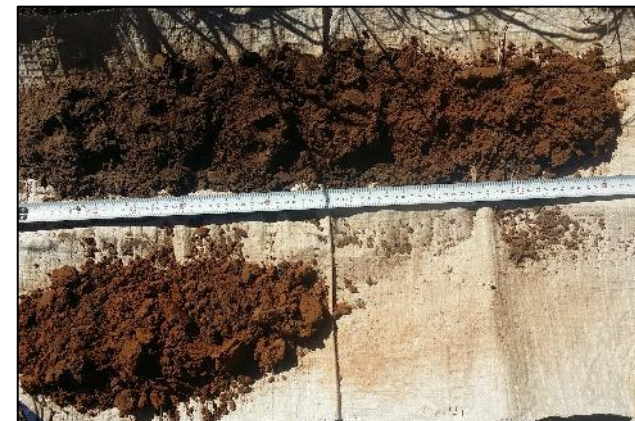
| <b>Soil Mapping Unit:</b><br>S2 | <b>CSIRO Land Systems (Gunn et al 1967):</b><br>Somerby, Monteagle, Connors,<br>Humboldt, Blackwater | <b>Location (GDA ZONE 55):</b><br>641896 mE 7547883 mN | <b>Aust. Soil Class. :</b><br>Haplic Brown Dermosol | <b>Site Survey Type:</b><br>Detailed - 50mm hand auger | <b>Survey Date:</b><br>19/6/2017 |

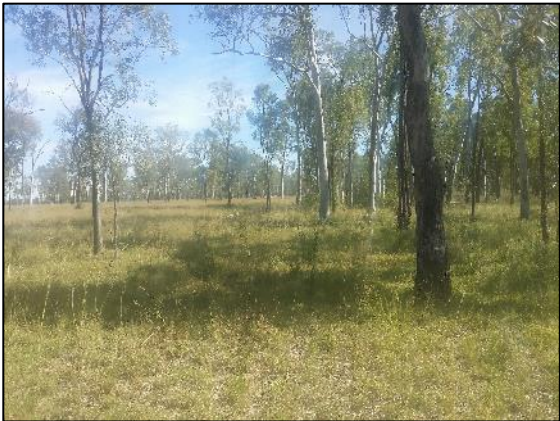
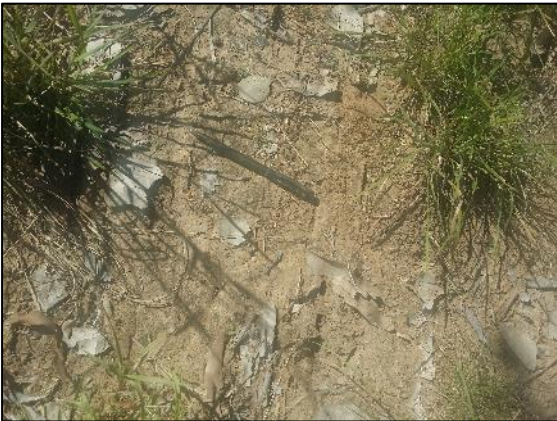
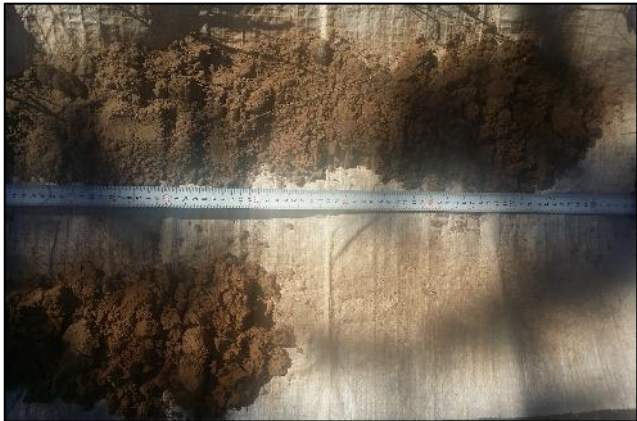
| <b>Soil Mapping Unit:</b><br>S2 | <b>CSIRO Land Systems (Gunn et al 1967):</b><br>Somerby, Monteagle, Connors,<br>Humboldt, Blackwater | <b>Location (GDA ZONE 55):</b><br>641130 mE 7547096 mN | <b>Aust. Soil Class. :</b><br>Haplic Brown Dermosol | <b>Site Survey Type:</b><br>Detailed - 50mm hand auger | <b>Survey Date:</b><br>19/6/2017 |
