**PEMBROKE**

**Olive Downs Coking Coal Project**  
Draft Environmental Impact Statement

**Appendix M**  
**Soil and Land**  
**Suitability**  
**Assessment**

Olive Downs Coking Coal Project

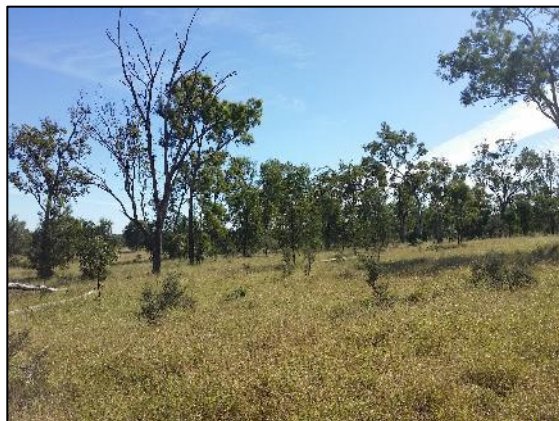
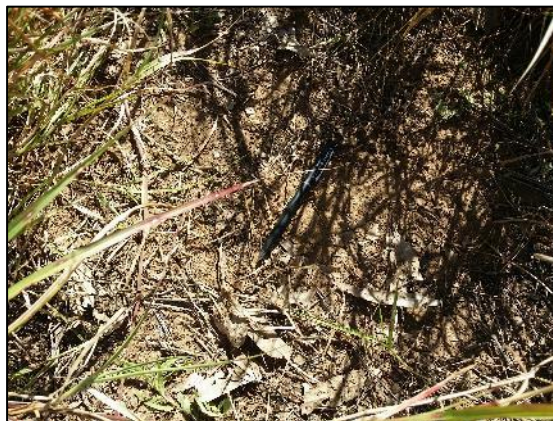
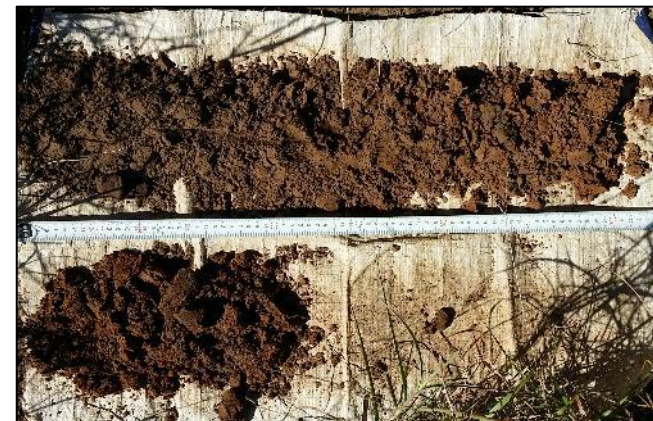
| Land use<br>Landform<br>Pattern,<br>Element,<br>Slope | Natural<br>Vegetation | Microrelief<br>Disturbance<br>Erosion | Surface<br>condition,<br>surface rock | Soil Profile Description | | | | | | | | | |
|---|---|---|---|---|---|---|---|---|---|---|---|---|---|
| | | | | B22<br>0.53 – 1.0 | Clayey<br>sand | Moderate,<br>weak, peds<br>5-20mm | Nil | 10YR4/4<br>Dark yellowish<br>brown | Dry, well<br>drained | One medium<br>root 5mm<br>thick found | 0.6 / 7.0<br>0.9 / 7.0 | | |

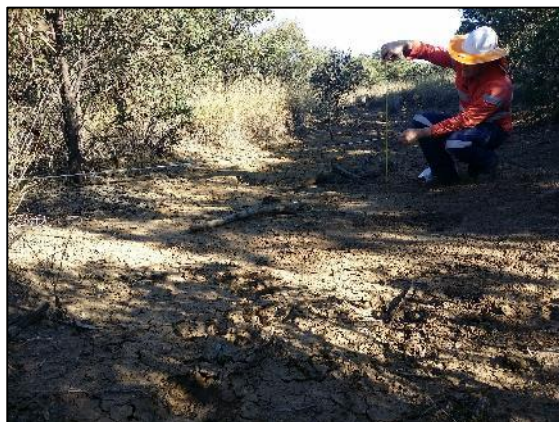
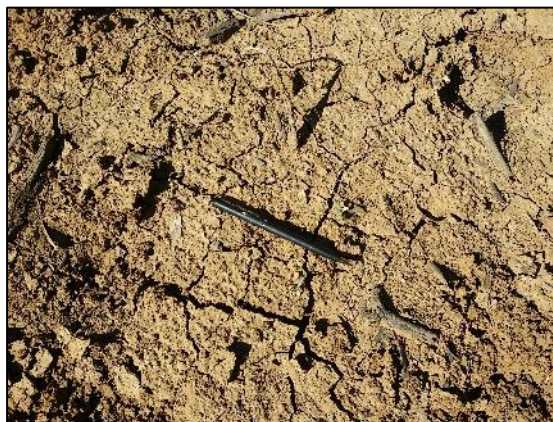
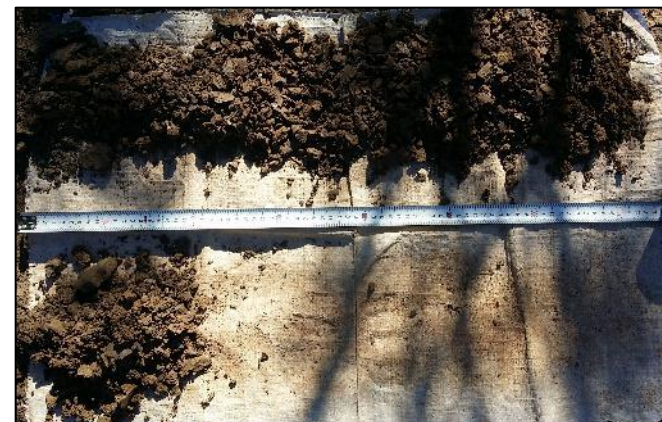
| Land use<br>Landform<br>Pattern,<br>Element,<br>Slope | Natural<br>Vegetation | Microrelief<br>Disturbance<br>Erosion | Surface<br>condition,<br>surface rock | Soil Profile Description | | | | | | | | | |
|---|---|---|---|---|---|---|---|---|---|---|---|---|---|
| Grazing, flat<br>plain | Brigalow<br>regrowth,<br>70%+<br>coverage | Melon holes<br>approx.. 4m<br>diameter,<br>0.4m deep,<br>depressions<br>at 50%<br>coverage. | Cracking with<br>crust | A1<br>0.00 – 0.09<br>Abrupt | Light clay | Weak, firm,<br>3-10mm<br>sub-angular | 2% coarse<br>fragments and<br>black nodules, 2-<br>5mm | 10YR3/2<br>Very dark grayish<br>brown | Dry, well<br>drained | Very few, fine<br>down to<br>0.05m | 0.05 – 6.5 | 0.0 – 0.1<br>0.3 – 0.4<br>0.6 – 0.7<br>0.8 – 0.9 | Refusal at<br>0.9m due to<br>rock/s..<br><br>Site located in<br>depression |

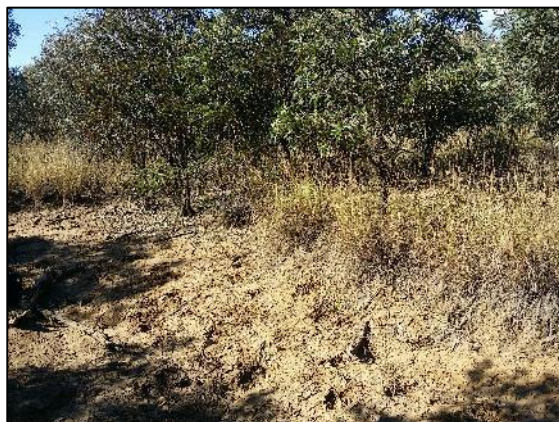
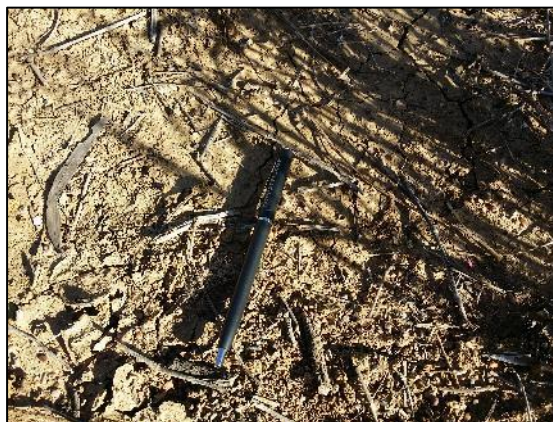
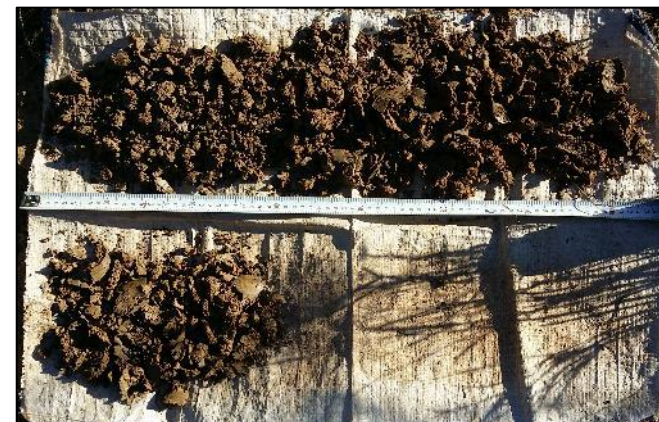
| Land use<br>Landform<br>Pattern,<br>Element,<br>Slope | Natural<br>Vegetation | Microrelief<br>Disturbance<br>Erosion | Surface<br>condition,<br>surface rock | Soil Profile Description | | | | | | | | | |
|---|---|---|---|---|---|---|---|---|---|---|---|---|---|
| Grazing, flat<br>plain | Brigalow<br>regrowth,<br>70%+<br>coverage | Melon holes<br>approx.. 4m<br>diameter,<br>0.4m deep,<br>depressions<br>at 50%<br>coverage | Cracking with<br>crust | A1<br>0.00 – 0.10<br>Abrupt | Light clay | Weak, firm,<br>3-10mm<br>sub-angular | 2% coarse<br>fragments and<br>black nodules, 2-<br>5mm | 10YR3/2<br>Very dark grayish<br>brown | Dry, well<br>drained | Very few, fine<br>down to<br>0.05m | 0.05 – 6.5 | 0.0 – 0.1<br>0.3 – 0.4<br>0.6 – 0.7<br>0.9 – 1.0 | Site located in<br>melon hole<br>mount, 3<br>metres from<br>12a |

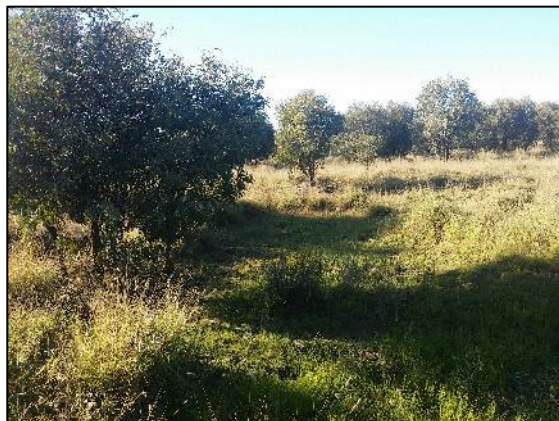
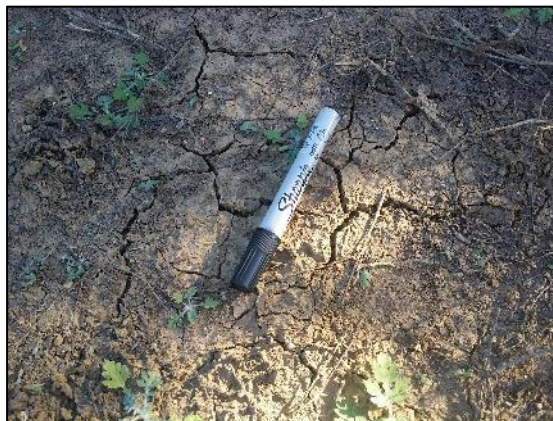
| Land use<br>Landform<br>Pattern,<br>Element,<br>Slope | Natural<br>Vegetation | Microrelief<br>Disturbance<br>Erosion | Surface<br>condition,<br>surface rock | Soil Profile Description | | | | | | | | | |
|---|---|---|---|---|---|---|---|---|---|---|---|---|---|
| Grazing, flat<br>plain | Brigalow<br>regrowth,<br>70%+<br>coverage | Melon holes<br>approx.. 4m<br>diameter,<br>0.4m deep,<br>depressions<br>at 50%<br>coverage | Cracking with<br>crust | A1<br>0.00– 0.10<br>Abrupt | Light clay | Weak,<br>angular,<br>Strong | 2% coarse<br>fragments and<br>black nodules, 2-<br>5mm | 10YR3/2<br>Very dark grayish<br>brown | Dry, well<br>drained | Very few, fine<br>down to<br>0.05m | 0.05 – 6.5 | No samples<br>taken | Site located in<br>melon hole<br>depression, |

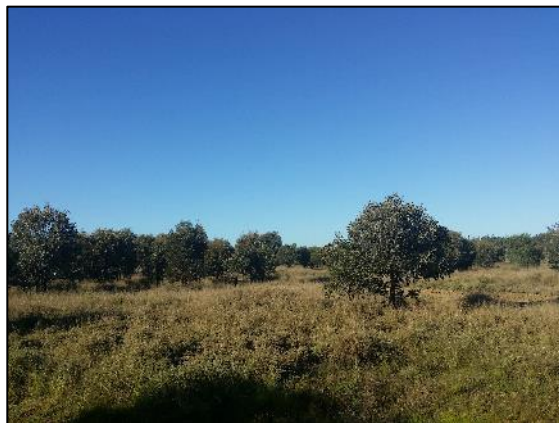
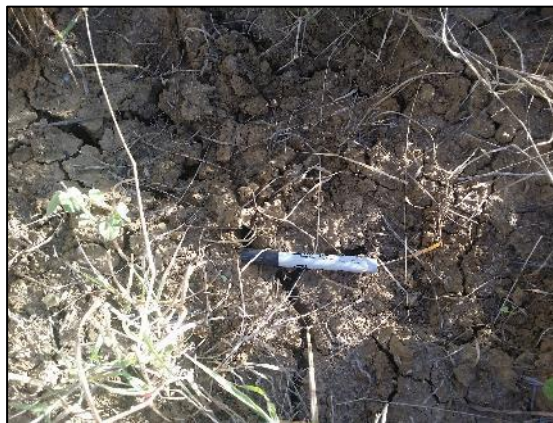
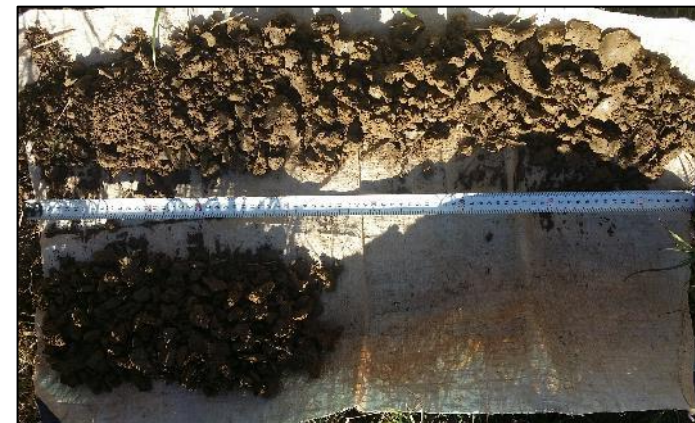
| Land use<br>Landform<br>Pattern,<br>Element,<br>Slope | Natural<br>Vegetation | Microrelief<br>Disturbance<br>Erosion | Surface<br>condition,<br>surface rock | Soil Profile Description | | | | | | | | | |
|---|---|---|---|---|---|---|---|---|---|---|---|---|---|
| Grazing, flat<br>plain | Brigalow<br>regrowth,<br>70%+<br>coverage | Melon holes<br>approx.. 4m<br>diameter,<br>0.4m deep,<br>depressions<br>at 50%<br>coverage | Cracking with<br>crust | A1<br>0.00 – 0.10<br>Abrupt | Light clay | Moderate,<br>angular,<br>Strong | 2% coarse<br>fragments and<br>black nodules, 2-<br>5mm | 10YR3/2<br>Very dark grayish<br>brown | Dry, well<br>drained | Very few, fine<br>down to<br>0.05m | 0.05 – 6.5 | No samples<br>taken | Site located<br>on melon hole<br>mound |

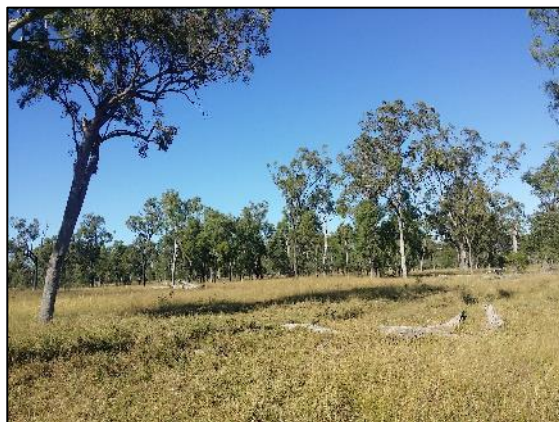
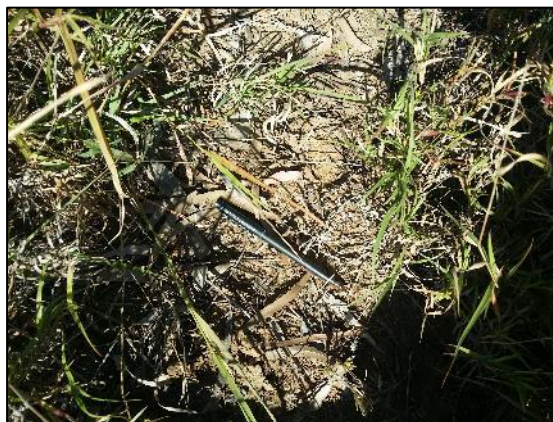
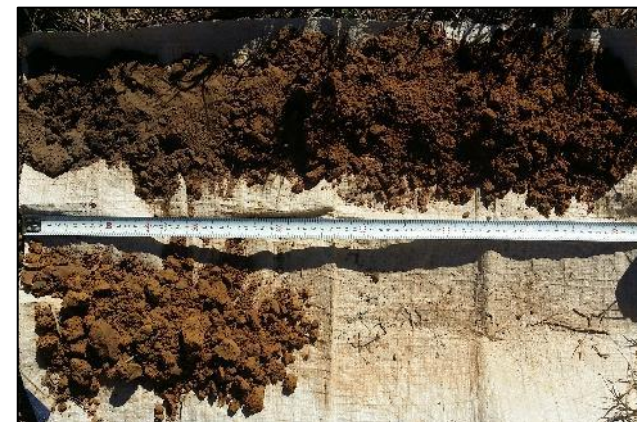
| Land use<br>Landform<br>Pattern,<br>Element,<br>Slope | Natural<br>Vegetation | Microrelief<br>Disturbance<br>Erosion | Surface<br>condition,<br>surface rock | Soil Profile Description | | | | | | | | | |
|---|---|---|---|---|---|---|---|---|---|---|---|---|---|
| Grazing, very<br>gently<br>undulating<br>plains, 1% | Very Sparse,<br>Moreton Bay<br>Ash, Blackbutt | Semi cleared | Firm, no<br>coarse<br>fragments | A11<br>0.0 – 0.22<br>Abrupt | Loamy<br>sand | Massive,<br>loose | Nil | 10YR3/2<br>Very dark grayish<br>brown | Dry, rapid | Few, very fine | 0.1 / 6.5 | No samples<br>taken | No additional<br>observations |
| | | | | A12<br>0.22 – 0.7<br>Abrupt | Clayey<br>sand | Weak<br>subangular<br>peds<br>20mm,<br>weak | Nil | 10YR4/4<br>Dark yellowish<br>brown | Humid, well<br>drained | Few, very fine | 0.3 / 7.0<br>0.6 / 7.0 | | |

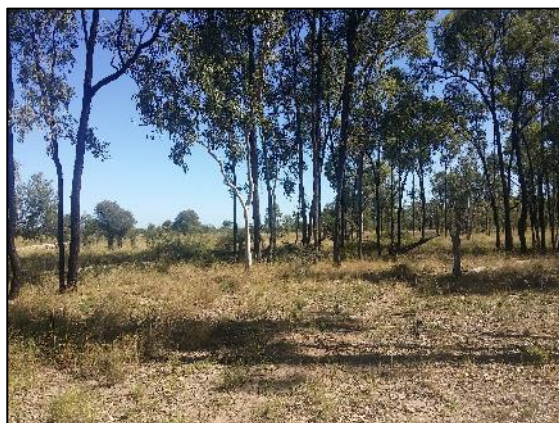
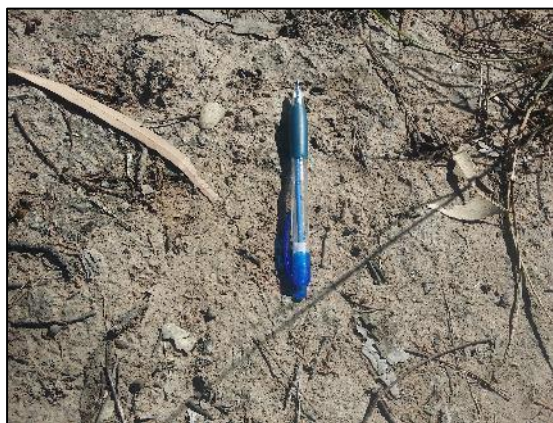
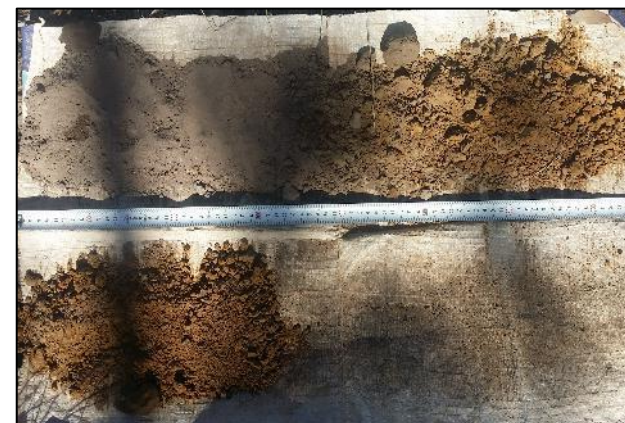
| Land use<br>Landform<br>Pattern,<br>Element,<br>Slope | Natural<br>Vegetation | Microrelief<br>Disturbance<br>Erosion | Surface<br>condition,<br>surface rock | Soil Profile Description | | | | | | | | | |
|---|---|---|---|---|---|---|---|---|---|---|---|---|---|
| Grazing,<br>gently<br>undulating<br>plain, 2.5%<br>mid-slope | Mostly<br>Ironbark and<br>Bloodwood,<br><5% Moreton<br>Bay Ash | Nil | Hard setting,<br><2% black<br>nodules and<br>coarse<br>fragments 2-<br>6mm diameter | A11<br>0.0 – 0.36<br>Abrupt | Loamy<br>Sand | Massive,<br>loose | Nil | 10YR3/2<br>Very dark grayish<br>brown<br>No mottle | Dry, rapid | Very few, very<br>fine | 0.10 / 7.0 | 0.00 – 0.10<br>0.36 – 0.46<br>0.60 – 0.70<br>0.90 - 100 | No additional<br>observations |

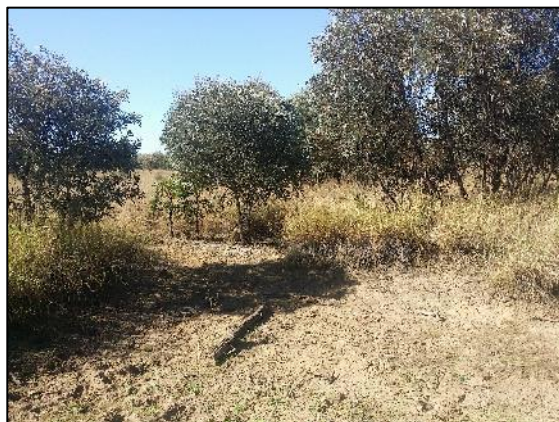
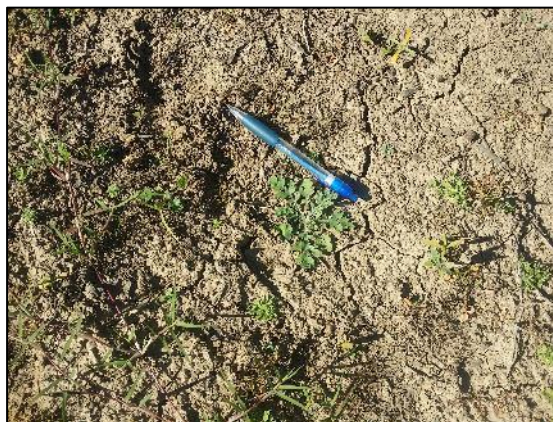
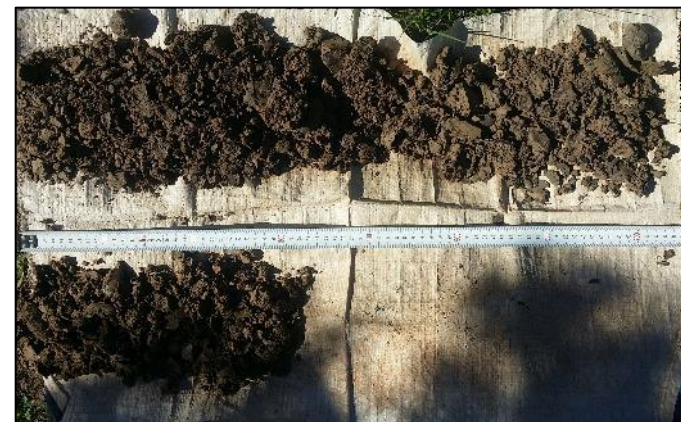
| Land use<br>Landform<br>Pattern,<br>Element,<br>Slope | Natural<br>Vegetation | Microrelief<br>Disturbance<br>Erosion | Surface<br>condition,<br>surface rock | Soil Profile Description | | | | | | | | | |
|---|---|---|---|---|---|---|---|---|---|---|---|---|---|
| Grazing, flat<br>plain | Brigalow<br>regrowth,<br>70%+<br>coverage | Melon holes<br>approx.. 4m<br>diameter,<br>0.4m deep,<br>depressions<br>at 50%<br>coverage | Cracking with<br>crust | A1<br>0.00 – 0.10<br>Abrupt | Light clay | Weak,<br>angular,<br>Strong | 2% coarse<br>fragments and<br>black nodules, 2-<br>5mm | 10YR3/2<br>Very dark grayish<br>brown | Dry, well<br>drained | Very few, fine<br>down to 0.1m | 0.05 – 6.5 | No samples<br>taken | Site located in<br>melon hole<br>depression, |

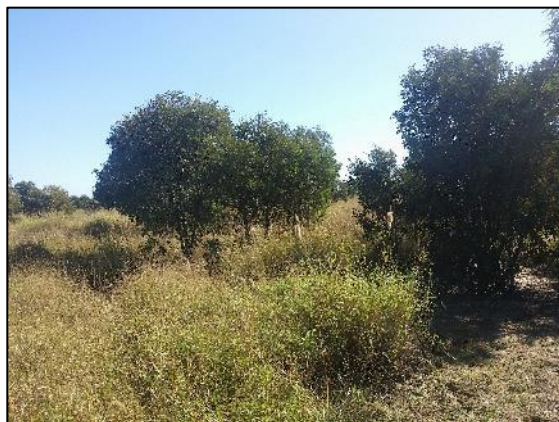
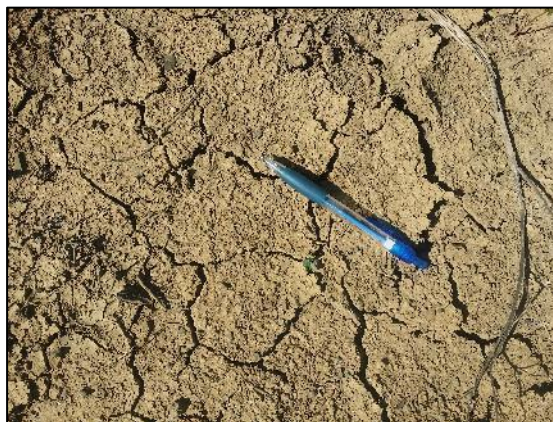
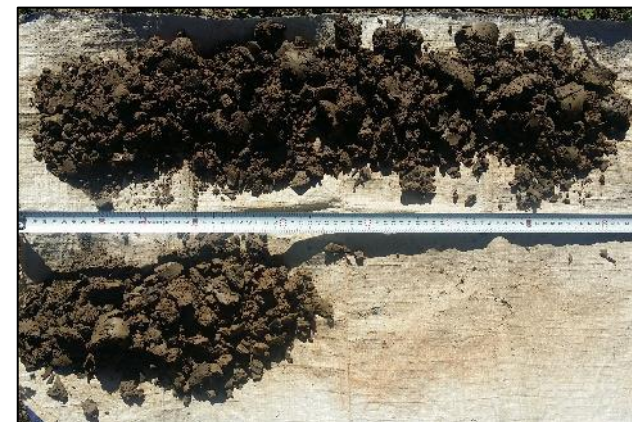
| Land use<br>Landform<br>Pattern,<br>Element,<br>Slope | Natural<br>Vegetation | Microrelief<br>Disturbance<br>Erosion | Surface<br>condition,<br>surface rock | Soil Profile Description | | | | | | | | | |
|---|---|---|---|---|---|---|---|---|---|---|---|---|---|
| Grazing, flat<br>plain | Brigalow<br>regrowth,<br>70%+<br>coverage | Melon holes<br>approx.. 4m<br>diameter,<br>0.4m deep,<br>depressions<br>at 50%<br>coverage | Cracking with<br>crust | A1<br>0.00 – 0.10<br>Abrupt | Light clay | Weak,<br>angular,<br>Strong | 2% coarse<br>fragments and<br>black nodules, 2-<br>5mm | 10YR3/2<br>Very dark grayish<br>brown | Dry, well<br>drained | Very few, fine<br>down to<br>0.05m | 0.05 – 6.5 | No samples<br>taken | Site located in<br>melon hole<br>depression, |

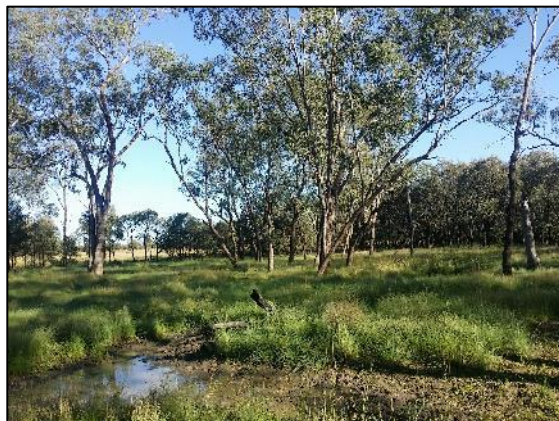
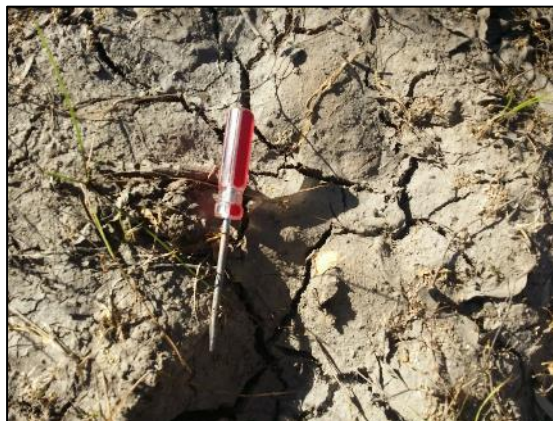
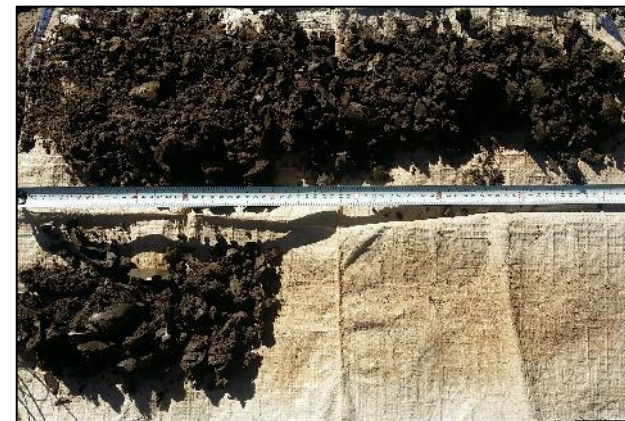
| Land use<br>Landform<br>Pattern,<br>Element,<br>Slope | Natural<br>Vegetation | Microrelief<br>Disturbance<br>Erosion | Surface<br>condition,<br>surface rock | Soil Profile Description | | | | | | | | | |
|---|---|---|---|---|---|---|---|---|---|---|---|---|---|
| Grazing,<br>opening<br>depression /<br>swamp<br>conditions<br>due to<br>landform | Brigalow / tall<br>sparse<br>woodlands | <20% minor<br>normal gilgai | Cracking,<br>poached | A1<br>0.00 – 0.27<br>Diffuse | Light clay | Weak, peds<br>1-10mm,<br>sub-<br>angular,<br>strength –<br>firm | <2% black<br>nodules 1-5mm | 10YR3/2<br>Very dark greyish<br>brown | Dry, well<br>drained | Few, very fine | 0.00 / 6.5 | No samples<br>taken | No additional<br>observations |
| | | | | B2<br>0.27 – 1.00 | Light clay | Moderate,<br>peds 1-<br>20mm, sub-<br>angular,<br>strength-<br>Very firm | <2% black<br>nodules 1-5mm | 10YR3/2<br>Very dark greyish<br>brown | Slightly<br>moist, well<br>drained | Few, very fine | 0.30 / 7.0<br>0.60 / 7.0<br>0.90 / 7.0 | | |

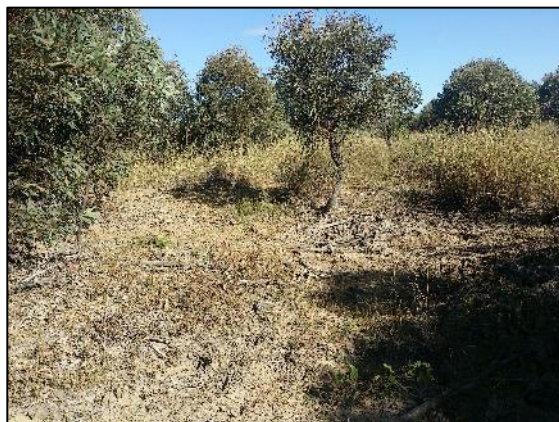
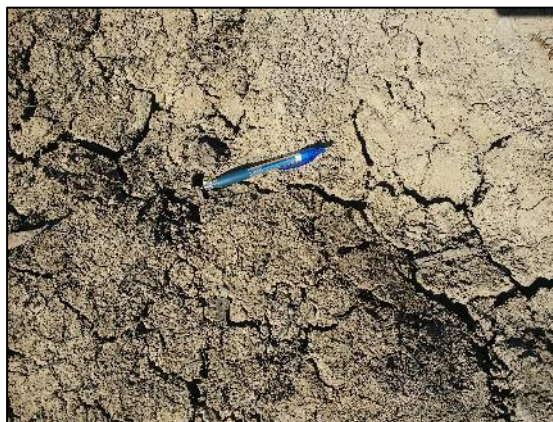
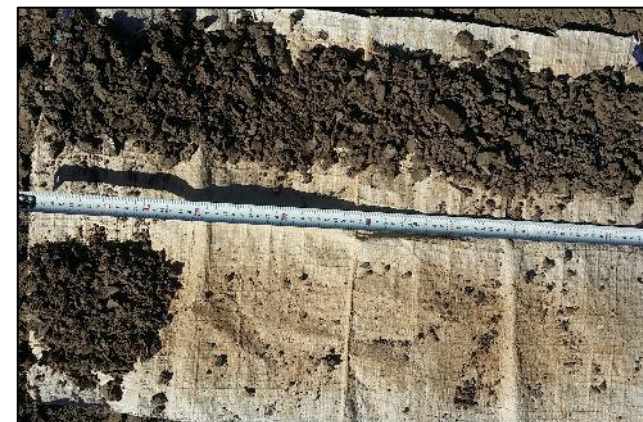
| Land use<br>Landform<br>Pattern,<br>Element,<br>Slope | Natural<br>Vegetation | Microrelief<br>Disturbance<br>Erosion | Surface<br>condition,<br>surface rock | Soil Profile Description | | | | | | | | | |
|---|---|---|---|---|---|---|---|---|---|---|---|---|---|
| Grazing, flat<br>plain | Brigalow<br>regrowth,<br>70%+<br>coverage | Melon holes<br>approx.. 4m<br>diameter,<br>0.4m deep,<br>depressions<br>at 50%<br>coverage | Cracking with<br>crust | A1<br>0.00– 0.10<br>Abrupt | Light clay | Weak,<br>angular,<br>Strong | 2% coarse<br>fragments and<br>black nodules, 2-<br>5mm | 10YR3/2<br>Very dark grayish<br>brown | Dry, well<br>drained | Very few, fine<br>down to<br>0.85m | 0.05 – 6.5 | No samples<br>taken | No recovery at<br>0.85m |

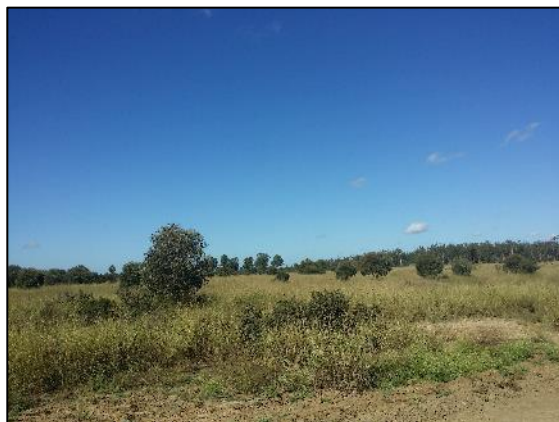
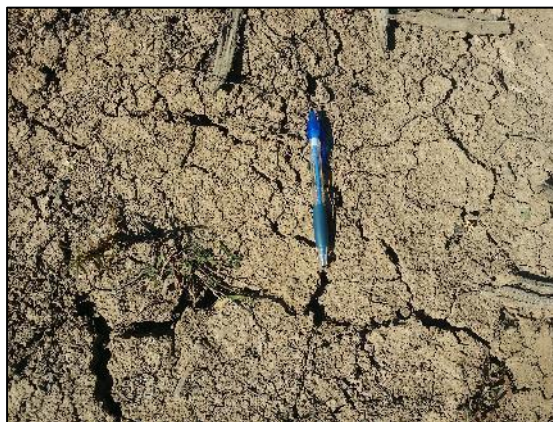
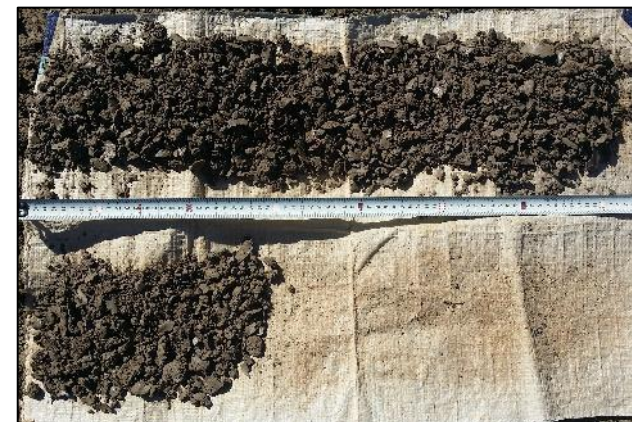
| Land use<br>Landform<br>Pattern,<br>Element,<br>Slope | Natural<br>Vegetation | Microrelief<br>Disturbance<br>Erosion | Surface<br>condition,<br>surface rock | Soil Profile Description | | | | | | | | | |
|---|---|---|---|---|---|---|---|---|---|---|---|---|---|
| Grazing, flat<br>plain | Brigalow<br>regrowth,<br>70%+<br>coverage | Melon holes<br>approx.. 4m<br>diameter,<br>0.4m deep,<br>depressions<br>at 50%<br>coverage | Cracking with<br>crust | A1<br>0.00 – 0.10<br>Abrupt | Light clay | Moderate,<br>angular,<br>Strong | 2% coarse<br>fragments and<br>black nodules, 2-<br>5mm | 10YR3/2<br>Very dark grayish<br>brown | Dry, well<br>drained | Very few, fine<br>down to 0.1m | 0.0 – 6.5 | No samples<br>taken | Site located in<br>melon hole<br>depression, |

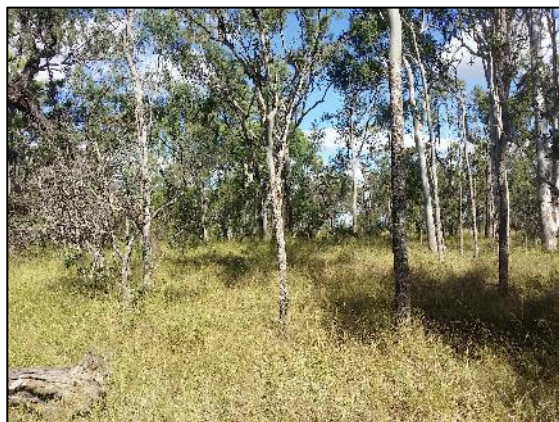
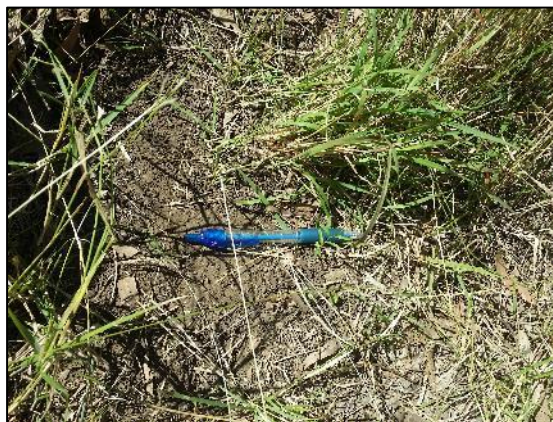
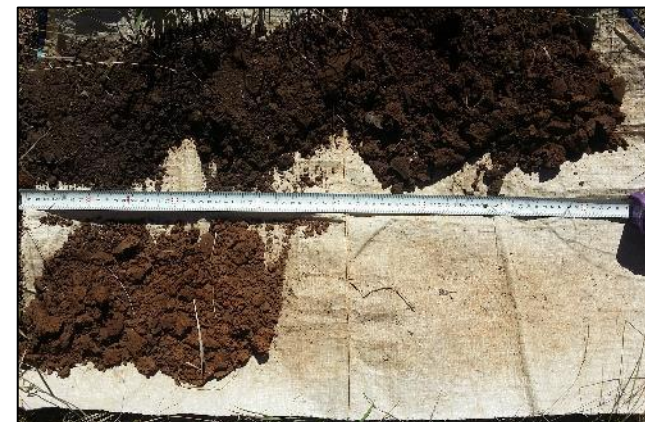
| <b>Soil Mapping Unit:</b><br>B1 | <b>CSIRO Land Systems (Gunn et al 1967):</b><br>Somerby, Monteagle, Humboldt | <b>Location (GDA ZONE 55):</b><br>645525 mE 7543737 mN | <b>Aust. Soil Class. :</b><br>Subnatric Brown Sodosol | <b>Site Survey Type:</b><br>Detailed - 50mm hand auger | <b>Survey Date:</b><br>21/6/2017 |

| Land use<br>Landform<br>Pattern,<br>Element,<br>Slope | Natural<br>Vegetation | Microrelief<br>Disturbance<br>Erosion | Surface<br>condition,<br>surface rock | Soil Profile Description | | | | | | | | | |
|---|---|---|---|---|---|---|---|---|---|---|---|---|---|
| Grazing, flat<br>plain 0%<br>slope | Moreton Bay<br>Ash, Blackbutt,<br>gums, long<br>grass | Nil | Soft, no coarse<br>fragments | A1<br>0.00 – 0.30<br>Abrupt | Silty loam | Weak, weak | Nil | 10YR2/1<br>Black | Dry, rapid | Very fine, few | 0.1 – 6.5 | 0.00 – 0.10<br>0.30 – 0.40<br>0.60 – 0.70<br>0.90 – 1.00 | No additional<br>observations |

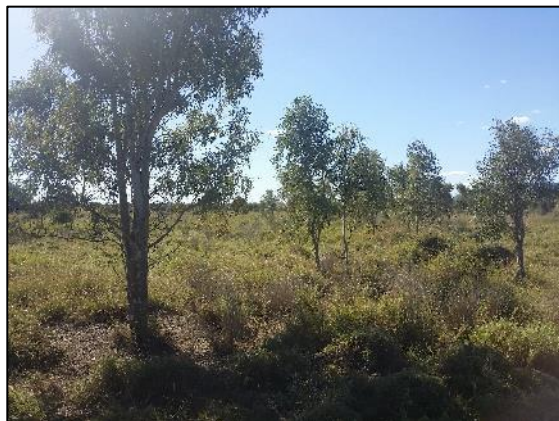
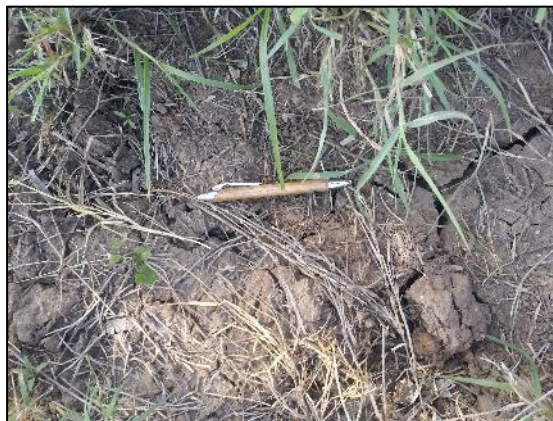
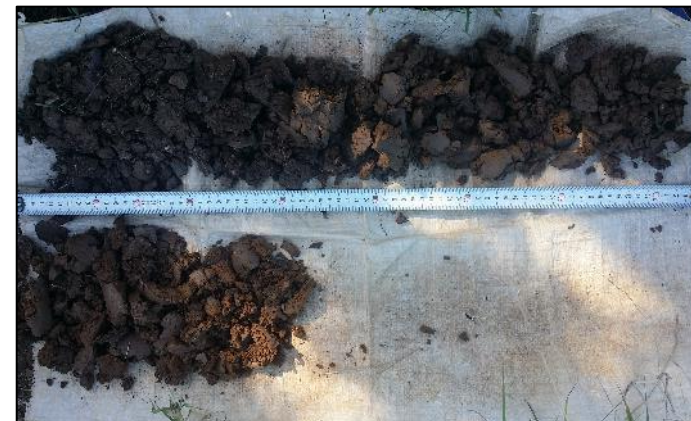
| <b>Soil Mapping Unit:</b><br>C2 | <b>CSIRO Land Systems (Gunn et al 1967):</b><br>Somerby, Monteagle, Connors,<br>Humboldt, Blackwater, Junee | <b>Location (GDA ZONE 55):</b><br>644923 mE 7542220 mN | <b>Aust. Soil Class. :</b><br>Brown Vertosol | <b>Site Survey Type:</b><br>Detailed - 50mm hand auger | <b>Survey Date:</b><br>21/6/2017 |

| Land use<br>Landform<br>Pattern,<br>Element,<br>Slope | Natural<br>Vegetation | Microrelief<br>Disturbance<br>Erosion | Surface<br>condition,<br>surface rock | Soil Profile Description | | | | | | | | | |
|---|---|---|---|---|---|---|---|---|---|---|---|---|---|
| Grazing, flat<br>plain <1.0% | Sparse<br>regrowth –<br>Brigalow and<br>other | Shallow linear<br>gilgai,<br>approx. 3m<br>diameter x<br>0.3m deep,<br>20-30%<br>coverage<br>Mound | Cracking, <2%<br>coarse<br>fragments<br><5mm<br>diameter | A1<br>0 – 0.21<br>Abrupt | Light clay | Weak,<br><10mm<br>peds, firm | <2% calcium<br>carbonate | 10YR4/3<br>Brown | Dry, well<br>drained | Fine, few | 0.10 / 8.0 | 0.00 - 0.10<br>0.30 – 0.40<br>0.70 – 0.80<br>0.90 – 1.00 | Site located in<br>gilgai<br>depression |
| | | | | B21<br>0.21 – 0.68<br>Clear | Light clay | Weak,<br><20mm<br>peds, firm | <2% black<br>nodules <5mm | 10YR4/3<br>Brown | Moderately<br>moist, well<br>drained | Very fine, few | 0.30 / 7.5<br>0.60 / 8.0 | | |
| | | | | B22<br>0.68 – 1.00 | Light clay | Moderate,<br><20mm<br>peds, firm | <2% black<br>nodules <5mm | 10YR4/4<br>Dark yellowish<br>brown | Moderately<br>moist, well<br>drained | Nil | 0.90 / 8.0 | | |

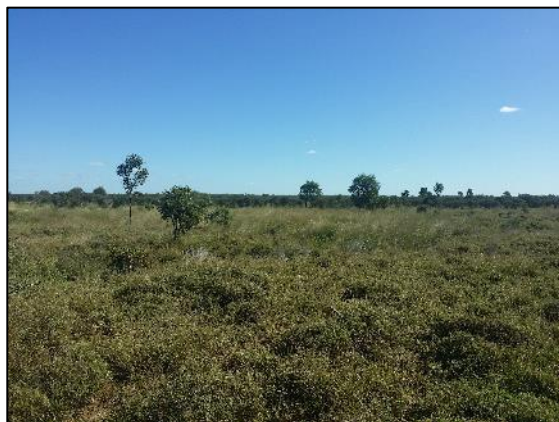
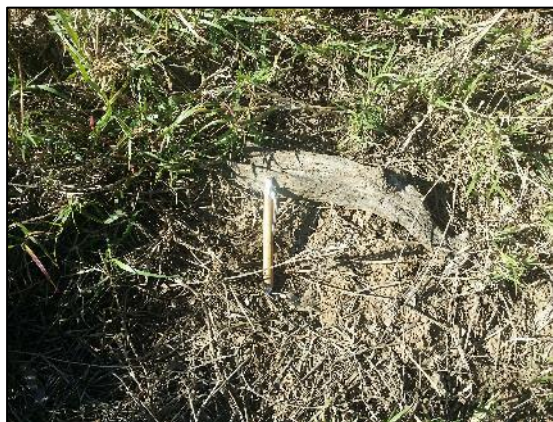
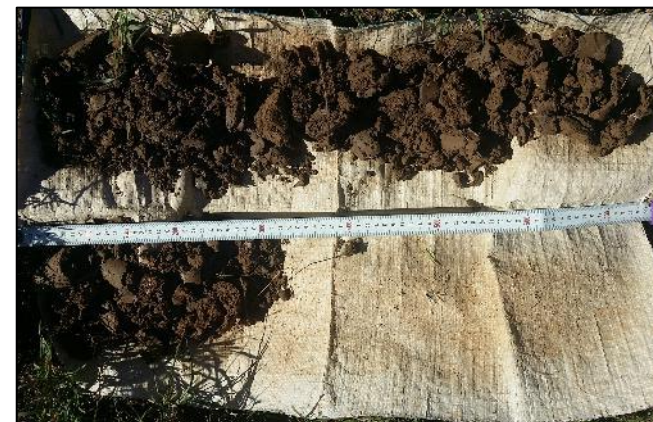
| <b>Soil Mapping Unit:</b><br>C2 | <b>CSIRO Land Systems (Gunn et al 1967):</b><br>Somerby, Monteagle, Connors,<br>Humboldt, Blackwater, Junee | <b>Location (GDA ZONE 55):</b><br>644923 mE 7542220 mN | <b>Aust. Soil Class. :</b><br>Brown Vertosol | <b>Site Survey Type:</b><br>Detailed - 50mm hand auger | <b>Survey Date:</b><br>21/6/2017 |

| Land use<br>Landform<br>Pattern,<br>Element,<br>Slope | Natural<br>Vegetation | Microrelief<br>Disturbance<br>Erosion | Surface<br>condition,<br>surface rock | Soil Profile Description | | | | | | | | | |
|---|---|---|---|---|---|---|---|---|---|---|---|---|---|
| Grazing, flat<br>plain <1.0% | Sparse<br>regrowth –<br>Brigalow and<br>other | Shallow linear<br>gilgai,<br>approx. 3m<br>diameter x<br>0.3m deep,<br>20-30%<br>coverage<br>Depression | Cracking, <2%<br>coarse<br>fragments<br><5mm<br>diameter | A1<br>0 – 0.21<br>Abrupt | Light clay | Weak,<br><10mm<br>peds, firm | <2% calcium<br>carbonate | 10YR4/3<br>Brown | Dry, well<br>drained | Fine, few | 0.10 / 8.0 | 0.00 – 0.10<br>0.30 – 0.40<br>0.60 – 0.70<br>0.90 – 1.00 | Site located<br>on gilgai<br>mound |
| | | | | B21<br>0.21 – 0.76<br>Clear | Light clay | Weak,<br><20mm<br>peds, firm | <2% black<br>nodules <5mm | 10YR4/3<br>Brown | Moderately<br>moist, well<br>drained | Very fine, few | 0.30 / 7.5<br>0.60 / 8.0 | | |
| | | | | B22<br>0.76 – 1.00 | Light clay | Moderate,<br><20mm<br>peds, firm | <2% black<br>nodules <5mm | 10YR4/4<br>Dark yellowish<br>brown | Moderately<br>moist, well<br>drained | Nil | 0.90 / 8.0 | | |

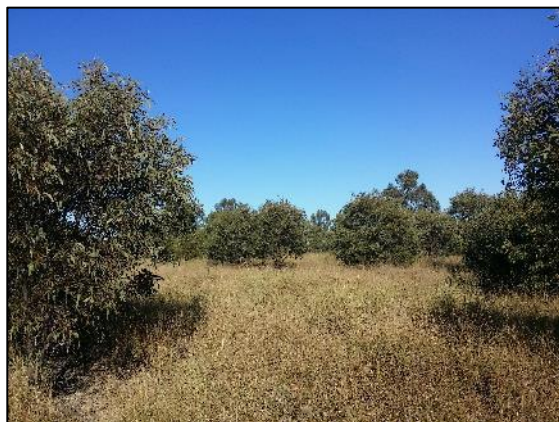
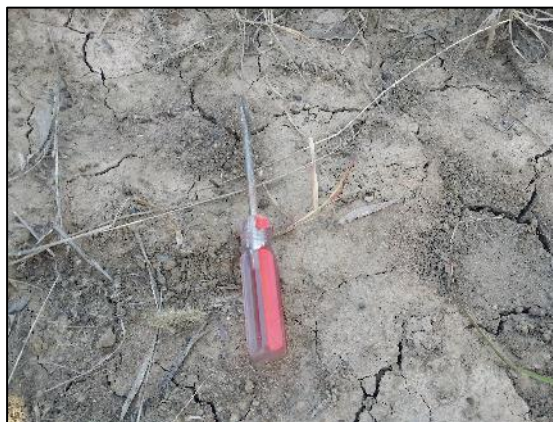
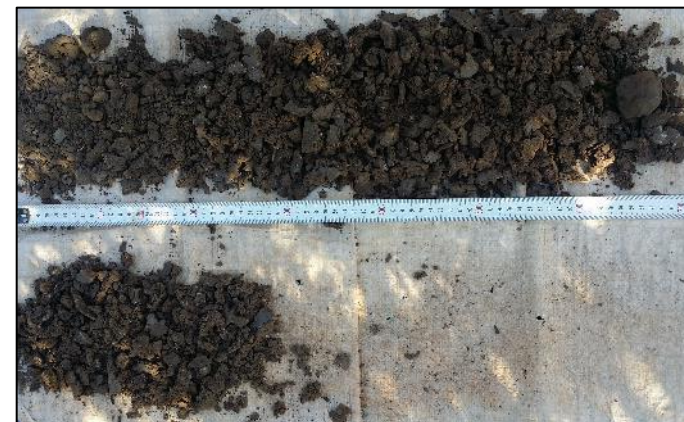
| <b>Soil Mapping Unit:</b><br>C2 | <b>CSIRO Land Systems (Gunn et al 1967):</b><br>Somerby, Monteagle, Connors,<br>Humboldt, Blackwater, Junee | <b>Location (GDA ZONE 55):</b><br>640146 mE 7543555 mN | <b>Aust. Soil Class. :</b><br>Brown Vertosol | <b>Site Survey Type:</b><br>Detailed - 50mm hand auger | <b>Survey Date:</b><br>22/6/2017 |

| Land use<br>Landform<br>Pattern,<br>Element,<br>Slope | Natural<br>Vegetation | Microrelief<br>Disturbance<br>Erosion | Surface<br>condition,<br>surface rock | Soil Profile Description | | | | | | | | | |
|---|---|---|---|---|---|---|---|---|---|---|---|---|---|
| Grazing, very<br>gently<br>undulating<br>plain, <1%<br>slope | Tall Brigalow<br>and Brigalow<br>regrowth, semi<br>sparse, limited<br>clearing 20-<br>30% coverage | Normal<br>gilgai, 30%<br>coverage,<br><0.3m deep | Cracking,<br><5mm cracks,<br>5% coarse<br>fragments<br><5mm | A1<br>0.00 – 0.19<br>Abrupt | Light<br>medium<br>clay | Weak,<br><10mm<br>peds,<br>subangular,<br>strength-<br>firm | 2% coarse<br>fragments | 10YR4/2<br>Dark grayish<br>brown | Dry, well<br>drained | Nil | 0.00 / 6.5 | 0.00 – 0.10<br>0.30 – 0.40<br>0.60 – 0.70<br>0.90 – 1.00 | Site located in<br>gilgai<br>depression |

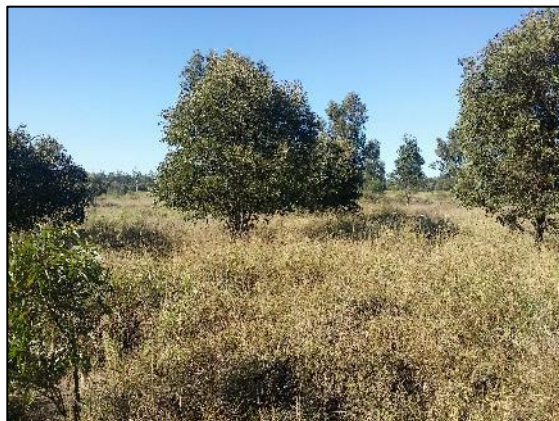
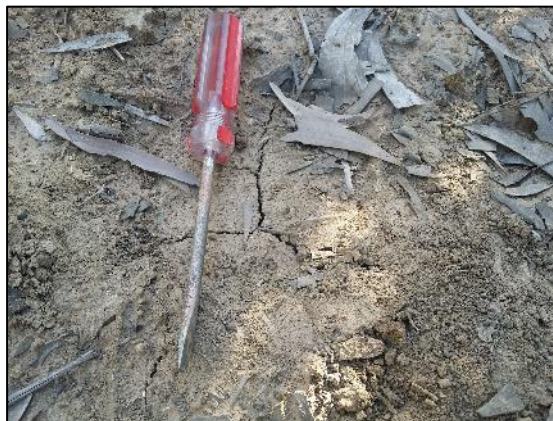
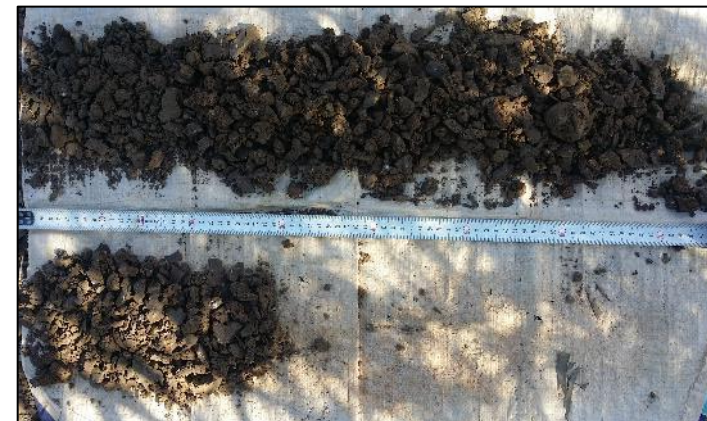
| <b>Soil Mapping Unit:</b><br>C2 | <b>CSIRO Land Systems (Gunn et al 1967):</b><br>Somerby, Monteagle, Connors,<br>Humboldt, Blackwater, Junee | <b>Location (GDA ZONE 55):</b><br>640146 mE 7543555 mN | <b>Aust. Soil Class. :</b><br>Brown Vertosol | <b>Site Survey Type:</b><br>Detailed - 50mm hand auger | <b>Survey Date:</b><br>22/6/2017 |

| Land use<br>Landform<br>Pattern,<br>Element,<br>Slope | Natural<br>Vegetation | Microrelief<br>Disturbance<br>Erosion | Surface<br>condition,<br>surface rock | Soil Profile Description | | | | | | | | | |
|---|---|---|---|---|---|---|---|---|---|---|---|---|---|
| Grazing, very<br>gently<br>undulating<br>plain, <1%<br>slope | Tall Brigalow<br>and Brigalow<br>regrowth, semi<br>sparse, limited<br>clearing 20-<br>30% coverage | Normal<br>gilgai, 30%<br>coverage,<br><0.3m deep | Cracking,<br><5mm cracks,<br>5% coarse<br>fragments<br><5mm | A1<br>0.00 – 0.25<br>Abrupt | Light<br>medium<br>clay | Moderate,<br><10mm<br>peds,<br>subangular,<br>strength-<br>firm | 2% coarse<br>fragments | 10YR4/2<br>Dark grayish<br>brown | Dry, well<br>drained | Nil | 0.00 / 6.5 | 0.00 – 0.10 | Site located<br>on gilgai<br>mound |

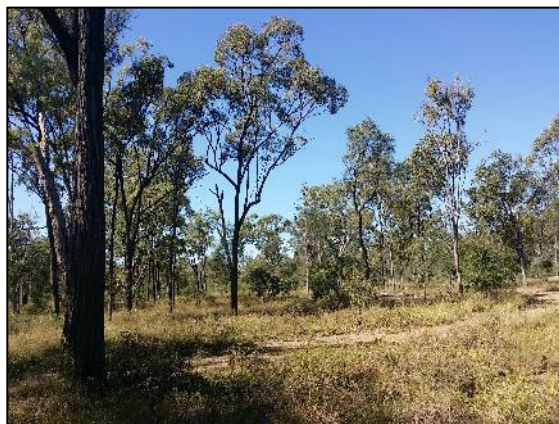
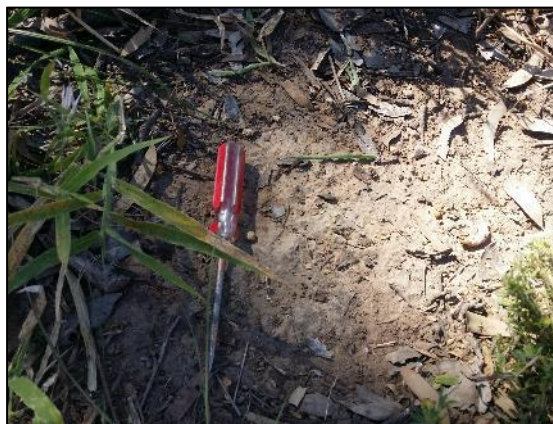
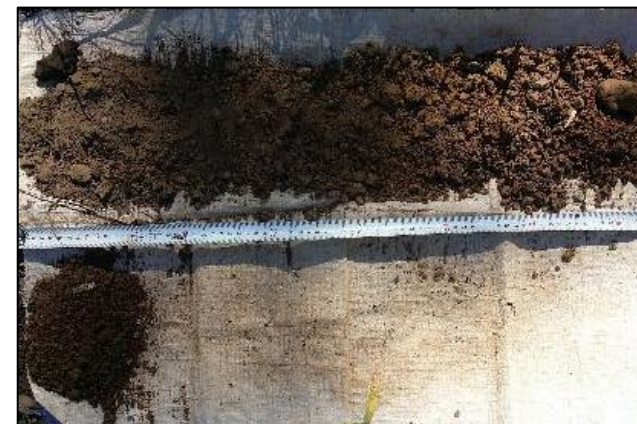
| <b>Soil Mapping Unit:</b><br>B1 | <b>CSIRO Land Systems (Gunn et al 1967):</b><br>Somerby, Monteagle, Humboldt | <b>Location (GDA ZONE 55):</b><br>641169 mE 7543418 mN | <b>Aust. Soil Class. :</b><br>Subnatric Brown Sodosol | <b>Site Survey Type:</b><br>Detailed - 50mm hand auger | <b>Survey Date:</b><br>22/6/2017 |

| Land use<br>Landform<br>Pattern,<br>Element,<br>Slope | Natural<br>Vegetation | Microrelief<br>Disturbance<br>Erosion | Surface<br>condition,<br>surface rock | Soil Profile Description | | | | | | | | | |
|---|---|---|---|---|---|---|---|---|---|---|---|---|---|
| Grazing, very<br>gently<br>undulating<br>plain, mid<br>slope 1-2% | Ironbark,<br>Poplar Box,<br>Moreton Bay<br>Ash | Nil | Hard setting,<br><5% coarse<br>fragments<br><10mm | A11<br>0.00 – 0.27<br>Diffuse | Loamy<br>sand | Massive,<br>loose | Nil | 10YR3/2<br>Very dark grayish<br>brown | Dry, rapid | Few, very fine | 0.10 / 6.5 | No samples<br>taken | No additional<br>observations |

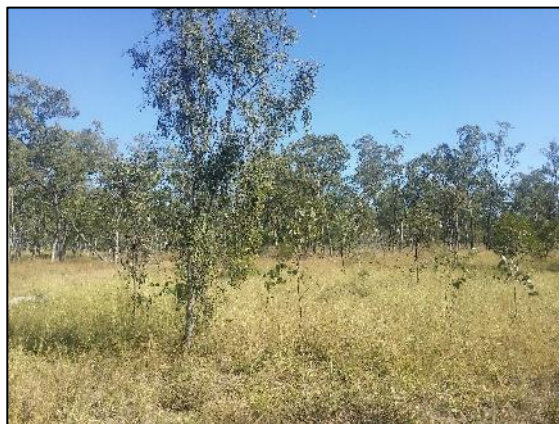
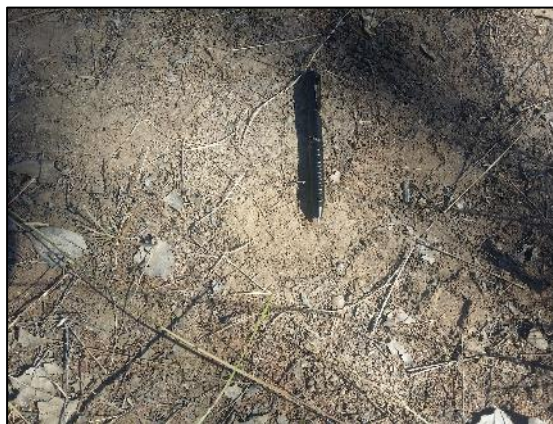
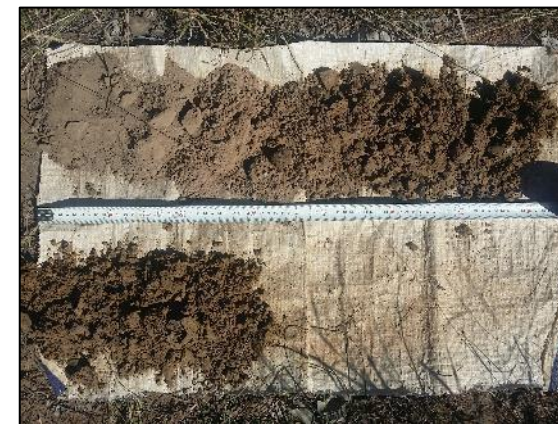
| <b>Soil Mapping Unit:</b><br>B1 | <b>CSIRO Land Systems (Gunn et al 1967):</b><br>Somerby, Monteagle, Humboldt | <b>Location (GDA ZONE 55):</b><br>639637 mE 7542190 mN | <b>Aust. Soil Class. :</b><br>Subnatric Brown Sodosol | <b>Site Survey Type:</b><br>Detailed - 50mm hand auger | <b>Survey Date:</b><br>22/6/2017 |

| Land use<br>Landform<br>Pattern,<br>Element,<br>Slope | Natural<br>Vegetation | Microrelief<br>Disturbance<br>Erosion | Surface<br>condition,<br>surface rock | Soil Profile Description | | | | | | | | | |
|---|---|---|---|---|---|---|---|---|---|---|---|---|---|
| Grazing, very<br>gently<br>undulating<br>plain, mid<br>slope 1-2% | Ironbark,<br>Poplar Box,<br>Moreton Bay<br>Ash | Nil | Hard setting,<br><5% coarse<br>fragments<br><10mm | A11<br>0.00 – 0.30<br>Diffuse | Loamy<br>sand | Massive,<br>loose | Nil | 10YR3/2<br>Very dark grayish<br>brown | Dry, rapid | Few, very fine | 0.10 / 6.5 | No samples<br>taken | No additional<br>observations |

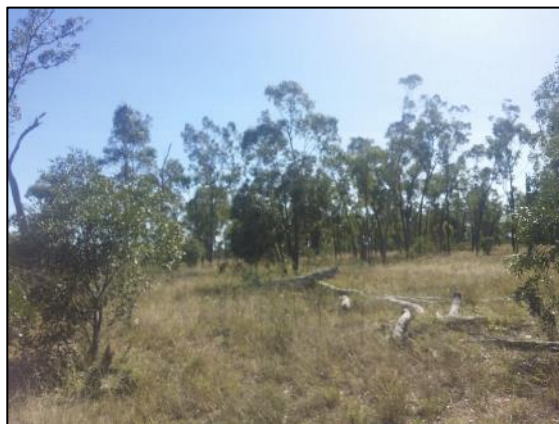
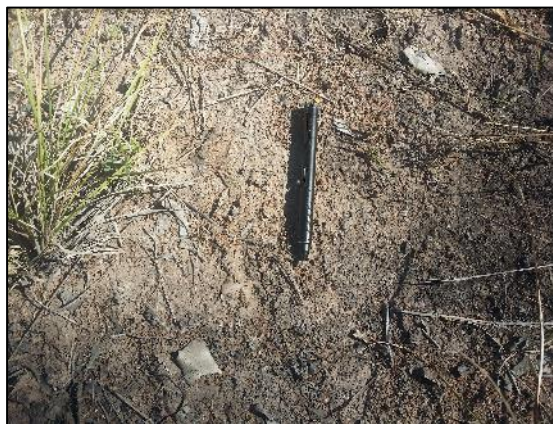
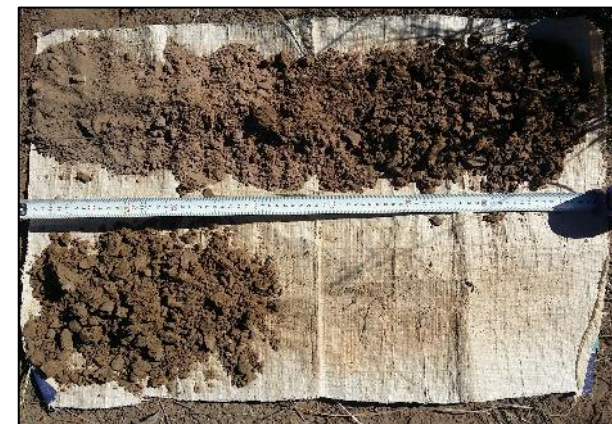
| <b>Soil Mapping Unit:</b><br>B1 | <b>CSIRO Land Systems (Gunn et al 1967):</b><br>Somerby, Monteagle, Humboldt | <b>Location (GDA ZONE 55):</b><br>642137 mE 7542156 mN | <b>Aust. Soil Class. :</b><br>Subnatric Brown Sodosol | <b>Site Survey Type:</b><br>Detailed - 50mm hand auger | <b>Survey Date:</b><br>22/6/2017 |

| Land use<br>Landform<br>Pattern,<br>Element,<br>Slope | Natural<br>Vegetation | Microrelief<br>Disturbance<br>Erosion | Surface<br>condition,<br>surface rock | Soil Profile Description | | | | | | | | | |
|---|---|---|---|---|---|---|---|---|---|---|---|---|---|
| Grazing, very<br>gently<br>undulating<br>plain, mid<br>slope 1-2% | Ironbark,<br>Poplar Box,<br>Moreton Bay<br>Ash | Nil | Hard setting,<br><5% coarse<br>fragments<br><10mm | A11<br>0.00 – 0.29<br>Diffuse | Loamy<br>sand | Massive,<br>loose | Nil | 10YR3/2<br>Very dark grayish<br>brown | Dry, rapid | Few, very fine | 0.10 / 6.5 | No samples<br>taken. | No additional<br>observations |

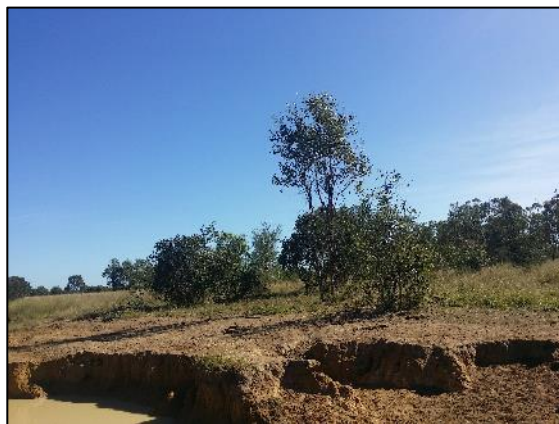
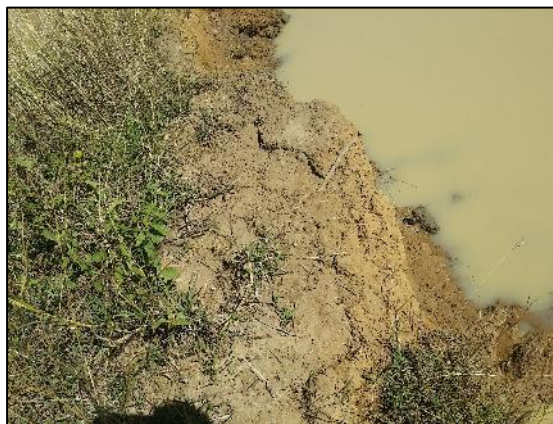
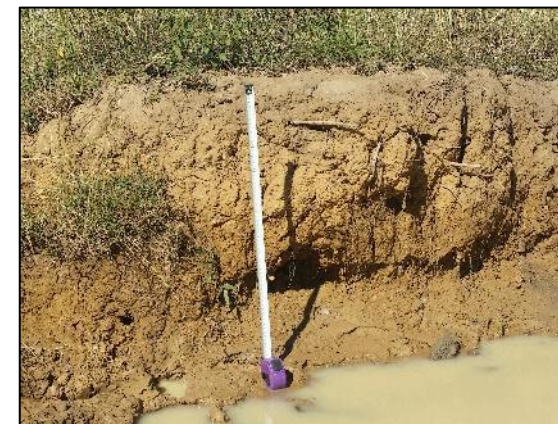
| <b>Soil Mapping Unit:</b><br>B1 | <b>CSIRO Land Systems (Gunn et al 1967):</b><br>Somerby, Monteagle, Humboldt | <b>Location (GDA ZONE 55):</b><br>641607 mE 7541014 mN | <b>Aust. Soil Class. :</b><br>Subnatric Brown Sodosol | <b>Site Survey Type:</b><br>Detailed - 50mm hand auger | <b>Survey Date:</b><br>22/6/2017 |

| Land use<br>Landform<br>Pattern,<br>Element,<br>Slope | Natural<br>Vegetation | Microrelief<br>Disturbance<br>Erosion | Surface<br>condition,<br>surface rock | Soil Profile Description | | | | | | | | | |
|---|---|---|---|---|---|---|---|---|---|---|---|---|---|
| Grazing,<br>gently<br>undulating<br>plain, nearby<br>gully mid<br>slope 2% | Ironbark,<br>Poplar Box,<br>Moreton Bay<br>Ash | Semi cleared | Hard setting,<br><5% coarse<br>fragments<br><10mm | A11<br>0.00 – 0.23<br>Diffuse | Loamy<br>sand | Massive,<br>loose | Nil | 10YR3/2<br>Very dark grayish<br>brown | Dry, rapid | Few, medium | 0.10 / 6.5 | No samples<br>taken | No additional<br>observations |
| | | | | B2<br>0.45 – 1.00 | Silty clay<br>loam | Weak<br>subangular,<br>Moderate<br>6-10mm<br>peds | <5% manganese<br>nodules | 10YR4/4<br>Dark yellowish<br>brown | Humid, well<br>drained | Nil | 0.60 / 6.5<br>0.90 / 7.0 | | |

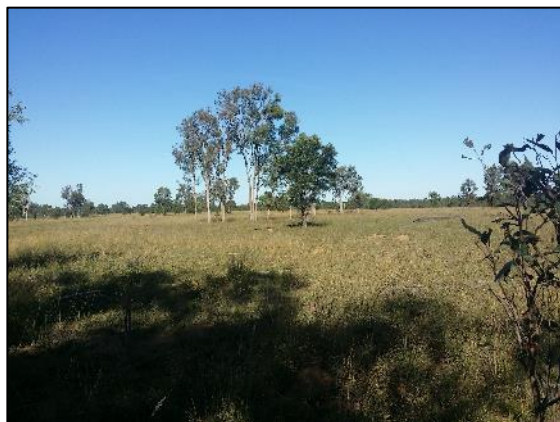
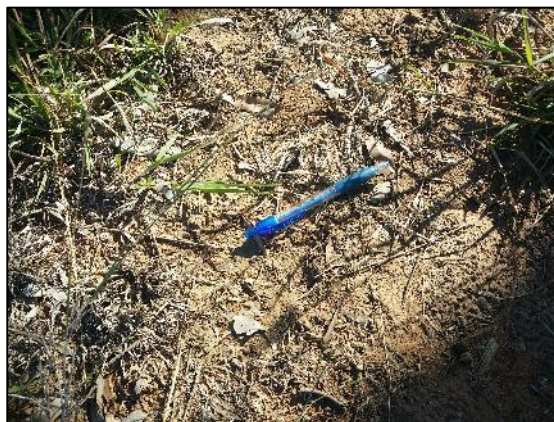
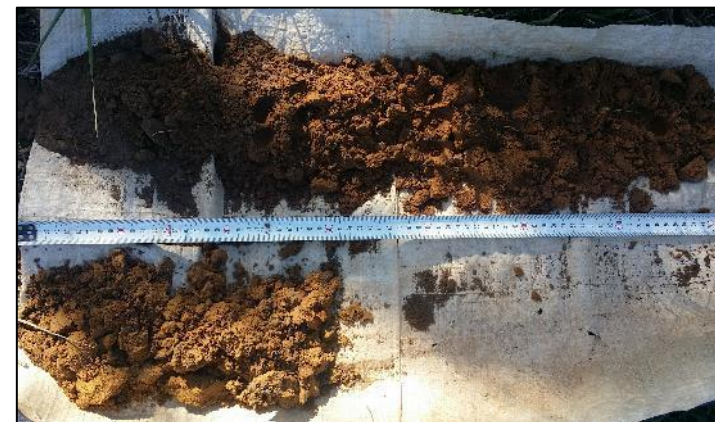
| <b>Soil Mapping Unit:</b><br>S2 | <b>CSIRO Land Systems (Gunn et al 1967):</b><br>Somerby, Monteagle, Connors,<br>Humboldt, Blackwater | <b>Location (GDA ZONE 55):</b><br>639834 mE 7541276 mN | <b>Aust. Soil Class. :</b><br>Haplic Brown Dermosol | <b>Site Survey Type:</b><br>Detailed - 50mm hand auger | <b>Survey Date:</b><br>22/6/2017 |

| Land use<br>Landform<br>Pattern,<br>Element,<br>Slope | Natural<br>Vegetation | Microrelief<br>Disturbance<br>Erosion | Surface<br>condition,<br>surface rock | Soil Profile Description | | | | | | | | | |
|---|---|---|---|---|---|---|---|---|---|---|---|---|---|
| | | | | B22<br>0.37 – 1.00 | Loamy<br>sand | Weak<br>subangular<br>peds 10-<br>30mm,<br>weak | <2% Coarse<br>fragments 2-<br>5mm and red<br>nodules | 10YR4/4<br>Dark yellowish<br>brown | Moderately<br>moist, rapid | Nil | 0.60 / 7.0<br>0.90 / 7.0 | | |
