**PEMBROKE**

**Olive Downs Coking Coal Project**  
Draft Environmental Impact Statement

**Appendix M**  
**Soil and Land**  
**Suitability**  
**Assessment**

Olive Downs Coking Coal Project

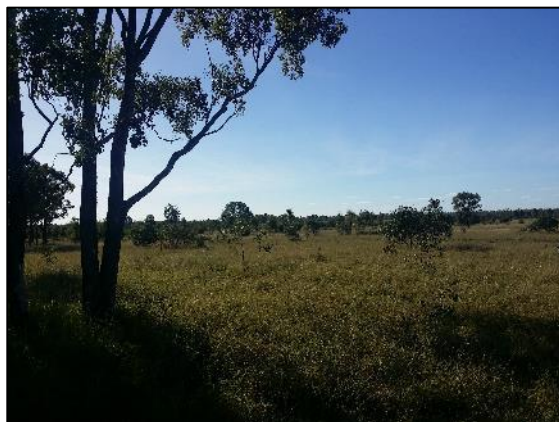
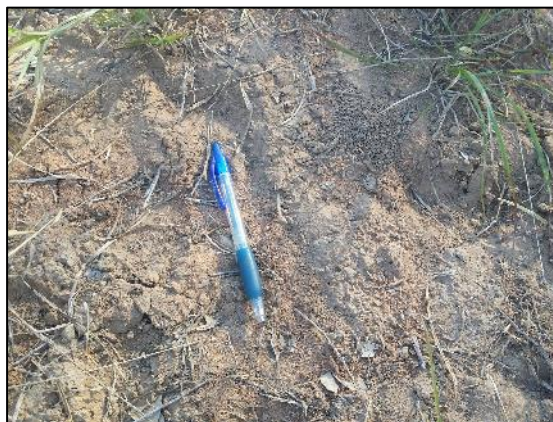
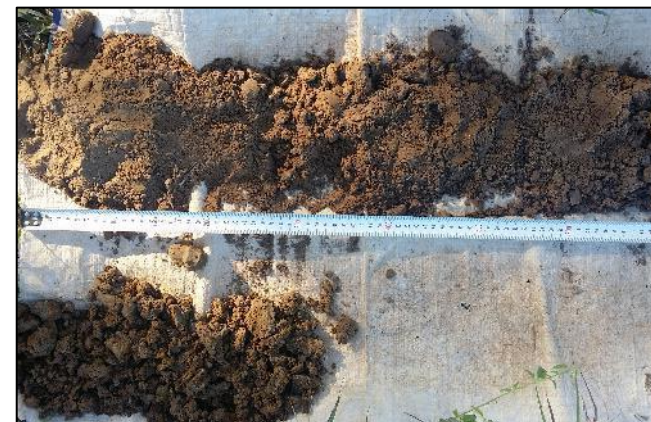
| <b>Soil Mapping Unit:</b><br>S1 | <b>CSIRO Land Systems (Gunn et al 1967):</b><br>Somerby, Monteagle, Connors,<br>Humboldt, Blackwater | <b>Location (GDA ZONE 55):</b><br>640566 mE 7540061 mN | <b>Aust. Soil Class. :</b><br>Brown Sodosol | <b>Site Survey Type:</b><br>Detailed - 50mm hand auger | <b>Survey Date:</b><br>22/6/2017 |

| Land use<br>Landform<br>Pattern,<br>Element,<br>Slope | Natural<br>Vegetation | Microrelief<br>Disturbance<br>Erosion | Surface<br>condition,<br>surface rock | Soil Profile Description | | | | | | | | | |
|---|---|---|---|---|---|---|---|---|---|---|---|---|---|
| Grazing,<br>Gently<br>undulating<br>plains, upper<br>slope 2.5% | Very sparse<br>Poplar Box<br>100m+ away,<br>Blackbutt,<br>Gums | Extensive<br>clearing | Hard settling,<br>trampled<br>surface, no<br>coarse<br>fragments | A11<br>0.00 – 0.25<br>Abrupt | Loamy<br>sand | Massive,<br>loose | Nil | 10YR3/3<br>Dark brown | Dry, rapid | Very fine, few | 0.1 / 6.5 | No samples<br>taken | No additional<br>observations |
| | | | | B2<br>0.68 – 1.00 | Clay loam<br>sandy | Moderate,<br>subangular<br>peds<br><20mm,<br>firm | <2% coarse<br>fragments 2-<br>5mm, black<br>nodules | 10YR4/4<br>Dark yellowish<br>brown<br>Mottle:<br>10YR5/8<br>Strong brown | Moderately<br>moist,<br>imperfectly<br>drained | Nil | 0.9 / 8.0 | | |

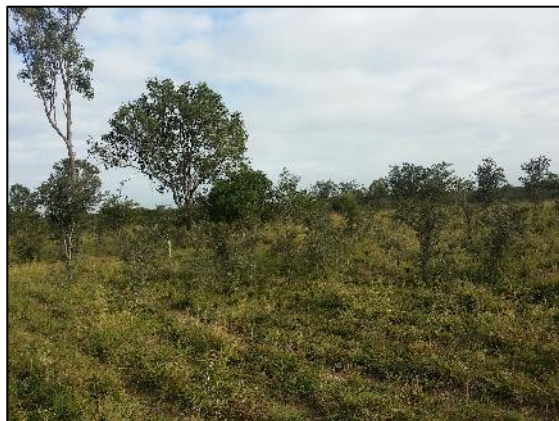
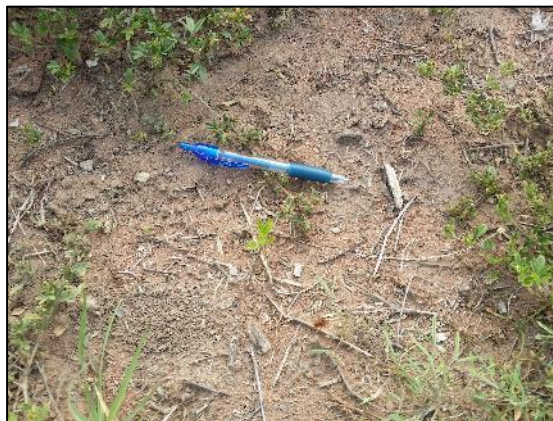
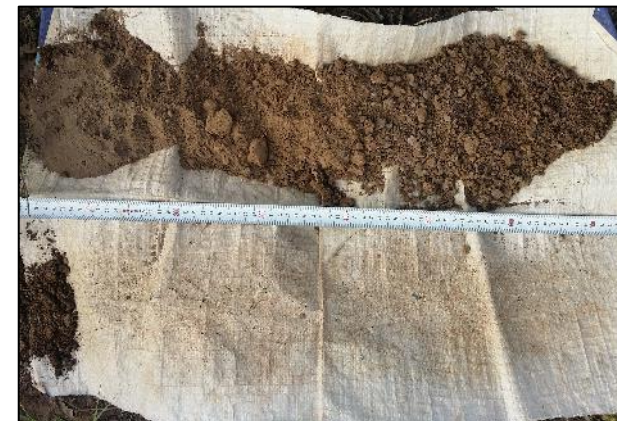
| <b>Soil Mapping Unit:</b><br>S1 | <b>CSIRO Land Systems (Gunn et al 1967):</b><br>Somerby, Monteagle, Connors,<br>Humboldt, Blackwater | <b>Location (GDA ZONE 55):</b><br>643054 mE 7539958 mN | <b>Aust. Soil Class. :</b><br>Brown Sodosol | <b>Site Survey Type:</b><br>Detailed - 50mm hand auger | <b>Survey Date:</b><br>23/6/2017 |

| Land use<br>Landform<br>Pattern,<br>Element,<br>Slope | Natural<br>Vegetation | Microrelief<br>Disturbance<br>Erosion | Surface<br>condition,<br>surface rock | Soil Profile Description | | | | | | | | | |
|---|---|---|---|---|---|---|---|---|---|---|---|---|---|
| Grazing,<br>ridge, upper<br>slope 1% | Sparse tall<br>woodland,<br>limited<br>clearing with<br>Poplar Box<br>regrowth | Semi cleared | Hard setting,<br>coarse<br>fragments 5%<br>5mm diameter | A11<br>0.00 – 0.27<br>Diffuse | Loamy<br>sand | Massive,<br>loose | Nil | 10YR3/2<br>Very dark grayish<br>brown | Dry, rapid | 0.00 / 6.5 | Very fine, few | No samples<br>taken | No recovery at<br>0.75m, hard to<br>auger |

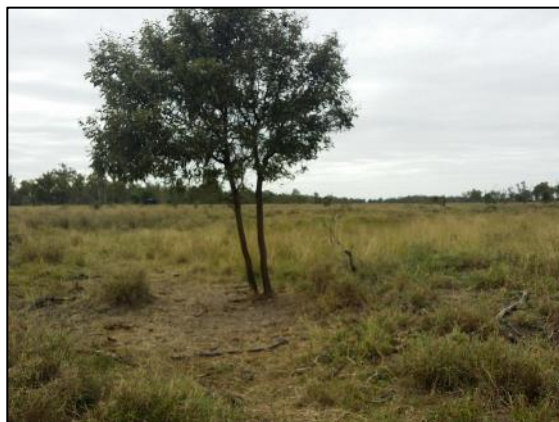
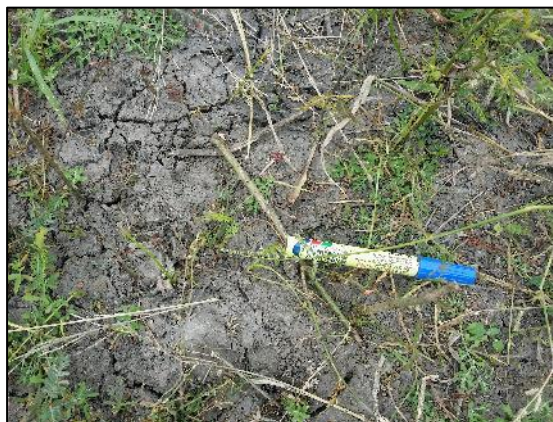
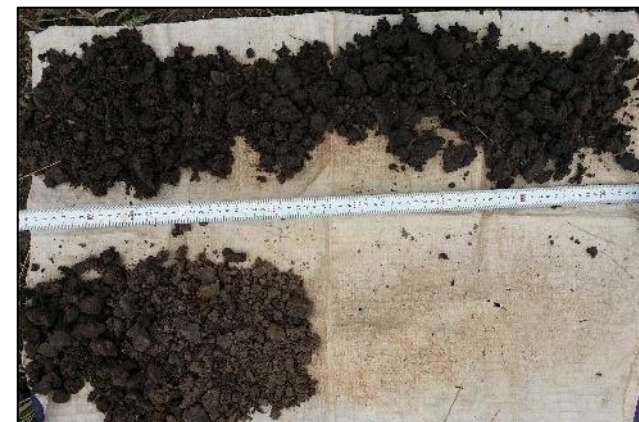
| <b>Soil Mapping Unit:</b><br>C2 | <b>CSIRO Land Systems (Gunn et al 1967):</b><br>Somerby, Monteagle, Connors,<br>Humboldt, Blackwater, Junee | <b>Location (GDA ZONE 55):</b><br>639343 mE 7540015 mN | <b>Aust. Soil Class. :</b><br>Brown Vertosol | <b>Site Survey Type:</b><br>Detailed - 50mm hand auger | <b>Survey Date:</b><br>23/6/2017 |

| Land use<br>Landform<br>Pattern,<br>Element,<br>Slope | Natural<br>Vegetation | Microrelief<br>Disturbance<br>Erosion | Surface<br>condition,<br>surface rock | Soil Profile Description | | | | | | | | | |
|---|---|---|---|---|---|---|---|---|---|---|---|---|---|
| Grazing, mid<br>slope, very<br>gently<br>undulating<br>plain, 1.5% | Brigalow<br>regrowth | Extensive<br>clearing,<br>previously<br>blade<br>ploughed | Hard setting,<br>cracking – fine<br>to moderate<br>cracks, <5%<br>coarse<br>fragments 2-<br>4mm | A1<br>0.00 – 0.18<br>Clear | Light clay | Weak<br>angular<br>peds<br><10mm,<br>firm | <2% coarse<br>fragments 2-<br>6mm | 10YR3/1<br>Very dark gray | Humid –<br>moderately<br>moist, well<br>drained | Very fine, few | 0.00 / 6.5 | 0.00 – 0.10<br>0.30 – 0.40<br>0.60 – 0.70<br>0.90 – 1.00 | No additional<br>observations |
| | | | | B21<br>0.18 – 0.70<br>Diffuse | Medium<br>clay | Moderate<br>angular<br>peds<br><20mm,<br>firm | <5% coarse<br>fragments 2-<br>6mm and black<br>nodules | 10YR3/1<br>Very dark gray | Moderately<br>moist, well<br>drained | Very fine, few | 0.30 / 6.5 | | |
| | | | | B22<br>0.70 – 0.81<br>Abrupt | Medium<br>clay | Moderate<br>angular<br>peds<br><20mm,<br>firm | Nil | 10YR3/2<br>Very dark grayish<br>brown | Moderately<br>moist, well<br>to<br>moderately<br>drained | Nil | 0.60 / 7.0 | | |

| Land use<br>Landform | Natural<br>Vegetation | Microrelief<br>Disturbance | Surface<br>condition. | Soil Profile Description | | | | | | | | |
|---|---|---|---|---|---|---|---|---|---|---|---|--|
| | | | | B23<br>0.81 – 1.05 | Silty clay<br>loam | Weak<br>angular<br>peds<br><10mm,<br>firm | - | 10YR4/2<br>Dark grayish<br>brown | Dry,<br>moderately<br>moist | - | 0.90 / 7.0 | |

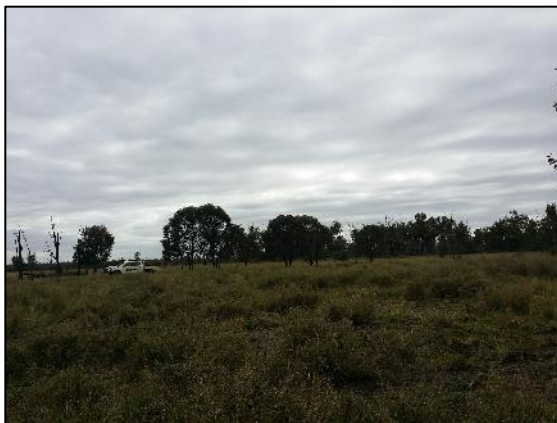
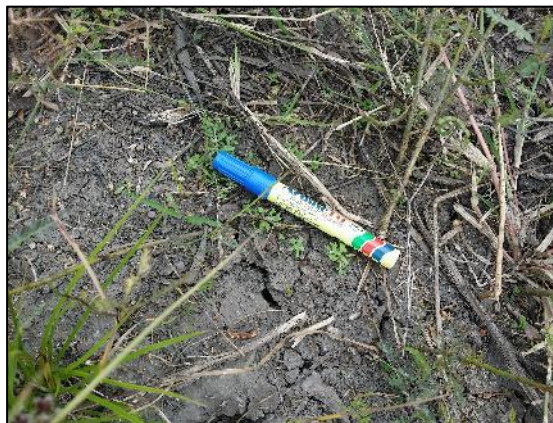
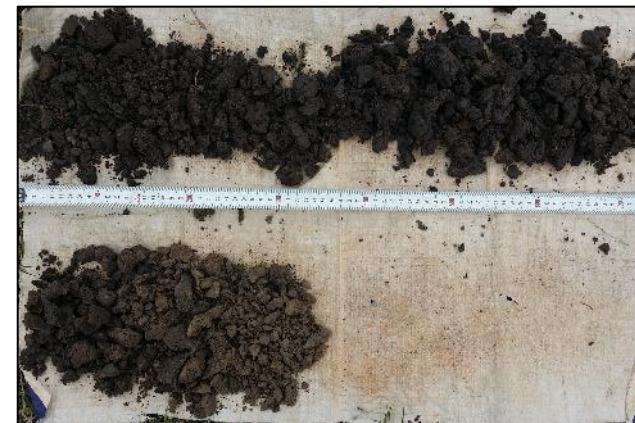
## Soil Profile

| <b>Soil Mapping Unit:</b><br>C2 | <b>CSIRO Land Systems (Gunn et al 1967):</b><br>Somerby, Monteagle, Connors,<br>Humboldt, Blackwater, Junee | <b>Location (GDA ZONE 55):</b><br>640332 mE 7538899 mN | <b>Aust. Soil Class. :</b><br>Brown Vertosol | <b>Site Survey Type:</b><br>Detailed - 50mm hand auger | <b>Survey Date:</b><br>23/6/2017 |

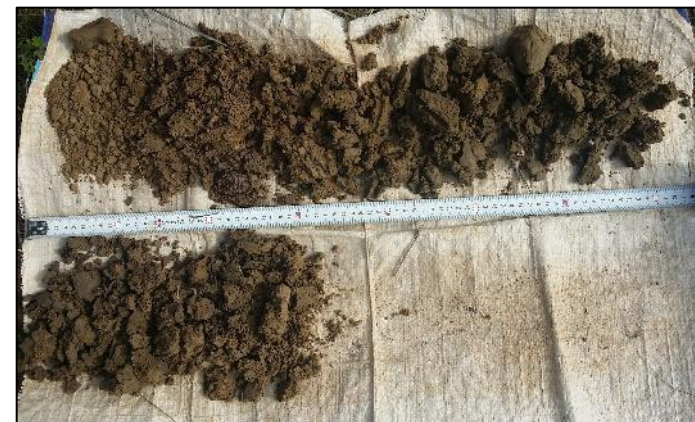
Soil Profile

| <b>Soil Mapping Unit:</b><br>C2 | <b>CSIRO Land Systems (Gunn et al 1967):</b><br>Somerby, Monteagle, Connors,<br>Humboldt, Blackwater, Juneee | <b>Location (GDA ZONE 55):</b><br>642009 mE 7538199 mN | <b>Aust. Soil Class. :</b><br>Brown Vertosol | <b>Site Survey Type:</b><br>Detailed - 50mm hand auger | <b>Survey Date:</b><br>23/6/2017 |

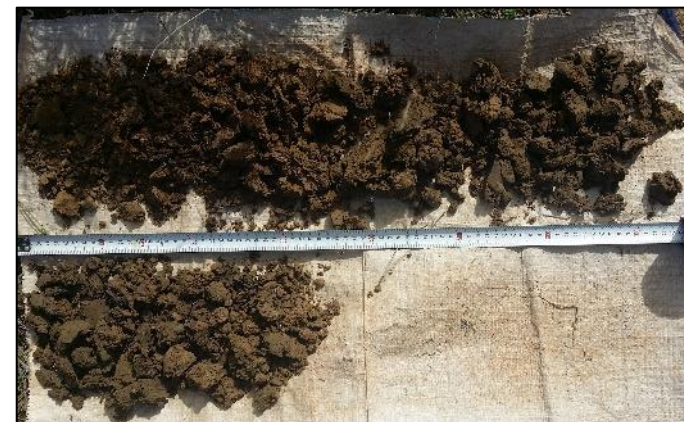
Soil Profile

| <b>Soil Mapping Unit:</b><br>C2 | <b>CSIRO Land Systems (Gunn et al 1967):</b><br>Somerby, Monteagle, Connors,<br>Humboldt, Blackwater, Junee | <b>Location (GDA ZONE 55):</b><br>640780 mE 7538332 mN | <b>Aust. Soil Class. :</b><br>Brown Vertosol | <b>Site Survey Type:</b><br>Detailed - 50mm hand auger | <b>Survey Date:</b><br>23/6/2017 |

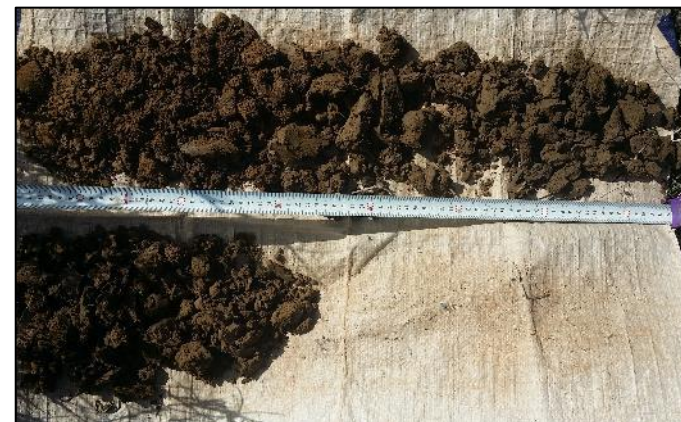
Soil Profile

| <b>Soil Mapping Unit:</b><br>C2 | <b>CSIRO Land Systems (Gunn et al 1967):</b><br>Somerby, Monteagle, Connors,<br>Humboldt, Blackwater, Junee | <b>Location (GDA ZONE 55):</b><br>642345 mE 7538845 mN | <b>Aust. Soil Class. :</b><br>Brown Vertosol | <b>Site Survey Type:</b><br>Detailed - 50mm hand auger | <b>Survey Date:</b><br>23/6/2017 |

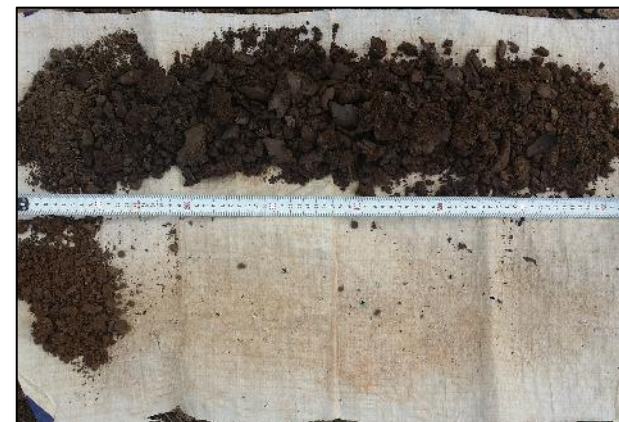
Soil Profile

| <b>Soil Mapping Unit:</b><br>C2 | <b>CSIRO Land Systems (Gunn et al 1967):</b><br>Somerby, Monteagle, Connors,<br>Humboldt, Blackwater, Junee | <b>Location (GDA ZONE 55):</b><br>645889 mE 7539715 mN | <b>Aust. Soil Class. :</b><br>Brown Vertosol | <b>Site Survey Type:</b><br>Detailed - 50mm hand auger | <b>Survey Date:</b><br>24/6/2017 |

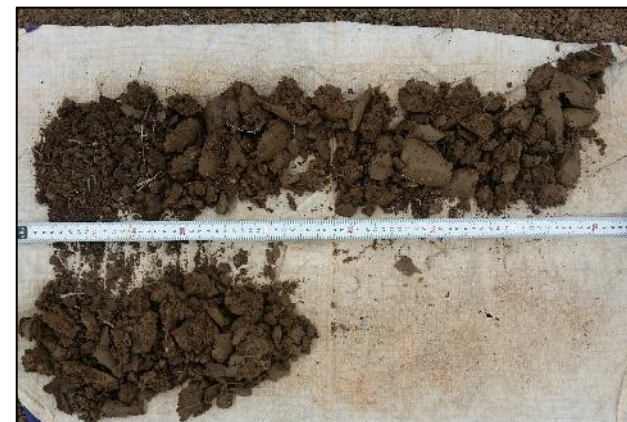
Soil Profile

| <b>Soil Mapping Unit:</b><br>C2 | <b>CSIRO Land Systems (Gunn et al 1967):</b><br>Somerby, Monteagle, Connors,<br>Humboldt, Blackwater, Junee | <b>Location (GDA ZONE 55):</b><br>644357 mE 7539882 mN | <b>Aust. Soil Class. :</b><br>Brown Vertosol | <b>Site Survey Type:</b><br>Detailed - 50mm hand auger | <b>Survey Date:</b><br>24/6/2017 |

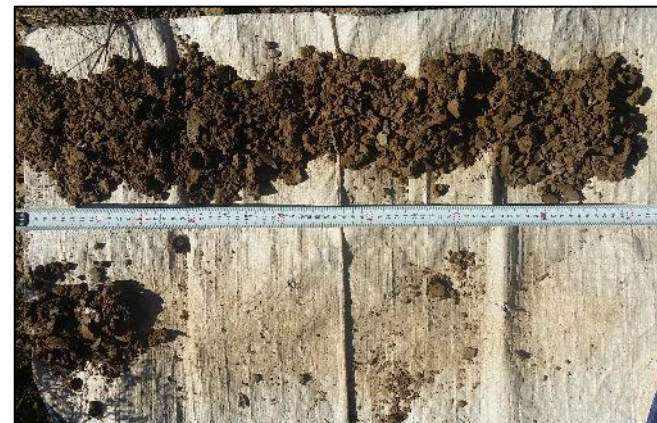
Soil Profile

| <b>Soil Mapping Unit:</b><br>C2 | <b>CSIRO Land Systems (Gunn et al 1967):</b><br>Somerby, Monteagle, Connors,<br>Humboldt, Blackwater, Junee | <b>Location (GDA ZONE 55):</b><br>646290 mE 7537672 mN | <b>Aust. Soil Class. :</b><br>Brown Vertosol | <b>Site Survey Type:</b><br>Detailed - 50mm hand auger | <b>Survey Date:</b><br>24/6/2017 |

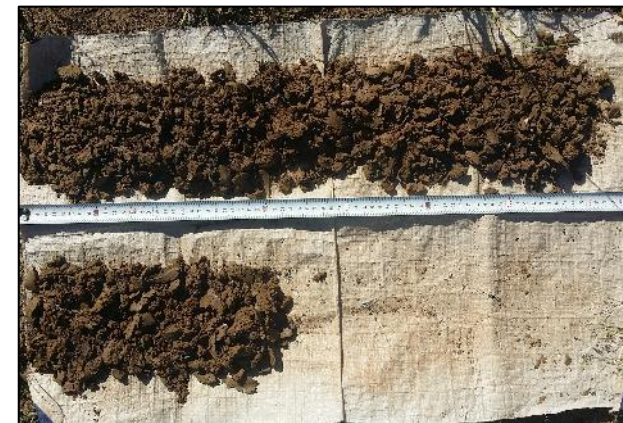
Soil Profile

| <b>Soil Mapping Unit:</b><br>C2 | <b>CSIRO Land Systems (Gunn et al 1967):</b><br>Somerby, Monteagle, Connors,<br>Humboldt, Blackwater, Junee | <b>Location (GDA ZONE 55):</b><br>646209 mE 7539072 mN | <b>Aust. Soil Class. :</b><br>Brown Vertosol | <b>Site Survey Type:</b><br>Detailed - 50mm hand auger | <b>Survey Date:</b><br>24/6/2017 |

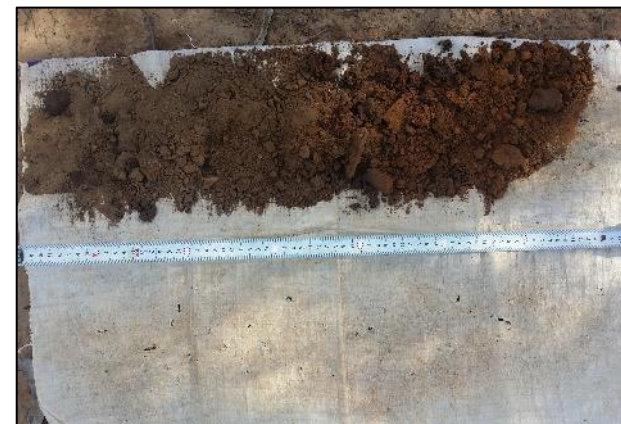
Soil Profile

| <b>Soil Mapping Unit:</b><br>B1 | <b>CSIRO Land Systems (Gunn et al 1967):</b><br>Somerby, Monteagle, Humboldt | <b>Location (GDA ZONE 55):</b><br>647284 mE 7537230 mN | <b>Aust. Soil Class. :</b><br>Subnatric Brown Sodosol | <b>Site Survey Type:</b><br>Detailed - 50mm hand auger | <b>Survey Date:</b><br>24/6/2017 |

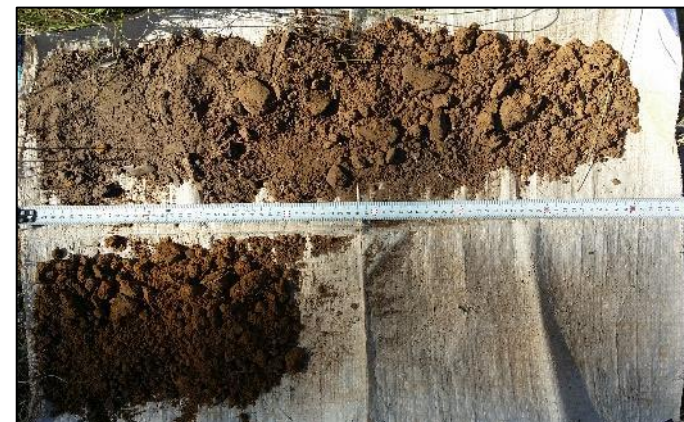
Soil Profile

| <b>Soil Mapping Unit:</b><br>S1 | <b>CSIRO Land Systems (Gunn et al 1967):</b><br>Somerby, Monteagle, Connors,<br>Humboldt, Blackwater | <b>Location (GDA ZONE 55):</b><br>645284 mE 7536971 mN | <b>Aust. Soil Class. :</b><br>Brown Sodosol | <b>Site Survey Type:</b><br>Detailed - 50mm hand auger | <b>Survey Date:</b><br>24/6/2017 |

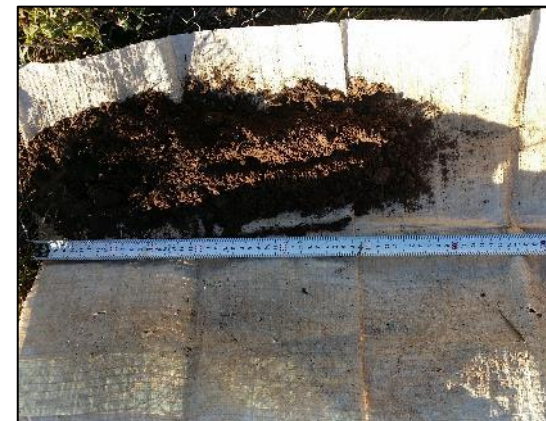
Soil Profile

| <b>Soil Mapping Unit:</b><br>S1 | <b>CSIRO Land Systems (Gunn et al 1967):</b><br>Somerby, Monteagle, Connors,<br>Humboldt, Blackwater | <b>Location (GDA ZONE 55):</b><br>643930 mE 7538329 mN | <b>Aust. Soil Class. :</b><br>Brown Sodosol | <b>Site Survey Type:</b><br>Detailed - 50mm hand auger | <b>Survey Date:</b><br>25/6/2017 |

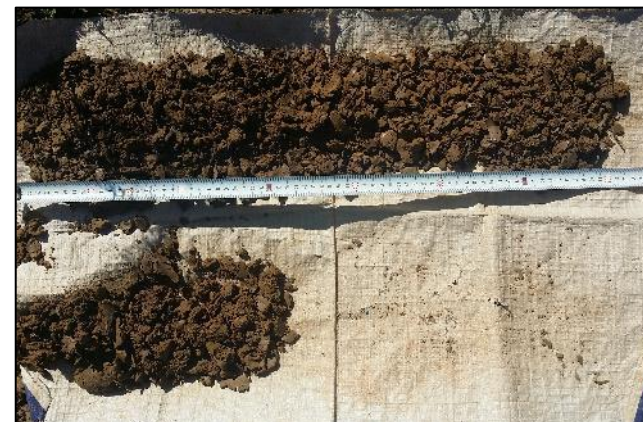
Soil Profile

| <b>Soil Mapping Unit:</b><br>C2 | <b>CSIRO Land Systems (Gunn et al 1967):</b><br>Somerby, Monteagle, Connors,<br>Humboldt, Blackwater, Junee | <b>Location (GDA ZONE 55):</b><br>647017 mE 7536252 mN | <b>Aust. Soil Class. :</b><br>Brown Vertosol | <b>Site Survey Type:</b><br>Detailed - 50mm hand auger | <b>Survey Date:</b><br>25/6/2017 |

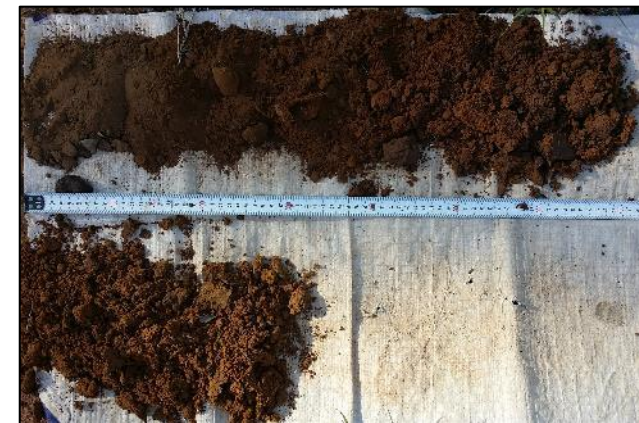
Soil Profile

| <b>Soil Mapping Unit:</b><br>S1 | <b>CSIRO Land Systems (Gunn et al 1967):</b><br>Somerby, Monteagle, Connors,<br>Humboldt, Blackwater | <b>Location (GDA ZONE 55):</b><br>645420 mE 7536076 mN | <b>Aust. Soil Class. :</b><br>Brown Sodosol | <b>Site Survey Type:</b><br>Detailed - 50mm hand auger | <b>Survey Date:</b><br>25/6/2017 |

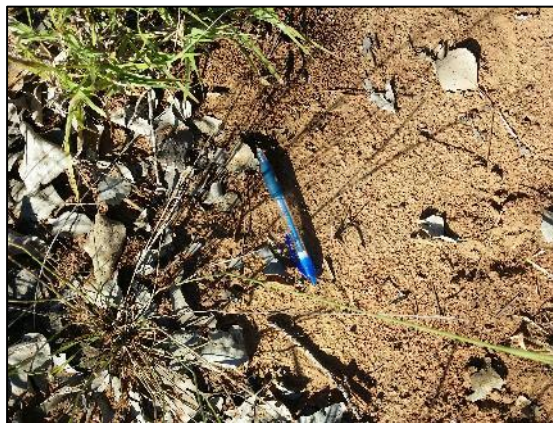
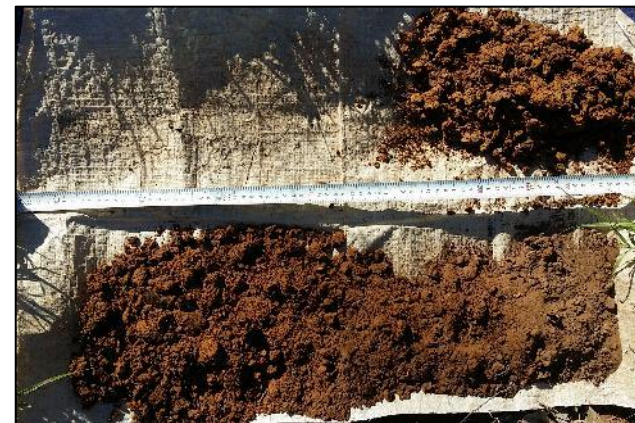
| Land use<br>Landform<br>Pattern,<br>Element,<br>Slope | Natural<br>Vegetation | Microrelief<br>Disturbance<br>Erosion | Surface<br>condition,<br>surface rock | Soil Profile Description | | | | | | | | | |
|---|---|---|---|---|---|---|---|---|---|---|---|---|---|
| Grazing, very<br>gently<br>undulating<br>plains, mid<br>slope 2% | Poplar Box,<br>some Moreton<br>Bay Ash | Nil | Firm, no<br>coarse<br>fragments | A11<br>0.00 – 0.25<br>Abrupt | Loamy<br>sand | Massive,<br>loose | Nil | 10YR3/3<br>Dark brown | Dry, rapid | Very fine, few | 0.10 / 6.0 | No samples<br>taken | No additional<br>observations |

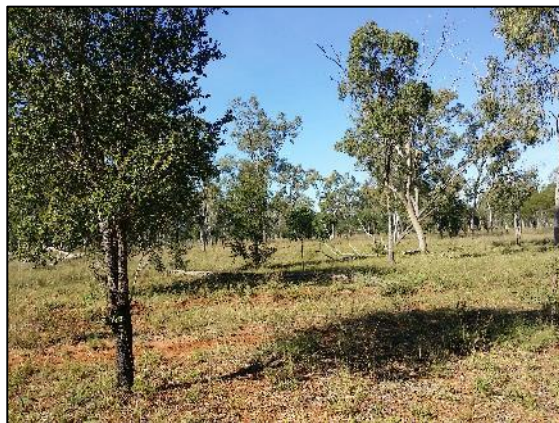
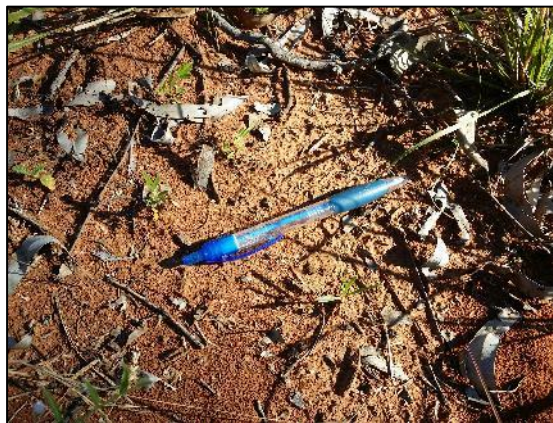
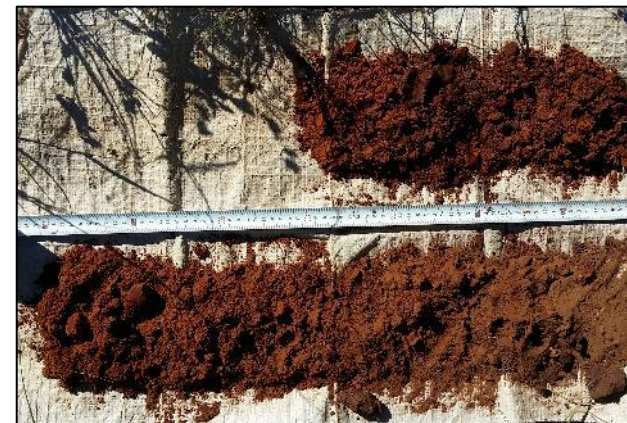
| Land use<br>Landform<br>Pattern,<br>Element,<br>Slope | Natural<br>Vegetation | Microrelief<br>Disturbance<br>Erosion | Surface<br>condition,<br>surface rock | Soil Profile Description | | | | | | | | | |
|---|---|---|---|---|---|---|---|---|---|---|---|---|---|
| Grazing,<br>Very gently<br>undulating<br>plains, mid<br>slope 2% | Blackbutt, Blue<br>Gum | Limited<br>clearing | Soft, no coarse<br>fragments | A11<br>0.00 – 0.10<br>Abrupt | Loamy<br>sand | Massive,<br>loose | Nil | 2.5YR3/3<br>Dark reddish<br>brown<br>No mottles | Dry, rapid | Very fine, very<br>few | 0.05 / 6.5 | 0.00 – 0.05<br>0.25 – 0.35<br>0.60 – 0.70<br>0.90 – 1.00 | No additional<br>observations |
| | | | | A12<br>0.10 – 0.37<br>Abrupt | Loamy<br>sand | Massive,<br>loose | Nil | 2.5YR3/4<br>No mottles | Dry, rapid | Very fine, very<br>few | 0.30 / 6.5 | | |

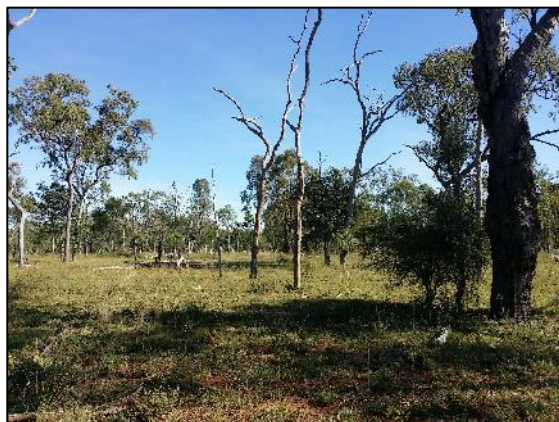
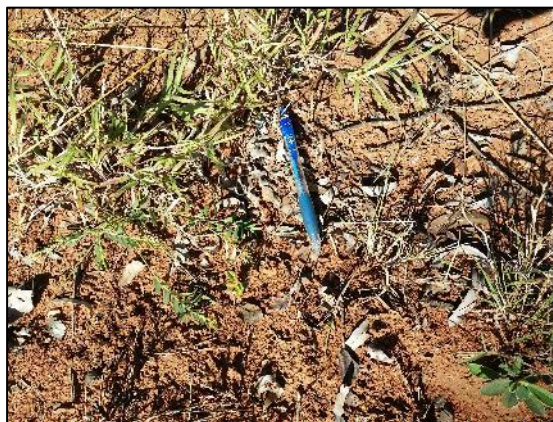
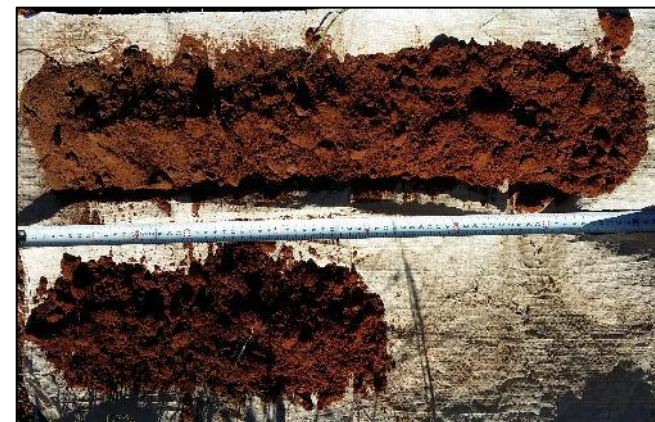
| Land use<br>Landform<br>Pattern,<br>Element,<br>Slope | Natural<br>Vegetation | Microrelief<br>Disturbance<br>Erosion | Surface<br>condition,<br>surface rock | Soil Profile Description | | | | | | | | | |
|---|---|---|---|---|---|---|---|---|---|---|---|---|---|
| Grazing,<br>gently<br>undulating<br>plains, mid<br>slope 1% | Blackbutt, Blue<br>Gum | Limited<br>clearing | Soft, no coarse<br>fragments | A11<br>0.00 – 0.10<br>Abrupt | Loamy<br>sand | Massive,<br>loose | Nil | 2.5YR3/3<br>Dark reddish<br>brown | Dry, rapid | Very fine, very<br>few | 0.05 / 6.5 | No samples<br>taken | No additional<br>observations |
| | | | | A12<br>0.10 – 0.36<br>Abrupt | Loamy<br>sand | Massive,<br>loose | Nil | 2.5YR3/4<br>Dark reddish<br>brown | Dry, rapid | Very fine, very<br>few | 0.30 / 6.5 | | |

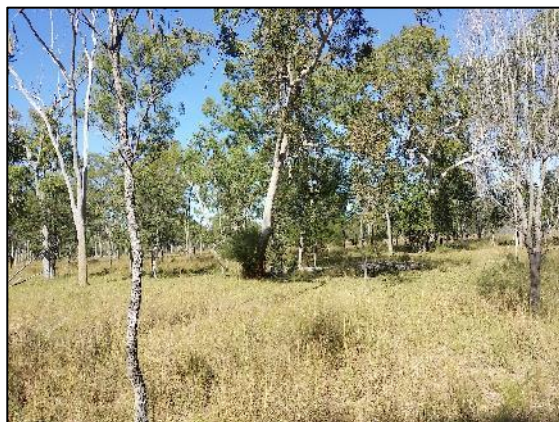
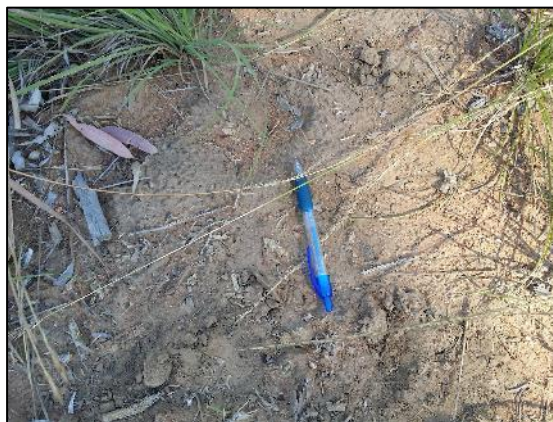
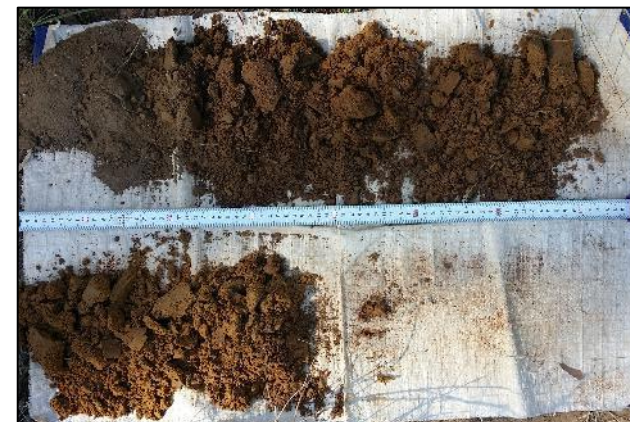
| Land use<br>Landform<br>Pattern,<br>Element,<br>Slope | Natural<br>Vegetation | Microrelief<br>Disturbance<br>Erosion | Surface<br>condition,<br>surface rock | Soil Profile Description | | | | | | | | | |
|---|---|---|---|---|---|---|---|---|---|---|---|---|---|
| | | | | B21<br>0.26 – 0.49<br>Abrupt | Loamy<br>sand | Weak, very<br>weak, peds<br><10mm | Nil | 10YR3/4<br>Dark yellowish<br>brown | Dry, humid | Nil | 0.3 / 6.5 | | |
| | | | | B22<br>0.49 – 1.0 | Loamy<br>sand | Moderate,<br>weak, peds<br>5-20mm | Nil | 10YR4/4<br>Dark yellowish<br>brown | Dry, humid | Nil | 0.6 / 7.0<br>0.9 / 7.0 | | |

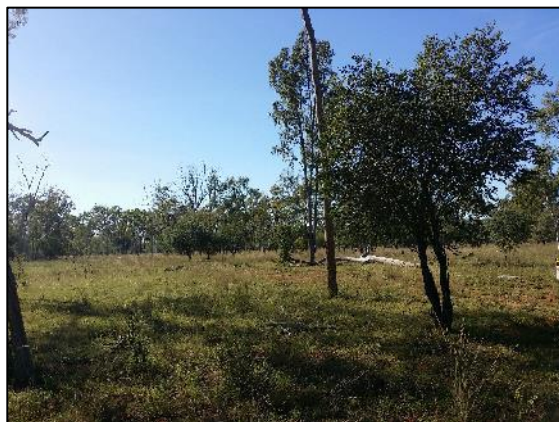
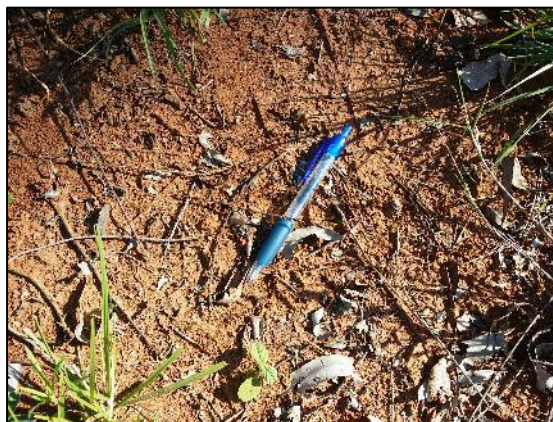
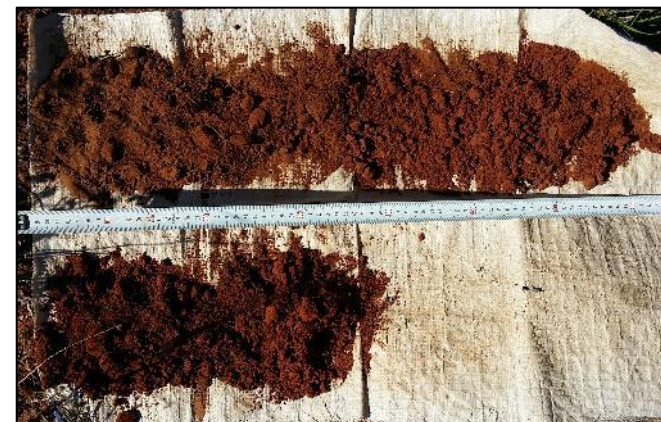
| Land use<br>Landform<br>Pattern,<br>Element,<br>Slope | Natural<br>Vegetation | Microrelief<br>Disturbance<br>Erosion | Surface<br>condition,<br>surface rock | Soil Profile Description | | | | | | | | | |
|---|---|---|---|---|---|---|---|---|---|---|---|---|---|
| Grazing,<br>gently<br>undulating<br>plains, upper<br>slope 1-2% | Blackbutt, Blue<br>Gum | Limited<br>clearing | Soft, no coarse<br>fragments | A11<br>0.00 – 0.12<br>Abrupt | Loamy<br>sand | Massive,<br>loose | Nil | 2.5YR3/3<br>Dark reddish<br>brown | Dry, rapid | Very fine, very<br>few | 0.05 / 6.5 | No samples<br>taken | No additional<br>observations |
| | | | | A12<br>0.10 – 0.38<br>Abrupt | Loamy<br>sand | Massive,<br>loose | Nil | 2.5YR3/4<br>Dark reddish<br>brown | Dry, rapid | Very fine, very<br>few | 0.30 / 6.5 | | |

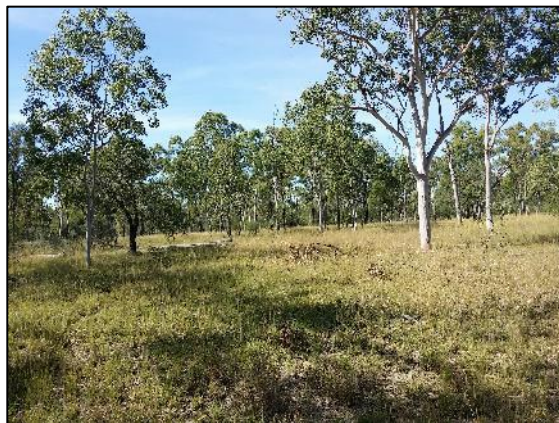
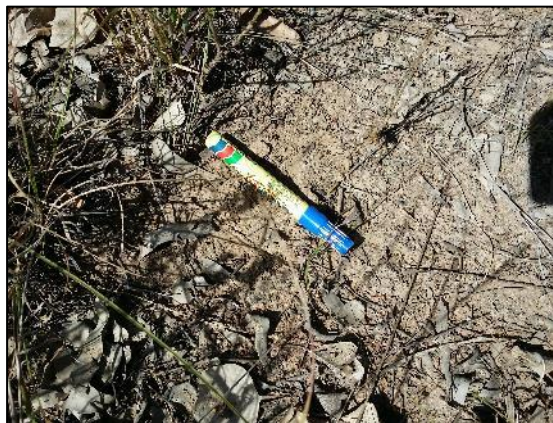
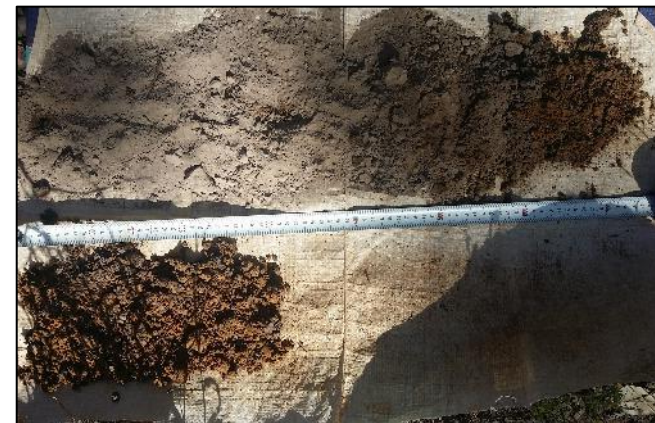
| Land use<br>Landform<br>Pattern,<br>Element,<br>Slope | Natural<br>Vegetation | Microrelief<br>Disturbance<br>Erosion | Surface<br>condition,<br>surface rock | Soil Profile Description | | | | | | | | | |
|---|---|---|---|---|---|---|---|---|---|---|---|---|---|
| Grazing,<br>gently<br>undulating<br>plains, upper<br>slope 2% | Mixed rall<br>woodlands;<br>Poplar Box,<br>White Gums,<br>Blackbutt | Nil | Firm / Hard<br>setting, no<br>coarse<br>fragments | A11<br>0.00 – 0.14<br>Abrupt | Loamy<br>sand | Massive,<br>loose | Nil | 10YR3/2<br>Very dark grayish<br>brown | Dry, rapid | Very fine, few | 0.10 / 6.0 | No samples<br>taken | No additional<br>observations |
| | | | | A12<br>0.14 – 0.58<br>Diffuse | Loamy<br>sand | Massive,<br>loose | <5% coarse<br>fragments and<br>manganese<br>nodules | 10YR4/2<br>Dark grayish<br>brown | Dry, rapid | Nil | 0.30 / 6.0 | | |

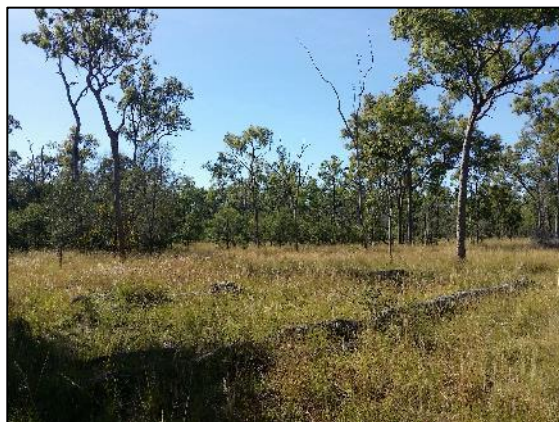
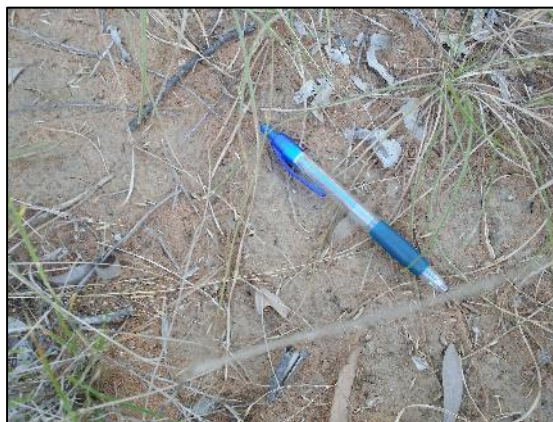
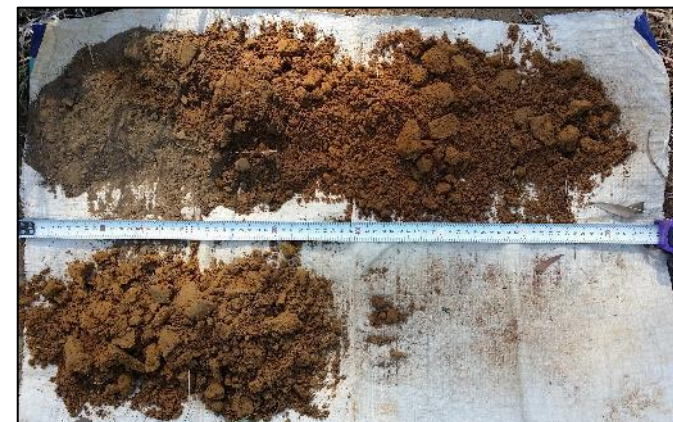
| Land use<br>Landform<br>Pattern,<br>Element,<br>Slope | Natural<br>Vegetation | Microrelief<br>Disturbance<br>Erosion | Surface<br>condition,<br>surface rock | Soil Profile Description | | | | | | | | | |
|---|---|---|---|---|---|---|---|---|---|---|---|---|---|
| | | | | B21<br>0.26 – 0.49<br>Abrupt | Loamy<br>sand | Weak, very<br>weak, peds<br><10mm | Nil | 10YR3/4<br>Dark yellowish<br>brown | Dry, humid | Nil | 0.3 / 6.5 | | |
| | | | | B22<br>0.49 – 1.0 | Loamy<br>sand | Moderate,<br>weak, peds<br>5-20mm | Nil | 10YR4/4<br>Dark yellowish<br>brown | Dry, humid | Nil | 0.6 / 7.0<br>0.9 / 7.0 | | |

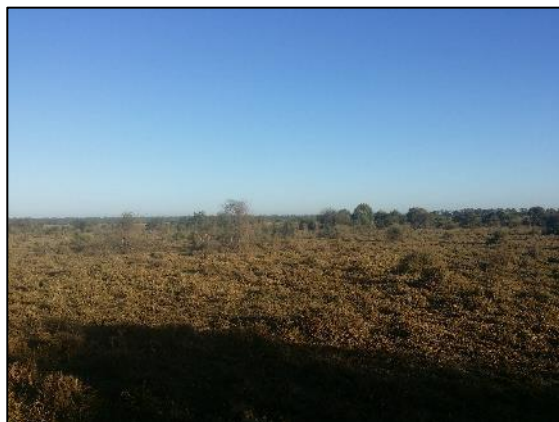
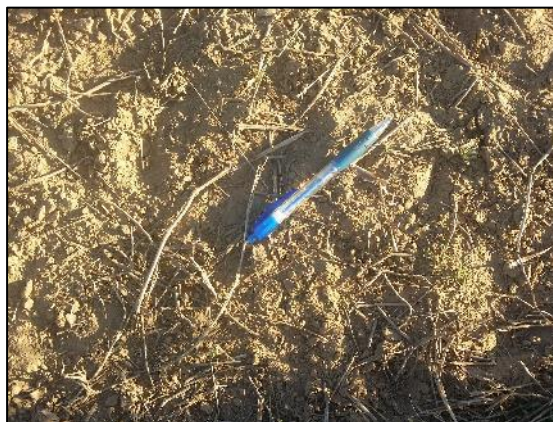
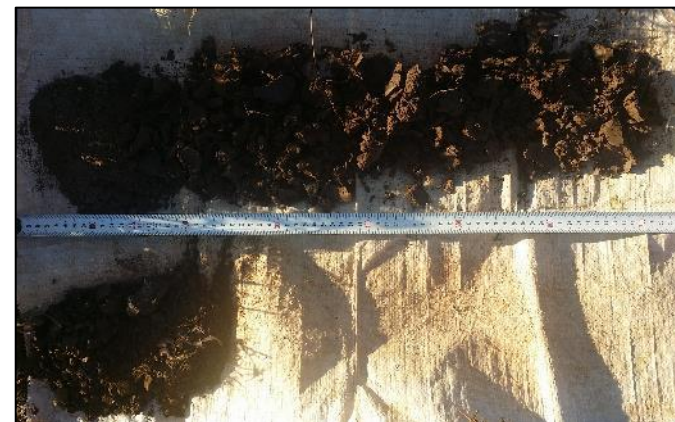
| Land use<br>Landform<br>Pattern,<br>Element,<br>Slope | Natural<br>Vegetation | Microrelief<br>Disturbance<br>Erosion | Surface<br>condition,<br>surface rock | Soil Profile Description | | | | | | | | | |
|---|---|---|---|---|---|---|---|---|---|---|---|---|---|
| Mid slope<br>1.5% | Sparse shrubs,<br>short grass | Minimal<br>gilgai visible,<br>complete<br>clearing | Firm, some<br>cracking, no<br>coarse<br>fragments | 0.00 – 0.18<br>Abrupt | Light clay | Weak peds<br>1-5mm,<br>firm | Nil | 10YR3/2<br>Very dark greyish<br>brown | Dry, well<br>drained | Fine, few | 0.05 / 7.0 | No samples<br>taken | No recovery at<br>0.80m |

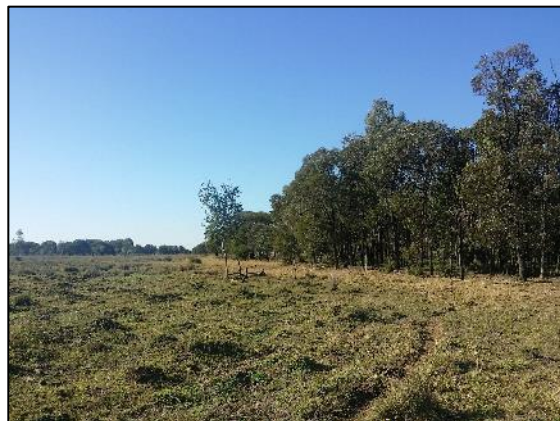
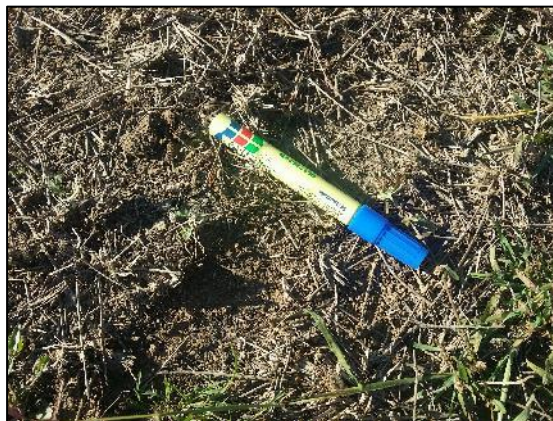
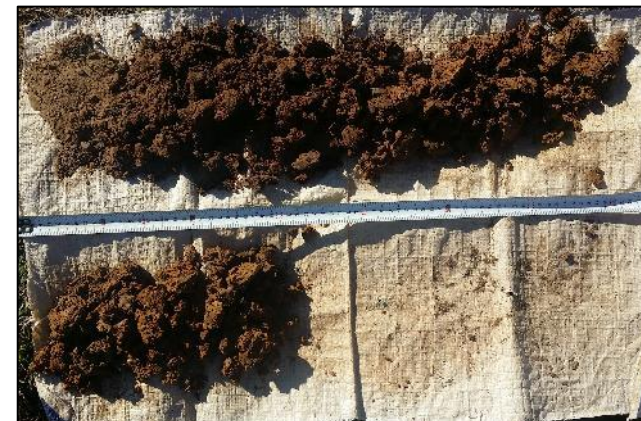
| Land use<br>Landform<br>Pattern,<br>Element,<br>Slope | Natural<br>Vegetation | Microrelief<br>Disturbance<br>Erosion | Surface<br>condition,<br>surface rock | Soil Profile Description | | | | | | | | | |
|---|---|---|---|---|---|---|---|---|---|---|---|---|---|
| Grazing,<br>gently<br>undulating<br>plains, lower<br>slope 2%<br>into water<br>body | Brigalow<br>regrowth, tall<br>Brigalow<br>nearby,<br>extensive<br>clearing | Extensive<br>clearing | Firm, fine<br>cracking,<br><10% coarse<br>fragments and<br>black nodules | A1<br>0.00 – 0.11<br>Abrupt | Sandy clay<br>loam | Massive<br>loose | Nil | 10YR3/2<br>Very dark greyish<br>brown | Dry, rapid | Fine, few | 0.05 / 6.5 | No samples<br>taken | Similar to site<br>55, but<br>textures vary<br>due to<br>proximity to<br>SMU<br>boundary |

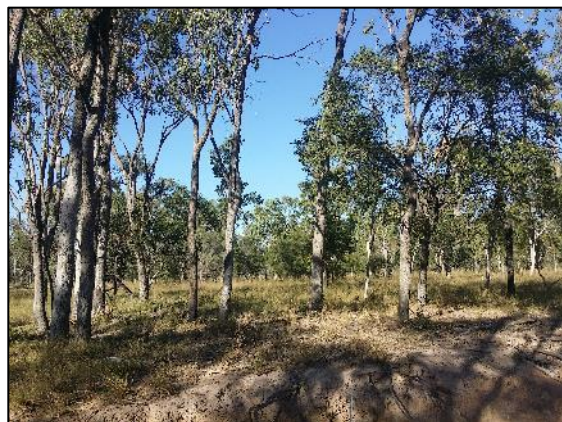
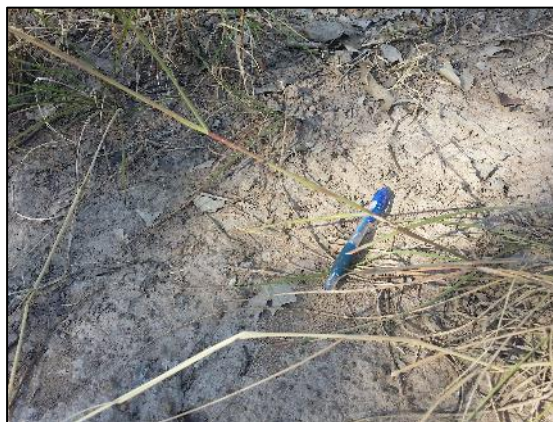
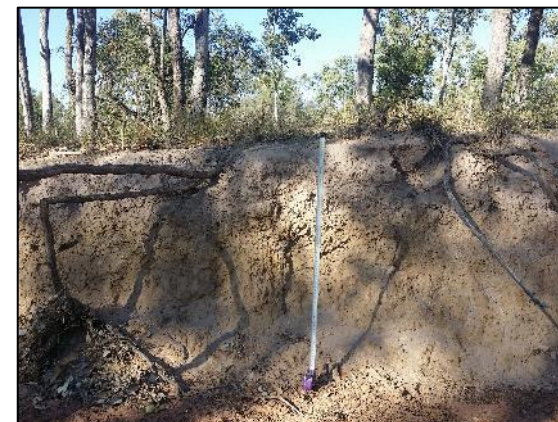
| Land use<br>Landform<br>Pattern,<br>Element,<br>Slope | Natural<br>Vegetation | Microrelief<br>Disturbance<br>Erosion | Surface<br>condition,<br>surface rock | Soil Profile Description | | | | | | | | | |
|---|---|---|---|---|---|---|---|---|---|---|---|---|---|
| Grazing,<br>gently<br>undulating<br>plains, upper<br>slope 2% | Mixed rall<br>woodlands;<br>Poplar Box,<br>White Gums,<br>Blackbutt | Nil | Firm / Hard<br>setting, no<br>coarse<br>fragments | A11<br>0.00 – 0.12<br>Abrupt | Loamy<br>sand | Massive,<br>loose | Nil | 10YR3/2<br>Very dark grayish<br>brown | Dry, rapid | Very fine, few | 0.10 / 6.0 | No samples<br>taken | No additional<br>observations |
| | | | | A12<br>0.12 – 0.61<br>Diffuse | Loamy<br>sand | Massive,<br>loose | <2% coarse<br>fragments and<br>manganese<br>nodules | 10YR4/2<br>Dark grayish<br>brown | Dry, rapid | Nil | 0.30 / 6.0 | | |

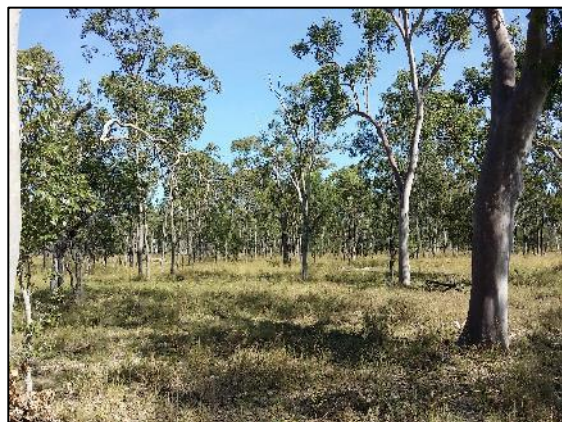
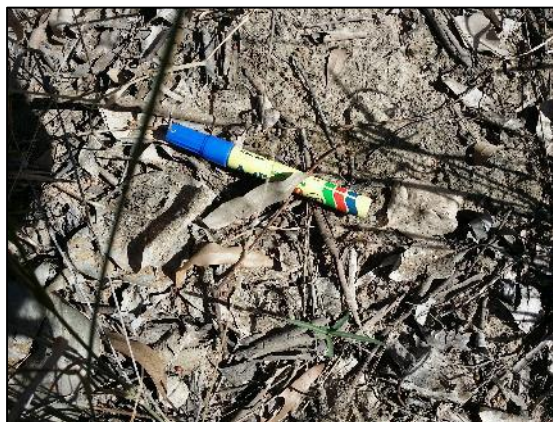
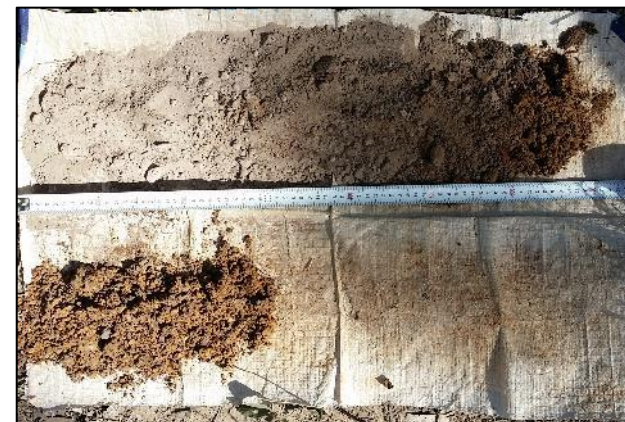
| Land use<br>Landform<br>Pattern,<br>Element,<br>Slope | Natural<br>Vegetation | Microrelief<br>Disturbance<br>Erosion | Surface<br>condition,<br>surface rock | Soil Profile Description | | | | | | | | | |
|---|---|---|---|---|---|---|---|---|---|---|---|---|---|
| Grazing,<br>gently<br>undulating<br>plains, upper<br>slope 2% | Mixed rall<br>woodlands;<br>Poplar Box,<br>White Gums,<br>Blackbutt | Nil | Firm / Hard<br>setting, no<br>coarse<br>fragments | A11<br>0.00 – 0.13<br>Abrupt | Loamy<br>sand | Massive,<br>loose | Nil | 10YR3/2<br>Very dark grayish<br>brown | Dry, rapid | Very fine, few | 0.10 / 6.0 | No samples<br>taken | No additional<br>observations |
| | | | | A12<br>0.13 – 0.57<br>Clear | Loamy<br>sand | Massive,<br>loose | <5% coarse<br>fragments and<br>manganese<br>nodules | 10YR4/2<br>Dark grayish<br>brown | Dry, rapid | Nil | 0.30 / 6.0 | | |

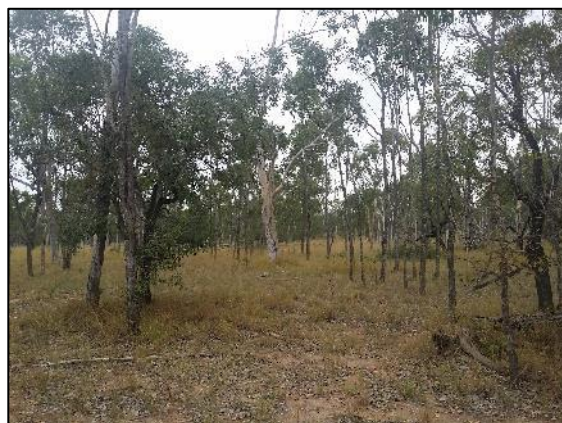
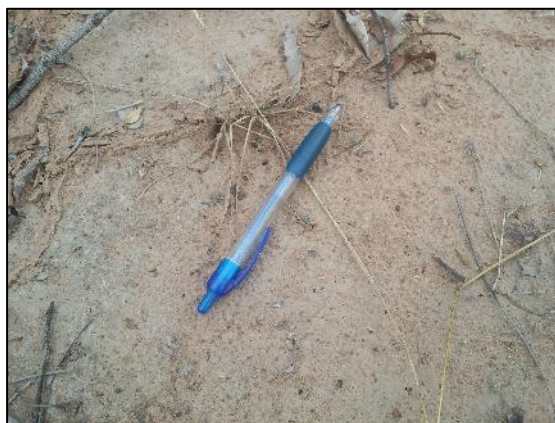
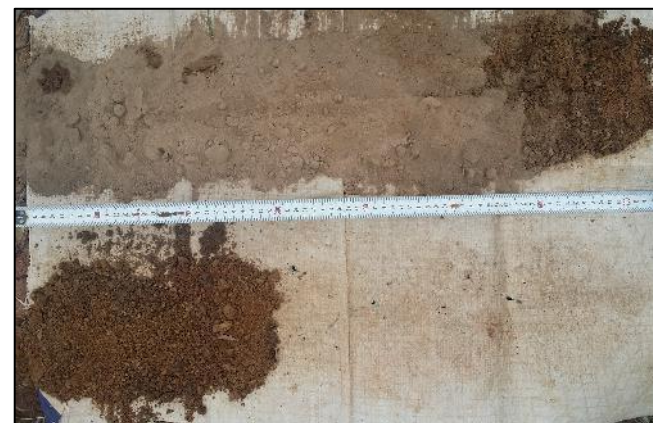
| Land use<br>Landform<br>Pattern,<br>Element,<br>Slope | Natural<br>Vegetation | Microrelief<br>Disturbance<br>Erosion | Surface<br>condition,<br>surface rock | Soil Profile Description | | | | | | | | | |
|---|---|---|---|---|---|---|---|---|---|---|---|---|---|
| Grazing, 2%<br>gently<br>undulating<br>plains,<br>midslope | Poplar Box<br>regrowth | Nil | Firm, <5%<br>coarse<br>fragments, 0-<br>10mm<br>diameter | A11<br>0 – 0.08<br>Abrupt | Loamy<br>sand | Massive,<br>loose | <2% coarse<br>fragments, 2-<br>6mm | 10YR4/3<br>Brown | Dry, rapid | Very fine, very<br>few | 0.05 / 6.5 | No samples<br>taken | No additional<br>observations |
| | | | | A12<br>0.08 – 0.60<br>Abrupt | Loamy<br>sand | Massive,<br>loose, peds<br><10%,<br>10mm,<br>rounded,<br>weak | Nil | 10YR4/4<br>Dark yellowish<br>brown | Dry, rapid | Very fine, very<br>few | 0.3 / 6.5<br>0.6 / 7.0 | | |

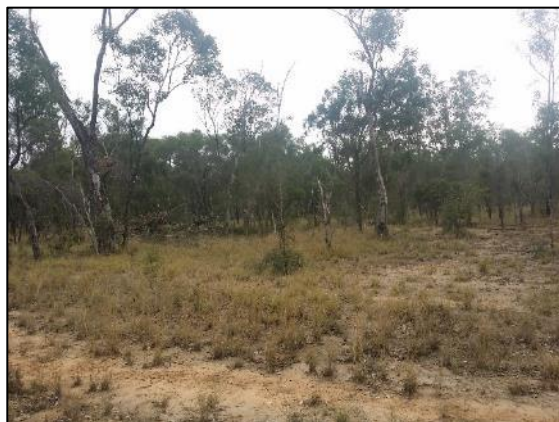
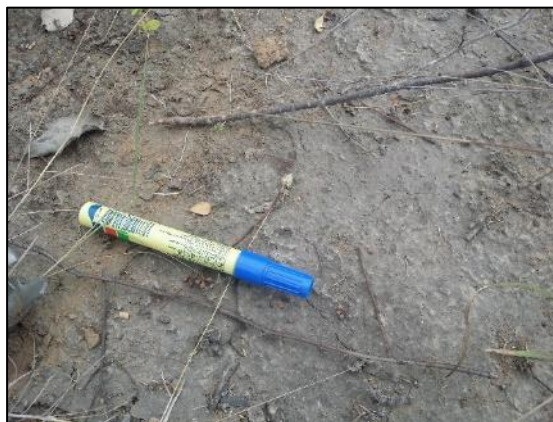
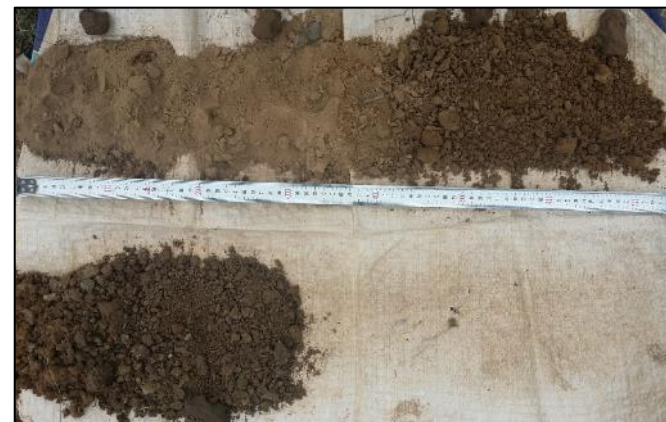
| Land use<br>Landform<br>Pattern,<br>Element,<br>Slope | Natural<br>Vegetation | Microrelief<br>Disturbance<br>Erosion | Surface<br>condition,<br>surface rock | Soil Profile Description | | | | | | | | | |
|---|---|---|---|---|---|---|---|---|---|---|---|---|---|
| Grazing,<br>gently<br>undulating<br>plains, mid<br>slope, 1.5% | Poplar Box<br>with various<br>woodlands<br>such as<br>Blackbutt | Access track<br>nearby | Hard setting<br>with minor<br>cracking,<br>no coarse<br>fragments | A11<br>0 – 0.12<br>Abrupt | Clayey<br>sand | Massive,<br>loose | Nil | 10YR3/3<br>Dark Brown<br>No mottle | Dry, rapid | Fine, very few | 0.05 / 6.5 | 0.0 – 0.1<br>0.3 – 0.4<br>0.5 – 0.6<br>0.6 – 0.7<br>0.9 – 1.0 | No additional<br>observations |

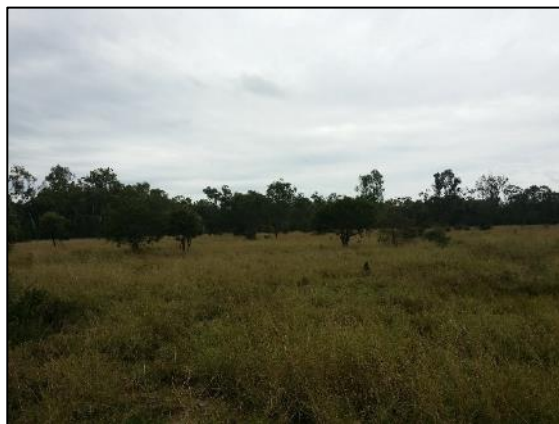
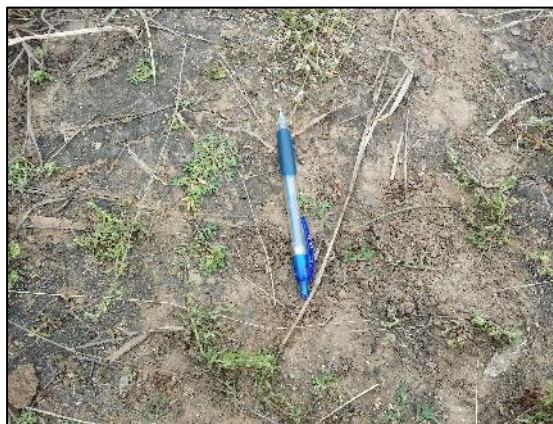
| Land use<br>Landform<br>Pattern,<br>Element,<br>Slope | Natural<br>Vegetation | Microrelief<br>Disturbance<br>Erosion | Surface<br>condition,<br>surface rock | Soil Profile Description | | | | | | | | | |
|---|---|---|---|---|---|---|---|---|---|---|---|---|---|
| Grazing, Flat<br>plain, <0.5% | Spare Morton<br>Bay Ash,<br>occasional<br>other<br>Eucalypts spp. | Shallow<br>gilgai,<br>extensive<br>clearing | Cracking,<br>surface crust,<br>no coarse<br>fragments | A11<br>0.0 – 0.08<br>Abrupt | Silty loam | Massive,<br>loose | Nil | 10YR4/2<br>Dark grayish<br>brown | Dry, rapid | Very few, fine | 0.05 / 6.5 | No samples<br>taken | No additional<br>observations |
