**PEMBROKE**

**Olive Downs Coking Coal Project**  
Draft Environmental Impact Statement

**Appendix M**  
**Soil and Land**  
**Suitability**  
**Assessment**

Olive Downs Coking Coal Project

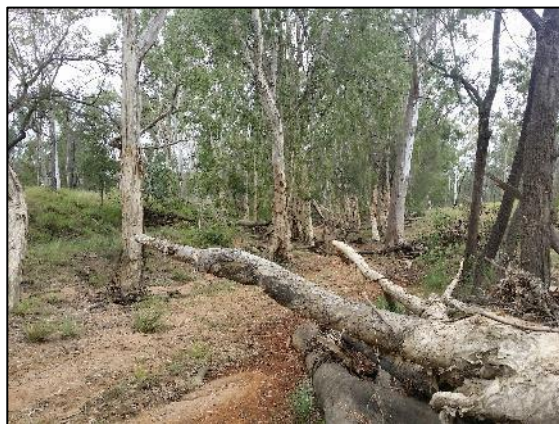
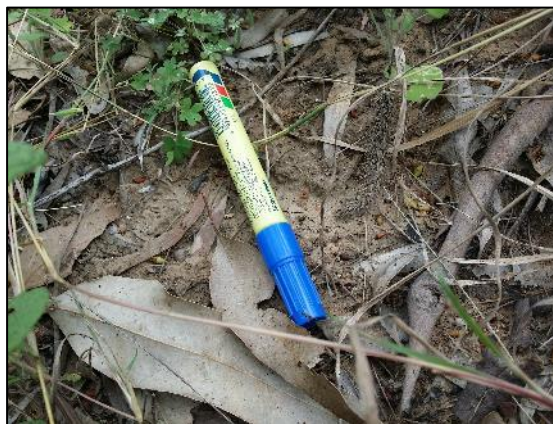
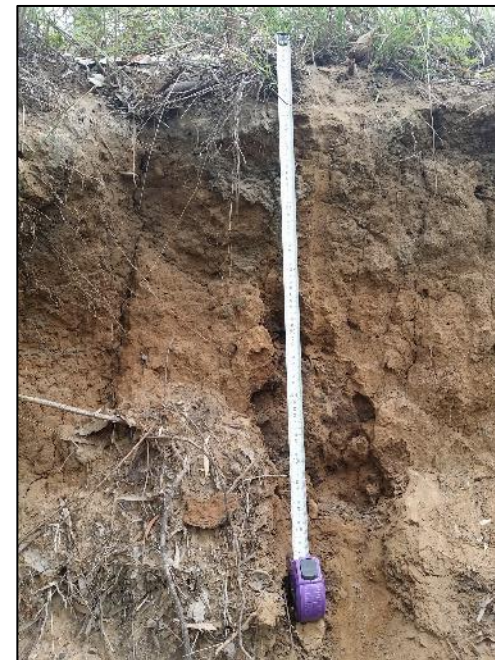
| <b>Soil Mapping Unit:</b><br>A1 | <b>CSIRO Land Systems (Gunn et al 1967):</b><br>Monteagle, Connors, Blackwater | <b>Location (GDA ZONE 55):</b><br>641685 mE 7533763 mN | <b>Aust. Soil Class. :</b><br>Haplic Grey Kandosol | <b>Site Survey Type:</b><br>Detailed - 50mm hand auger | <b>Survey Date:</b><br>7/7/2017 |

| Land use<br>Landform<br>Pattern,<br>Element,<br>Slope | Natural<br>Vegetation | Microrelief<br>Disturbance<br>Erosion | Surface<br>condition,<br>surface rock | Soil Profile Description | | | | | | | | | |
|---|---|---|---|---|---|---|---|---|---|---|---|---|---|
| Drainage<br>line <1% | Moreton Bay<br>Ash, Paperbark<br>and various<br>eucalyptus | Gully erosion | Firm, <1 % 1-<br>3mm coarse<br>fragments | A1<br>0 – 0.55<br>Abrupt | Loam | Massive<br>loose | Nil | 10YR3/2<br>Very dark greyish<br>brown<br>No mottles | Dry, rapid | Fine, few | 0.1 / 6.5<br>0.4 / 6.5 | No samples<br>taken | Cutting, open<br>face |
| | | | | B2<br>0.55 – 1.00 | Sandy<br>loam | Massive<br>loose | Nil | 10YR3/3<br>Dark brown<br>No mottles | Dry, rapid | Fine, few | 0.6 / 6.5<br>0.9 / 6.5 | | |

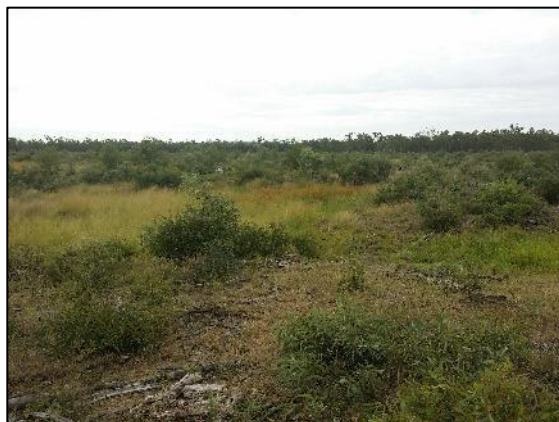
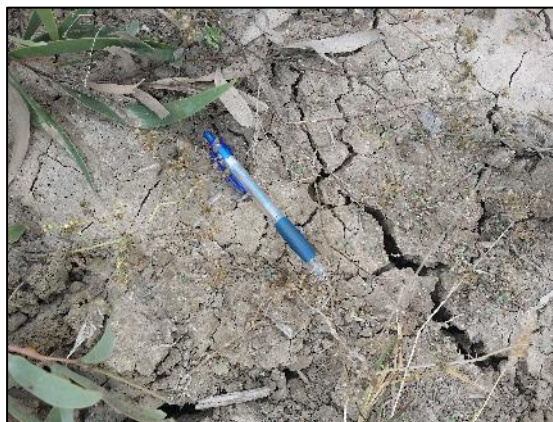
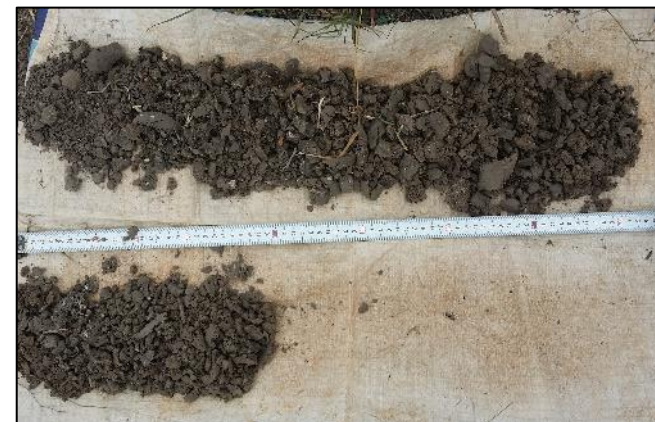
| <b>Soil Mapping Unit:</b><br>C1 | <b>CSIRO Land Systems (Gunn et al 1967):</b><br>Somerby, Monteagle, Connors,<br>Humboldt, Blackwater, Junee | <b>Location (GDA ZONE 55):</b><br>642716 mE 7535827 mN | <b>Aust. Soil Class. :</b><br>Endohypersodic Brown Vertosol | <b>Site Survey Type:</b><br>Detailed - 50mm hand auger | <b>Survey Date:</b><br>7/7/2017 |

| Land use<br>Landform<br>Pattern,<br>Element,<br>Slope | Natural<br>Vegetation | Microrelief<br>Disturbance<br>Erosion | Surface<br>condition,<br>surface rock | Soil Profile Description | | | | | | | | | |
|---|---|---|---|---|---|---|---|---|---|---|---|---|---|
| Grazing, Flat<br>plain, <0.5% | Brigalow plus<br>regrowth 40%<br>cover | Melon holes<br>5-10m wide<br>0.5m deep,<br>20% cover. | Cracking 3-<br>10mm,<br>crusting | A1<br>0.00 – 0.12<br>Abrupt | Light clay | Moderate,<br>strong 5-<br>15mm sub-<br>angular | Nil | 10YR3/2<br>Very dark grayish<br>brown | Dry, well<br>drained | Few, fine | 0.1 / 7.5 | No samples<br>taken | Check aerial<br>imagery |

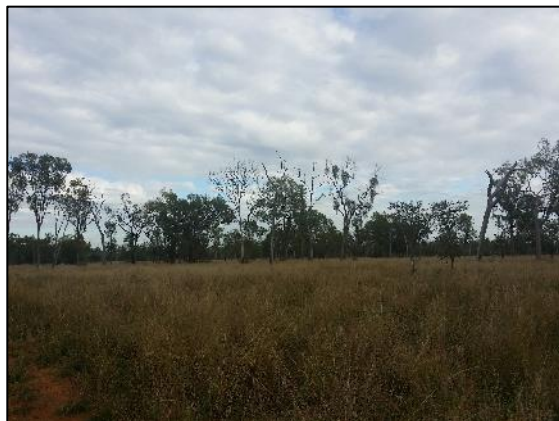
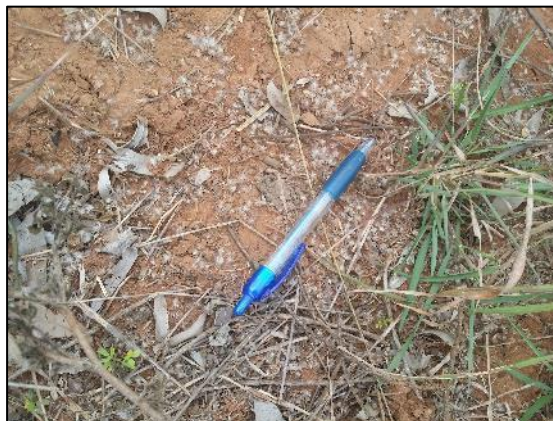
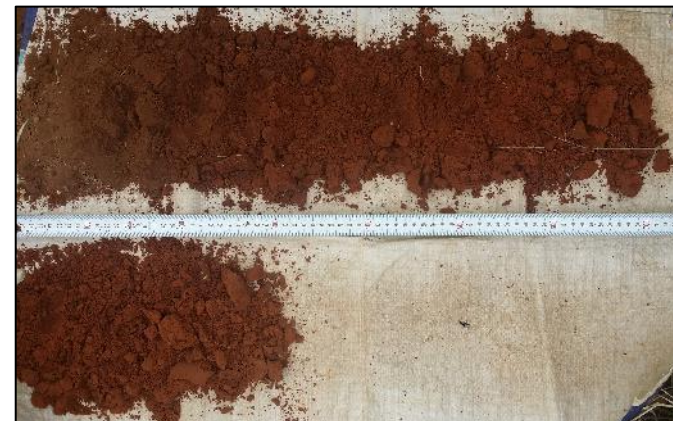
| <b>Soil Mapping Unit:</b><br>R1 | <b>CSIRO Land Systems (Gunn et al 1967):</b><br>Somerby, Monteagle, Connors,<br>Humboldt, Blackwater, Junee | <b>Location (GDA ZONE 55):</b><br>641517 mE 7536522 mN | <b>Aust. Soil Class. :</b><br>Red Rudosol | <b>Site Survey Type:</b><br>Detailed - 50mm hand auger | <b>Survey Date:</b><br>8/7/2017 |

| Land use<br>Landform<br>Pattern,<br>Element,<br>Slope | Natural<br>Vegetation | Microrelief<br>Disturbance<br>Erosion | Surface<br>condition,<br>surface rock | Soil Profile Description | | | | | | | | | |
|---|---|---|---|---|---|---|---|---|---|---|---|---|---|
| Grazing, 1%<br>Very gently<br>undulating<br>plains | Blackbutt,<br>minor<br>Moreton Bay<br>Ash | Nil<br>microrelief<br>Extensive<br>clearing<br>No erosion | Firm to soft,<br>no coarse<br>fragments | A1<br>0 – 0.13<br>Abrupt | Loamy<br>sand | Massive,<br>loose | Nil | 5YR3/3<br>Dark reddish<br>brown | Dry, rapid | Fine, few | 0.05 / - | No samples<br>taken | No additional<br>observations |

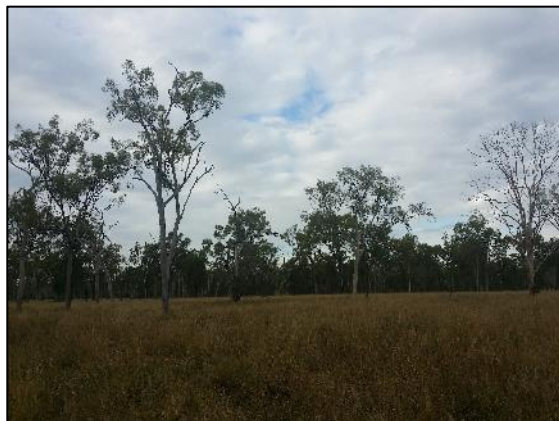
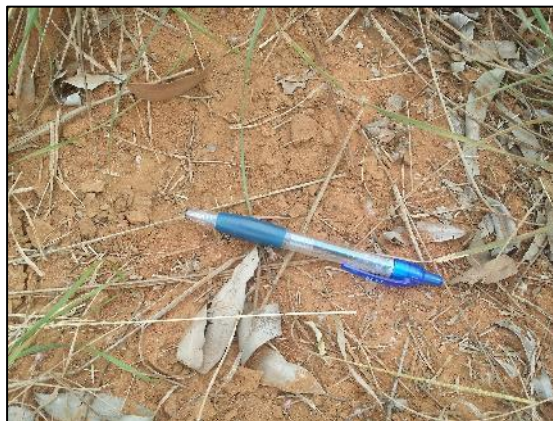
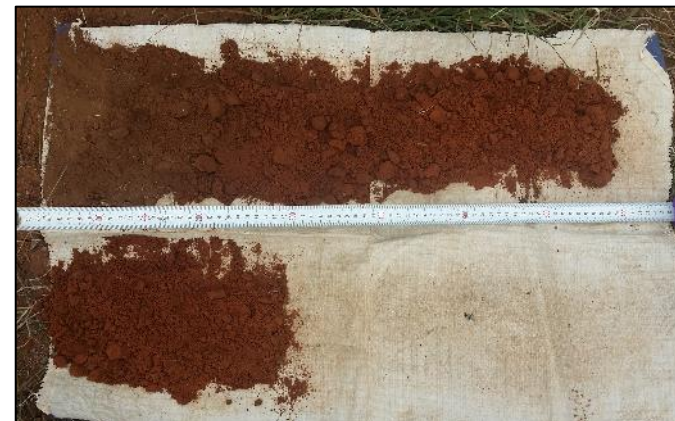
| <b>Soil Mapping Unit:</b><br>S2 | <b>CSIRO Land Systems (Gunn et al 1967):</b><br>Somerby, Monteagle, Connors,<br>Humboldt, Blackwater | <b>Location (GDA ZONE 55):</b><br>640759 mE 7536657 mN | <b>Aust. Soil Class. :</b><br>Haplic Brown Dermosol | <b>Site Survey Type:</b><br>Detailed - 50mm hand auger | <b>Survey Date:</b><br>8/7/2017 |

| Land use<br>Landform<br>Pattern,<br>Element,<br>Slope | Natural<br>Vegetation | Microrelief<br>Disturbance<br>Erosion | Surface<br>condition,<br>surface rock | Soil Profile Description | | | | | | | | | |
|---|---|---|---|---|---|---|---|---|---|---|---|---|---|
| Grazing, 2%<br>Very gently<br>undulating<br>plain,<br>downslope | Blackbutt | Nil<br>microrelief<br>Slightly<br>clearing<br>No erosion | Firm to soft,<br>no coarse<br>fragments | A1<br>0 – 0.14<br>Abrupt | Clayey<br>sand | Massive,<br>loose | Nil | 5YR3/3<br>Dark reddish<br>brown | Dry, rapid | Fine, few | 0.05 / - | No samples<br>taken | No additional<br>observations |

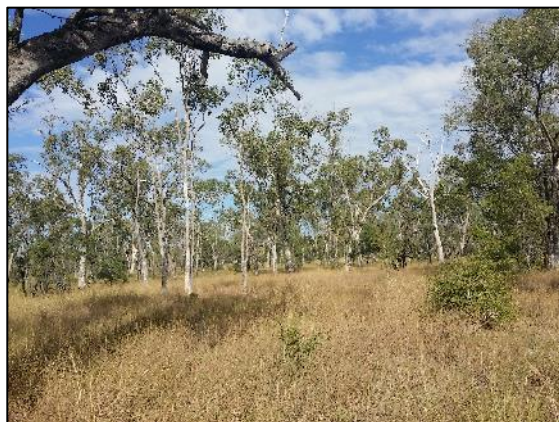
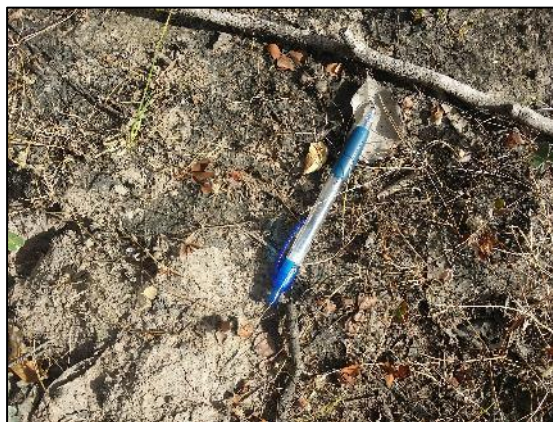
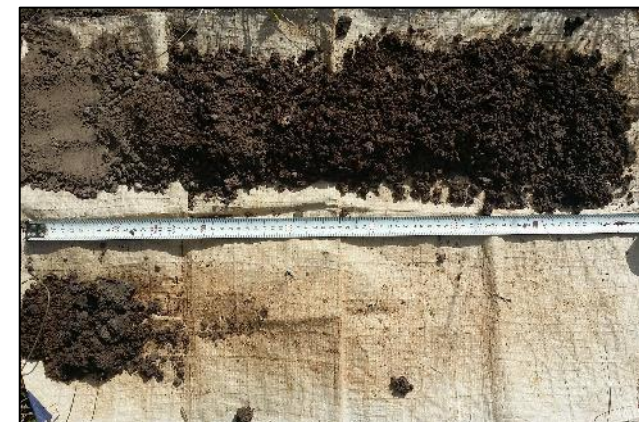
| <b>Soil Mapping Unit:</b><br>S2 | <b>CSIRO Land Systems (Gunn et al 1967):</b><br>Somerby, Monteagle, Connors,<br>Humboldt, Blackwater | <b>Location (GDA ZONE 55):</b><br>641596 mE 7536037 mN | <b>Aust. Soil Class. :</b><br>Haplic Brown Dermosol | <b>Site Survey Type:</b><br>Detailed - 50mm hand auger | <b>Survey Date:</b><br>8/7/2017 |

| Land use<br>Landform<br>Pattern,<br>Element,<br>Slope | Natural<br>Vegetation | Microrelief<br>Disturbance<br>Erosion | Surface<br>condition,<br>surface rock | Soil Profile Description | | | | | | | | | |
|---|---|---|---|---|---|---|---|---|---|---|---|---|---|
| Grazing, very<br>gently<br>undulating,<br>mid-slope,<br><1.5% | Moreton Bay<br>Ash, Poplar<br>Box | Nil | Hard setting,<br>no coarse<br>fragments | A1<br>0 – 0.10<br>Abrupt | Clayey<br>sand | Massive,<br>loose | <1% coarse<br>fragments,<br><2mm | 10YR3/2<br>Very dark greyish<br>brown | Dry, rapid | Fine, few | 0.1 / - | 0.0 – 0.1<br>0.3 – 0.4<br>0.6 – 0.7 | Boundary<br>150m to the<br>south east,<br>eucalyptus |

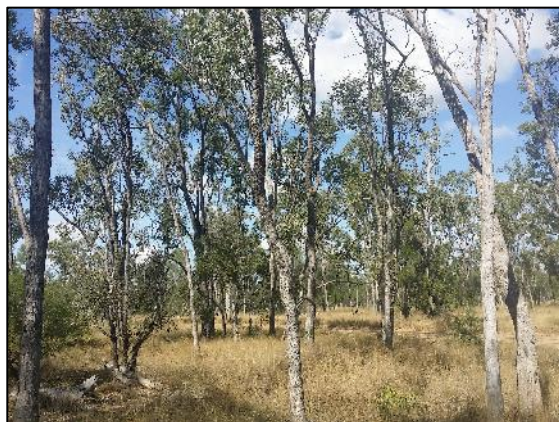
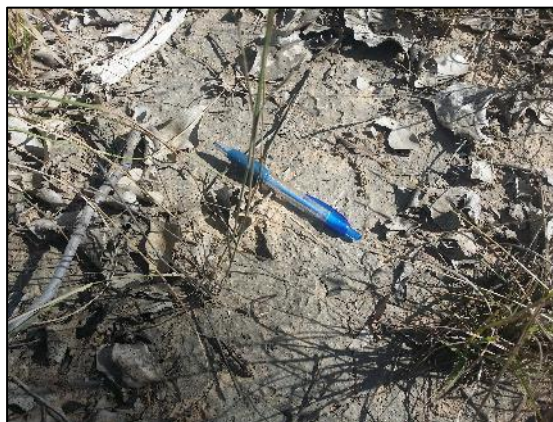
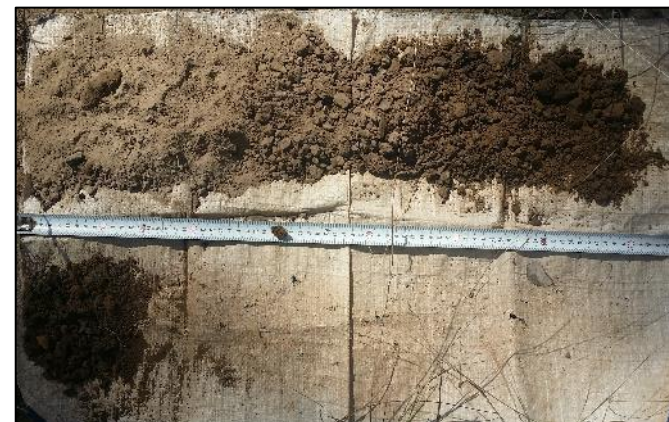
| <b>Soil Mapping Unit:</b><br>S1 | <b>CSIRO Land Systems (Gunn et al 1967):</b><br>Somerby, Monteagle, Connors,<br>Humboldt, Blackwater | <b>Location (GDA ZONE 55):</b><br>641184 mE 7534924 mN | <b>Aust. Soil Class. :</b><br>Brown Sodosol | <b>Site Survey Type:</b><br>Detailed - 50mm hand auger | <b>Survey Date:</b><br>8/7/2017 |

| Land use<br>Landform<br>Pattern,<br>Element,<br>Slope | Natural<br>Vegetation | Microrelief<br>Disturbance<br>Erosion | Surface<br>condition,<br>surface rock | Soil Profile Description | | | | | | | | | |
|---|---|---|---|---|---|---|---|---|---|---|---|---|---|
| Flat plain<br>0.5% | Poplar Box | Minor<br>clearing | Hard setting,<br>no coarse<br>fragments | A11<br>0.00 – 0.26<br>Abrupt | Loamy<br>sand | Massive,<br>loose | Nil | 10YR4/2<br>Dark grayish<br>brown | Dry, rapid | Very fine, very<br>few | 0.10 / 6.0 | No samples<br>taken | No recovery at<br>0.80m |

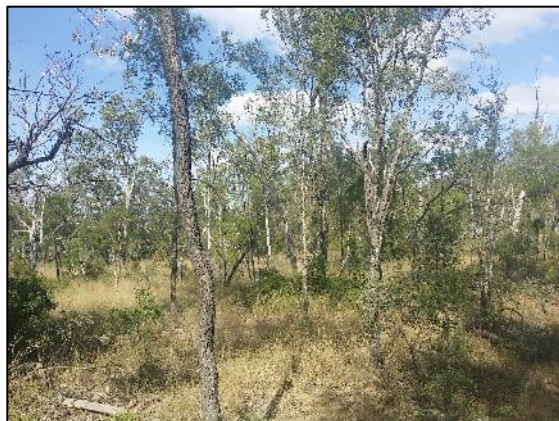
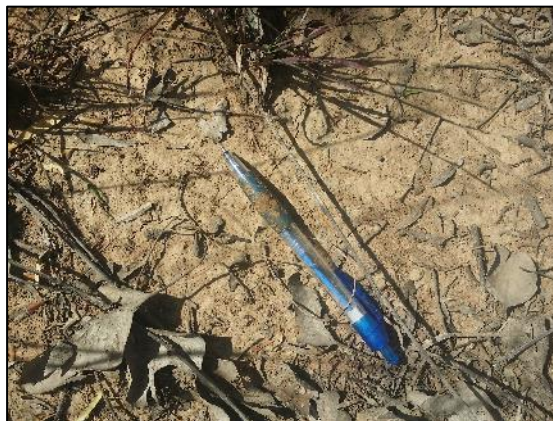
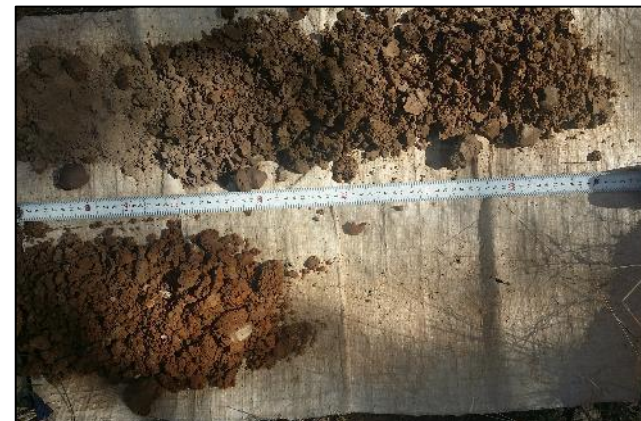
| <b>Soil Mapping Unit:</b><br>L1 | <b>CSIRO Land Systems (Gunn et al 1967):</b><br>Monteagle, Connors, Humboldt,<br>Blackwater | <b>Location (GDA ZONE 55):</b><br>641301 mE 7533293 mN | <b>Aust. Soil Class. :</b><br>Mesonatric Brown Sodosol | <b>Site Survey Type:</b><br>Detailed - 50mm hand auger | <b>Survey Date:</b><br>8/7/2017 |

| Land use<br>Landform<br>Pattern,<br>Element,<br>Slope | Natural<br>Vegetation | Microrelief<br>Disturbance<br>Erosion | Surface<br>condition,<br>surface rock | Soil Profile Description | | | | | | | | | |
|---|---|---|---|---|---|---|---|---|---|---|---|---|---|
| Grazing, flat<br>plain 0.5% | Poplar Box,<br>Ironbark,<br>various<br>regrowth | Nil | Hard setting,<br>some very<br>minor<br>cracking, no<br>coarse<br>fragments | A1<br>0.00 – 0.18<br>Abrupt | Clayey<br>sand | Massive<br>weak | Nil | 10YR4/2<br>Dark greyish<br>brown<br>No mottle | Dry, rapid | Very few, very<br>fine | 0.10 / 6.5 | 0.00 – 0.10<br>0.30 – 0.40<br>0.60 – 0.70<br>0.90 – 1.00 | No additional<br>observations |

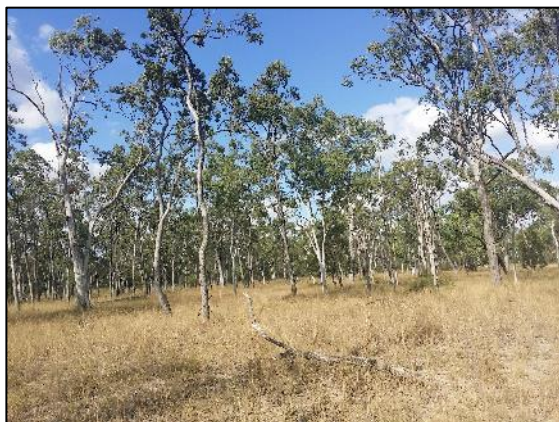
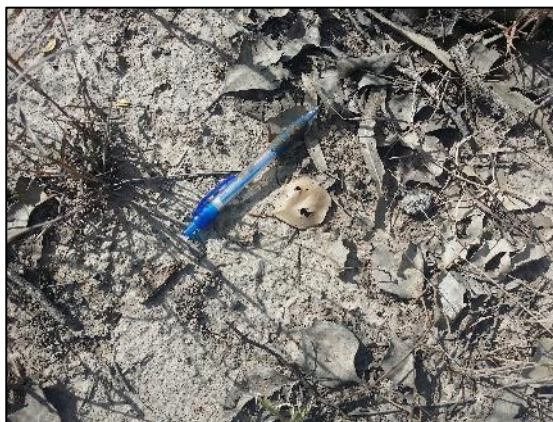
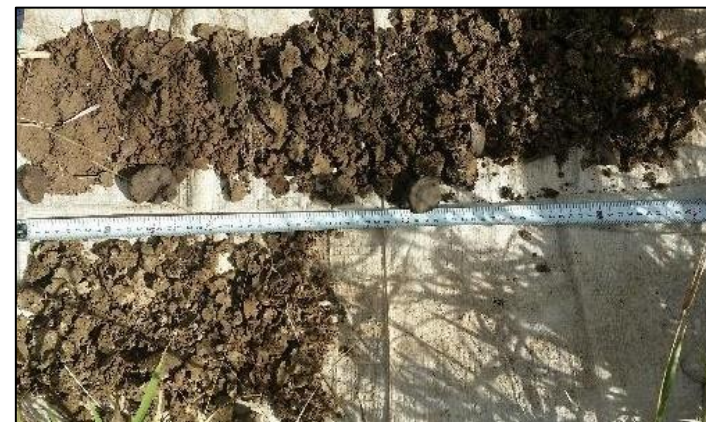
| <b>Soil Mapping Unit:</b><br>L1 | <b>CSIRO Land Systems (Gunn et al 1967):</b><br>Monteagle, Connors, Humboldt,<br>Blackwater | <b>Location (GDA ZONE 55):</b><br>639657 mE 7533857 mN | <b>Aust. Soil Class. :</b><br>Mesonatric Brown Sodosol | <b>Site Survey Type:</b><br>Detailed - 50mm hand auger | <b>Survey Date:</b><br>8/7/2017 |

| Land use<br>Landform<br>Pattern,<br>Element,<br>Slope | Natural<br>Vegetation | Microrelief<br>Disturbance<br>Erosion | Surface<br>condition,<br>surface rock | Soil Profile Description | | | | | | | | | |
|---|---|---|---|---|---|---|---|---|---|---|---|---|---|
| Grazing, flat<br>plain 0.5% | Poplar Box | Nil | Hard setting,<br><5% coarse<br>fragments,<br>minor<br>cracking | A11<br>0.00 – 0.06<br>Abrupt | Loamy<br>sand | Massive,<br>weak | Nil | 10YR4/2<br>Dark greyish<br>brown | Dry, rapid | Very fine, very<br>few | 0.10 / 6.5 | No samples<br>taken | No additional<br>observations |

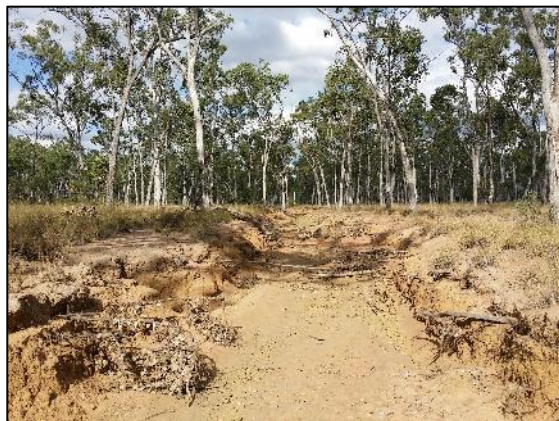
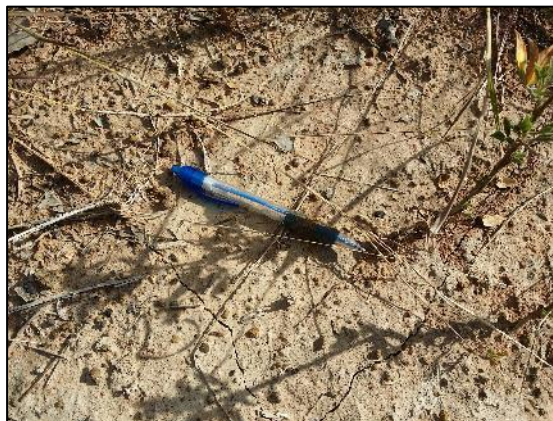
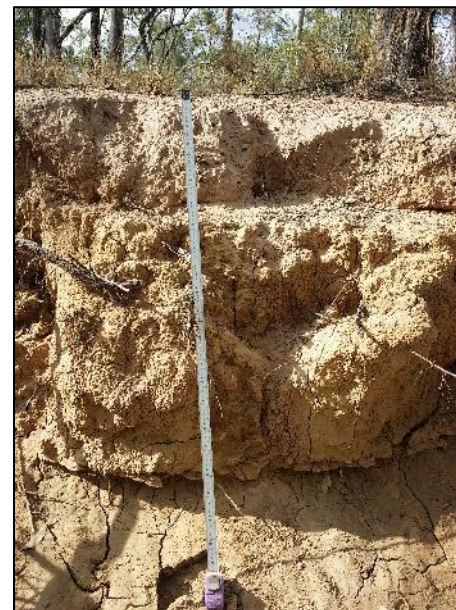
| <b>Soil Mapping Unit:</b><br>L1 | <b>CSIRO Land Systems (Gunn et al 1967):</b><br>Monteagle, Connors, Humboldt,<br>Blackwater | <b>Location (GDA ZONE 55):</b><br>642876 mE 7532061 mN | <b>Aust. Soil Class. :</b><br>Mesonatric Brown Sodosol | <b>Site Survey Type:</b><br>Detailed - 50mm hand auger | <b>Survey Date:</b><br>8/7/2017 |

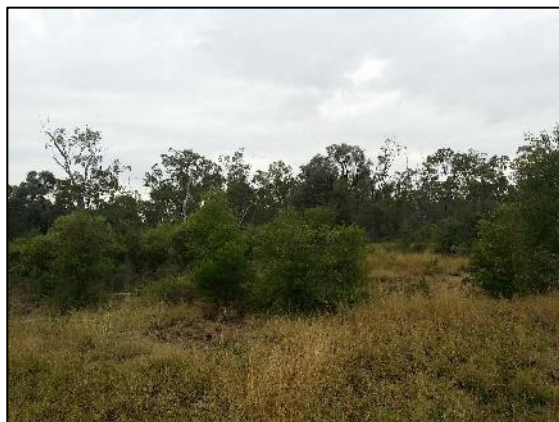
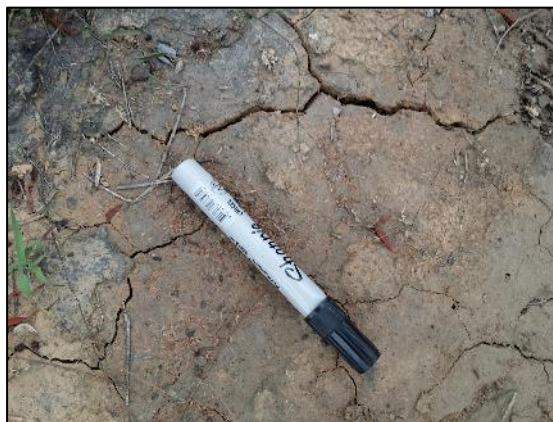
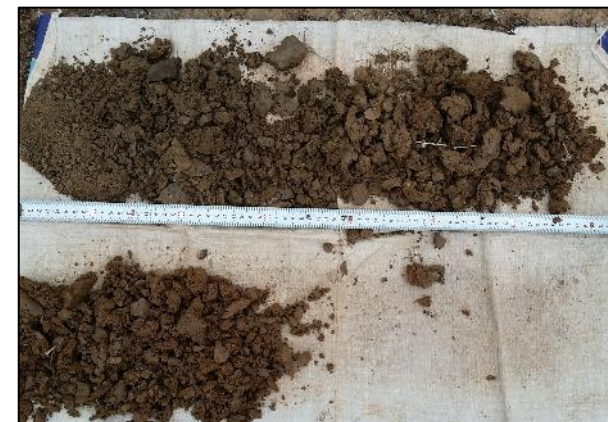
| <b>Soil Mapping Unit:</b><br>C2 | <b>CSIRO Land Systems (Gunn et al 1967):</b><br>Somerby, Monteagle, Connors,<br>Humboldt, Blackwater, Junee | <b>Location (GDA ZONE 55):</b><br>641112 mE 7533281 mN | <b>Aust. Soil Class. :</b><br>Brown Vertosol | <b>Site Survey Type:</b><br>Detailed - 50mm hand auger | <b>Survey Date:</b><br>9/7/2017 |

| Land use<br>Landform<br>Pattern,<br>Element,<br>Slope | Natural<br>Vegetation | Microrelief<br>Disturbance<br>Erosion | Surface<br>condition,<br>surface rock | Soil Profile Description | | | | | | | | | |
|---|---|---|---|---|---|---|---|---|---|---|---|---|---|
| Grazing,<br>gently<br>undulating<br>plains, flat<br>plain 0.5% | Open area,<br>various<br>occasional<br>regrowth,<br>some Brigalow<br>nearby | Very minor<br>normal gilgai | Hard setting,<br>cracking 1-<br>3mm, <1%<br>coarse<br>fragments 1-<br>3mm | A1<br>0.00 – 0.13<br>Abrupt | Light clay | Weak<br>subangular<br>peds 2-<br>10mm, firm | Nil | 10YR3/3<br>Dark brown | Dry, well<br>drained | Very few, very<br>fine | 0.00 / 7.5 | No samples<br>taken | No additional<br>observations |

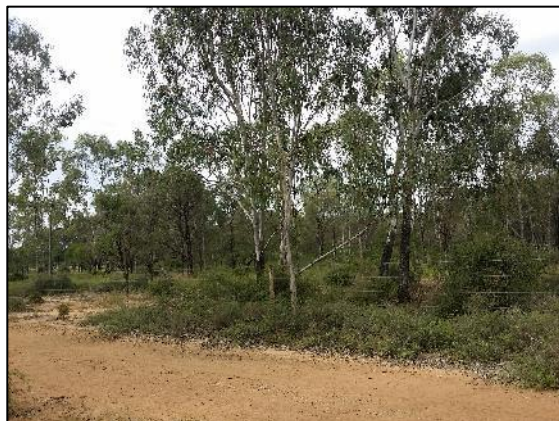
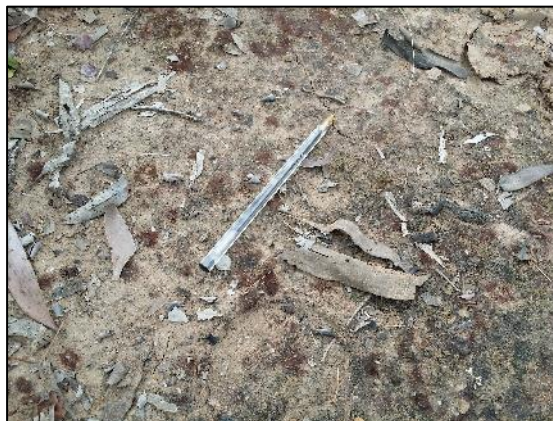
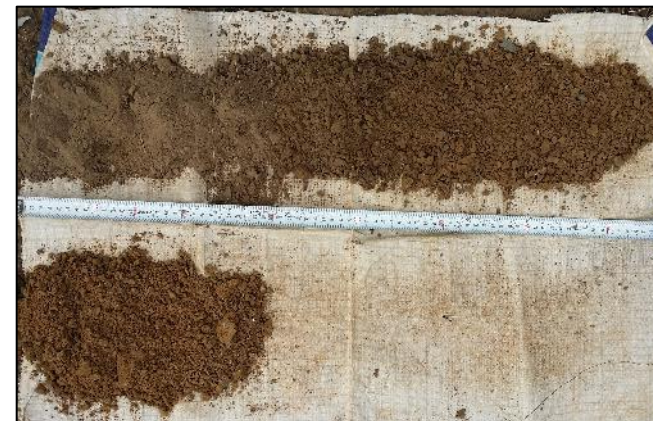
| <b>Soil Mapping Unit:</b><br>S1 | <b>CSIRO Land Systems (Gunn et al 1967):</b><br>Somerby, Monteagle, Connors,<br>Humboldt, Blackwater | <b>Location (GDA ZONE 55):</b><br>638941 mE 7536129 mN | <b>Aust. Soil Class. :</b><br>Brown Sodosol | <b>Site Survey Type:</b><br>Detailed - 50mm hand auger | <b>Survey Date:</b><br>9/7/2017 |

| Land use<br>Landform<br>Pattern,<br>Element,<br>Slope | Natural<br>Vegetation | Microrelief<br>Disturbance<br>Erosion | Surface<br>condition,<br>surface rock | Soil Profile Description | | | | | | | | | |
|---|---|---|---|---|---|---|---|---|---|---|---|---|---|
| Grazing, very<br>gently<br>undulating<br>plains, | Poplar box,<br>minor<br>Moreton Bay<br>Ash | Nil | Hardsetting,<br>minor fine<br>cracking | A1<br>0.00 – 0.29<br>Abrupt | Loamy<br>sand | Massive,<br>loose | Nil | 10YR4/3<br>Brown | Dry, Rapid | Fine, few | Nil | No samples<br>taken | No additional<br>observations |

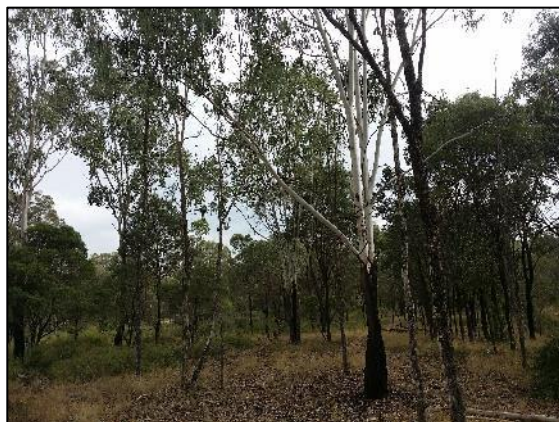
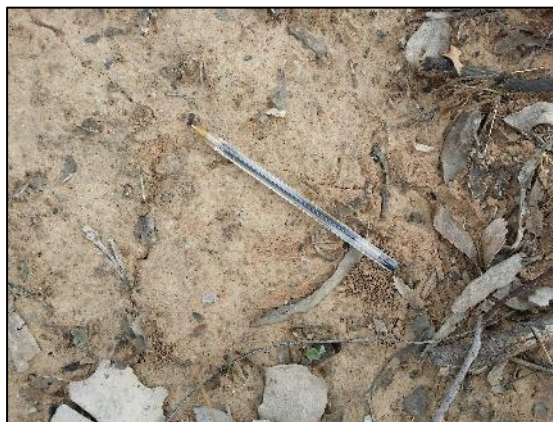
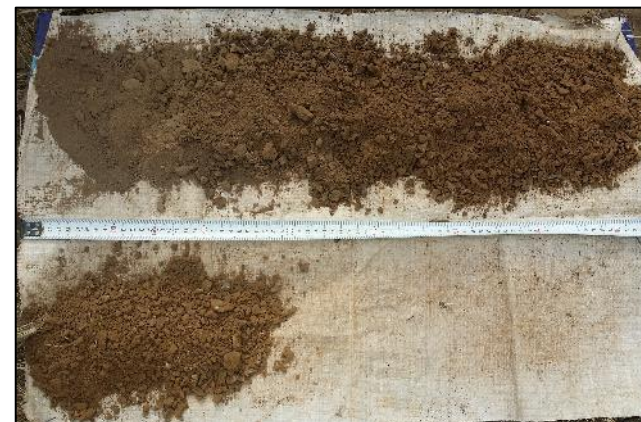
| <b>Soil Mapping Unit:</b><br>S1 | <b>CSIRO Land Systems (Gunn et al 1967):</b><br>Somerby, Monteagle, Connors,<br>Humboldt, Blackwater | <b>Location (GDA ZONE 55):</b><br>638343 mE 7536301 mN | <b>Aust. Soil Class. :</b><br>Brown Sodosol | <b>Site Survey Type:</b><br>Detailed - 50mm hand auger | <b>Survey Date:</b><br>9/7/2017 |

| Land use<br>Landform<br>Pattern,<br>Element,<br>Slope | Natural<br>Vegetation | Microrelief<br>Disturbance<br>Erosion | Surface<br>condition,<br>surface rock | Soil Profile Description | | | | | | | | | |
|---|---|---|---|---|---|---|---|---|---|---|---|---|---|
| Grazing, very<br>gently<br>undulating<br>plains, | Poplar box,<br>minor<br>Moreton Bay<br>Ash | Nil | Hardsetting,<br>minor fine<br>cracking | A1<br>0.00 – 0.29<br>Abrupt | Loamy<br>sand | Massive,<br>loose | Nil | 10YR4/3<br>Brown | Dry, Rapid | Fine, few | Nil | No samples<br>taken | No additional<br>observations |

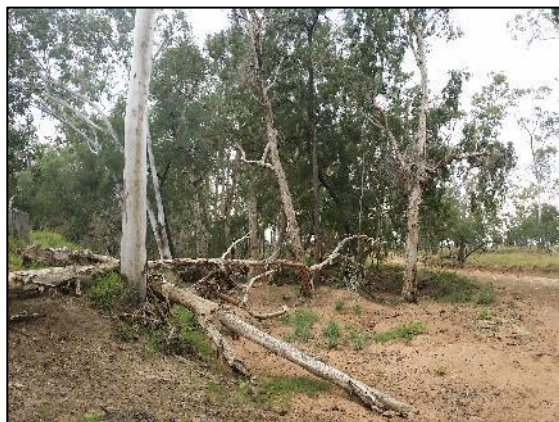
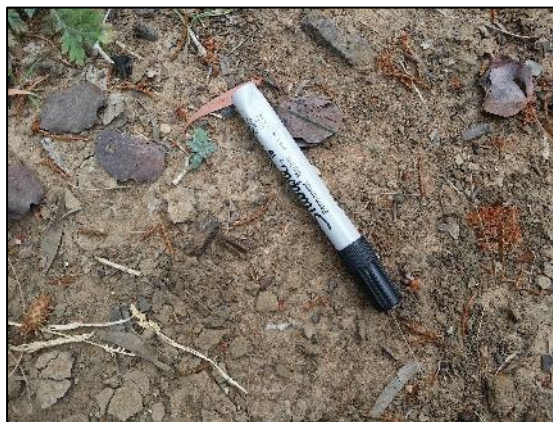
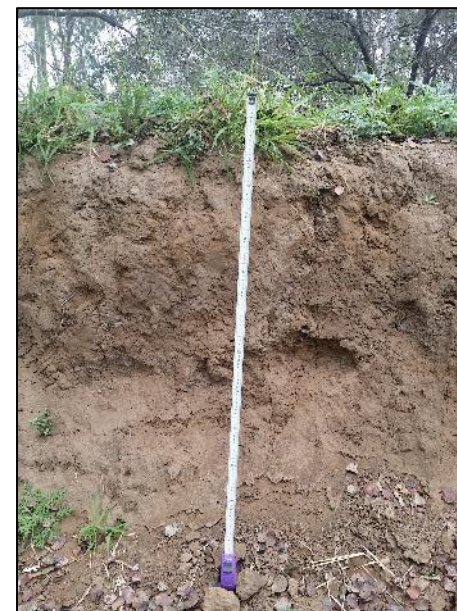
| <b>Soil Mapping Unit:</b><br>A1 | <b>CSIRO Land Systems (Gunn et al 1967):</b><br>Monteagle, Connors, Blackwater | <b>Location (GDA ZONE 55):</b><br>637205 mE 7536563 mN | <b>Aust. Soil Class. :</b><br>Haplic Grey Kandosol | <b>Site Survey Type:</b><br>Detailed - 50mm hand auger | <b>Survey Date:</b><br>9/7/2017 |

| Land use<br>Landform<br>Pattern,<br>Element,<br>Slope | Natural<br>Vegetation | Microrelief<br>Disturbance<br>Erosion | Surface<br>condition,<br>surface rock | Soil Profile Description | | | | | | | | | |
|---|---|---|---|---|---|---|---|---|---|---|---|---|---|
| Drainage<br>line | Moreton Bay<br>Ash, Paperbark<br>and various<br>eucalyptus | Gully erosion | Firm, <1 % 1-<br>3mm coarse<br>fragments | A1<br>0.00 – 0.40<br>Abrupt | Loam | Massive<br>loose | Nil | 10YR3/2<br>Very dark greyish<br>brown | Dry, rapid | Fine, few | 0.1 / 6.5<br>0.4 / 6.5 | No samples<br>taken | No additional<br>observations |
| | | | | B2<br>0.40 – 1.00 | Sandy<br>loam | Massive<br>loose | Nil | 10YR3/2<br>Very dark greyish<br>brown | Dry, rapid | Fine, few | 0.6 / 6.5<br>0.9 / 6.5 | | |

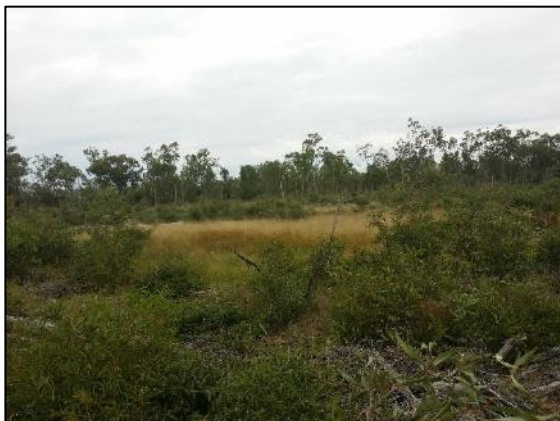
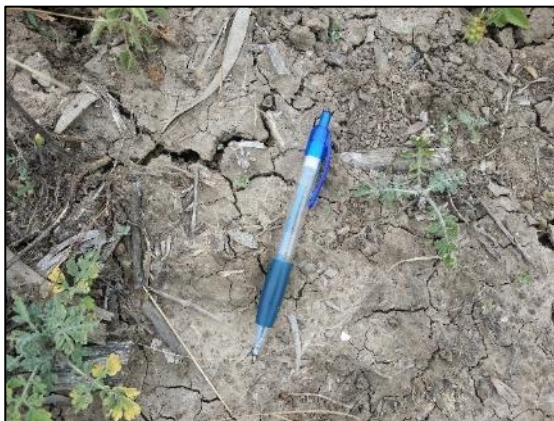
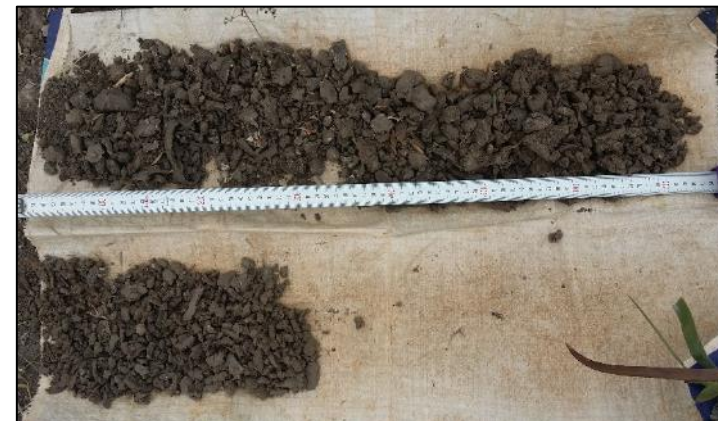
| Land use<br>Landform<br>Pattern,<br>Element,<br>Slope | Natural<br>Vegetation | Microrelief<br>Disturbance<br>Erosion | Surface<br>condition,<br>surface rock | Soil Profile Description | | | | | | | | | |
|---|---|---|---|---|---|---|---|---|---|---|---|---|---|
| Grazing, Flat<br>plain, <0.5% | Brigalow plus<br>regrowth 40%<br>cover | Normal gilgai<br>5-10m wide<br><0.3m deep,<br>20% cover. | Cracking 3-<br>10mm,<br>crusting | A1<br>0.0 – 0.11<br>Abrupt | Light clay | Moderate,<br>strong 5-<br>15mm sub-<br>angular | Nil | 10YR3/2<br>Very dark grayish<br>brown | Dry, well<br>drained | Few, fine | 0.1 / 7.5 | No samples<br>taken | Cracking<br>surface begins<br>200m to south |

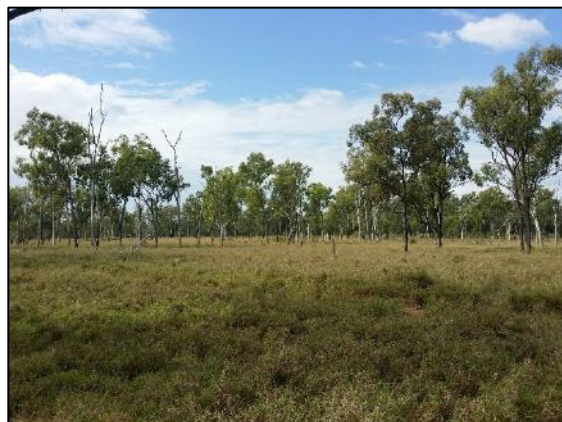
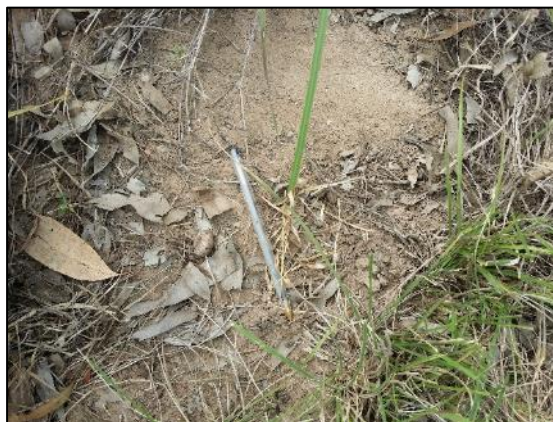
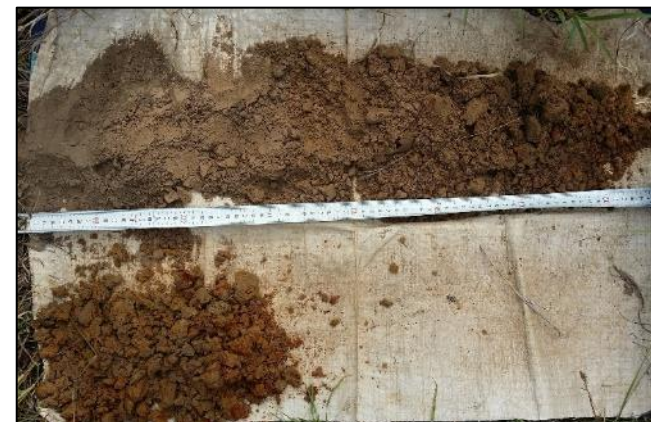
| Land use<br>Landform<br>Pattern,<br>Element,<br>Slope | Natural<br>Vegetation | Microrelief<br>Disturbance<br>Erosion | Surface<br>condition,<br>surface rock | Soil Profile Description | | | | | | | | | |
|---|---|---|---|---|---|---|---|---|---|---|---|---|---|
| Grazing,<br>Upper slope<br>2% | Eucalypts,<br>Blackbutt,<br>Ironbark | Nil | Firm, no<br>coarse<br>fragments | A11<br>0.00-0.10<br>Abrupt | Loamy<br>sand | Massive,<br>loose | Nil | 7.5YR3/2<br>Dark brown | Dry, Rapid | Fine, very few | 0.1 / 6.5 | No samples<br>taken | No additional<br>observations |
| | | | | A12<br>0.10-0.60<br>Abrupt | Loamy<br>sand | Massive,<br>loose | Nil | 7.5YR4/2<br>Brown | Dry, Rapid | Fine, very few | 0.3 / 6.5 | | |
| | | | | B22<br>0.90-1.00 | Clay loamy<br>sand | Moderate,<br>sub angular<br>peds 5-<br>15mm,<br>weak | Nil | 7.5YR4/4<br>Brown<br>Mottle<br>2% 2.5YR3/6 Dark<br>red<br>30% 10YR5/8<br>Yellowish brown | Moderately<br>moist, Well<br>drained | Nil | 0.9 / 6.5 | | |

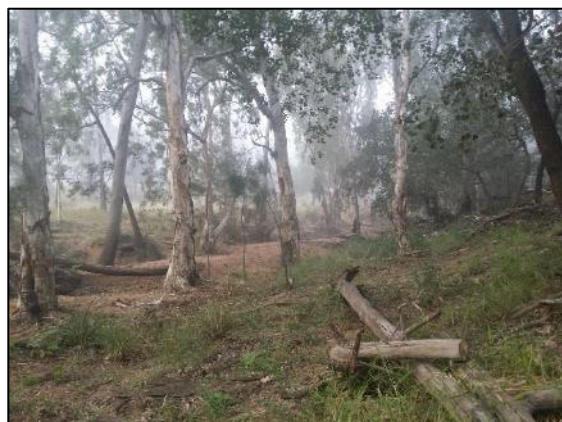
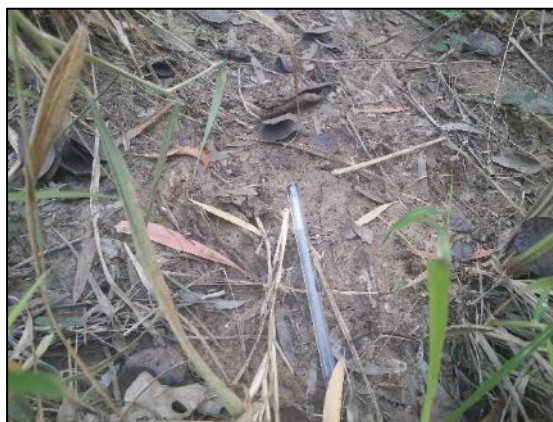
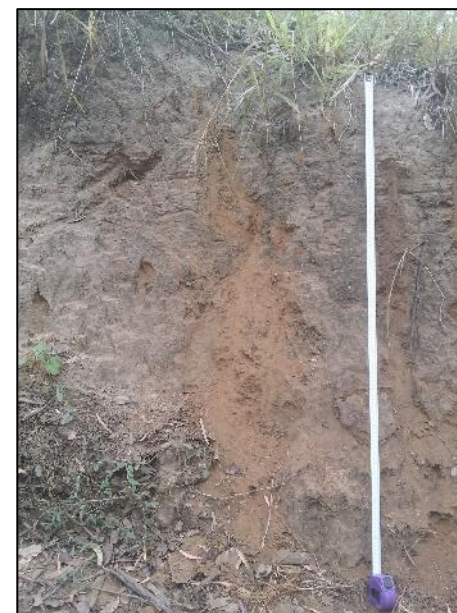
| Land use<br>Landform<br>Pattern,<br>Element,<br>Slope | Natural<br>Vegetation | Microrelief<br>Disturbance<br>Erosion | Surface<br>condition,<br>surface rock | Soil Profile Description | | | | | | | | | |
|---|---|---|---|---|---|---|---|---|---|---|---|---|---|
| Drainage<br>line | Moreton Bay<br>Ash, Paperbark<br>and various<br>eucalyptus | Gully erosion | Firm, <1 % 1-<br>3mm coarse<br>fragments | A1<br>0.00 – 0.40<br>Abrupt | Loam | Massive<br>loose | Nil | 10YR3/2<br>Very dark greyish<br>brown | Dry, rapid | Fine, few | 0.1 / 6.5<br>0.4 / 6.5 | No samples<br>taken | No additional<br>observations |
| | | | | B2<br>0.40 – 1.00 | Sandy<br>loam | Massive<br>loose | Nil | 10YR3/2<br>Very dark greyish<br>brown | Dry, rapid | Fine, few | 0.6 / 6.5<br>0.9 / 6.5 | | |

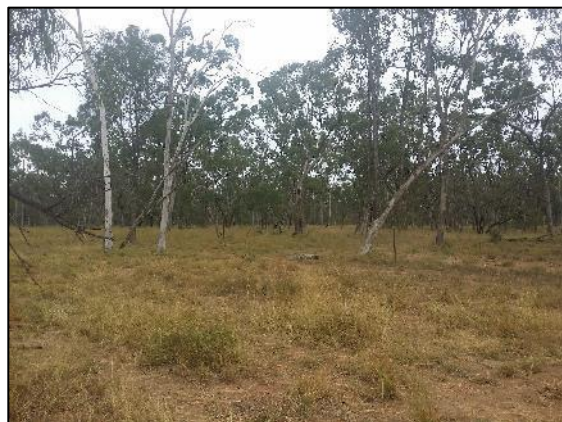
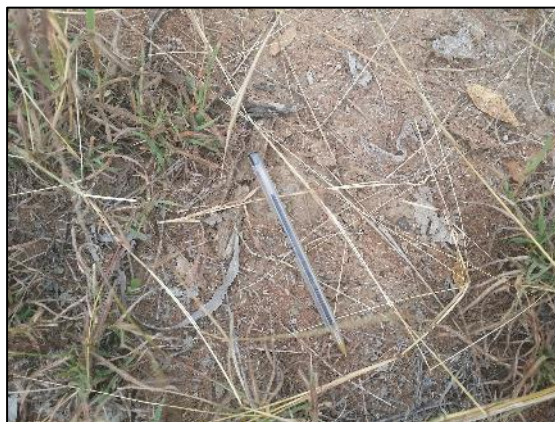
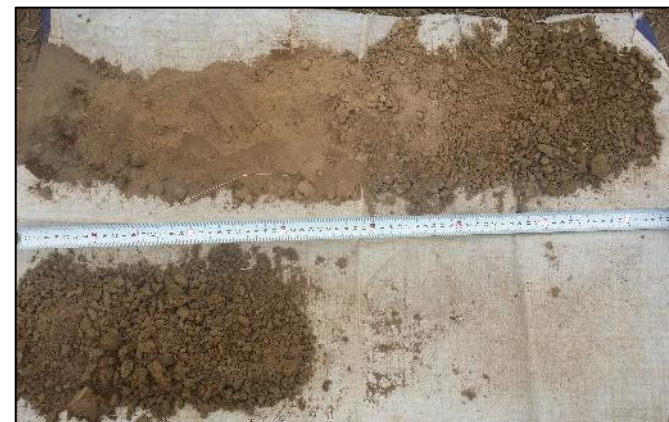
| Land use<br>Landform<br>Pattern,<br>Element,<br>Slope | Natural<br>Vegetation | Microrelief<br>Disturbance<br>Erosion | Surface<br>condition,<br>surface rock | Soil Profile Description | | | | | | | | | |
|---|---|---|---|---|---|---|---|---|---|---|---|---|---|
| Grazing,<br>gently<br>undulating<br>plains, upper<br>slope | Poplar box | Semi-cleared | Nil | A11<br>0.00-0.08<br>Abrupt | Loamy<br>Sand | Massive,<br>loose | Nil | 10YR4/3 Brown | Dry, Rapid | Very few, very<br>fine | 0.10 / 6.5 | No samples<br>taken | No additional<br>observations |
| | | | | A12<br>0.08-0.39<br>Abrupt | Loamy<br>Sand | Massive,<br>loose | Nil | 10YR4/4<br>Dark yellowish<br>brown | Dry, Rapid | Very few, very<br>fine | 0.30 / 6.5 | | |

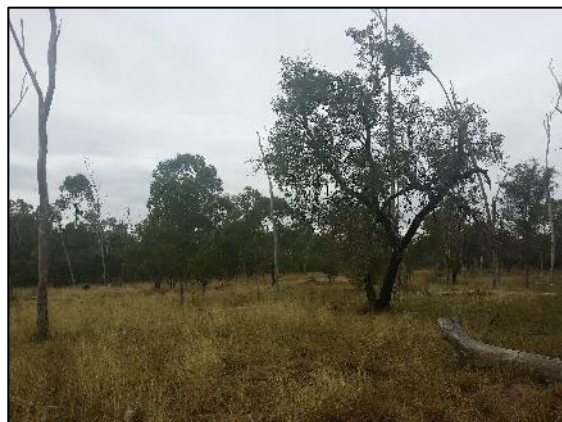
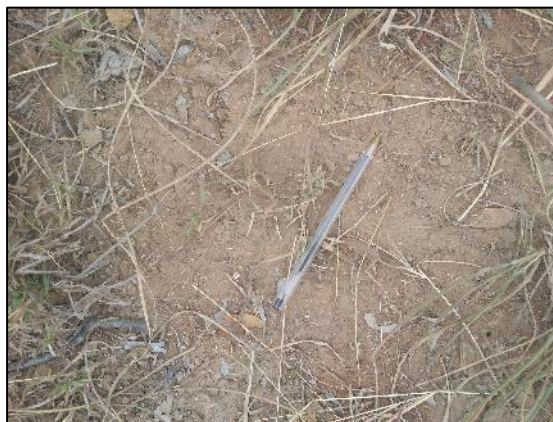
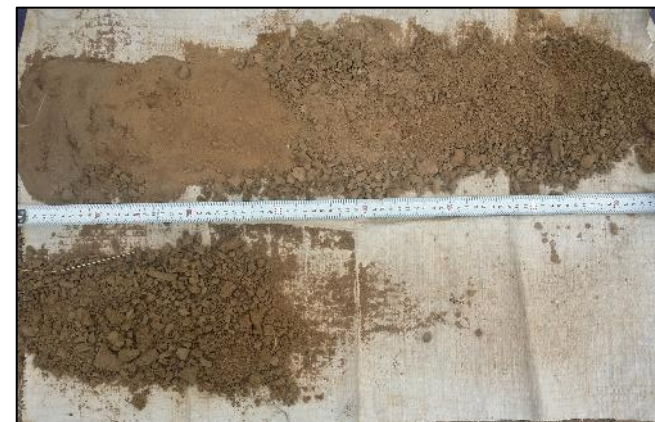
| Land use<br>Landform<br>Pattern,<br>Element,<br>Slope | Natural<br>Vegetation | Microrelief<br>Disturbance<br>Erosion | Surface<br>condition,<br>surface rock | Soil Profile Description | | | | | | | | | |
|---|---|---|---|---|---|---|---|---|---|---|---|---|---|
| Grazing,<br>gently<br>undulating<br>plains, upper<br>slope | Poplar box | Semi-cleared | Nil | A11<br>0.00-0.10<br>Abrupt | Loamy<br>Sand | Massive,<br>loose | Nil | 10YR4/3<br>Brown | Dry, Rapid | Very few, very<br>fine | 0.10 / 6.5 | No samples<br>taken | No additional<br>observations |
| | | | | A12<br>0.10-0.35<br>Abrupt | Loamy<br>Sand | Massive,<br>loose | Nil | 10YR4/4<br>Dark yellowish<br>brown | Dry, Rapid | Very few, very<br>fine | 0.30 / 6.5 | | |

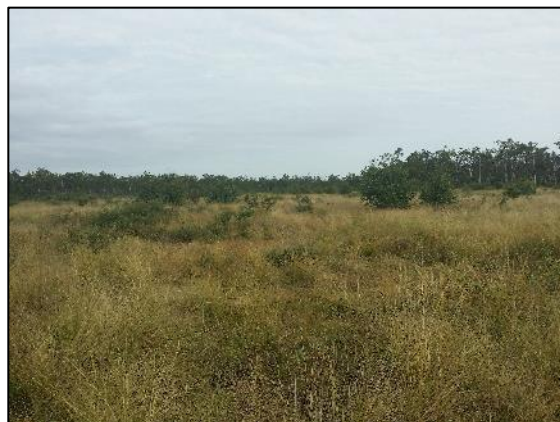
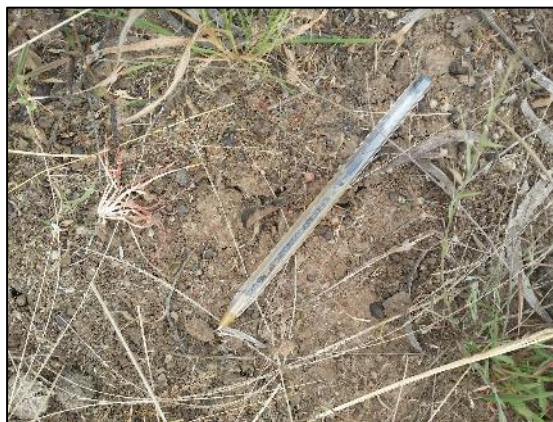
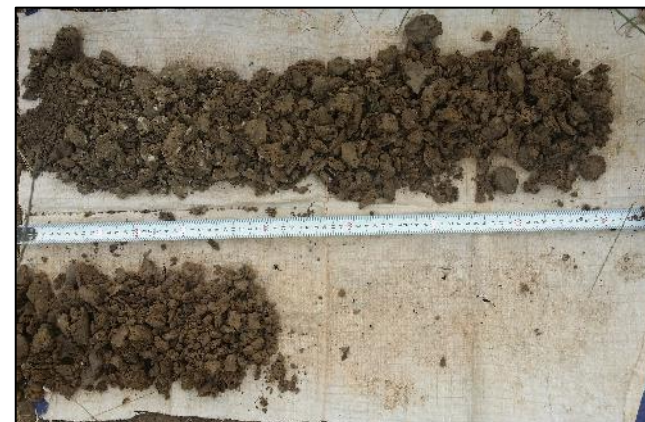
| Land use<br>Landform<br>Pattern,<br>Element,<br>Slope | Natural<br>Vegetation | Microrelief<br>Disturbance<br>Erosion | Surface<br>condition,<br>surface rock | Soil Profile Description | | | | | | | | | |
|---|---|---|---|---|---|---|---|---|---|---|---|---|---|
| Grazing,<br>gently<br>undulating<br>plains, flat<br>plain 0.5% | Open area,<br>various<br>occasional<br>regrowth,<br>some Brigalow<br>nearby | Very minor<br>normal gilgai | Hard setting,<br>cracking 1-<br>3mm, <1%<br>coarse<br>fragments 1-<br>3mm | A1<br>0.00 – 0.10<br>Abrupt | Light clay | Weak<br>subangular<br>peds 3-<br>10mm, firm | Calcium<br>carbonate 2% | 10YR3/3<br>Dark brown | Dry, well<br>drained | Very few, very<br>fine | 0.00 / 8.0 | No samples<br>taken | No additional<br>observations |

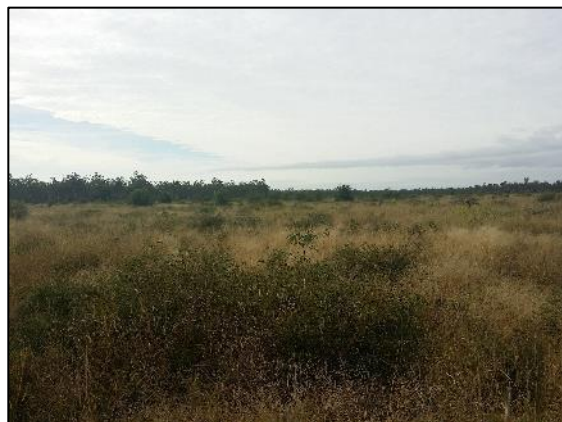
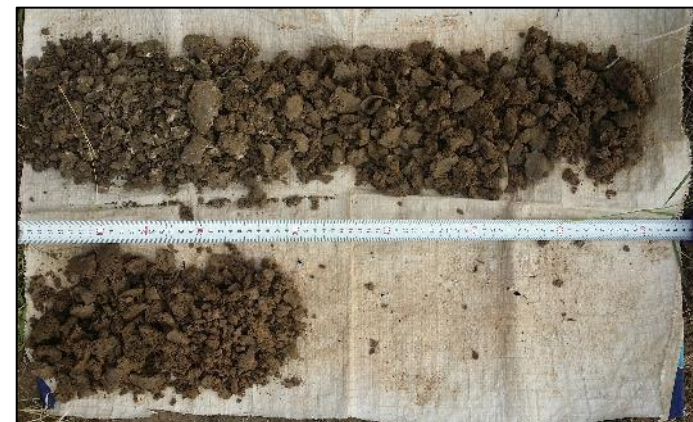
| Land use<br>Landform<br>Pattern,<br>Element,<br>Slope | Natural<br>Vegetation | Microrelief<br>Disturbance<br>Erosion | Surface<br>condition,<br>surface rock | Soil Profile Description | | | | | | | | | |
|---|---|---|---|---|---|---|---|---|---|---|---|---|---|
| Grazing,<br>gently<br>undulating<br>plains, flat<br>plain 0.5% | Open area,<br>various<br>occasional<br>regrowth,<br>some Brigalow<br>nearby | Very minor<br>normal gilgai | Hard setting,<br>cracking 1-<br>3mm, <1%<br>coarse<br>fragments 1-<br>3mm | A1<br>0.00 – 0.10<br>Abrupt | Light clay | Weak<br>subangular<br>peds 3-<br>10mm, firm | Calcium<br>carbonate 2% | 10YR3/3<br>Dark brown | Dry, well<br>drained | Very few, very<br>fine | 0.00 / 8.0 | No samples<br>taken | No additional<br>observations |

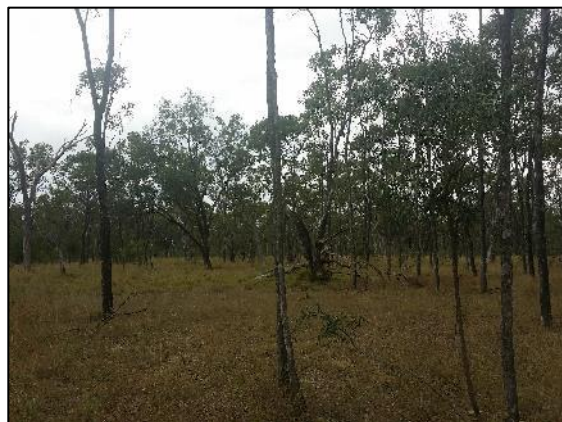
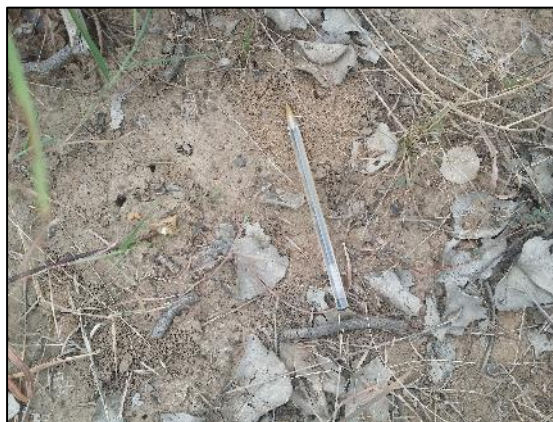
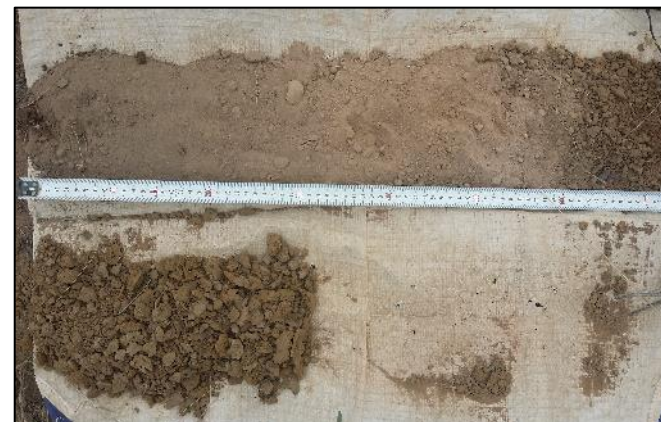
| Land use<br>Landform<br>Pattern,<br>Element,<br>Slope | Natural<br>Vegetation | Microrelief<br>Disturbance<br>Erosion | Surface<br>condition,<br>surface rock | Soil Profile Description | | | | | | | | | |
|---|---|---|---|---|---|---|---|---|---|---|---|---|---|
| Grazing,<br>gently<br>undulating<br>plains, mid<br>slope 1.0% | Poplar box | Nil | Hard setting,<br>cracking 1-<br>3mm, <1%<br>coarse<br>fragments 1-<br>3mm | A11<br>0.00-0.09<br>Abrupt | Loamy<br>Sand | Massive,<br>loose | Nil | 10YR4/2<br>Dark grayish<br>brown | Dry, Rapid | Very few, very<br>fine | 0.10 / 6.0 | No samples<br>taken | Difficulty<br>augering past<br>0.60m |
| | | | | A12<br>0.09-0.58<br>Abrupt | Loamy<br>Sand | Massive,<br>loose | Nil | 10YR4/3<br>Brown | Dry, Rapid | Nil | 0.30 / 6.0 | | |

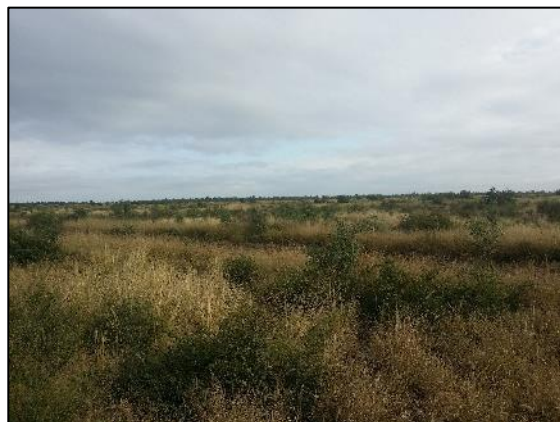
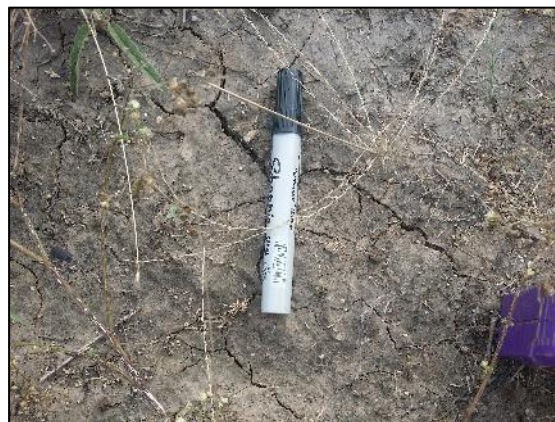
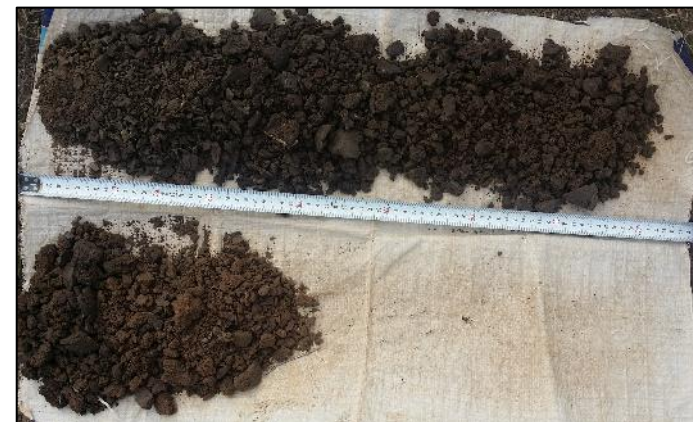
| Land use<br>Landform<br>Pattern,<br>Element,<br>Slope | Natural<br>Vegetation | Microrelief<br>Disturbance<br>Erosion | Surface<br>condition,<br>surface rock | Soil Profile Description | | | | | | | | | |
|---|---|---|---|---|---|---|---|---|---|---|---|---|---|
| Grazing, flat<br>plain 0.5% | Brigalow<br>regrowth | Extensive<br>clearing,<br>very minor<br>shallow gilgai | Cracking,<br>surface crust,<br>no coarse<br>fragments | A1<br>0.00-0.09<br>Abrupt | Light clay | Weak, firm,<br><10mm<br>sub-angular | <1% coarse<br>fragments | 10YR3/2<br>Very dark grey<br>brown | Dry, well<br>drained | Few, very fine | Nil | No samples<br>taken | Depression |

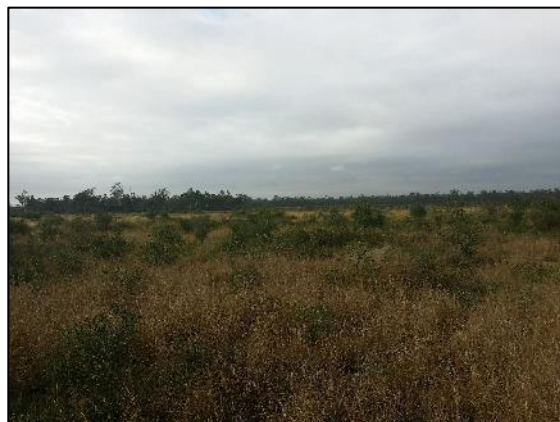
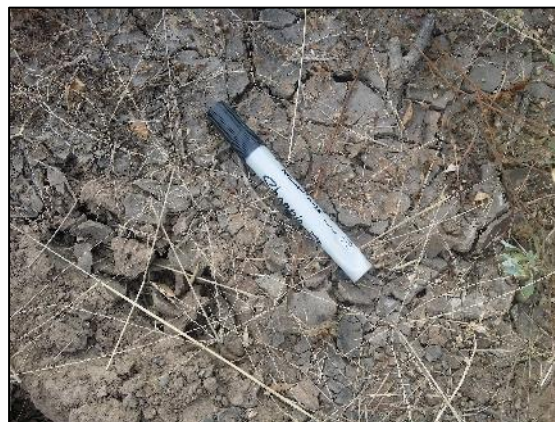
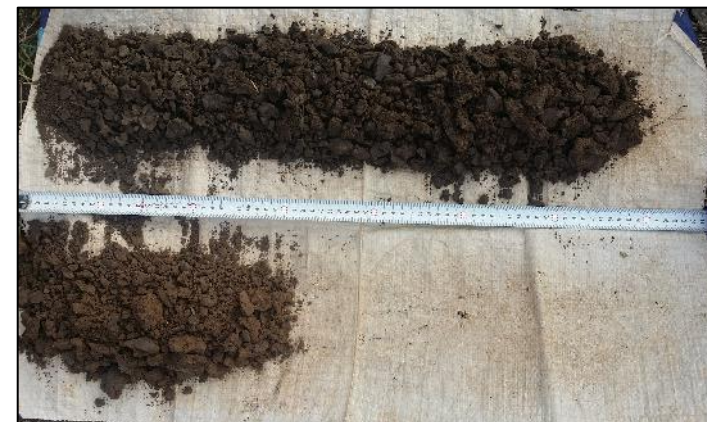
| Land use<br>Landform<br>Pattern,<br>Element,<br>Slope | Natural<br>Vegetation | Microrelief<br>Disturbance<br>Erosion | Surface<br>condition,<br>surface rock | Soil Profile Description | | | | | | | | | |
|---|---|---|---|---|---|---|---|---|---|---|---|---|---|
| Grazing, flat<br>plain 0.5% | Brigalow<br>regrowth | Extensive<br>clearing,<br>very minor<br>shallow gilgai | Cracking,<br>surface crust,<br>no coarse<br>fragments | A1<br>0.00-0.10<br>Abrupt | Light clay | Weak, firm,<br><10mm<br>sub-angular | <1% coarse<br>fragments | 10YR3/2<br>Very dark grey<br>brown | Dry, well<br>drained | Few, very fine | Nil | No samples<br>taken | Mound |
