**PEMBROKE**

**Olive Downs Coking Coal Project**  
Draft Environmental Impact Statement

**Appendix M**  
**Soil and Land**  
**Suitability**  
**Assessment**

Olive Downs Coking Coal Project

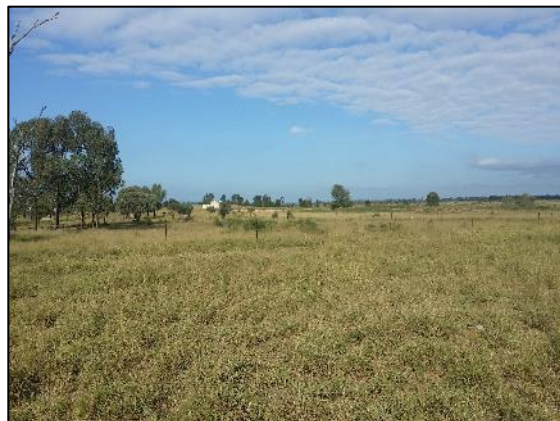
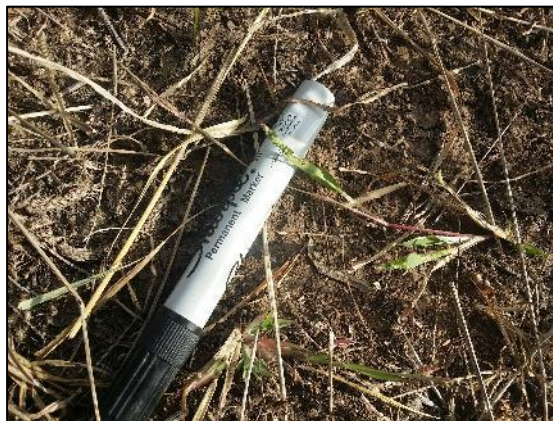
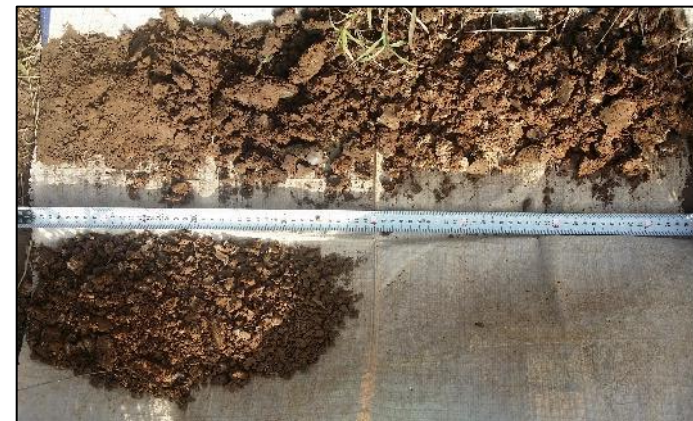
| Land use<br>Landform<br>Pattern,<br>Element,<br>Slope | Natural<br>Vegetation | Microrelief<br>Disturbance<br>Erosion | Surface<br>condition,<br>surface rock | Soil Profile Description | | | | | | | | | |
|---|---|---|---|---|---|---|---|---|---|---|---|---|---|
| Grazing,<br>gently<br>undulating<br>plains, lower<br>slope 2% | Eucalypts | Limited<br>clearing,<br>Nil<br>microrelief<br>Nil Erosion | Firm, no<br>coarse<br>fragments,<br>minor<br>cracking | A1<br>0.00-0.12<br>Abrupt | Loamy<br>Sand | Massive,<br>very weak | Nil | 10YR2/2<br>Very dark brown | Dry, Rapid | Very few, very<br>fine | 0.10 / 6.0 | No samples<br>taken | No additional<br>observations |

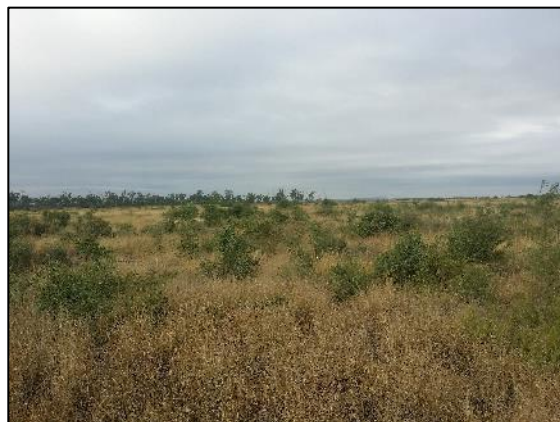
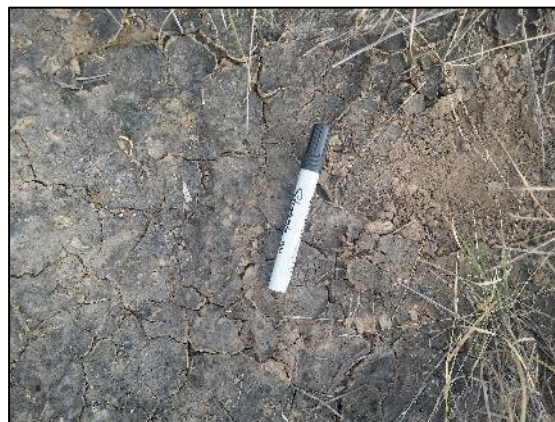
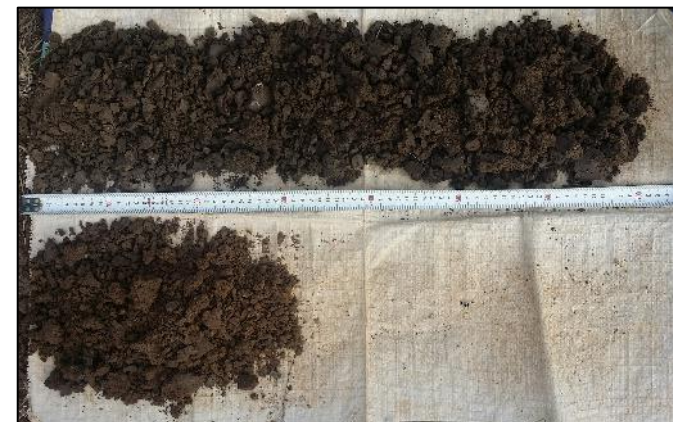
| Land use<br>Landform<br>Pattern,<br>Element,<br>Slope | Natural<br>Vegetation | Microrelief<br>Disturbance<br>Erosion | Surface<br>condition,<br>surface rock | Soil Profile Description | | | | | | | | | |
|---|---|---|---|---|---|---|---|---|---|---|---|---|---|
| Grazing, flat<br>plain 0.5% | Brigalow<br>regrowth | Extensive<br>clearing,<br>very minor<br>shallow gilgai | Cracking,<br>surface crust,<br>no coarse<br>fragments | A1<br>0.00-0.10<br>Abrupt | Light clay | Weak, firm,<br><10mm<br>sub-angular | <1% coarse<br>fragments | 10YR3/2<br>Very dark grey<br>brown | Dry, well<br>drained | Few, very fine | Nil | No samples<br>taken | Depression |

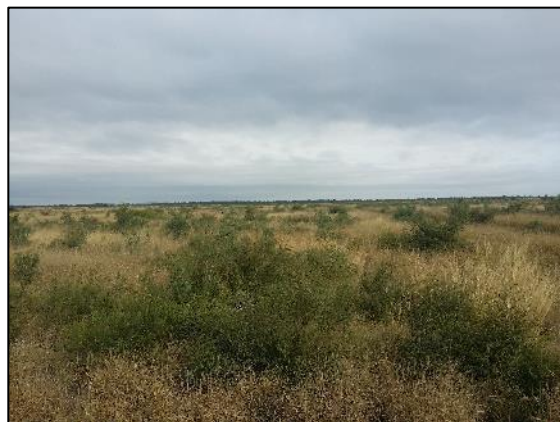
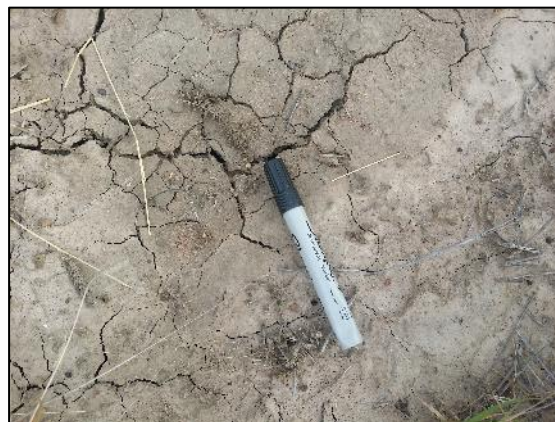
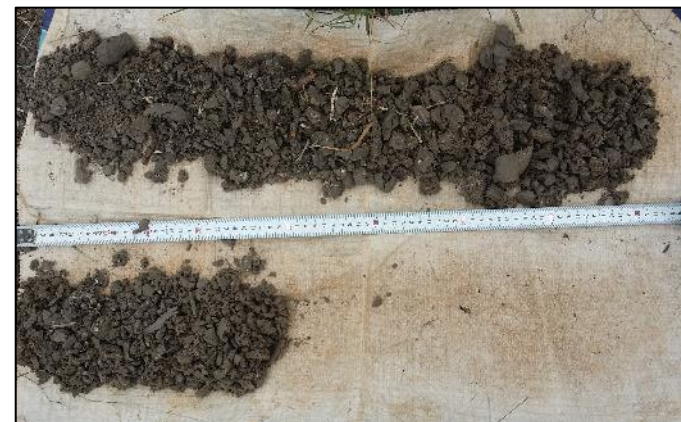
| Land use<br>Landform<br>Pattern,<br>Element,<br>Slope | Natural<br>Vegetation | Microrelief<br>Disturbance<br>Erosion | Surface<br>condition,<br>surface rock | Soil Profile Description | | | | | | | | | |
|---|---|---|---|---|---|---|---|---|---|---|---|---|---|
| Grazing, flat<br>plain 0.5% | Brigalow<br>regrowth | Extensive<br>clearing,<br>very minor<br>shallow gilgai | Cracking,<br>surface crust,<br>no coarse<br>fragments | A1<br>0.00-0.12<br>Abrupt | Light clay | Weak, firm,<br><10mm<br>sub-angular | <1% coarse<br>fragments | 10YR3/2<br>Very dark grey<br>brown | Dry, well<br>drained | Few, very fine | Nil | No samples<br>taken | Depression |

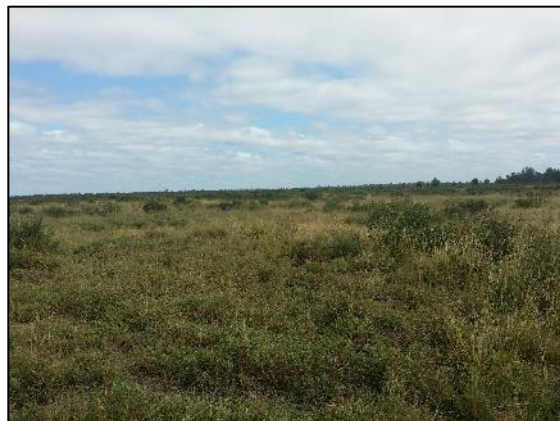
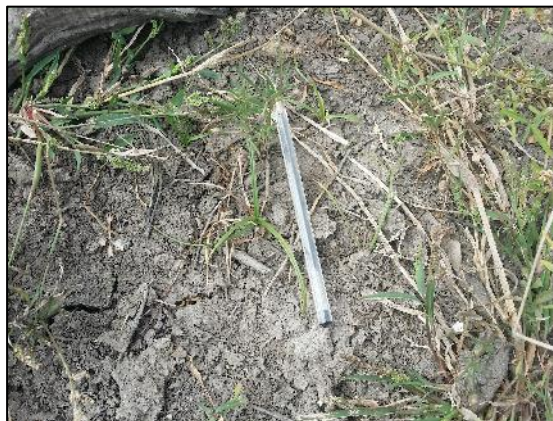
| Land use<br>Landform<br>Pattern,<br>Element,<br>Slope | Natural<br>Vegetation | Microrelief<br>Disturbance<br>Erosion | Surface<br>condition,<br>surface rock | Soil Profile Description | | | | | | | | | |
|---|---|---|---|---|---|---|---|---|---|---|---|---|---|
| Grazing,<br>gently<br>undulating<br>plains, upper<br>slope, 1.0% | Regrowth,<br>shrubs | Shallow<br>gilgai,<br>Extensive<br>clearing | Cracking,<br>No coarse<br>fragments | A1<br>0.00-0.10<br>Abrupt | Light clay | Weak, firm,<br><10mm<br>sub-angular | Nil | 10YR3/2<br>Very dark grey<br>brown | Dry, well<br>drained | Few, very fine | 0.10 / 6.5 | No samples<br>taken | No additional<br>observations |

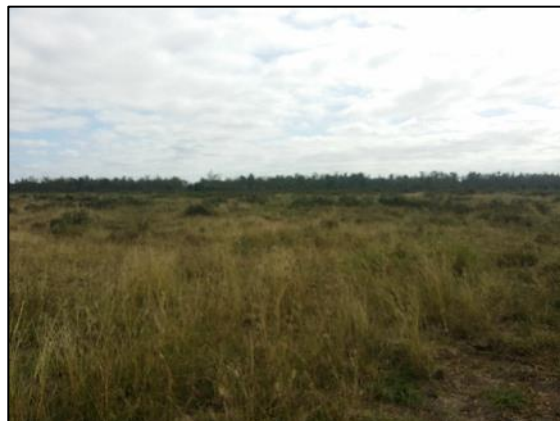
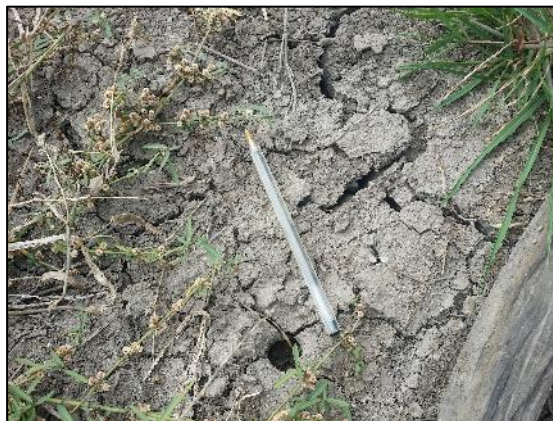
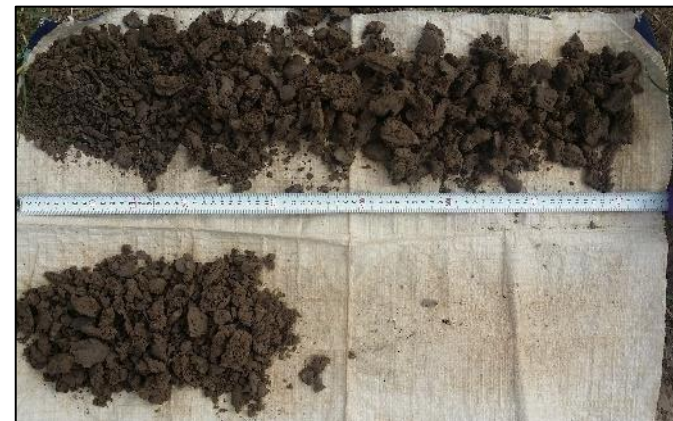
Soil Profile

| <b>Soil Mapping Unit:</b><br>C2 | <b>CSIRO Land Systems (Gunn et al 1967):</b><br>Somerby, Monteagle, Connors,<br>Humboldt, Blackwater, Junee | <b>Location (GDA ZONE 55):</b><br>635087 mE 7535166 mN | <b>Aust. Soil Class. :</b><br>Brown Vertosol | <b>Site Survey Type:</b><br>Detailed - 50mm hand auger | <b>Survey Date:</b><br>11/7/2017 |

| Land use<br>Landform<br>Pattern,<br>Element,<br>Slope | Natural<br>Vegetation | Microrelief<br>Disturbance<br>Erosion | Surface<br>condition,<br>surface rock | Soil Profile Description | | | | | | | | | |
|---|---|---|---|---|---|---|---|---|---|---|---|---|---|
| Grazing,<br>gently<br>undulating<br>plains, upper<br>slope, 1.0% | Regrowth,<br>shrubs | Shallow<br>gilgai,<br>Extensive<br>clearing | Cracking,<br>No coarse<br>fragments | A1<br>0.00-0.10<br>Abrupt | Light clay | Weak, firm,<br><10mm<br>sub-angular | Nil | 10YR3/2<br>Very dark grey<br>brown | Dry, well<br>drained | Few, very fine | 0.10 / 6.5 | No samples<br>taken | No additional<br>observations |

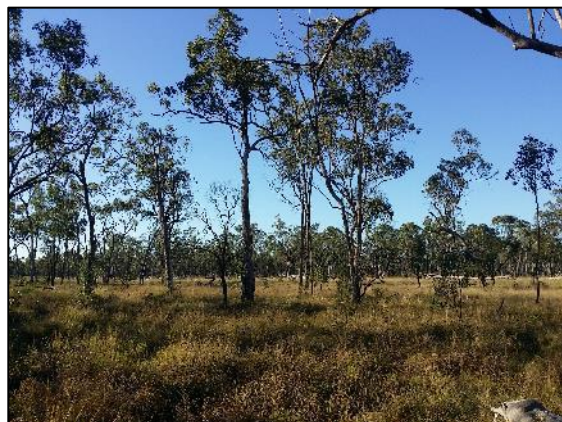
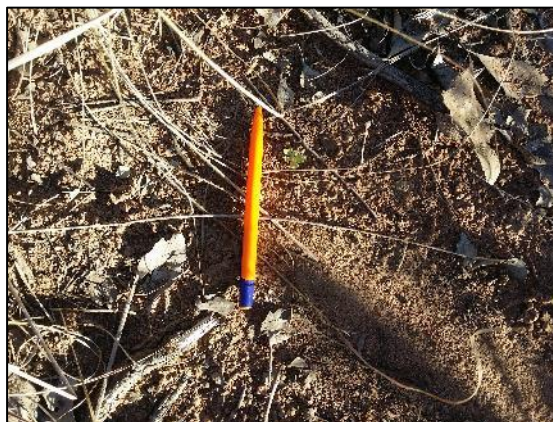
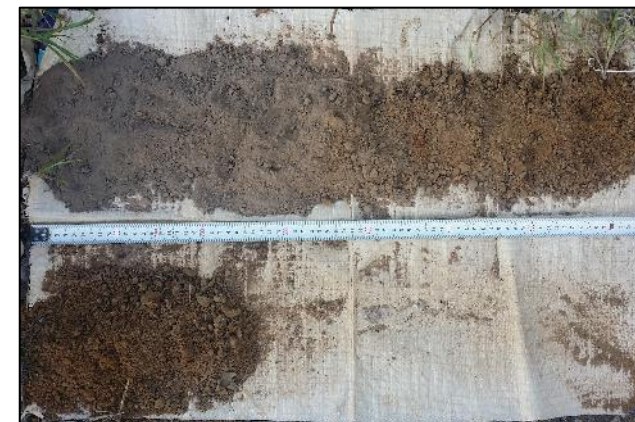
Soil Profile

| <b>Soil Mapping Unit:</b><br>S2 | <b>CSIRO Land Systems (Gunn et al 1967):</b><br>Somerby, Monteagle, Connors,<br>Humboldt, Blackwater | <b>Location (GDA ZONE 55):</b><br>635264 mE 7536132 mN | <b>Aust. Soil Class. :</b><br>Haplic Brown Dermosol | <b>Site Survey Type:</b><br>Detailed - 50mm hand auger | <b>Survey Date:</b><br>11/7/2017 |

| Land use<br>Landform<br>Pattern,<br>Element,<br>Slope | Natural<br>Vegetation | Microrelief<br>Disturbance<br>Erosion | Surface<br>condition,<br>surface rock | Soil Profile Description | | | | | | | | | |
|---|---|---|---|---|---|---|---|---|---|---|---|---|---|
| Grazing,<br>Very gently<br>undulating<br>plains, upper<br>slope, 0.5% | Poplar box | Nil | Firm,<br>No coarse<br>fragments | A1<br>0.00-0.32<br>Abrupt | Clayey<br>sand | Weak,<br>weak/loose | Nil | 10YR3/2<br>Very dark greyish<br>brown | Dry, rapid | Very few, very<br>fine | 0.10 / 7.5<br>0.30 / 7.5 | No samples<br>taken | Refusal at<br>0.95m |

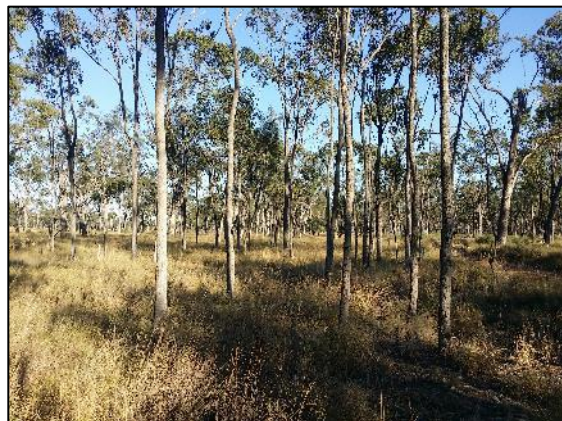
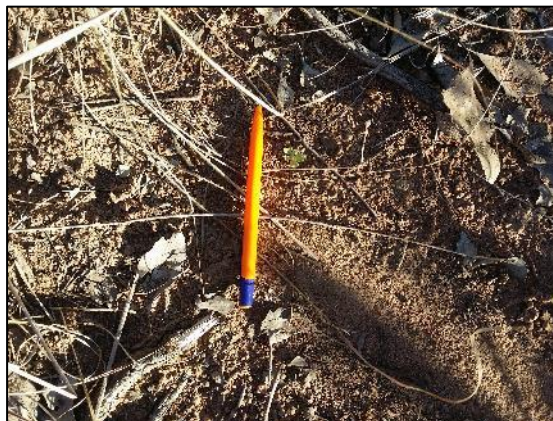
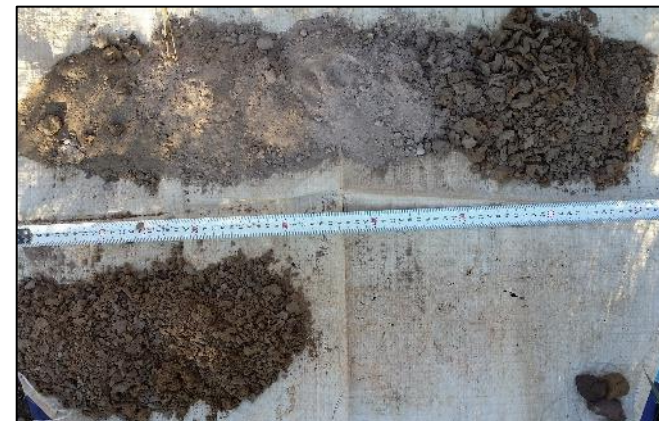
Soil Profile

| <b>Soil Mapping Unit:</b><br>L2 | <b>CSIRO Land Systems (Gunn et al 1967):</b><br>Monteagle, Connors, Humboldt,<br>Blackwater | <b>Location (GDA ZONE 55):</b><br>634095 mE 7537118 mN | <b>Aust. Soil Class. :</b><br>Mesonatric Brown Sodosol | <b>Site Survey Type:</b><br>Detailed - 50mm hand auger | <b>Survey Date:</b><br>12/7/2017 |

| Land use<br>Landform<br>Pattern,<br>Element,<br>Slope | Natural<br>Vegetation | Microrelief<br>Disturbance<br>Erosion | Surface<br>condition,<br>surface rock | Soil Profile Description | | | | | | | | | |
|---|---|---|---|---|---|---|---|---|---|---|---|---|---|
| Grazing,<br>Very gently<br>undulating<br>plains, upper<br>slope, 0.5% | Poplar box | Nil | Firm,<br>No coarse<br>fragments | A11<br>0.00-0.14<br>Abrupt | Loamy<br>sand | Massive,<br>loose | Nil | 10YR3/3<br>Dark brown | Dry, rapid | Very few, very<br>fine | 0.10 / 7.0 | 0.0-0.1<br>0.3-0.4<br>0.6-0.7<br>0.9-1.0 | No additional<br>observations |

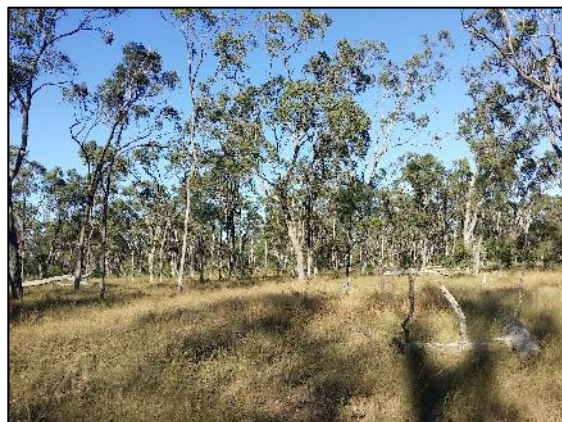
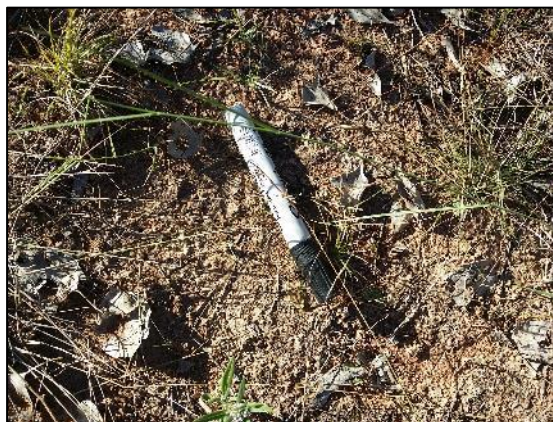
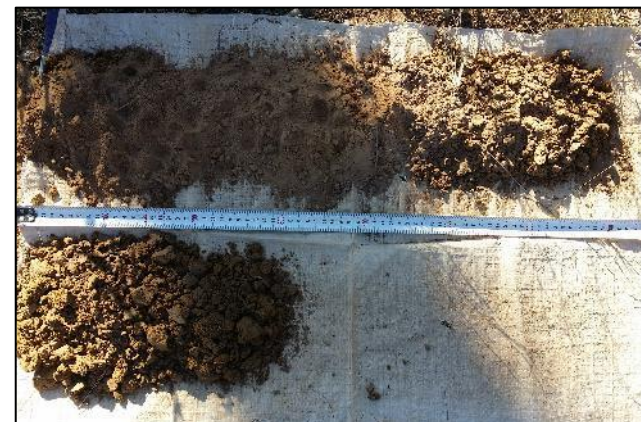
Soil Profile

| <b>Soil Mapping Unit:</b><br>S1 | <b>CSIRO Land Systems (Gunn et al 1967):</b><br>Somerby, Monteagle, Connors,<br>Humboldt, Blackwater | <b>Location (GDA ZONE 55):</b><br>635679 mE 7536839 mN | <b>Aust. Soil Class. :</b><br>Brown Sodosol | <b>Site Survey Type:</b><br>Detailed - 50mm hand auger | <b>Survey Date:</b><br>12/7/2017 |

| Land use<br>Landform<br>Pattern,<br>Element,<br>Slope | Natural<br>Vegetation | Microrelief<br>Disturbance<br>Erosion | Surface<br>condition,<br>surface rock | Soil Profile Description | | | | | | | | | |
|---|---|---|---|---|---|---|---|---|---|---|---|---|---|
| Grazing,<br>Very gently<br>undulating<br>plains, upper<br>slope, 0.5% | Poplar box | Nil | Firm,<br>No coarse<br>fragments | A1<br>0.00-0.44<br>Abrupt | Loamy<br>sand | Massive,<br>loose | <10%<br>2-6mm coarse<br>fragments | 10YR4/3<br>Brown | Dry, rapid | Very few, very<br>fine | 0.10 / 7.0 | No samples<br>taken | No additional<br>observations |

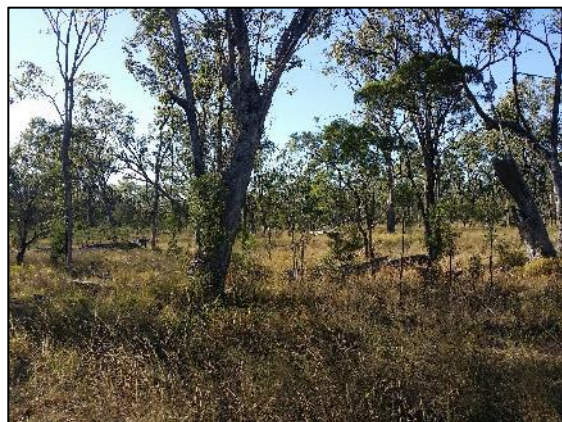
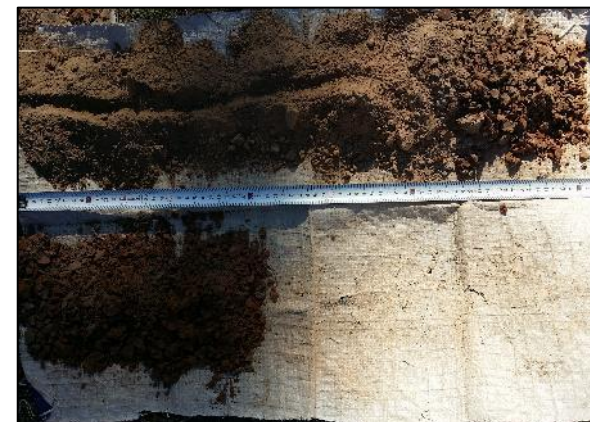
Soil Profile

| <b>Soil Mapping Unit:</b><br>L2 | <b>CSIRO Land Systems (Gunn et al 1967):</b><br>Monteagle, Connors, Humboldt,<br>Blackwater | <b>Location (GDA ZONE 55):</b><br>636775 mE 7538190 mN | <b>Aust. Soil Class. :</b><br>Mesonatric Brown Sodosol | <b>Site Survey Type:</b><br>Detailed - 50mm hand auger | <b>Survey Date:</b><br>/7/2017 |

| Land use<br>Landform<br>Pattern,<br>Element,<br>Slope | Natural<br>Vegetation | Microrelief<br>Disturbance<br>Erosion | Surface<br>condition,<br>surface rock | Soil Profile Description | | | | | | | | | |
|---|---|---|---|---|---|---|---|---|---|---|---|---|---|
| Grazing,<br>Very gently<br>undulating<br>plains, upper<br>slope, 0.5% | Poplar box | Nil | Firm,<br>No coarse<br>fragments | A1<br>0.00-0.52<br>Abrupt | Loamy<br>sand | Massive,<br>loose | <10%<br>2-6mm coarse<br>fragments | 10YR3/3<br>Dark brown | Dry, rapid | Very few, very<br>fine | 0.10 / 7.0 | No samples<br>taken | No additional<br>observations |

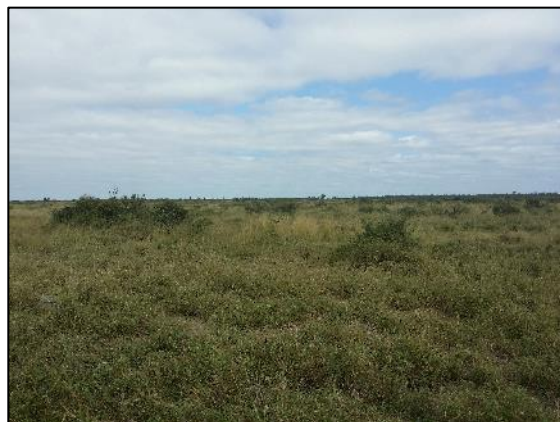
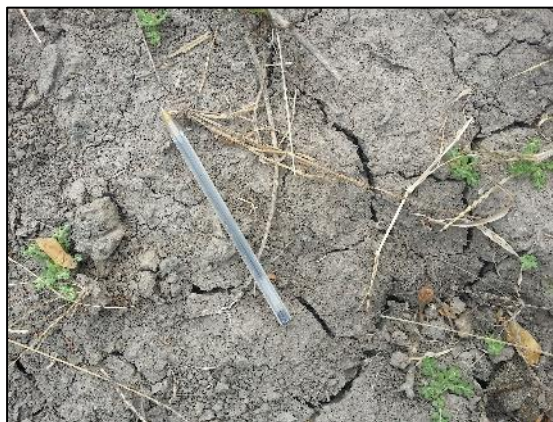
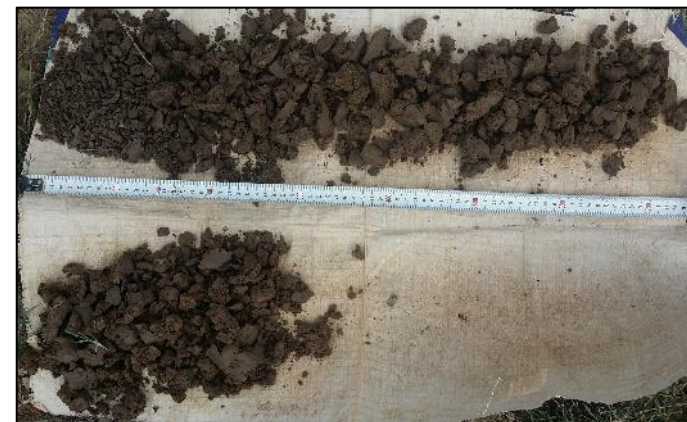
Soil Profile

| <b>Soil Mapping Unit:</b><br>C2 | <b>CSIRO Land Systems (Gunn et al 1967):</b><br>Somerby, Monteagle, Connors,<br>Humboldt, Blackwater, Junee | <b>Location (GDA ZONE 55):</b><br>636346 mE 7538814 mN | <b>Aust. Soil Class. :</b><br>Brown Vertosol | <b>Site Survey Type:</b><br>Detailed - 50mm hand auger | <b>Survey Date:</b><br>12/7/2017 |

| Land use<br>Landform<br>Pattern,<br>Element,<br>Slope | Natural<br>Vegetation | Microrelief<br>Disturbance<br>Erosion | Surface<br>condition,<br>surface rock | Soil Profile Description | | | | | | | | | |
|---|---|---|---|---|---|---|---|---|---|---|---|---|---|
| Grazing,<br>gently<br>undulating<br>plains, upper<br>slope, 1.0% | Regrowth,<br>shrubs | Shallow<br>gilgai,<br>Extensive<br>clearing | Cracking,<br>No coarse<br>fragments | A1<br>0.00-0.10<br>Abrupt | Light clay | Weak, firm,<br><10mm<br>sub-angular | Nil | 10YR3/2<br>Very dark grey<br>brown | Dry, well<br>drained | Few, very fine | 0.10 / 6.5 | No samples<br>taken | No additional<br>observations |

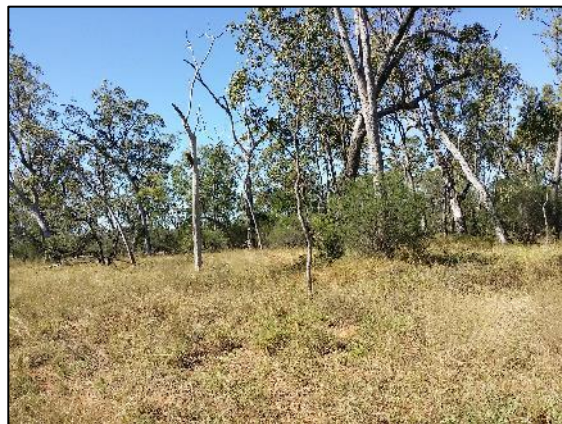
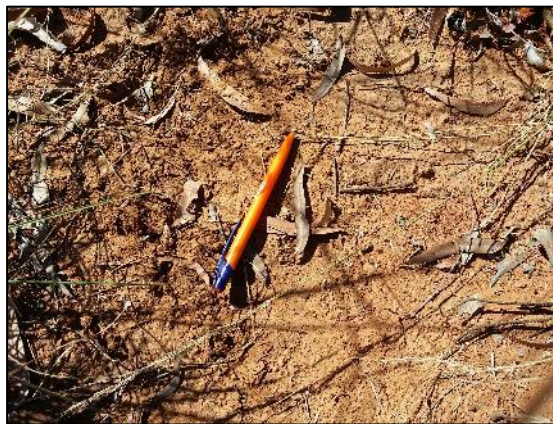
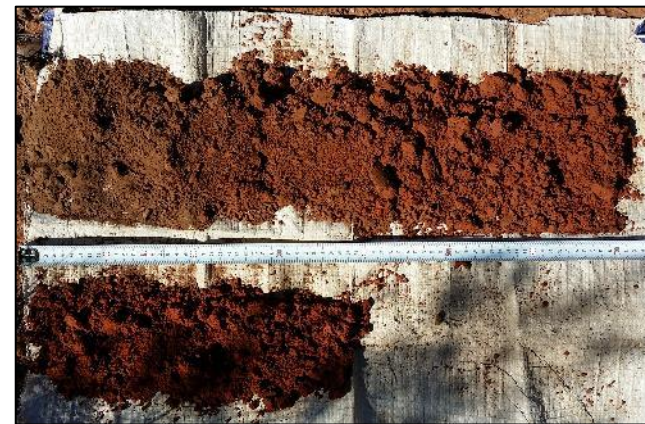
Soil Profile

| <b>Soil Mapping Unit:</b><br>R1 | <b>CSIRO Land Systems (Gunn et al 1967):</b><br>Somerby, Monteagle, Connors,<br>Humboldt, Blackwater, Juneee | <b>Location (GDA ZONE 55):</b><br>639736 mE 7537440 mN | <b>Aust. Soil Class. :</b><br>Red Rudosol | <b>Site Survey Type:</b><br>Detailed - 50mm hand auger | <b>Survey Date:</b><br>12/7/2017 |

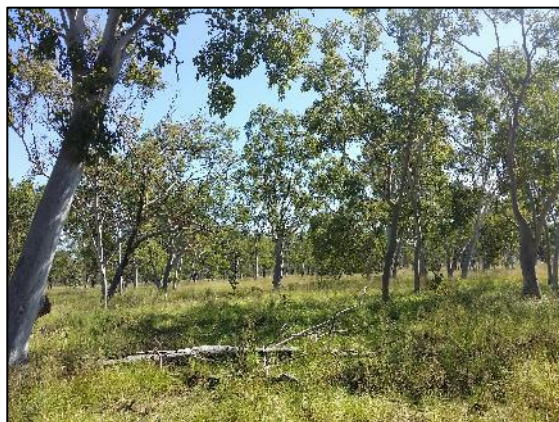
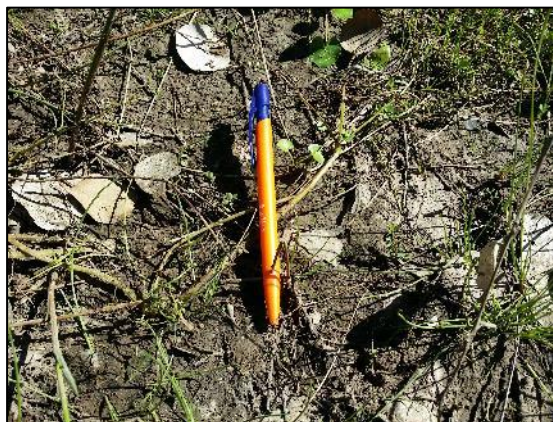
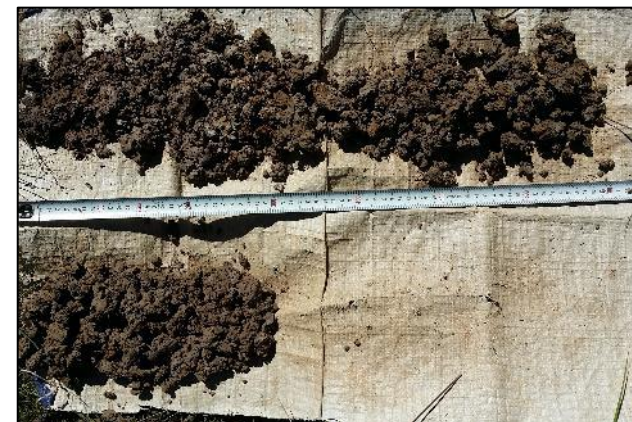
Soil Profile

| <b>Soil Mapping Unit:</b><br>A2 | <b>CSIRO Land Systems (Gunn et al 1967):</b><br>Somerby, Monteagle, Connors,<br>Humboldt, Blackwater | <b>Location (GDA ZONE 55):</b><br>644069 mE 7534469 mN | <b>Aust. Soil Class. :</b><br>Subnatric Grey Sodosol | <b>Site Survey Type:</b><br>Detailed - 50mm hand auger | <b>Survey Date:</b><br>12/7/2017 |

| Land use<br>Landform<br>Pattern,<br>Element,<br>Slope | Natural<br>Vegetation | Microrelief<br>Disturbance<br>Erosion | Surface<br>condition,<br>surface rock | Soil Profile Description | | | | | | | | | |
|---|---|---|---|---|---|---|---|---|---|---|---|---|---|
| Grazing,<br>Large open<br>depression | Eucalypts | Nil | Soft, moist, no<br>coarse<br>fragments | A1<br>0.00-0.04<br>Abrupt | Clayey<br>sand | Weak, weak | Nil | 10YR4/1<br>Dark grey | Moist, rapid | Very few, very<br>fine | 0.02 / 6.5 | 0.0-0.04<br>0.15-0.25<br>0.40-0.50<br>0.90-1.00 | No additional<br>observations |
| | | | | A2<br>0.04-0.25<br>Abrupt | Loamy<br>Sand | Weak, weak | <10%<br>2-4mmcoarse<br>fragments | 10YR4/4<br>Dark yellowish<br>brown | Moist, rapid | Very few, very<br>fine | | | |
| | | | | B2<br>0.25-1.00 | Light<br>medium<br>clay | Moderate,<br>weak<br>30-60mm<br>sub angular | <10%<br>2-4mmcoarse<br>fragments | 10YR4/3<br>Brown<br>Mottle<br>10YR5/6<br>Yellowish brown | Moist,<br>imperfect | Nil | 0.30 / 6.5<br>0.60 / 6.5<br>0.90 / 6.5 | | |

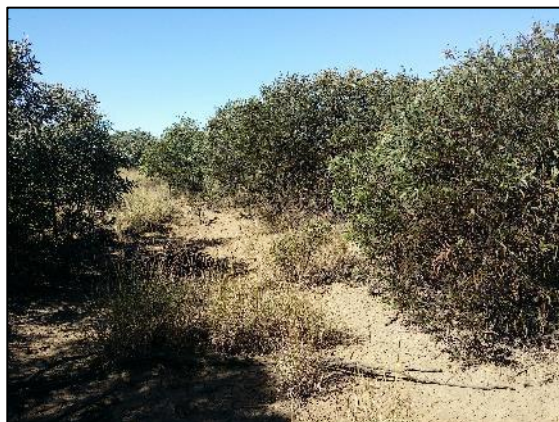
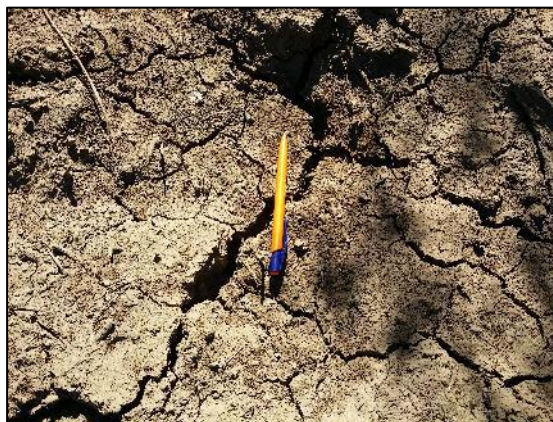
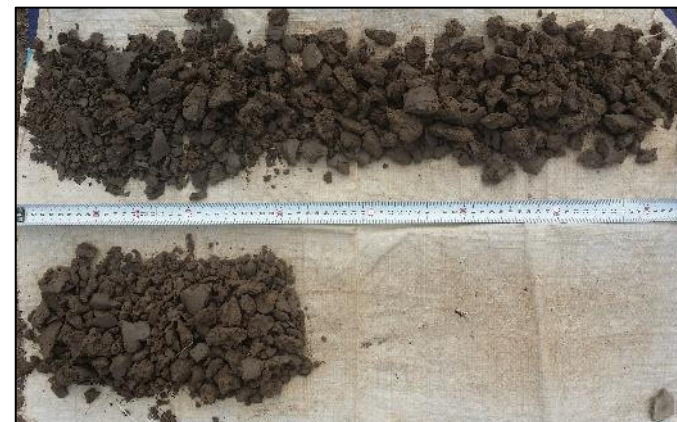
Soil Profile

| <b>Soil Mapping Unit:</b><br>C2 | <b>CSIRO Land Systems (Gunn et al 1967):</b><br>Somerby, Monteagle, Connors,<br>Humboldt, Blackwater, Junee | <b>Location (GDA ZONE 55):</b><br>643376 mE 7533082 mN | <b>Aust. Soil Class. :</b><br>Brown Vertosol | <b>Site Survey Type:</b><br>Detailed - 50mm hand auger | <b>Survey Date:</b><br>/7/2017 |

| Land use<br>Landform<br>Pattern,<br>Element,<br>Slope | Natural<br>Vegetation | Microrelief<br>Disturbance<br>Erosion | Surface<br>condition,<br>surface rock | Soil Profile Description | | | | | | | | | |
|---|---|---|---|---|---|---|---|---|---|---|---|---|---|
| Grazing,<br>gently<br>undulating<br>plains, upper<br>slope, 0.5% | Regrowth,<br>Brigalow | Normal gilgai<br>0.10-0.30<br>depth, 50%<br>coverage | Cracking,<br>No coarse<br>fragments | A1<br>0.00-0.10<br>Abrupt | Light clay | Weak, firm,<br><10mm<br>sub-angular | Nil | 10YR3/2<br>Very dark grey<br>brown | Dry, well<br>drained | Few, very fine | 0.10 / 6.5 | No samples<br>taken | Mound |

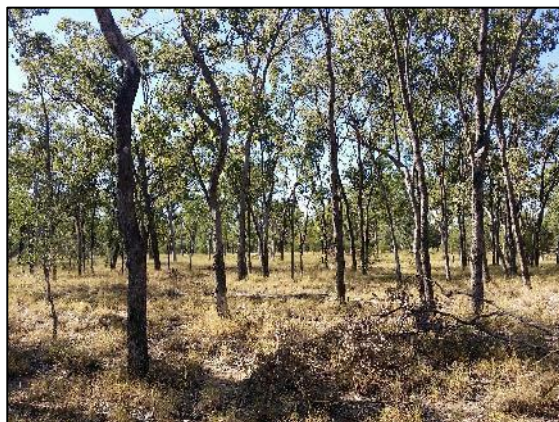
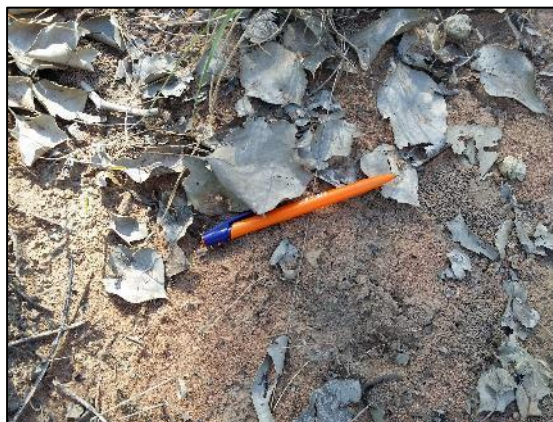
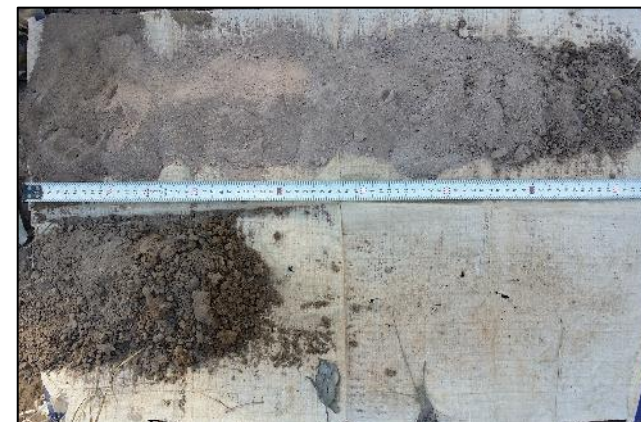
Soil Profile

| <b>Soil Mapping Unit:</b><br>S1 | <b>CSIRO Land Systems (Gunn et al 1967):</b><br>Somerby, Monteagle, Connors,<br>Humboldt, Blackwater | <b>Location (GDA ZONE 55):</b><br>644747 mE 7533749 mN | <b>Aust. Soil Class:</b><br>Brown Sodosol | <b>Site Survey Type:</b><br>Detailed - 50mm hand auger | <b>Survey Date:</b><br>12/7/2017 |

| Land use<br>Landform<br>Pattern,<br>Element,<br>Slope | Natural<br>Vegetation | Microrelief<br>Disturbance<br>Erosion | Surface<br>condition,<br>surface rock | Soil Profile Description | | | | | | | | | |
|---|---|---|---|---|---|---|---|---|---|---|---|---|---|
| Grazing,<br>Gently<br>undulating<br>plains, mid-<br>slope, 3.0% | Poplar box | Nil | Hard setting,<br>no coarse<br>fragments | A1<br>0.00-0.61<br>Abrupt | Clayey<br>Sand | Apedal,<br>loose | Nil | 10YR3/2<br>Very dark grayish<br>brown | Dry, rapid | Very few, very<br>fine | 0.10 / 6.5<br>0.30 / 6.5<br>0.60 / 6.5 | No samples<br>taken | No additional<br>observations |

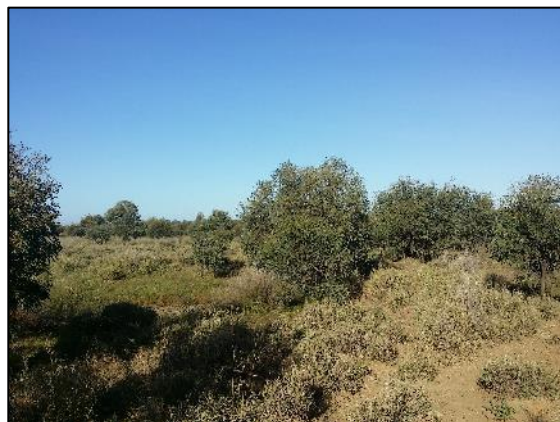
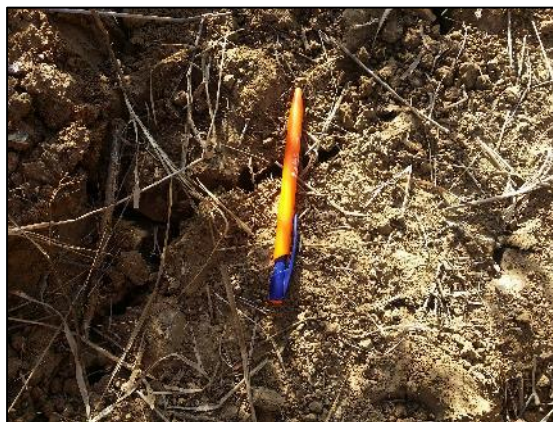
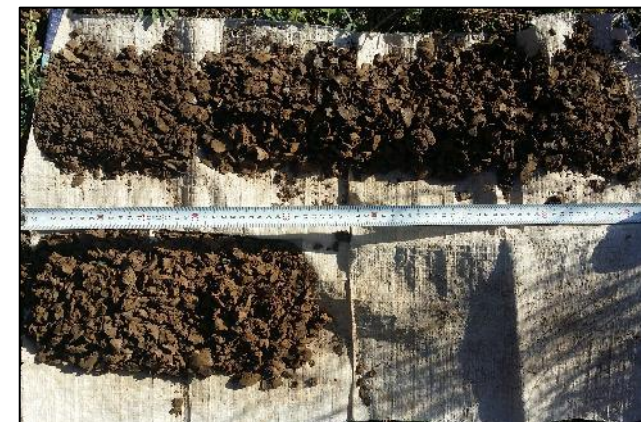
Soil Profile

| <b>Soil Mapping Unit:</b><br>C2 | <b>CSIRO Land Systems (Gunn et al 1967):</b><br>Somerby, Monteagle, Connors,<br>Humboldt, Blackwater, Junee | <b>Location (GDA ZONE 55):</b><br>646568 mE 7534581 mN | <b>Aust. Soil Class. :</b><br>Brown Vertosol | <b>Site Survey Type:</b><br>Detailed - 50mm hand auger | <b>Survey Date:</b><br>13/7/2017 |

| Land use<br>Landform<br>Pattern,<br>Element,<br>Slope | Natural<br>Vegetation | Microrelief<br>Disturbance<br>Erosion | Surface<br>condition,<br>surface rock | Soil Profile Description | | | | | | | | | |
|---|---|---|---|---|---|---|---|---|---|---|---|---|---|
| Grazing, Flat<br>plain, <0.5% | Brigalow<br>regrowth | Normal<br>gilgai, <0.3m<br>40% coverage | Cracking, 5-<br>20mm peds,<br>no coarse<br>fragments | A1<br>0.00-0.18<br>Abrupt | Light clay | Weak, firm,<br>3-15mm<br>sub-angular | Nil | 7.5YR3/2<br>Dark brown | Dry, well<br>drained | Very few,<br>very fine | 0.10 / 7.5 | No samples<br>taken | No additional<br>observations |

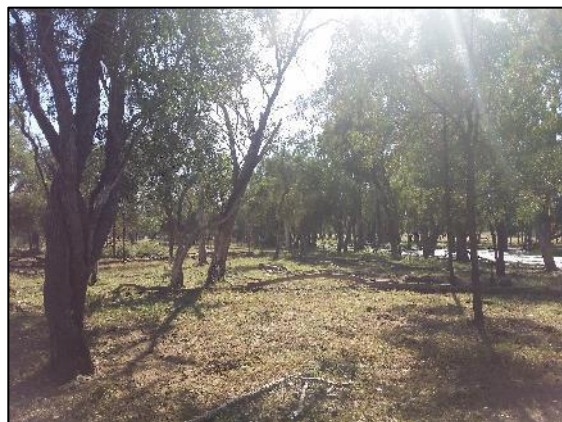
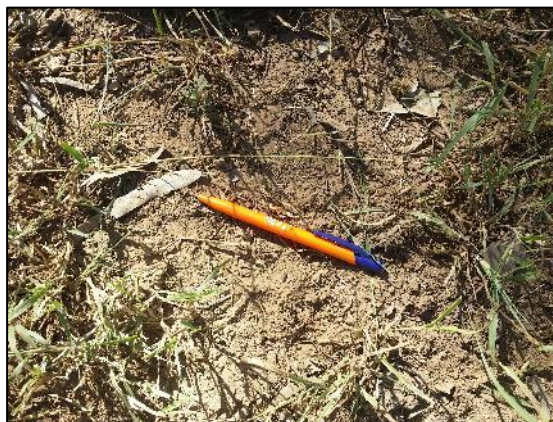
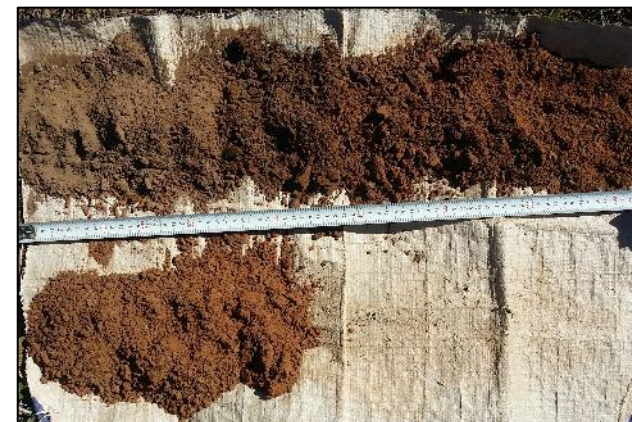
Soil Profile

| <b>Soil Mapping Unit:</b><br>A2 | <b>CSIRO Land Systems (Gunn et al 1967):</b><br>Somerby, Monteagle, Connors,<br>Humboldt, Blackwater | <b>Location (GDA ZONE 55):</b><br>648469 mE 7534176 mN | <b>Aust. Soil Class. :</b><br>Subnatric Grey Sodosol | <b>Site Survey Type:</b><br>Detailed - 50mm hand auger | <b>Survey Date:</b><br>13/7/2017 |

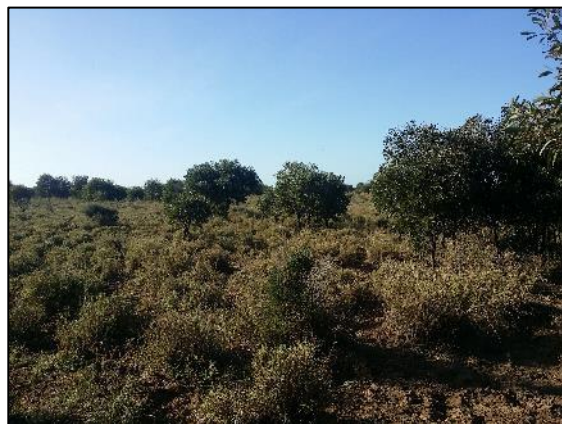
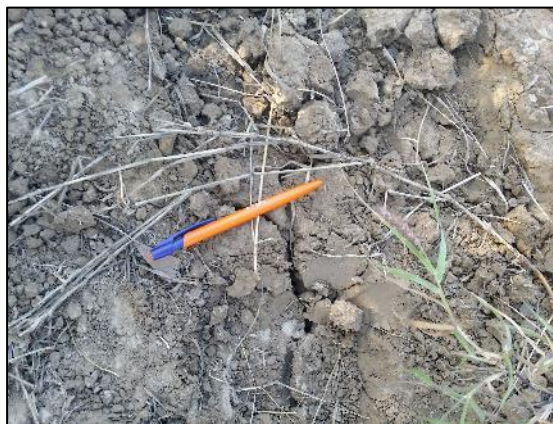
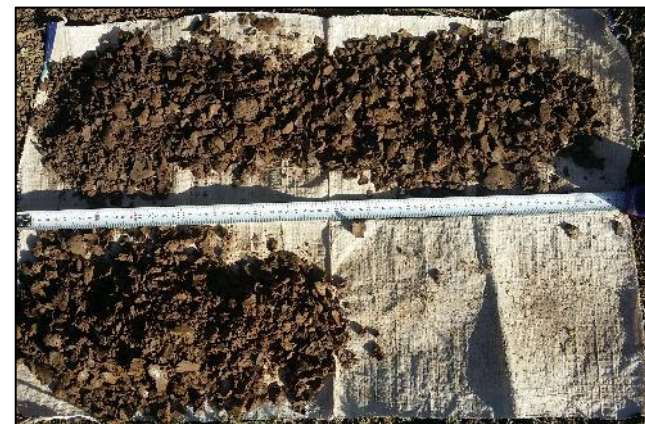
Soil Profile

| <b>Soil Mapping Unit:</b> | <b>CSIRO Land Systems (Gunn et al 1967):</b> | <b>Location (GDA ZONE 55):</b><br>647484 mE 7533515 mN | <b>Aust. Soil Class. :</b> | <b>Site Survey Type:</b><br>Detailed - 50mm hand auger | <b>Survey Date:</b><br>13/7/2017 |

| Land use<br>Landform<br>Pattern,<br>Element,<br>Slope | Natural<br>Vegetation | Microrelief<br>Disturbance<br>Erosion | Surface<br>condition,<br>surface rock | Soil Profile Description | | | | | | | | | |
|---|---|---|---|---|---|---|---|---|---|---|---|---|---|
| Grazing, Flat<br>plain, <0.5% | Brigalow<br>regrowth | Normal<br>gilgai, <0.3m<br>40% coverage | Cracking, 5-<br>20mm peds,<br>no coarse<br>fragments | 0.00-0.19<br>Abrupt | Light clay | Weak, firm,<br>3-15mm<br>sub-angular | Nil | 7.5YR3/2<br>Dark brown | Dry, well<br>drained | Very few,<br>very fine | 0.10 / 7.5 | No samples<br>taken | No additional<br>observations |

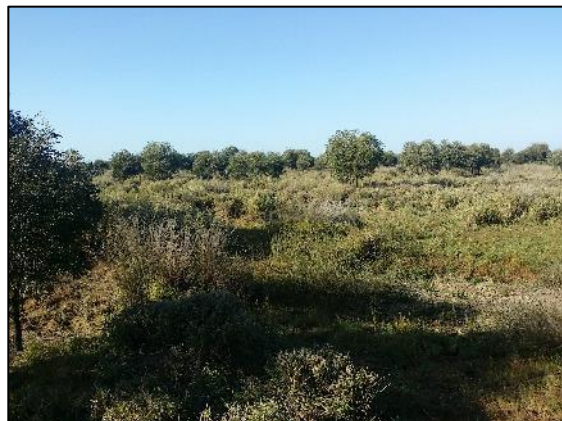
Landscape

| <b>Soil Mapping Unit:</b><br>C2 | <b>CSIRO Land Systems (Gunn et al 1967):</b><br>Somerby, Monteagle, Connors,<br>Humboldt, Blackwater, Junee | <b>Location (GDA ZONE 55):</b><br>648525 mE 7532703 mN | <b>Aust. Soil Class. :</b><br>Brown Vertosol | <b>Site Survey Type:</b><br>Detailed - 50mm hand auger | <b>Survey Date:</b><br>13/7/2017 |

| Land use<br>Landform<br>Pattern,<br>Element,<br>Slope | Natural<br>Vegetation | Microrelief<br>Disturbance<br>Erosion | Surface<br>condition,<br>surface rock | Soil Profile Description | | | | | | | | | |
|---|---|---|---|---|---|---|---|---|---|---|---|---|---|
| Grazing, Flat<br>plain, <0.5% | Brigalow<br>regrowth | Normal<br>gilgai, <0.3m<br>40% coverage | Cracking, 5-<br>20mm peds,<br>no coarse<br>fragments | A1<br>0.00-0.20<br>Abrupt | Light clay | Weak, firm,<br>3-15mm<br>sub-angular | Nil | 7.5YR3/2<br>Dark brown | Dry, well<br>drained | Very few,<br>very fine | 0.10 / 7.5 | No samples<br>taken | No additional<br>observations |

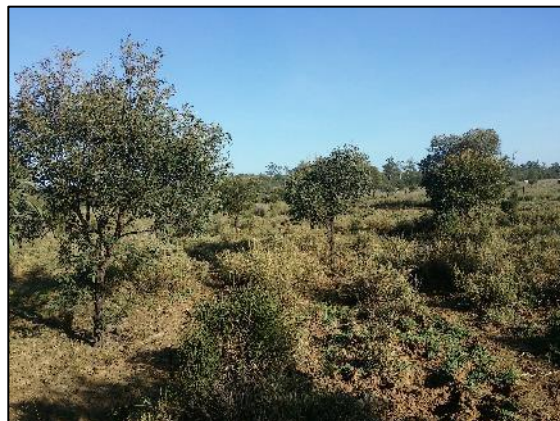
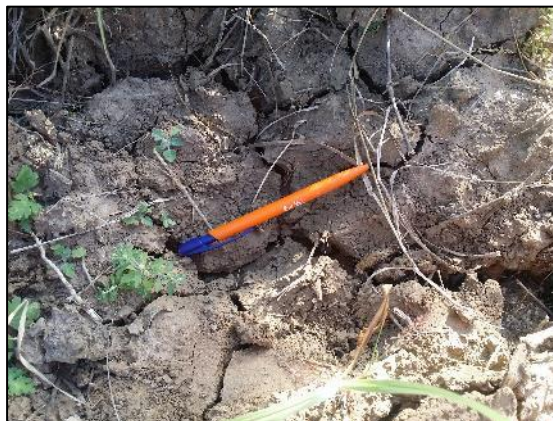
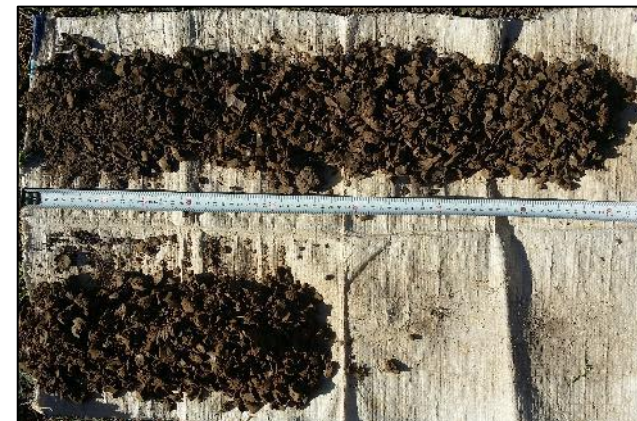
| Land use<br>Landform<br>Pattern,<br>Element,<br>Slope | Natural<br>Vegetation | Microrelief<br>Disturbance<br>Erosion | Surface<br>condition,<br>surface rock | Soil Profile Description | | | | | | | | | |
|---|---|---|---|---|---|---|---|---|---|---|---|---|---|
| Grazing, Flat<br>plain, <0.5% | Brigalow<br>regrowth | Normal<br>gilgai, <0.3m<br>40% coverage | Cracking, 5-<br>20mm peds,<br>no coarse<br>fragments | A1<br>0.00-0.18<br>Abrupt | Light clay | Weak, firm,<br>3-15mm<br>sub-angular | Nil | 7.5YR3/2<br>Dark brown | Dry, well<br>drained | Very few,<br>very fine | 0.10 / 7.5 | No samples<br>taken | No additional<br>observations |

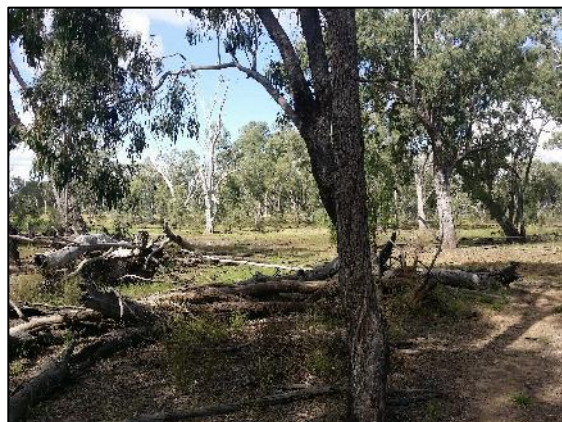
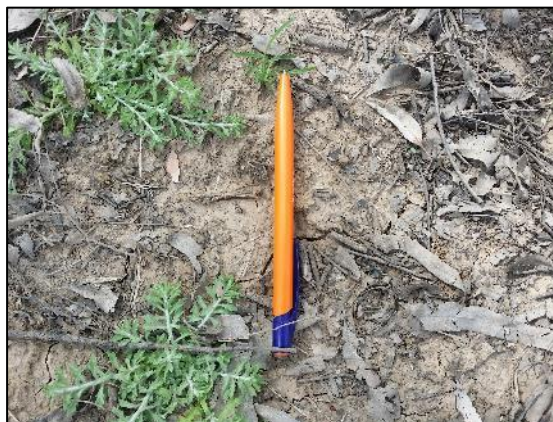
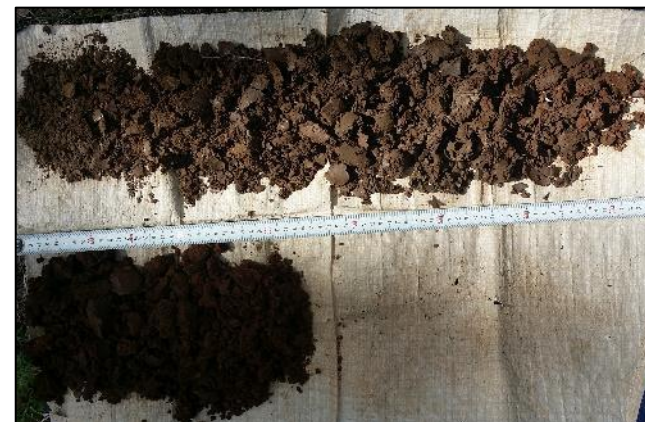
| Land use<br>Landform<br>Pattern,<br>Element,<br>Slope | Natural<br>Vegetation | Microrelief<br>Disturbance<br>Erosion | Surface<br>condition,<br>surface rock | Soil Profile Description | | | | | | | | | |
|---|---|---|---|---|---|---|---|---|---|---|---|---|---|
| Grazing,<br>gently<br>undulating<br>plains, lower<br>slope, wide<br>depression<br>with water | Eucalypts | Gully erosion<br>nearby | Hard setting,<br>minor<br>cracking, no<br>coarse<br>fragments | A1<br>0.00-0.16<br>Abrupt | Clay Loam | Weak, firm,<br>5-10mm<br>sub-angular | Nil | 10YR3/3<br>Dark brown | Dry, well<br>drained | Very few, very<br>fine | 0.10 / 6.0 | 0.0-0.10<br>0.30-0.40<br>0.60-0.70<br>0.90-1.00 | No additional<br>observations |

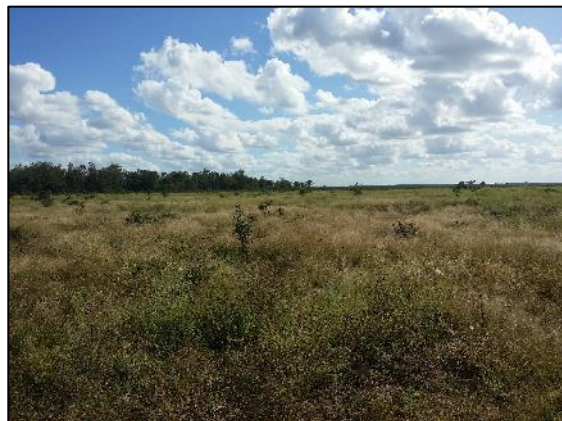
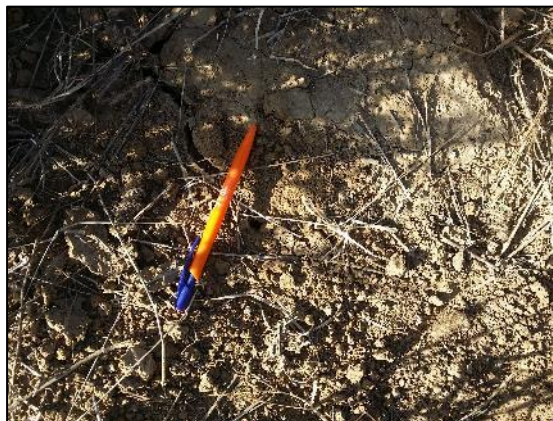
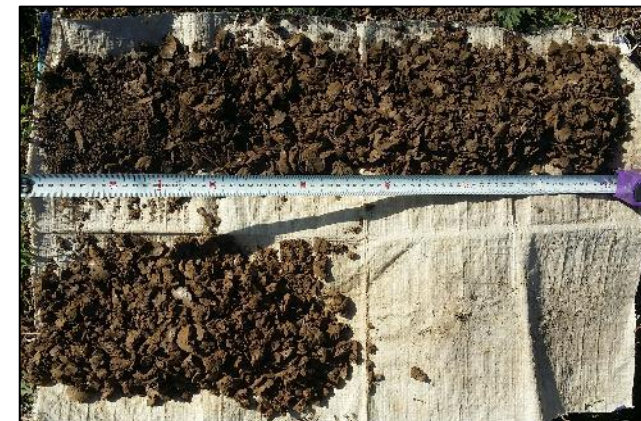
| Land use<br>Landform<br>Pattern,<br>Element,<br>Slope | Natural<br>Vegetation | Microrelief<br>Disturbance<br>Erosion | Surface<br>condition,<br>surface rock | Soil Profile Description | | | | | | | | | |
|---|---|---|---|---|---|---|---|---|---|---|---|---|---|
| Grazing, Flat<br>plain, <0.5% | Brigalow<br>regrowth | Normal<br>gilgai, <0.3m<br>40% coverage | Cracking, 5-<br>20mm peds,<br>no coarse<br>fragments | A1<br>0.00-0.20<br>Abrupt | Light clay | Weak, firm,<br>3-15mm<br>sub-angular | Nil | 7.5YR3/2<br>Dark brown | Dry, well<br>drained | Very few,<br>very fine | 0.10 / 7.5 | No samples<br>taken | No additional<br>observations |

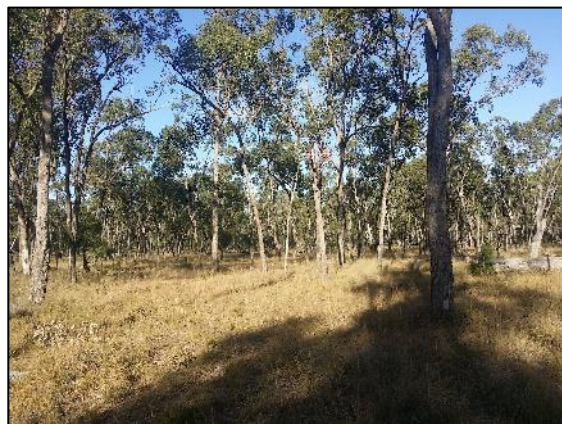
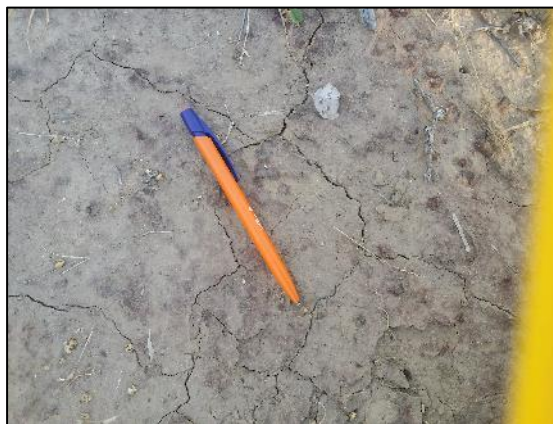
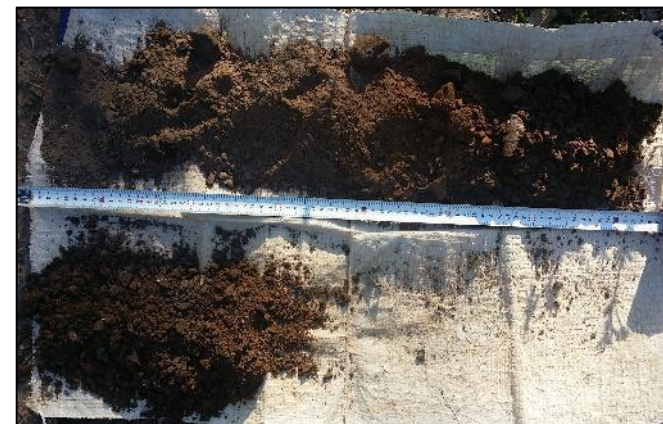
| Land use<br>Landform<br>Pattern,<br>Element,<br>Slope | Natural<br>Vegetation | Microrelief<br>Disturbance<br>Erosion | Surface<br>condition,<br>surface rock | Soil Profile Description | | | | | | | | | |
|---|---|---|---|---|---|---|---|---|---|---|---|---|---|
| Grazing, Flat<br>plain, <0.5% | Poplar box,<br>Minor<br>Brigalow<br>regrowth | Minor to no<br>disturbance | Cracking, 5-<br>20mm peds,<br>no coarse<br>fragments | A11<br>0.00-0.26<br>Abrupt | Silty loam | Massive,<br>loose | Nil | 10YR4/2<br>Dark grayish<br>brown | Dry, well<br>drained | Very few, very<br>fine | 0.05 / 6.0<br>0.20 / 6.0 | 0.00-0.05<br>0.40-0.50<br>0.60-0.70<br>0.90-1.00 | No additional<br>observations |
| | | | | A12<br>0.26-0.56<br>Abrupt | Silty loam | Massive,<br>loose | Nil | 10YR4/4<br>Dark yellowish<br>brown | Dry, well<br>drained | Very few, very<br>fine | 0.40 / 6.0<br>0.60 / 6.5 | | |

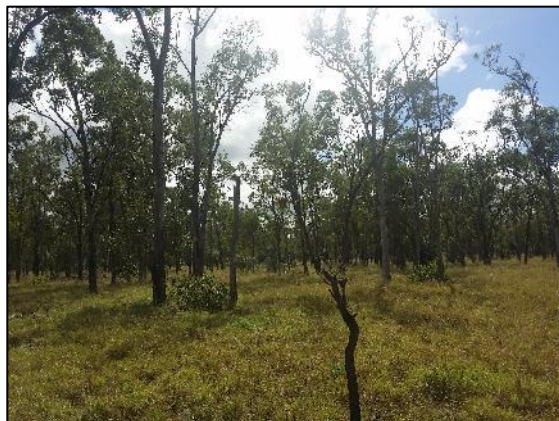
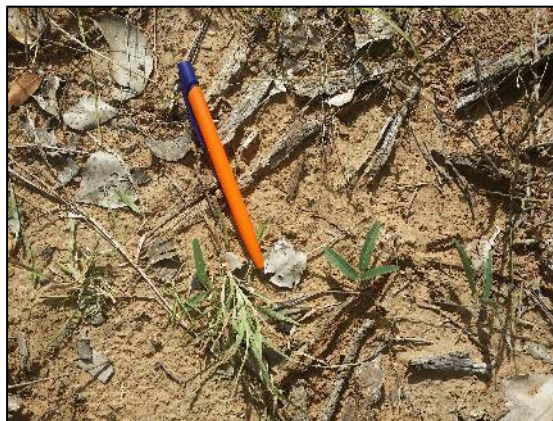
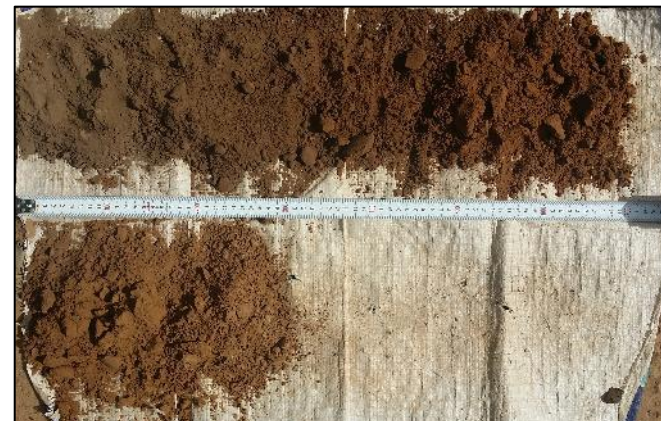
| Land use<br>Landform<br>Pattern,<br>Element,<br>Slope | Natural<br>Vegetation | Microrelief<br>Disturbance<br>Erosion | Surface<br>condition,<br>surface rock | Soil Profile Description | | | | | | | | | |
|---|---|---|---|---|---|---|---|---|---|---|---|---|---|
| Grazing, very<br>gently<br>undulating<br>plains,<br><1.0% | Poplar box | Nil | Hard setting,<br>minor<br>cracking,<br>no coarse<br>fragments | A1<br>0.00-0.33<br>Abrupt | Clayey<br>sand | Massive,<br>loose | Nil | 10YR4/3<br>Brown | Dry, rapid | Very few, very<br>fine | Nil | No samples<br>taken | No additional<br>observations |
| | | | | B21<br>0.33-0.47<br>Abrupt | Loamy<br>sand | Massive,<br>loose | Nil | 10YR4/4<br>Dark yellowish<br>brown | Dry, rapid | Very few, very<br>fine | Nil | | |

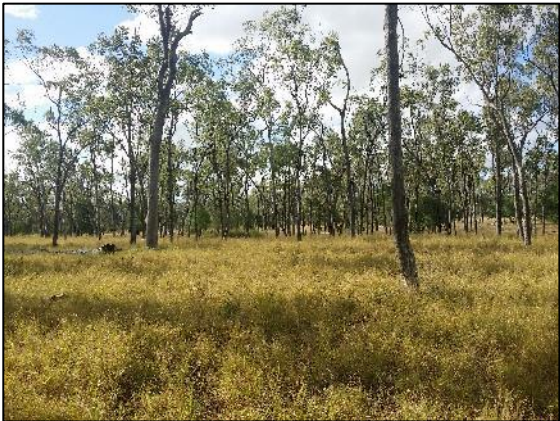
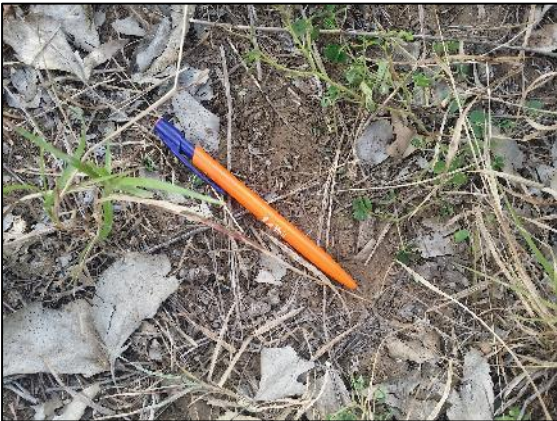
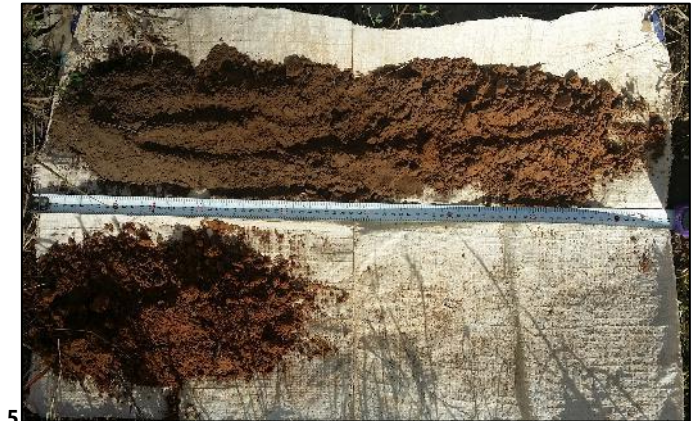
| Land use<br>Landform<br>Pattern,<br>Element,<br>Slope | Natural<br>Vegetation | Microrelief<br>Disturbance<br>Erosion | Surface<br>condition,<br>surface rock | Soil Profile Description | | | | | | | | | |
|---|---|---|---|---|---|---|---|---|---|---|---|---|---|
| Grazing,<br>gently<br>undulating<br>plains, upper<br>slope <2.0% | Poplar box | Nil | Soft,<br>no coarse<br>fragments | A1<br>0.00-0.27<br>Abrupt | Clayey<br>sand | Massive,<br>loose | Nil | 10YR3/2<br>Very dark grayish<br>brown | Dry, rapid | Very few, very<br>fine | Nil | No samples<br>taken | No additional<br>observations |
| | | | | B21<br>0.27-0.52<br>Abrupt | Loamy<br>sand | Massive,<br>loose | Nil | 10YR4/4<br>Dark yellowish<br>brown | Dry, rapid | Very few, very<br>fine | Nil | | |
