**PEMBROKE**

**Olive Downs Coking Coal Project**  
Draft Environmental Impact Statement

**Appendix M**  
**Soil and Land**  
**Suitability**  
**Assessment**

Olive Downs Coking Coal Project

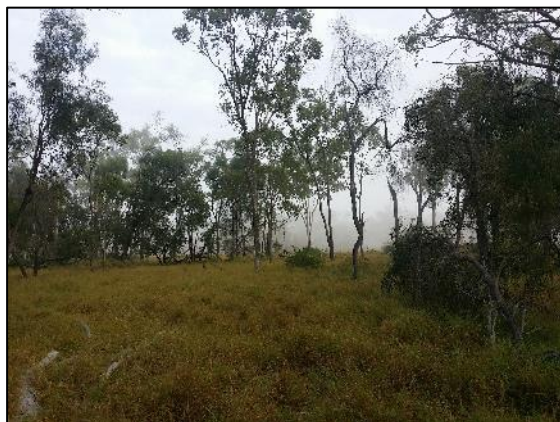
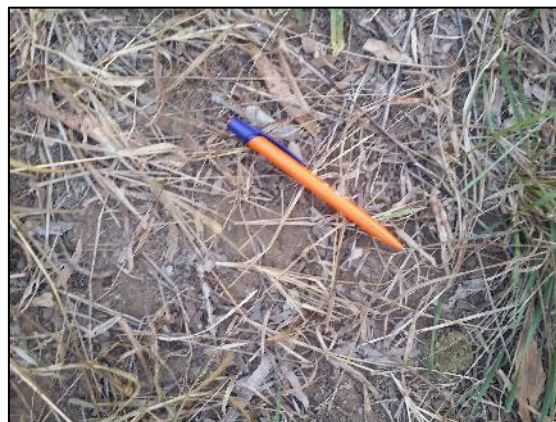
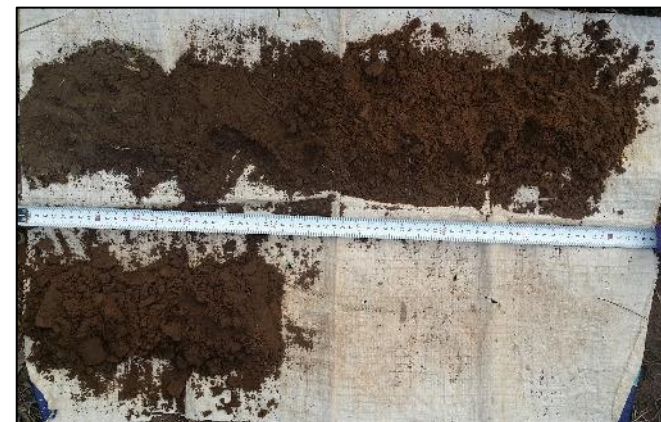
| Land use<br>Landform<br>Pattern,<br>Element,<br>Slope | Natural<br>Vegetation | Microrelief<br>Disturbance<br>Erosion | Surface<br>condition,<br>surface rock | Soil Profile Description | | | | | | | | | |
|---|---|---|---|---|---|---|---|---|---|---|---|---|---|
| Grazing, very<br>gently<br>undulating<br>plains, upper<br>slope <0.5% | Poplar box,<br>Eucalypts,<br>Moreton Bay<br>Ash | Nil | Firm,<br>no coarse<br>fragments | A1<br>.00-0.10<br>Abrupt | Clayey<br>sand | Massive,<br>loose | Nil | 10YR3/2<br>Very dark brown | Dry, rapid | Very few, very<br>fine | 0.10 / 6.0 | No samples<br>taken | No additional<br>observations |
| | | | | B21<br>0.10-0.38<br>Abrupt | Loamy<br>sand | Massive,<br>loose | Nil | 10YR42/2<br>Very dark brown | Dry, rapid | Very few, very<br>fine | 0.30 / 6.0 | | |

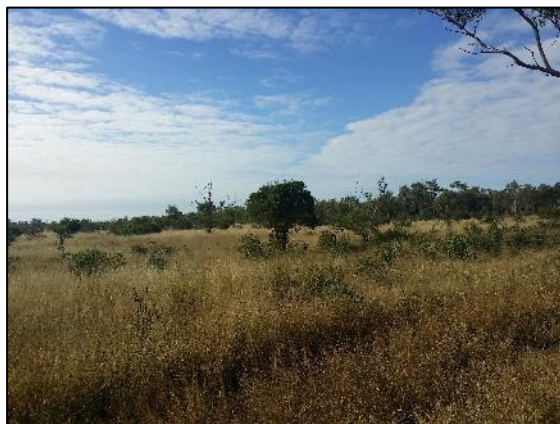
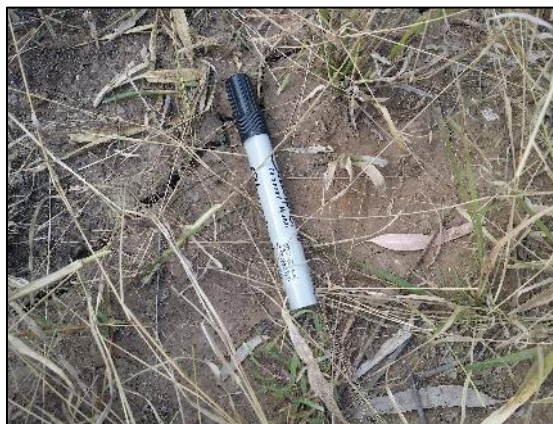
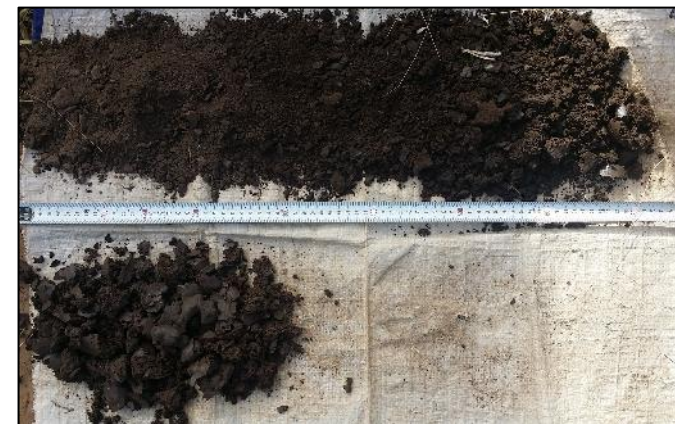
| Land use<br>Landform<br>Pattern,<br>Element,<br>Slope | Natural<br>Vegetation | Microrelief<br>Disturbance<br>Erosion | Surface<br>condition,<br>surface rock | Soil Profile Description | | | | | | | | | |
|---|---|---|---|---|---|---|---|---|---|---|---|---|---|
| Grazing,<br>Gently<br>undulating<br>plains, Upper<br>slope, <2.0% | Long native<br>grass, various<br>sparse<br>regrowth,<br>surrounding<br>eucalypts | Extensive<br>clearing | Cracking,<br>no coarse<br>fragments | A1<br>0.00-0.11<br>Abrupt | Silty clay<br>loam | Weak, firm,<br><5mm sub-<br>angular | <2% <10mm<br>coarse<br>fragments | 10YR3/1<br>Very dark gray | Dry, well<br>drained | Very few, very<br>fine | 0.05 / 6.0 | No samples<br>taken | No additional<br>observations |

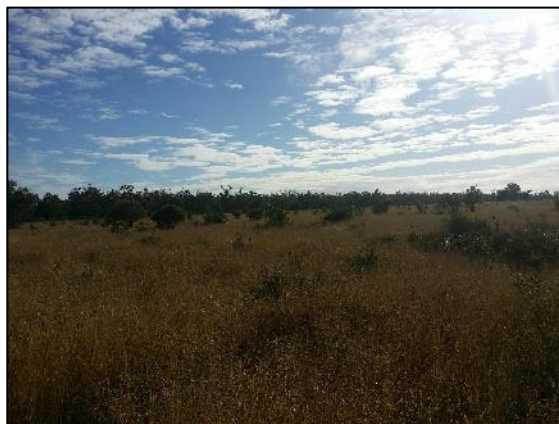
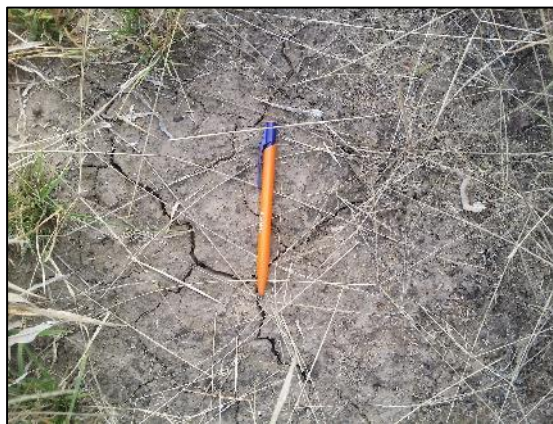
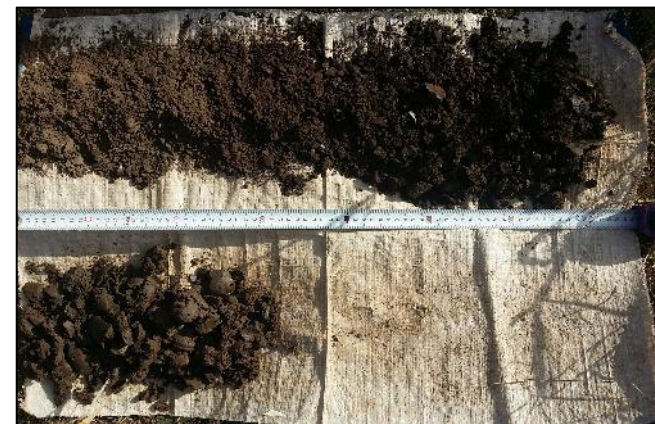
| Land use<br>Landform<br>Pattern,<br>Element,<br>Slope | Natural<br>Vegetation | Microrelief<br>Disturbance<br>Erosion | Surface<br>condition,<br>surface rock | Soil Profile Description | | | | | | | | | |
|---|---|---|---|---|---|---|---|---|---|---|---|---|---|
| Grazing,<br>Gently<br>undulating<br>plains, Upper<br>slope, <2.0% | Long native<br>grass, various<br>sparse<br>regrowth,<br>surrounding<br>eucalypts | Extensive<br>clearing | Cracking,<br>no coarse<br>fragments | A1<br>0.00-0.10<br>Abrupt | Silty clay<br>loam | Weak, firm,<br><5mm sub-<br>angular | <2% <10mm<br>coarse<br>fragments | 10YR3/1<br>Very dark gray | Dry, well<br>drained | Very few, very<br>fine | 0.05 / 6.0 | No samples<br>taken | No additional<br>observations |

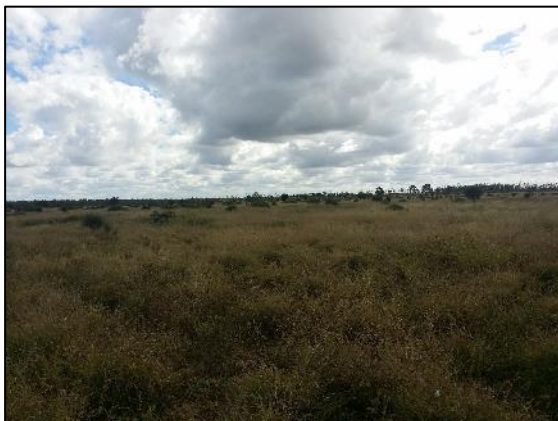
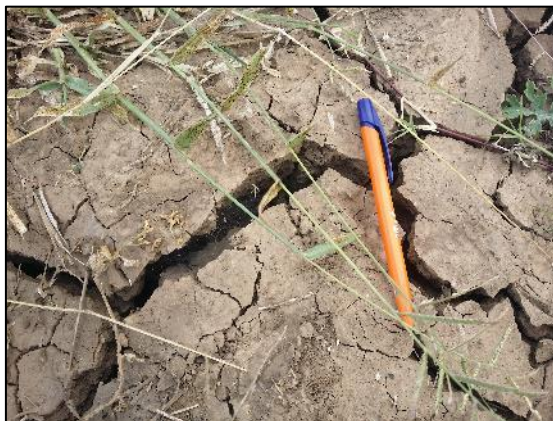
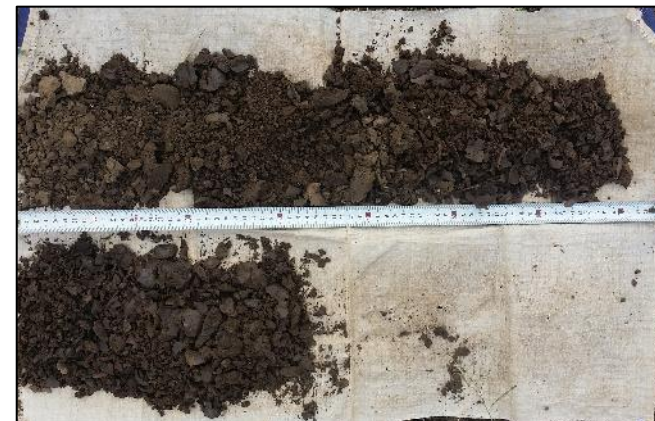
| Land use<br>Landform<br>Pattern,<br>Element,<br>Slope | Natural<br>Vegetation | Microrelief<br>Disturbance<br>Erosion | Surface<br>condition,<br>surface rock | Soil Profile Description | | | | | | | | | |
|---|---|---|---|---|---|---|---|---|---|---|---|---|---|
| Grazing,<br>Gently<br>undulating<br>plains, Lower<br>slope, <2.0% | Long native<br>grass, various<br>sparse<br>regrowth | Normal<br>gilgai,<br>extensive<br>clearing | Cracking,<br>no coarse<br>fragments | A1<br>0.00-0.09<br>Abrupt | Sandy clay<br>loam | Moderate,<br>very firm,<br><10mm<br>sub-angular | Nil | 10YR4/2<br>Dark grayish<br>brown | Dry, rapid | Very few, very<br>fine | 0.05 / 6.5 | No samples<br>taken | No additional<br>observations |

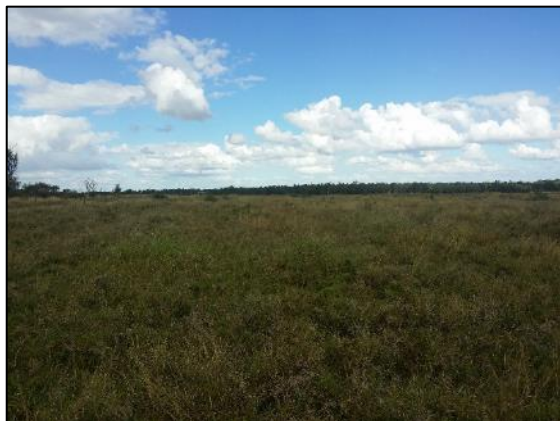
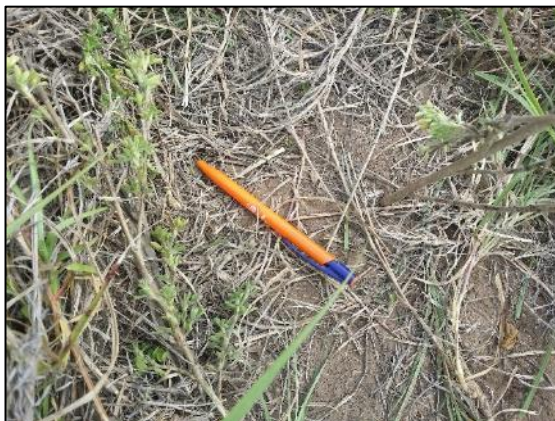
| Land use<br>Landform<br>Pattern,<br>Element,<br>Slope | Natural<br>Vegetation | Microrelief<br>Disturbance<br>Erosion | Surface<br>condition,<br>surface rock | Soil Profile Description | | | | | | | | | |
|---|---|---|---|---|---|---|---|---|---|---|---|---|---|
| Grazing,<br>Gently<br>undulating<br>plains, Upper<br>slope, <2.0% | Long native<br>grasses | Extensive<br>clearing | Firm,<br>no coarse<br>fragments | A11<br>0.00-0.14<br>Abrupt | Loamy<br>sand | Massive,<br>loose | Nil | 10YR2/2<br>Very dark brown | Dry, rapid | Few, very fine | 0.10 / 6.5 | No samples<br>taken | No additional<br>observations |

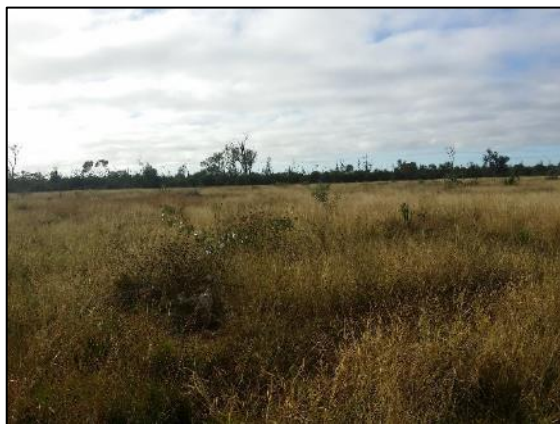
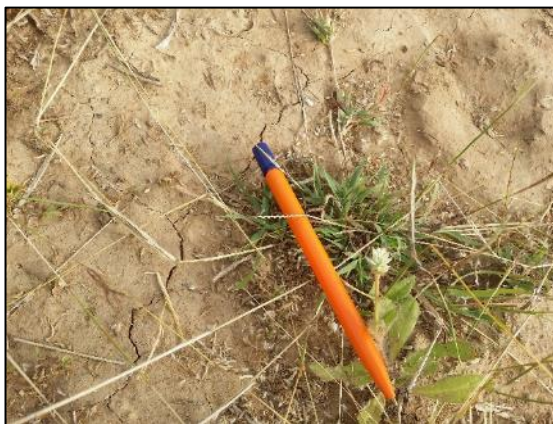
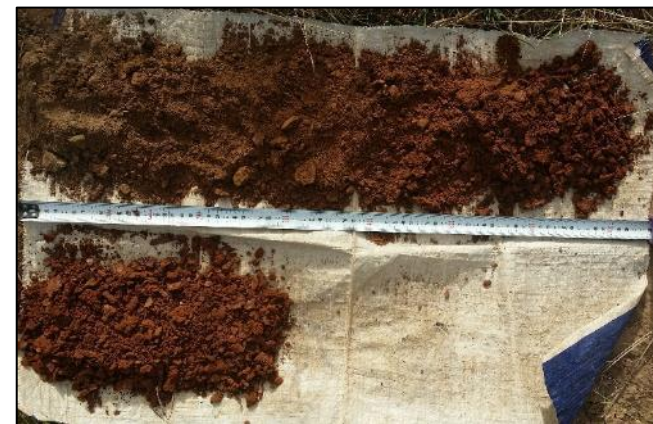
| Land use<br>Landform<br>Pattern,<br>Element,<br>Slope | Natural<br>Vegetation | Microrelief<br>Disturbance<br>Erosion | Surface<br>condition,<br>surface rock | Soil Profile Description | | | | | | | | | |
| | | | | Horizon<br>Depth (m),<br>Boundary | Texture | Structure,<br>Strength | Inclusions<br>Segregations | Colour, Mottle | Moisture,<br>Drainage | Roots | Depth (m) / Field<br>pH | Sample (m) | Observations |
| Grazing, Flat<br>plain <0.5% | Long native<br>grasses | Extensive<br>clearing | Hard setting,<br>minor<br>cracking,<br>no coarse<br>fragments | A11<br>0.00-0.11<br>Abrupt | Silty loam | Massive,<br>loose | Nil | 10YR4/3<br>Brown | Dry, well<br>drained | Very few, very<br>fine | 0.05 / 6.0 | No samples<br>taken | No additional<br>observations |

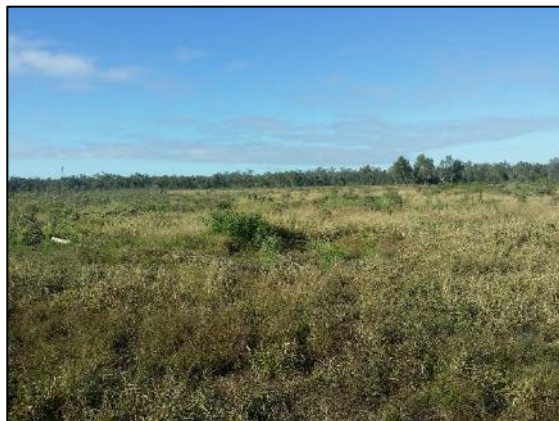
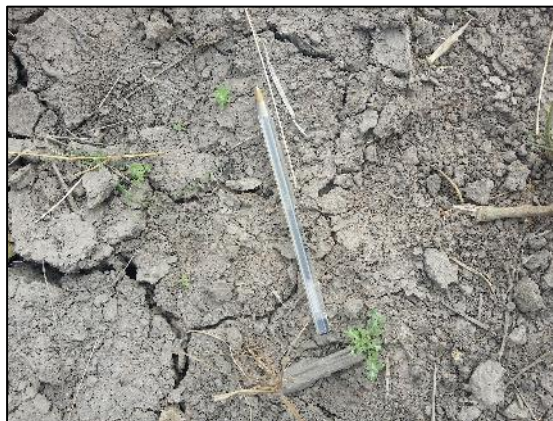
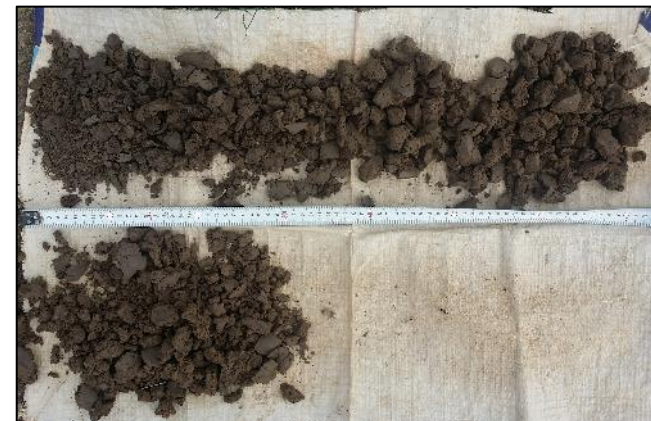
| Land use<br>Landform<br>Pattern,<br>Element,<br>Slope | Natural<br>Vegetation | Microrelief<br>Disturbance<br>Erosion | Surface<br>condition,<br>surface rock | Soil Profile Description | | | | | | | | | |
| | | | | Horizon<br>Depth (m),<br>Boundary | Texture | Structure,<br>Strength | Inclusions<br>Segregations | Colour, Mottle | Moisture,<br>Drainage | Roots | Depth (m) / Field<br>pH | Sample (m) | Observations |
| Grazing, Flat<br>plain <0.5% | Native grass | Normal<br>gilgai,<br>extensive<br>clearing | Cracking,<br>no coarse<br>fragments | A1<br>0.00-0.10<br>Abrupt | Sandy clay<br>loam | Moderate,<br>very firm,<br><10mm<br>sub-angular | Nil | 10YR4/2<br>Dark grayish<br>brown | Dry, rapid | Very few, very<br>fine | 0.05 / 6.5 | No samples<br>taken | No additional<br>observations |

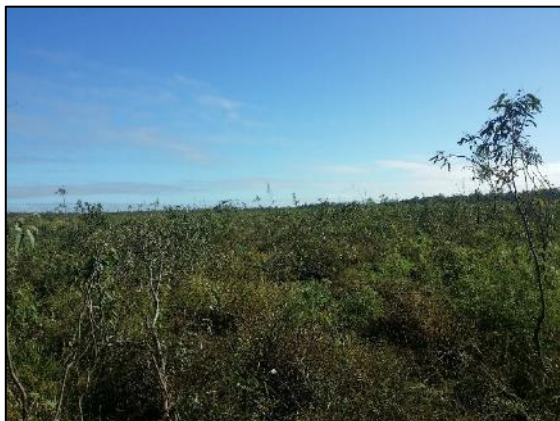
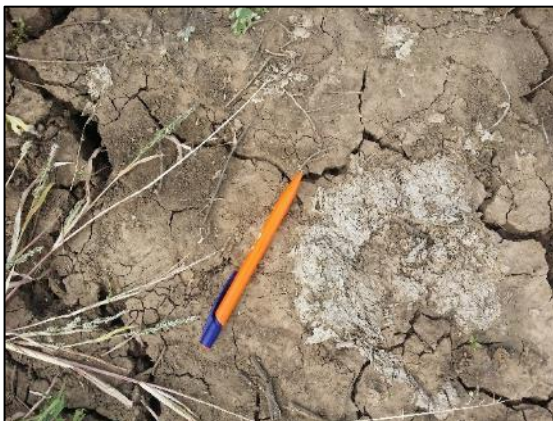
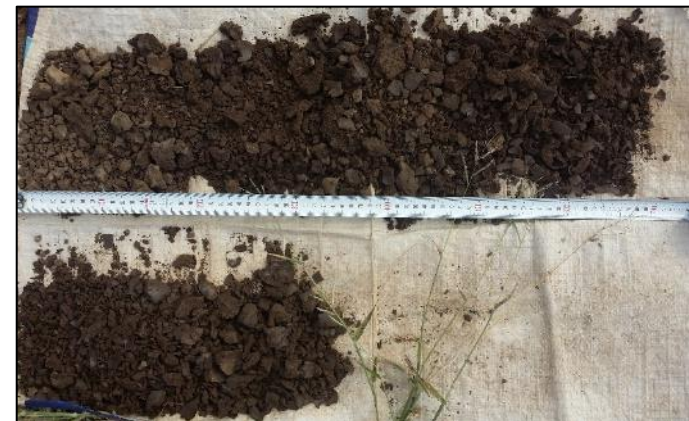
| Land use<br>Landform<br>Pattern,<br>Element,<br>Slope | Natural<br>Vegetation | Microrelief<br>Disturbance<br>Erosion | Surface<br>condition,<br>surface rock | Soil Profile Description | | | | | | | | | |
| | | | | Horizon<br>Depth (m),<br>Boundary | Texture | Structure,<br>Strength | Inclusions<br>Segregations | Colour, Mottle | Moisture,<br>Drainage | Roots | Depth (m) / Field<br>pH | Sample (m) | Observations |
| Grazing,<br>gently<br>undulating<br>plains, lower<br>slope /<br>Depression<br>creek | Eucalypts,<br>Blackbutt<br>regrowth,<br>boundary of<br>Brigalow | Shallow<br>gilgai,<br>extensive<br>clearing | Cracking,<br>no coarse<br>fragments | A1<br>0.00-0.10<br>Abrupt | Sandy clay<br>loam | Moderate,<br>very firm,<br><10mm<br>sub-angular | Nil | 10YR4/2<br>Dark grayish<br>brown | Dry, rapid | Very few, very<br>fine | 0.05 / 6.5 | No samples<br>taken | No additional<br>observations |

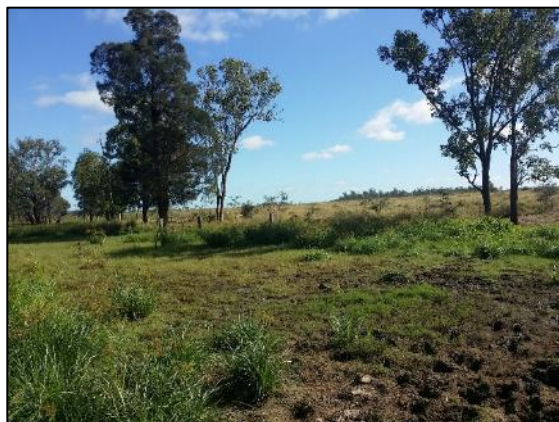
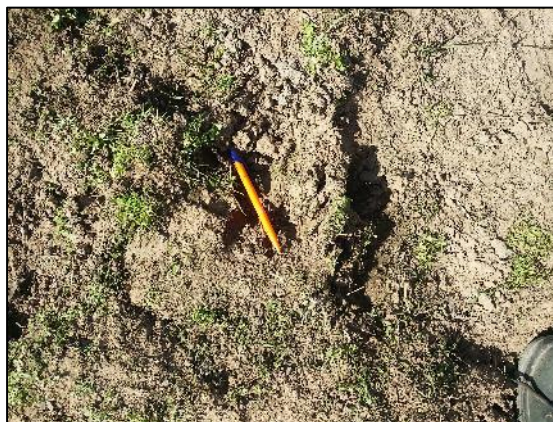
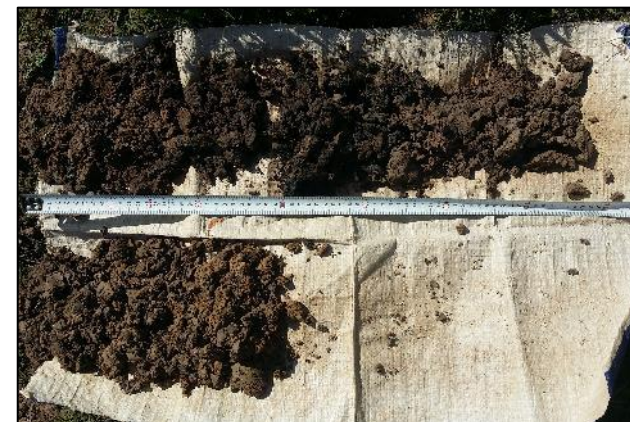
| Land use<br>Landform<br>Pattern,<br>Element,<br>Slope | Natural<br>Vegetation | Microrelief<br>Disturbance<br>Erosion | Surface<br>condition,<br>surface rock | Soil Profile Description | | | | | | | | | |
|---|---|---|---|---|---|---|---|---|---|---|---|---|---|
| Grazing,<br>gently<br>undulating<br>plains,<br>Depression | Eucalypts,<br>Moreton Bay<br>Ash | Depression | Poached,<br>moist, nearby<br>cracking, no<br>coarse<br>fragments | A1<br>0.00-0.12<br>Abrupt | Loamy<br>sand | Massive,<br>loose | Nil | 10YR3/3<br>Dark brown | Moderately<br>moist, rapid | Very few, very<br>fine | 0.10 / 7.0 | No samples<br>taken | No additional<br>observations |
| | | | | B21<br>0.12-0.40<br>Abrupt | Clayey<br>loam | Moderate,<br>10-30mm,<br>firm | Buried ash 30% | 10YR3/2<br>Very dark greyish<br>brown | Moderately<br>moist, rapid | Nil | 0.30 / 7.0 | | |
| | | | | B22<br>0.40-1.00 | Clayey<br>sand | Moderate,<br>weak | Nil | 10YR4/3<br>Brown<br>Mottle<br>10YR5/8 2%<br>Yellowish brown | Moderately<br>moist, rapid | Nil | 0.60 / 7.5<br>0.90 / 7.5 | | |

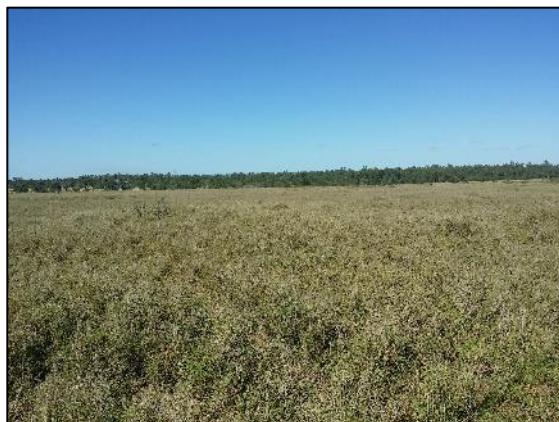
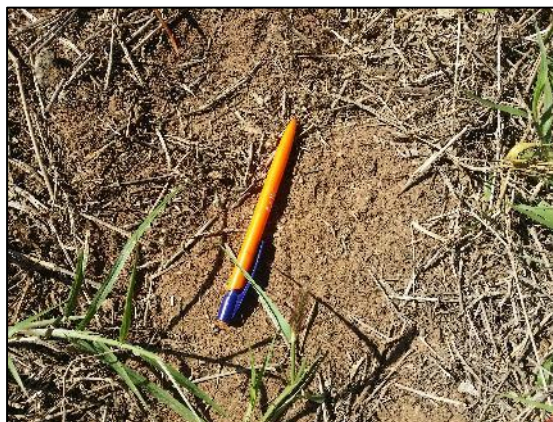
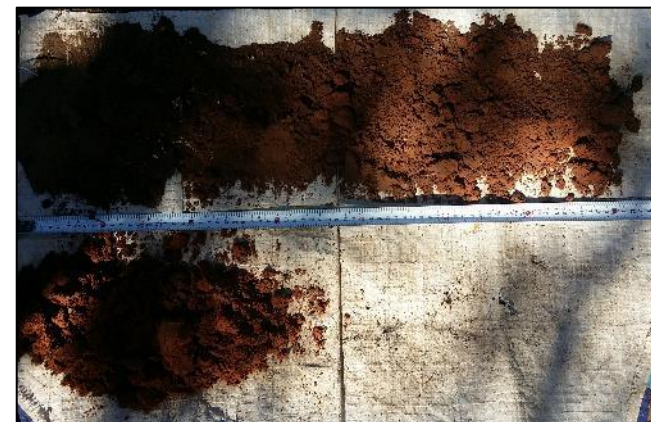
| Land use<br>Landform<br>Pattern,<br>Element,<br>Slope | Natural<br>Vegetation | Microrelief<br>Disturbance<br>Erosion | Surface<br>condition,<br>surface rock | Soil Profile Description | | | | | | | | | |
|---|---|---|---|---|---|---|---|---|---|---|---|---|---|
| Grazing,<br>gently<br>undulating<br>plains, mid-<br>slope <1% | Native grasses | Extensive<br>clearing | Soft, no coarse<br>fragments | A11<br>0.00-0.09<br>Abrupt | Clayey<br>sand | Massive,<br>loose | Nil | 10YR4/3<br>Brown | Dry, rapid | Very few, very<br>fine | 0.05 / 6.5 | No samples<br>taken | No additional<br>observations |
| | | | | A12<br>0.09-0.48<br>Abrupt | Clayey<br>sand | Massive,<br>loose | Nil | 7.5YR3/2<br>Brown | Dry, rapid | Nil | 0.30 / 6.5 | | |

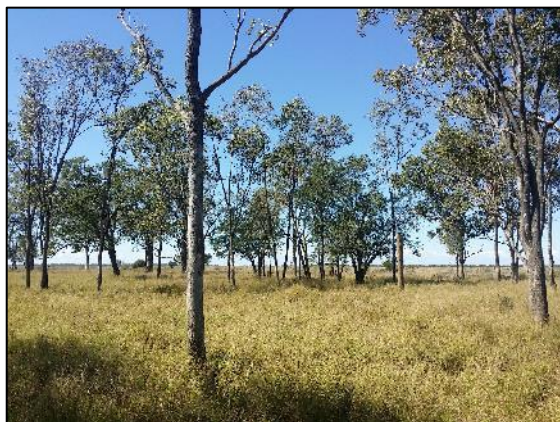
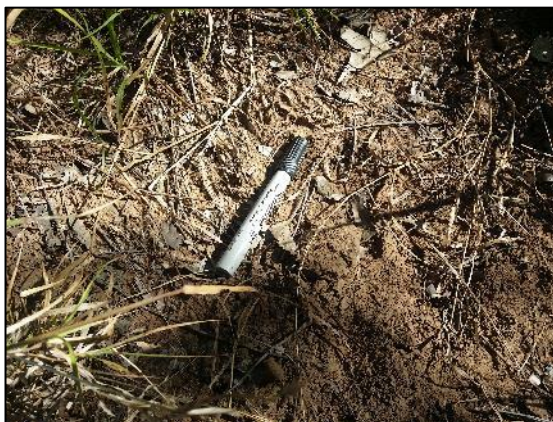
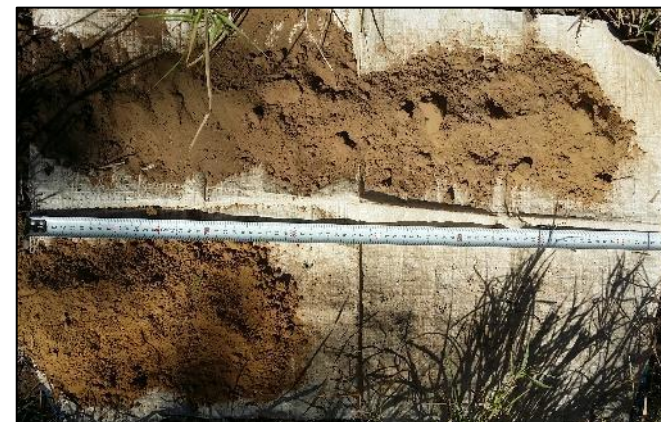
| Land use<br>Landform<br>Pattern,<br>Element,<br>Slope | Natural<br>Vegetation | Microrelief<br>Disturbance<br>Erosion | Surface<br>condition,<br>surface rock | Soil Profile Description | | | | | | | | | |
|---|---|---|---|---|---|---|---|---|---|---|---|---|---|
| Grazing,<br>gently<br>undulating<br>plains, mid-<br>slope <1.0% | Poplar box | Nil | Soft, no coarse<br>fragments | A11<br>0.00-0.04<br>Abrupt | Clayey<br>sand | Massive,<br>loose | Nil | 10YR3/2<br>Very dark greyish<br>brown | Dry, rapid | Very few, very<br>fine | 0.05 / 6.5 | No samples<br>taken | No additional<br>observations |
| | | | | A12<br>0.04-0.25<br>Abrupt | Clayey<br>sand | Massive,<br>loose | Nil | 10YR3/3<br>Dark brown | Dry, rapid | Very few, very<br>fine | 0.30 / 6.5 | | |

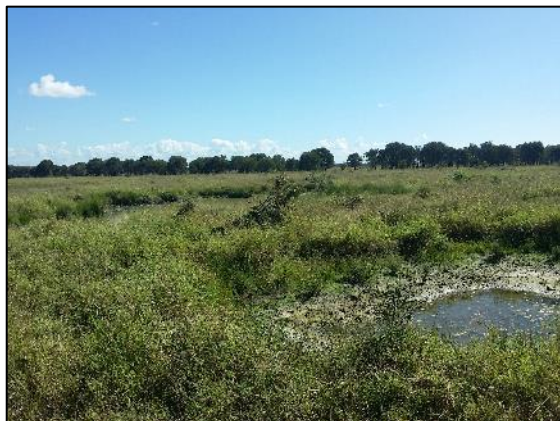
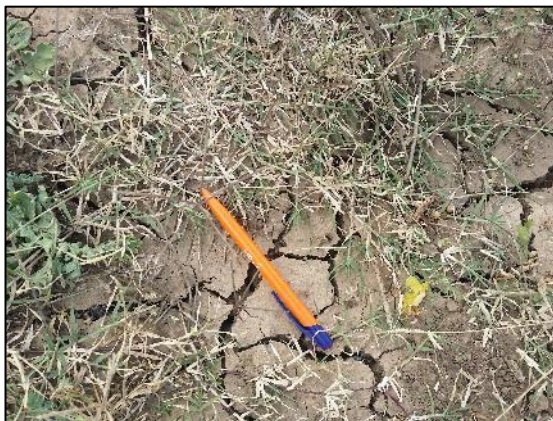
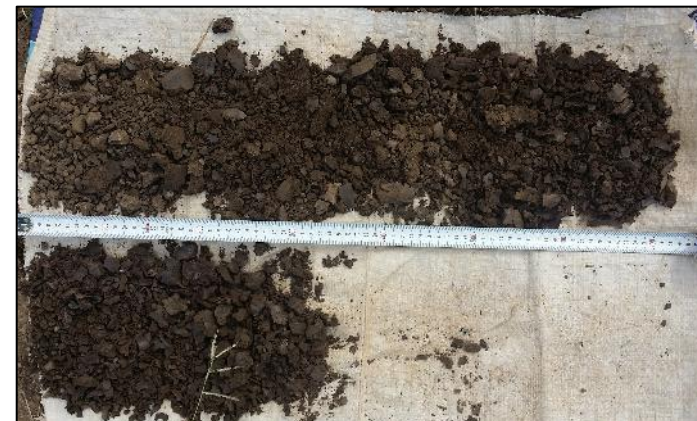
| Land use<br>Landform<br>Pattern,<br>Element,<br>Slope | Natural<br>Vegetation | Microrelief<br>Disturbance<br>Erosion | Surface<br>condition,<br>surface rock | Soil Profile Description | | | | | | | | | |
|---|---|---|---|---|---|---|---|---|---|---|---|---|---|
| Grazing,<br>Gently<br>undulating<br>plains, Lower<br>slope, <2.0% | Long native<br>grass, various<br>sparse<br>regrowth | Normal<br>gilgai,<br>extensive<br>clearing | Cracking,<br>no coarse<br>fragments | A1<br>0.00-0.09<br>Abrupt | Sandy clay<br>loam | Moderate,<br>very firm,<br><10mm<br>sub-angular | Nil | 10YR4/2<br>Dark grayish<br>brown | Dry, rapid | Very few, very<br>fine | 0.05 / 6.5 | No samples<br>taken | No additional<br>observations |

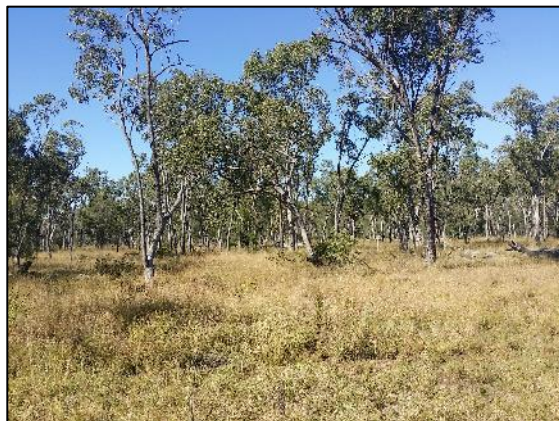
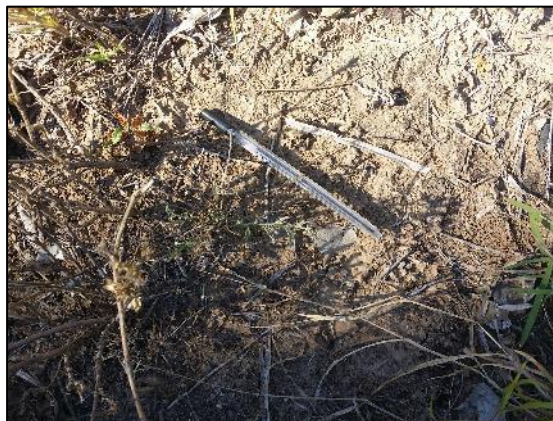
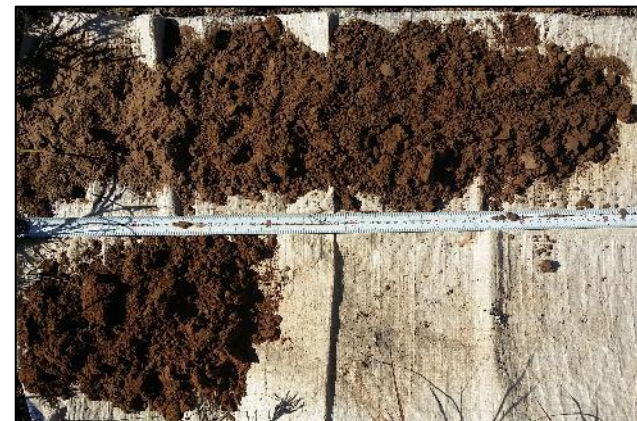
| Land use<br>Landform<br>Pattern,<br>Element,<br>Slope | Natural<br>Vegetation | Microrelief<br>Disturbance<br>Erosion | Surface<br>condition,<br>surface rock | Soil Profile Description | | | | | | | | | |
|---|---|---|---|---|---|---|---|---|---|---|---|---|---|
| Grazing,<br>gently<br>undulating<br>plains, lower<br>slope 1.0% | Poplar box | Minor<br>clearing,<br>nearby track | Firm, no<br>coarse<br>fragments | A1<br>0.00-0.18<br>Abrupt | Clayey<br>sand | Massive,<br>loose | Nil | 10YR4/4<br>Dark yellowish<br>brown | Dry, rapid | Very few, very<br>fine | 0.10 / 6.5 | No samples<br>taken | No additional<br>observations |

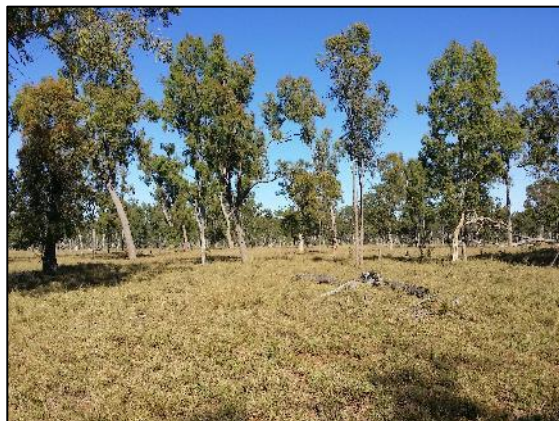
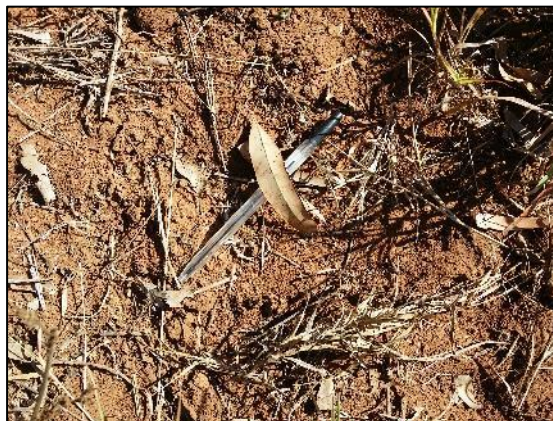
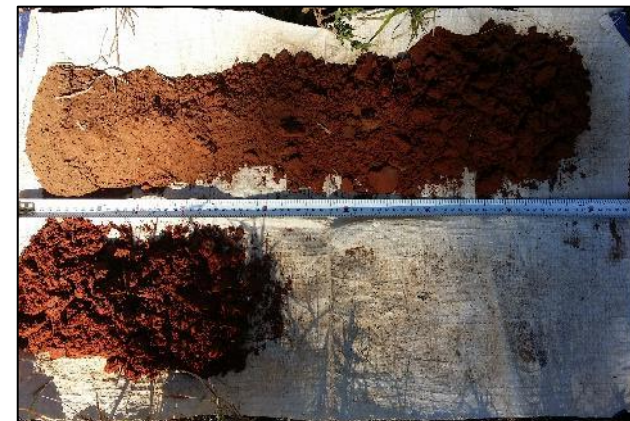
| Land use<br>Landform<br>Pattern,<br>Element,<br>Slope | Natural<br>Vegetation | Microrelief<br>Disturbance<br>Erosion | Surface<br>condition,<br>surface rock | Soil Profile Description | | | | | | | | | |
|---|---|---|---|---|---|---|---|---|---|---|---|---|---|
| Grazing, very<br>wide crest<br>1.0% | Blackbutt, very<br>minor poplar<br>box, very<br>minor<br>Moreton Bay<br>Ash | Nil | Firm, no<br>coarse<br>fragments | A11<br>0.00-0.20<br>Abrupt | Loamy<br>sand | Massive,<br>loose,<br>single grain | Nil | 2.5YR3/3<br>Dark reddish<br>brown | Dry, rapid | Very few, very<br>fine | 0.10 / 6.5 | No samples<br>taken | No additional<br>observations |

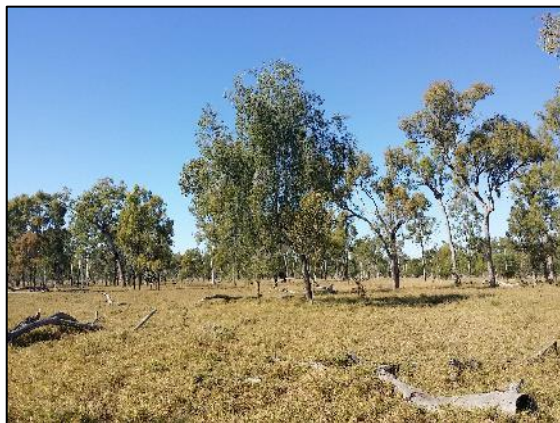
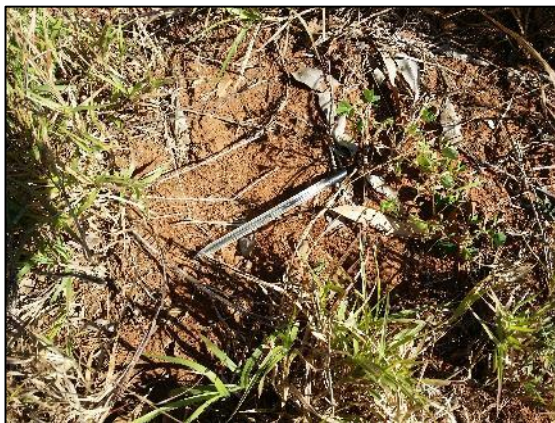
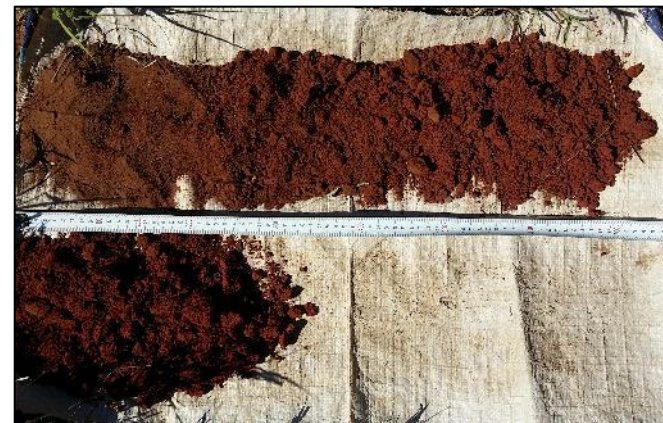
| Land use<br>Landform<br>Pattern,<br>Element,<br>Slope | Natural<br>Vegetation | Microrelief<br>Disturbance<br>Erosion | Surface<br>condition,<br>surface rock | Soil Profile Description | | | | | | | | | |
|---|---|---|---|---|---|---|---|---|---|---|---|---|---|
| Grazing,<br>gently<br>undulating<br>plain, upper<br>slope 1.5% | Blackbutt | Limited<br>clearing | Firm, no<br>coarse<br>fragments | A11<br>0.00-0.18<br>Abrupt | Loamy<br>sand | Massive,<br>loose,<br>single grain | Nil | 2.5YR3/3<br>Dark reddish<br>brown | Dry, rapid | Very few, very<br>fine | 0.10 / 6.5 | No samples<br>taken | No additional<br>observations |

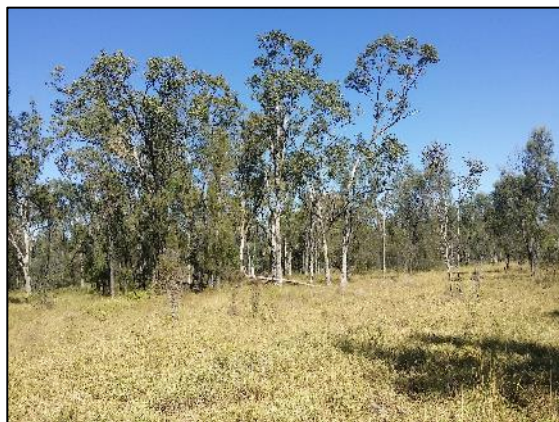
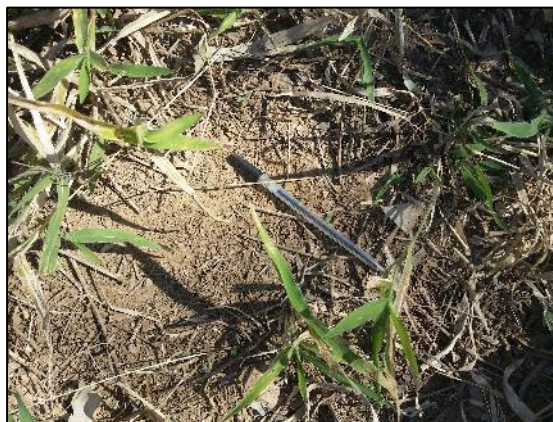
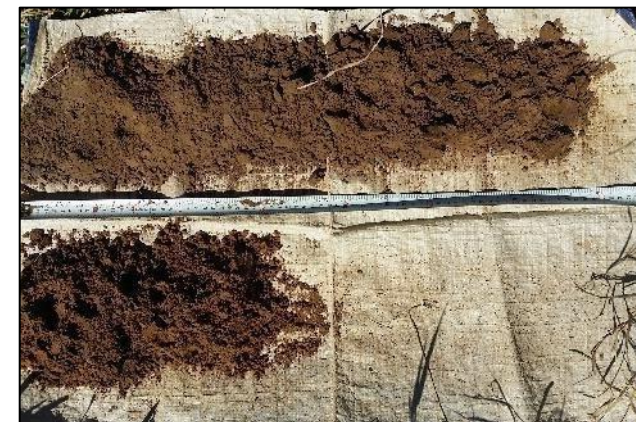
| Land use<br>Landform<br>Pattern,<br>Element,<br>Slope | Natural<br>Vegetation | Microrelief<br>Disturbance<br>Erosion | Surface<br>condition,<br>surface rock | Soil Profile Description | | | | | | | | | |
|---|---|---|---|---|---|---|---|---|---|---|---|---|---|
| Grazing,<br>gently<br>undulating<br>plain, mid-<br>slope 1.5% | Poplar box,<br>Blackbutt | Nil | Firm to hard<br>setting, no<br>coarse<br>fragments | A1<br>0.00-0.08<br>Abrupt | Clayey<br>sand | Massive,<br>loose | Nil | 10YR4/2<br>Dark grayish<br>brown | Dry, rapid | Very few, very<br>fine | 0.10 / 6.5 | No samples<br>taken | No additional<br>observations |
| | | | | B21<br>0.08-0.70<br>Abrupt | Loamy<br>sand | Massive,<br>loose | Nil | 10YR4/3<br>Brown | Dry, rapid | Very few, very<br>fine | 0.40 / 6.5 | | |
| | | | | B22<br>0.70-1.00 | Loamy<br>sand | Massive,<br>loose | Nil | 10YR4/3<br>Brown | Dry, rapid | Nil | 0.60 / 6.5<br>0.90 / 7.0 | | |

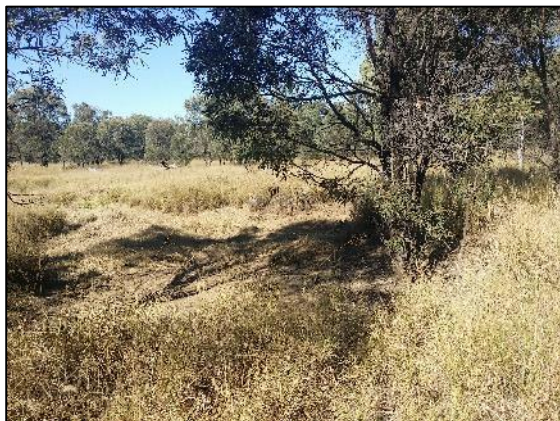
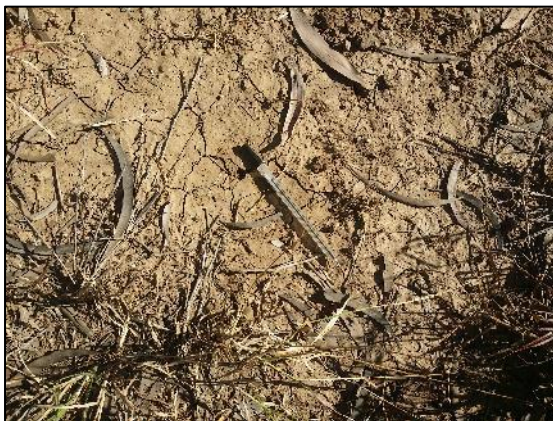
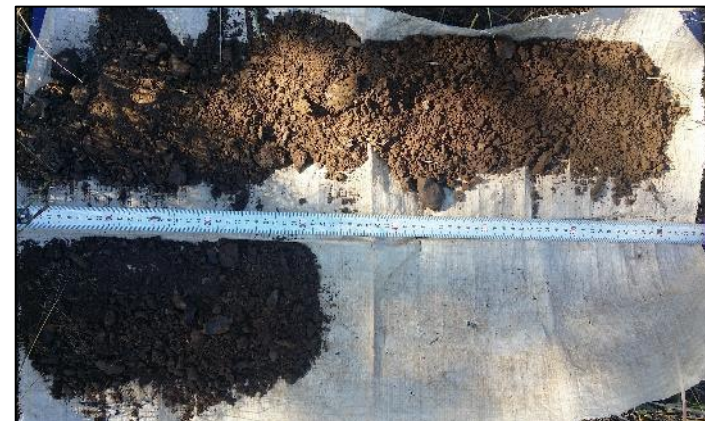
| Land use<br>Landform<br>Pattern,<br>Element,<br>Slope | Natural<br>Vegetation | Microrelief<br>Disturbance<br>Erosion | Surface<br>condition,<br>surface rock | Soil Profile Description | | | | | | | | | |
|---|---|---|---|---|---|---|---|---|---|---|---|---|---|
| Grazing,<br>gently<br>undulating<br>plain, lower<br>slope 0.5% | Brigalow<br>regrowth | Melon holes<br>0.30-0.40<br>deep, 50%<br>coverage 2.0-<br>4.0m wide | Hard setting,<br>cracking,<br>no coarse<br>fragments | A1<br>0.00-0.08<br>Abrupt | Light clay | Moderate,<br>weak, 5-<br>10mm peds | Nil | 10YR3/2<br>Very dark grayish<br>brown | Dry, well<br>drained | Very few, very<br>fine | 0.10 / 6.5 | No samples<br>taken | No additional<br>observations |

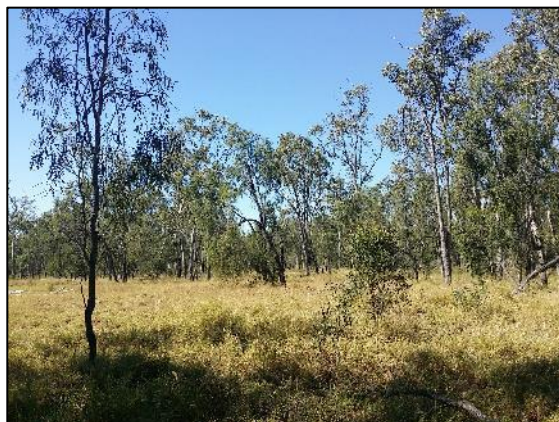
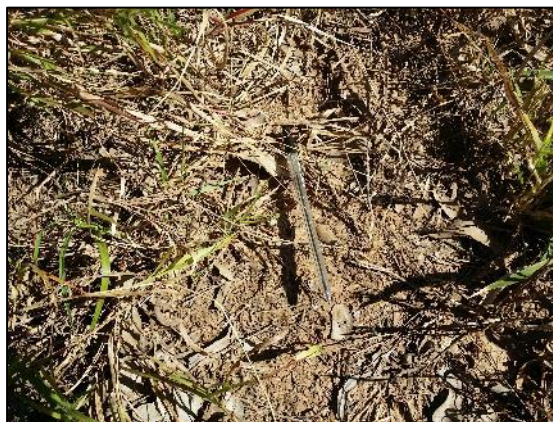
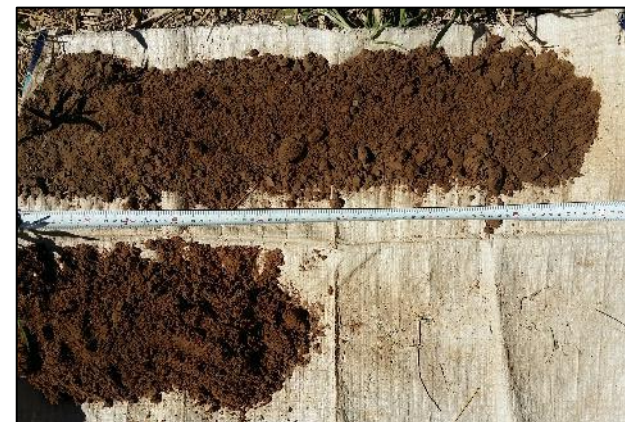
| Land use<br>Landform<br>Pattern,<br>Element,<br>Slope | Natural<br>Vegetation | Microrelief<br>Disturbance<br>Erosion | Surface<br>condition,<br>surface rock | Soil Profile Description | | | | | | | | | |
|---|---|---|---|---|---|---|---|---|---|---|---|---|---|
| Grazing,<br>gently<br>undulating<br>plain, simple<br>slope 1.5% | Poplar box,<br>Blackbutt | Nil | Firm,<br>no coarse<br>fragments | A1<br>0.00-0.10<br>Abrupt | Clayey<br>sand | Massive,<br>loose | Nil | 10YR4/2<br>Dark grayish<br>brown | Dry, rapid | Very few, very<br>fine | 0.10 / 6.5 | No samples<br>taken | No additional<br>observations |
| | | | | B21<br>0.10-0.68<br>Abrupt | Loamy<br>sand | Massive,<br>loose | Nil | 10YR4/3<br>Brown | Dry, rapid | Very few, very<br>fine | 0.40 / 6.5 | | |
| | | | | B22<br>0.68-1.00 | Loamy<br>sand | Massive,<br>loose | Nil | 10YR4/3<br>Brown | Dry, rapid | Nil | 0.60 / 6.5<br>0.90 / 7.0 | | |

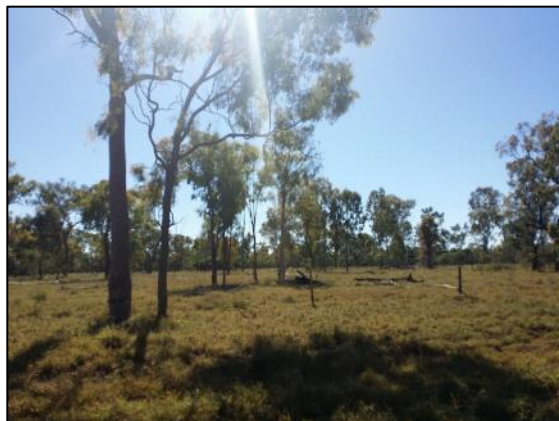
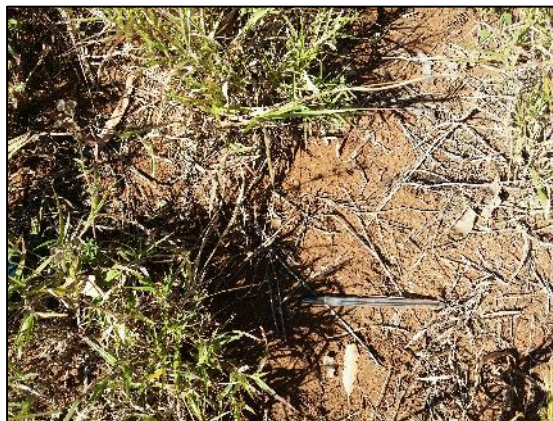
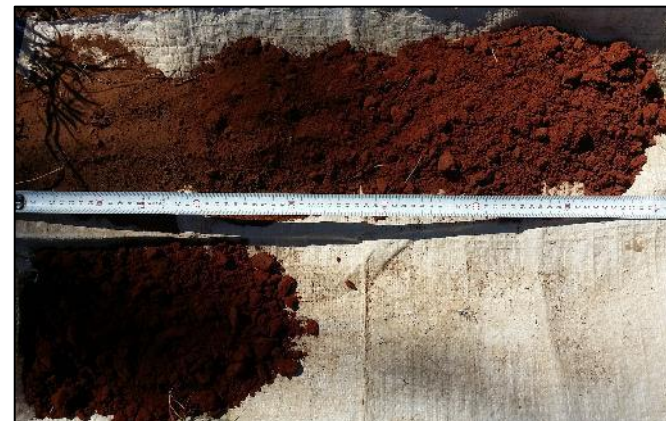
Landscape

Surface

Soil Profile

| Land use<br>Landform<br>Pattern,<br>Element,<br>Slope | Natural<br>Vegetation | Microrelief<br>Disturbance<br>Erosion | Surface<br>condition,<br>surface rock | Soil Profile Description | | | | | | | | | |
|---|---|---|---|---|---|---|---|---|---|---|---|---|---|
| Grazing,<br>Gently<br>undulating<br>plains, upper<br>slope 1.0% | Blackbutt | Nil | Firm, no<br>coarse<br>fragments | A11<br>0.00-0.20<br>Abrupt | Loamy<br>sand | Massive,<br>loose,<br>single grain | Nil | 2.5YR3/3<br>Dark reddish<br>brown | Dry, rapid | Very few, very<br>fine | 0.10 / 6.5 | No samples<br>taken | No additional<br>observations |

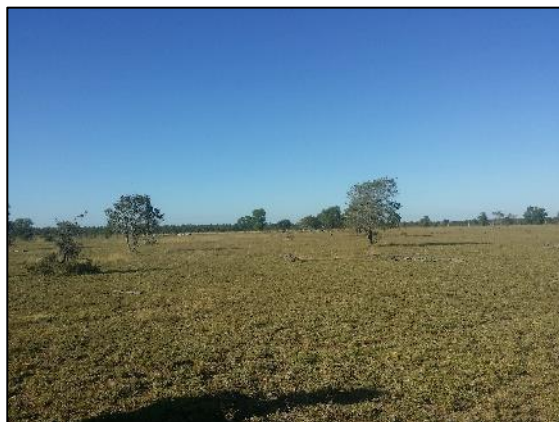
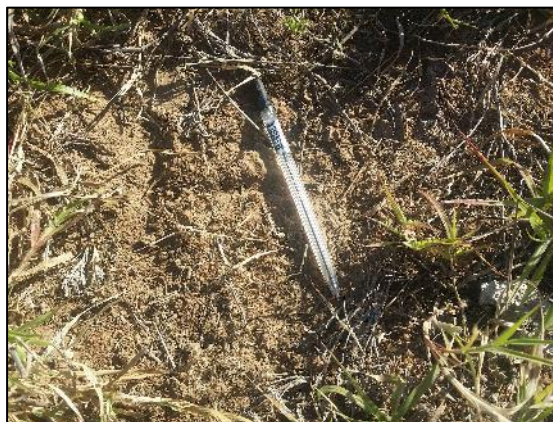
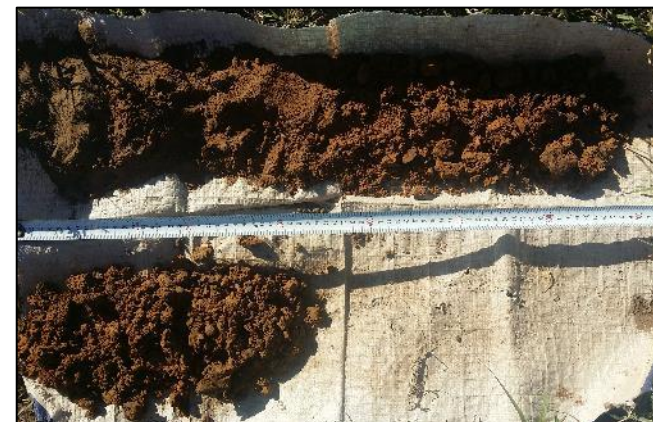
Landscape

Surface

Soil Profile

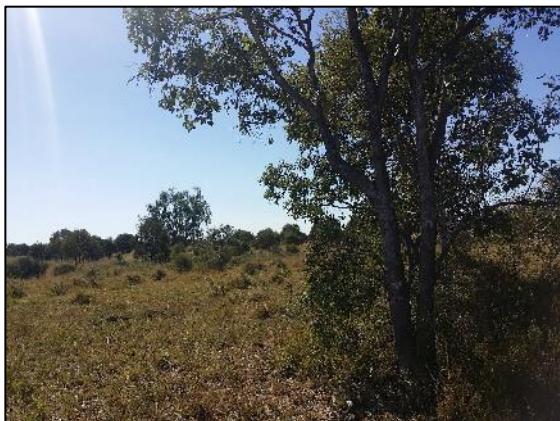
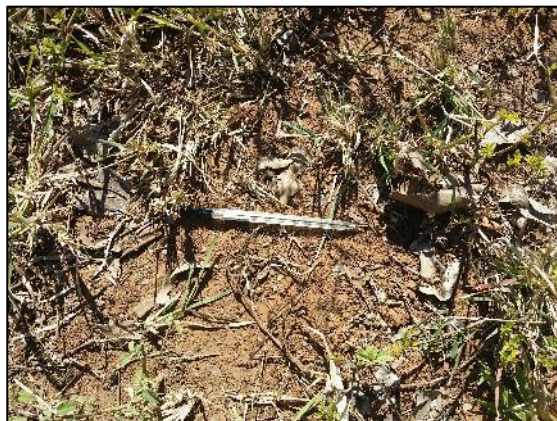
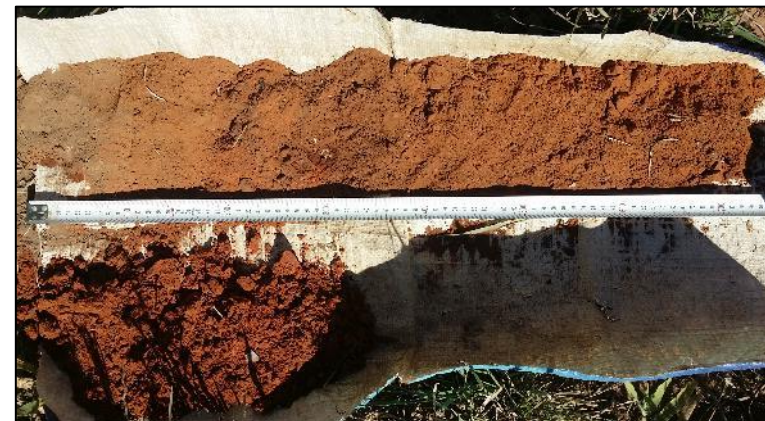
Landscape

Surface

Soil Profile

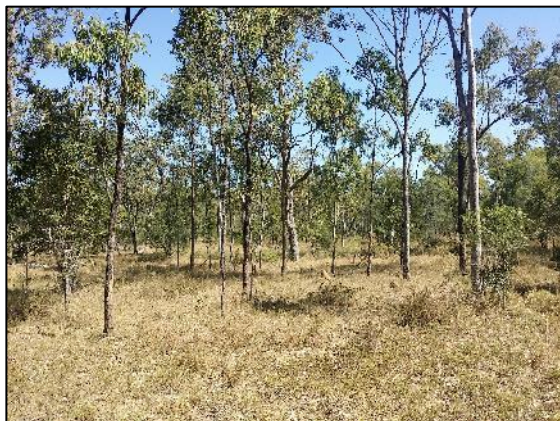
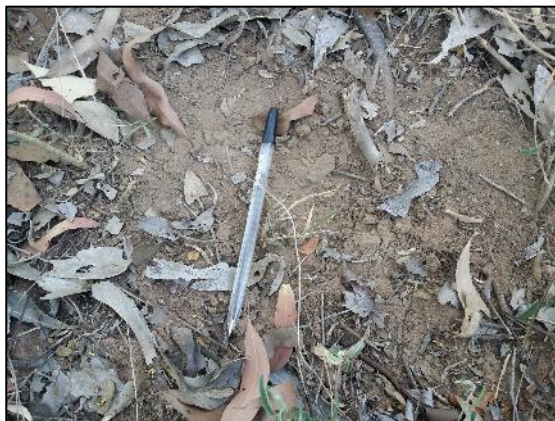
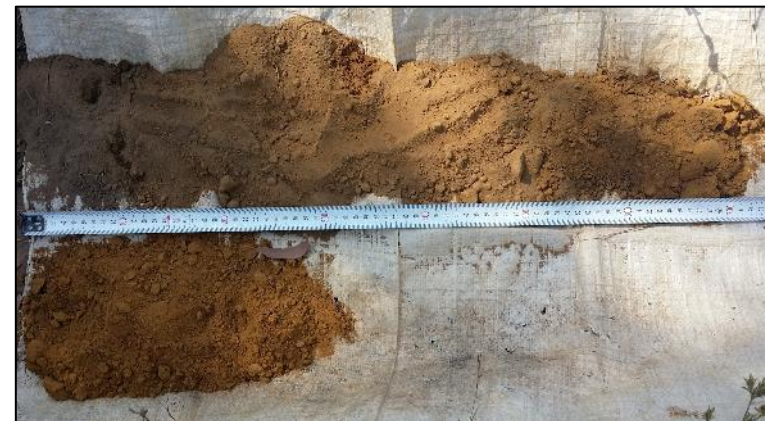
Landscape

Surface

Soil Profile

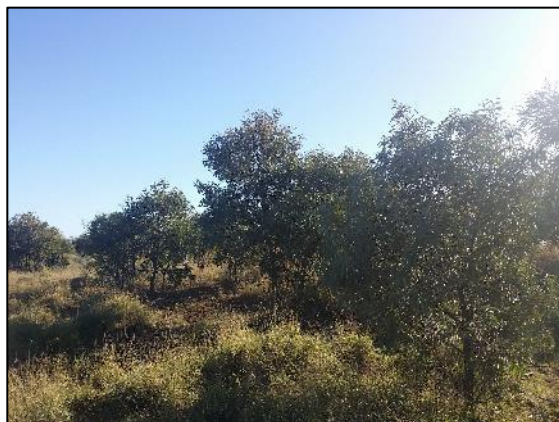
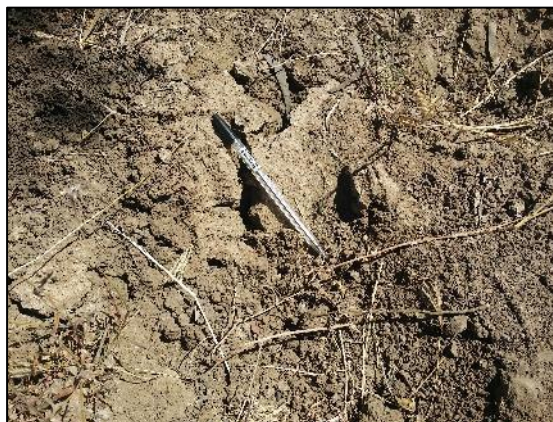
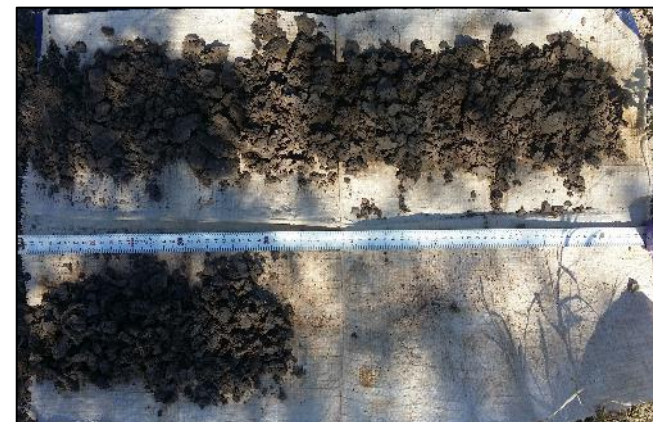
Landscape

Surface

Soil Profile

| Land use<br>Landform<br>Pattern,<br>Element,<br>Slope | Natural<br>Vegetation | Microrelief<br>Disturbance<br>Erosion | Surface<br>condition,<br>surface rock | Soil Profile Description | | | | | | | | | |
|---|---|---|---|---|---|---|---|---|---|---|---|---|---|
| Grazing,<br>Gently<br>undulating<br>plains, mid<br>slope <1.0% | Brigalow<br>regrowth | Melon holes,<br>0.40m deep,<br>3-6m 50%<br>coverage | Cracking 2-<br>10mm, no<br>coarse<br>fragments | A1<br>0.00-0.10<br>Abrupt | Light clay | Weak, firm,<br>3-10mm<br>sub-angular | Nil | 10YR3/2<br>Very dark greyish<br>brown | Dry, well<br>drained | Very few, very<br>fine | 0.10 / 7.0 | No samples<br>taken | Mound |

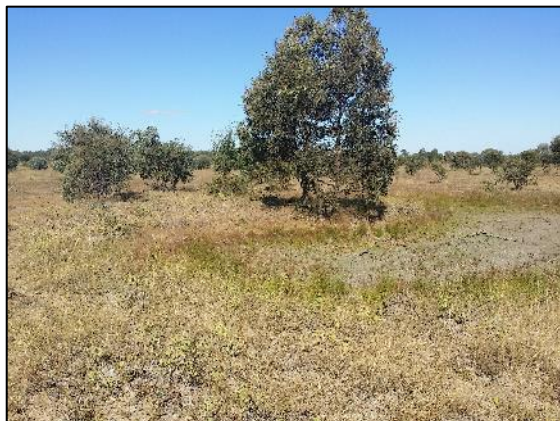
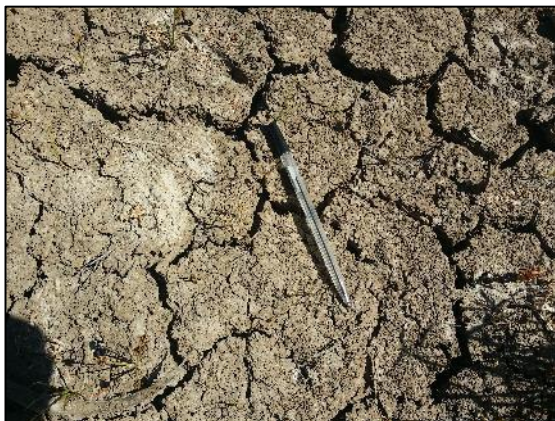
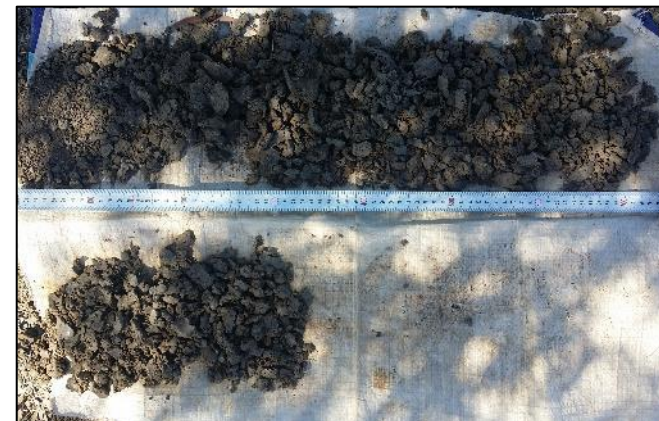
Landscape

Surface

Soil Profile

| Land use<br>Landform<br>Pattern,<br>Element,<br>Slope | Natural<br>Vegetation | Microrelief<br>Disturbance<br>Erosion | Surface<br>condition,<br>surface rock | Soil Profile Description | | | | | | | | | |
|---|---|---|---|---|---|---|---|---|---|---|---|---|---|
| Grazing,<br>Gently<br>undulating<br>plains, mid<br>slope <1.0% | Brigalow<br>regrowth | Extensive<br>clearing,<br>Melon holes,<br>0.40m deep,<br>3-6m 50%<br>coverage | Cracking 2-<br>10mm, no<br>coarse<br>fragments | A1<br>0.00-0.10<br>Abrupt | Light clay | Weak, firm,<br>3-10mm<br>sub-angular | Nil | 10YR3/2<br>Very dark greyish<br>brown | Dry, well<br>drained | Very few, very<br>fine | 0.10 / 7.0 | No samples<br>taken | Depression |
