**PEMBROKE**

**Olive Downs Coking Coal Project**  
Draft Environmental Impact Statement

**Appendix M**  
**Soil and Land**  
**Suitability**  
**Assessment**

Olive Downs Coking Coal Project

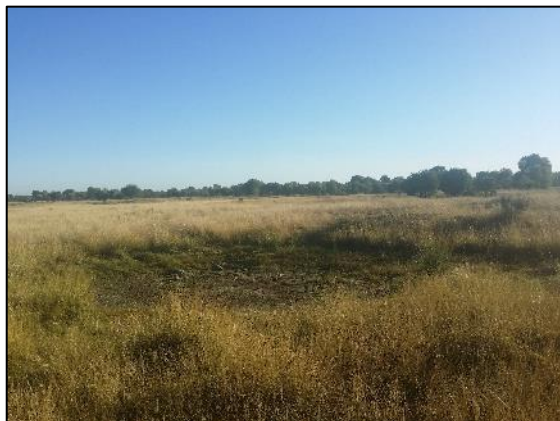
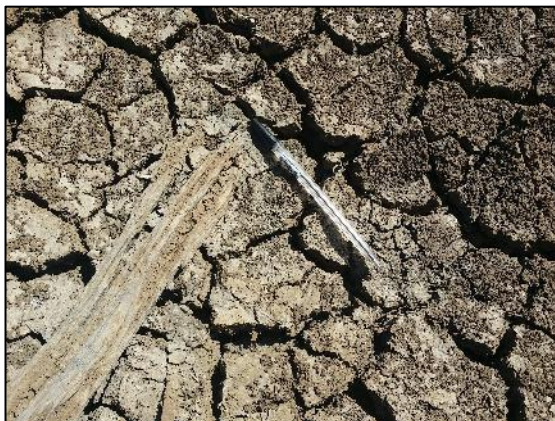
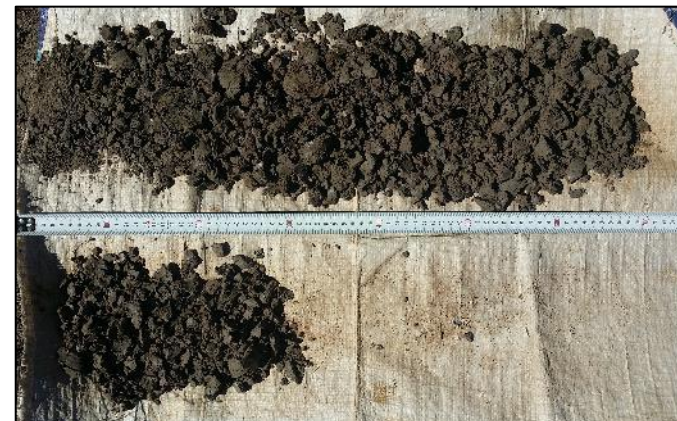
Landscape

Surface

Soil Profile

| Land use<br>Landform<br>Pattern,<br>Element,<br>Slope | Natural<br>Vegetation | Microrelief<br>Disturbance<br>Erosion | Surface<br>condition,<br>surface rock | Soil Profile Description | | | | | | | | | |
|---|---|---|---|---|---|---|---|---|---|---|---|---|---|
| Grazing, Flat<br>plain <0.5% | Brigalow<br>regrowth | Extensive<br>clearing,<br>Melon holes,<br>0.40m deep,<br>3-6m 50%<br>coverage | Cracking 2-<br>10mm, no<br>coarse<br>fragments | A1<br>0.00-0.11<br>Abrupt | Light clay | Weak, firm,<br>3-10mm<br>sub-angular | Nil | 10YR3/2<br>Very dark greyish<br>brown | Dry, well<br>drained | Very few, very<br>fine | 0.10 / 7.0 | No samples<br>taken | Depression |

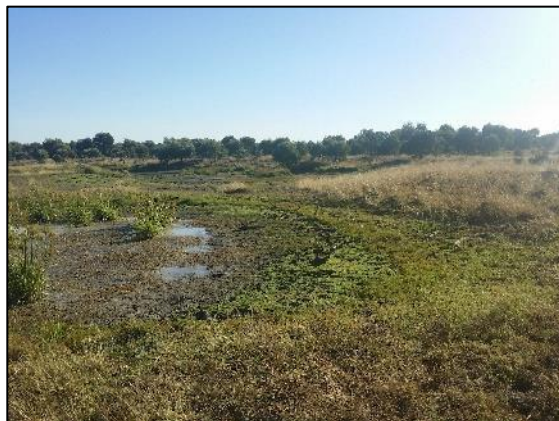
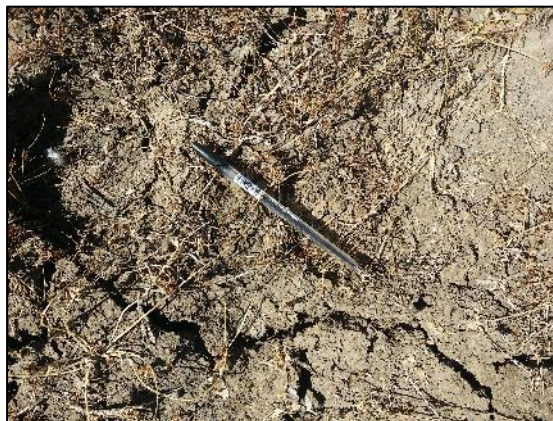
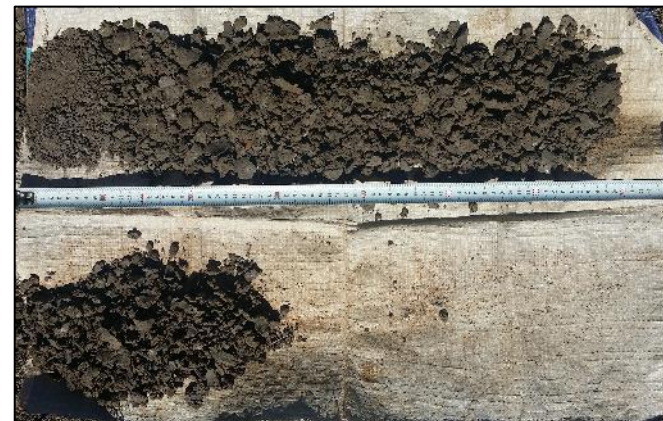
**Landscape**

**Surface**

**Soil Profile**

| Land use<br>Landform<br>Pattern,<br>Element,<br>Slope | Natural<br>Vegetation | Microrelief<br>Disturbance<br>Erosion | Surface<br>condition,<br>surface rock | Soil Profile Description | | | | | | | | | |
|---|---|---|---|---|---|---|---|---|---|---|---|---|---|
| Grazing, Flat<br>plain <0.5% | Brigalow<br>regrowth | Extensive<br>clearing,<br>Melon holes,<br>0.40m deep,<br>3-6m 50%<br>coverage | Cracking 2-<br>10mm, no<br>coarse<br>fragments | A1<br>0.00-0.10<br>Abrupt | Light clay | Moderate,<br>firm, 3-<br>10mm sub-<br>angular | Nil | 10YR3/2<br>Very dark greyish<br>brown | Dry, well<br>drained | Very few, very<br>fine | 0.10 / 7.0 | No samples<br>taken | Mound |

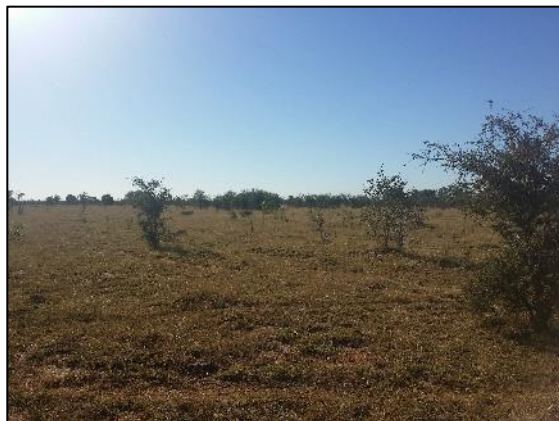
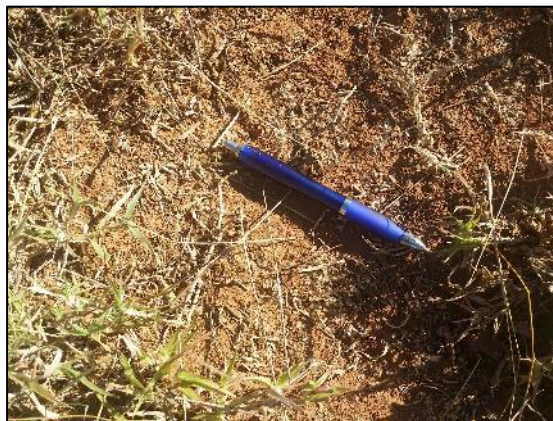
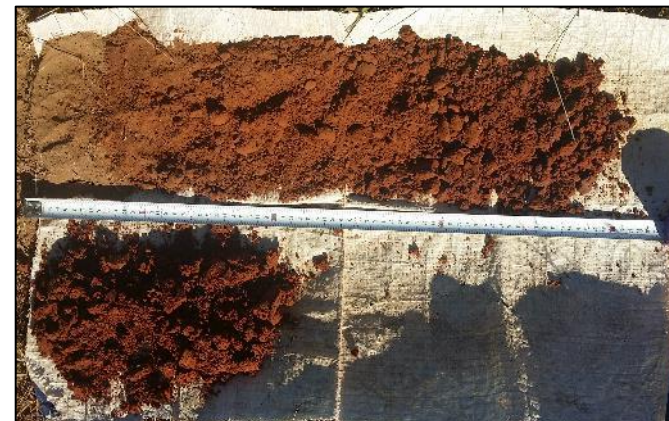
Landscape

Surface

Soil Profile

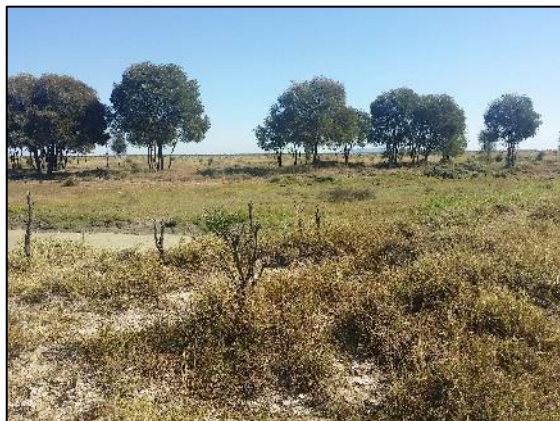
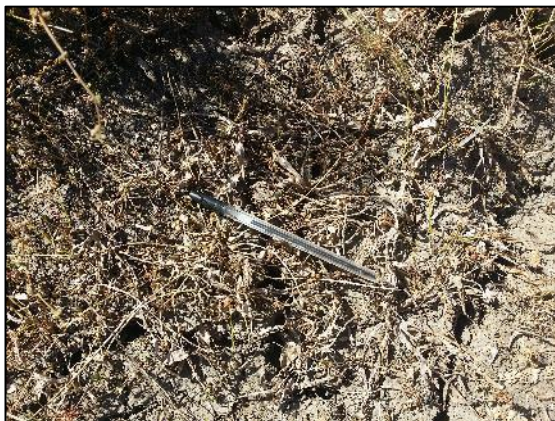
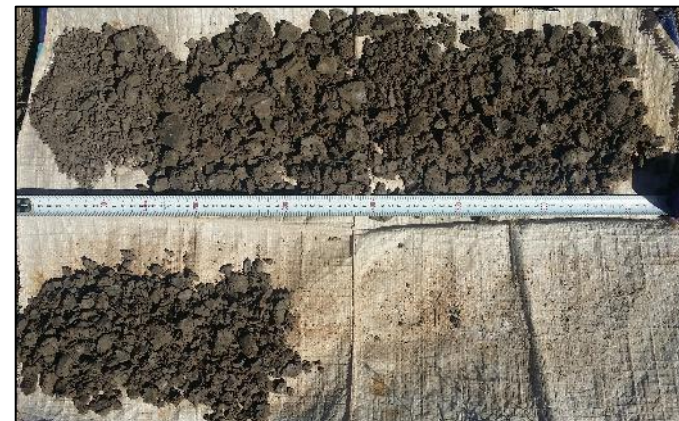
Landscape

Surface

Soil Profile

| Land use<br>Landform<br>Pattern,<br>Element,<br>Slope | Natural<br>Vegetation | Microrelief<br>Disturbance<br>Erosion | Surface<br>condition,<br>surface rock | Soil Profile Description | | | | | | | | | |
|---|---|---|---|---|---|---|---|---|---|---|---|---|---|
| Grazing, Flat<br>plain <0.5% | Brigalow<br>regrowth | Extensive<br>clearing,<br>Melon holes,<br>0.40m deep,<br>3-6m 50%<br>coverage | Cracking 2-<br>10mm, no<br>coarse<br>fragments | A1<br>0.00-0.11<br>Abrupt | Light clay | Moderate,<br>firm, 3-<br>10mm sub-<br>angular | Nil | 10YR3/2<br>Very dark greyish<br>brown | Dry, well<br>drained | Very few, very<br>fine | 0.10 / 7.0 | No samples<br>taken | Mound |

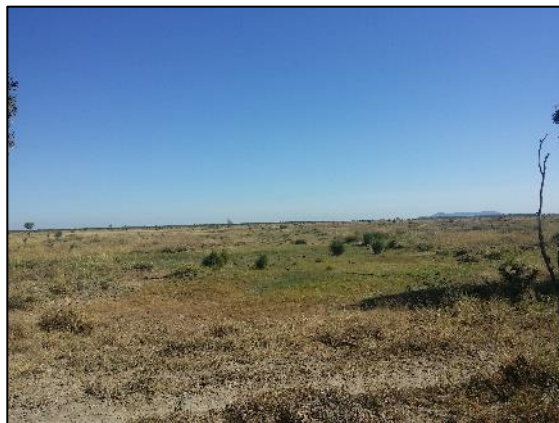
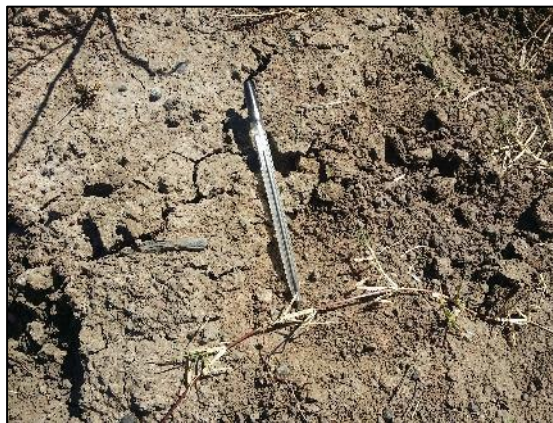
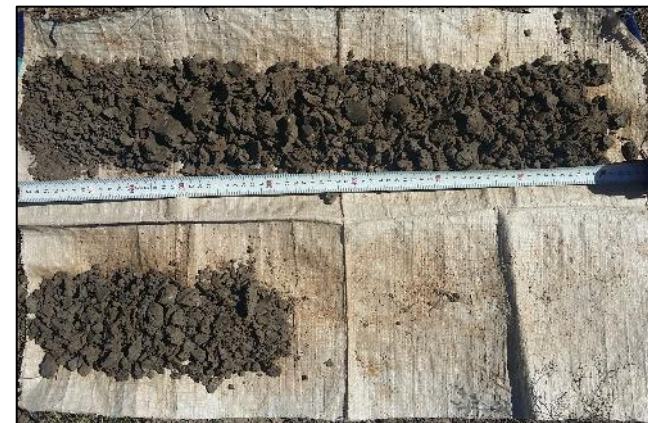
Landscape

Surface

Soil Profile

| Land use<br>Landform<br>Pattern,<br>Element,<br>Slope | Natural<br>Vegetation | Microrelief<br>Disturbance<br>Erosion | Surface<br>condition,<br>surface rock | Soil Profile Description | | | | | | | | | |
|---|---|---|---|---|---|---|---|---|---|---|---|---|---|
| Grazing,<br>Very gently<br>undulating<br>plain, mid-<br>slope 1.0% | Brigalow<br>regrowth | Extensive<br>clearing,<br>Melon holes,<br>0.40m deep,<br>3-6m 50%<br>coverage | Cracking 2-<br>10mm, no<br>coarse<br>fragments | A1<br>0.00-0.11<br>Abrupt | Light clay | Moderate,<br>firm, 3-<br>10mm sub-<br>angular | Nil | 10YR3/2<br>Very dark greyish<br>brown | Dry, well<br>drained | Very few, very<br>fine | 0.10 / 7.0 | No samples<br>taken | Depression |

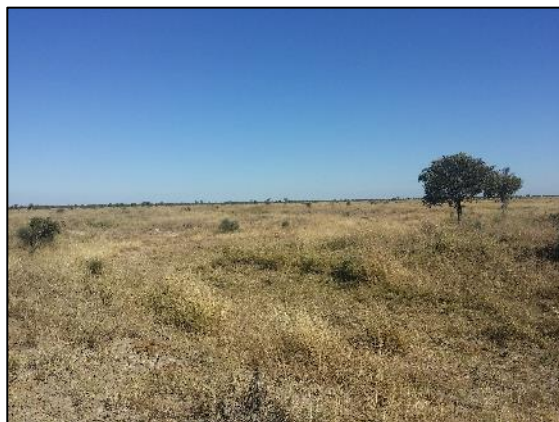
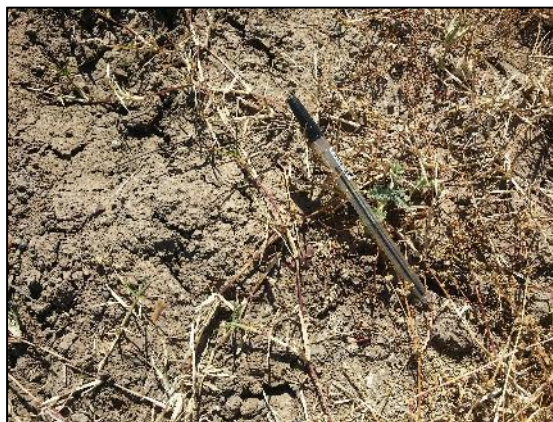
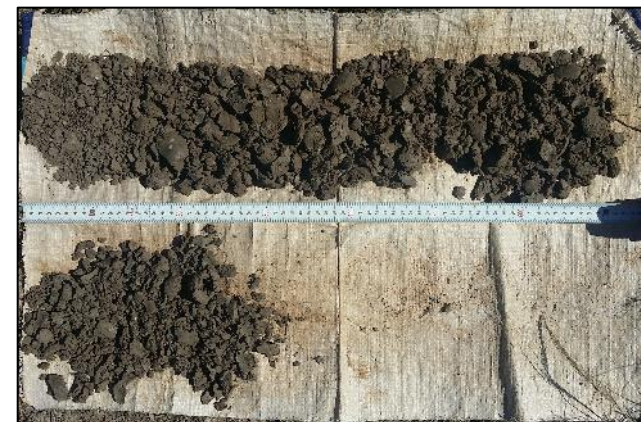
Landscape

Surface

Soil Profile

| Land use<br>Landform<br>Pattern,<br>Element,<br>Slope | Natural<br>Vegetation | Microrelief<br>Disturbance<br>Erosion | Surface<br>condition,<br>surface rock | Soil Profile Description | | | | | | | | | |
|---|---|---|---|---|---|---|---|---|---|---|---|---|---|
| Grazing,<br>Very gently<br>undulating<br>plain, mid-<br>slope 1.0% | Brigalow<br>regrowth | Extensive<br>clearing,<br>Melon holes,<br>0.40m deep,<br>3-6m 50%<br>coverage | Cracking 2-<br>10mm, no<br>coarse<br>fragments | A1<br>0.00-0.13<br>Abrupt | Light clay | Moderate,<br>firm, 3-<br>10mm sub-<br>angular | Nil | 10YR3/2<br>Very dark greyish<br>brown | Dry, well<br>drained | Very few, very<br>fine | 0.10 / 7.0 | No samples<br>taken | Mound |

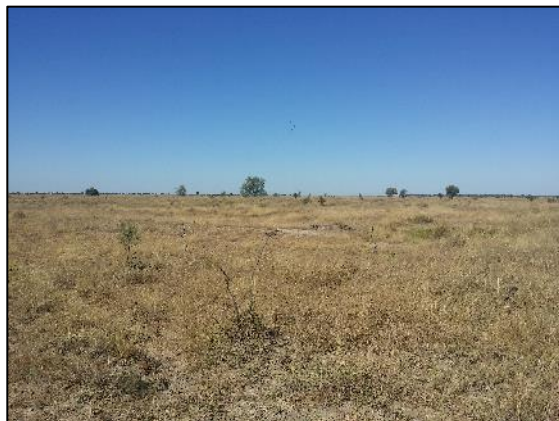
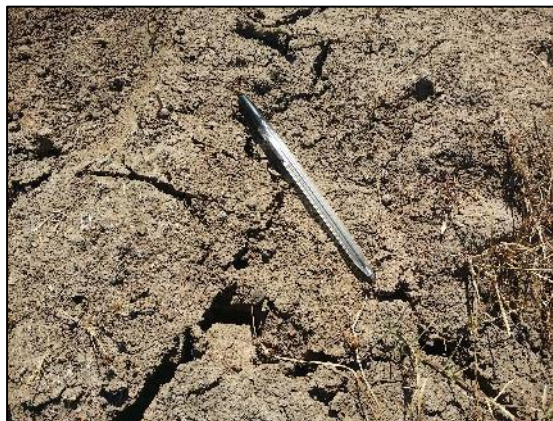
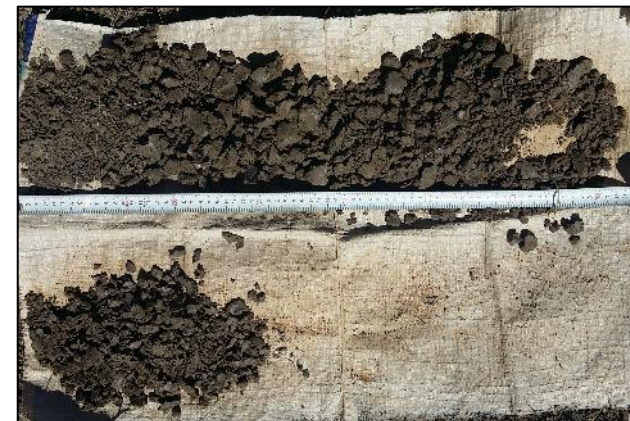
Landscape

Surface

Soil Profile

| Land use<br>Landform<br>Pattern,<br>Element,<br>Slope | Natural<br>Vegetation | Microrelief<br>Disturbance<br>Erosion | Surface<br>condition,<br>surface rock | Soil Profile Description | | | | | | | | | |
|---|---|---|---|---|---|---|---|---|---|---|---|---|---|
| Grazing,<br>Very gently<br>undulating<br>plains, mid<br>slope <1.0% | Brigalow<br>regrowth | Extensive<br>clearing,<br>Melon holes,<br>0.40m deep,<br>3-6m 50%<br>coverage | Cracking 2-<br>10mm, no<br>coarse<br>fragments | A1<br>0.00-0.10<br>Abrupt | Light clay | Moderate,<br>firm, 3-<br>10mm sub-<br>angular | Nil | 10YR3/2<br>Very dark greyish<br>brown | Dry, well<br>drained | Very few, very<br>fine | 0.10 / 7.0 | No samples<br>taken | Depression |

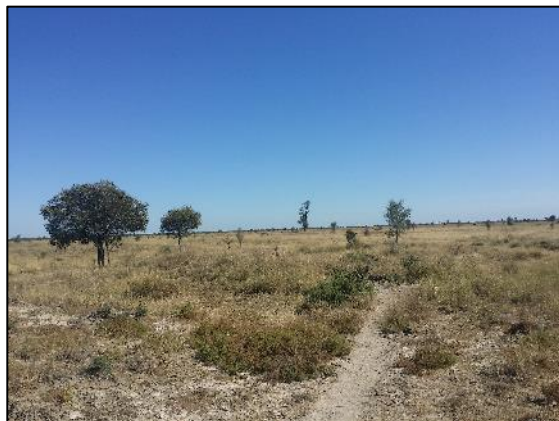
Landscape

| Land use<br>Landform<br>Pattern,<br>Element,<br>Slope | Natural<br>Vegetation | Microrelief<br>Disturbance<br>Erosion | Surface<br>condition,<br>surface rock | Soil Profile Description | | | | | | | | | |
|---|---|---|---|---|---|---|---|---|---|---|---|---|---|
| Grazing,<br>Very gently<br>undulating<br>plains, mid<br>slope <1.0% | Brigalow<br>regrowth | Extensive<br>clearing,<br>Melon holes,<br>0.40m deep,<br>3-6m 50%<br>coverage | Cracking 2-<br>10mm, no<br>coarse<br>fragments | A1<br>0.00-0.11<br>Abrupt | Light clay | Moderate,<br>firm, 3-<br>10mm sub-<br>angular | Nil | 10YR3/2<br>Very dark greyish<br>brown | Dry, well<br>drained | Very few, very<br>fine | 0.10 / 7.0 | No samples<br>taken | Mound |

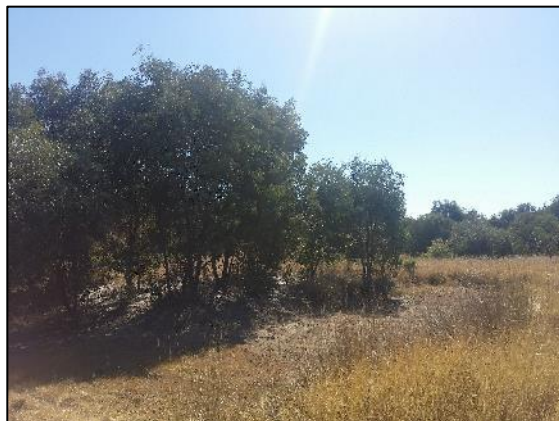
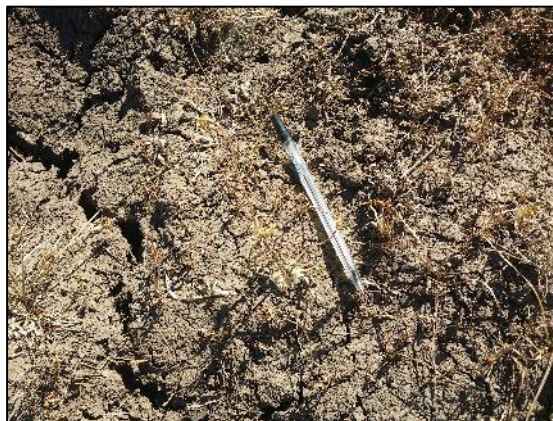
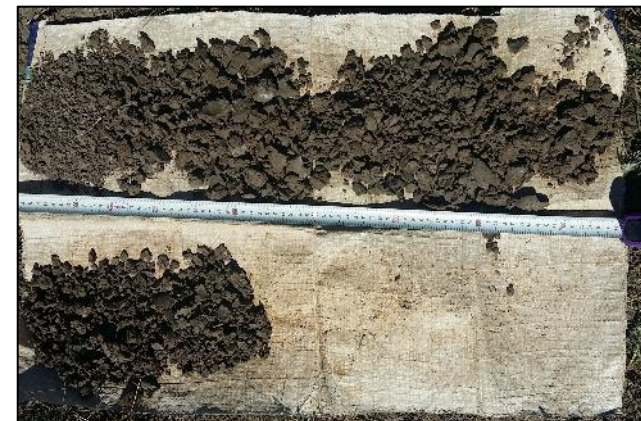
| <b>Soil Mapping Unit:</b><br>C1 | <b>CSIRO Land Systems (Gunn et al 1967):</b><br>Somerby, Monteagle, Connors,<br>Humboldt, Blackwater, Junee | <b>Location (GDA ZONE 55):</b><br>663668 mE 7529201 mN | <b>Aust. Soil Class. :</b><br>Endohypersodic Brown Vertosol | <b>Site Survey Type:</b><br>Detailed - 50mm hand auger | <b>Survey Date:</b><br>30/7/2017 |

| Land use<br>Landform<br>Pattern,<br>Element,<br>Slope | Natural<br>Vegetation | Microrelief<br>Disturbance<br>Erosion | Surface<br>condition,<br>surface rock | Soil Profile Description | | | | | | | | | |
|---|---|---|---|---|---|---|---|---|---|---|---|---|---|
| Grazing,<br>Very gently<br>undulating<br>plains, mid<br>slope <1.0% | Brigalow<br>regrowth | Extensive<br>clearing,<br>Melon holes,<br>0.40m deep,<br>3-6m 50%<br>coverage | Cracking 2-<br>10mm, no<br>coarse<br>fragments | A1<br>0.00-0.10<br>Abrupt | Light clay | Moderate,<br>firm, 3-<br>10mm sub-<br>angular | Nil | 10YR3/2<br>Very dark greyish<br>brown | Dry, well<br>drained | Very few, very<br>fine | 0.10 / 7.0 | No samples<br>taken | Mound |

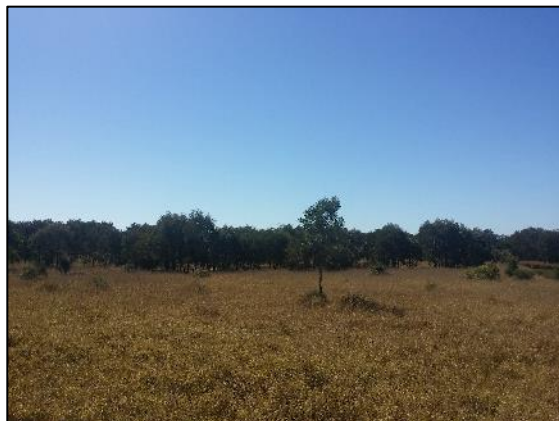
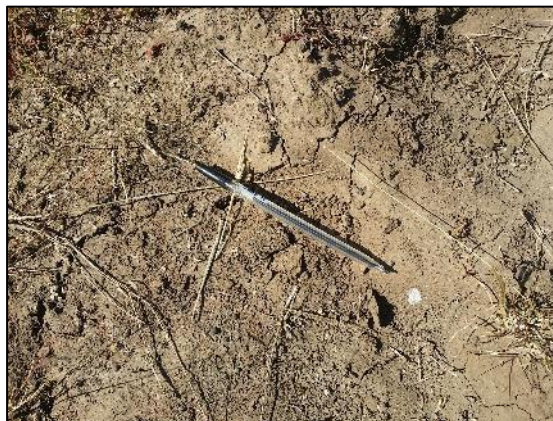
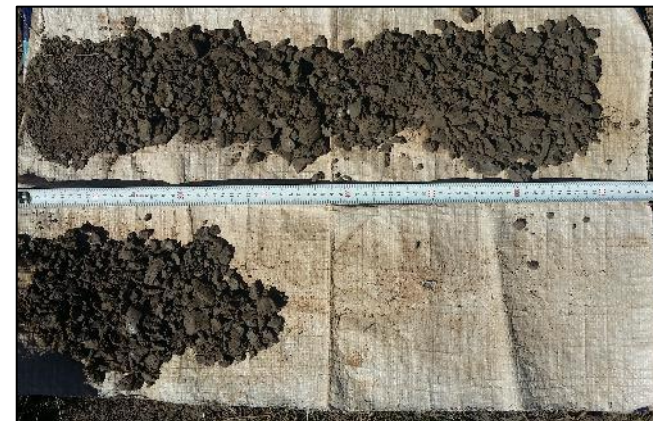
| <b>Soil Mapping Unit:</b><br>C1 | <b>CSIRO Land Systems (Gunn et al 1967):</b><br>Somerby, Monteagle, Connors,<br>Humboldt, Blackwater, Juneee | <b>Location (GDA ZONE 55):</b><br>664015 mE 7527856 mN | <b>Aust. Soil Class. :</b><br>Endohypersodic Brown Vertosol | <b>Site Survey Type:</b><br>Detailed - 50mm hand auger | <b>Survey Date:</b><br>30/7/2017 |

| Land use<br>Landform<br>Pattern,<br>Element,<br>Slope | Natural<br>Vegetation | Microrelief<br>Disturbance<br>Erosion | Surface<br>condition,<br>surface rock | Soil Profile Description | | | | | | | | | |
|---|---|---|---|---|---|---|---|---|---|---|---|---|---|
| Grazing,<br>Very gently<br>undulating<br>plains, lower<br>slope 1.0% | Brigalow<br>regrowth | Extensive<br>clearing,<br>Melon holes,<br>0.40m deep,<br>3-6m 50%<br>coverage | Cracking 2-<br>10mm, no<br>coarse<br>fragments | A1<br>0.00-0.10<br>Abrupt | Light clay | Moderate,<br>firm, 3-<br>10mm sub-<br>angular | Nil | 10YR3/2<br>Very dark greyish<br>brown | Dry, well<br>drained | Very few, very<br>fine | 0.10 / 7.0 | No samples<br>taken | No additional<br>observations |

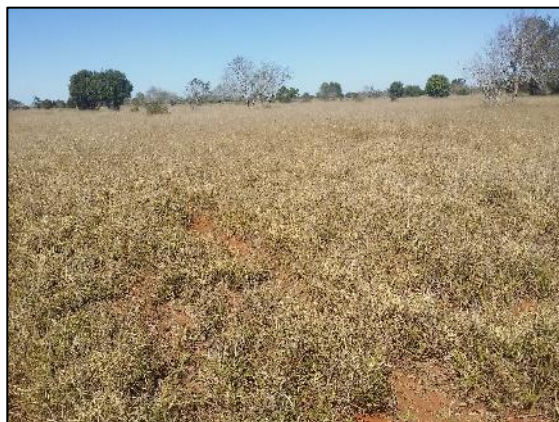
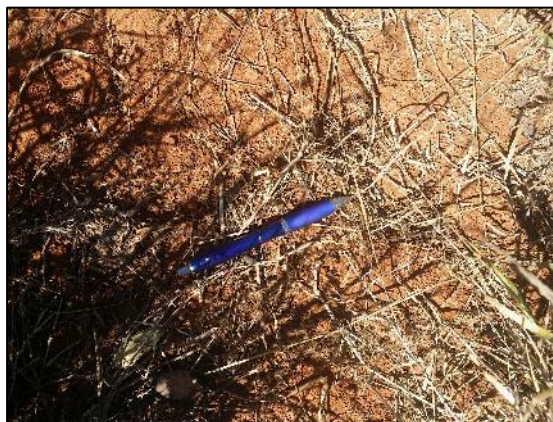
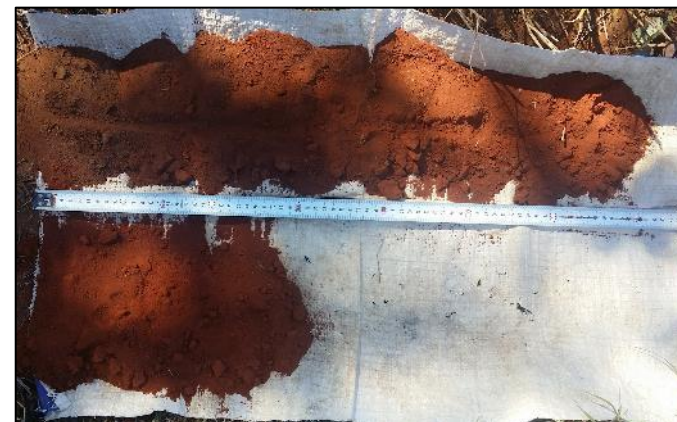
| <b>Soil Mapping Unit:</b><br>R1 | <b>CSIRO Land Systems (Gunn et al 1967):</b><br>Somerby, Monteagle, Connors,<br>Humboldt, Blackwater, Junee | <b>Location (GDA ZONE 55):</b><br>664274 mE 7527288 mN | <b>Aust. Soil Class. :</b><br>Red Rudosol | <b>Site Survey Type:</b><br>Detailed - 50mm hand auger | <b>Survey Date:</b><br>30/7/2017 |

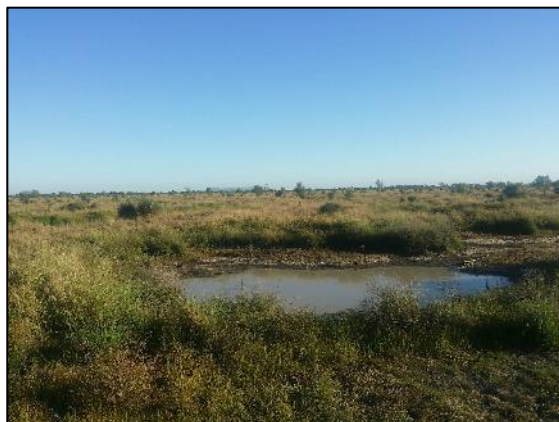
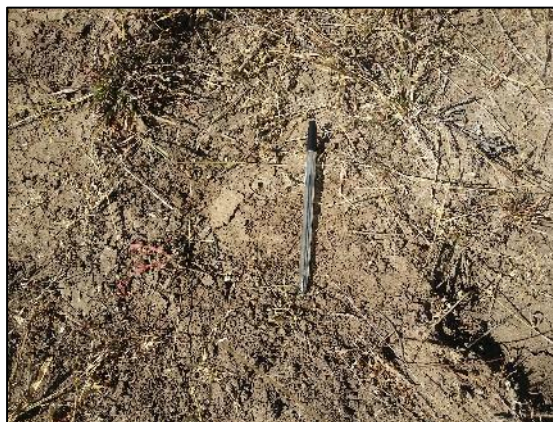
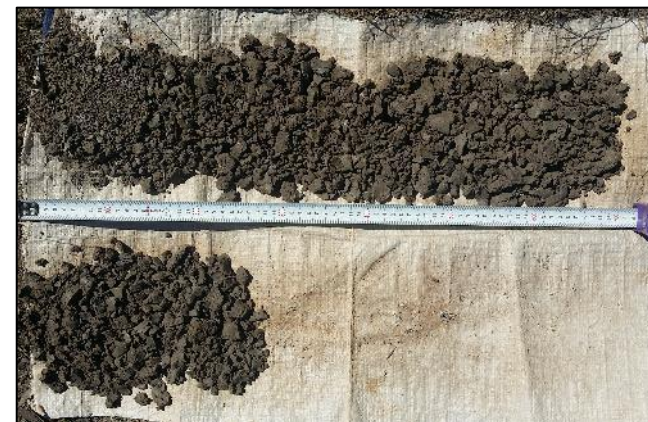
| <b>Soil Mapping Unit:</b><br>C1 | <b>CSIRO Land Systems (Gunn et al 1967):</b><br>Somerby, Monteagle, Connors,<br>Humboldt, Blackwater, Junee | <b>Location (GDA ZONE 55):</b><br>662583 mE 7526662 mN | <b>Aust. Soil Class. :</b><br>Endohypersodic Brown Vertosol | <b>Site Survey Type:</b><br>Detailed - 50mm hand auger | <b>Survey Date:</b><br>/7/2017 |

| Land use<br>Landform<br>Pattern,<br>Element,<br>Slope | Natural<br>Vegetation | Microrelief<br>Disturbance<br>Erosion | Surface<br>condition,<br>surface rock | Soil Profile Description | | | | | | | | | |
|---|---|---|---|---|---|---|---|---|---|---|---|---|---|
| Grazing, Flat<br>plain <0.5% | Sparse<br>Brigalow<br>regrowth | Extensive<br>clearing,<br>Melon holes,<br>0.40m deep,<br>3-6m 50%<br>coverage | Cracking 2-<br>10mm, no<br>coarse<br>fragments | A1<br>0.00-0.10<br>Abrupt | Light clay | Moderate,<br>firm, 3-<br>10mm sub-<br>angular | Nil | 10YR3/2<br>Very dark greyish<br>brown | Dry, well<br>drained | Very few, very<br>fine | 0.10 / 7.0 | No samples<br>taken | Mound |

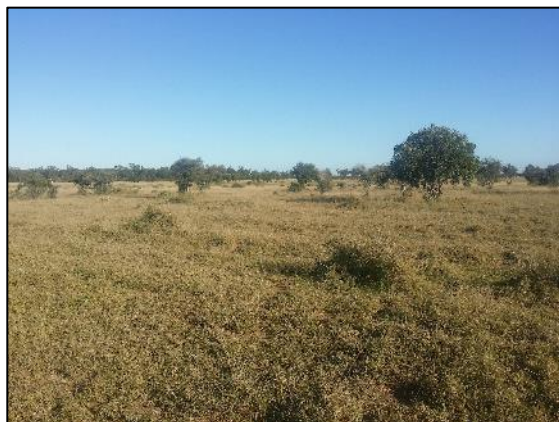
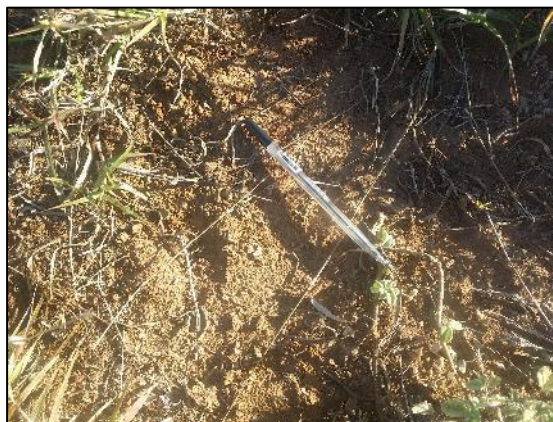
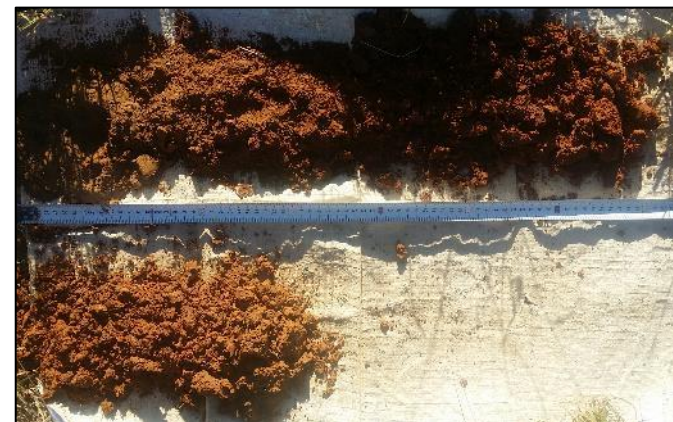
| <b>Soil Mapping Unit:</b><br>R2 | <b>CSIRO Land Systems (Gunn et al 1967):</b><br>Somerby, Monteagle, Humboldt,<br>Blackwater, Junee | <b>Location (GDA ZONE 55):</b><br>661088 mE 7525448 mN | <b>Aust. Soil Class. :</b><br>Haplic Red Chromosol | <b>Site Survey Type:</b><br>Detailed - 50mm hand auger | <b>Survey Date:</b><br>30/7/2017 |

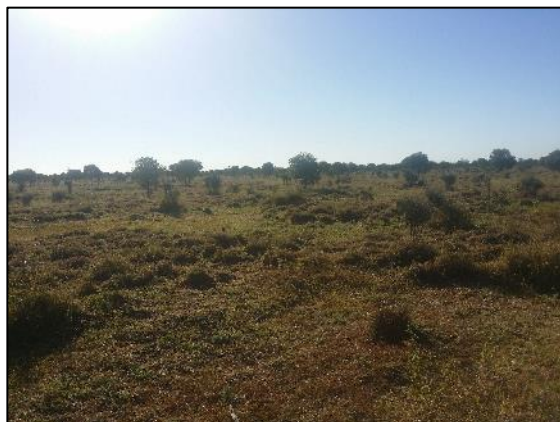
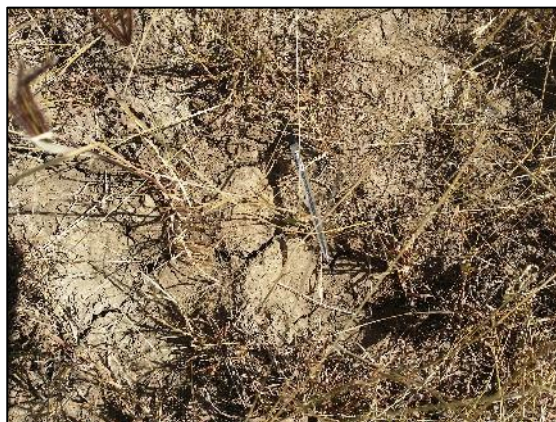
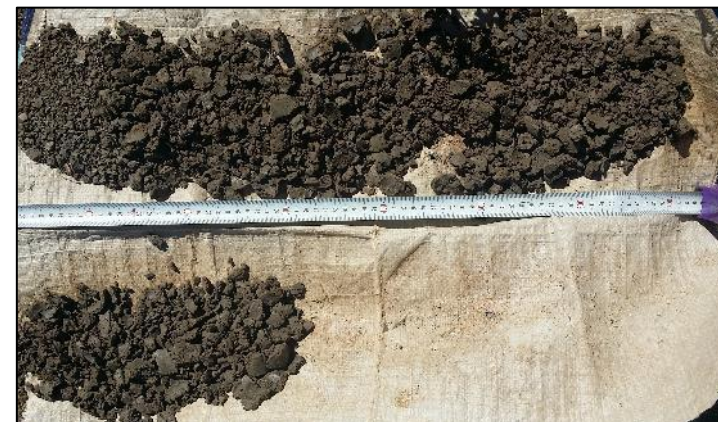
| <b>Soil Mapping Unit:</b><br>C1 | <b>CSIRO Land Systems (Gunn et al 1967):</b><br>Somerby, Monteagle, Connors,<br>Humboldt, Blackwater, Junee | <b>Location (GDA ZONE 55):</b><br>661208 mE 7524699 mN | <b>Aust. Soil Class. :</b><br>Endohypersodic Brown Vertosol | <b>Site Survey Type:</b><br>Detailed - 50mm hand auger | <b>Survey Date:</b><br>31/7/2017 |

| Land use<br>Landform<br>Pattern,<br>Element,<br>Slope | Natural<br>Vegetation | Microrelief<br>Disturbance<br>Erosion | Surface<br>condition,<br>surface rock | Soil Profile Description | | | | | | | | | |
|---|---|---|---|---|---|---|---|---|---|---|---|---|---|
| Grazing,<br>Very gently<br>undulating<br>plains, upper<br>slope 1.0% | Brigalow<br>regrowth | Extensive<br>clearing,<br>Melon holes,<br>0.40m deep,<br>3-6m 50%<br>coverage | Cracking 2-<br>10mm, no<br>coarse<br>fragments | A1<br>0.00-0.10<br>Abrupt | Light clay | Moderate,<br>firm, 3-<br>10mm sub-<br>angular | Nil | 10YR3/2<br>Very dark greyish<br>brown | Dry, well<br>drained | Very few, very<br>fine | 0.10 / 7.0 | No samples<br>taken | Depression |

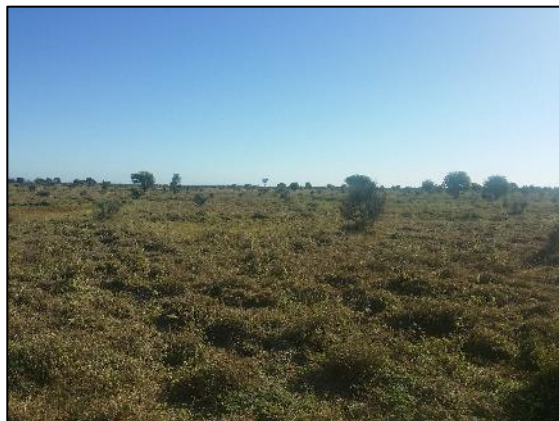
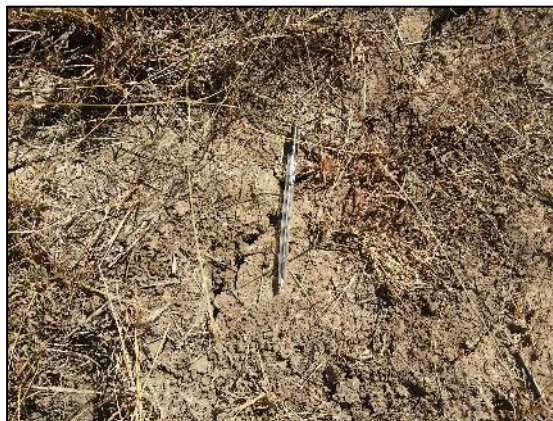
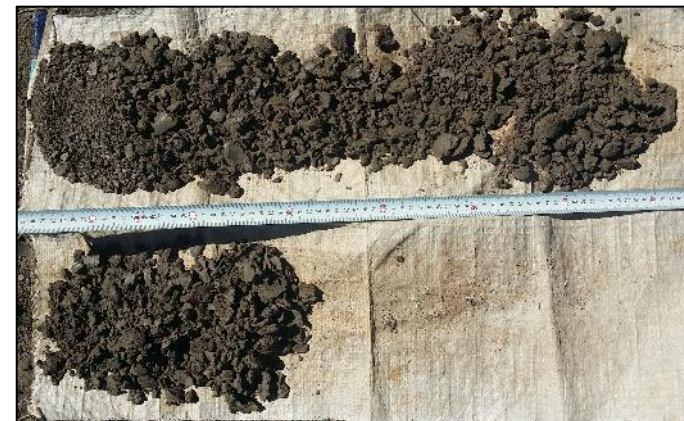
| <b>Soil Mapping Unit:</b><br>C1 | <b>CSIRO Land Systems (Gunn et al 1967):</b><br>Somerby, Monteagle, Connors,<br>Humboldt, Blackwater, Junee | <b>Location (GDA ZONE 55):</b><br>662277 mE 7523306 mN | <b>Aust. Soil Class. :</b><br>Endohypersodic Brown Vertosol | <b>Site Survey Type:</b><br>Detailed - 50mm hand auger | <b>Survey Date:</b><br>/7/2017 |

| Land use<br>Landform<br>Pattern,<br>Element,<br>Slope | Natural<br>Vegetation | Microrelief<br>Disturbance<br>Erosion | Surface<br>condition,<br>surface rock | Soil Profile Description | | | | | | | | | |
|---|---|---|---|---|---|---|---|---|---|---|---|---|---|
| Grazing,<br>Very gently<br>undulating<br>plains, mid-<br>slope 1.0% | Brigalow<br>regrowth | Extensive<br>clearing,<br>Melon holes,<br>0.40m deep,<br>3-6m 50%<br>coverage | Cracking 2-<br>10mm, no<br>coarse<br>fragments | A1<br>0.00-0.09<br>Abrupt | Light clay | Moderate,<br>firm, 3-<br>10mm sub-<br>angular | Nil | 10YR3/2<br>Very dark greyish<br>brown | Dry, well<br>drained | Very few, very<br>fine | 0.10 / 7.0 | No samples<br>taken | Mound |

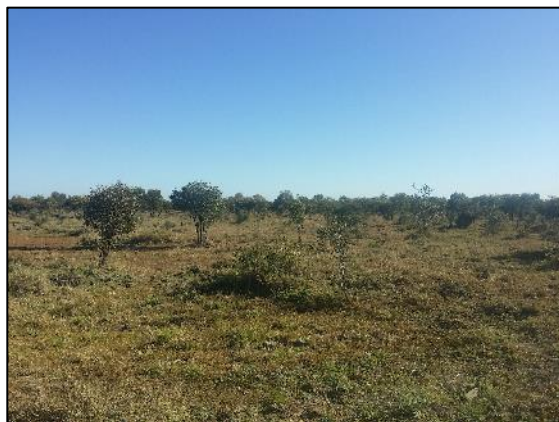
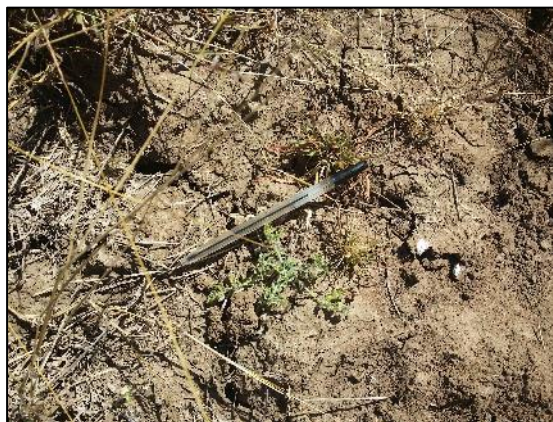
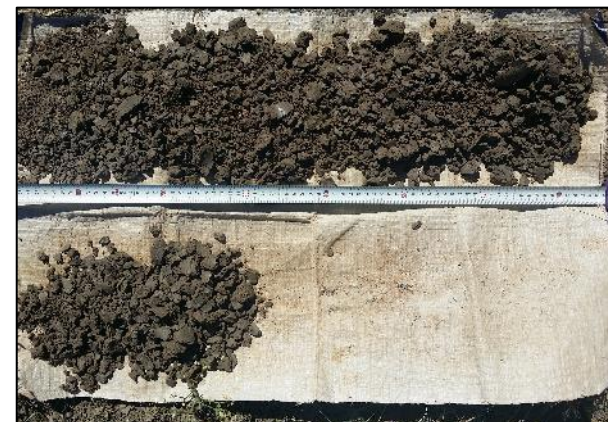
| <b>Soil Mapping Unit:</b><br>C1 | <b>CSIRO Land Systems (Gunn et al 1967):</b><br>Somerby, Monteagle, Connors,<br>Humboldt, Blackwater, Junee | <b>Location (GDA ZONE 55):</b><br>663573 mE 7523798 mN | <b>Aust. Soil Class. :</b><br>Endohypersodic Brown Vertosol | <b>Site Survey Type:</b><br>Detailed - 50mm hand auger | <b>Survey Date:</b><br>31/7/2017 |

| Land use<br>Landform<br>Pattern,<br>Element,<br>Slope | Natural<br>Vegetation | Microrelief<br>Disturbance<br>Erosion | Surface<br>condition,<br>surface rock | Soil Profile Description | | | | | | | | | |
|---|---|---|---|---|---|---|---|---|---|---|---|---|---|
| Grazing,<br>Very gently<br>undulating<br>plains, mid-<br>slope 1.0% | Brigalow<br>regrowth | Extensive<br>clearing,<br>Melon holes,<br>0.40m deep,<br>3-6m 50%<br>coverage | Cracking 2-<br>10mm, no<br>coarse<br>fragments | A1<br>0.00-0.09<br>Abrupt | Light clay | Moderate,<br>firm, 3-<br>10mm sub-<br>angular | Nil | 10YR3/2<br>Very dark greyish<br>brown | Dry, well<br>drained | Very few, very<br>fine | 0.10 / 7.0 | No samples<br>taken | Depression |

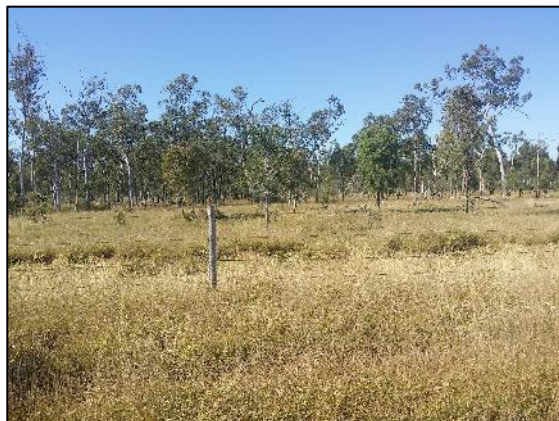
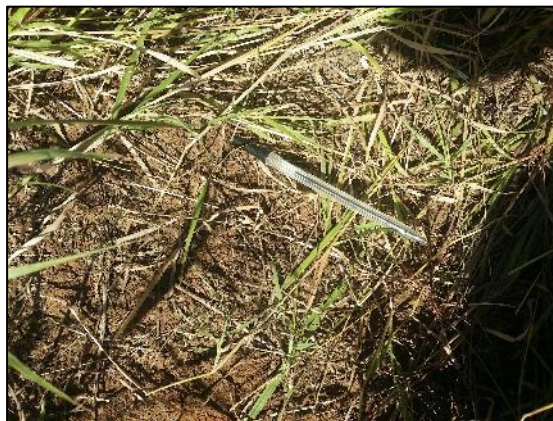
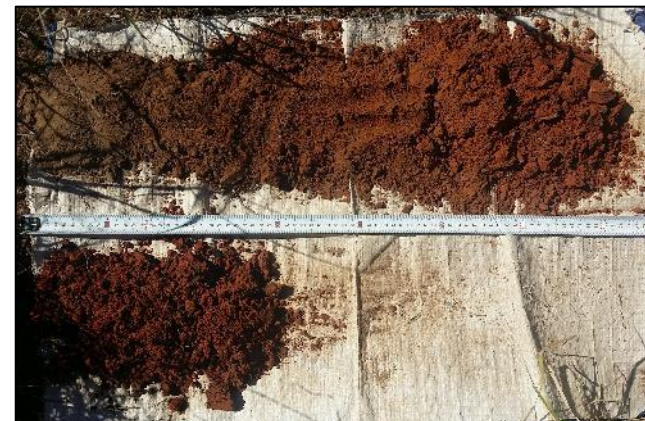
| <b>Soil Mapping Unit:</b><br>R2 | <b>CSIRO Land Systems (Gunn et al 1967):</b><br>Somerby, Monteagle, Humboldt,<br>Blackwater, Junee | <b>Location (GDA ZONE 55):</b><br>661705 mE 7521700 mN | <b>Aust. Soil Class. :</b><br>Haplic Red Chromosol | <b>Site Survey Type:</b><br>Detailed - 50mm hand auger | <b>Survey Date:</b><br>31/7/2017 |

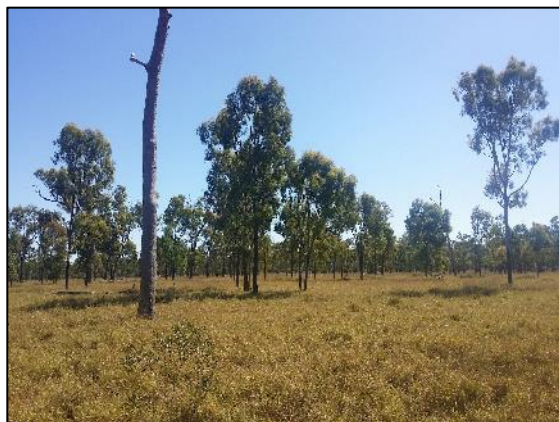
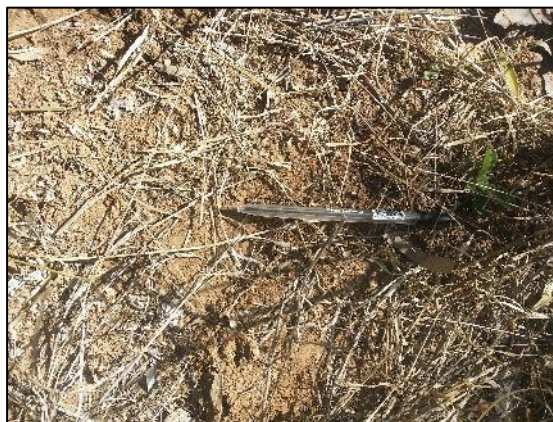
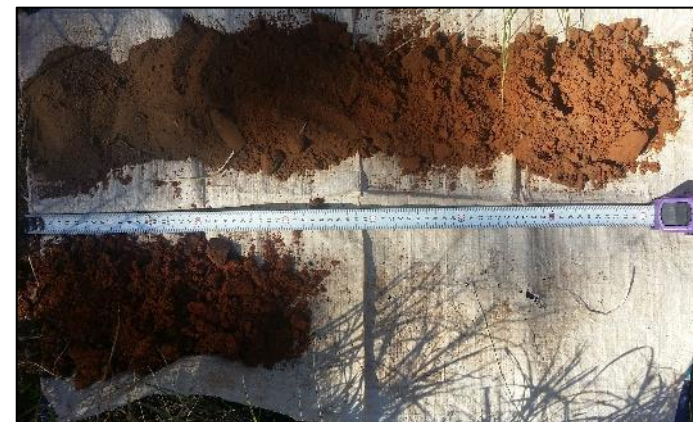
| <b>Soil Mapping Unit:</b><br>R2 | <b>CSIRO Land Systems (Gunn et al 1967):</b><br>Somerby, Monteagle, Humboldt,<br>Blackwater, Junee | <b>Location (GDA ZONE 55):</b><br>660701 mE 7520607 mN | <b>Aust. Soil Class. :</b><br>Haplic Red Chromosol | <b>Site Survey Type:</b><br>Detailed - 50mm hand auger | <b>Survey Date:</b><br>31/7/2017 |

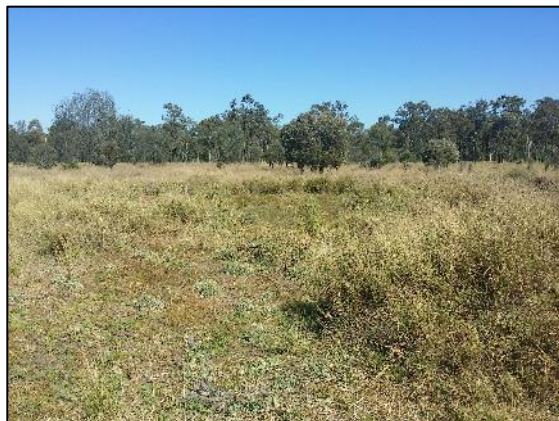
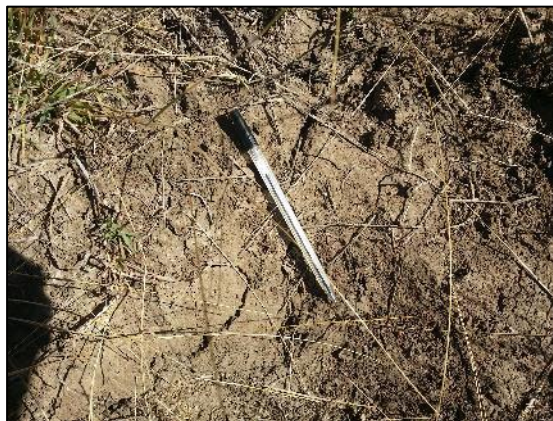
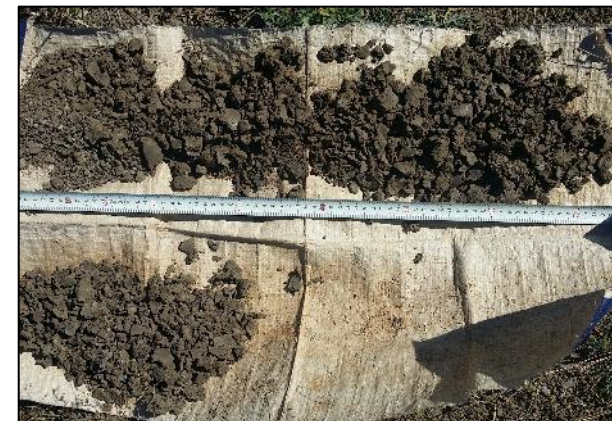
| <b>Soil Mapping Unit:</b><br>C2 | <b>CSIRO Land Systems (Gunn et al 1967):</b><br>Somerby, Monteagle, Connors,<br>Humboldt, Blackwater, Junee | <b>Location (GDA ZONE 55):</b><br>658969 mE 7520534 mN | <b>Aust. Soil Class. :</b><br>Brown Vertosol | <b>Site Survey Type:</b><br>Detailed - 50mm hand auger | <b>Survey Date:</b><br>31/7/2017 |

| Land use<br>Landform<br>Pattern,<br>Element,<br>Slope | Natural<br>Vegetation | Microrelief<br>Disturbance<br>Erosion | Surface<br>condition,<br>surface rock | Soil Profile Description | | | | | | | | | |
|---|---|---|---|---|---|---|---|---|---|---|---|---|---|
| Grazing, Flat<br>plain <0.5% | Brigalow<br>regrowth | Extensive<br>clearing,<br>Melon holes,<br>0.40m deep,<br>3-6m 50%<br>coverage | Firm, cracking<br>2-10mm, no<br>coarse<br>fragments | A1<br>0.00-0.11<br>Abrupt | Light clay | Moderate,<br>firm, 3-<br>10mm sub-<br>angular | Nil | 10YR3/2<br>Very dark greyish<br>brown | Dry, well<br>drained | Very few, very<br>fine | 0.10 / 7.0 | No samples<br>taken | No additional<br>observations |

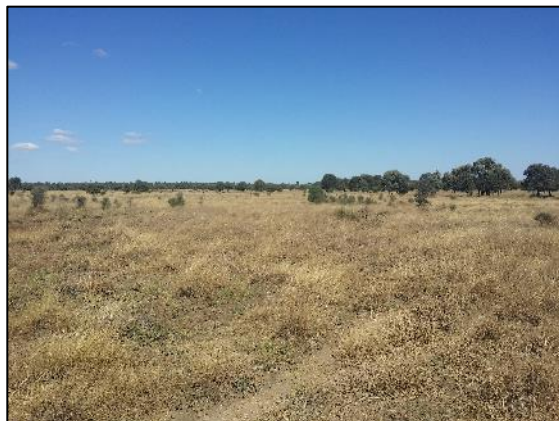
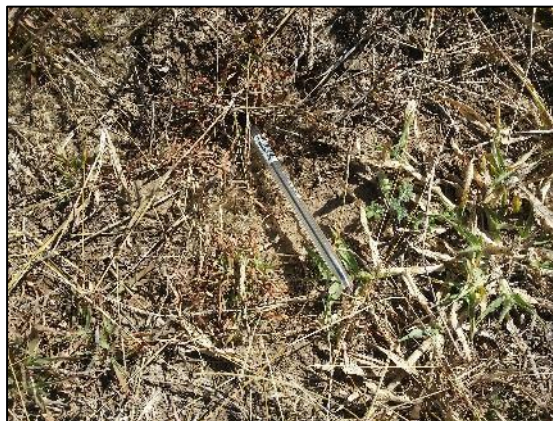
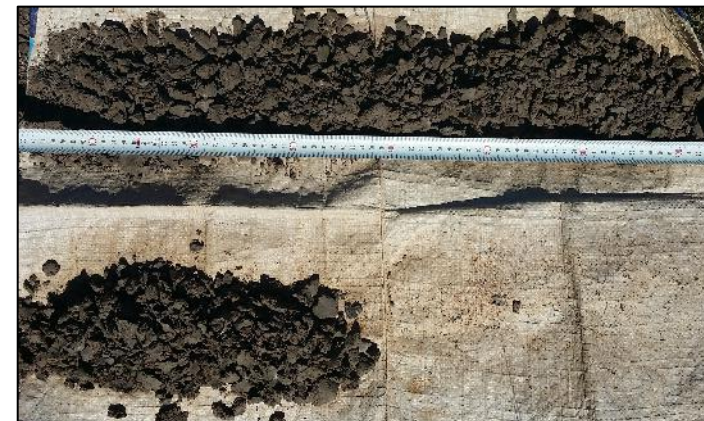
| <b>Soil Mapping Unit:</b><br>C2 | <b>CSIRO Land Systems (Gunn et al 1967):</b><br>Somerby, Monteagle, Connors,<br>Humboldt, Blackwater, Junee | <b>Location (GDA ZONE 55):</b><br>660283 mE 7522488 mN | <b>Aust. Soil Class. :</b><br>Brown Vertosol | <b>Site Survey Type:</b><br>Detailed - 50mm hand auger | <b>Survey Date:</b><br>1/8/2017 |

| Land use<br>Landform<br>Pattern,<br>Element,<br>Slope | Natural<br>Vegetation | Microrelief<br>Disturbance<br>Erosion | Surface<br>condition,<br>surface rock | Soil Profile Description | | | | | | | | | |
|---|---|---|---|---|---|---|---|---|---|---|---|---|---|
| Grazing,<br>Very gently<br>undulating<br>plain 1.0% | Brigalow<br>regrowth | Extensive<br>clearing,<br>Gilgai, 0.30m<br>deep, 3-6m<br>50% coverage | Cracking 2-<br>10mm, no<br>coarse<br>fragments | A1<br>0.00-0.11<br>Abrupt | Light clay | Moderate,<br>firm, 3-<br>10mm sub-<br>angular | Nil | 10YR3/2<br>Very dark greyish<br>brown | Dry, well<br>drained | Very few, very<br>fine | 0.10 / 7.0 | No samples<br>taken | Depression |

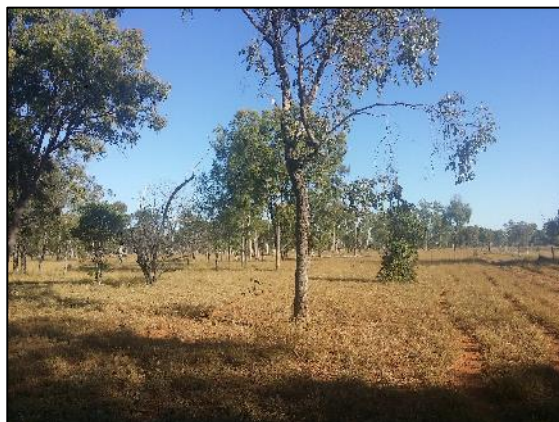
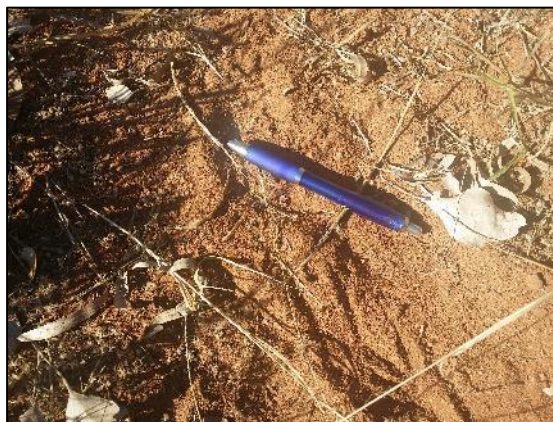
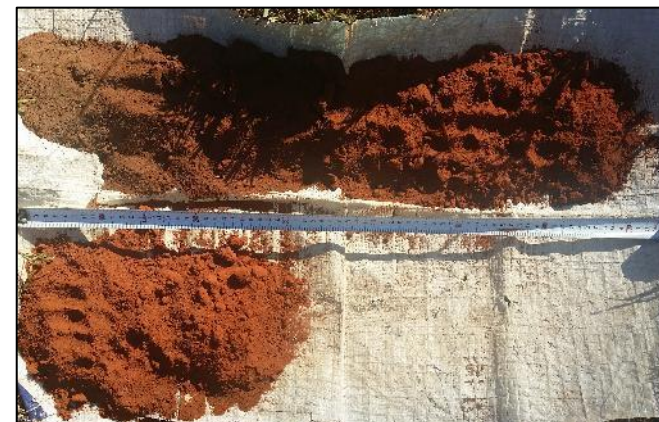
Landscape

Surface

Soil Profile

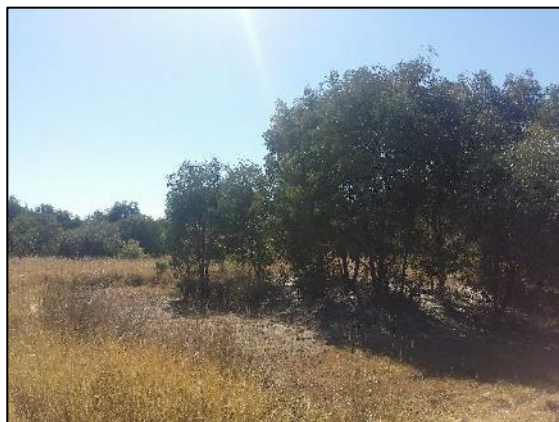
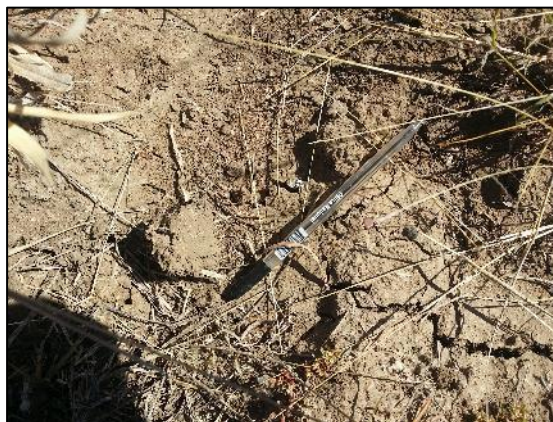
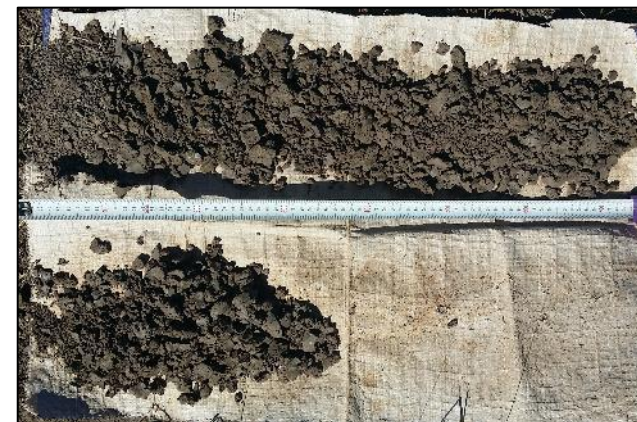
Landscape

Surface

Soil Profile

| Land use<br>Landform<br>Pattern,<br>Element,<br>Slope | Natural<br>Vegetation | Microrelief<br>Disturbance<br>Erosion | Surface<br>condition,<br>surface rock | Soil Profile Description | | | | | | | | | |
|---|---|---|---|---|---|---|---|---|---|---|---|---|---|
| Grazing, Flat<br>plain <0.5% | Brigalow<br>regrowth | Gilgai, 0.30m<br>deep, 3-6m<br>50% coverage | Cracking 2-<br>10mm, no<br>coarse<br>fragments | A1<br>0.00-0.09<br>Abrupt | Light clay | Moderate,<br>firm, 3-<br>10mm sub-<br>angular | Nil | 10YR3/2<br>Very dark greyish<br>brown | Dry, well<br>drained | Very few, very<br>fine | 0.10 / 7.0 | No samples<br>taken | Mound |

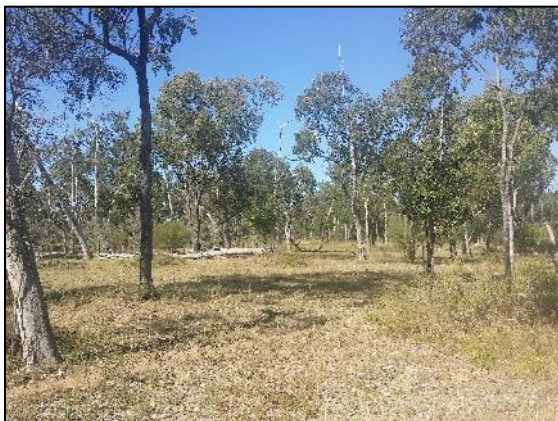
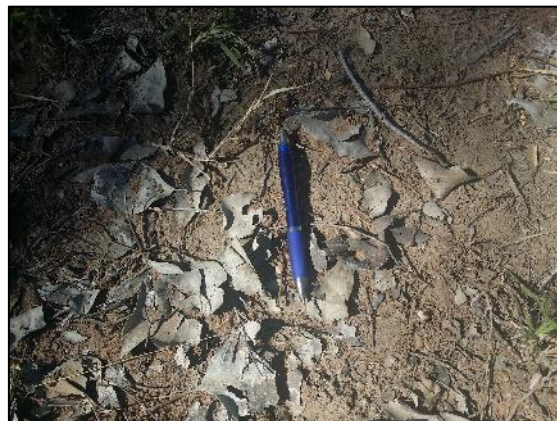
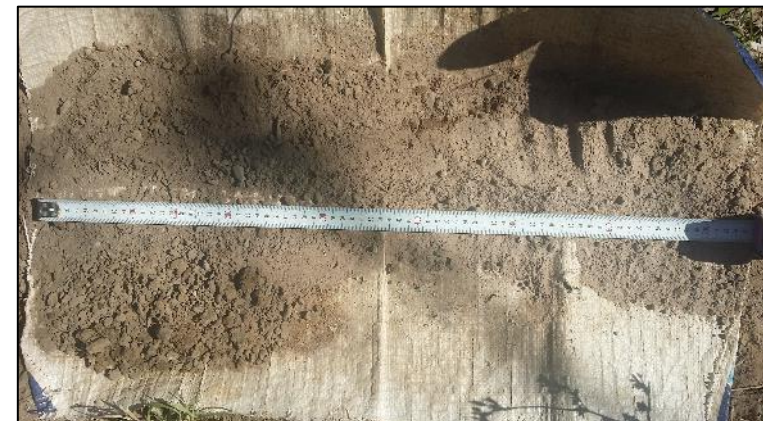
Landscape

Surface

Soil Profile

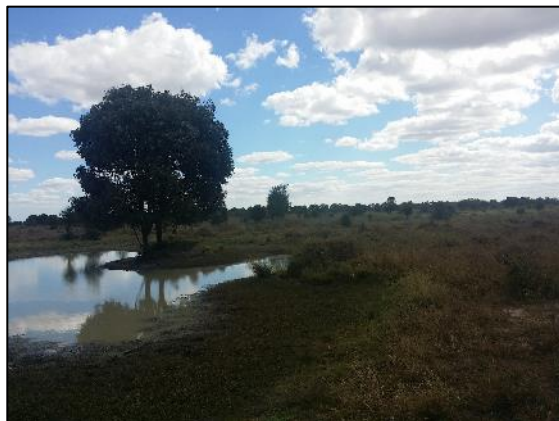
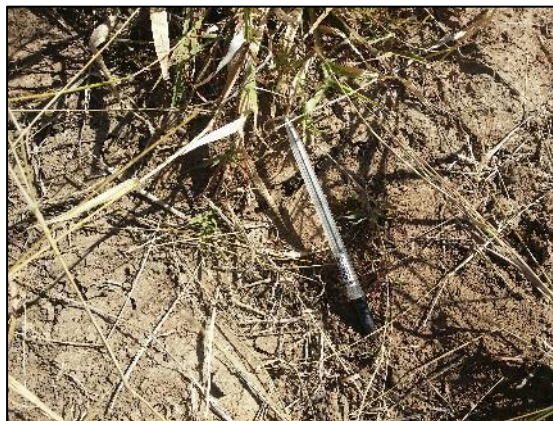
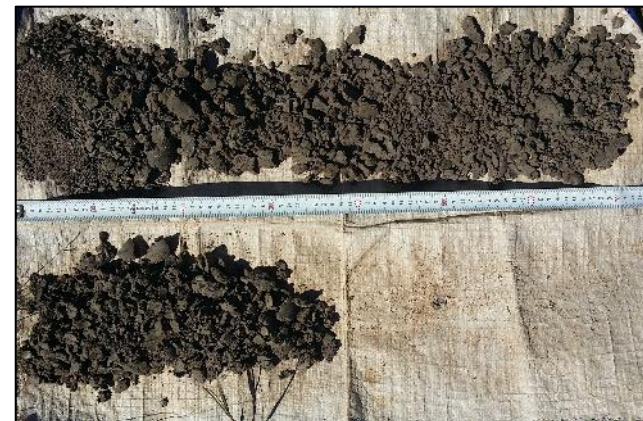
Landscape

Surface

Soil Profile

| Land use<br>Landform<br>Pattern,<br>Element,<br>Slope | Natural<br>Vegetation | Microrelief<br>Disturbance<br>Erosion | Surface<br>condition,<br>surface rock | Soil Profile Description | | | | | | | | | |
|---|---|---|---|---|---|---|---|---|---|---|---|---|---|
| Grazing, Flat<br>plain <0.5% | Brigalow<br>regrowth | Melon holes,<br>0.40m deep,<br>3-6m 50%<br>coverage | Cracking 2-<br>10mm, no<br>coarse<br>fragments | A1<br>0.00-0.10<br>Abrupt | Light clay | Moderate,<br>firm, 3-<br>10mm sub-<br>angular | Nil | 10YR3/2<br>Very dark greyish<br>brown | Dry, well<br>drained | Very few, very<br>fine | 0.10 / 7.0 | No samples<br>taken | Mound |
