**PEMBROKE**

**Olive Downs Coking Coal Project**  
Draft Environmental Impact Statement

**Appendix M**  
**Soil and Land**  
**Suitability**  
**Assessment**

Olive Downs Coking Coal Project

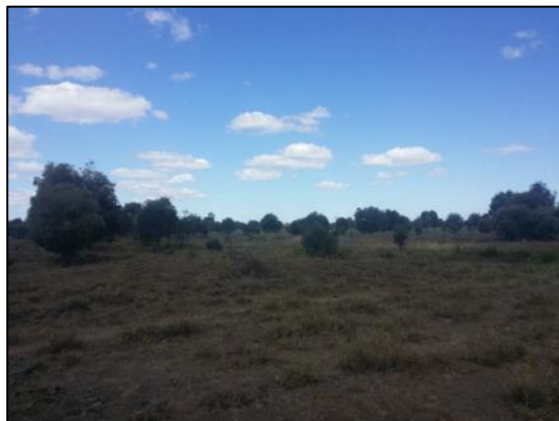
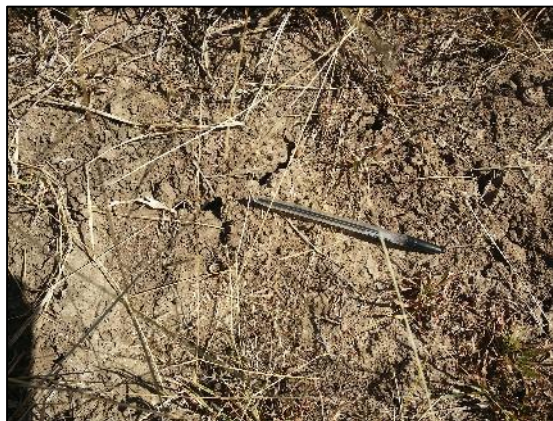
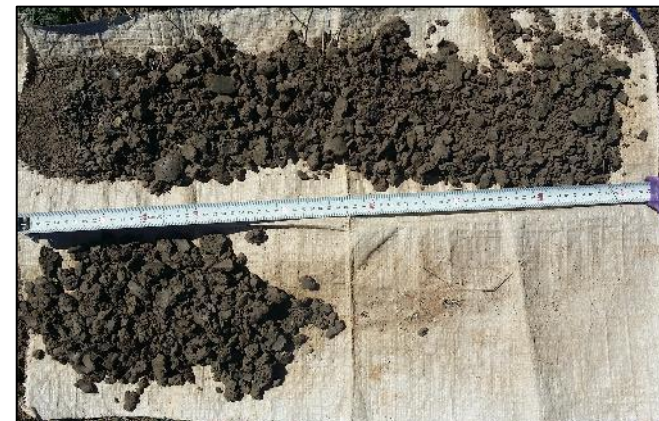
Landscape

Surface

Soil Profile

| Land use<br>Landform<br>Pattern,<br>Element,<br>Slope | Natural<br>Vegetation | Microrelief<br>Disturbance<br>Erosion | Surface<br>condition,<br>surface rock | Soil Profile Description | | | | | | | | | |
|---|---|---|---|---|---|---|---|---|---|---|---|---|---|
| Grazing, Flat<br>plain <0.5% | Brigalow<br>regrowth | Melon holes,<br>0.5m deep, 3-<br>6m 50%<br>coverage | Cracking 2-<br>10mm, no<br>coarse<br>fragments | A1<br>0.00-0.09<br>Abrupt | Light clay | Moderate,<br>firm, 3-<br>10mm sub-<br>angular | Nil | 10YR3/2<br>Very dark greyish<br>brown | Dry, well<br>drained | Very few, very<br>fine | 0.10 / 7.0 | No samples<br>taken | Depression |

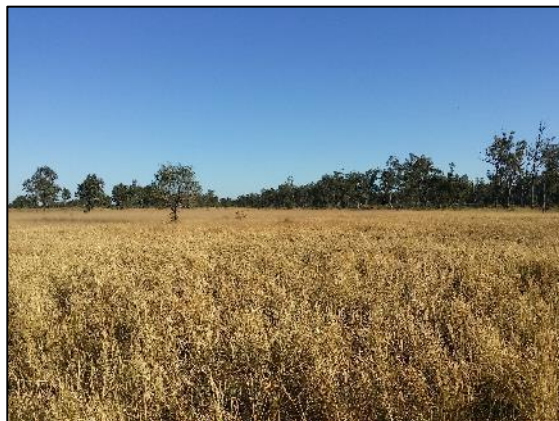
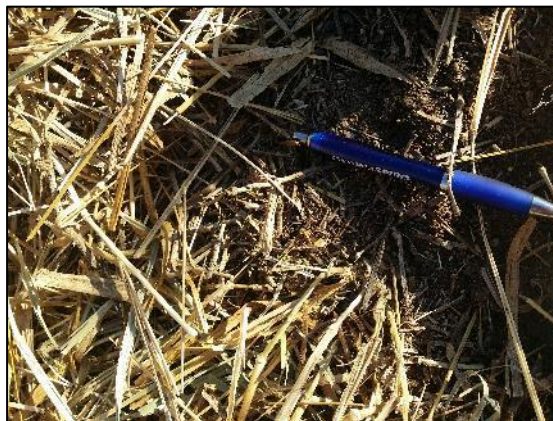
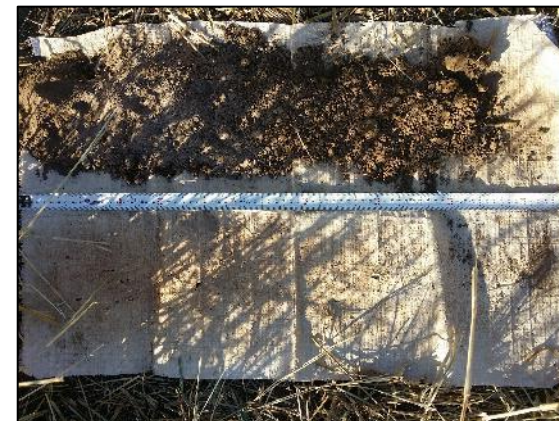
Landscape

Surface

Soil Profile

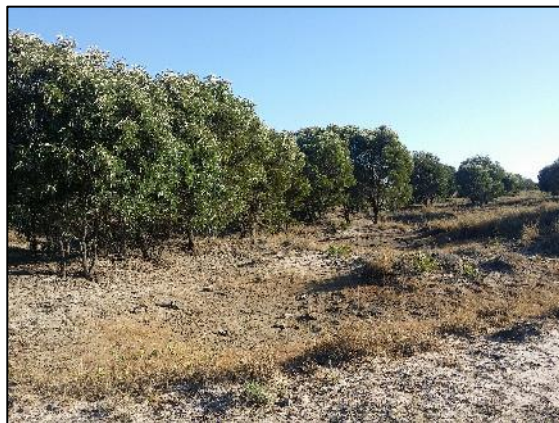
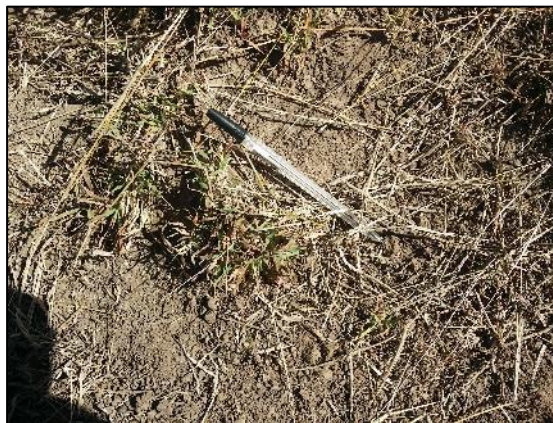
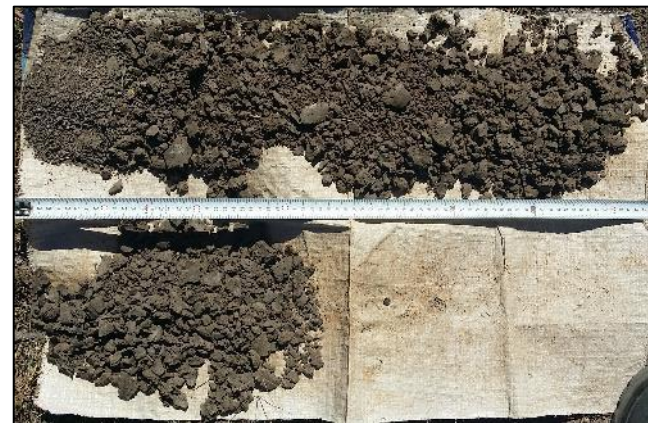
Landscape

Surface

Soil Profile

| Land use<br>Landform<br>Pattern,<br>Element,<br>Slope | Natural<br>Vegetation | Microrelief<br>Disturbance<br>Erosion | Surface<br>condition,<br>surface rock | Soil Profile Description | | | | | | | | | |
|---|---|---|---|---|---|---|---|---|---|---|---|---|---|
| Grazing, Flat<br>plain <0.5% | Brigalow<br>regrowth | Melon holes,<br>0.5m deep, 3-<br>6m 50%<br>coverage | Cracking 2-<br>10mm, no<br>coarse<br>fragments | A1<br>0.00-0.11<br>Abrupt | Light clay | Moderate,<br>firm, 3-<br>10mm sub-<br>angular | Nil | 10YR3/2<br>Very dark greyish<br>brown | Dry, well<br>drained | Very few, very<br>fine | 0.10 / 7.0 | No samples<br>taken | Depression |

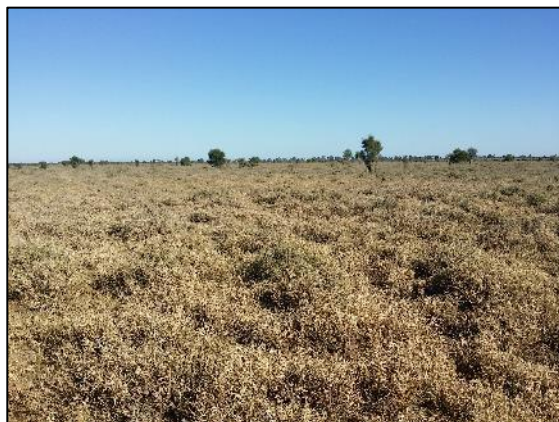
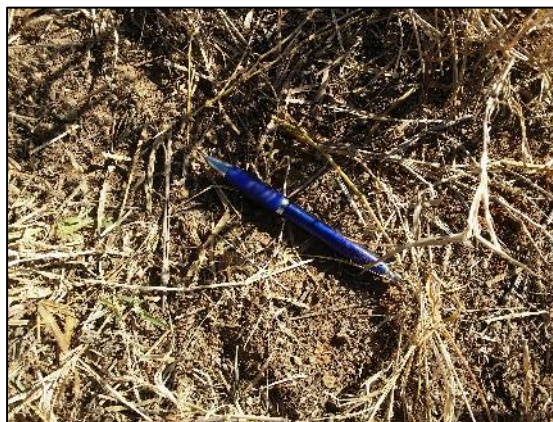
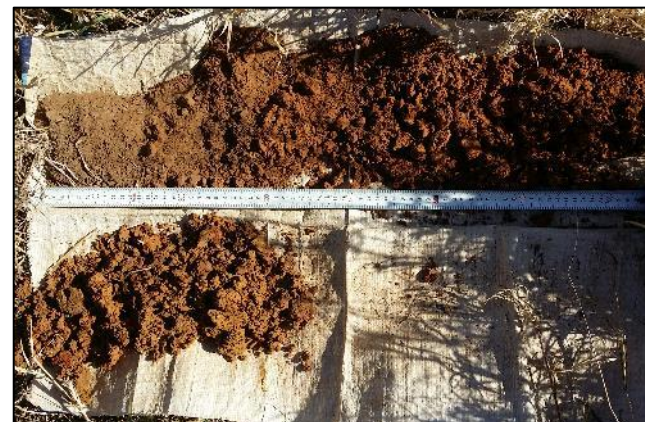
Landscape

Surface

Soil Profile

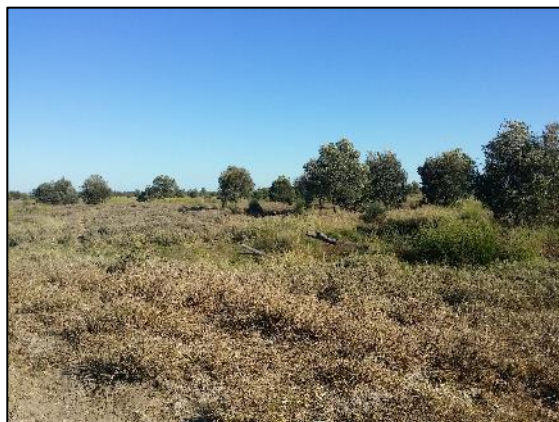
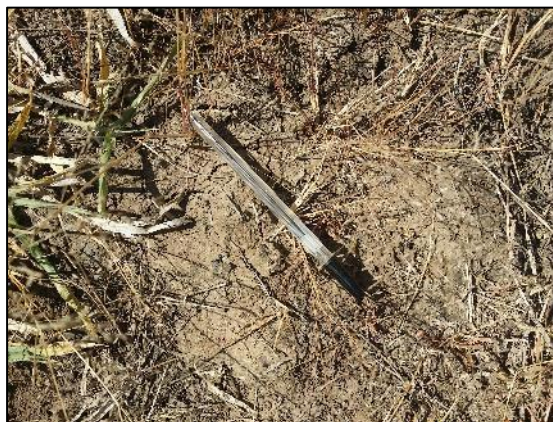
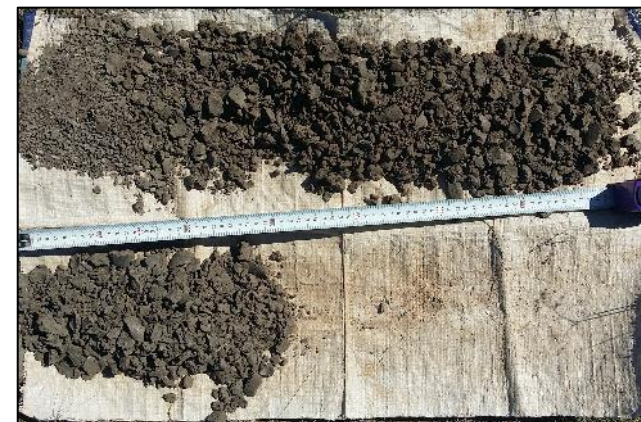
Landscape

Surface

Soil Profile

| Land use<br>Landform<br>Pattern,<br>Element,<br>Slope | Natural<br>Vegetation | Microrelief<br>Disturbance<br>Erosion | Surface<br>condition,<br>surface rock | Soil Profile Description | | | | | | | | | |
|---|---|---|---|---|---|---|---|---|---|---|---|---|---|
| Grazing,<br>Very gently<br>undulating<br>plains, lower<br>slope <1.5% | Brigalow<br>regrowth | Melon holes,<br>0.5m deep, 3-<br>6m 50%<br>coverage | Cracking 2-<br>10mm, no<br>coarse<br>fragments | A1<br>0.00-0.11<br>Abrupt | Light clay | Moderate,<br>firm, 3-<br>10mm sub-<br>angular | Nil | 10YR3/2<br>Very dark greyish<br>brown | Dry, well<br>drained | Very few, very<br>fine | 0.10 / 7.0 | No samples<br>taken | Mound |

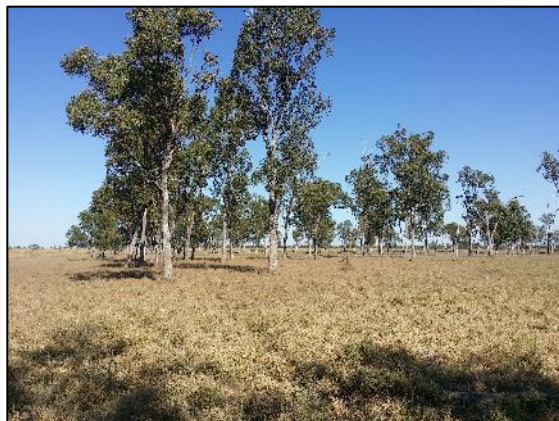
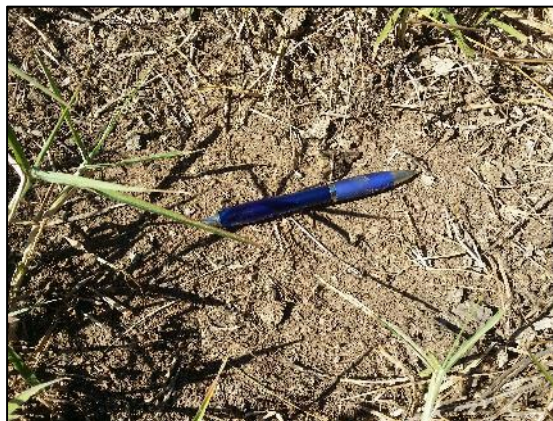
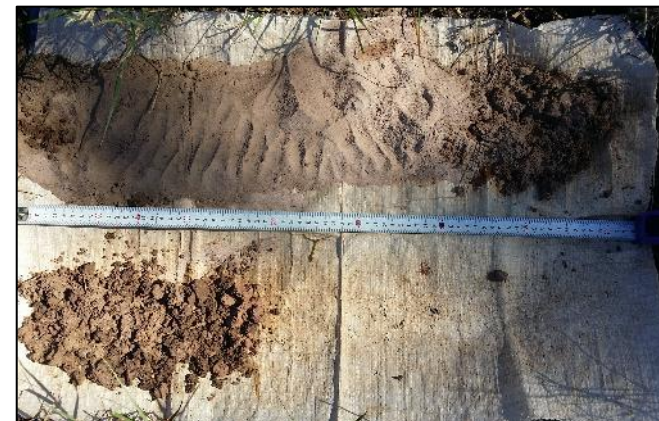
Landscape

Surface

Soil Profile

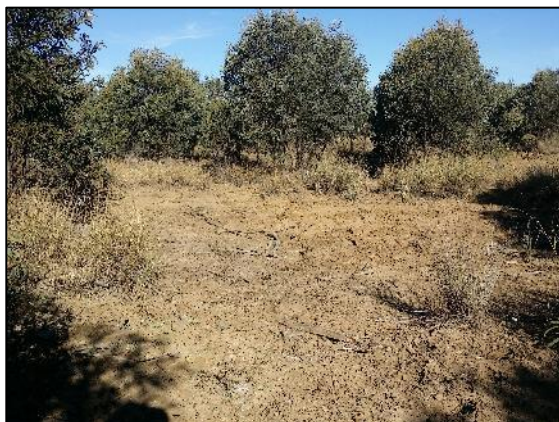
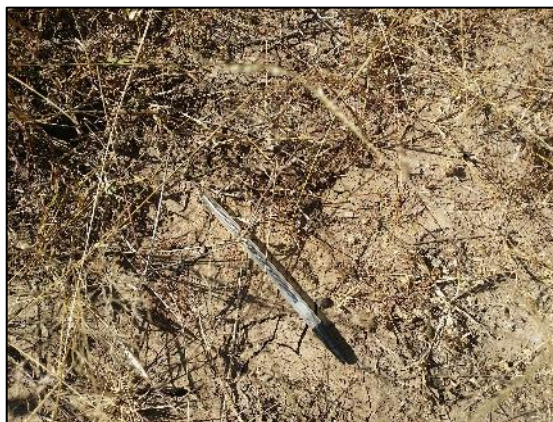
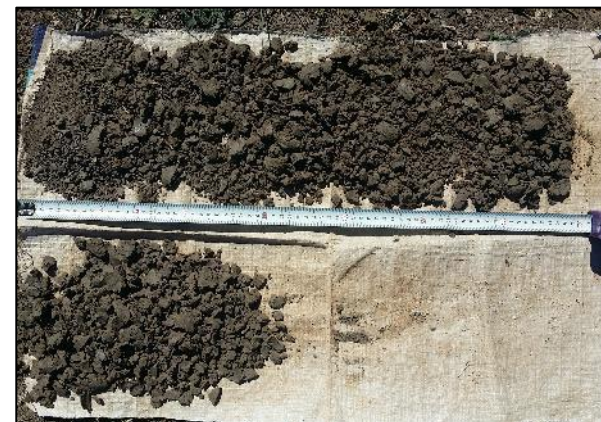
Landscape

Surface

Soil Profile

| Land use<br>Landform<br>Pattern,<br>Element,<br>Slope | Natural<br>Vegetation | Microrelief<br>Disturbance<br>Erosion | Surface<br>condition,<br>surface rock | Soil Profile Description | | | | | | | | | |
|---|---|---|---|---|---|---|---|---|---|---|---|---|---|
| Grazing, Flat<br>plain <0.5% | Brigalow<br>regrowth | Melon holes,<br>0.5m deep, 3-<br>6m 50%<br>coverage | Cracking 2-<br>10mm, no<br>coarse<br>fragments | A1<br>0.00-0.08<br>Abrupt | Light clay | Moderate,<br>firm, 3-<br>10mm sub-<br>angular | Nil | 10YR3/2<br>Very dark greyish<br>brown | Dry, well<br>drained | Very few, very<br>fine | 0.10 / 7.0 | No samples<br>taken | Depression |

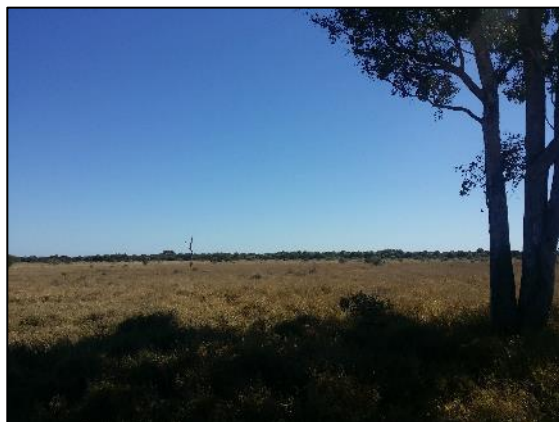
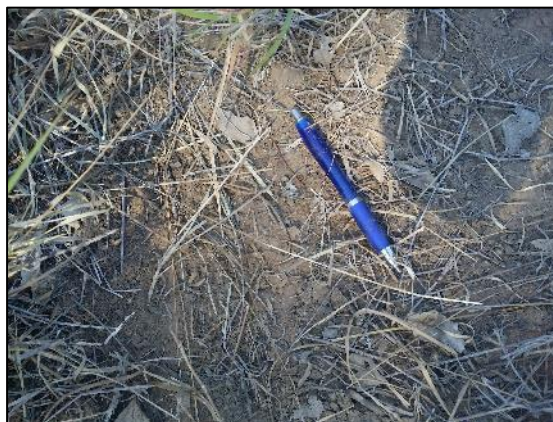
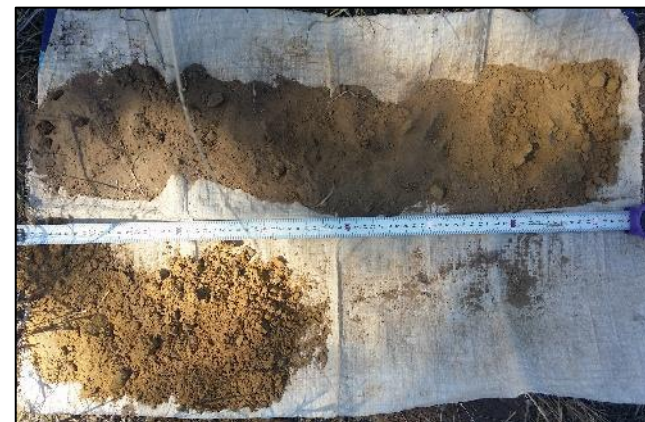
Landscape

Surface

Soil Profile

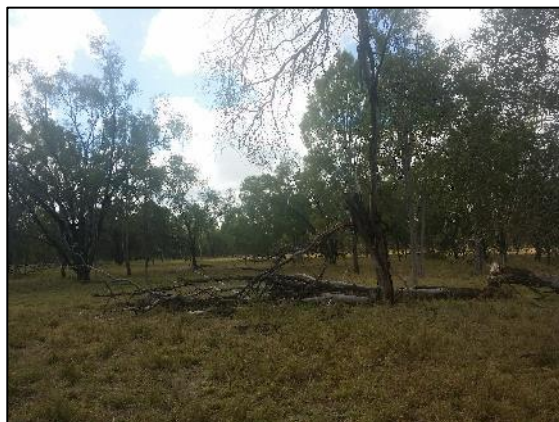
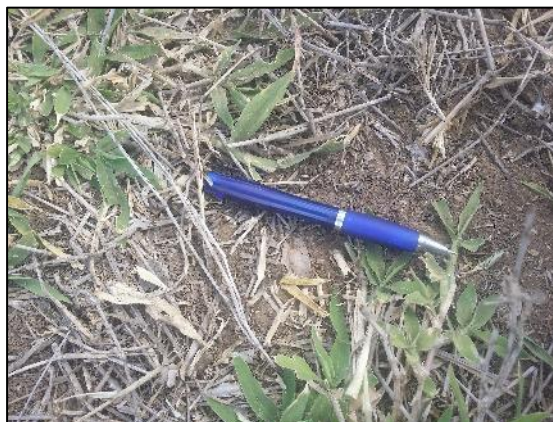
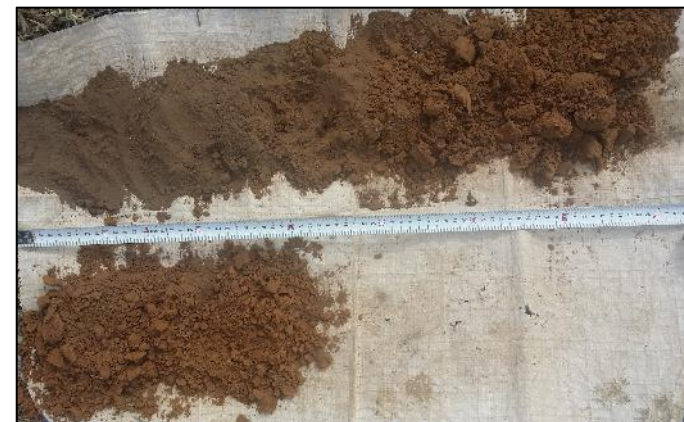
Landscape

Surface

Soil Profile

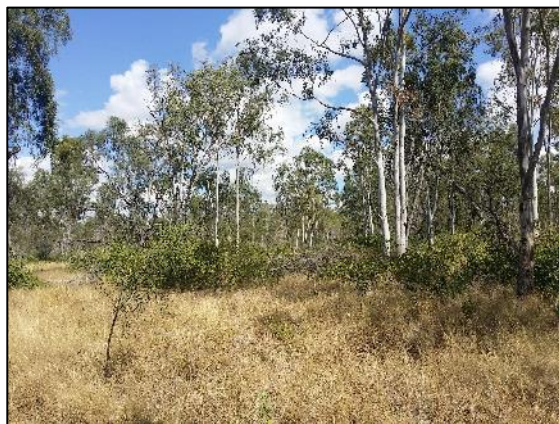
Landscape

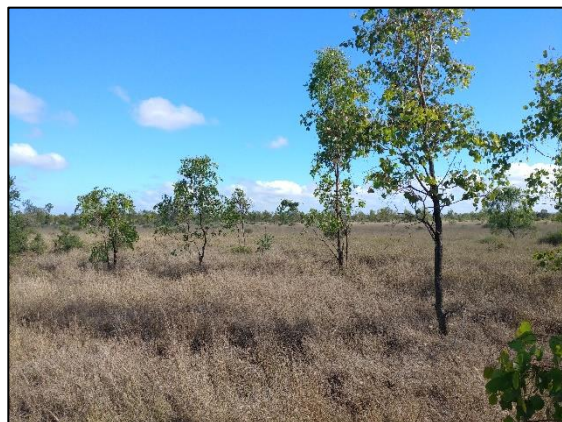
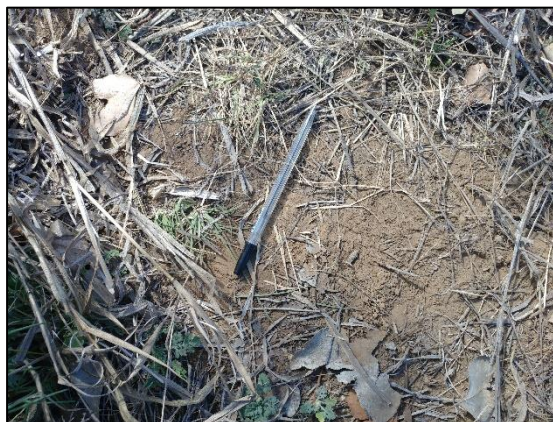
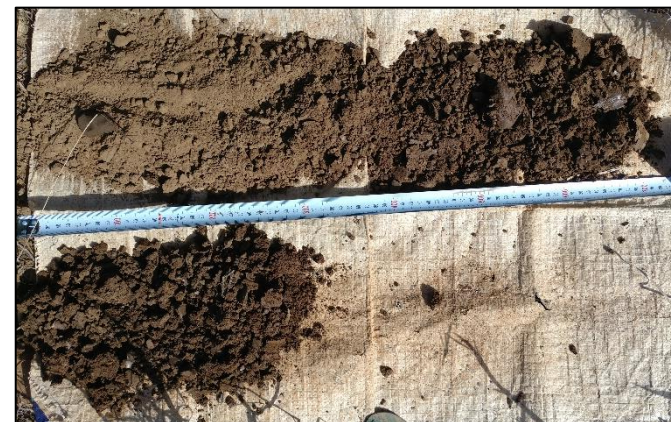
| Land use<br>Landform<br>Pattern,<br>Element,<br>Slope | Natural<br>Vegetation | Microrelief<br>Disturbance<br>Erosion | Surface<br>condition,<br>surface rock | Soil Profile Description | | | | | | | | | |
|---|---|---|---|---|---|---|---|---|---|---|---|---|---|
| Grazing,<br>Very gently<br>undulating<br>plain, lower<br>slope <2.0% | Poplar box | Extensive<br>cleared | Firm,<br>Fine cracking,<br>no coarse<br>fragments | A11<br>0.00-0.30<br>Gradual | Silty loam | Weak,,<br>weak<br><10mm<br>sub-angular | Nil | 10YR3/3<br>Dark brown | Dry, rapid | Few, fine | 0.05 / 6.0 | No samples<br>taken | No additional<br>observations |

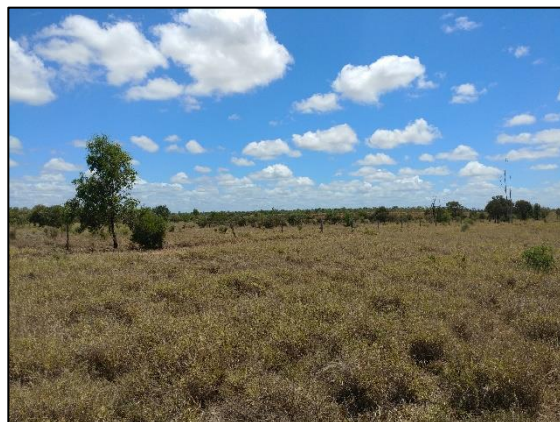
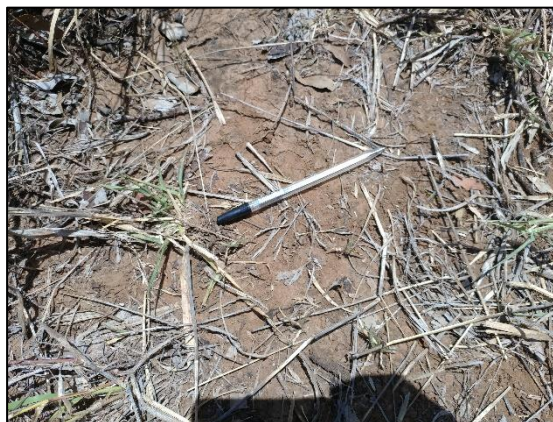
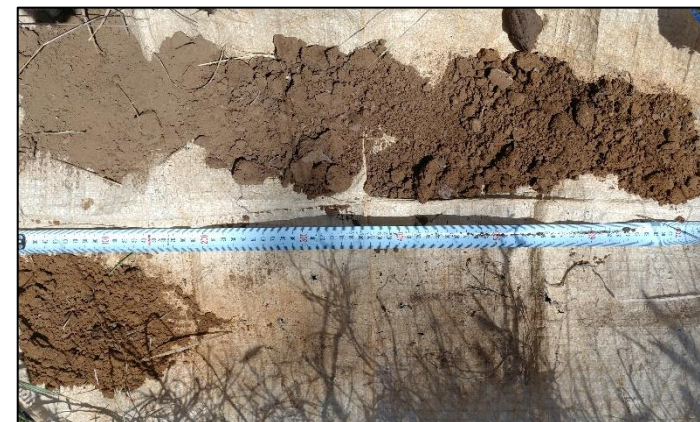
| Land use<br>Landform<br>Pattern,<br>Element,<br>Slope | Natural<br>Vegetation | Microrelief<br>Disturbance<br>Erosion | Surface<br>condition,<br>surface rock | Soil Profile Description | | | | | | | | | |
|---|---|---|---|---|---|---|---|---|---|---|---|---|---|
| Grazing,<br>Flat plain,<br><0.5% | Brigalow,<br>Eucalypt<br>regrowth | Extensive<br>clearing,<br>No<br>microrelief,<br>No erosion | Cracking, soft<br>to firm, no<br>coarse<br>fragments | A1<br>0.00-0.22<br>Abrupt | Silty loam | Weak,<br>weak,<br><10mm sub<br>rounded | Nil | 10YR2/2<br>Very dark brown | Dry, rapid | Few, fine | 0.05 / 6.0 | No samples<br>taken | No additional<br>observations |

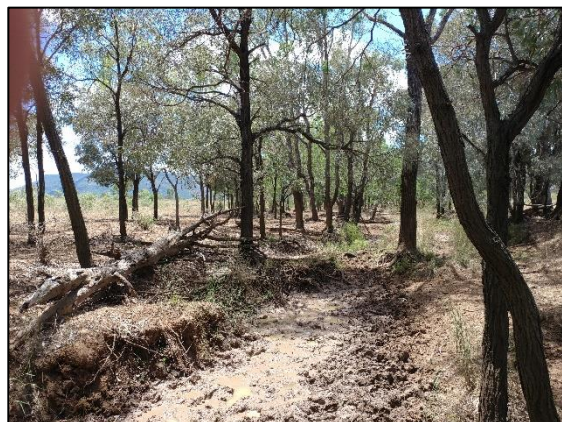
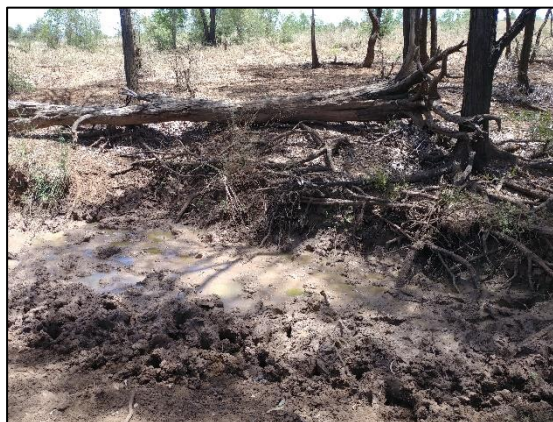
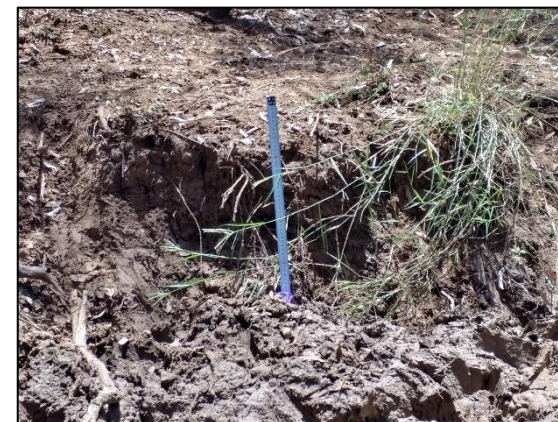
| Land use<br>Landform<br>Pattern,<br>Element,<br>Slope | Natural<br>Vegetation | Microrelief<br>Disturbance<br>Erosion | Surface<br>condition,<br>surface rock | Soil Profile Description | | | | | | | | | |
|---|---|---|---|---|---|---|---|---|---|---|---|---|---|
| Grazing,<br>Flat plain,<br>Open<br>depression<br><1.5% | Brigalow | Gully erosion,<br>no micro<br>relief,<br>No<br>disturbance | Cracking,<br>Soft to firm,<br>no coarse<br>fragments | A1<br>0.00-0.60<br>Abrupt | Silty loam | Weak,<br>weak,<br><10mm sub<br>rounded | Nil | 10YR2/2<br>Very dark brown | Dry, rapid | Few, fine | 0.05 / 6.0 | No samples<br>taken | No additional<br>observations |

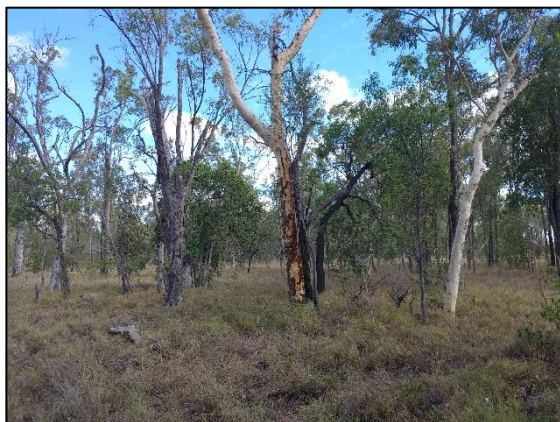
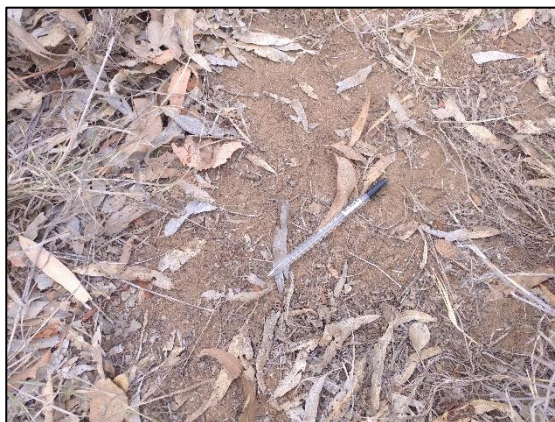
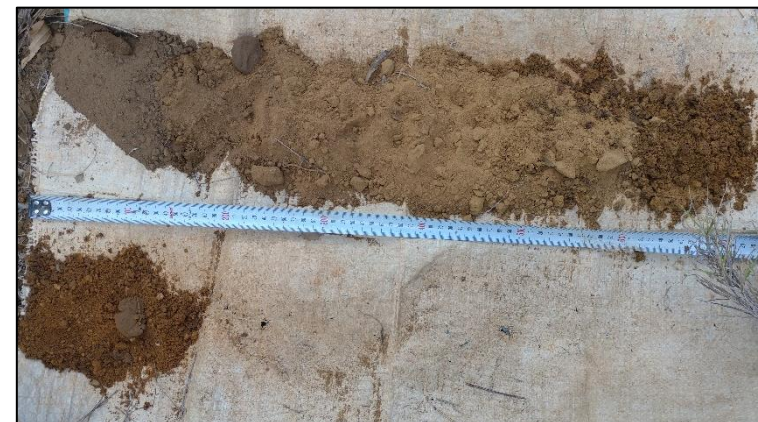
| Land use<br>Landform<br>Pattern,<br>Element,<br>Slope | Natural<br>Vegetation | Microrelief<br>Disturbance<br>Erosion | Surface<br>condition,<br>surface rock | Soil Profile Description | | | | | | | | | |
|---|---|---|---|---|---|---|---|---|---|---|---|---|---|
| Grazing,<br>Gently<br>undulating<br>plain, lower<br>slope <2.0% | Poplar box,<br>minor<br>Eucalypts | Nil | Soft, loose,<br>no coarse<br>fragments | A11<br>0.00-0.12<br>Abrupt | Loamy<br>sand | Massive,<br>weak | Nil | 10YR3/2<br>Very dark brown | Dry, rapid | Few, fine | 0.10 / 6.5 | No samples<br>taken | No additional<br>observations |

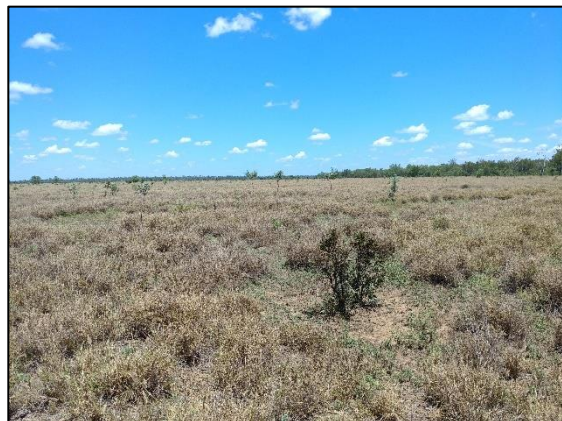
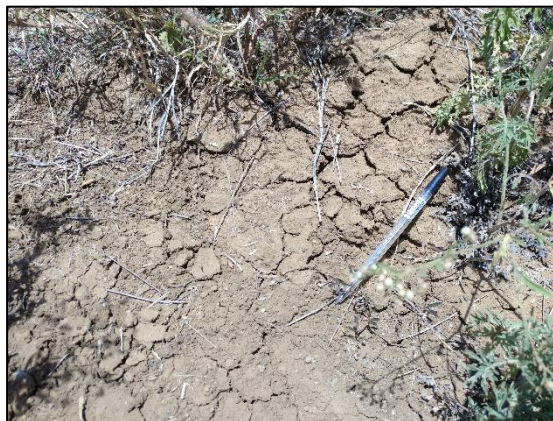
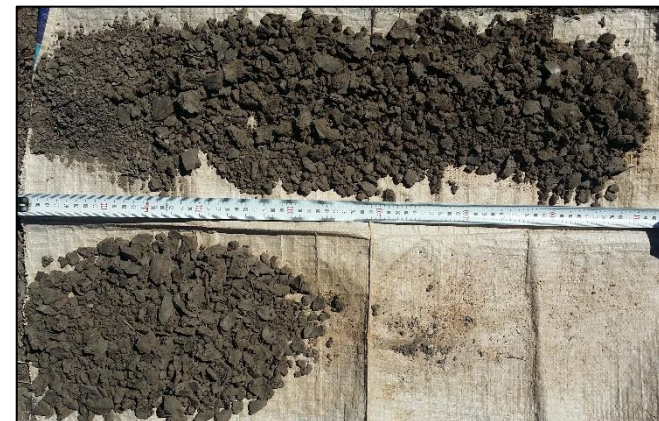
| Land use<br>Landform<br>Pattern,<br>Element,<br>Slope | Natural<br>Vegetation | Microrelief<br>Disturbance<br>Erosion | Surface<br>condition,<br>surface rock | Soil Profile Description | | | | | | | | | |
|---|---|---|---|---|---|---|---|---|---|---|---|---|---|
| Grazing, Flat<br>plain <0.5% | Brigalow<br>regrowth | Extensive<br>clearing,<br>Minor normal<br>gilgai <20%<br>coverage 3-<br>5m wide and<br><0.30m in<br>depth | Cracking, firm | A1<br>0.00-0.11<br>Abrupt | Light clay | Weak, firm,<br>3-10mm<br>sub-angular | Nil | 10YR3/2<br>Very dark greyish<br>brown | Dry, well<br>drained | Very few, very<br>fine | 0.10 / 7.0 | No samples<br>taken | No additional<br>observations |

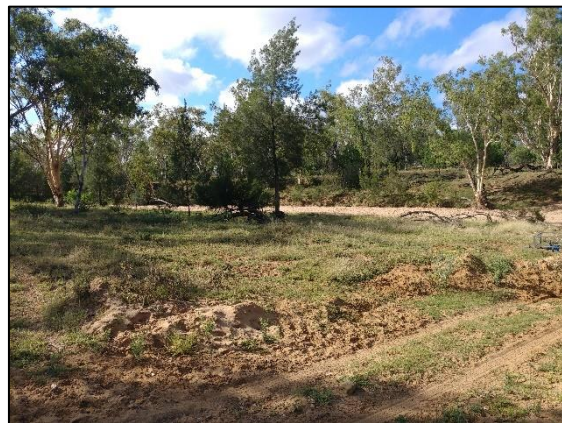
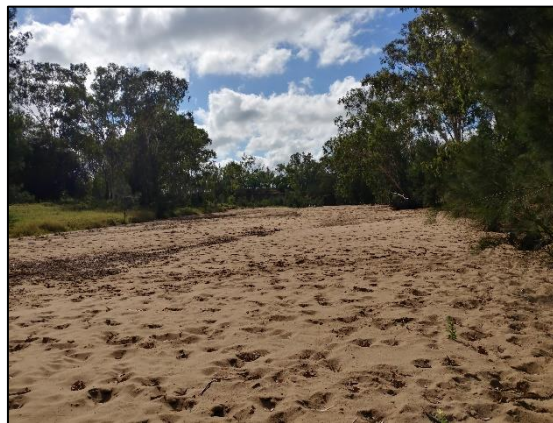
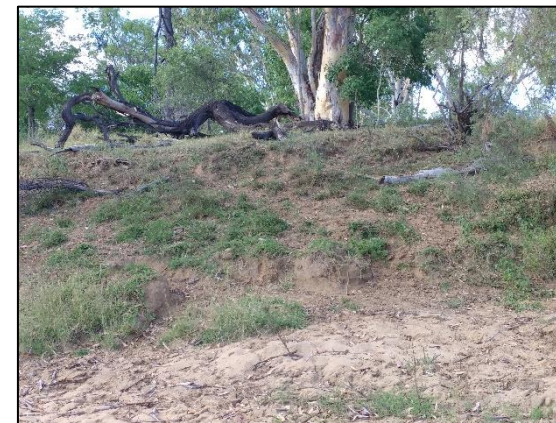
| Land use<br>Landform<br>Pattern,<br>Element,<br>Slope | Natural<br>Vegetation | Microrelief<br>Disturbance<br>Erosion | Surface<br>condition,<br>surface rock | Soil Profile Description | | | | | | | | | |
|---|---|---|---|---|---|---|---|---|---|---|---|---|---|
| Grazing,<br>Creek, gully /<br>open<br>depression | Eucalypts | Gully erosion,<br>No<br>microrelief<br>No erosion | Soft, loose, no<br>coarse<br>fragments | Nil | Loamy<br>sand | Massive,<br>weak | Nil | 10YR5/2<br>Grayish brown | Dry, rapid | Few, fine | Nil | No samples<br>taken | No additional<br>observations |

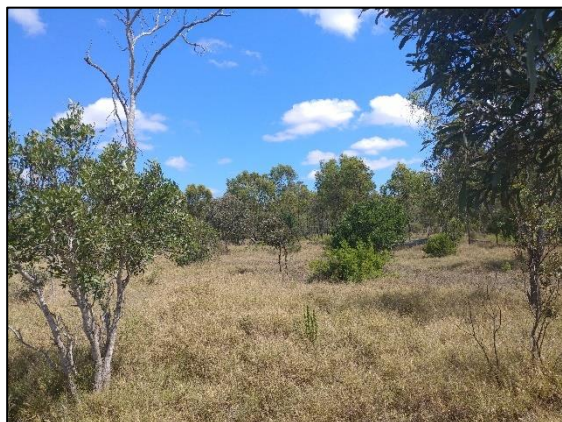
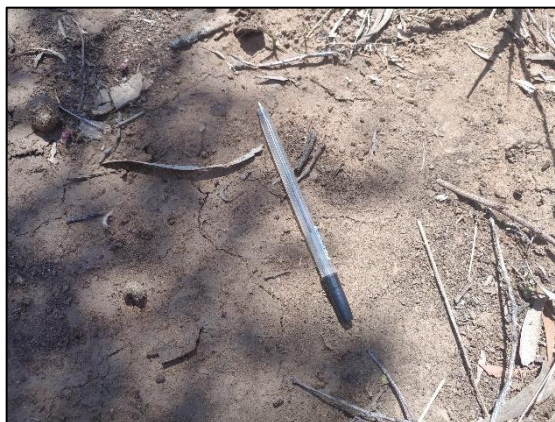
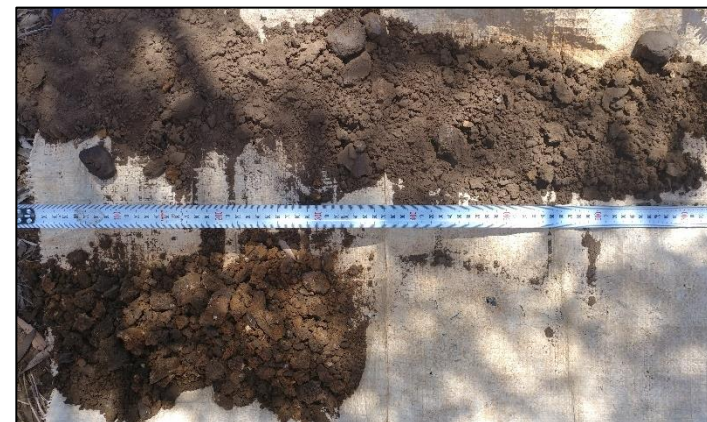
| Land use<br>Landform<br>Pattern,<br>Element,<br>Slope | Natural<br>Vegetation | Microrelief<br>Disturbance<br>Erosion | Surface<br>condition,<br>surface rock | Soil Profile Description | | | | | | | | | |
|---|---|---|---|---|---|---|---|---|---|---|---|---|---|
| Grazing,<br>Very gently<br>undulating<br>plain, lower<br>slope <1.0% | Mixed<br>vegetation,<br>Brigalow<br>regrowth and<br>Poplar Box | Nil | Firm to hard<br>setting, minor<br>fine cracking,<br>no coarse<br>fragments | A11<br>0.00-0.10<br>Abrupt | Silty loam | Weak, weak | Nil | 10YR2/2<br>Very dark brown | Dry, rapid | Very few, very<br>fine | 0.05 / 6.5 | No samples<br>taken | No additional<br>observations |

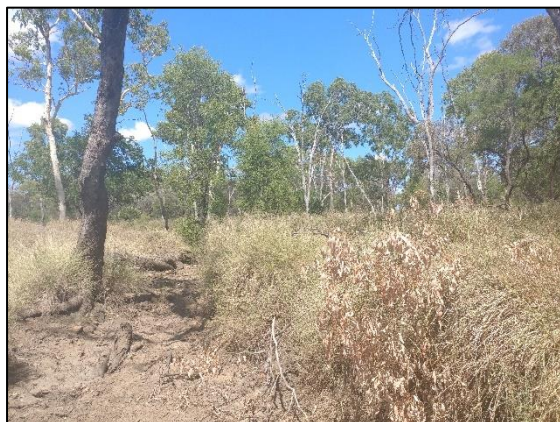
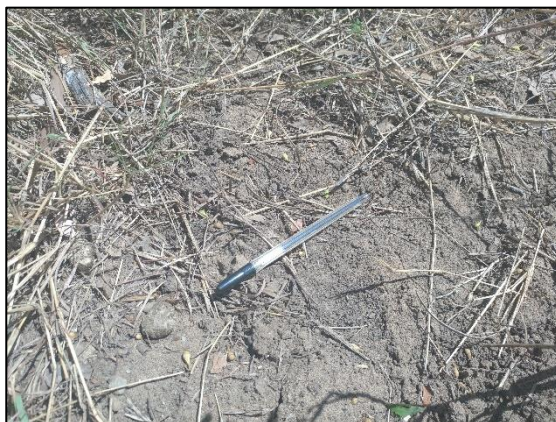
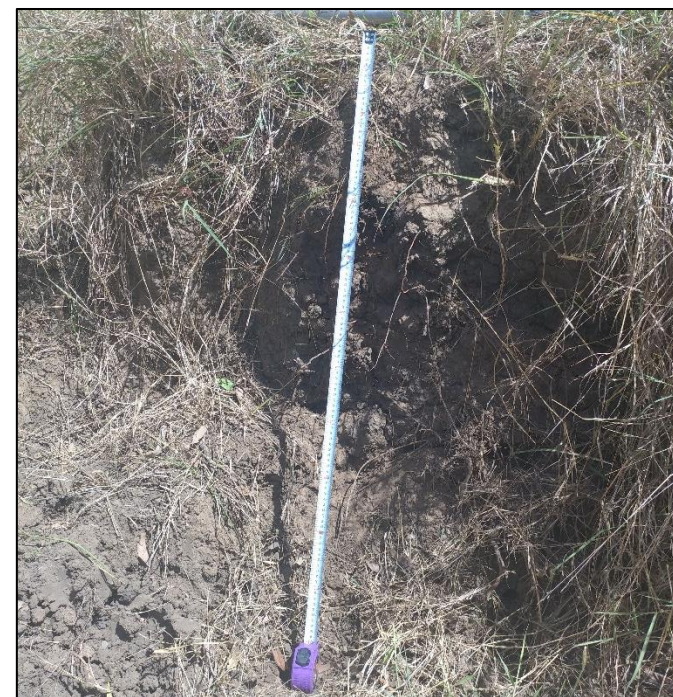
| Land use<br>Landform<br>Pattern,<br>Element,<br>Slope | Natural<br>Vegetation | Microrelief<br>Disturbance<br>Erosion | Surface<br>condition,<br>surface rock | Soil Profile Description | | | | | | | | | |
|---|---|---|---|---|---|---|---|---|---|---|---|---|---|
| Grazing,<br>Open<br>Depression | Eucalypts,<br>minor<br>Brigalow | Gully erosion,<br>No<br>microrelief<br>No<br>disturbance | Loose,<br><5% <5mm<br>coarse<br>fragments | A11<br>0.00-0.40<br>Abrupt | Loamy<br>sand | Massive,<br>weak | Nil | 10YR2/2<br>Very dark brown | Dry, rapid | Few, fine | 0.05 / 6.0 | No samples<br>taken | No additional<br>observations |

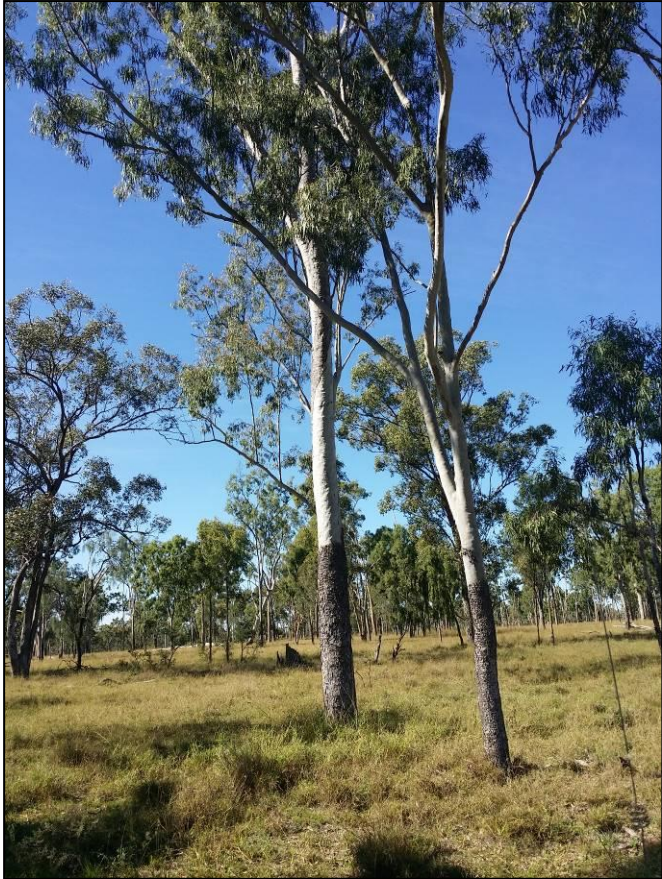
| Site No. | Location<br>(GDA94 Zone 53) | Soil Mapping Unit | Comments / Pictures |
|---|---|---|---|
| Ob6 | 638723 mE<br>7547859 mN | S1 | <p>Poplar Box only to north, towards south various mixed vegetation, Moreton Bay Ash, Poplar Box, and Gums</p> |

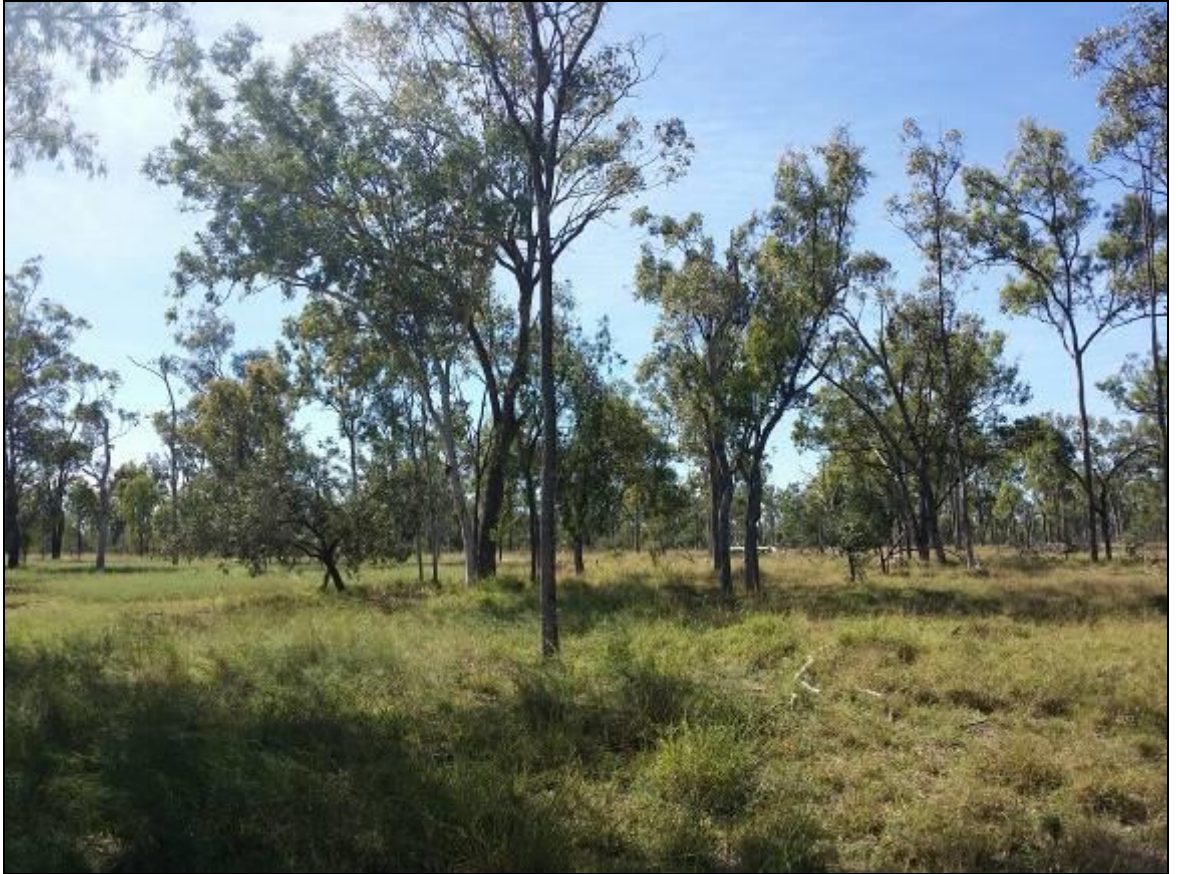
| Site No. | Location<br>(GDA94 Zone 53) | Soil Mapping Unit | Comments / Pictures |
|---|---|---|---|
| Ob7 | 638617 mE<br>7547036 mN | S1 | <p>Poplar Box only to north, towards south various mixed vegetation</p> |

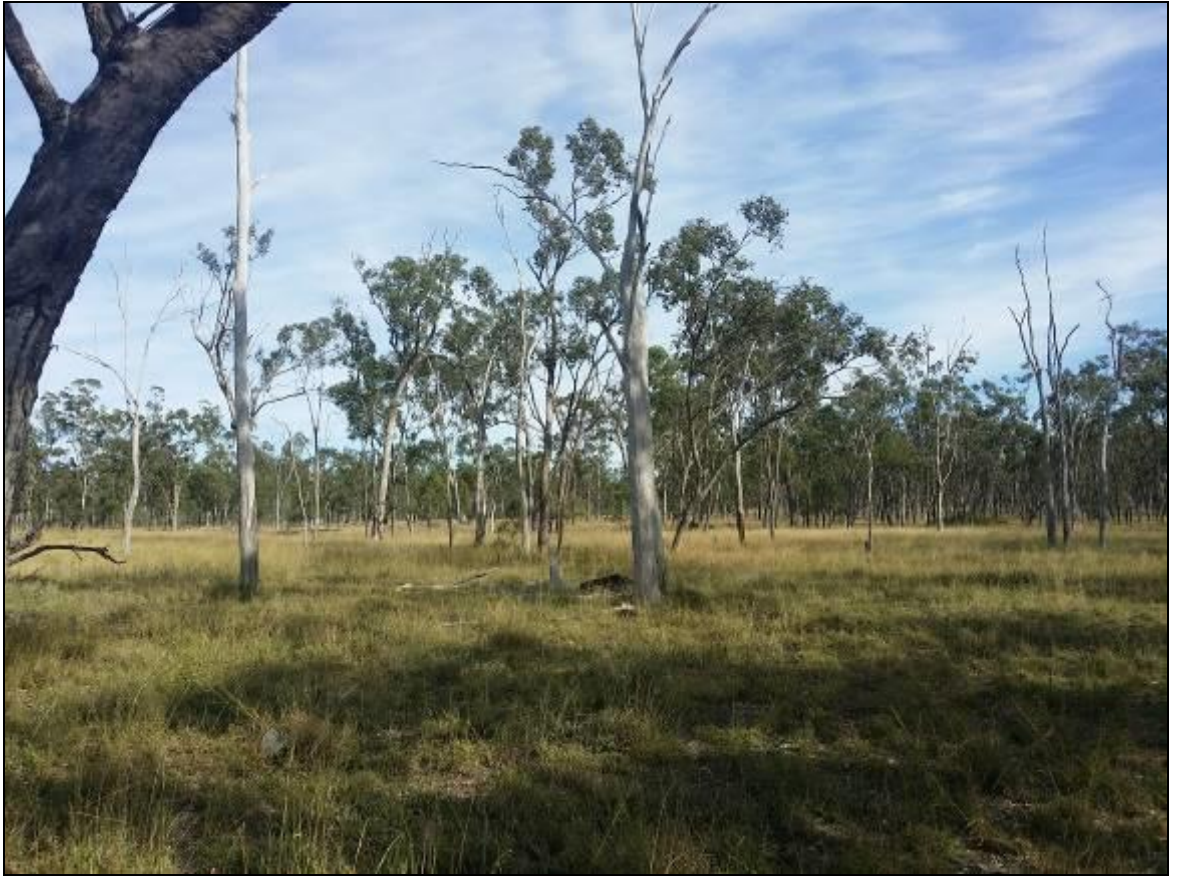
| Site No. | Location<br>(GDA94 Zone 53) | Soil Mapping Unit | Comments / Pictures |
|---|---|---|---|
| Ob18 | 639963 mE<br>7546770 mN | S2 | Gums, Poplar Box<br> |

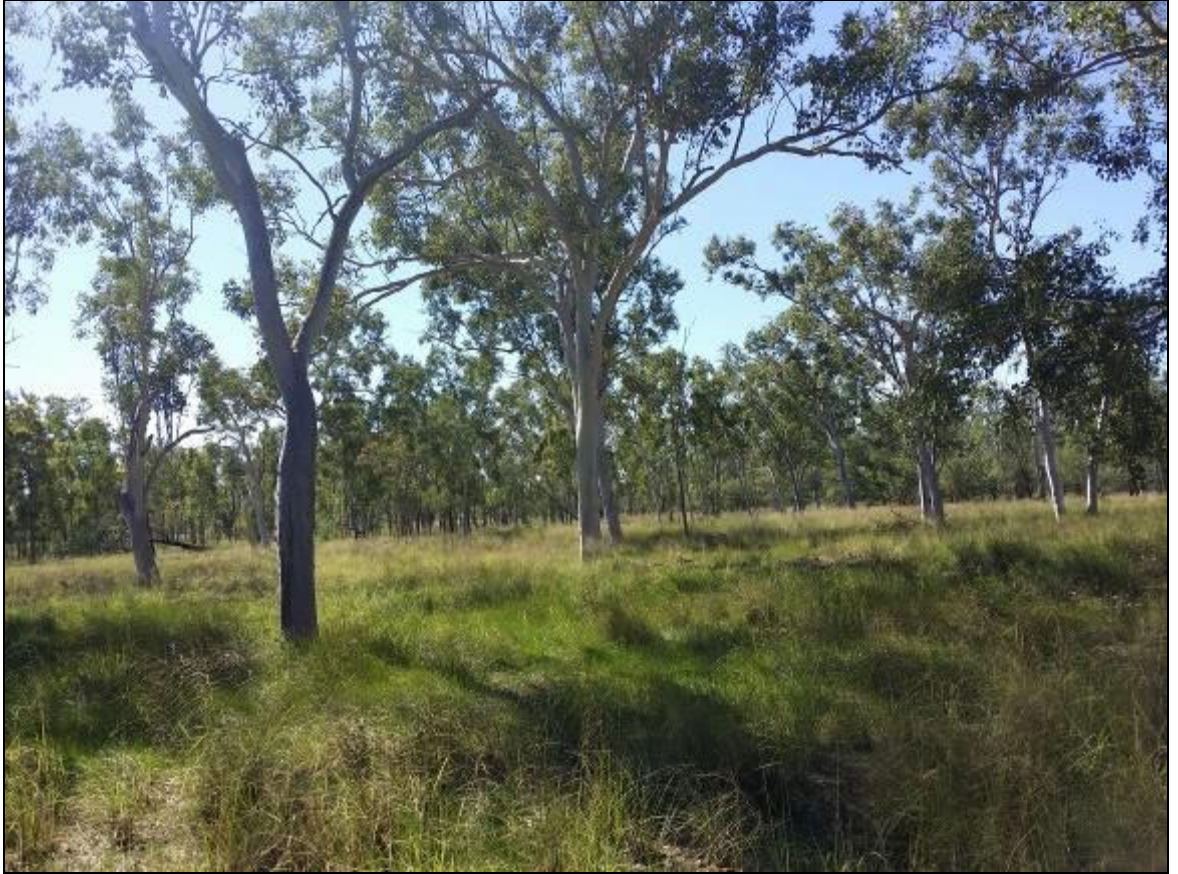
| Site No. | Location<br>(GDA94 Zone 53) | Soil Mapping Unit | Comments / Pictures |
|---|---|---|---|
| Ob24 | 642279 mE<br>7547774 mN | S2 | <p>Gums, firm sandy surface</p> A photograph showing a gum tree with a thick, dark trunk and a spreading canopy of green leaves. The tree is situated in a field of tall, dry grass. In the background, there are more trees and a clear blue sky. |

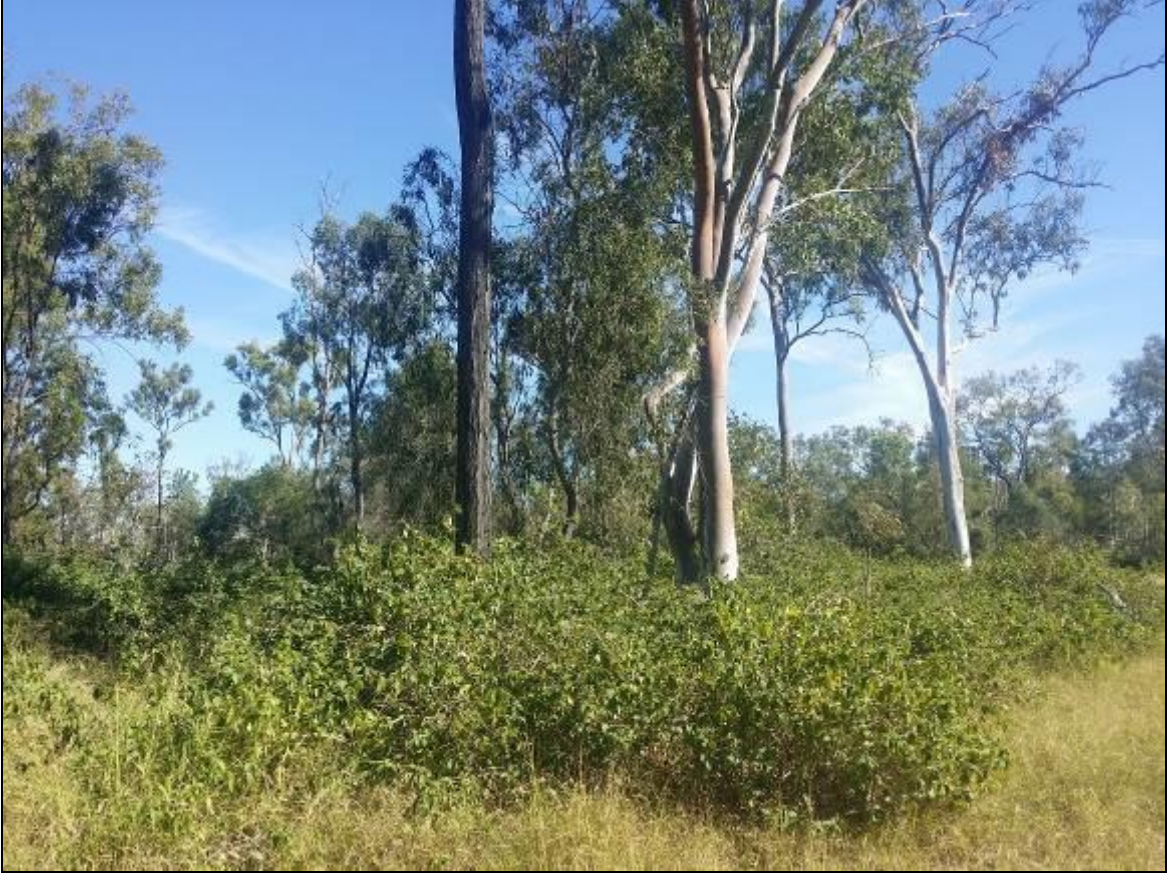
| Site No. | Location<br>(GDA94 Zone 53) | Soil Mapping Unit | Comments / Pictures |
|---|---|---|---|
| Ob25 | 642525 mE<br>7547379 mN | S2 | Firm surface, Ironbark, White Gums<br> |

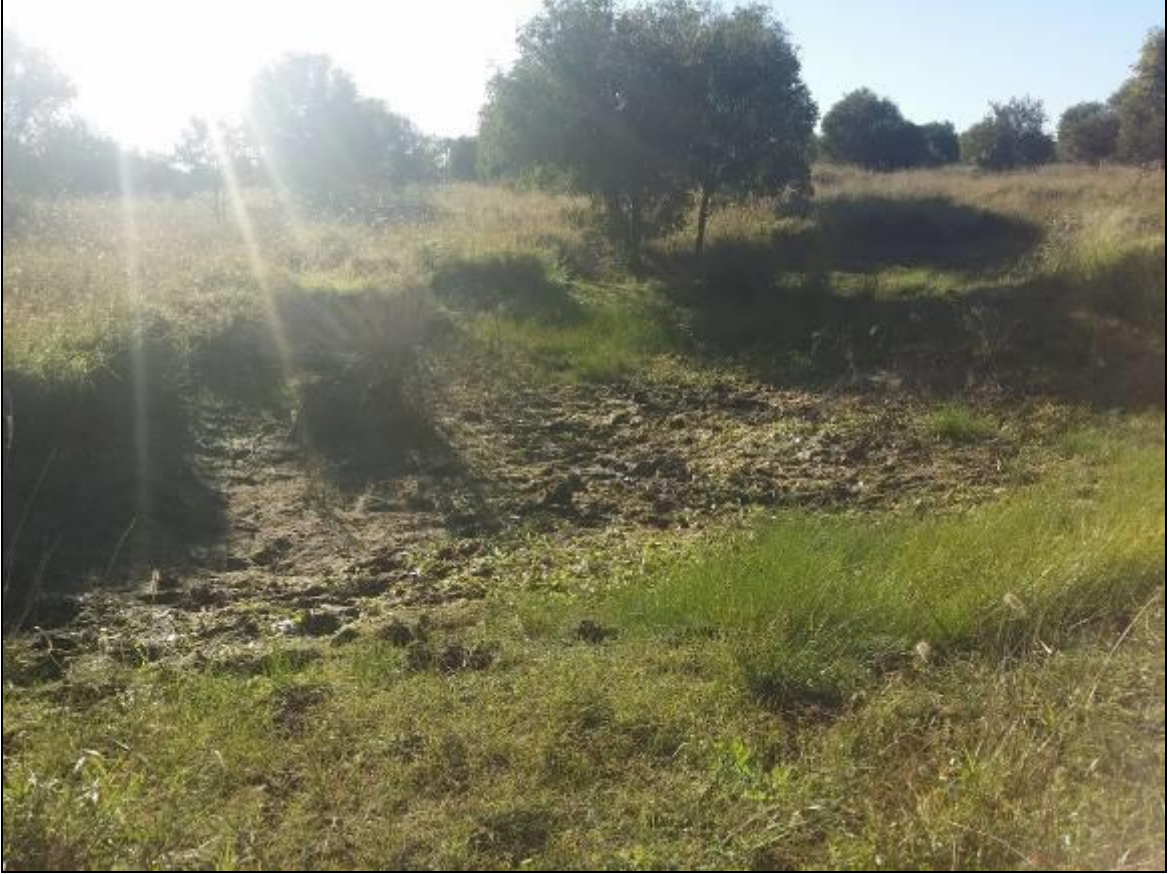
| Site No. | Location<br>(GDA94 Zone 53) | Soil Mapping Unit | Comments / Pictures |
|---|---|---|---|
| Ob38 | 641966 mE<br>7546043 mN | C1 | Melon holes approx. 4m diameter, 0.4m deep, depressions at 50% coverage, cracking surface<br> |

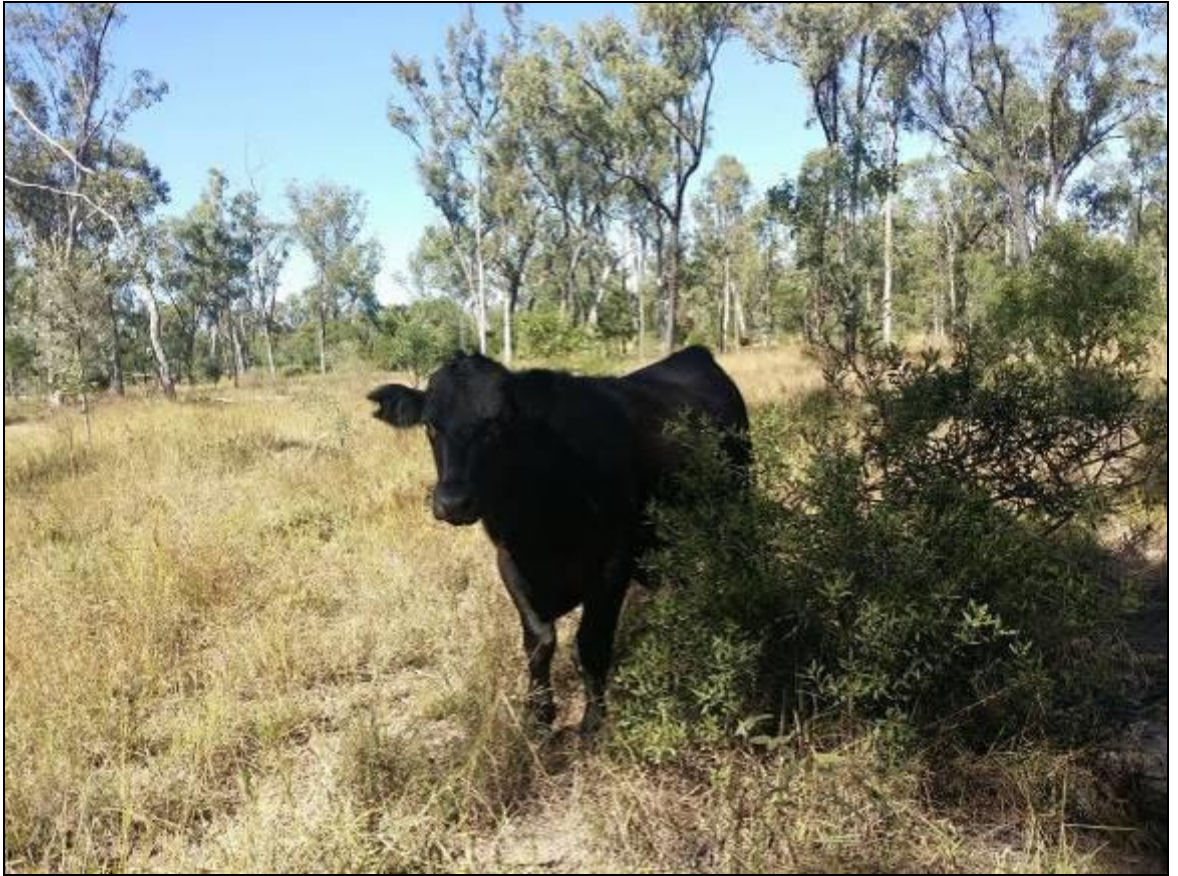
| Site No. | Location<br>(GDA94 Zone 53) | Soil Mapping Unit | Comments / Pictures |
|---|---|---|---|
| Ob59 | 639673 mE<br>7544810 mN | B1 | <p>Poplar Box, Ironbark, silty loam surface, land use grazing</p> |
