**PEMBROKE**

**Olive Downs Coking Coal Project**  
Draft Environmental Impact Statement

**Appendix M**  
**Soil and Land**  
**Suitability**  
**Assessment**

Olive Downs Coking Coal Project

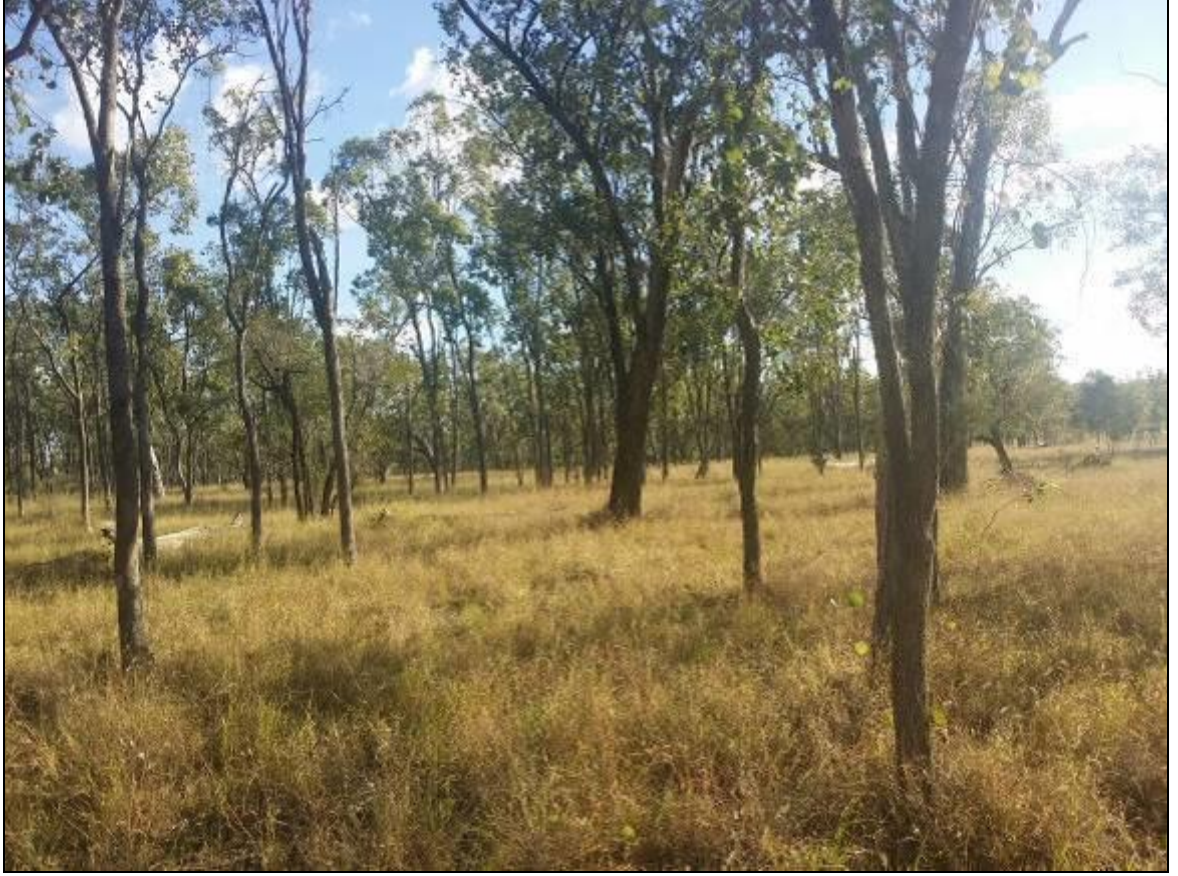
| Site No. | Location<br>(GDA94 Zone 53) | Soil Mapping Unit | Comments / Pictures |
|---|---|---|---|
| Ob71 | 642282 mE<br>7543922 mN | B1 | <p>Poplar Box</p> |

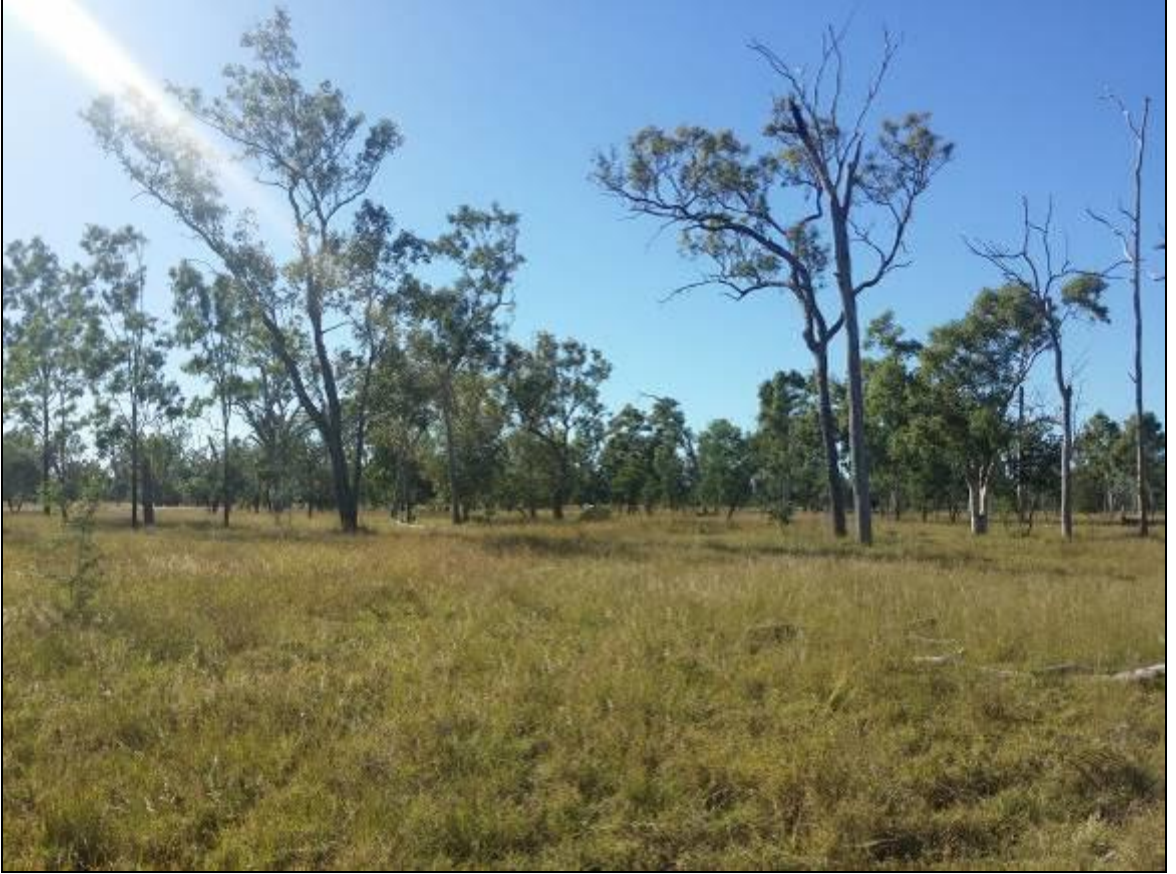
| Site No. | Location<br>(GDA94 Zone 53) | Soil Mapping Unit | Comments / Pictures |
|---|---|---|---|
| Ob72 | 641817 mE<br>7543722 mN | B1 | <p>Poplar Box</p> |

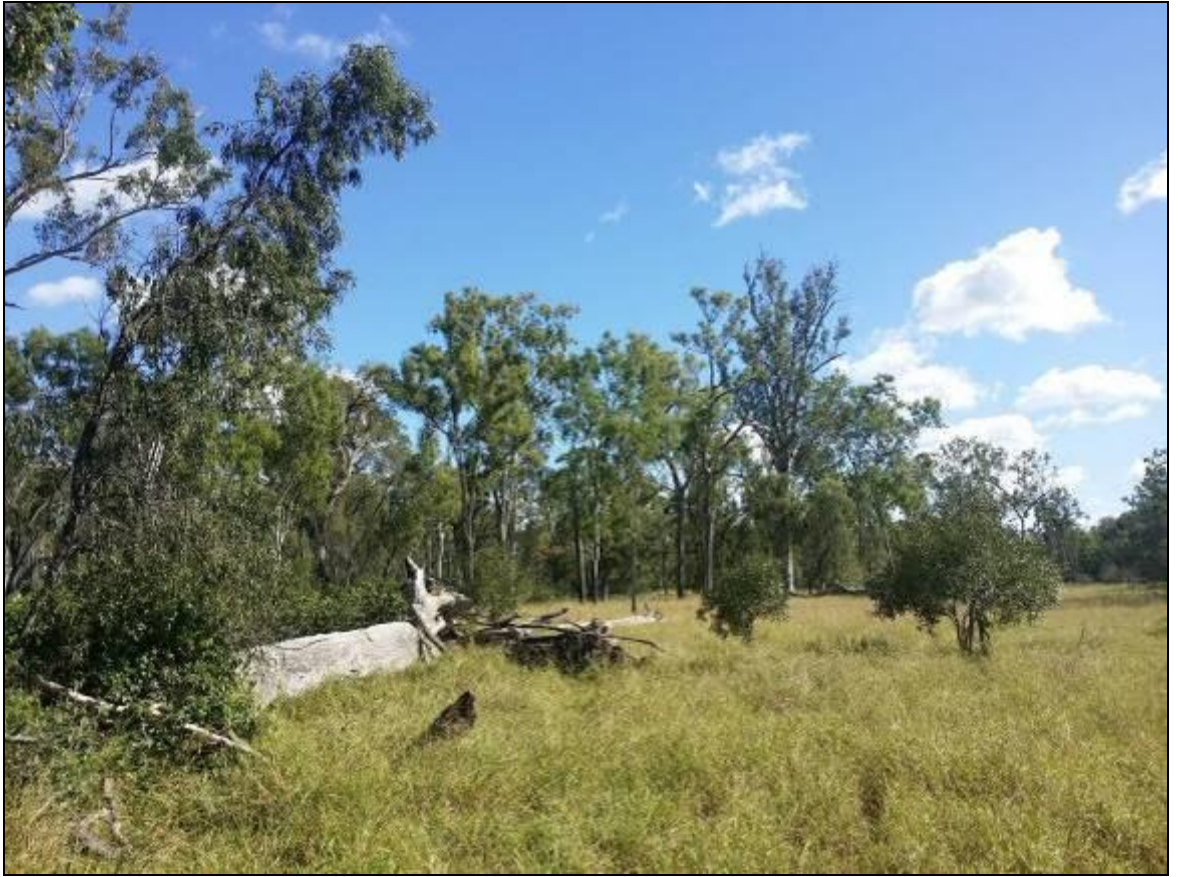
| Site No. | Location<br>(GDA94 Zone 53) | Soil Mapping Unit | Comments / Pictures |
|---|---|---|---|
| Ob94 | 642565 mE<br>7541626 mN | B1 | <p>Mixed vegetation including Ironbark, Poplar Box and Blackbutt</p> |

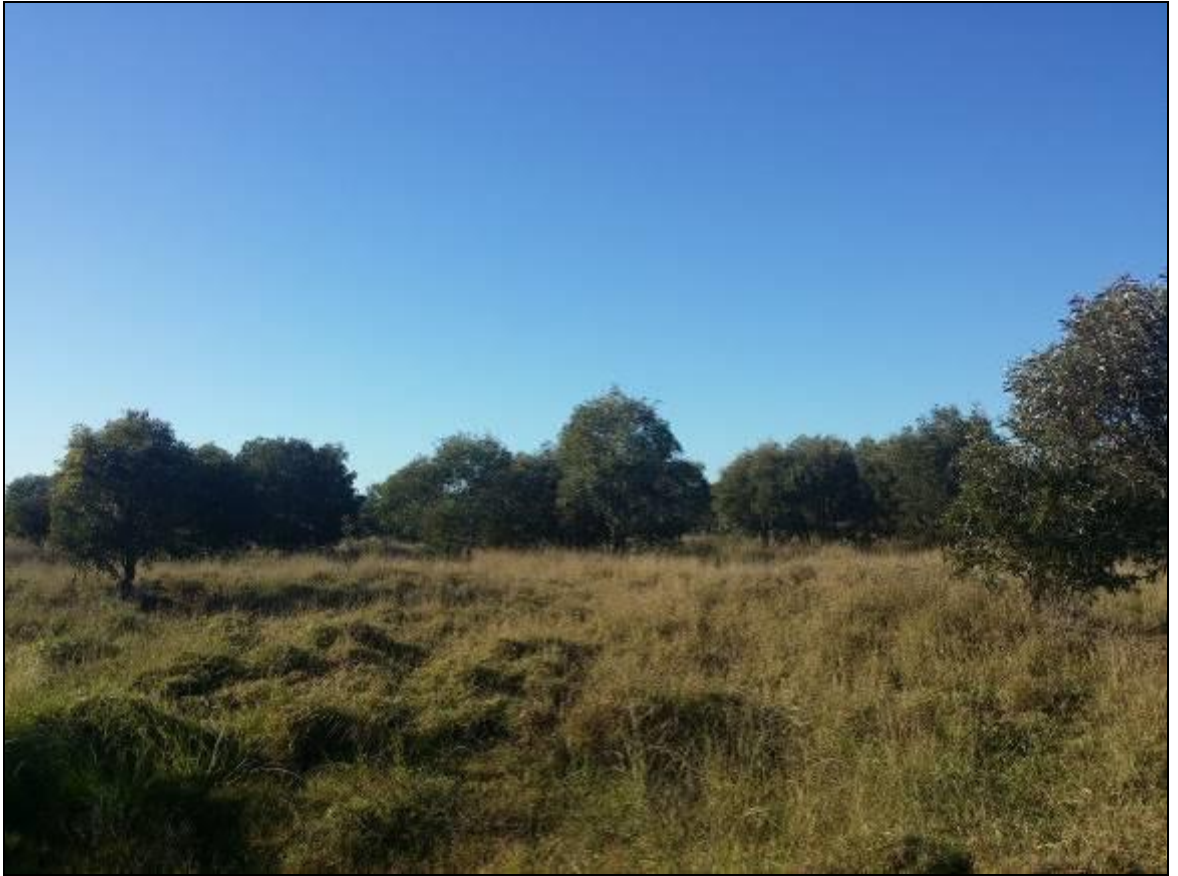
| Site No. | Location<br>(GDA94 Zone 53) | Soil Mapping Unit | Comments / Pictures |
|---|---|---|---|
| Ob97 | 643220 mE<br>7543467 mN | C1 | Brigalow, melon holes, cracking surface<br> |

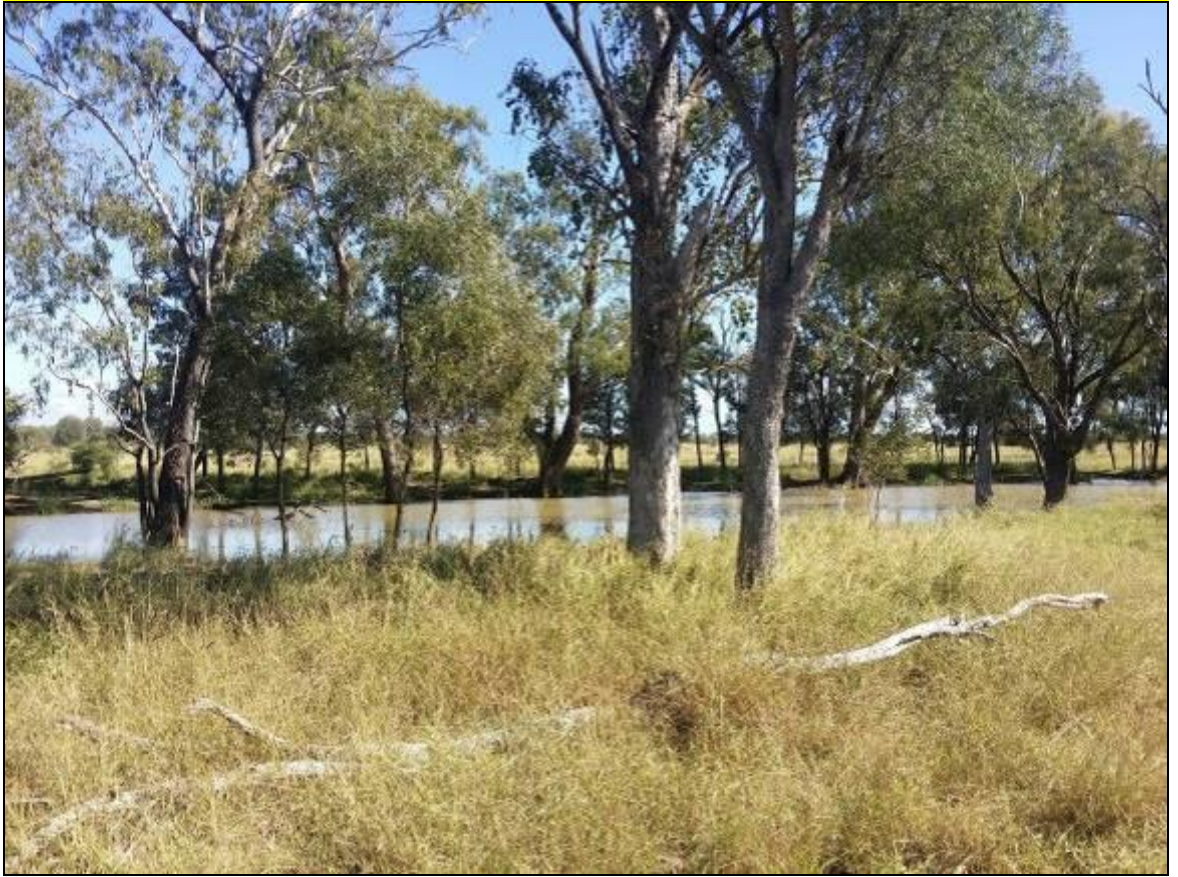
| Site No. | Location<br>(GDA94 Zone 53) | Soil Mapping Unit | Comments / Pictures |
|---|---|---|---|
| Ob99 | 643495 mE<br>7544624 mN | C2 | <p>Inundated depression</p> |

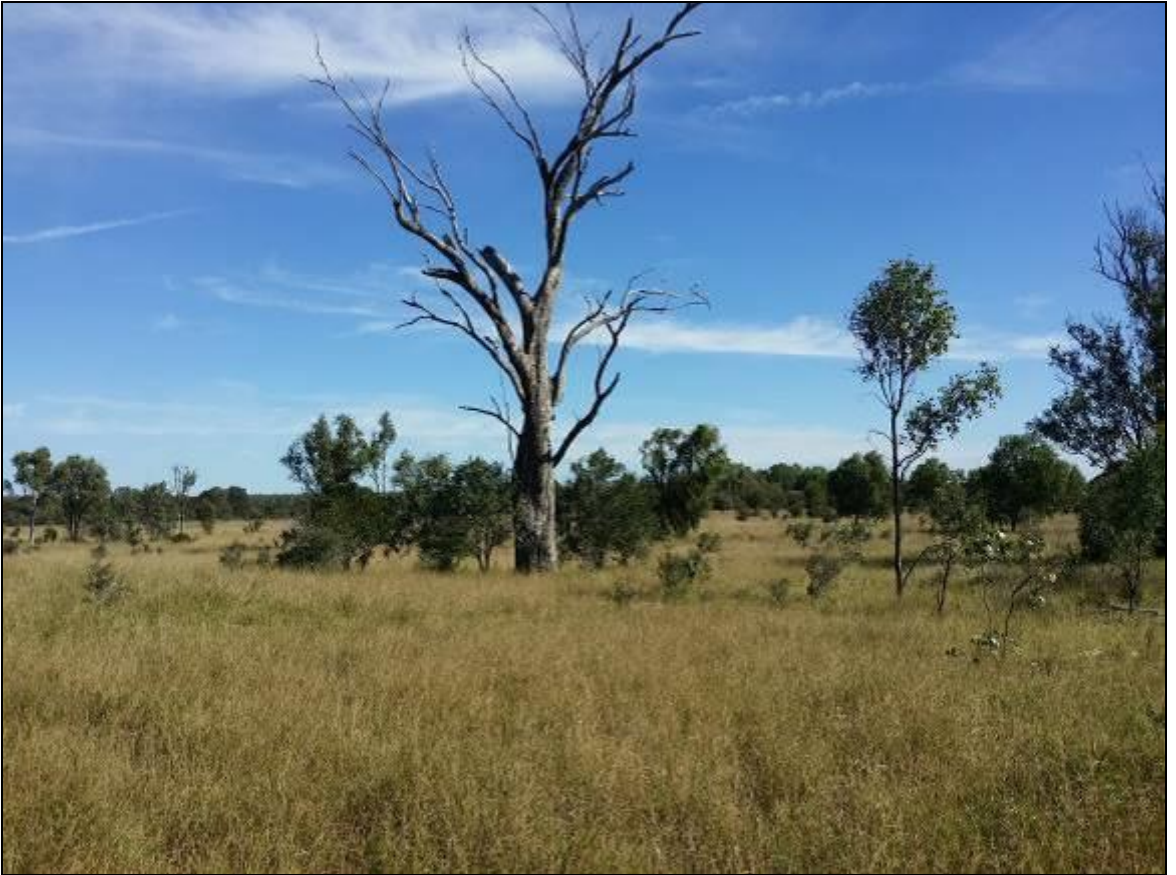
| Site No. | Location<br>(GDA94 Zone 53) | Soil Mapping Unit | Comments / Pictures |
|---|---|---|---|
| Ob116 | 645333 mE<br>7542509 mN | C2 | Cracking surface, Poplar Box 100m to east<br> |

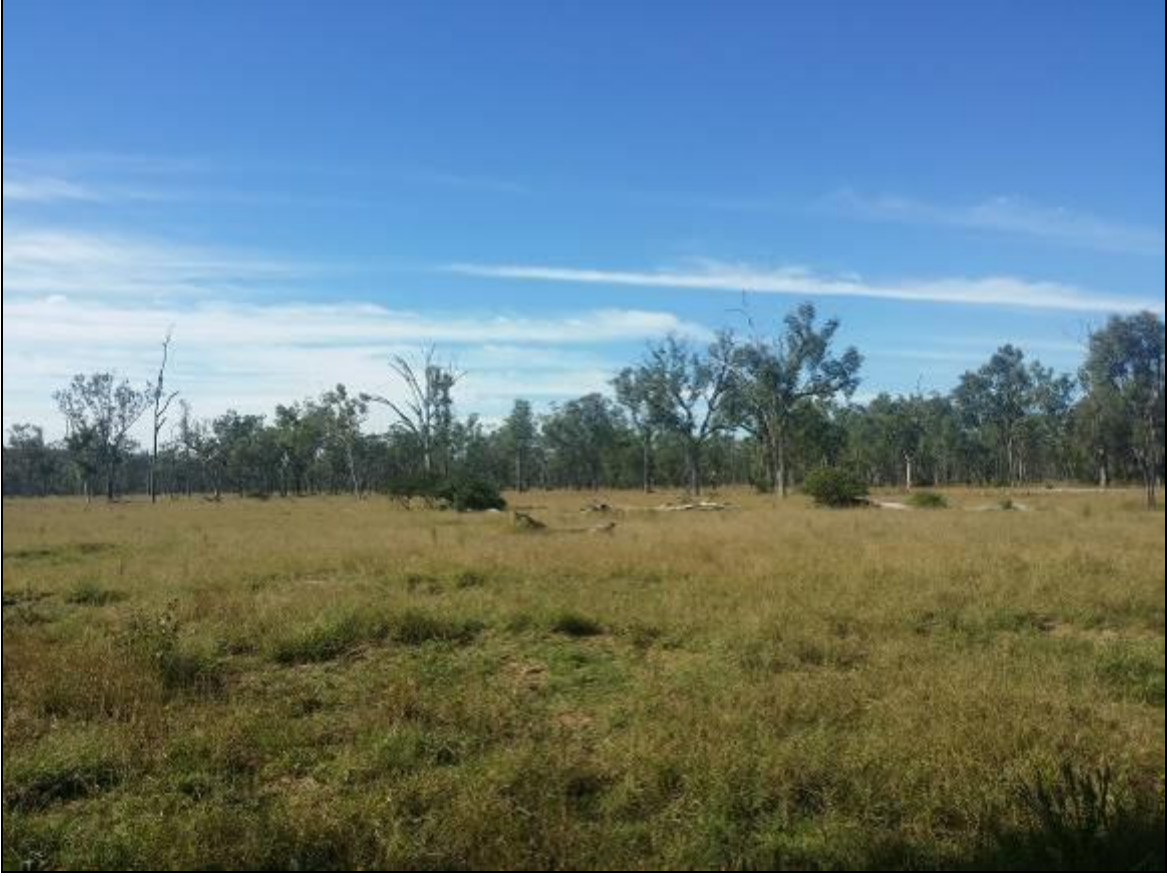
| Site No. | Location<br>(GDA94 Zone 53) | Soil Mapping Unit | Comments / Pictures |
|---|---|---|---|
| Ob129 | 639315 mE<br>7540373 mN | S2 | <p>Firm light brown surface, cleared</p> |

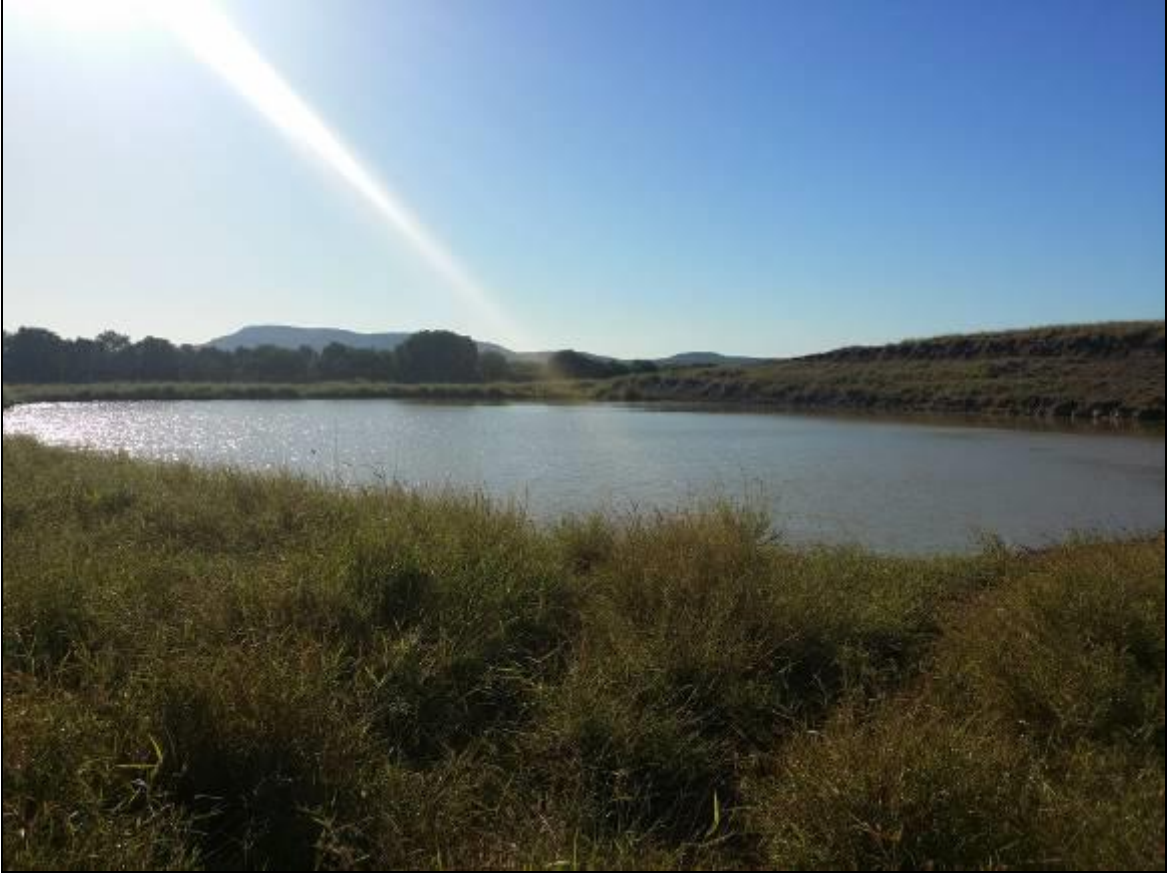
| Site No. | Location<br>(GDA94 Zone 53) | Soil Mapping Unit | Comments / Pictures |
|---|---|---|---|
| Ob130 | 640866 mE<br>7540195 mN | C2 | Cracking surface, dam<br> |

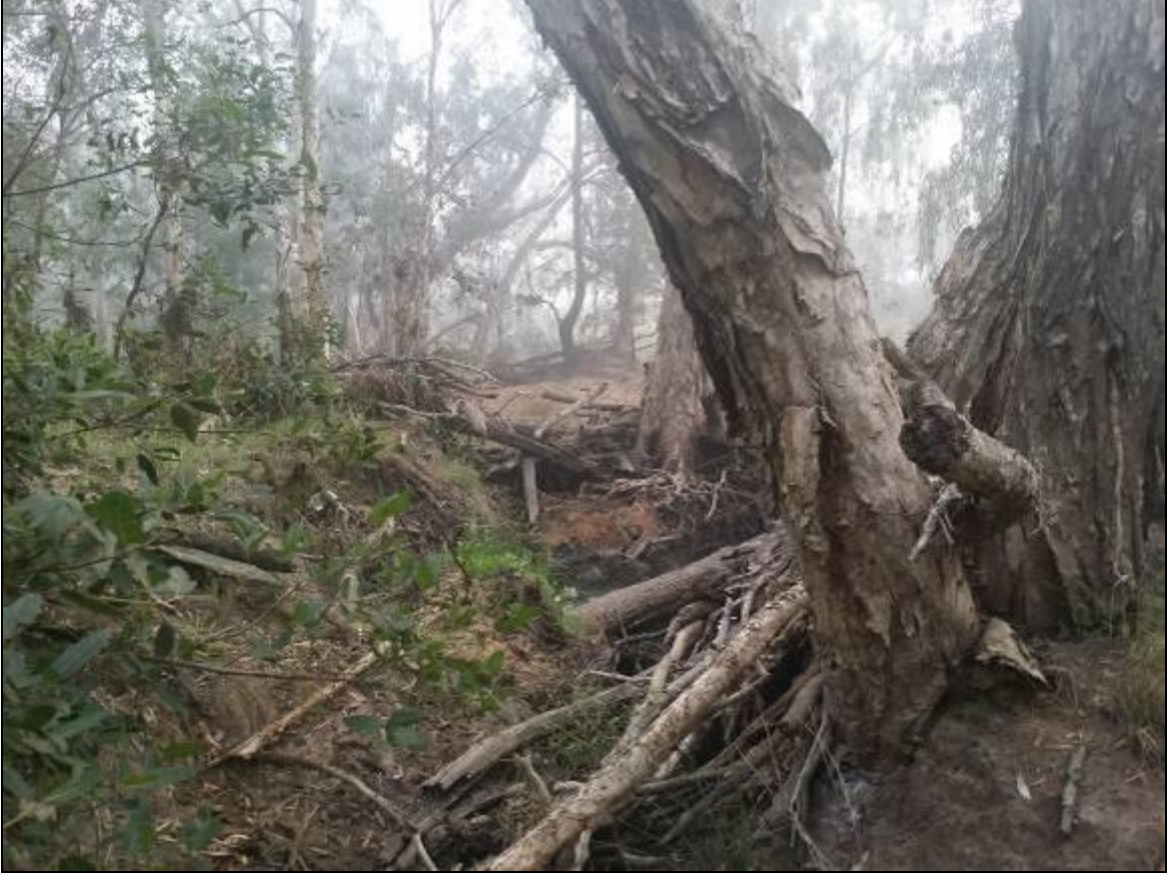
| Site No. | Location<br>(GDA94 Zone 53) | Soil Mapping Unit | Comments / Pictures |
|---|---|---|---|
| Ob187 | 636670 mE<br>7537857 mN | A1 | Drainage line, depression, Paperbark<br> |

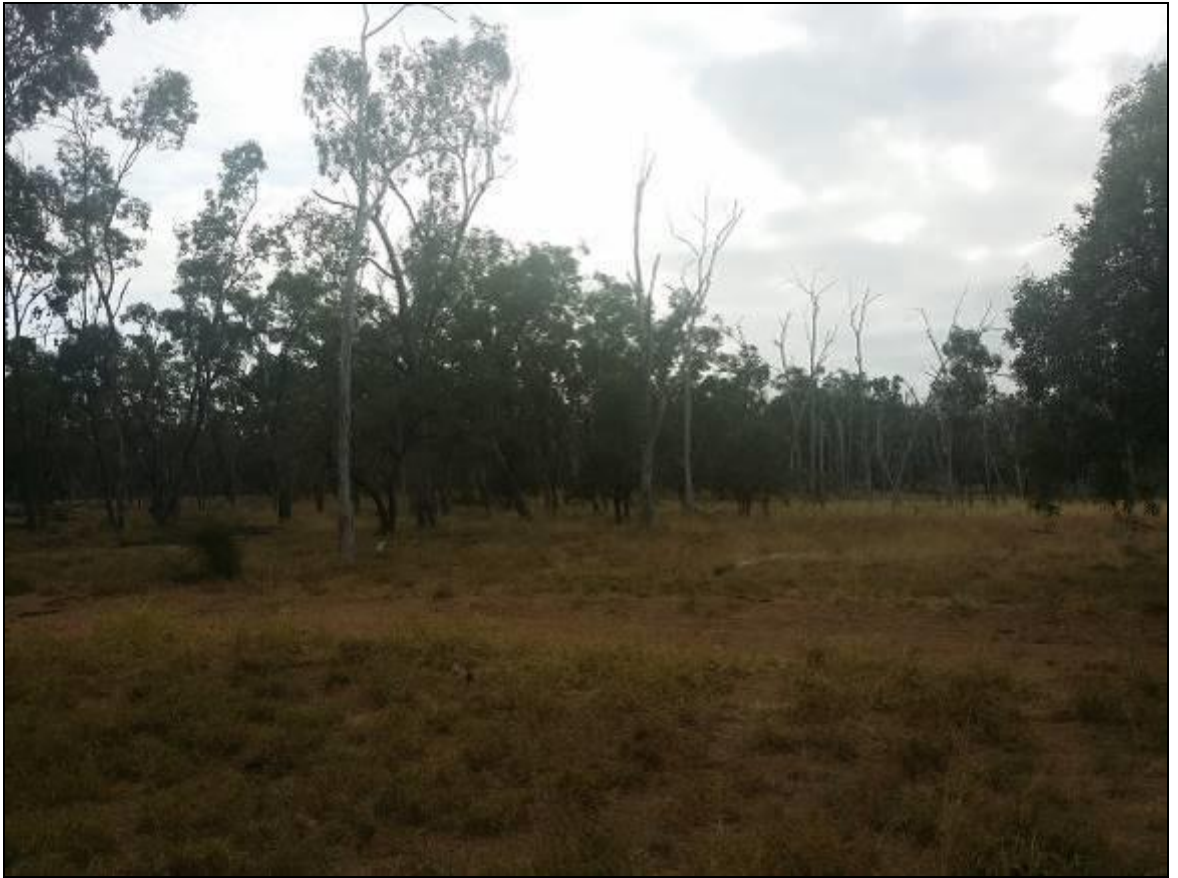
| Site No. | Location<br>(GDA94 Zone 53) | Soil Mapping Unit | Comments / Pictures |
|---|---|---|---|
| Ob215 | 640768 mE<br>7535197 mN | S1 | <p>Poplar Box, sandy surface</p> |

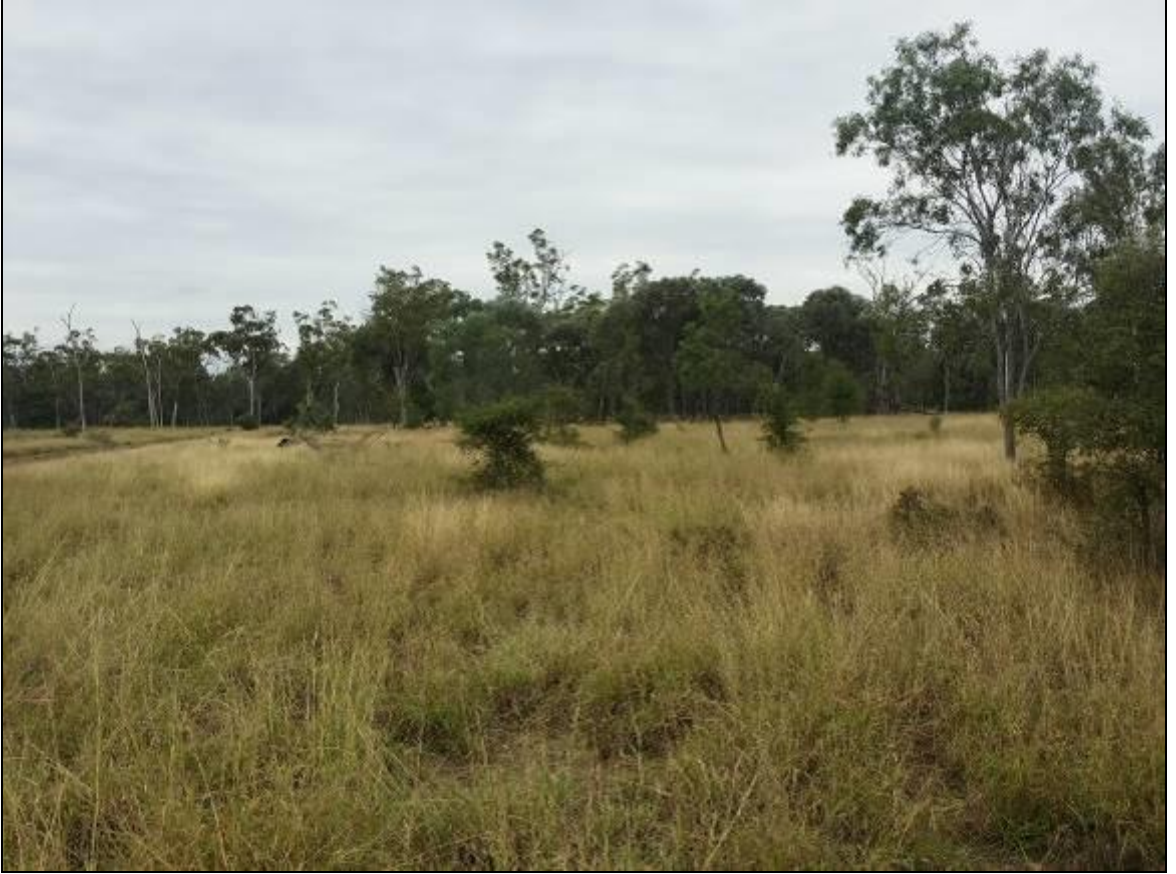
| Site No. | Location<br>(GDA94 Zone 53) | Soil Mapping Unit | Comments / Pictures |
|---|---|---|---|
| Ob221 | 640153 mE<br>7535160 mN | L2 | <p>Sparse regrowth, Poplar Box and Moreton Bay Ash</p> |

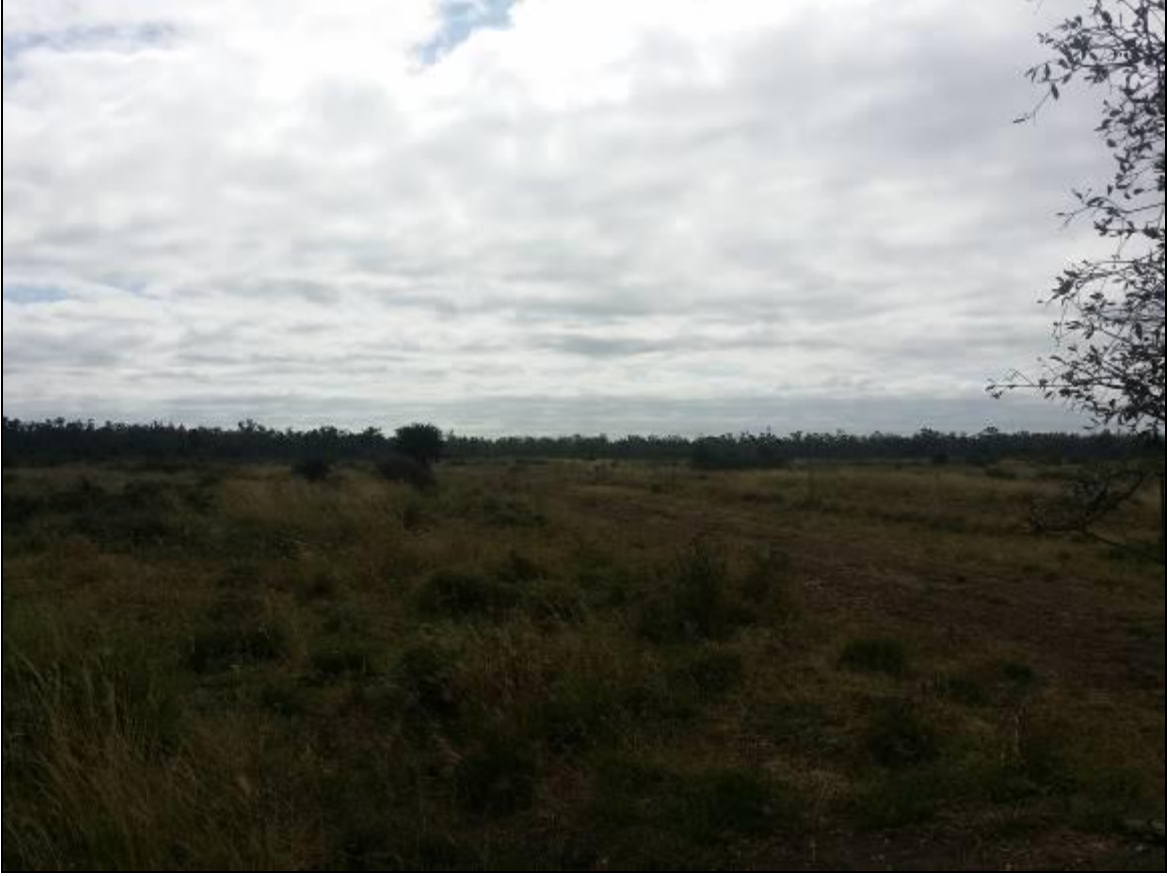
| Site No. | Location<br>(GDA94 Zone 53) | Soil Mapping Unit | Comments / Pictures |
|---|---|---|---|
| Ob254 | 635054 mE<br>7534753 mN | C2 | Normal gilgai, Brigalow regrowth<br> |

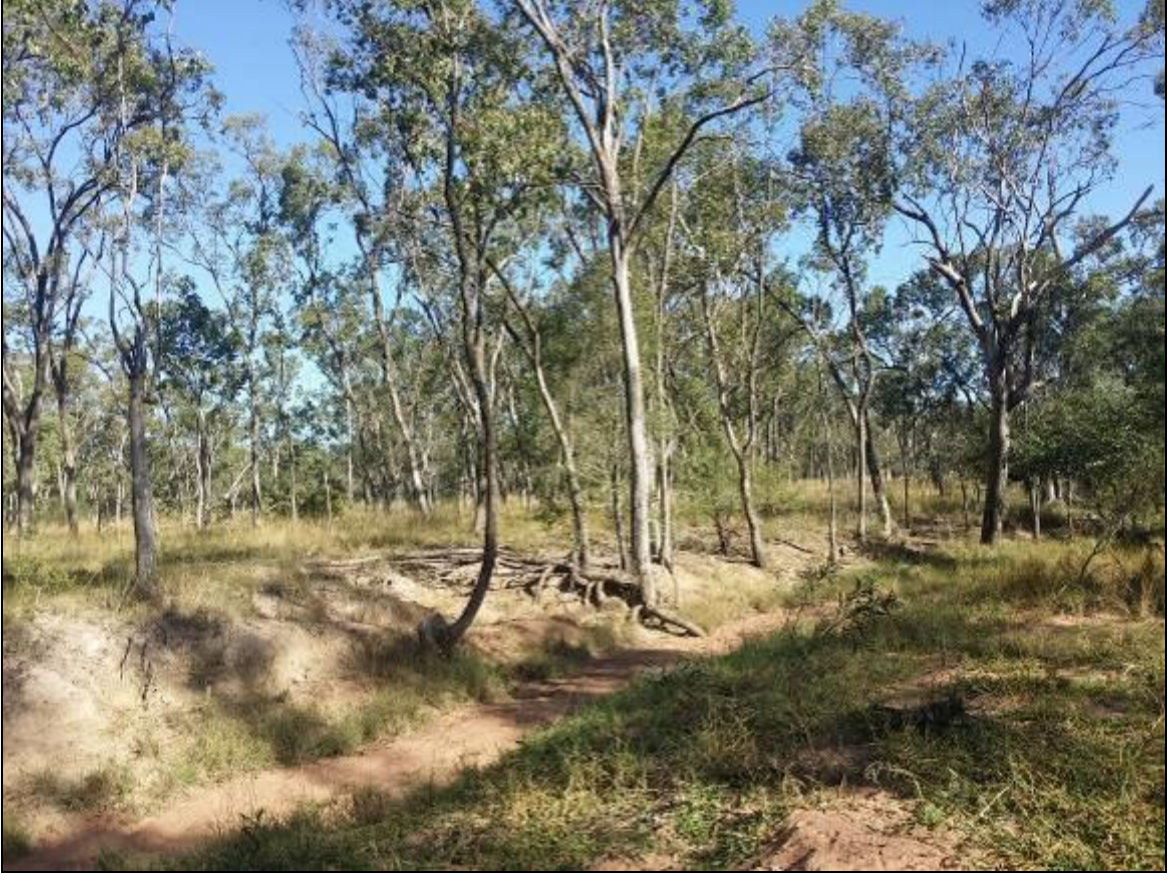
| Site No. | Location<br>(GDA94 Zone 53) | Soil Mapping Unit | Comments / Pictures |
|---|---|---|---|
| Ob255 | 634506 mE<br>7535378 mN | S2 | <p>Depression to the north, Poplar Box</p> |

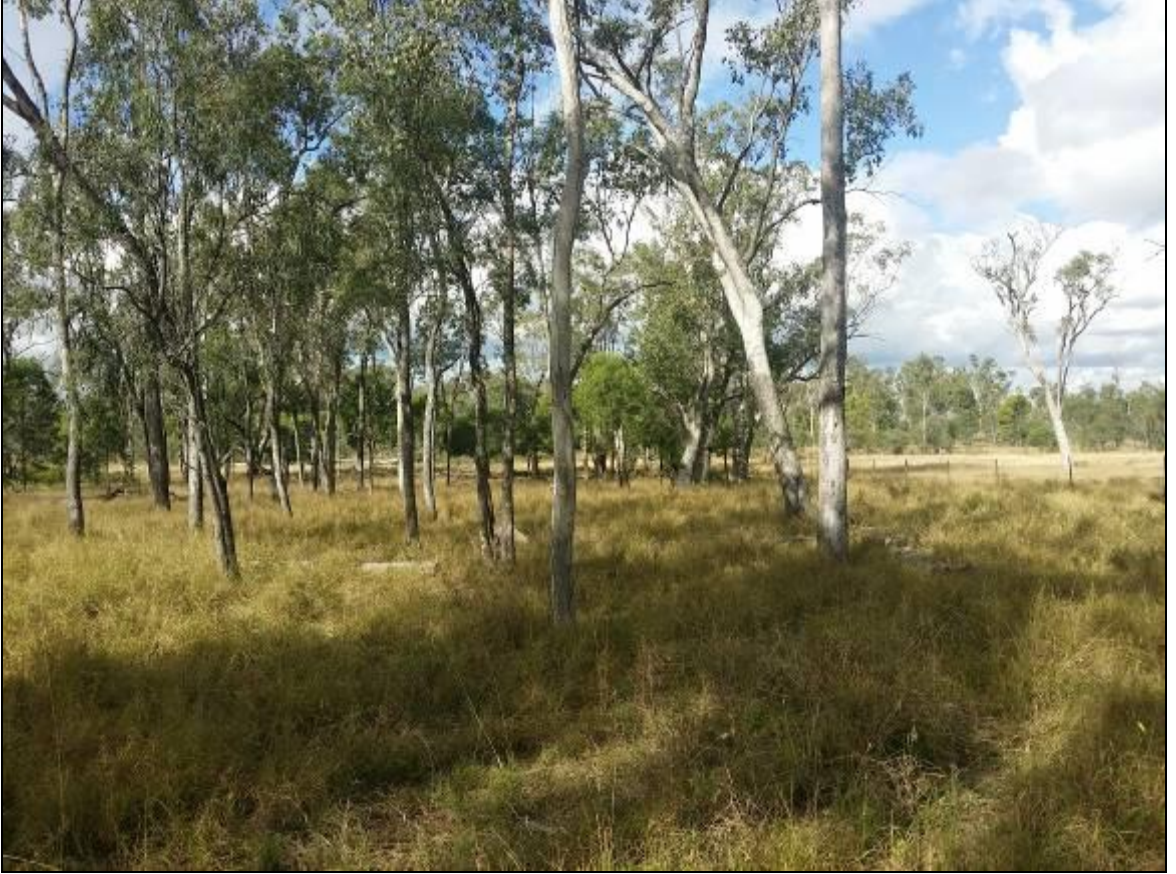
| Site No. | Location<br>(GDA94 Zone 53) | Soil Mapping Unit | Comments / Pictures |
|---|---|---|---|
| Ob258 | 634657 mE<br>7536638 mN | L2 | <p>Poplar Box wood lands</p> |

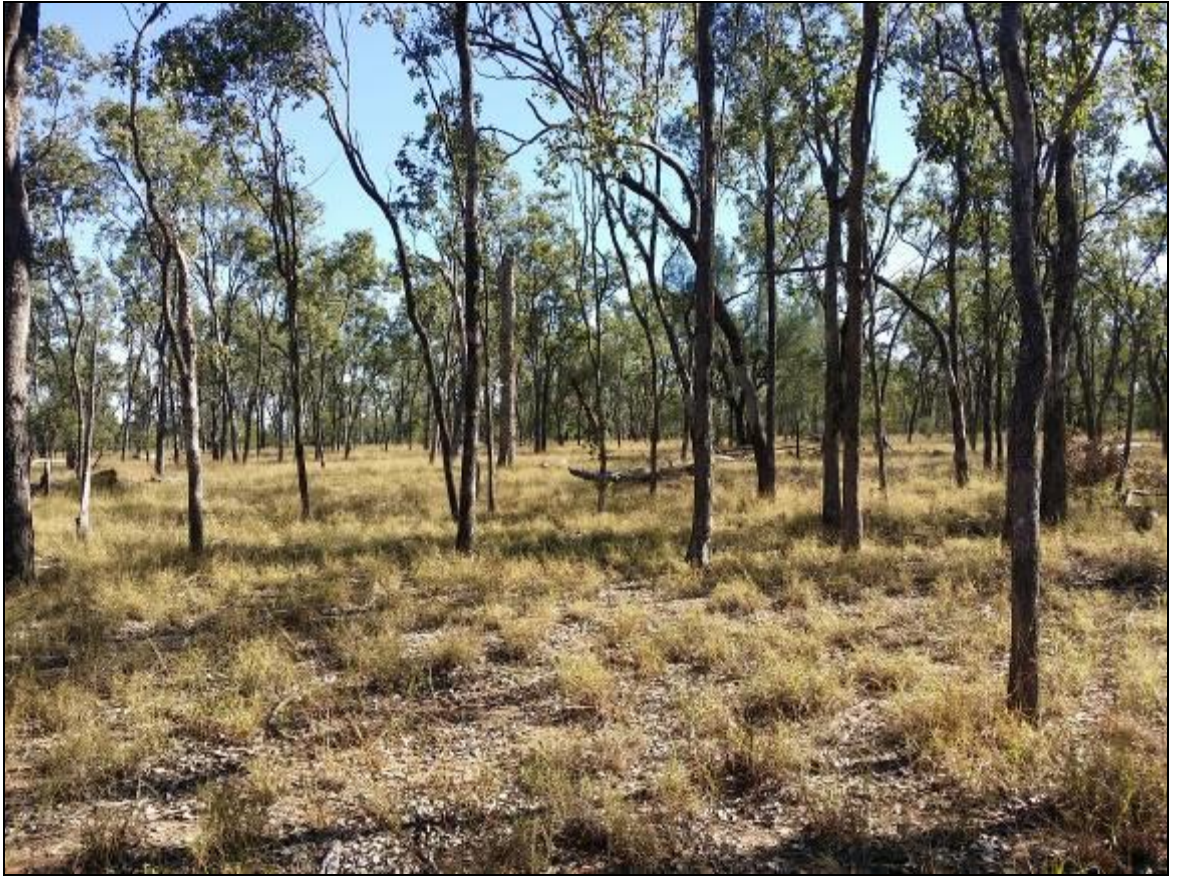
| Site No. | Location<br>(GDA94 Zone 53) | Soil Mapping Unit | Comments / Pictures |
|---|---|---|---|
| Ob273 | 636213 mE<br>7536564 mN | L2 | Dense Poplar box woodlands<br> |

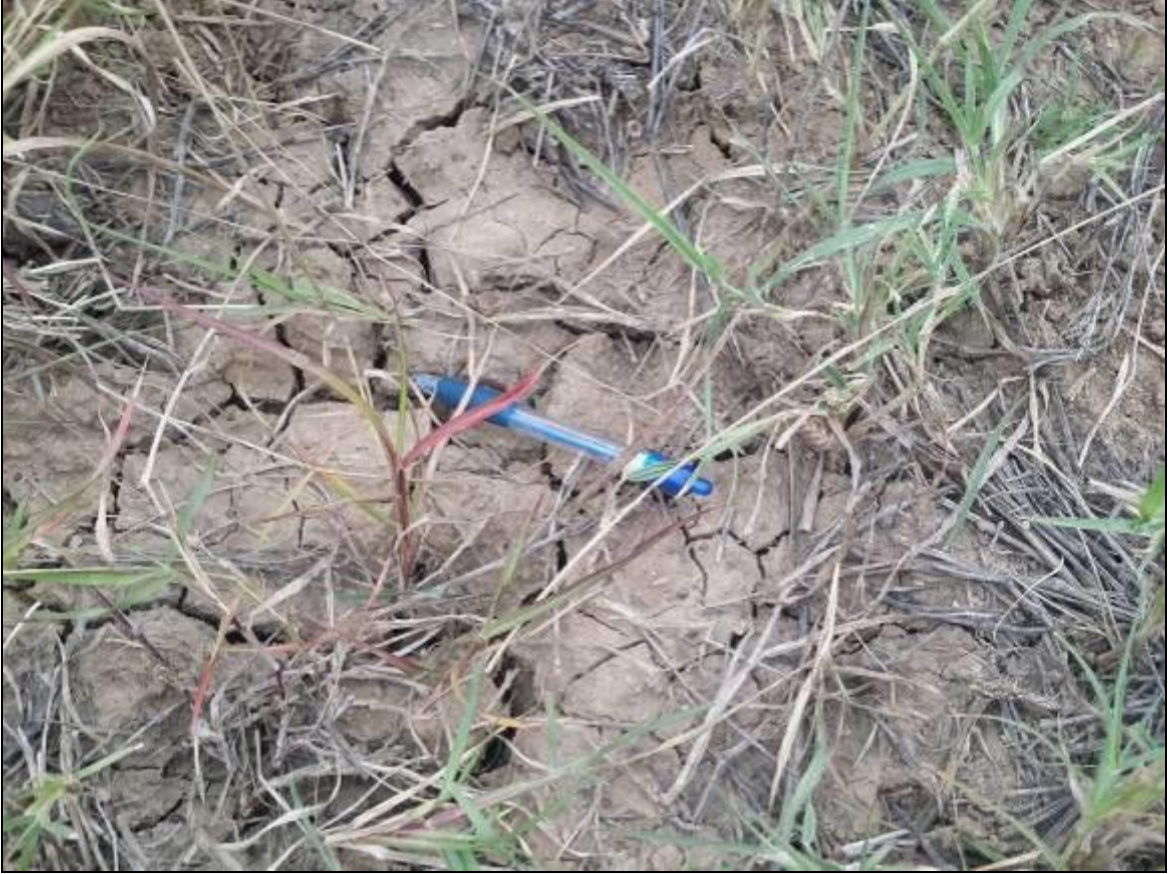
| Site No. | Location<br>(GDA94 Zone 53) | Soil Mapping Unit | Comments / Pictures |
|---|---|---|---|
| Ob281 | 638873 mE<br>7536754 mN | C2 | Cracking clay surface<br> |

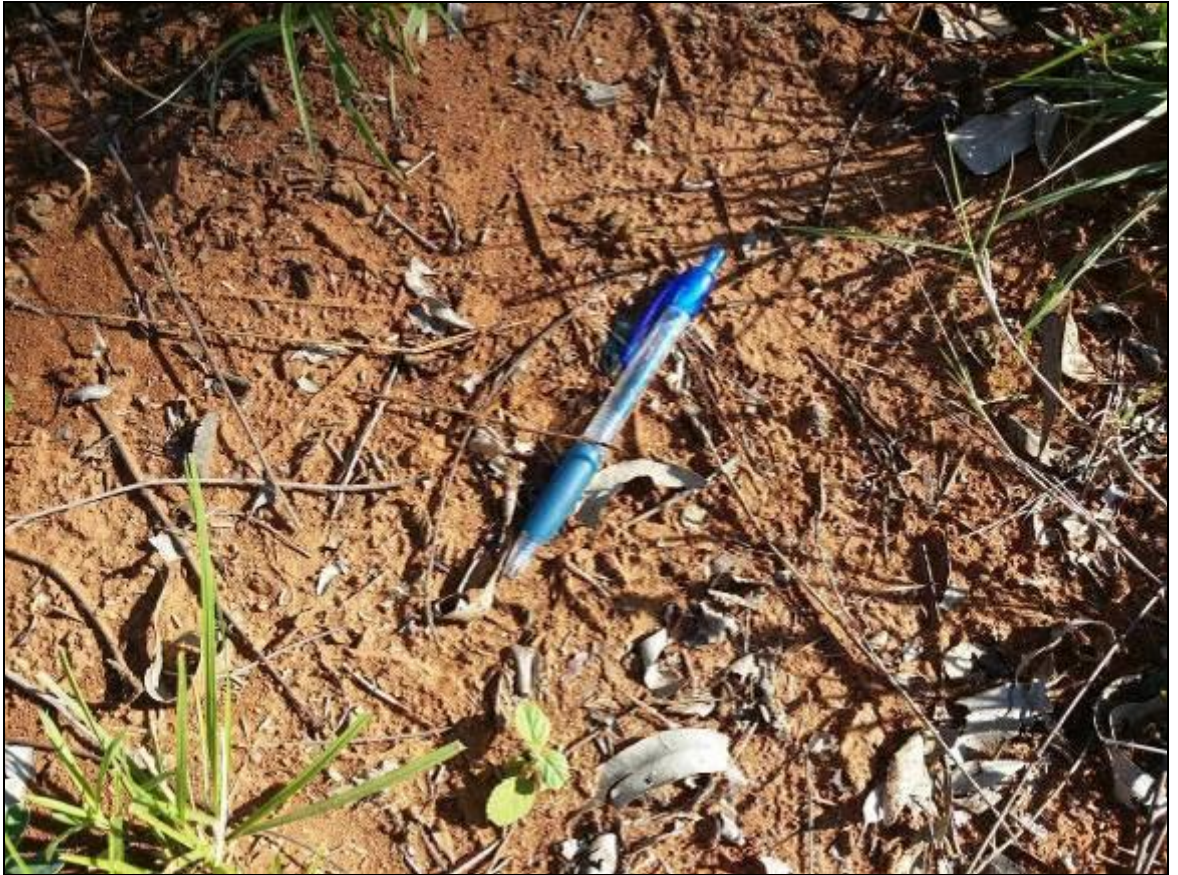
| Site No. | Location<br>(GDA94 Zone 53) | Soil Mapping Unit | Comments / Pictures |
|---|---|---|---|
| Ob310 | 642785 mE<br>7535003 mN | R1 | Red surface<br> |

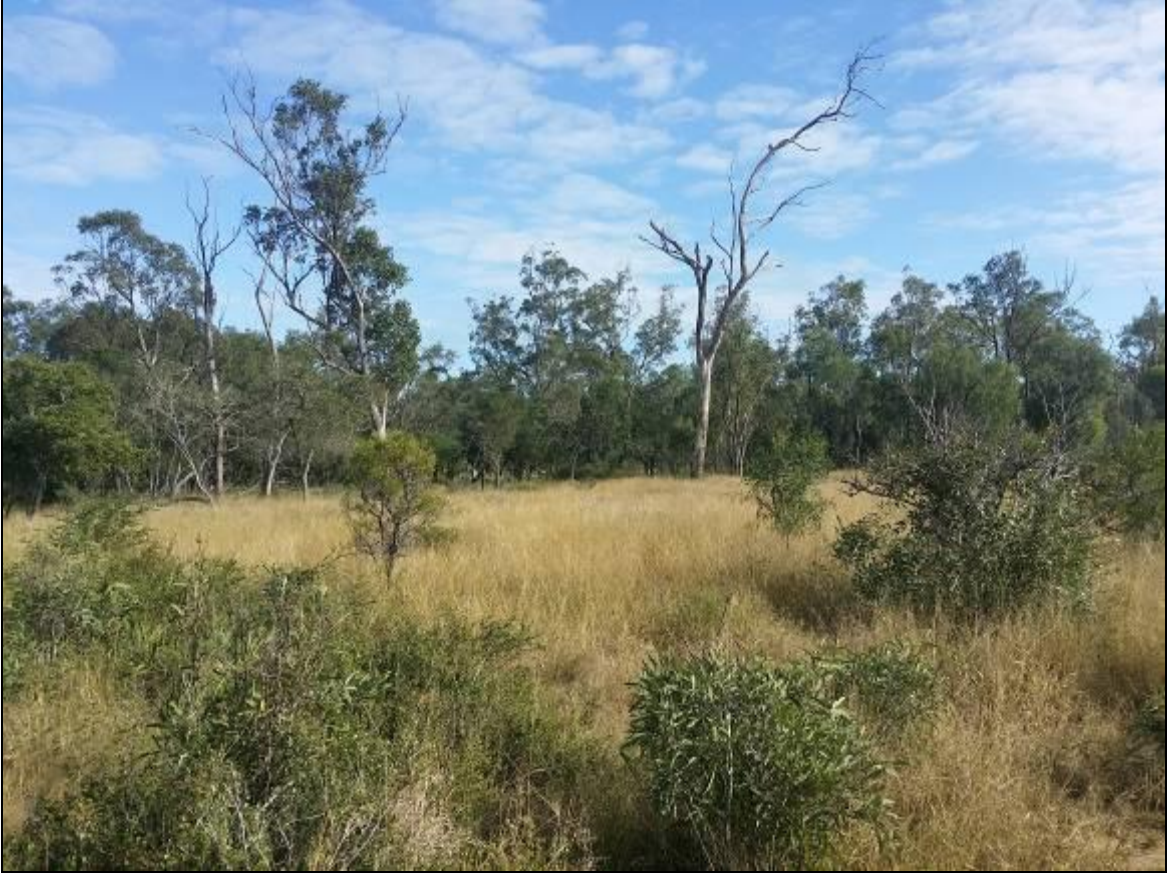
| Site No. | Location<br>(GDA94 Zone 53) | Soil Mapping Unit | Comments / Pictures |
|---|---|---|---|
| Ob314 | 642944 mE<br>7536282 mN | C1 | Brigalow, cracking clays with melon hole relief, boundary with start of Poplar Box 100M= away at the east<br> |

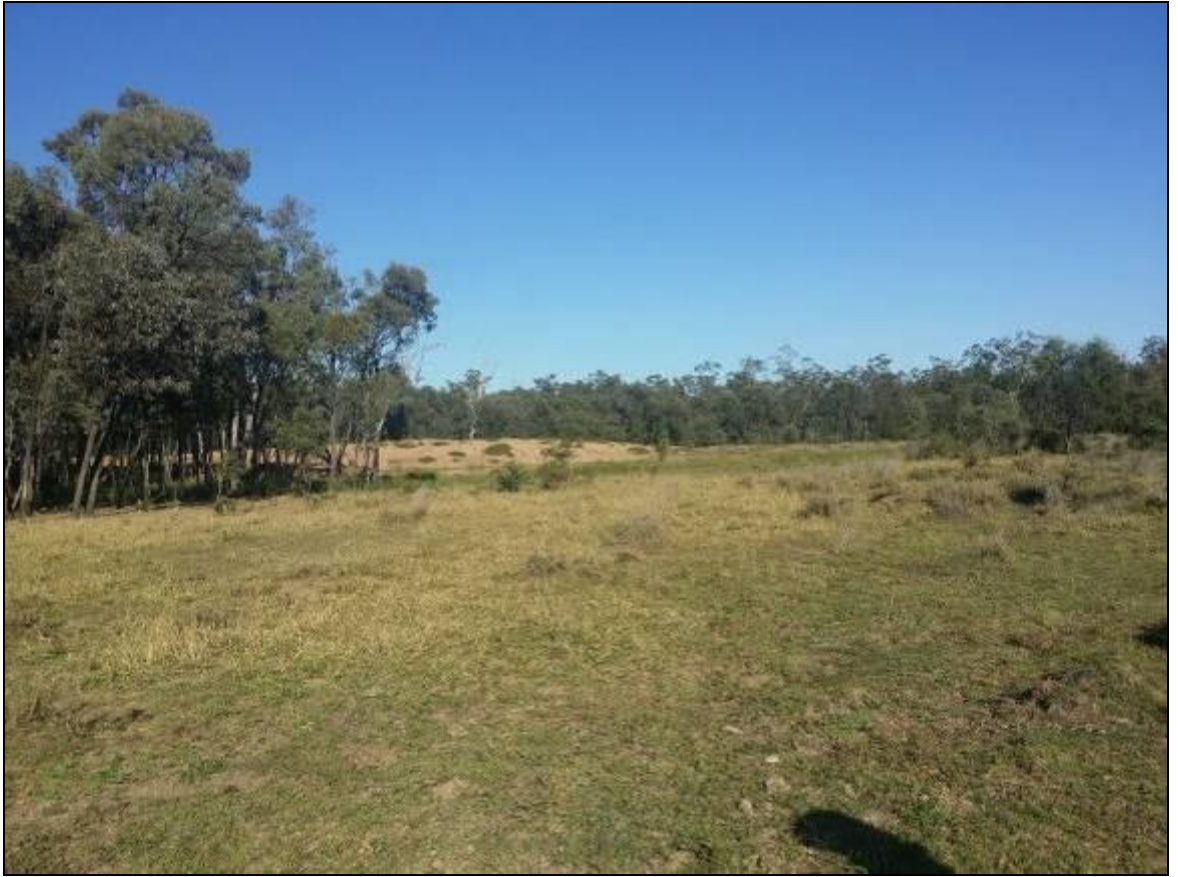
| Site No. | Location<br>(GDA94 Zone 53) | Soil Mapping Unit | Comments / Pictures |
|---|---|---|---|
| Ob321 | 645881 mE<br>7535125 mN | C2 | Brigalow, minor normal gilgai<br> |

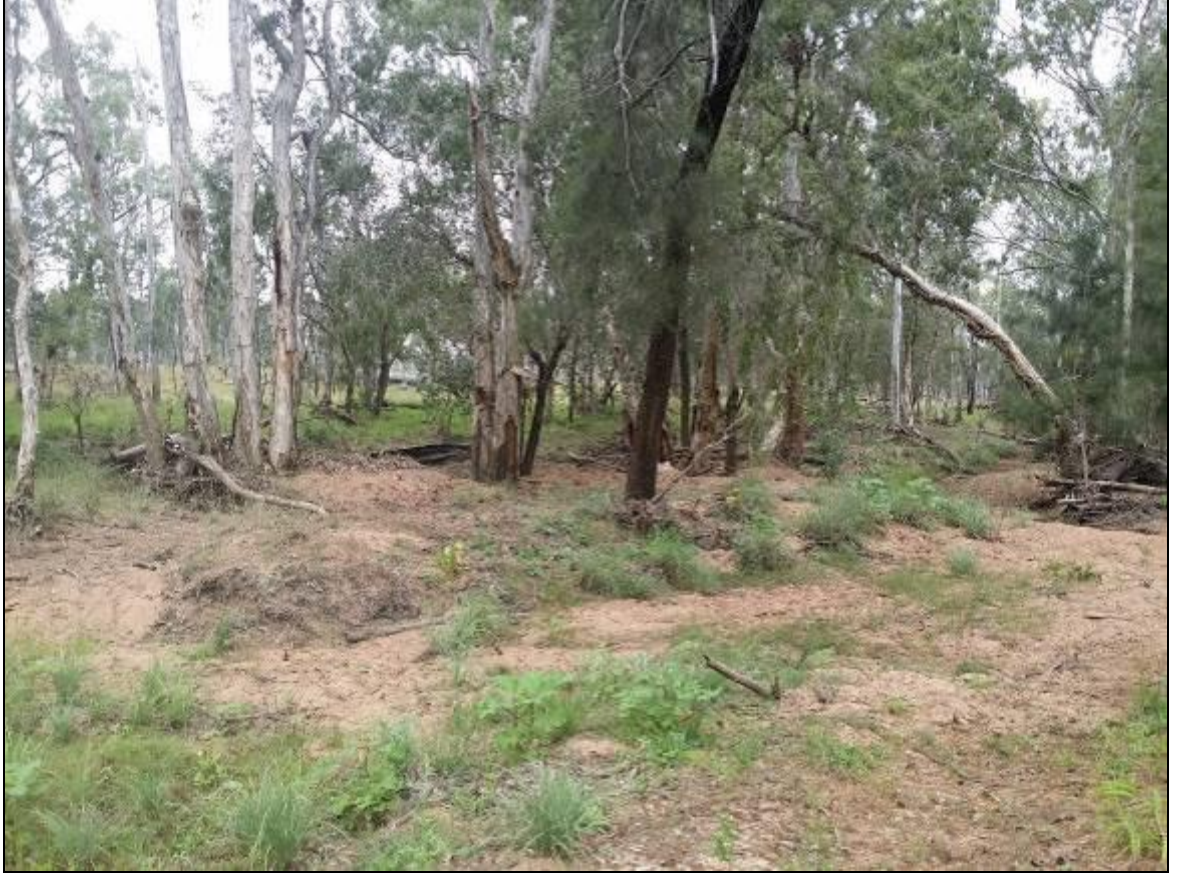
| Site No. | Location<br>(GDA94 Zone 53) | Soil Mapping Unit | Comments / Pictures |
|---|---|---|---|
| Ob346 | 641617 mE<br>7534316 mN | A1 | <p>Drainage line, Paperbark and Gums</p> |

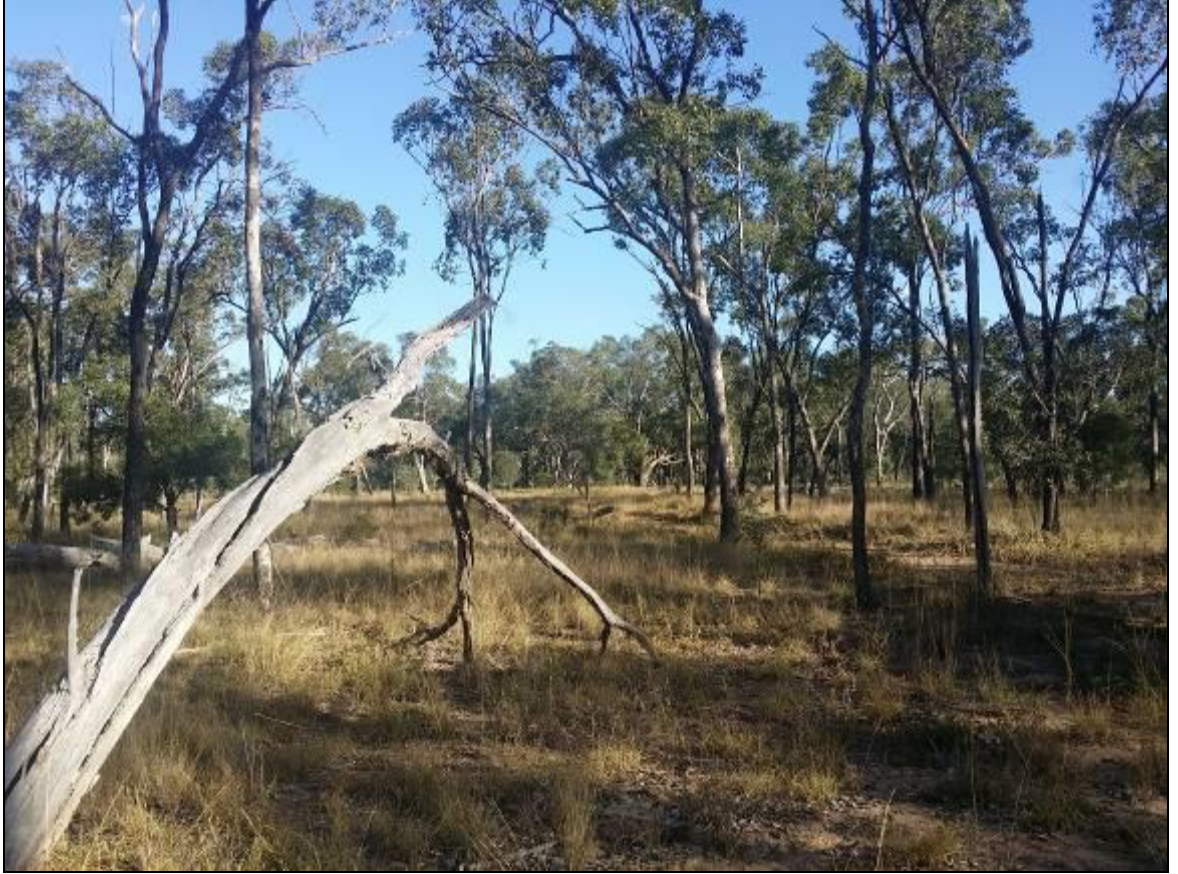
| Site No. | Location<br>(GDA94 Zone 53) | Soil Mapping Unit | Comments / Pictures |
|---|---|---|---|
| Ob354 | 641433 mE<br>7531699 mN | S1 | <p>Poplar Box, firm light brown surface, gently undulating plain</p> |
