**PEMBROKE**

**Olive Downs Coking Coal Project**  
Draft Environmental Impact Statement

**Appendix M**  
**Soil and Land**  
**Suitability**  
**Assessment**

Olive Downs Coking Coal Project

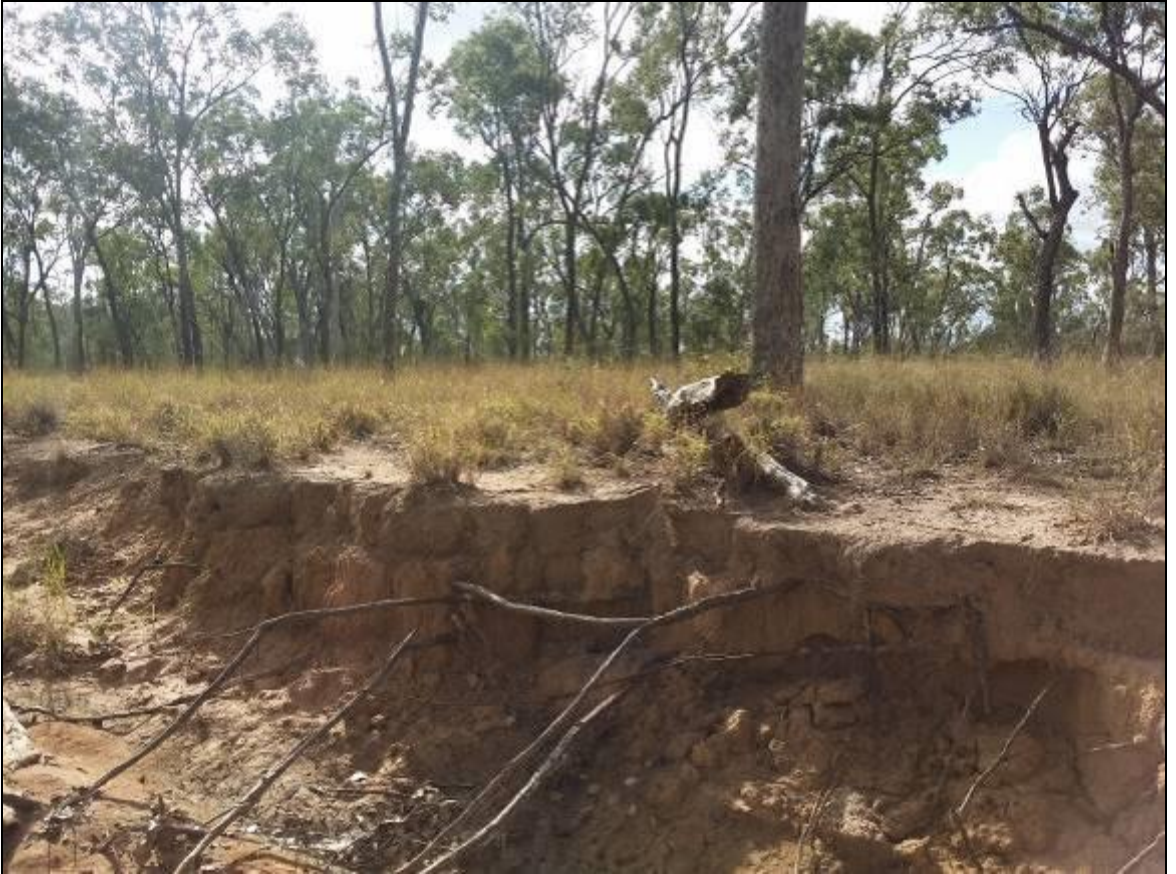
| Site No. | Location<br>(GDA94 Zone 53) | Soil Mapping Unit | Comments / Pictures |
|---|---|---|---|
| Ob358 | 643516 mE<br>7531698 mN | L1 | Eroded area, minor drainage line, loamy sand surface, Poplar Box<br> |

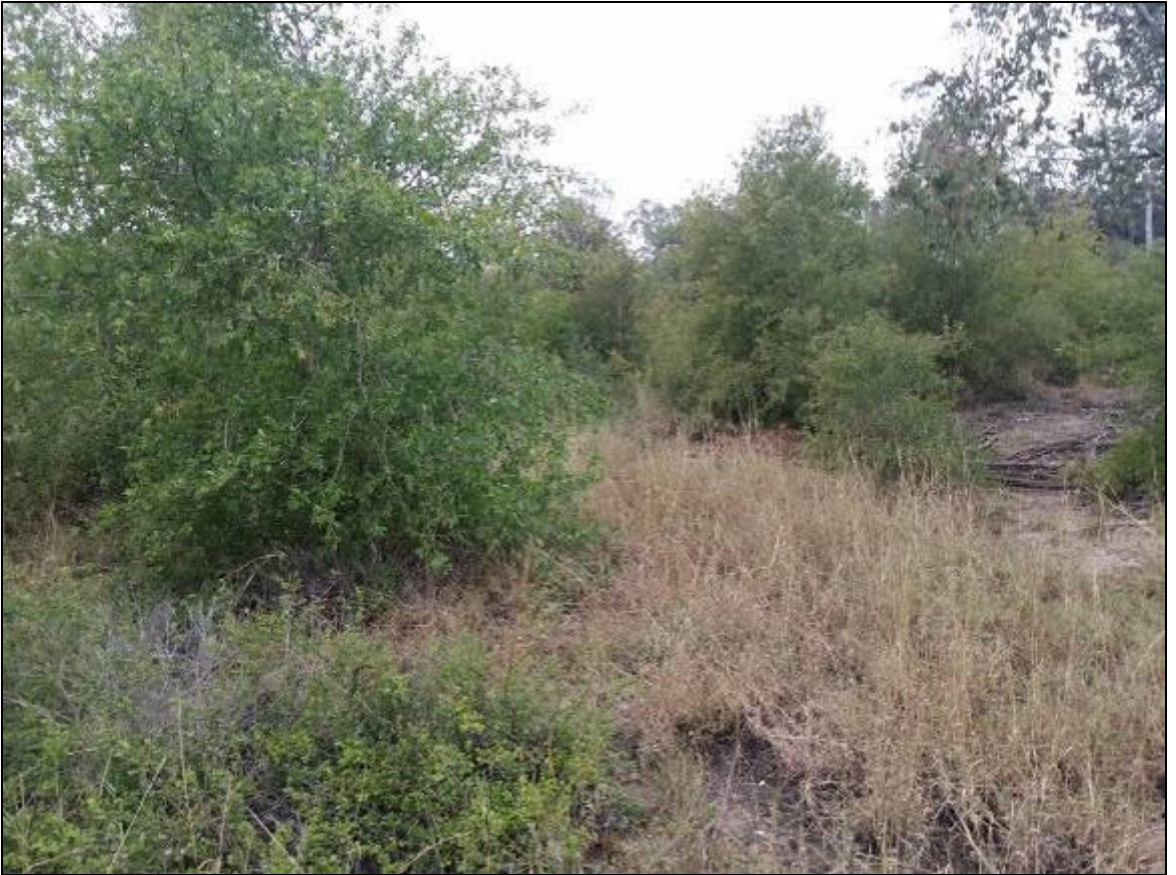
| Site No. | Location<br>(GDA94 Zone 53) | Soil Mapping Unit | Comments / Pictures |
|---|---|---|---|
| Ob362 | 640929 mE<br>7533548 mN | C2/L1 Boundary | Cracking surface to the west, mixed vegetation<br> |

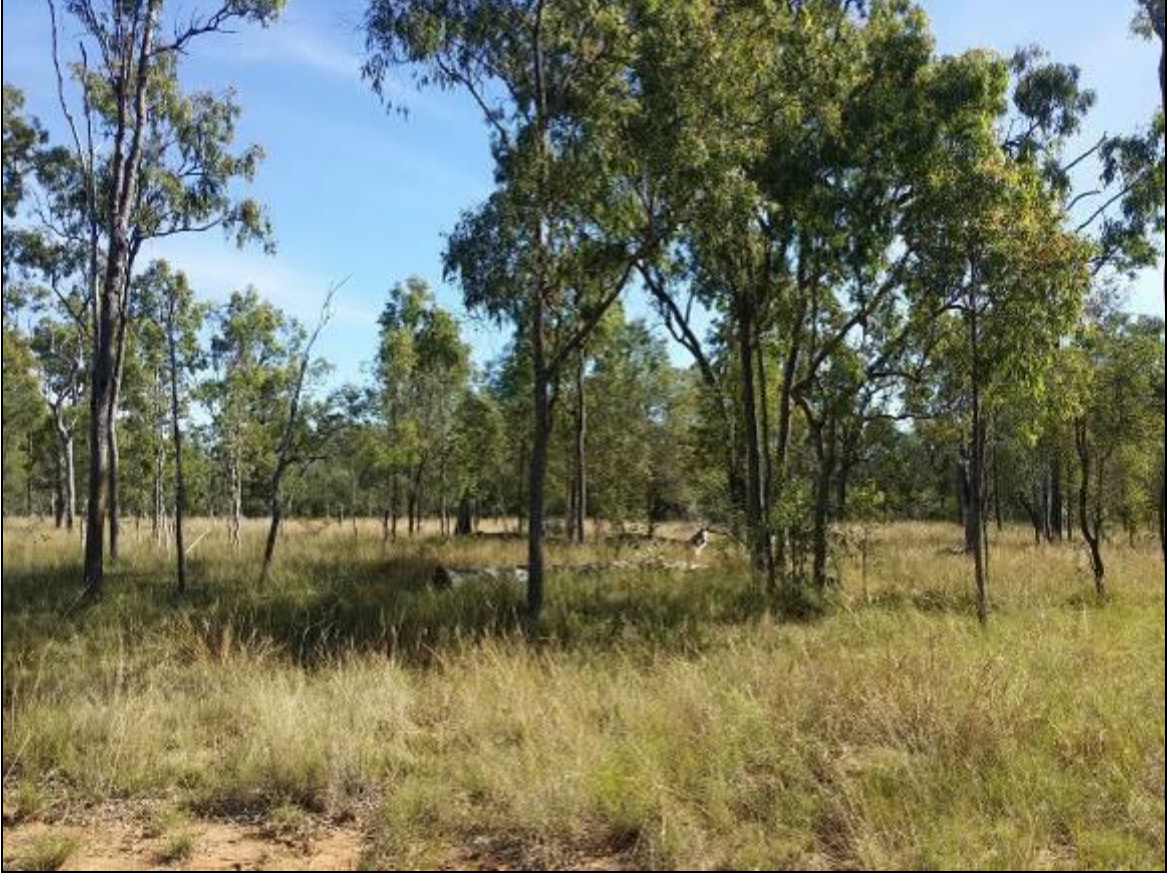
| Site No. | Location<br>(GDA94 Zone 53) | Soil Mapping Unit | Comments / Pictures |
|---|---|---|---|
| Ob386 | 648239 mE<br>7534928 mN | A2 | <p>Poplar Box to west, Blackbutt to east</p> |

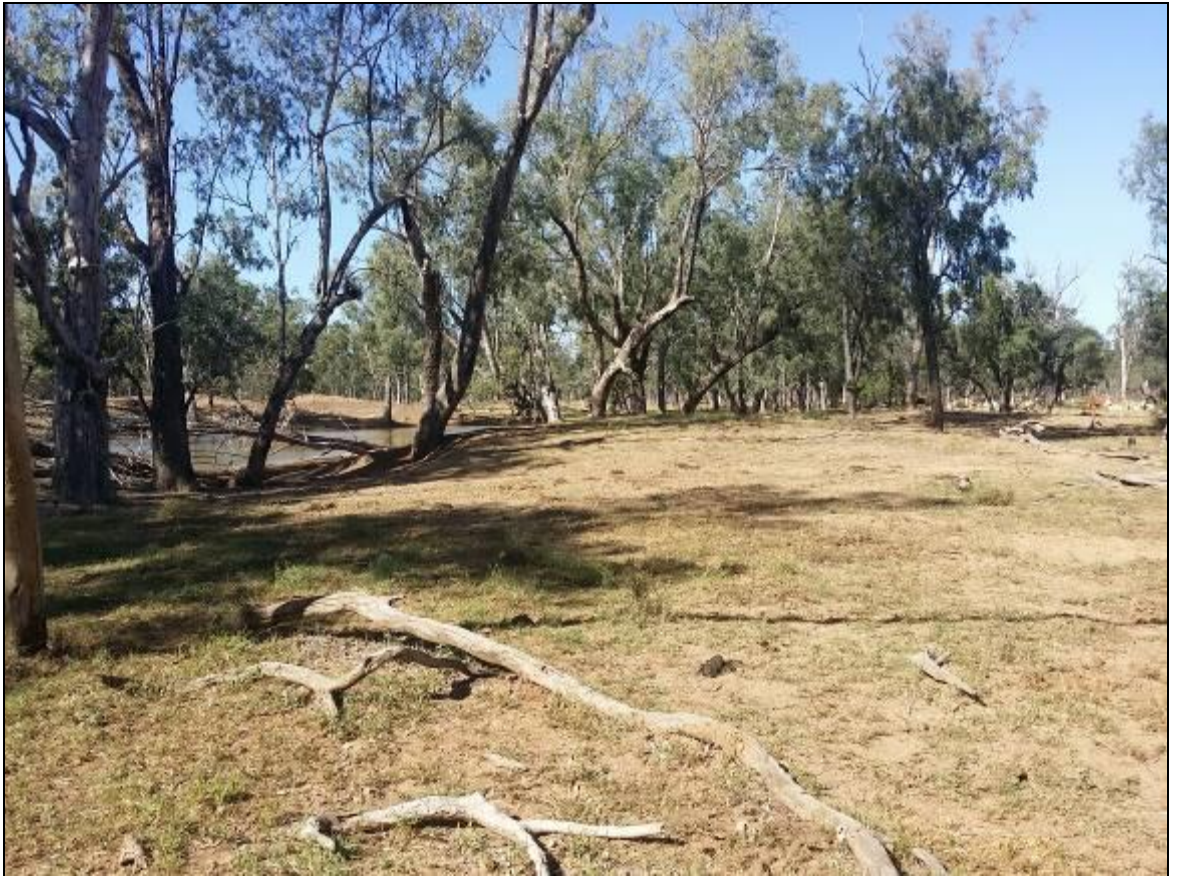
| Site No. | Location<br>(GDA94 Zone 53) | Soil Mapping Unit | Comments / Pictures |
|---|---|---|---|
| Ob402 | 649894 mE<br>7533990 mN | A2 | Drainage line<br> |

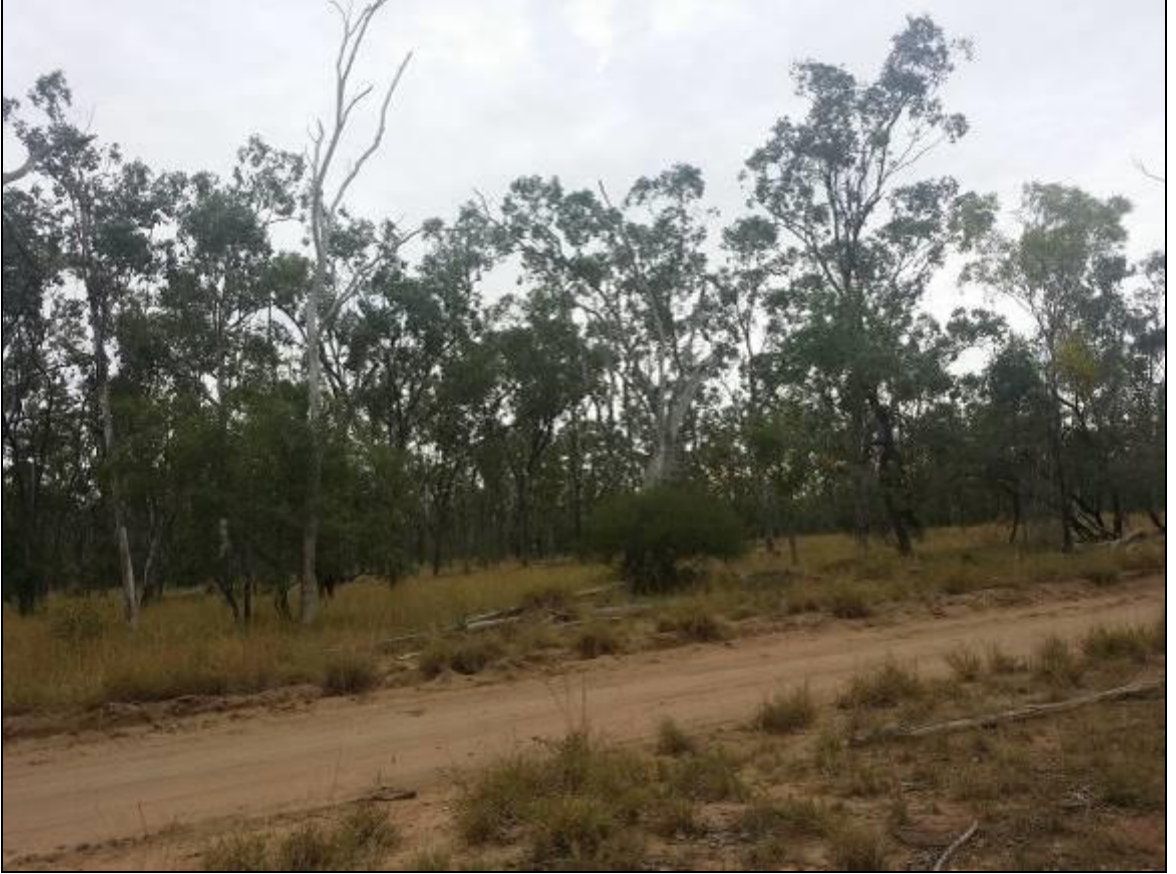
| Site No. | Location<br>(GDA94 Zone 53) | Soil Mapping Unit | Comments / Pictures |
|---|---|---|---|
| Ob412 | 651590 mE<br>7535098 mN | S2 | <p>Poplar Box and Gums</p> |

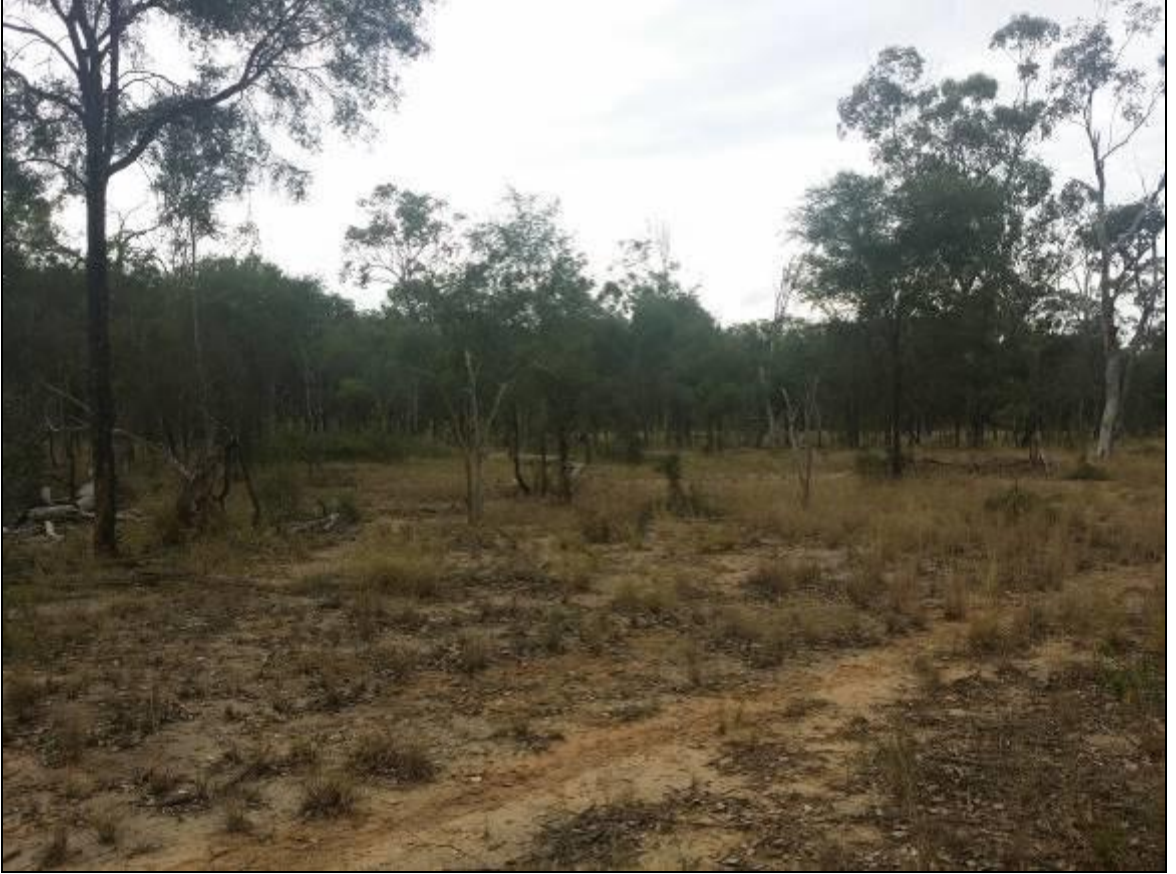
| Site No. | Location<br>(GDA94 Zone 53) | Soil Mapping Unit | Comments / Pictures |
|---|---|---|---|
| Ob442 | 650354 mE<br>7531677 mN | B2 | <p>Mixed vegetation, silty loam texture for surface soil horizon</p> |

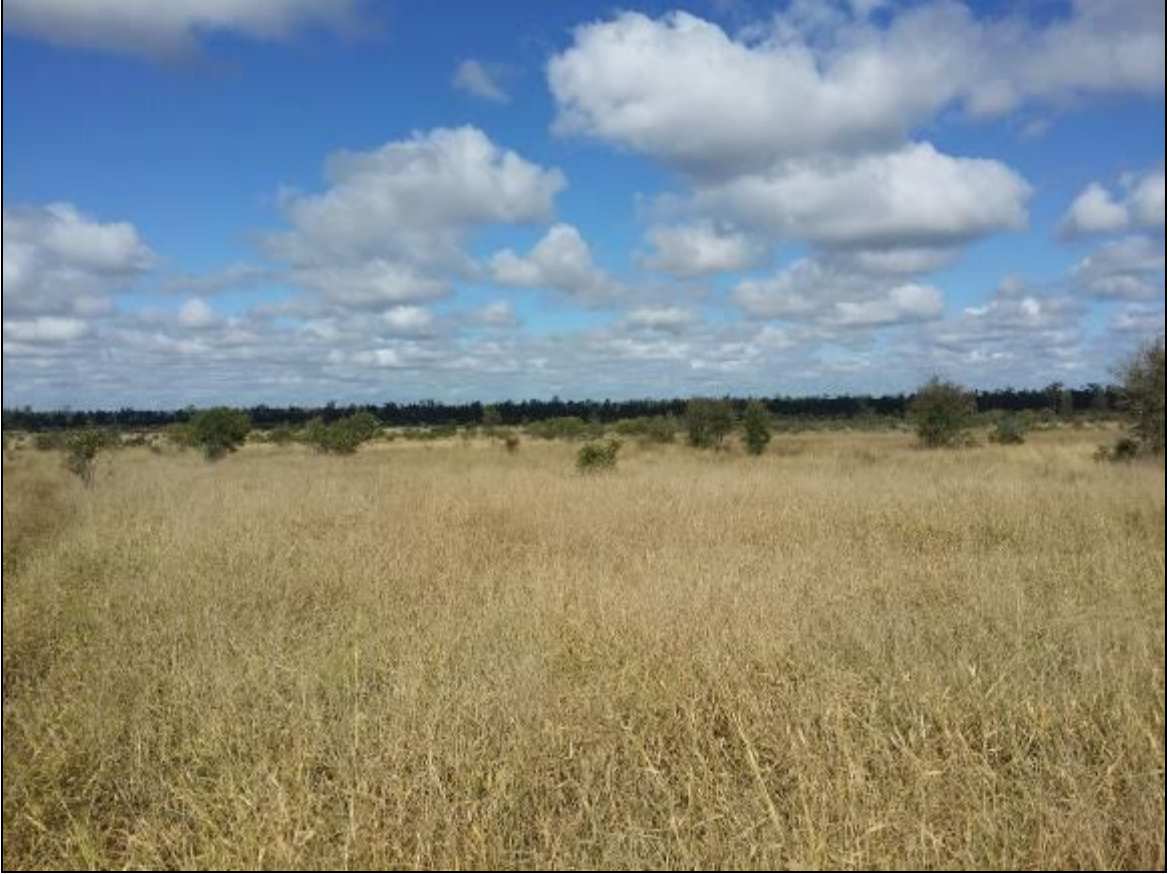
| Site No. | Location<br>(GDA94 Zone 53) | Soil Mapping Unit | Comments / Pictures |
|---|---|---|---|
| Ob465 | 653229 mE<br>7530049 mN | L1 | <p>Firm light brown surface, non-cracking</p> |

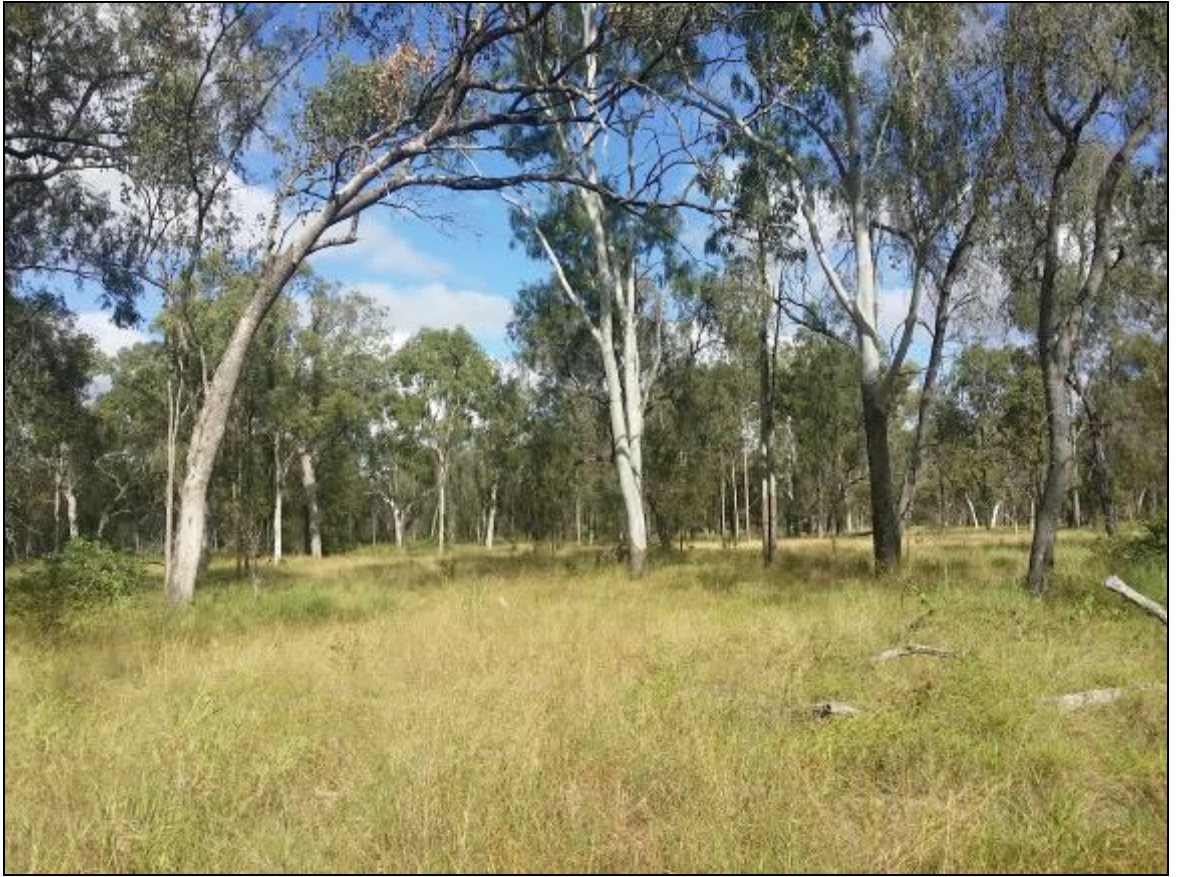
| Site No. | Location<br>(GDA94 Zone 53) | Soil Mapping Unit | Comments / Pictures |
|---|---|---|---|
| Ob471 | 651447 mE<br>7529708 mN | S2 | <p>Sandy soft surface, gums and Poplar Box</p> |

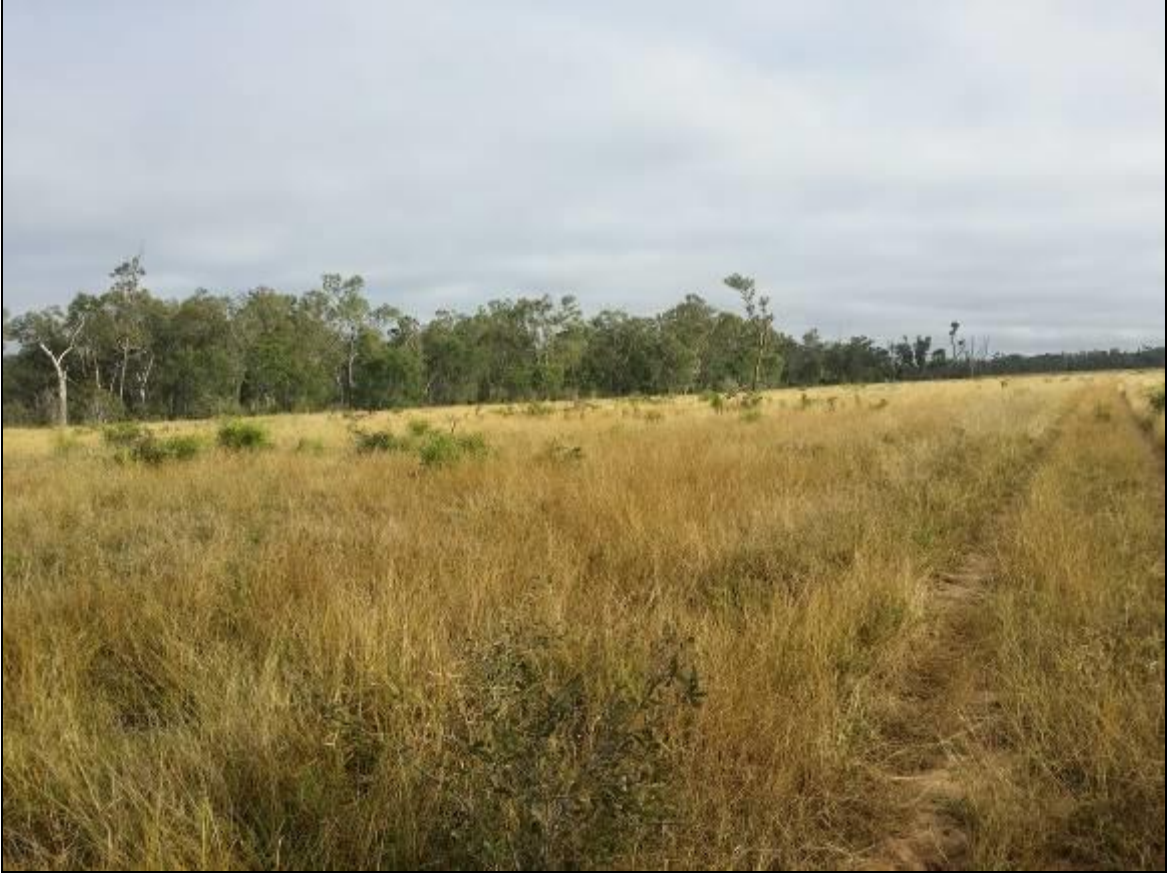
| Site No. | Location<br>(GDA94 Zone 53) | Soil Mapping Unit | Comments / Pictures |
|---|---|---|---|
| Ob478 | 652623 mE<br>7528966 mN | B2 | <p>Silty loam surface, uncleared area to the south with mixed vegetation</p> |

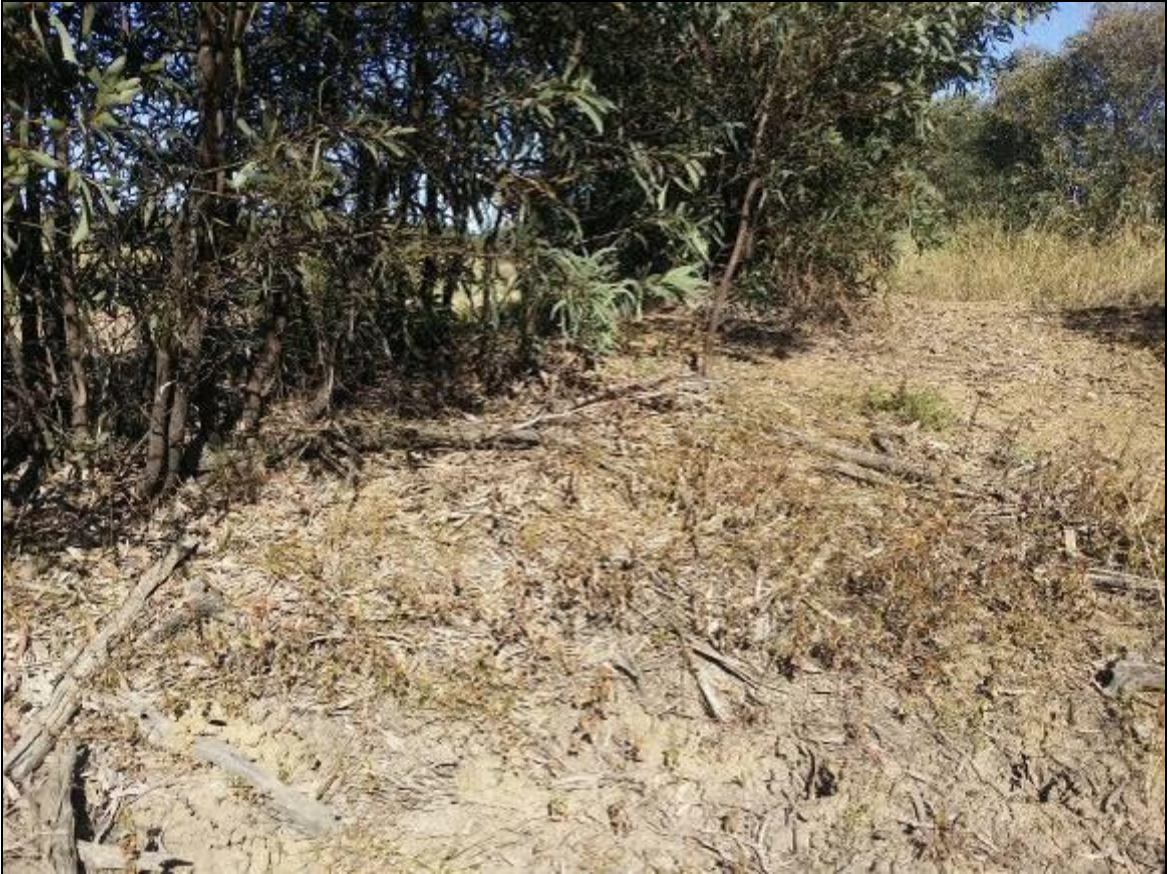
| Site No. | Location<br>(GDA94 Zone 53) | Soil Mapping Unit | Comments / Pictures |
|---|---|---|---|
| Ob518 | 656777 mE<br>7529569 mN | C1 | Melon holes, 50% coverage 0.5m+ deep, 3-5m wide, Brigalow<br> |

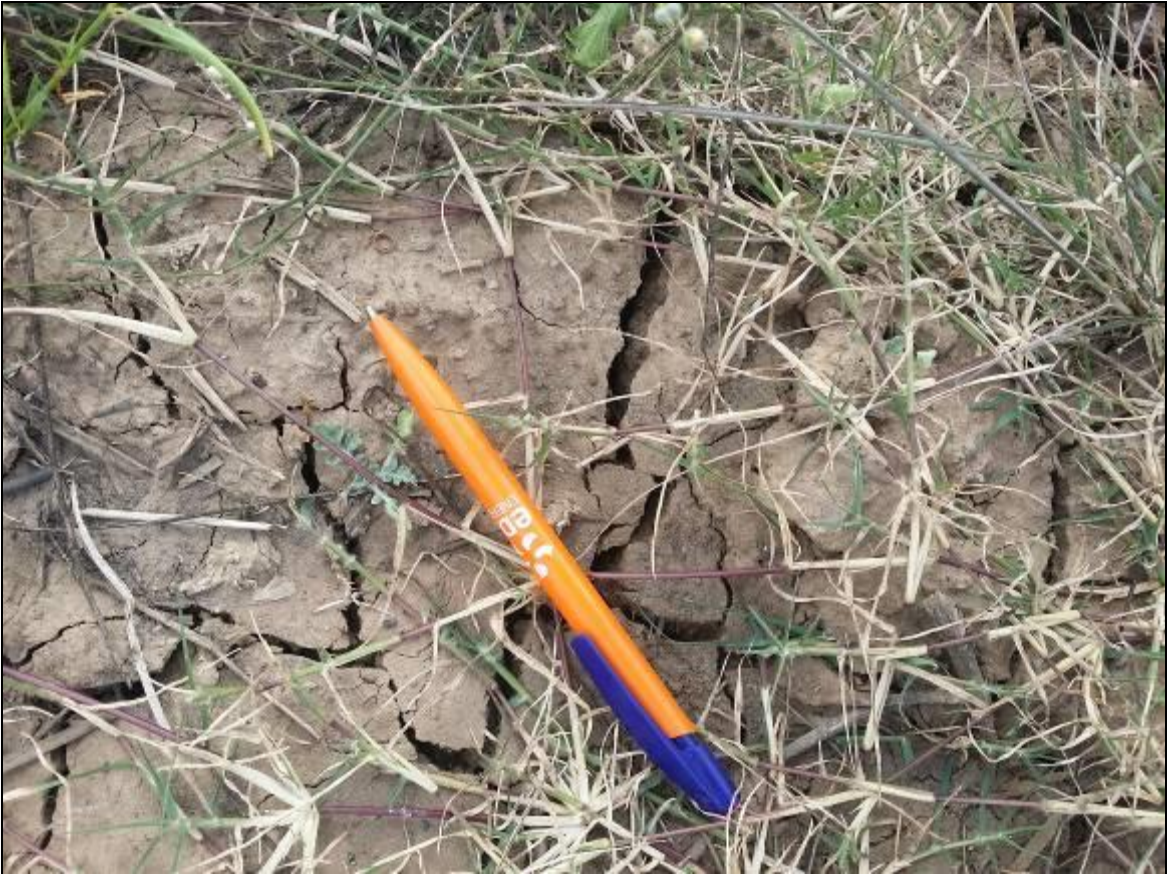
| Site No. | Location<br>(GDA94 Zone 53) | Soil Mapping Unit | Comments / Pictures |
|---|---|---|---|
| Ob551 | 658520 mE<br>7526807 mN | C1 | Cracking clays, melon holes, <50% coverage 0.5m+ deep<br> |

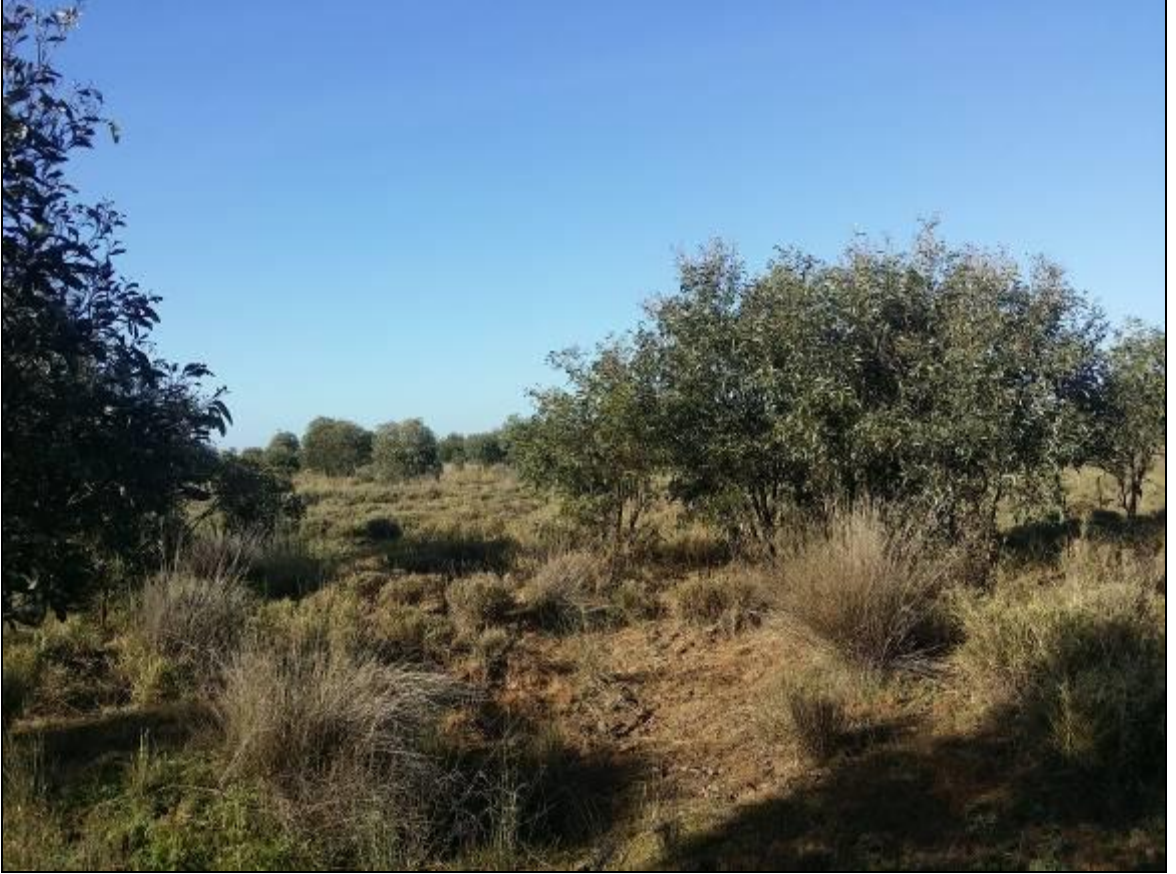
| Site No. | Location<br>(GDA94 Zone 53) | Soil Mapping Unit | Comments / Pictures |
|---|---|---|---|
| Ob650 | 664594 mE<br>7524854 mN | C1 | <p>Melon holes &lt;0.5m deep, Brigalow, cracking clay surface</p> |

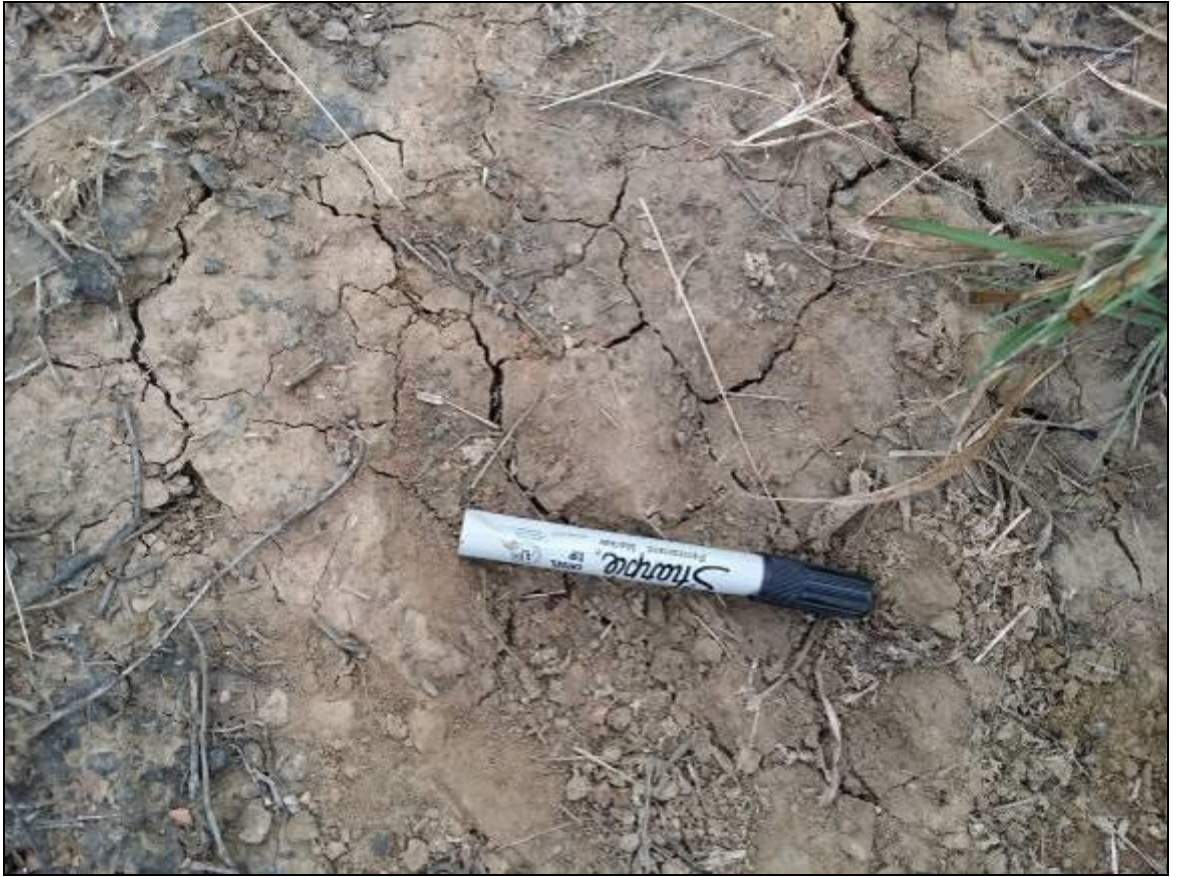
| Site No. | Location<br>(GDA94 Zone 53) | Soil Mapping Unit | Comments / Pictures |
|---|---|---|---|
| Ob660 | 660040 mE<br>7519880 mN | C2 | <p>Brigalow regrowth observed, cracking surface</p> |

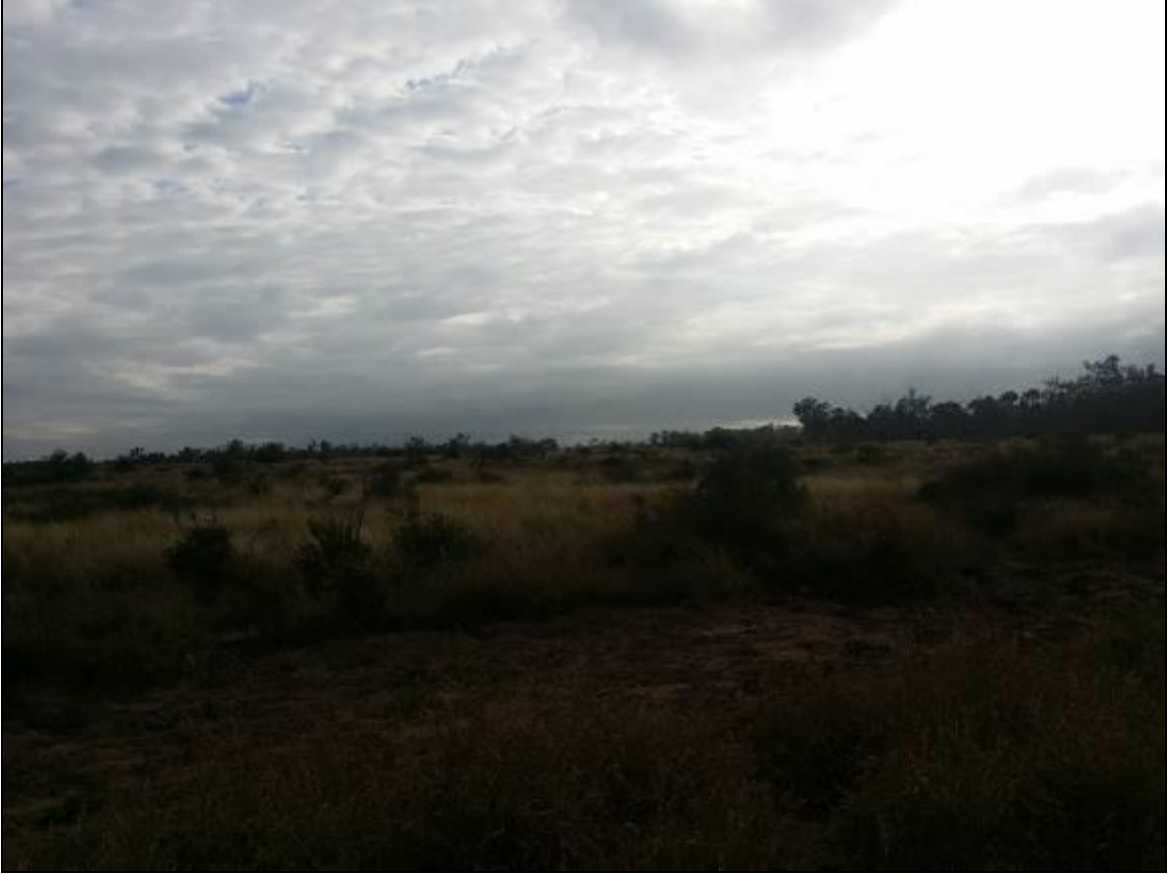
| Site No. | Location<br>(GDA94 Zone 53) | Soil Mapping Unit | Comments / Pictures |
|---|---|---|---|
| Ob668 | 659017 mE<br>7521390 mN | C2 | Cracking clay surface with minor normal gilgai<br> |

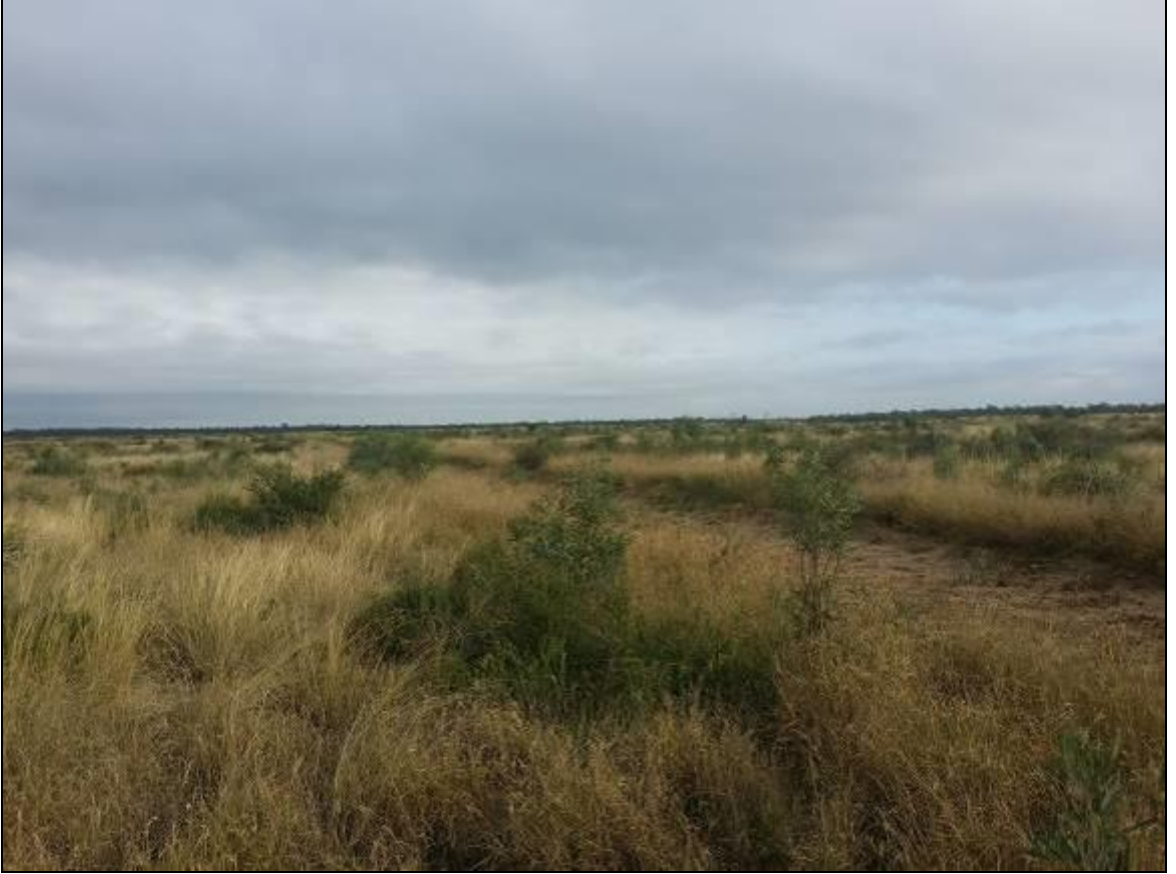
| Site No. | Location<br>(GDA94 Zone 53) | Soil Mapping Unit | Comments / Pictures |
|---|---|---|---|
| Ob710 | 659761 mE<br>7522174 mN | C2 | Cracking clays and normal gilgai<br> |

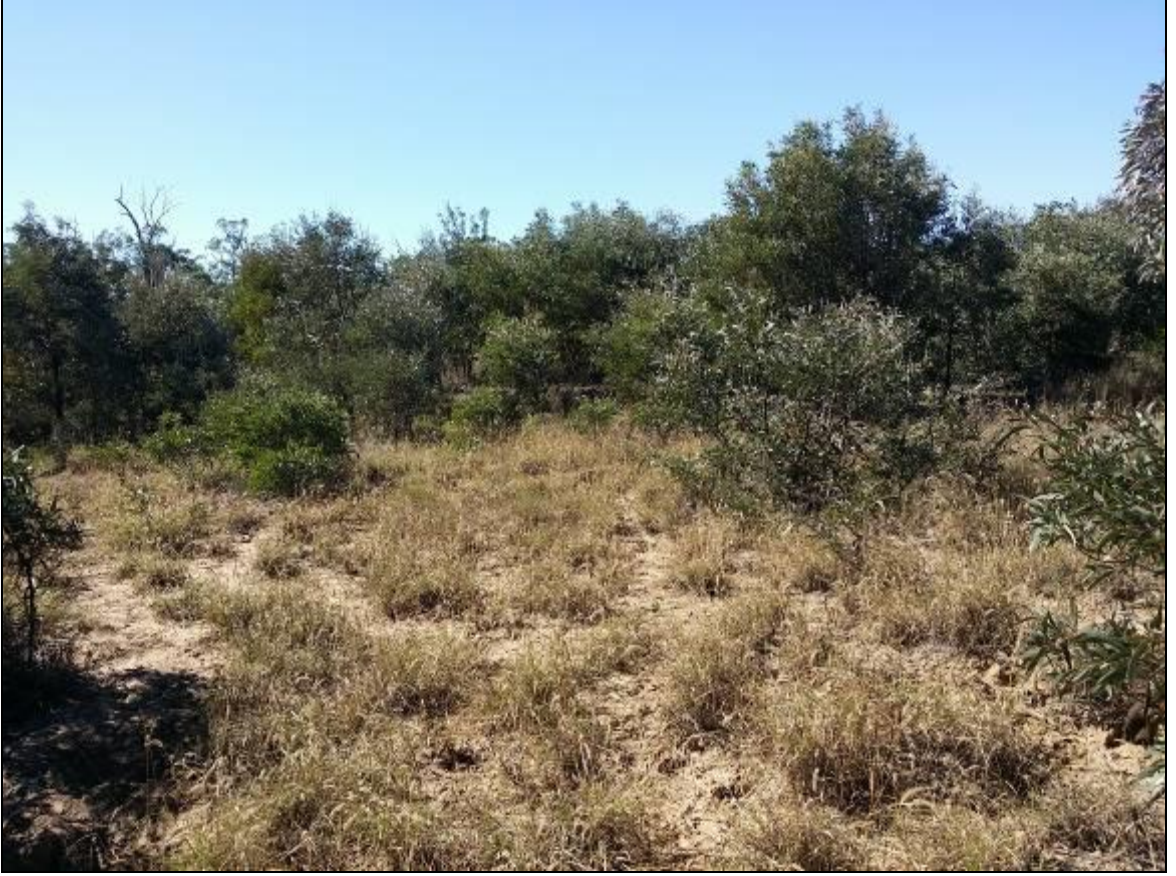
| Site No. | Location<br>(GDA94 Zone 53) | Soil Mapping Unit | Comments / Pictures |
|---|---|---|---|
| Ob716 | 657293 mE<br>7522377 mN | C2 | Brigalow regrowth<br> |

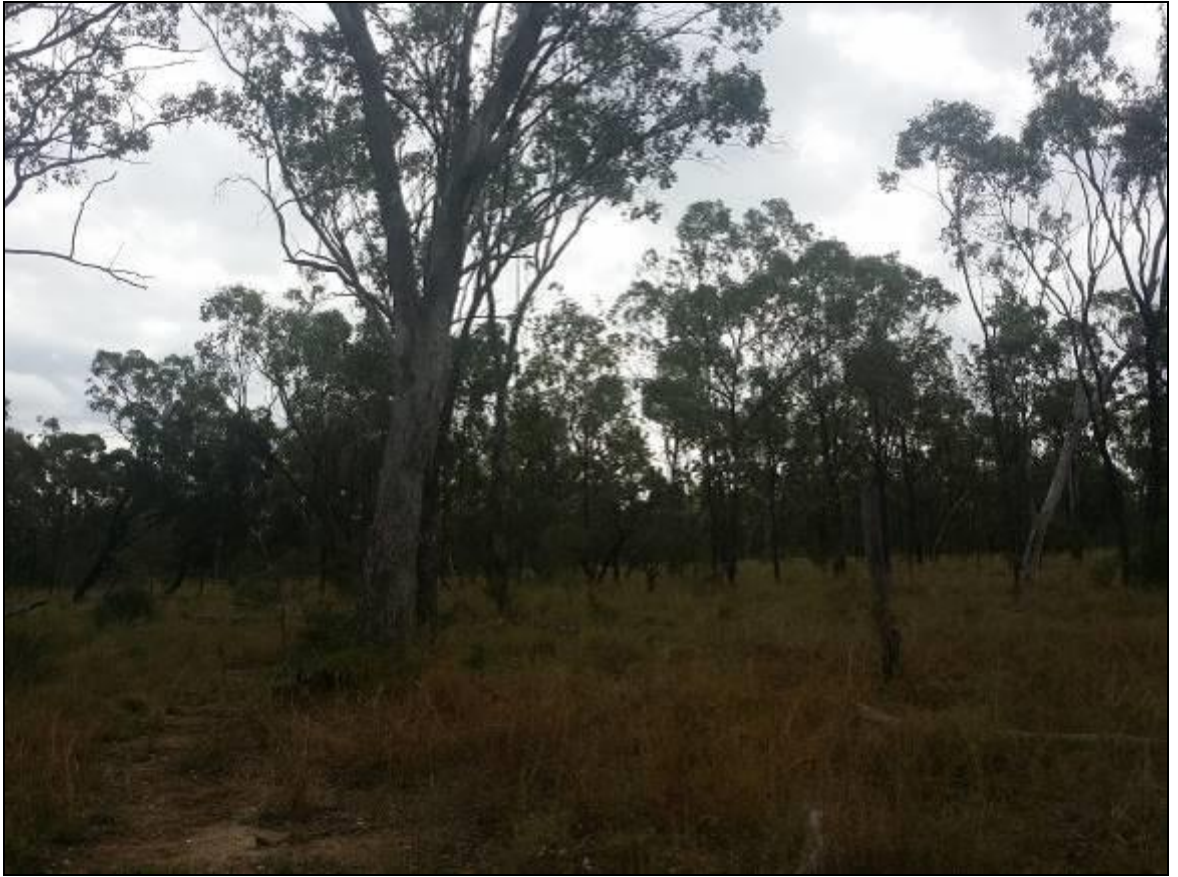
| Site No. | Location<br>(GDA94 Zone 53) | Soil Mapping Unit | Comments / Pictures |
|---|---|---|---|
| Ob717 | 656838 mE<br>7522708 mN | S2 | <p>Poplar box woodlands</p> |

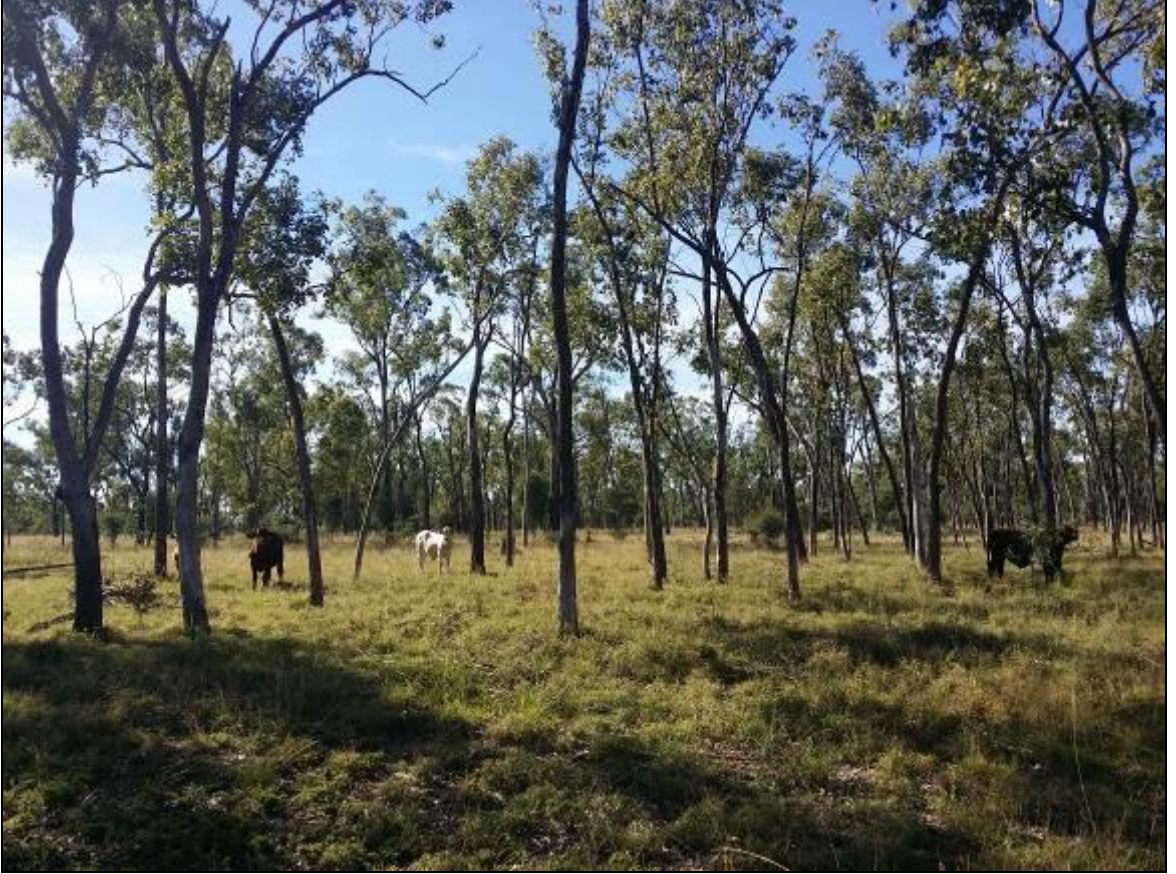
| Site No. | Location<br>(GDA94 Zone 53) | Soil Mapping Unit | Comments / Pictures |
|---|---|---|---|
| Ob747 | 637980 mE<br>7547441 mN | S1 | <p>Poplar box woodlands</p> |

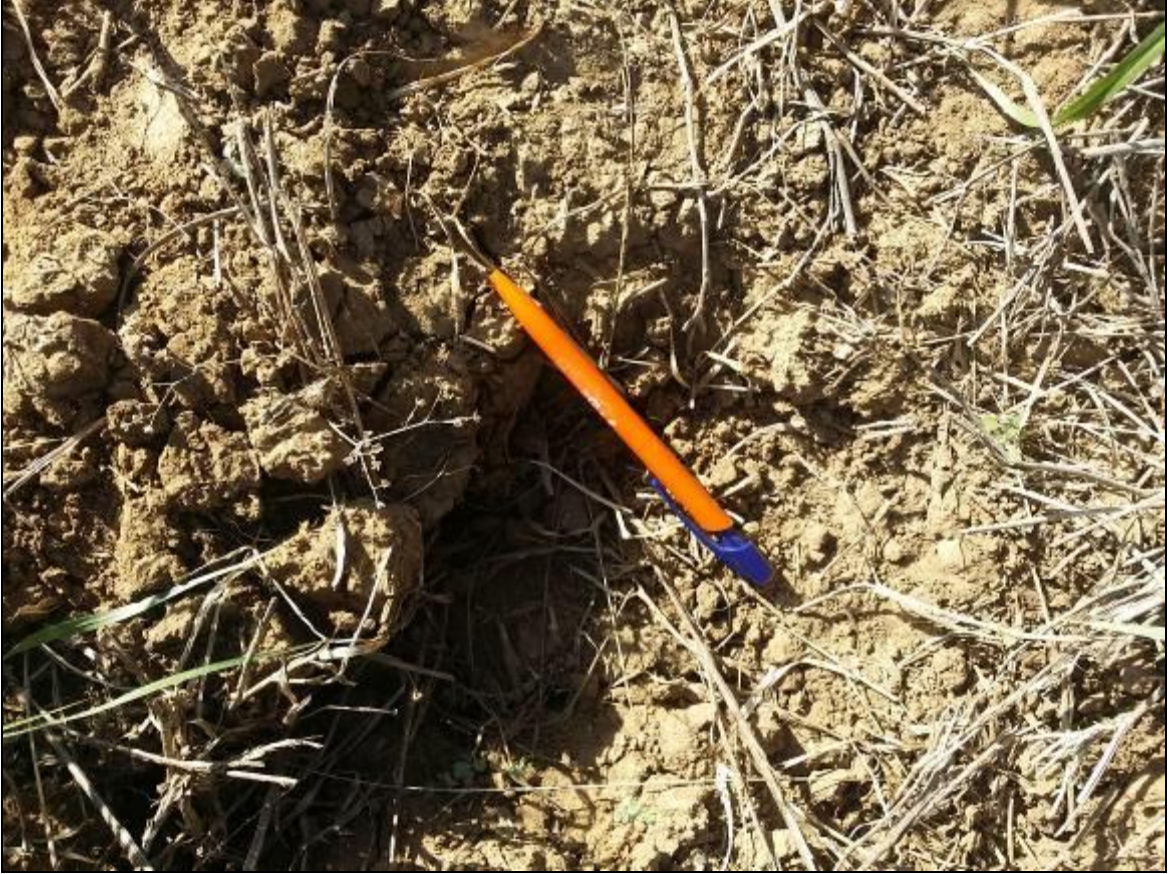
| Site No. | Location<br>(GDA94 Zone 53) | Soil Mapping Unit | Comments / Pictures |
|---|---|---|---|
| Ob758 | 643605 mE<br>7537960 mN | C2 | <p>Gilgai, cracking clay surface</p> |

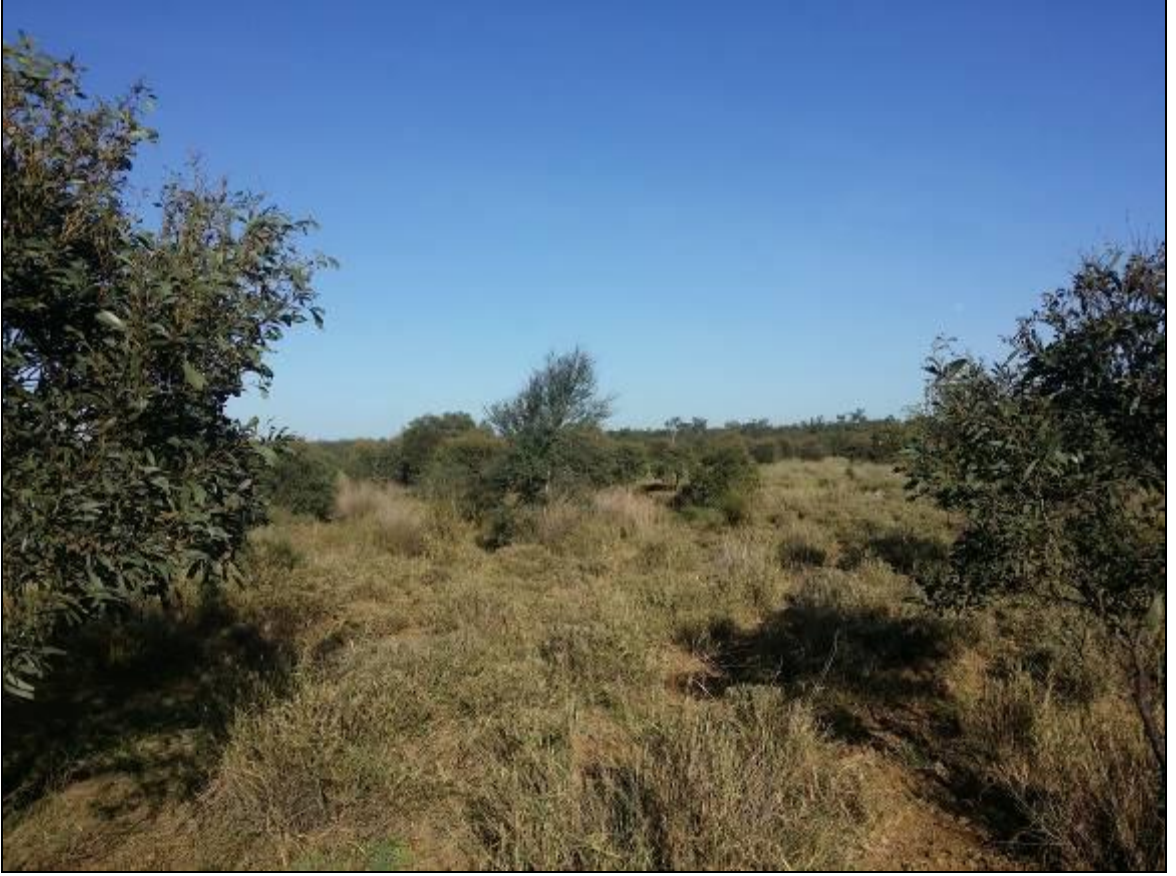
| Site No. | Location<br>(GDA94 Zone 53) | Soil Mapping Unit | Comments / Pictures |
|---|---|---|---|
| Ob773 | 643522 mE<br>7544500 mN | C1/C2 Boundary | <p>Inundated depression, melon holes to the west, gilgai to the east</p> |

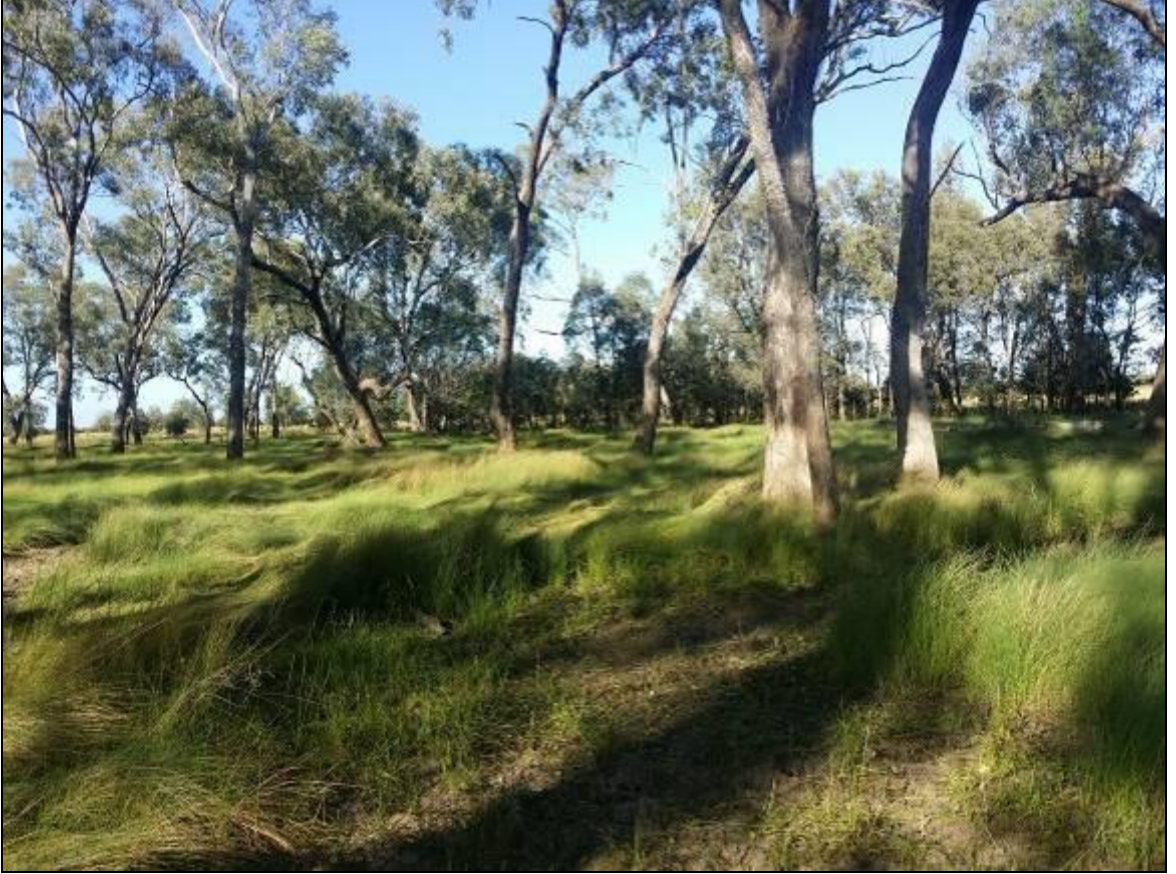
| Site No. | Location<br>(GDA94 Zone 53) | Soil Mapping Unit | Comments / Pictures |
|---|---|---|---|
| Ob774 | 642855 mE<br>7545593 mN | C1 | Depression, cracking clay surface, moist<br> |
