**PEMBROKE**

**Olive Downs Coking Coal Project**  
Draft Environmental Impact Statement

**Appendix M**  
**Soil and Land**  
**Suitability**  
**Assessment**

Olive Downs Coking Coal Project

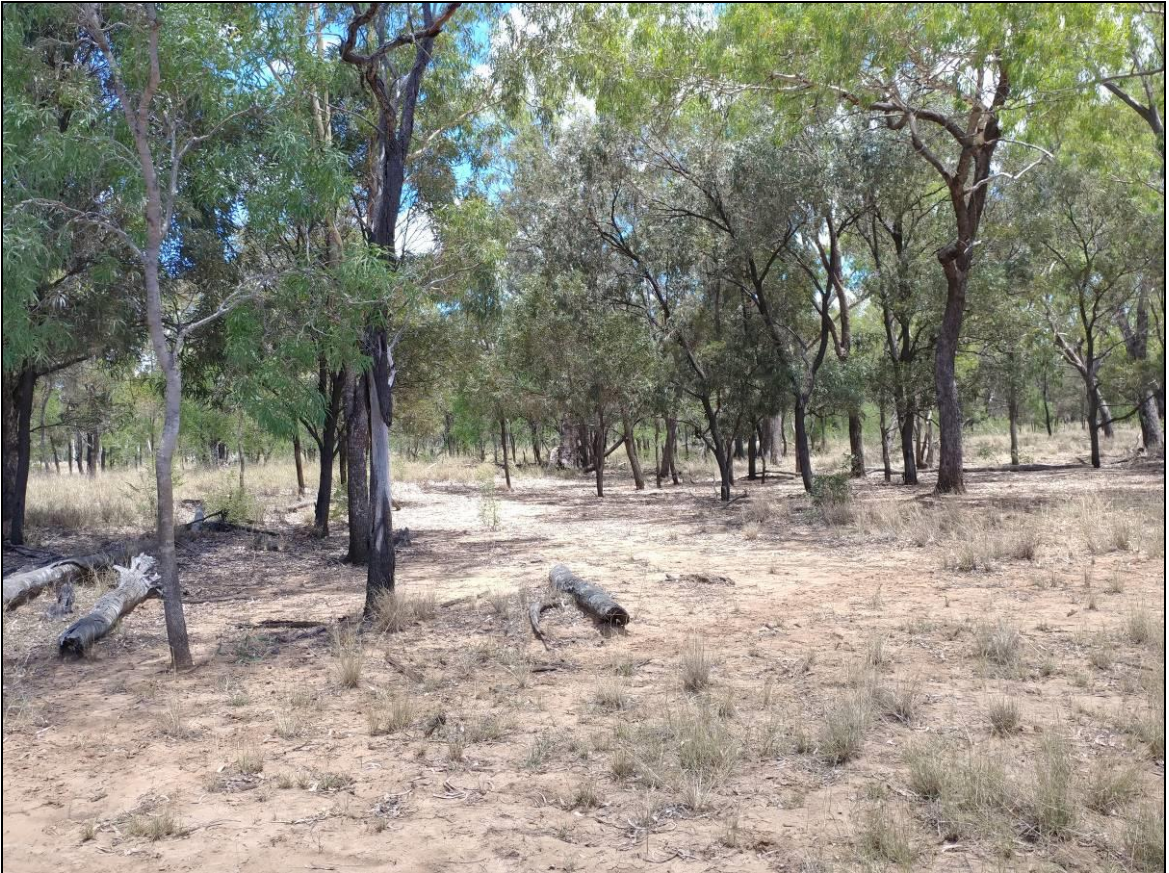
| Site No. | Location<br>(GDA94 Zone 53) | Soil Mapping Unit | Comments / Pictures |
|---|---|---|---|
| Ob792 | 643587 mE<br>7547438 mN | B2-DV / B2 Boundary | Depressions and wide drainage lines to north, Brigalow with cracking surface<br> |

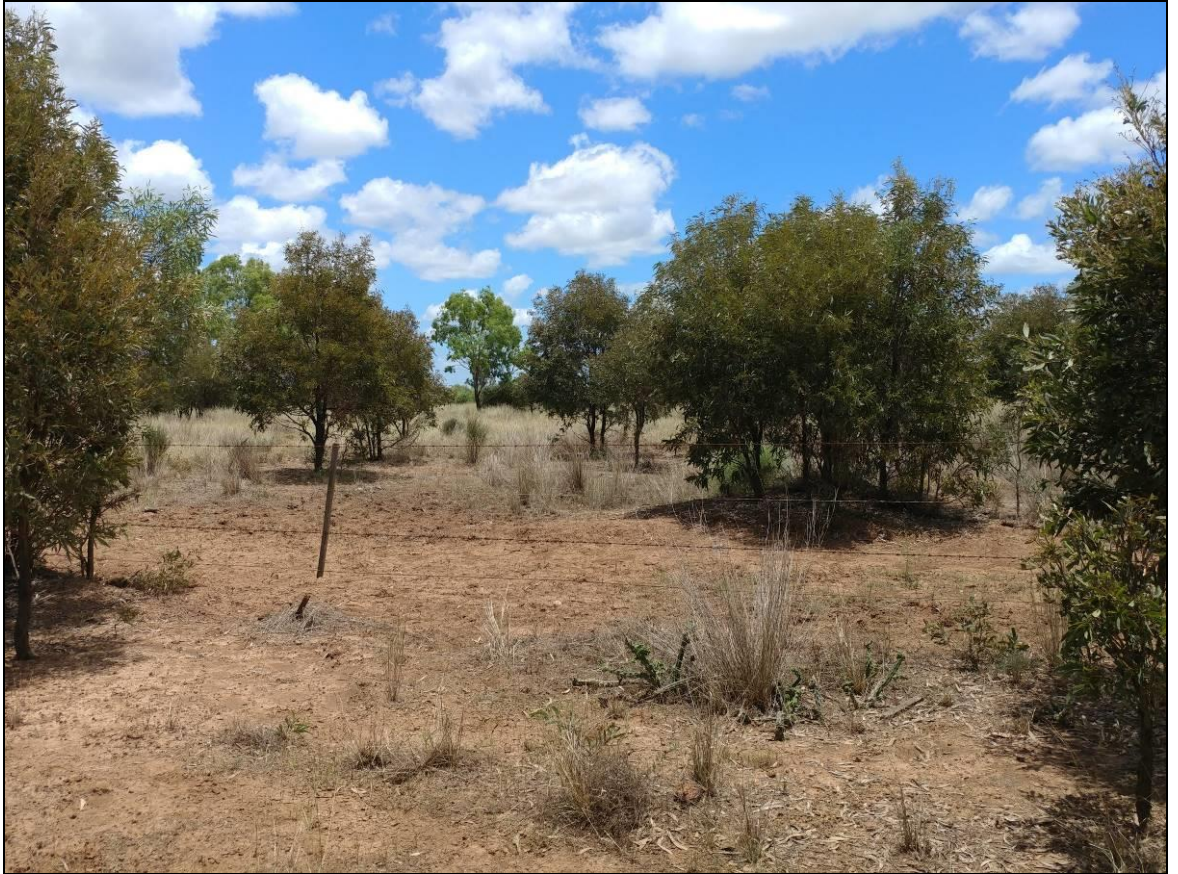
| Site No. | Location<br>(GDA94 Zone 53) | Soil Mapping Unit | Comments / Pictures |
|---|---|---|---|
| Ob798 | 643475 mE<br>7548823 mN | B2 | Wide depression, with silty loam surface and very fine cracking<br> |

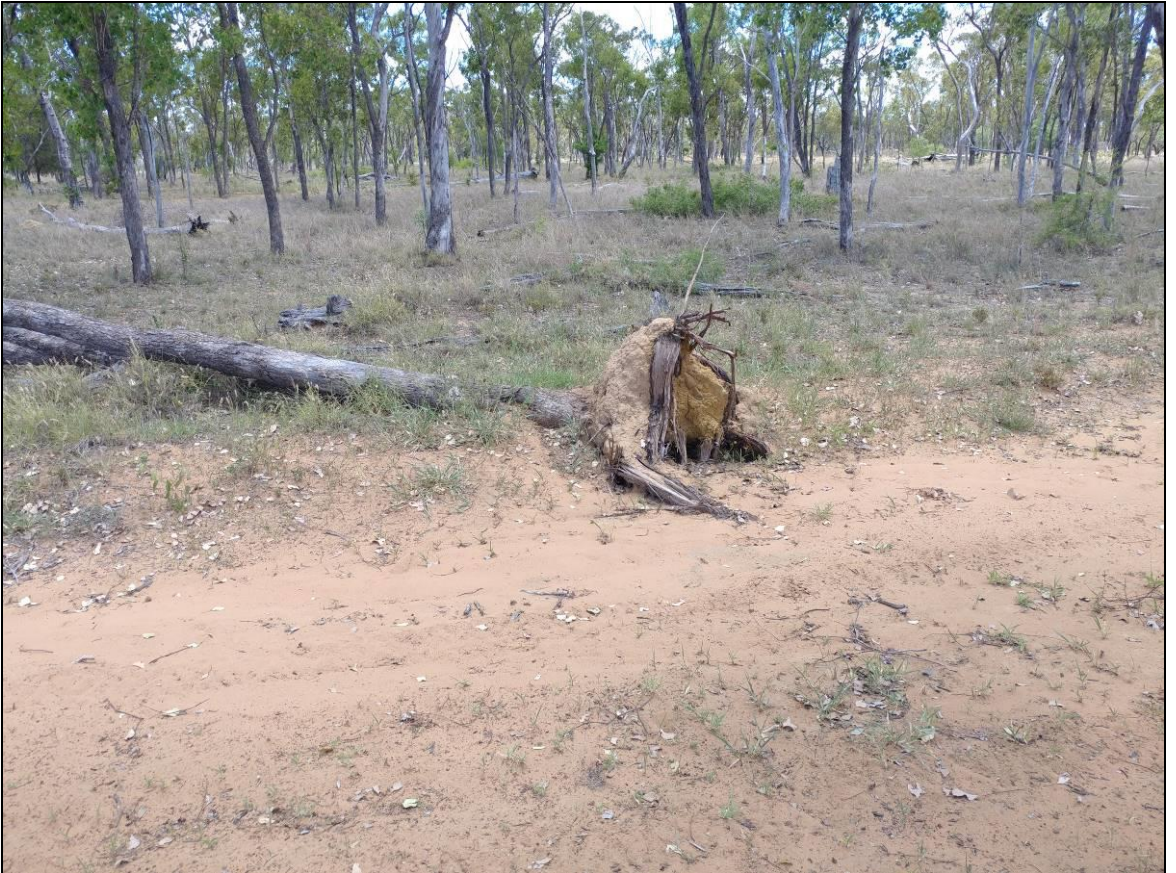
| Site No. | Location<br>(GDA94 Zone 53) | Soil Mapping Unit | Comments / Pictures |
|---|---|---|---|
| Ob800 | 644378 mE<br>7549246 mN | S2 | <p>Poplar Box, light brown sandy surface</p> |

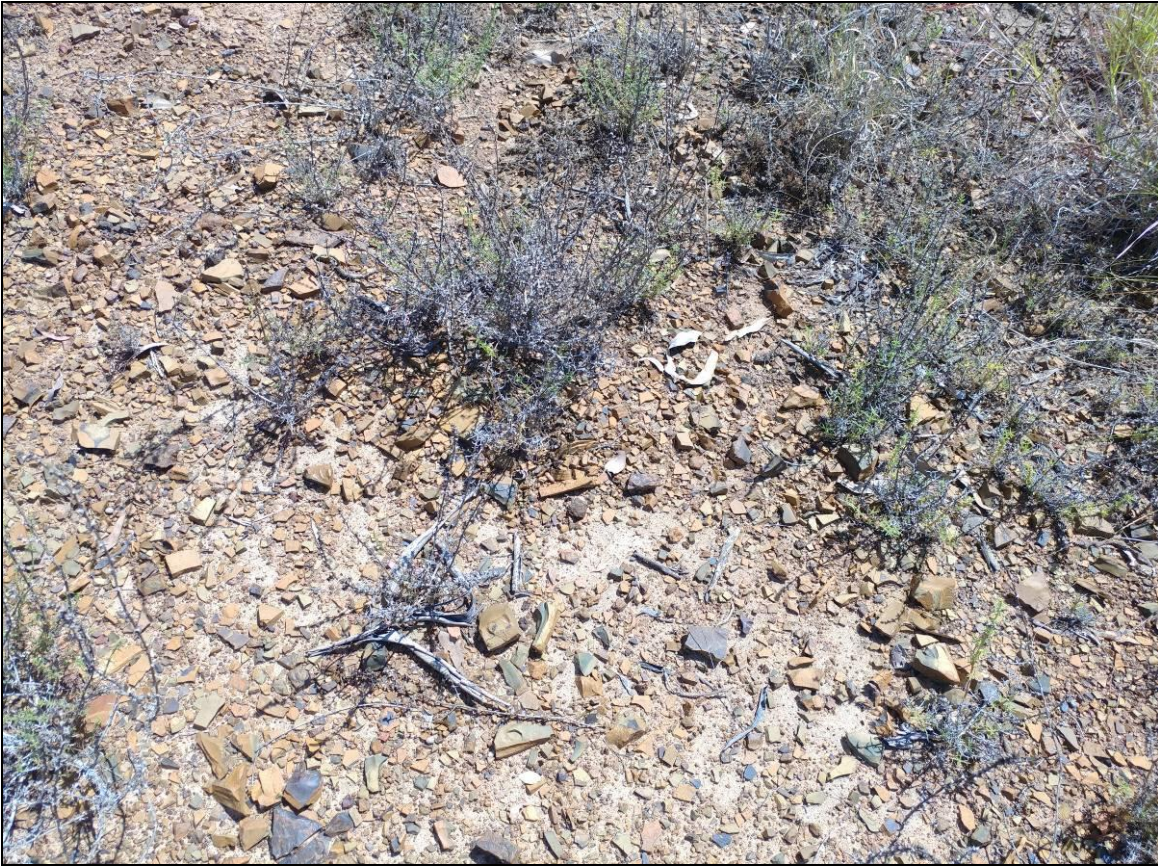
| Site No. | Location<br>(GDA94 Zone 53) | Soil Mapping Unit | Comments / Pictures |
|---|---|---|---|
| Ob810 | 631352 mE<br>7552744 mN | B2 | <p>Fine cracking surface, small area of very rocky surface</p> |

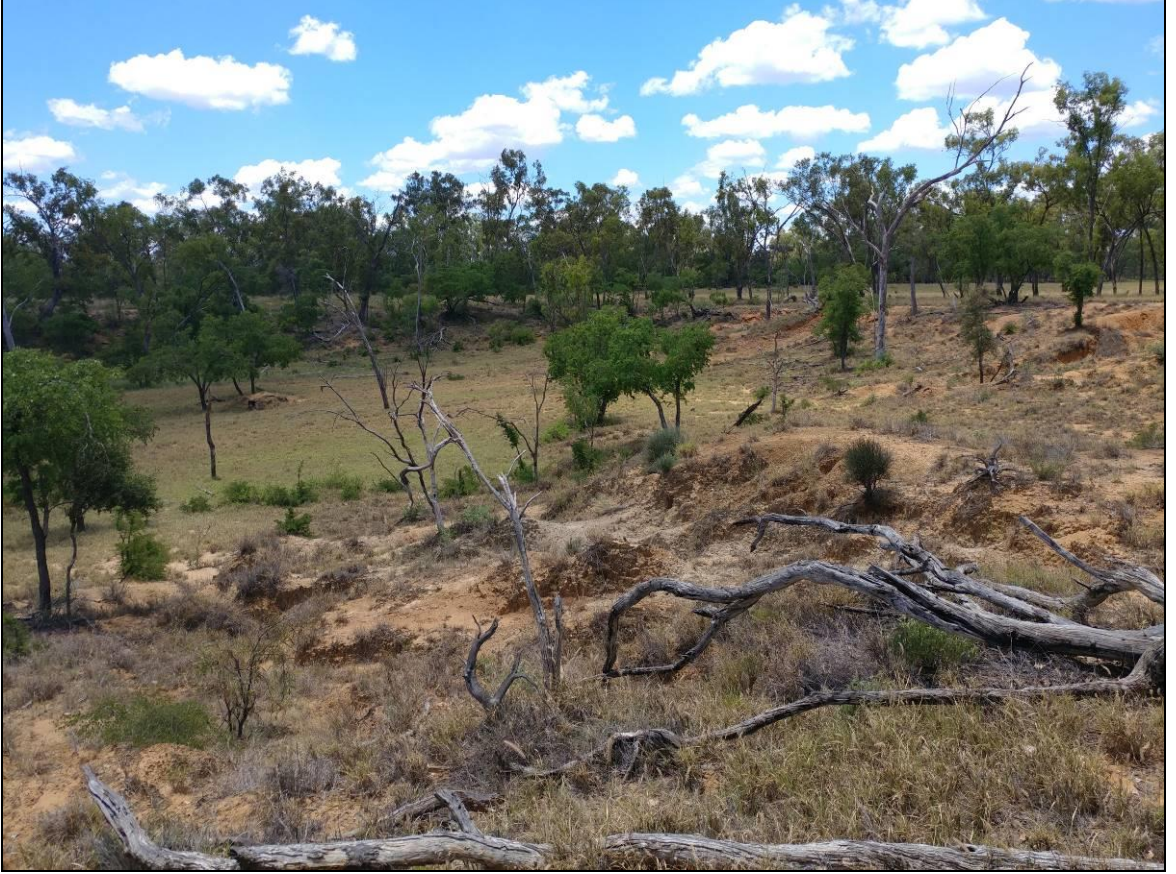
| Site No. | Location<br>(GDA94 Zone 53) | Soil Mapping Unit | Comments / Pictures |
|---|---|---|---|
| Ob816 | 623304 mE<br>7553655 mN | S1 | Wide depression, 6-8m deep, Poplar Box, loamy sand surface<br> |

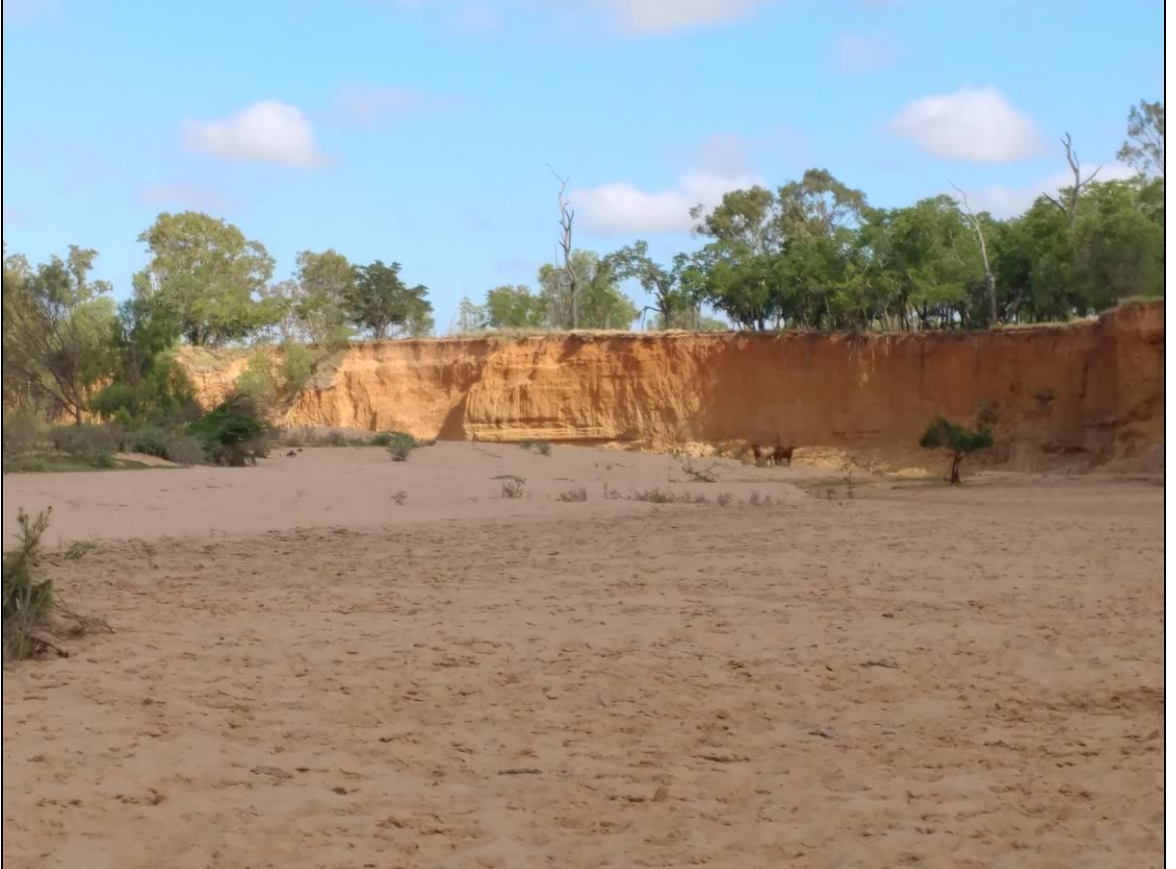
| Site No. | Location<br>(GDA94 Zone 53) | Soil Mapping Unit | Comments / Pictures |
|---|---|---|---|
| Ob818 | 619185 mE<br>7552267 mN | S2 | <p>Drainage line with 6m+ drop-off, creek bed coarse sandy, soil profile on cuttings loamy sand throughout, gums</p> |
