**Port of Gladstone  
Gatcombe and Golding Cutting  
Channel Duplication Project**

**Appendix E1  
Channel Duplication  
Project – Final  
Geotechnical Report**

**Port of Gladstone  
Gatcombe and Golding Cutting  
Channel Duplication Project**  
Final Geotechnical Report  
**Gladstone Ports Corporation**

19 August 2015  
Revision: 2  
Reference: 245852

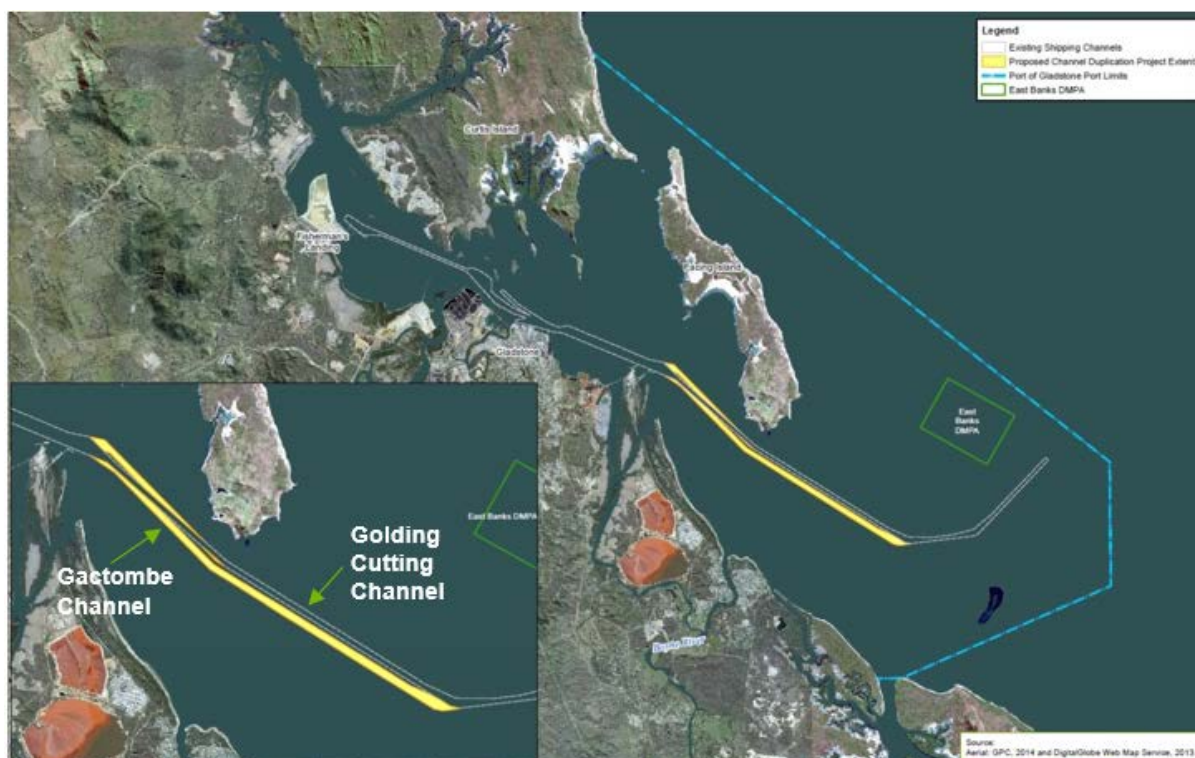
Figure 1 Location of the proposed Gatcombe and Golding Cutting duplicate channels

The Port of Gladstone is situated approximately 525 km north of Brisbane. The proposed deepening and duplication of the existing Gatcombe and Golding Cutting Channels (Figure 1), is part of the GPC's strategy to facilitate the potential increase in port throughput into the future and to mitigate the risks caused by additional vessels utilising the port's shipping channels.

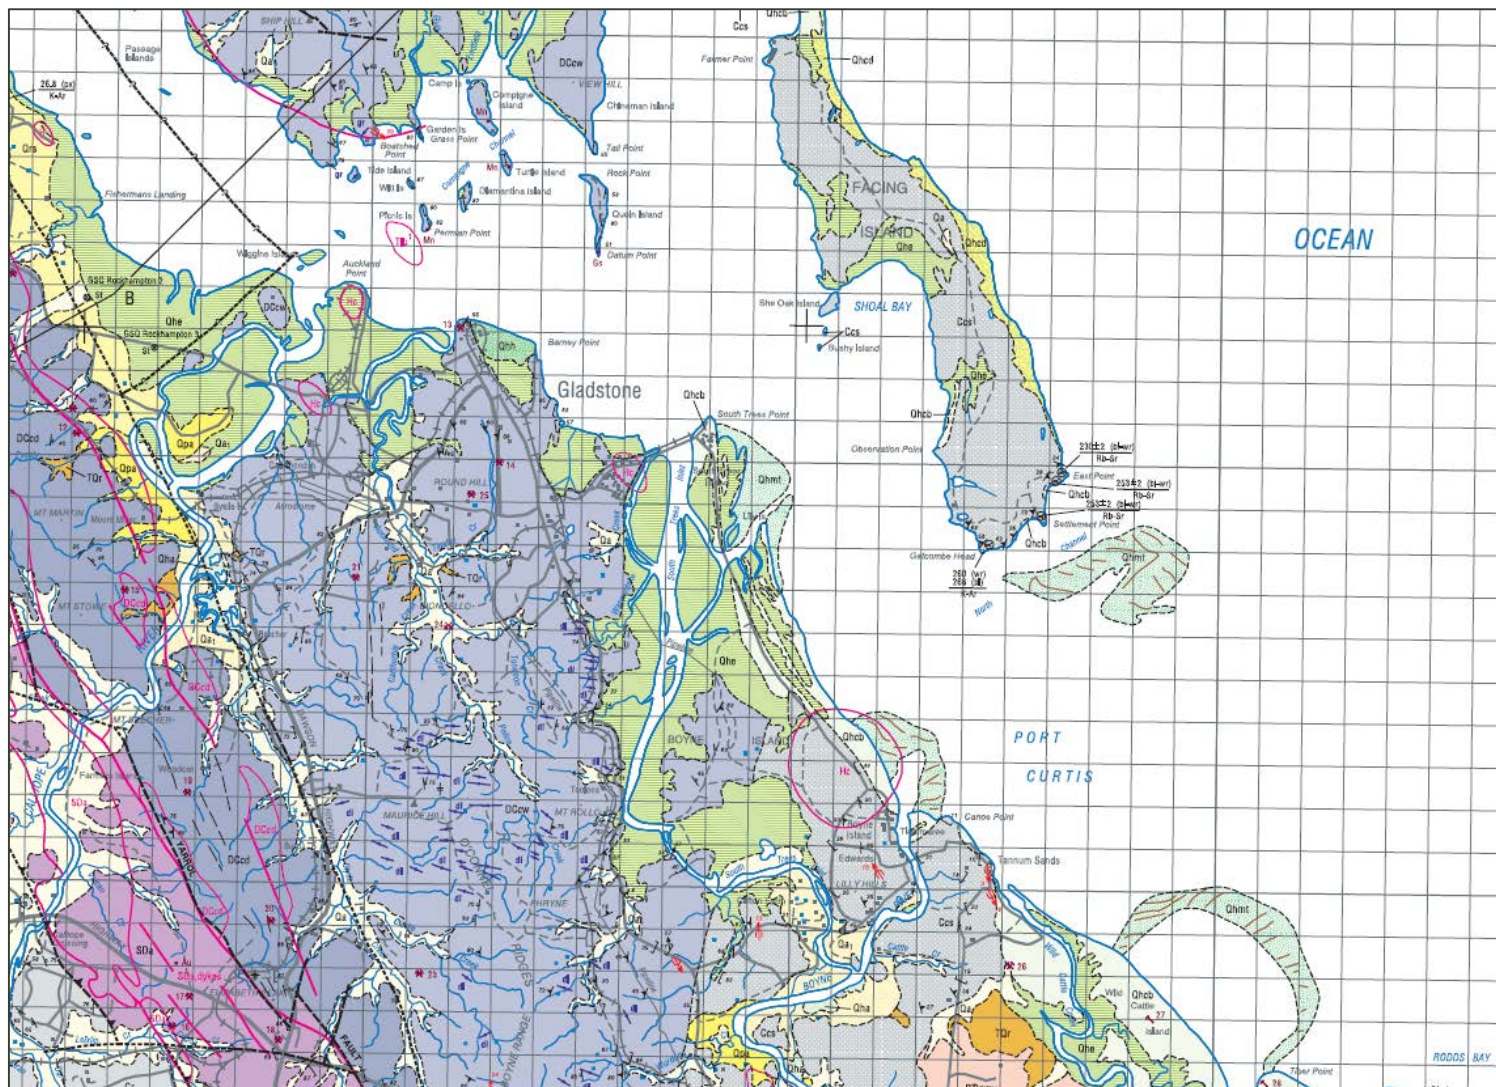
Figure 2 Excerpt from the 1:100,000 scale geological map Gladstone Special (sheet 9150 and part 9151) (Queensland Government Department of Natural Resources and Mines 2006)

The results from the geophysical investigation carried out by Marine and Earth Sciences in 2011 for GPC reflect the geological structure of the area as described above.

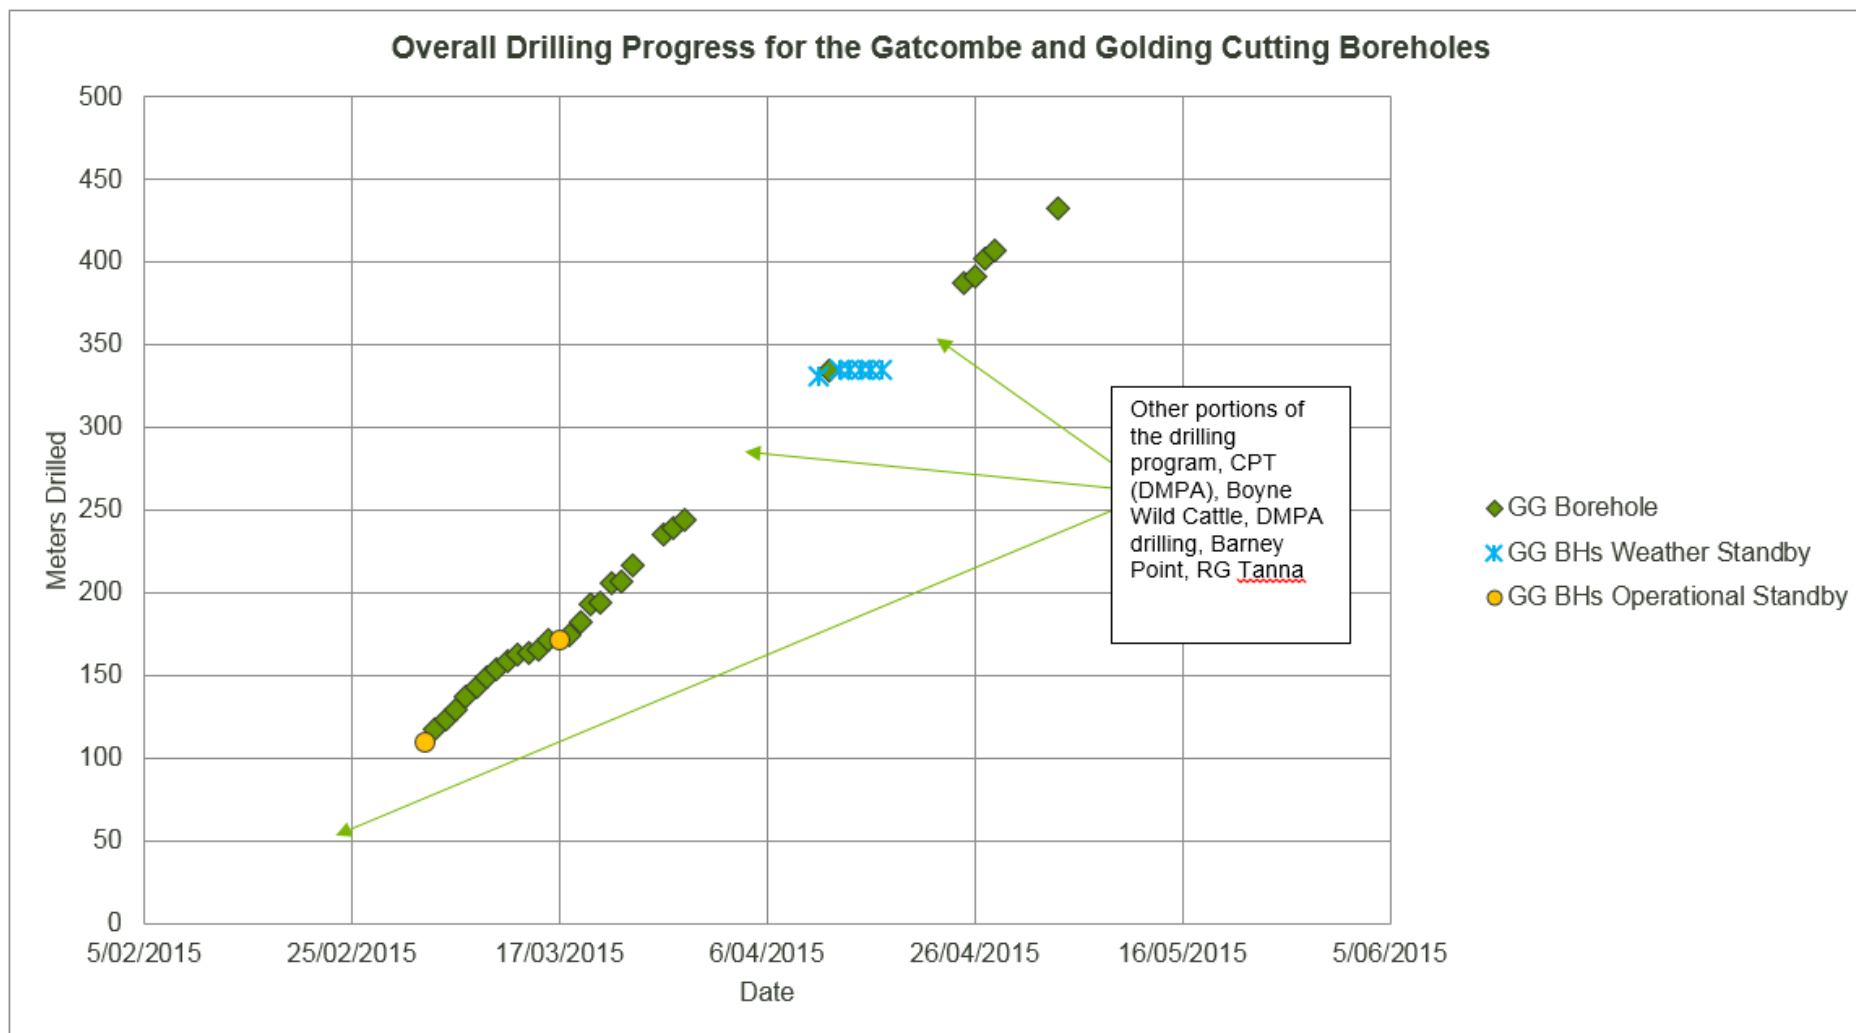
Figure 6 Overall drilling progress for the program of work within the Gatcombe and Golding Cutting Channels

Figure 6 demonstrates the actual drilling progress, showing metres drilled per day over the duration of the fieldwork program. Following completion of the CPT testing approximately 16% of the total 94 days of fieldwork were lost to standby, including the disruption caused by TC Marcia. Despite isolated poor weather such as TC Marcia, and associated residual large swells, the program progressed smoothly with few delays beyond shipping movements and waiting for tidal currents. The average drilling production rate for the entire program was 6.45 m/shift.

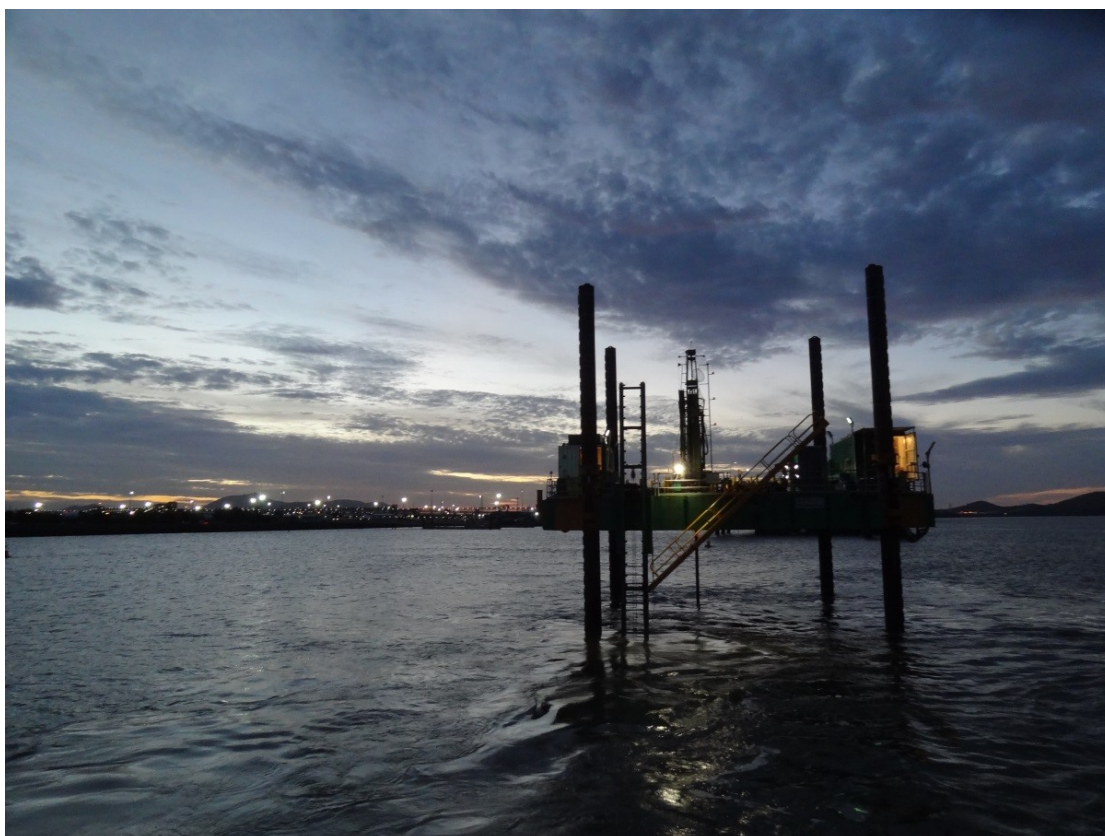
Photograph 1 View of the J&S Jack up barge "Ocean Driller II"

The J&S JUB is a modular 4 legged jack-up platform with a total deck load capacity of approximately 44 tonnes. Once in position over a borehole, the barge is jacked up to its operational height above sea level. Operational height is determined by tides and prevailing sea state conditions. In general, the barge is jacked up to have a 1 m air gap during high tide to account for waves. This relatively small air gap was chosen due to the sheltered harbour location, although the barge could be jacked higher during stormy conditions to account for prevailing sea state and surge conditions when necessary. The JUB was equipped with an Edson 3000 G rotary drilling rig, along with portable storage facilities for equipment and consumables. A photograph of the Ocean Driller 2 JUB is presented below in Photograph 1. Select photographs from the investigation, including JUB and location, are provided in Appendix D.

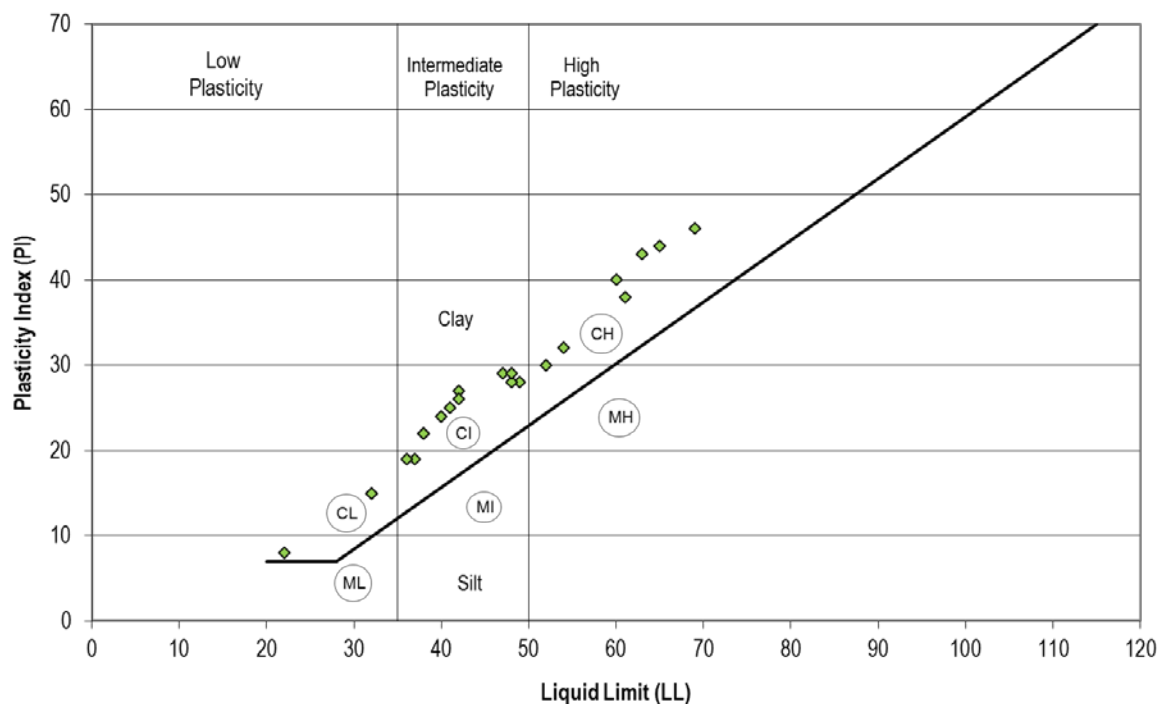
Figure 10 Atterberg results from the Golding Cutting Channel

Figure 8 to Figure 10 present the Atterberg results split between the two channels that require dredging, and a combined plot showing all of the results. Fewer tests were sampled for Atterberg testing in the Gatcombe Channel due to the high percentage of non-cohesive material encountered.

It should be noted that the majority of the high plasticity results were obtained from only three boreholes (ie GG17, GG18 and GG21) indicating an isolated zone of highly plastic clay.

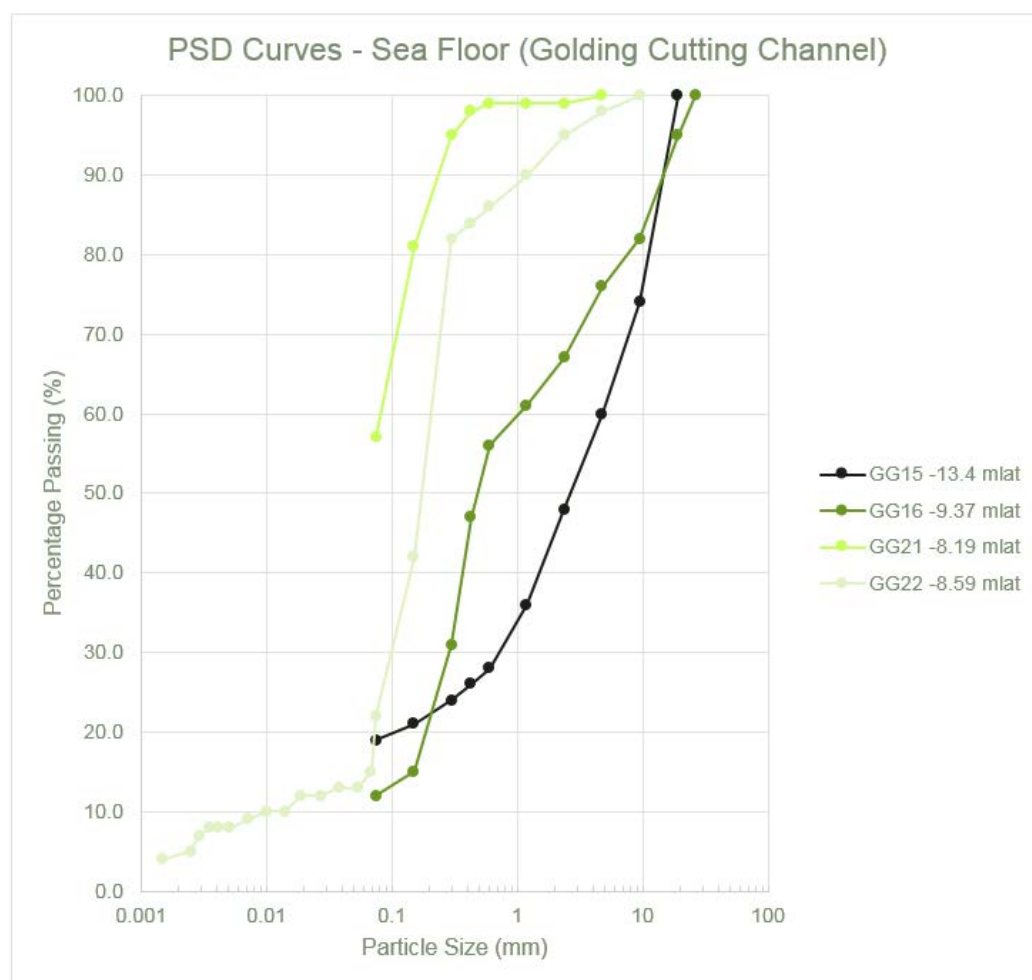
Figure 15 PSD graph showing the particle distribution curves for the seafloor material within the Golding Cutting Channel

For both the Gatcombe and Golding Cutting Channels, the PSD results attributed to the surficial seafloor layer (Figure 15) and Layer 1 (Figure 16) show the greatest variation. It is expected this is in part due to sampling bias, with samples collected in the cohesive materials undergoing Atterberg Limits testing, as opposed to PSD testing. Also, increased diversity in material type may be found in the upper layers due to tidal action and the ongoing movement of surficial sediments.

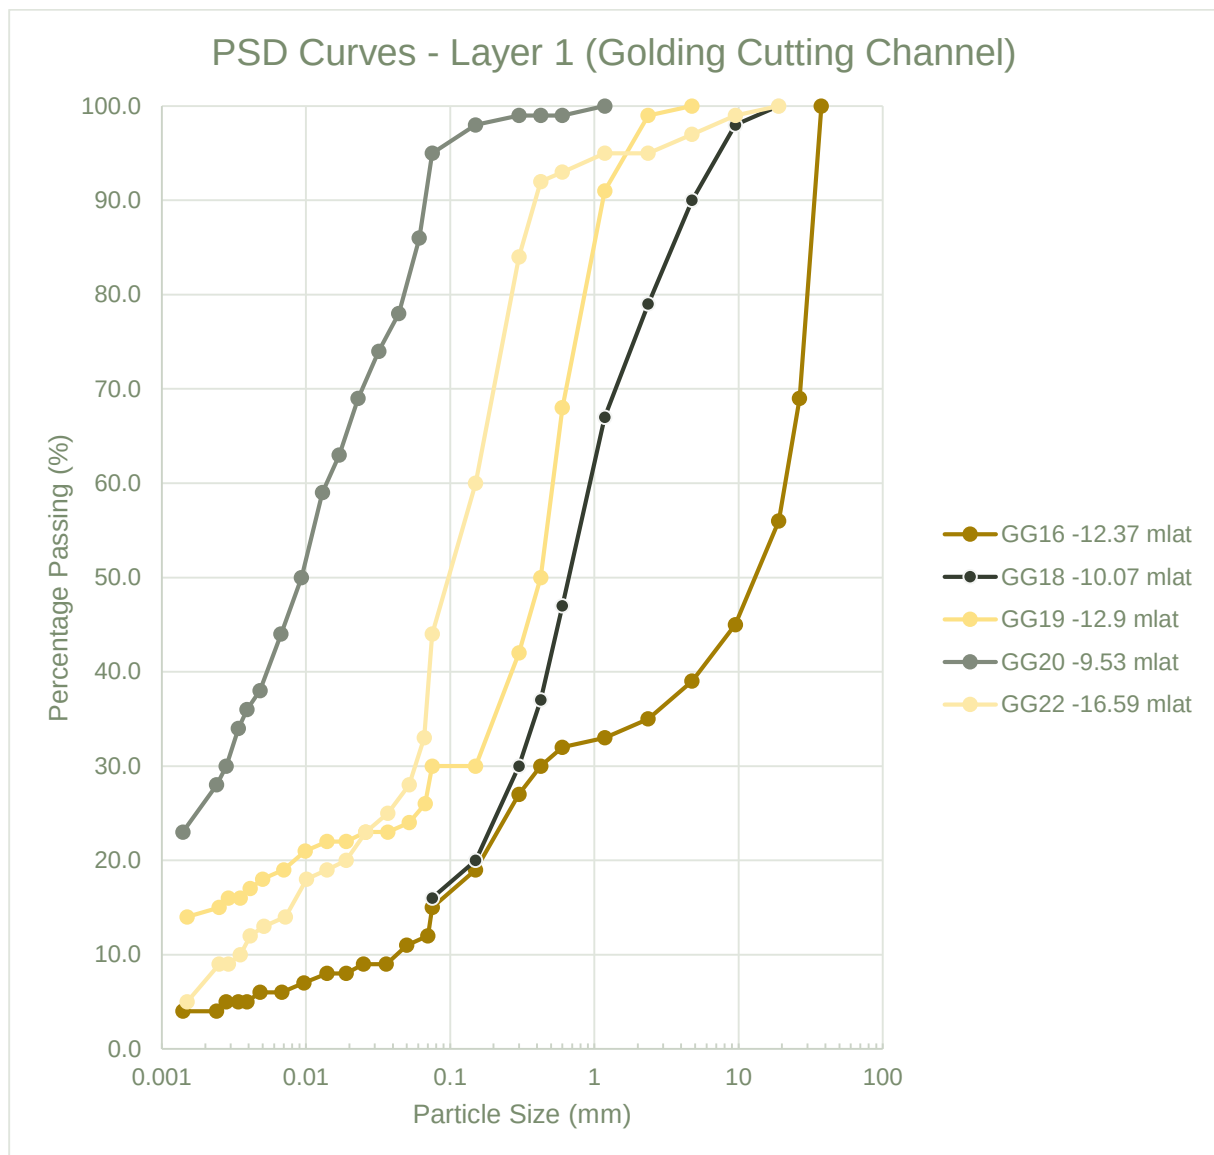
**Figure 16** PSD graph showing the particle distribution curves for Layer 1 within the Golding Cutting Channel

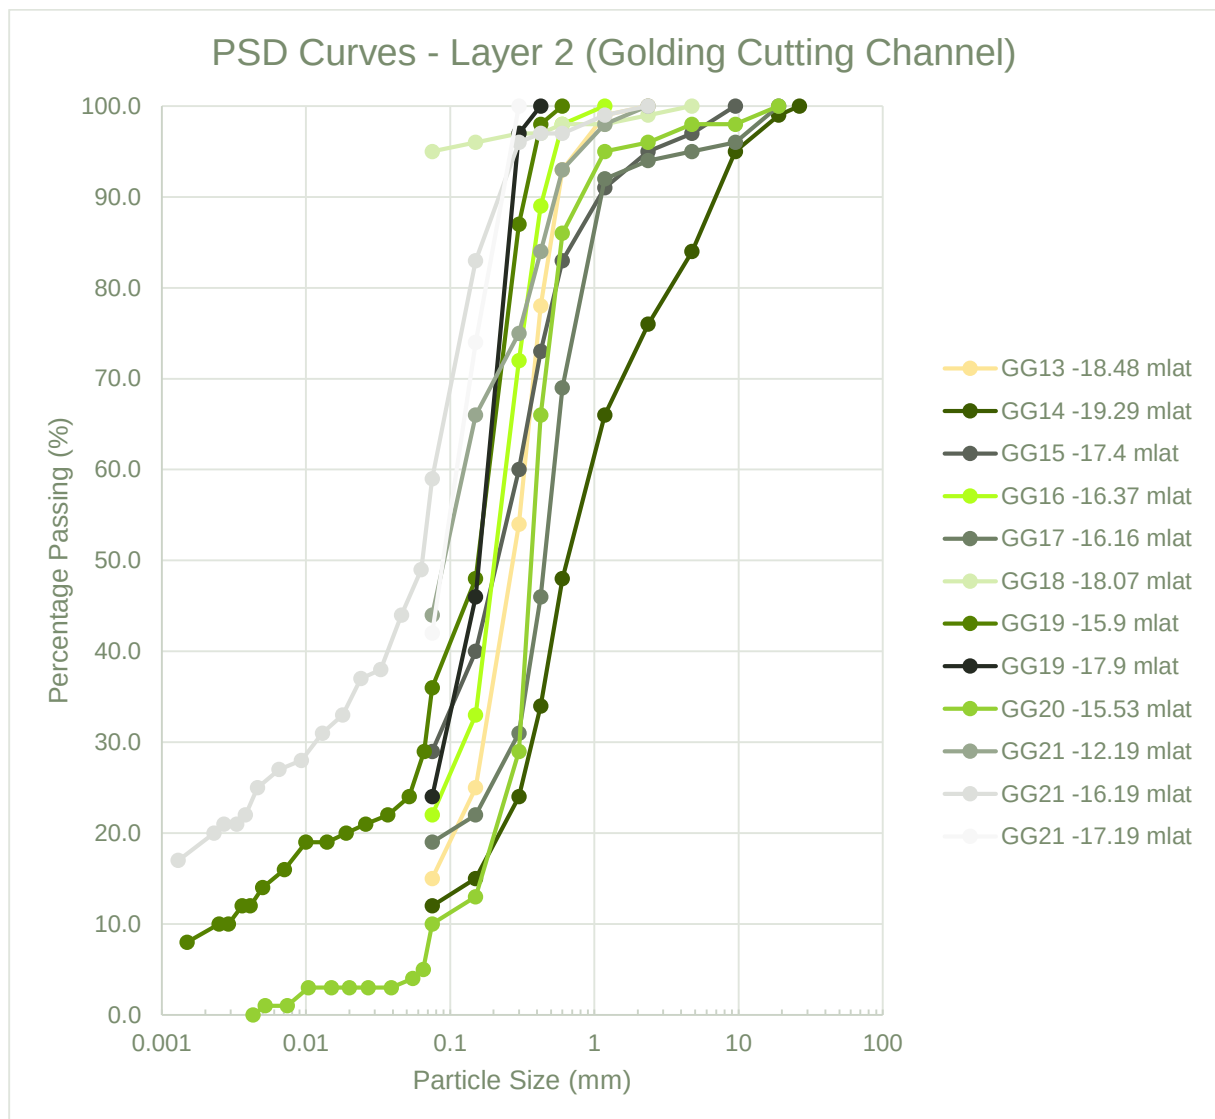
**Figure 17** PSD graph showing the particle distribution curves for Layer 2 within the Golding Cutting Channel

In terms of the Golding Cutting Channel, the Layer 2 PSD graphs prove that in general this material comprises sand (Figure 17). The gravel content in the Golding Cutting Channel is, however, found to be reduced when compared to the results from the Gatcombe Channel.

A notable outlier in the Golding Layer 2 results is observed at GG18 (-18.07 m LAT). This is due to a zone of sandy clay observed within the stratigraphy at that location.

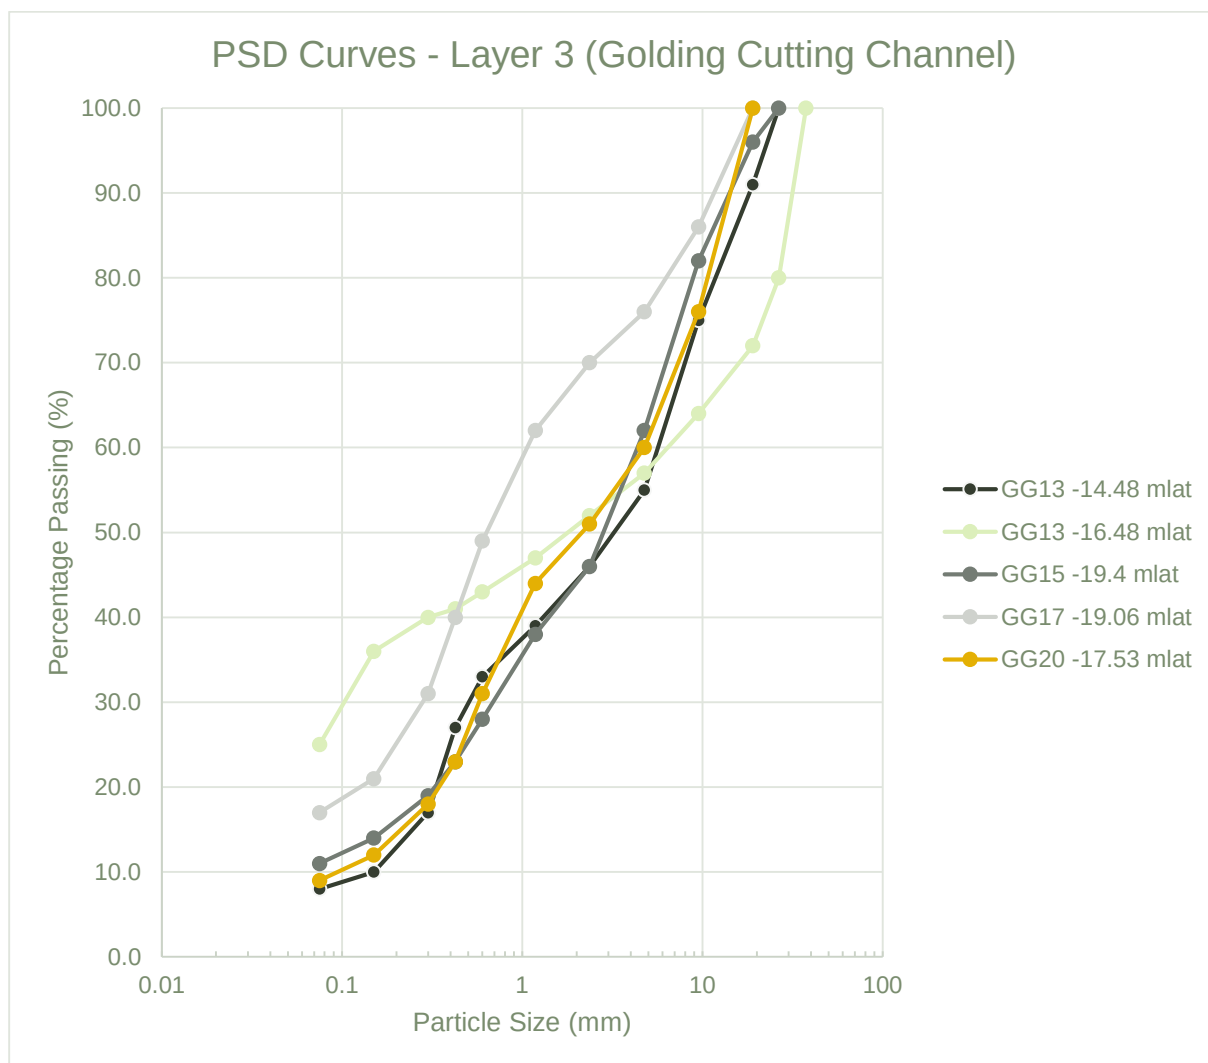
**Figure 18** PSD graph showing the particle distribution curves for Layer 3 within the Golding Cutting Channel

Layer 3 within the Golding Cutting Channel, while still considered to be predominantly gravel, also demonstrates a similar reduction in gravel content and a higher percentage of both sand and fines (Figure 18).

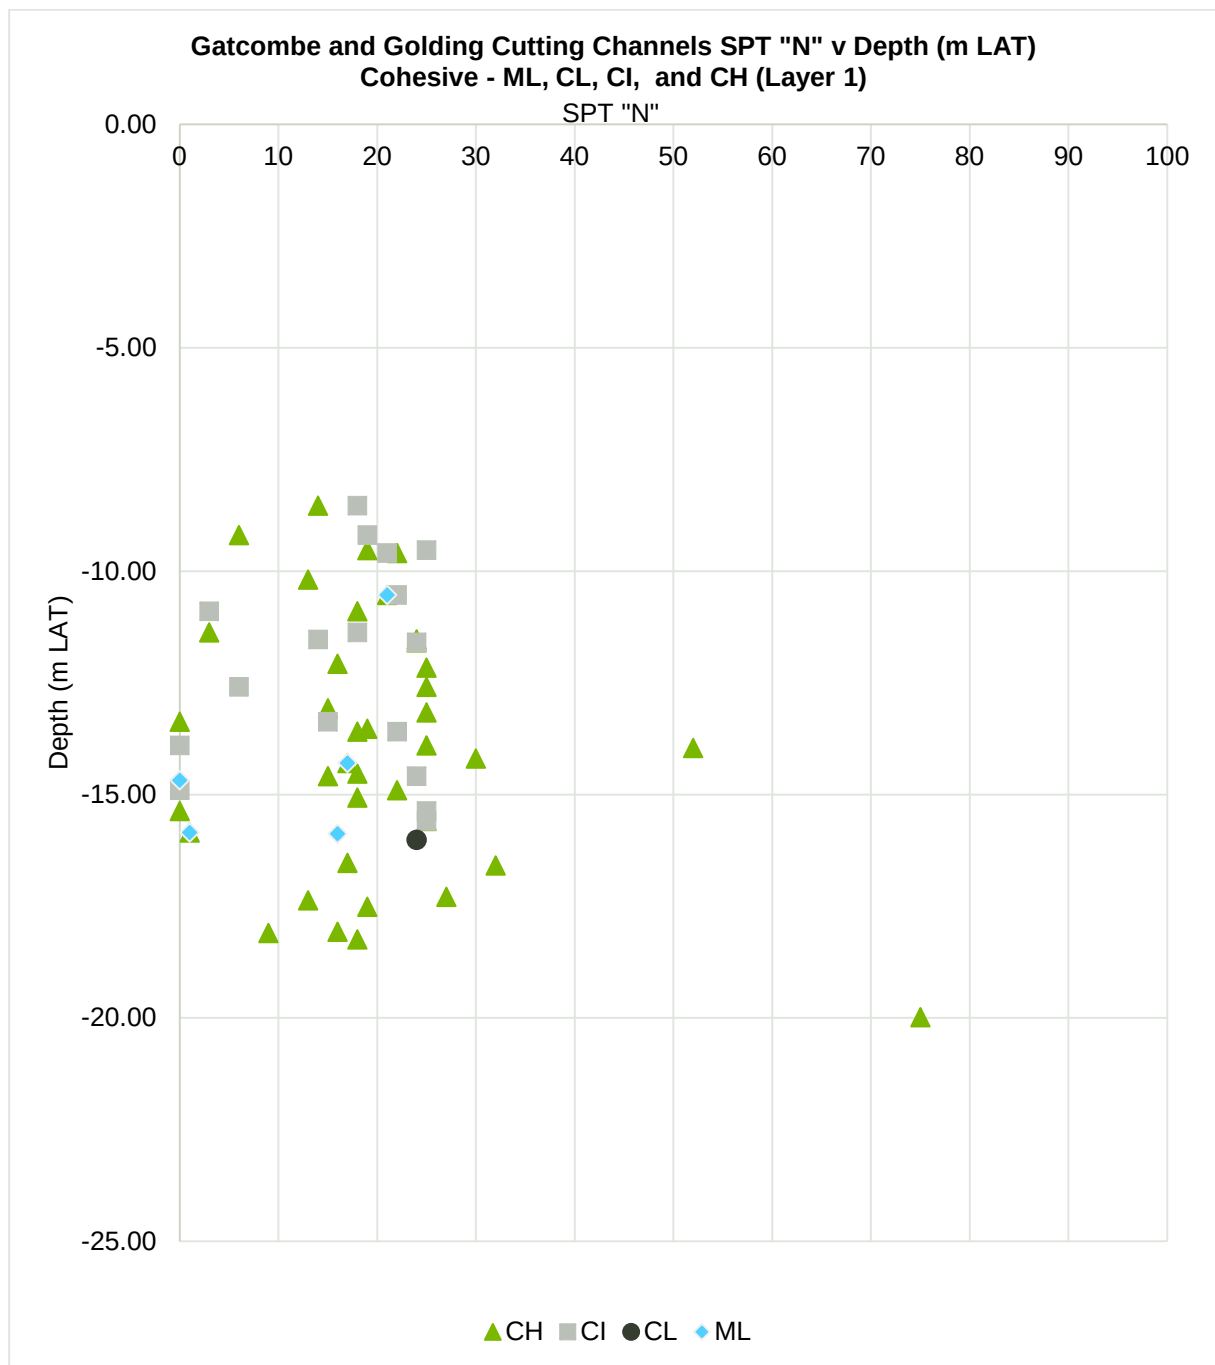
Figure 19 Cohesive soils (Layer 1) SPT "N" v m LAT

Two SPT values greater than 40 blows, representing hard clay or silt (>200 kPa) are also shown on the graph. Of particular significance is SPT result N=52 blows at -13.96 m LAT within GG17. This material was logged as a high plasticity sandy clay, with fine to coarse subangular to subrounded gravel encountered just below the end of the SPT test. This material occurs below the proposed Stage 1 design dredging but will be within the Stage 2 design dredging depth of -16.1 m LAT.

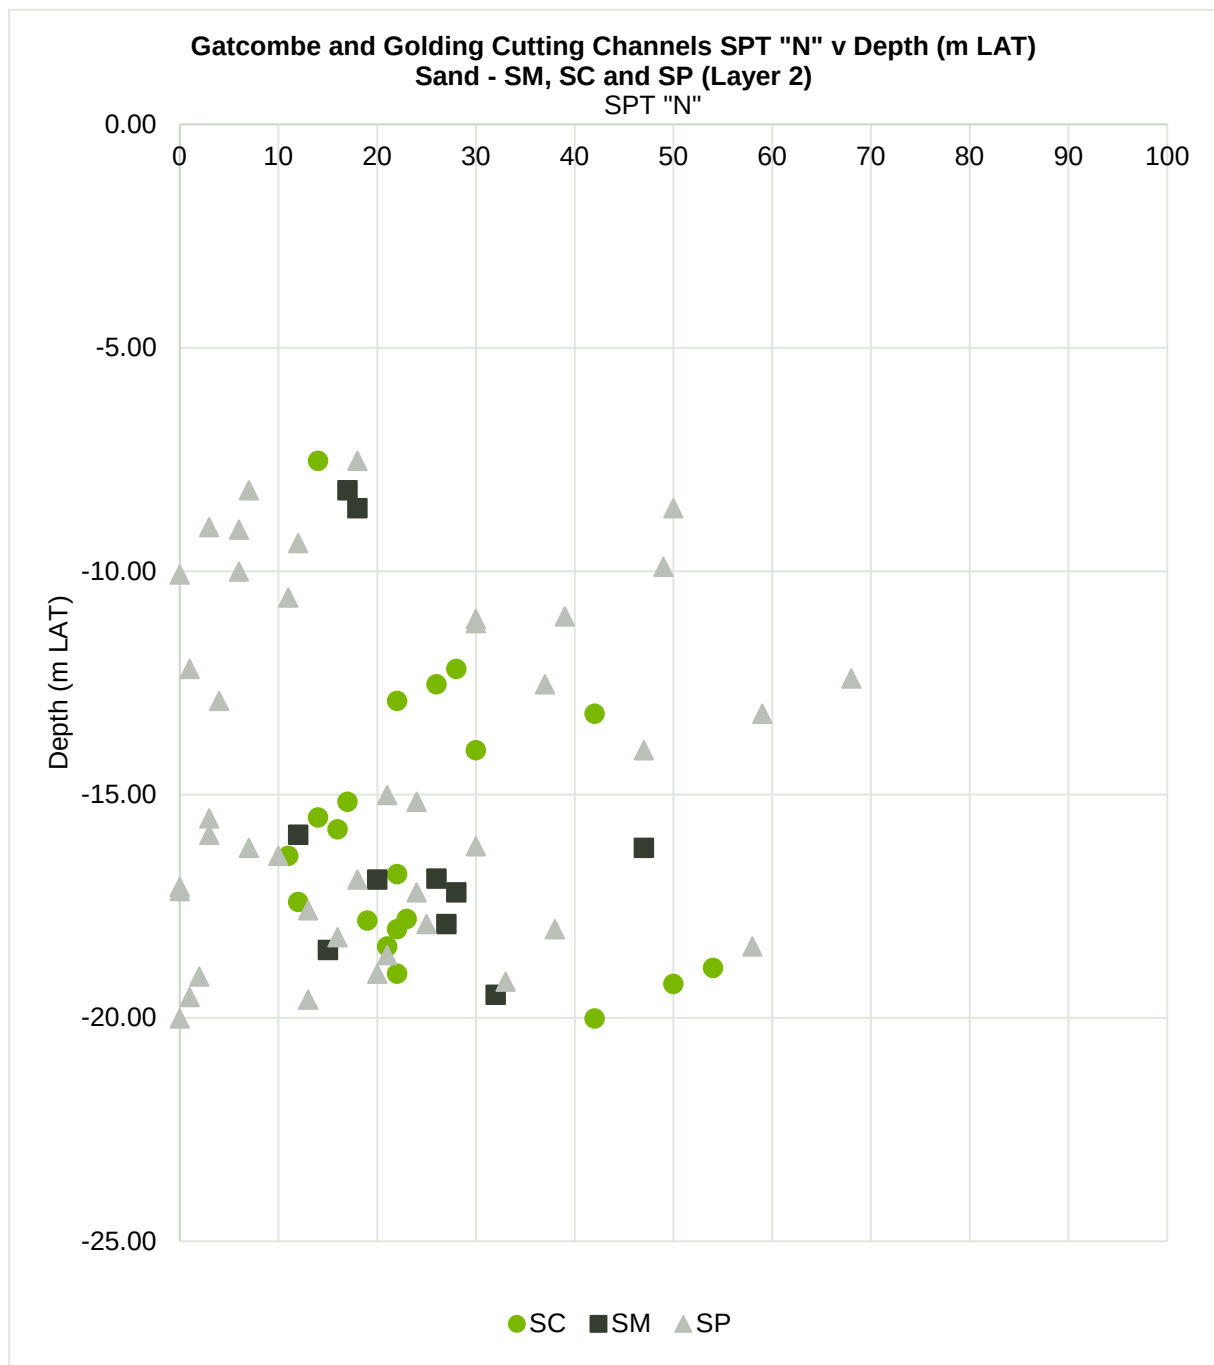
**Figure 20** Sand soils (Layer 2) SPT "N" v m LAT

The SPT test results for the predominantly sand Layer 2 material (Figure 20) show that material density generally improves with depth, though a significant proportion of the SP (poorly sorted sand) material was found to be very loose between -15 m LAT and -20 m LAT. The majority "N" values were found within the 10 to 30 blows range (medium dense). The next largest grouping was between 30 and 50 blows (dense).

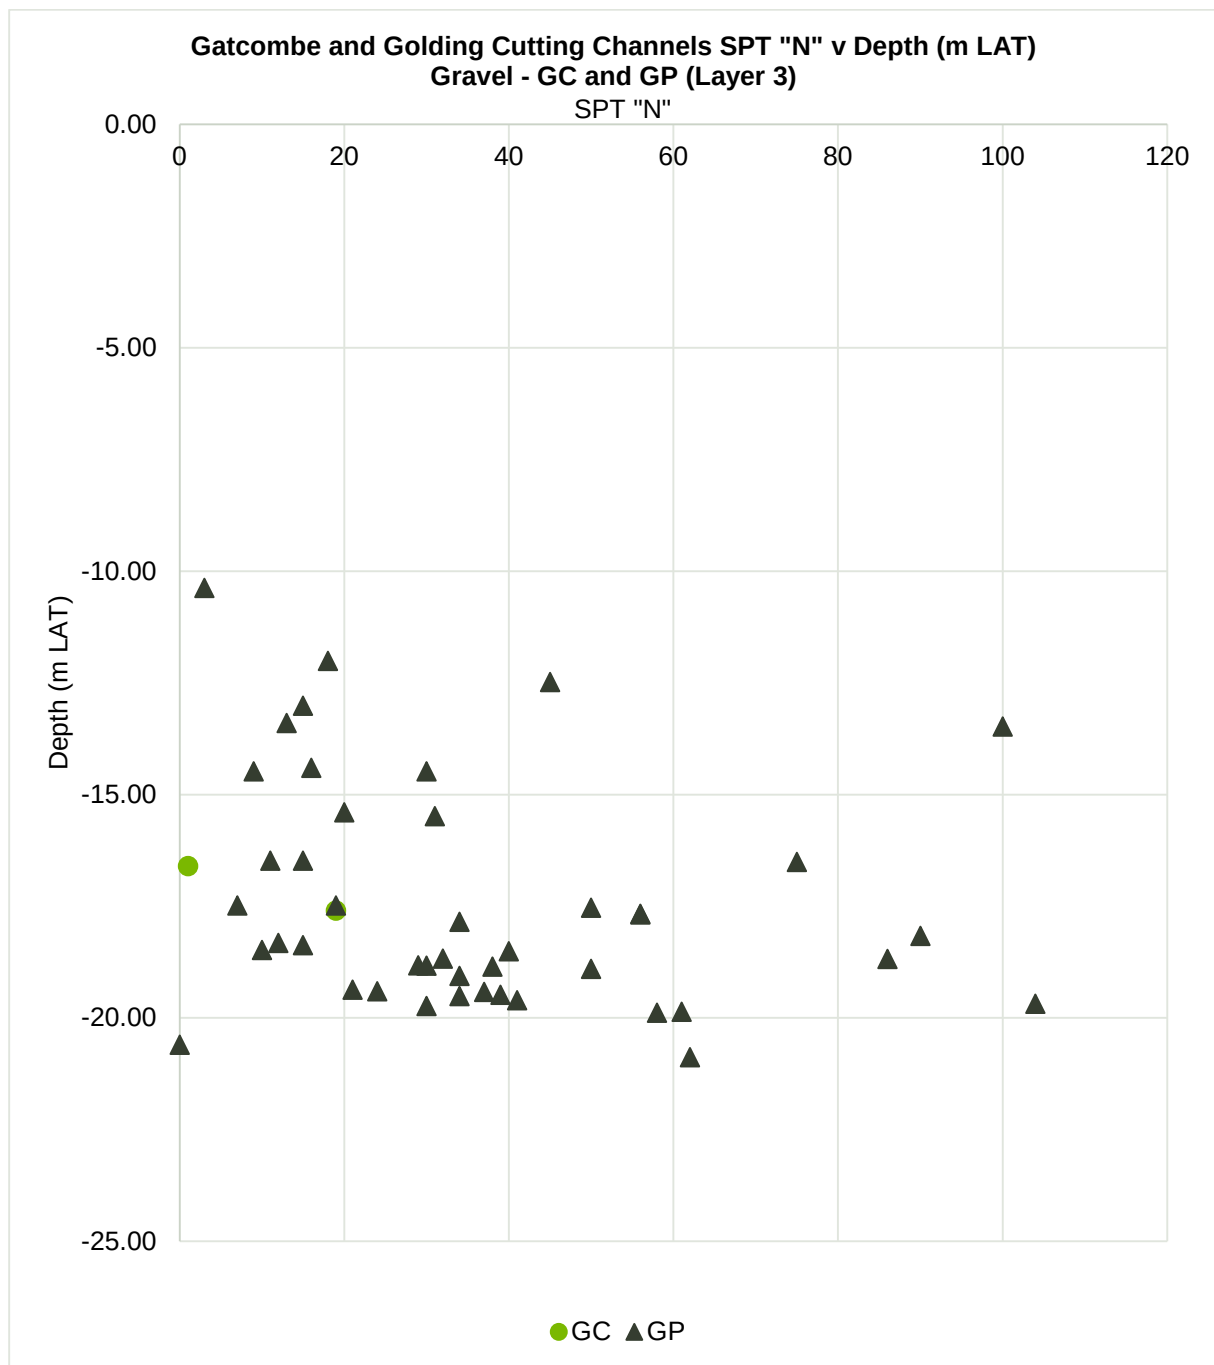
**Figure 21** Gravel soils (Layer 3) SPT "N" v m LAT

Figure 21 shows that above -17.5 m LAT, the SPT "N" values for the gravel material (Layer 3) were found to be typically medium dense (between 10 and 30 blows), whereas below -17.5 m LAT, the gravel was found to be dense (between 30 and 50 blows) and even very dense (>50 blows).

Several outlying SPT "N" values in excess of 60 blows are likely to be the result of testing a large cobble or boulder and may not truly be representative of the in situ density.

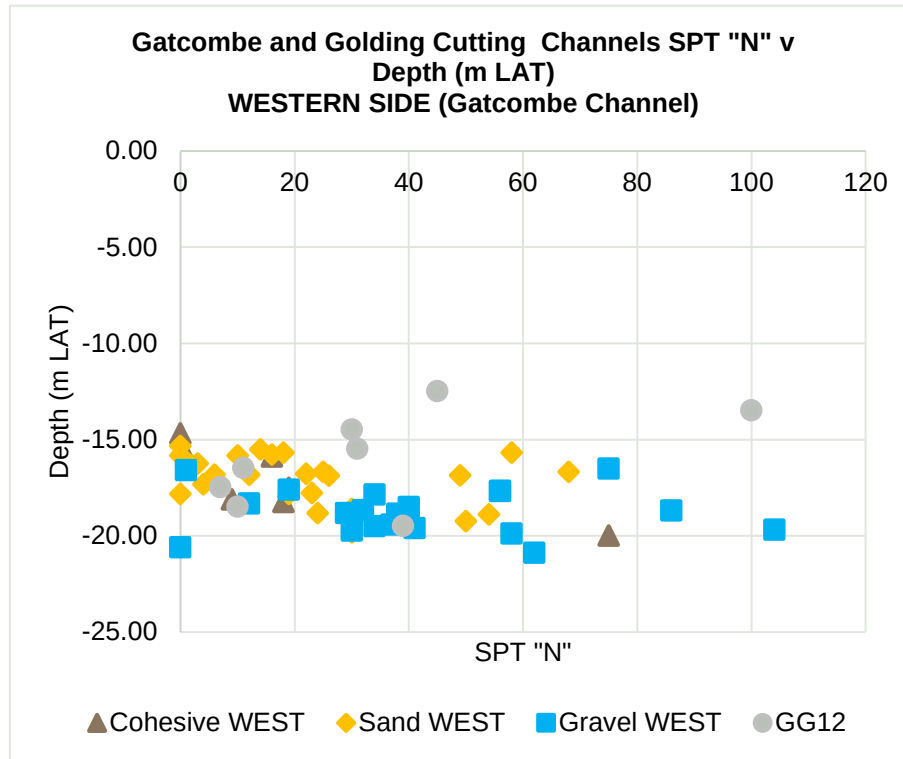
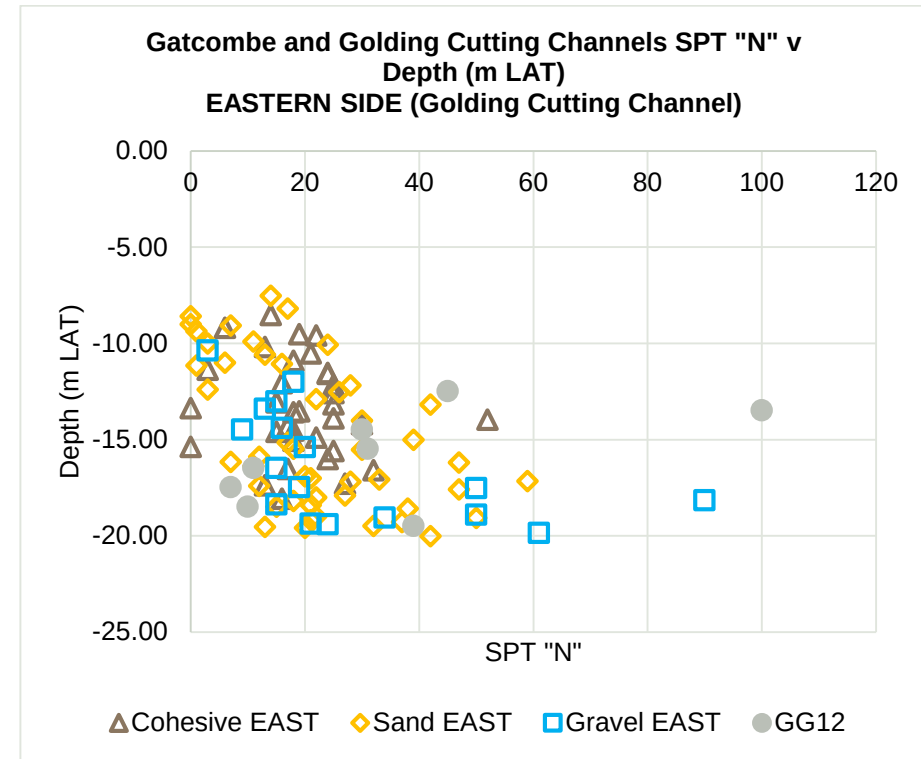
**Figure 22** Gatcombe and Golding Cutting Channels SPT Results v depth (m LAT)

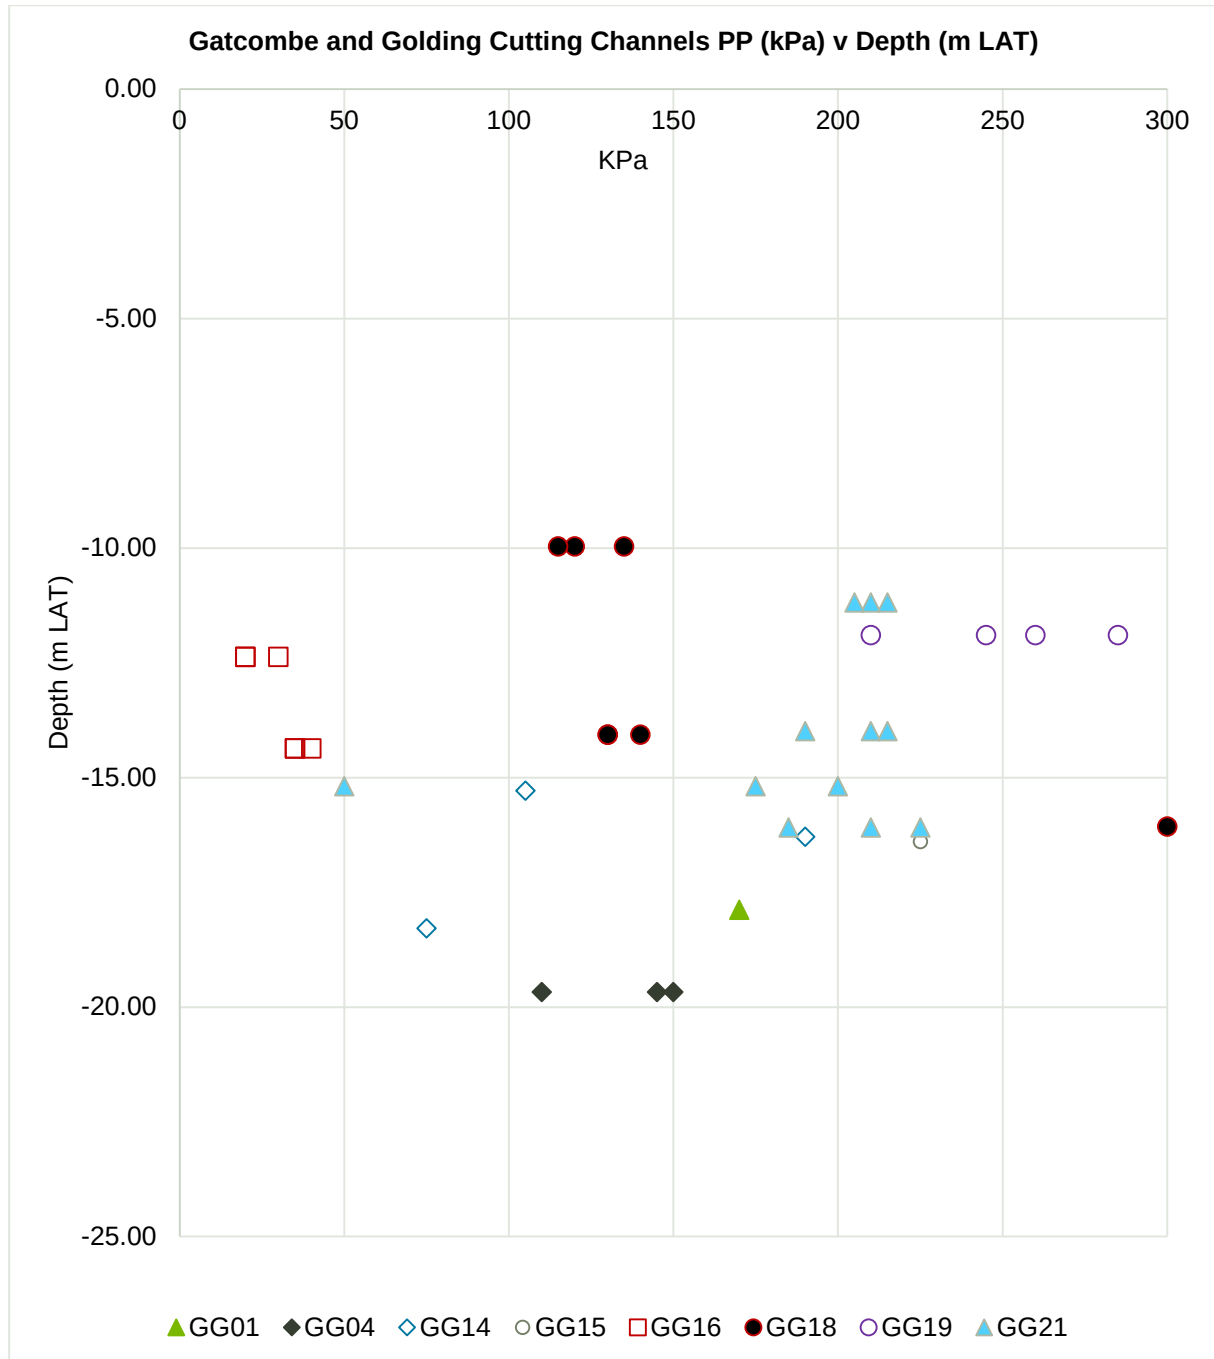
Figure 23 Pocket penetrometer results

Pocket penetrometer tests were conducted in cohesive soils where undisturbed tube samples (U63) or piston samples were taken. The pocket penetrometer test can be used to estimate shear strength of cohesive soils and the results are presented in Figure 23 .

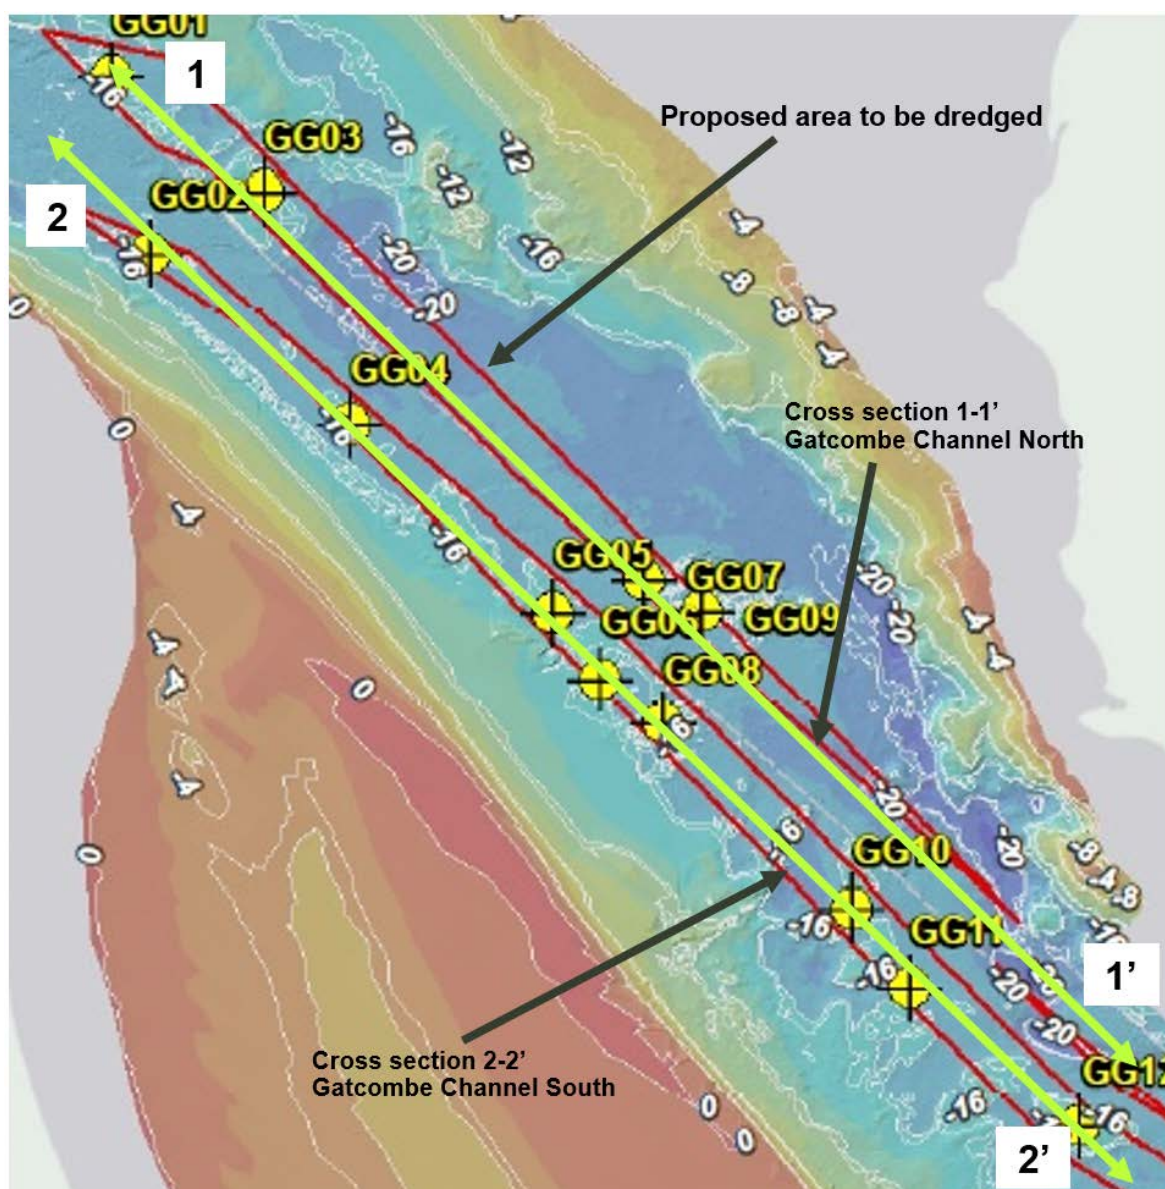
Figure 24 Plan showing location of sections within the Gatcombe Channel (NTS). Sea floor contours are in m LAT and based on bathymetric data provided by GPC

Two sections were drawn from the boreholes within this channel, as depicted in (Figure 24) for both northern and southern sections. This was undertaken as several of the boreholes were offset and a single section proved difficult to produce.
