**Port of Gladstone  
Gatcombe and Golding Cutting  
Channel Duplication Project**

**Appendix E1  
Channel Duplication  
Project – Final  
Geotechnical Report**

**Port of Gladstone  
Gatcombe and Golding Cutting  
Channel Duplication Project**  
Final Geotechnical Report  
**Gladstone Ports Corporation**

19 August 2015  
Revision: 2  
Reference: 245852

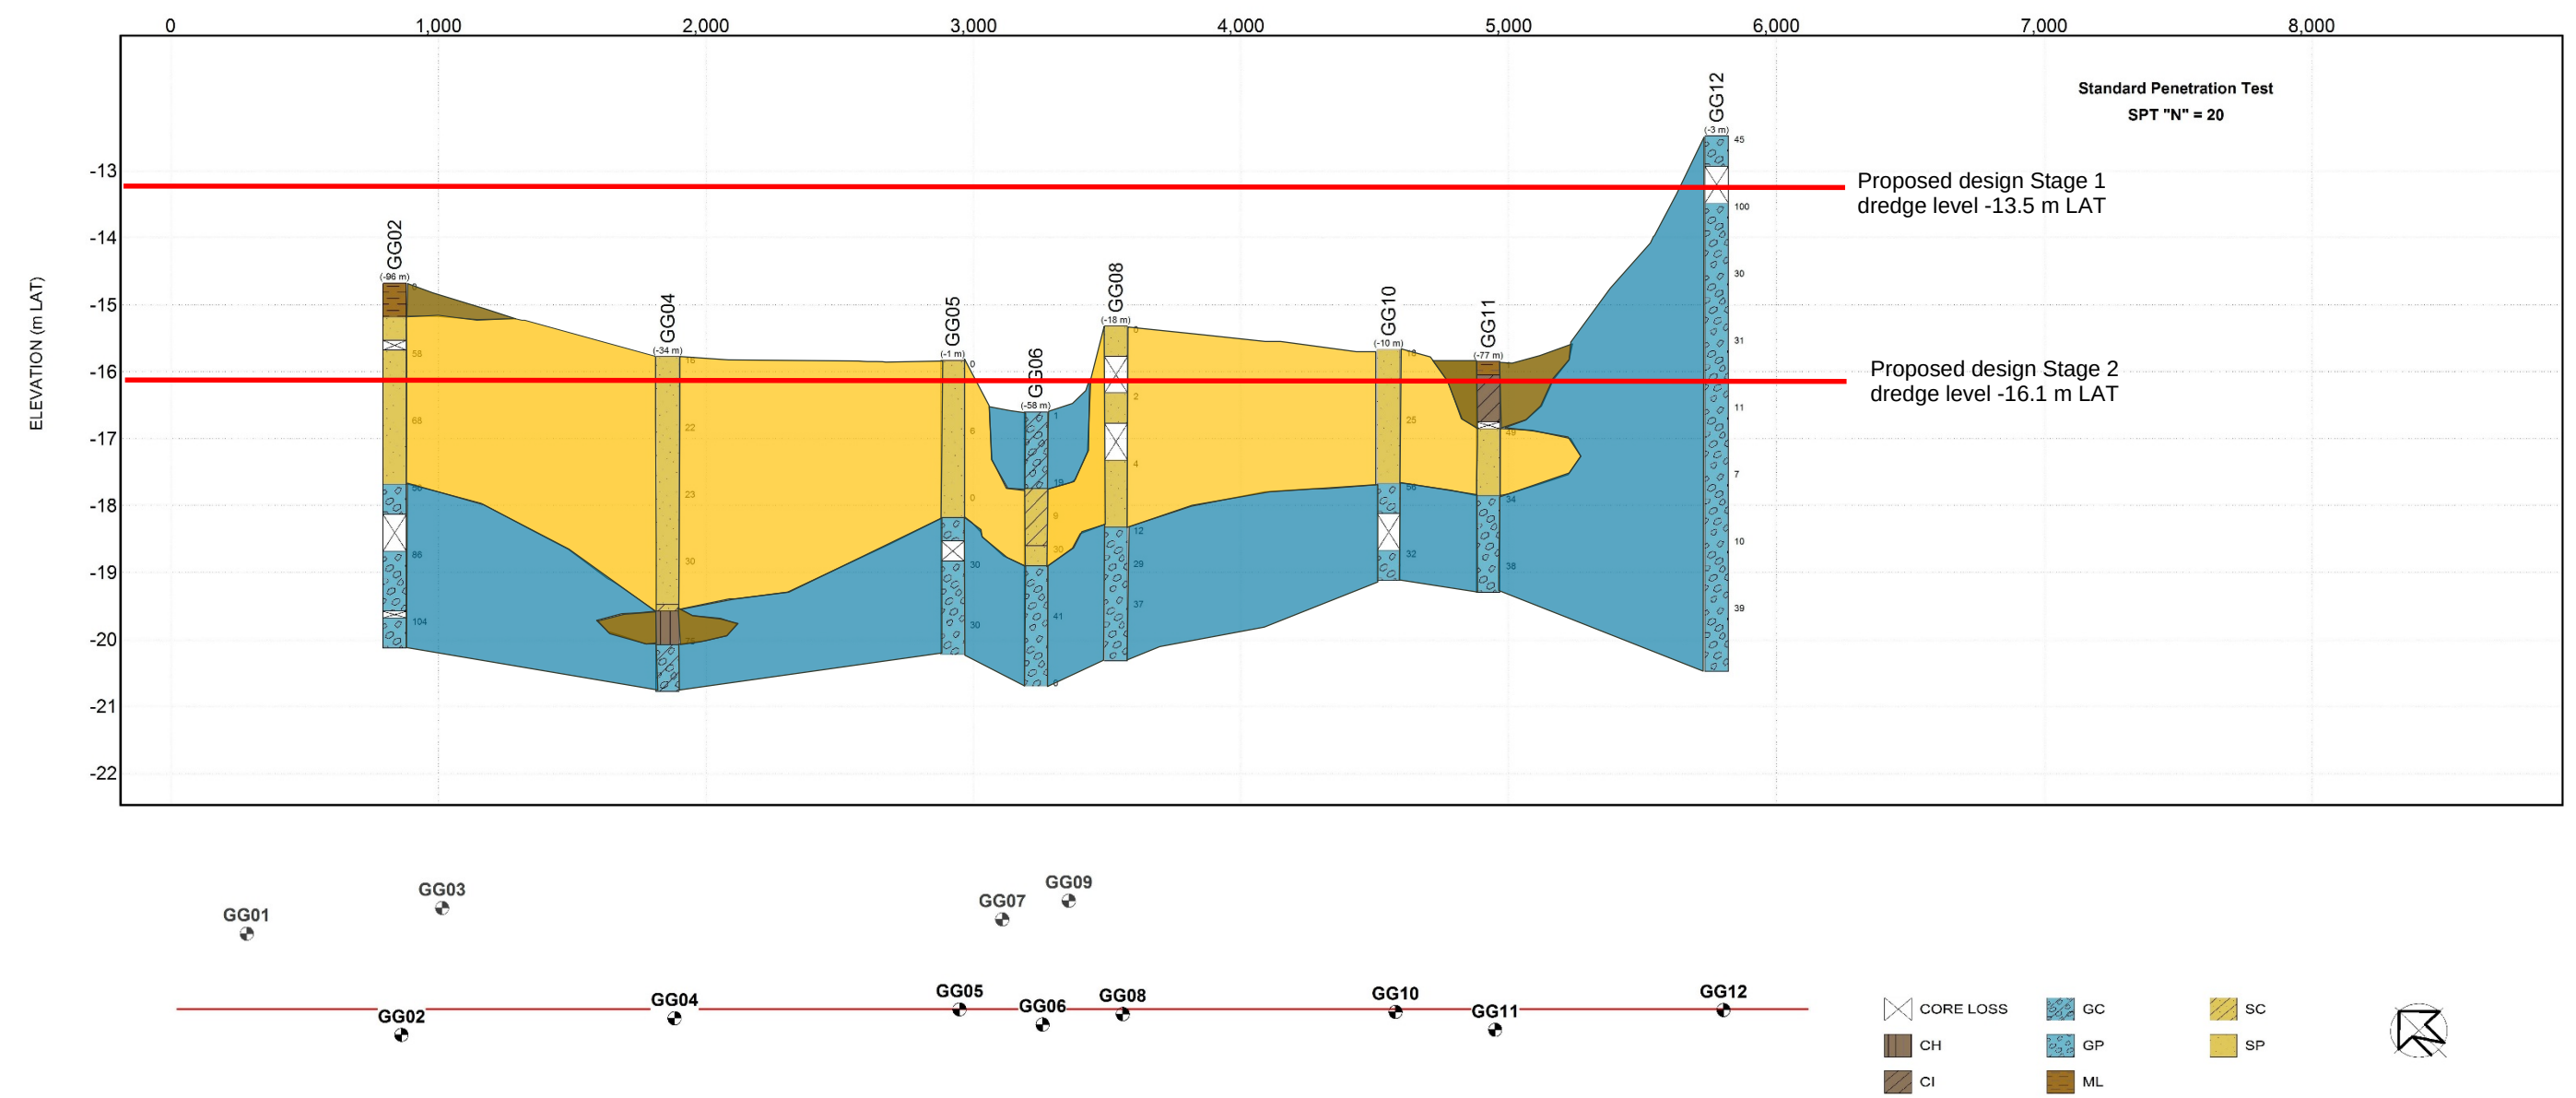
Figure 26 Sketch of the interpreted geological section for Gatcombe Channel (south) (NTS)

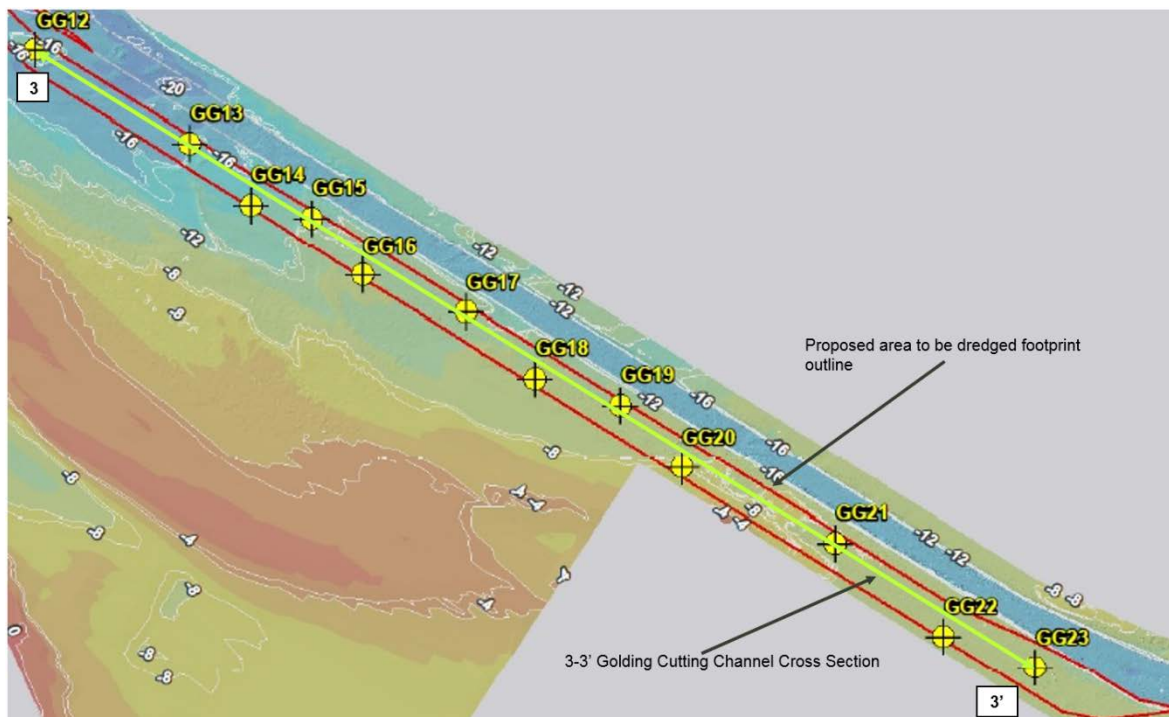
Figure 27 Plan showing location of section within the Golding Cutting Channel (NTS). Seafloor contours are in m LAT and based on bathymetric data provided by GPC

The Golding Cutting Channel section comprises eleven (11) boreholes (GG13 to GG23) with seafloor materials described as being loose to medium dense, poorly graded gravel, clayey and poorly graded sand (Figure 27 and Figure 28). As with the Gatcombe Channel sections, the boreholes undertaken for the Golding Cutting Channel do not clearly portray a definitive geological patterns based on soil type. However, unlike the Gatcombe boreholes, the Golding Cutting section contains a significant amount of cohesive material between approximate levels -7.53 m LAT (GG20) and -18.3 m LAT (GG14). This cohesive layer comprises low to high plasticity silt and low, medium and high plasticity clay. The cohesive material ranges in consistency from very soft to very stiff.

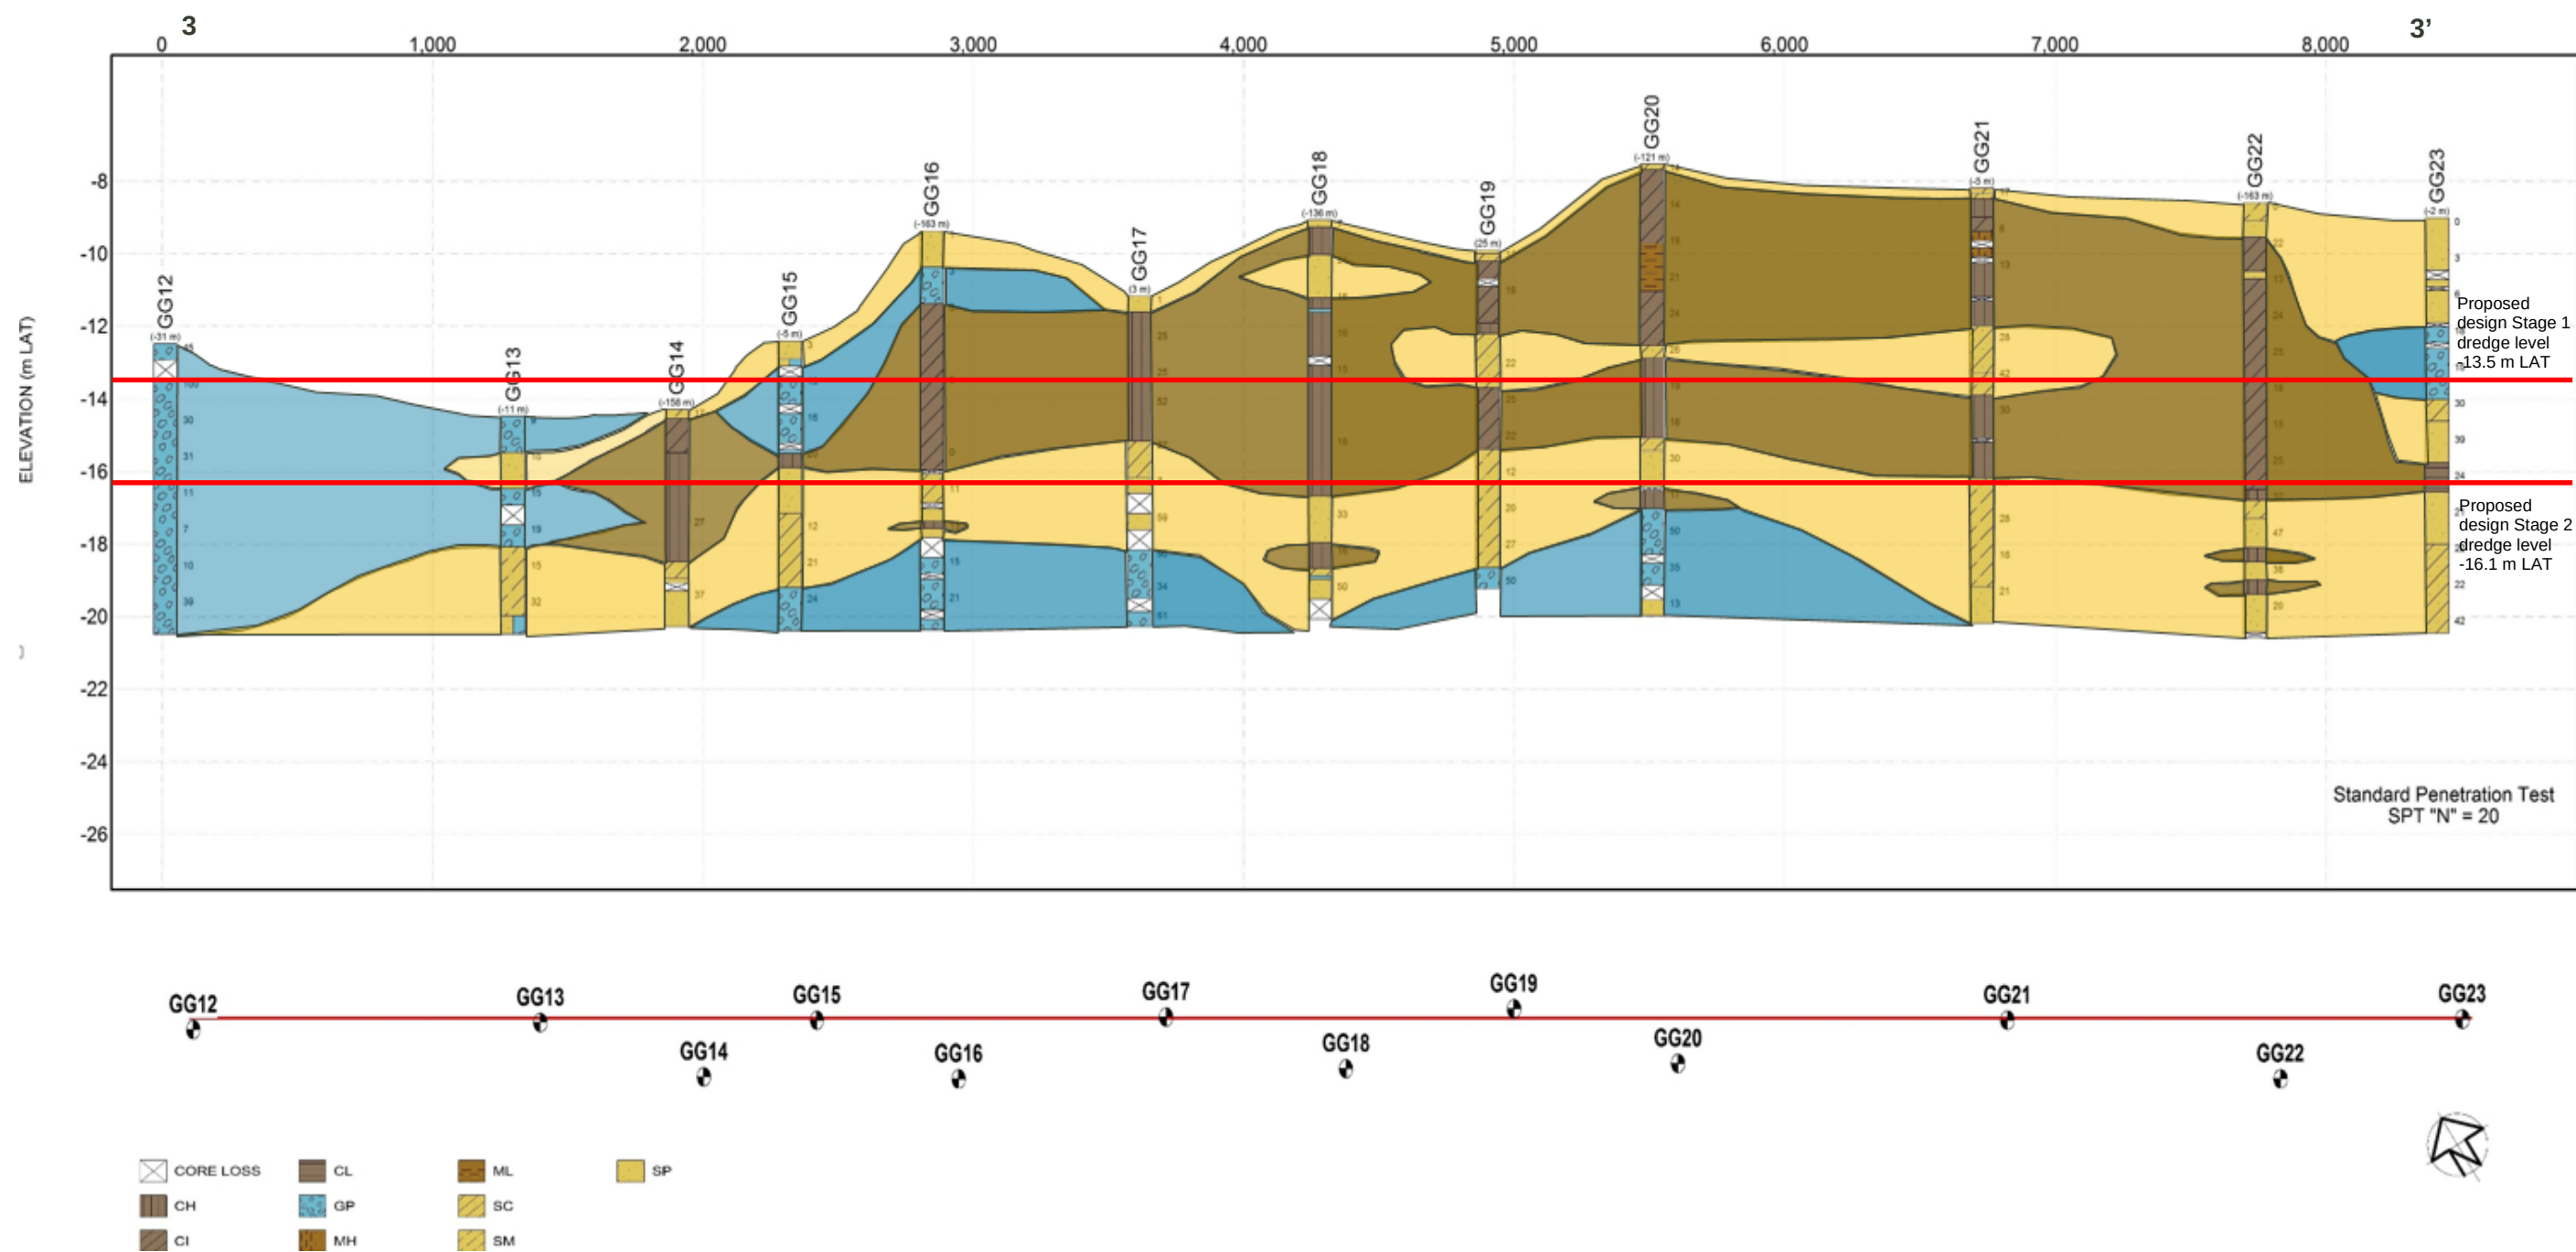
Figure 28 Sketch of the interpreted geological section for Golding Cutting Channel (NTS)

Beneath the cohesive layer, soil described as principally sand (clayey sand, poorly graded sand etc) was recorded, and beneath the sand, a layer of principally gravel was recognised. The complex depositional history of the area can be seen from the geological sketch Figure 28, where the interpreted cohesive layer contains several sand lenses, and the interpreted sand layer contains several cohesive layers. A layer of loose to medium dense gravel was interpreted between GG15 and GG16 between circa -12 m LAT and -16 m LAT.

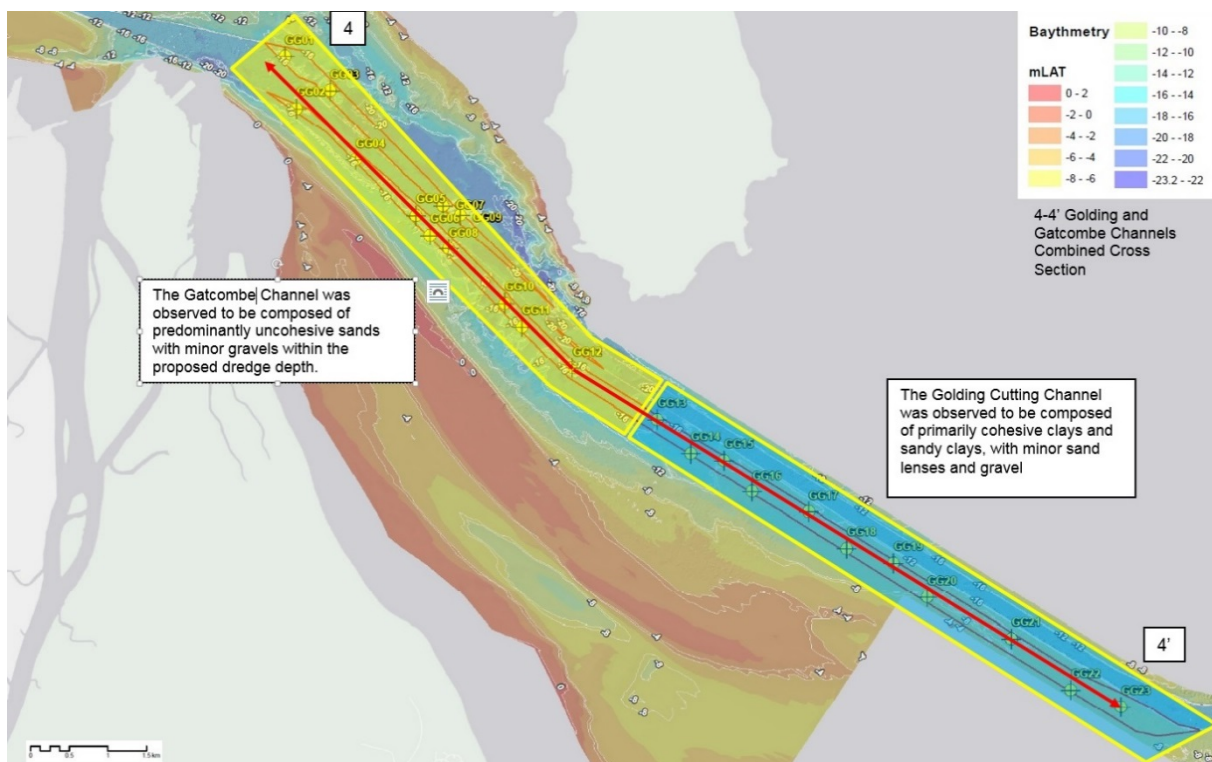
Figure 29 Plan showing the section line for the combined Gatcombe and Golding Cutting Channels (NTS) and the general distribution of materials within the two channels. Seafloor contours are in m LAT and based on bathymetric data provided by GPC

This general rise in seabed level in the vicinity of borehole GG15 is a change of roughly 5 m and is considered to have been formed by a combination of the complex underlying geological structures of the area, which is known to comprise a series of buried or partially buried horst and graben structures.

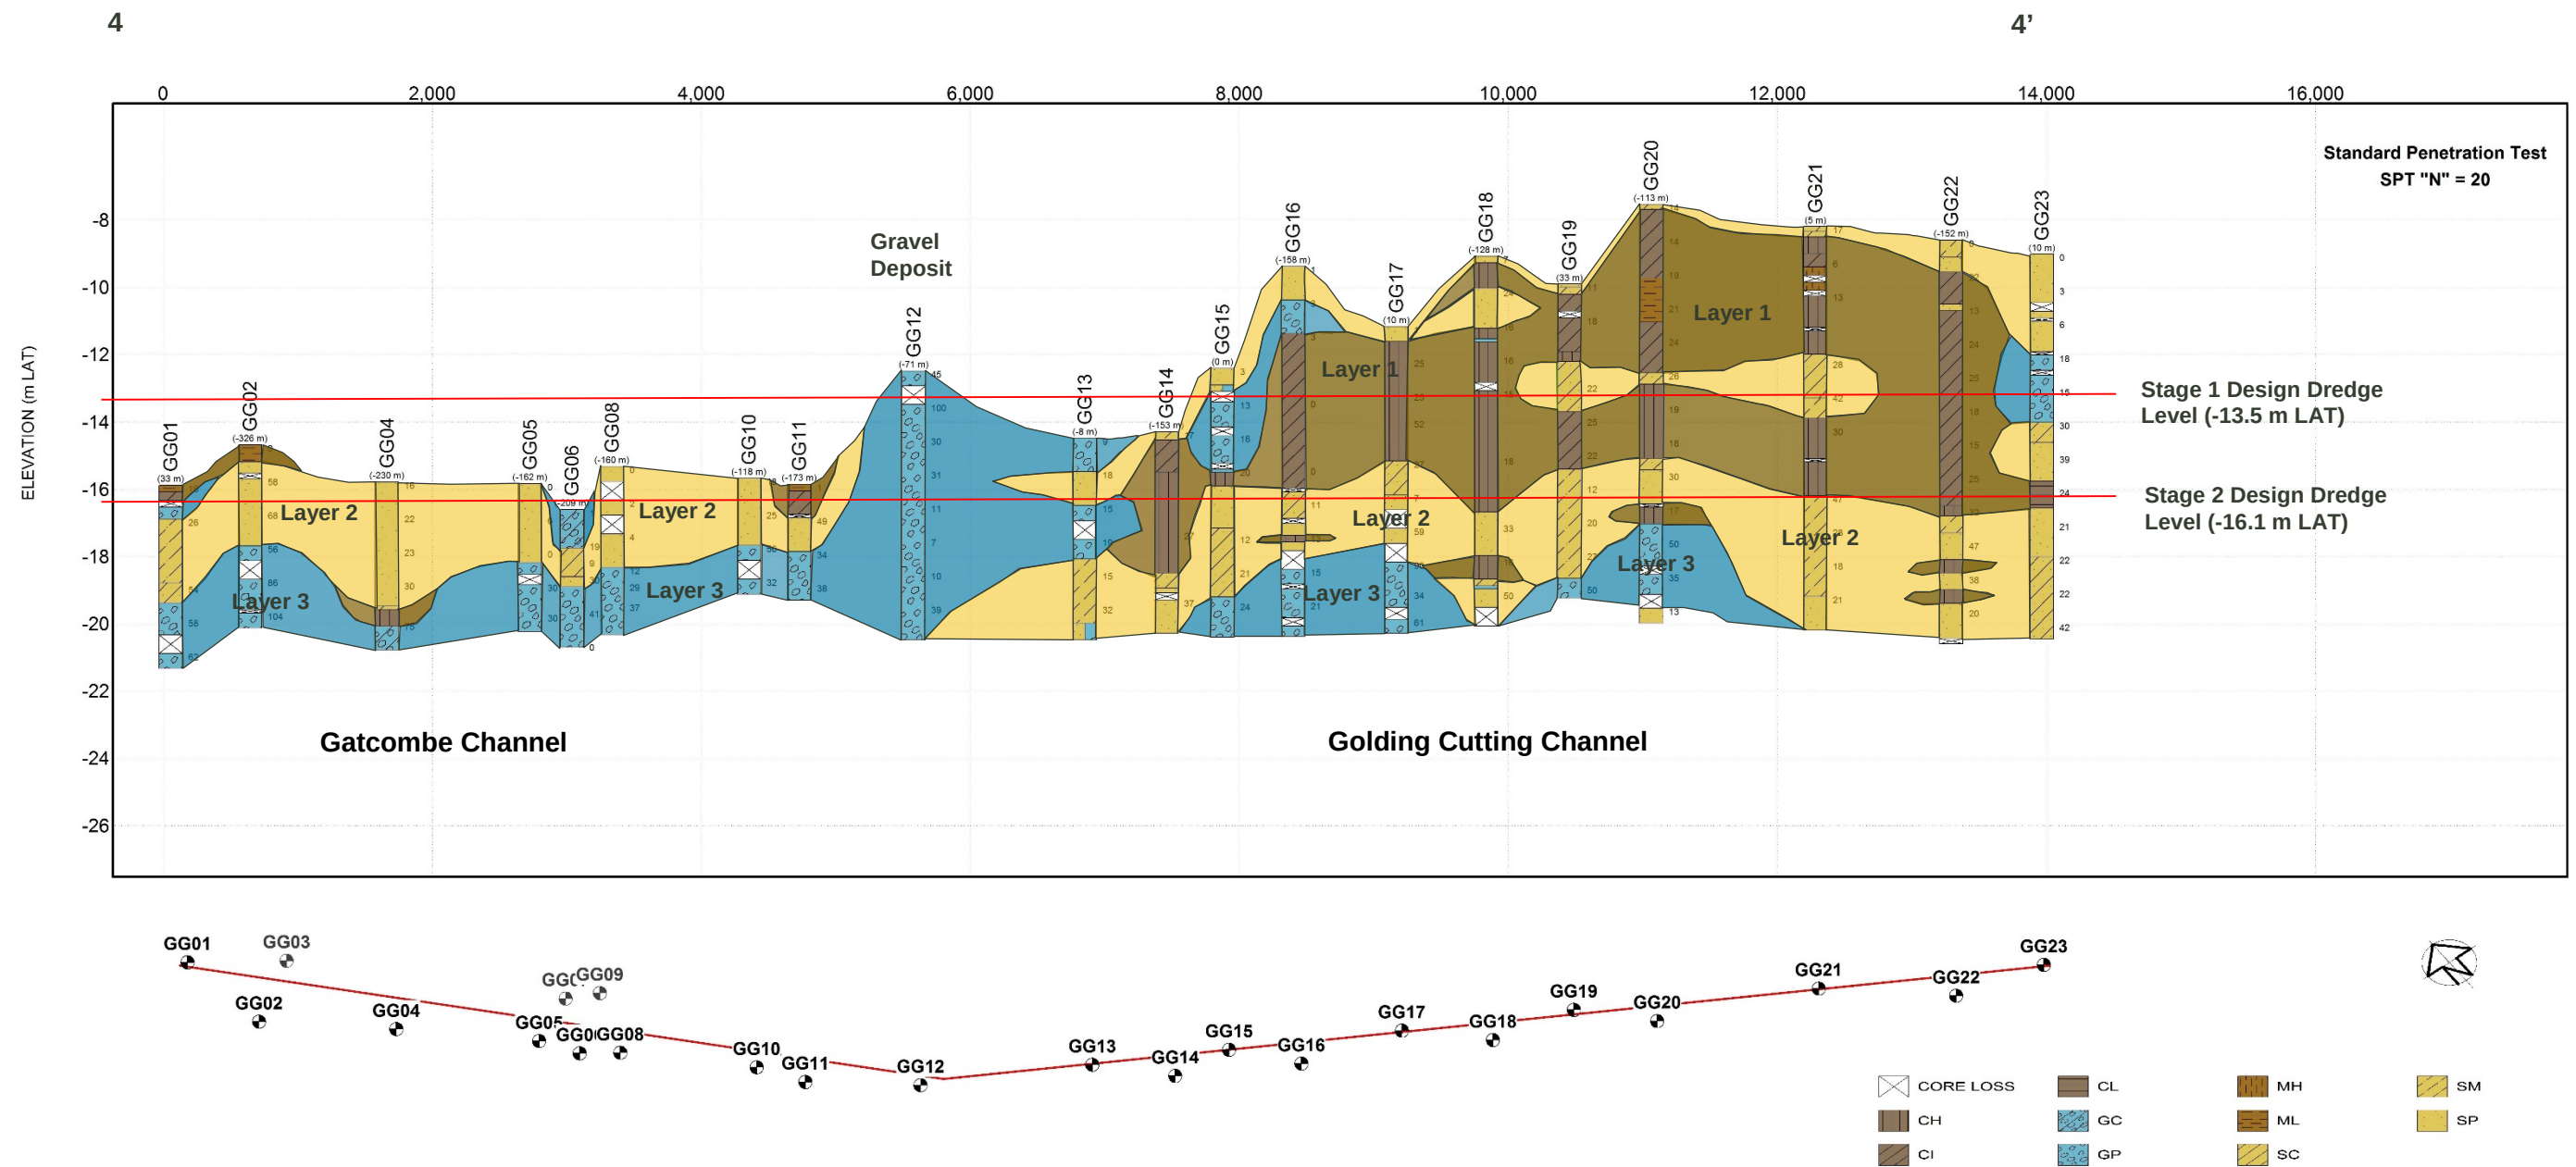
Figure 30 Sketch of the interpreted geological section for the combined Gatcombe and Golden Cutting channel (NTS)

A second observation of the combined section is that “rock”, whether extremely weathered or better, was not encountered during the borehole investigation. This observation corresponds with the geophysical surveys performed over the Gatcombe and Golding Cutting channel areas. The existing surveys indicate that rock is typically located below -26 m LAT though some high level reflectors were observed in the vicinity of GG01 to GG03 and between GG13 and GG18. Based on the drilling performed in these areas, the higher level reflector at these locations was composed primarily of coarse grained gravel lenses likely deposited by the adjacent Boyne River. No bedrock was observed in these borehole locations within the proposed dredging depth. Rock, in the form of sediments and metasediments of the Curtis Island Group, is expected at greater depths. The presence of rock cannot however, be ruled out of the proposed dredging.

For the Stage 2 dredging, removal of Layer 2 (principally sand) will be required from the Gatcombe Channel above -16.1 m LAT, with more gravel from the deposit around GG12 requiring removal. Both Layer 1 and Layer 2 will require dredging as part of the Stage 2 dredging program.

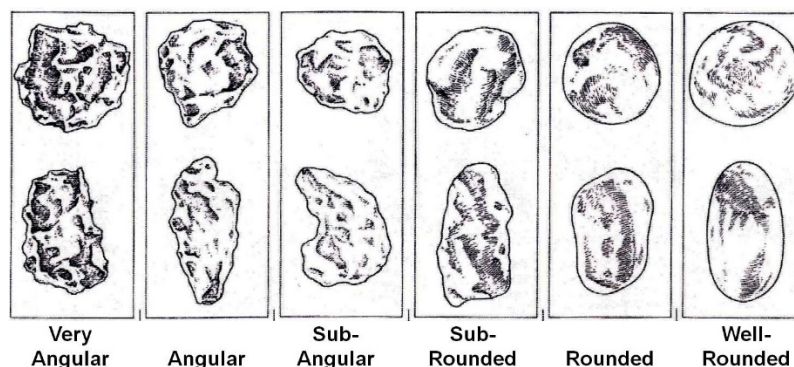
Figure 31 Example of particle angularity for soil particles

Sand recovered from the drilling comprises quartz and shell fragments. Particles are predominantly quartzose in composition. Grains range from sub rounded to sub angular and are fine to course grained. Sands form part of the majority of the soils types found during the site investigations including sandy clays and sandy gravel as well as predominantly sand mixtures with clays, gravels or both. Sands are likely to be abrasive and consideration should be taken to carry out further sampling and testing of soil materials recovered and now stored in a GPC facility. Testing of these materials will inform interested parties of the likely wear and tear on dredging equipment.
