**Port of Gladstone  
Gatcombe and Golding Cutting  
Channel Duplication Project**

**Appendix E2  
Port of Gladstone  
DMPA and Western  
Basin – Final  
Geotechnical Report**

**Port of Gladstone  
DMPA and Western Basin  
Preliminary Geotechnical Report  
Gladstone Ports Corporation**

**28 September 2015**

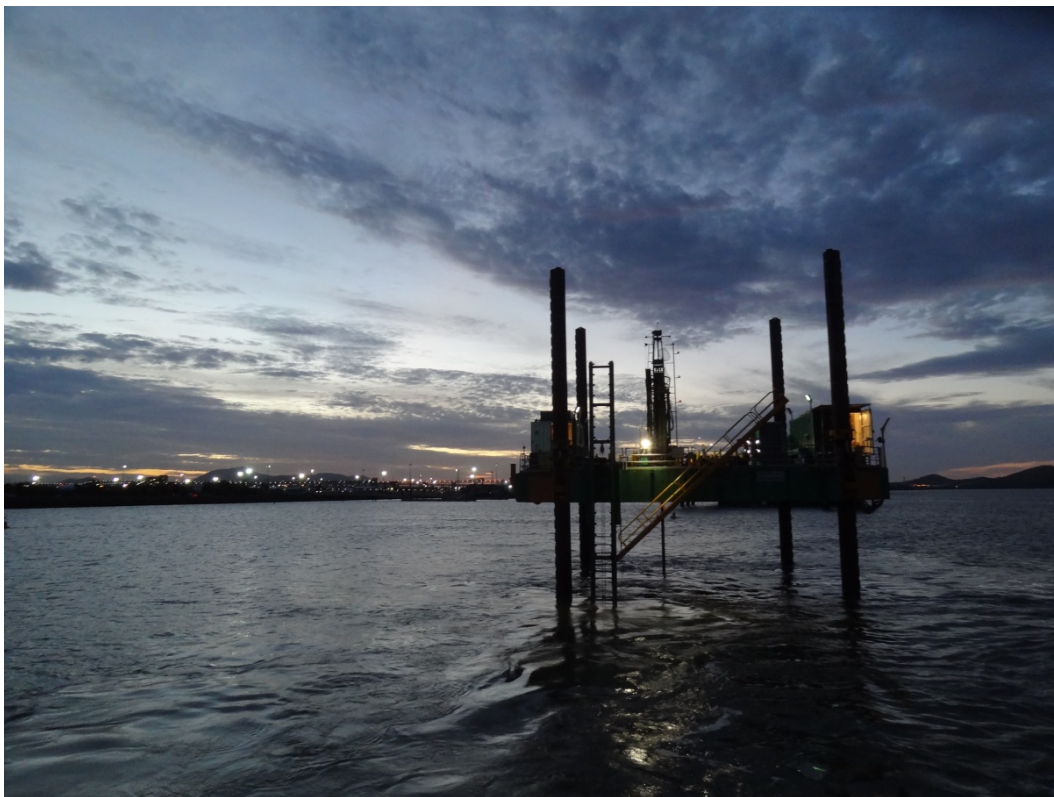
Photograph 1 View of the J&S Jack up barge "Ocean Driller II"

The J&S JUB is a modular 4 legged jack-up platform with a total deck load capacity of approximately 44 tonnes. Once in position over a borehole, the barge is jacked up to its operational height above sea level. Operational height is determined by tides and prevailing sea state conditions. In general, the barge is jacked up to have a 1 m air gap during high tide to account for waves. This relatively small air gap was chosen due to the sheltered harbour location, although the barge could be jacked higher during stormy conditions to account for prevailing sea state and surge conditions when necessary. The JUB was equipped with an Edson 3000 G rotary drilling rig, along with portable storage facilities for equipment and consumables. A photograph of the Ocean Driller 2 JUB is presented below in Photograph 1. Select photographs from the investigation, including JUB and location, are provided in Appendix D.
