# **Wandoan Coal Project**

## **Aquatic Ecology Impact Assessment**

**PB Australia Pty Ltd**

**frc environmental**

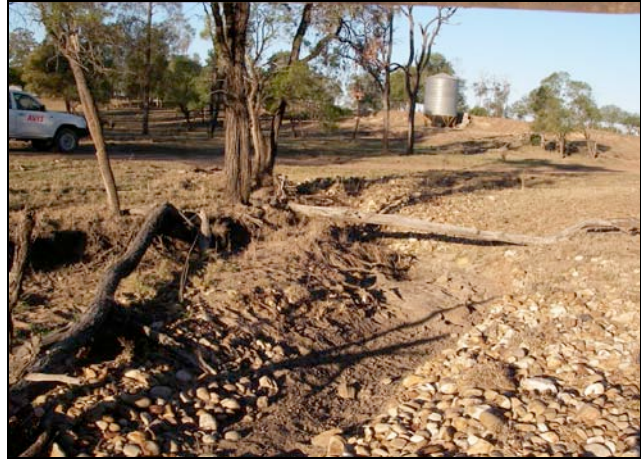
Figure 4.3

Site 13 had a variety of substrate types, including cobbles, and fallen branches that would provide in-stream habitat.

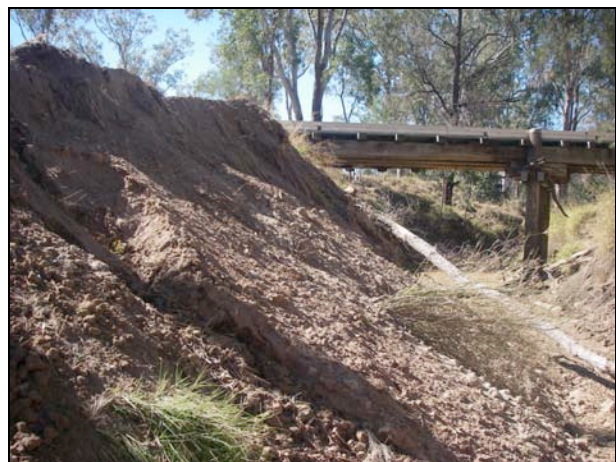
Figure 4.4

Sandy material appeared to have been pushed over the bank of the creek at Site 9.

The higher order streams generally had higher River Bioassessment scores. This was mainly because there was more riparian vegetation at these sites, including a higher cover of large trees in the riparian zone. This vegetation provided shading of the channel; roots, fallen branches and logs for in-stream physical habitat; and stabilised the banks at some sites. The exception to this trend was Wandoan Creek at Bundi Road (reconnaissance site 9), a third order stream, which had the lowest score of all of the sites surveyed. This was due to human impacts on bank stability and riparian vegetation at this site, potentially related to nearby road maintenance. It appeared as though sandy material had been pushed down the bank of the channel by a dozer, adjacent to the bridge crossing. This meant that the bank was devoid of vegetation and quite unstable, with the loose material falling into the bottom of the channel (Figure 4.4).

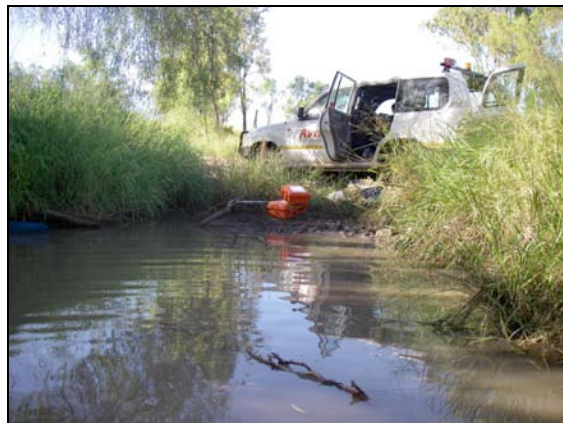
Figure 4.5

The dirt crossing of Kabunga Road at Spring Creek forms a physical barrier to water flows and aquatic fauna passage during periods of low flow.

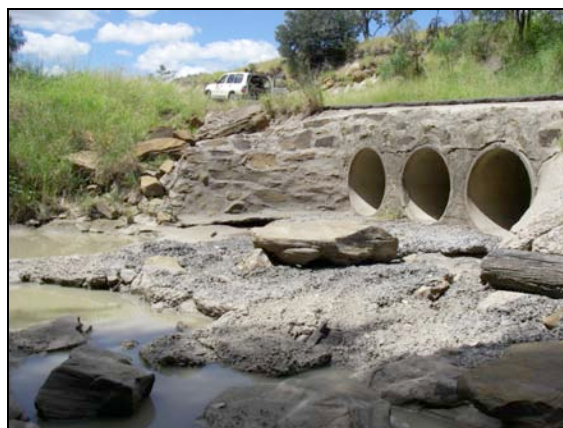
Figure 4.7

The undersized culverts on Grosmont Road at Woleebee Creek are likely to restrict aquatic fauna passage during periods of low to moderate flow.

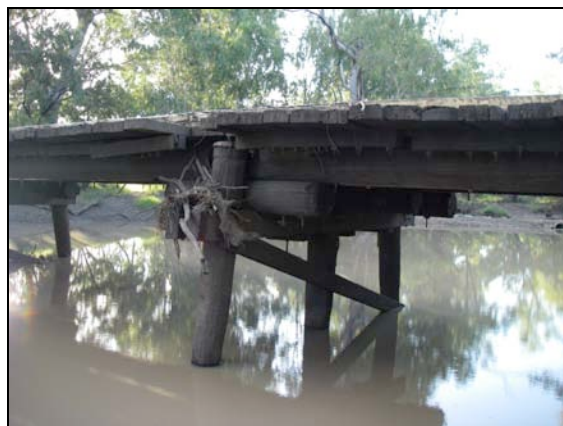
Figure 4.8

The bridge pylons on Roma Taroom Road at Juandah Creek are unlikely to restrict aquatic fauna movements.

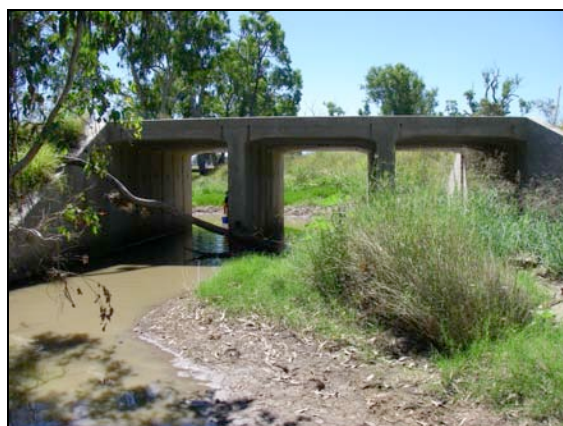
Figure 4.10

The large box culverts on Jackson Wandoan Road at Frank Creek are unlikely to restrict aquatic fauna movements.

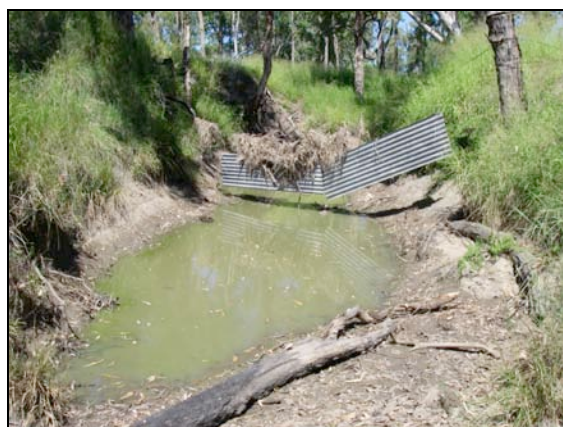
On Frank Creek at Jackson Wandoan Road, a corrugated iron fence crossed the creek and trapped debris, which may restrict aquatic fauna passage in some conditions.

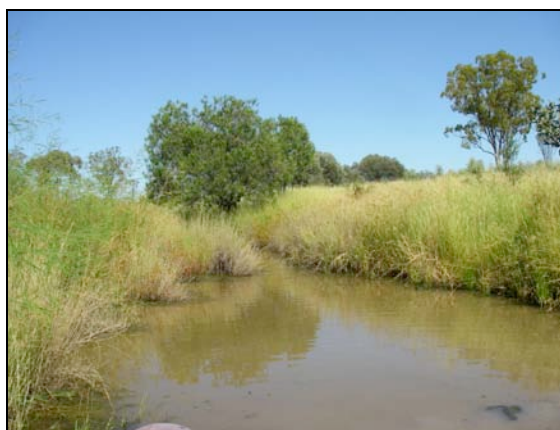
Figure 4.11

At Organ Creek at Bundi Road, the riparian zone was < 2 m wide and dominated by grasses.

Across the study area, riparian zones were generally 5 – 10 m wide but ranged from < 2 m at Mount Organ Creek (Figure 4.11) to 20 m at Juandah Creek at Roma Taroom Road (Figure 4.12). Grasses typically dominated the riparian zone of the creeks, although shrubs and trees also grew at most sites. There was a substantial increase in grass coverage across the study area between the initial field reconnaissance in August 2007 and the flora and fauna survey in March 2008 (particularly at Spring Creek and Juandah Creek). The cover of trees was generally  $\leq 20\%$ , but was 40% at Juandah Creek at Roma Taroom Road (downstream of the MLAs).

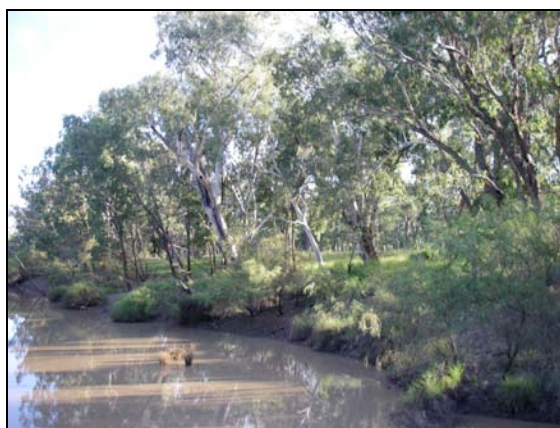
Figure 4.12

At Juandah Creek at Roma Taroom Road, the riparian zone was 20 m wide and included several shrubs and large trees.

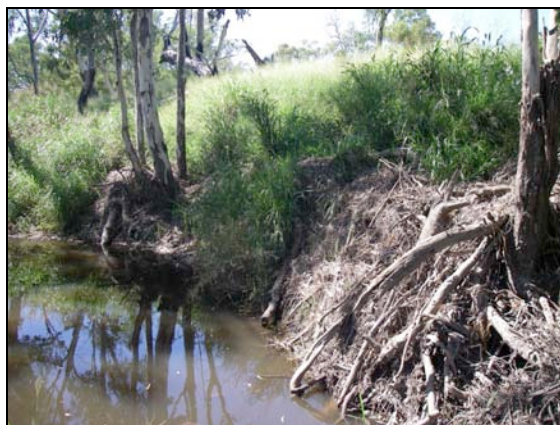
Figure 4.13

Juandah Creek generally had steep banks that were stabilised by vegetation along most of its length.

There was some bank erosion at each of sites in the study area, apart from very small first order streams, which had very low banks. Steep banks were common in larger-order creeks, and appeared to be the result of water scouring during periods of high flow. Despite the steep banks, bank stability was often maintained by a relatively high cover of bank vegetation (Figure 4.13). At some sites, disturbance caused by cattle access (Figure 4.14) or riparian vegetation clearing had negatively affected bank stability.

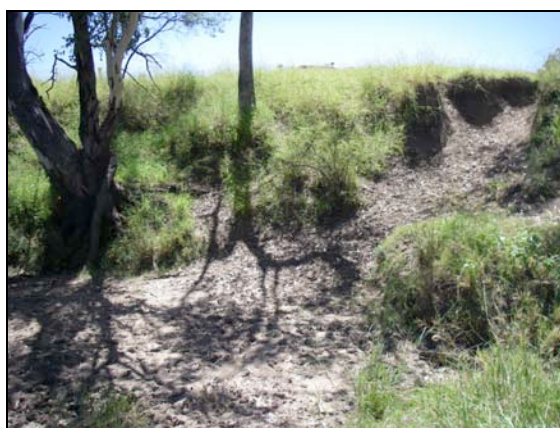
Figure 4.14

Cattle had accessed the creek bed at Mud Creek.

There was some bank erosion at each of sites in the study area, apart from very small first order streams such as Slatehill Creek (site 2) and a tributary of Roche Creek (site 6), which had very low banks. Steep banks were common in larger-order creeks, and appeared to be the result of water scouring during periods of high flow. Despite the steep banks, bank stability was often maintained by a relatively high cover of bank vegetation, particularly in Juandah Creek, where many large Eucalypts lined the banks (Figure 4.13). At some sites, disturbance caused by cattle access (Figure 4.14) had negatively affected bank stability.

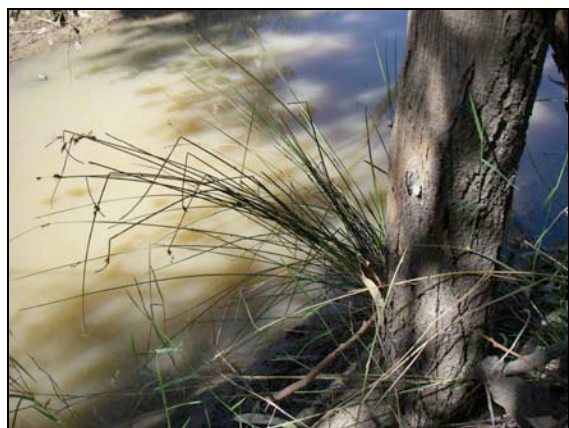
Figure 4.15

Trailing bank vegetation provided instream habitat at Frank Creek.

The overall habitat condition of the creek systems was moderate, with some physical aquatic habitat found at most of the sites. At most of the sites, habitat was generally in the form of undercut banks, trailing bank vegetation and some terrestrial leaves and sticks where there was overhanging vegetation (Figure 4.15). At sites surveyed in higher order creeks, there was generally greater habitat availability, as there was more water present and large trees on the banks provided tree roots and fallen branches / logs as habitat (Figure 4.16). For example, previous high flows in Woleebee Creek appeared to have created large log jams (Figure 4.17), which increased habitat diversity.

The overall habitat condition of the creek systems was moderate, with some physical aquatic habitat found at most of the sites. Physical aquatic habitat was more abundant in the larger order creeks in the study area (Roche Creek and Juandah Creek) than in the small (first order). At most of the sites, habitat was generally in the form of undercut banks, expose tree roots and terrestrial debris, including some branches and logs where trees were abundant in the riparian zone (Figure 4.15).

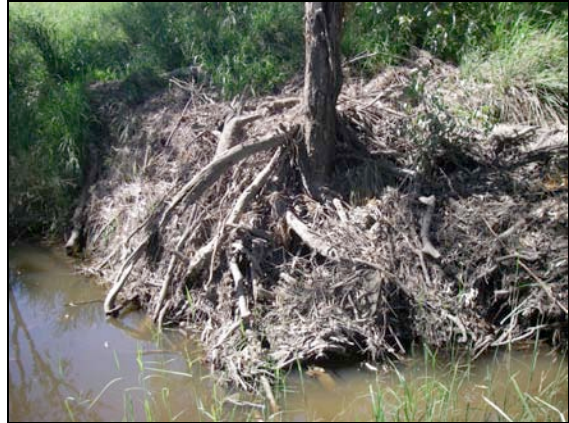
Figure 4.16

Undercut banks, tree roots and terrestrial debris provided habitat at Juandah Creek at the highway.

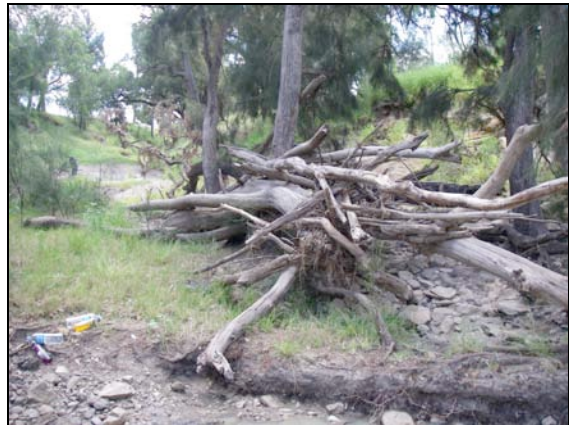
Figure 4.17

A large log jam at Woleebee Creek at Grosmont Road.

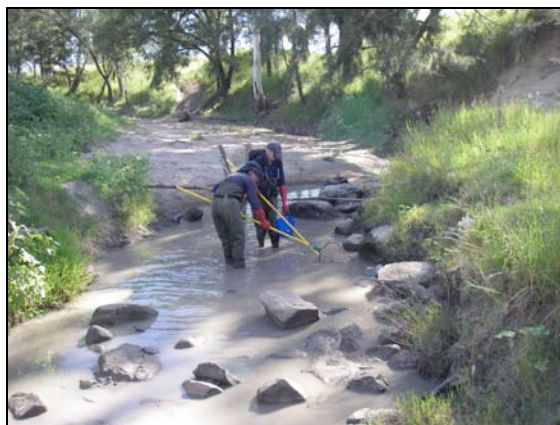
Woleebee Creek at Boral Rd (site 4) was a series of small, shallow, isolated pools in an otherwise dry creek bed.

Electrical conductivity is proportional to the salinity of a water body, i.e. more saline water is more conductive. High conductivity could be associated with evaporation (effectively concentrating the salts in the remaining water): sites 2, 4, 5 & 9 consisted of a series of small (< 10 m long), shallow ( $\leq 0.5$  m mean depth), isolated pools in an otherwise dry creek bed (e.g. Figure 4.24 & Figure 4.25), whereas the pool at site 6 was much larger (> 200 m long and 1 m mean depth) (Figure 4.26).

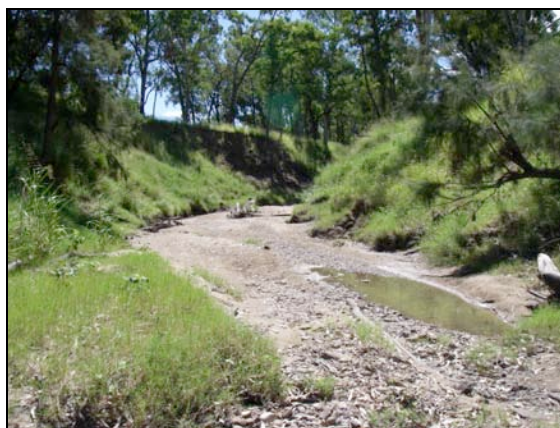
Figure 4.25

Juandah Creek at Booral Rd (site 9) was a series of small, shallow, isolated pools in an otherwise dry creek bed.

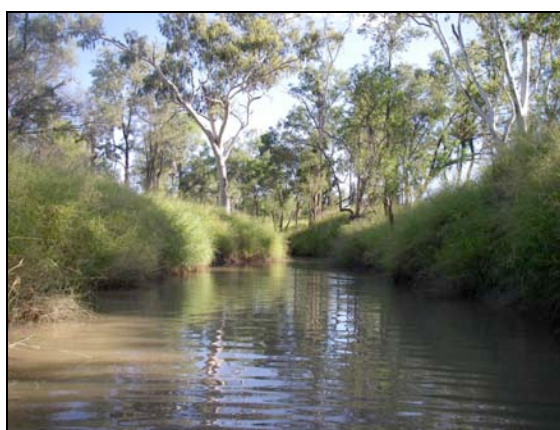
Figure 4.26

The pool at Spring Creek at Kabunga Rd (site 6) was relatively large.

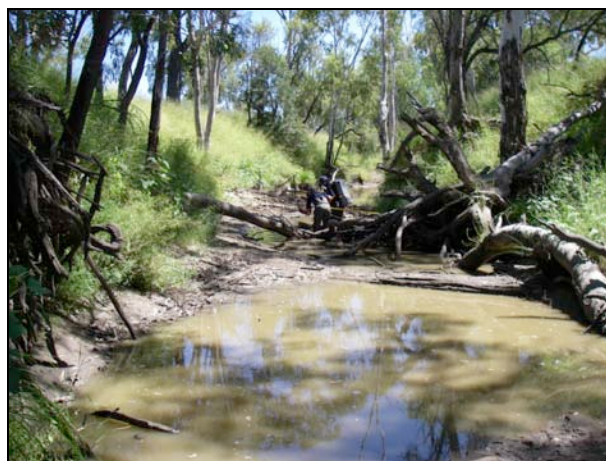
Figure 4.58

Good riparian cover and large woody debris at site 5 on Mud Creek.

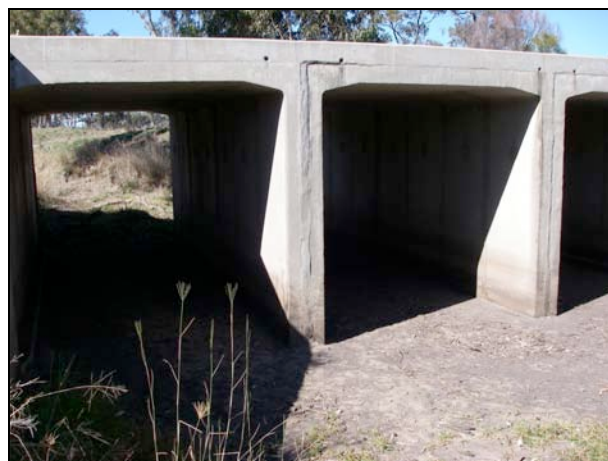
Figure 6.1

The box culvert on Frank Creek at the crossing of Jackson Wandoan Rd is large and would allow the effective passage of aquatic fauna.

Stream crossings can create waterway barriers that prevent or impede movements of aquatic fauna such as fishes and turtles. Within the MLAs, there are some examples of existing successful, culvert-based road crossings. Multiple large section box culverts carry all but flood-flows, and enable the effective passage of aquatic fauna (Figure 6.1). However, there are also examples of poorly-designed pipe culverts and undersized box culverts that would obstruct fish passage at certain times of the year (refer to Section 4.1). That is, fish passage is already restricted in the MLAs. Poorly-designed fish crossings associated with the Project have the potential to further impact on fish movement within the study area. Adoption of best practice design with respect to fish passage will avoid this potential impact, as discussed further in Section 7.7.3.

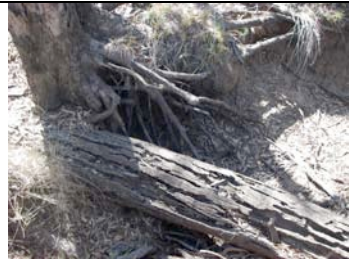
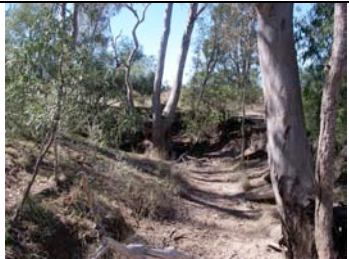
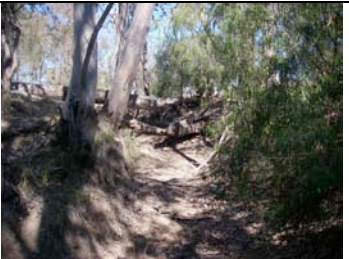
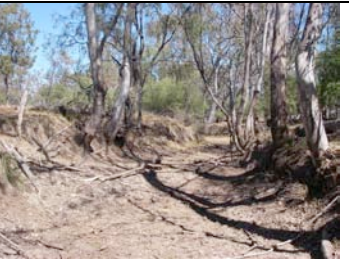
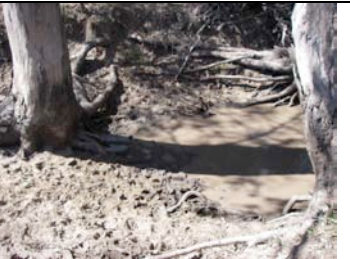
| Fallen logs and tree roots provided habitat | Large trees helped to stabilise the banks | Riparian vegetation provided canopy cover of the channel | Much of the stream bed was sandy and dry | Cattle have access to the creek |

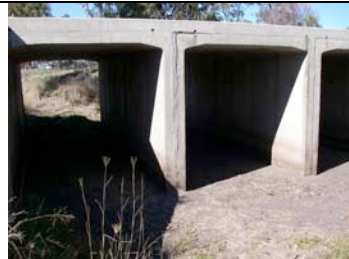
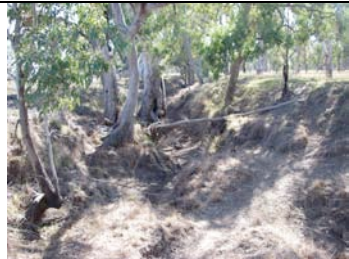
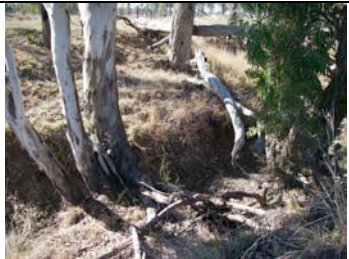
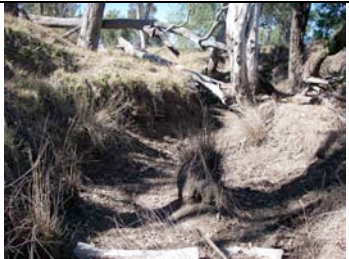
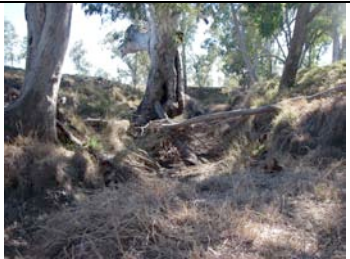
| Box culvert under Jackson-Wandoan Road | Banks were covered by grass and trees | Steep banks were stabilised by trees | Slightly eroded banks on the outside of a bend | Fallen logs and branches provided habitat |

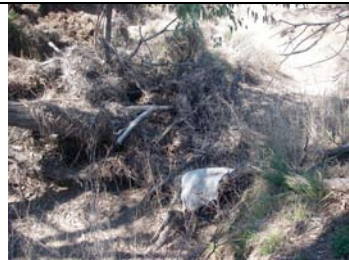
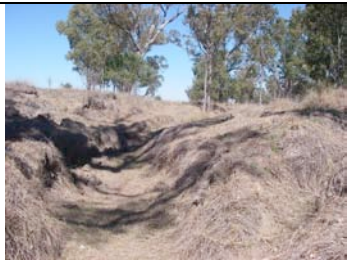
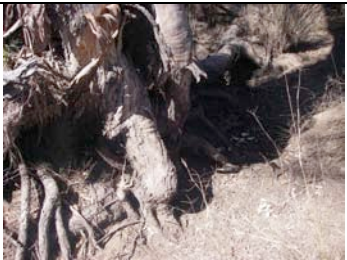
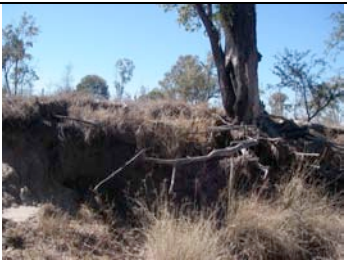
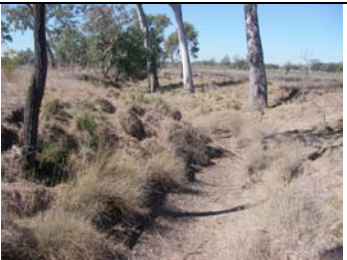
| | Survey Date: 8/08/07<br>Written By: TS      Approved By: LT | frc site number 3<br>UTM Zone 55K    792788 E    7107103 N WGS84 | |

| A small log jam provided habitat | Banks were devoid of trees in places | Tree roots provided habitat | Erosion on the outside of a bend | The banks were small and stable in places |

Comments: Fallen terrestrial debris provided in-stream habitat. Habitat condition reduced by erosion and cattle access. Moderate condition overall.

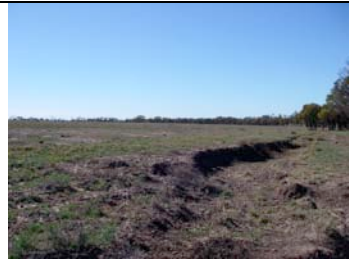
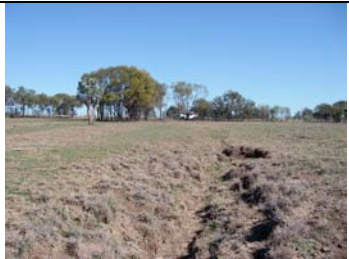
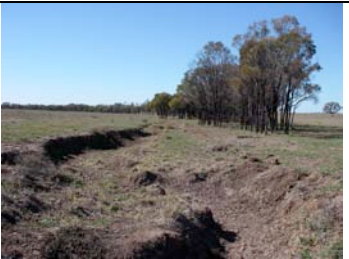
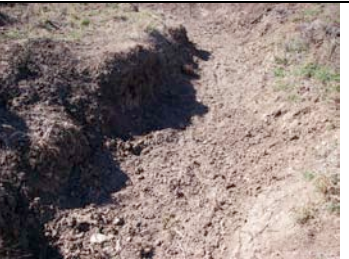
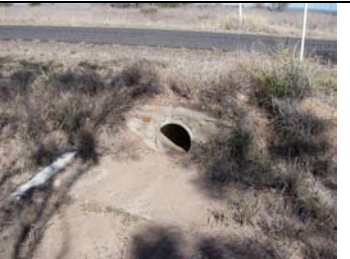
| | Survey Date: 7/08/07<br>Written By: TS      Approved By: LT | frc site number 4<br>UTM Zone 55K 791701 E 7105303 N WGS84 | |

| The stream was a small gully | There were few trees in the riparian zone | A stand of Acacias grew away from the right bank | There was some small-scale erosion | The creek flows under the road via a pipe |

Comments: Small first order stream through pasture land. No structure for in-stream habitat and few trees in the paddock. Poor condition.

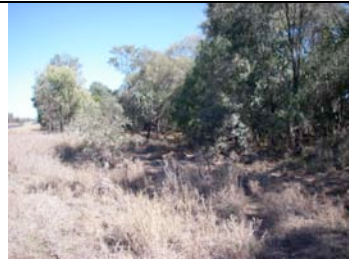
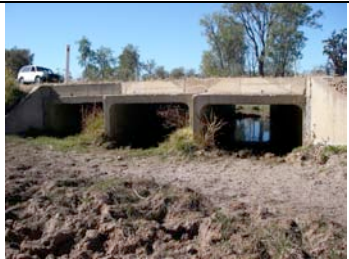
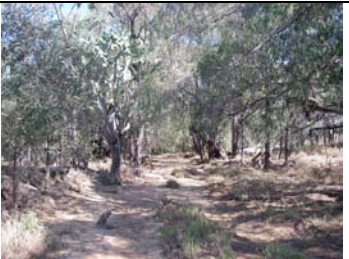
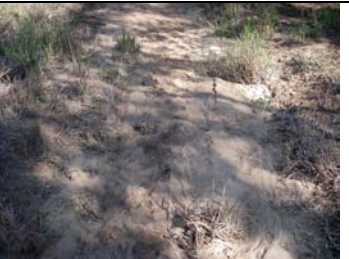
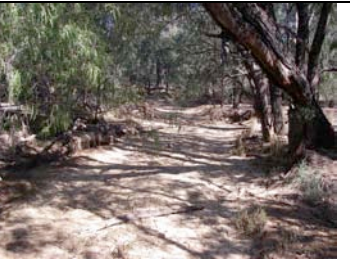
| | Survey Date: 8/08/07<br>Written By: TS      Approved By: LT | frc site number 5<br>UTM Zone 55K    790071 E    7108843 N WGS84 | |

| The channel ran beside the road | Box culvert under Jackson-Wandoan Rd | There was natural riparian vegetation | The stream bed was sandy | Trees provided overhanging vegetation |

Comments: Small first order stream with a sandy substrate. Culvert under the road would allow fish passage and the riparian vegetation was in-tact. Lack of in-stream physical habitat diversity reduced habitat condition. Moderate condition overall.

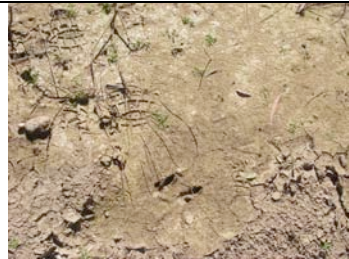
| Mat algae grew on moist sediment | A fallen log upstream of the road would provide habitat | Loose sediment was falling into the creek bed | The pooled water was shallow and turbid | Sediment appeared to have been pushed over the bank |

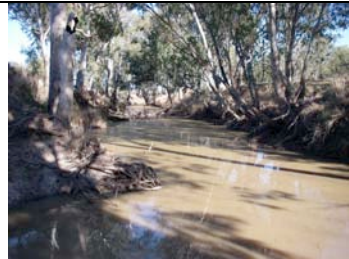
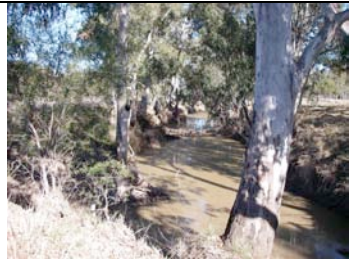
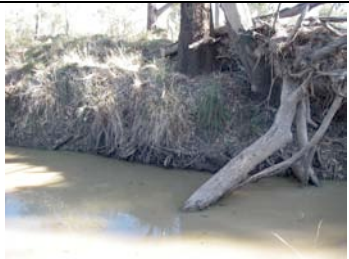
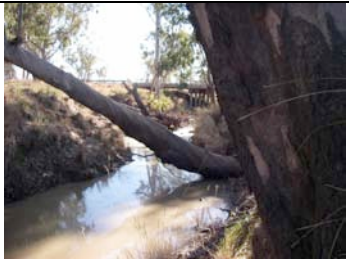
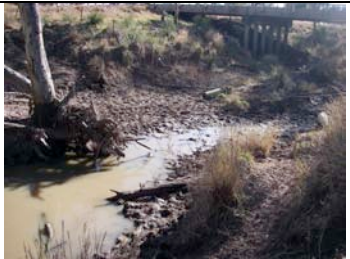
| The site held substantial water but there was no flow | Large trees helped to stabilise banks | Fallen logs and edge vegetation provided habitat | Riparian trees provided shading and fallen logs | The creek was dry near the bridge |

Comments: Good edge habitat compared with the other sites sampled. Logs, tree roots and branches provided in-stream habitat. Some disturbance from bridge and rubbish disposal. Moderate condition overall.

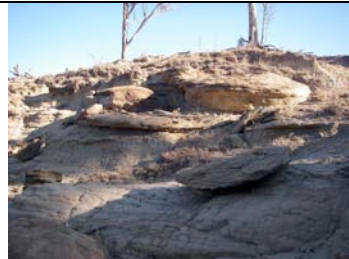
| Some of the banks were sandstone | A large sandy run habitat | Tree roots and boulders would provide habitat | The road crossing was a dirt track | There was good vegetative cover on the banks |

Comments: Tree roots and substrate diversity provide in-stream habitat. Dirt road crossing is not a barrier to flow or fish passage. Evidence of cattle access to the creek reduces overall condition. Moderate condition.

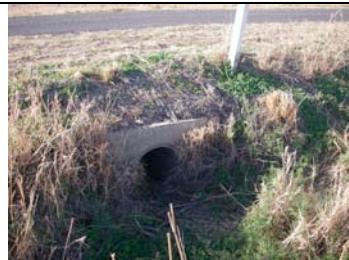
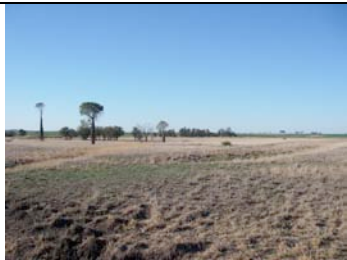
| A small pipe allows flow under the road | The creek was a small channel through cropping land | The creek ran through taller crops upstream of the road | There was no riparian vegetation | |

Comments: Small channel through agricultural land. No riparian vegetation or in-stream habitat obvious. Poor condition.

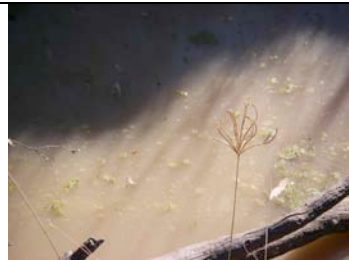
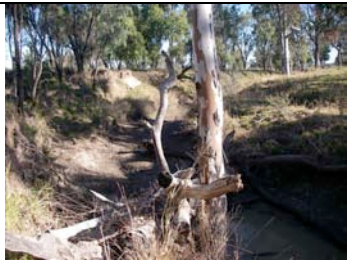
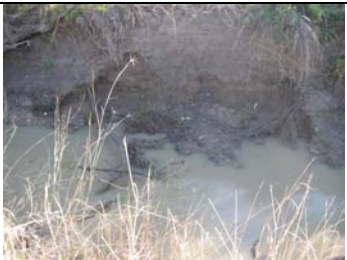
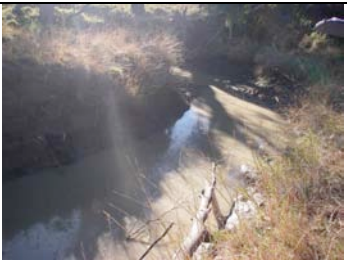
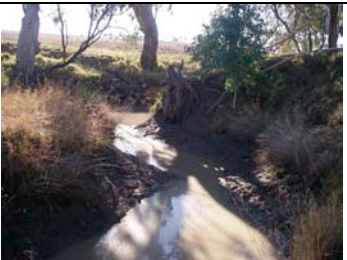
| | Survey Date: 7/08/07 | frc site number 14 | |

| Floating algae in the water column | Good tree cover in the riparian zone | There was some aggradation of fine sediment | The water was turbid | The banks were steep and bare in places |

Comments: Fallen logs and branches, cobbles and bends / depth contours provided in-stream habitat diversity. There was floating filamentous algae in the water column. Moderate condition overall.

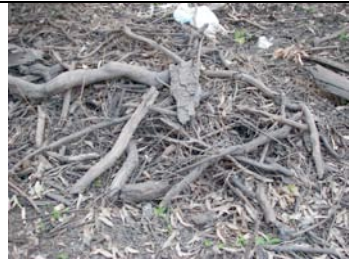
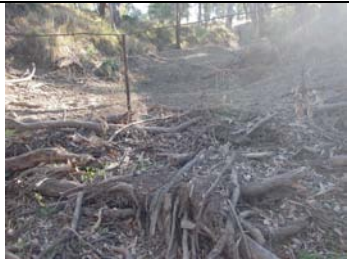
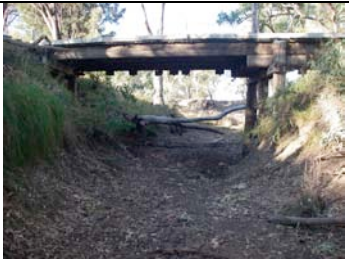
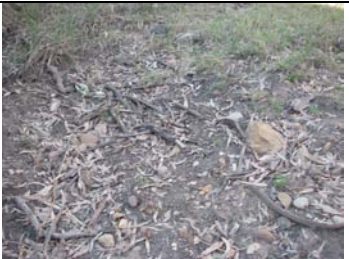
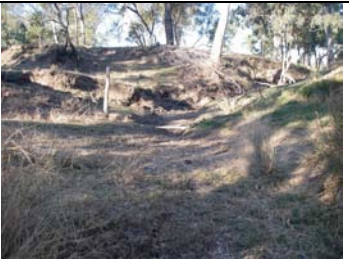
| | Survey Date: 7/08/07 | frc site number 15 | |

| Terrestrial debris in the channel. | Terrestrial debris caught on a fence through the channel | The bridge crossing of Crossmont Rd | There was a high cover of detritus on the stream bed | There were some bare, steep banks |

Comments: Terrestrial debris was abundant. Trees in the riparian zone provided good canopy cover. Moderate erosion reduced the overall condition to moderate.

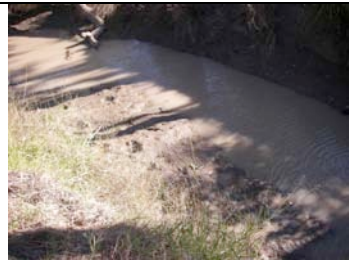
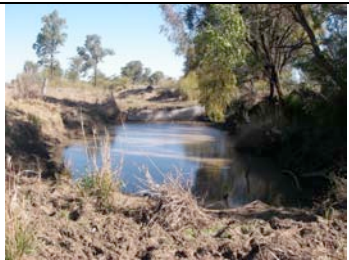
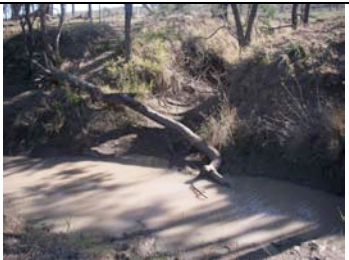
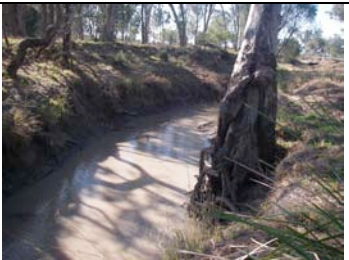
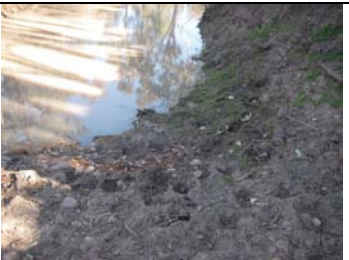
| | Survey Date: 07/08/07<br>Written By: TS<br>Date Issued: 28/09/2007 | frc site number 16<br>UTM Zone 55K 780723 E 7120888 N WGS84 | |

| Aggradation of fine sediment | Pool downstream of the road | Terrestrial debris provided habitat | Some large trees helped to stabilise banks | Cattle have direct access to the creek |

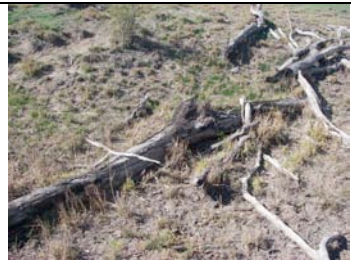
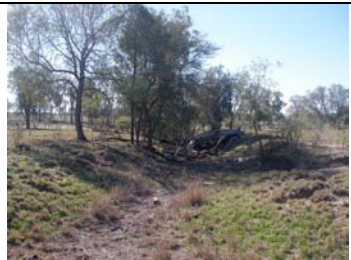
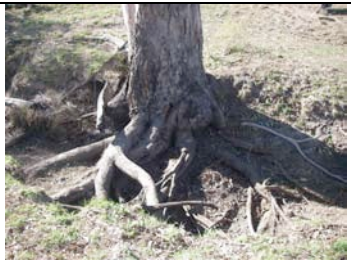
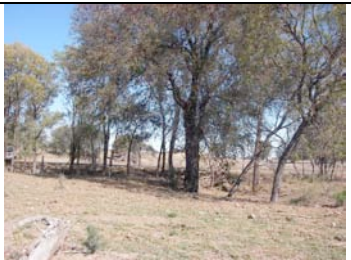
| | UTM Zone 55K 772346 E 7120241 N WGS84 | | |

Comments: The banks were steep, although trees helped to stabilise the banks. Cattle have direct access to the creek and there was a relatively low amount of in-stream habitat diversity. Moderate condition.

| Fallen logs and branches would provide habitat | The banks were relatively stable | Exposed tree roots would provide habitat | Trees lined parts of the channel | |

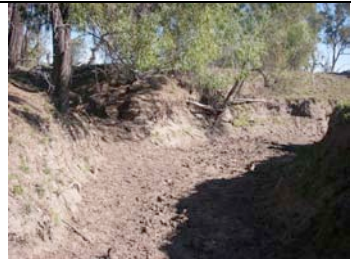
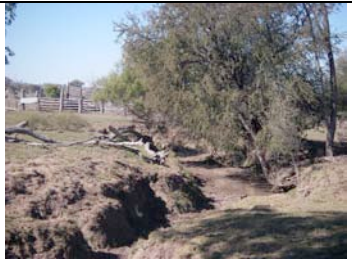
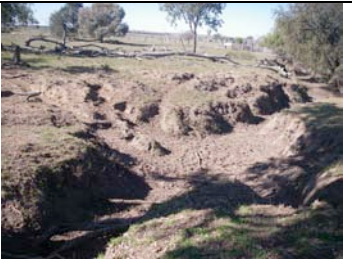
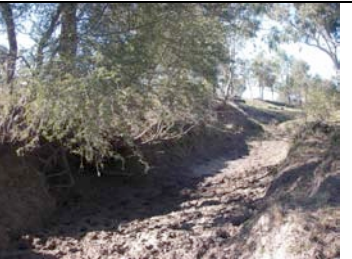
| | Survey Date: 7/08/07 | frc site number 18 | |

Comments: Small first-order stream that had some in-stream habitat diversity. Trees grew along only parts of the channel. Cattle and horses have access to the channel. Moderate condition for a small first order stream.

| Erosion at the confluence of two tributaries | There were few trees in the riparian zone | Many of the banks were bare and eroded | Cattle have access to the channel | |

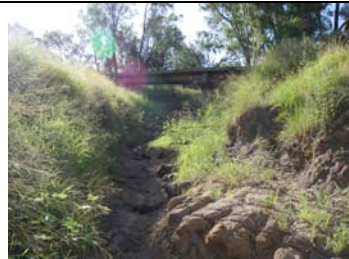
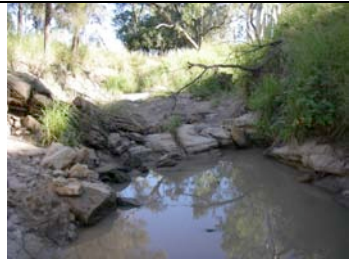
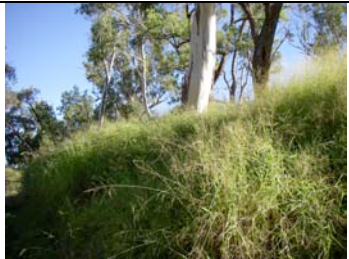
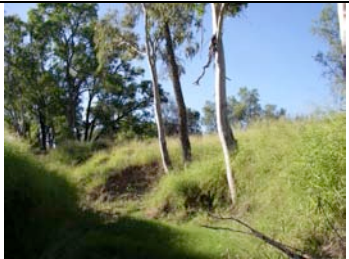
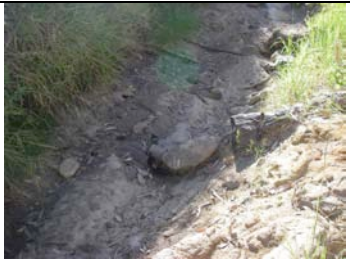
| | frc site number | | 1 (reconnaissance site S3) | | |

| View downstream through the channel | View upstream through the channel | View of left bank | View of right bank | A variety of substrates provided cover |

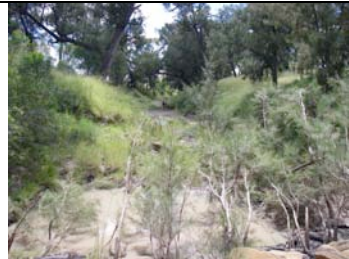
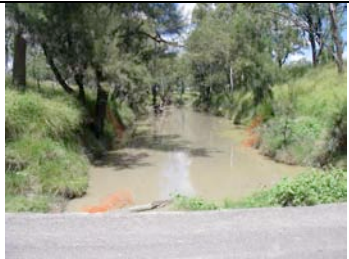
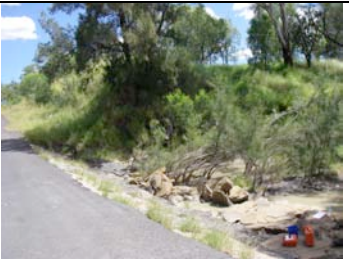
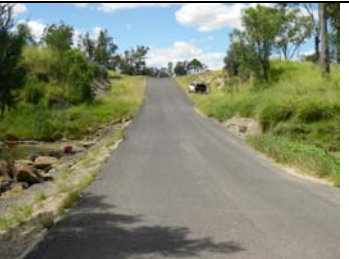
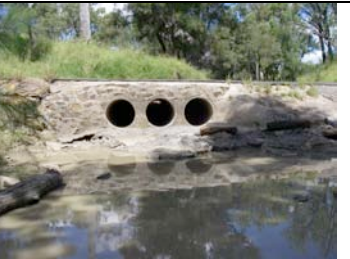
| View downstream through the channel | View upstream through the channel | View of left bank (downstream of road) | View of right bank | Culverts were 90% blocked with flood debris |

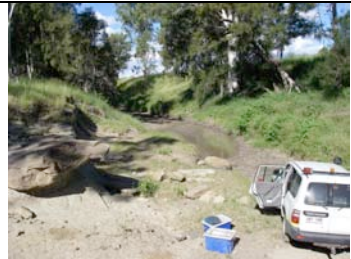
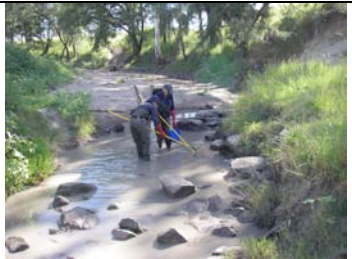
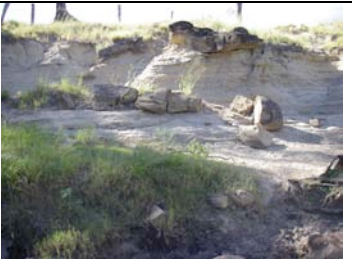
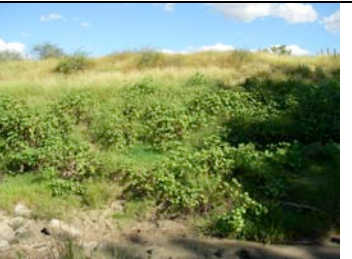
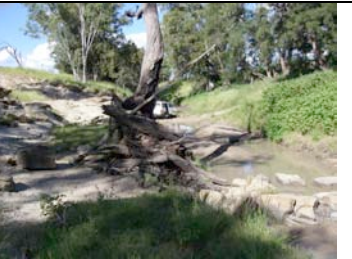
| | frc site number | | 3 (reconnaissance site S11) | | |

| View downstream through the channel | View upstream through the channel | View of left bank | View of right bank | A log jam indicated recent flood event |

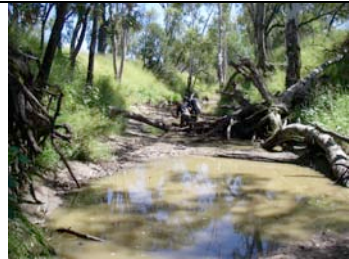
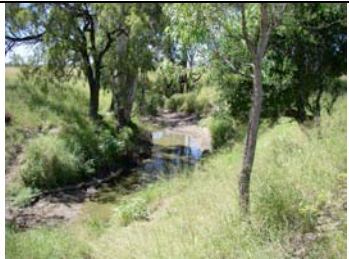
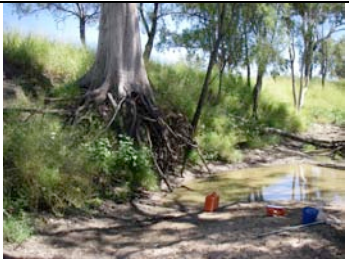
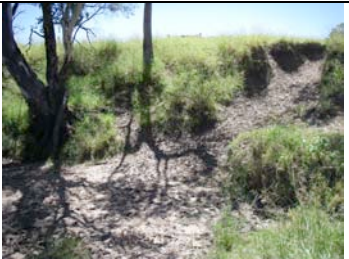
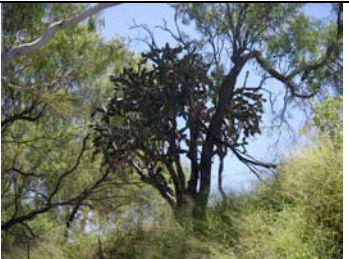
| | Date Issued: | April 2008 | UTM Zone | 55K 787,623 E 7,115,657 N WGS84 | |

| View downstream through the channel | View upstream (from the left bank) | View of left bank | View of right bank | Prickly pear in the riparian zone |

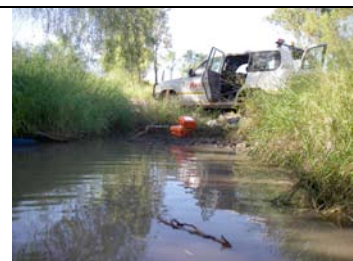
| | | | frc site number | 5 (reconnaissance site S15) | |

View downstream through the channel

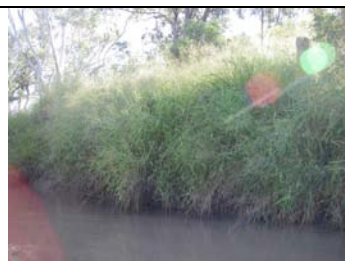
View of left bank

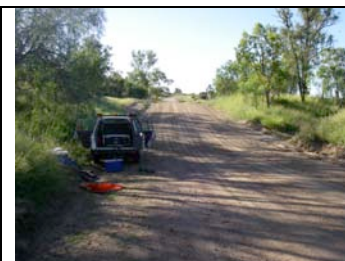
The road crossing did not have culverts

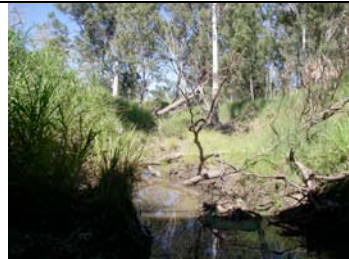
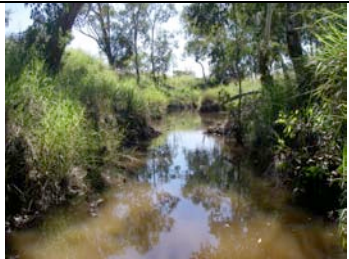
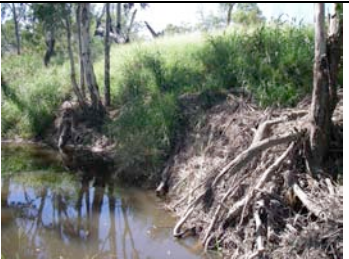
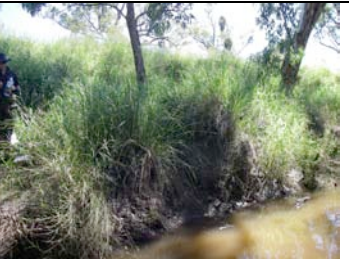
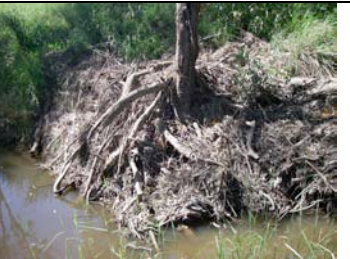
| View downstream through the channel | View upstream through the channel | View of left bank | View of right bank | Detritus provided habitat |

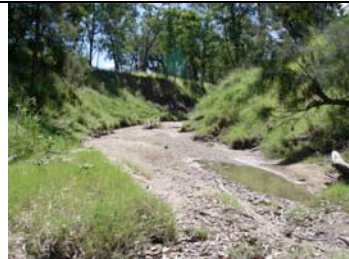
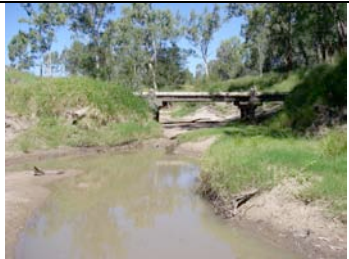
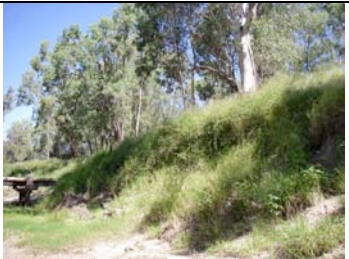
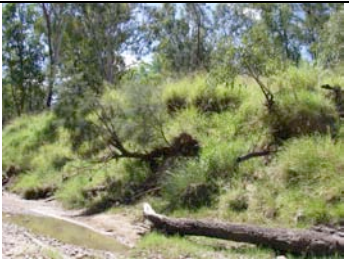
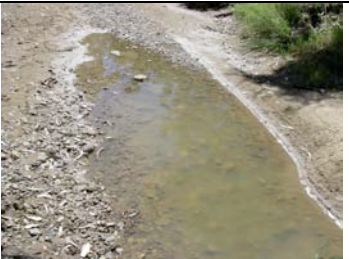
| View downstream through the channel | View upstream through the channel | View of left bank | View of right bank | Substrate included cobbles, pebbles and gravel. |

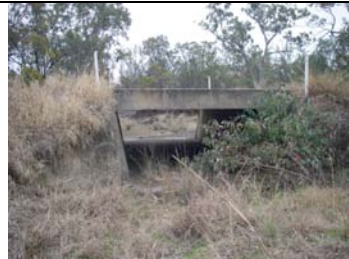
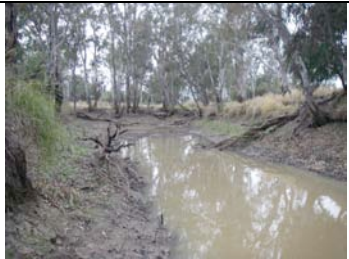
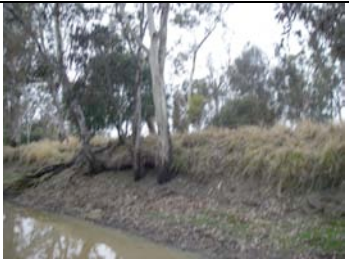
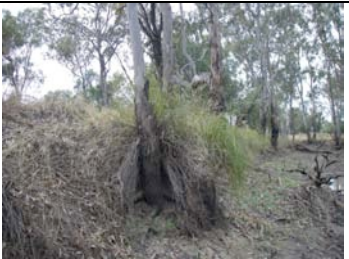
| View downstream through the channel | View upstream through the channel | View of left bank | View of right bank | |

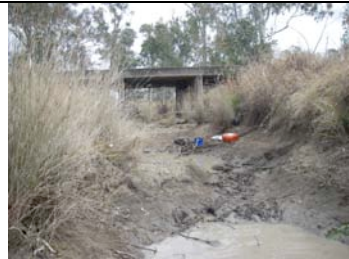
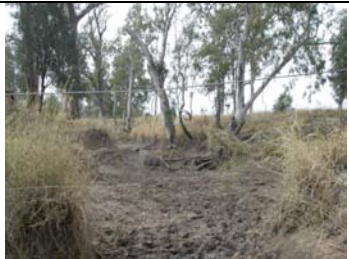
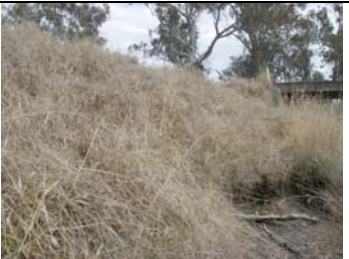
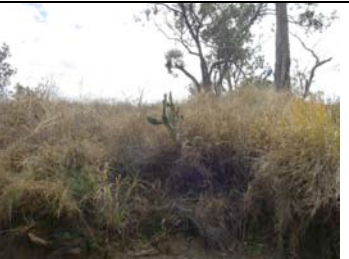
| View downstream through the channel | View upstream through the channel | View of left bank | View of right bank | |

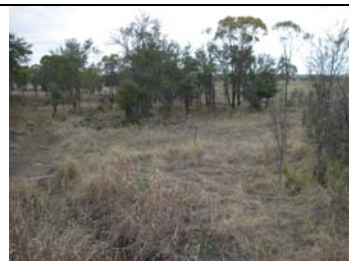
View of right bank

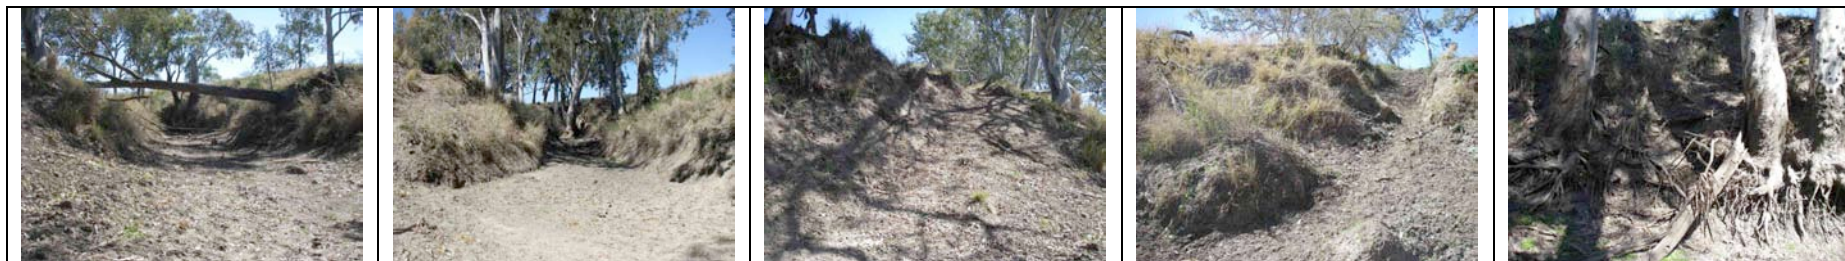
View downstream through the channel

View upstream through the channel
