# Winchester South Project

## Aquatic Ecology and Stygofauna Assessment

**May 2021**

Report Title: Winchester South Project: Aquatic Ecology and Stygofauna Assessment

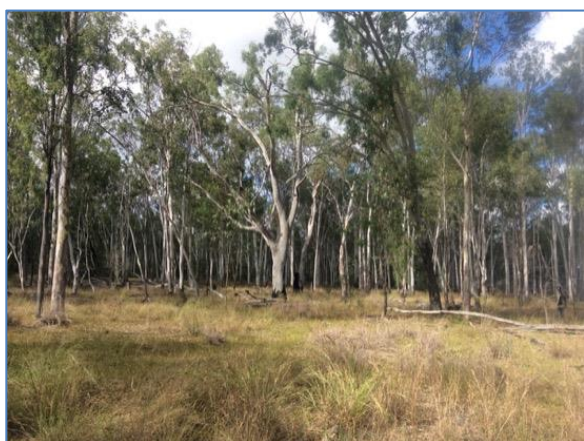
Figure 3.4 Good riparian coverage and emergent aquatic plants at site PW1 (HES wetland) in May 2019
