# WINCHESTER SOUTH PROJECT

## Environmental Impact Statement

# Soils and Land Suitability Assessment

Winchester South Project  
Whitehaven WS Pty Ltd

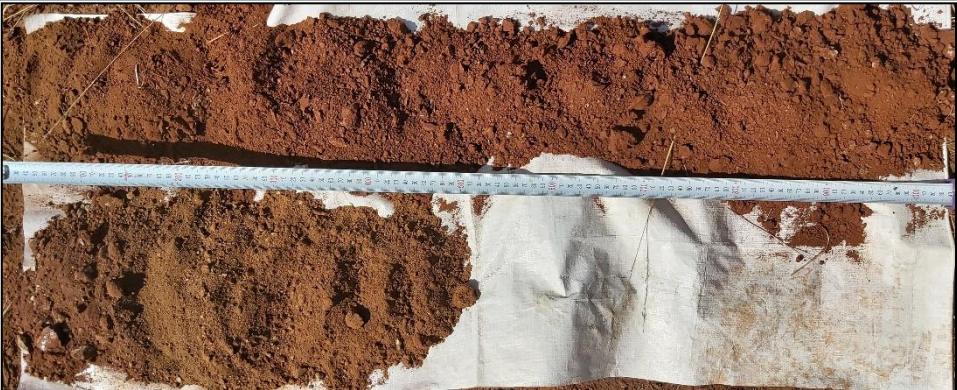
| Site 75 | | | | | | | | |

**Table 4-48: Soil Profile Morphology Summary SMU T2**
