**BORDER TO GOWRIE** REVISED DRAFT ENVIRONMENTAL IMPACT STATEMENT

## Geomorphology Report

## Baseline field inspection site records and photos

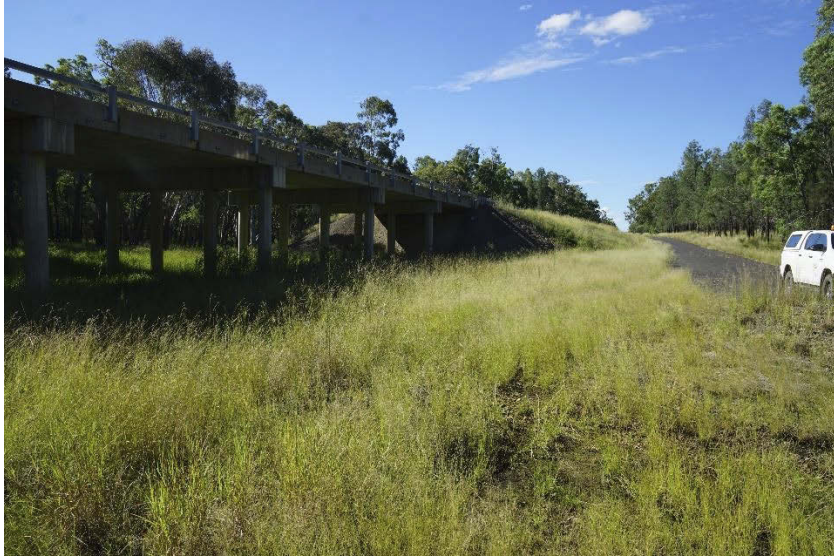
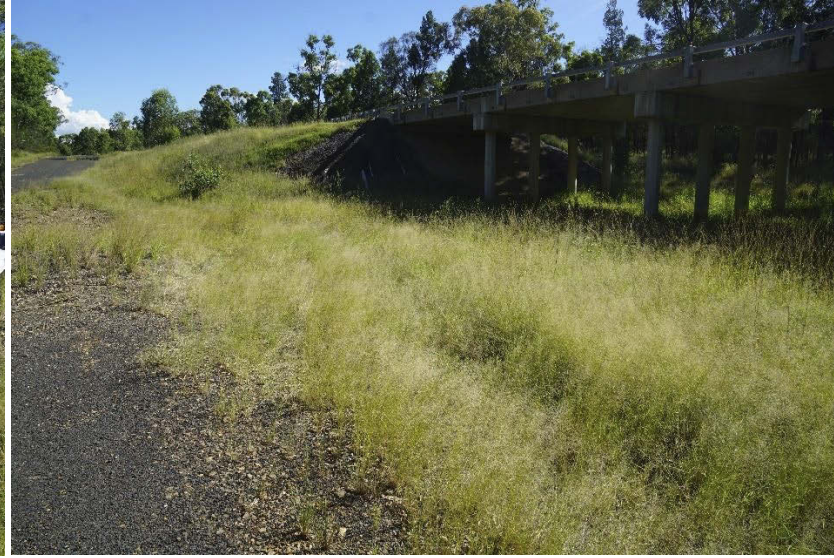
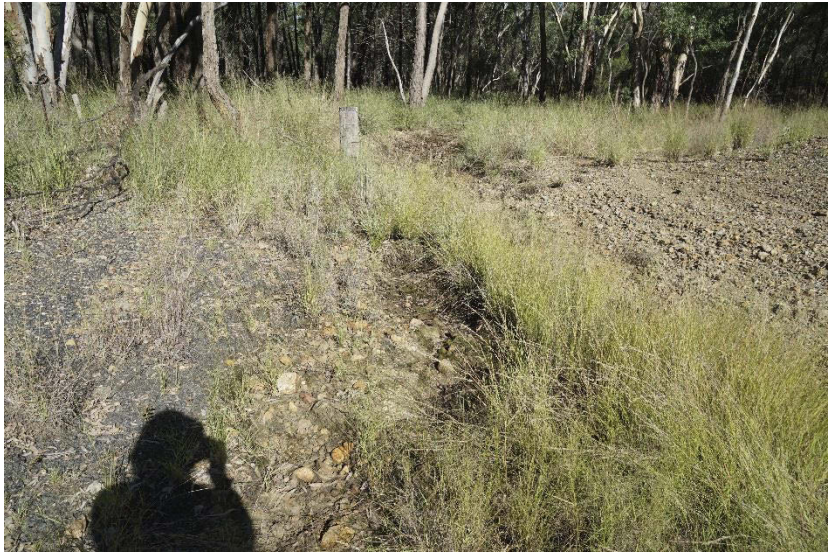
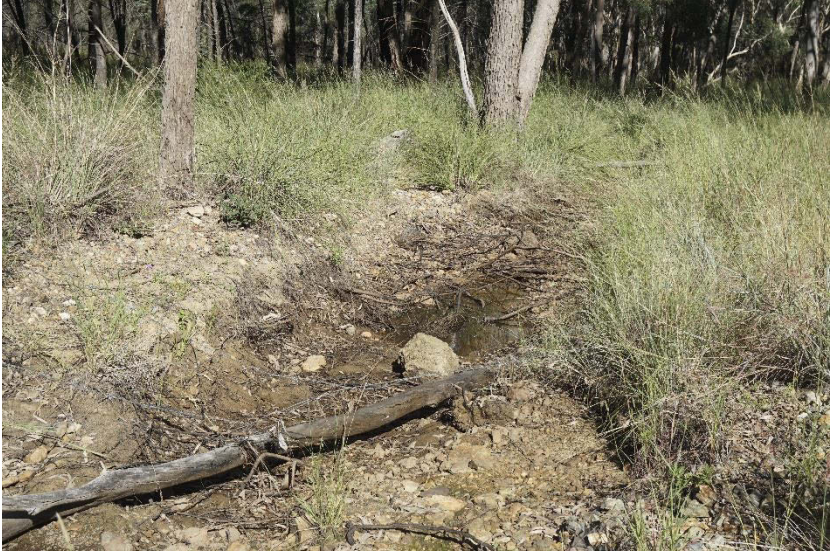
F. 4 Site 1h/EP16a photographs. From right bank (top left), right bank detail (top right), across channel towards true left bank (bottom left), Looking upstream towards the weir (under water) from right bank (bottom right)

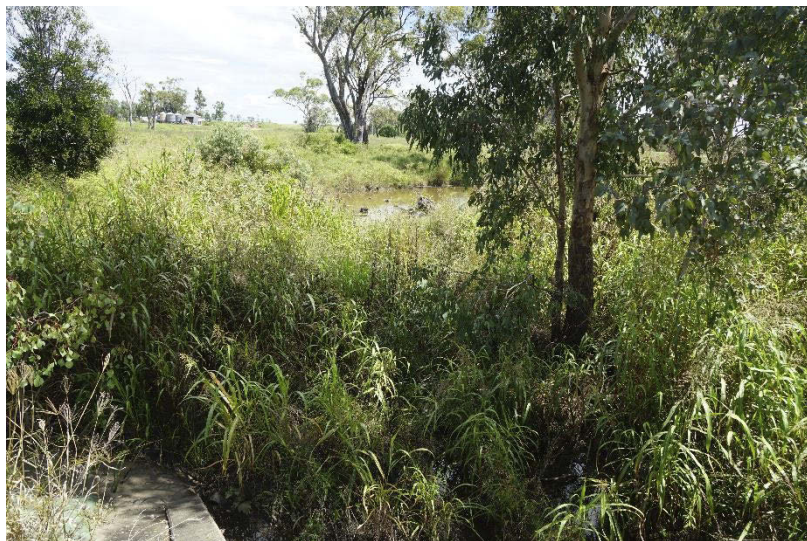
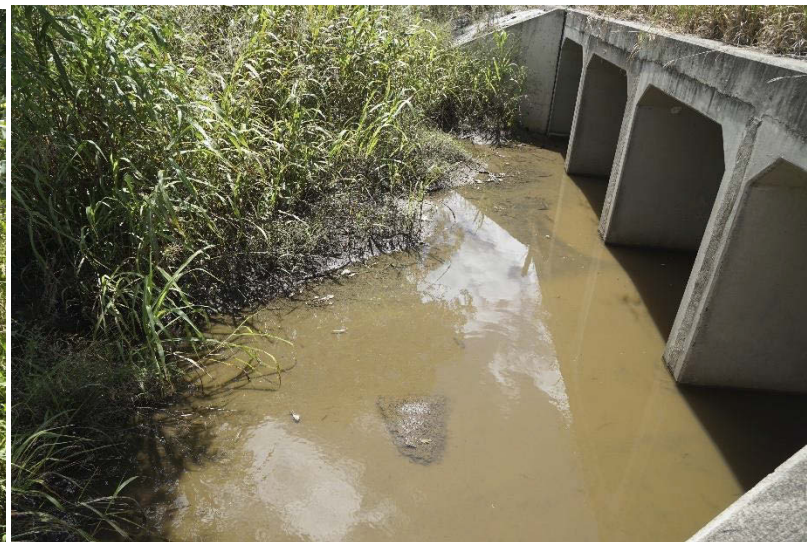
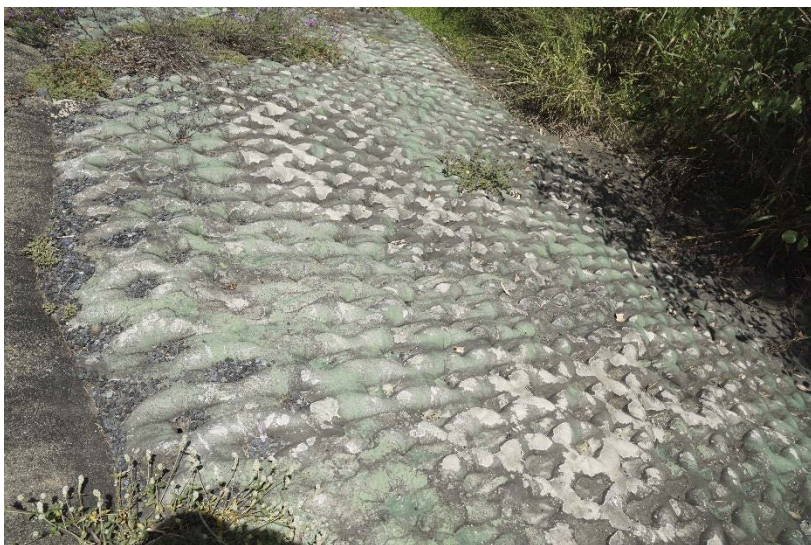
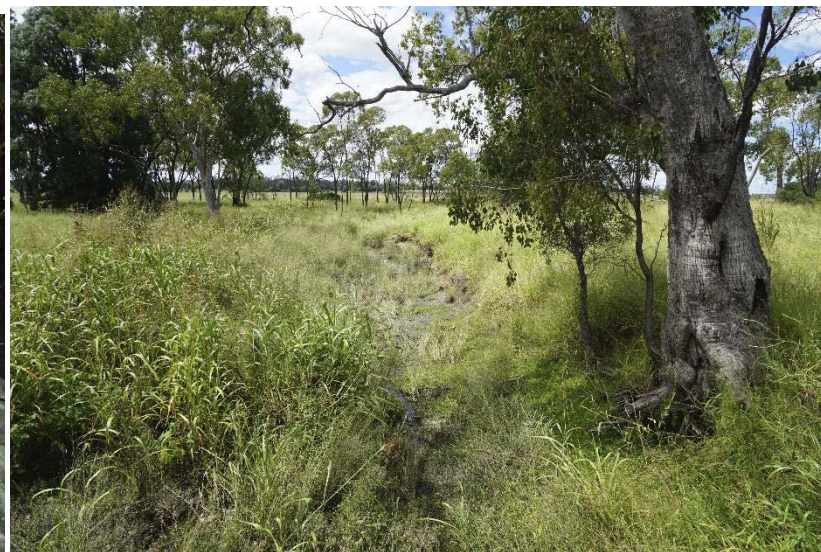
F. 5 Site 2/EP34 photographs. Upstream (top left), downstream (top right), downstream detail 1 (bottom left), downstream detail 2 (bottom right).

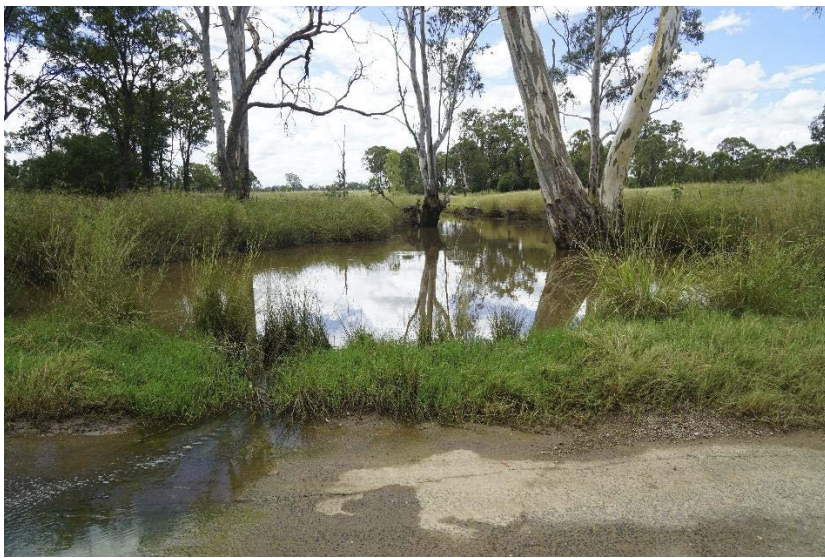
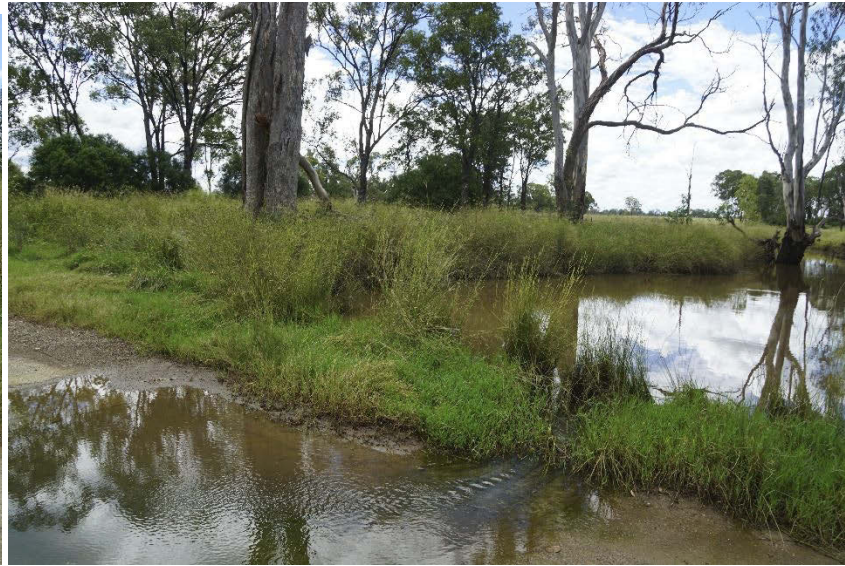
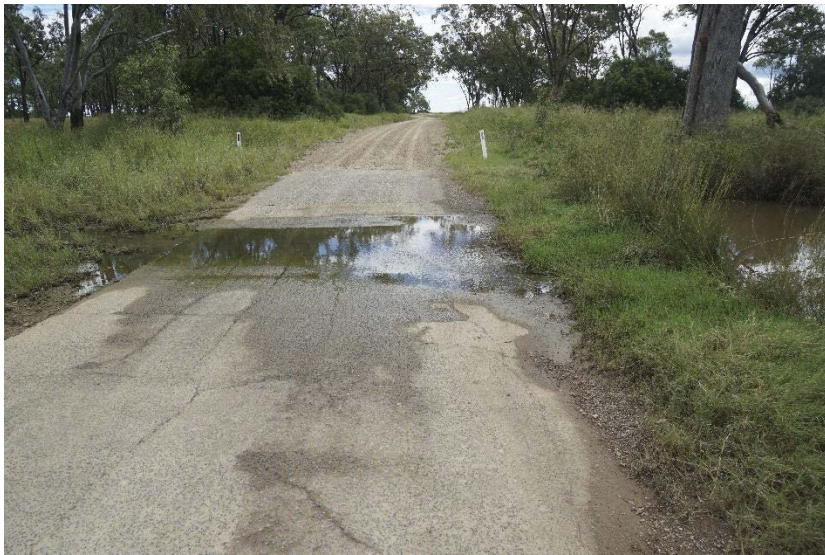
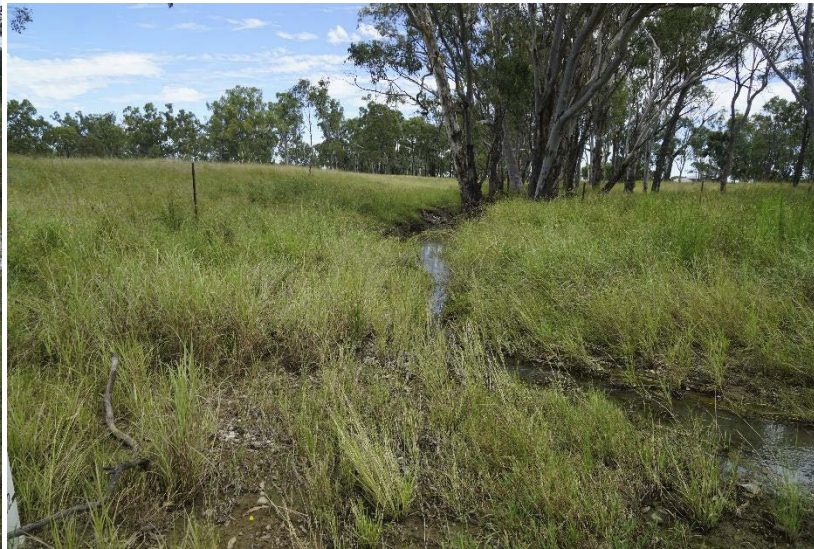
F. 6 Site 3a/EP28 photographs. Upstream overview 1 (top left), culvert detail 1 (top right), culvert detail 2 (bottom left), upstream overview 2 (bottom right)

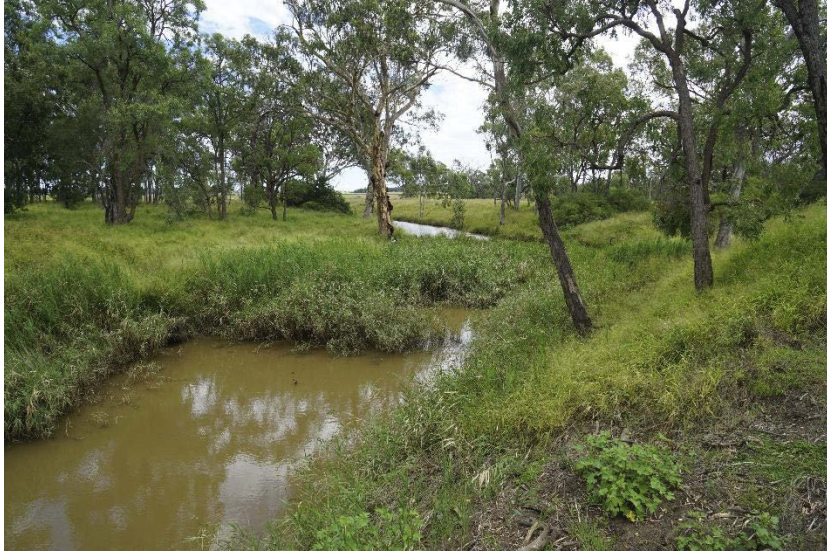
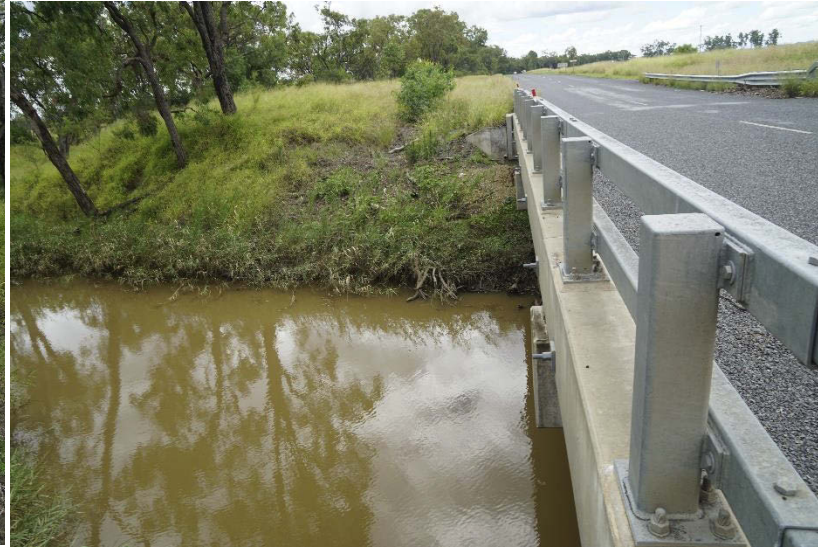
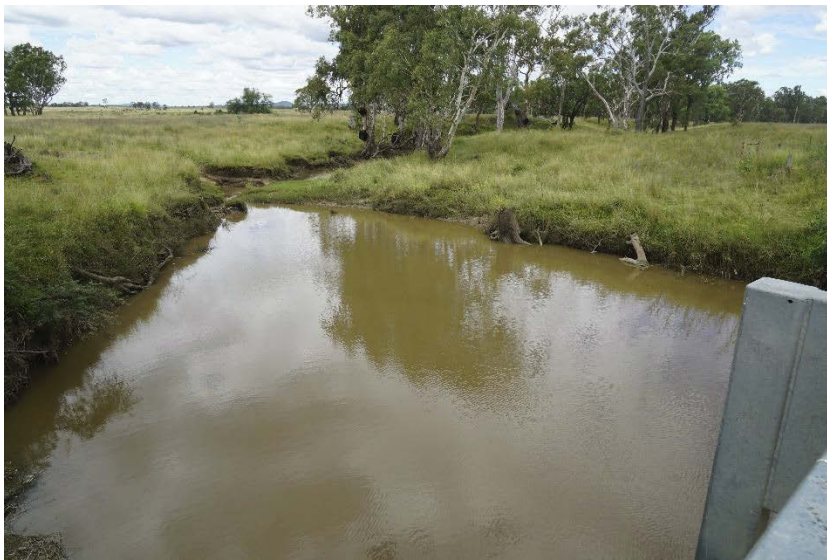
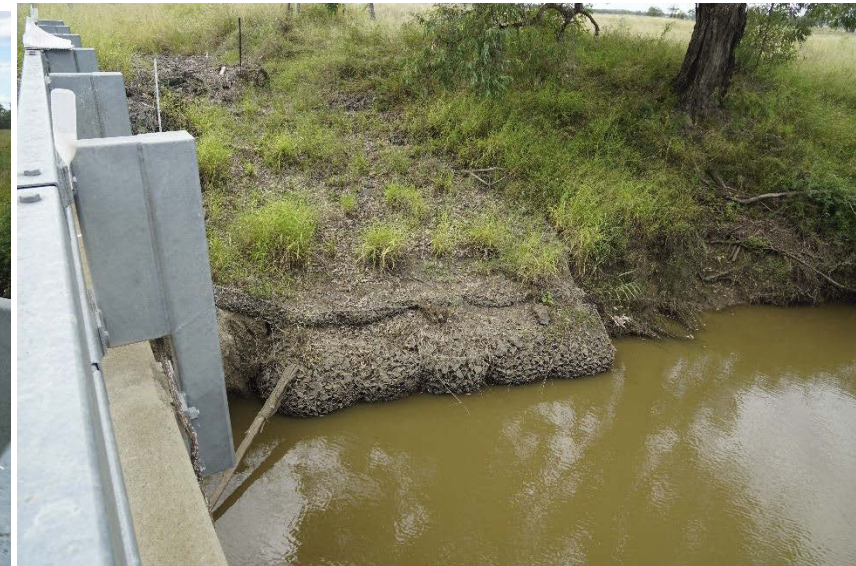
F. 7 Site 3b photographs. Upstream overview (top left), upstream detail (top right), carriageway (bottom left), downstream (bottom right).

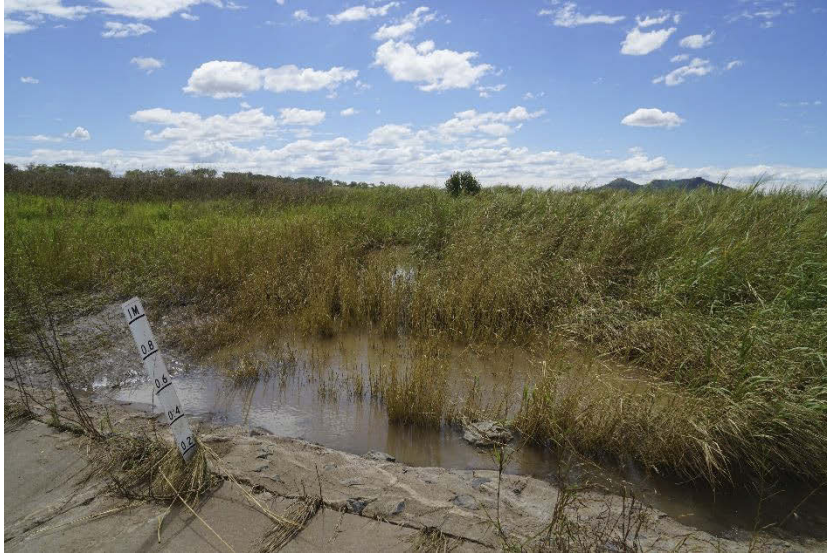
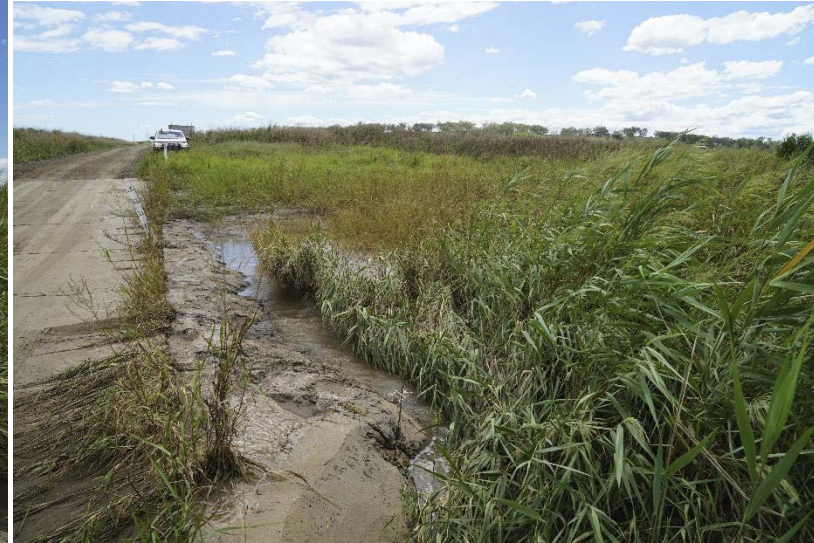
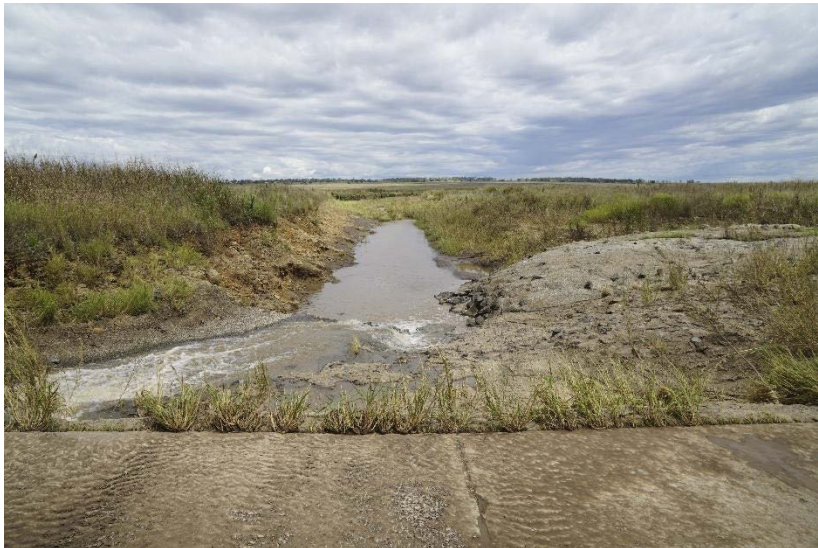
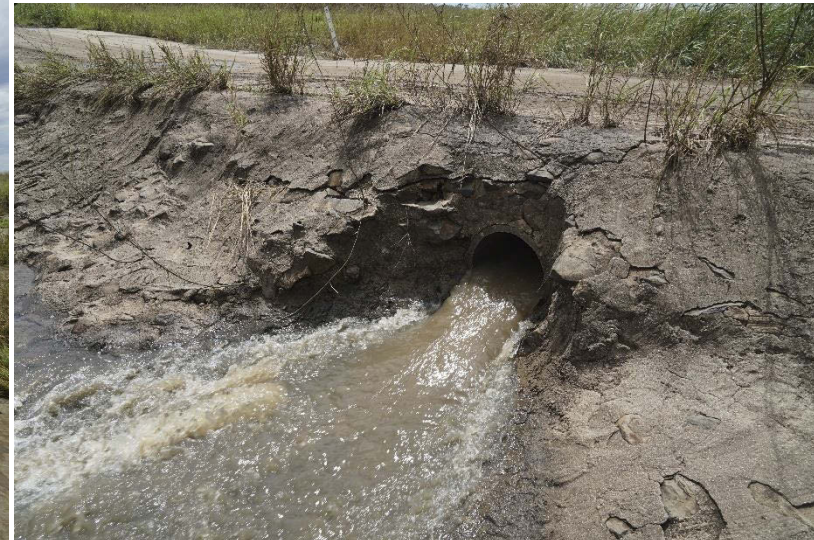
F. 8 Site 5/EP29 photographs. Upstream (top left), upstream detail (top right), downstream (bottom left), downstream detail (bottom right).

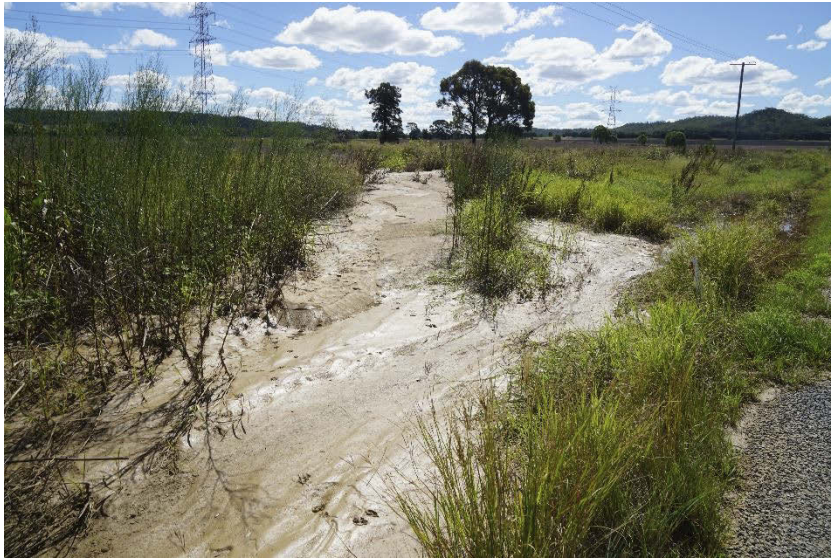
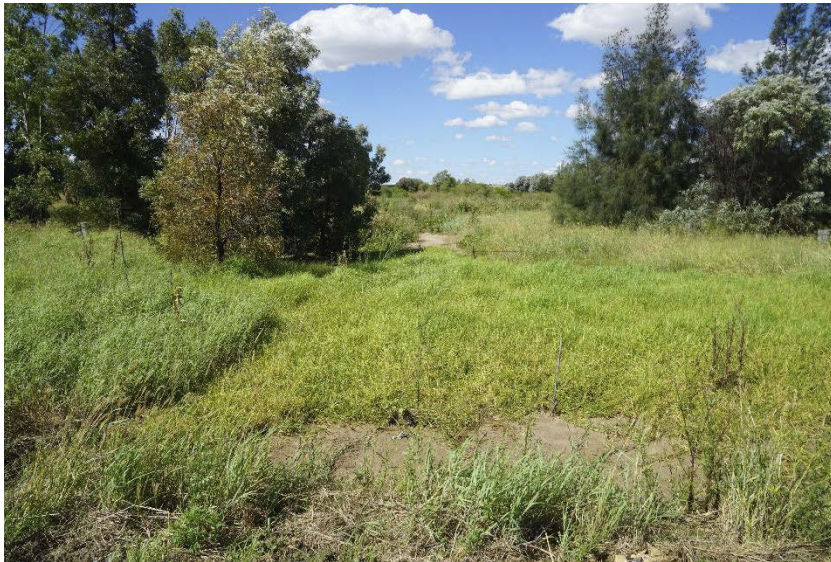
| Coordinates | | | | | | | | | Erosion Potential (sites with existing infrastructure) | | Channel | | | | | Material | | Floodplain | | | |
|---|---|---|---|---|---|---|---|---|---|---|---|---|---|---|---|---|---|---|---|---|---|
| 6/EP2 | Both | Local - well developed channel | C1 | Dry Creek | vertosols | no data | 379928 | 6954140 | Concrete culverted causeway. One round approx. 450mm diameter culvert. | Erosion at interface between concreted section and natural river bed causing undercutting at downstream side. Erosion in channel downstream of culvert. Ponding upstream of culvert | Low sinuosity channel | 2-3 m wide downstream | Channel artificially straightened at this site. | Vegetation in channel bank. Vegetation is tall grass, no trees. | Some erosion of rocks on left bank downstream. Water benched up on upstream side of causeway. Fine sediment deposited in grass as overland flow. River has flowed overland to right of causeway, flattened grass and eroded soil, re-joins main channel after concrete section ~15m downstream. | Mud | Downstream left bank is weathered and eroded basalt Approx. 50m downstream from causeway L bank changes to subvertical, dark soil. Some slumping into river channel. Right bank in shallow dipping, soil and vegetated with grasses and some small shrubs. | NA | NA | NA | Water flow level approx. 1.5m above causeway inferred from flattened grass. |

F. 9 Site 6/EP2 photographs. Upstream (top left), upstream detail (top right), downstream (bottom left), downstream detail (bottom right)

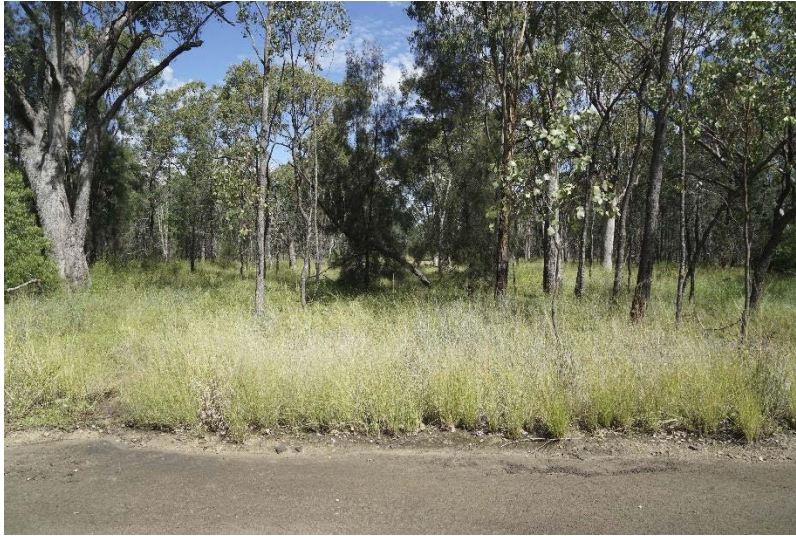
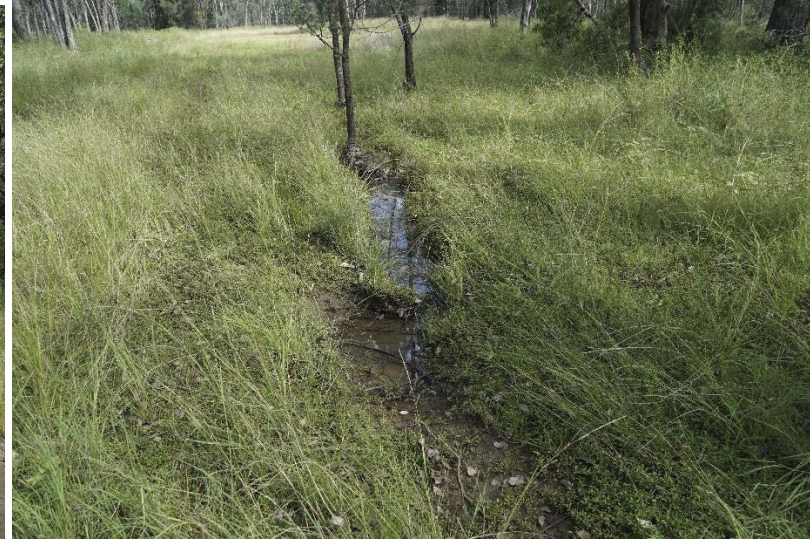
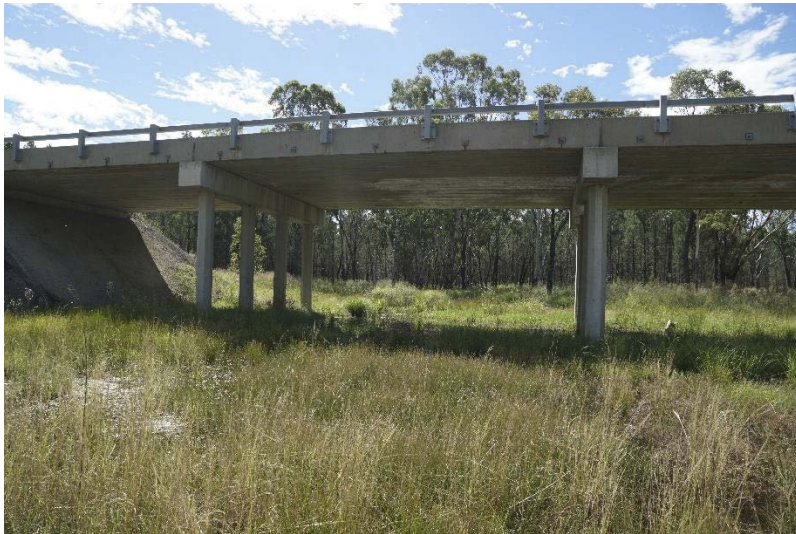
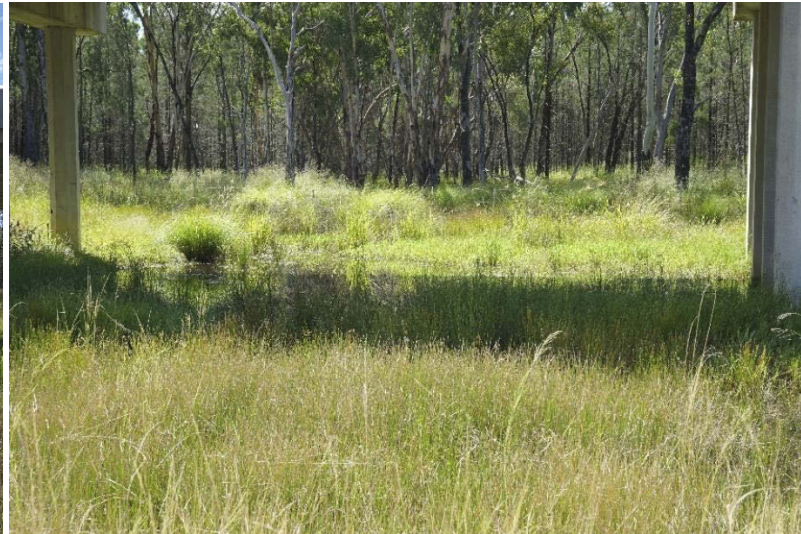
*F. 12 Site 10/EP31 photographs. Downstream, from road verge (road surface in lower part of the photo) (top left), downstream detail (top right), upstream (bottom left), upstream detail (bottom right)*

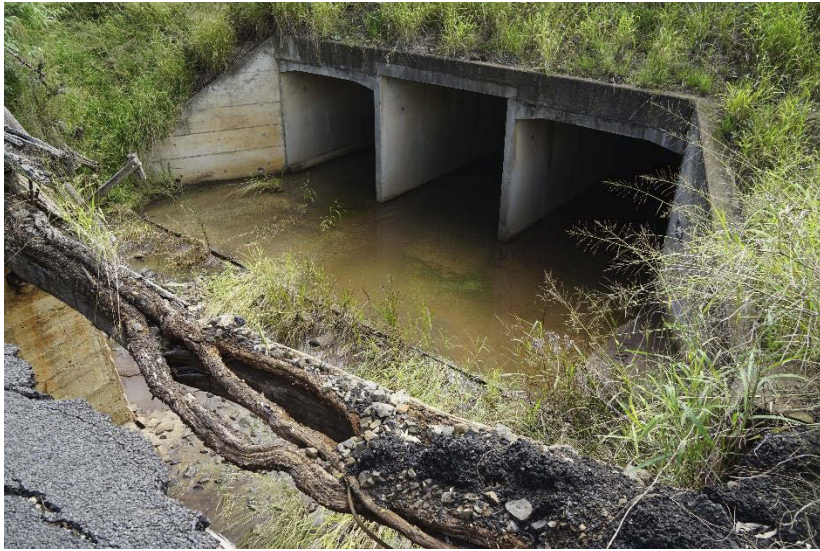
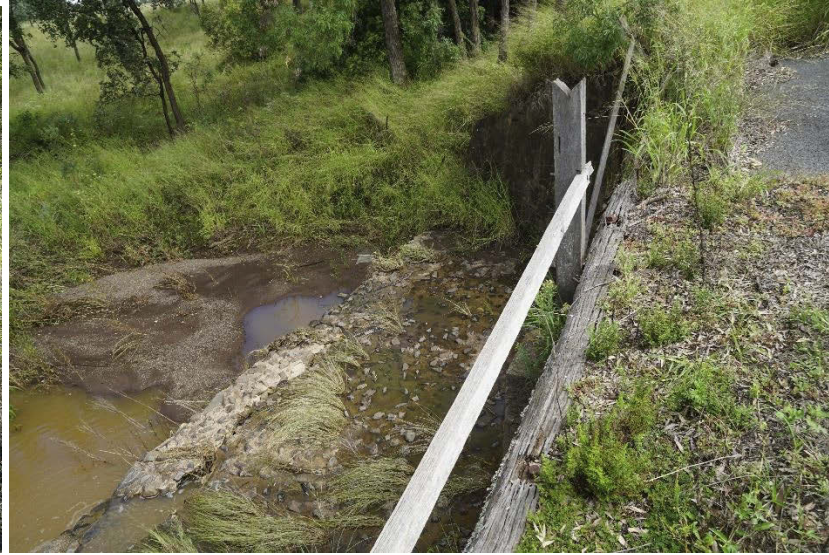
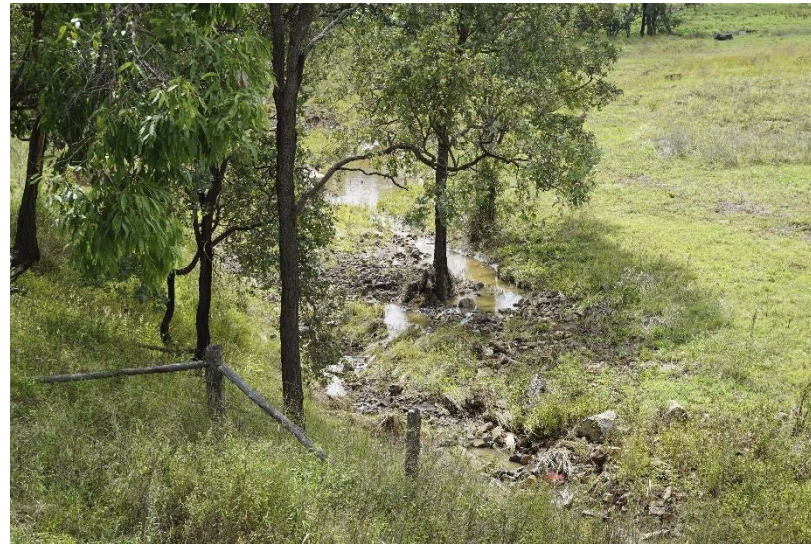
| Coordinates | | | | | | | | | Erosion Potential (sites with existing infrastructure) | | Channel | | | | | Material | | Floodplain | | | |
|---|---|---|---|---|---|---|---|---|---|---|---|---|---|---|---|---|---|---|---|---|---|
| 11/ EP7 | Both | Local - poorly developed channel | | NC3 | dermosols | vertosols/dermosols | 374473 | 6941233 | 3 box culverts, 2.5x2m each, with wingwalls, road embankment over top approx. 4m thick. Concrete base. Damaged and closed old bridge structure (immediately downstream of culverts), has wingwalls base in rock and concrete. | No sign of damage or major deposition at base. Some silt in bed of culverts, shows ripples. Scour hole at transition with natural channel | Low sinuosity channel | Approx. 7m wide. Banks of downstream channel are gradual and not steep. Upstream has steep bank on right side, almost flat on left side | Approx. 30m downstream appears to be gravel in channel bed. Origin unclear. Small pools within channel | Grass with some trees | Minor deposition. | Sandy silt with some gravel. Rock, boulders, bricks, rubble in base. | Vegetated, slope gentle | NA | NA | NA | |

*F. 13 Site 11/EP7 photographs. Upstream (top left), upstream opposing side of carriageway (top right), downstream (bottom).*

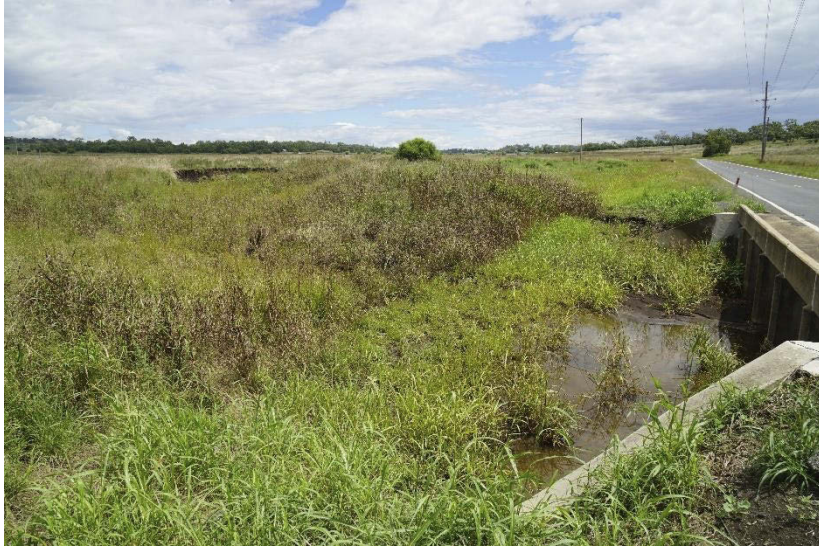
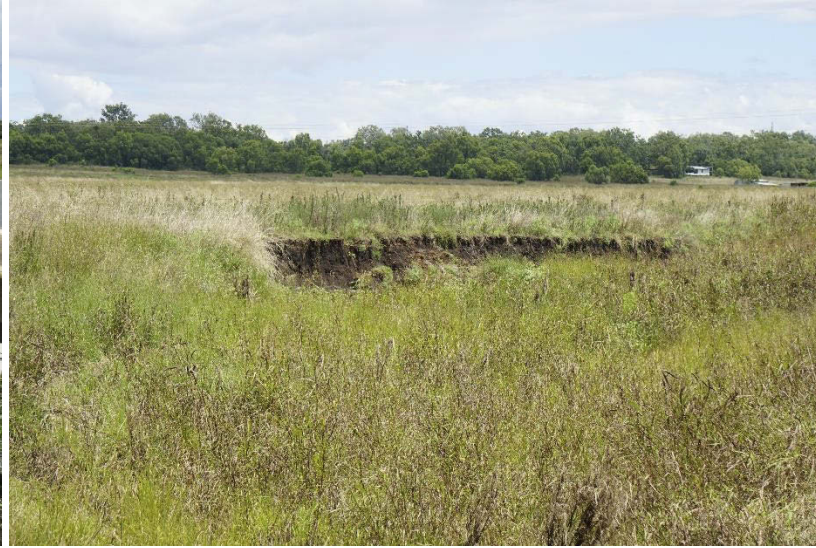
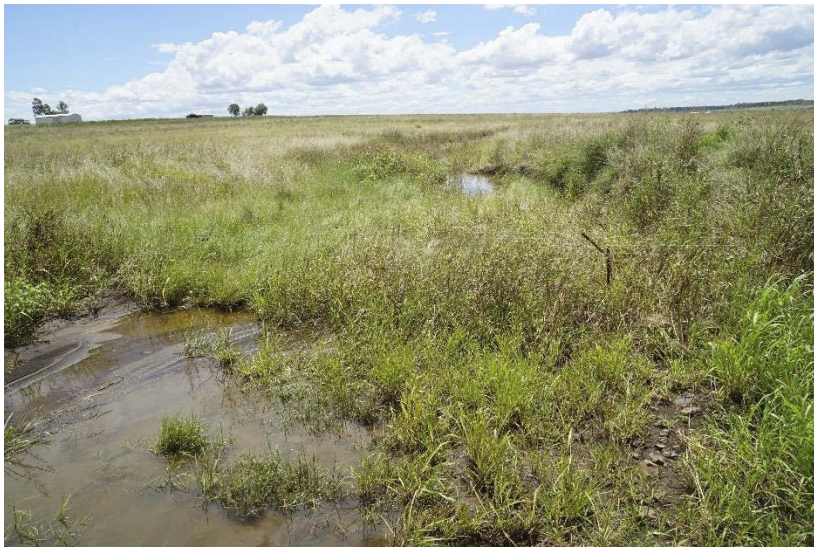
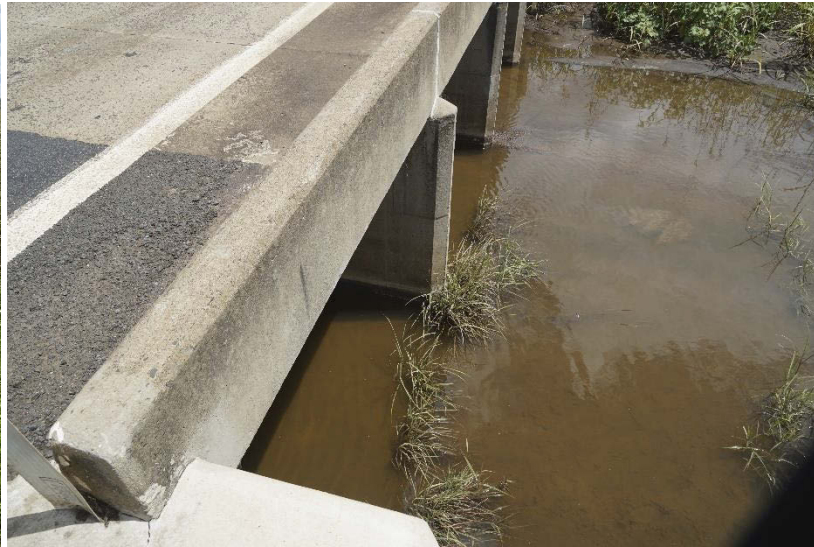
F. 14 Site 12 photographs. 4WD track (top left), uphill (top right), further uphill detail (bottom left), downstream side of road (bottom right).

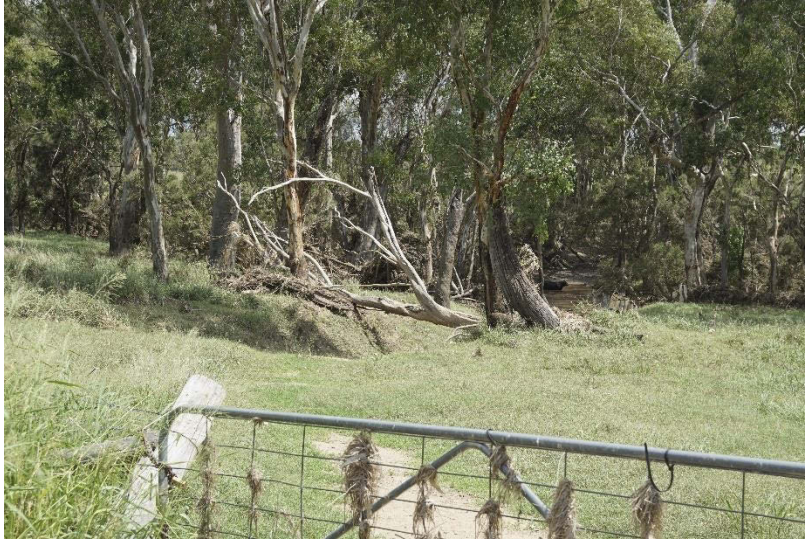
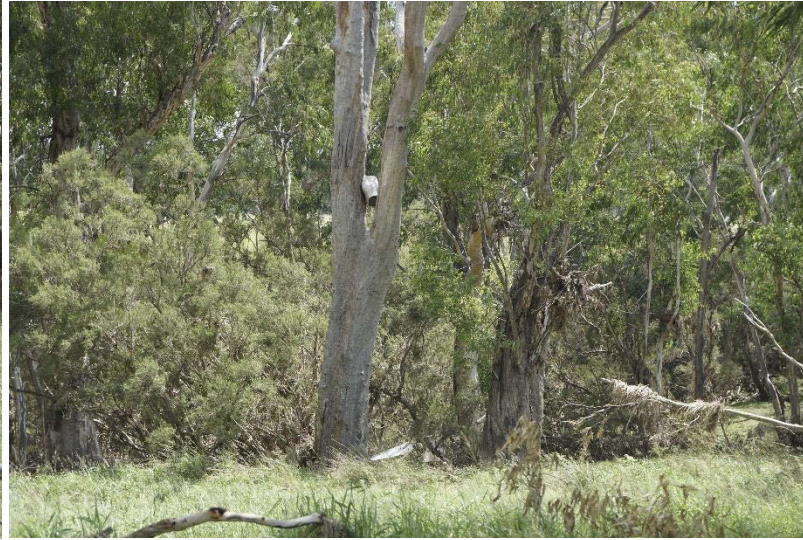
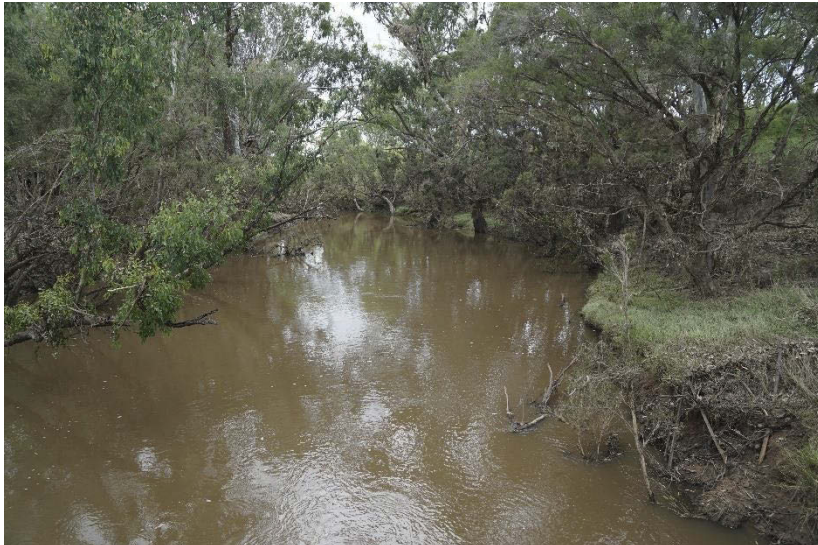
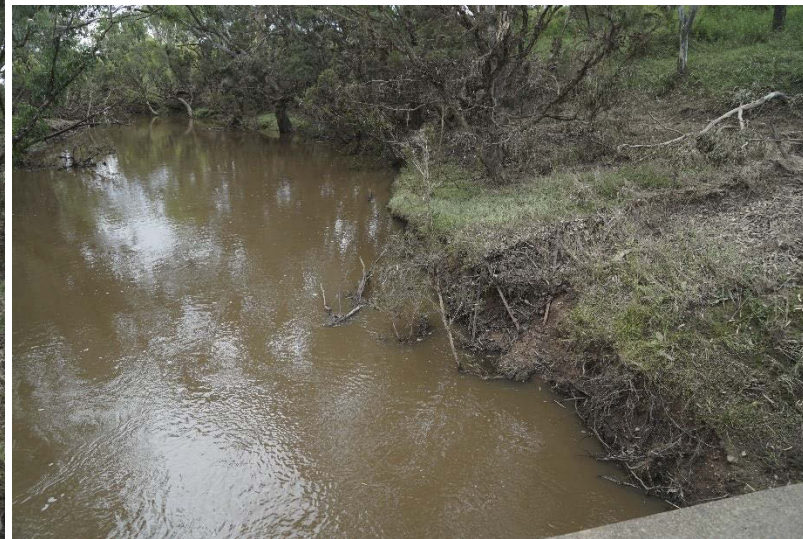
F. 15 Site 14/EP3b photographs. Upstream from right bank (top left), upstream detail (top right), downstream (bottom left), downstream culvert (bottom right).

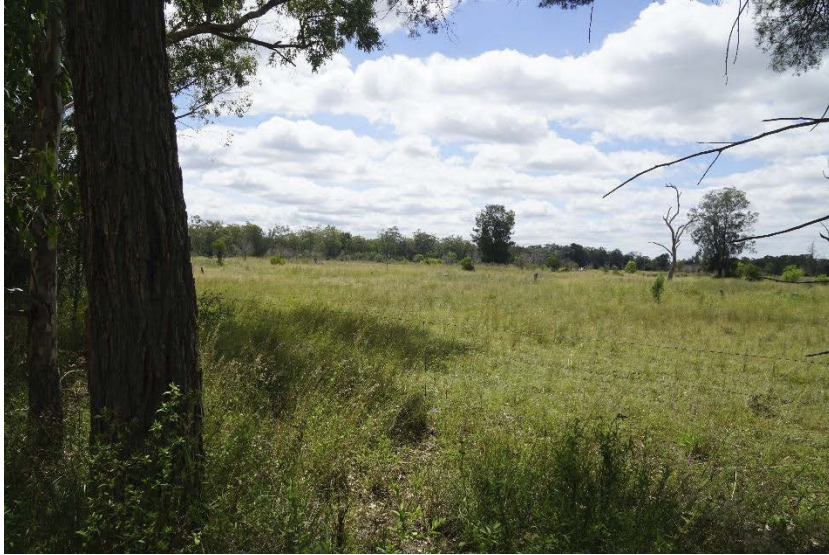
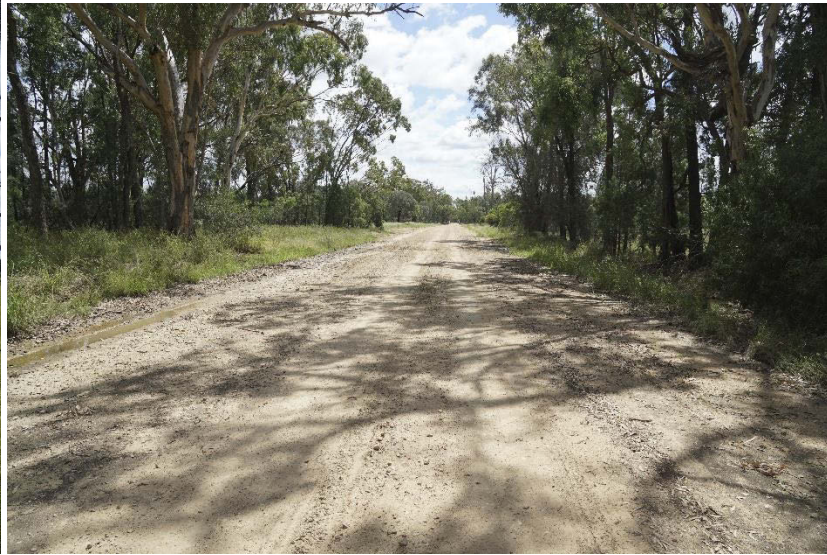
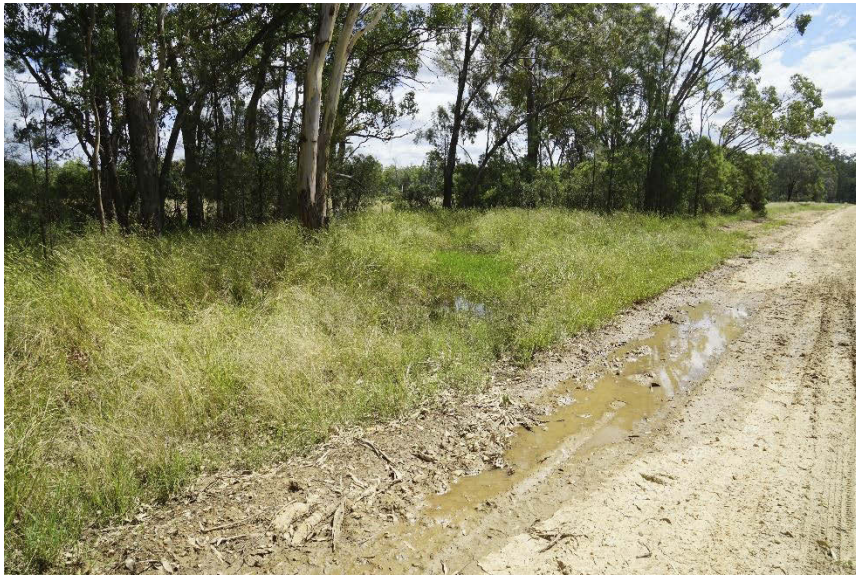
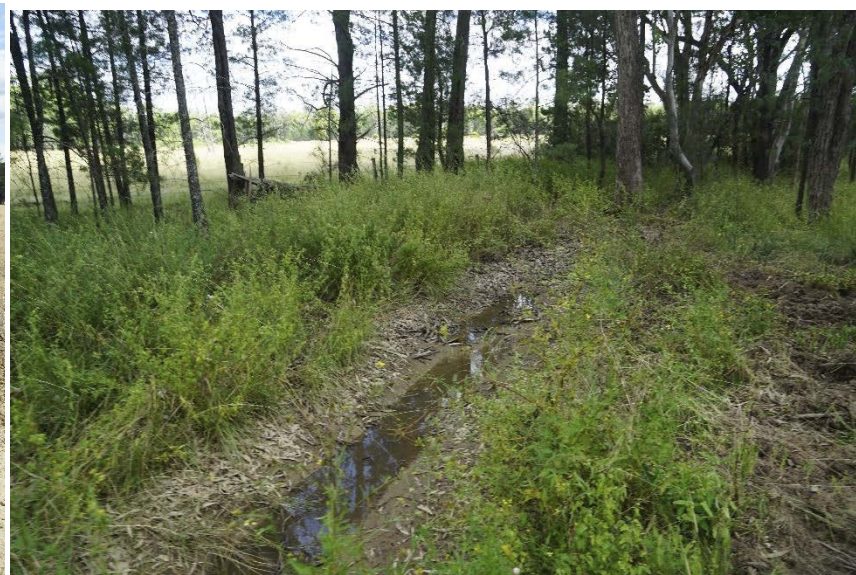
F. 17 Site 16 photographs. South along road (top left), field to east (top right), field to west (bottom left), road to north (bottom right).

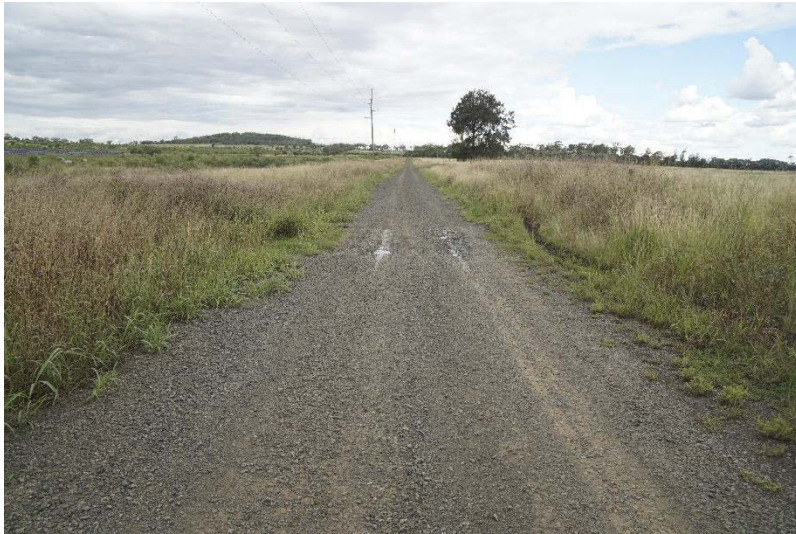
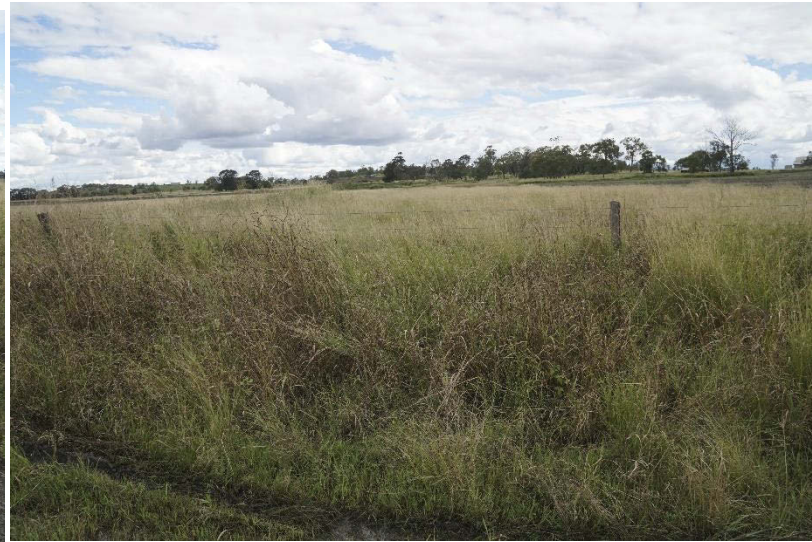
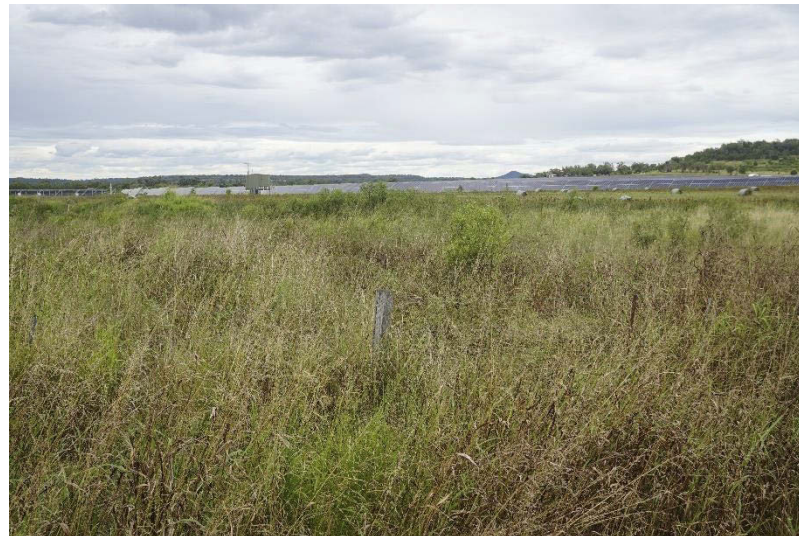
F. 18 Site 17/EP39 photographs. Field to east (top left), road facing north (top right), road detail (bottom left), artificial channel (bottom right).

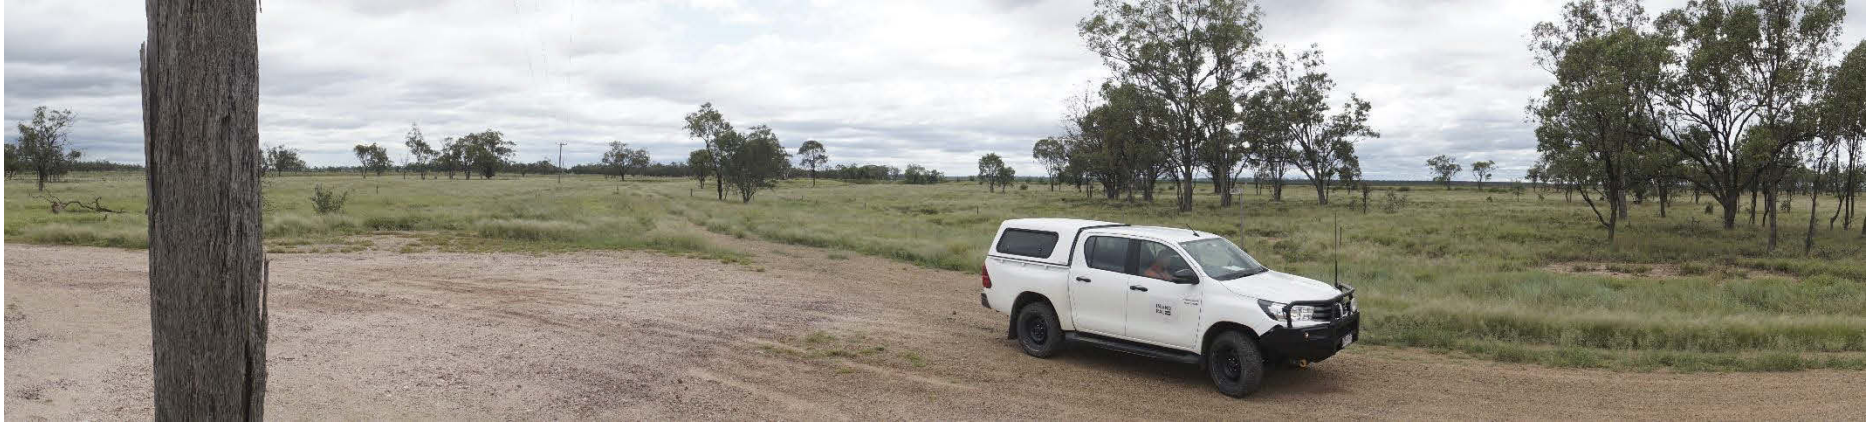
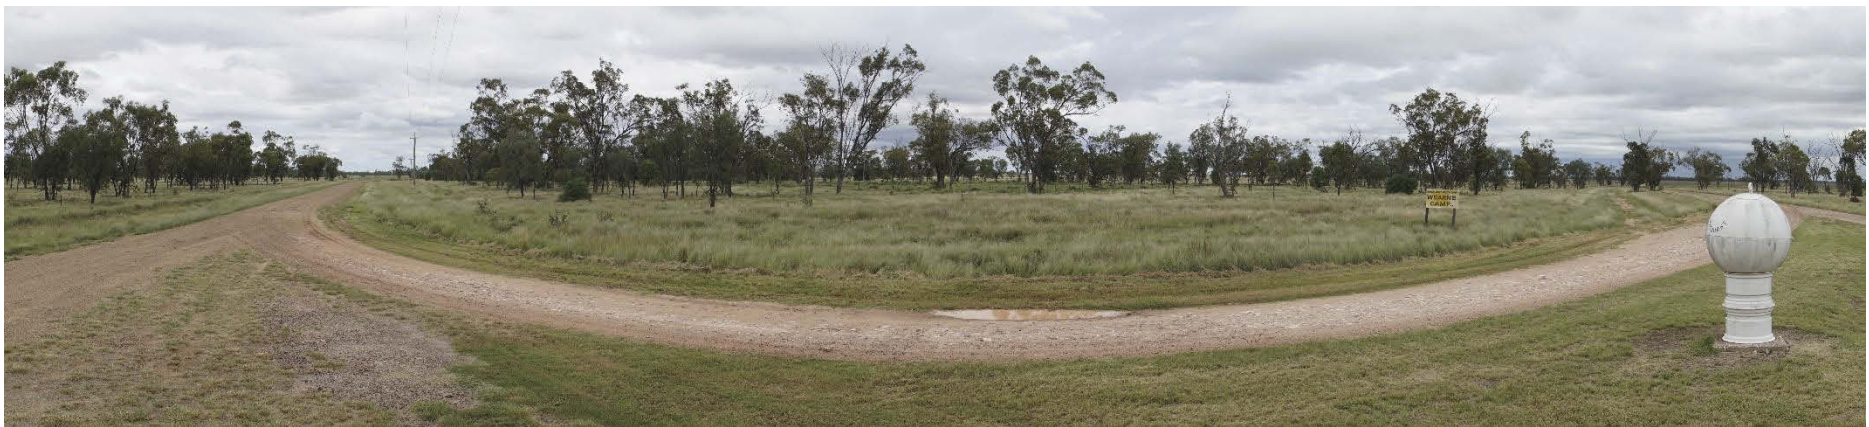
F. 19 Site 19 photographs. View down road (top left) and either side of road (top right and bottom).
