**BORDER TO GOWRIE** REVISED DRAFT ENVIRONMENTAL IMPACT STATEMENT

## Geomorphology Report

## Baseline field inspection site records and photos

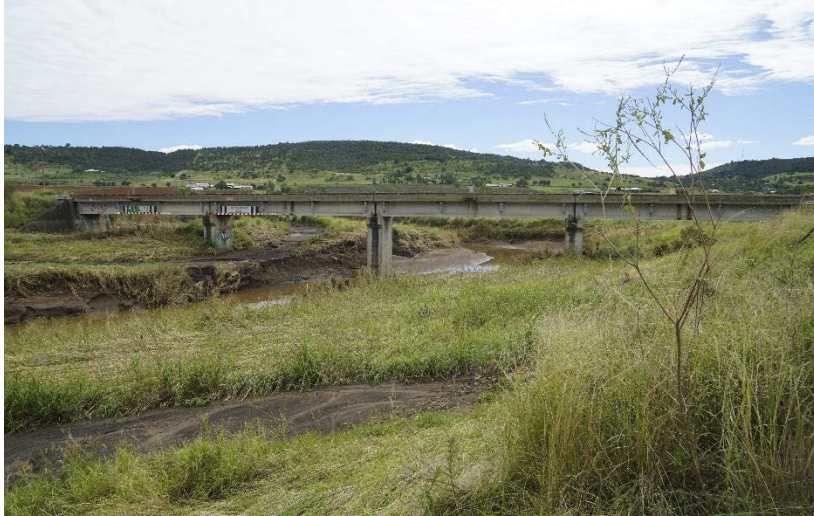
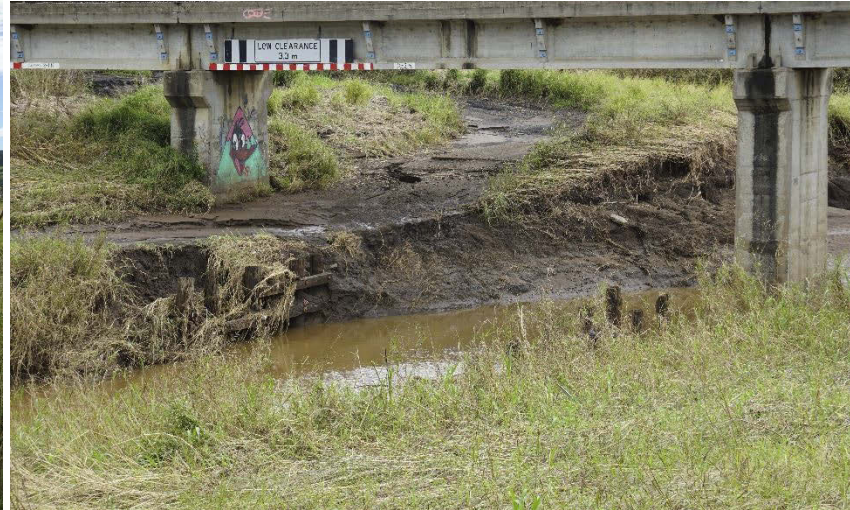
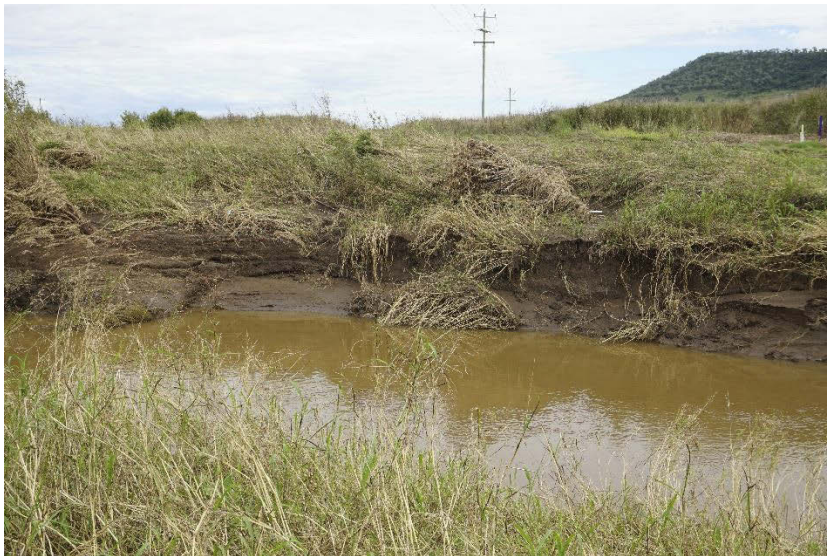
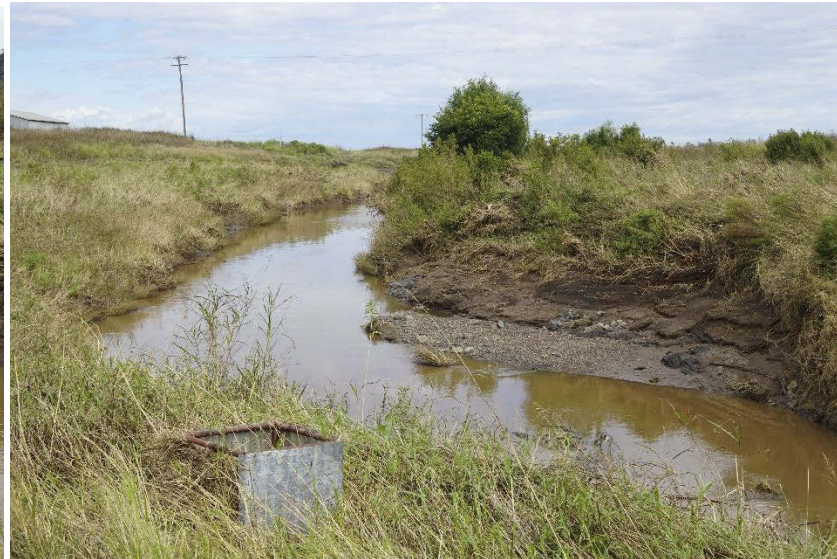
| Coordinates | | | | | | | | | Erosion Potential (sites with existing infrastructure) | | Channel | | | | | Material | | Floodplain | | | |
|---|---|---|---|---|---|---|---|---|---|---|---|---|---|---|---|---|---|---|---|---|---|
| EP1a | EP | Local- poorly developed channel | | Gowrie Creek | vertosols | ferrosols | 386118 | 6958498 | Rail bridge, retaining wall on right bank | Erosion on both banks, erosion and failure behind retaining wall. Deposition of silty sand material on inside of bends. Localised gravel dropout on inside of bend downstream of bridge on right | Meandering | Channel approx. 10-15m wide. Main channel 1.5-3m deep (from top of water level). Steep/subvertical banks. Approx. 5-6m from water level to underside of bridge. | In channel bars. | Grass on banks | Bank erosion downstream of bridge. Silty fine overbank deposits on both bends. | Silt/sand with minor gravels | Dark, silt/clay. Some ~400mm diameter boulders in grass on left bank deposited. | NA | NA | NA | Indications of water flow to approx. 0.5m below underside of rail bridge (flattened grass). |

*F. 23 EP1a photographs. Looking upstream towards the true right bank from left bank (top left), upstream detail of right bank (top right), across channel detail looking towards true right bank (bottom left), looking downstream (bottom right).*

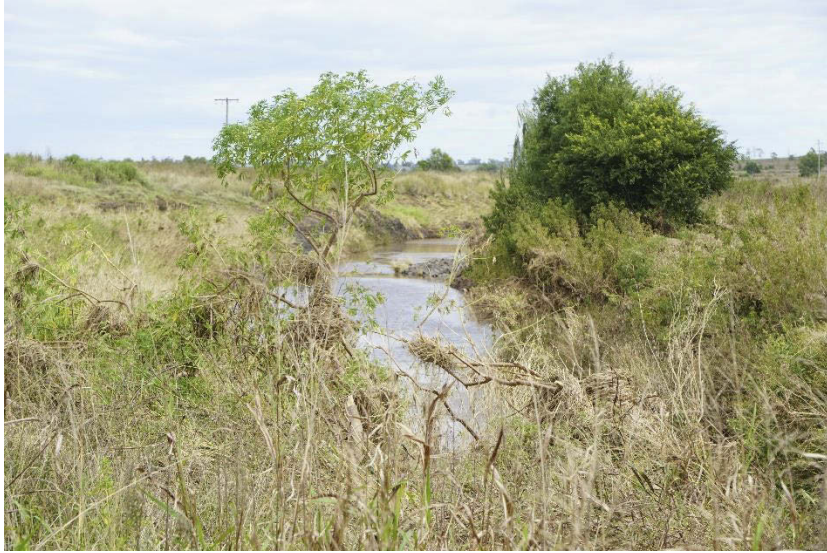
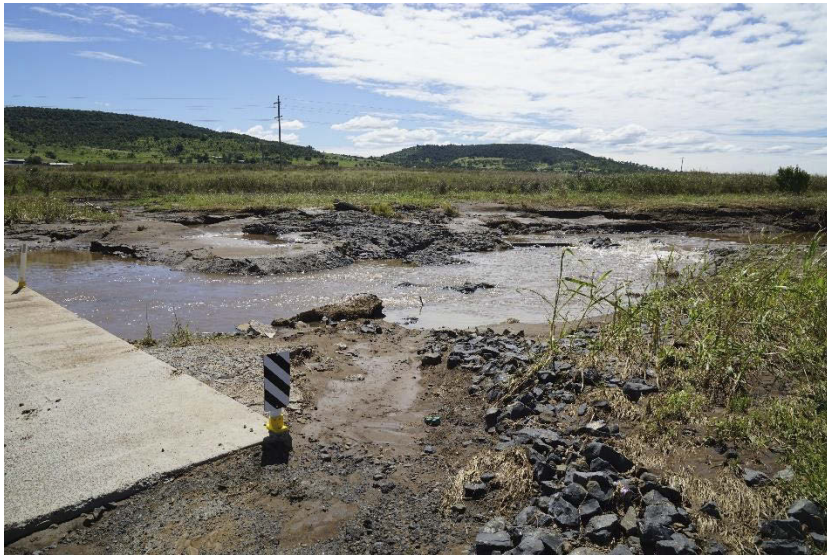
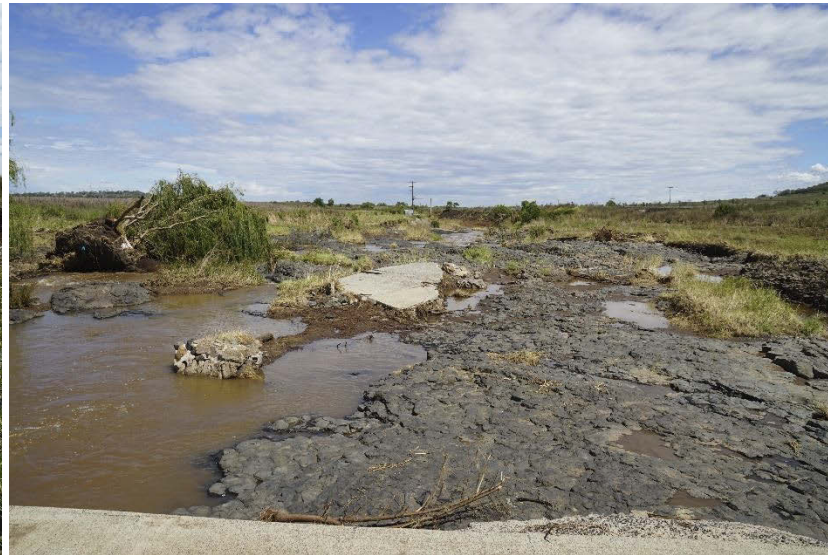
| Coordinates | | | | | | | | | Erosion Potential (sites with existing infrastructure) | | Channel | | | | | Material | | Floodplain | | | |
|---|---|---|---|---|---|---|---|---|---|---|---|---|---|---|---|---|---|---|---|---|---|
| EP1b | EP | Local- poorly developed channel | | Gowrie Creek | vertosols | ferrosols | 385947 | 6958461 | Ford/culverts: 3 culverts, box, 1.5x2.5m approx. Large broken concrete slabs in river, maybe from previous flood event and ford replaced? | Upstream and downstream of ford are volcanic rock outcrops. Deposition of fine silt on both banks. Tree uprooted on channel bank. | Low sinuosity section of a meandering channel | Shallow vegetated banks | Lateral bars | Grass on banks | Channel appears narrower upstream of the ford. Channel likely rock controlled in the ford area based on outcrop. Deposition on inside of channel bend, and erosion on outside of bend. | sand/silt/clay with volcanic rock outcrops and some gravels | Some dumping on bank, less erosion than at bridge site. | NA | NA | NA | Water has exceeded channel height. |

F. 24 EP1b photographs. Looking upstream (top left), ford/culvert looking downstream left bank (bottom left), right bank (bottom right).

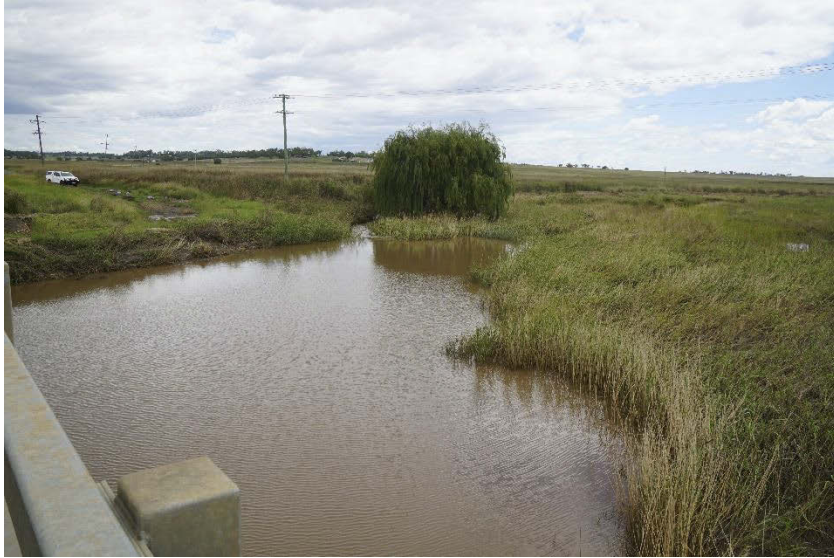
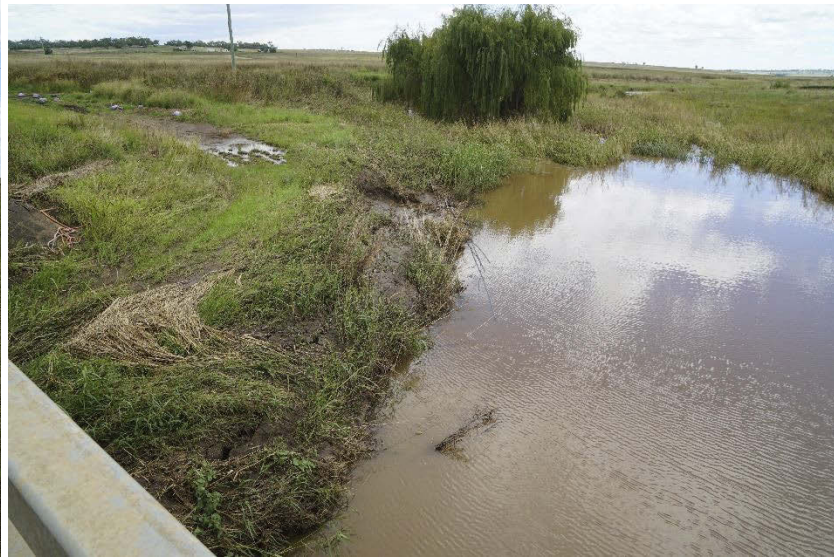
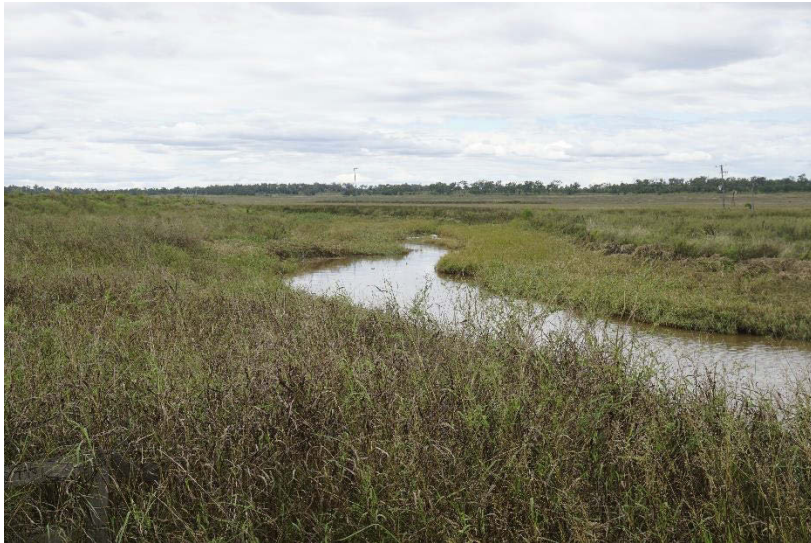
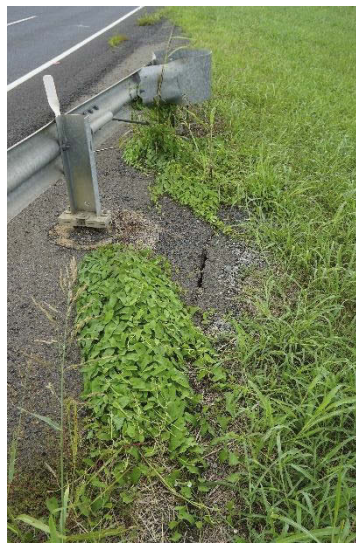
| Coordinates | | | | | | | | | Erosion Potential (sites with existing infrastructure) | | Channel | | | | | Material | | Floodplain | | | |
|---|---|---|---|---|---|---|---|---|---|---|---|---|---|---|---|---|---|---|---|---|---|
| EP3a | EP | Local - well developed channel | C1 | Westbrook Creek | vertosols | no data | 379662 | 6952297 | 2-lane concrete and asphalt bridge. | Covering of silt, indicates overtopping during flood. Bank slumping on the downstream true left bank. Minor cracking in seal on downstream side of left abutment, not major. | Low sinuosity channel, chain of ponds | Bridge crosses' over 'pond' overall channel width to outer banks approx. 30m wide immediately downstream of road bridge, narrowing to an indistinct grassy channel to approx. 15m 30 m downstream. | In channel bench on upstream right bank | Grass with sparse trees on bank | Slight erosion noted on downstream banks. Some fines deposition in grass on fairway immediately upstream of bridge. | NA (underwater) | Dark, silt/clay with grass cover | NA | NA | NA | No obvious signs of significant overland flow on flood plain. Barriers on bridge have covering of silt, may indicate overtopping during flood. |

F. 25 EP3a photographs. Downstream (top left), downstream detail (top right), upstream (bottom left), upstream detail (bottom right).

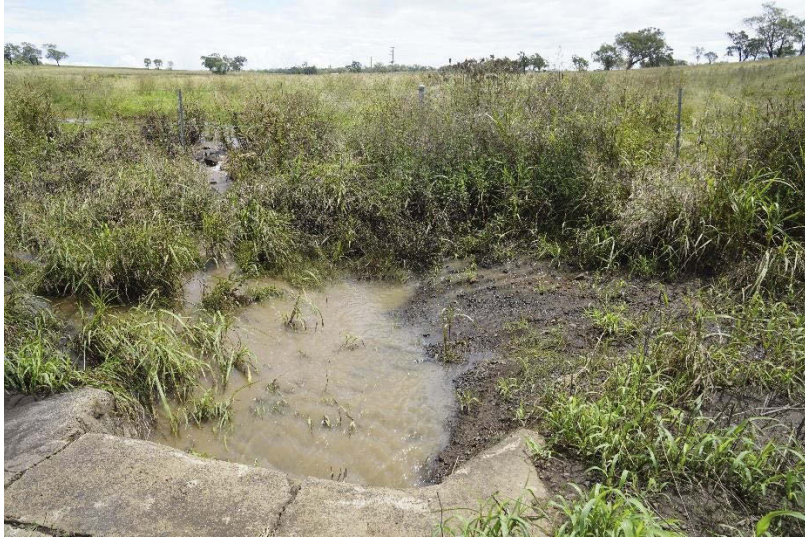
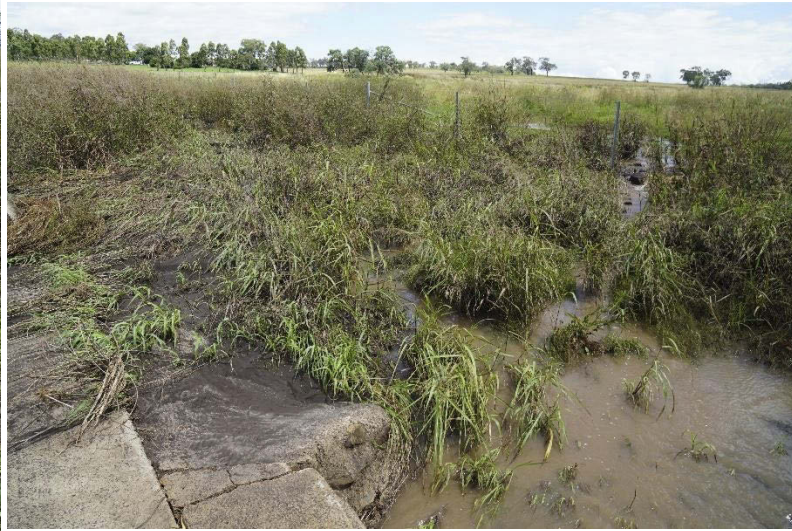
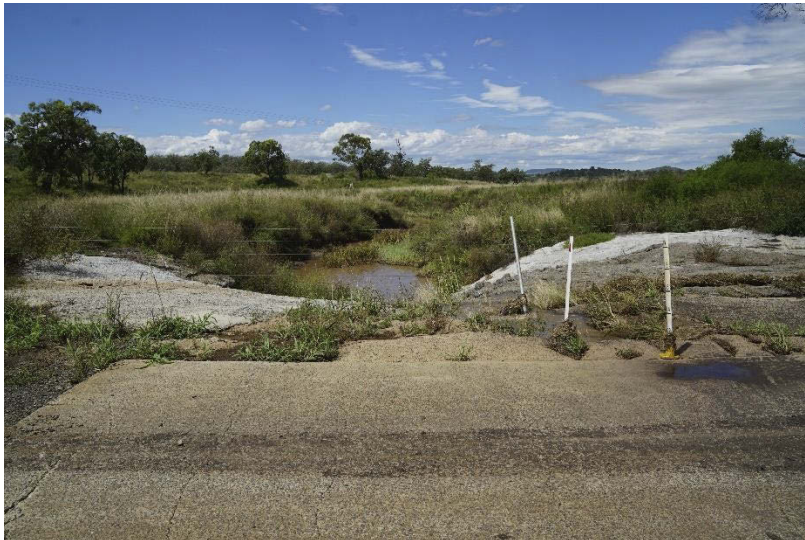
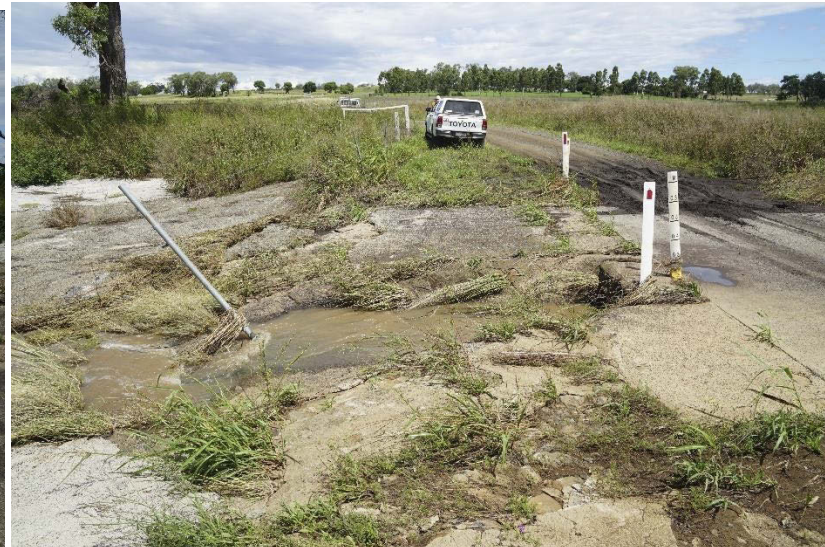
| Coordinates | | | | | | | | | Erosion Potential (sites with existing infrastructure) | | Channel | | | | | Material | | Floodplain | | | |
|---|---|---|---|---|---|---|---|---|---|---|---|---|---|---|---|---|---|---|---|---|---|
| EP4 | EP | Local - developed channel sections | C1 | One Mile Creek | vertosols | no data | 376863 | 6948296 | Causeway, concrete with approx. 2mx1.5m culvert. Concrete weir downstream of causeway. Elevation from culvert outflow down to current river level approx. 2.5-3m | Ponding upstream, some bank erosion downstream | Low sinuosity channel downstream of causeway, upstream channel indistinct | Upstream channel indistinct. Overall fairway approx. 80m wide. Downstream channel is approx. 15m wide and 3-4m deep, | Multiple small discontinuous channels and ponds in fairway . Low sinuosity channel approx. 1.5m to 3 m deep. | Upstream channel vegetated with long grass. | Dark silt and clay with some sand deposited in vegetation and on road right side of causeway. Signs of overland flow above banks not obvious on downstream side. Slumping at downstream right bank into channel. Low sinuosity channel may have developed due to local scour downstream of causeway. Channel deepening and widening occurring downstream o Berghafer road. | Silt/clay | Dark silt and clay with some sand and gravel with grass cover. | NA | NA | NA | Water inferred to have been 30 cm deep across top of causeway from height of vegetation detritus on fence and depth gauge. |

F. 26 EP4 photographs. Upstream (top left), upstream detail (top right), downstream (bottom left), downstream detail (bottom right).

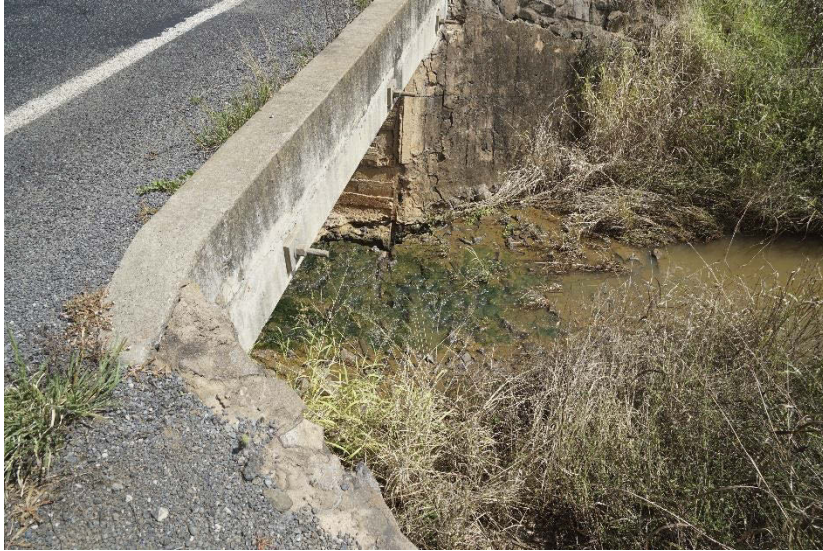
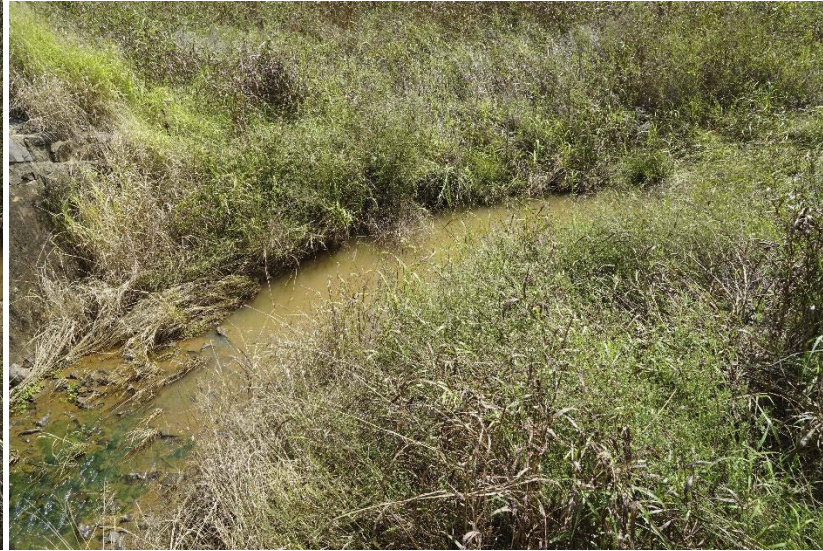
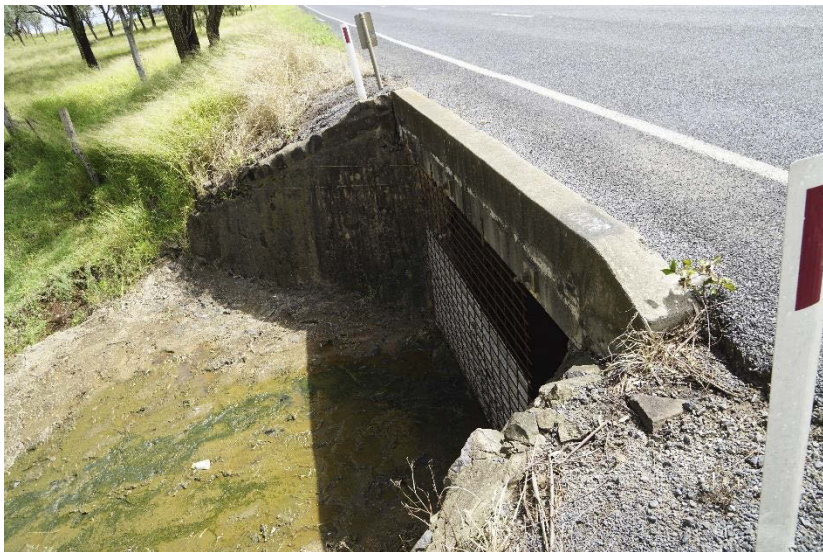
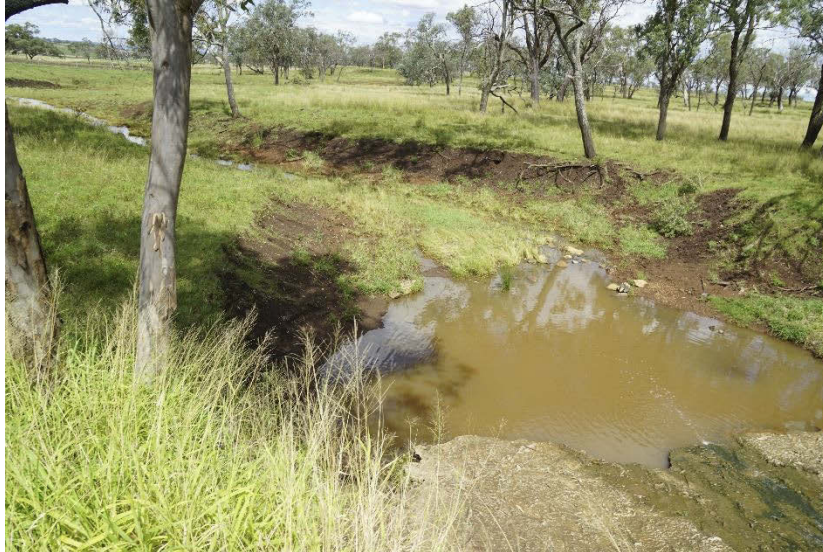
F. 28 EP6 photographs. Upstream 1 (top left), upstream 2 (top right), downstream 1 (bottom left), downstream right (bottom right).

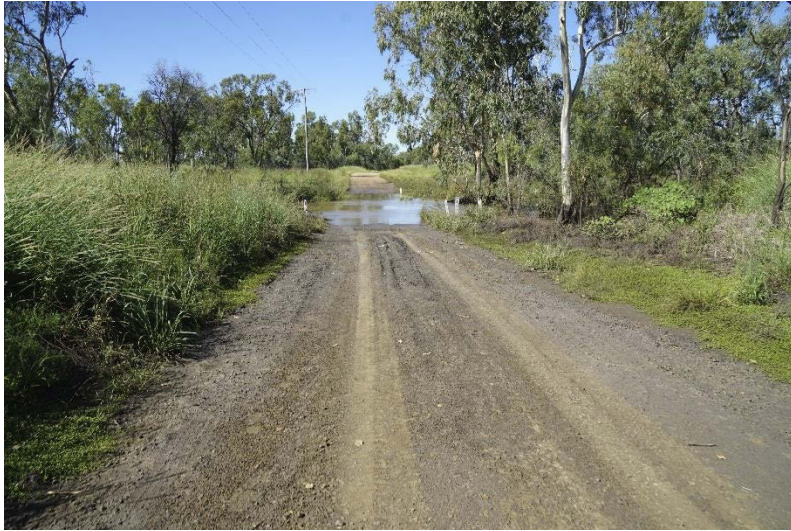
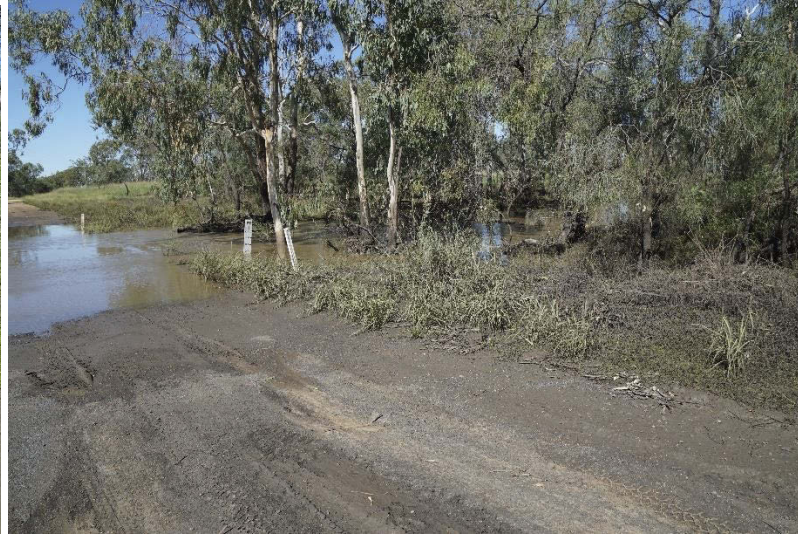
F. 31      EP17 photographs. From right bank (top left), detail 1 (top right), detail 2 (bottom).

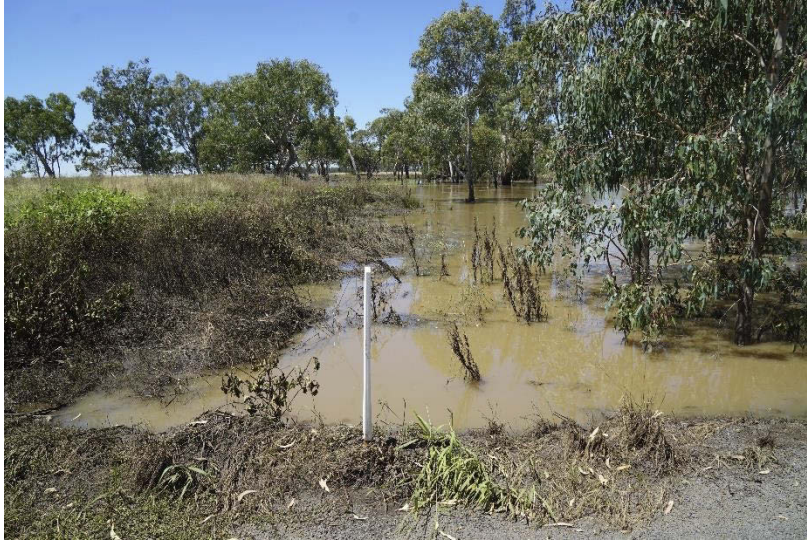
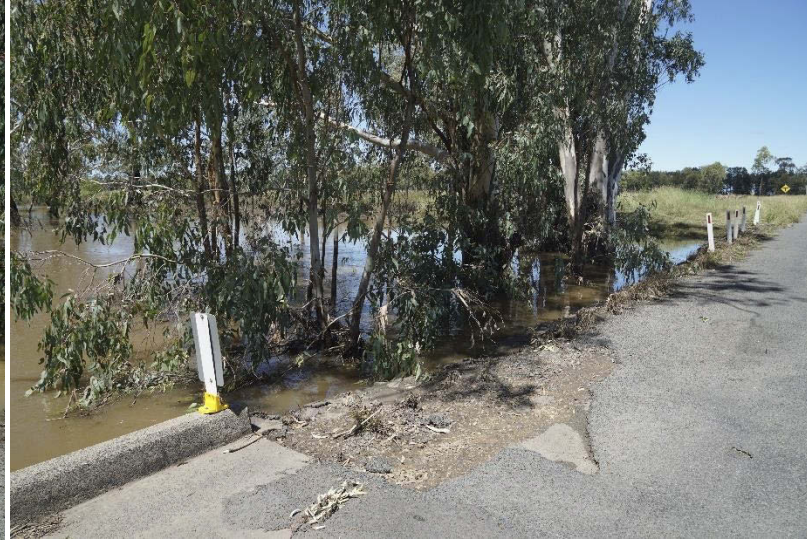
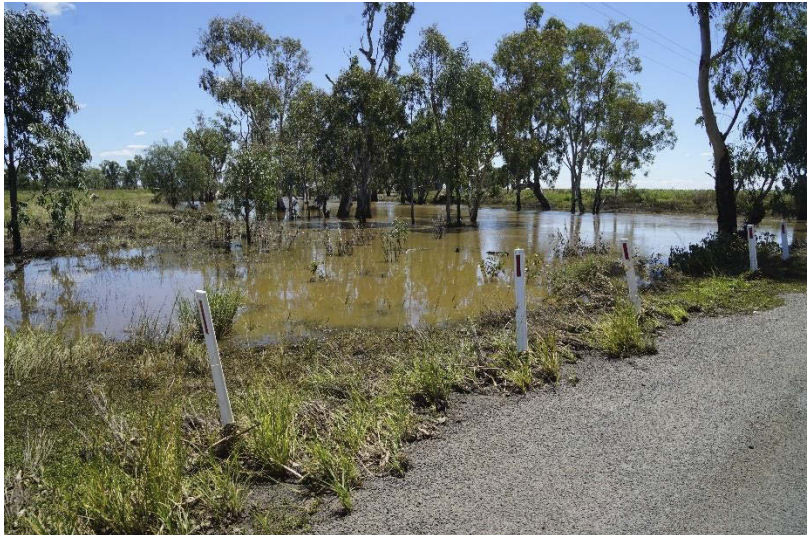
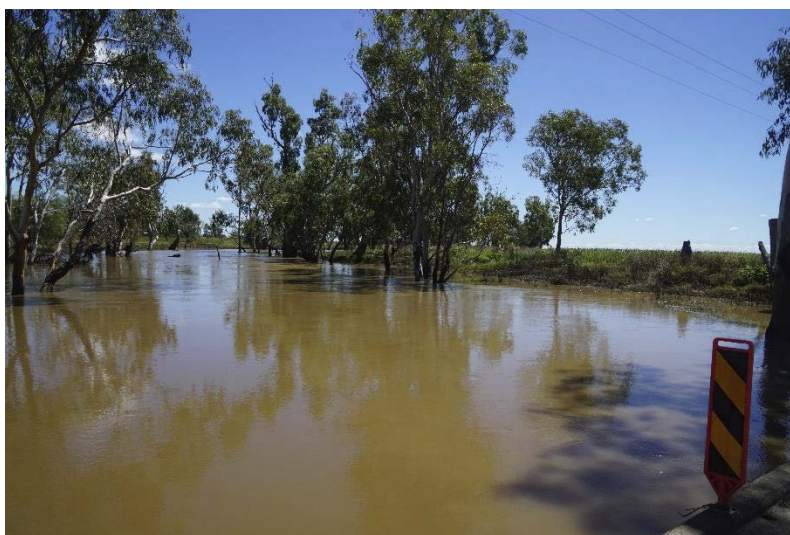
F. 32 EP17a photographs. Upstream 1 (top left), upstream 2 (top right), downstream 1 (bottom left), downstream 2 (bottom right).

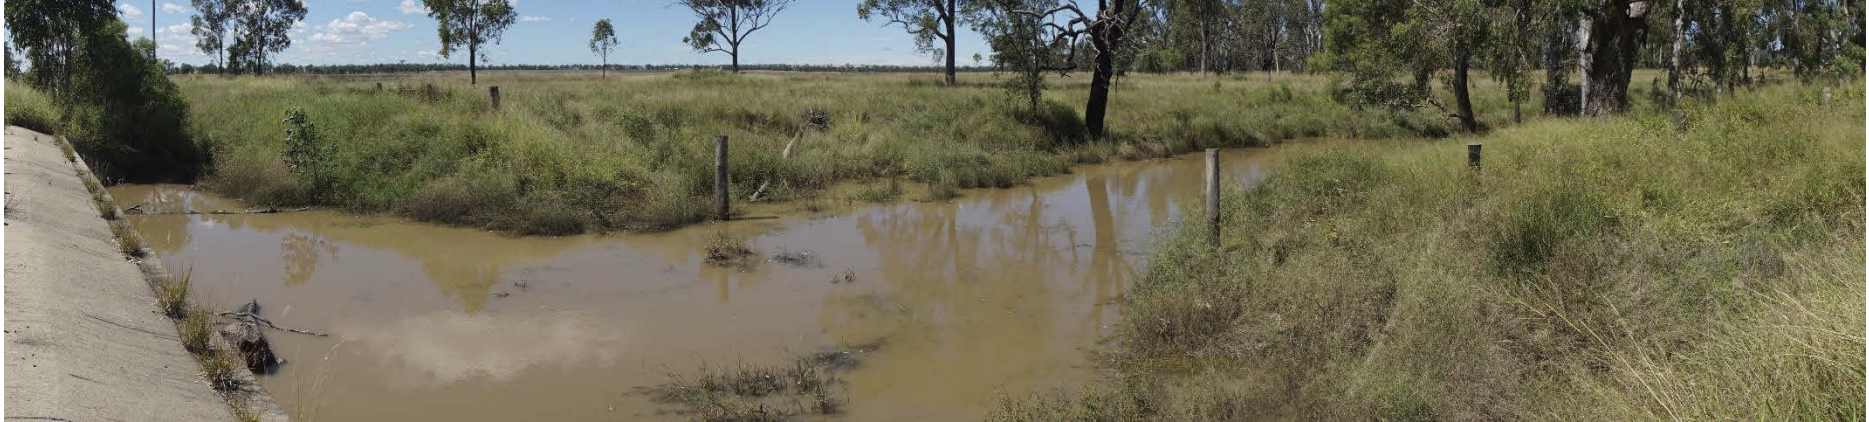
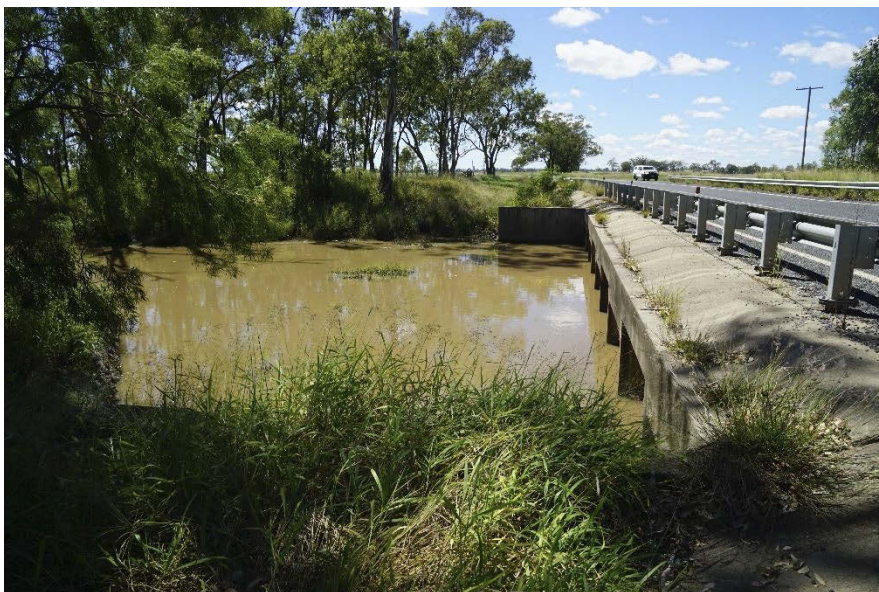
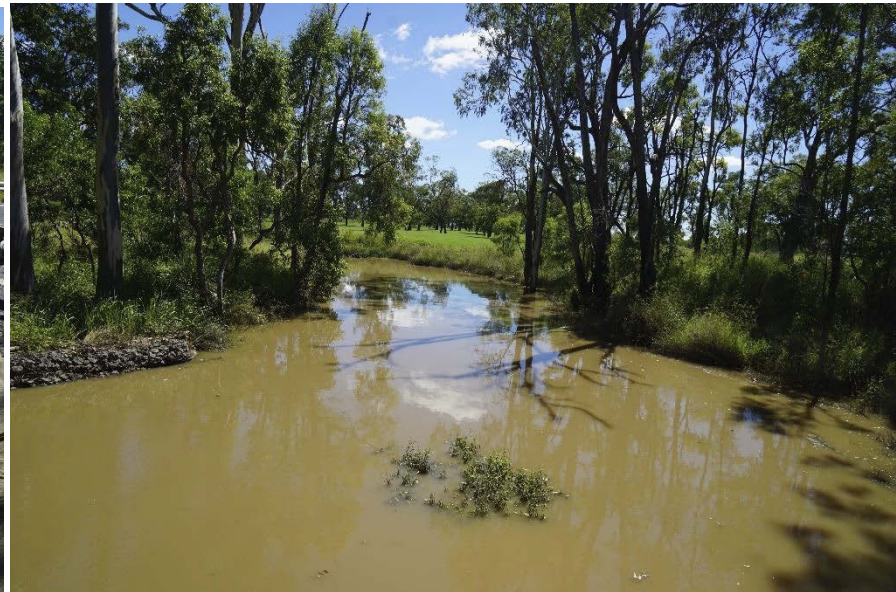
F. 33 EP18 photographs. Upstream (top), downstream 1 (bottom left), downstream 2 (bottom right).

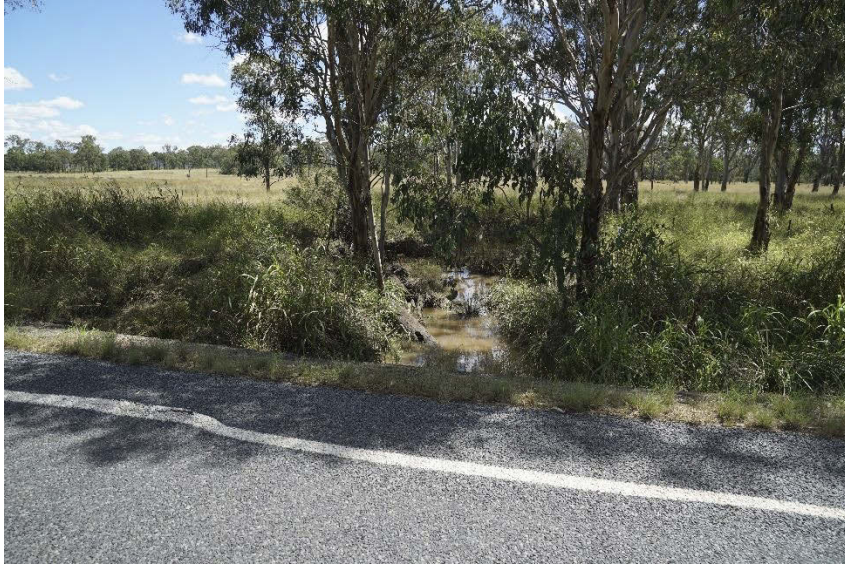
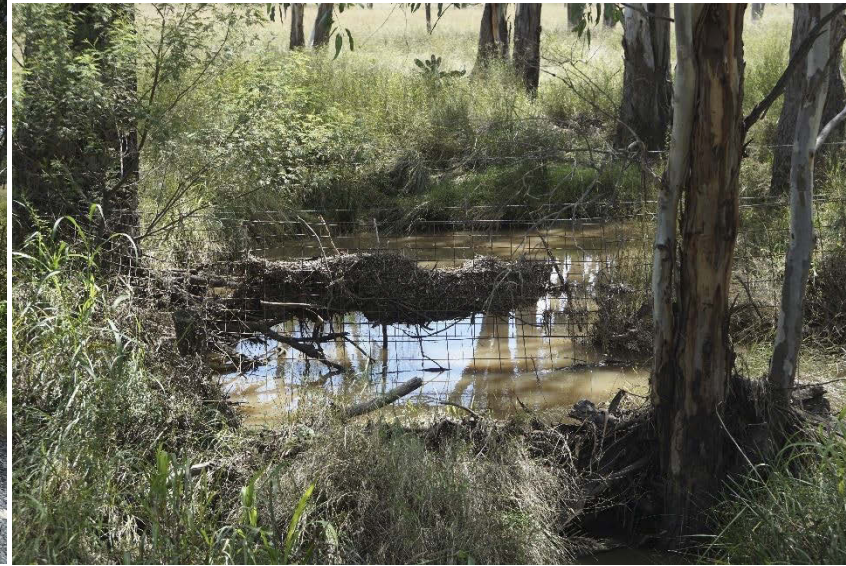
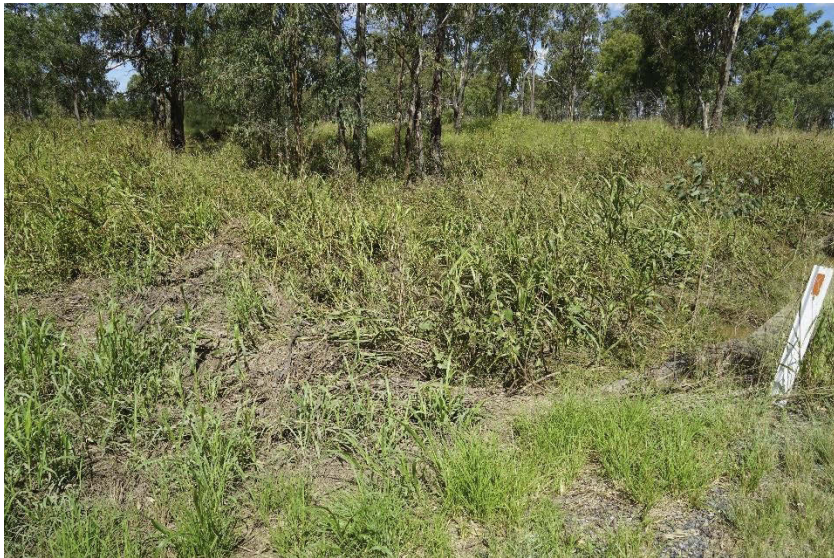
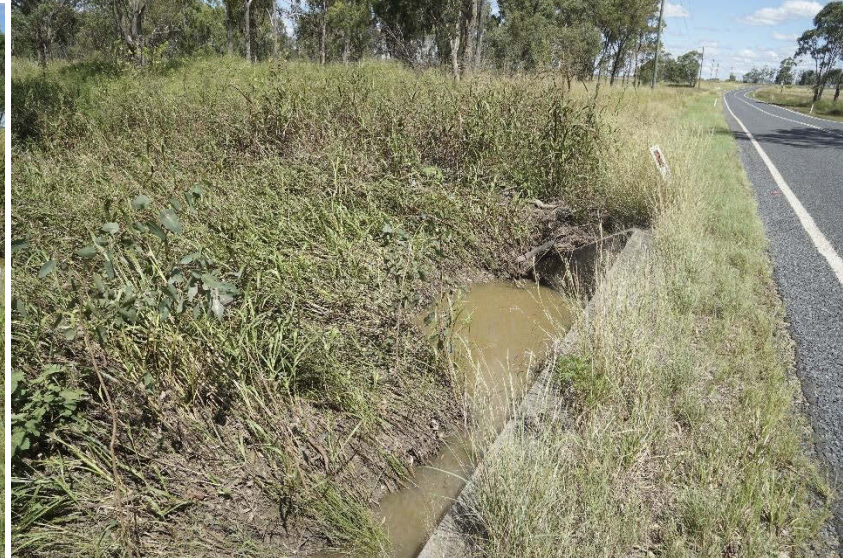
F. 34 EP19 photographs. Upstream (top left), upstream detail (top right), downstream (bottom left), downstream detail (bottom right).

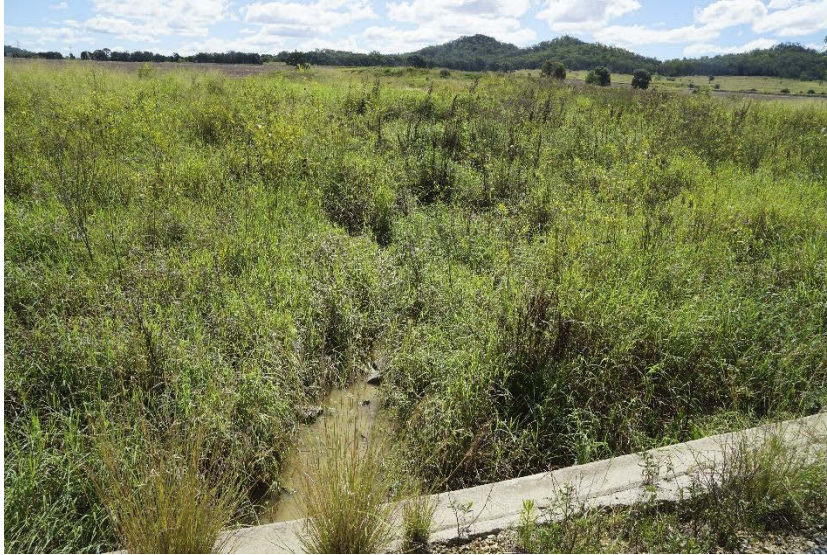
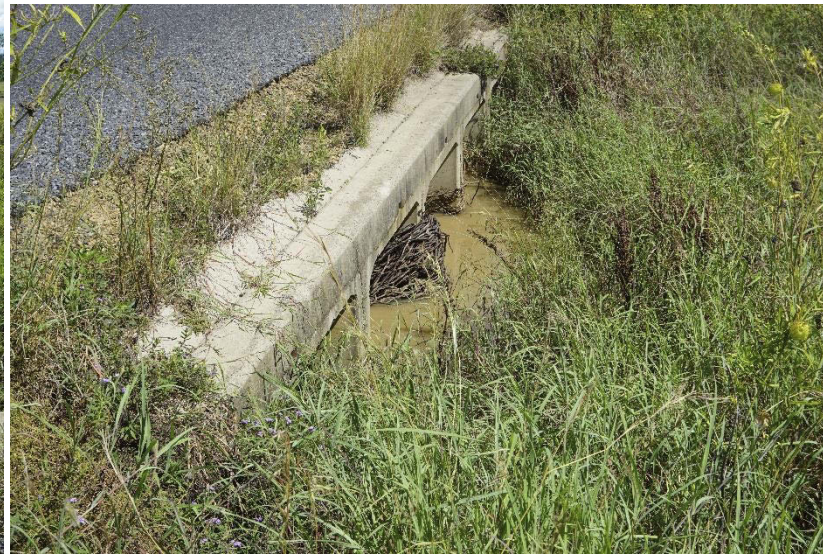
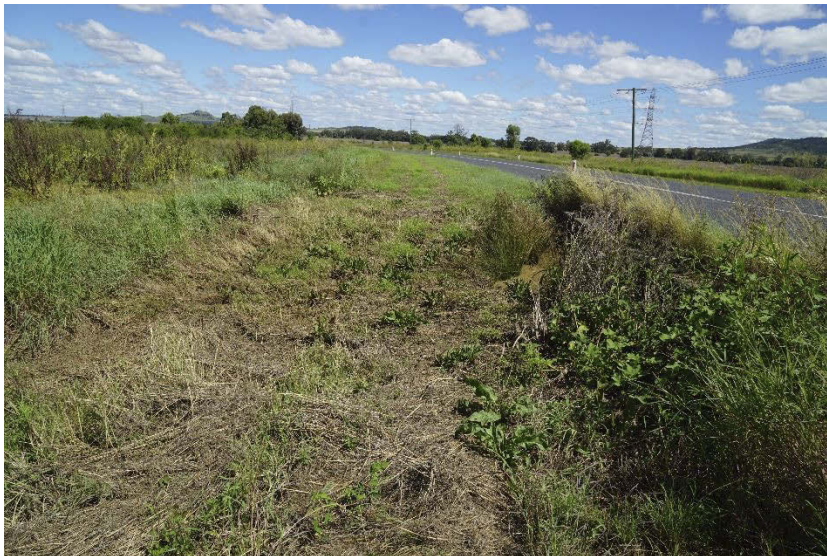
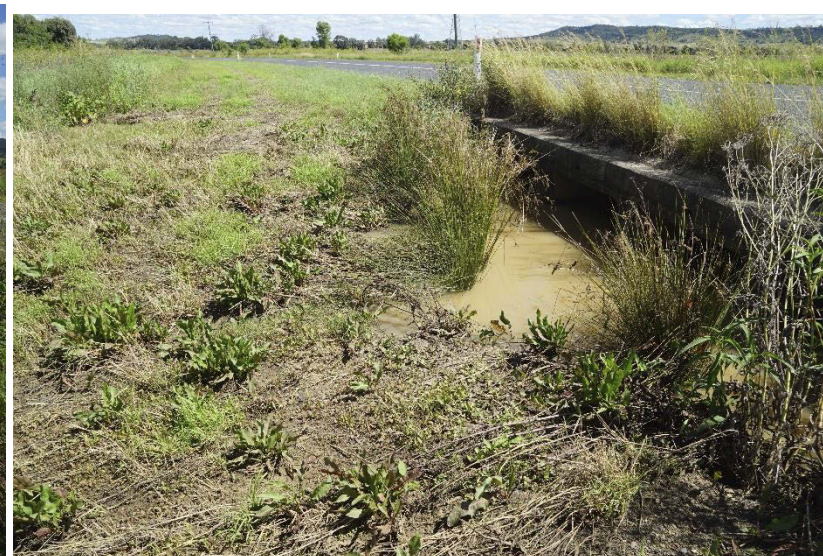
F. 35 Site 8/EP21 photographs. Upstream (top left), upstream detail (top right), downstream (bottom left), downstream detail (bottom right).

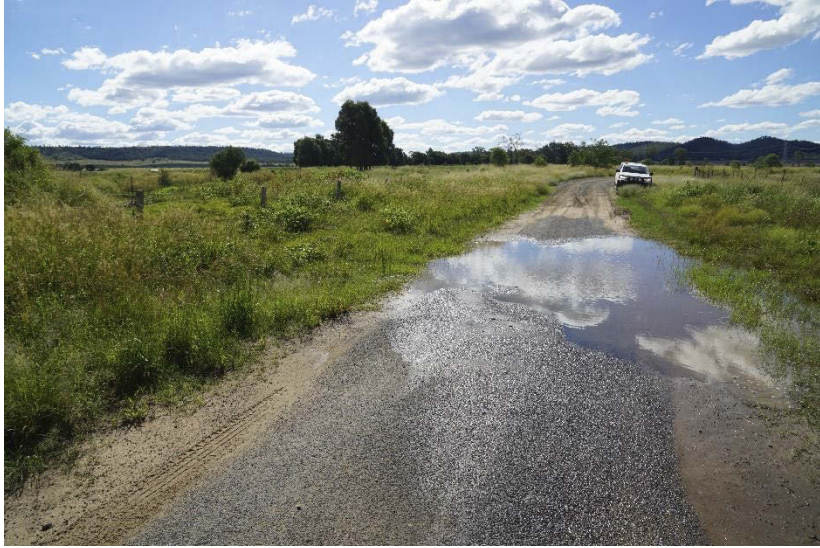
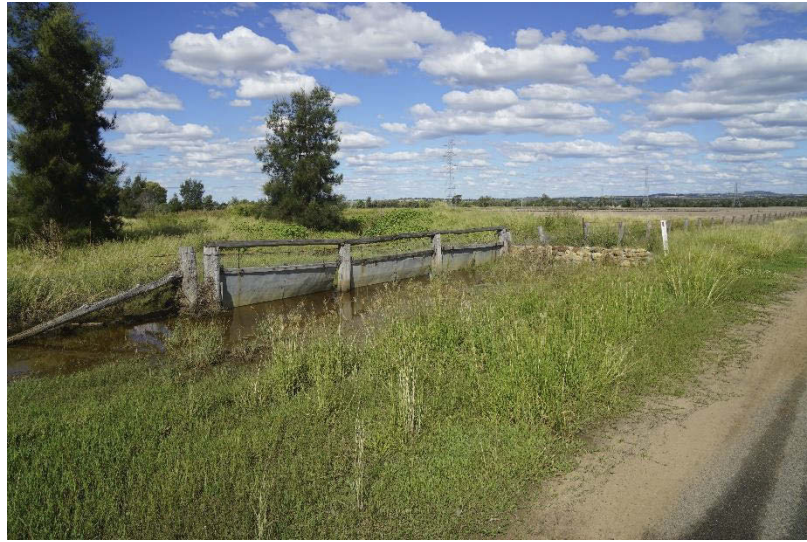
*F. 36      EP22 photographs. Facing NW (left), facing SE (right).*

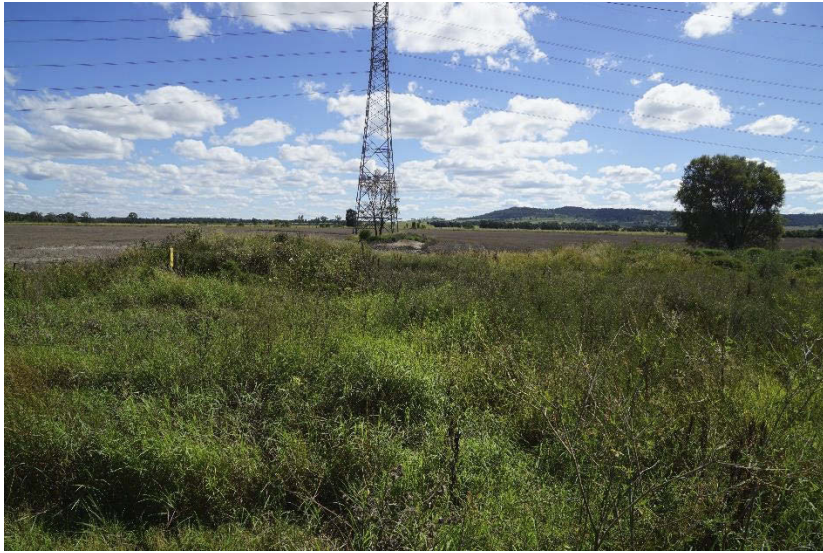
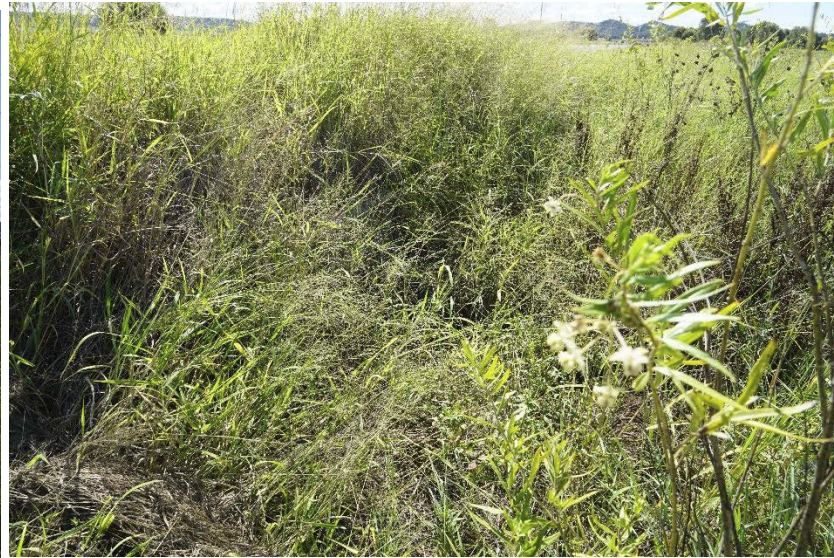
F. 37     *EP22a photographs.*

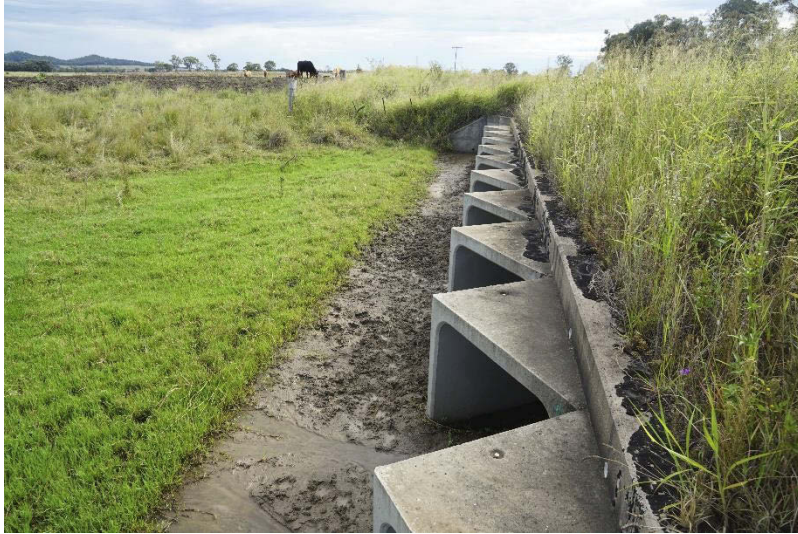
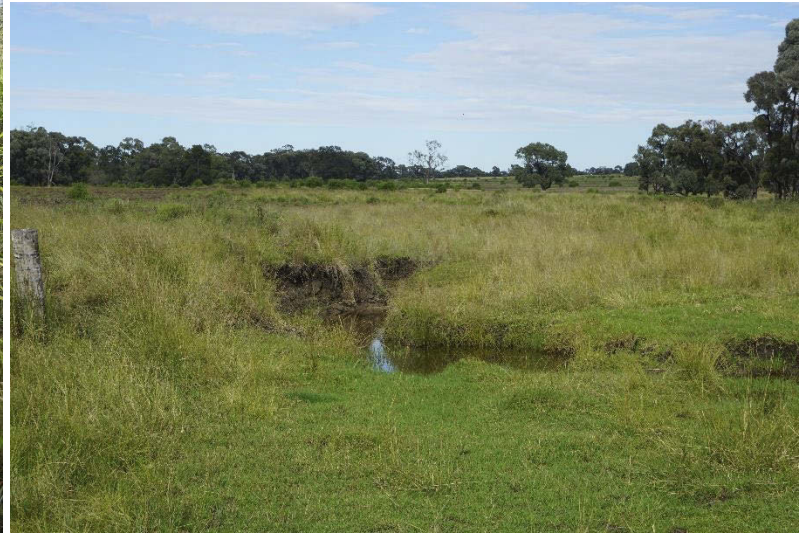
F. 38 EP23 photographs. Upstream detail 1 (top left), upstream detail 2 (top right), downstream (bottom).

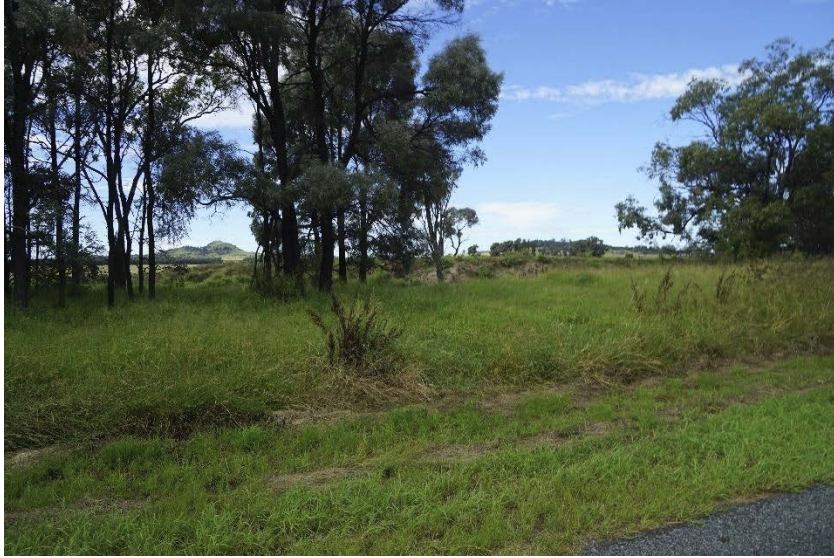
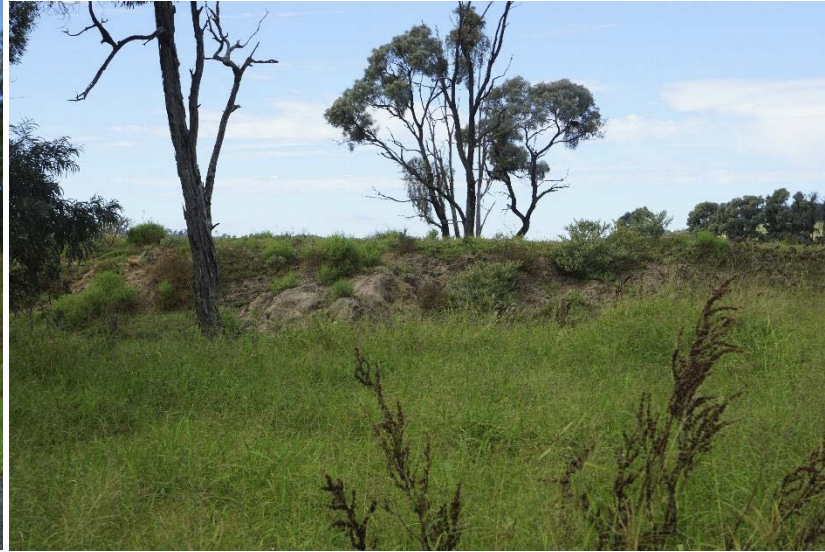
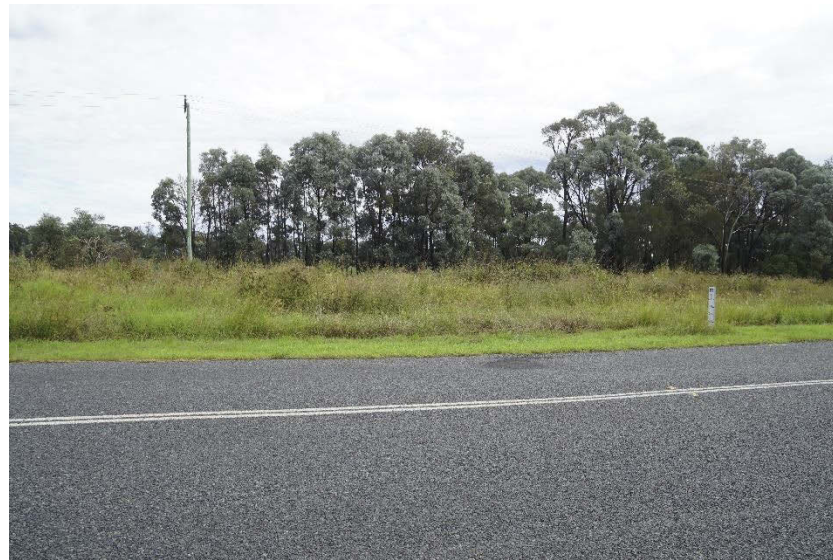
F. 39 EP23a photographs. Upstream (top left), upstream detail (top right), downstream (bottom).
