**BORDER TO GOWRIE** REVISED DRAFT ENVIRONMENTAL IMPACT STATEMENT

## Geomorphology Report

## Baseline field inspection site records and photos

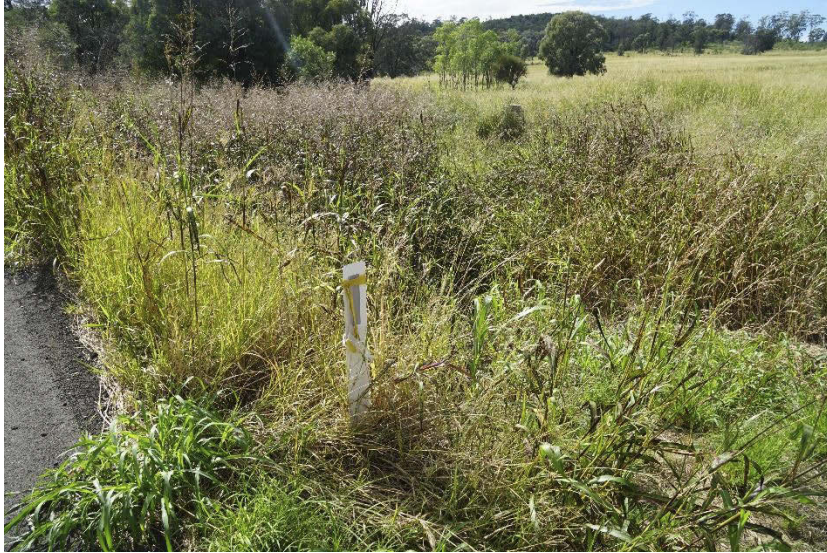
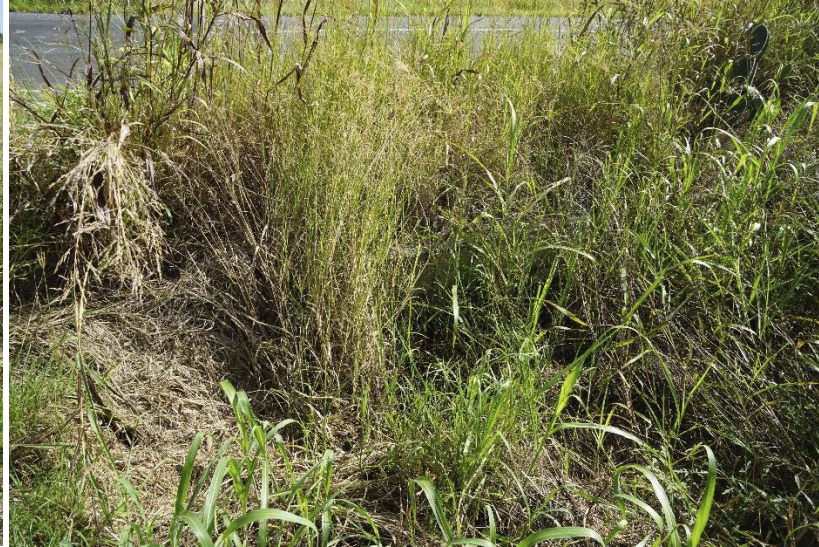
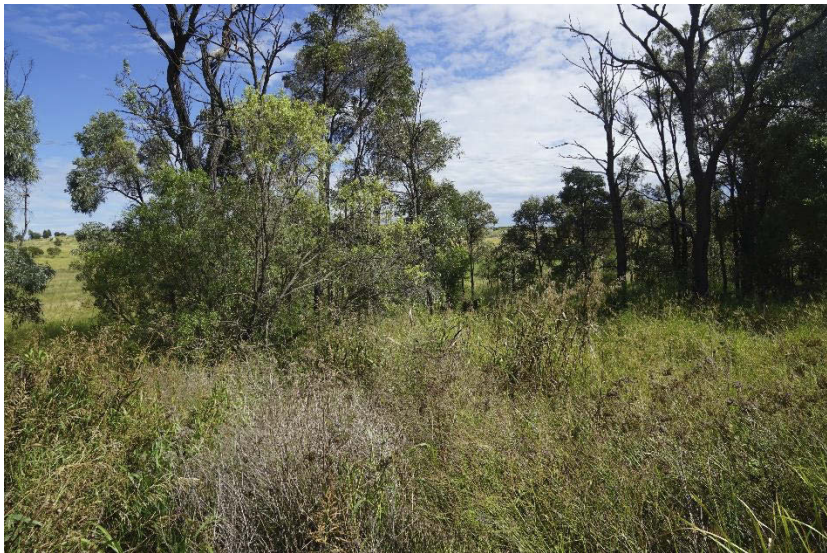
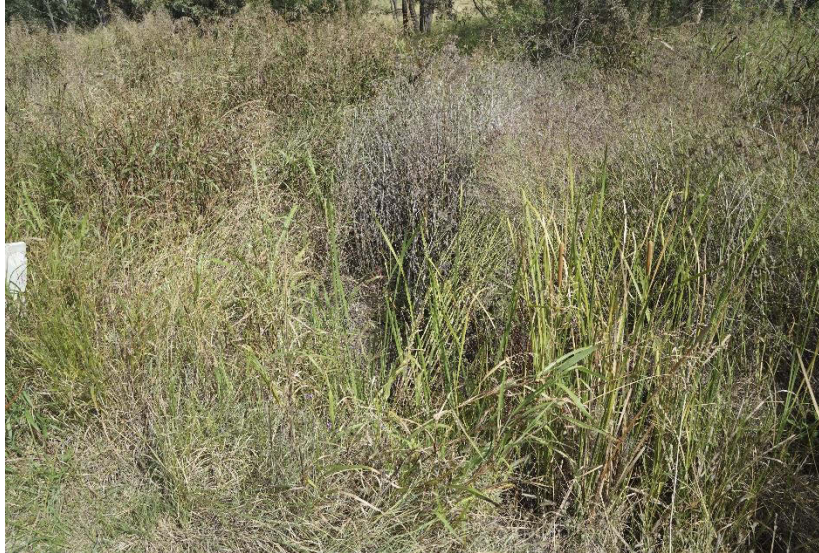
F. 40 EP24 photographs. Upstream (top left), upstream detail (top right), downstream (bottom left), downstream detail (bottom right).

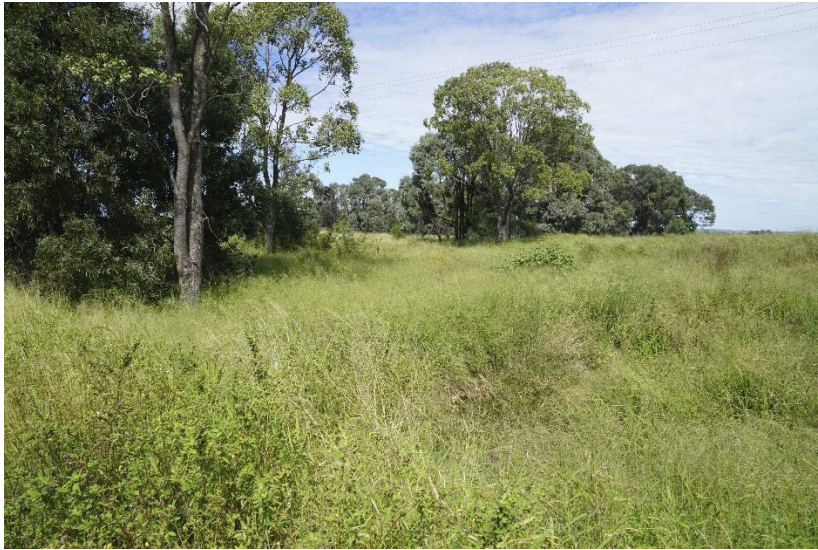
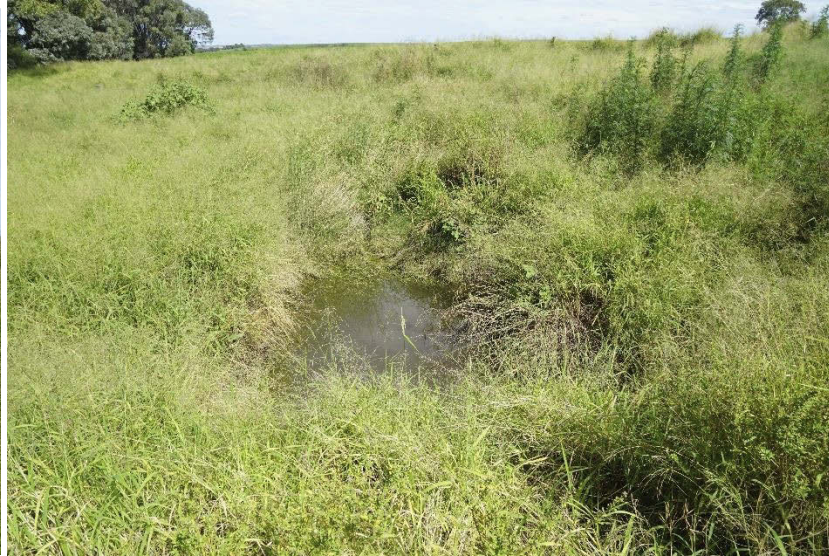
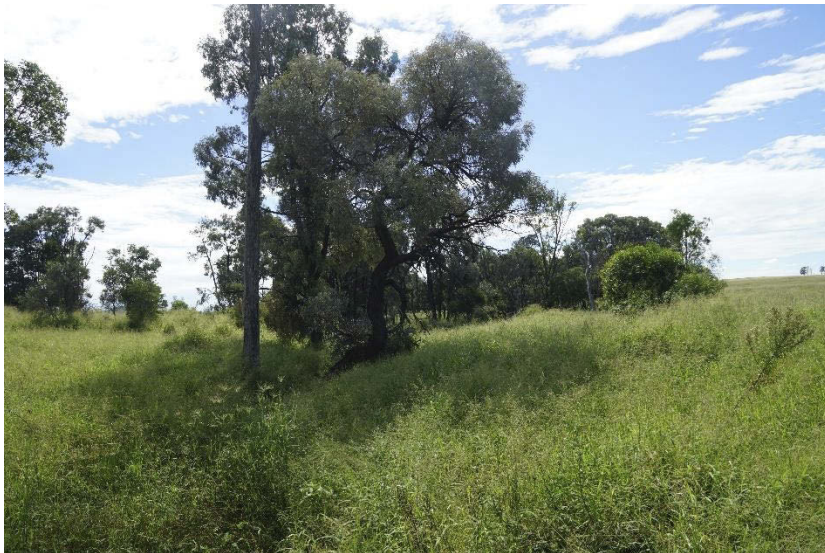
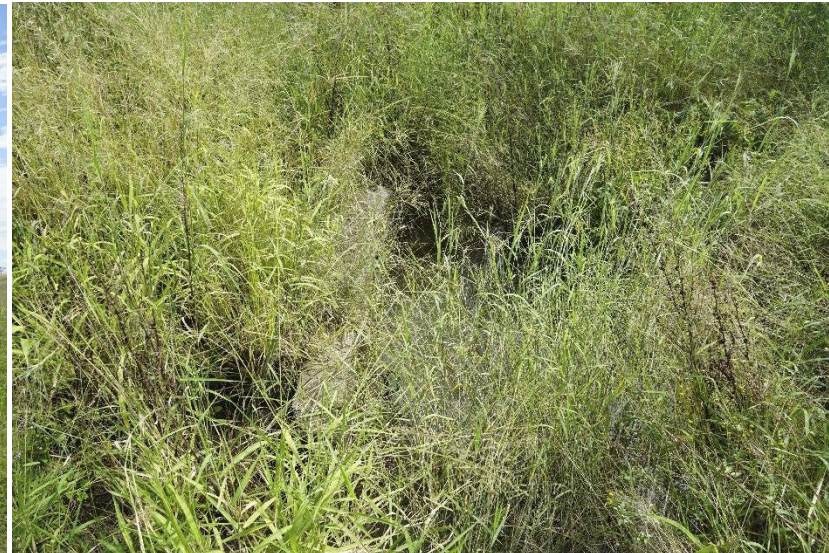
F. 41 EP24a photographs. Upstream (top left), upstream detail (top right), downstream (bottom left), downstream detail (bottom right).

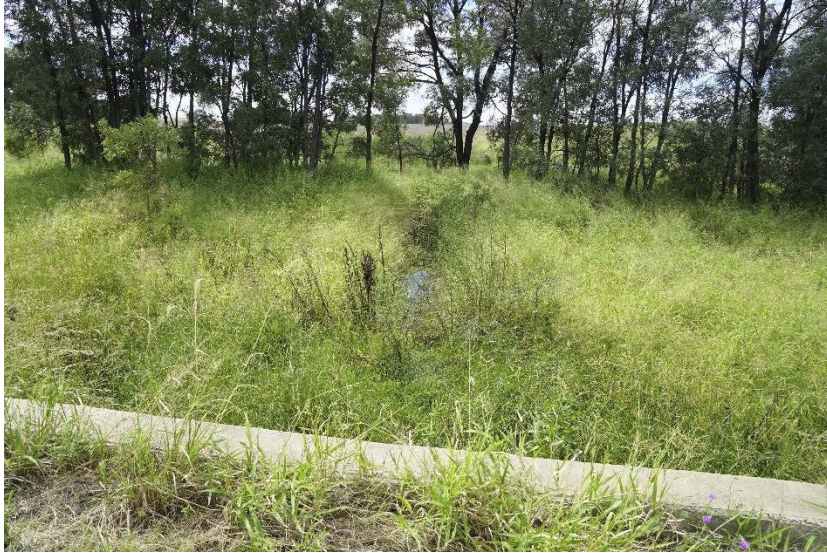
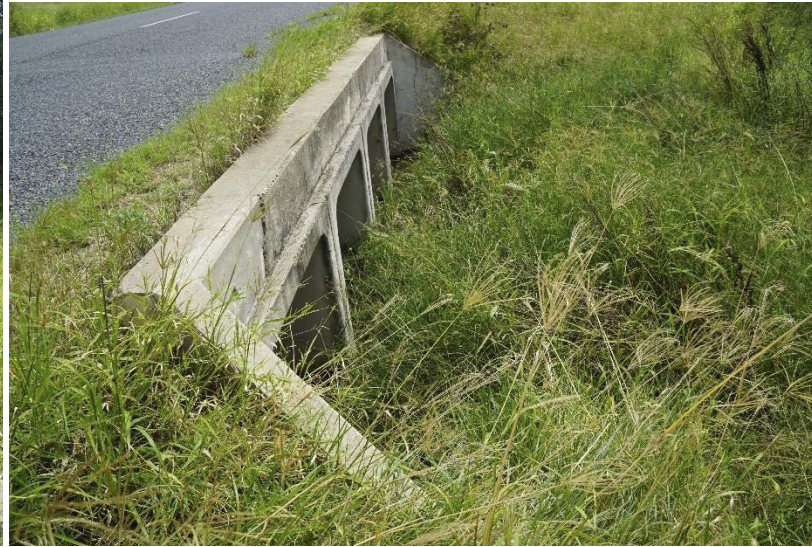
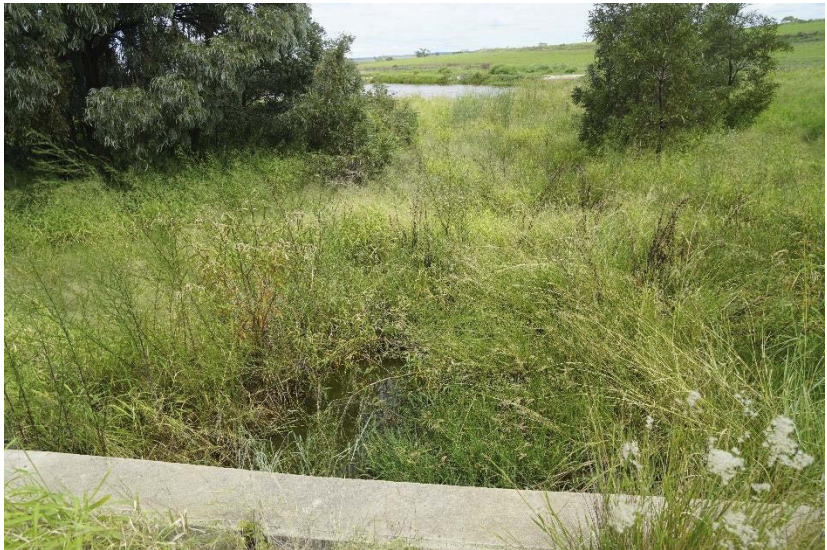
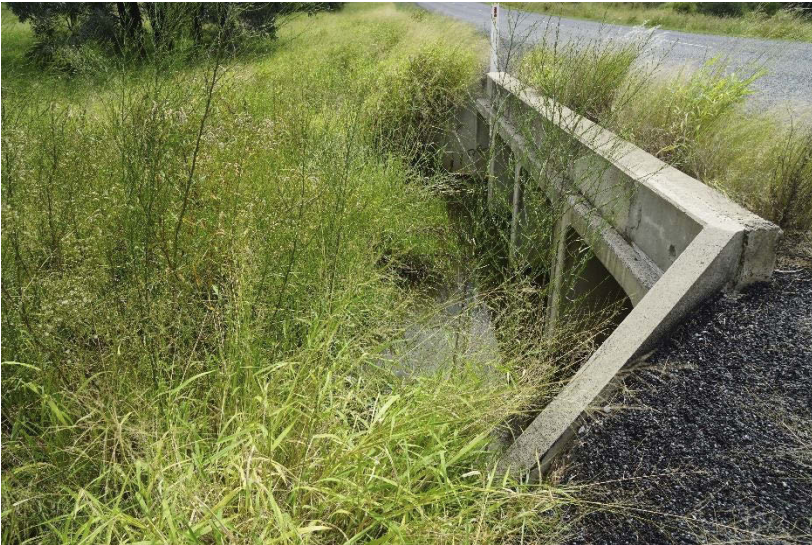
F. 42 EP25 photographs. Downstream (top left), downstream detail (top right), upstream (bottom left), downstream detail (bottom right).

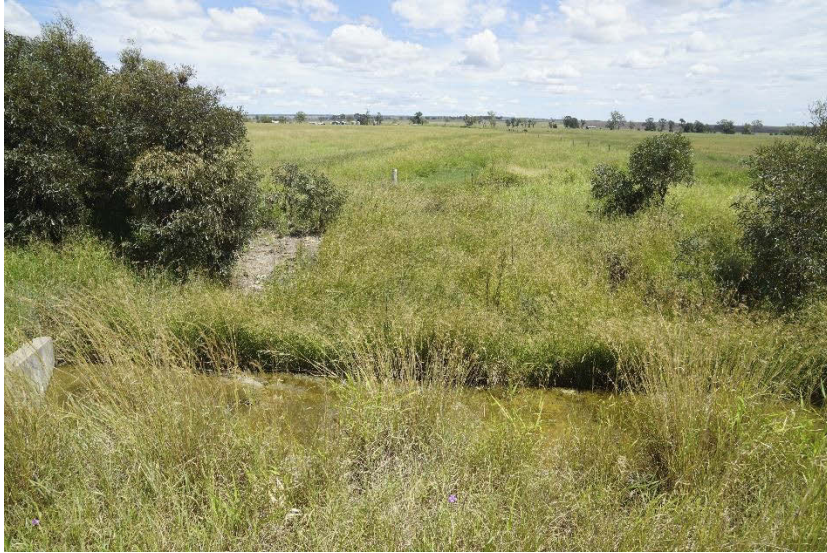
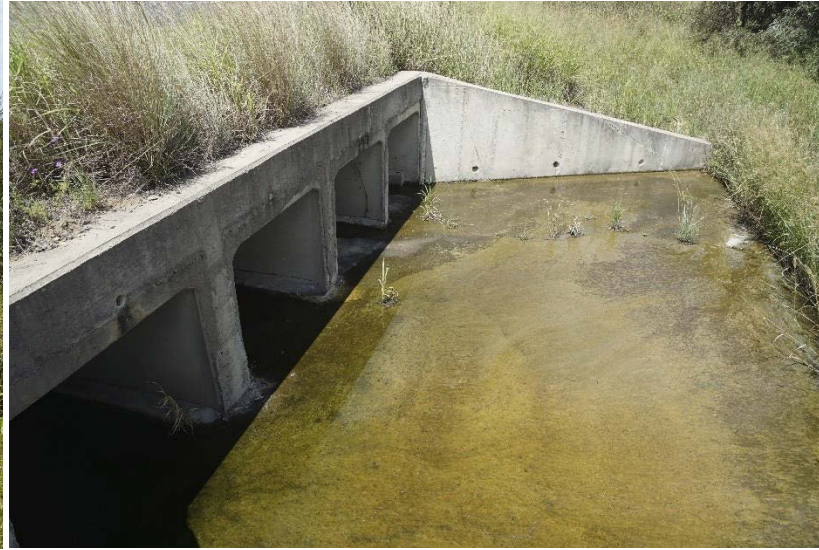
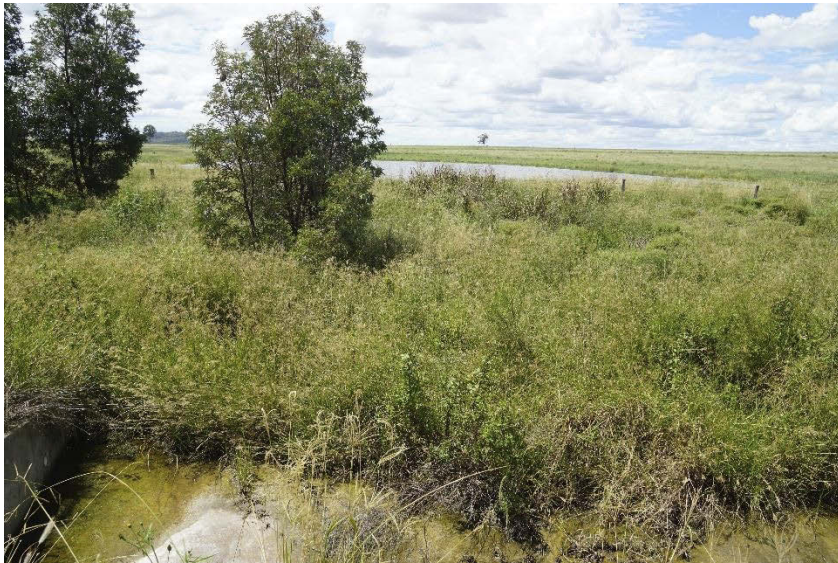
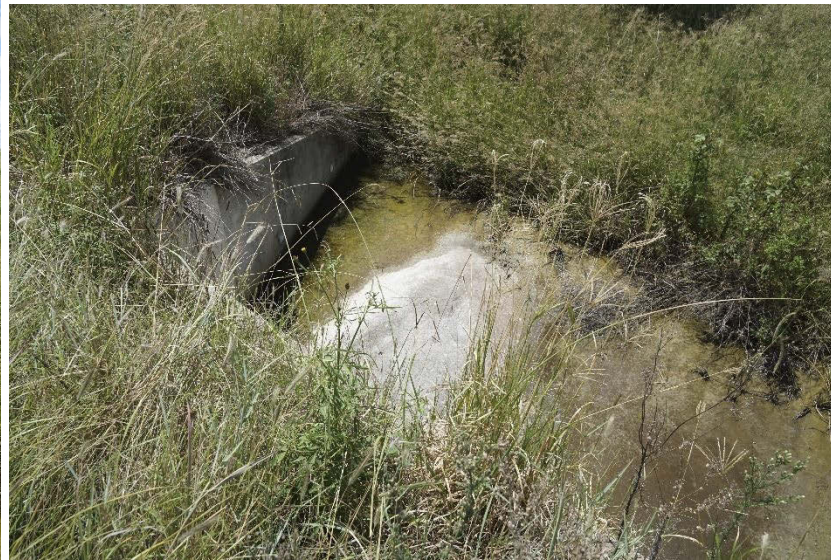
F. 43 EP26 photographs. Upstream (top left), upstream detail (top right), downstream (bottom left), downstream detail (bottom right).

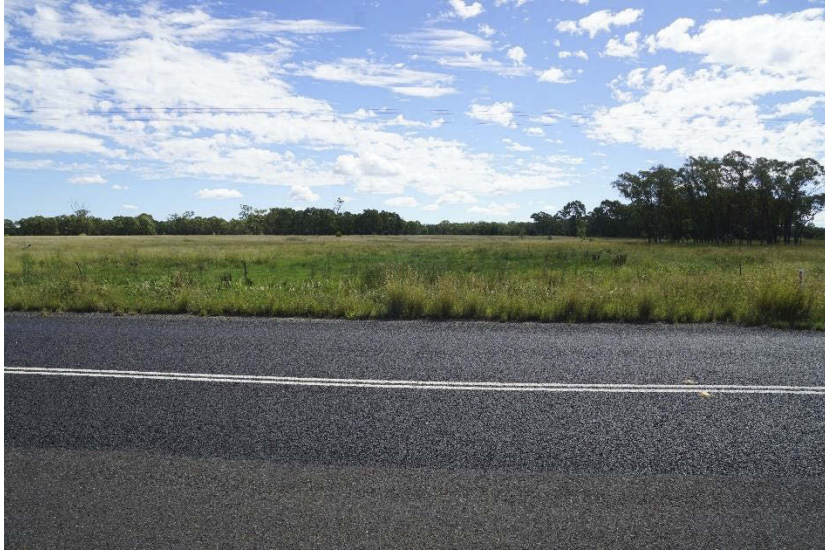
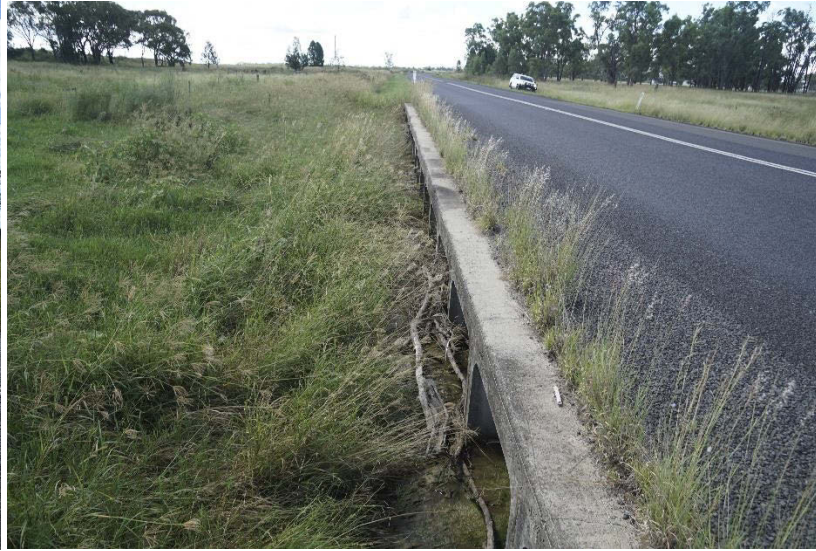
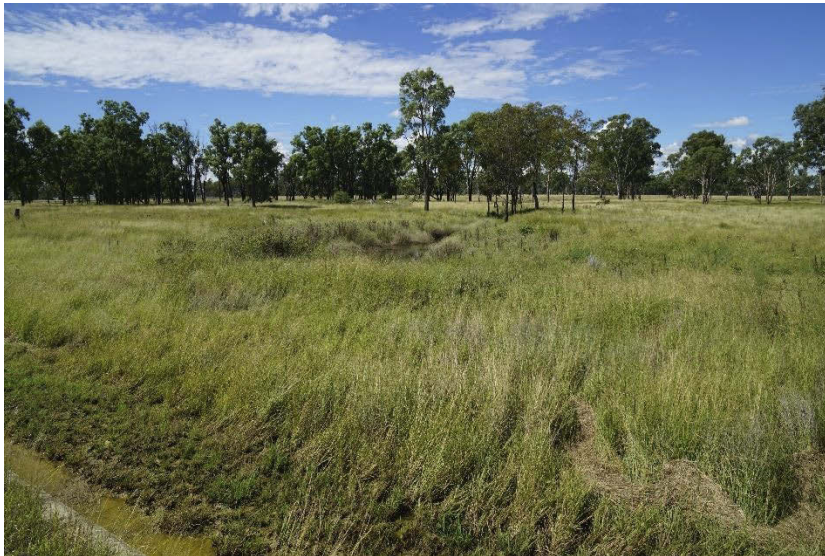
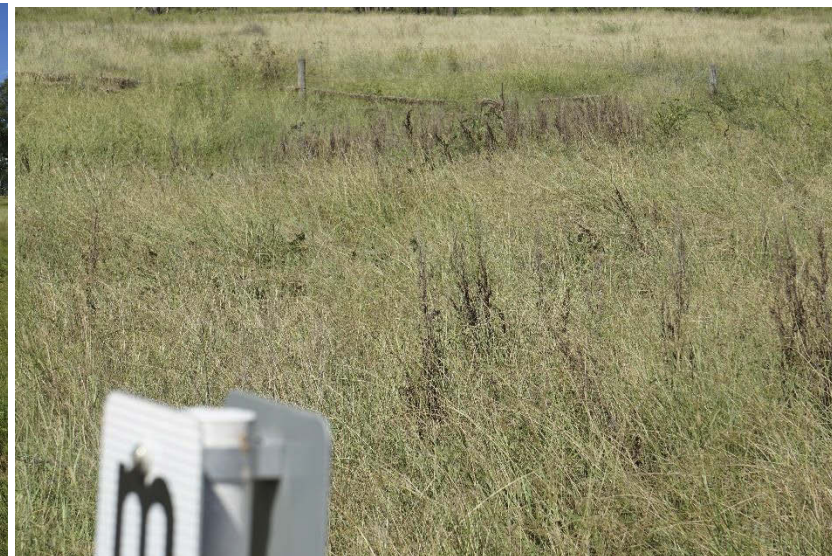
F. 44      *EP27 photographs. Upstream (top left), upstream detail (top right), downstream (bottom left), downstream detail (bottom right).*

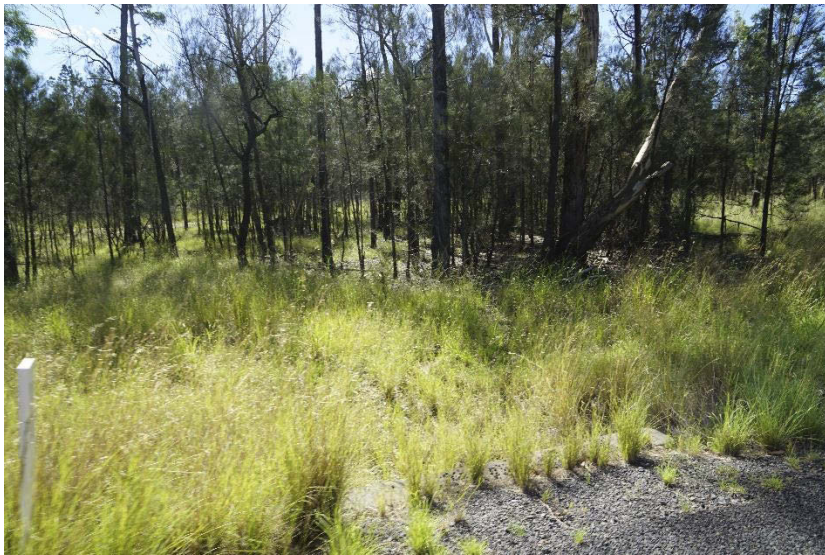
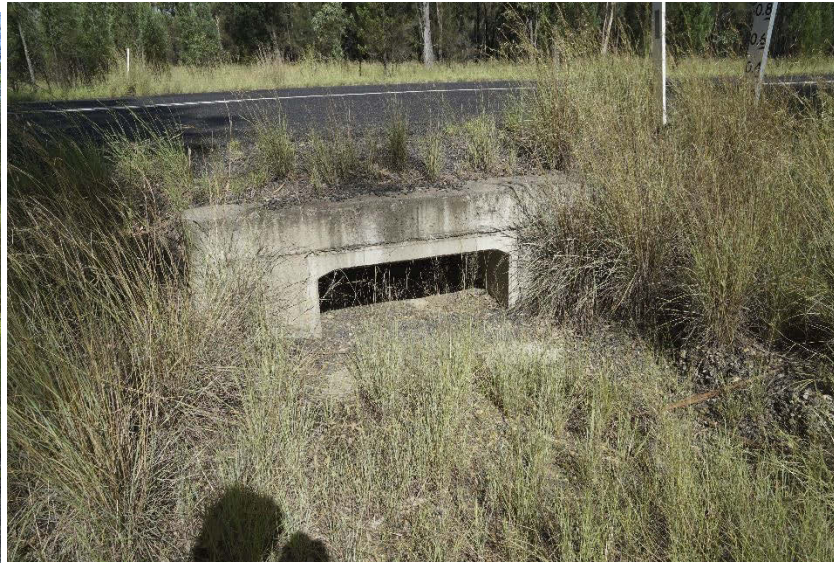
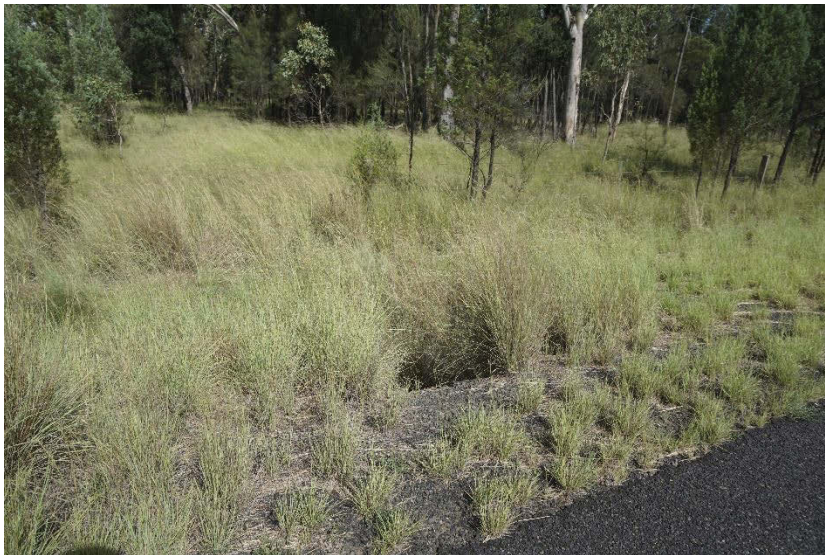
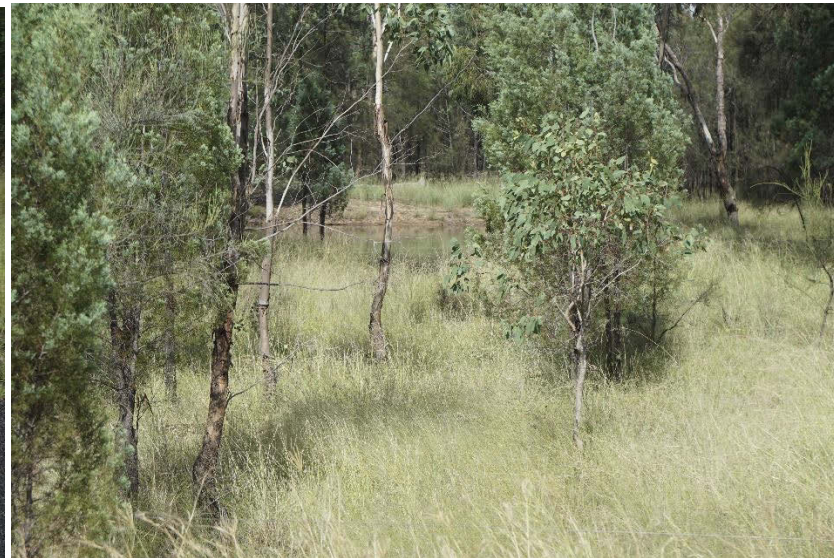
F. 45 EP30 photographs. Upstream (top left), upstream detail (top right), downstream (bottom left), downstream detail (bottom right).

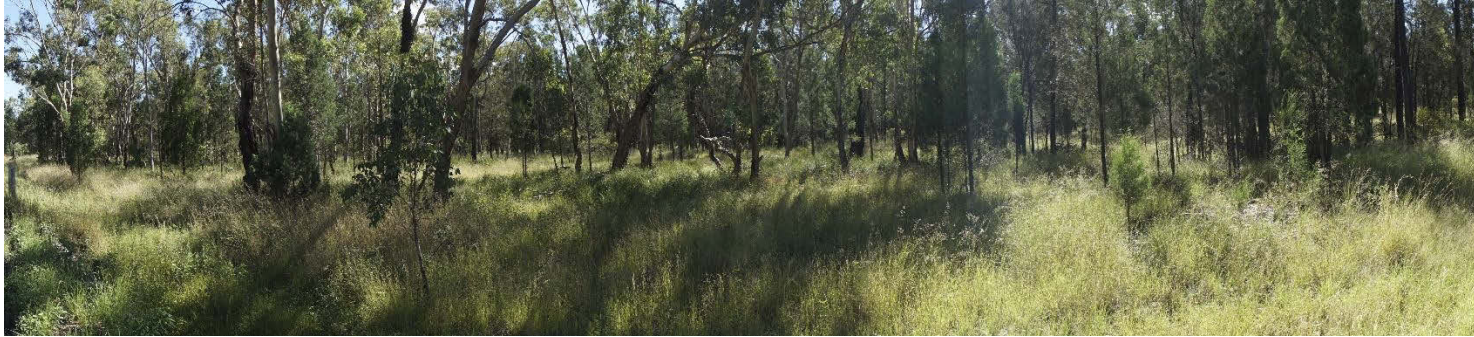
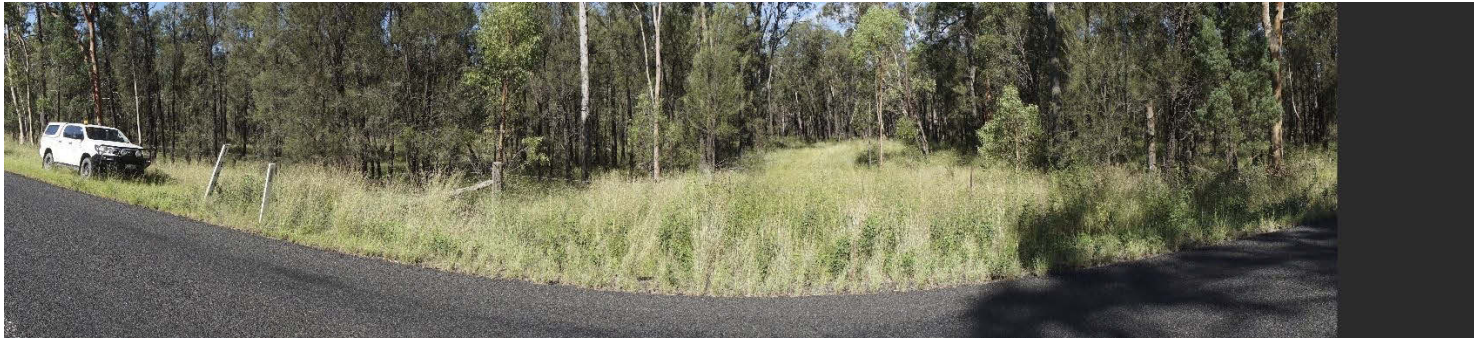
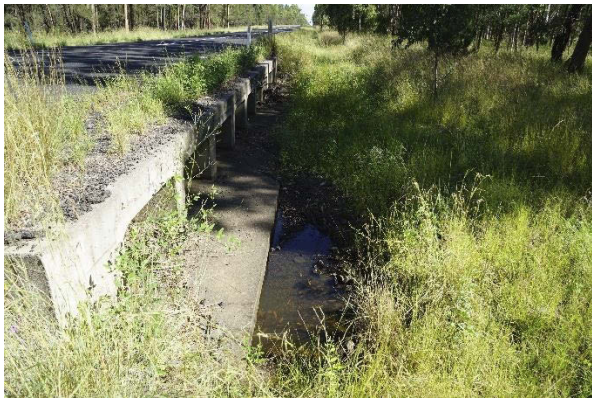
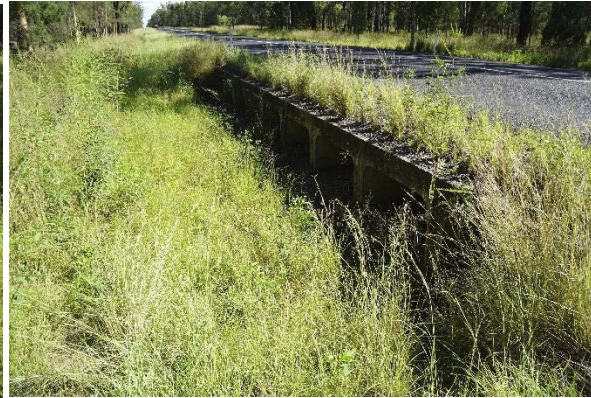
F. 46      EP32 photographs. Upstream (top left), culvert upstream end (top right), downstream (bottom left), downstream 2 (bottom right).

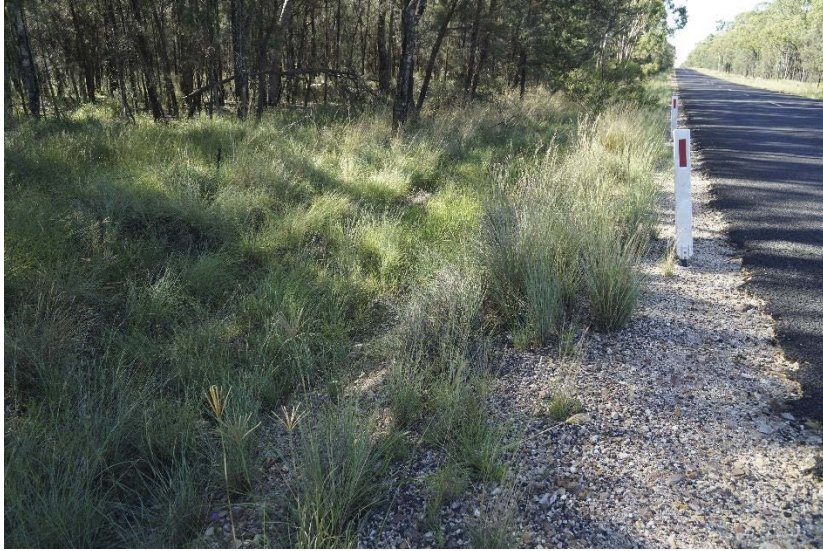
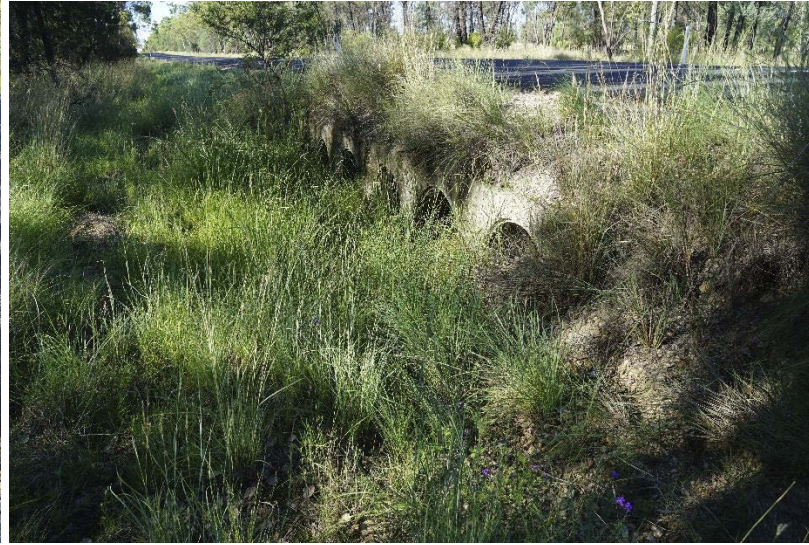
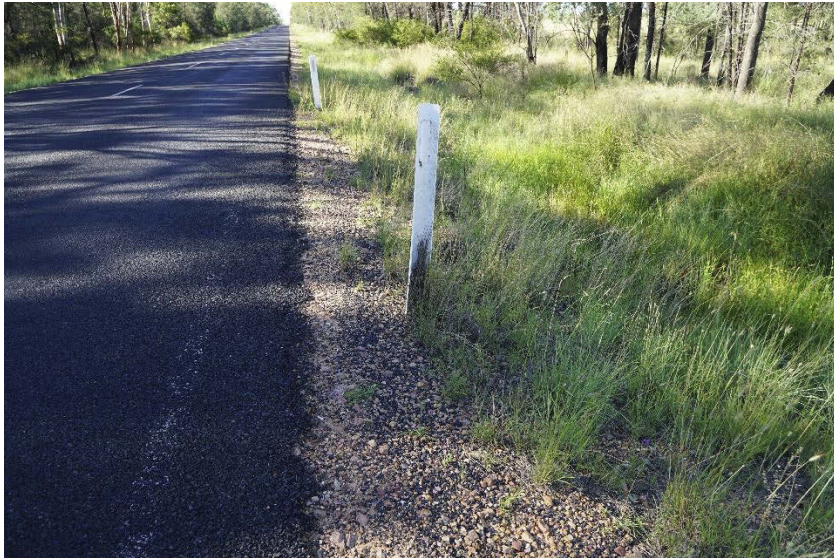
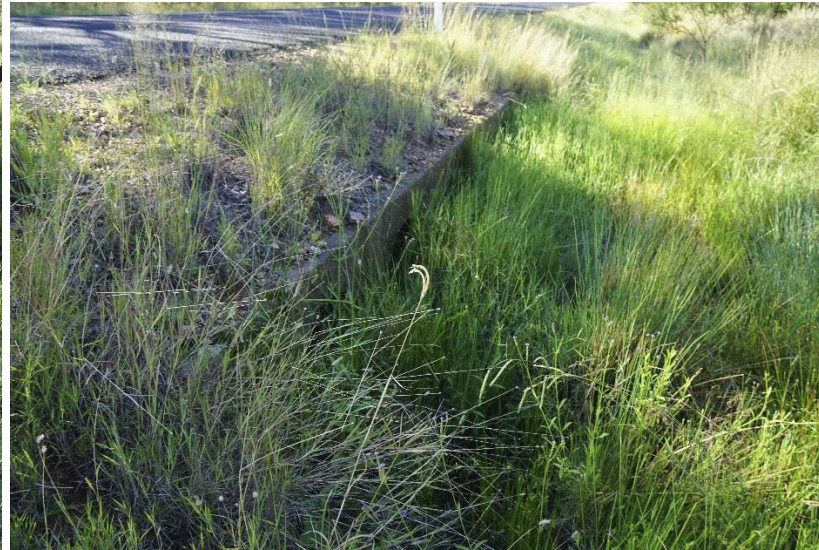
F. 47 EP33 photographs. Panorama upstream (top), panorama downstream (middle), upstream detail (bottom left), downstream detail (bottom right).

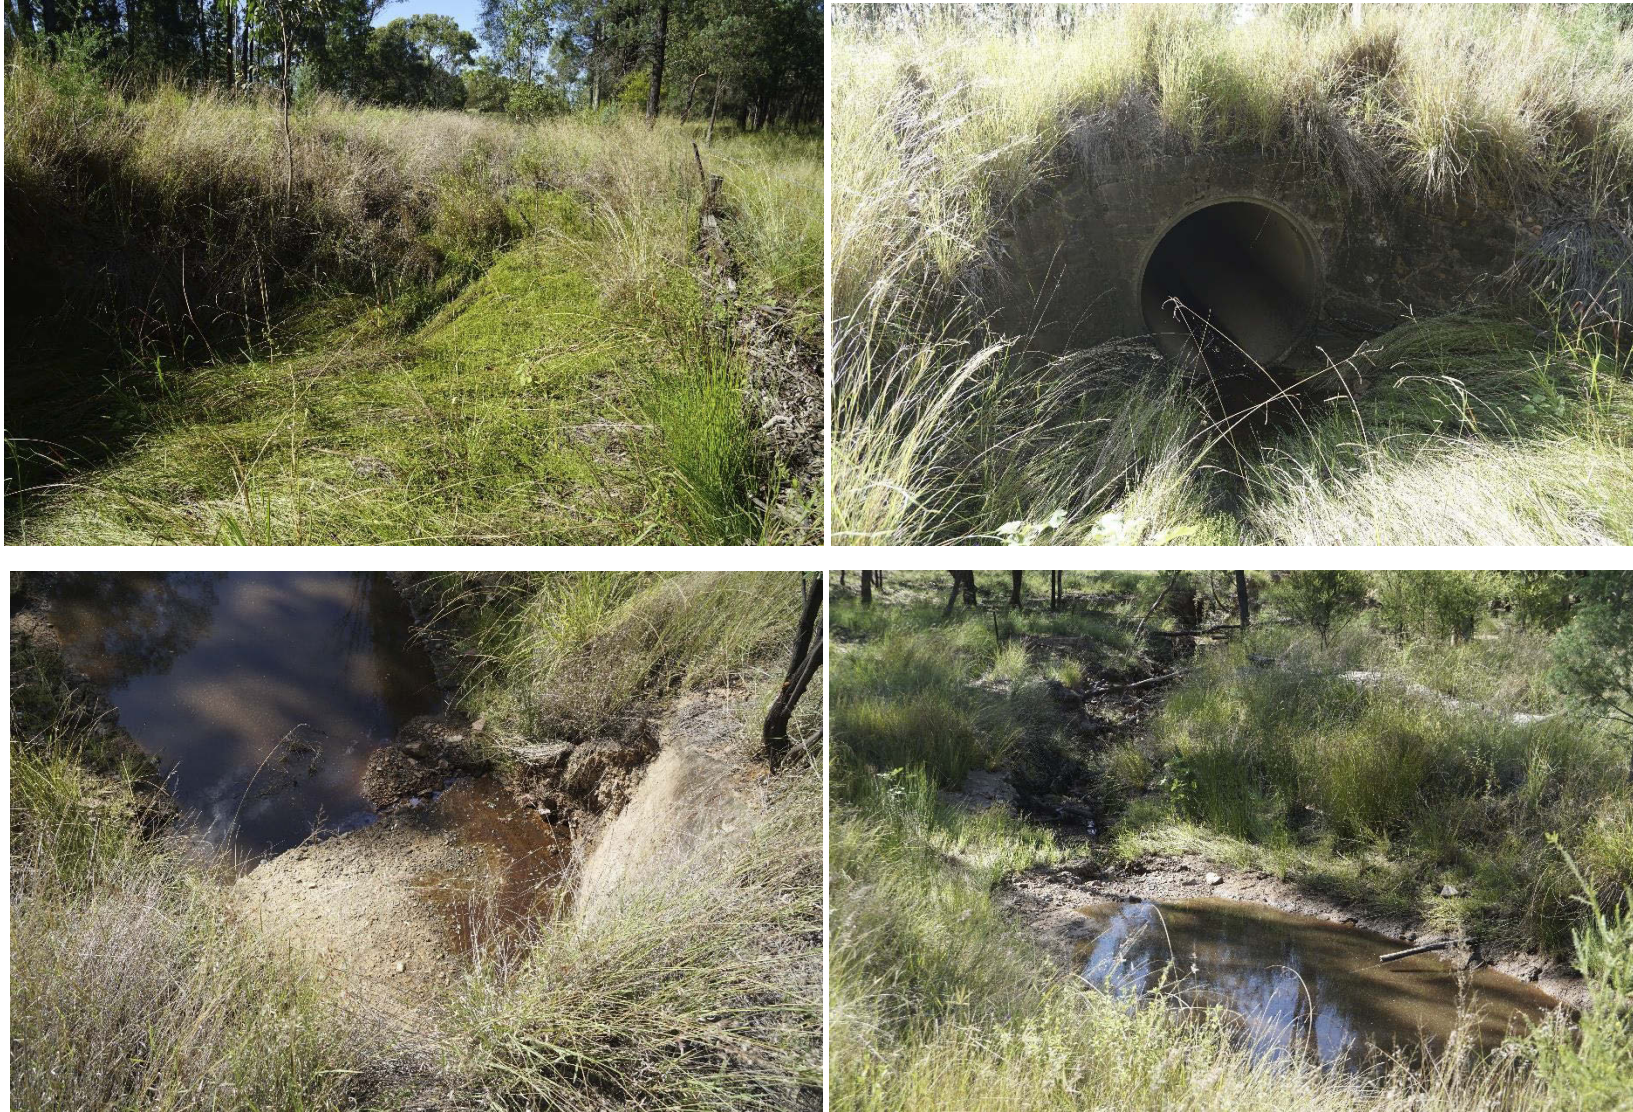
F. 48      EP36 photographs. Upstream (top left), upstream detail (top right), downstream (bottom left), downstream detail (bottom right).

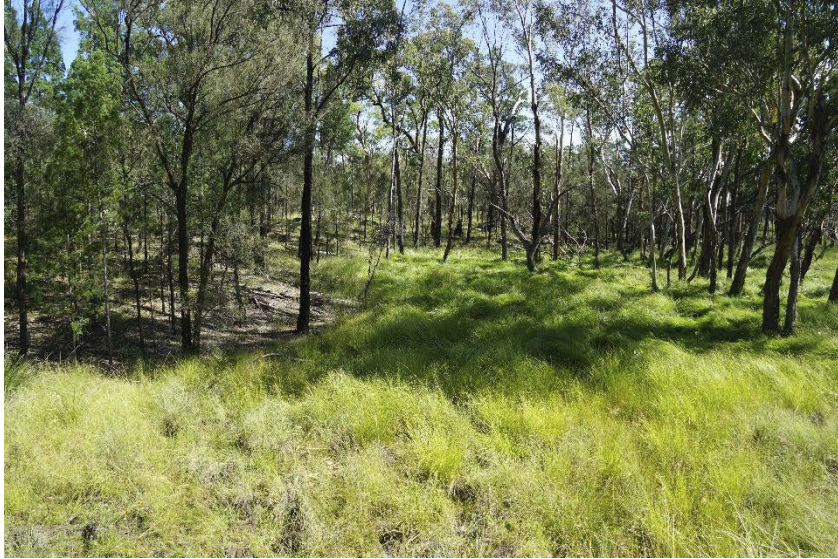
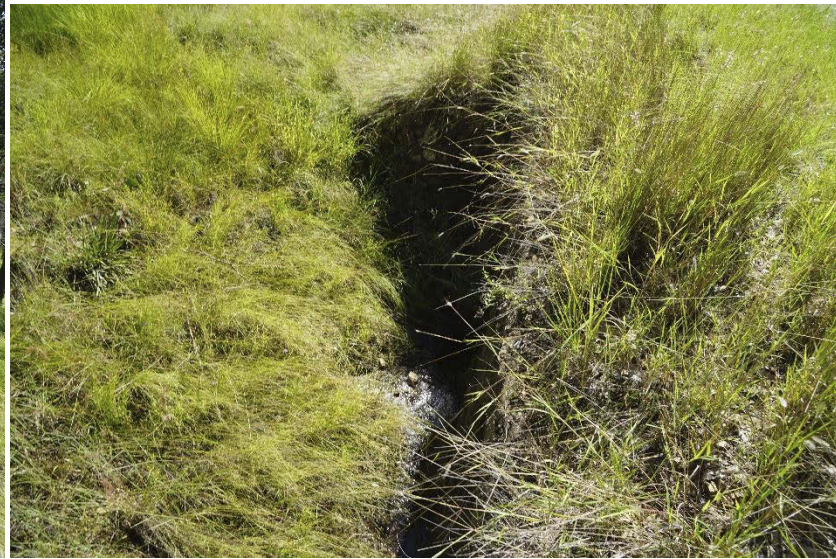
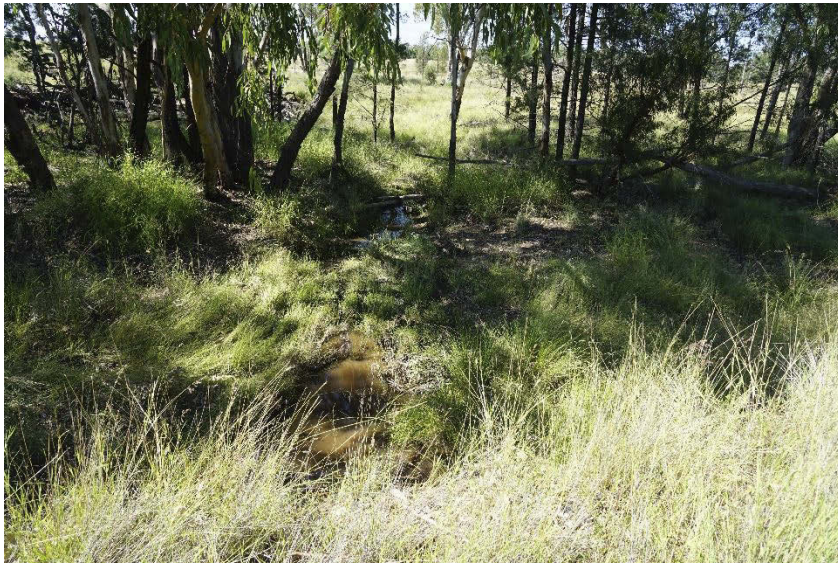
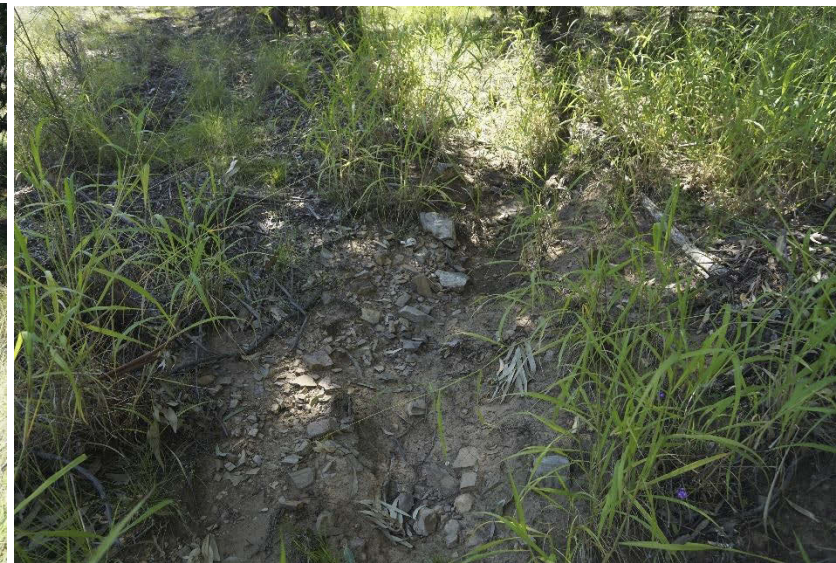
F. 49 EP37 photographs. Upstream (top left), upstream detail (top right), downstream detail 1 (bottom left), downstream detail 2 (bottom right).

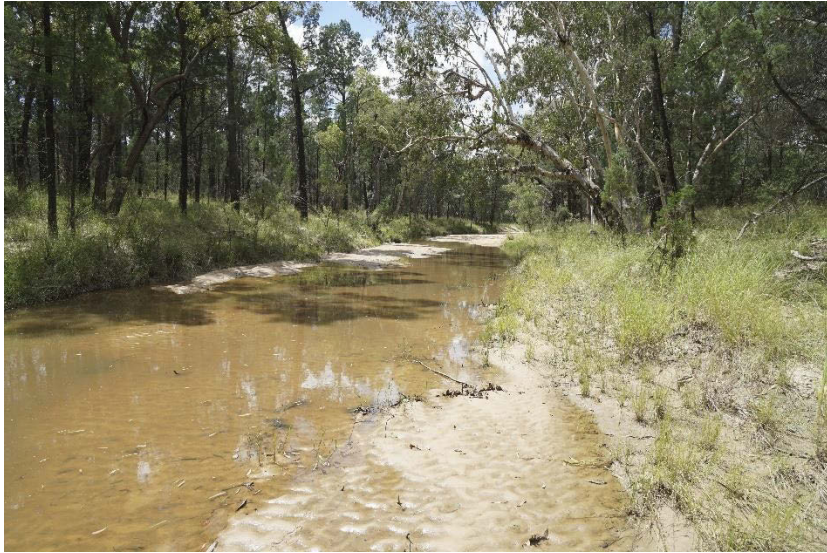
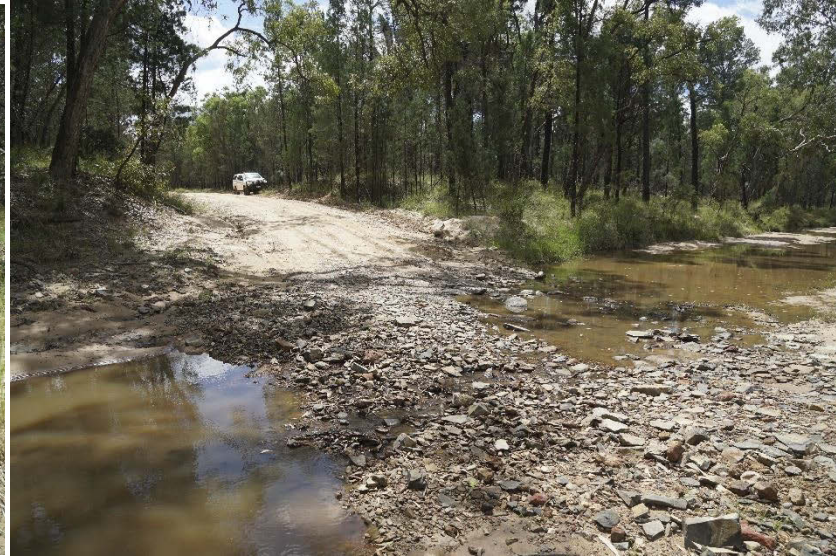
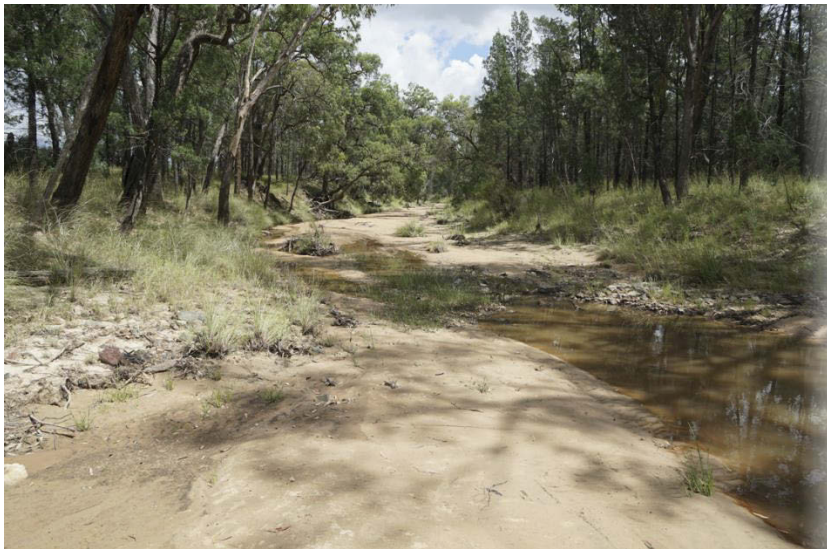
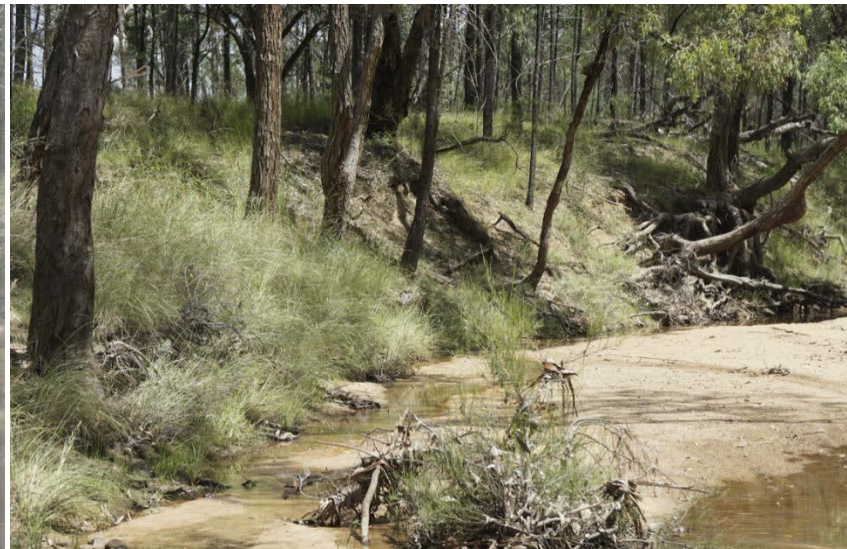
F. 50 EP38 photographs. Upstream (top left), upstream detail (top right), downstream (bottom left), downstream detail (bottom right).

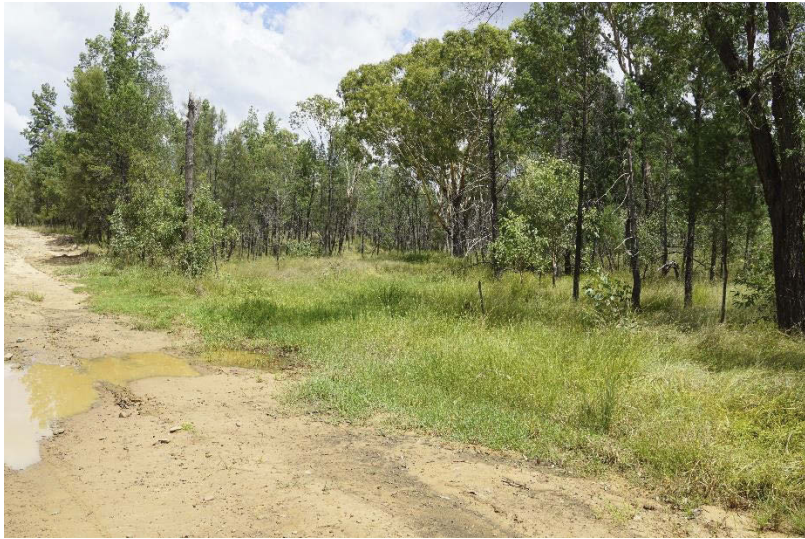
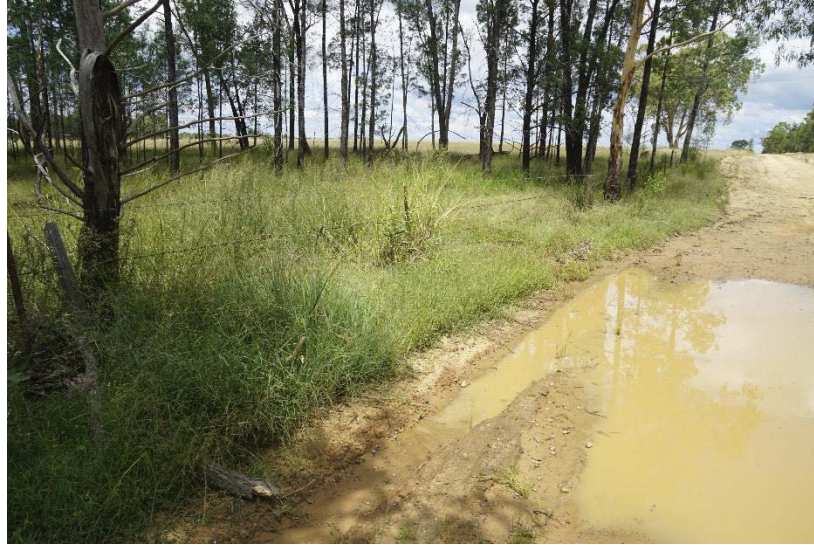
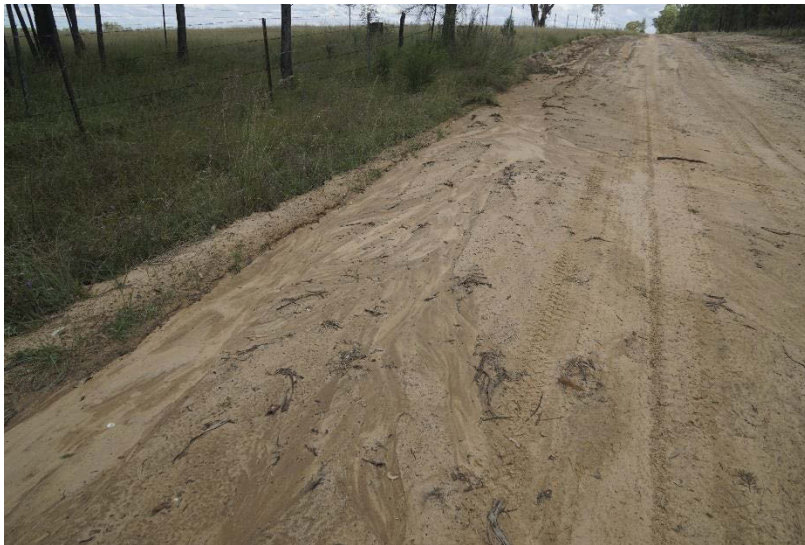
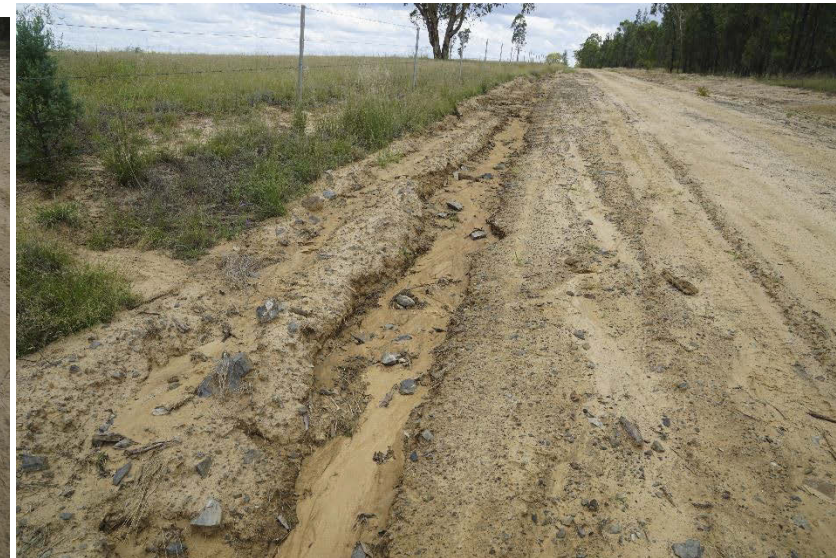
F. 51 4/EP40 photographs. Upstream (top left), ford (top right), Downstream (bottom left) downstream detail of scour in banks (bottom right).
