**BORDER TO GOWRIE** REVISED DRAFT ENVIRONMENTAL IMPACT STATEMENT

## Geomorphology Report

## Baseline field inspection site records and photos

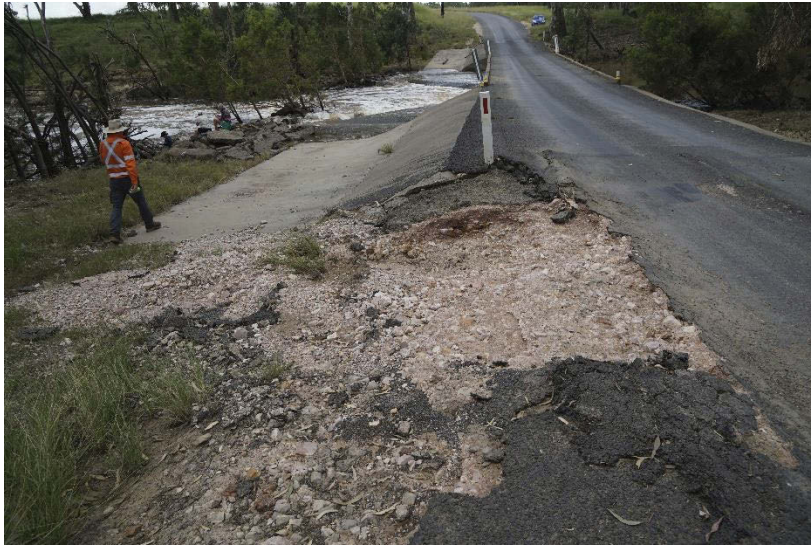
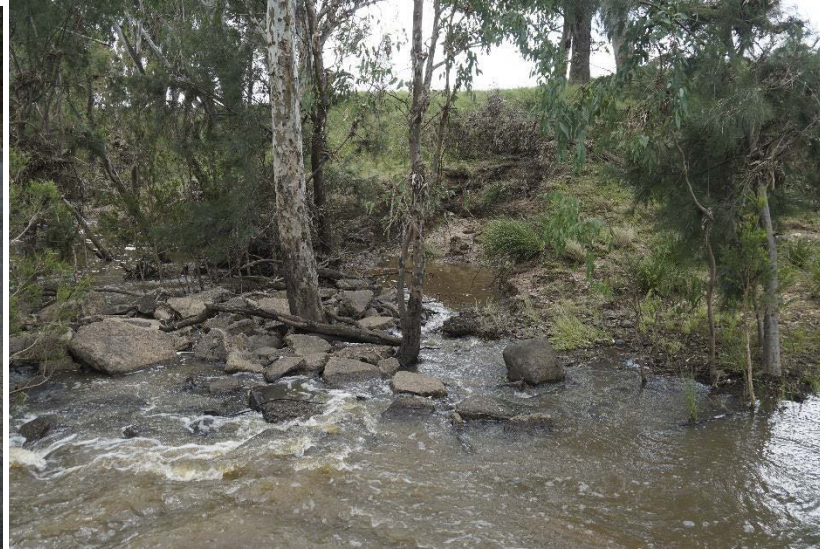
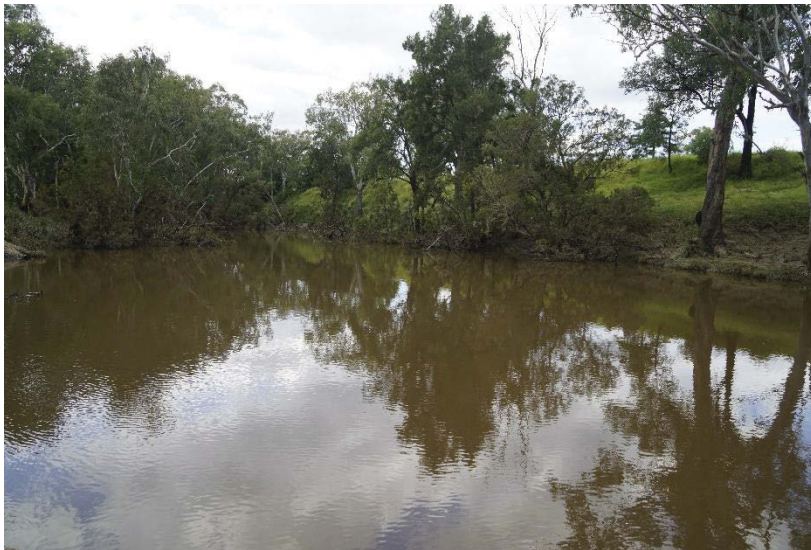
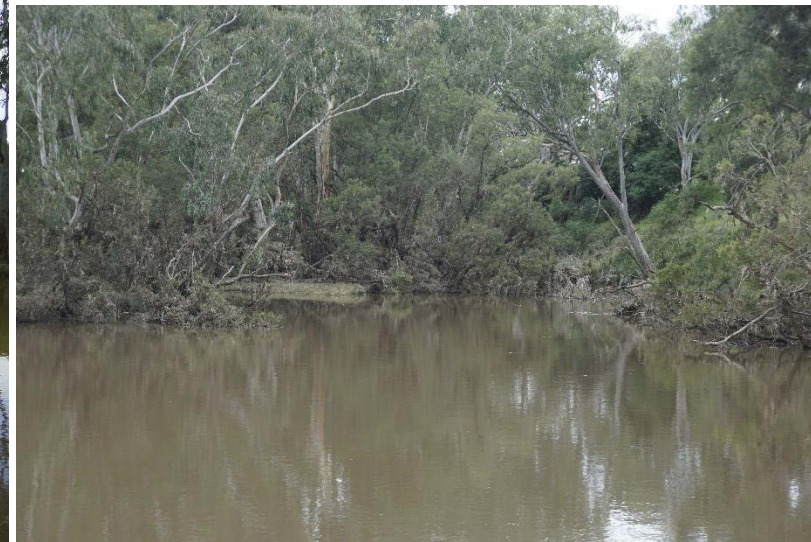
F. 52      EP41 photographs. Upstream (top left), downstream (top right), sand on road (bottom left and right).

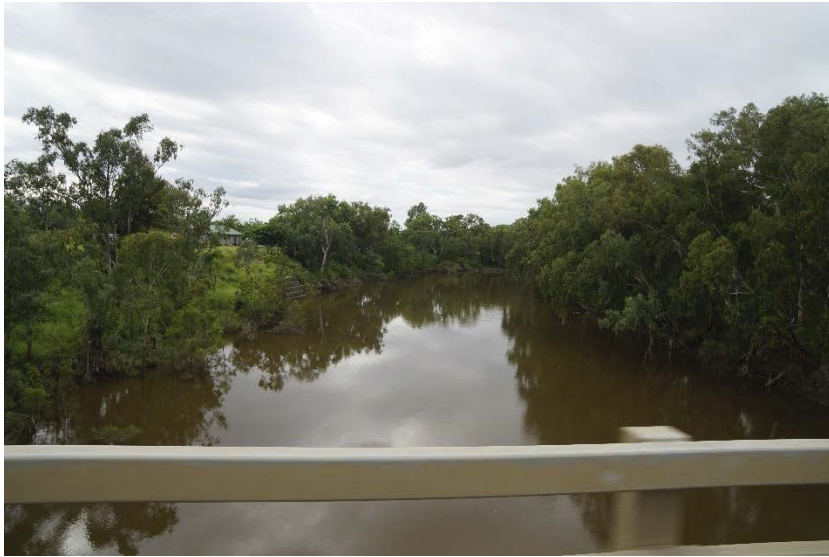
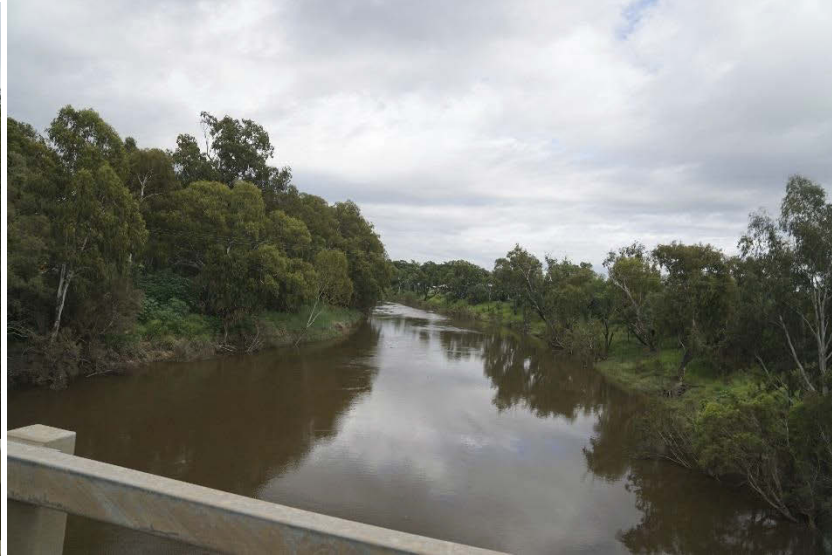
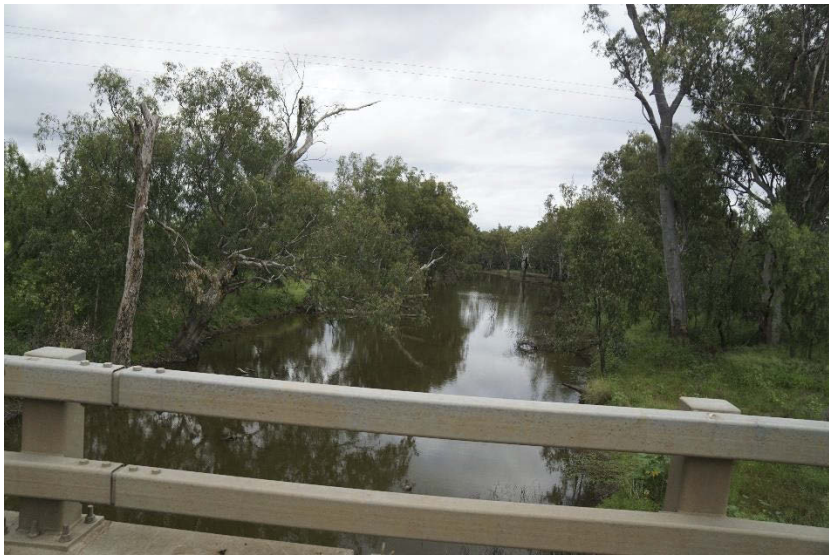
F. 53      EP42 photographs. Downstream (top left), downstream detail (top right), upstream (bottom left), upstream detail (bottom right).

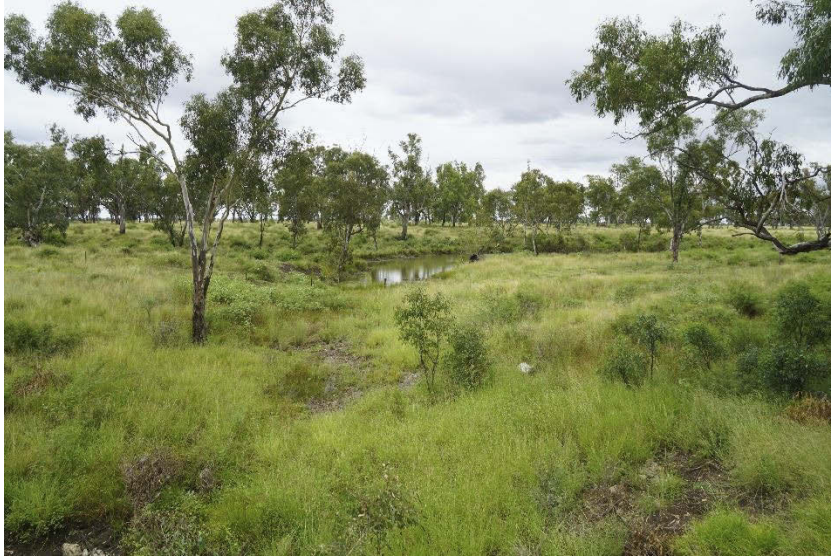
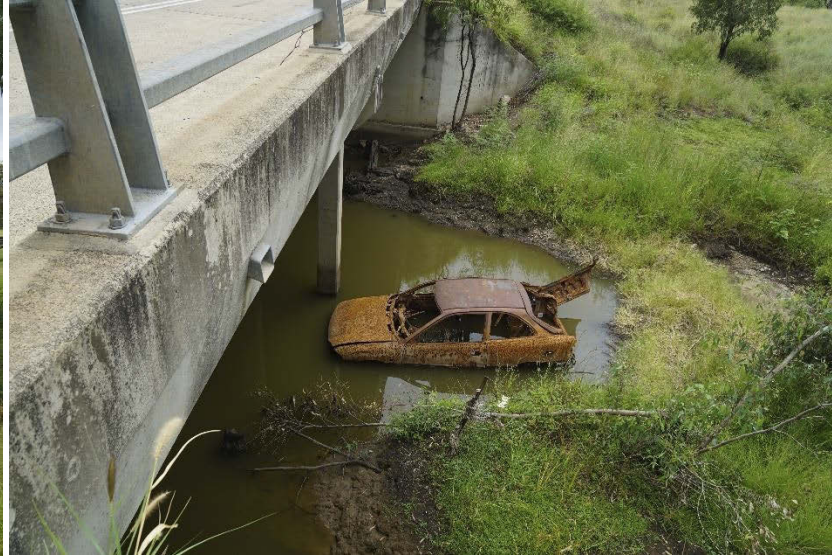
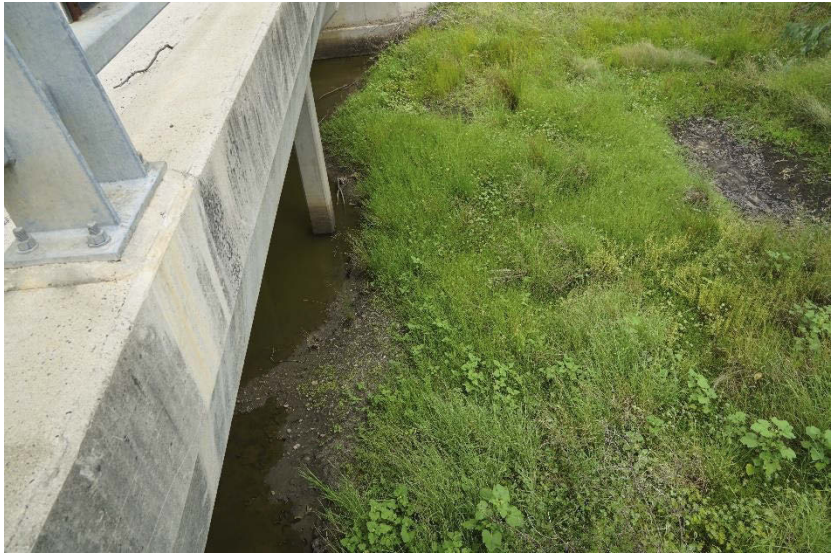
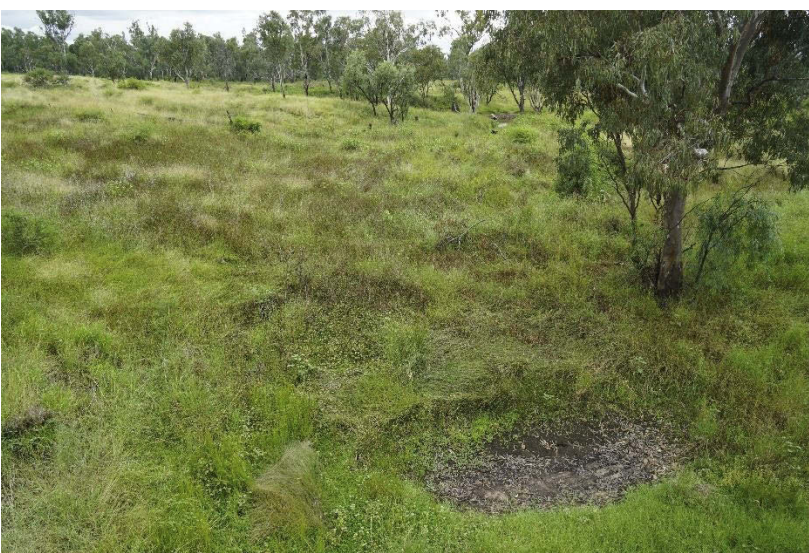
F. 54      EP43 photographs. Downstream northern bridge (top left), upstream northern bridge (top right), downstream southern bridge (bottom left)

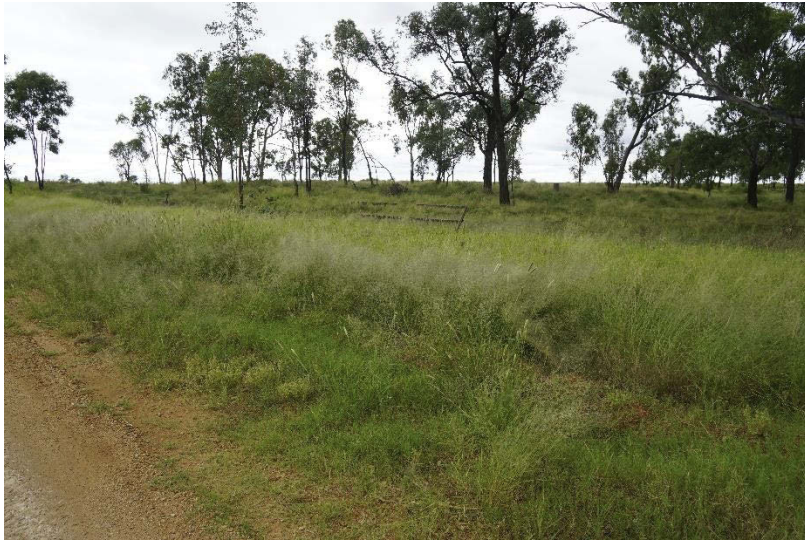
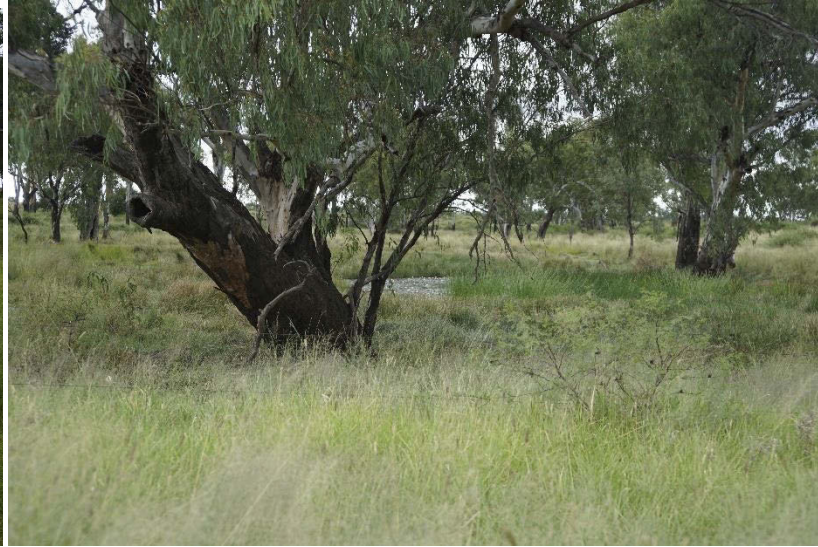
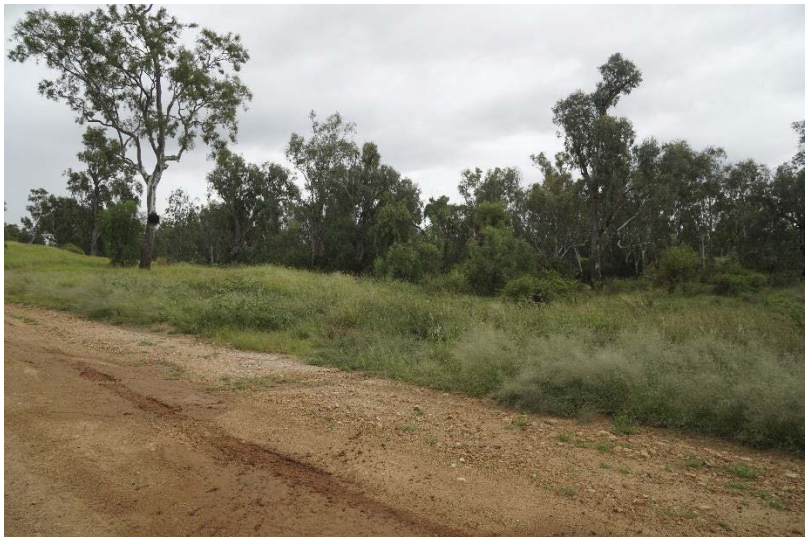
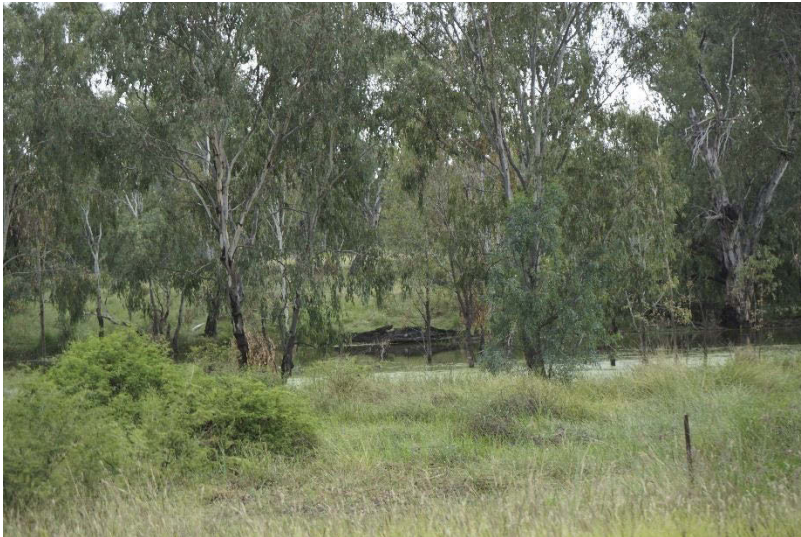
F. 55 EP44 photographs. Upstream (top left), upstream detail (top right), downstream detail (bottom left), downstream (bottom right).

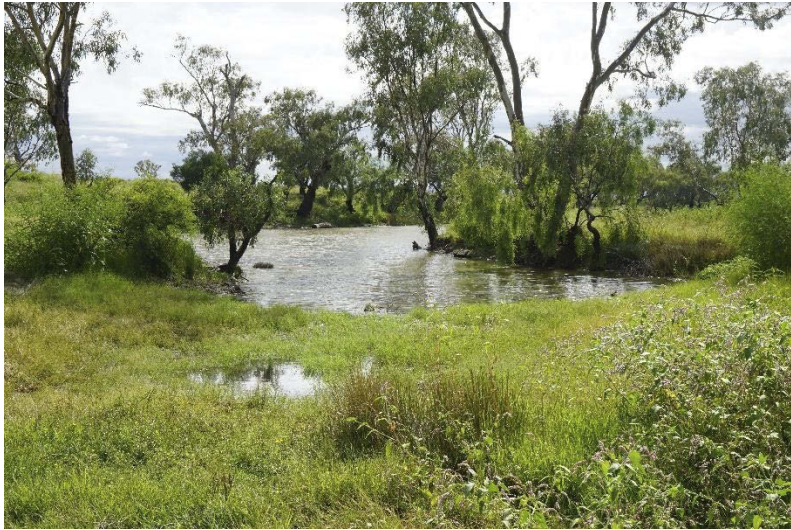
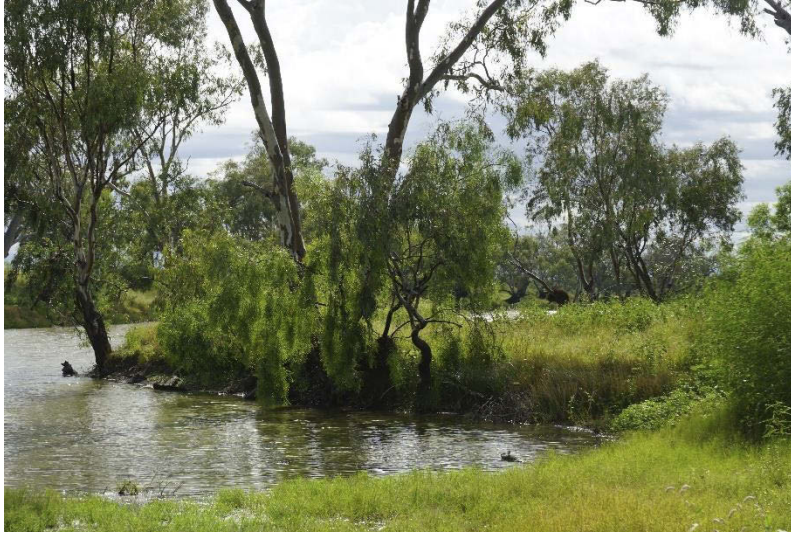
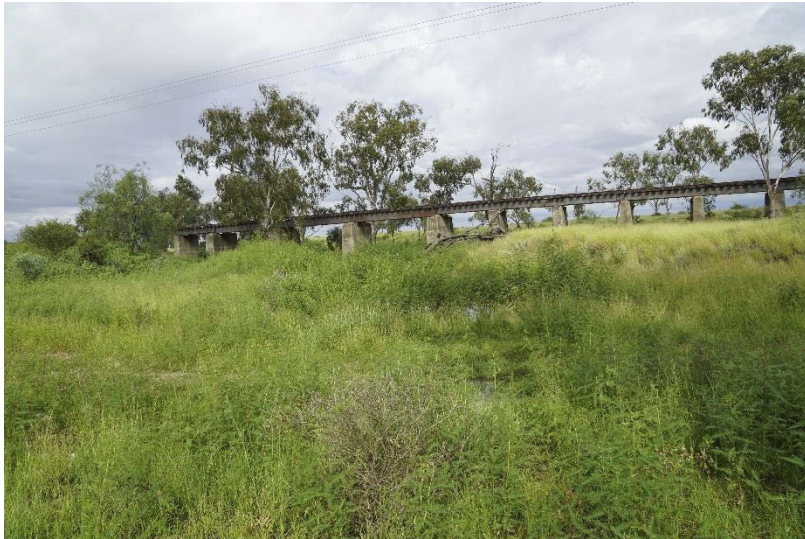
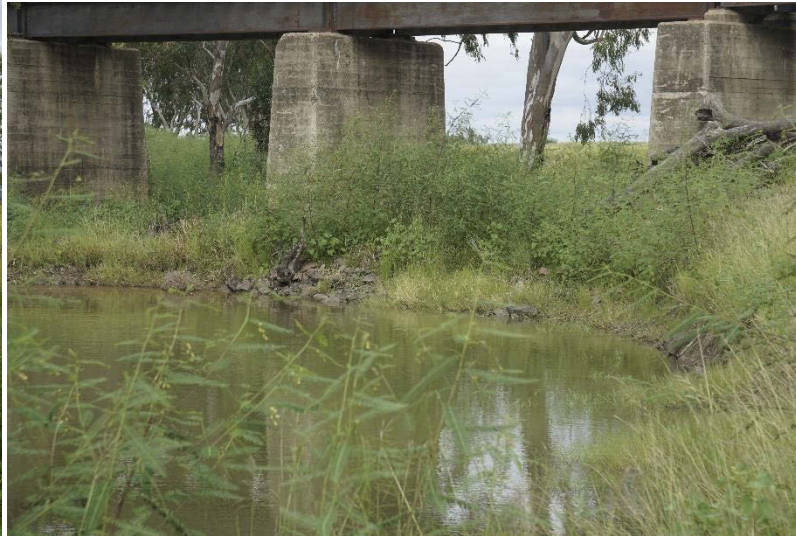
F. 56 EP44a photographs. Upstream (top left), upstream detail (top right), downstream (bottom left), downstream detail (bottom right).

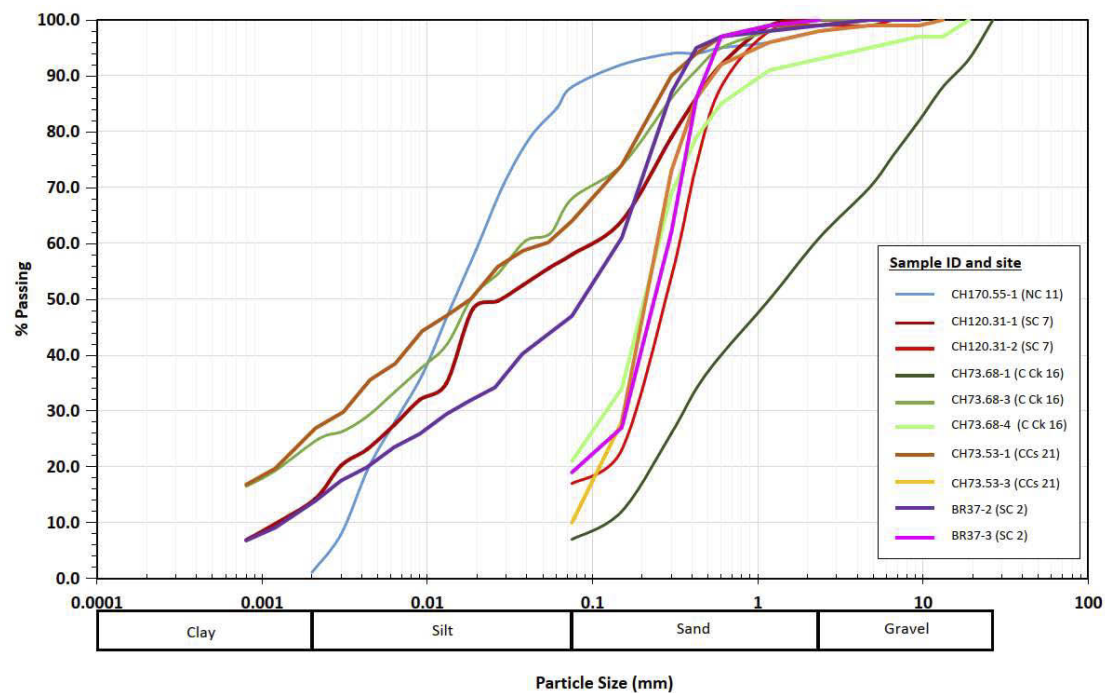
Figure I.1 Particle size distribution testing results for all high-risk sites

Two distinct material types based on particle size were common across most of the sites, a fine to medium grained sand and a sandy silt/clay. The bank material for each site described in the sections below is based on the behaviour type as assessed by Atterberg limit testing, rather than the particle size.

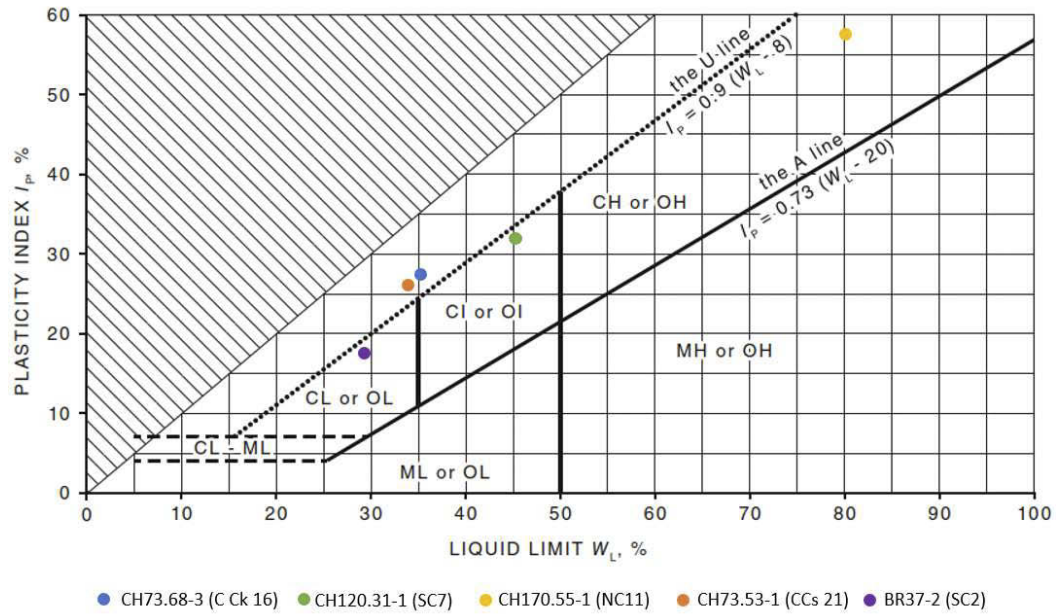
Figure I.2 Atterberg limit testing results

Results from the Atterberg limit testing are presented in Figure I.2. All samples tested plot above the A line on the graph therefore all behave as clay rather than silt. Four of the samples are low plasticity clays and one (site NC11) is a high plasticity clay.

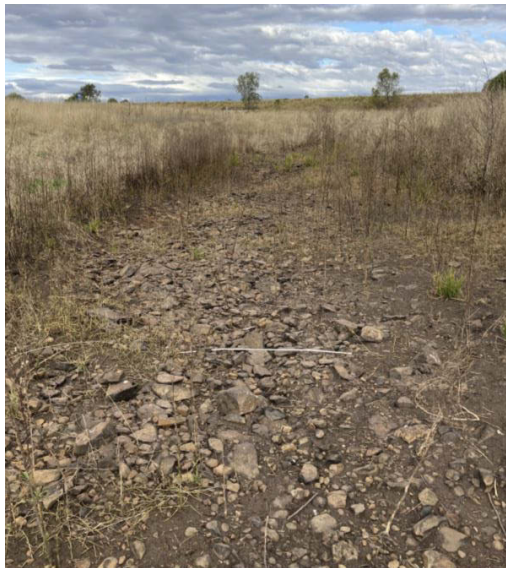
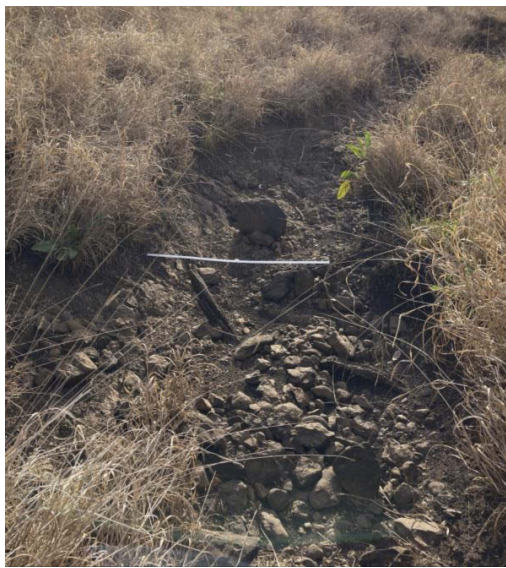
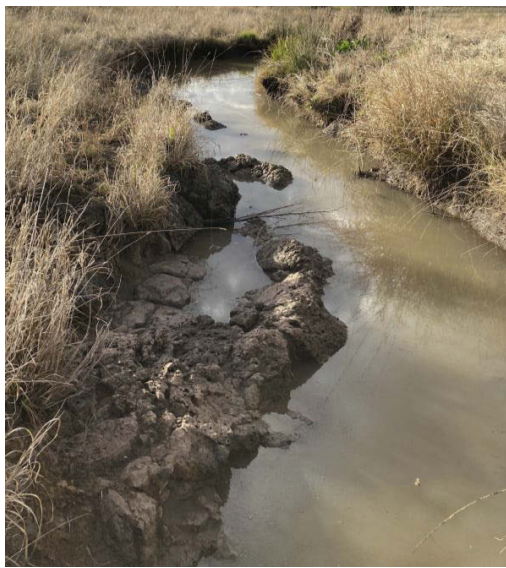
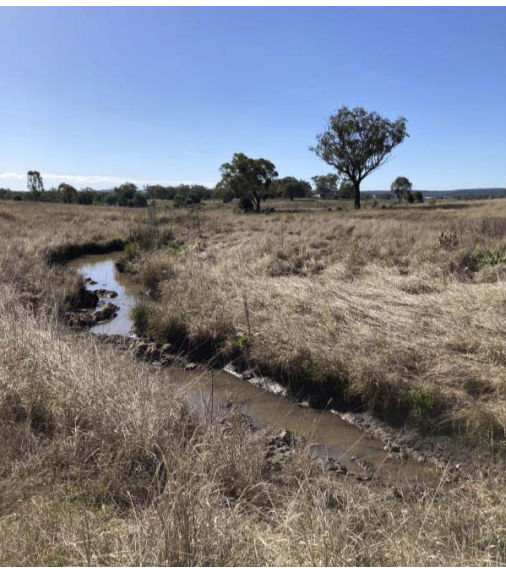
| P1 – looking upstream from entrance into pond | P2 – looking downstream from upstream of culvert location, 1 m staff for scale | P3 – looking downstream from downstream near culvert location | P4 – main channel looking obliquely downstream |

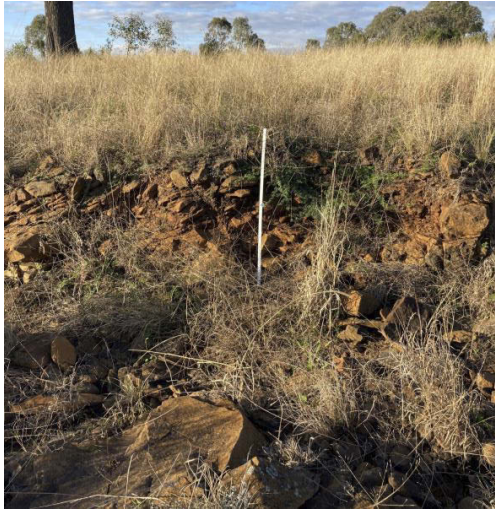
P5 – rock lined bank on true right downstream of culvert, 1 m staff for scale

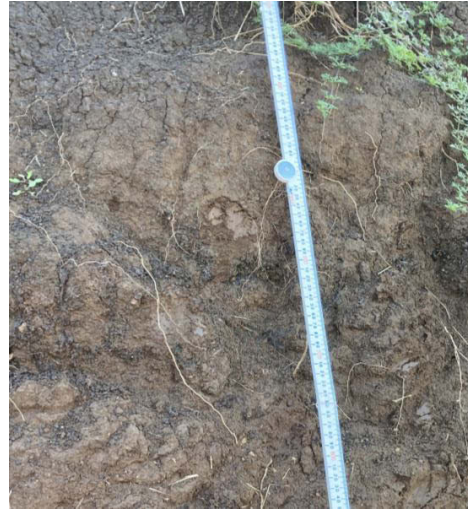
P6 – silty CLAY bank on true left downstream of culvert. Sample 1 & 2.

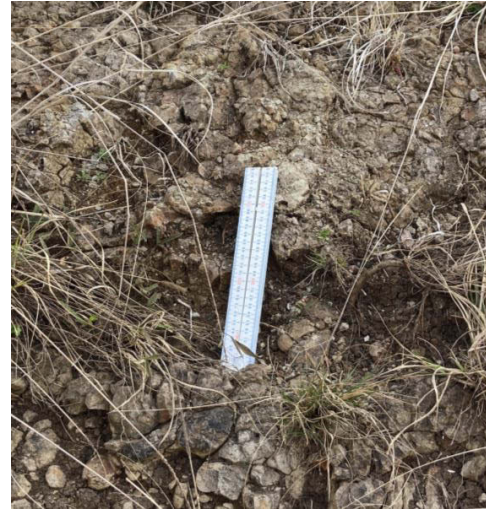
P7 – weathered rock bank near culvert, 0.25 m white staff for scale

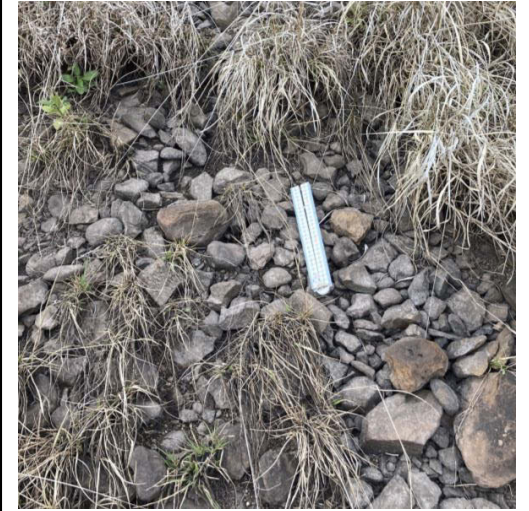
P8 – gravel bed material upstream of culvert, 0.25 m white staff for scale

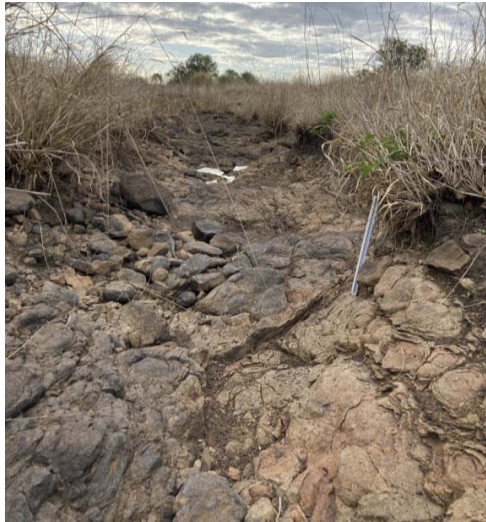
P9 – rock lined channel bed near culvert, 0.25 m white staff for scale

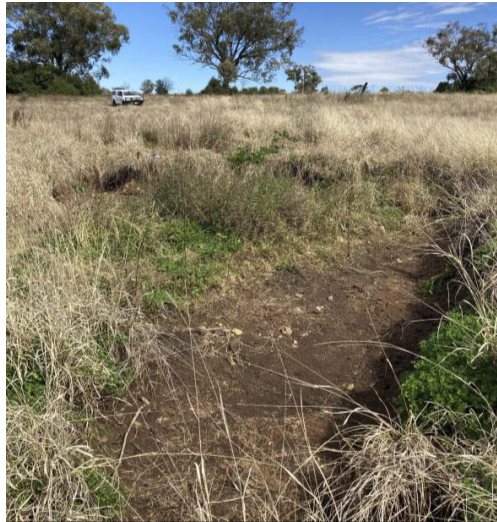
P10 – eroded area in soil downstream from culvert (site E2)

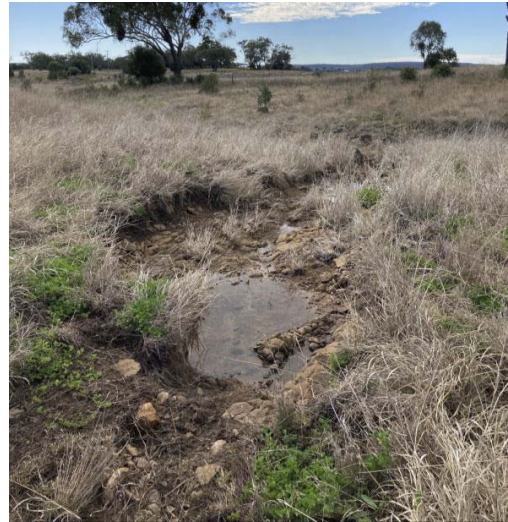
| Contemporary Channel Morphology | Bed and Bank Material | Vegetation | Erosion Observations | Manning's roughness 'n' |
|---|---|---|---|---|
| Narrow, shallow channel with some sections well defined. Flow has been diverted into manmade pond. Flattened vegetation downstream of pond indicates recent overland flow outside of the main channel. | Bed and bank material differs along channel, it varies between rock (basalt), silt, gravel and grassed sections. See Figure 13 in Drawing set E for details. | Channel is partially grassed. Floodplain is grassed pasture with sparse established trees. | Generally stable. Two areas of bank erosion observed downstream see photo P10 and P11 below. | 0.030 – 0.035<br><br>Some grass/weeds, little or no brush<br><br>Theoretical 'n' = 0.0325* |

P11 – bank erosion in soil above rock lined channel downstream from culvert (site E3)

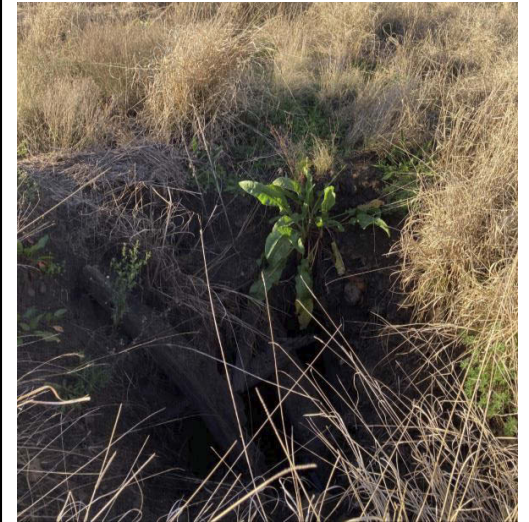
P12 – 2 m x 2 m hole within floodplain, may not be natural (site E4)

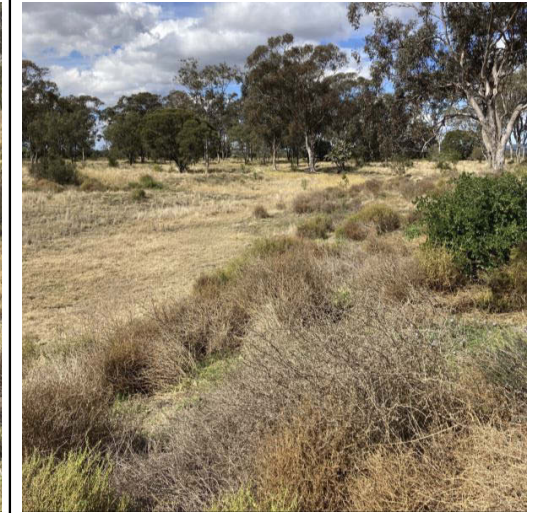
P8 – looking downstream from true right of pond. Area of historic scour identified in aerial images.

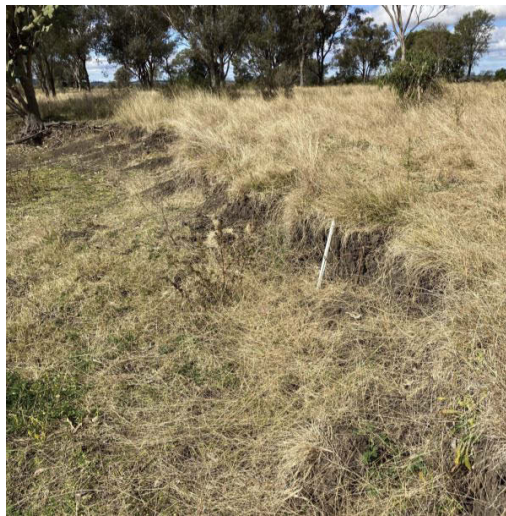
P9 – erosion on true right bank downstream of pond (not in main channel). 0.5 m staff for scale.

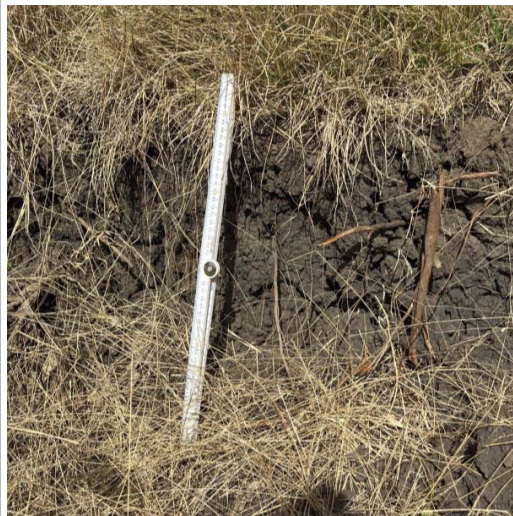
P10 – close up of erosion on true right bank downstream of pond. 0.5 m staff for scale (site E1)

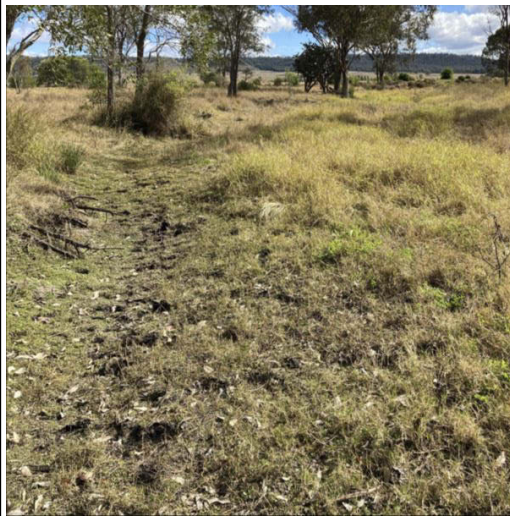
P11 – downstream from bank erosion, looking upstream towards pond

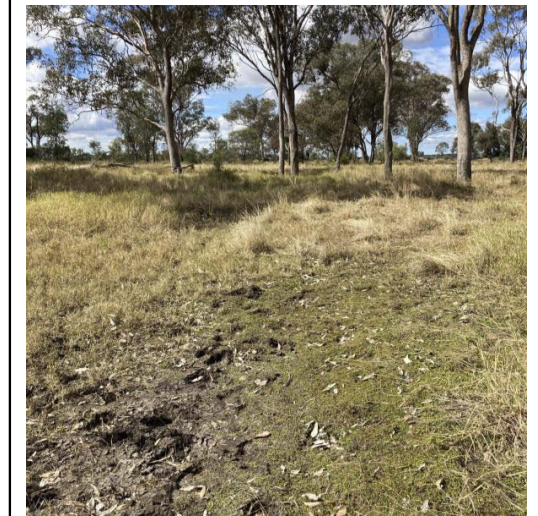
P12 – downstream from bank erosion, looking downstream

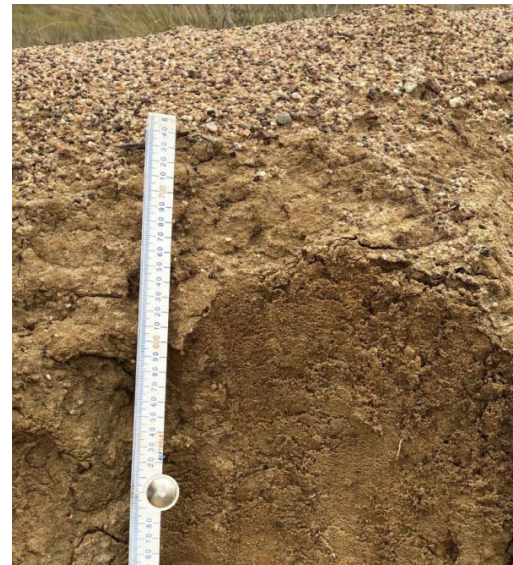
| P1 – looking downstream from proposed culvert site | P2 – looking upstream from downstream extent of proposed culvert location | P3 – looking downstream from upstream extent of proposed culvert location | P4 – example of bank material exposed. Silty sand with eroded duricrust on top. Sample 4 location. |

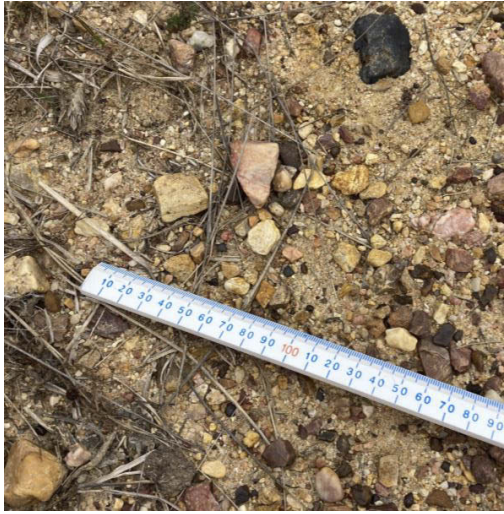
P5 – gravel armouring on bank, derived locally from erosion of duricrust

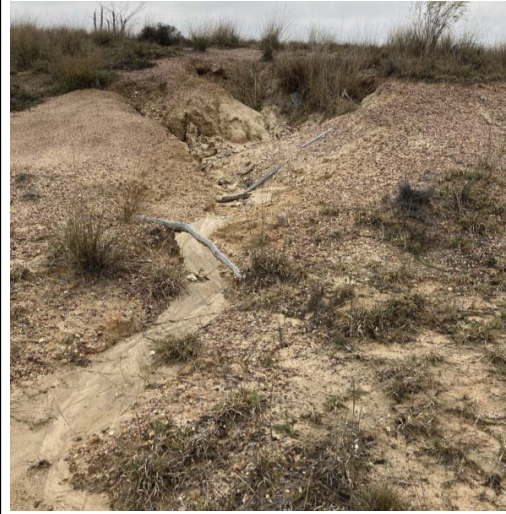
P7 – bank erosion upstream of proposed culvert (site E6)

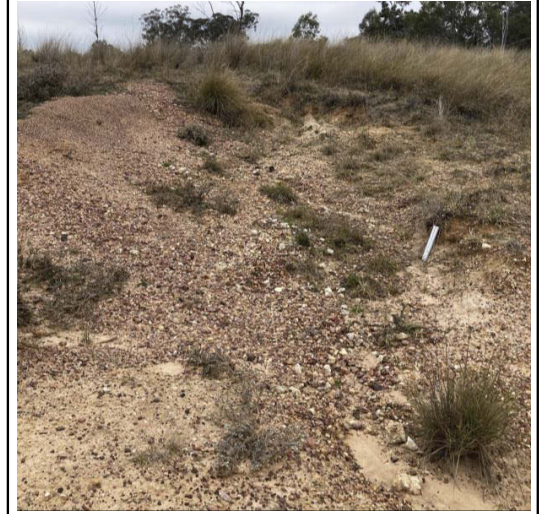
P8 – bank erosion downstream of proposed culvert (site E2)

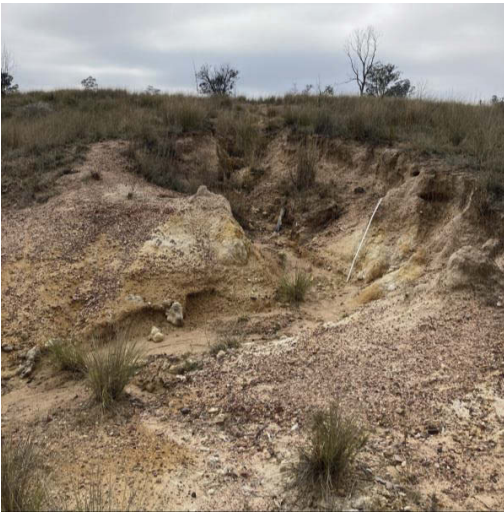
P9 – gully erosion downstream of proposed culvert (site E3)

The main geomorphic process at this site is gully erosion. Most of the gully is grassed however there are approximately 10 areas of bare ground on the banks and side gullies. These are typically < 150 m<sup>2</sup> in area and showed evidence for rainsplash and sheetwash erosion. These areas are illustrated and described within Revised draft EIS Geomorphology technical report, on Figure 9 in Drawing set E, Appendix A with photos in Appendix J. Two photos from Appendix J are included in Figure 3.

Figure 3 C Ck 16 site photos. Left, Photos P3 – looking downstream towards proposed culvert location. Right, Photo P9 – gulley erosion on side gully downstream of Project alignment, just outside the earthworks area.

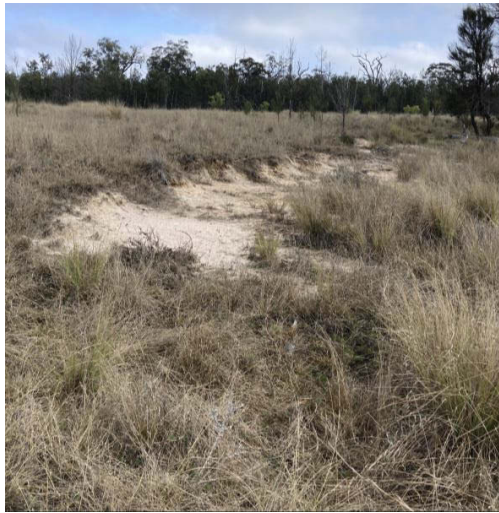
P10 – bank erosion upstream of proposed culvert (site E4)

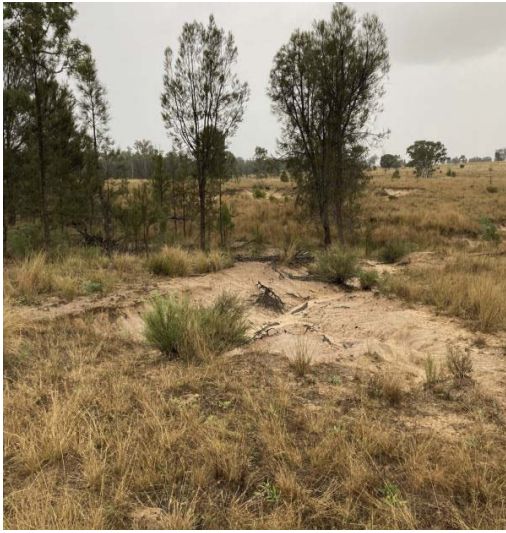
| P1 – looking downstream from proposed culvert site | P2 – looking upstream from proposed culvert location | P3 – looking northeast along alignment, illustrating erosion at culvert location | P4 - bank material. Sand overlaying sandy silty clay |

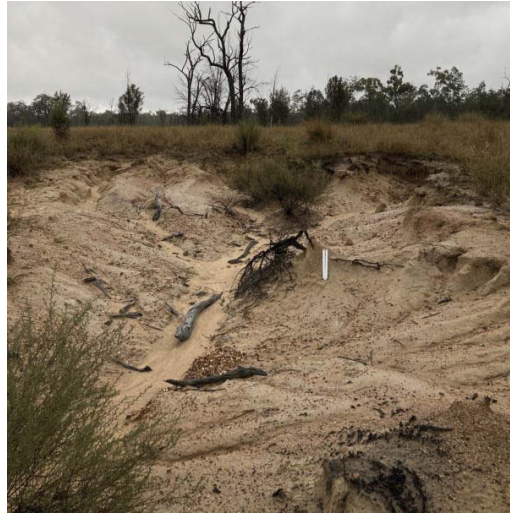
P7 – bank erosion on true left at culvert location, white staff for scale 0.5 m (site E12).

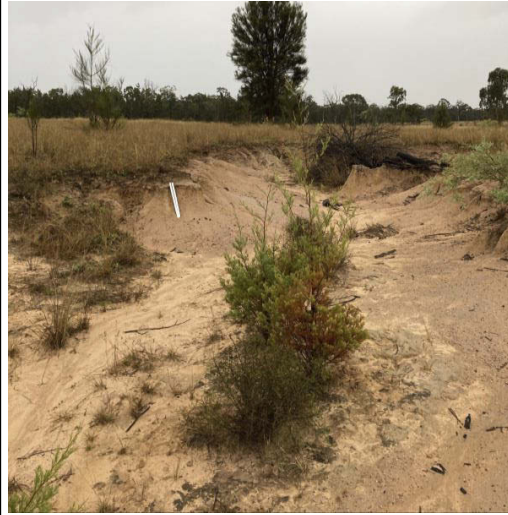
P8 – bank erosion on true left, downstream of culvert, white staff for scale 1.0 m (site E12)

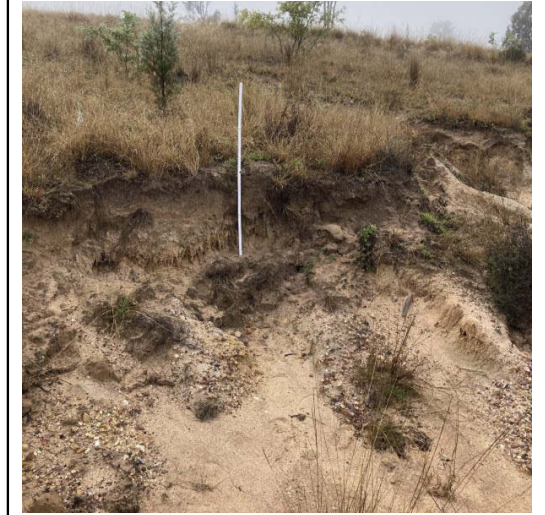
P9 – bank erosion on true right downstream of culvert, white staff for scale 1.0 m (site E14).

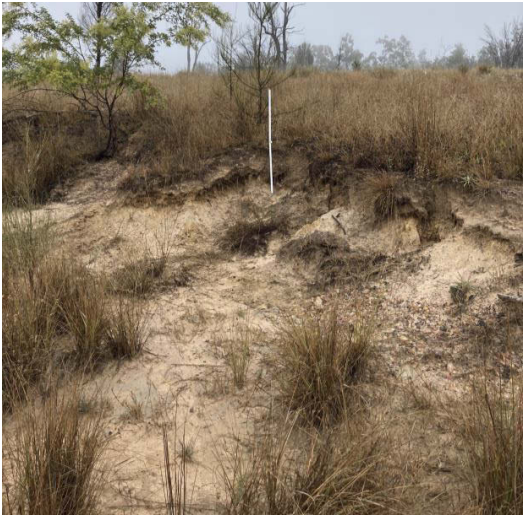
P10 – sample 1 location, true left bank culvert

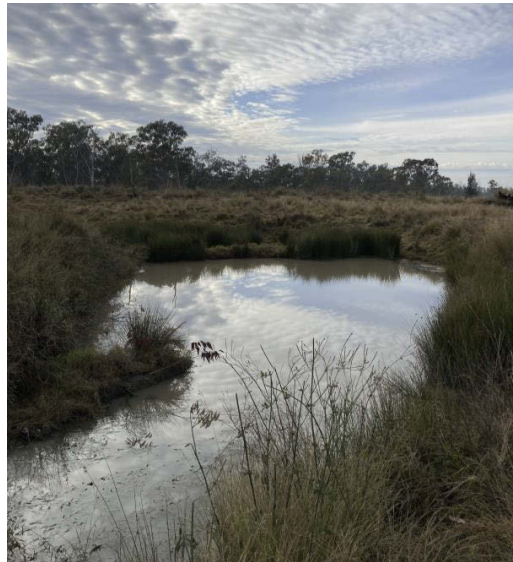
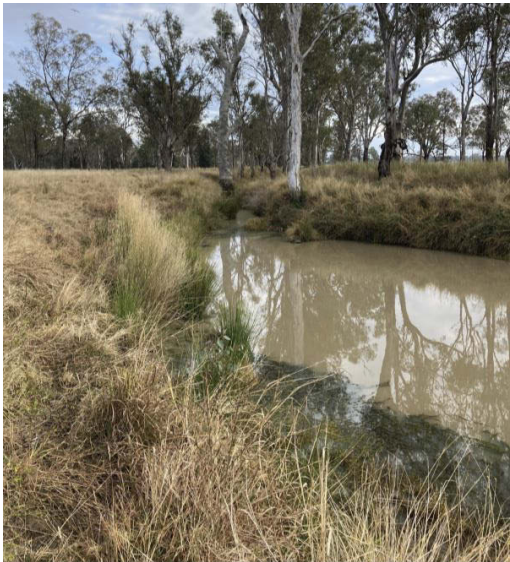
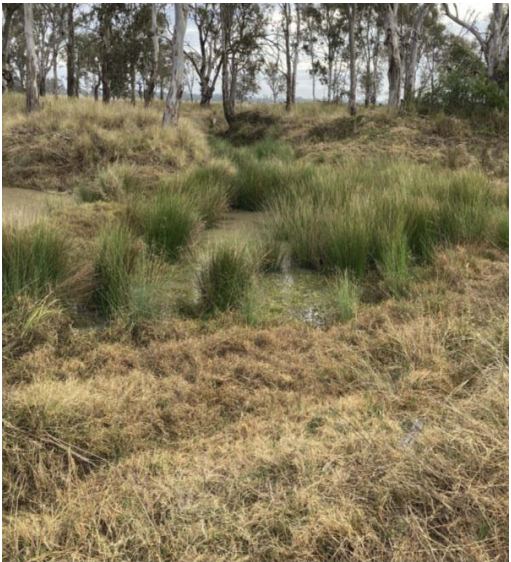
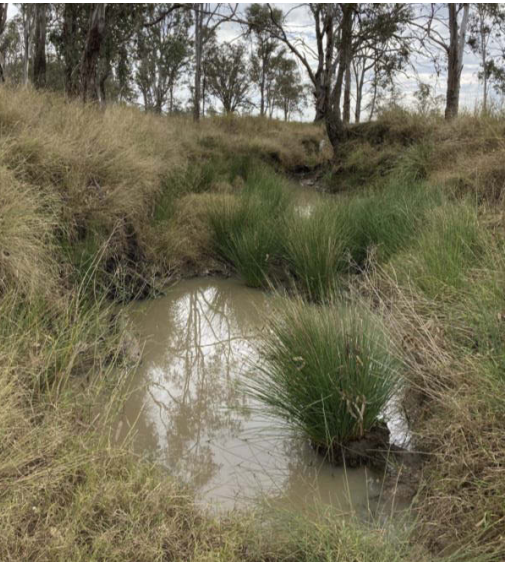
| P1 – looking downstream at meander bend, with manmade embankment | P2 – looking upstream from the meander bend | P3 – looking downstream from meander bend corner | P4 – looking downstream from meander bend |

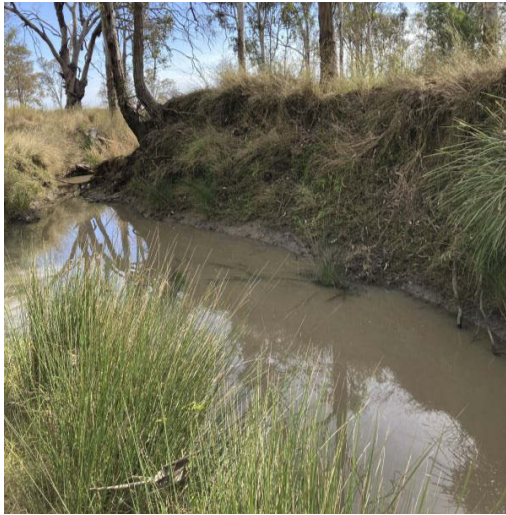
P6 – sand deposition on inside of meander bend (site D1)

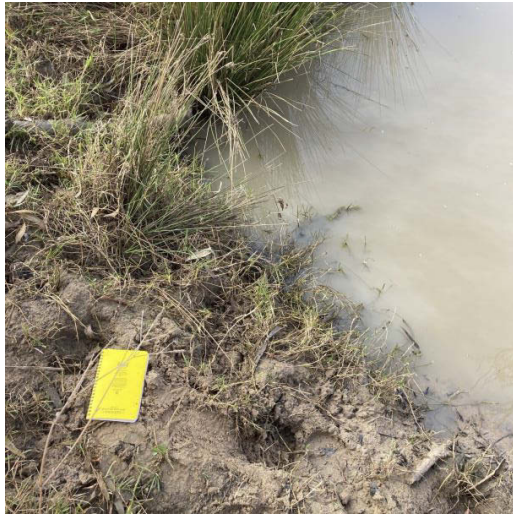
P7 - bed material downstream of meander bend, silt with gravel and cobble armouring

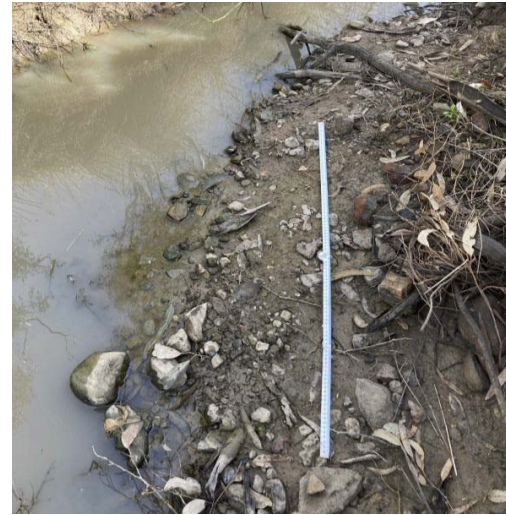
P8 – bank material sample downstream of meander bend (sandy silty clay) – sample 2

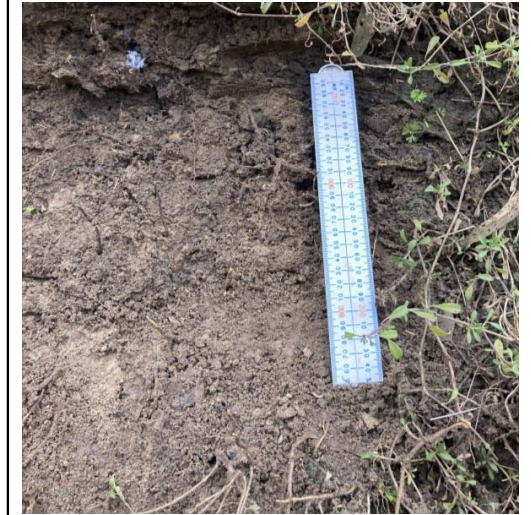
P9 – bank material in area of meander bend (silty sand) – sample 3

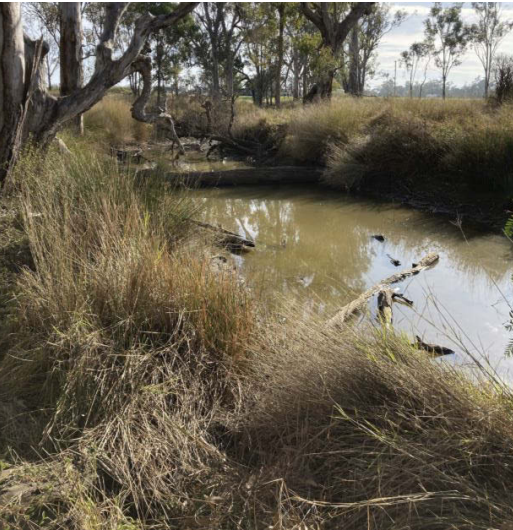
P11 – erosion at bend downstream of meander bend (site E2)

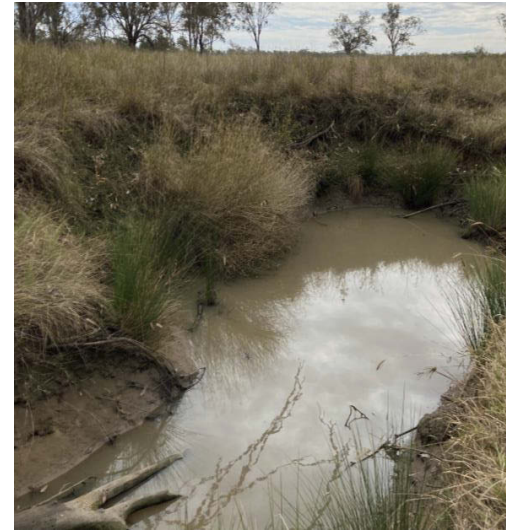
P12 – sand bar & woody debris deposition within channel downstream of meander bend (site D2)

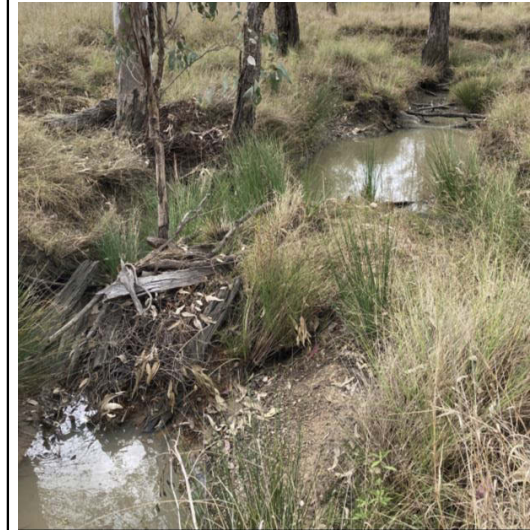
P13 – erosion at bend downstream of meander bend (site E3)

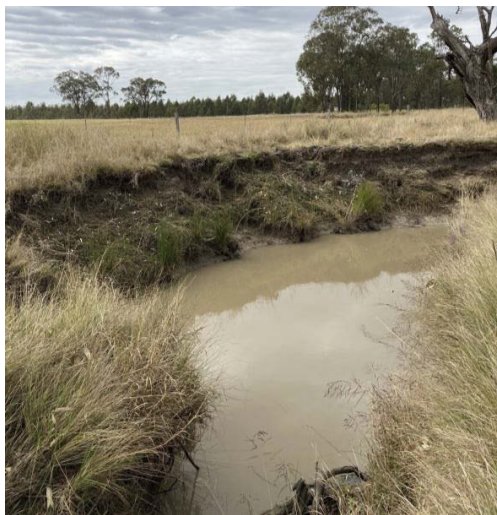
P14 – in channel vegetated sand bar upstream of meander bend (ICB2)

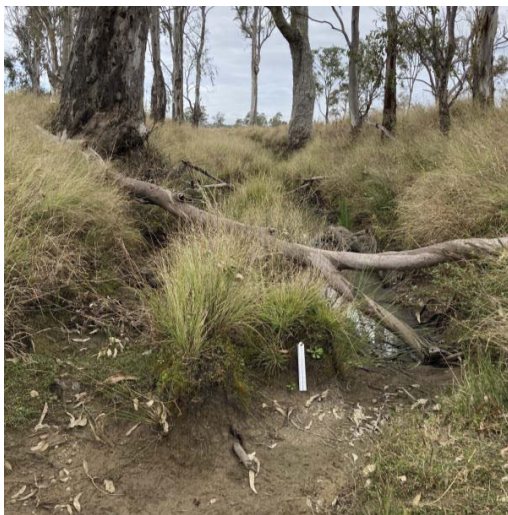
P15 – upstream of road culvert, looking downstream

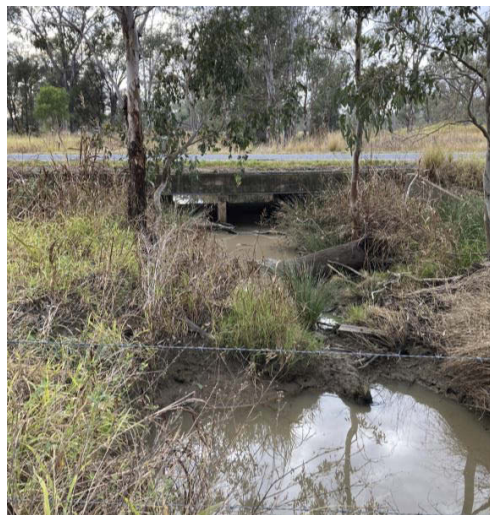
P16 – bank erosion downstream of road culvert (site E4)

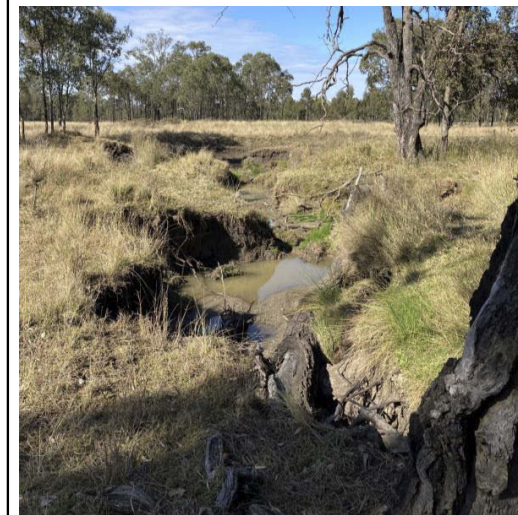
P17 – downstream of road culvert area of channel that has been naturally dammed (site E4)
