**BORDER TO GOWRIE** REVISED DRAFT ENVIRONMENTAL IMPACT STATEMENT

## Geomorphology Report

## Baseline field inspection site records and photos

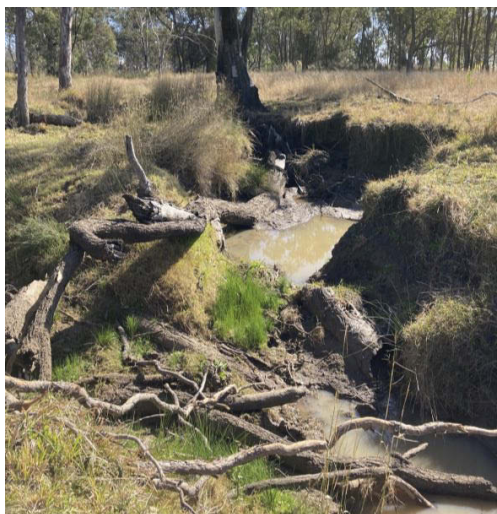
P18 – bank erosion and slumping downstream of road culvert, 1 m white staff for scale (site E4)
