## Riverbank Erosion Assessment

**Cardno (Qld) Pty Ltd**

## NORTHEAST BUSINESS PARK RIVERBANK EROSION ASSESSMENT

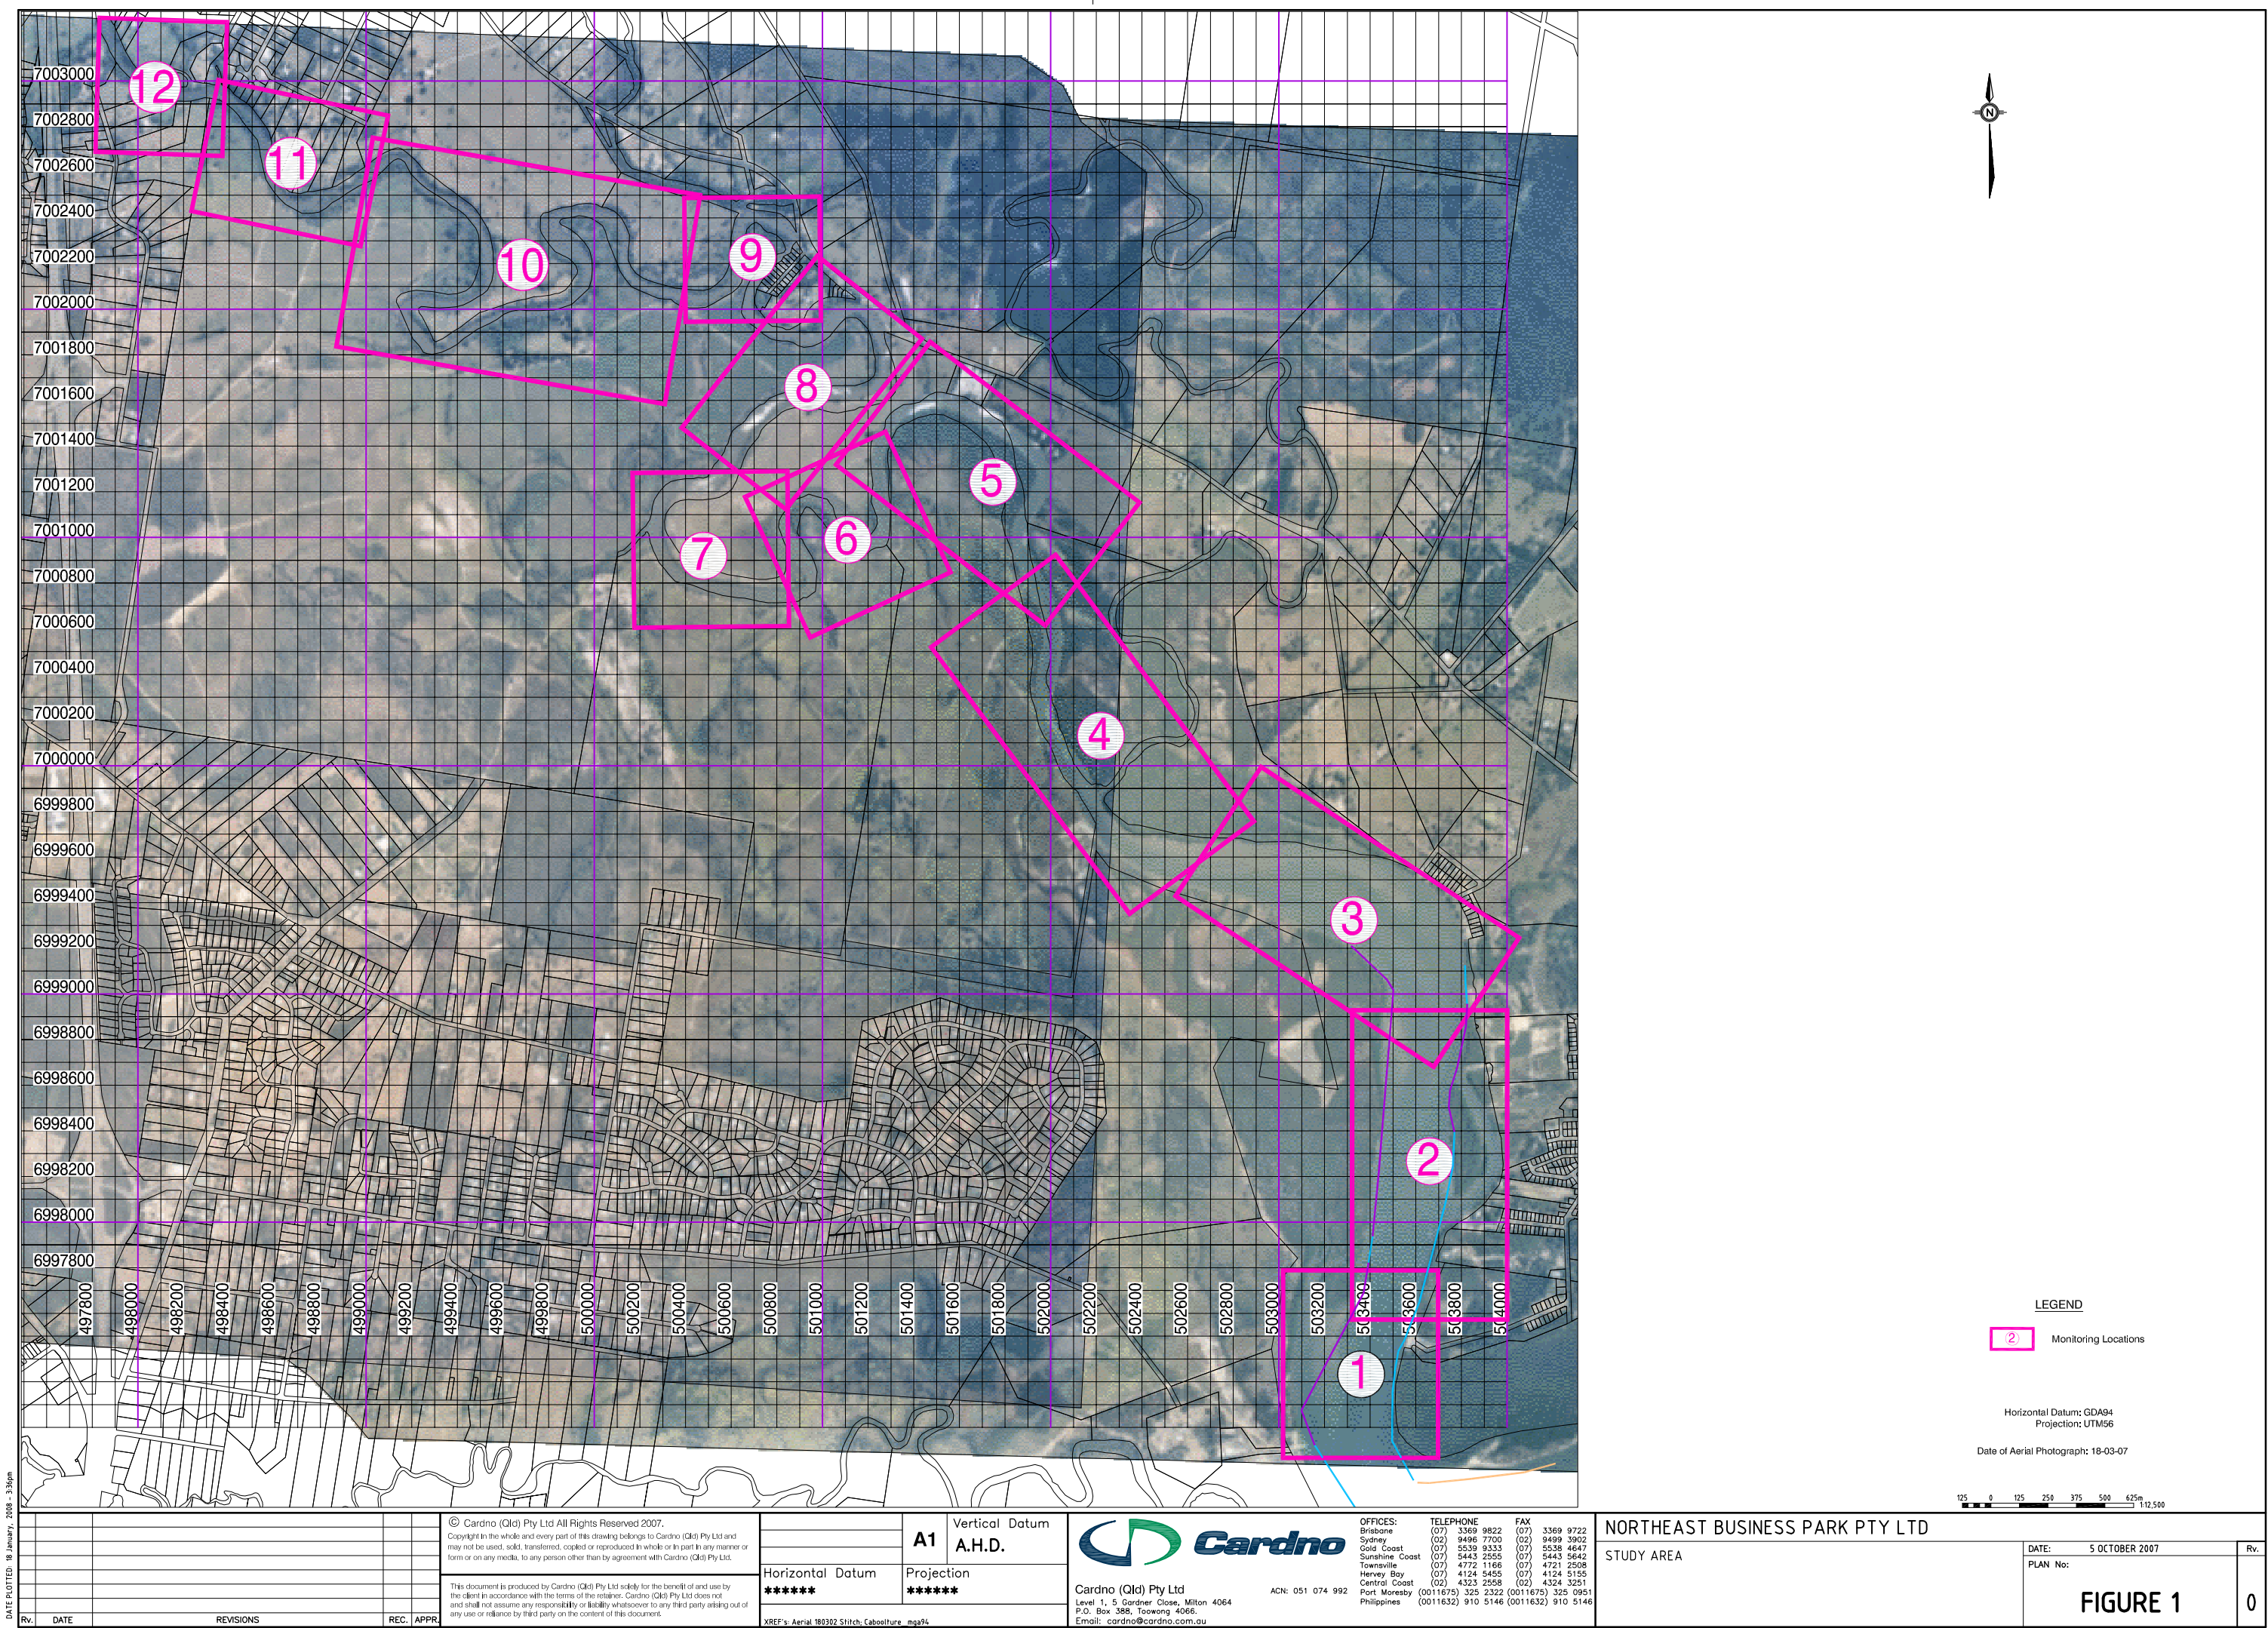
| PLAN No: | FIGURE 1 | 0 |

The Caboolture River was divided into reaches using aerial photography. Each reach is a section of the river within which river characteristics are similar. Characteristics considered include slope, channel geometry, fringing vegetation, adjacent land uses and tidal influences. Reach environs making up the study area are presented in Figure 1.

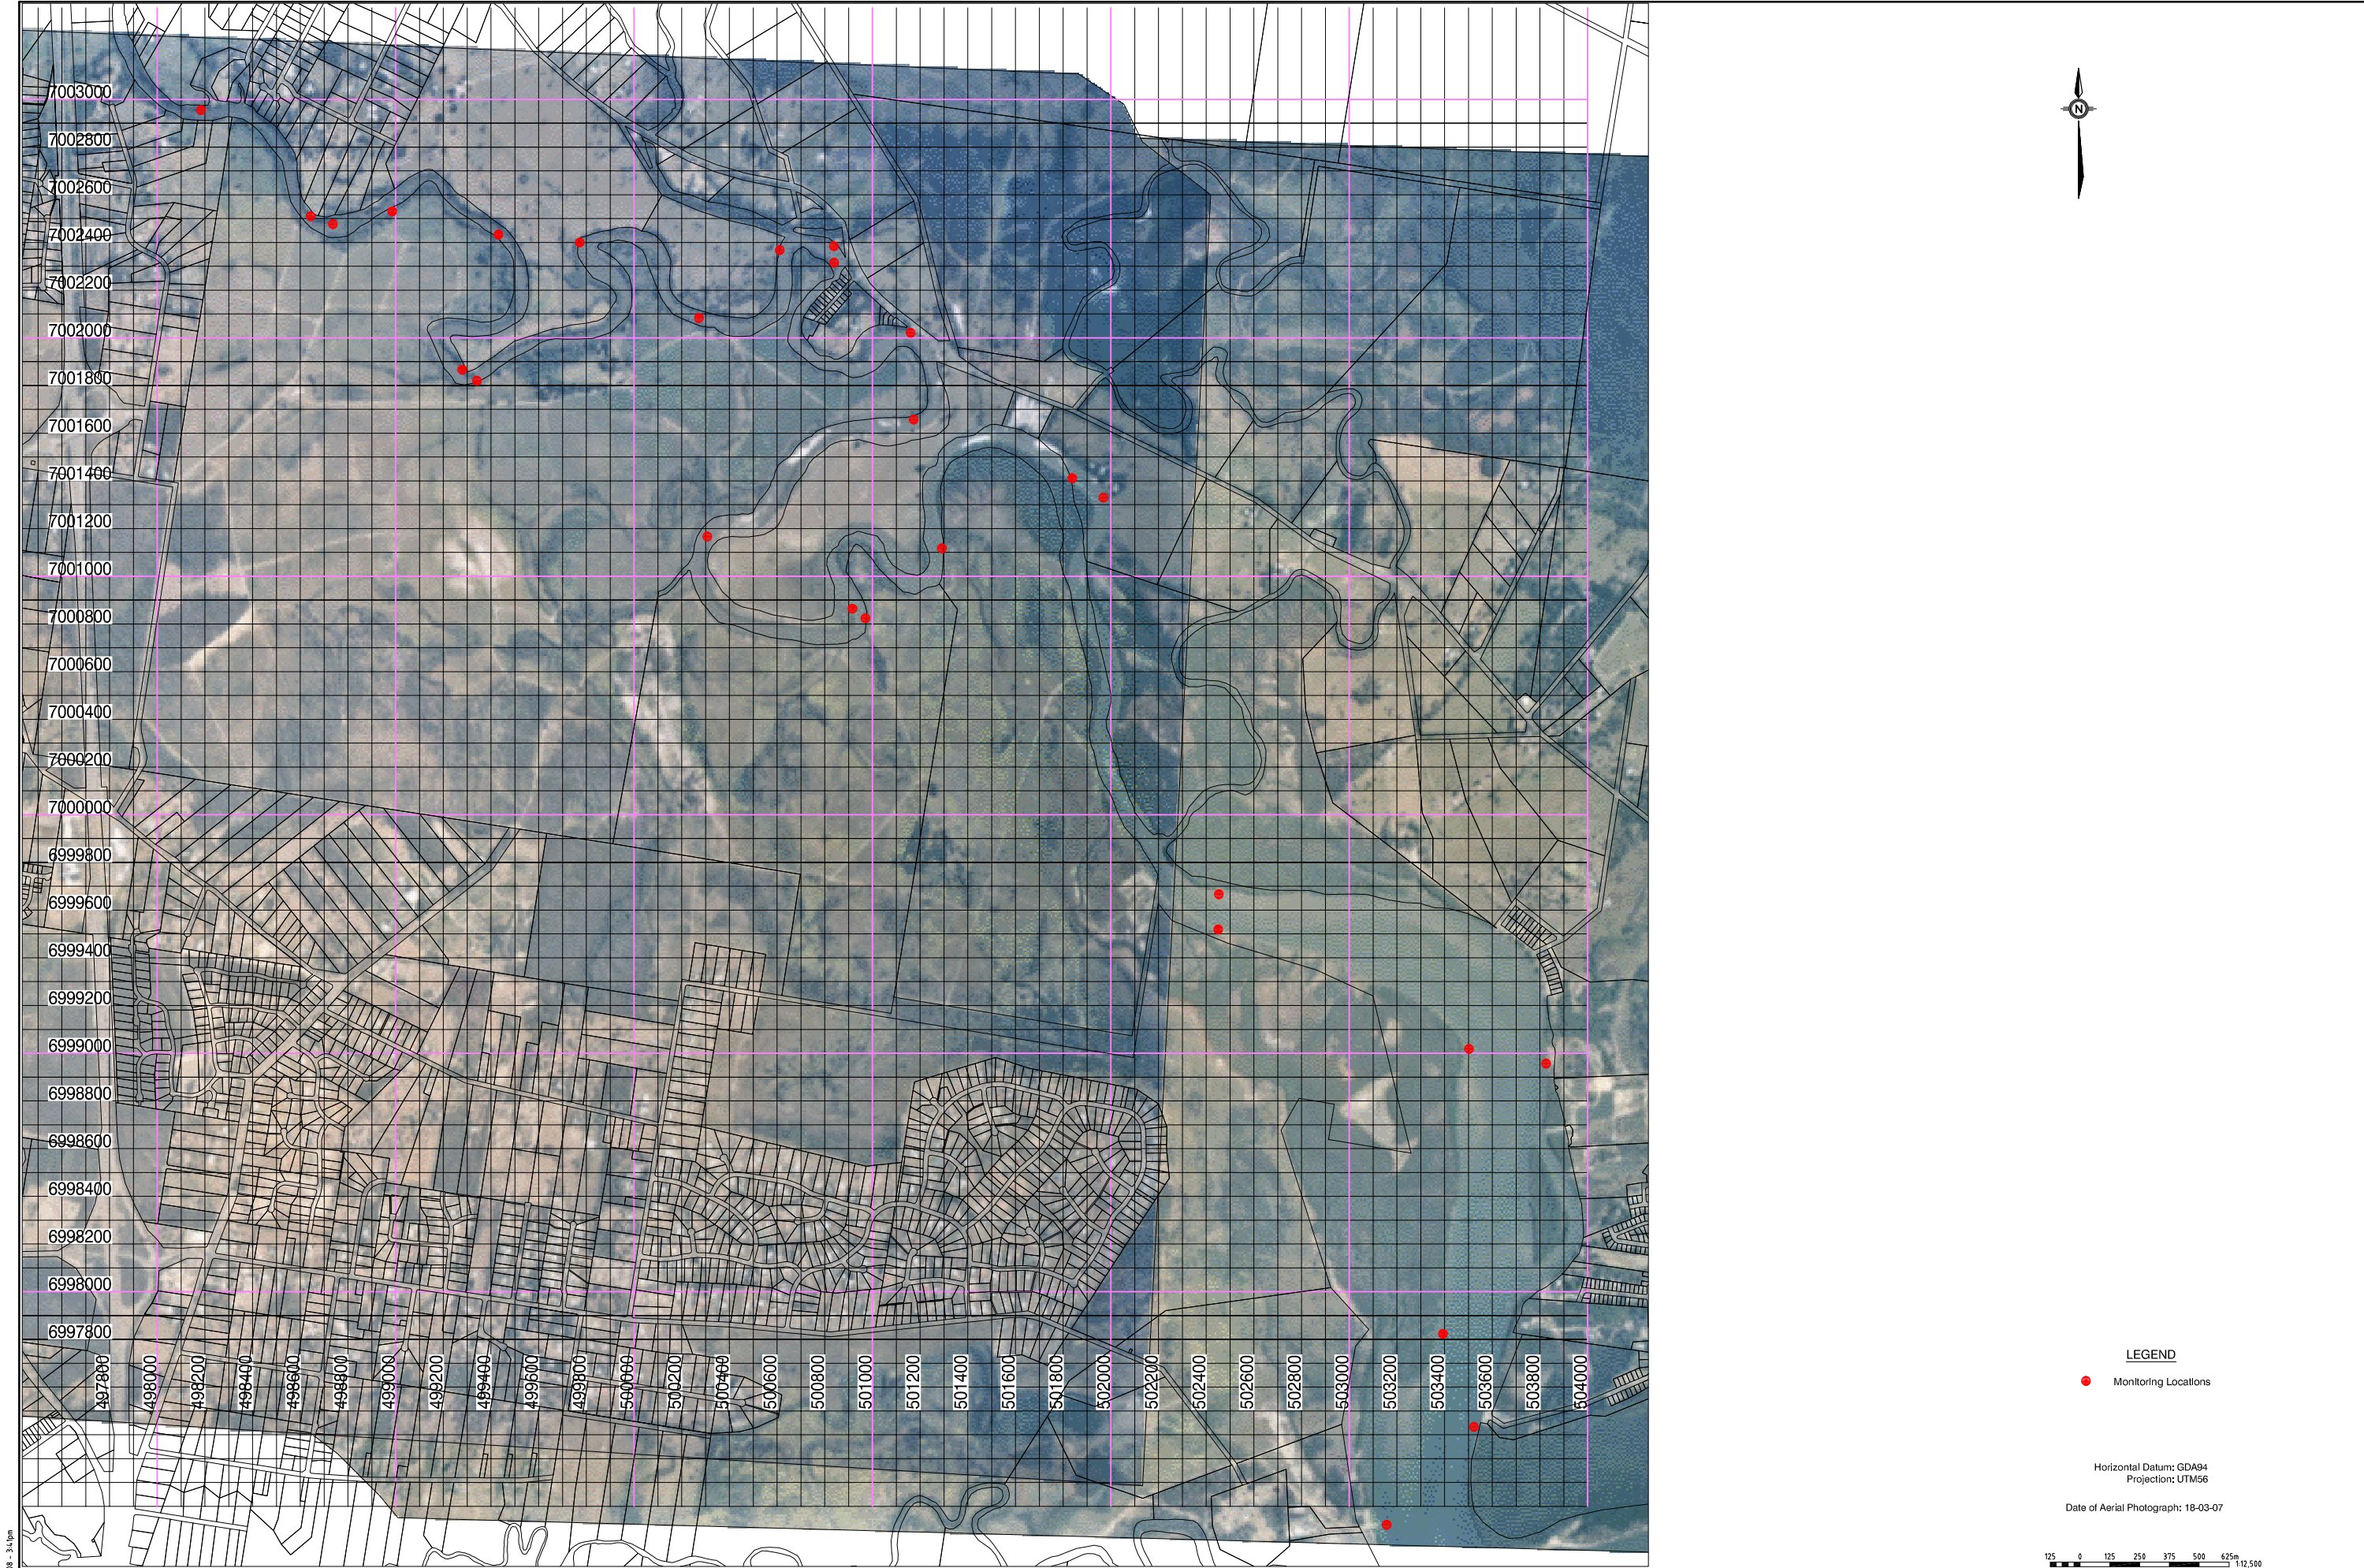
FIGURE 5

Potential permanent monitoring points have been identified in Figure 5 of this assessment.
