# Visual Impact Addendum to the Assessment Report

Wandoan Coal Project  
Southern coal seam methane  
water supply pipeline

**Integral**  
landscape architecture  
& visual planning

July 2009

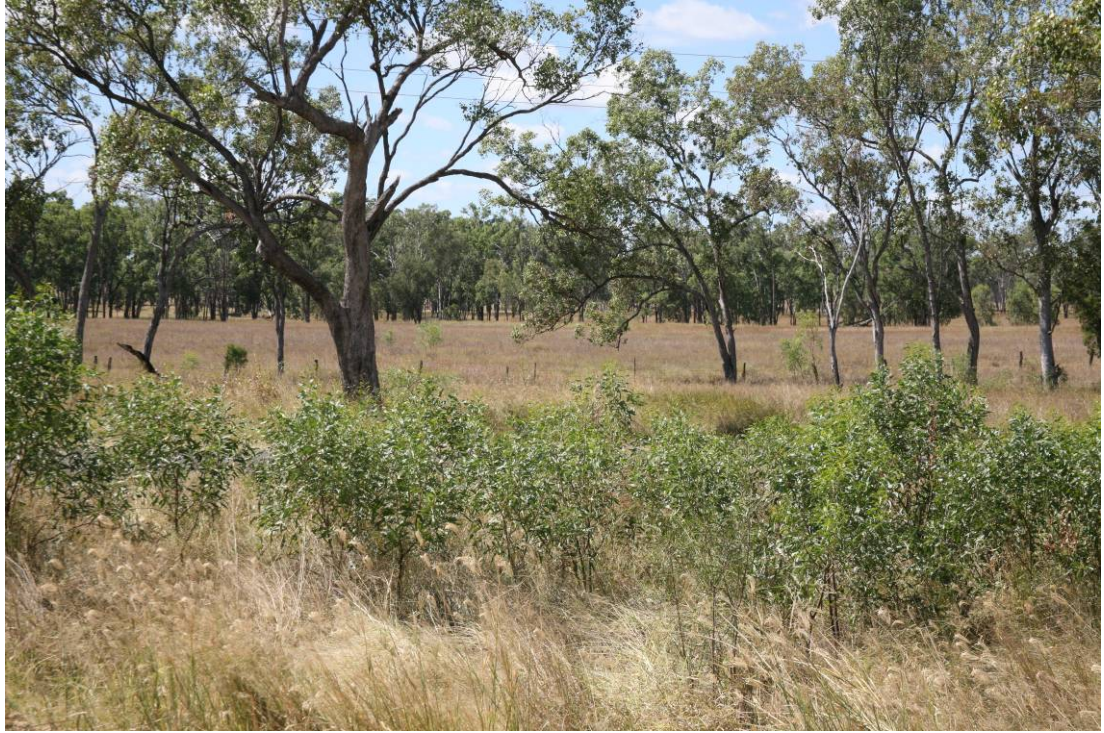
Topography in this VMU is gently undulating from approximate elevations of 300m to 320m. This section of the Leichhardt Highway differs from the southern sections of the highway in that it is predominantly, open grassland, cropping and live-stock grazing lands with scattered tree cover, see Figure 3-2.

**Figure 3-2:** *This VMU is dominated by grassland with scattered low tree cover.*

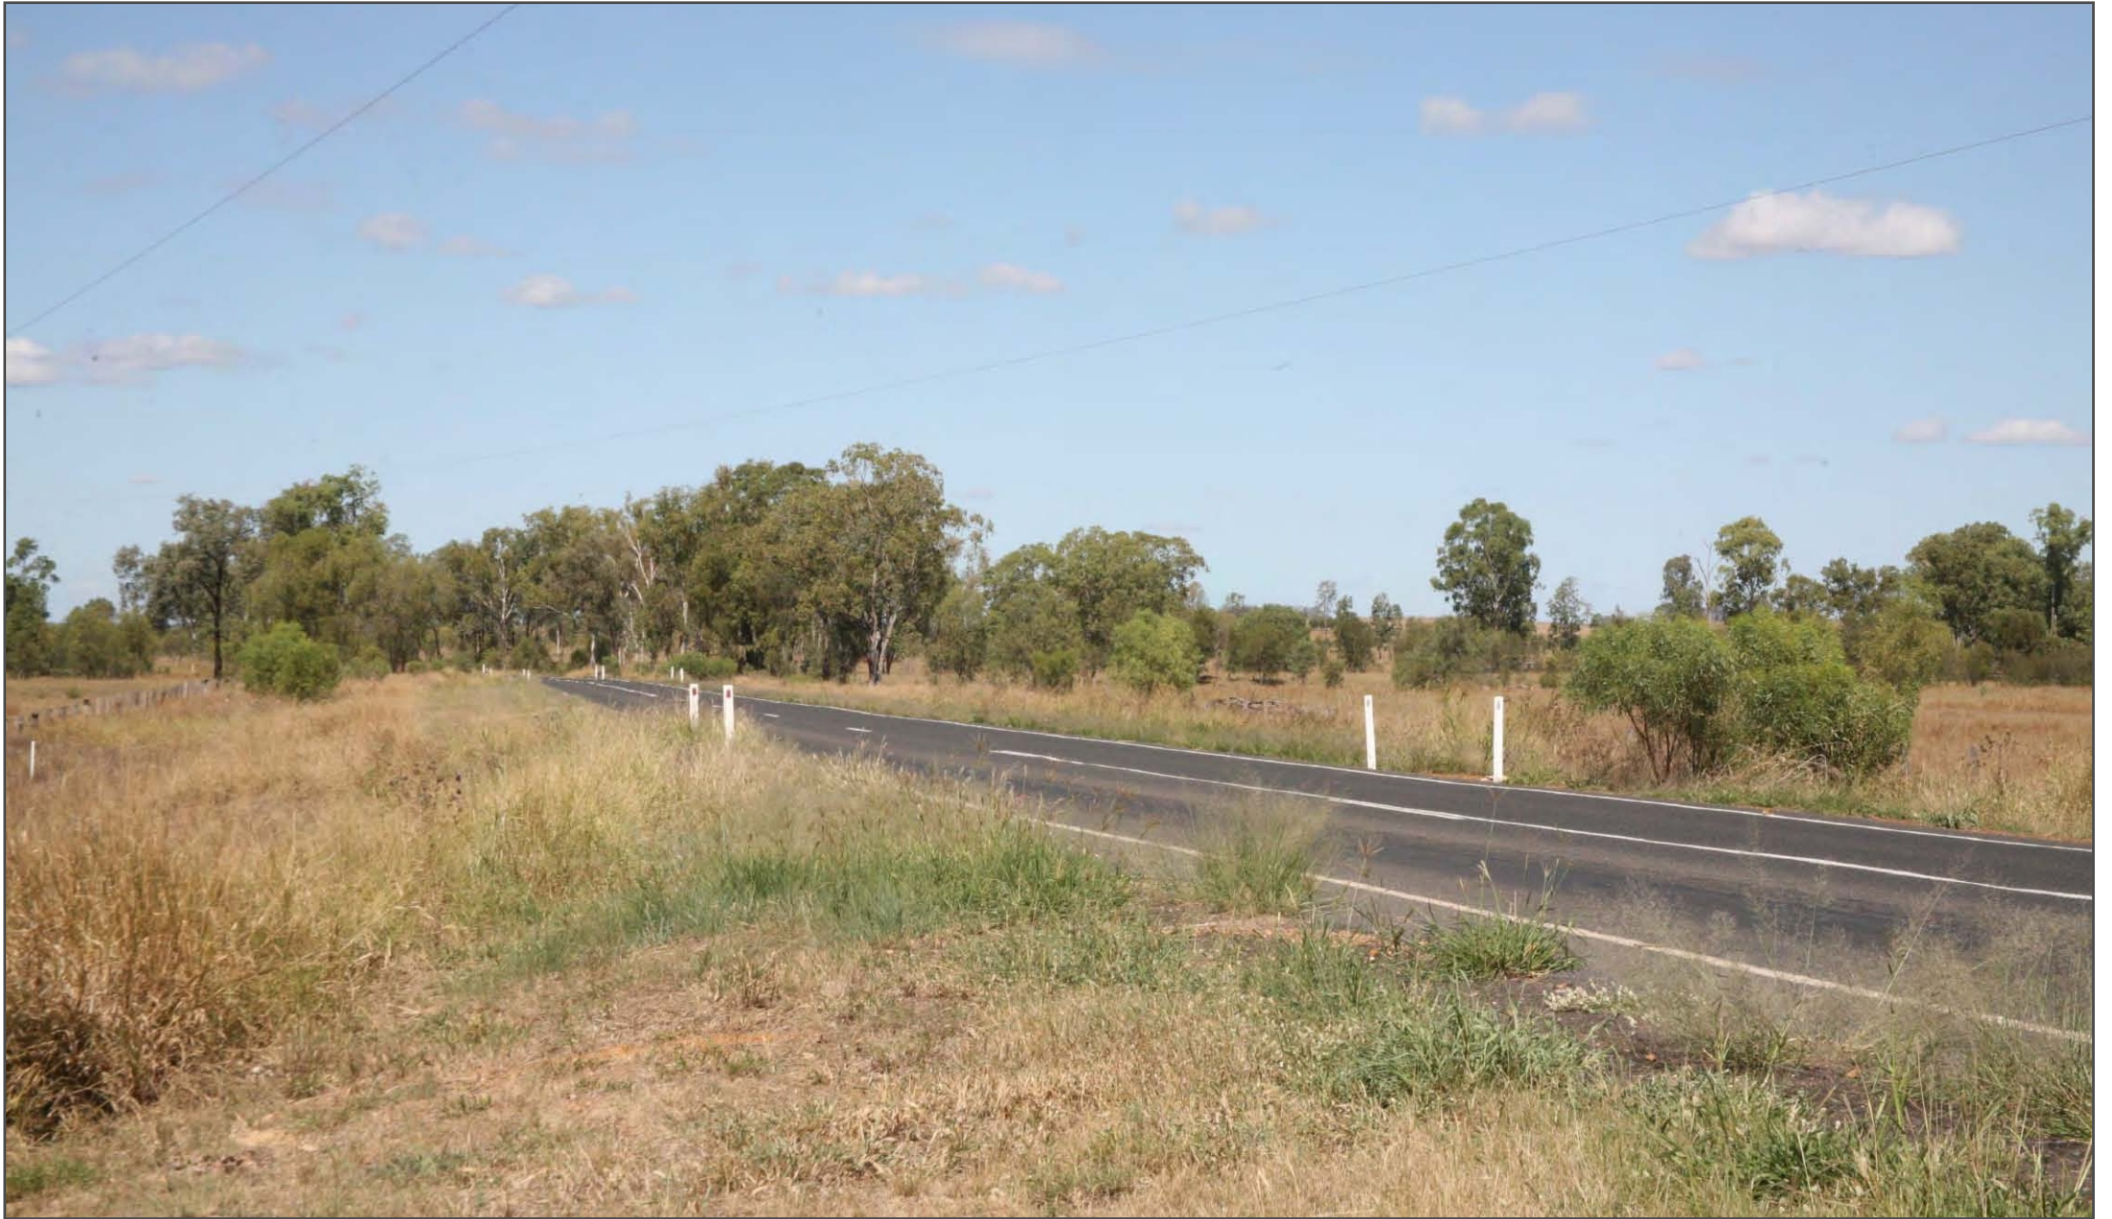
The photomontage illustrates the viewpoint from the eastern side of the Leichhardt Highway, immediately south of Guluguba, on the corner of Dorsets Road and the Leichhardt Highway. As shown in Figure 5-2a the viewpoint is generally looking south along the pipeline route, located within the western side of the road reserve of the highway.

The existing visual setting in this location of the highway is grassland with scattered tree cover, see Figure 5-2a. Construction of the pipeline will create a temporary change in the visual setting; see Figure 5-2b, due to the colour contrast of soil against existing grassland. The change is short lived in grass areas until grass cover is restored. In areas where tree cover is removed however, the visual effect will initially be higher. The visual effect will reduce relatively quickly as the new landscape borrows views from the existing background views and contrast levels are reduced.

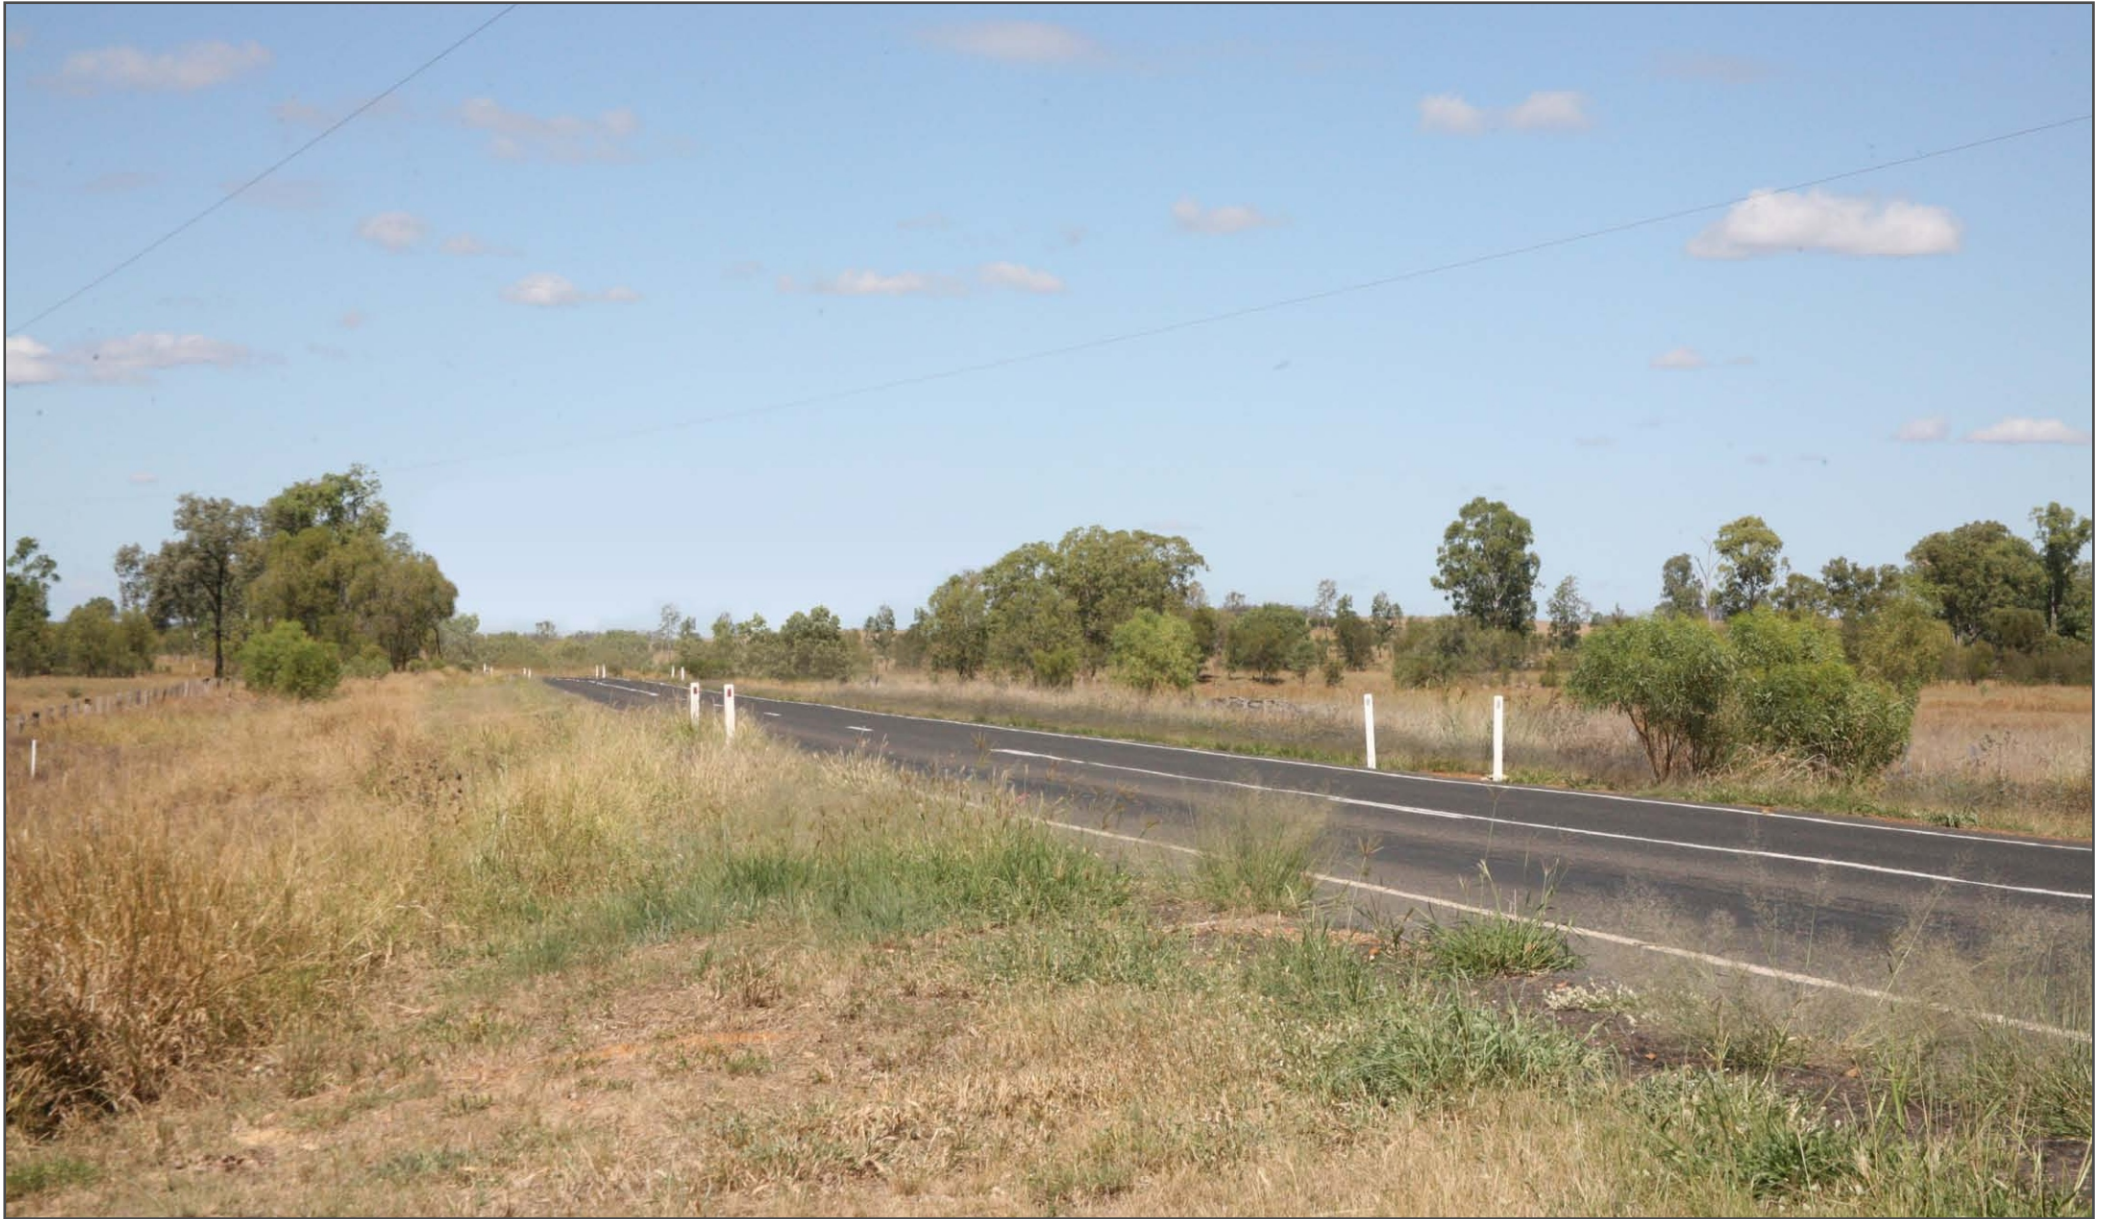
Figure 5-2b  
Photomontage from the viewpoint following construction and initial rehabilitation
